# Landslide Hazards in Vermont

U.S. GEOLOGICAL SURVEY BULLETIN 2043

Prepared in cooperation with the  
Vermont Geological Survey

A discussion of recent and historic landslides in Vermont,  
detailing hazards, processes, and slope movement in numerous  
soil and rock types

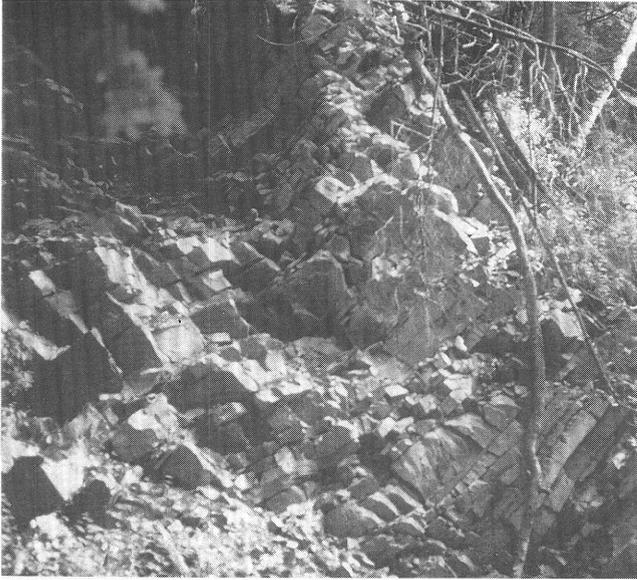
**Figure 1.** The intensity of jointing in the Cheshire Quartzite facilitates failure by allowing gravity as well as normal freeze-thaw action to open the joints more rapidly.

Failure of a jointed bedrock slope commonly occurs where two intersecting joint surfaces emerge on a slope face to form a V-shaped notch (fig. 1). Hydrostatic pressure along joint surfaces can reduce the effective stress and cause sliding in the rock mass bordered by these joints.

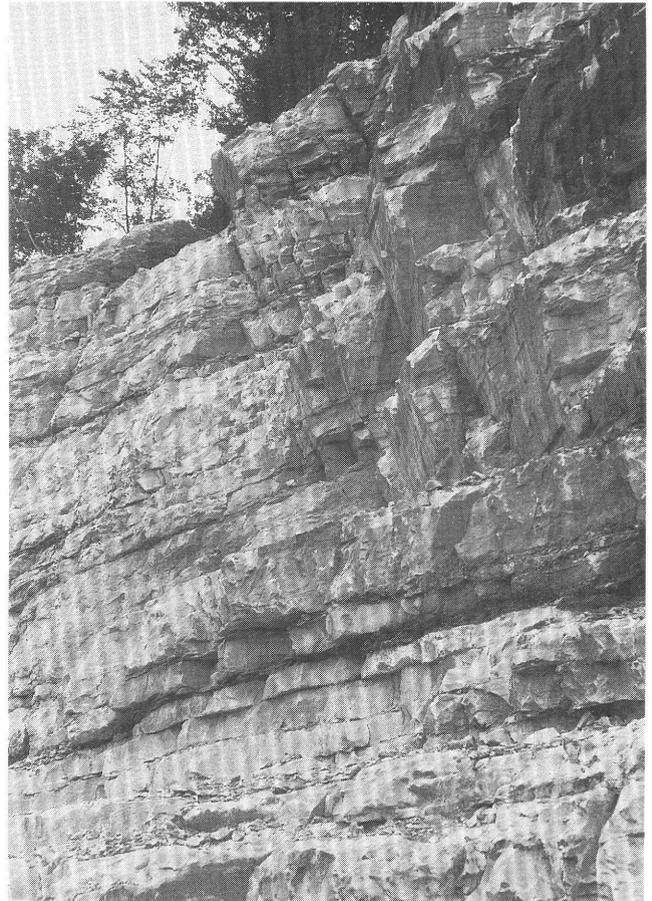
**Figure 2.** An example of a vertical joint set (upper right) with a second set intersecting at a large angle (subhorizontal). Toppling failure would occur in the direction of dip of the subhorizontal joint set. This site is on U.S. Route 7 near East Dorset.

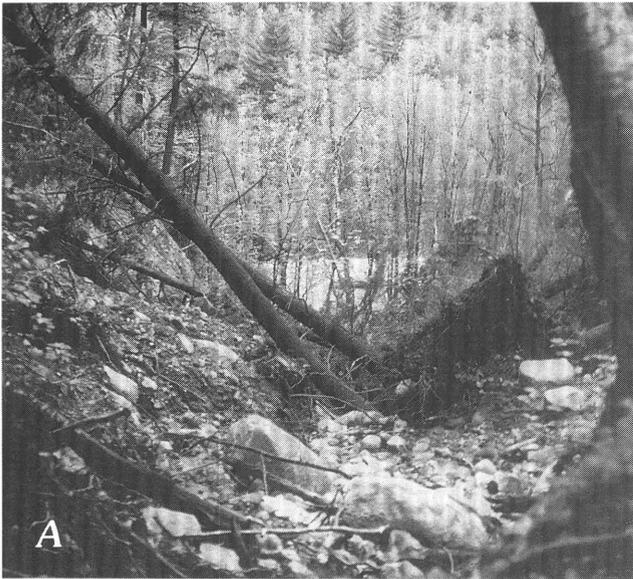
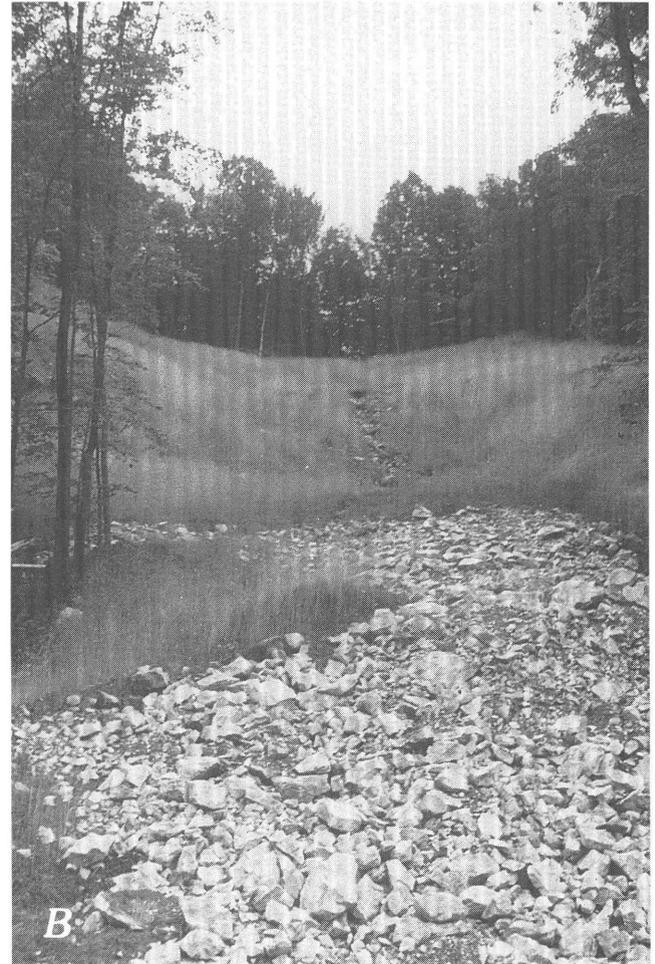
This short digest of landslides and floods in Vermont covers 150 years from the late 18th into the early 20th century. With the amounts of precipitation and flooding described, some slope failures also undoubtedly occurred. The slope movements probably did not affect the valley dwellers to the same extent as did the floods. The floods that devastated Connecticut Valley communities during the 1920's and 1930's led to construction of numerous flood control projects by the Army Corps of Engineers on many Connecticut River tributaries. While these structures have solved the major flooding conditions, potential for landsliding remains. For example, in 1976, and again in 1984, slides occurred on East Mountain in Mendon, (site 15, fig. 3) and blocked U.S. Route 4 (fig. 4).

**Figure 4.** *A*, The 1984 debris flow on East Mountain at Mendon, looking downslope; clear area in background is pavement of U.S. Route 4. This slide developed when a breach occurred across a logging road upslope. Water courses higher on the mountain were diverted to this breach by continued erosion. *B*, A view of the same slide area, looking upslope, from U.S. Route 4 a year later. The artificial drainage structures blend in well with the natural drainage.

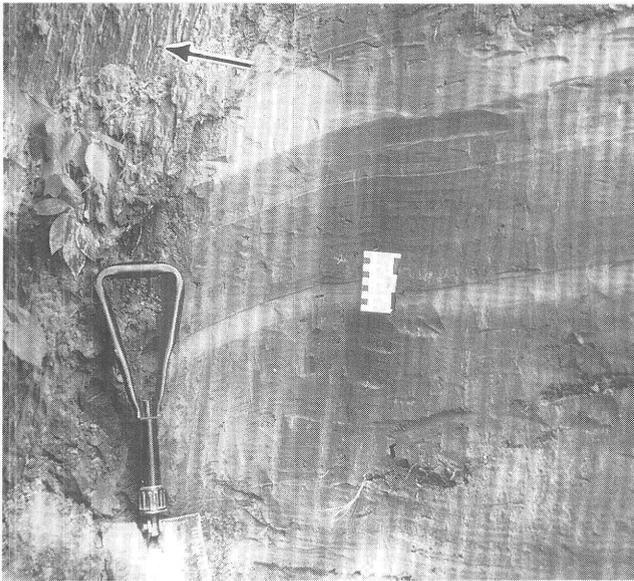
**Figure 5.** Rhythmite sequence at North Springfield flood-control reservoir. Slickensides (arrow) from where the material slid on the scarp can be seen in the extreme upper left.

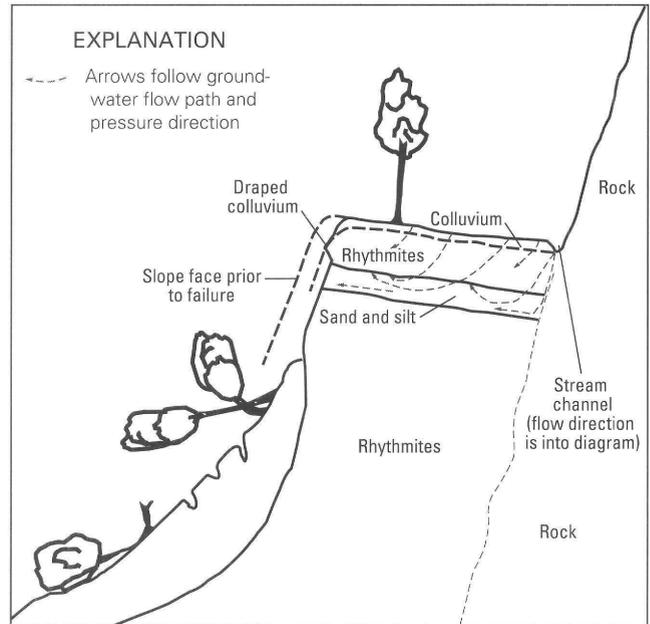
**Figure 6.** A typical rhythmite sequence. Streams often cut channels parallel to the rock wall. The water feeds into the more permeable layers, approximately following the base-flow vector arrows shown, and thus increases pore-water pressure. Slope failures are triggered because effective normal stress is reduced by the increased pore water.

pressure occur in two places: at the contact of the rhythmite with overlying crossbedded deltaic or colluvial deposits and in the silt and fine sand layers within the rhythmite.

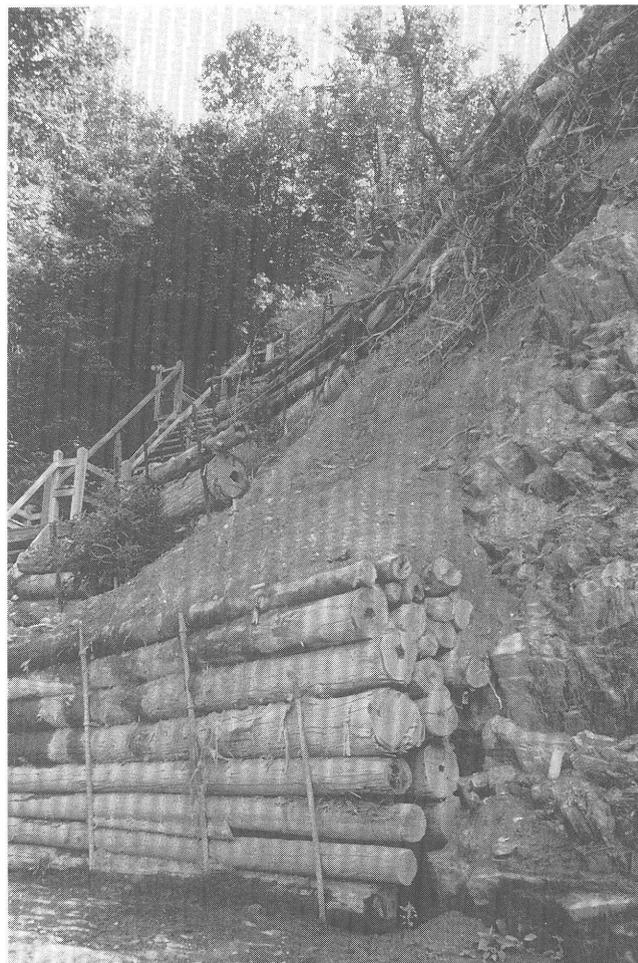
**Figure 7.** Shoreline slope failure on Lake Champlain near Vergennes. Both soil and bedrock failed. The timber cribbing has been placed in an attempt toward stemming further failures.

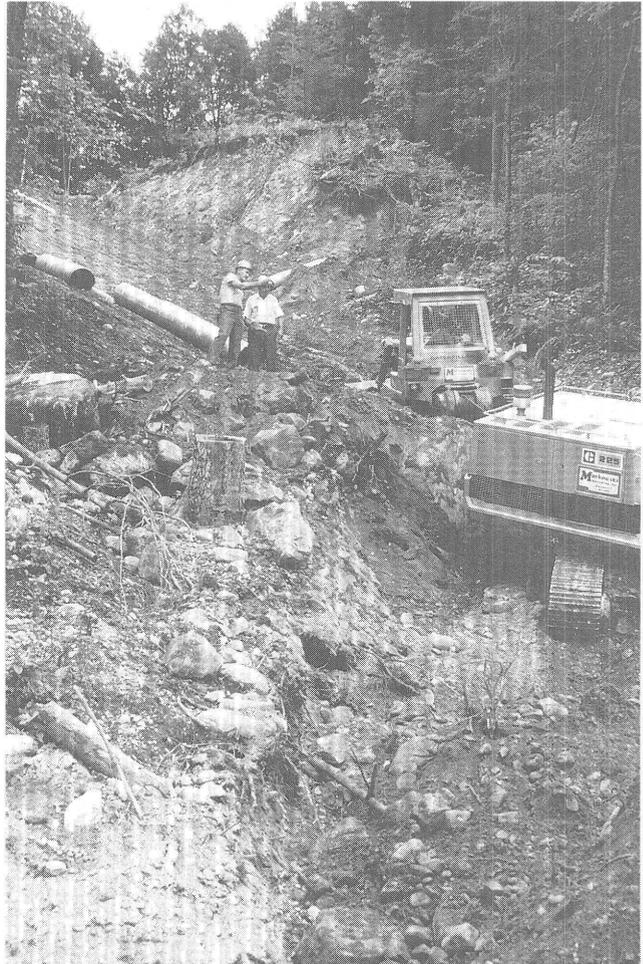
**Figure 8.** Slide being repaired on East Mountain, Mendon. The slide chute has carried debris onto U.S. Route 4 several times. Regrading and the placement of drains to move excess water flow have mitigated the danger associated with this slide.

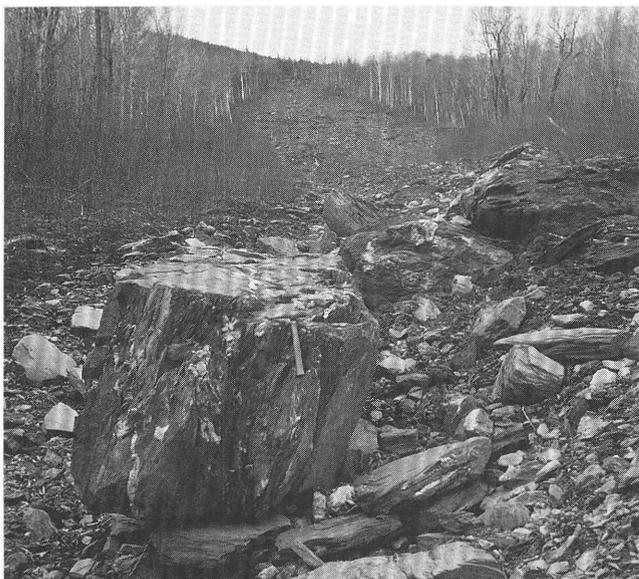
**Figure 9.** Debris avalanche scar from failure on August 10, 1976, on Dorset Mountain. This was one of at least four separate landslides that occurred on the south-facing slopes of this mountain (site 6, fig. 13). Several thousand cubic meters of soil, detached joint blocks of rock, and at least 40 ha of trees rushed downslope along runout paths up to 4.2 km in length. These slope failures were preceded by several days of rain that culminated in a heavy cloudburst (Ratté and Rhodes, 1981).

fig. 13) of 1976 illustrates high-velocity flows. This avalanche covered a distance of 3 km in less than 5 min traveling at an average rate of 10 m/s. Four almost simultaneous debris avalanches from Dorset Mountain destroyed 40 ha of trees (Ratté and Rhodes, 1981).

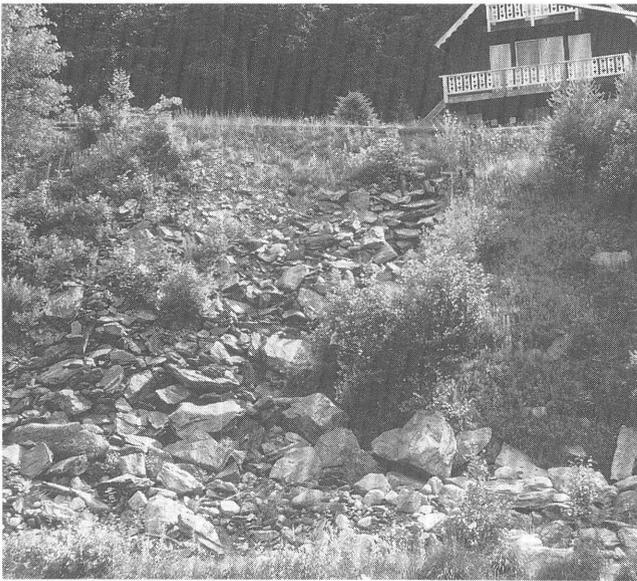
**Figure 11.** The Andover Brook has undercut its bank in front of this house. Riprap has been placed on the slope in the hope that future undercutting and loss of the house will be prevented.

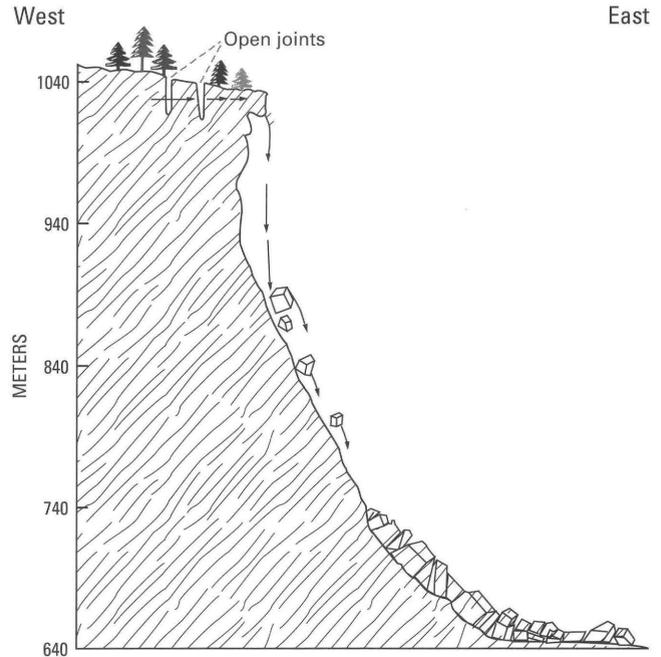
**Figure 14.** Generalized section through Smugglers Notch (site 1, fig. 13) showing rockfalls and debris accumulation at the base of the slope. The open joints observed at several locations at the top of many slopes indicate that significant horizontal displacement, probably caused by frost action, occurs at early stages in the rockfall process. The collision of a large block with a relatively thick vegetated soil mat downslope may trigger a debris avalanche.

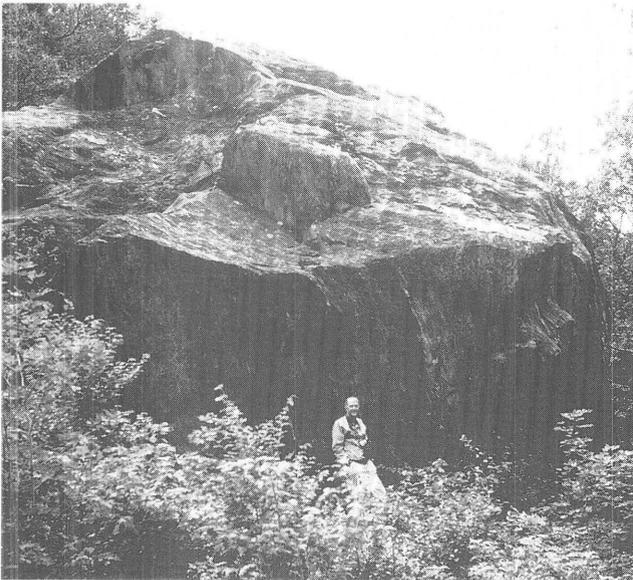
and tumbled intact to the valley floor. King Rock has an estimated weight of 6,000 tons (fig. 15). Some rockfalls that occur during periods of heavy rain may fall or tumble onto saturated soil and unconsolidated glacial deposits and trigger a debris avalanche. Curiously, the 1983 Smugglers Notch event occurred during a relatively dry period.

**Figure 15.** The 6,000-ton King Rock on Vermont Route 108 in Smugglers Notch. Note the person in front of the rock for scale.

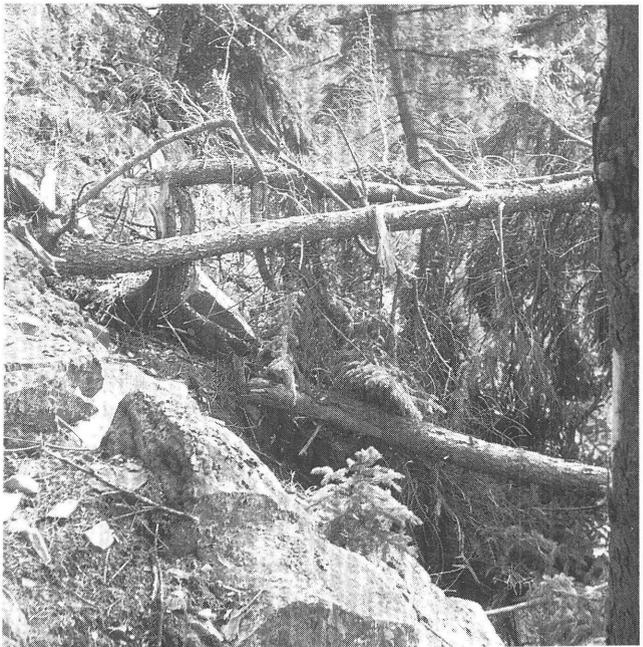
**Figure 17.** Damage to trees caused by blocks of Cheshire Quartzite tumbling down the dip slope. The block movements occurred in the early spring, the characteristic time for freeze-thaw-induced displacements.

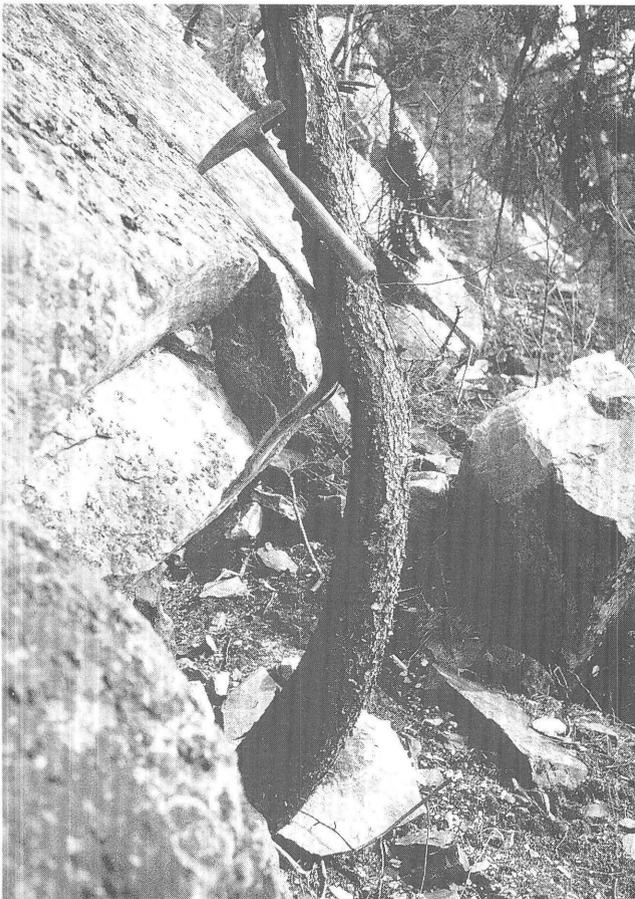
or bench, they may tumble and develop rotational momentum. An excellent example of block slides, which exhibited both translational and rotational movement, is at White Rocks Recreation Area, 29 km south of Rutland (site 4, fig. 13; fig. 16). The rock here is moderately massive Cambrian Cheshire Quartzite. The westerly facing mountainside at this location is parallel to the dip of the bedding. Initial block sliding was probably in response to freeze-thaw cycling. Under such conditions, large blocks that have become unstable more than likely slid down the dip slope of a joint, destroying trees (fig. 17).

**Figure 16.** Block slide at White Rocks, near Wallingford, south of Rutland (site 4, fig. 13). Bedding dips down to the right (west).

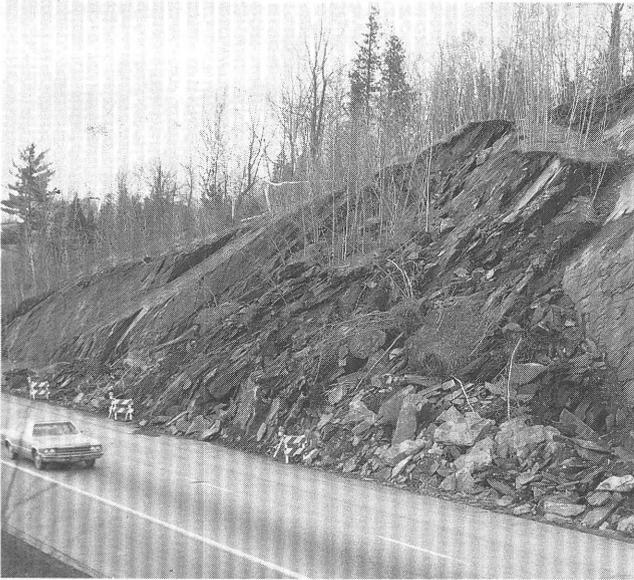
**Figure 21.** Rockslide of May 4, 1985, along the southbound roadway of Interstate 89 at South Barre (location 3, fig. 19). Foliation dips approximately 60° east (toward the highway). Such dip surfaces serve as failure surfaces.

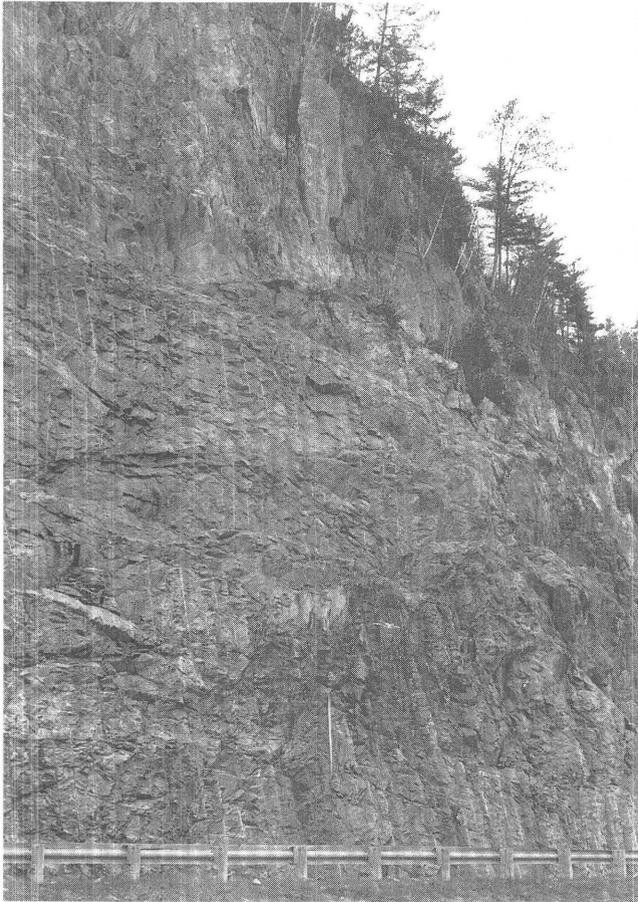
**Figure 22.** View of the Palisades rockcut at Fairlee (location 5, fig. 19). The southbound lane is hidden behind the guardrail in the foreground. Loose blocks originated near the crest of this rockcut at a height of several meters above the pre-split area (indicated by the closely spaced drill marks seen on the rock face).

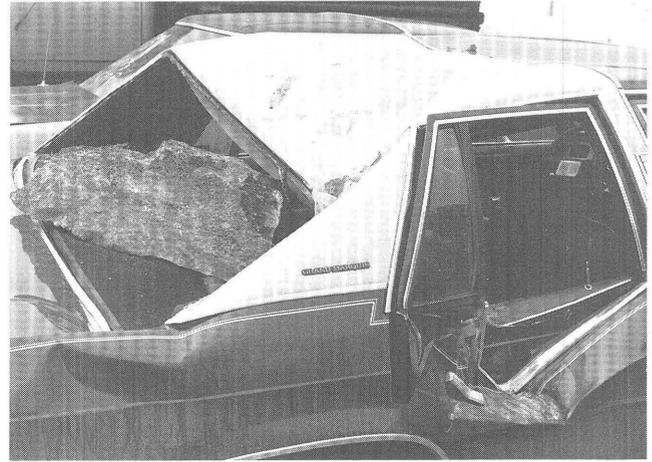
**Figure 23.** A vehicle damaged by the March 9, 1987, rockfall at Fairlee (location 5, fig. 19).

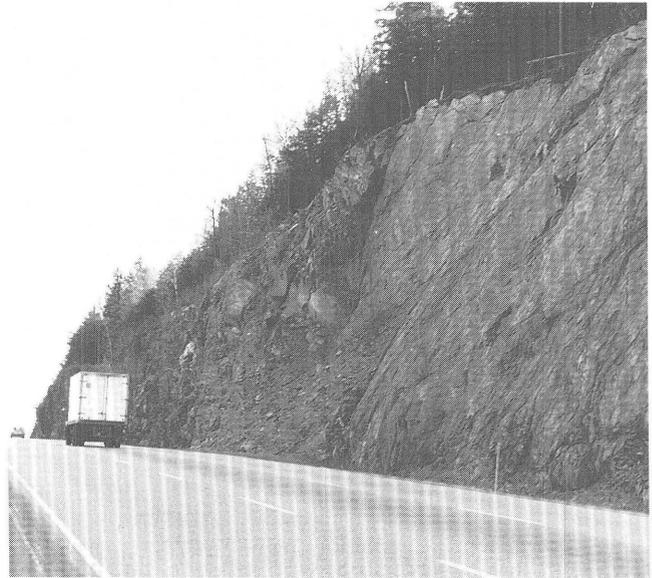
Another rockfall of about 3,500 m<sup>3</sup> occurred about 7:00 p.m. on October 10, 1968, along southbound I-91 between posted mile 34.70 and 34.90 in Rockingham (location 8, fig. 19). This failure took place along the steep east-dipping foliation in the phyllite-slate unit of the Littleton Formation (Doll and others, 1961) in a very deep,

**Figure 24.** Scar of the October 10, 1968, rockslide near Interchange 6 (Rockingham) on Interstate 91 (location 8, fig. 19). The view is looking south along a steep, east-dipping foliation surface upon which sliding took place. Note the hanging undercut slab at the south end of the cut.

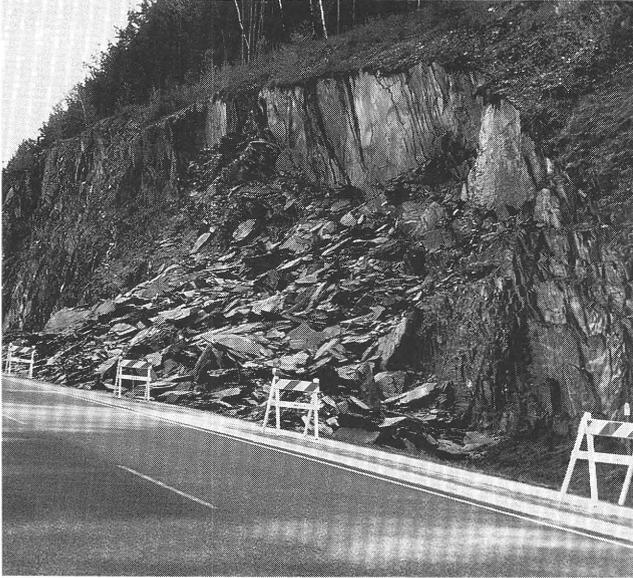
The last example of rockfalls from Interstate Highway rockcuts is a topple that occurred on southbound I-91 between Thetford and Fairlee on the morning of April 30, 1977 (location 7, fig. 19; fig. 25). The rock is the Meetinghouse Slate Member of the Lower Devonian Gile Mountain Formation (Doll and others, 1961). The foliation

**Figure 25.** Scar and resulting debris of the April 30, 1977, rockslide along the southbound cut face of Interstate 91 at Fairlee (location 5, fig. 19).
