Tectonic Creep in the Hayward Fault Zone California

GEOLOGICAL SURVEY CIRCULAR 525

**TECTONIC CREEP IN THE
HAYWARD FAULT ZONE
CALIFORNIA**

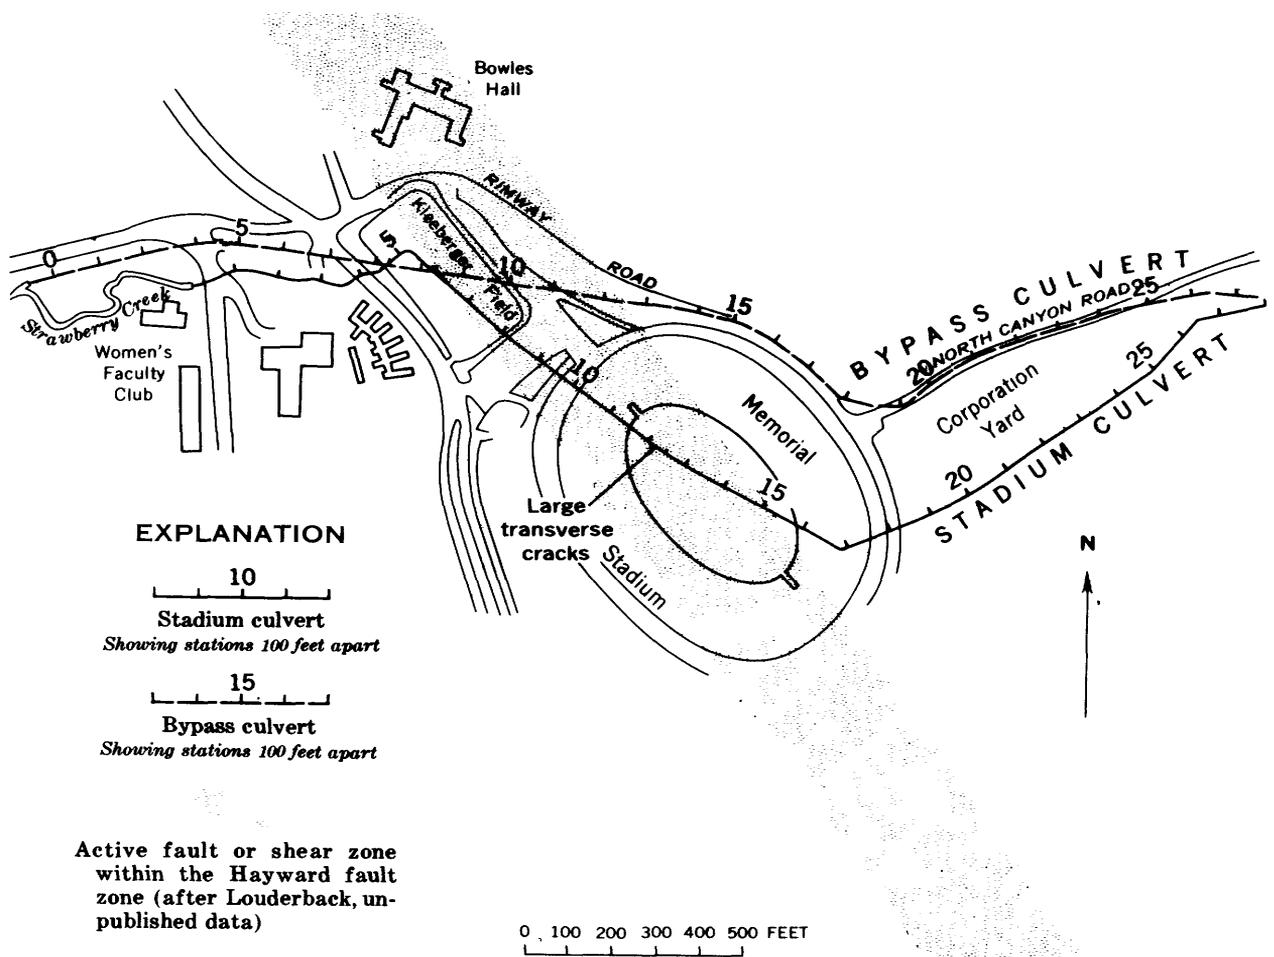
Figure 3.—Location of University of California Memorial Stadium, Berkeley, Calif.; fault or shear zone within the Hayward fault zone (stippled); two Strawberry Creek culverts, with station designations on culverts; and location of major cracking of stadium culvert.

Minor cracks in the culvert were noted when it was first inspected in 1932. Complete records of repair at that time are not available, but it is assumed that some repairs were made. In 1948 the culvert was again inspected and was found to be in very poor condition. In addition to leaky construction joints, holes in the floor (invert), and minor cracking, two large cracks were observed at stations 12+51.5 and 12+57 (fig. 3).

When the culvert was inspected in 1965, the damage consisted of some leaky, construction joints; erosion of the invert; hairline cracks on the northeast side of the culvert at approximately stations 8+45, 9+25, and 10+70 and between stations 14+27 and 15+80; and two major cracks at approximately stations 12+50 and 12+55. There is no doubt that the latter two cracks are the same as those previously recorded at stations 12+51.5 and 12+57.

The northwest (downstream) major crack, at about station 12+50, trends approximately at right angles to the culvert walls; in 1965 it had a maximum width of 1-1/4 inches in the floor and a maximum width of 3-1/2 inches on the northeast side of the ceiling, between the centerline and the junction with the wall. The southeastern (upstream) crack, which has a sinuous trend across the floor, showed a maximum gap of a quarter of an inch in the floor and a maximum width of 2-3/4 inches on the southwest side of the wall. No lateral or vertical displacement of the cracks was apparent; the slight left-lateral offset reported in 1948 could not be confirmed. Water was pouring from the ceiling at both cracks, and the sides of the cracks and the walls near the cracks were coated with iron-stained calcium-carbonate, undoubtedly deposited by water entering the culvert through the cracks.

The main area of cracking and repair—stations 10+50 to 13+00—is thought to lie within an active sheared band or fault which is part of the Hayward fault zone (G. D. Louderback, unpub. data). The general trend of the fault probably crosses the culvert at an angle of about 20°. Right-lateral movement along this fault has taken place, as evidenced by the offsetting of Strawberry Creek. Right-lateral movement along the active zone would exert tension on the culvert, and tension cracks would be expected in the

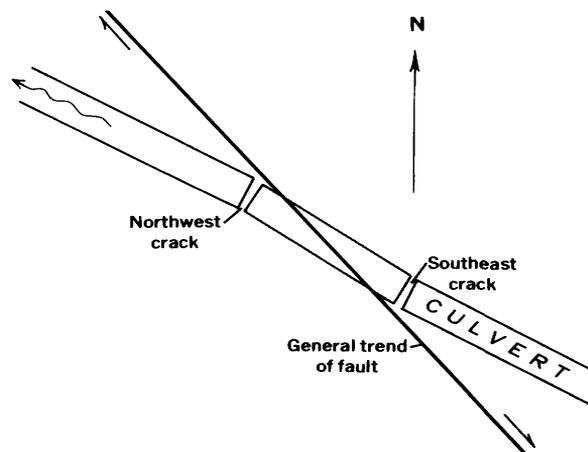
walls of the culvert. The formation and constant widening of the cracks that have been observed have probably resulted from such tensile stresses, and do not provide a direct measure of total movement on the fault since the culvert was installed.

No measurable lateral or vertical displacement of the cracks was observed, but the culvert appears to be slightly deflected laterally in the area of the two major cracks (fig. 4). Detailed measurements have not yet been made.

Figure 4.—General relationship of fault to damaged culvert under the University of California Memorial Stadium, relative direction of movement of opposite sides of fault, and nature of damage to culvert (not to scale).

Preliminary observations indicate that the stadium culvert has been slightly offset in a right-lateral direction. This apparent right-lateral deflection is consistent with direction of creep noted elsewhere on the fault.

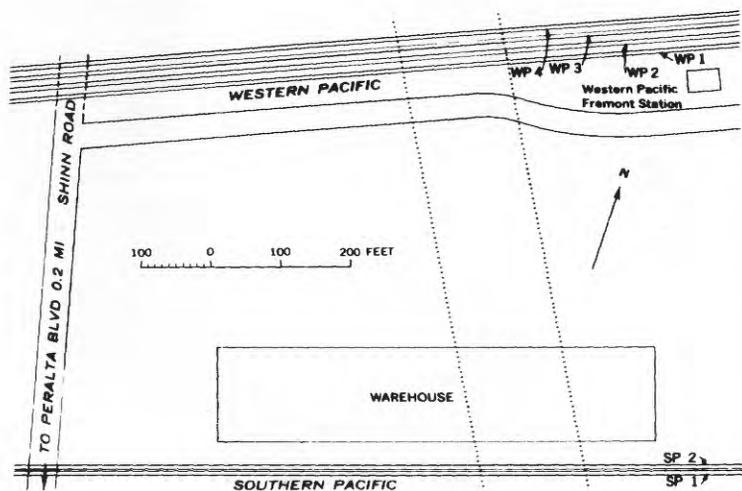
Six sets of railroad tracks in the Niles district of Fremont have been bent and shifted laterally by creep along the Hayward fault. The location of the tracks is shown on figure 2 (loc. C) and on figure 5.

◀ Figure 5.—Zone of principal deformation (within dotted lines) of Western Pacific and Southern Pacific railroad track in Fremont.

deformation is in a narrower zone (stippled on fig. 5). The deformation is moderately sharp on the sidings and yard tracks (figs. 6 and 7) but is smooth and difficult to see on the main-line tracks, owing to more frequent maintenance and heavier and faster traffic that tends to remove irregularities. The sharpest bends show a lateral shift of about 4 inches in 70 feet (fig. 6) and 6 inches in 60 feet (fig. 7). No vertical movement has been detected.

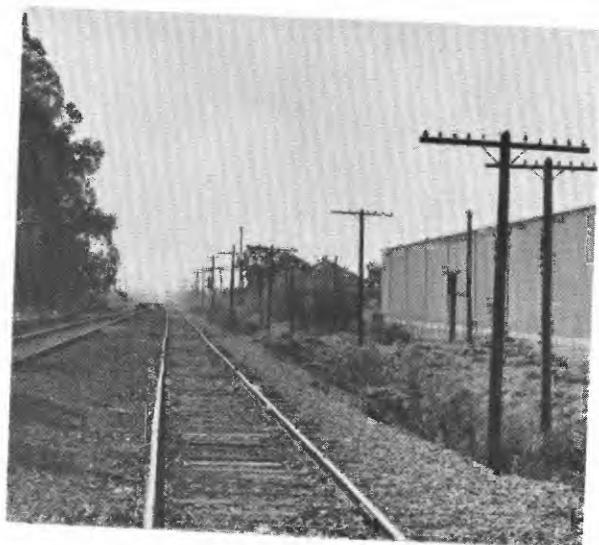
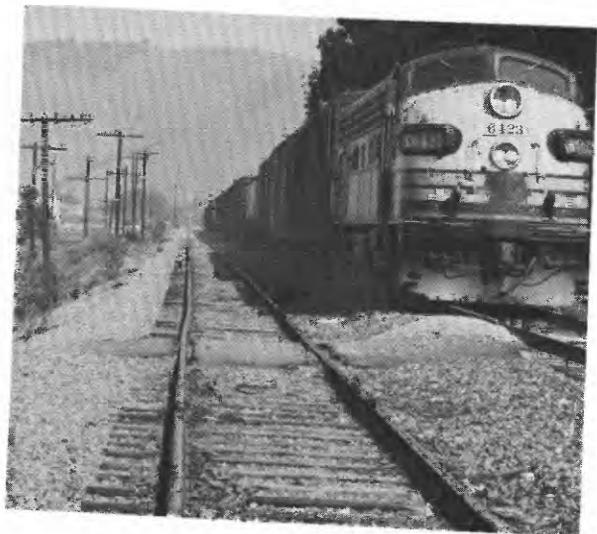
Figure 6.—Deformation of Southern Pacific siding by creep on the Hayward fault. A, View westward; note new warehouse on right side. B, View eastward.

The rate of movement is evidently variable. The main-line Southern Pacific and Western Pacific tracks, first laid about 55 years ago, both show a total shift of about 8 inches, or an average rate of shift of more than 0.14 inches per year. The rate must vary greatly, however, as lateral shifts of as much as 1-1/2 inches within a period of 2 or 3 days were reported by D. J. Laughlin (Western Pacific Railroad, oral commun., 1965), who said that the rapid movements apparently do not coincide with local earthquakes.

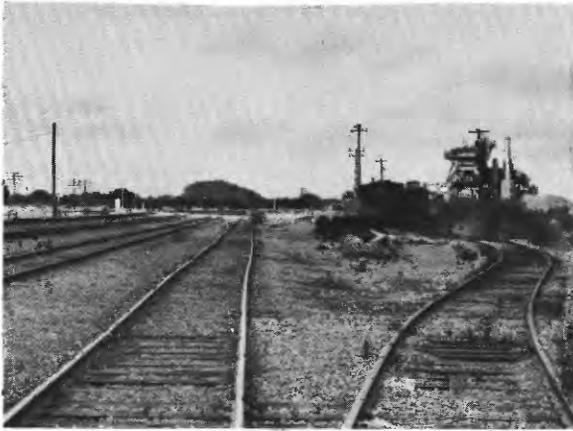
Figure 7.—View westward along Western Pacific tracks showing deformation of rails (center of photo.) by creep on the Hayward fault. Curve in tracks on right side is not the result of creep.

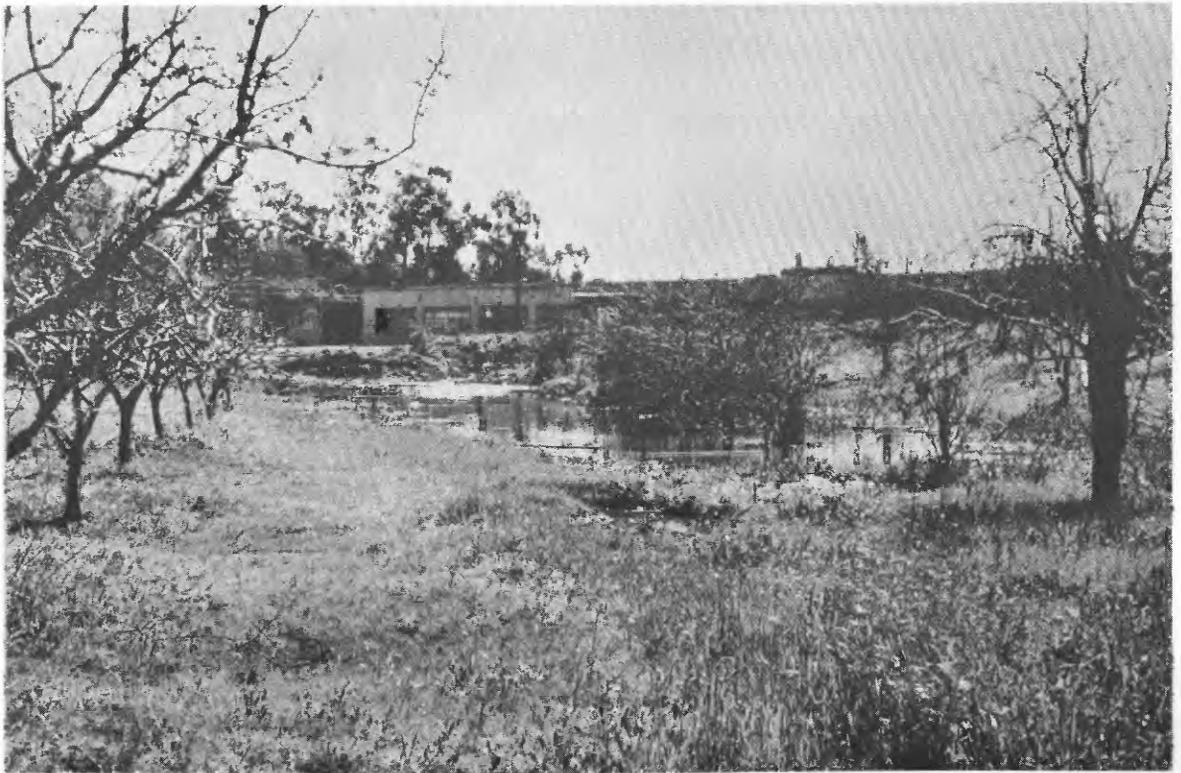
Figure 9.—View looking southeast along strike of Hayward fault, showing sag pond along the trace of the fault and a building extending into the fault zone.

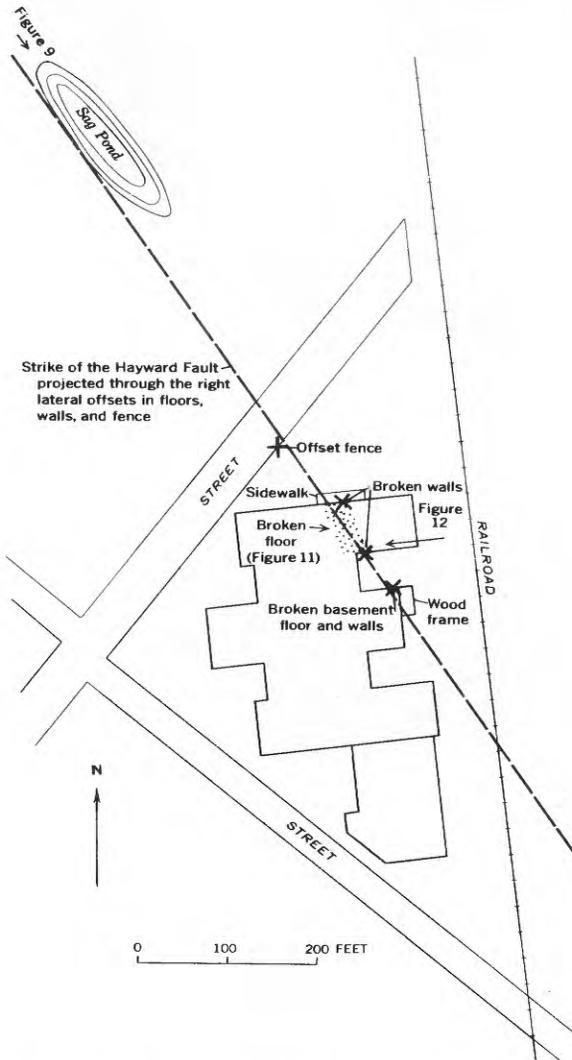
The main building (fig. 10) was erected in 1921, according to local residents. The building has nonreinforced concrete walls, a wood roof, and a concrete floor slab most of which is on grade. Most of the main building is on the southwest side of the Hayward fault zone which trends northwest through the northeast part of the main building (fig. 10).

All the offsets and damage, when plotted on a map (fig. 10), align parallel to the northwest strike of the Hayward fault and are within the fault zone. This damage appears to be limited to a band less than 10 feet wide and may indicate movement on a single fault plane within the Hayward fault zone; however, the width of the disturbed band may be wider. The rate of creep appears to be 6 inches in 44 years. A more complete answer will not be known until detailed studies are made.

Figure 10.—General configurations of damaged building and nearby offset fence.

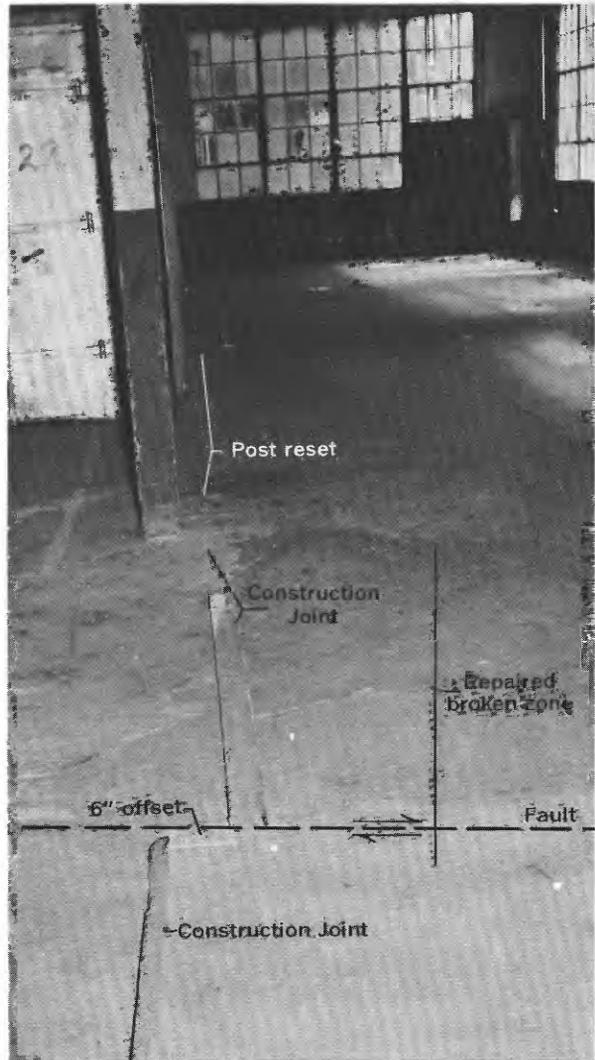
by 200 feet, has been cracked and offset along a crack so that the northeast part of the slab appears to have moved 6 inches to the southeast with respect to the southwest part (fig. 11). The exterior walls, which are 10 inches thick, have been bent, broken, and offset (fig. 12); the interior and exterior columns are as much as 6 inches out of plumb (fig. 11); and the roof has bowed right laterally.

Figure 11.—View looking northeast and almost perpendicular to strike of fault inside building straddling fault. Construction joint in floor slab has been displaced approximately 6 inches right laterally.

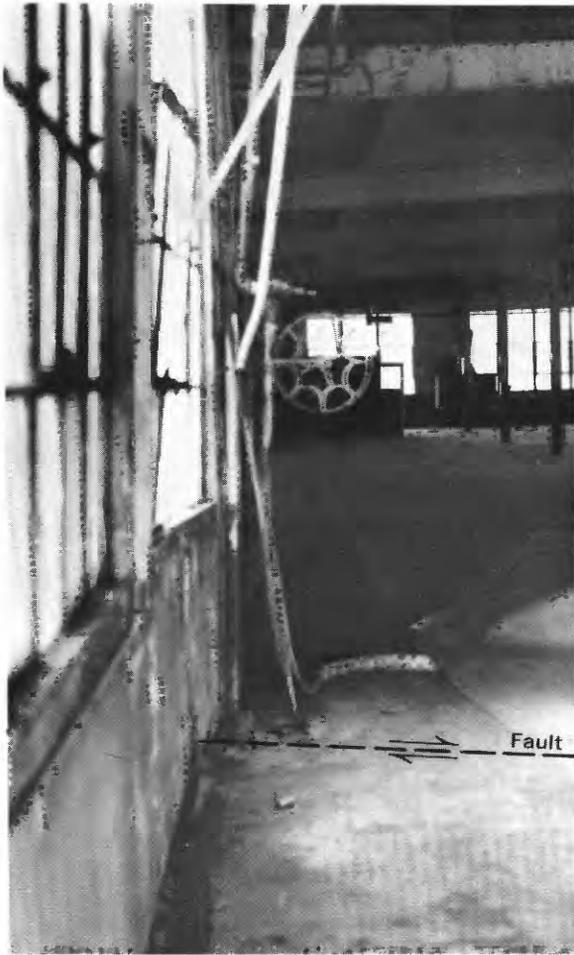
Figure 12.—View looking west and nearly perpendicular to fault along inside south wall of building.
