Coastal Change During Hurricane Isabel 2003

On September 18, 2003, Hurricane Isabel made landfall on the northern Outer Banks of North Carolina. At the U.S. Army Corps of Engineer's Field Research Facility in Duck, 125 km north of where the eyewall cut across Hatteras Island, the Category 2 storm generated record conditions for the 27 years of monitoring. The storm produced an 8.1 m high wave measured at a waverider buoy in 20 m of water and a 1.5 m storm surge.

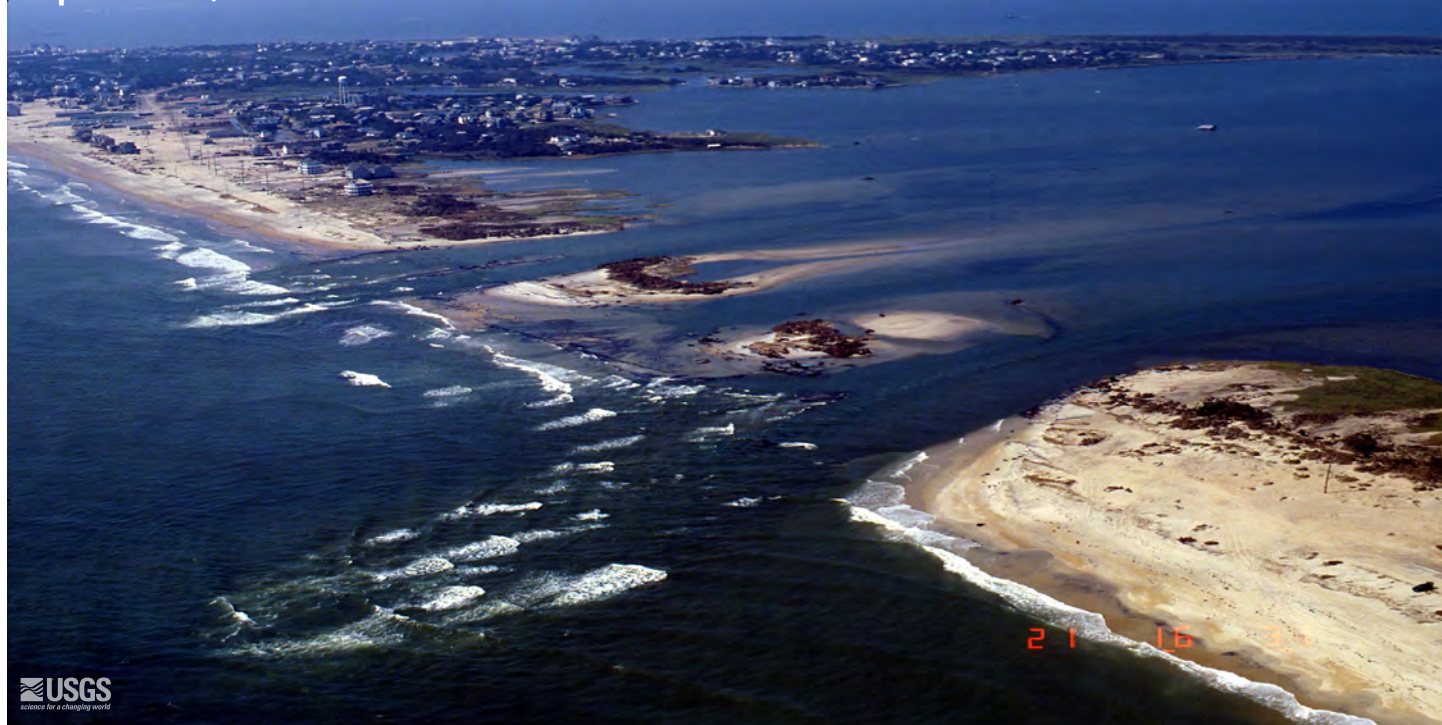
associated with the opening of a new breach about 500 m wide that divided into three separate channels that completely severed the island southwest of Cape Hatteras. The main breach, and a smaller one several kilometers to the south (not shown), occurred at minima in both island elevation and island width.

Figure 2. Hurricane Isabel opened a breach in the island southwest of Cape Hatteras. Combined waves and storm surge attacked the island where the dunes were lowest and the island was narrowest.

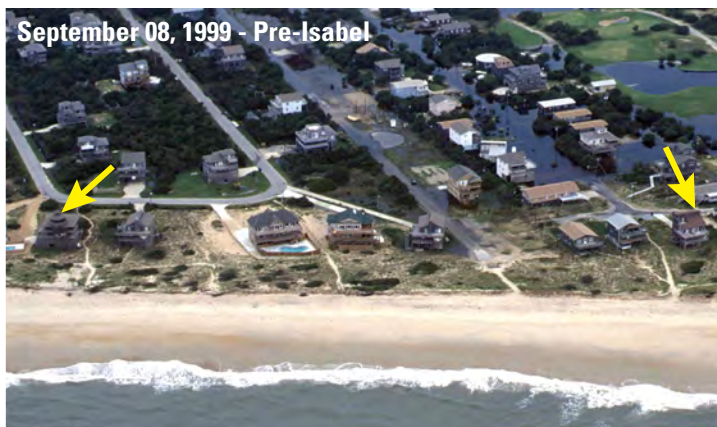
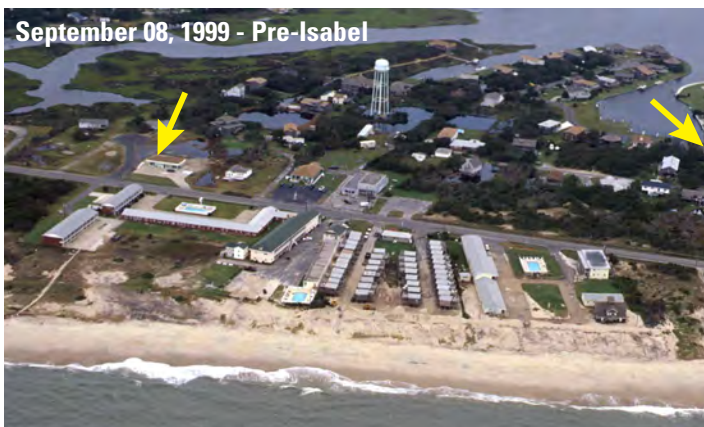
Figure 3. Frisco, North Carolina. USGS aerial photography taken before and after the landfall of Hurricane Isabel. Storm surge and waves overwashed the dunes located seaward of the first row of houses and deposited that sand across the island. (Arrows in all images point to the same features.)

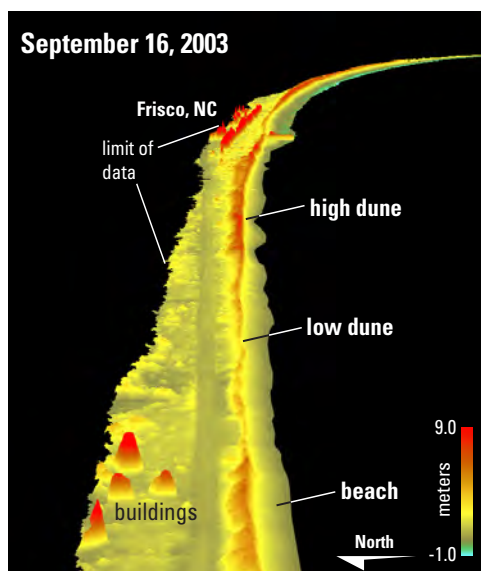
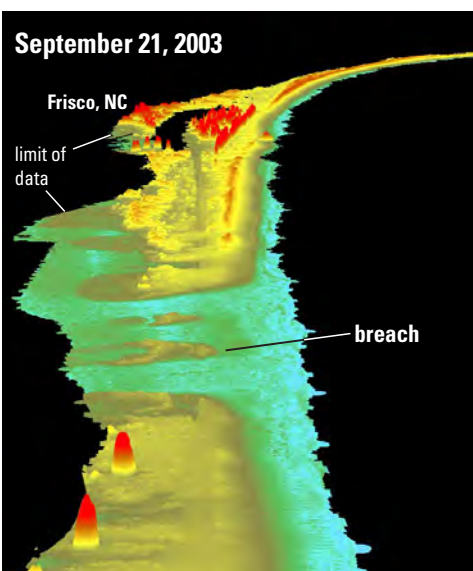
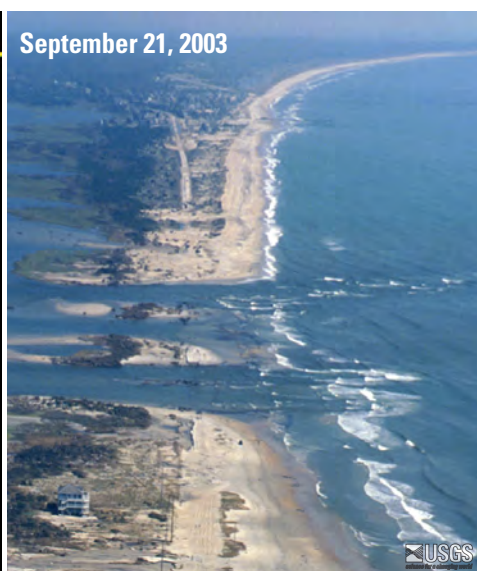
Figure 5. Hatteras Island, North Carolina. Analyses of NASA Experimental Advanced Airborne Research Lidar (EAARL) data from the island show extensive beach changes and dune erosion, as well as the destruction of infrastructure and buildings. Upper right and center: Lidar images show high-resolution topography of a portion of the coast measured with NASA's EAARL before and after Hurricane Isabel. The different colors indicate different elevations, where in the warmer colors represent higher elevations (see scale). Right: An oblique photograph taken by USGS on the same day as the post-storm lidar survey.
