## Coastal Change During Hurricane Ivan 2004

Category 3 Hurricane Ivan came ashore near Gulf Shores, Alabama, on September 16, 2004. The barrier islands of the northern Gulf of Mexico near the Florida/Alabama border were exposed to the strongest winds. The communities of Gulf Shores, Pine Island, and Orange Beach, Alabama, are, in places, very low lying with their dunes rising up only several meters. These dunes were unable to contain the 3- to 4-m storm surge.

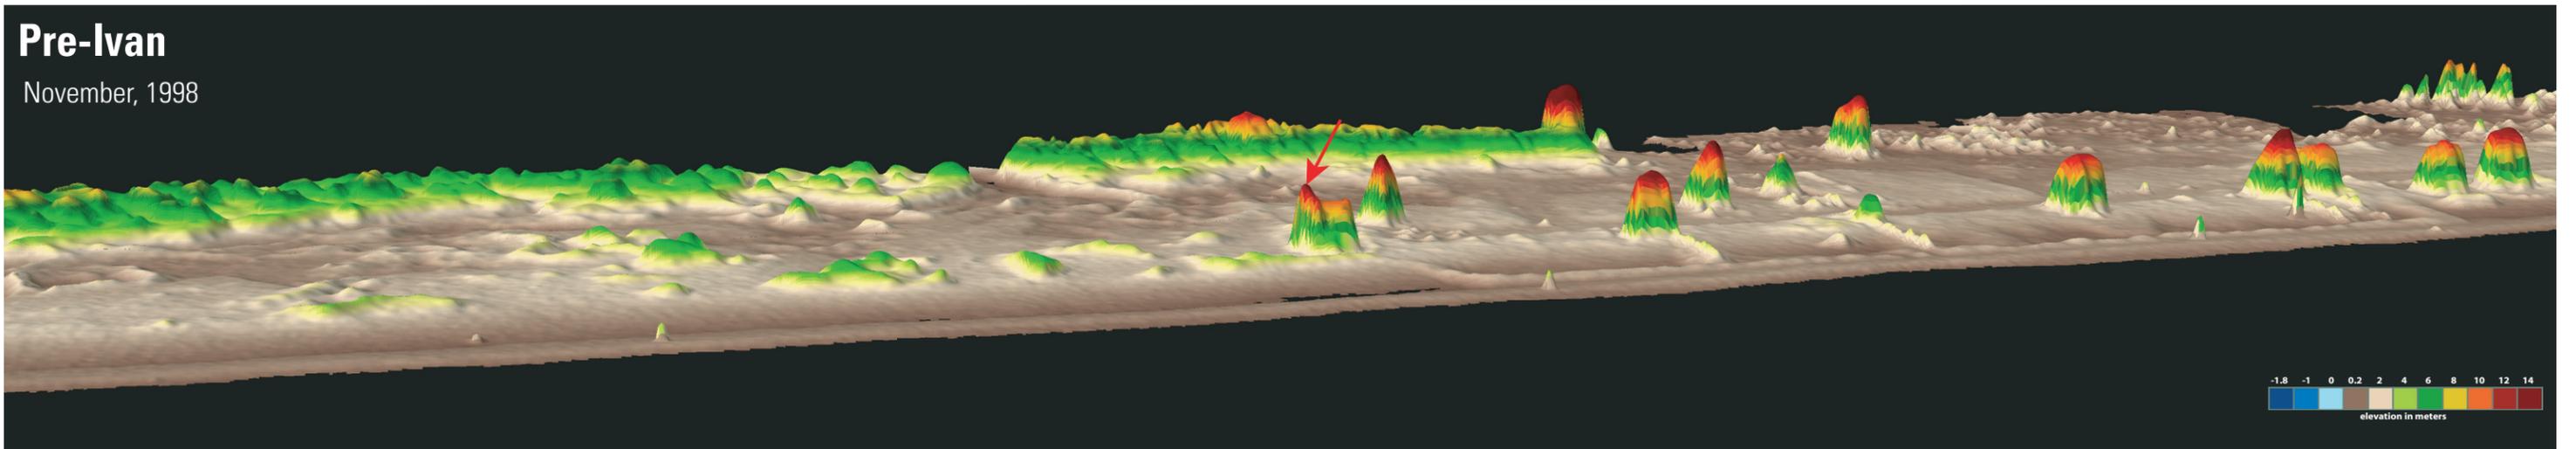
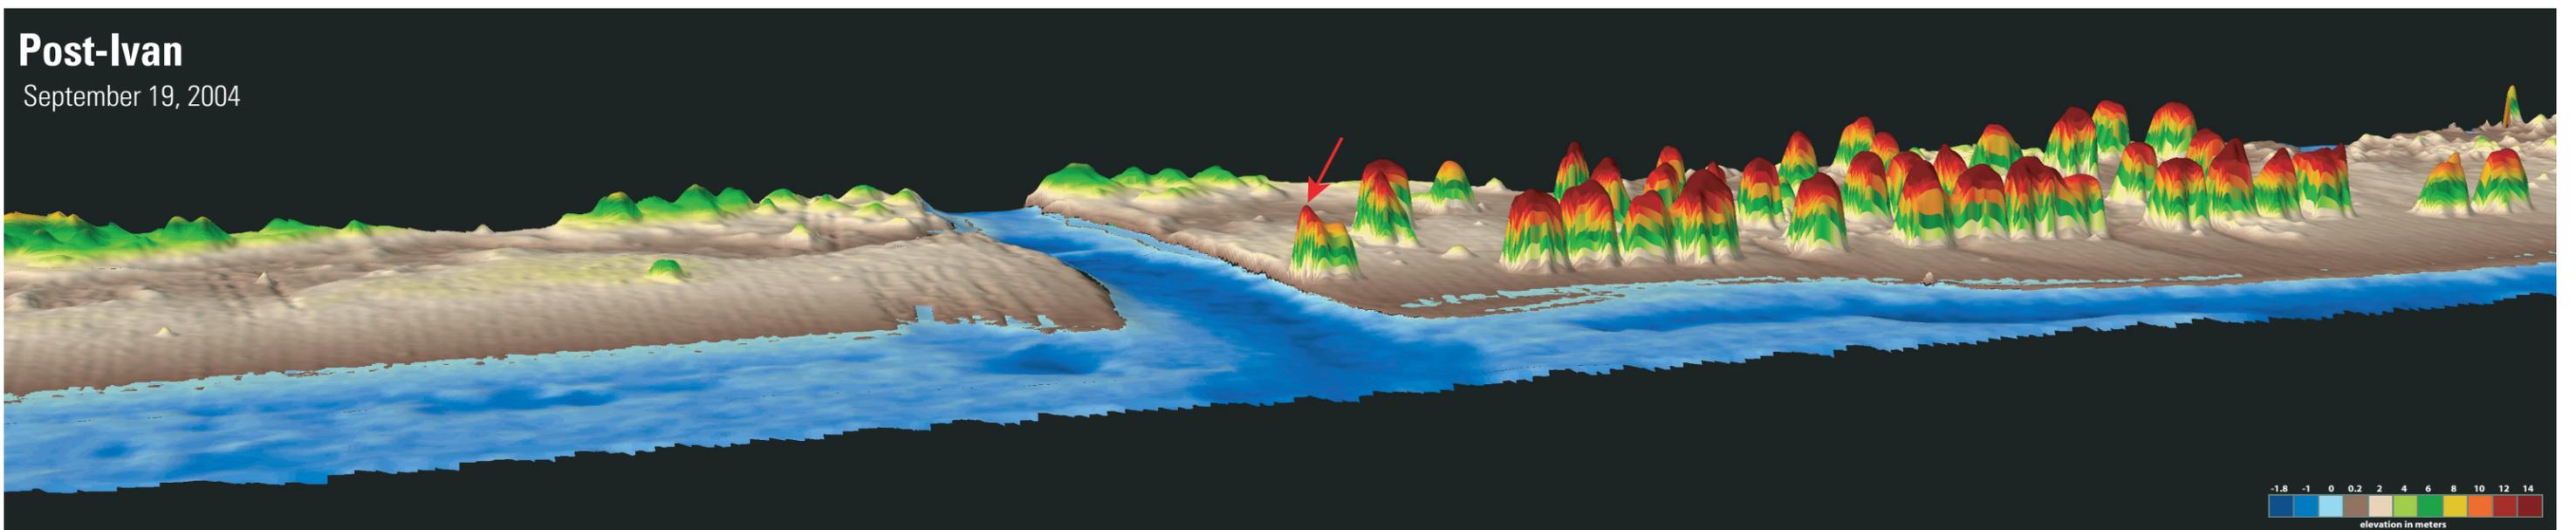
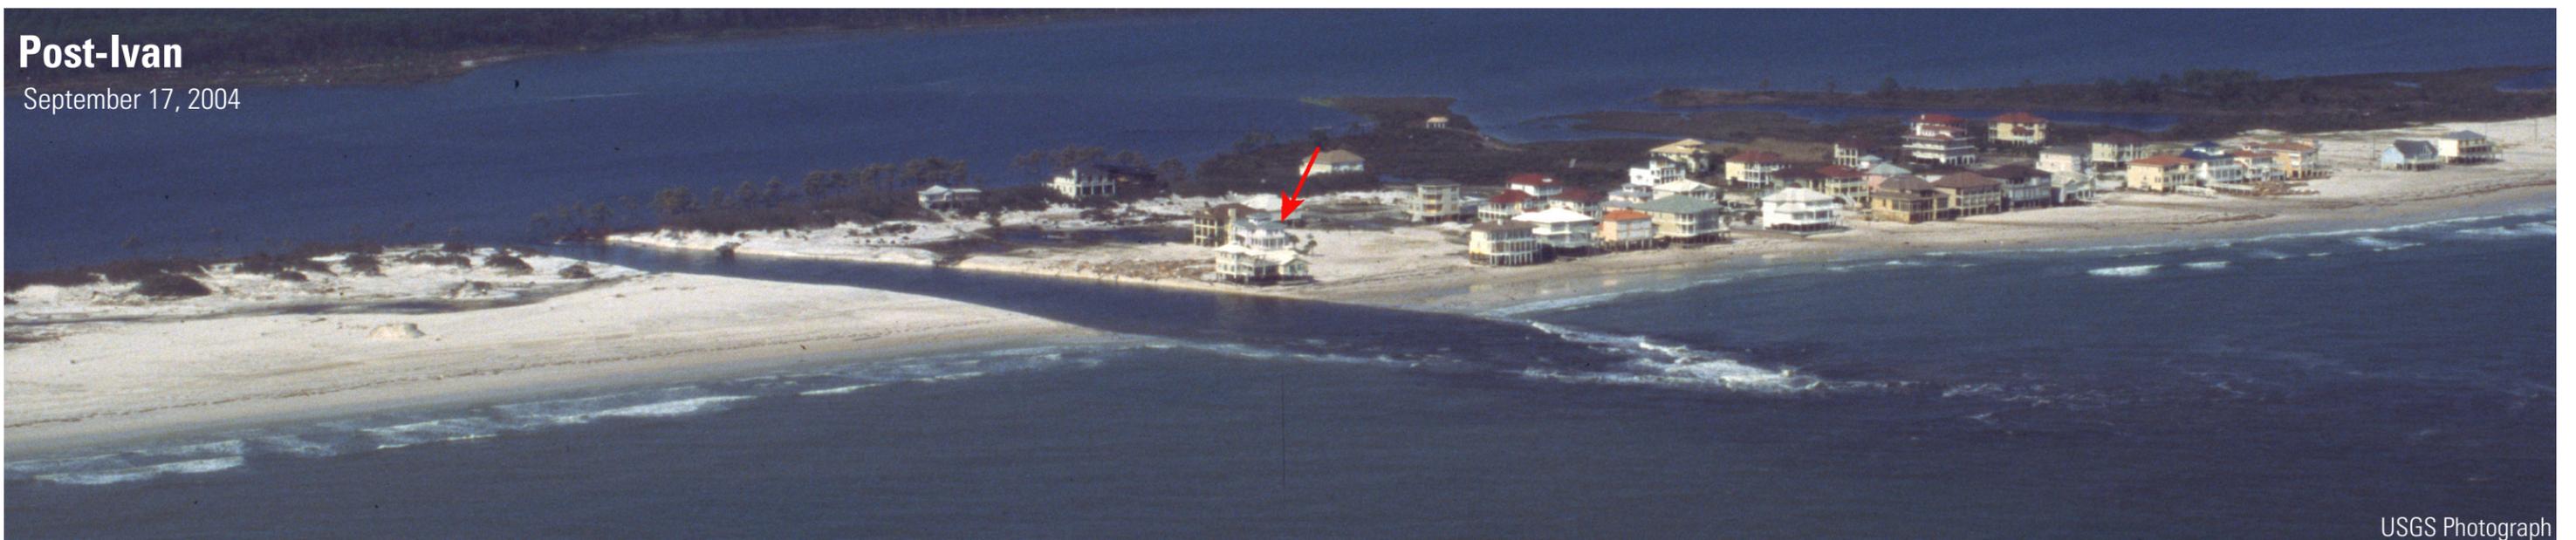
**Figure 3.** Pine Island, Alabama. Top and Center: Topography/bathymetry measured with lidar before and after the impact of Hurricane Ivan showing a new breach that severed the island. (Note the new houses that were built between the surveys. Houses appear in the topography as rectangular mounds. Their warmer colors indicate higher elevations.) Bottom image: A USGS aerial photograph shows the new breach following landfall. (Arrows in all images point to the same features.)

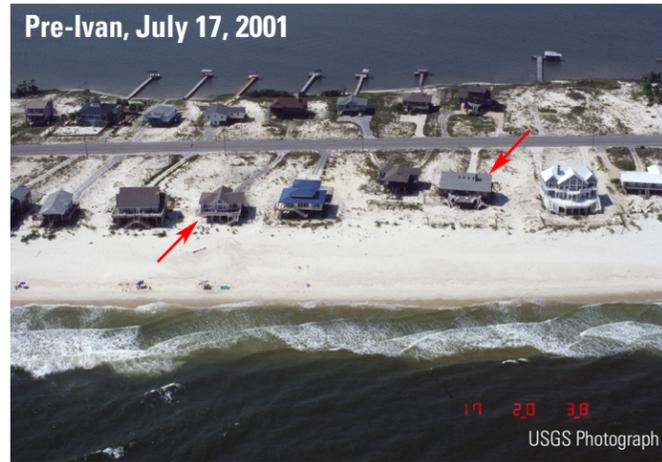
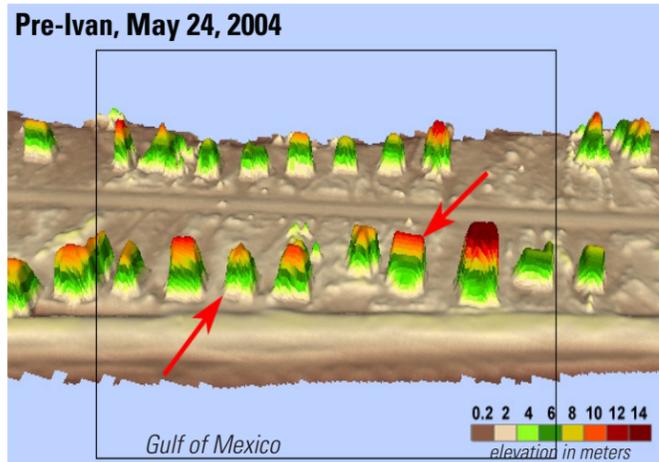
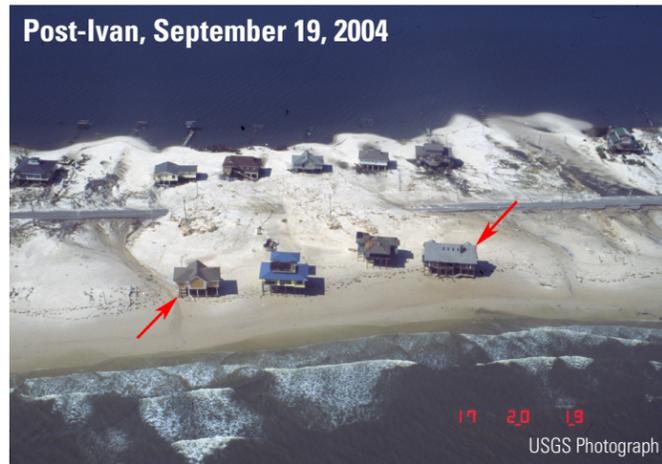
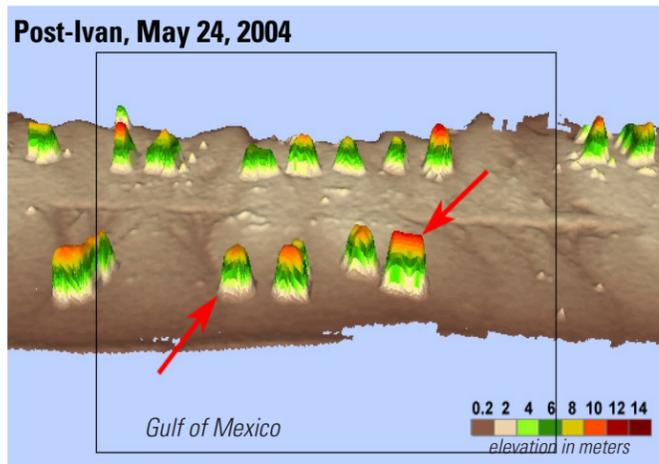
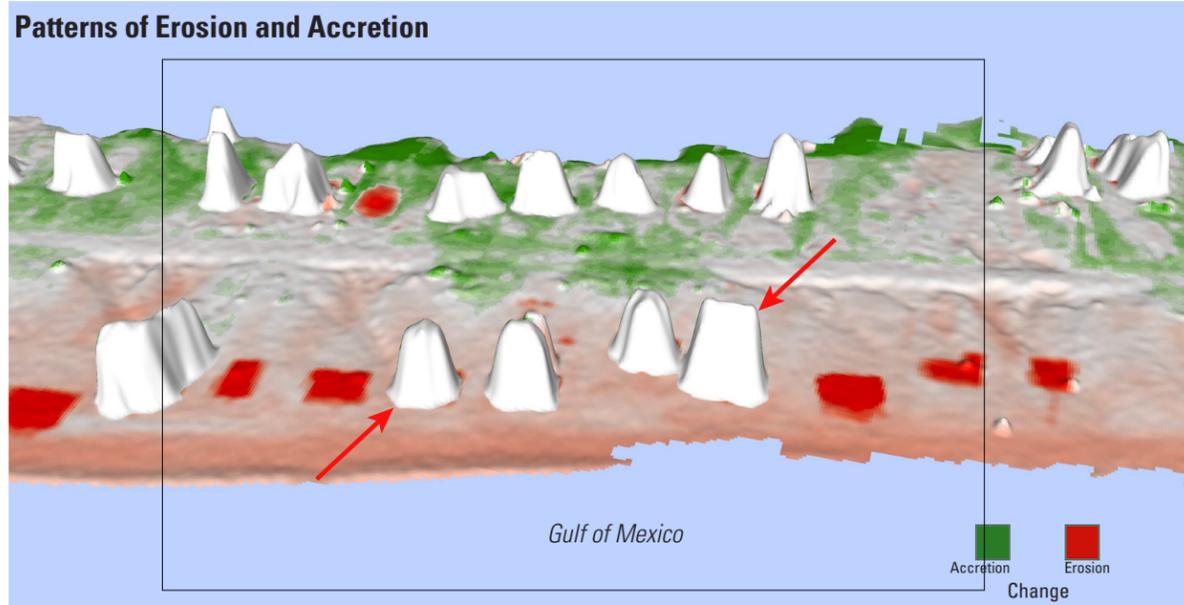
**Figure 4.** Gulf Shores, Alabama. Upper left: USGS before and after aerial photographs showing the loss of houses during Ivan. Upper right: Before and after laser mapping (lidar) topography of the same area shown in the photos (warmer colors represent higher elevations, (for example, houses). Bottom center: Vertical elevation change (erosion and accretion) that occurred as a result of the storm. The red rectangles indicate houses that were completely destroyed and swept from the island into the back bay. (Arrows in all images point to the same features.)

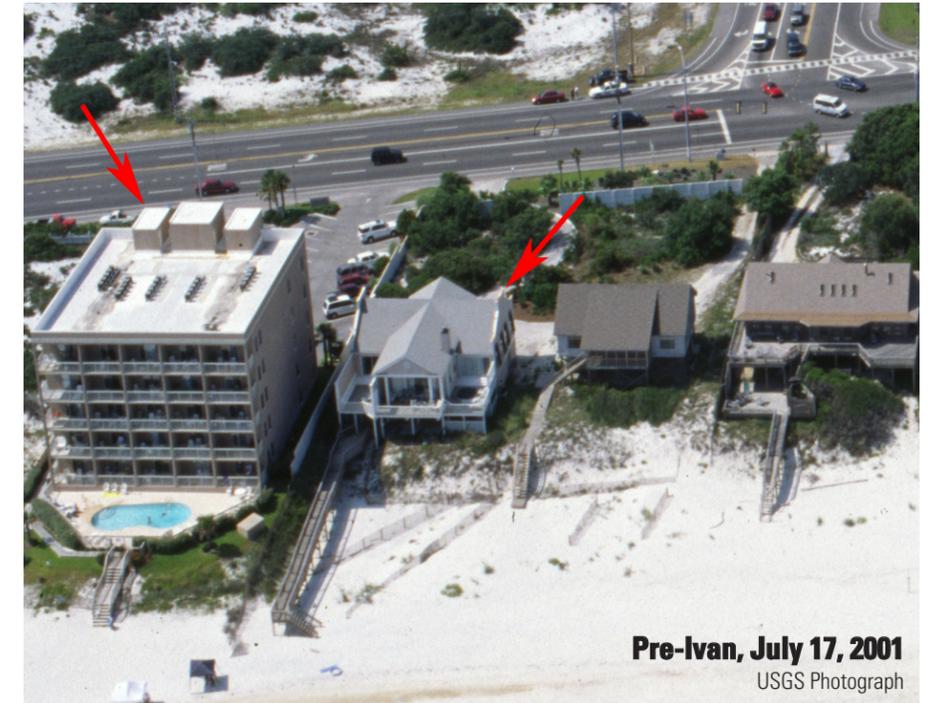
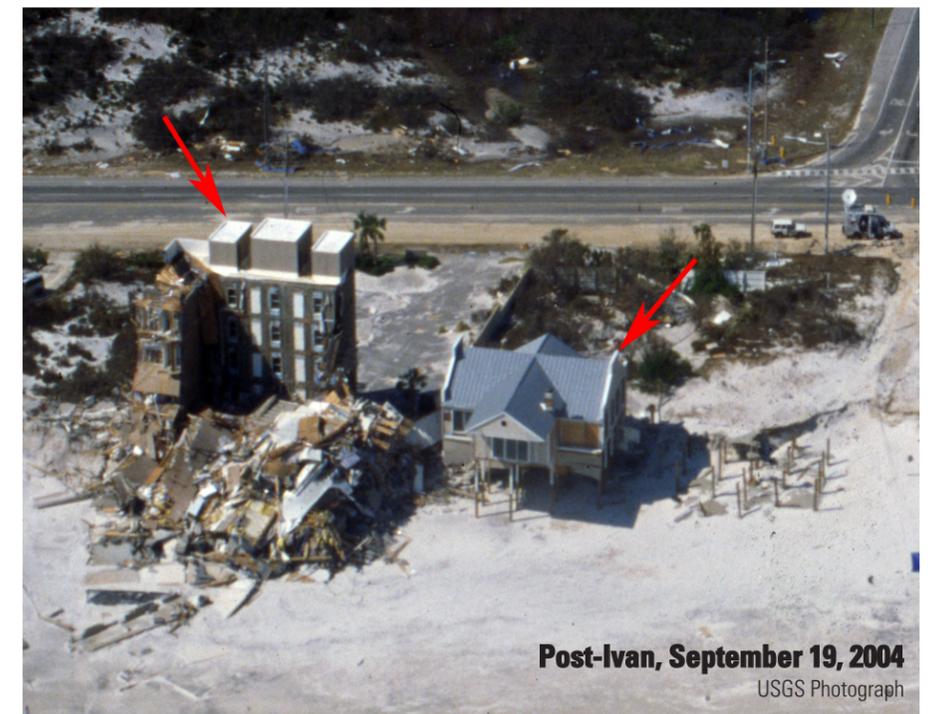
**Figure 2.** Orange Beach, Alabama. USGS aerial photographs taken before and after the landfall of Hurricane Ivan show the failure of a five-story condominium tower. The only parts of the structure that remain standing after Hurricane Ivan are the elevator and stairwell shafts. Airborne laser mapping data showed that the sand dune on which this building was constructed was subjected to about 3 m of vertical erosion during the storm. (Arrows in all images point to the same feature.)
