GEOLOGIC INVESTIGATION AT THE SITE OF
the POST OFFICE BUILDING
WELCH, WEST VIRGINIA

GEOLOGIC INVESTIGATION AT THE SITE OF THE POST OFFICE BUILDING,
WELCH, WEST VIRGINIA

By Harold H. Hawkins

Geologic Report on Core Drilling at Welch, West Virginia, Post Office

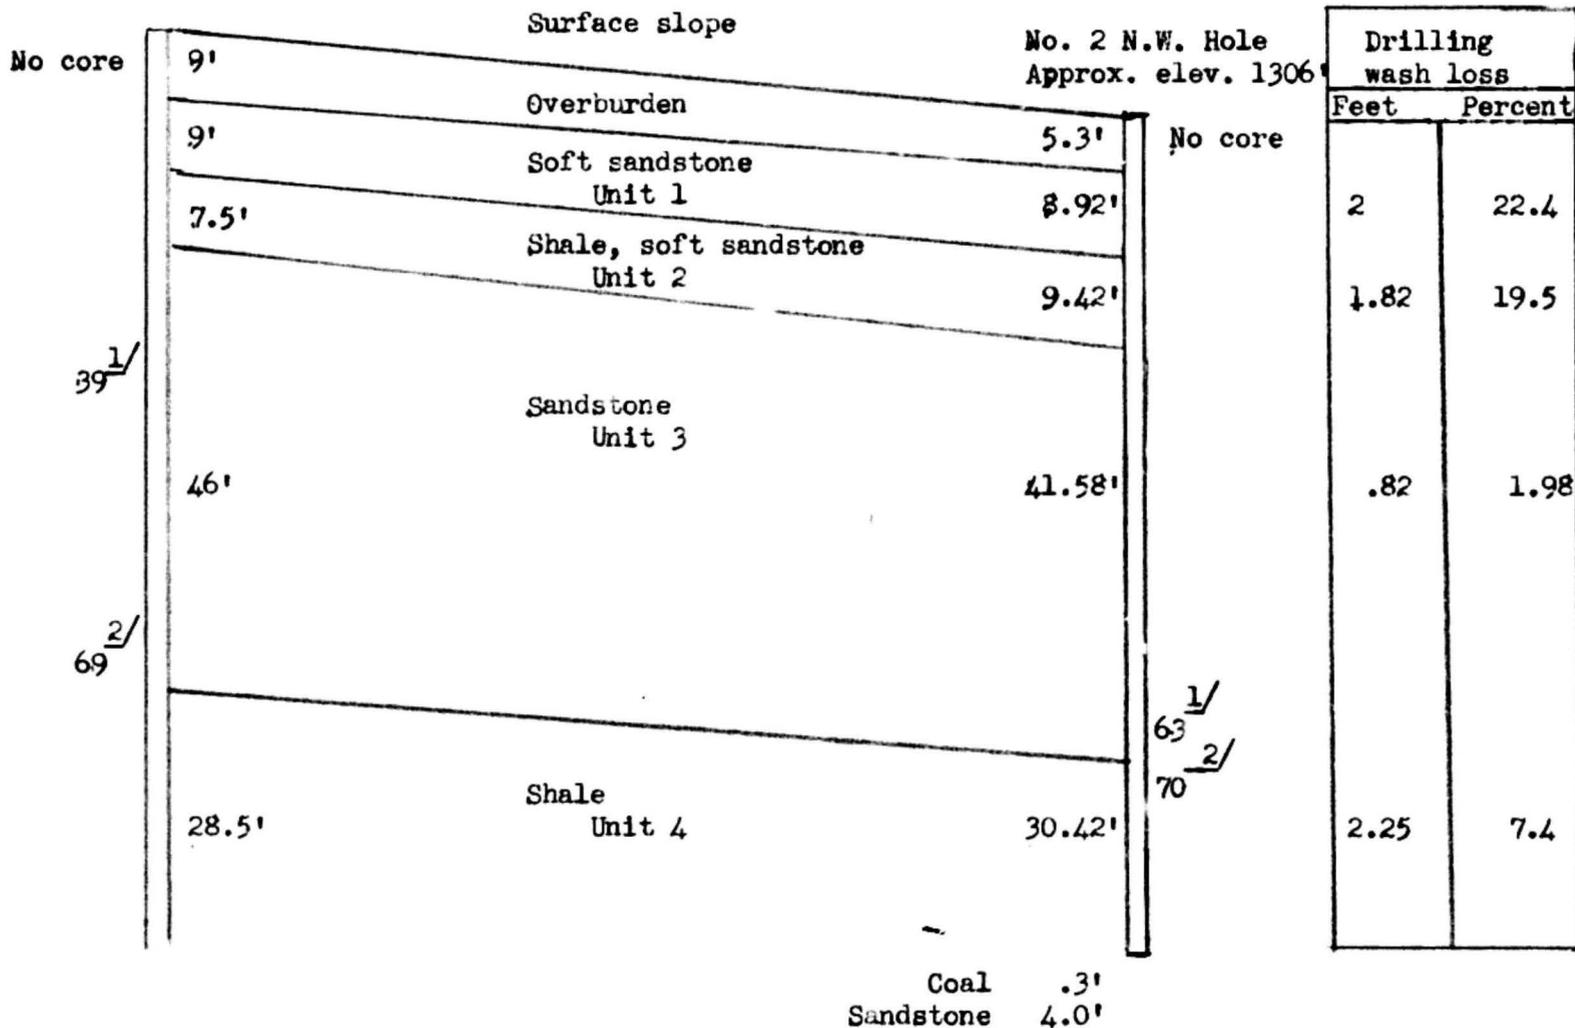
Diagrammatic Cross Section

The apparently westerly dipping bedrock section revealed by the cores recovered from the 100-foot holes drilled near the northeast and northwest corners of the post office may be summarized as follows:

Inasmuch as the Post Office building is reported to have shown no signs of cracking for several years subsequent to completion in 1936, it could be assumed that the footings were located on Unit 1 of the

bedrock section rather than in the overburden above that unit. It seems reasonable to suspect that the cracking of the walls may be the result of water having entered the bedrock section, wetting the soft shaly streaks, and facilitating possible down-dip slippage. This water may have come from clogging of the subdrainage system, from broken mains in the vicinity, from precipitation that has percolated downward through the upper layers of rocks, or by any combination of these.

Suggestions concerning remedial work: If the footings of the buildings are actually on Rock Unit 1 and the softer shaly portions are being washed out by water:

If, however, the building is not actually footed on Unit 1 of the rock section, but rests upon some portion of the overburden (a condition which can be determined by pitting) it will then be necessary to crib up or grout any existing gaps between the footings and Rock Unit 1; in addition some of the steps suggested above should possibly be undertaken.
