Riverbank erosion and ground-water conditions
at Beaver, Alaska

Roger M. Waller

October 1957

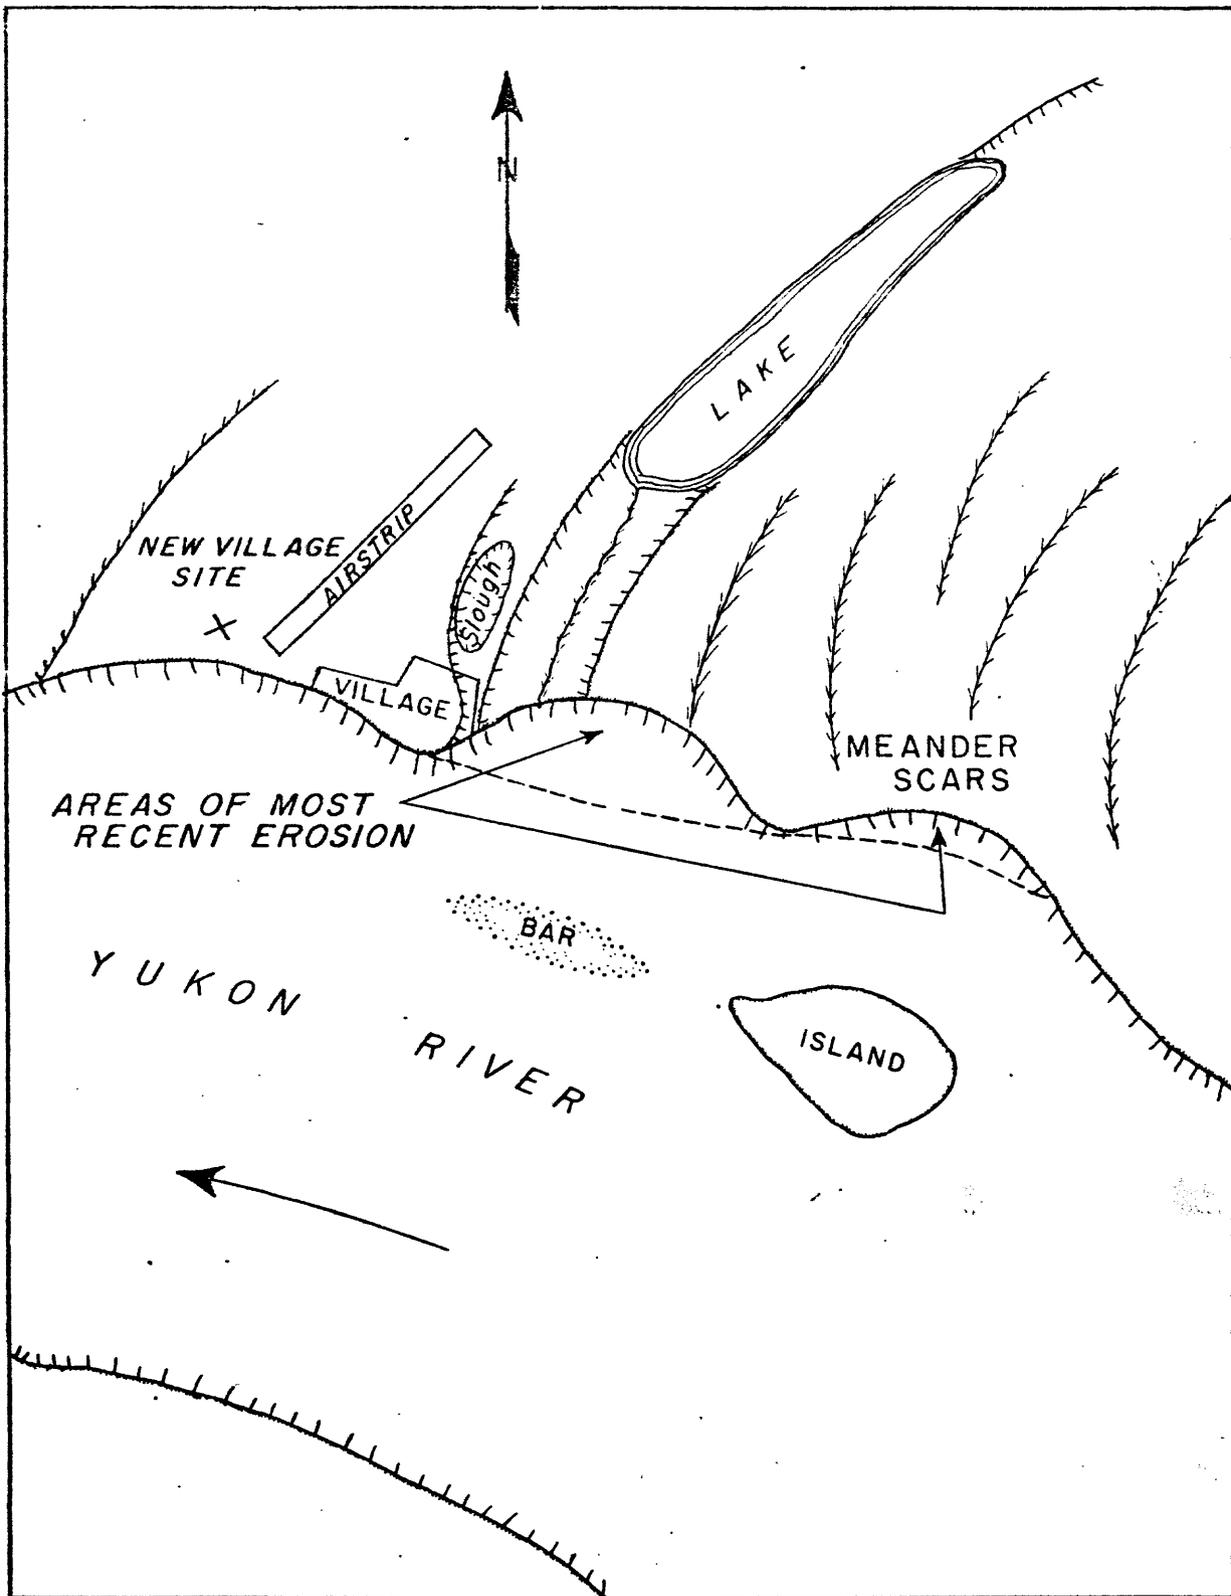
Figure 1-- Sketch map of Beaver area, Alaska

At the upstream end of the village the land surface is about 3 to 8 feet lower than the top of the riverbank in front of the village. This low land is an abandoned and partially filled meander channel of the river. Silt, sand and organic material are exposed in the bank above river level. Gravel underlies this layer near the village. Much of this low area, about half a mile long, was being actively eroded by the river at the time of the investigation.

More rapid erosion because of an increase in river current appears to be a factor also. The villagers reported, and maps indicate, that a gravel bar is exposed at lower river level opposite the actively eroding bank (fig. 1). This bar is approximately a third of the way across the main channel and downstream from an island. The gravel bar undoubtedly divides and directs a portion of the current toward the north bank. Leopold and Wolman,^{4/} in their summary of braided rivers, conclude that after deposition of a gravel bar in a river, the current is deflected against the banks of the channel causing them to be eroded. The villagers reported that the summer low flow of the river around the gravel bar and against the bank is more destructive than the flood flow when the bar is not exposed. Williams (1952, p. 520) concludes that wind-generated waves from the southwest are a very effective erosive agent on the north bank of the Yukon River during the summer. Hence, it appears that current and wave action are combined to form a more effective erosion agent.

In summarizing the causes of the increased erosion upstream from the village it appears to the writer that the predominant cause is probably the presence and enlargement of the gravel bar in the river which is directing a part of the current against the bank.

Another factor which could deter the erosion would be a change in the river channel. The abandoned meander at the upstream edge of the village (see fig. 1) extends for about 5 miles to the northeast. The upstream end of this partly filled meander is about 100 feet from the bank of the Yukon river and the bank at that point is being eroded. It is possible that if, and when, a flood cuts into this old meander the river will reoccupy the meander.

The new village site (see fig. 1) picked by the villagers would appear to be the least likely area to undergo river erosion in the near future. Subsurface conditions would be similar to those in the present village area.
