UNITED STATES
DEPARTMENT OF THE INTERIOR
GEOLOGICAL SURVEY

CHANNEL EROSION SURVEYS ALONG THE TAPS ROUTE,
ALASKA 1977

OPEN-FILE REPORT 78-611
(Basic Data)

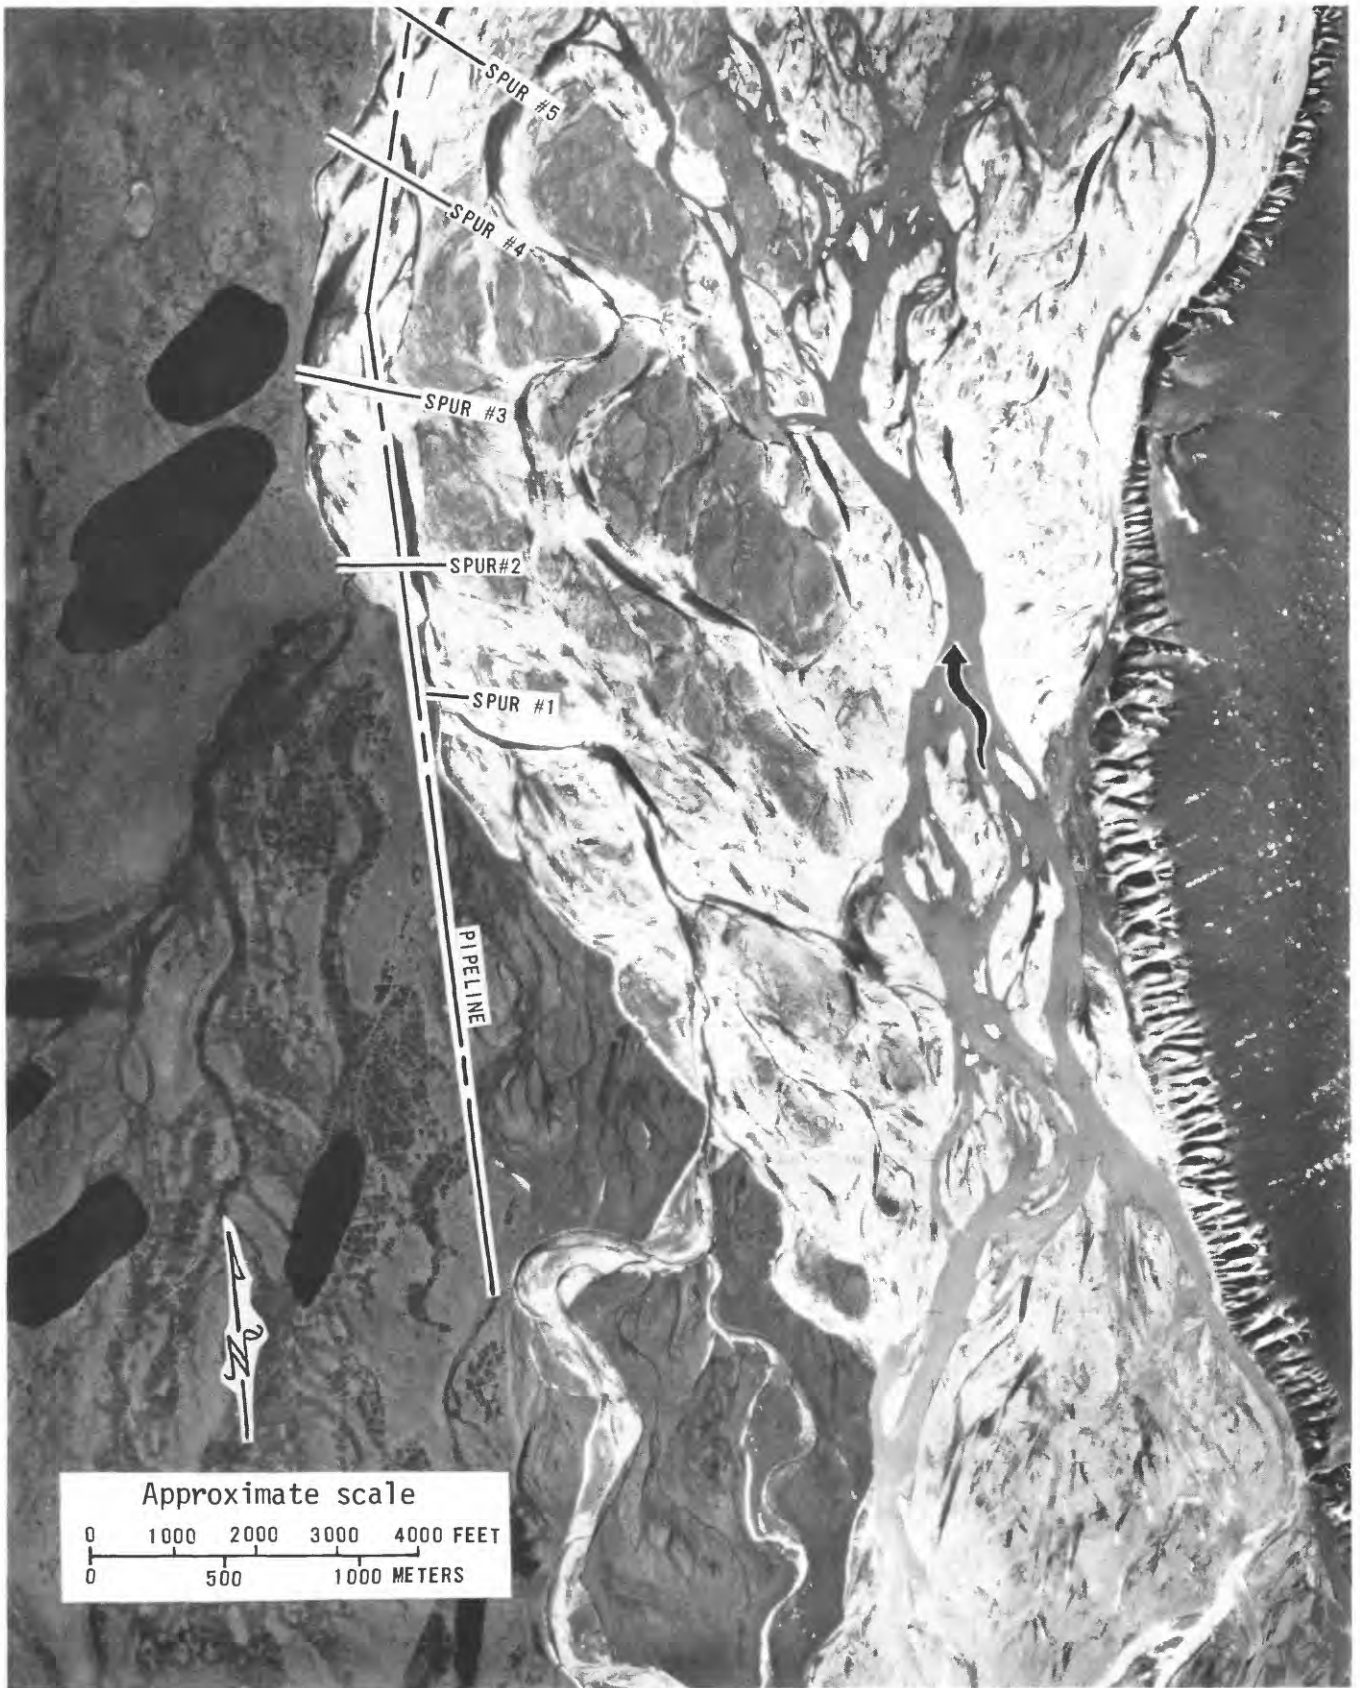
Figure 2.--Sagavanirktok River at Alignment No. 134 near Deadhorse, August 31, 1969.
AIR PHOTO TECH

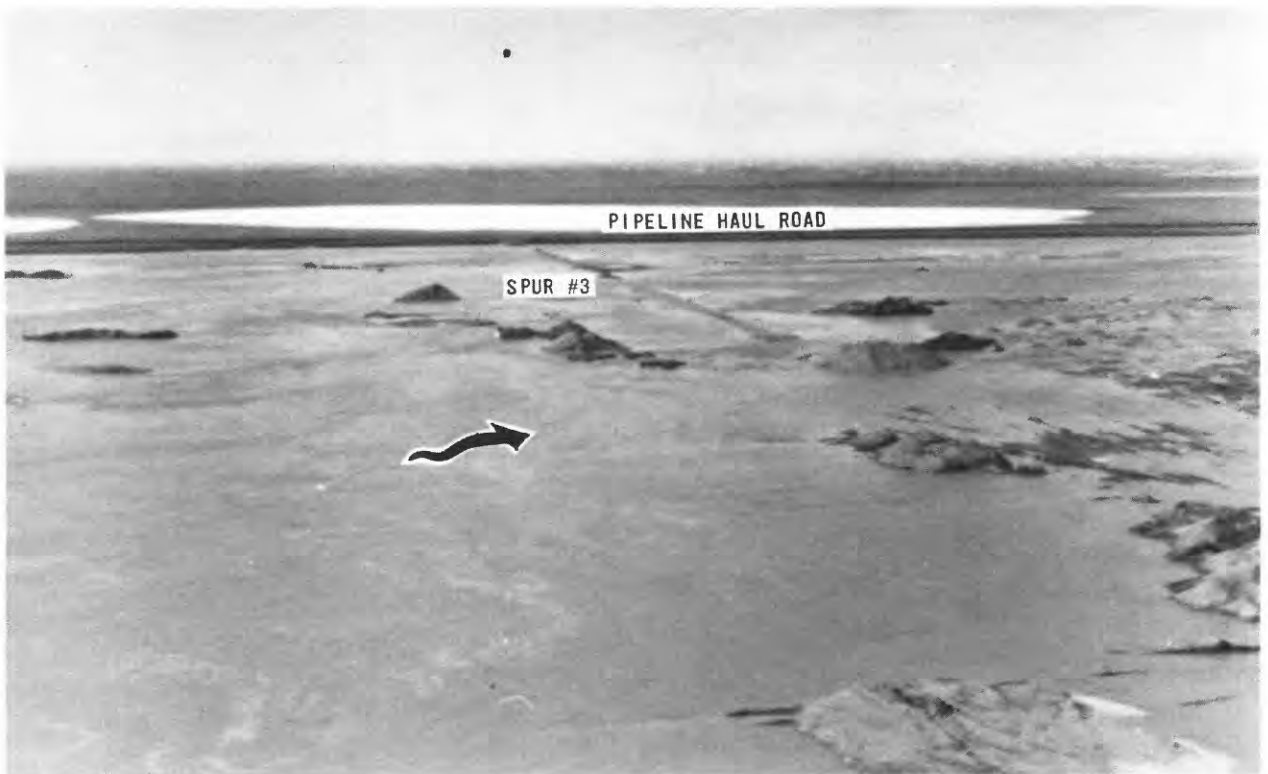
The breached spur dikes at least partially dammed off the subchannel and were overtopped and partially washed out. They failed to force the river to develop adequate flood conveyance elsewhere in the flood plain.

The spur dikes were designed to protect the pipeline from the pipeline design flood of 122,000 ft³/s. The peak discharge at the spur dike field is not known. Sixty miles upstream at the USGS gaging station, Sagavanirktok River near Sagwon, which is above the confluence of the Ivashak River and several smaller tributaries, the peak discharge was 29,500 ft³/s on June 5. This was the largest flood in the station's seven-year history. Even though the stage was higher than anticipated, it is highly unlikely that the discharge along alignment No. 134 approached that of the pipeline design flood.

Figure 4.--Spur dike no. 3 on Alignment No.134 of the Sagavanirktok River near Deadhorse, June 6, 1977.

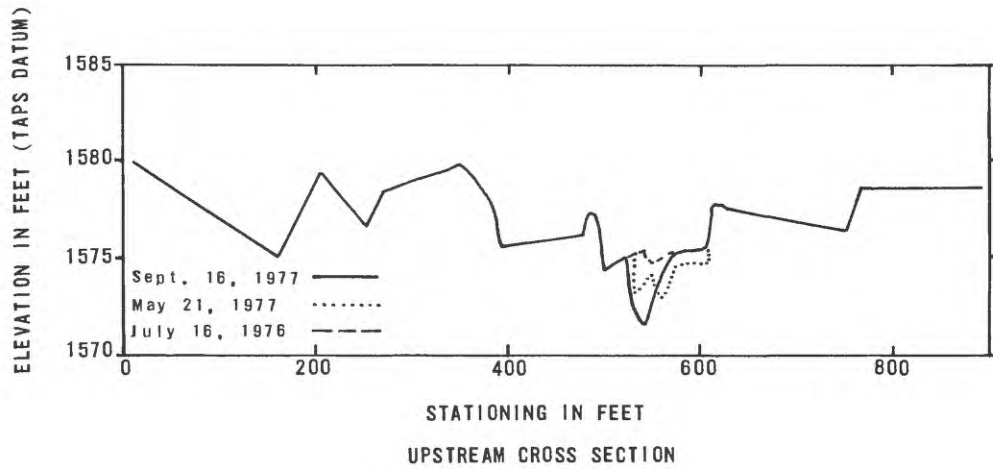
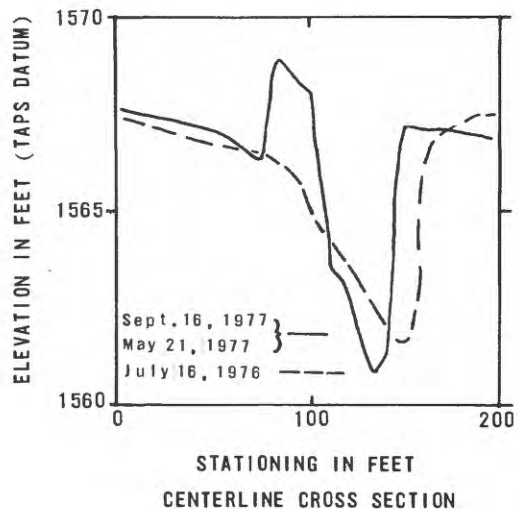
Figure 7. -- Cross sections of Snowden Creek near Dietrich Camp.

The crossing site was resurveyed on both May 21 and September 16, 1977. In May, changes were found in the upstream cross section and changes due to the completion of construction were found in the centerline section. In addition, the September survey showed that upstream thalweg had deepened since May (fig. 7). The peak discharge of July 31, 1976, was measured by indirect methods on May 21, 1977, at a site about 0.5 mi upstream from the pipeline. The peak discharge was 460 ft³/s or about 30 (ft³/s)/mi².

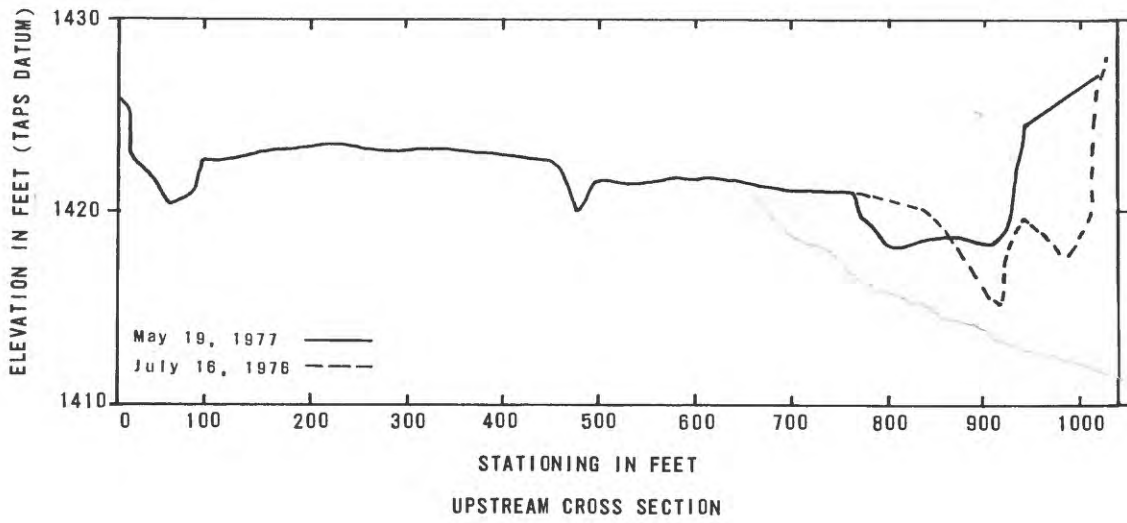
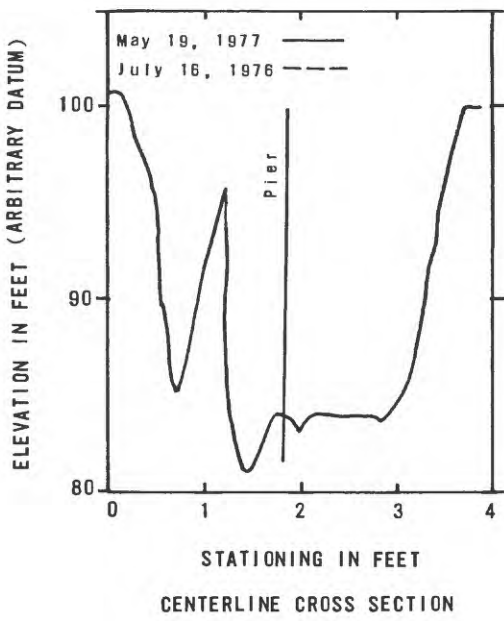
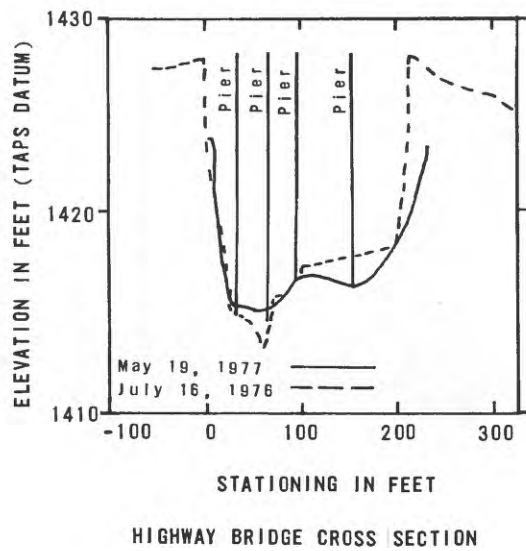
Figure 9. -- Cross section of Dietrich River at Bettles River.

The site was resurveyed on May 19, 1977. No reliable datum was established for this year's centerline section; thus it cannot be rigorously compared to last year's. However, it is evident that the construction activities have changed the section's shape considerably. Both the upstream and the highway bridge section have also changed (fig. 9). No survey was taken on the downstream section.

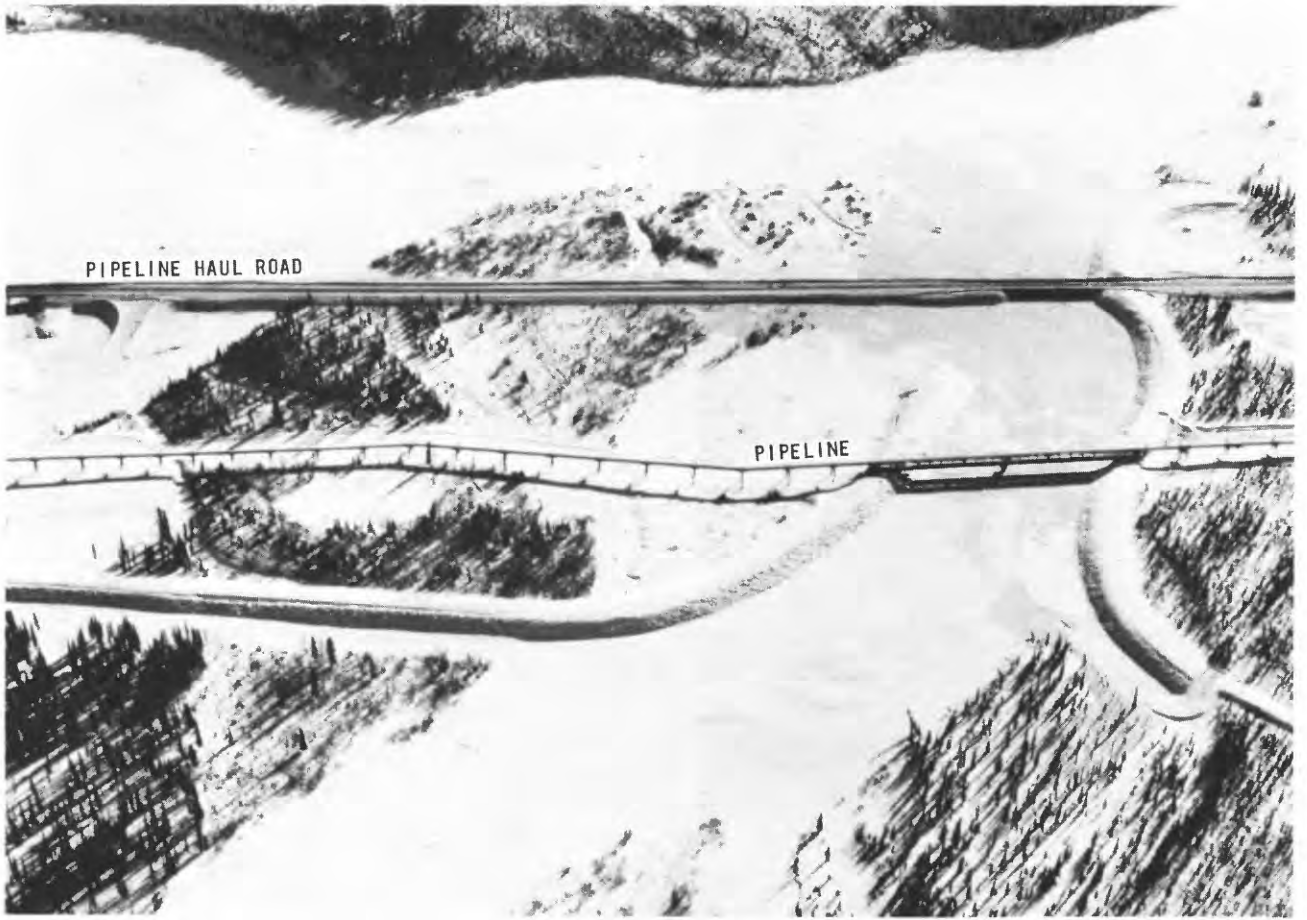
Figure 12 shows an active icing in progress on March 23, 1977.
On-site observations indicated that the icing was caused by the
highway bridge for the haul road. This year's survey indicated
that the icing caused little or no erosion.

Figure 12.--Icing in progress on the Hammond River near Wiseman, March 23, 1977.

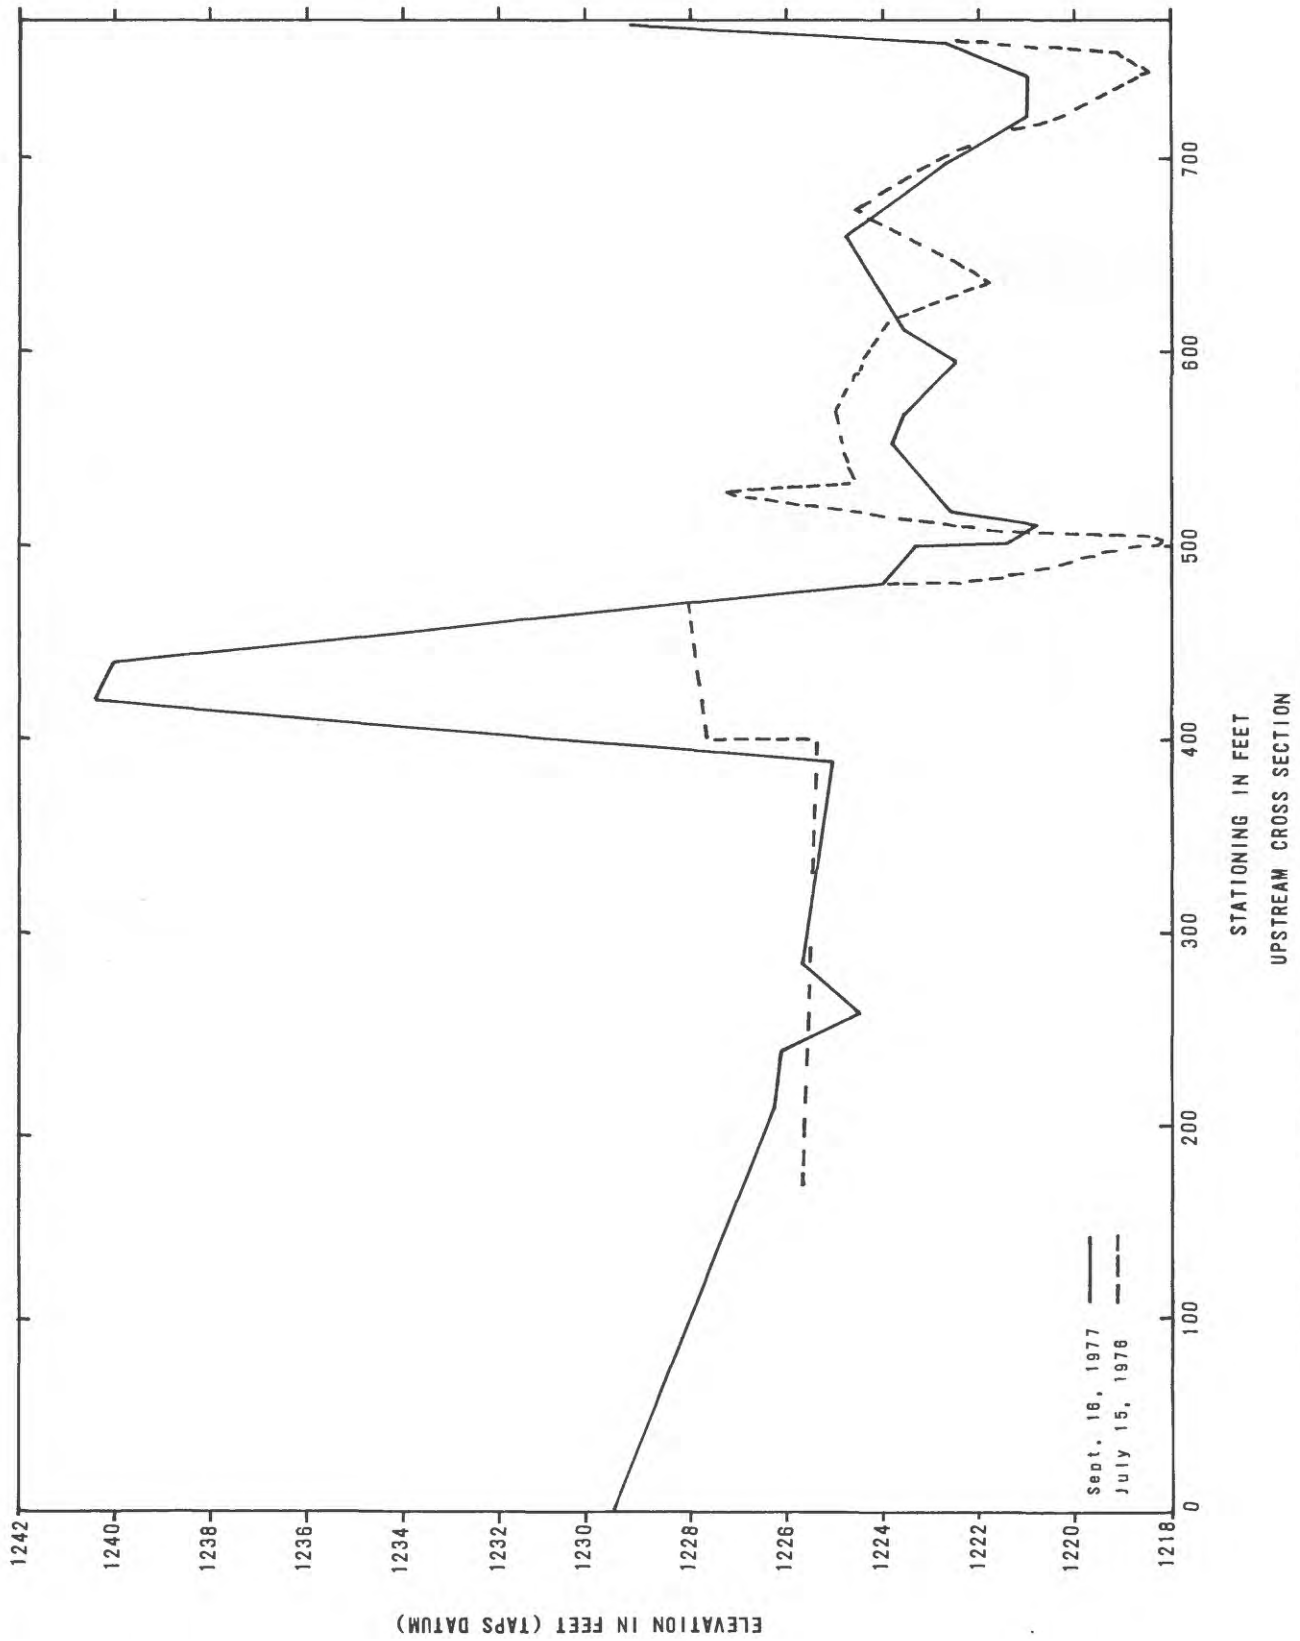
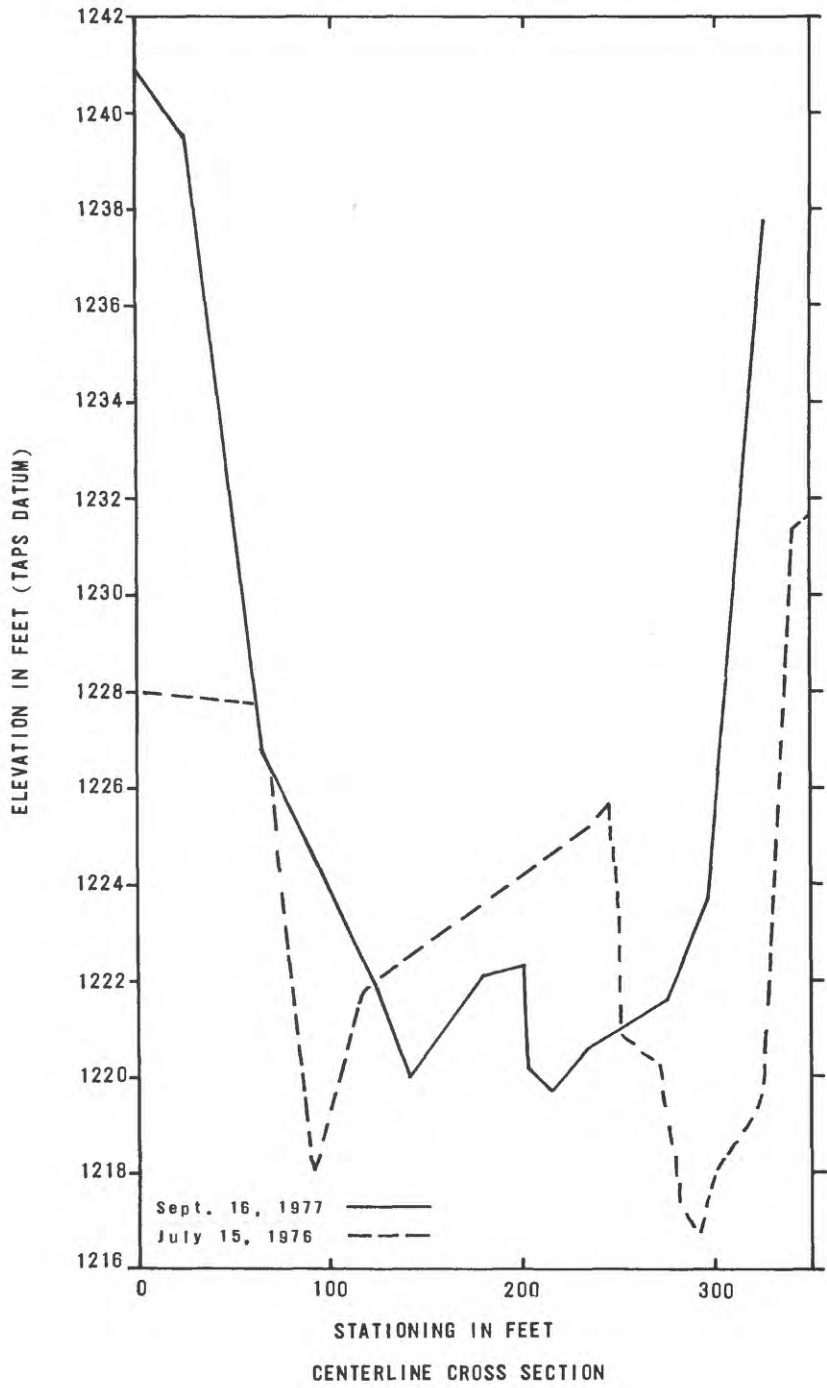
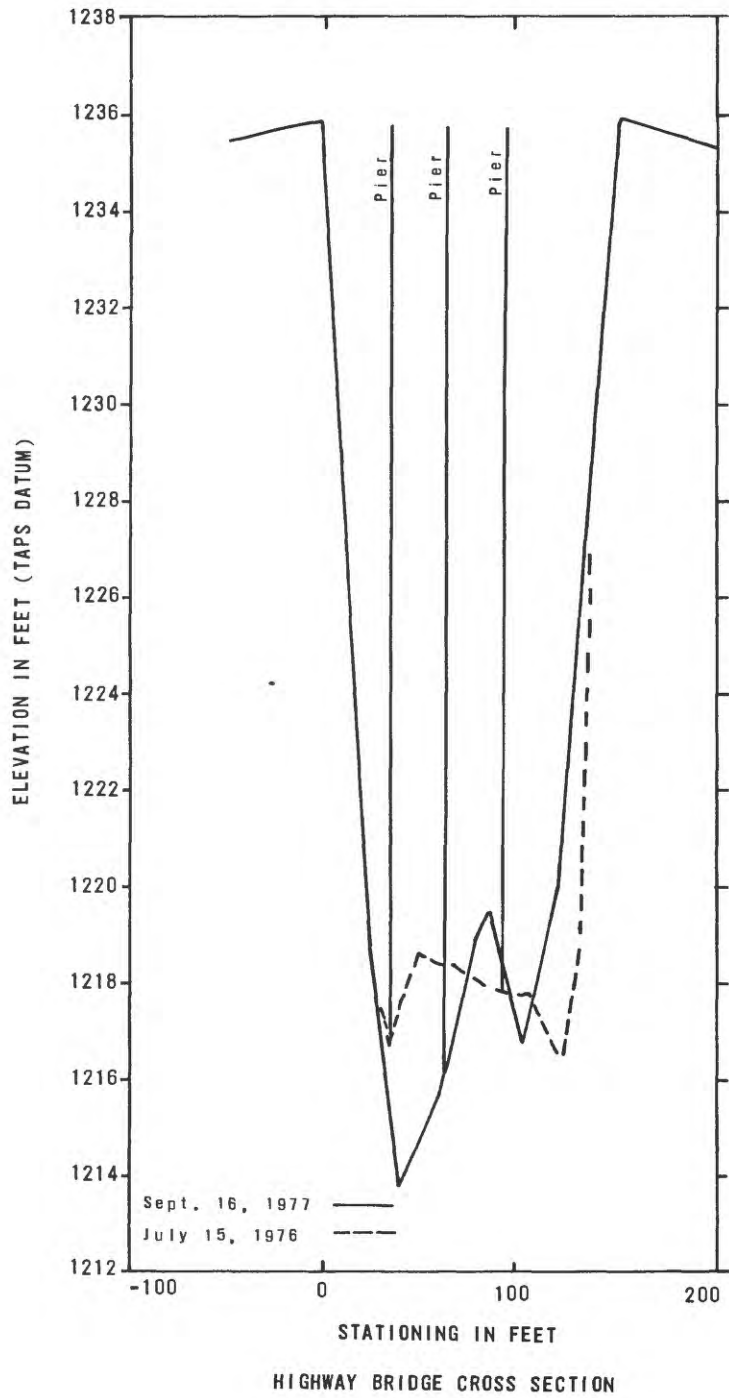
Figure 13. -- Cross sections of the Hammond River near Wiseman.

The crossing site was resurveyed on September 16, 1977.
Figure 13 shows the changes in the three surveyed sections. The
thalwegs of all three sections have become shallower by over 2.5
ft. No survey was made on the downstream section this year.

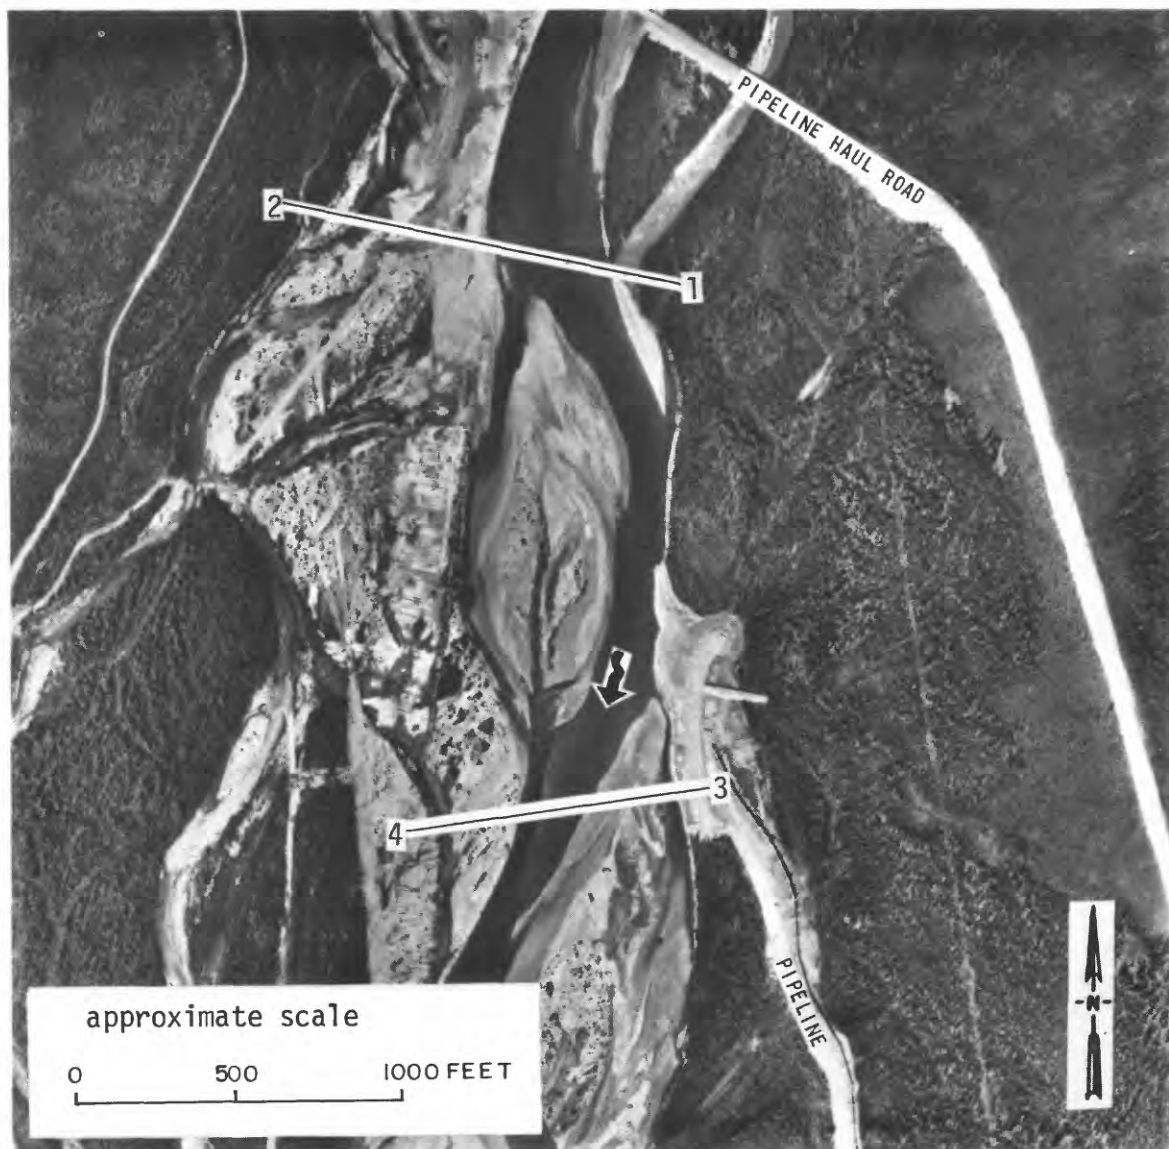
Figure 14. -- Middle Fork Koyukuk River near Wiseman, July 12, 1977.
AIR PHOTO TECH

1977 Surveillance.--Figure 14 shows the Middle Fork Koyukuk River near Wiseman crossing site on July 12, 1977. As noted in the discussion of the Middle Fork Koyukuk River at Hammond River site, a record flood occurred on this river during spring breakup. During the last year, construction has been largely completed. Protective dikes on both banks of the centerline have been finished, and the deep hole just off the right bank has been backfilled.

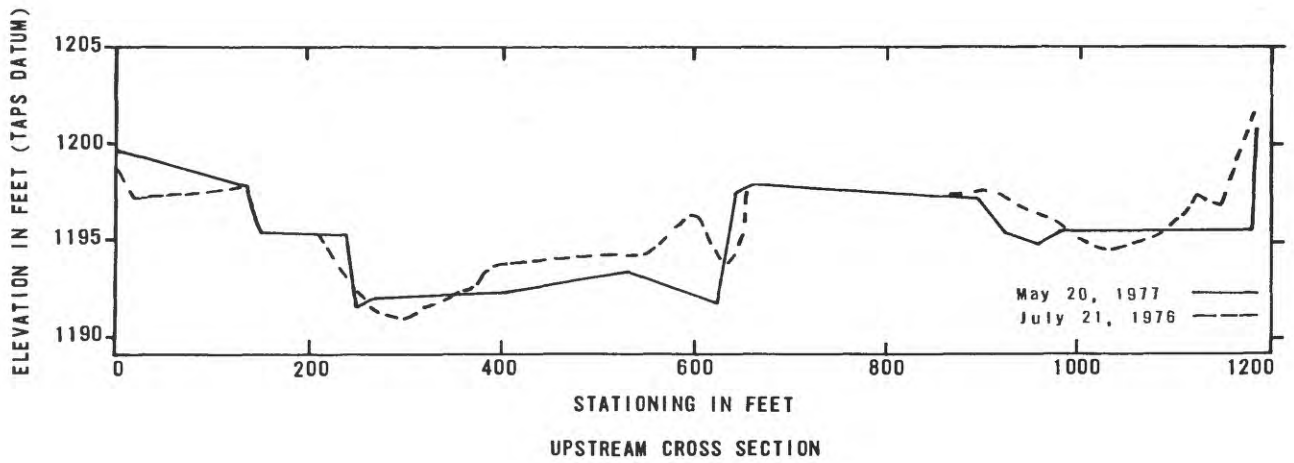
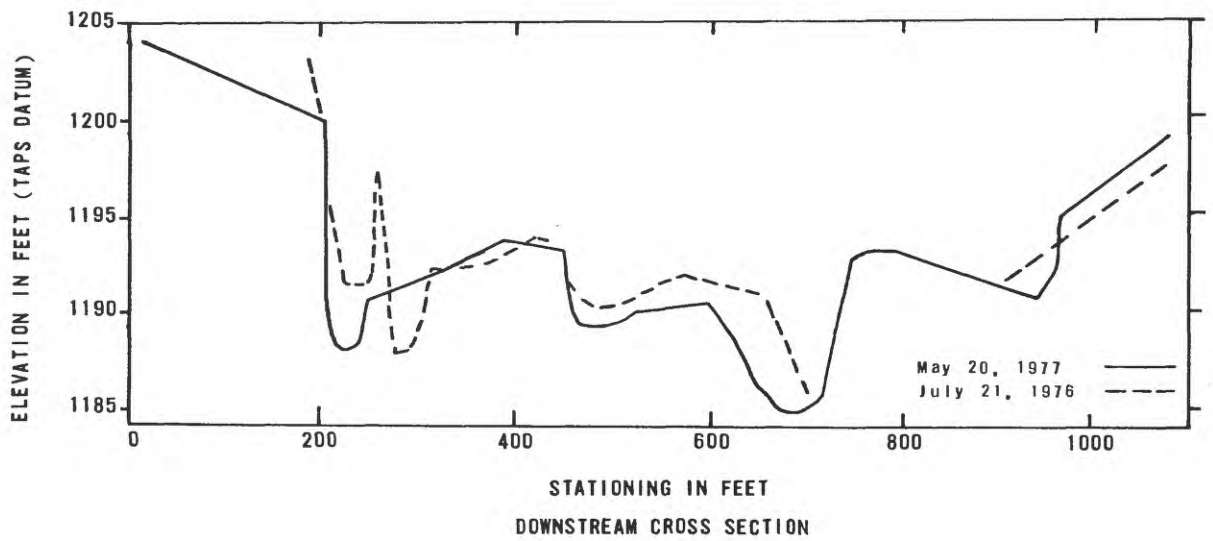
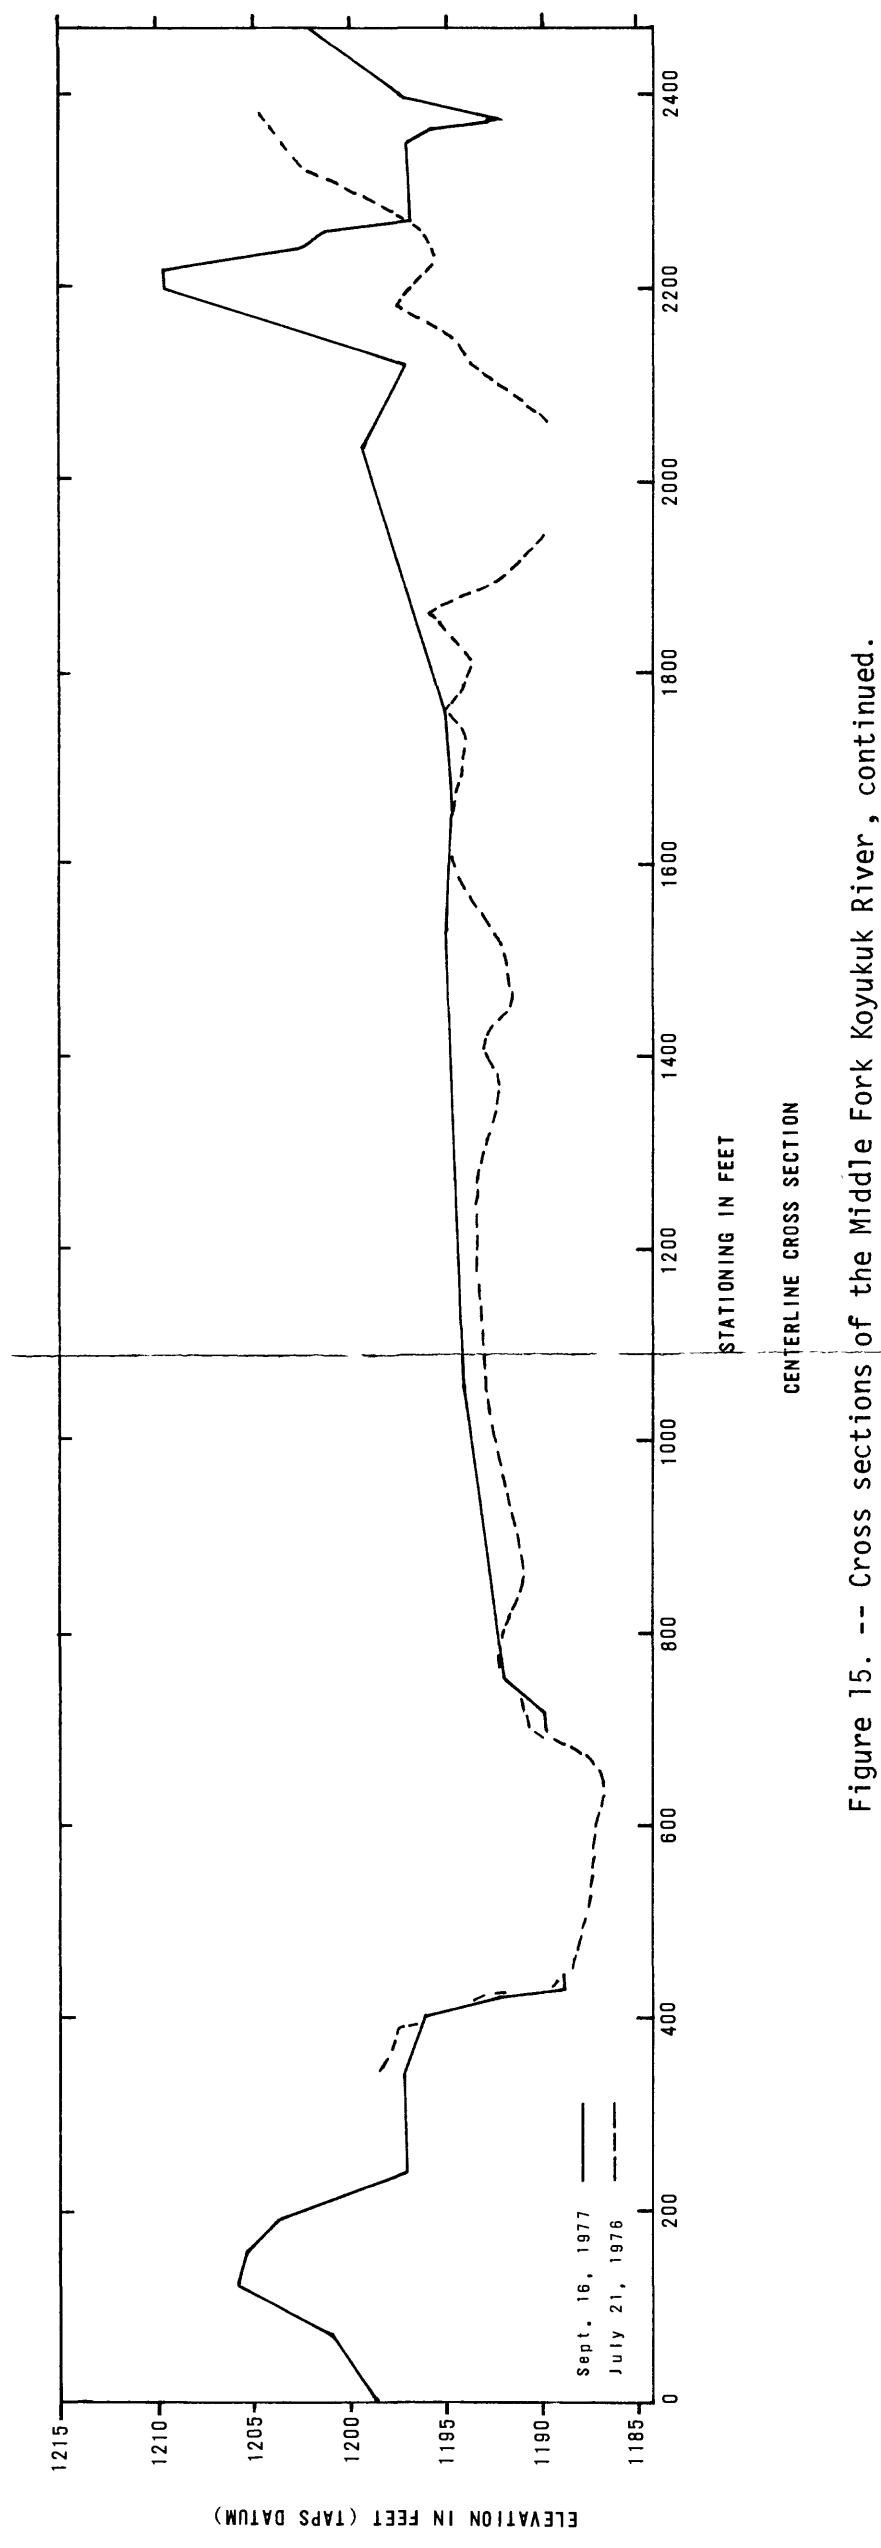
Figure 15. -- Cross sections of the Middle Fork Koyukuk River.

The upstream and downstream cross sections were resurveyed on May 20, 1977, and the centerline on September 16. Figure 15 shows the changes which occurred in all cross sections.

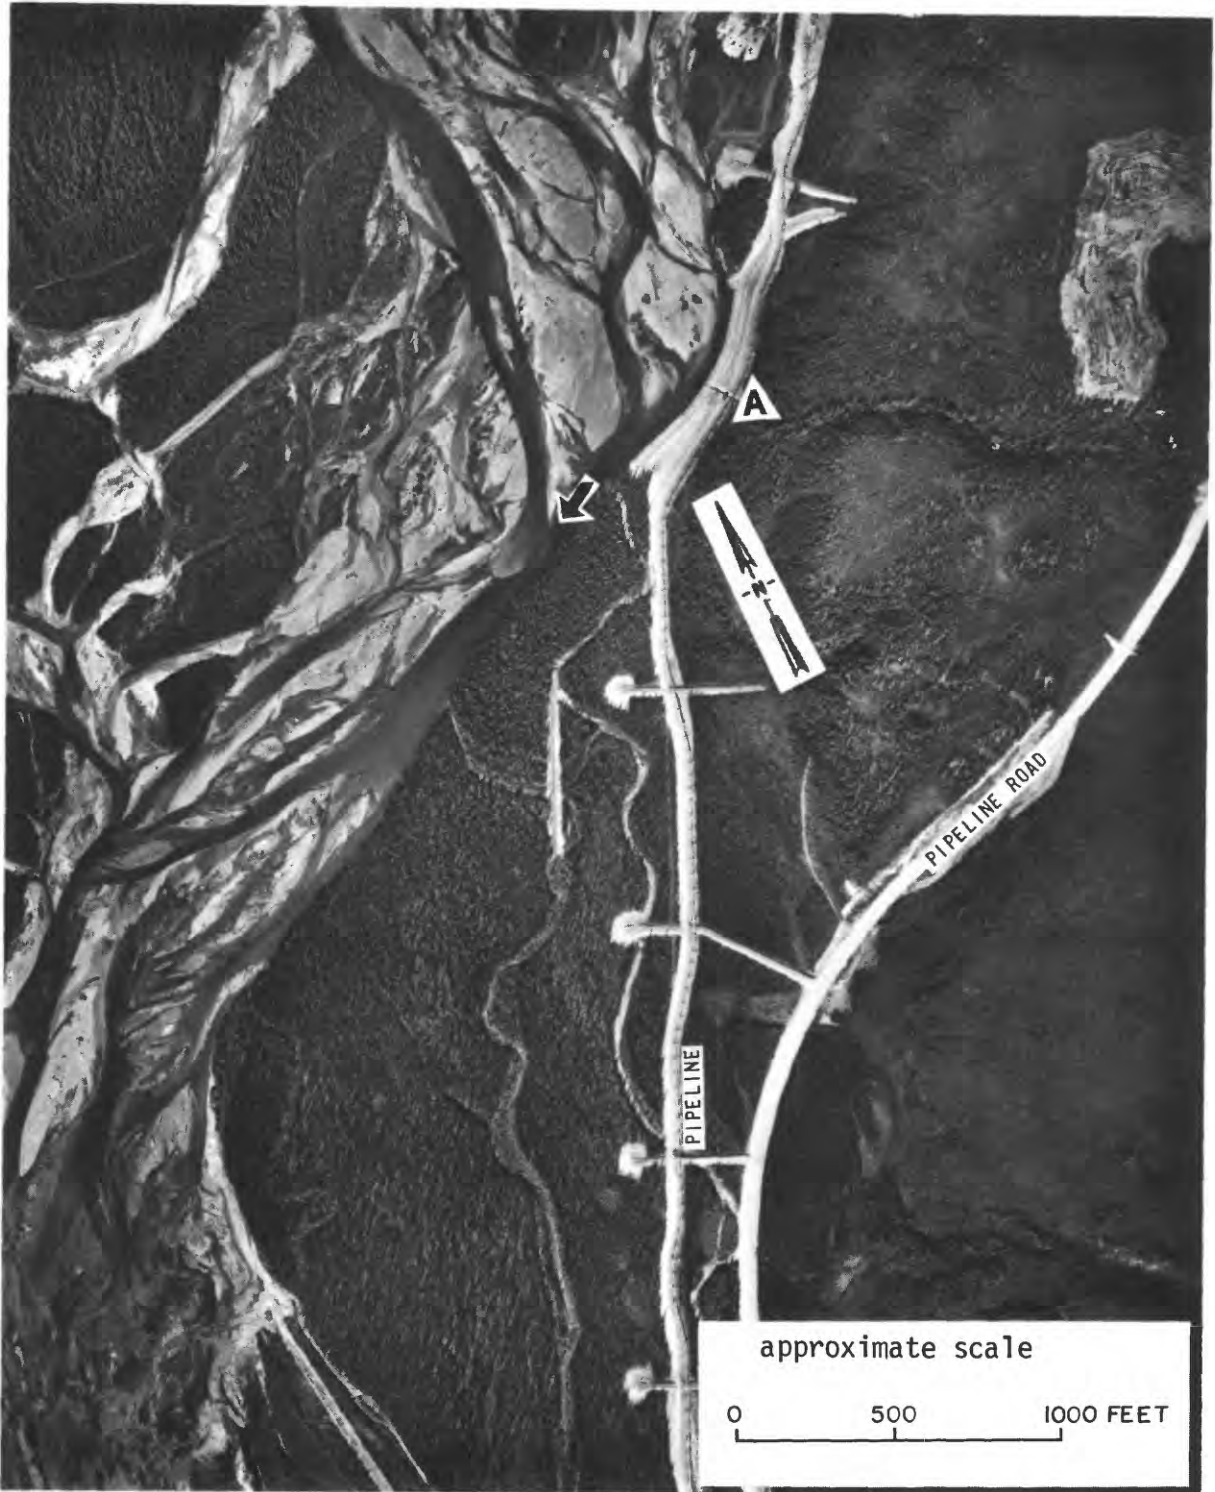
Figure 16. -- Middle Fork Koyukuk River near Coldfoot, July 12, 1977.
AIR PHOTO TECH

1977 Surveillance.--Figure 16 shows the Middle Fork Koyukuk River near Coldfoot crossing site on July 12, 1977. During the last year, pipeline construction has been completed along the left bank. As noted in the discussion of the Middle Fork Koyukuk River at Hammond River site, a record flood occurred on this river during spring breakup.

Comparison of the 1976 and 1977 air photos and a visual inspection of the site made in May 1977 indicate that no significant bank erosion has occurred. The photos show that the river's major conveyance has shifted toward the right bank at site A, continuing a trend noted in last year's report. Consequently, the zone of intense erosion on the left bank has moved approximately 1,400 ft downstream from the 1976 location at site A.

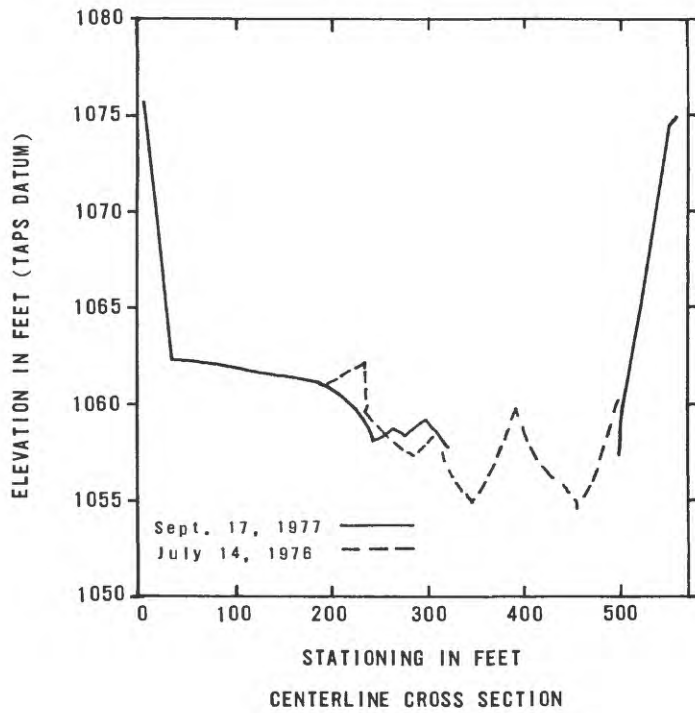
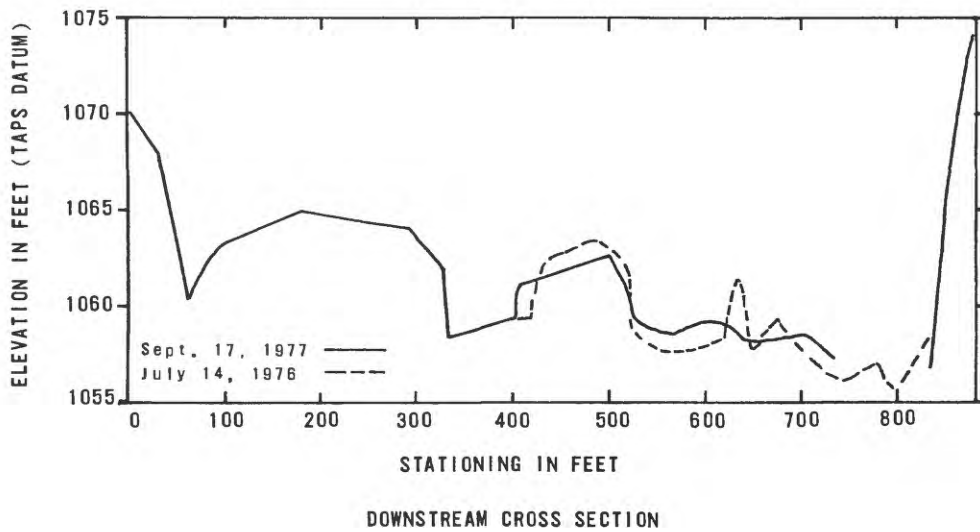
Figure 18. -- Cross sections of the South Fork Koyukuk River near Wiseman.

1977 Surveillance.--Figure 17 shows the South Fork Koyukuk site on July 12, 1977. The site was resurveyed on September 17, 1977. There has been no significant change in the upstream cross section since 1975, but minor changes were found in both the centerline and downstream cross sections (fig. 18).

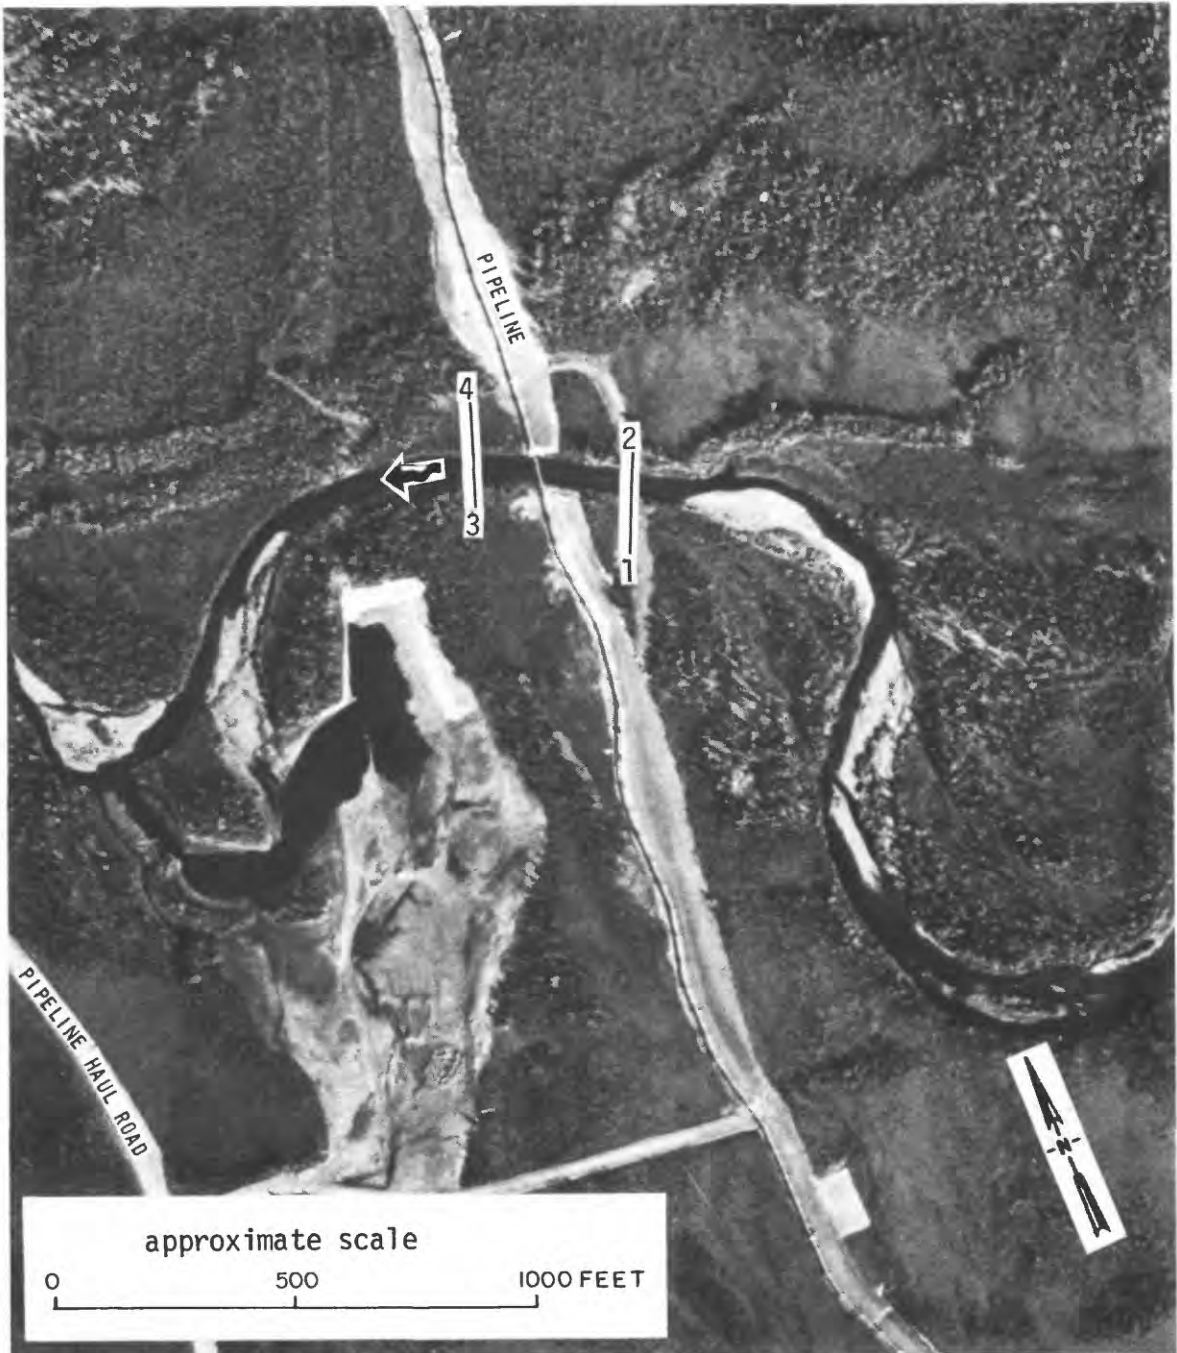
Figure 21. -- Prospect Creek near Prospect Creek camp, September 1, 1977.
AIR PHOTO TECH

1977 Surveillance.--Figure 21 shows the Prospect Creek site as of
September 1, 1977. During the last year, there has been some grading
on the upstream and centerline cross sections, and the access bridge
over the upstream crossing has been removed. The site was resurveyed
on September 17, 1977, and no significant changes were found in any
cross section.

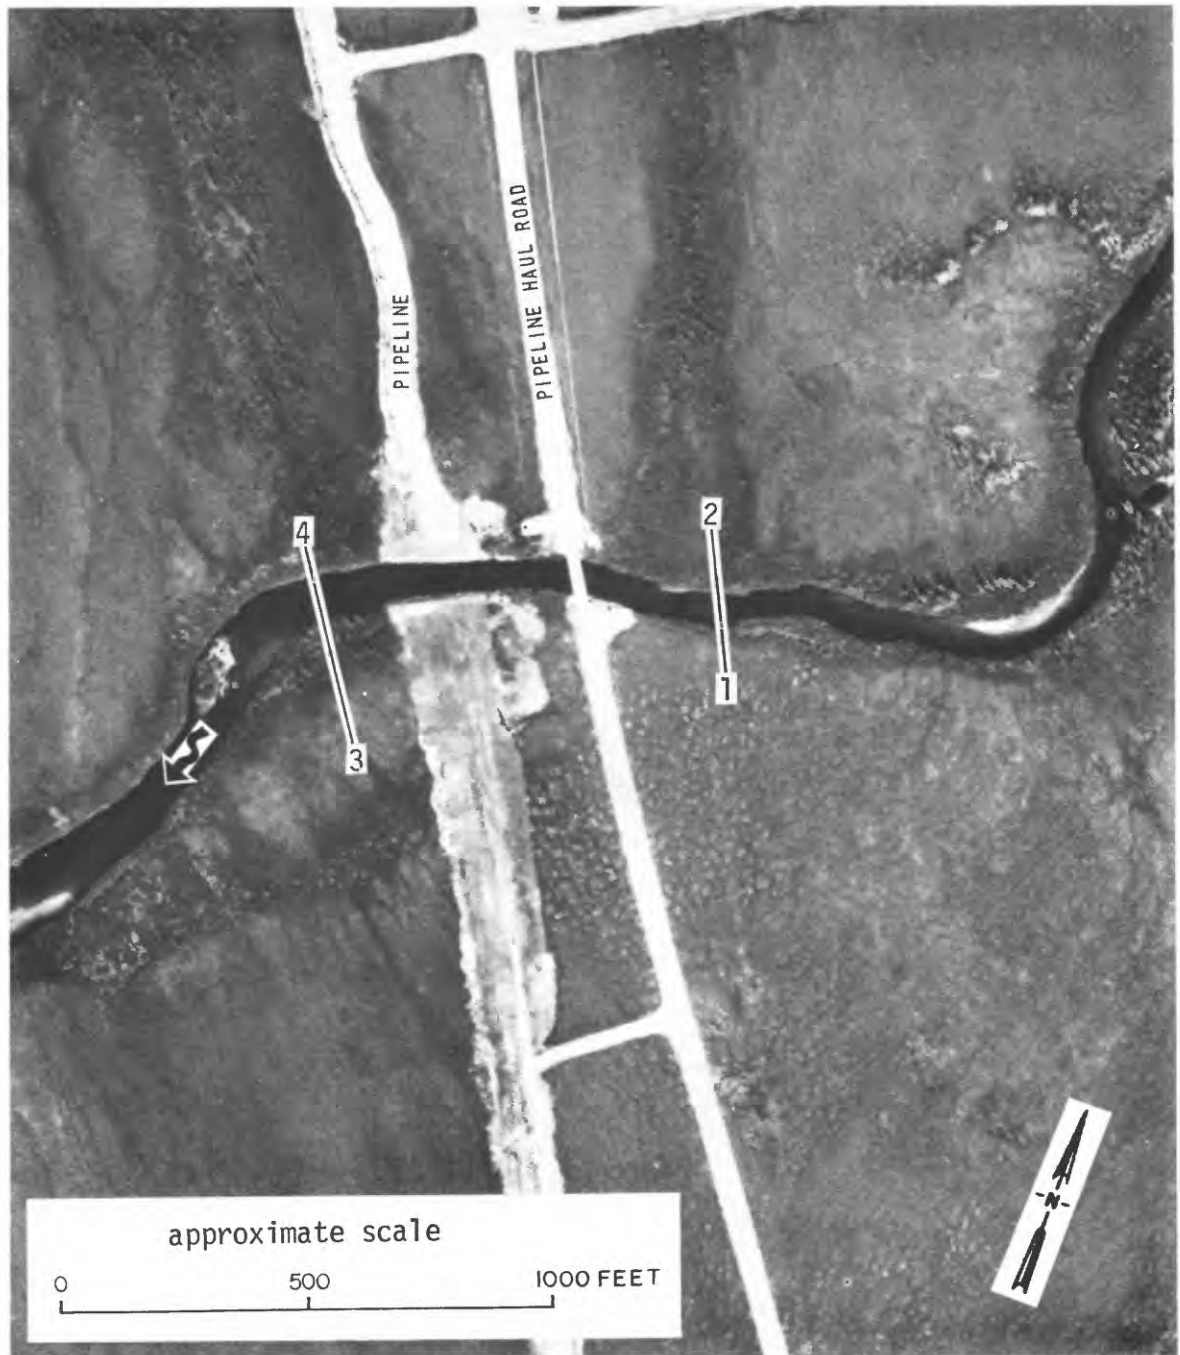
Figure 22. -- Kanuti River near Bettles, July 13, 1977.
AIR PHOTO TECH

1977 Surveillance.--Figure 22 shows the Kanuti River crossing site on July 13, 1977. The site was resurveyed on September 19, 1977. During the last year, protective dikes have been constructed on both banks of the centerline cross section. In addition, grading has changed the bank's profile, but that of the stream remains unchanged. There were no significant changes in either the upstream or downstream cross section.
