UNITED STATES
DEPARTMENT OF THE INTERIOR
GEOLOGICAL SURVEY

CHANNEL EROSION SURVEYS ALONG THE TAPS ROUTE,
ALASKA 1977

OPEN-FILE REPORT 78-611
(Basic Data)

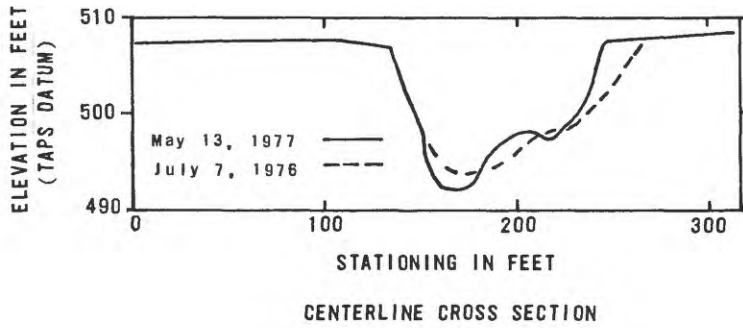
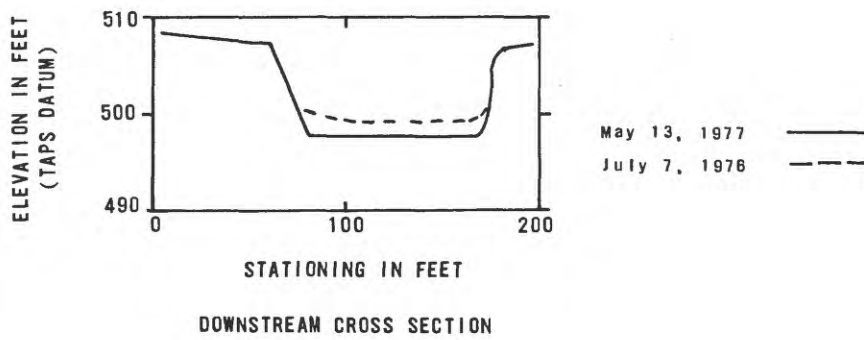
Figure 26. -- Cross sections of the Chatanika River near Olmes.

The site was resurveyed on May 13, 1977. No significant change was found at the upstream cross section, but the downstream and centerline sections both displayed marginal deepening of their thalwegs (fig. 26).

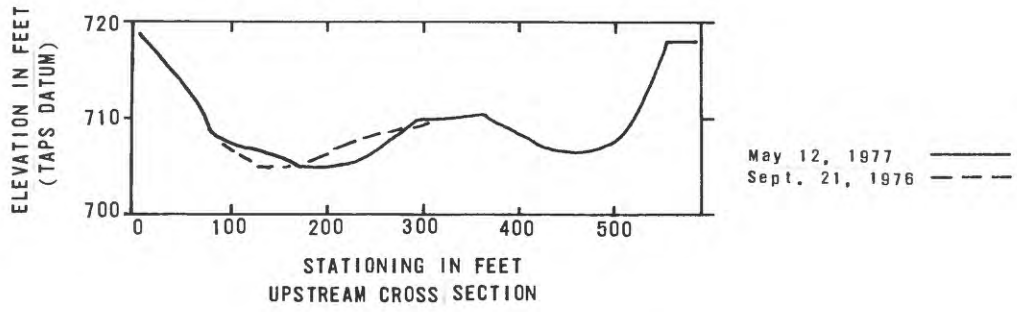
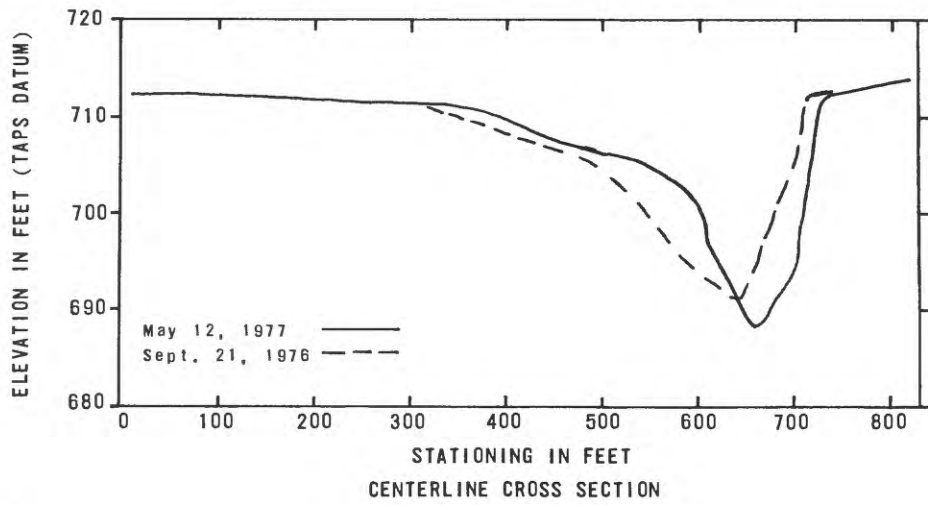
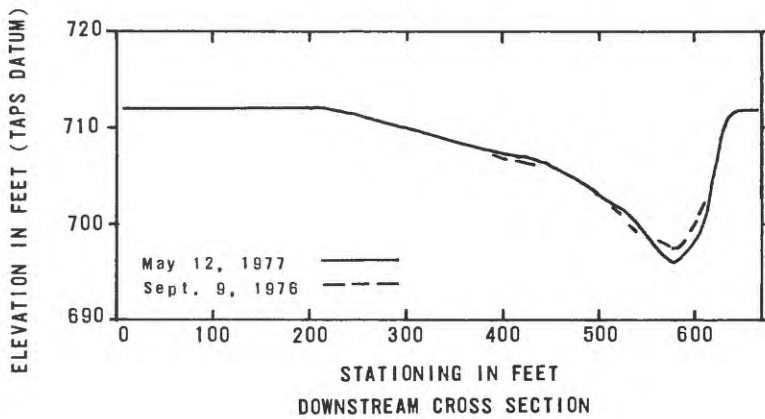
Figure 28. -- Cross sections of the Salcha River near Salchaket.

1977 Surveillance.--Figure 27 shows the Salcha River crossing on July 13, 1977. The site was resurveyed on May 12, 1977. The river at this site continues to be active; changes were found in all three cross sections. In each case the right bank has been eroded. The most dramatic effects occurred at the centerline where over 10 ft of lateral erosion and over 6.2 ft of vertical scour (fig. 28) were measured during the breakup flood. The peak of the flood occurred on May 19. It was measured as 11,500 ft³/s at the Salcha River gage near Salchaket, and is considered a moderate flood.

Taken together, the three cross sections indicate that the meander has widened during the last year, continuing a trend noted in 1974.

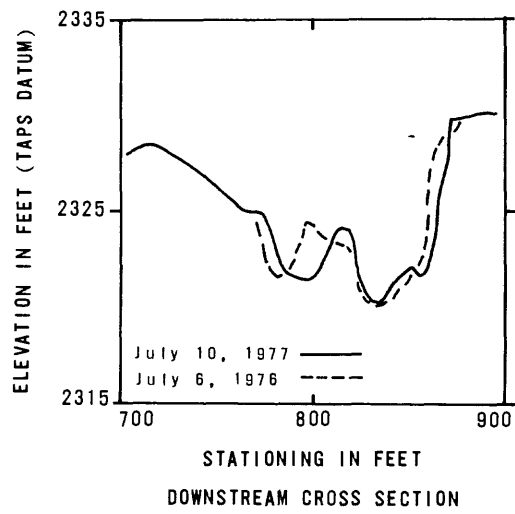
Figure 30. -- Cross section of Flood Creek near Rapids.

There were no significant changes in either the upstream or centerline cross sections except for a berm construction on the centerline 250 ft southeast of Flood Creek. The only noticeable difference in the downstream cross section is that the channel has moved approximately 8 ft northwest (fig. 30).

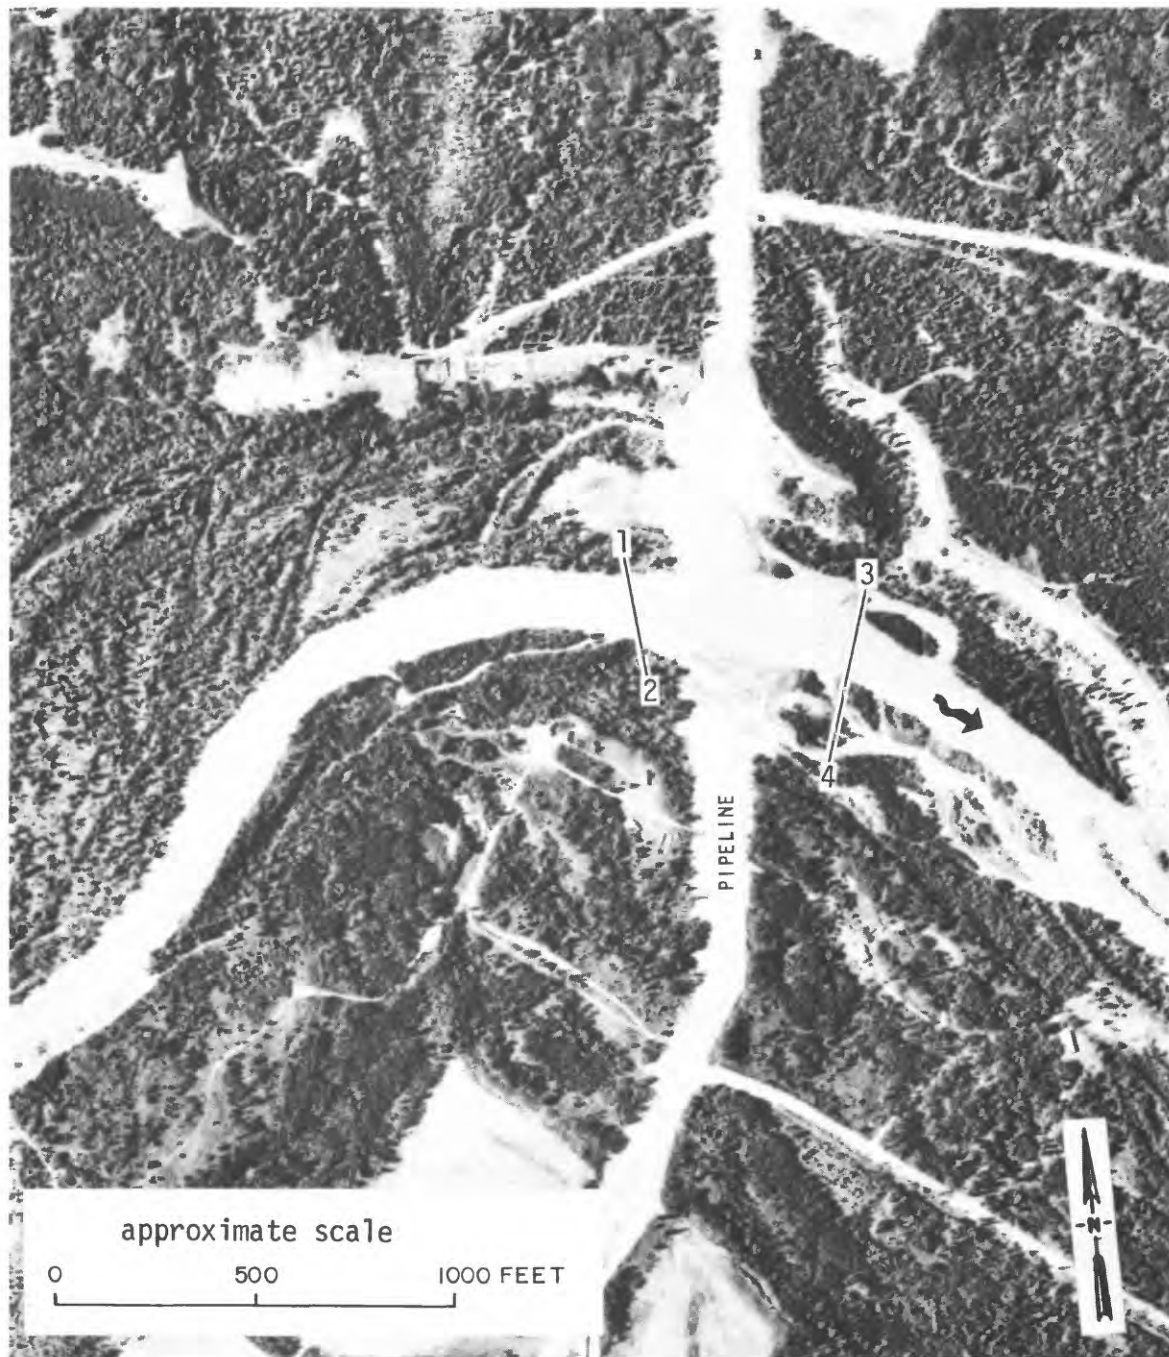
Figure 37. -- Klutina River near Copper Center, July 29, 1977.

1977 Surveillance.--Figure 37 shows the Klutina River site on July 29, 1977.
Comparison of the 1976 and 1977 photography, and a visual inspection
made on September 23, 1977, indicate that no significant change has
occurred. No cross sections were measured.

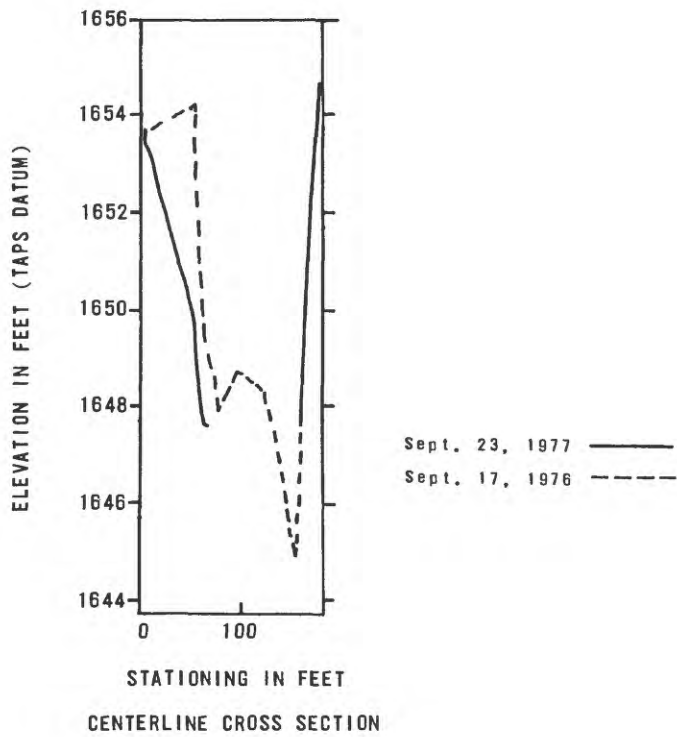
Figure 39. -- Cross section of the Tonsina River near Tonsina.

This site was resurveyed on September 23, 1977. No significant changes were found in either the upstream or downstream cross sections, but the centerline section was found to have widened slightly (fig. 39).

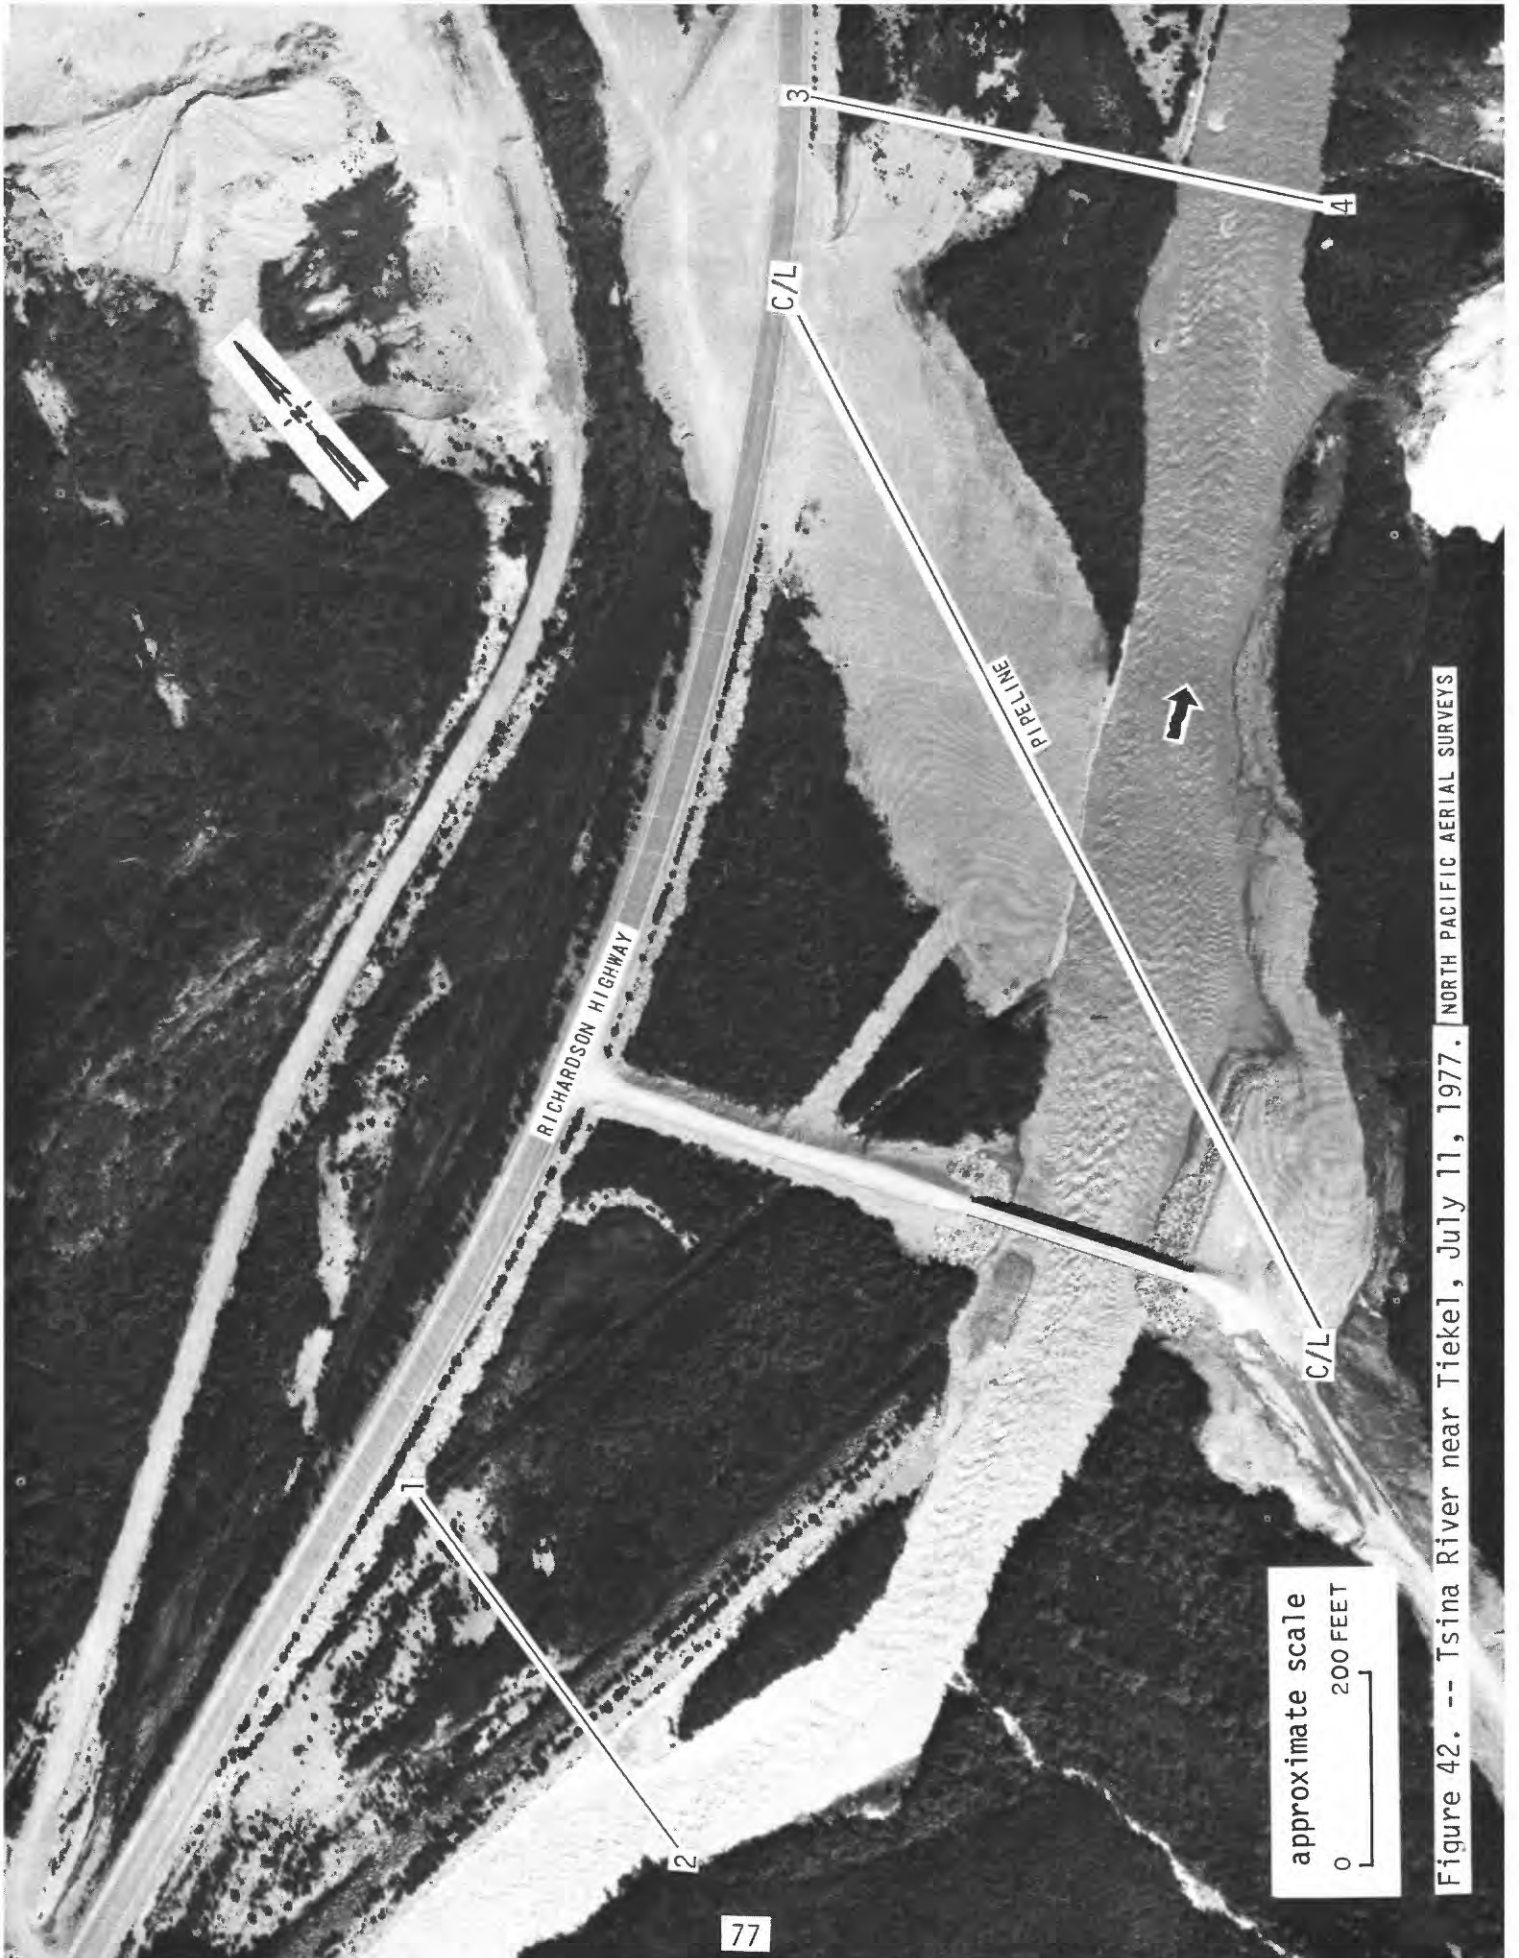
Figure 42. -- Tsina River near Tiel, July 11, 1977. NORTH PACIFIC AERIAL SURVEYS

1977 Surveillance.--Figure 42 displays the Tsina River near Tiekel crossing site on July 11, 1977. The crossing was resurveyed photogrammetrically on that date and was visited in September. Except for a dike constructed across the right bank of the centerline, no significant changes were found in any of the three cross sections.

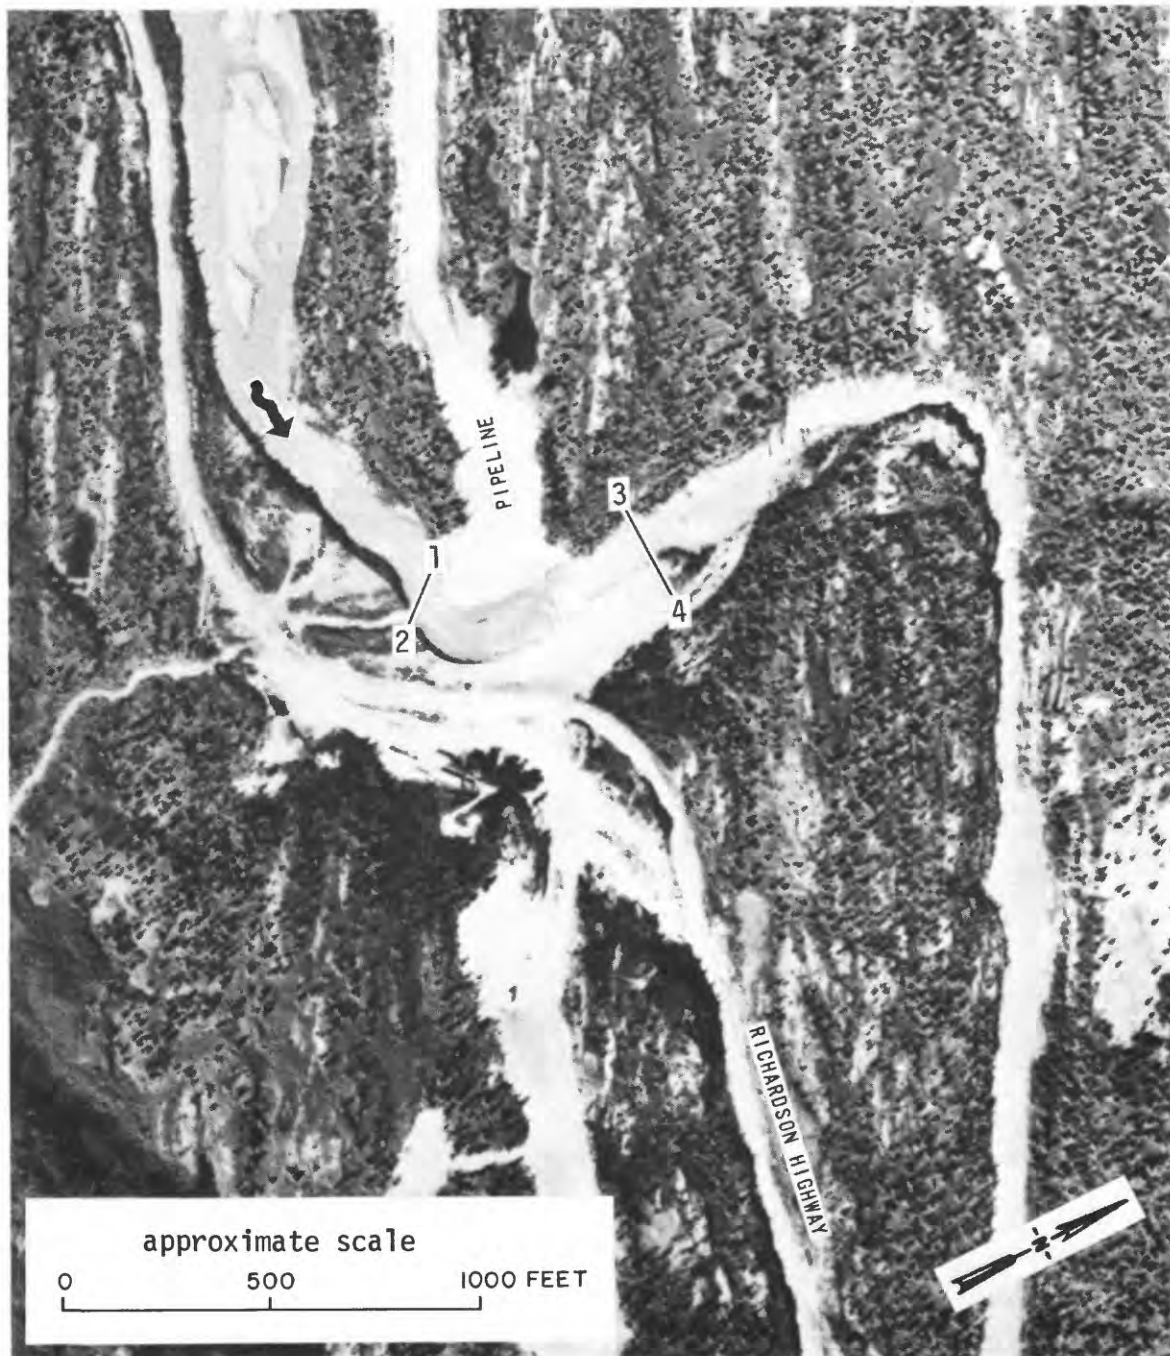
Figure 43. -- Tsina River near Ptarmigan, July 11, 1977. AIR PHOTO TECH

1977 Surveillance.--Figure 43 shows the Tsina River near Ptarmigan crossing site on July 11, 1977. This crossing was resurveyed on September 22, 1977. During the past year, the reference points for the upstream crossing have been destroyed, and the cross section could not be exactly resurveyed. A new upstream cross section was therefore established. Its shape and on-site visual observations indicate that there has been no significant change in this cross section. No changes have been noted in either the centerline or downstream sections since the site was established in 1973.

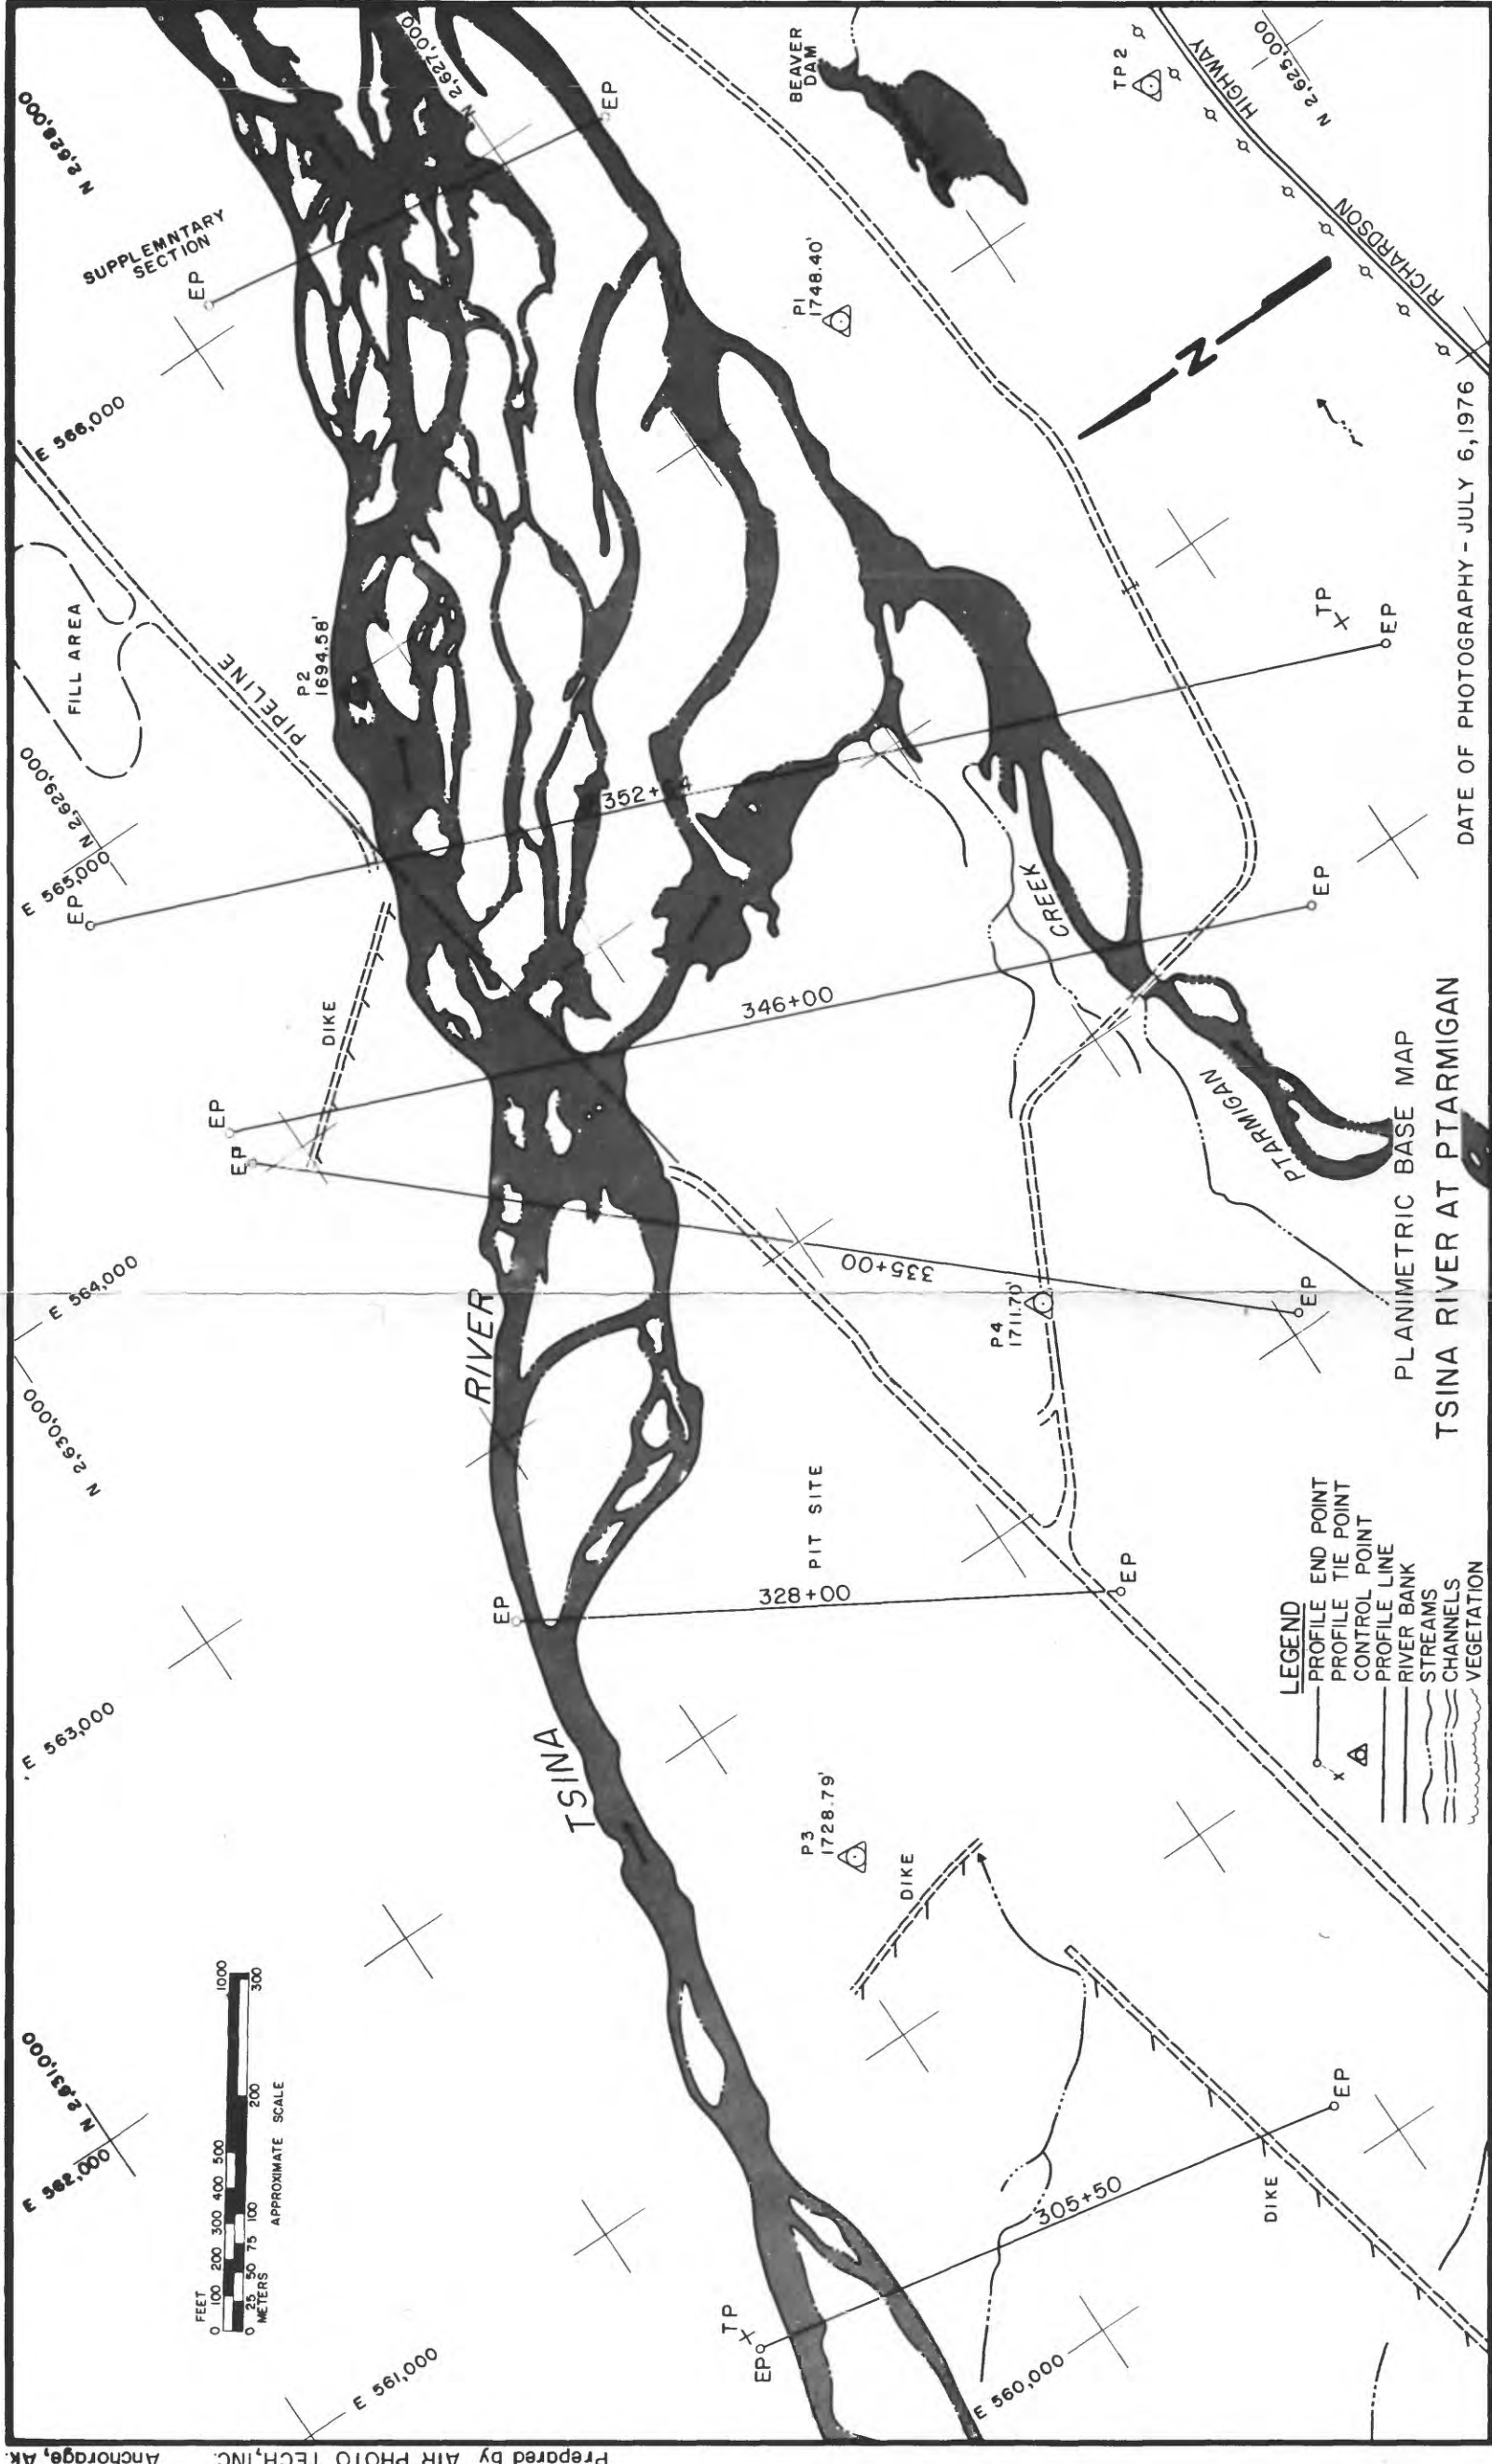
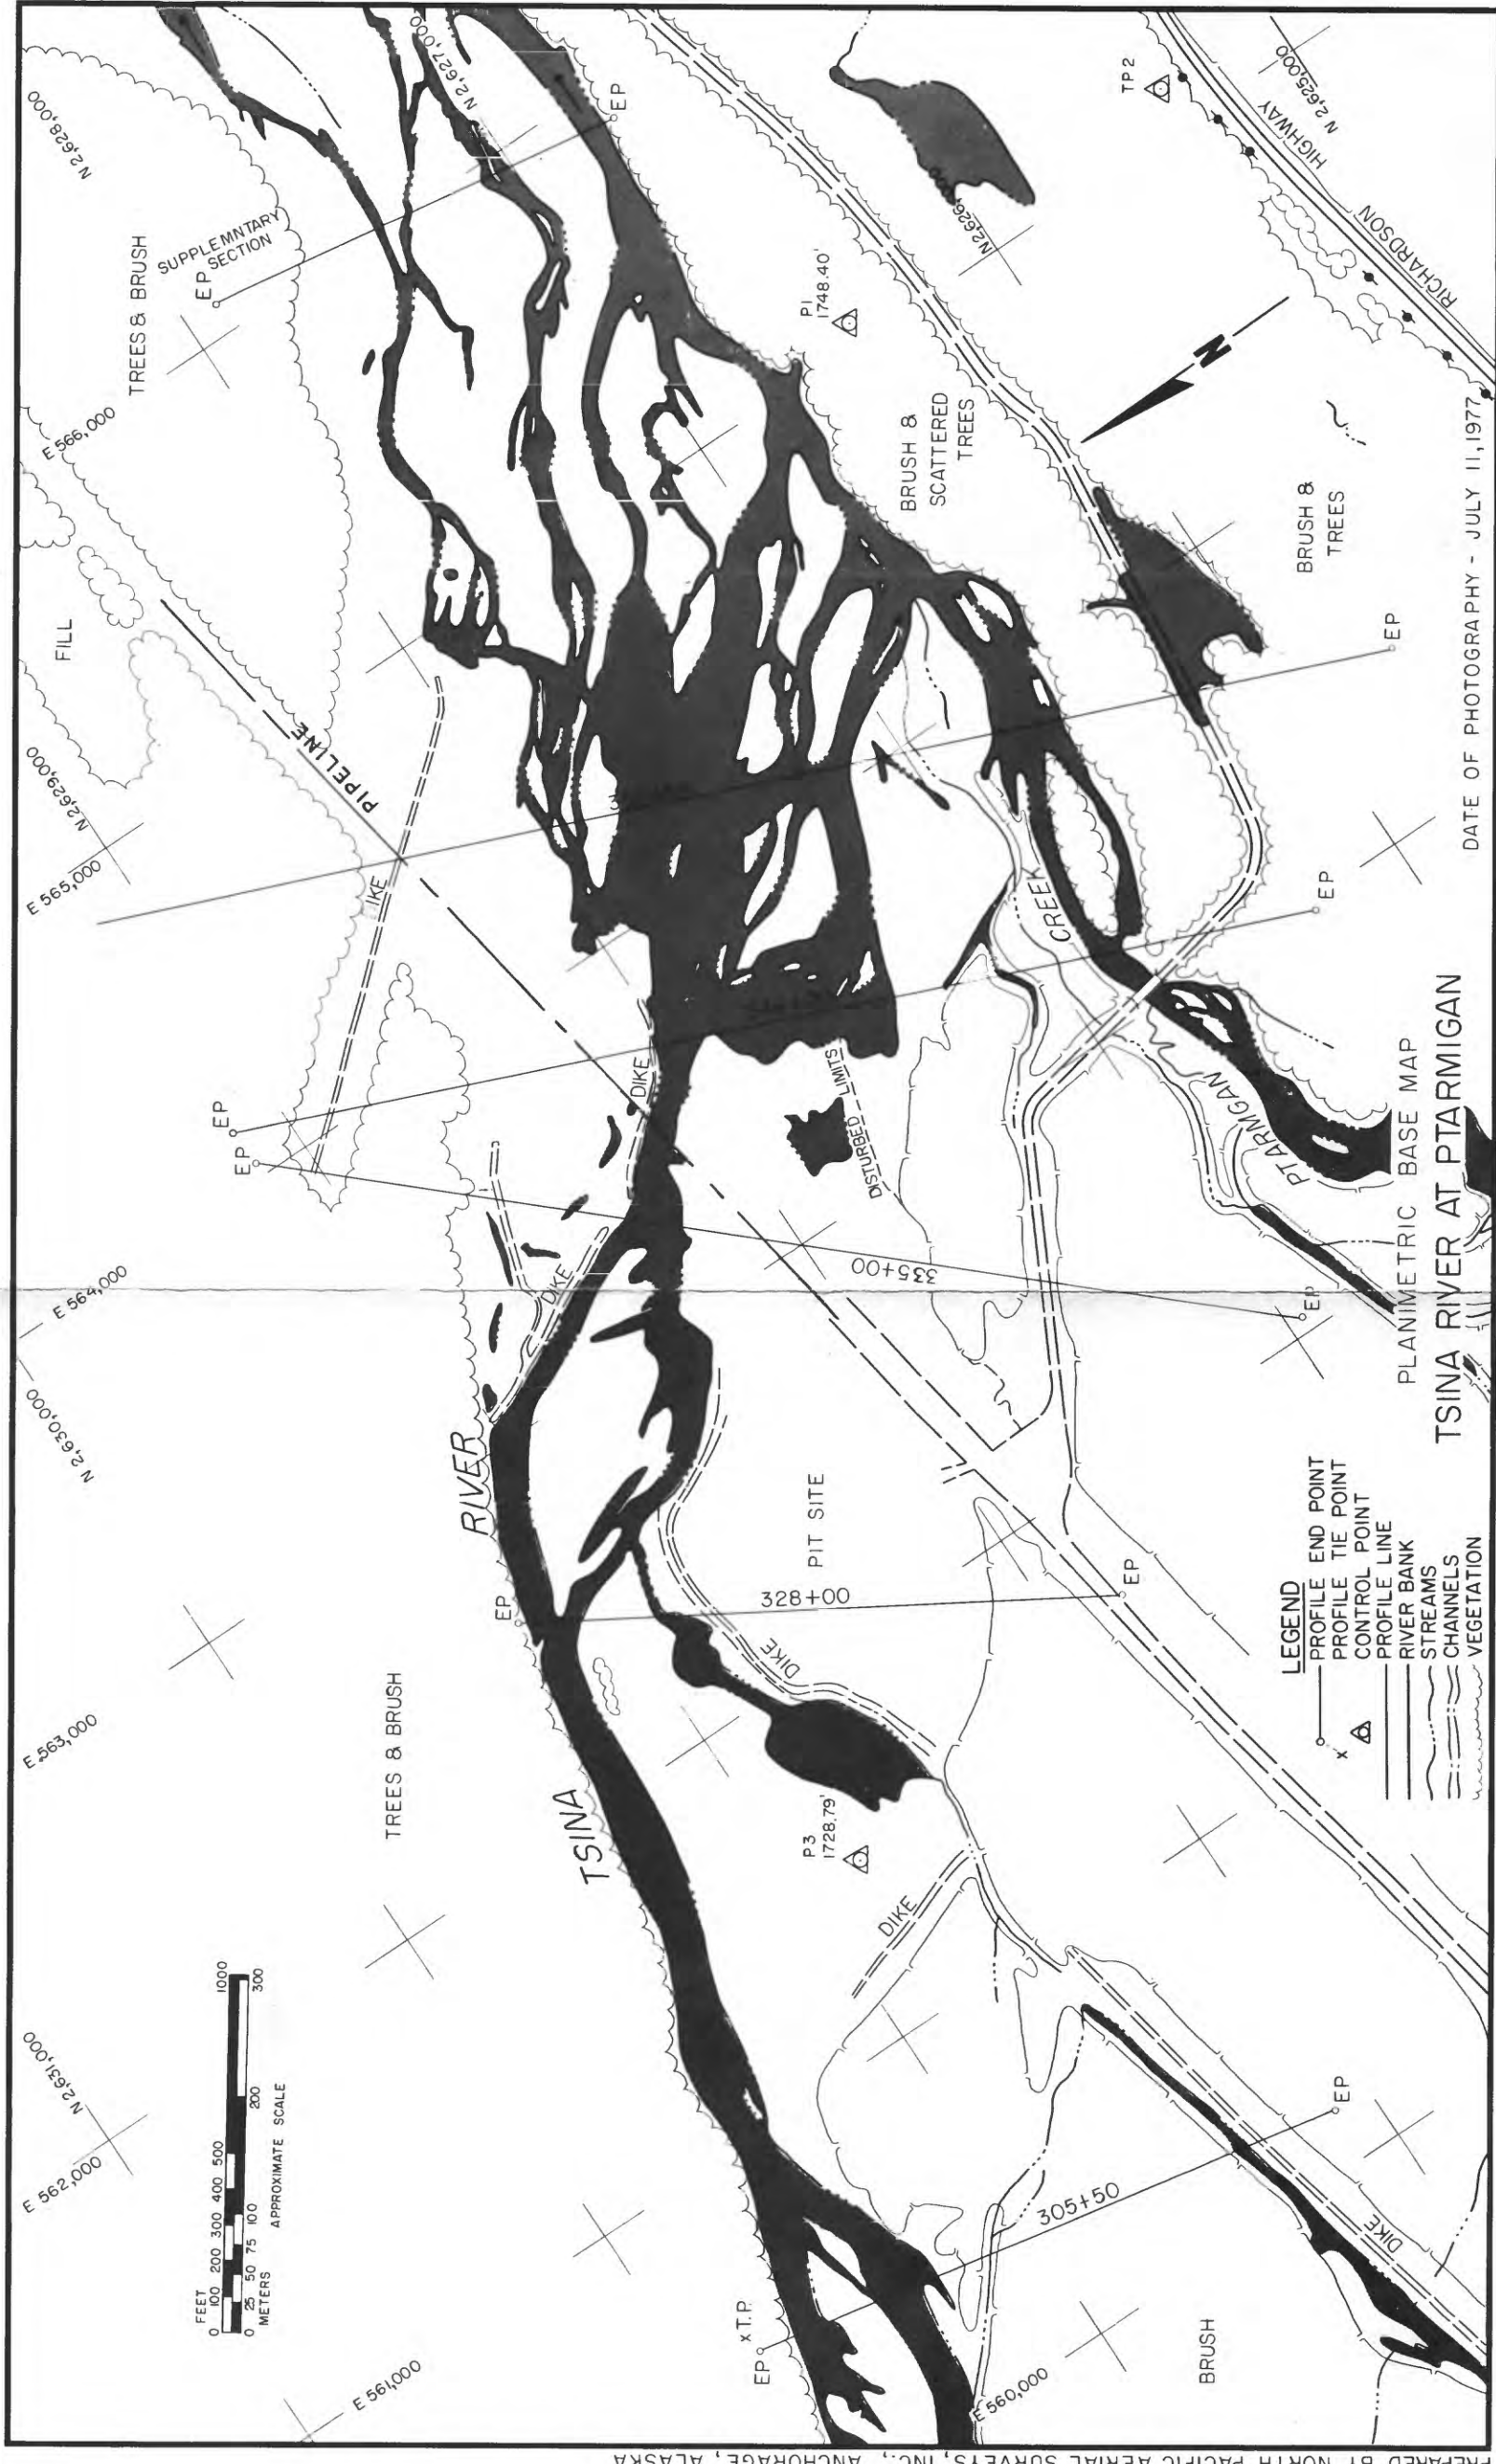
Figure 45a. -- Planimetric map of the Tsina River at Ptarmigan, July 6, 1976.

There has been no significant change in the channelway of the 305+50, 328+00 and 335+00 cross sections, but the big stockpile of gravel on the right side of the channel just north of the centerline has been removed since 1976. Cross sections 346+00, 352+64 and the supplementary section have changed considerably. However, the channels are within the major banks of the stream, and no significant erosion of vegetated area or the flood plain has occurred (fig. 45 a and b).

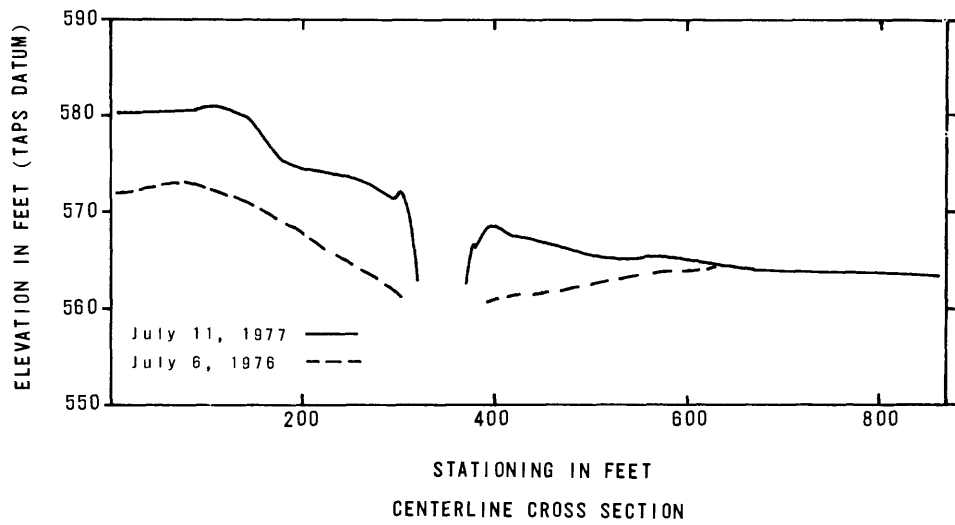
Figure 47. -- Cross section of Sheep Creek near Valdez.

No significant changes were found in either the upstream or downstream cross sections. Figure 47 displays changes made by construction equipment on the centerline in the last year.
