UNITED STATES
DEPARTMENT OF THE INTERIOR
GEOLOGICAL SURVEY

CHANNEL EROSION SURVEYS ALONG THE TAPS ROUTE,
ALASKA 1977

OPEN-FILE REPORT 78-611
(Basic Data)

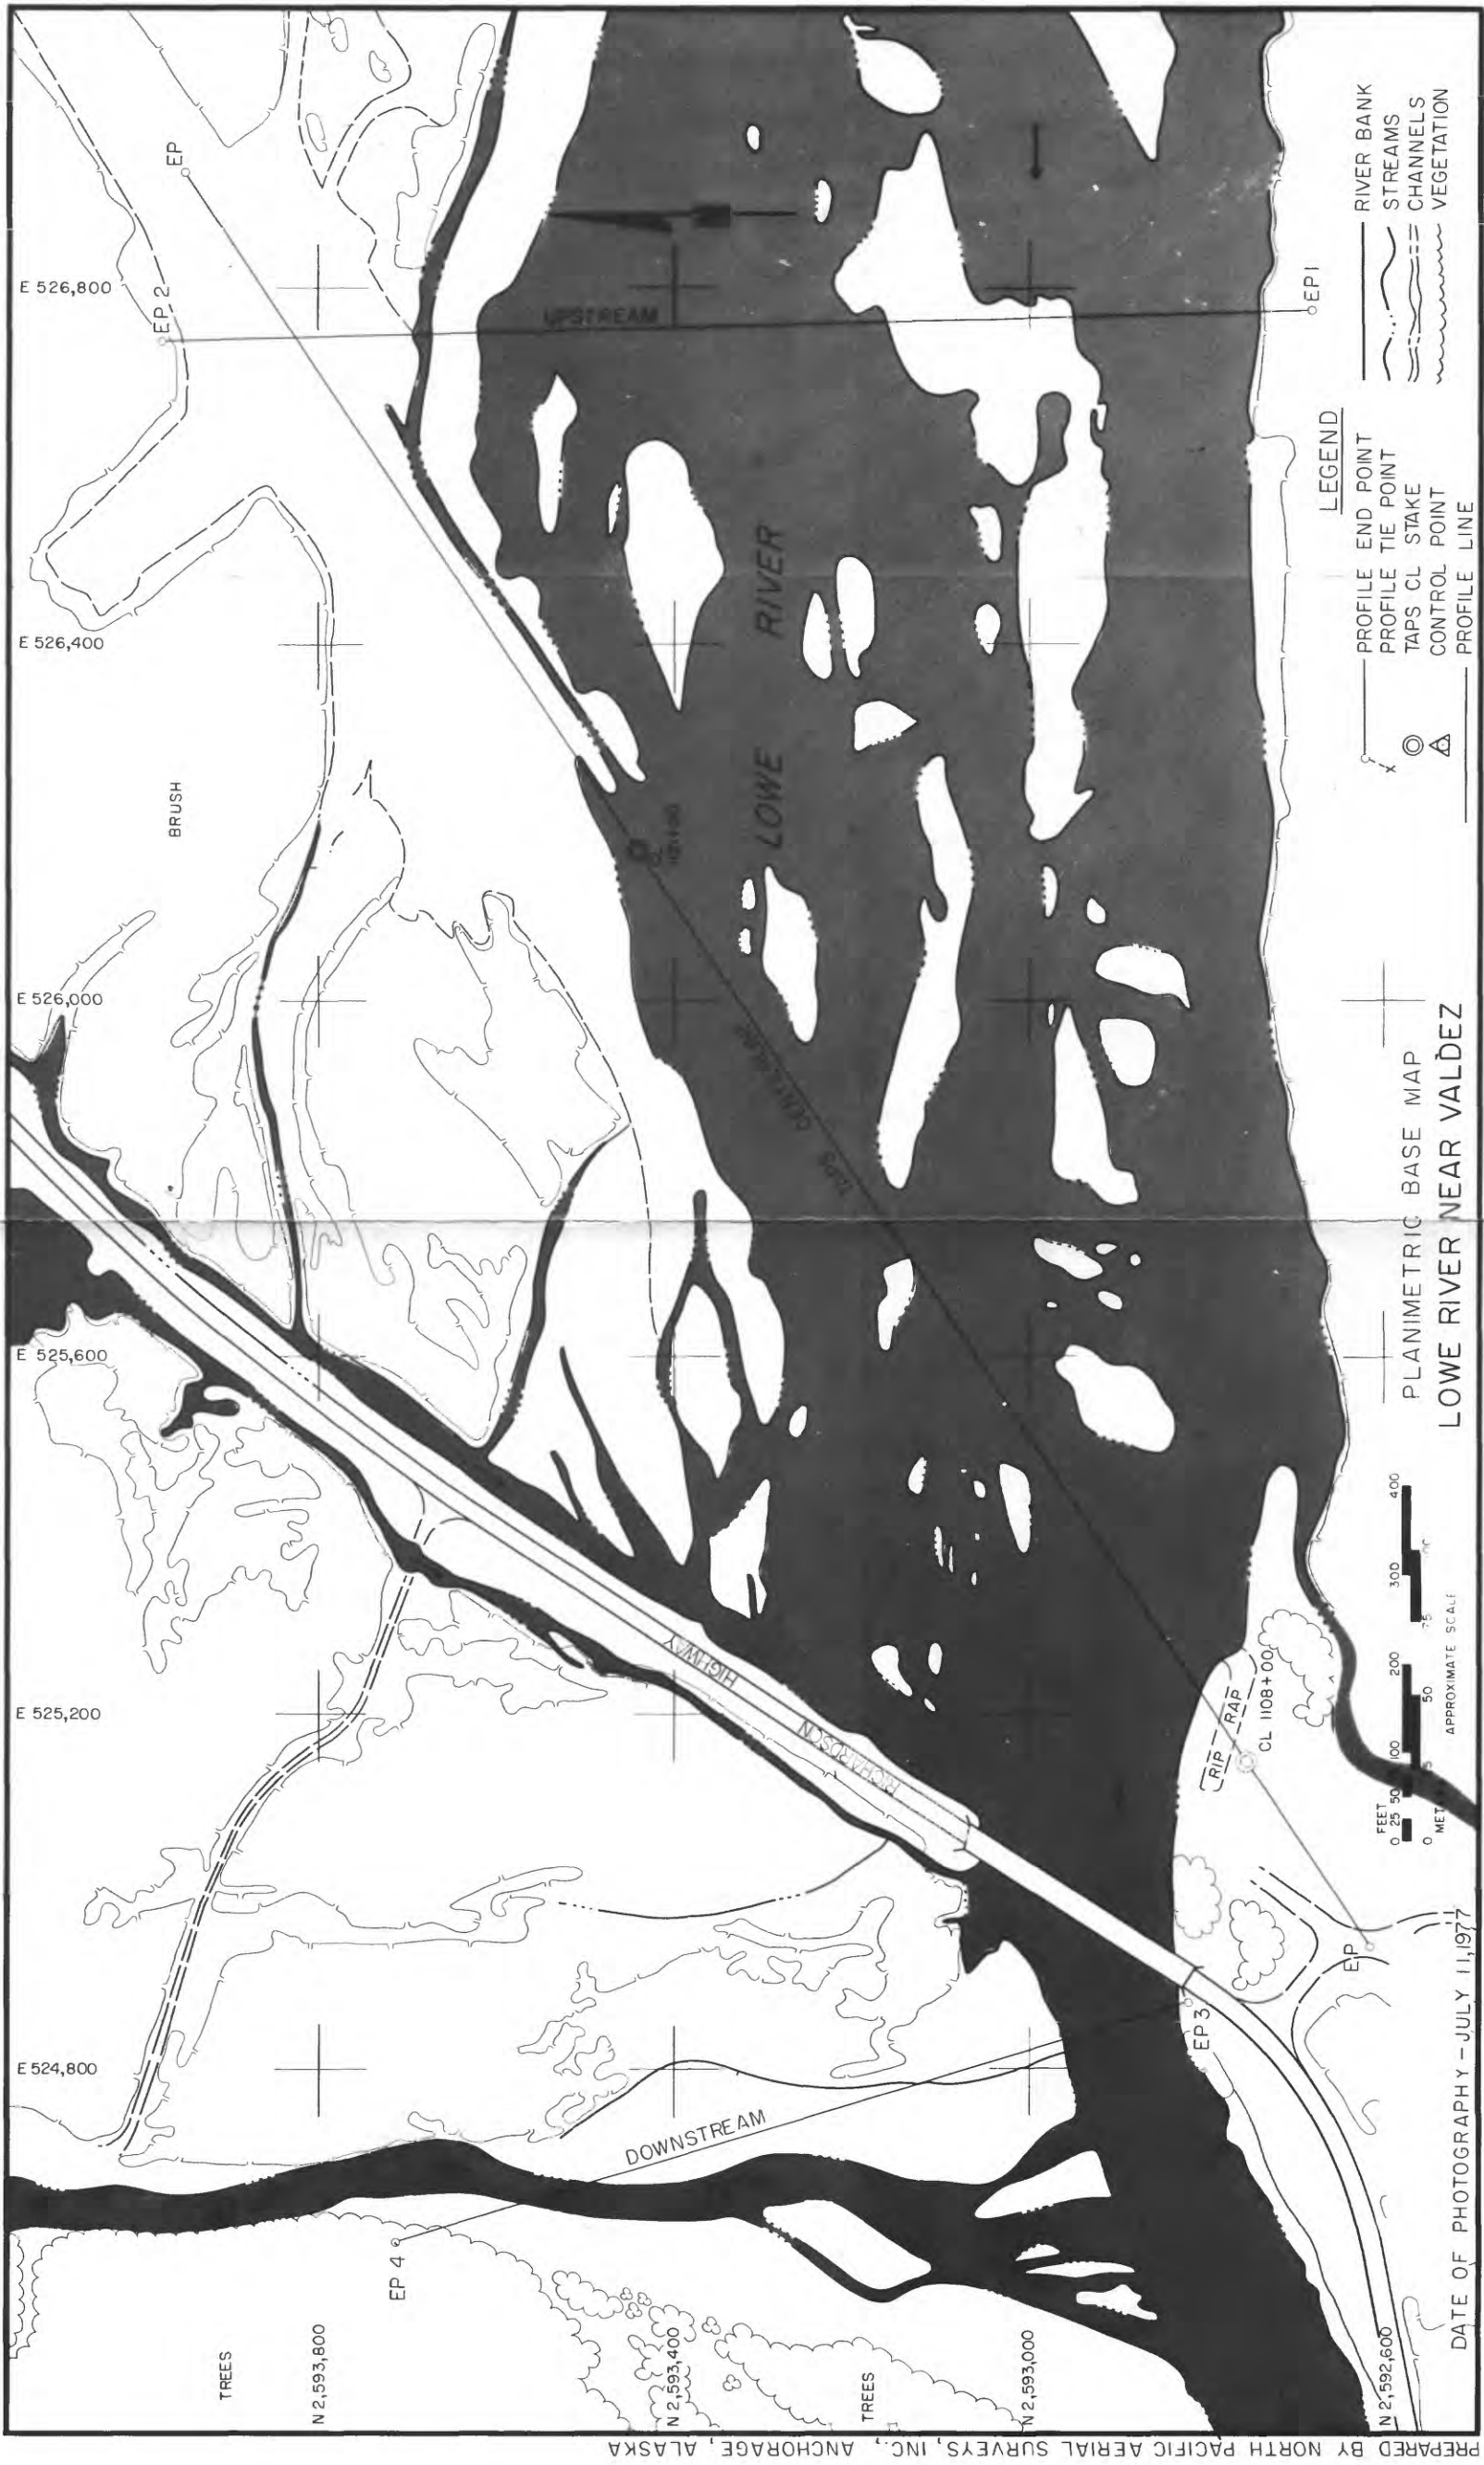
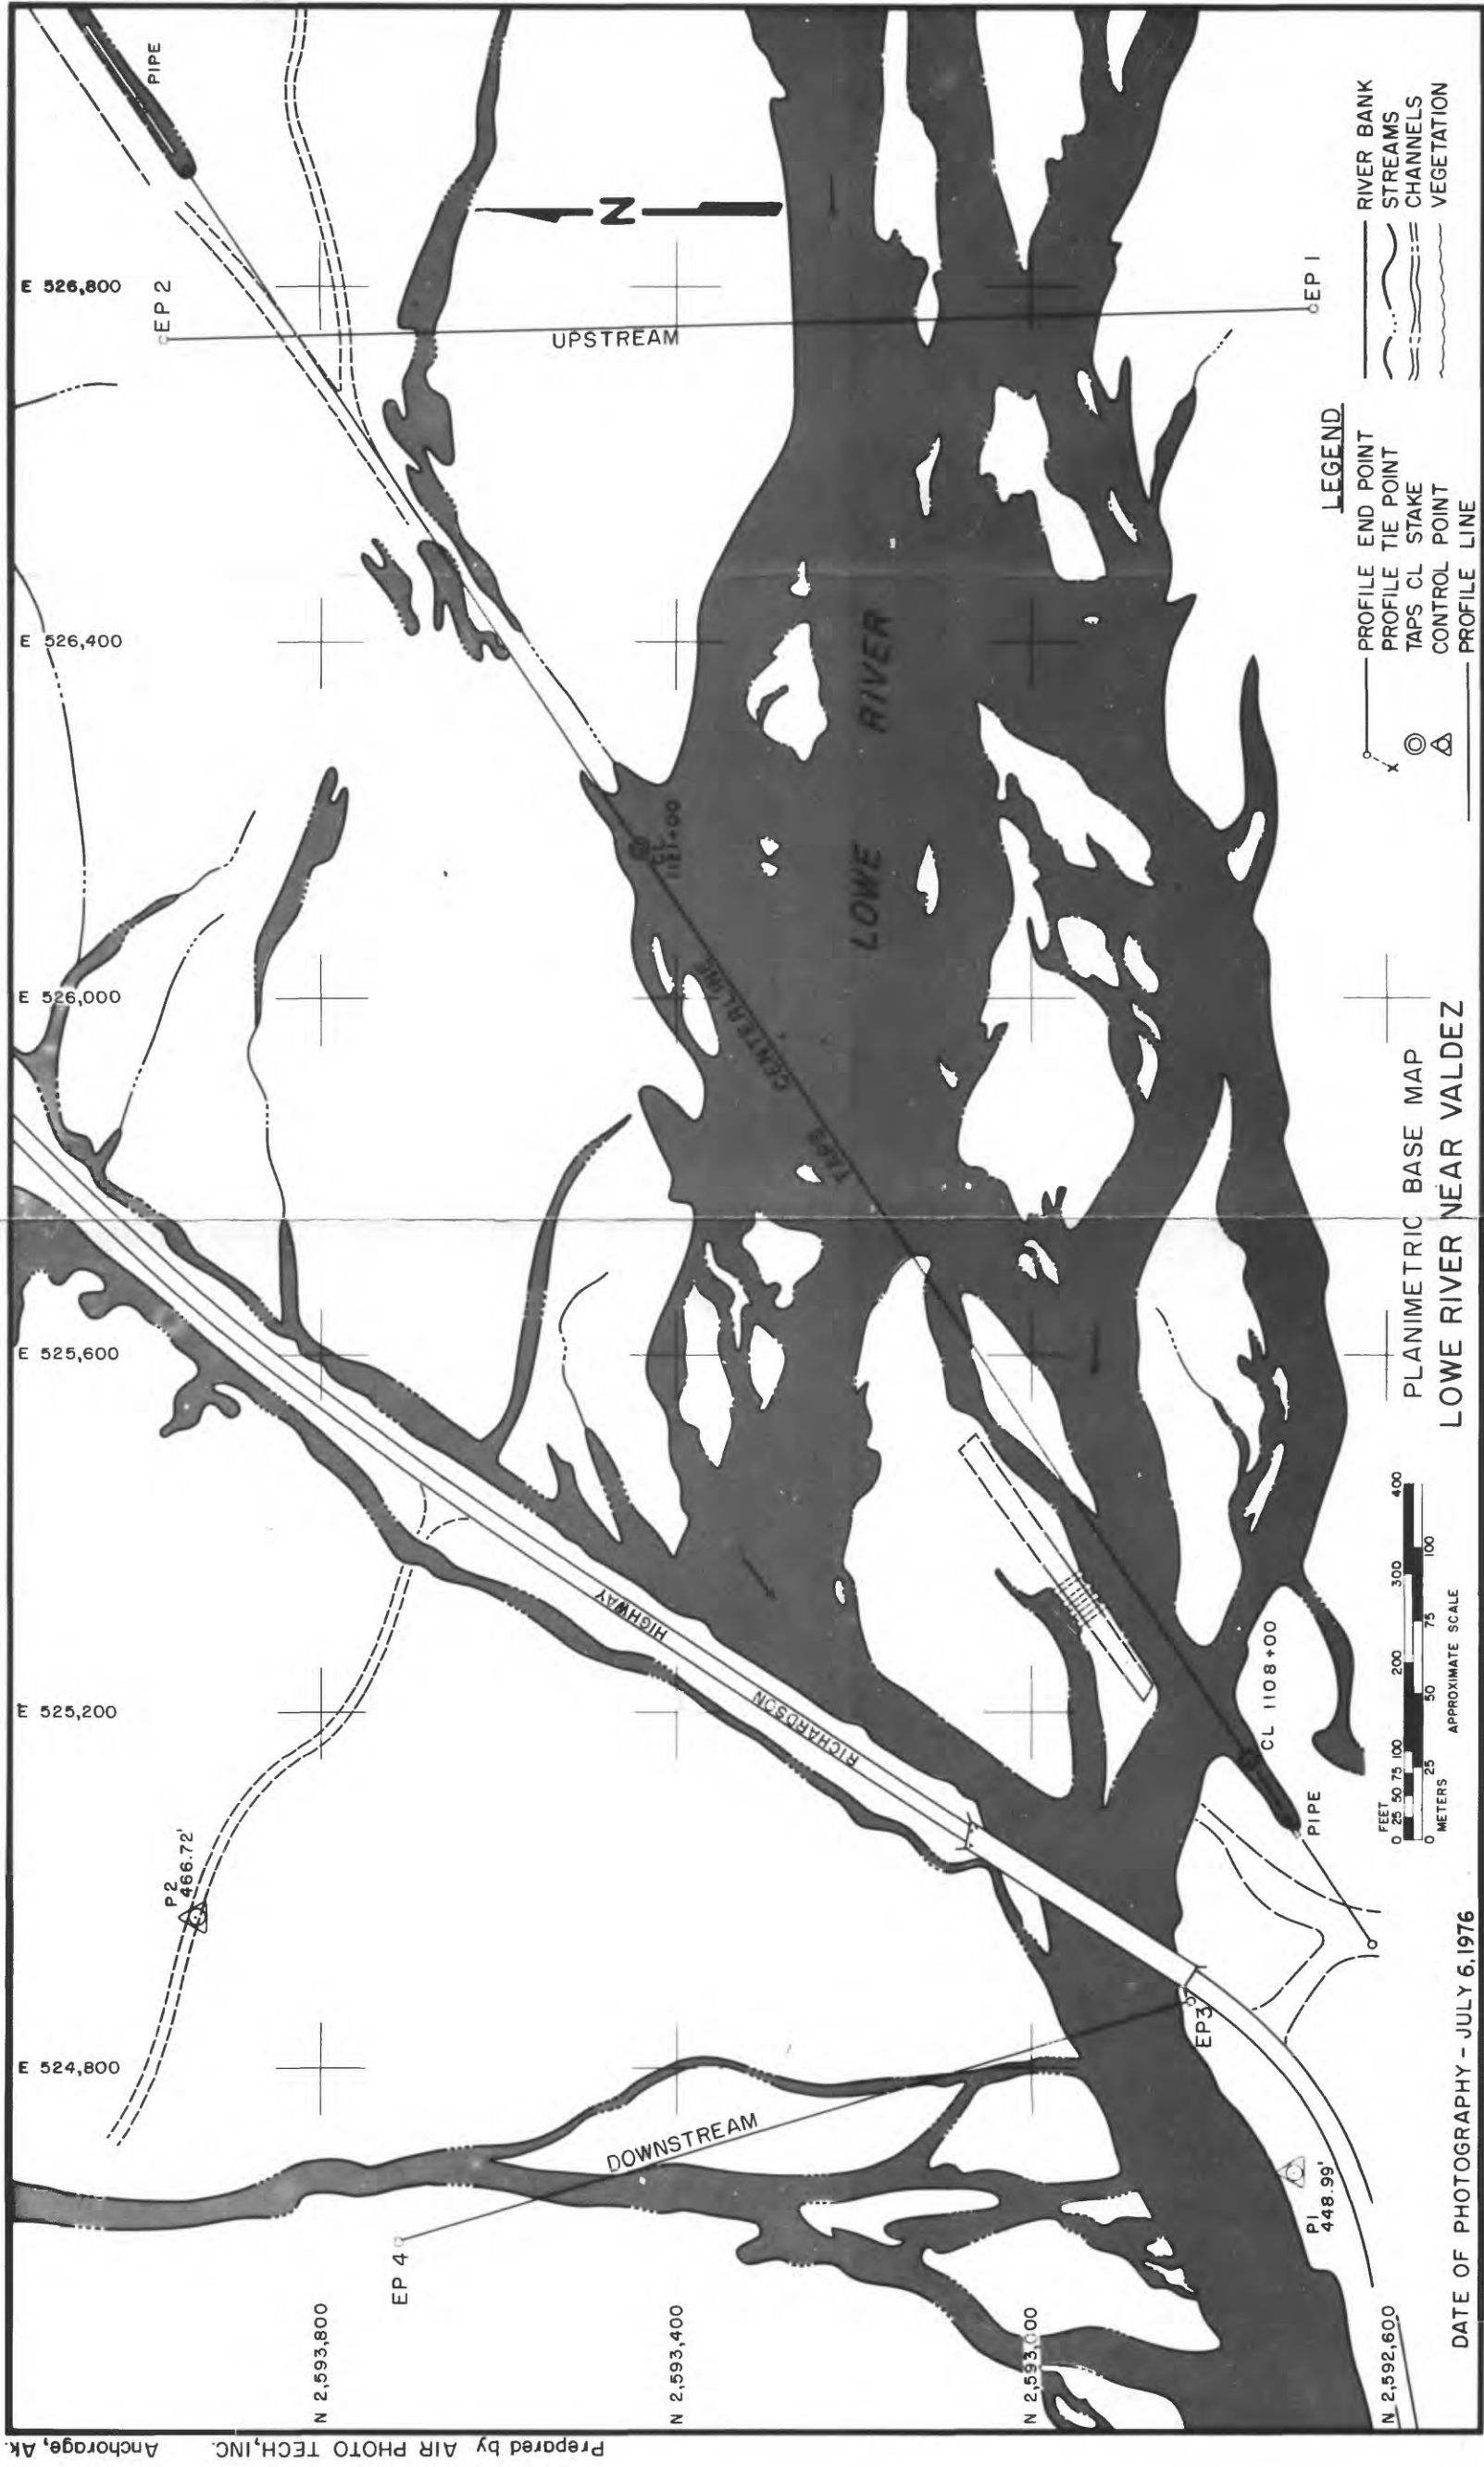
Figure 49a. -- Planimetric map of the Lowe River near Valdez.

No significant change was found in the downstream cross section, but high water has covered the flood plain along the right bank at the upstream section. During the last year, the left bank of the centerline has been backfilled and a rip-rap dike has been constructed at the shore. This changed the profile of the left bank at the centerline, but the remainder of the cross section is identical to the last year's (fig. 49).
