DEPARTMENT OF THE INTERIOR
UNITED STATES GEOLOGICAL SURVEY

GEOLOGIC ROAD LOG
ALYESKA HAUL ROAD, ALASKA
JUNE-AUGUST, 1975

OPEN FILE REPORT
79-227

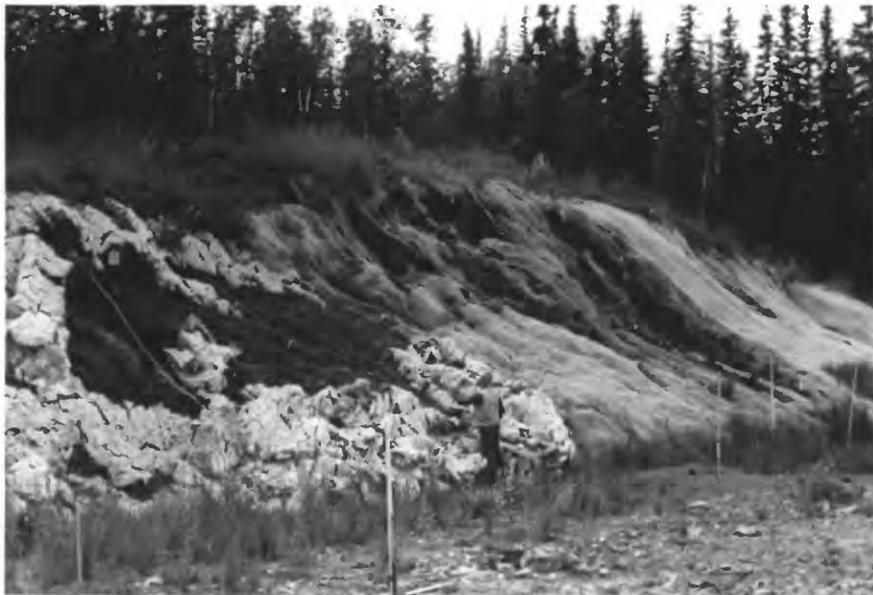
*8	94.2	Road crosses valley of unnamed tributary to Richardson Creek. Roadway wet and slightly rutted on June 23; dry and firm on August 1.
*9	94.7	Cut 10 m deep in organic silt. Although sprayed with plastic foam and partly vegetated, cut still slumping and flowing on August 1 due to thaw of ice-rich permafrost (Fig. 1).
*10	99.4	Probable solifluction slope along west side of road. Some soil flowage into roadside ditch, but condition of roadway is excellent.
*11	104.8	Cut along east side of road showed local minor gullyng on June 23 but appeared stable on August 1.

Figure 1. Destruction of insulating plastic foam by slump and flowage into road cut, Mile 94.6 (Site 9), August 1, 1975.

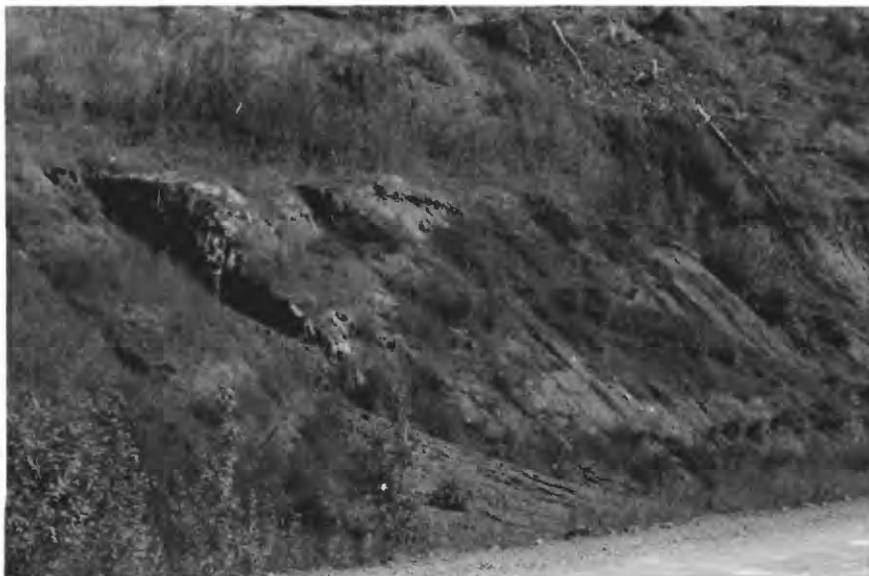
Figure 2. Gullies in cut at Mile 108.5 (Site 13). August 1, 1975.

Site No.	Mileage	Description
12	107.7	Several faults evident in stable bedrock cut.
*13	108.5	Cut severely gullied near north end, with debris cones filling roadside ditch in several places. Cut had become largely stabilized by August 1, and was about 50% vegetated with only 1 gully still active (Fig. 2).
*14	116.7-116.9	Probable solifluction slope along west side of road. Some soil flowage into roadside ditch.
15	116.9-118.2	Road descends steep grade into valley of Isom Creek. Cuts along west side of roadway expose as much as 25 m of bedrock and 10 m of loess and weathered rock. All cuts stable except for minor surface spalling and shallow gullying on June 23. On August 1, silt exposures were still spalling slightly, but debris aprons at their bases were becoming vegetated.
*16	122.7	Trough over a subsided culvert was observed on June 23. No trace of the problem remained on August 1.
*17	128.3-129.4	Steep descent down bluffs south of the Yukon River. Series of cuts 6-15 m deep expose silt above occasional bedrock. Faces of cuts showed minor slumping and flowage on June 23, but most cuts were stable and partly vegetated by August 1. Although a few cuts were still retreating by shallow slumping and gullying on August 1, roadway and cuts were generally in good condition.

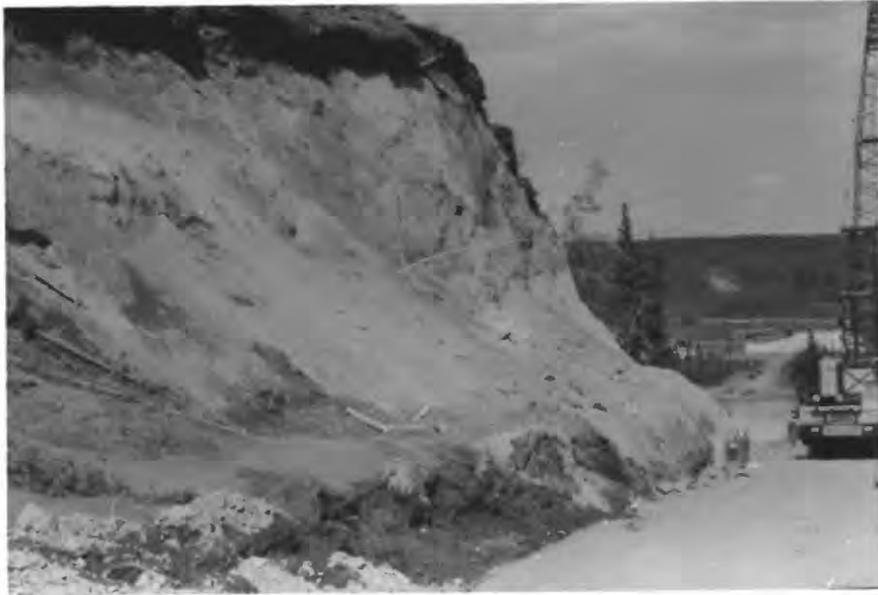
Figure 3 (above). Cut into silt and bedrock at south abutment of Yukon River bridge (Site 20). August 1, 1975.

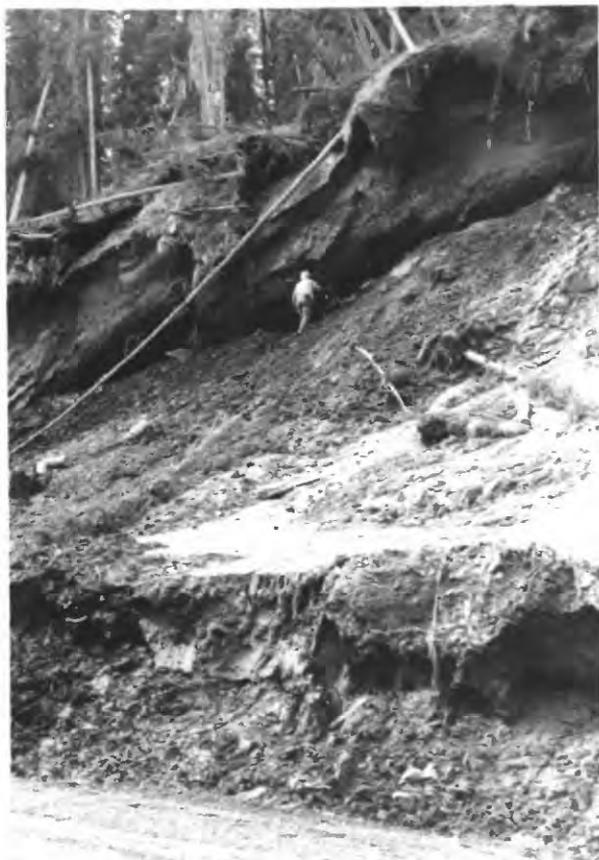
Figure 4 (left). Ice-rich silt immediately south of area shown in Figure 3. Permafrost is thawing rapidly, causing retreat of vertical face and accumulation of debris slope at its base. August 1, 1975.

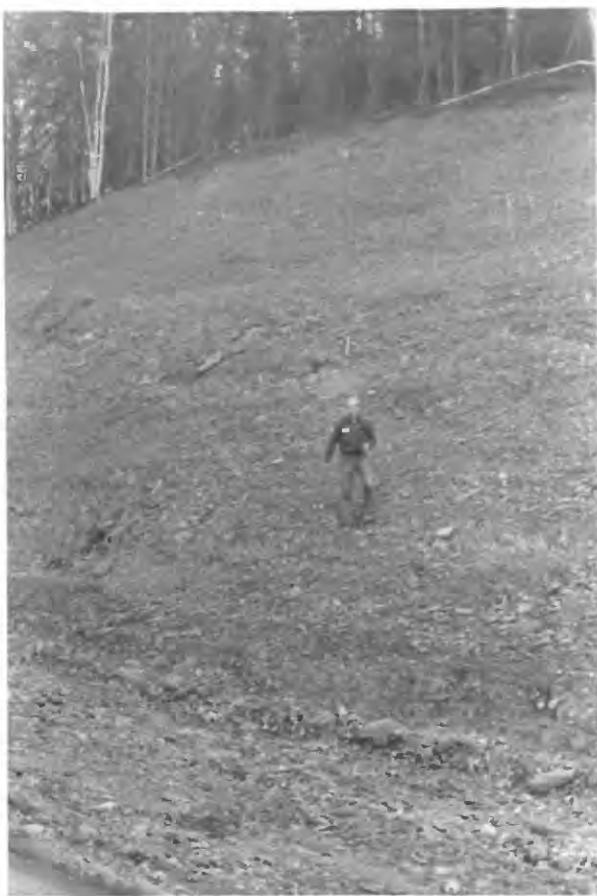
Figure 11 (left). Road cut through shattered bedrock at Mile 15.4 (Site 30). June 24, 1975.

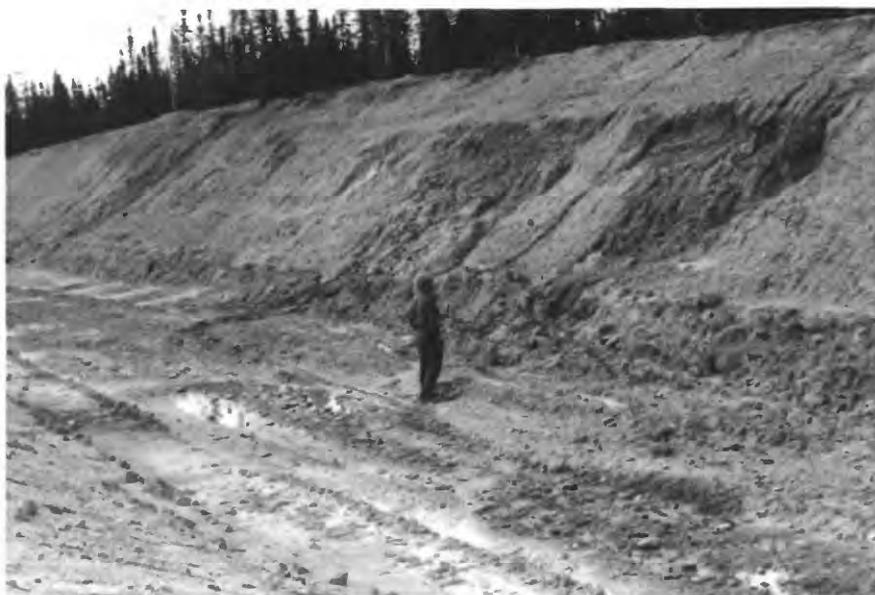
*32	18.4	Minor siltation in ditch along east side of road on June 24; apparently derived from road subgrade. Continued minor sloughing of road edge evident on August 1.
*33	18.8	Cut 6 m deep along both sides of road has been graded back and badly smeared. Appears to consist of silt and sand above oxidized sandy grus. Minor flowage and gullying of cut faces on June 24, and both ditches were somewhat gullied. No problems noted on August 1.
34	19.2	Cut through ridge crest exposes grus over granitic rock with possible thin gravel cap (too smeared to be certain). Natural ground surface very stable.
35	20.1	Cut through ridge crest exposes 4 m of subrounded to sub-angular fluvial gravel up to 5 cm in diameter. Upper 0.5 m is oxidized.
*36	21.0	Cut into alluvial terrace exposes sand and granules above gravel. Some gullying evident on August 1, with sloughing into roadside ditch which contained standing water in places (Fig. 12).

Figure 12 (below). Unstable road cut in alluvium at Mile 21.0 (Site 36). August 1, 1975.

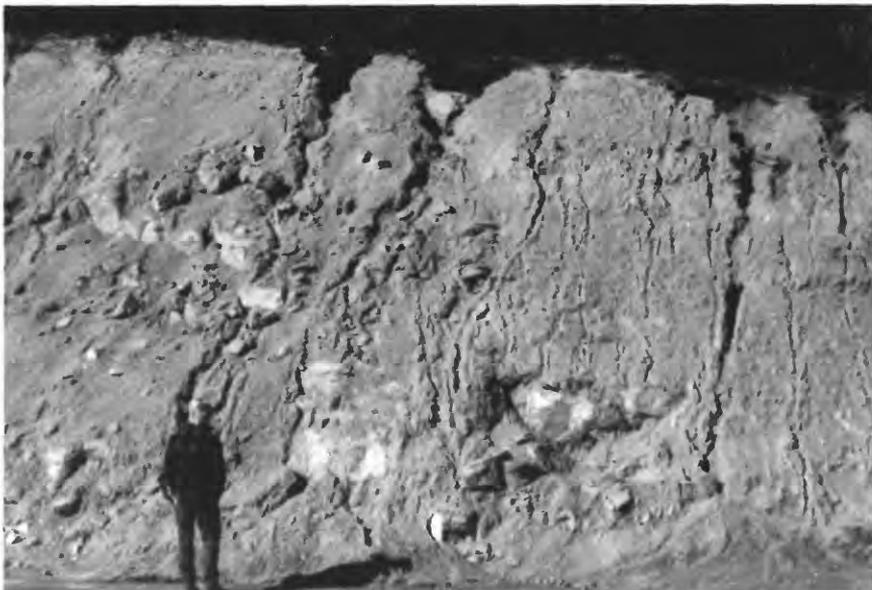
Figure 14. Gullies eroded into road cut near Old Man Camp (Site 46). August 1, 1975.

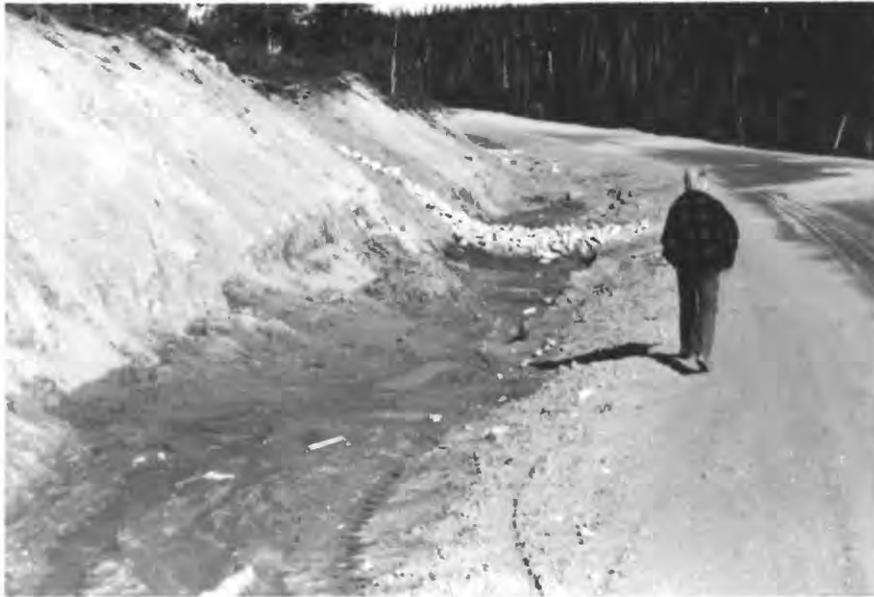
Figure 15. Wet, debris-filled ditch near Old Man Camp (Site 46). August 1, 1975.

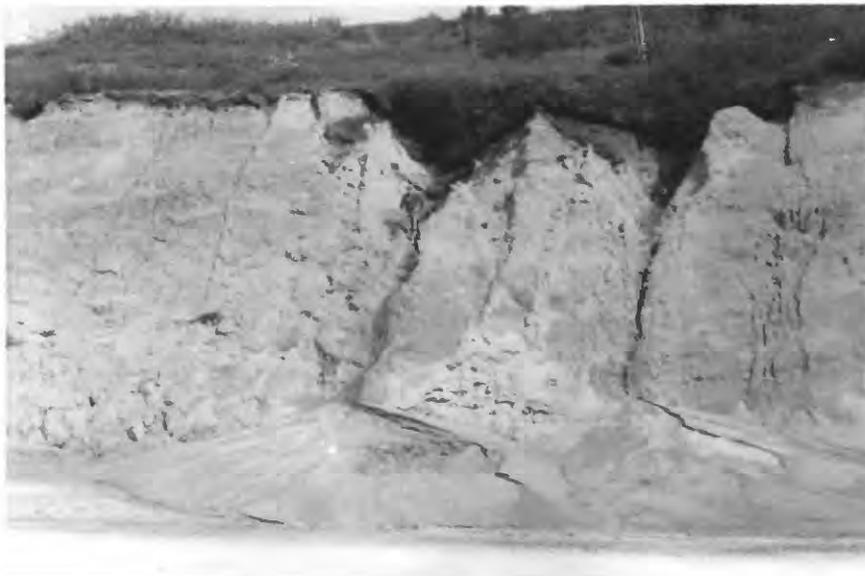
*47	56.2	Cuts 6 m deep along both sides of road expose grus over granite and volcanic rocks. A deep swale fill consisting of arkosic sand has been deeply dissected by gullying at Mile 56.9 (Fig. 16).
*48	59-60	Probable solifluction slope west of road. No evident effect on roadway, but drainage was ponded against road in several places on June 24.
49	61.0	Road crosses Fish Creek.

Figure 16. Large gullies and fans on road cut at Mile 56.9 (Site 47). June 24, 1975.

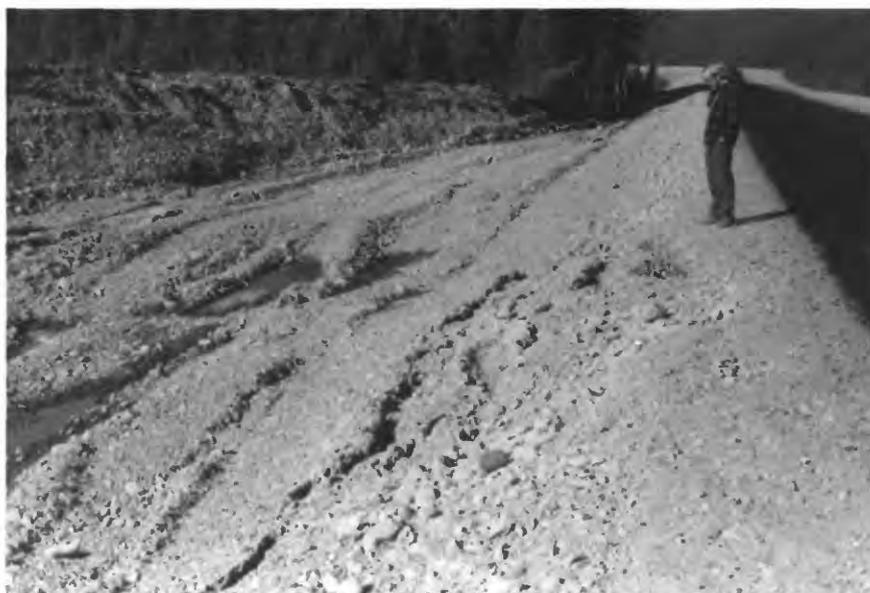
Figure 18. Sloughing of road edge into ditch at Site 58. August 1, 1975.

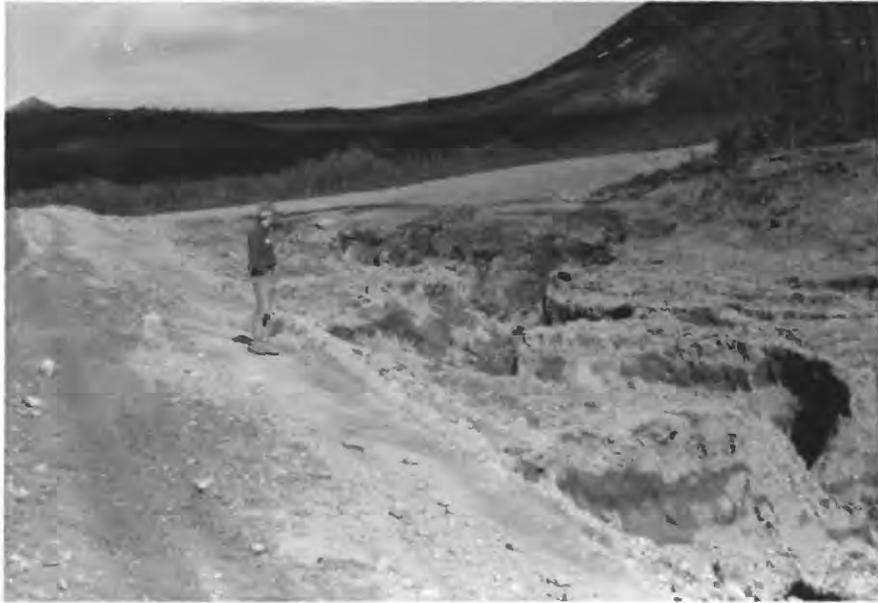
Figure 21. Gully erosion in roadside ditch at Site 71. June 24, 1975.

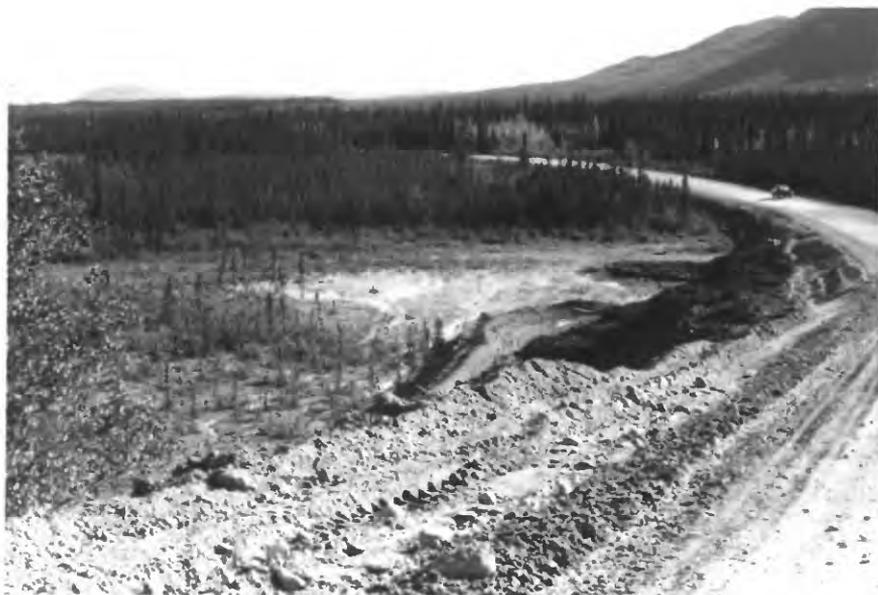
Figure 22. Siltation at base of road grade, Site 71. June 24, 1975.

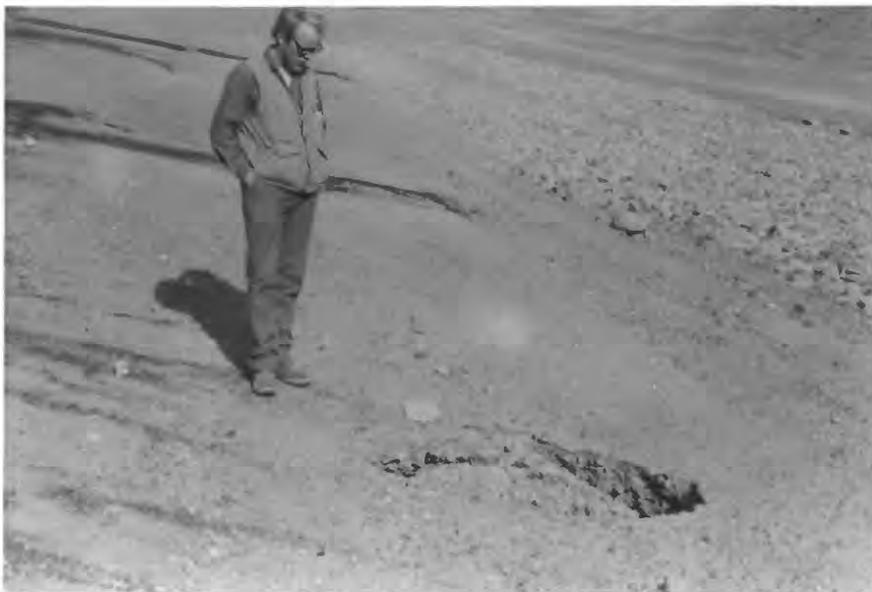
Figure 24. Piping in roadside ditch at Site 71. July 31, 1975.

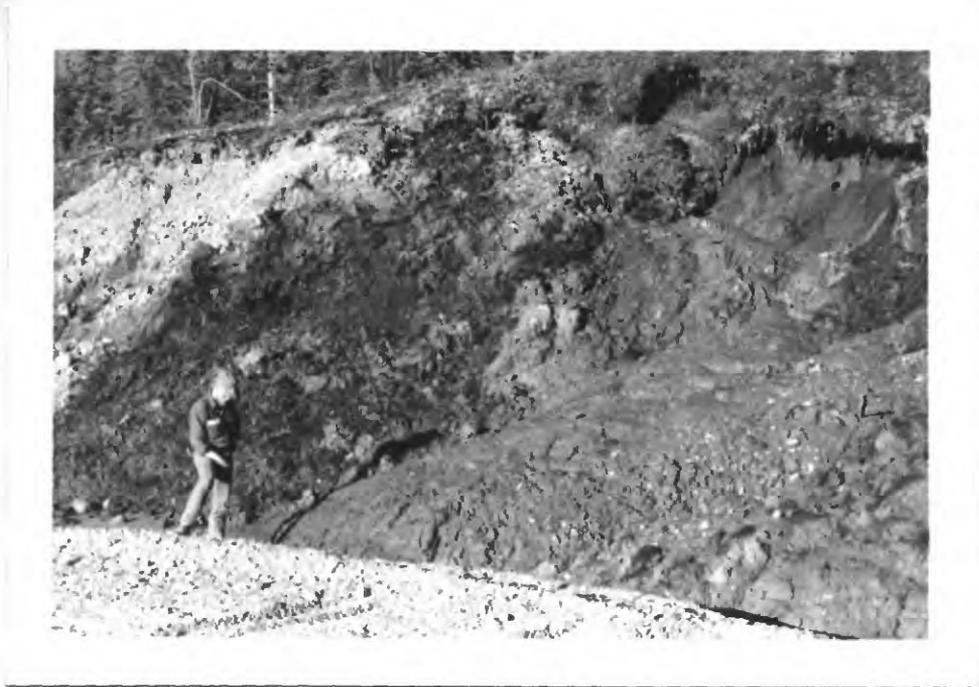
72	117.2	Road cut 12-15 m high exposes probable fan deposits (Fig. 25). Clasts poorly bedded and sorted, but most are angular, of local lithology, and range from pebbles to very small boulders. No striated or faceted clasts evident. Cut dry and stable, with only slight raveling.
73	117.4	Shallow (2-3 m) cuts into till. Dry and stable.
*74	117.5-118.5	Road crosses poorly drained upland which appears to be ground moraine. Solifluction appears to be widespread, but roadway dry and stable.
*75	119.7	Cut along east side of road stands 6-7 m high. Muck and gravel alternately exposed, with ice-rich muck probably forming channel fills in gravel. Upon thawing, muck yields lobes of flowing mud which have nearly filled roadside ditch in places (Fig. 26). Two flow lobes still

Figure 26. Mudflow at Site 75. June 24, 1975.

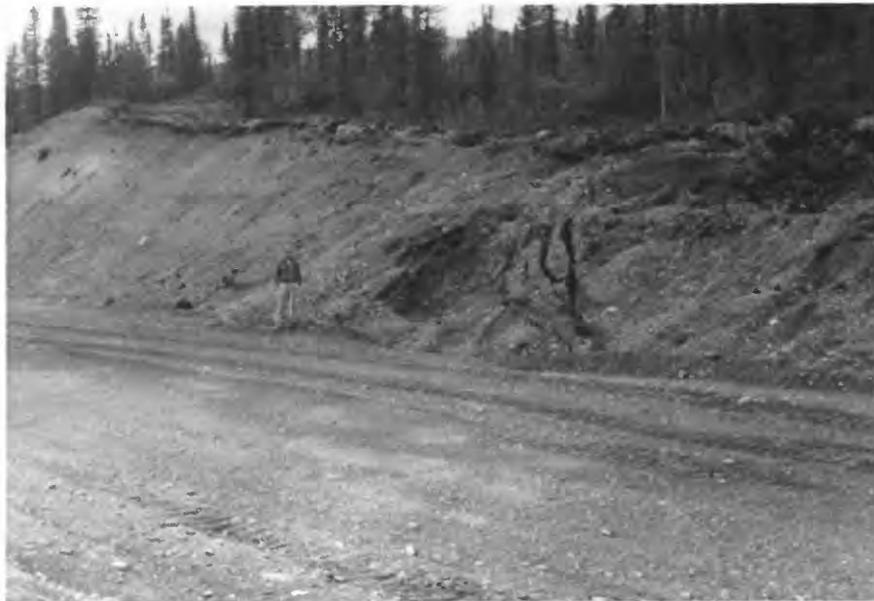
Site No.	Mileage	Description
*83	137.0	Cut 5-7 m deep along west side of road exposes till which contains deep kettle fill of silt and organic matter. Fill probably was permanently frozen and ice-rich prior to road construction because concentric tension fractures now surround an actively subsiding thermokarst depression at this site (Fig. 29). Area was still actively subsiding on July 31 (Fig. 30), and subsidence also was noted on pipeline work pad about 1 mile to the southwest.
84	137.1- 137.2	Long cut where road drops from moraine surface down to fan of Minnie Creek. South end of cut exposes water-washed ice-contact drift of 2 kames; north end of cut exposes up to 10 m of stratified ice-contact deposits associated with a third kame (Fig. 31). Cut was stable on July 31, but minor flows, slumps, and creep had obscured its face.
85	137.3	Road crosses Minnie Creek.
86	137.7	Cut 4 m deep along east side of road exposes gravel of Minnie Creek fan. Boulders up to 50 cm diameter are common, with clasts occasionally as large as 70 cm. Minnie Creek may have reworked older glacial deposits, because nearly all large clasts are subrounded rather than angular to subangular.

Figure 29. Thermokarst subsidence at Site 83. Subsidence is taking place beneath a berm of gravel which has been emplaced over face of road cut. June 25, 1975.

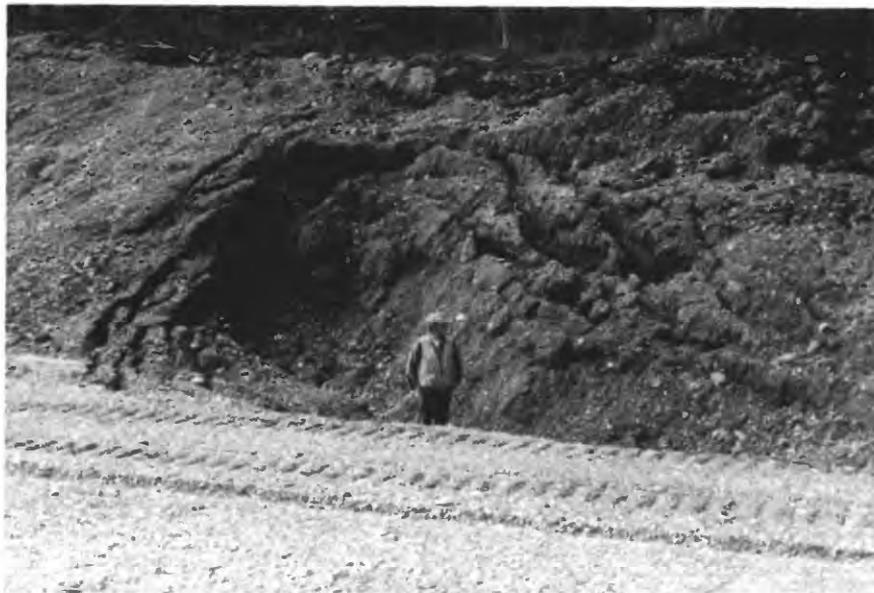
Figure 30. Continued thermokarst subsidence at Site 83. July 31, 1975.

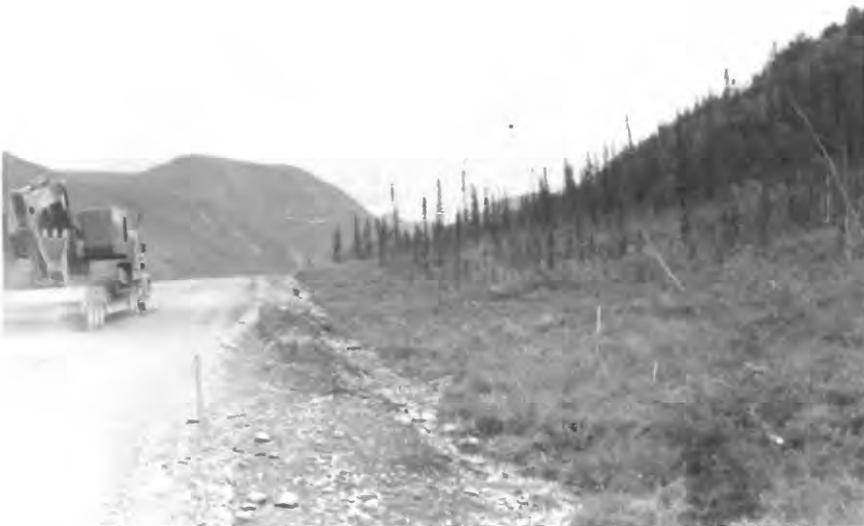
*87	137.9- 138.4	Probable solifluction slope impinges on road from east (Fig. 32). Silt and organic silt are exposed in cut 2 m deep at Mile 138.4 where road begins to drop onto active floodplain of Middle Fork of the Koyukuk River.
88	138.6	Road crosses Middle Fork then follows its floodplain. Occasional cuts expose fluvial sand and gravel in banks up to 2 m high.
89	141.0	Road crosses Middle Fork again, resuming position along east bank of river.
90	148.0	Road crosses Gold Creek. Fluvial sand and gravel exposed in cuts 3-4 m deep where road drops to floor of Gold Creek Valley.
91	148.8	Road crosses Linda Creek. Cuts on both sides of creek, as at Site 90. Graded, seeded, and stable by July 31.
*92	149.7- 152.7	Probable solifluction slope extends from valley side to east edge of haul road. Some drainage ponded in ditch along road edge, and road shoulder appears soft in places. Slope steepens to 7° at Mile 151.9, where solifluction appears especially active.

Figure 32. Active solifluction slope (Site 87). June 25, 1975.

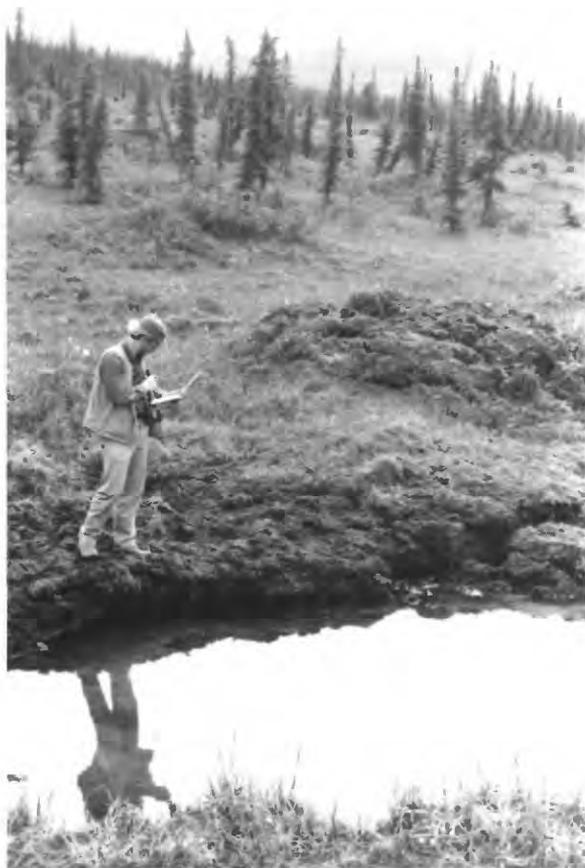
Figure 34 (left). Active palsa (note tension cracks) and thaw pond at Site 94. June 25, 1975.

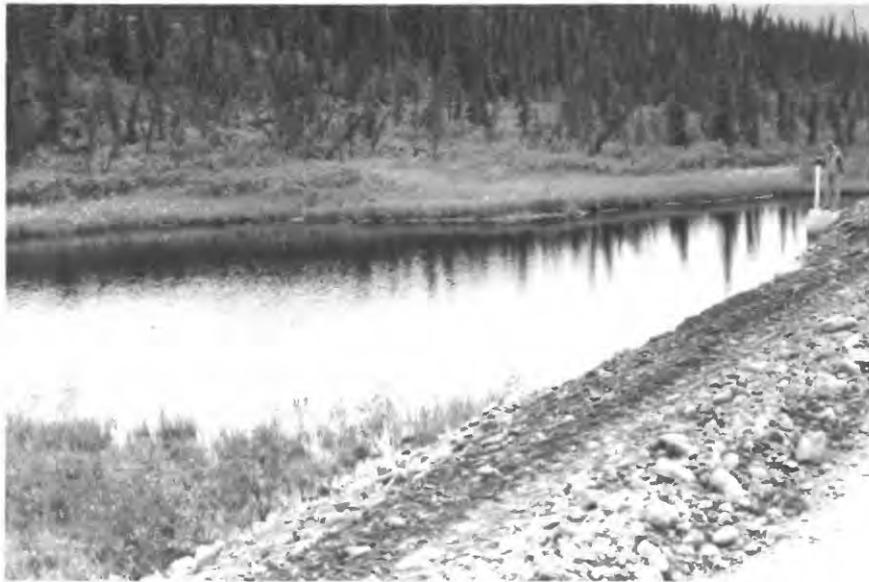
Figure 35. Pond formed since road construction (Site 100). June 25, 1975.

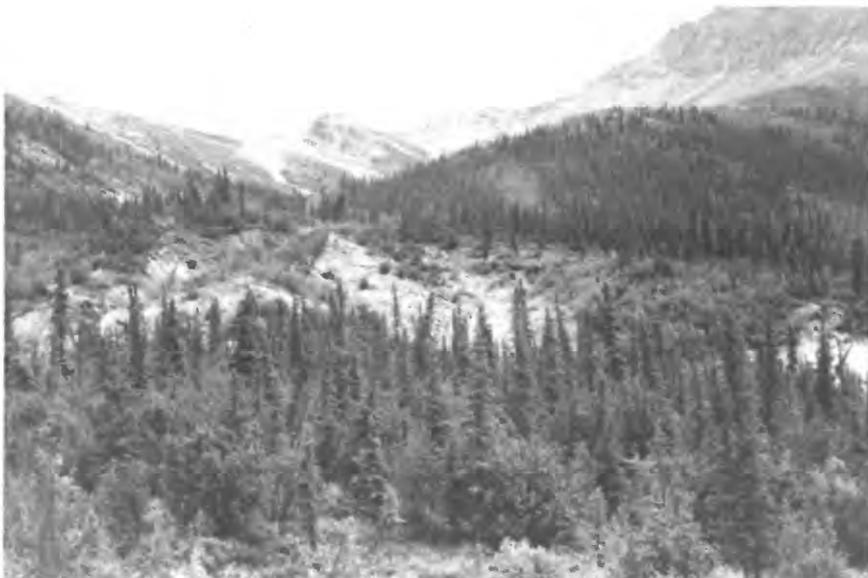
Figure 36. Front of probably active rock glacier close to haul road at Site 107. June 25, 1975.

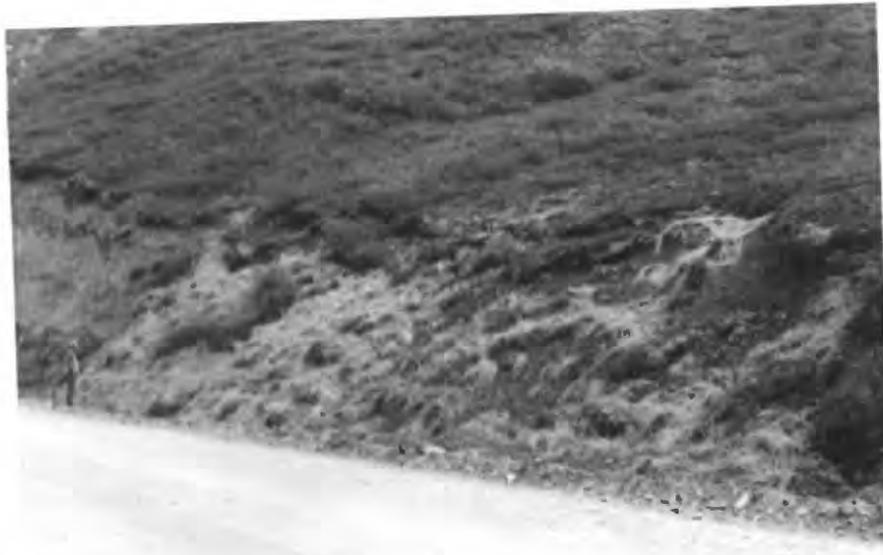
Site No.	Mileage	Description
*119	189.6- 190.6	Nearly continuous cuts 10-20 m high border road to the east, exposing slate beneath colluvium which thickens across floors of swales. Minor raveling of exposed bedrock was noted on June 25, and debris cones were encroaching on road in a few places. Slope activity was observed in 2 areas on July 31. A portion of the cut intersecting a silt-filled drainage swale at Mile 190.0 exhibited minor slumps and flows, which disrupted the blanket of straw insulation placed at this site (Fig. 37). A large elongate flow at Mile 190.1 extends from roadway down to the valley bottom (Fig. 38). It is fed by water and mud emerging from drainage swales along east side of the roadway (Fig. 39), at a place where road has been inadequately culverted. The flow was covered with a blanket of straw, which has been broken by continued flowage.
*120	190.6	Dietrich Pass (Chandalar Shelf). Cuts up to nearly 30 m height expose black slate. Cut along east side of road is generally stable, but cut along west side is subject to landsliding down cleavage planes which dip steeply toward road. Numerous slides cover this portion of the cut, and many tension cracks occur above its head.

Figure 37. Colluvium-filled swale reactivated by road cut at Mile 190.0 (Site 119). July 31, 1975.

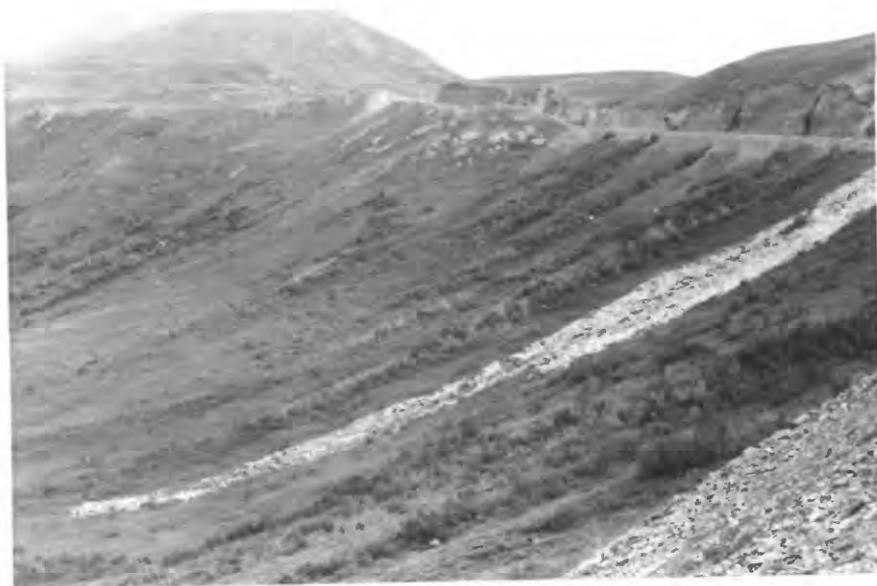
Figure 38. Large earthflow originating at Mile 190.1 (Site 119). July 31, 1975.

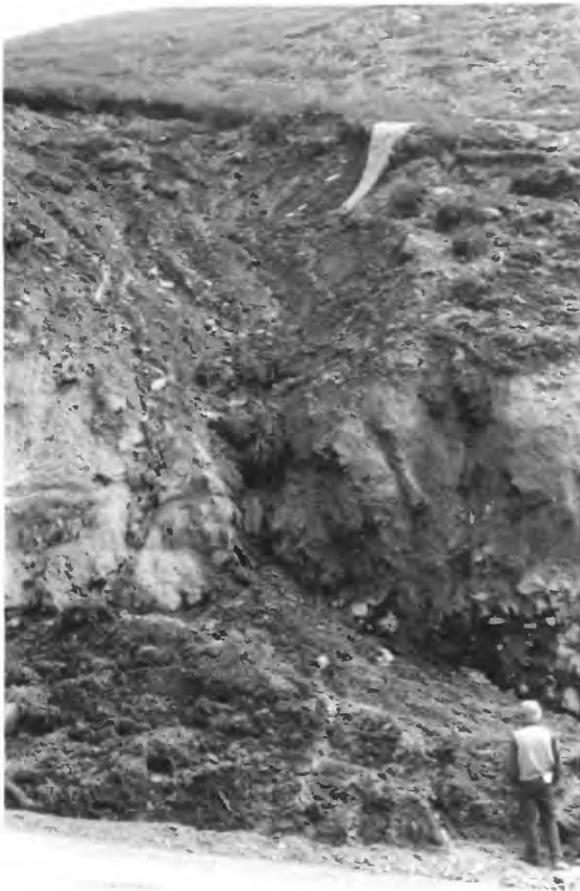
Figure 39 (left). Active flows and debris cone east of road at Mile 190.1 (Site 119). July 31, 1975.

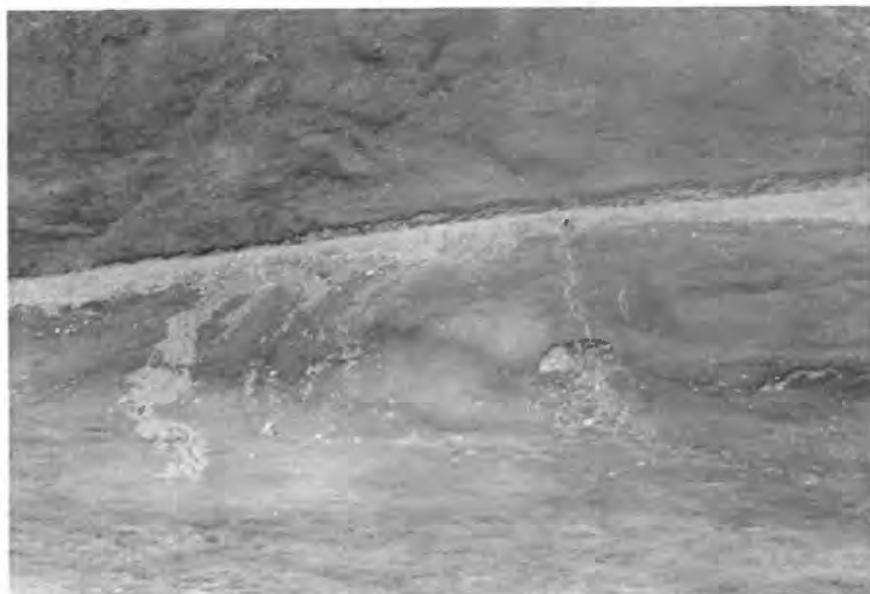
Figure 42. Closeup of debris tongues and earthflow which originate along road bed at ca. Mile 197.2 (Site 124). June 25, 1975.

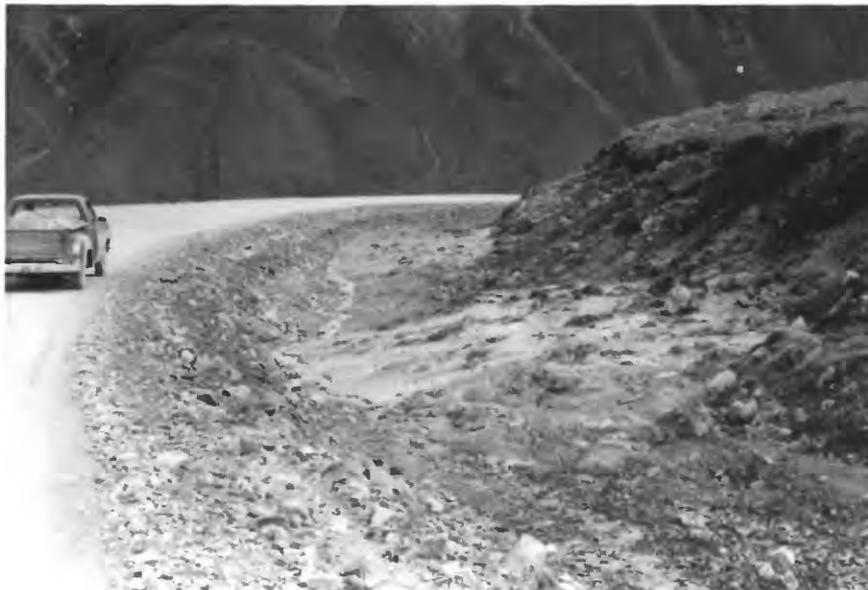
Figure 44. Flows into roadside ditch along north flank of Atigun Pass (Site 128). June 25, 1975.

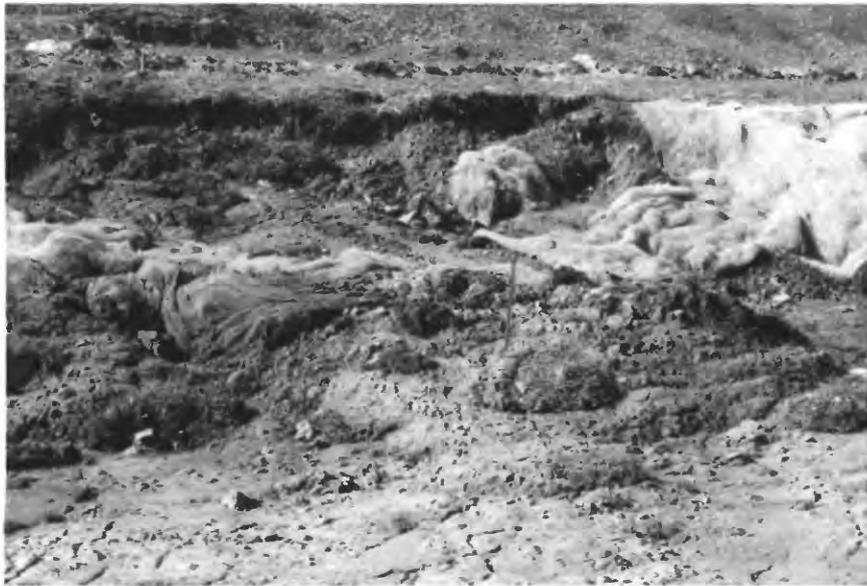
Site No.	Mileage	Description
		Most of the cuts were fairly stable on June 25, although a few slumps were evident and occasional tension cracks occurred at tops of the cuts. Most cuts still appeared stable on July 31, but 4 minor problem areas were noted:
		Mile 196.9: Soft spot on road associated with seepage zone in road cut.
		Mile 197.3: Soft spot on road; cause unknown.
		Mile 197.5: Ditch filled with rubble from small slides.
		Mile 197.7: Seepage zone in road cut.
*125	198.6	Summit of Atigun Pass. Talus and bedrock exposed in cuts to 20 m deep along west side of road. The rock is highly fractured and subject to minor raveling.
126	199.0	Road crosses inactive rock glacier (Fig. 43).
*127	199.5	Persisting snowbanks along east side of road on June 25.
*128	199.7	Cut along east side of road exposes 3-6 m of ice-rich stony silt. Minor flows extended from base of cut into roadside ditch on June 25 (Fig. 44). When revisited on July 8, cut had been freshly graded and covered with mat of insulating material. Renewed flowage had disrupted much of the insulating mat by July 31, and about 10% of the cut was actively flowing (Fig. 45).

Figure 45. Continued flowage at Site 128. July 31, 1975.

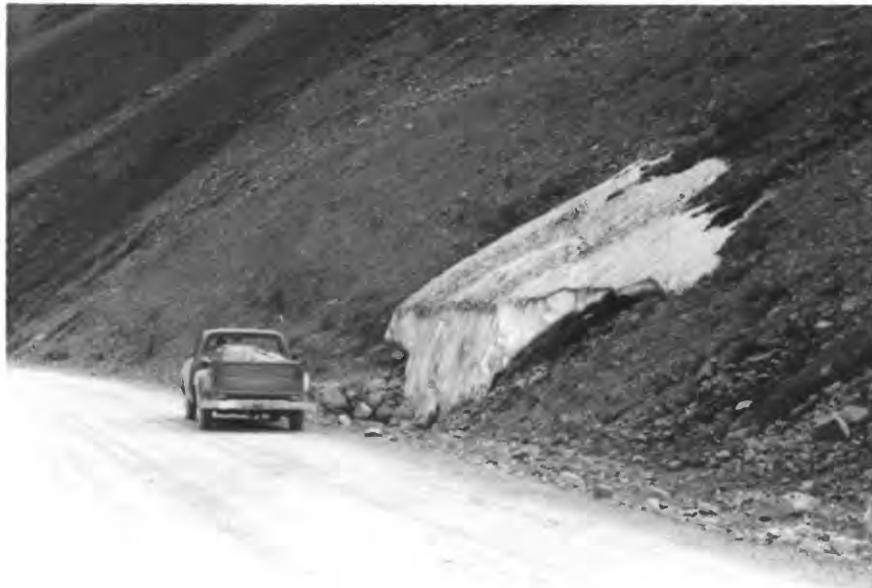
Figure 46. Persisting snowbank at road margin on north flank of Atigun Pass (Site 129). June 25, 1975.

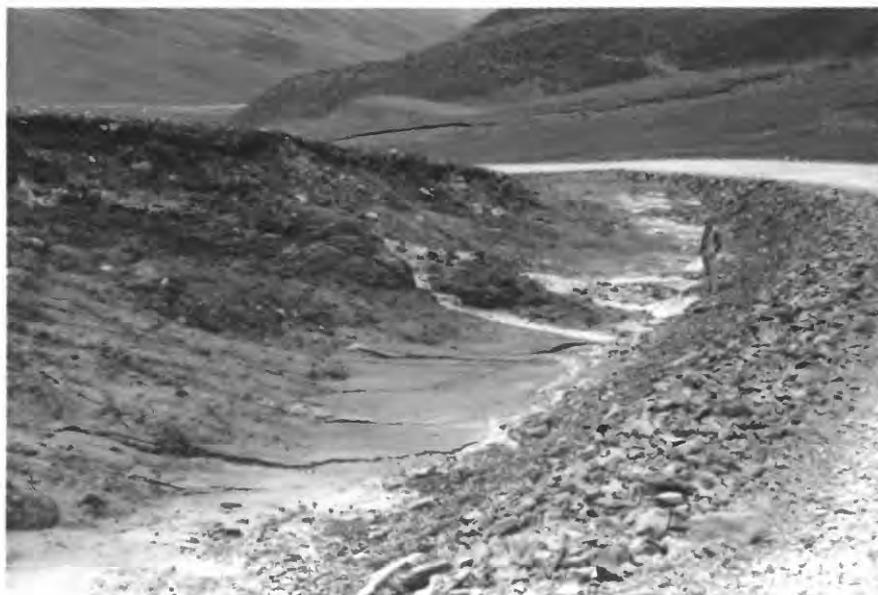
*129	199.7-199.9	Persisting snowbanks along southeast side of road on June 25 (Fig. 46).
*130	200.4	Road crosses very active debris slope (Fig. 47). Cuts 3-5 m deep expose rock rubble in ice-rich silty matrix. Cut west of road was highly unstable on June 25 owing to thaw of ice-rich permafrost. Mudflows, generated along face of cut, were filling roadside ditch (Fig. 48). Bank had been freshly covered with mat of insulating material when seen again on July 8, but by July 31 active flows had disrupted about 10% of the mat along both sides of road (Figs. 49 and 50).
*131	201.1	Road intersects a steep alpine fan which bears fresh-appearing levees and boulder litter indicative of repeated debris flows or slush flows (Fig. 51). Most boulders are weathered, but some lack weathering and lichen cover and may have been deposited recently (Fig. 52).

Figure 48. Flows into western roadside ditch at Site 130. June 25, 1975.

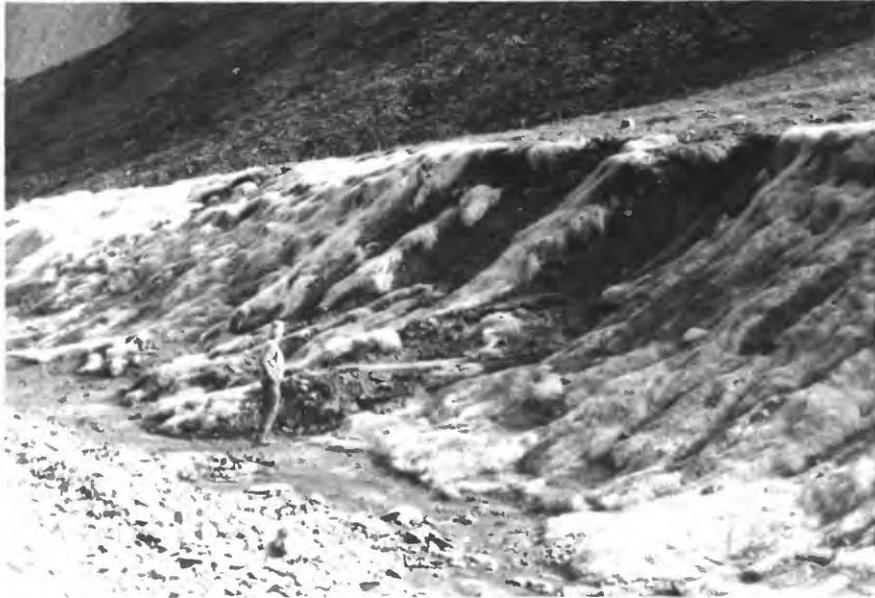
Figure 49. Active flows into eastern roadside ditch at Site 130. July 31, 1975.

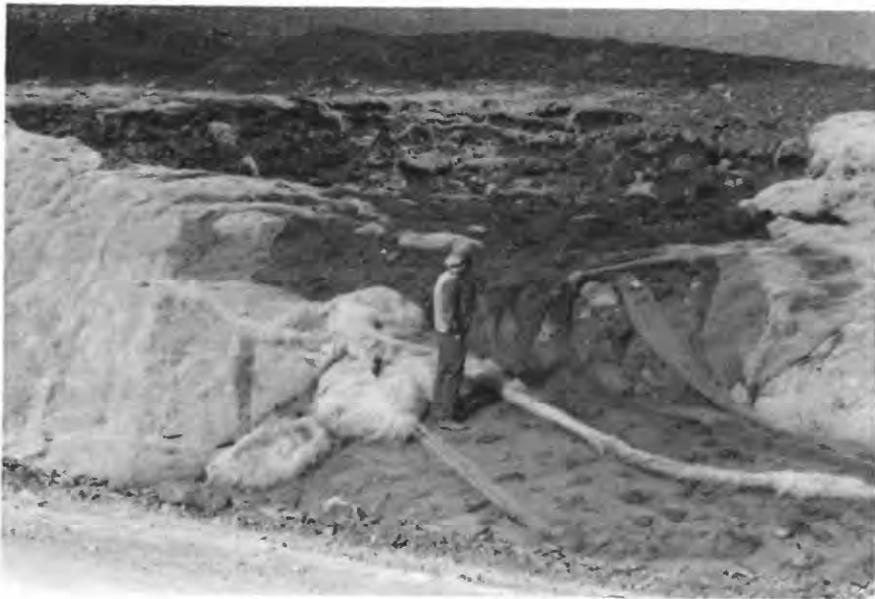
Figure 50. Active flows into western roadside ditch at Site 130. July 31, 1975.

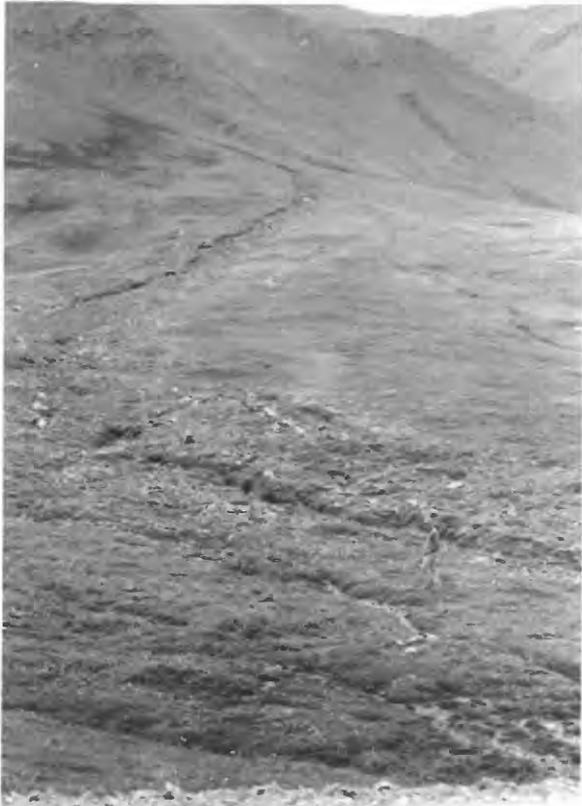
Figure 51 (left). Steep alpine fan north of Atigun Pass (Site 131). Haul road visible at base of photograph. July 31, 1975.

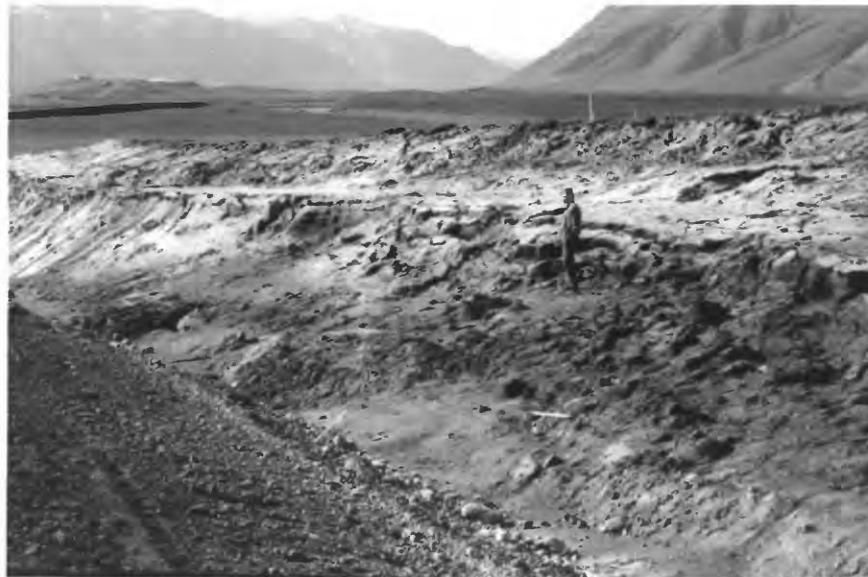
*139	214.4	Steep alpine fan with prominent levees and channel intersects haul road (Fig. 53). Boulders with diameters of 1 m or more have been carried by flows of debris or slush rather than by running water.
*140	218.8	Road crosses an active alluvial fan. Unweathered, lichen-free boulders up to 60-70 cm (and occasionally 1 m) diameter litter fan surface along both sides of roadway.
141	221.3	Road crosses inactive alluvial fan with surface almost entirely vegetated. Stones to nearly 1 m diameter are exposed in road cuts 3-4 m deep.
142	224.0	Cuts 3 m deep along both sides of road expose eolian sand above glaciolacustrine sand. The sand is bedded, and contains buried organic matter.
143	224.8	Road crosses Atigun River.
*144	224.9	Cuts up to 9 m deep along both sides of road expose fluvial or glaciolacustrine sand and peat, with some overlying eolian sand. Cuts had been revegetated when revisited on July 31, but were still subject to continued minor slumping (Fig. 54).

Figure 54. Slumping of eastern roadcut at north bank of Atigun River (Site 144). July 31, 1975.

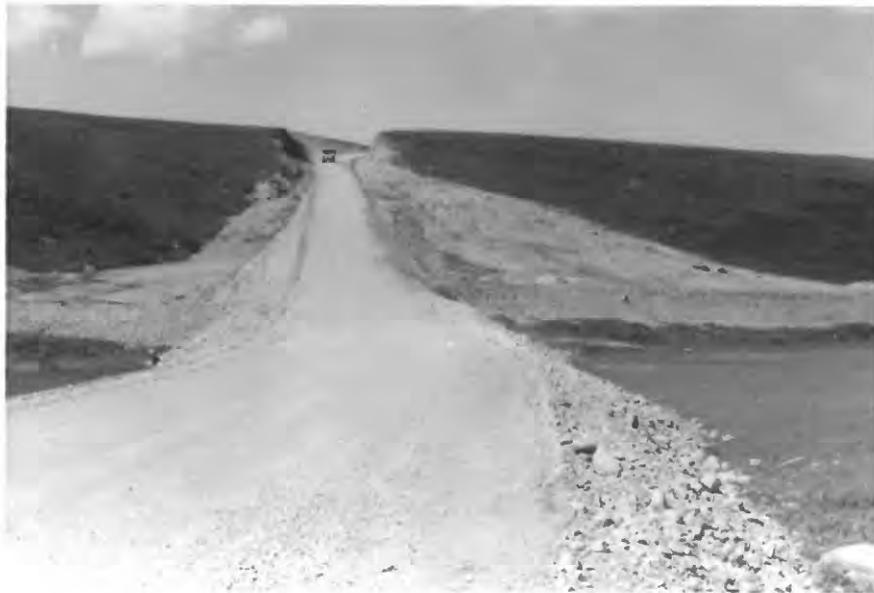
Site No.	Mileage	Description
156	264.7	Begin descent to flood plain of Sagavanirktok River. Cut along west side of road exposes 7 m of grey outwash gravel (rounded stones up to cobble size in a sandy matrix) beneath 40 cm of frost-churned stony silt (Fig. 55).
157	264.7- 269.3	Road follows flood plain of Sagavanirktok River. Excellent gravel subgrade.
*158	269.8	Pond has formed on the upslope (west) side of road where intersected by access road leading to pipeline work pad.
159	269.3- 275.8	Crossing Itkillik-age end moraines. No problems evident on July 7.
*160	276.2- 277.2	Several soft places on road, possibly due either to thaw subsidence or to compaction of poorly graded or improperly emplaced fill. No thermokarst is evident beyond edges of roadway in these places.
*161	277.5	Drainage impounded by road and pipeline work pad has formed 3 shallow ponds.
*162	280.9	Road leaves flood plain of Sagavanirktok River and ascends about 50 m up steep grade to upland surface underlain by bedrock and glacial deposits (Fig. 56). In 1974, road cuts exposed muck and peat with ice wedges and other massive ground ice above a lens of till resting on bedrock (Fig. 57). By July 1975, massive ground ice no longer was visible in road cuts, but continued melting was causing slope retreat by slump and flowage (Fig. 58). Liquefied muck and till were discharging down both roadside ditches into basins behind dikes built at the base of the grade (Fig. 56).

Figure 56. Road cuts into ice-rich muck above till and bedrock (Site 162). Disturbed areas on slope are mudflows and restraining structures. July 7, 1975.

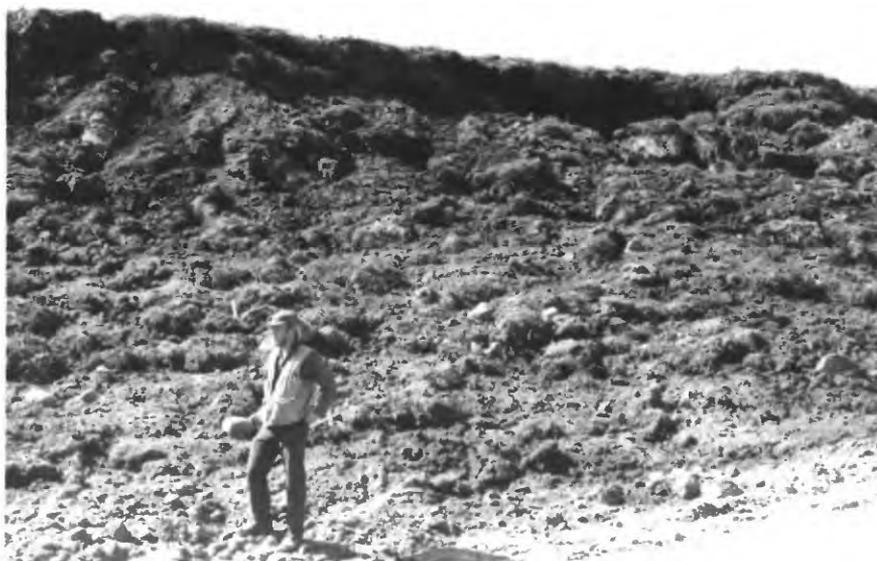
Figure 58, Western road cut at Site 162 one year later. July 7, 1975.
