UNITED STATES DEPARTMENT OF THE INTERIOR
MINERALS MANAGEMENT SERVICE
and
GEOLOGICAL SURVEY

INVESTIGATION OF OCTOBER 1982 BLOWOUT AND FIRE,
EUGENE ISLAND BLOCK 361, GULF OF MEXICO

OPEN-FILE REPORT 83-113

1983

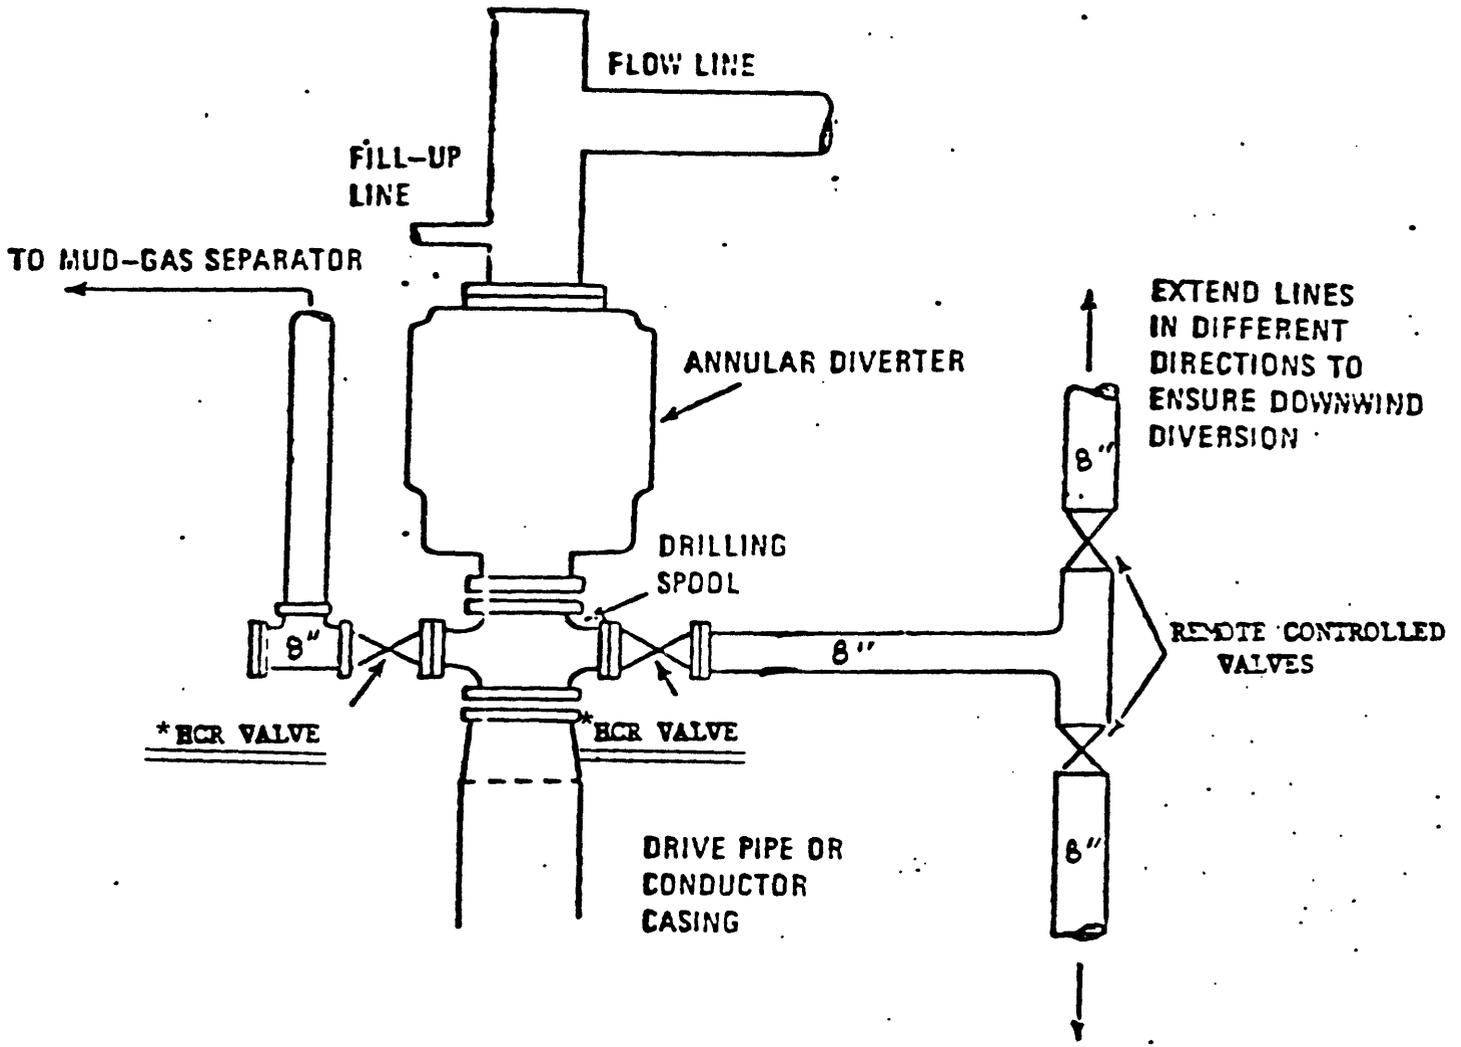
Diverter Manifold and Annular Preventer

The diverter valves, as shown in the Appendix, Attachment No. 4, were installed as part of the control head on the 24-inch OD drive pipe on October 9, on the 20-inch OD conductor on October 13, and on the 16-inch OD conductor on October 16. On October 9 and again on October 16, the diverter valves were opened and closed to assure operation. On October 17, the diverter valves, while in a closed position, were subjected to 650 psi pressure as part of a 5-minute bleed off test of the casing shoe. However, on October 21 when the Chevron representative decided to switch the returns from a gas-mud separator direction to a horizontal vent direction, the valves would not operate. After several minutes, one valve was made to function.

* Pneumatic 8-inch diverter valves, used to divert either to the separator or to the horizontal line overboard.

1. A diverter manifold, when installed with an annular preventer for shallow drilling, should not be used for purposes other than diverting to the outside when well flow commences.
2. Where shallow gas sands are present and two conductor casings are run, a conventional blowout preventer arrangement may be preferable over a diverter setup. Such would be the case when the lower conductor has sufficient integrity to contain the flow if a blowout occurs.

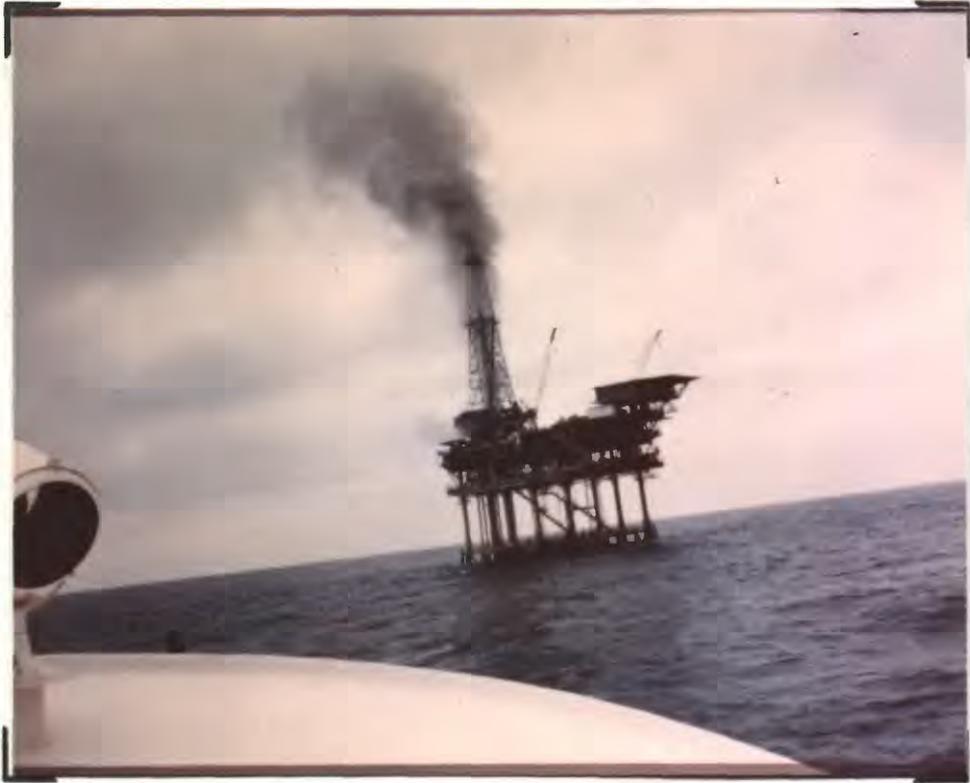
Well blowing out before ignition, October 21, 1982

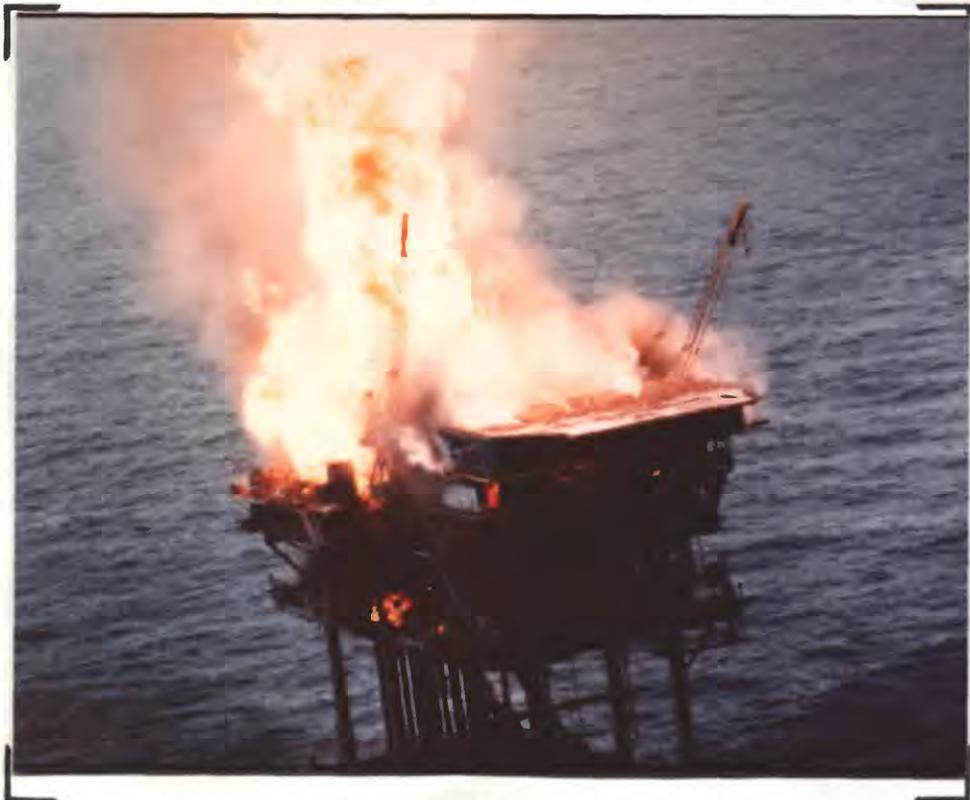
Well blowing out and afire, October 22, 1982

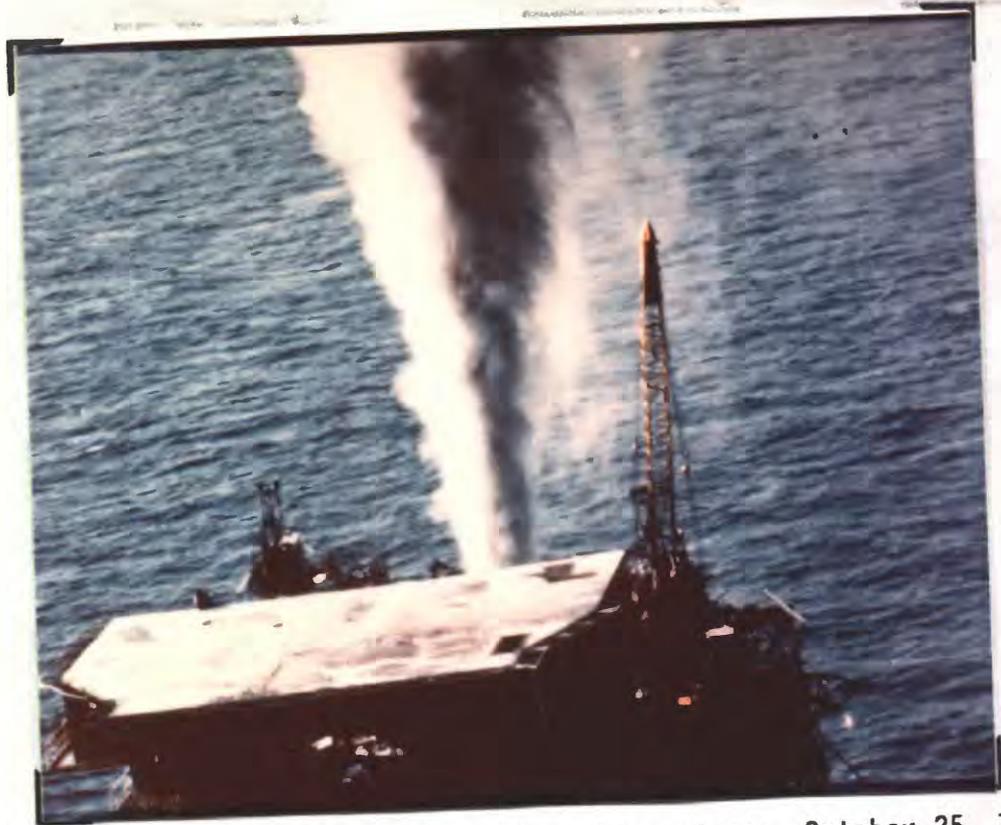
Fire extinguished, well blowing salt water and gas, October 25, 1982

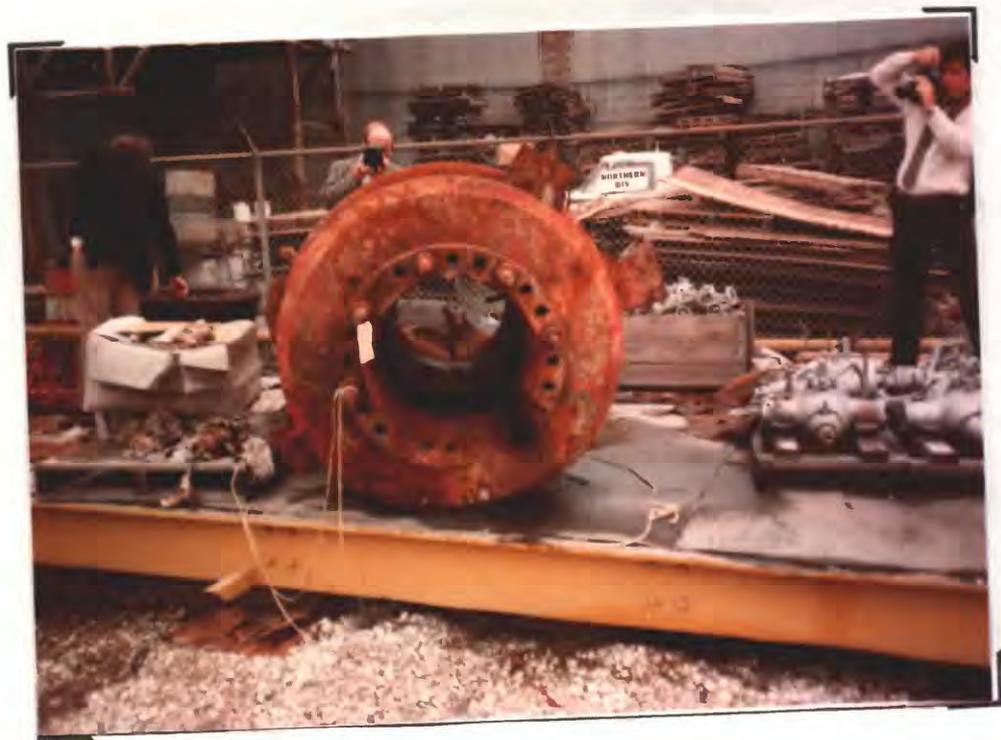
Well-control was lost about 3:30 a.m., October 21, 1982, and a full-scale gas blowout was immediately apparent. The gas flow was charged by one or more shallow gas sands with slightly abnormal pressures. The flow was outside the drill pipe and upward through the annular preventer.

Flange cutout below the annular preventer by abrasive blowing action

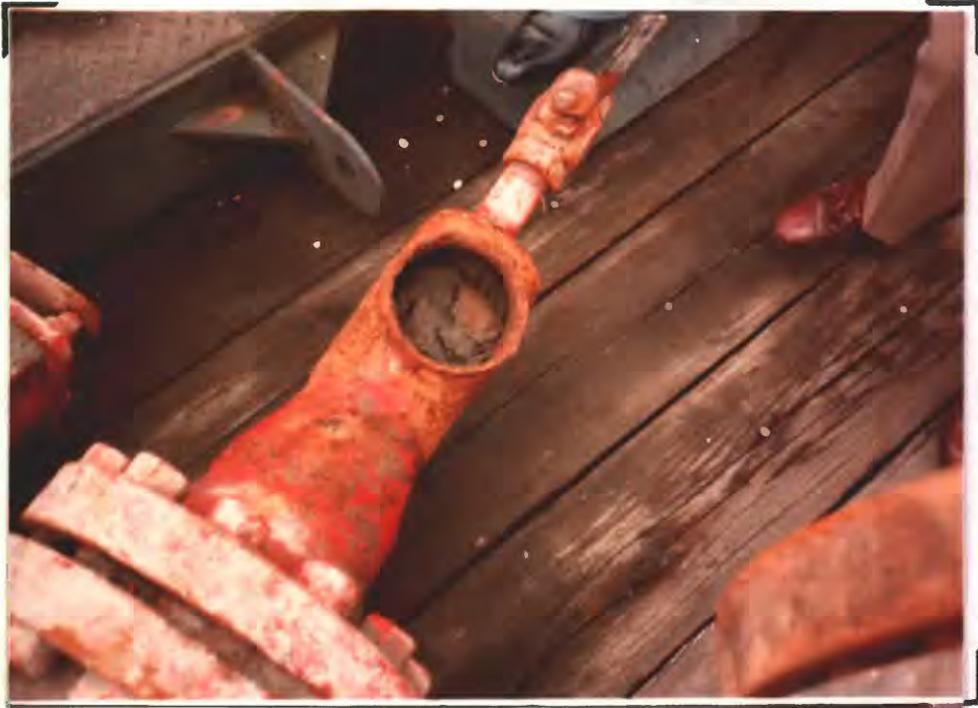
The 8-inch ball-type diverter valves, rated at a working pressure of 2160 psi and actuated pneumatically, had worked under lesser pressures than 450 psi after testing the casing shoe. Upon examination following the blowout, no clue could be found to trace the malfunction. When the air was connected to the actuator, nothing happened because the seal within the actuator in each case would not hold pressure. Having been subjected to rather high temperatures during the blowout and fire, failure of the seals was not surprising.

Diverter valve with broken connection downstream

3. Diverter valves and controls, whether pneumatic, mechanical, or hydraulic, should be installed with appropriate protection to avoid damage which might jeopardize momentary use. Also, the usual large-diameter diverter valve should not be opened and closed as a choke valve under pressure.
4. With gumbo conditions, the drilling mud must have sufficient viscosity, and annular velocities must be high enough to sweep the annulus and keep the hole clean. This means proper treatment of the mud and high-powered, high-volume pumps. With this combination, hole problems with gumbo can be tolerated and sometimes can be lessened.

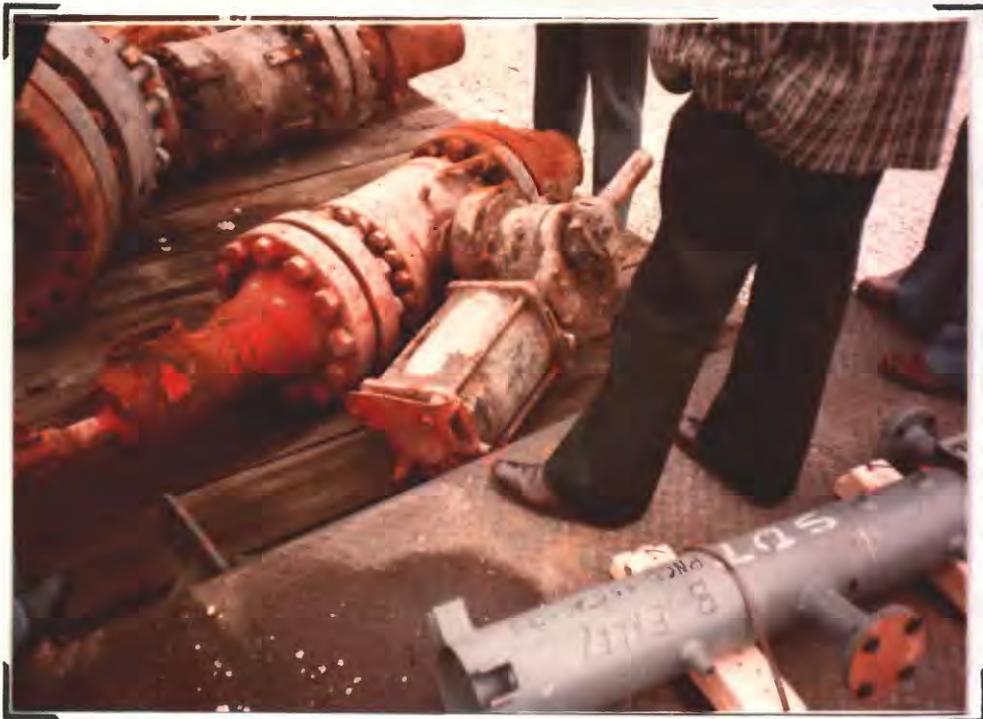
Upon further analysis of the valve apparatus in Chevron's equipment yard, a Panel member noted that the 3/8-inch stainless steel line in the valve actuator manifold was bent, suggesting the possibility that insufficient air pressure was reaching the actuator to the open valve. However, when the bending took place, before or after the blowout, could not be determined.

Another view of the same equipment, including the actuator

2. Small power lines, whether pneumatic or hydraulic, making up the actuator manifold from the control lever to the diverter valves coming off the blowout preventer stack shall be protected either by covering or enclosing or by attaching to a fixed object such as a beam.

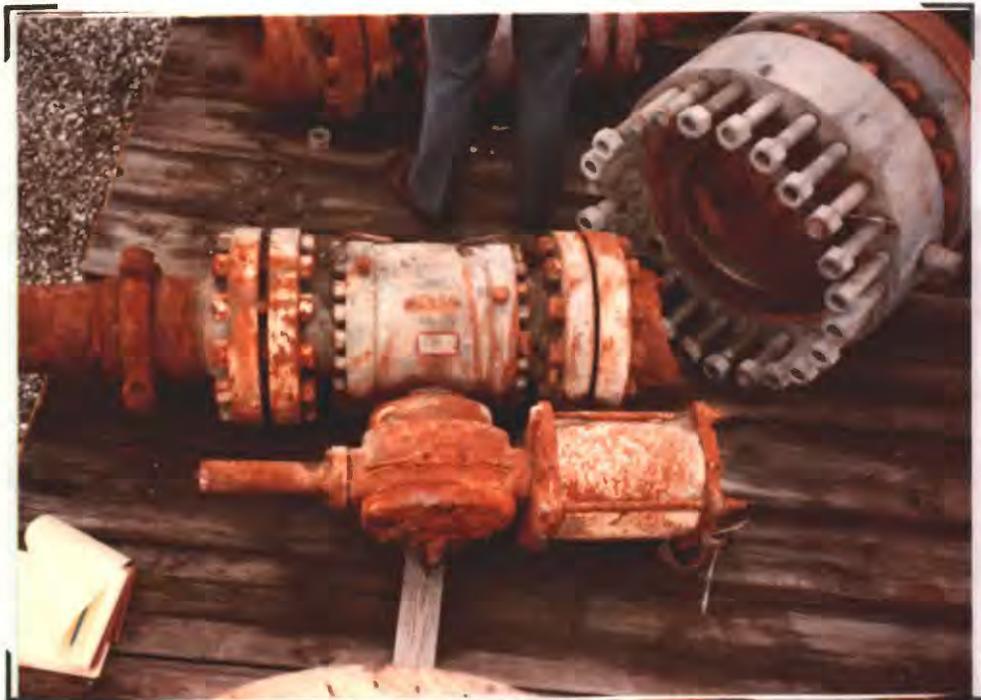
that is, lever action from the rig floor would not reverse the valve positions and allow the well to vent itself horizontally away from the rig. Efforts to operate the valves continued for another 20 to 30 minutes before the pressure mounted in the 6-inch line to the gas-mud separator and caused it to rupture. Most likely, the line became plugged with gumbo (see the Appendix, Attachment No. 8).

Diverter valve (with actuator) as connected to
diverter line to the outside
