**DEPARTMENT OF THE INTERIOR
U.S. GEOLOGICAL SURVEY**

**Preliminary isoseismal map for the Sierra Madre, California,
earthquake of June 28, 1991 UTC**

Open-File Report 91-388

by
Carl W. Stover and B. Glen Reagor

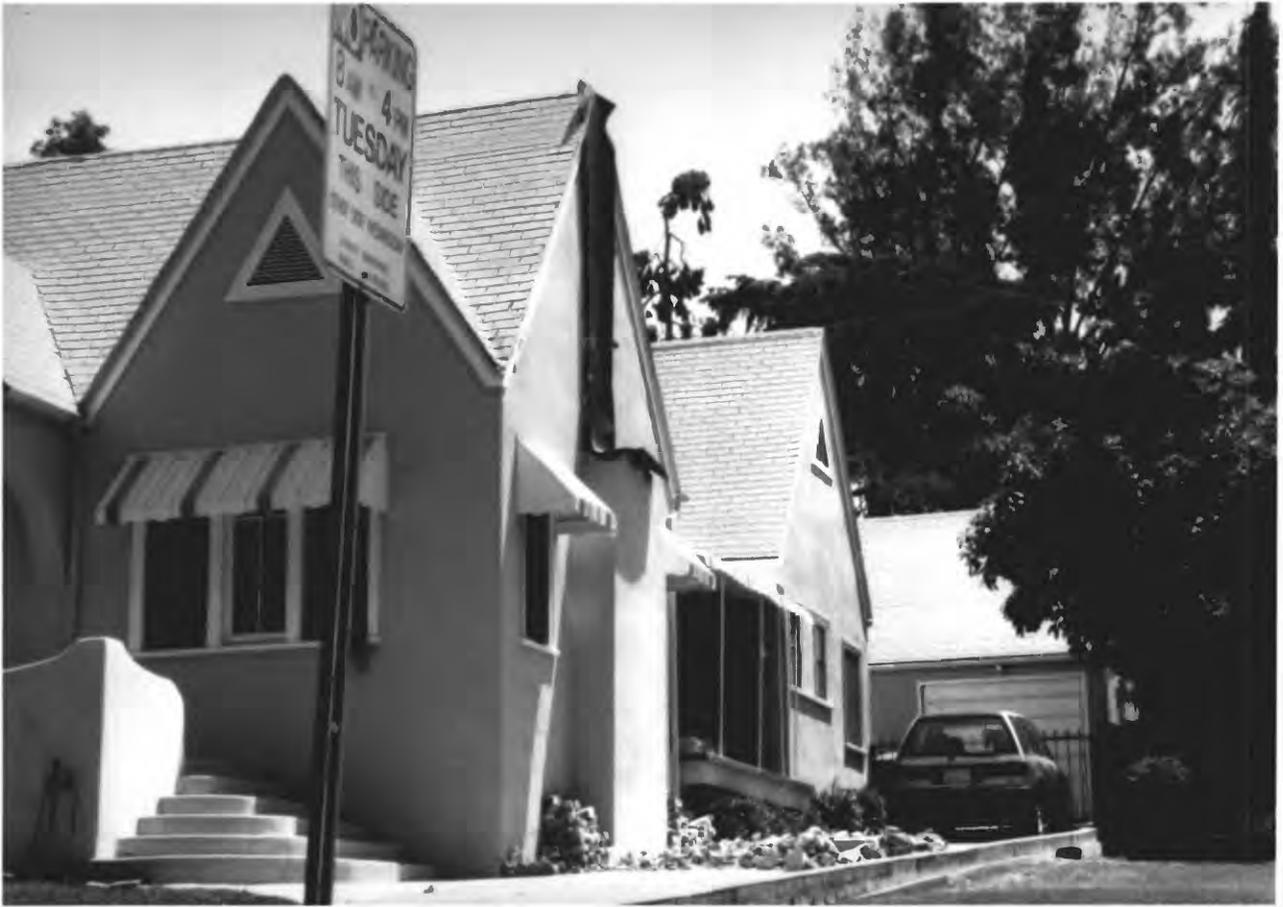
Monrovia–Houses on North Alta Vista Street and Myrtle Avenue were shifted off their foundations; chimneys were broken and fallen throughout the northern part of the community (figs. 3 and 4); water and gas lines were broken in many areas; windows were shattered; one home (fig. 5) at 433 Primrose Avenue (built in 1906) was virtually destroyed and condemned; interior walls cracked; and electric lines were down on Canyon and Foothill Boulevards.

Figure 3. Fallen chimney on North Myrtle Avenue in Monrovia.

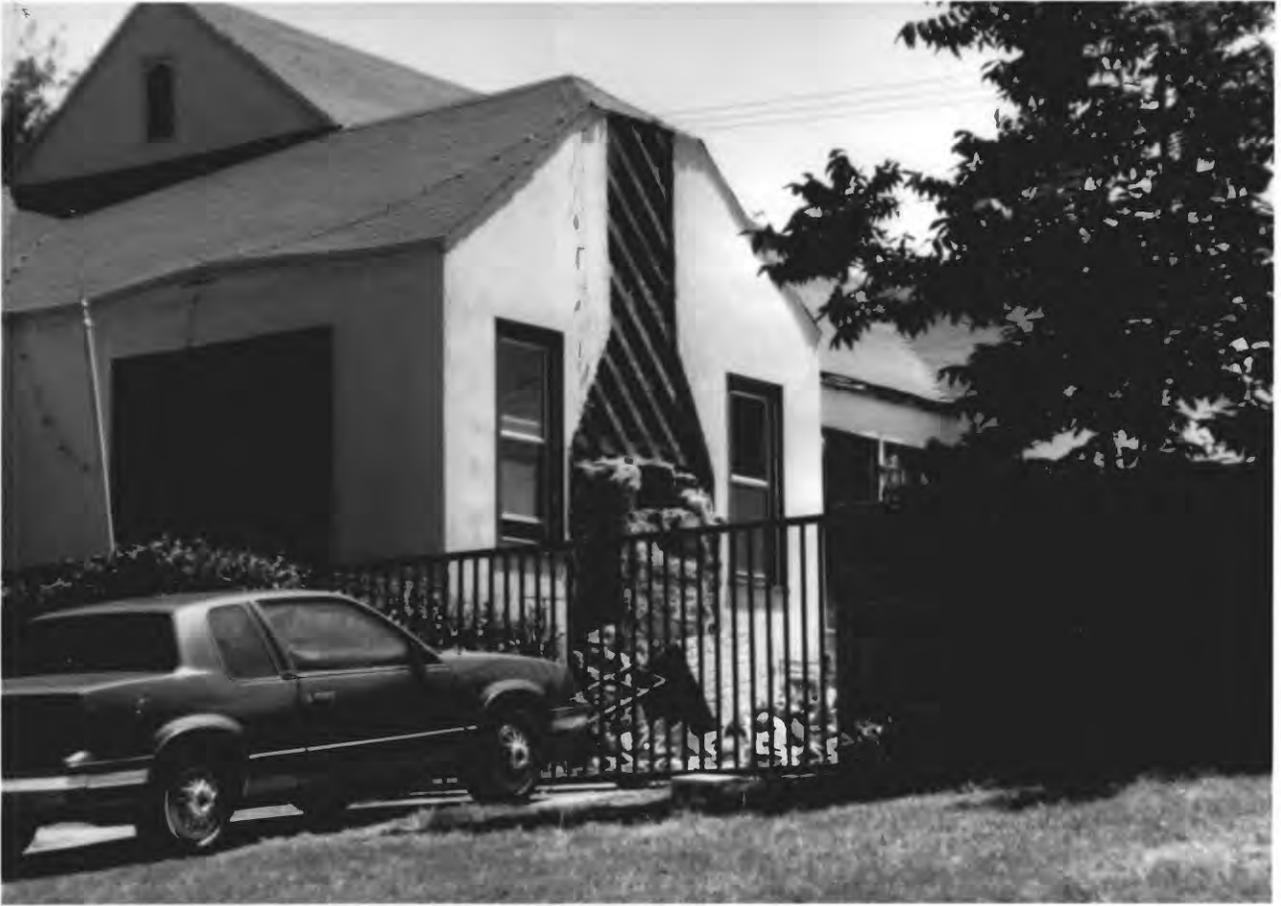
Figure 4. Fallen chimney on Patterson Drive in Monrovia.

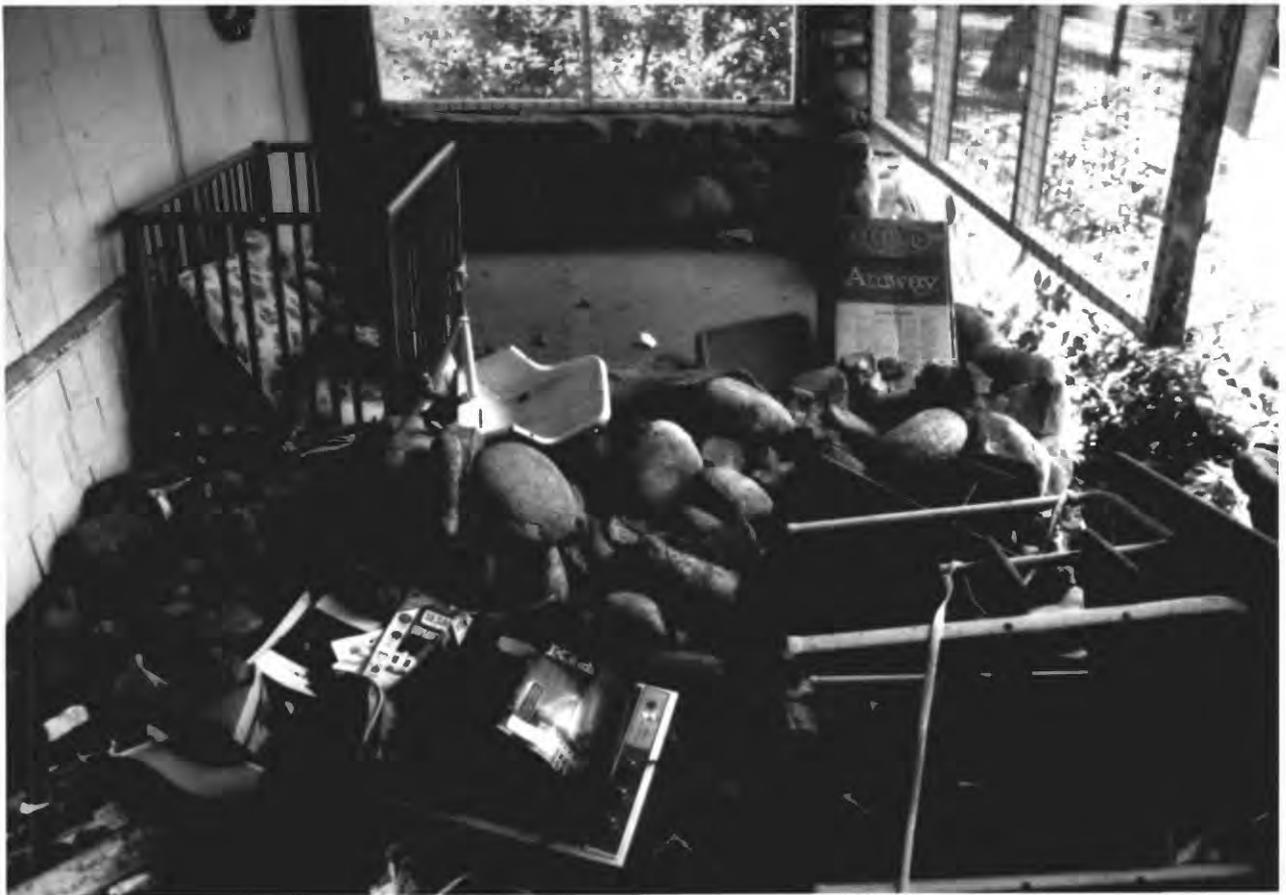
Figure 5. Collapsed stone wall pillar of a home at 433 Primrose Avenue in Monrovia.

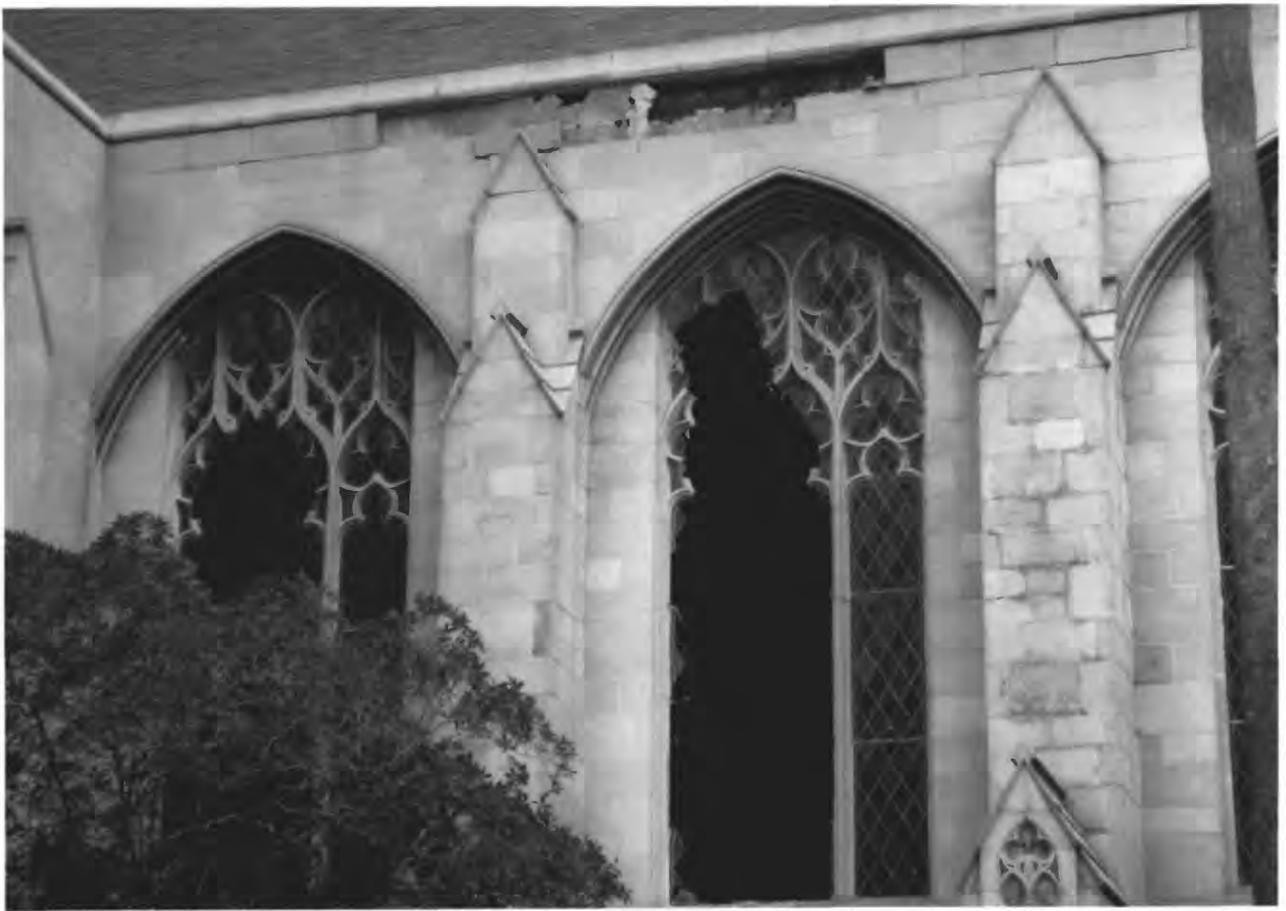
Pasadena– The press reported that 380 structures suffered some damage. This damage consisted of cracked and fallen chimneys, cracked interior and exterior walls, shattered windows, broken water lines, and damaged merchandise in stores. The Westminster Presbyterian Church on North Lake Avenue (fig. 6) had two eight-ft-high stone turrets fall from the 110-ft bell tower, one through the roof the church, the other breaking the sidewalk in front of a side entrance; also, two large stained glass windows were broken out and stones from the south wall fell. A large section of the south brick wall of the Pasadena Playhouse (fig. 7) fell through the roof of an adjoining business and a large portion of the

Figure 6. Damage to Westminster Presbyterian Church on North Lake Street in Pasadena.

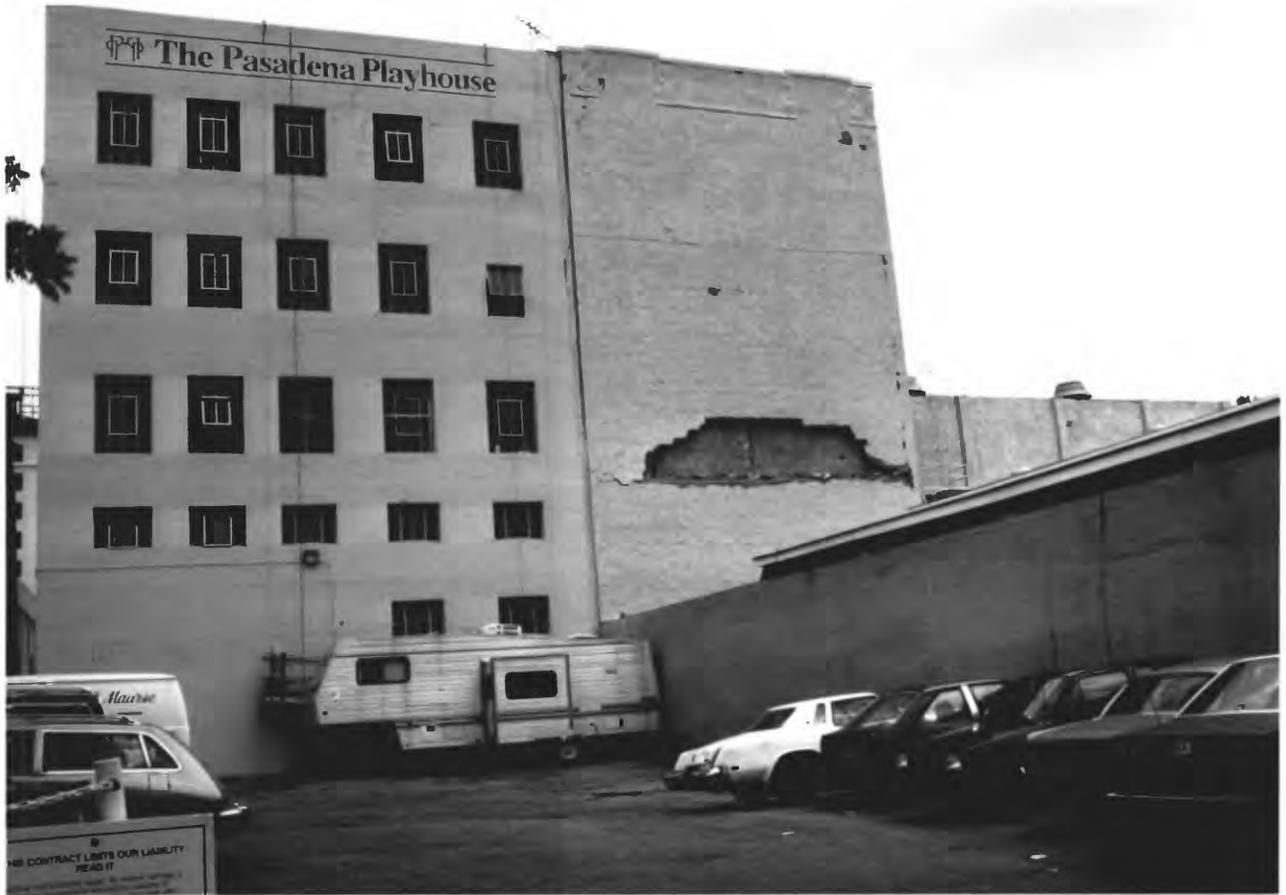
Figure 7. Damage to the Pasadena Playhouse in Pasadena.

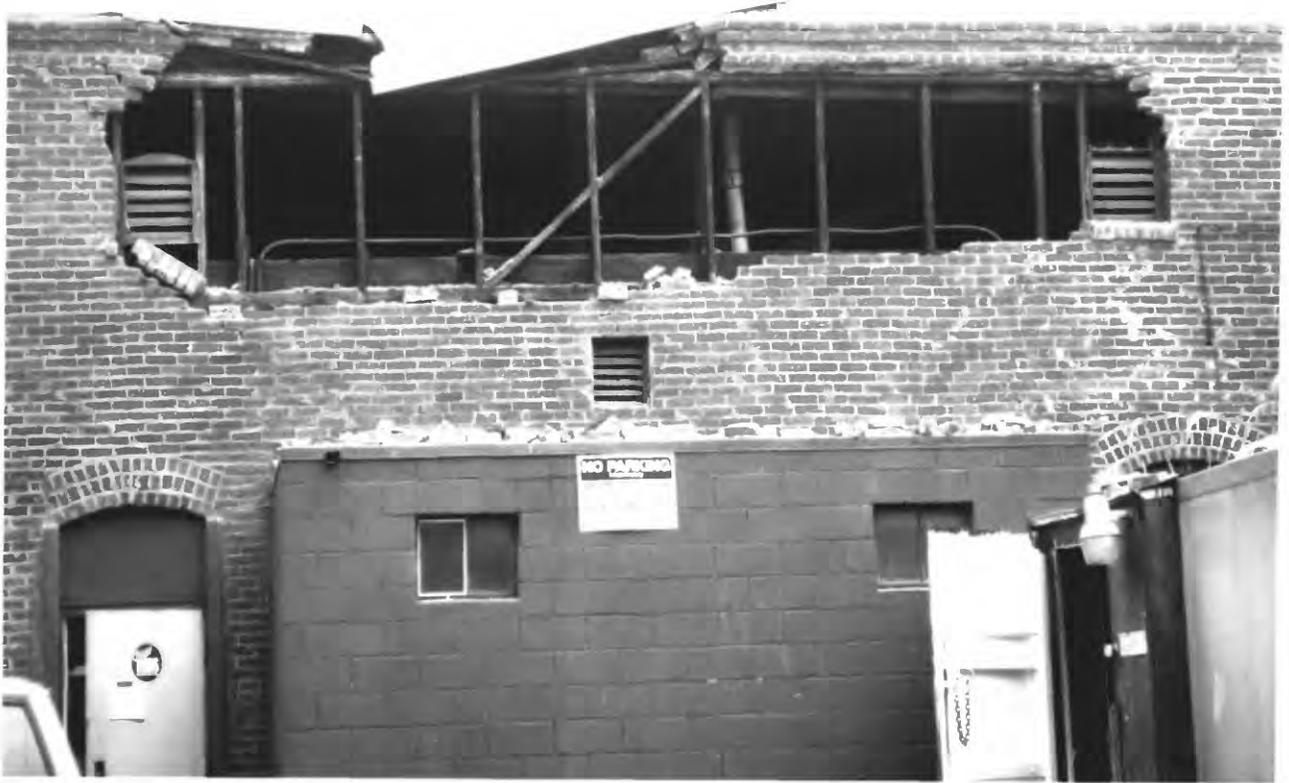
south wall of the Chicago for Ribes Restaurant (fig. 8) at 90 W. Colorado Boulevard collapsed. Many of the older buildings lost sections of bricks from the top portion of exterior walls.

Figure 8. Damage to the Chicago for Ribs restaurant on Colorado Boulevard in Pasadena.

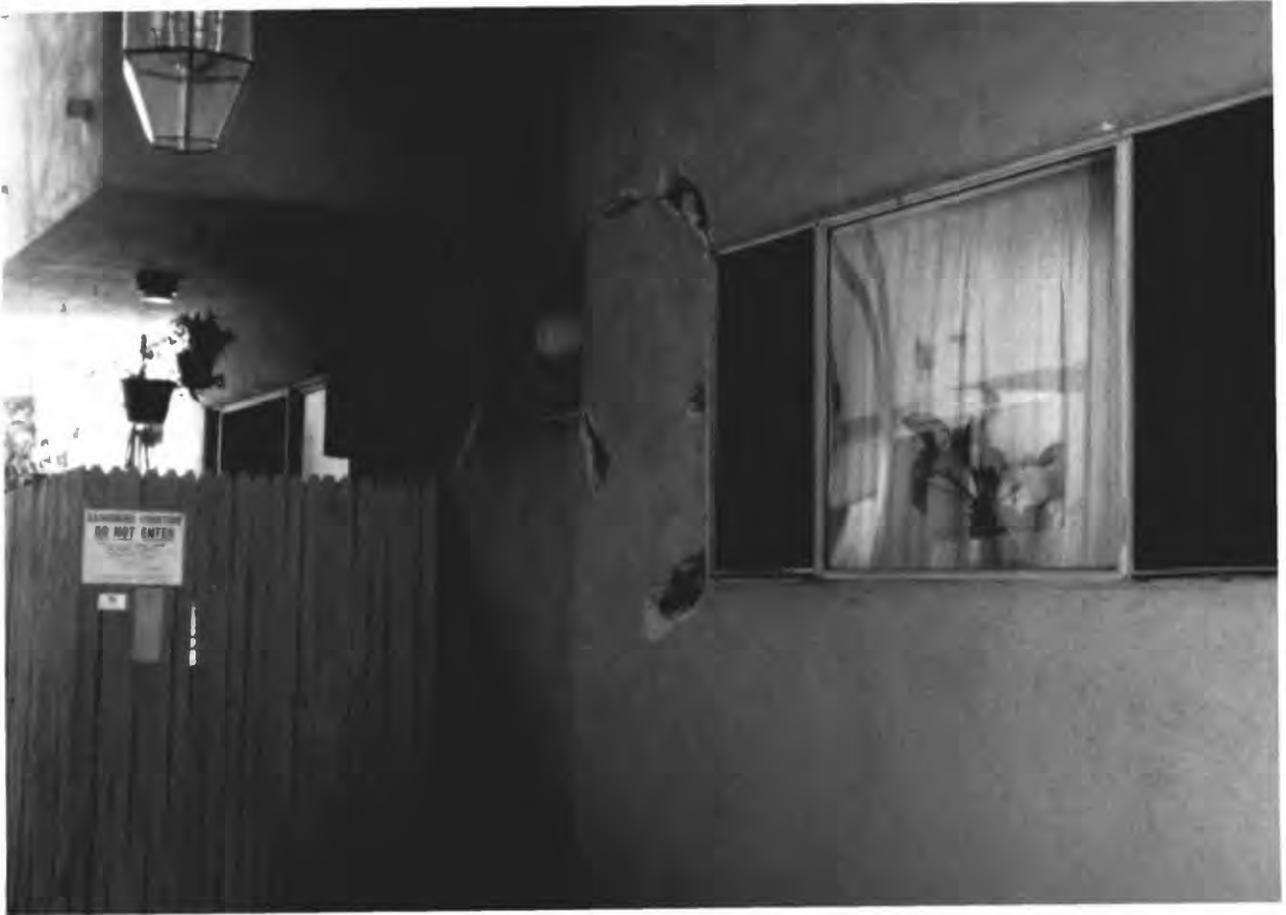
Sierra Madre—Many homes and several businesses suffered damage. The homes had cracked and fallen chimneys; a few slid off their foundations; interior and exterior walls were cracked; windows were broken; and there was broken glassware throughout the interior. Business damage generally consisted of some bricks fallen from exterior walls, broken plate glass windows, broken water lines, and destroyed merchandise. Two apartments had badly cracked exterior walls and were condemned (figs. 9 and 10). The Passionate Community Monastery (built in 1931) on Sunnyside Avenue had large cracks in the walls throughout the building, stained glass windows were broken, and section of plaster fell from exterior walls. Two churches had cracked bell towers and the City Hall (fig. 11) had a badly cracked cupola that was later torn down. Retaining walls (fig. 12) were cracked and broken and furniture slid several feet across the floors of homes.

Figure 9. Cracked walls at the entrance to apartment building at 634 West Sierra Madre Boulevard in Sierra Madre.

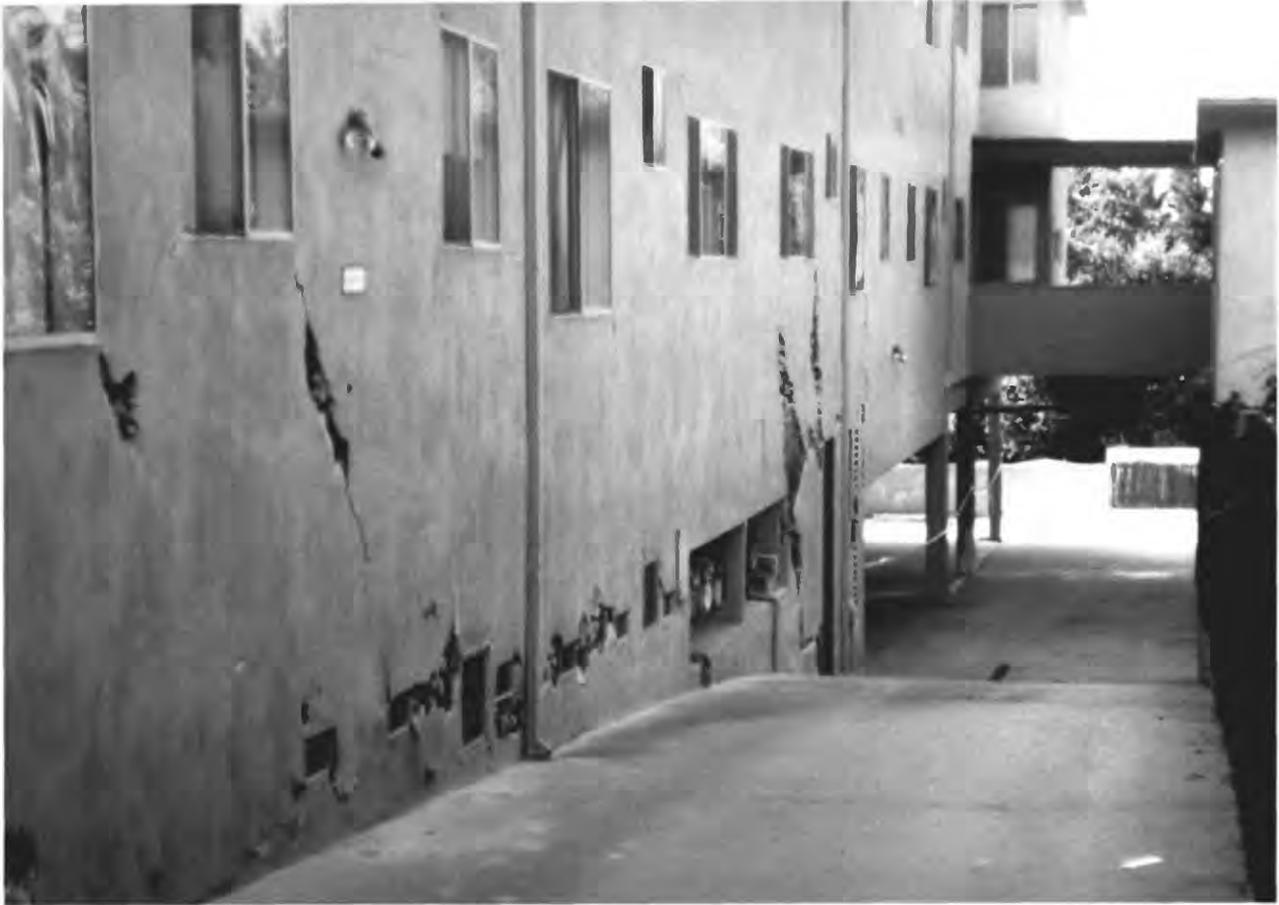
Figure 10. Cracked west wall of the apartment building at 634 West Sierra Madre Boulevard in Sierra Madre.

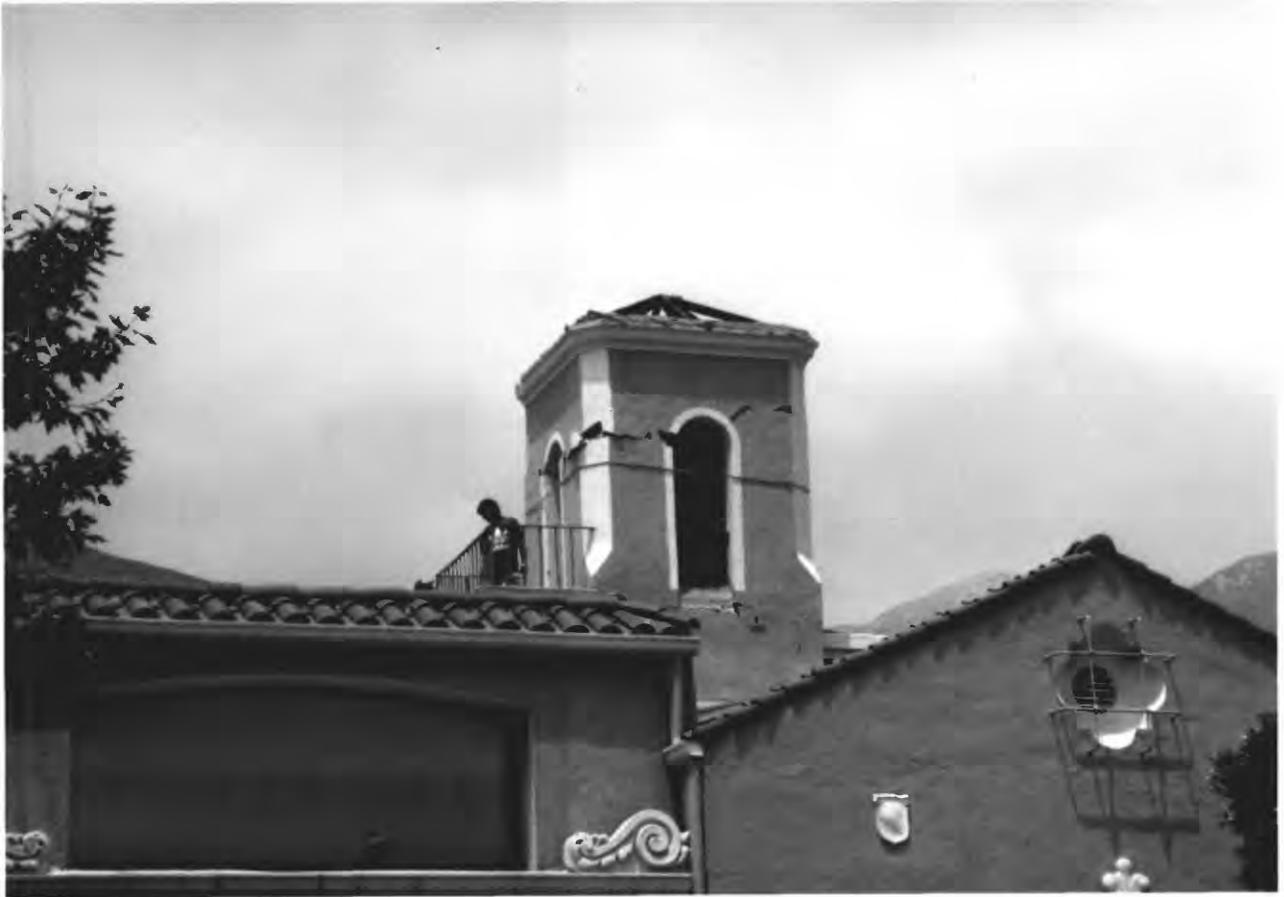
Figure 11. Cracked cupola of the City Hall in Sierra Madre.

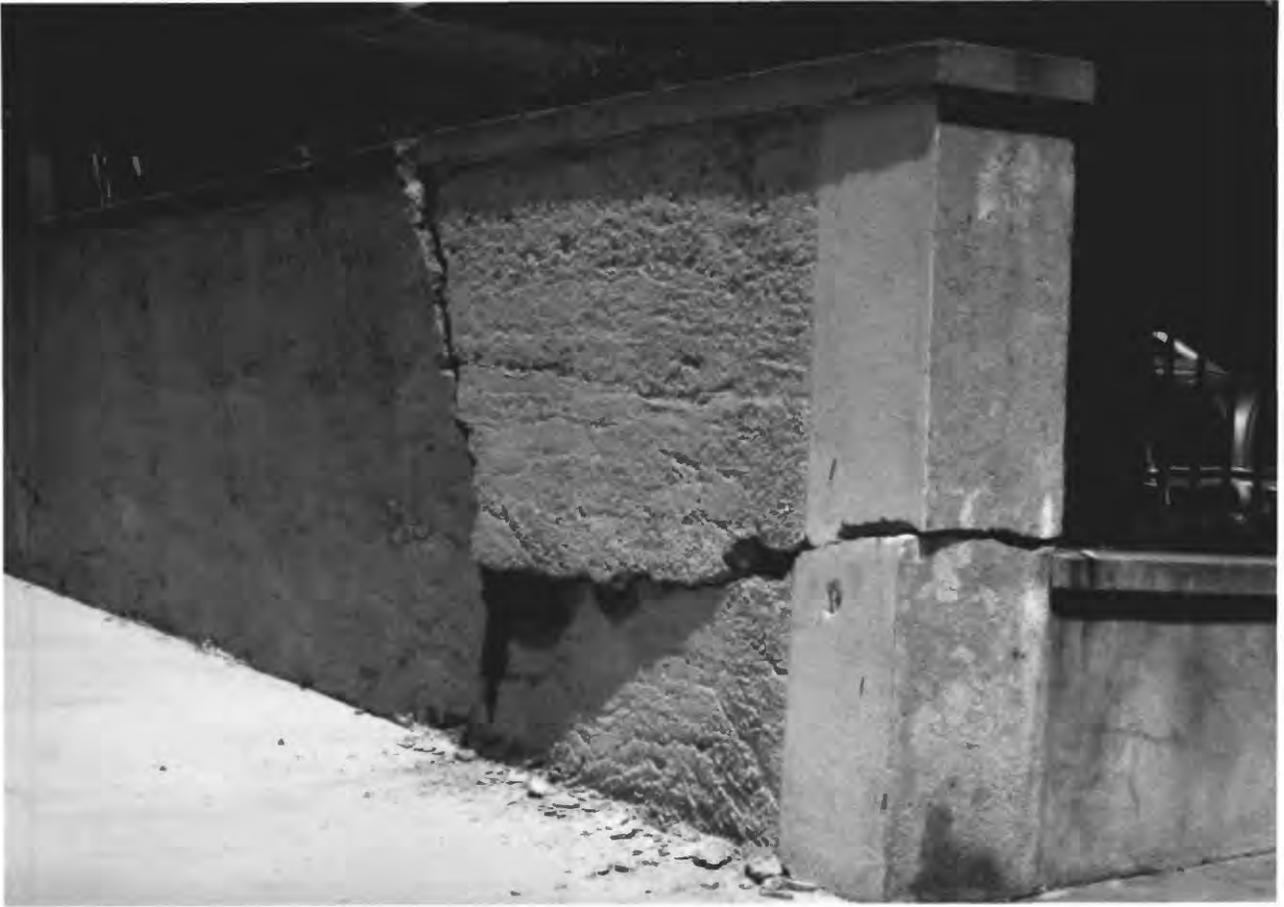
Figure 12. Broken retaining wall on Lima Street in Sierra Madre.
