U. S. GEOLOGICAL SURVEY

The Contribution of Marble Characteristics to the Failure of Column Capital  
Volutes at the Jefferson Memorial, Washington, D.C.

Elaine S. McGee

Open-File Report 91-432

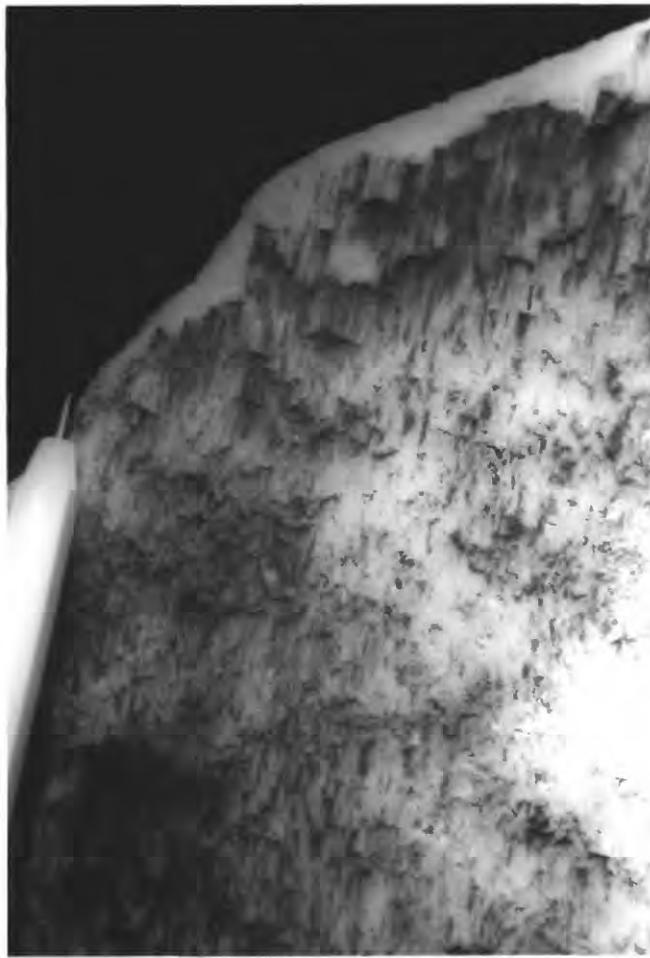
Figure 3A. Example of fracture form: Stepping fracture.

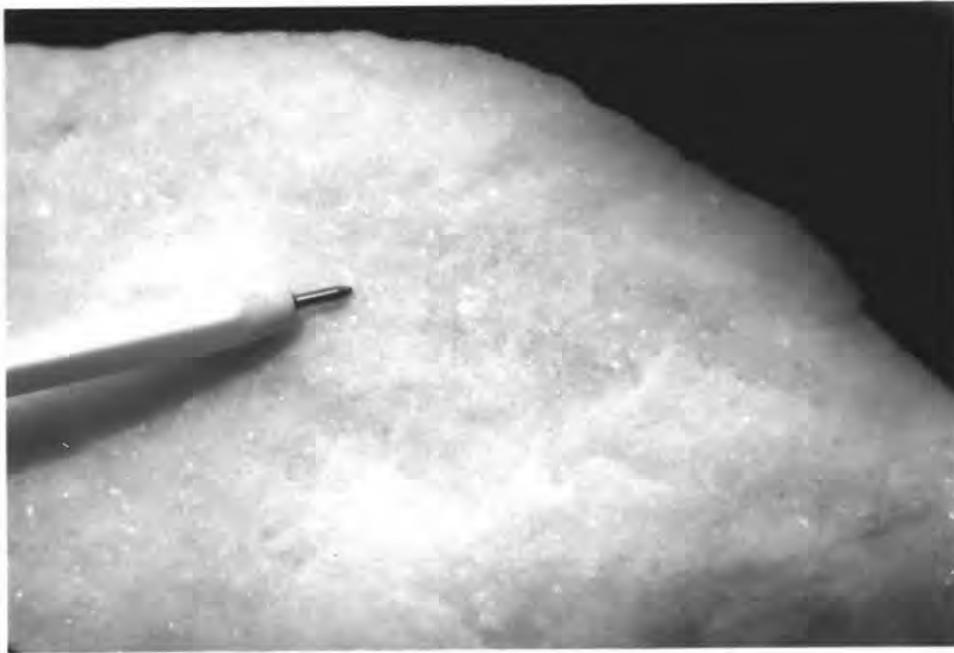
Figure 3B. Example of fracture form: Massive fracture.

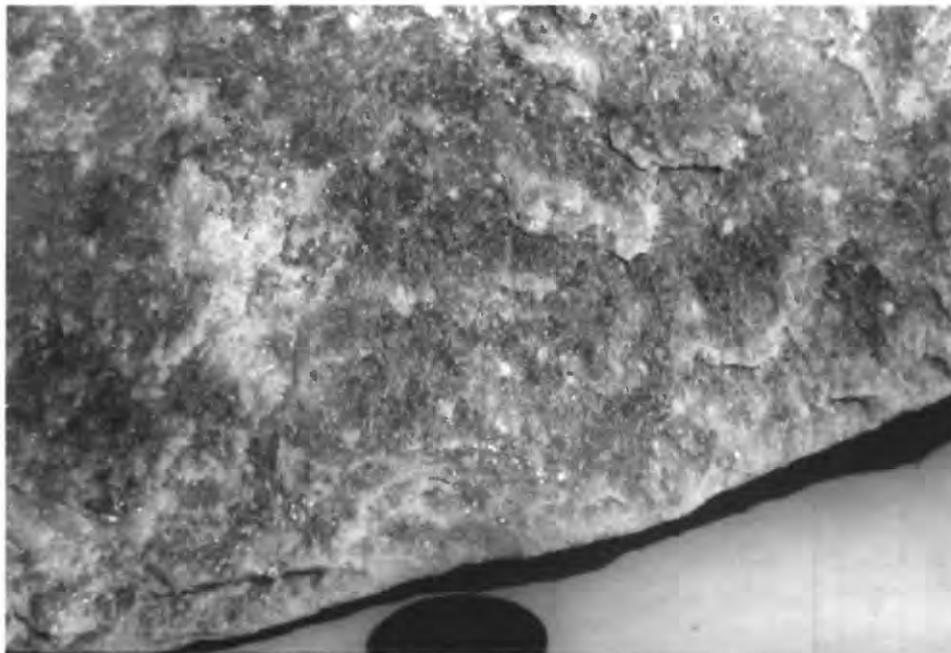
Figure 3C. Example of fracture form: Planar fracture. Penny (lower center) for scale.

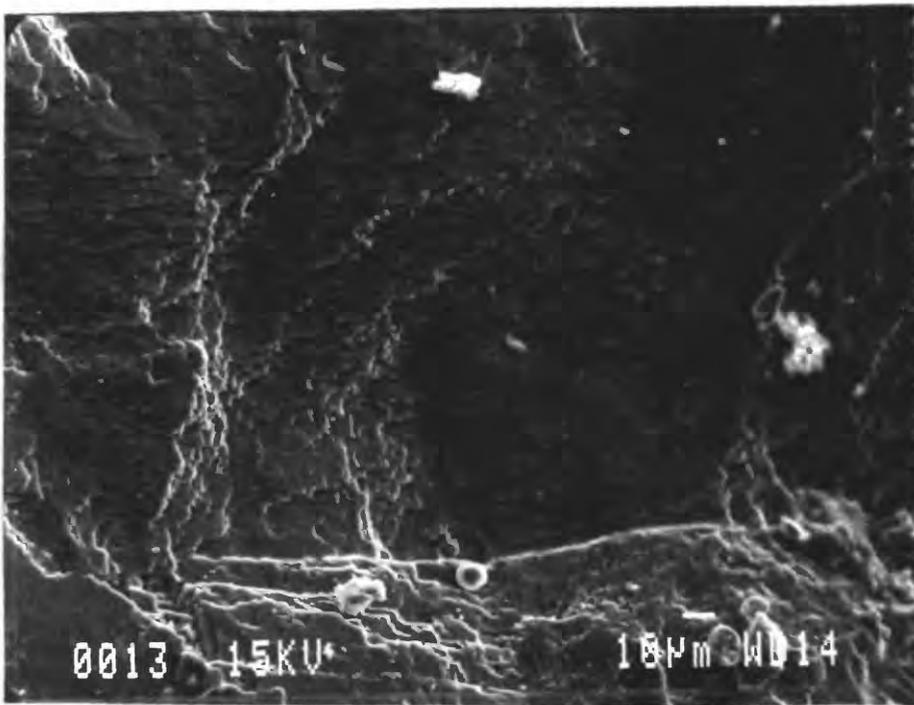
Sample 15A. Calcite is the main phase found in this sample. It has a stepped habit that forms orderly, repeating rectangular edges, probably controlled by the cleavage habit of calcite. Some loose grains of dirt (eg. quartz, and organic particles) were observed scattered on the surface of some of the calcite.

Figure 4. Blocky, stepped calcite seen with scanning electron microscopy, sample 15A. See also photos for samples: 15A, 38A, 43B, 45D, 51D.

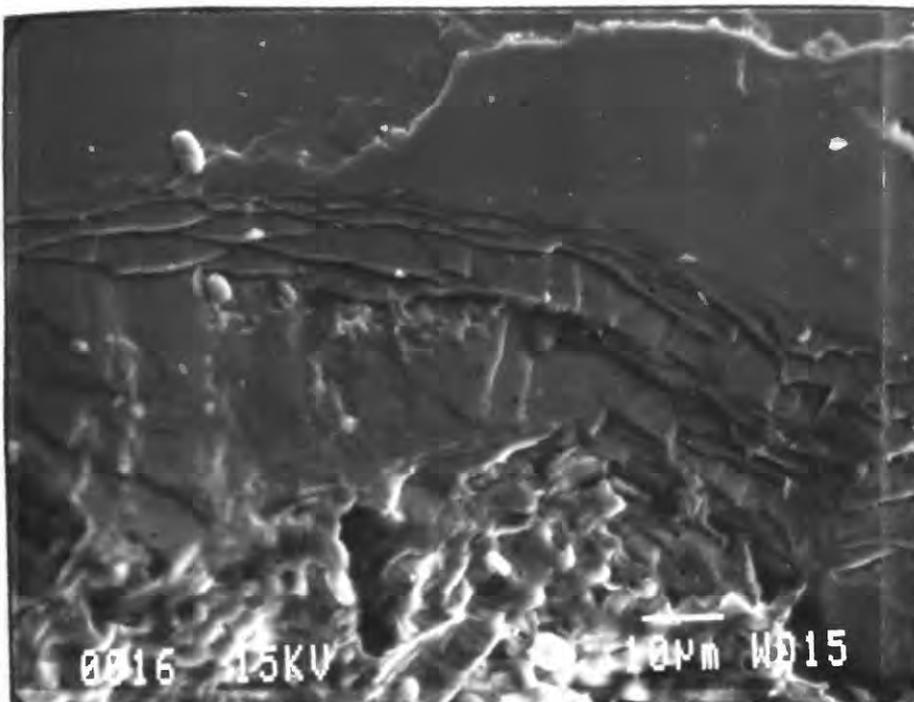
Figure 5. Planar habit of calcite seen with scanning electron microscopy, sample 25C. See also photos for samples: 38A, 45D, 51D.

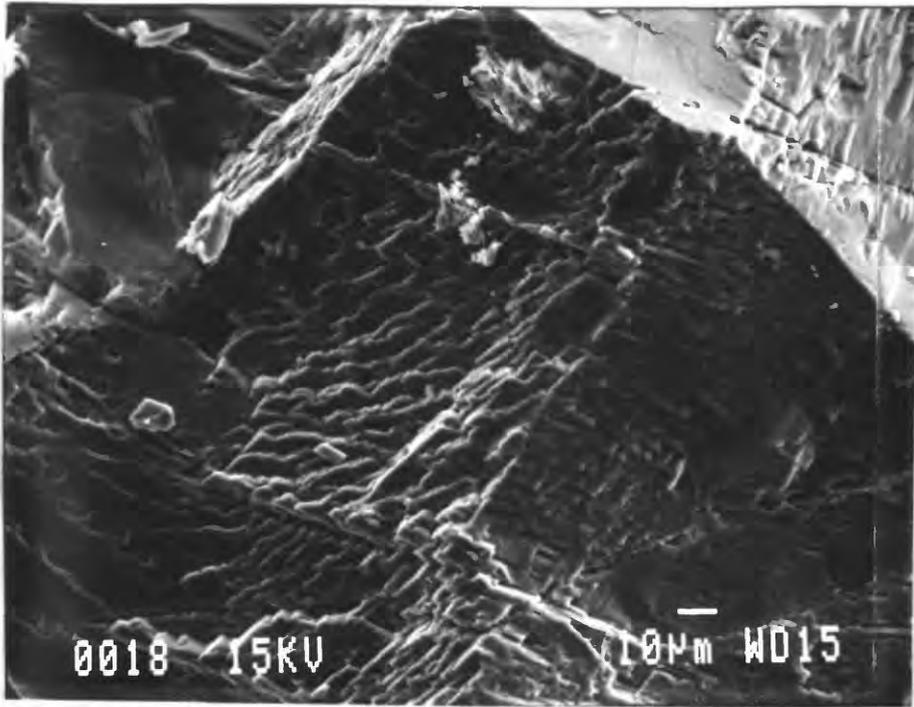
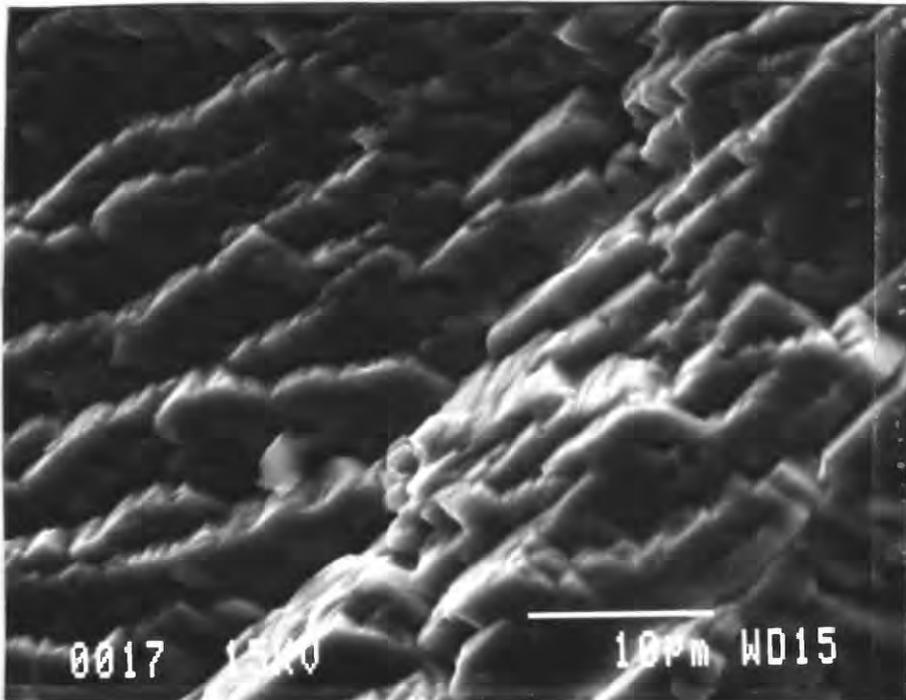
Sample 51D. Blocky steps of calcite are the dominant feature with fairly abundant muscovite that occurs as books and grains with rounded edges that are scattered and usually coplanar with the calcite. Sphene is also present as a rare primary phase. Small gypsum crystals were observed in three forms on calcite surfaces as a secondary phase.

Figure 6. Stepped habit of calcite carries to even very fine scales, sample 51D; A. area of steps, and B. close-up view of center area shown in A.

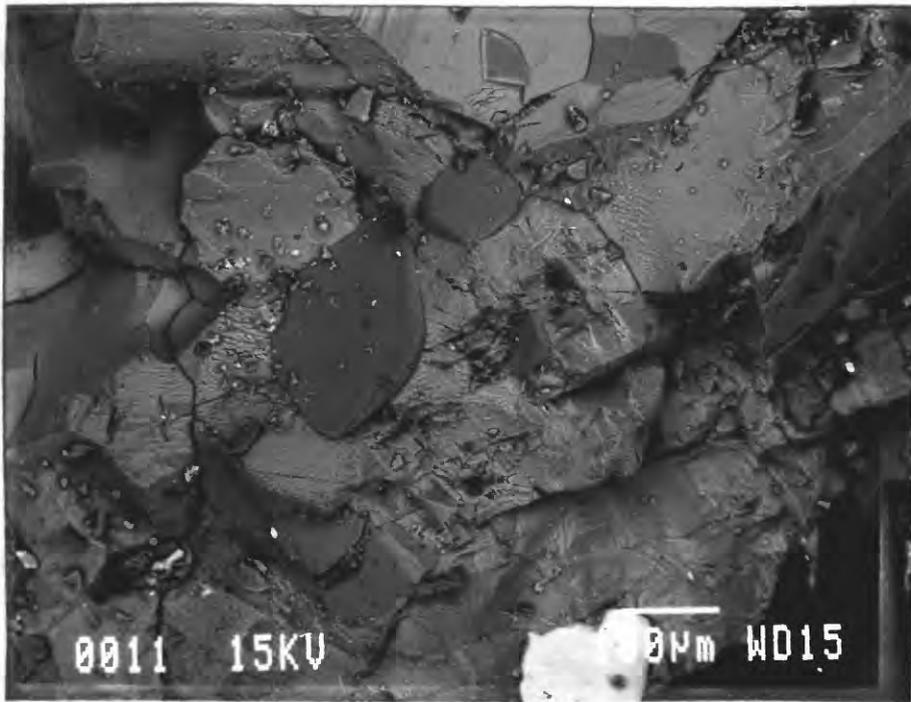
Figure 7. Sheet silicate inclusions are random, individual grains; sample 51D (backscattered electron image), mica grains are smooth darker gray grains with slightly rounded edges. See also photos for samples: 45D, 51D.

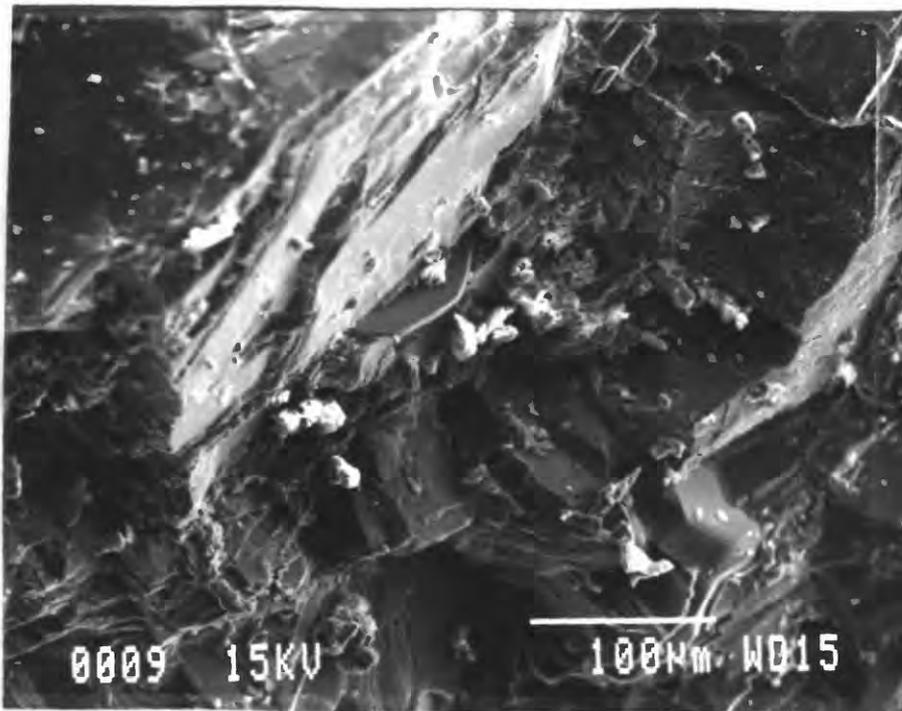
Figure 8. Inclusions in clusters that are co-planar with the calcite, sample 51D. Mica grains at the center and lower right corner of the photograph protrude from the calcite ledges and have smooth surfaces and hexagonal edges.

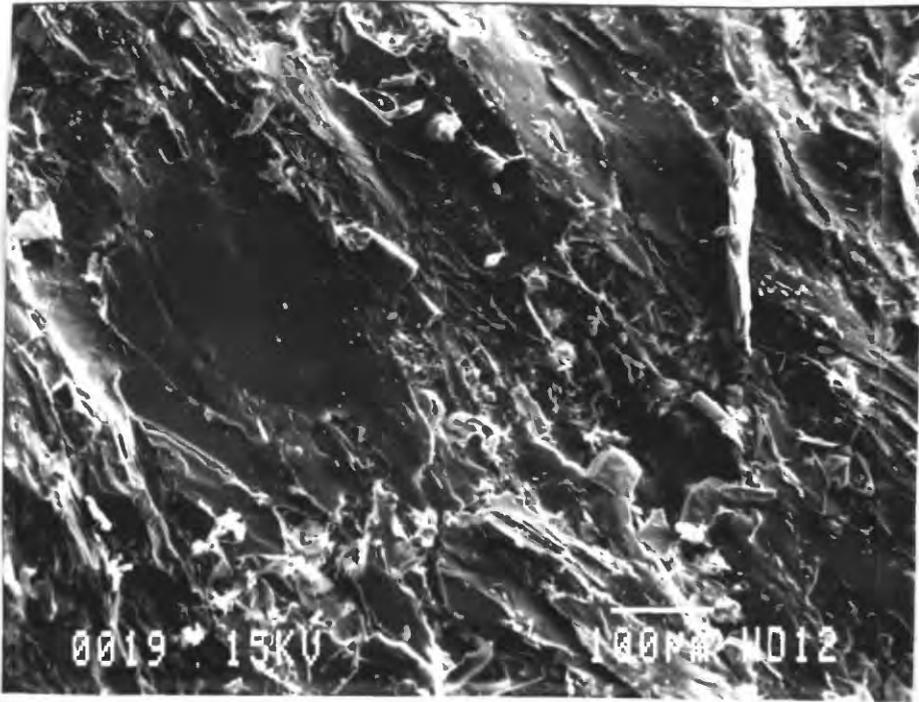
Sample 26D. The fracture surface primarily consists of sheet silicates (phlogopite and chlorite) with minor pyrite and very minor apatite. The sheet silicate minerals form irregular, nearly flat layers and are intermingled. The form of the fracture surface is controlled by the habit and appearance of the sheet silicates. Calcite is only rarely visible on this sample.

Figure 9. Mica predominant surface texture is in sheaves of grains that are not blocky; sample 26D; compare with blocky calcite photos in figure 4. See also a localized area of mica-rich inclusions in photos of sample 45D.

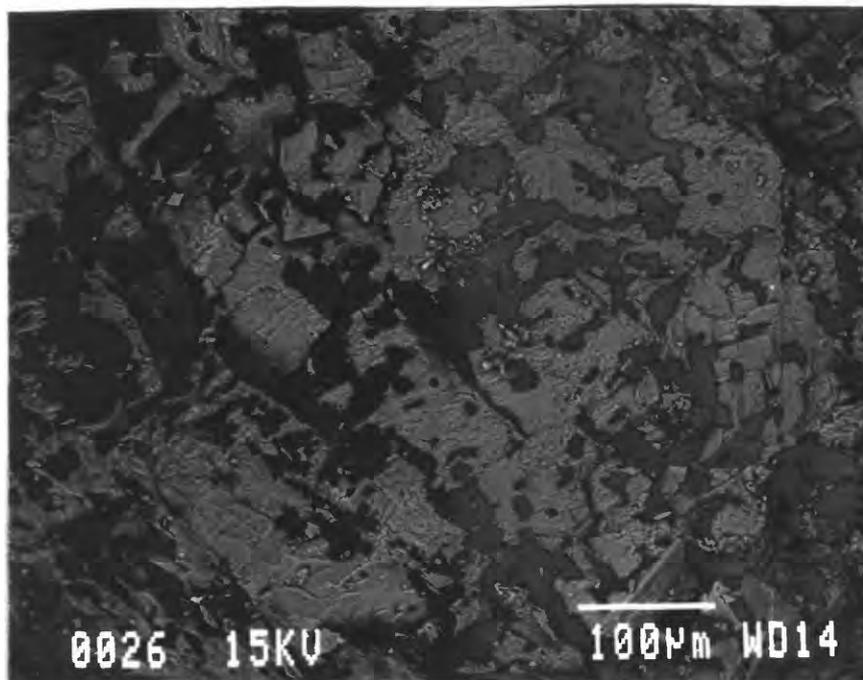
Figure 10. Organic accumulation appears black in a backscattered electron image of sample 25C, but does not hide the dominant surface feature of blocky, stepped calcite. See other photos for 25C.

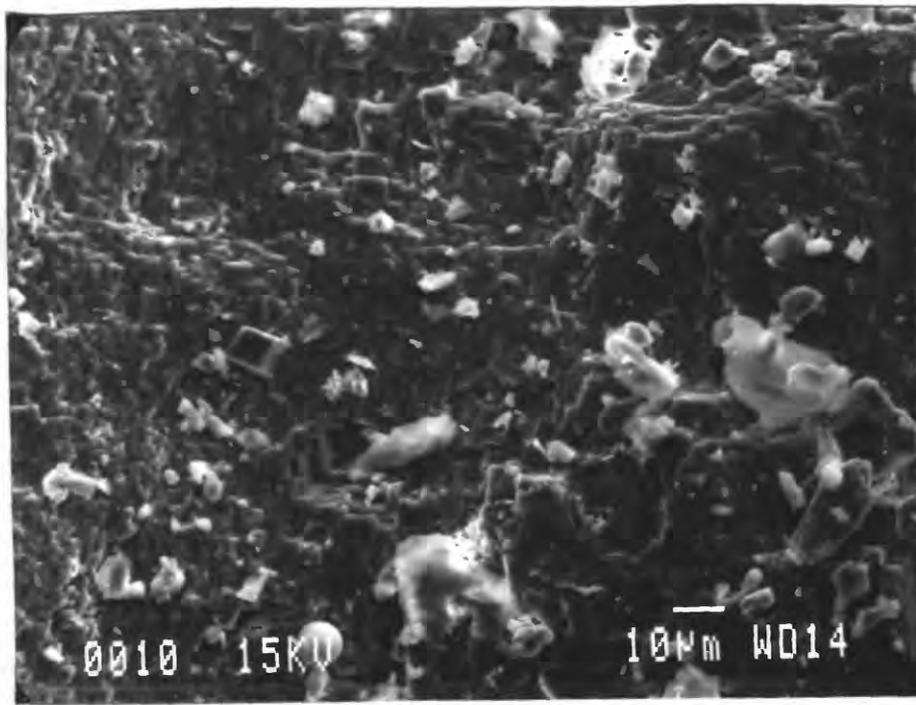
Figure 11. Dirt and particulate accumulation appears as surficial litter on the stepped calcite surface underneath, sample 15A. See also photos for 25C, 45D.

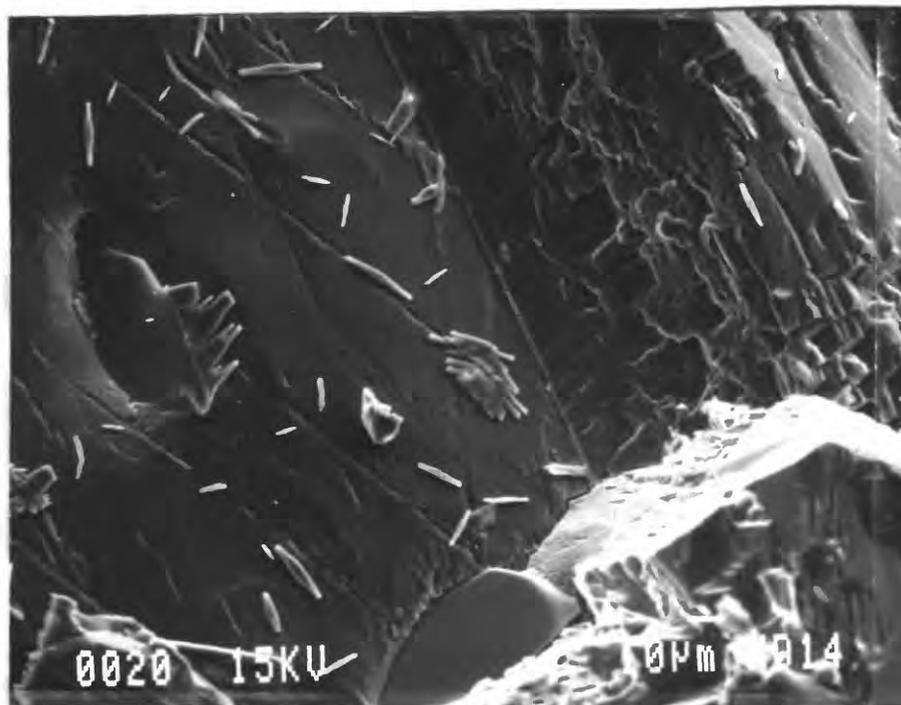
Figure 12. Gypsum crystals appear as small needles on the calcite surface; some of the needles have begun to form small clusters but all are small and the dominant surface feature is the habit of the calcite; sample 51D. See also photos for 43B, 51D.

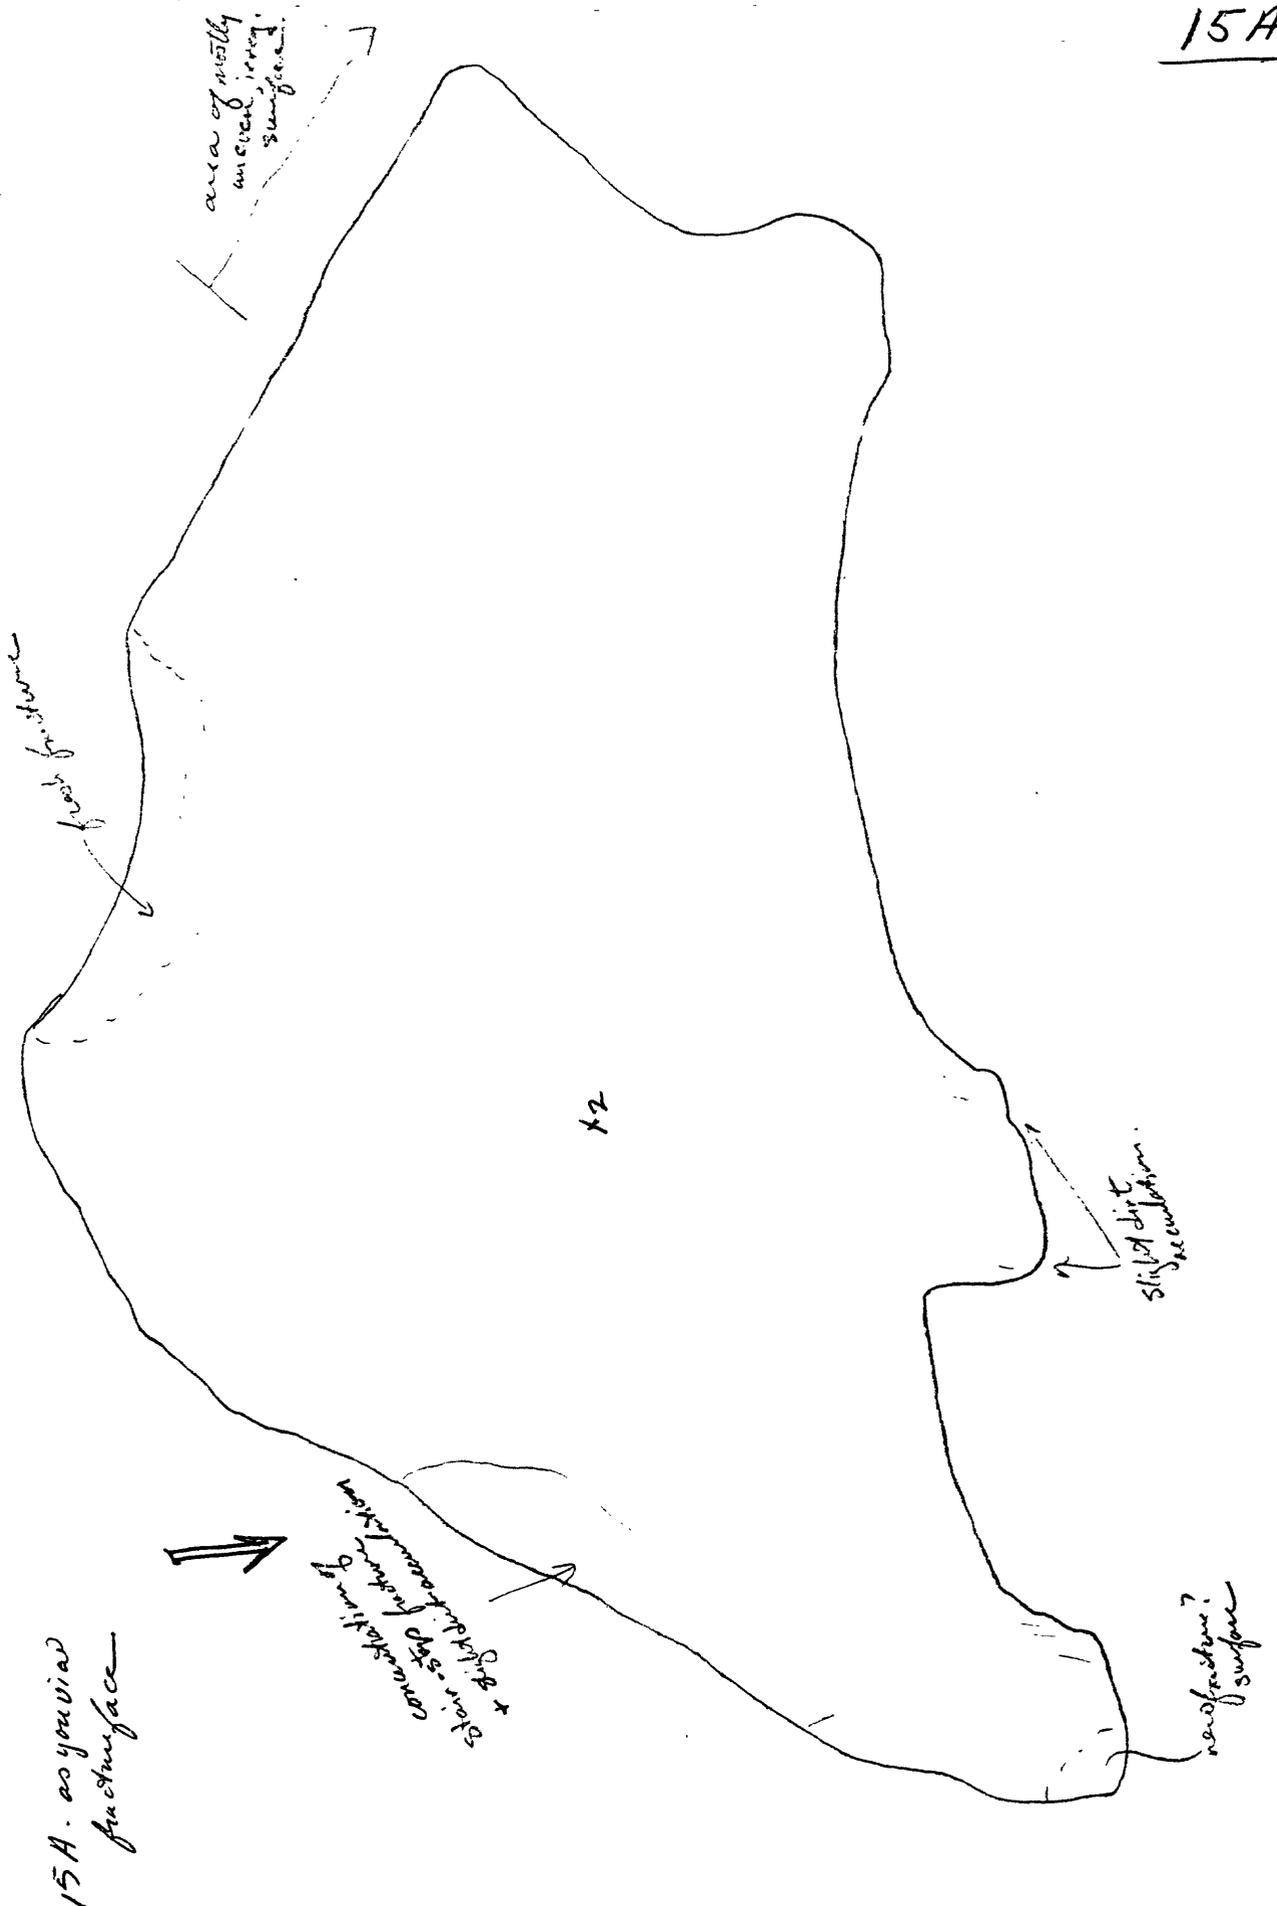
15A. as you view fracture

Sample 15A. The fracture surface is mostly white, with some areas of minor dirt

accumulation. Most of the fracture face is characterized by a layered "stair step" surface. The calcite is white with a dull luster to its surface; there are no other mineral phases readily visible, visually or optically on the surface. Calcite grains are angular to sub-rounded, mostly 0.2 - 0.4 mm size, and some are up to 1.5 mm. Very small inclusions of pyrite (0.05mm) and rutile (0.1mm) were observed on some of the samples taken from the fracture face.

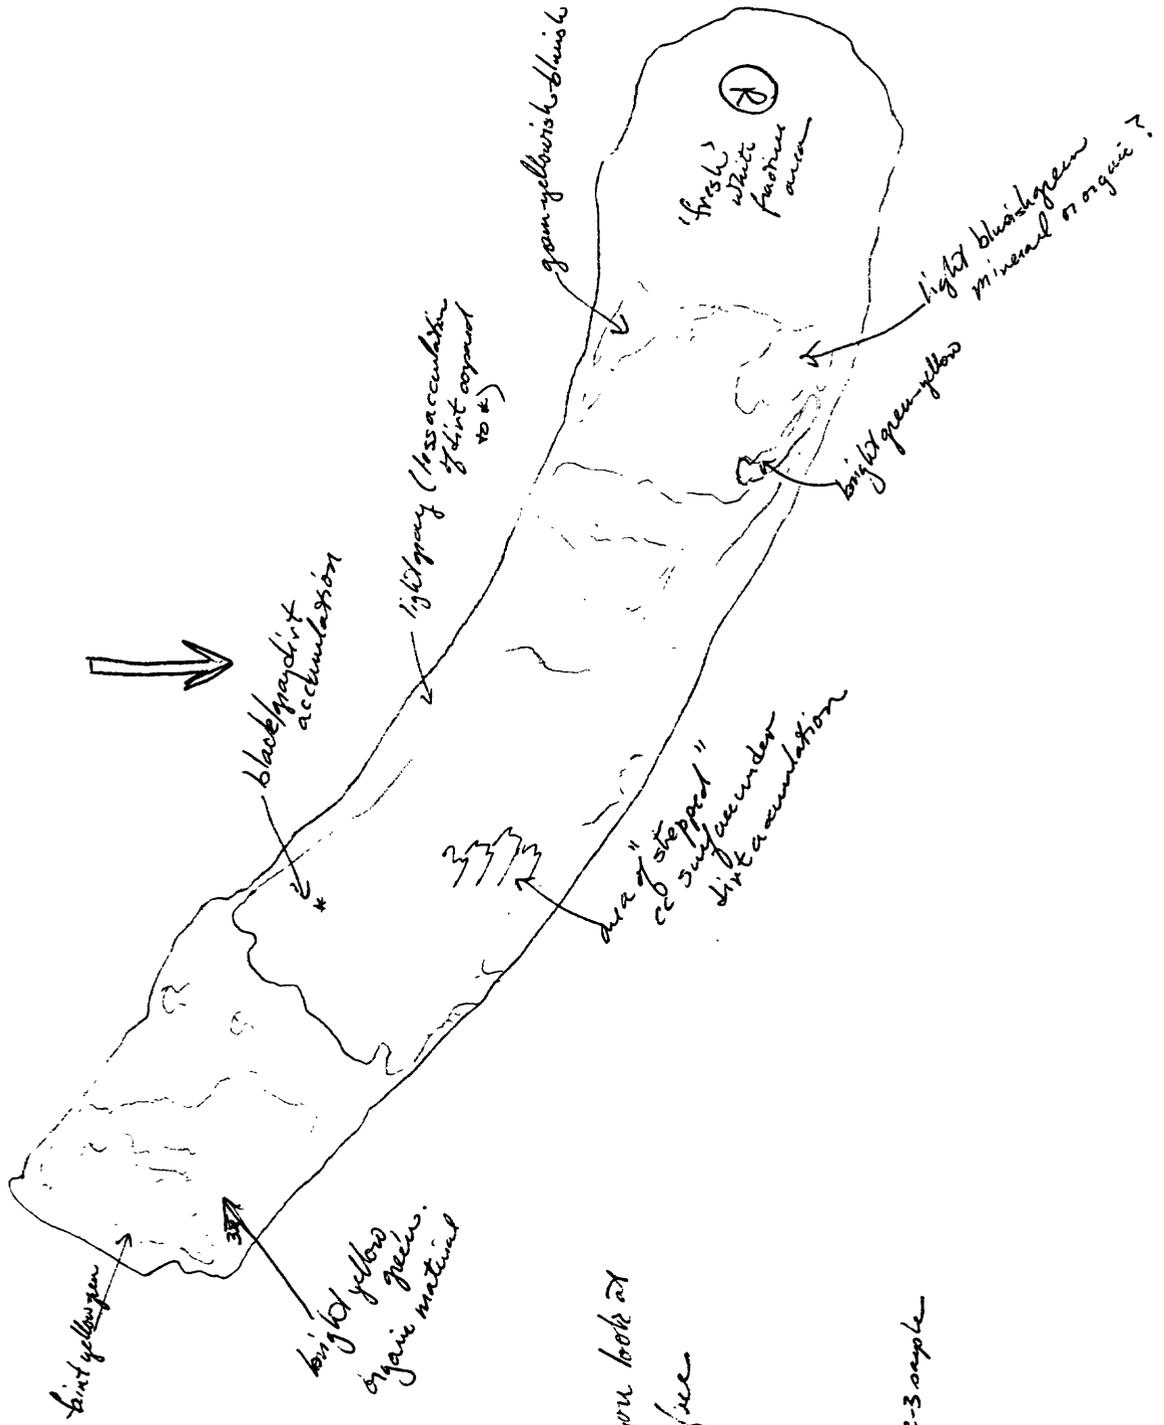
25C - as you look at  
fracture

Sample 25C. The central portion of the fracture surface has a lot of dirt accumulation; the two ends appear sugary and freshly broken. On one end of the fracture face there is an area of bright yellow-green accumulation that appears organic in origin, possibly algae. The calcite underneath the dirt that accumulated in the central area has a jagged, blocky fracture. Loose calcite grains, especially abundant because the outer surface of the sample is pervasively sugared in texture, are angular in shape and cloudy-white colored. Grains are commonly 0.5 to 1.3 mm size. The accumulations of dirt and organic material on this sample are especially notable, suggesting that the crack may have been present for quite some time, and open to extensive penetration by water and dirt.

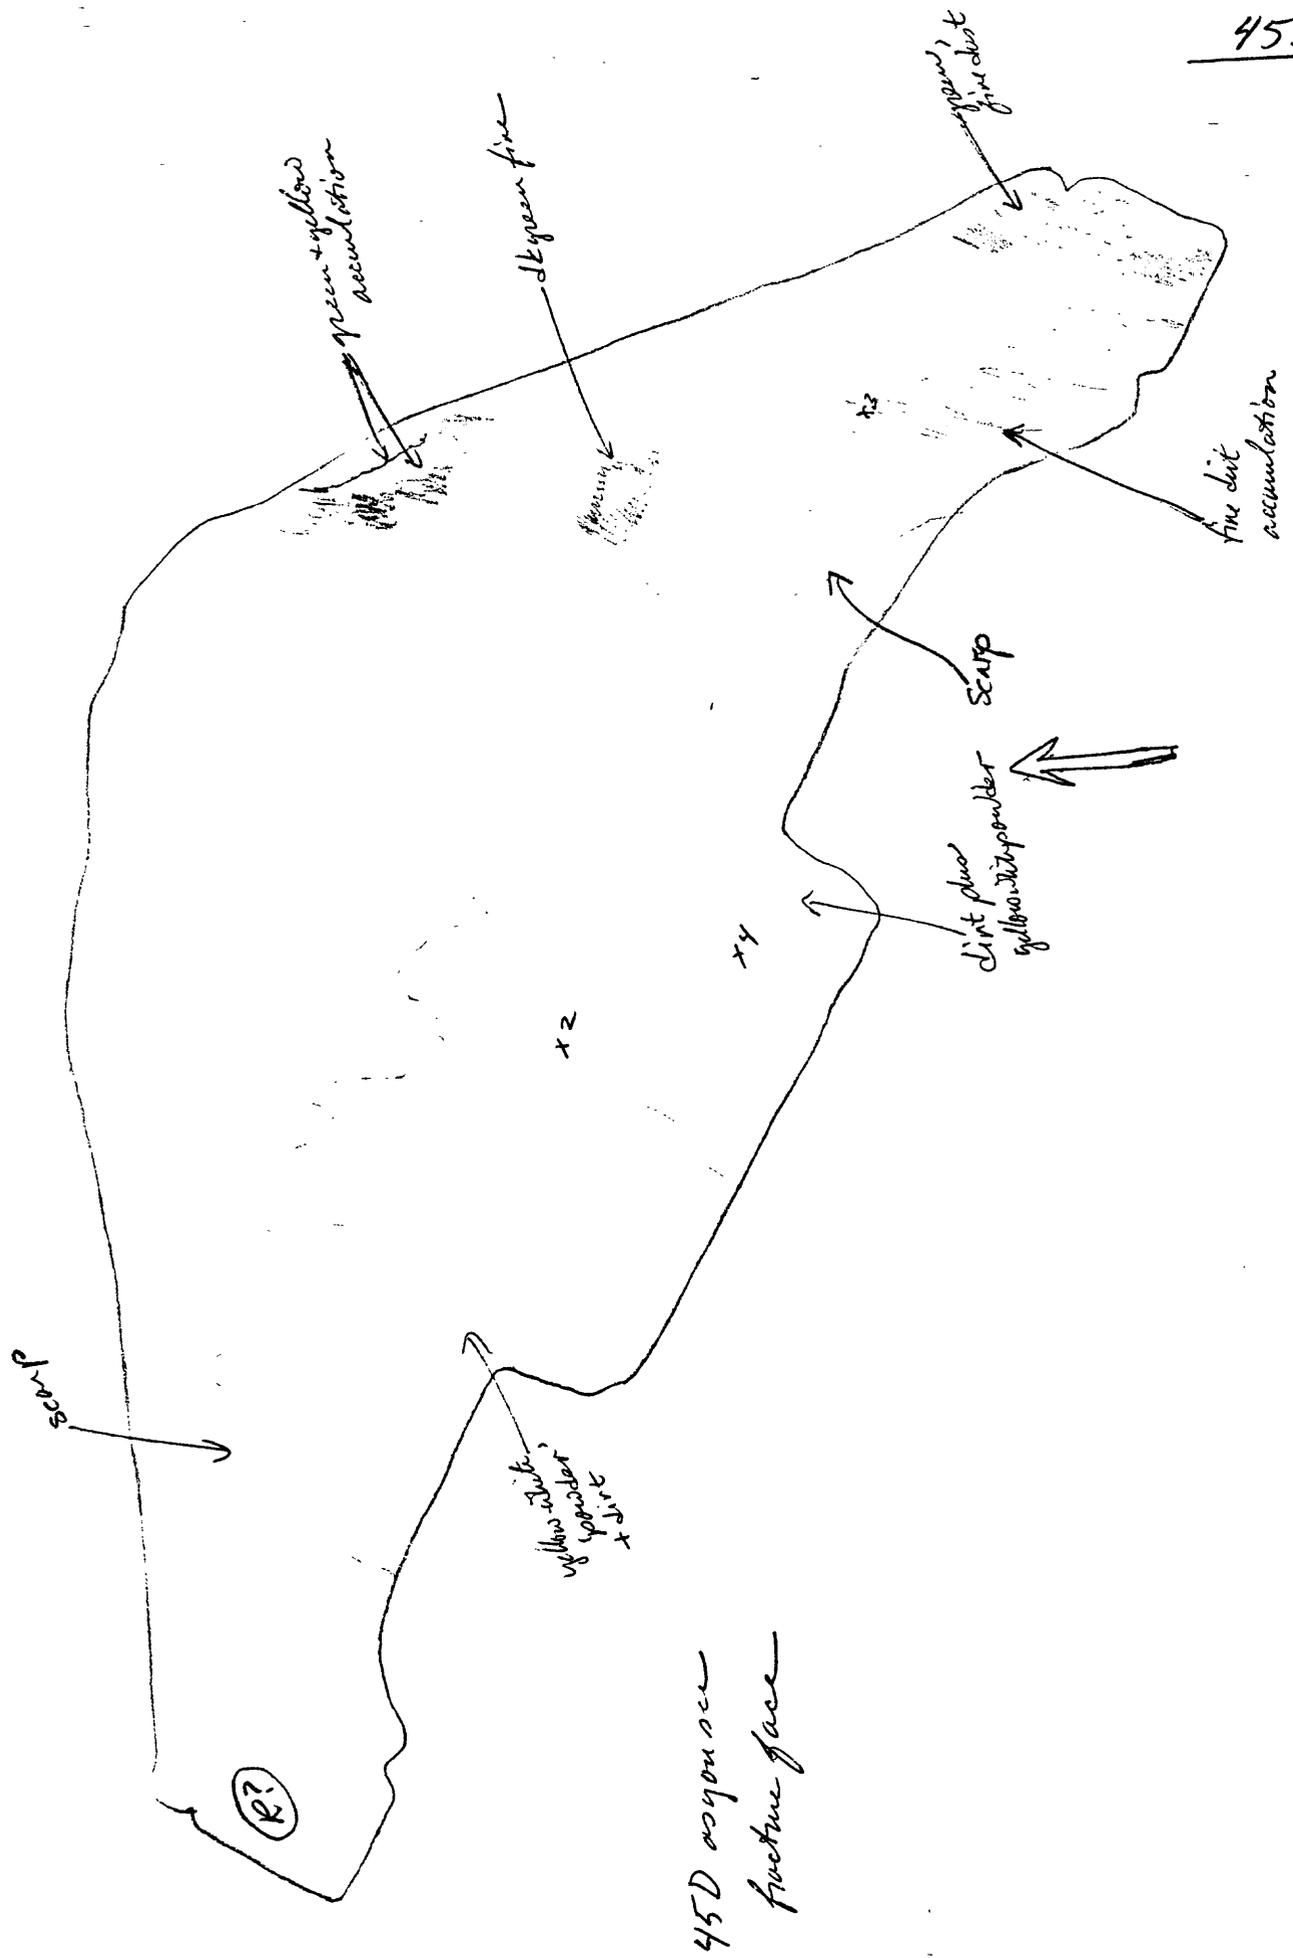
45D as you see  
fracture face

Sample 45D. The fracture face is uneven and irregular, and it has areas of white, gray, yellow-white, and some green coloration. The surface has a shingled fracture pattern and there are no obvious areas of recent (fresh) fracture. Three areas of green accumulation consist of fine, soft, round green (apparently) organic particles that are concentrated between grains or along surface irregularities. In some areas, white translucent to opaque calcite grains are intermingled with plates and flakes of white or clear mica. The mica is in small flakes that lie parallel to each other and to the surface, giving some pieces a linear, foliated appearance. Angular calcite grains are either about 0.5 mm or nearly 1-2 mm in size.

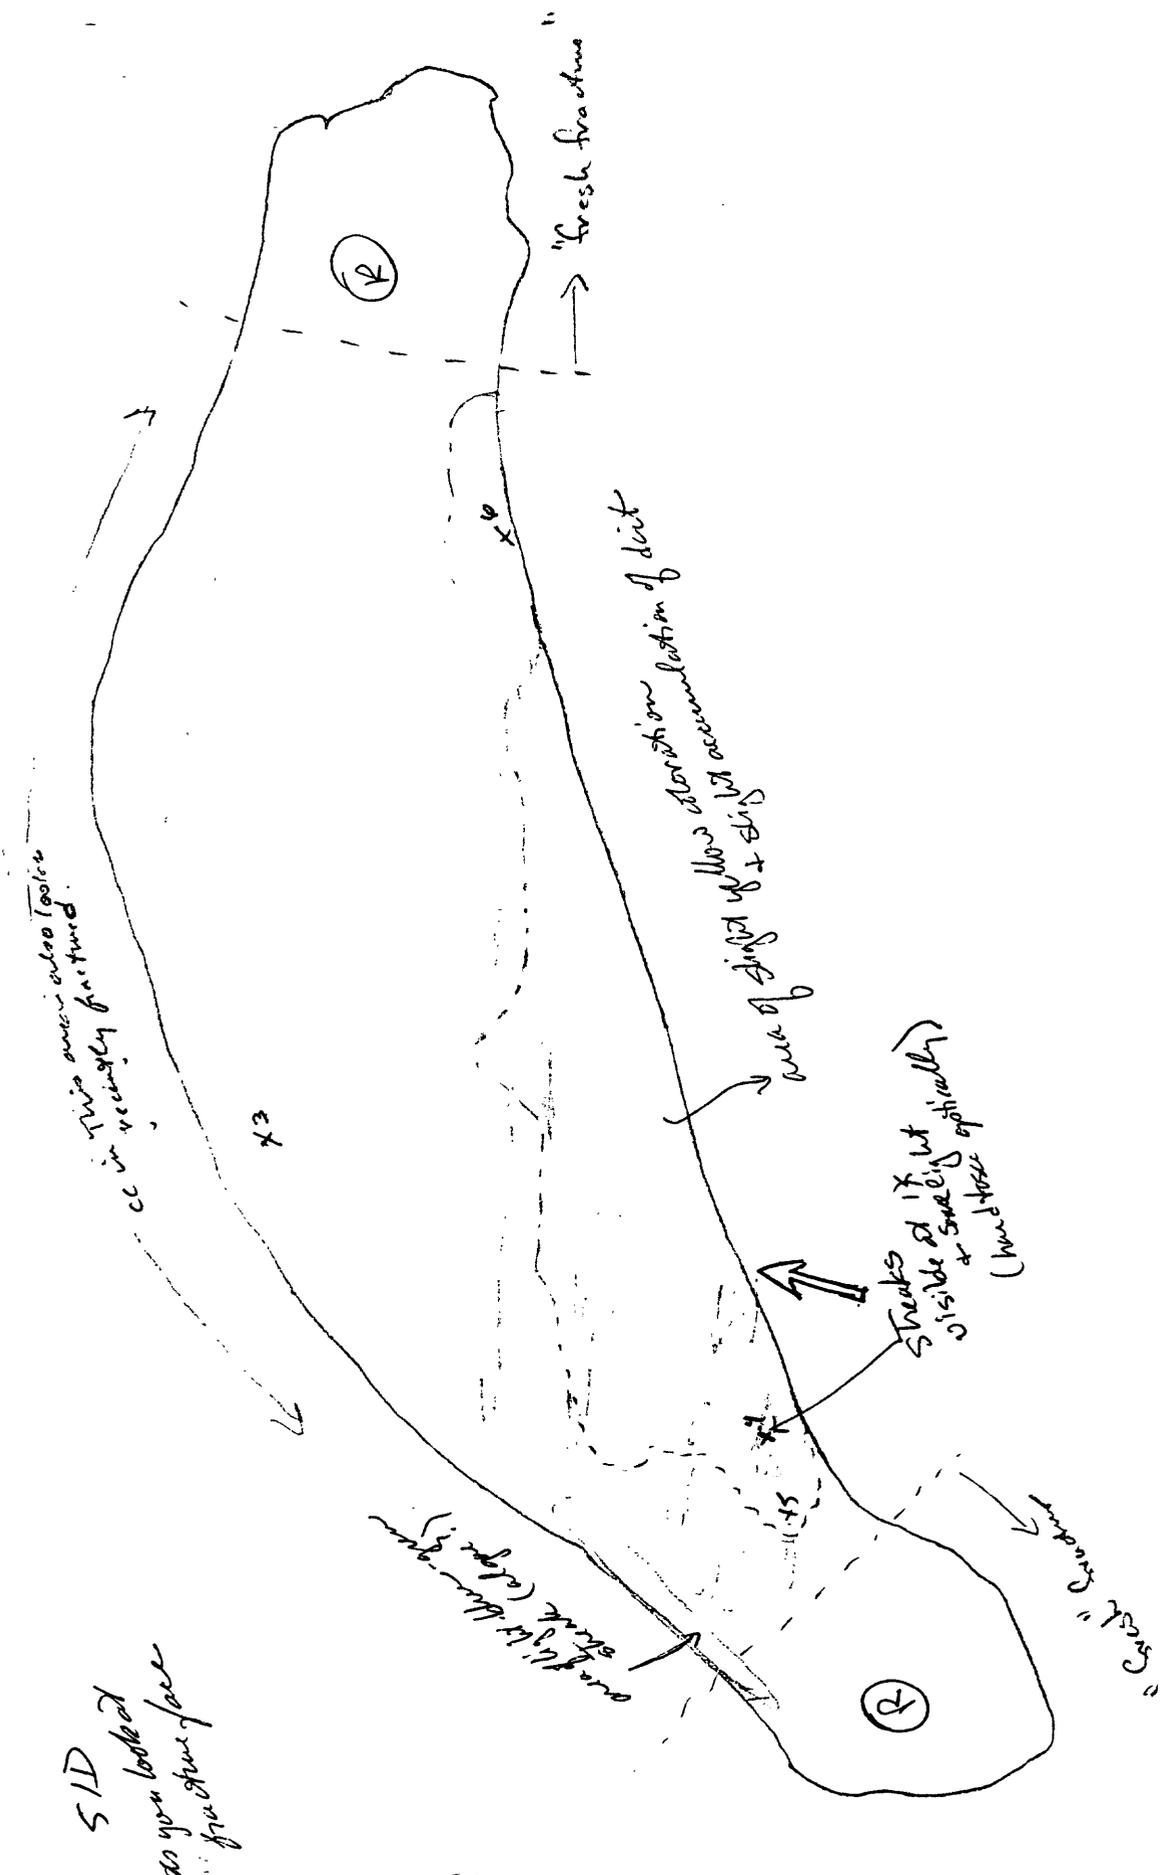
51D  
 as you look at  
 fracture face

Sample 51D. Most of the fracture face is white with some yellowing and a slight dirt concentration near the outer edge. There is a light blue-green streak along the fracture face - inner face edge on the left end of the sample. The light blue-green streak consists of very fine organic "particles" that are concentrated along grain edges and cracks. The fracture surface is uneven and has some shingling, but it has no regular "stair step" pattern. Calcite grains are

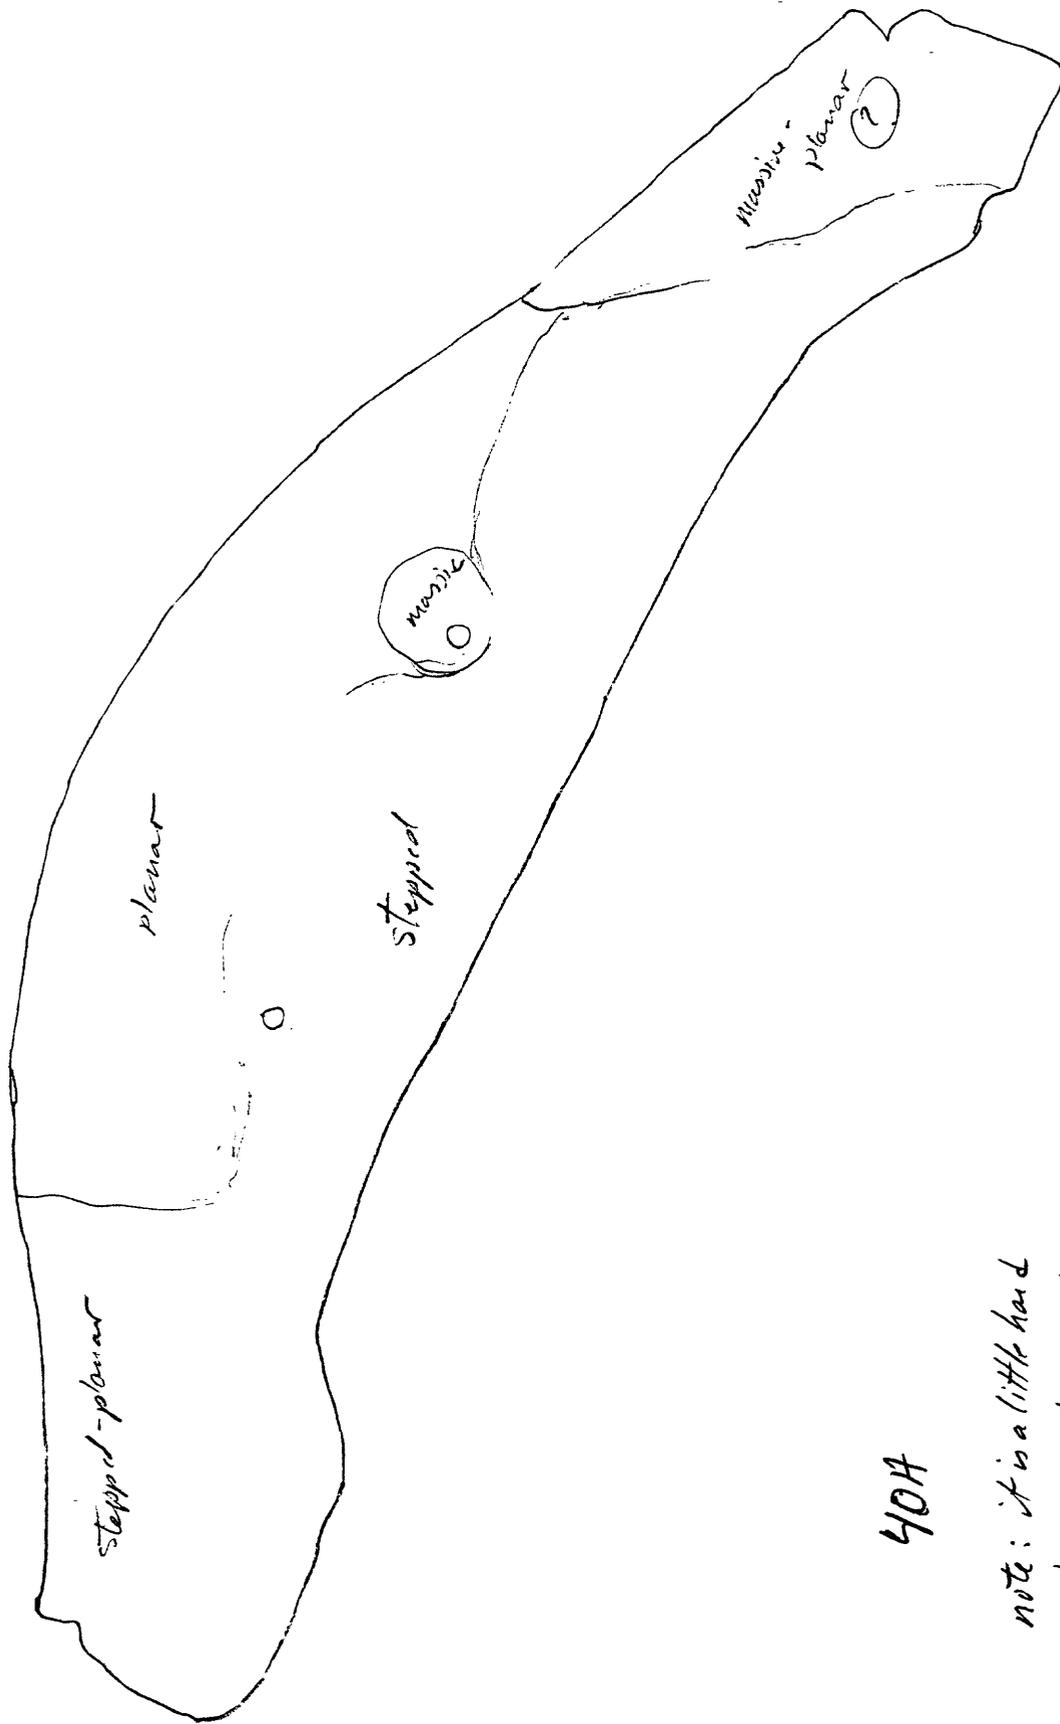
40A

note: it is a little hard to see fracture surface here because of the adhesive remnants

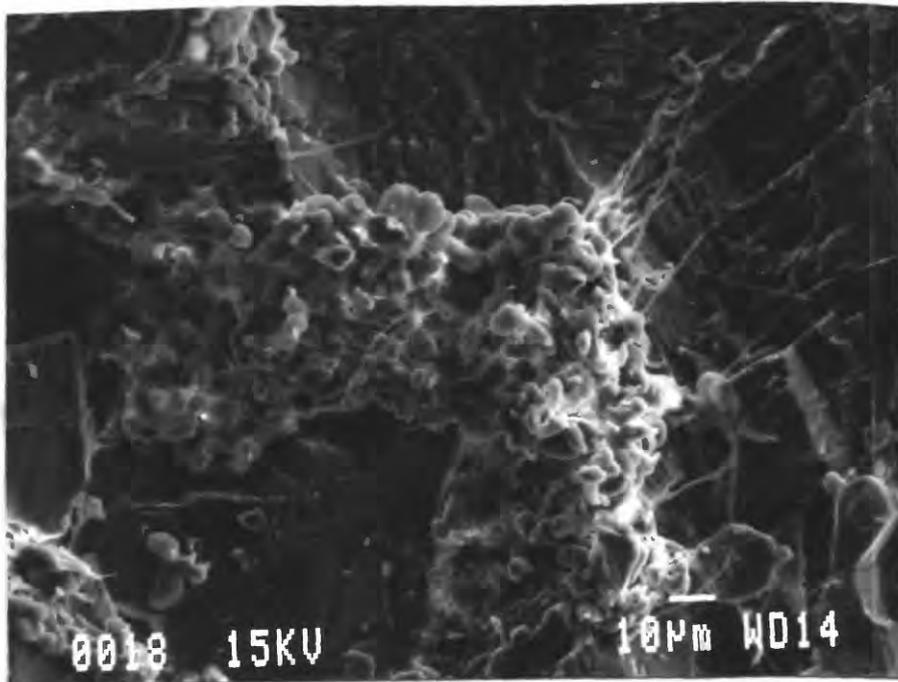
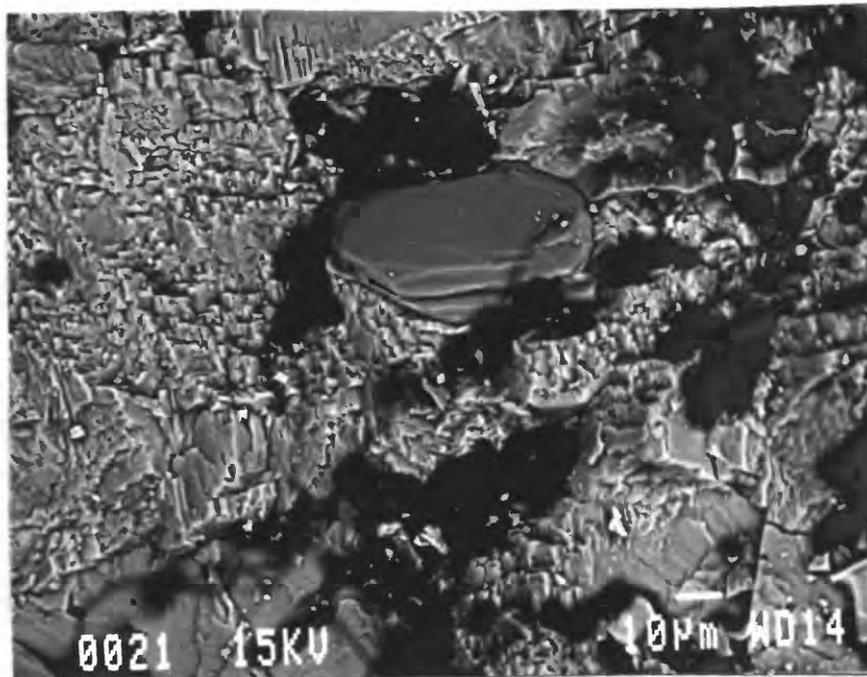
Sample 25C:

0018 - organic material on blocky calcite

0021 - blocky calcite, with a muscovite inclusion (smooth, rounded grain at center), and organic material (black); backscattered electron image.

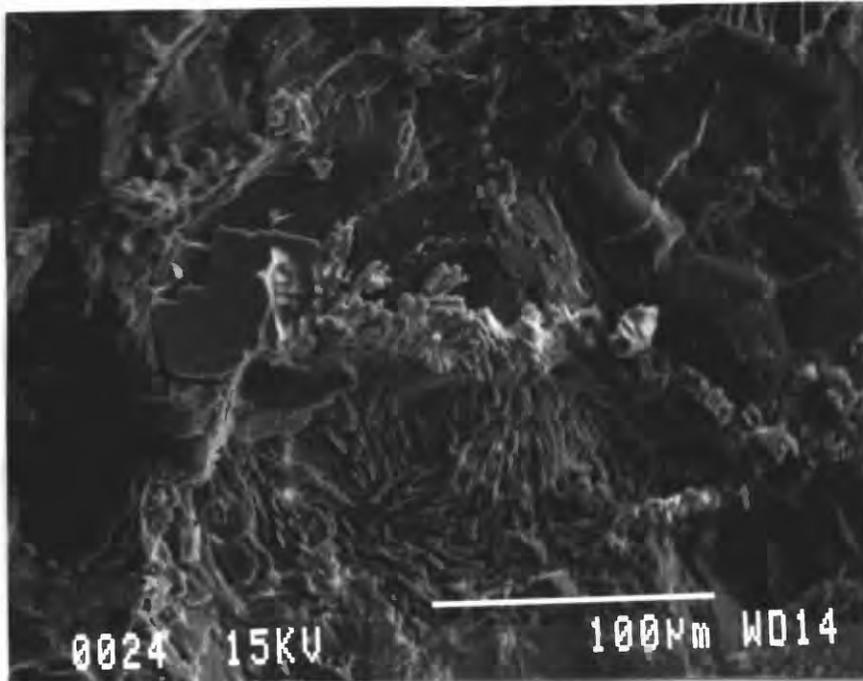
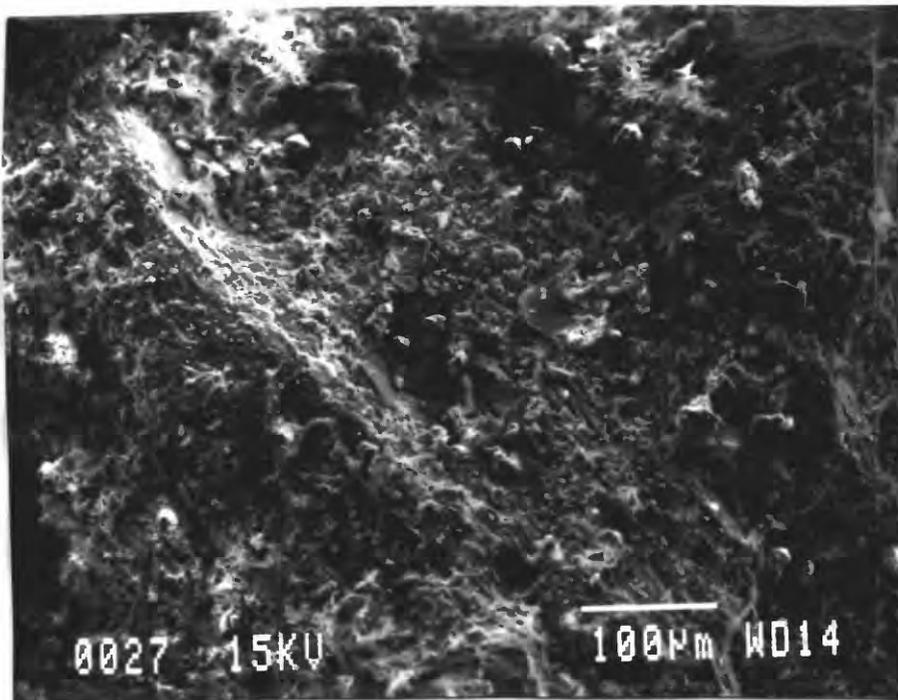
Sample 25C:

0024 - gypsum crystals (rectangular grains, clustered near lower center), covering an area of blocky calcite.

0027 - dirt covering and obscuring the calcite surface
