U. S. GEOLOGICAL SURVEY

The Contribution of Marble Characteristics to the Failure of Column Capital  
Volutes at the Jefferson Memorial, Washington, D.C.

Elaine S. McGee

Open-File Report 91-432

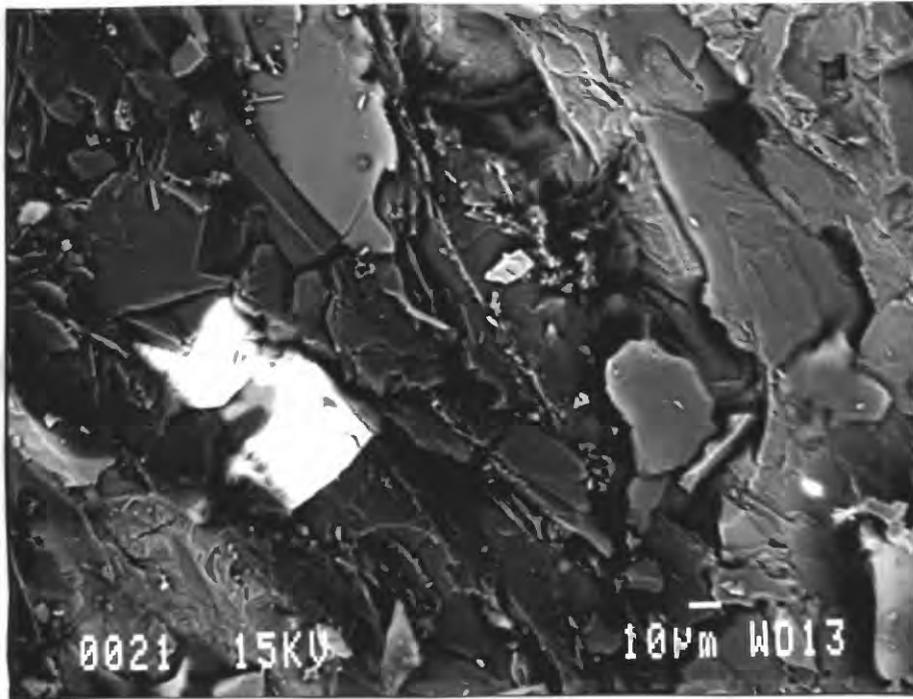
Sample 26D:

0021 - backscattered electron image of chlorite + phlogopite rich area; bright white grains are pyrite.

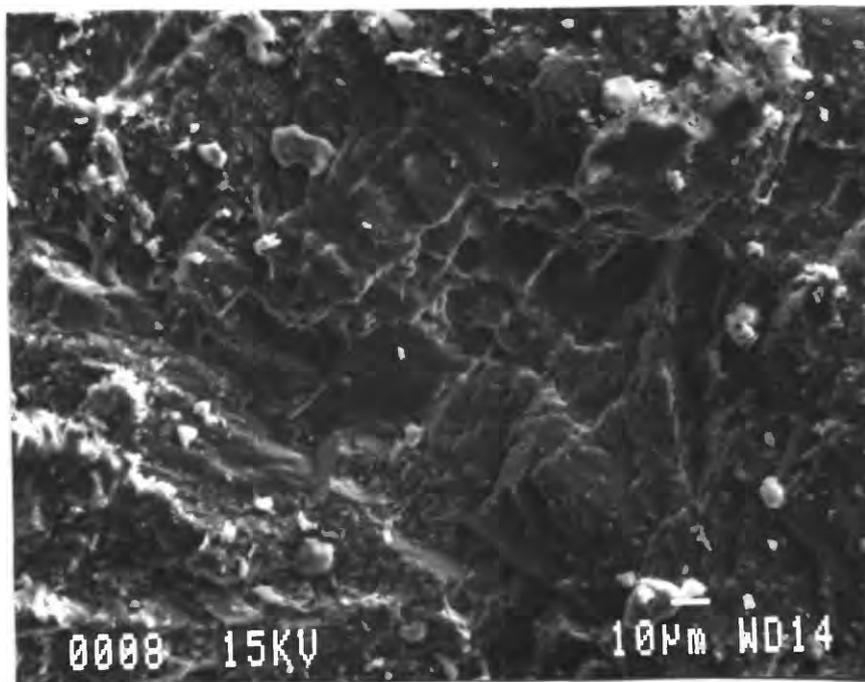
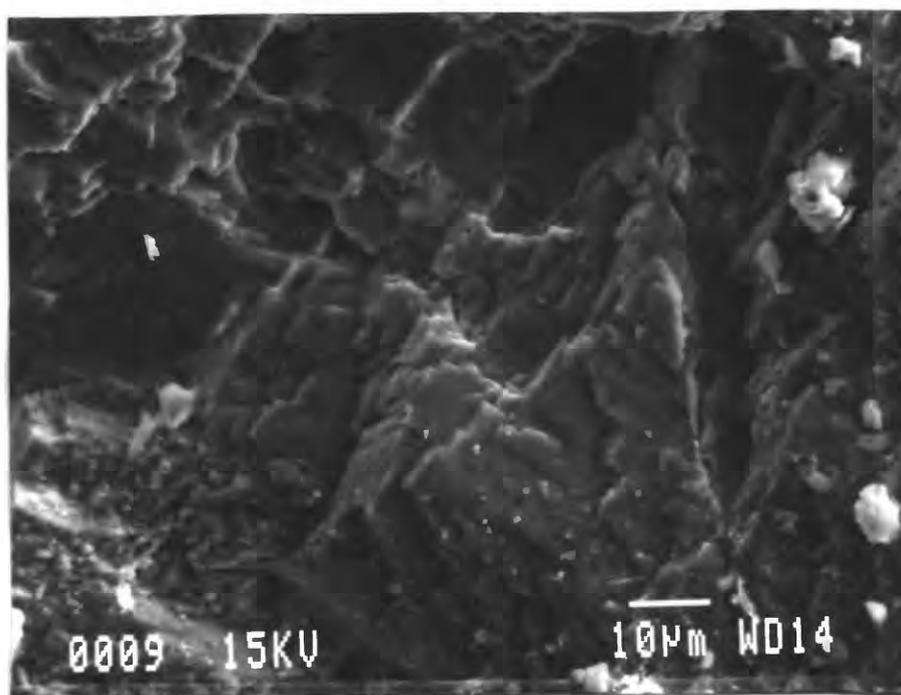
Sample 38A:

0008 - stepped calcite surface with some dirt accumulation.

0009 - detail of stepped calcite in photo 0008.

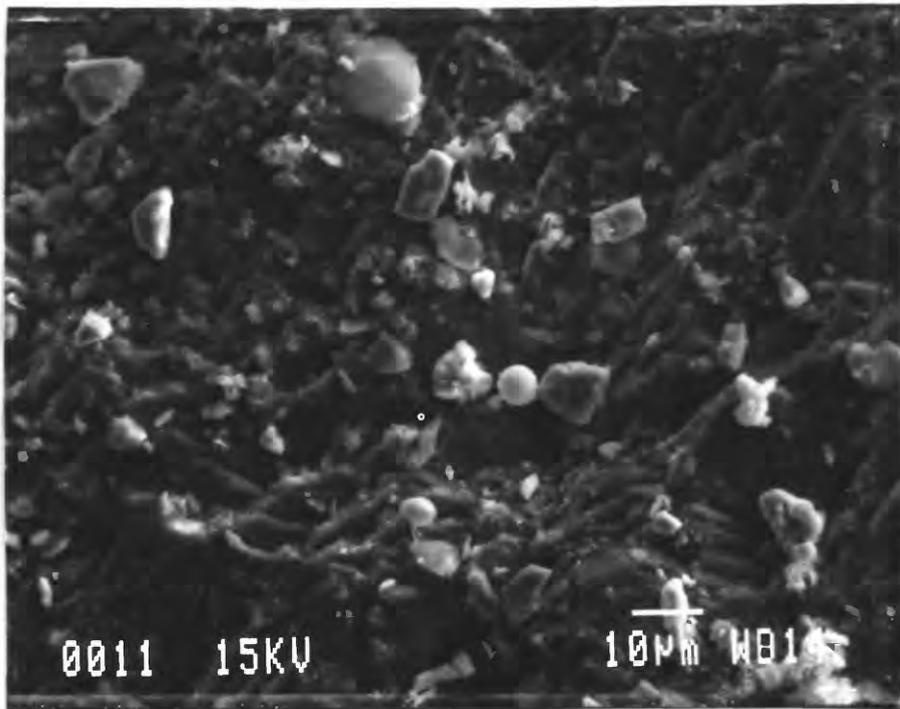
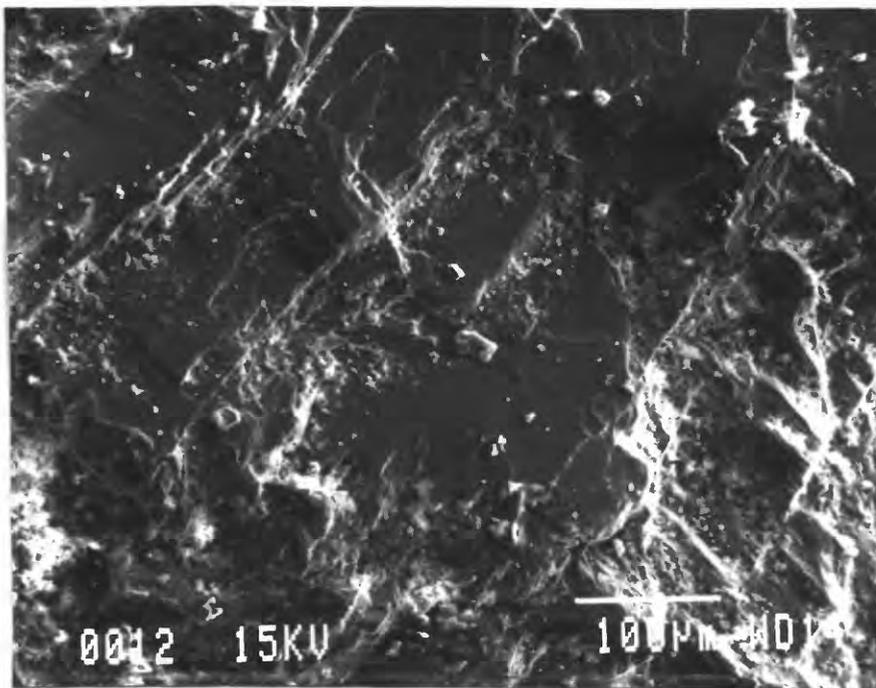
Sample 38A:

0011 - calcite surface with dirt accumulation; particles rest on calcite surface without indicating any reaction has occurred between the dirt and the calcite.

0012 - planar habit of calcite.

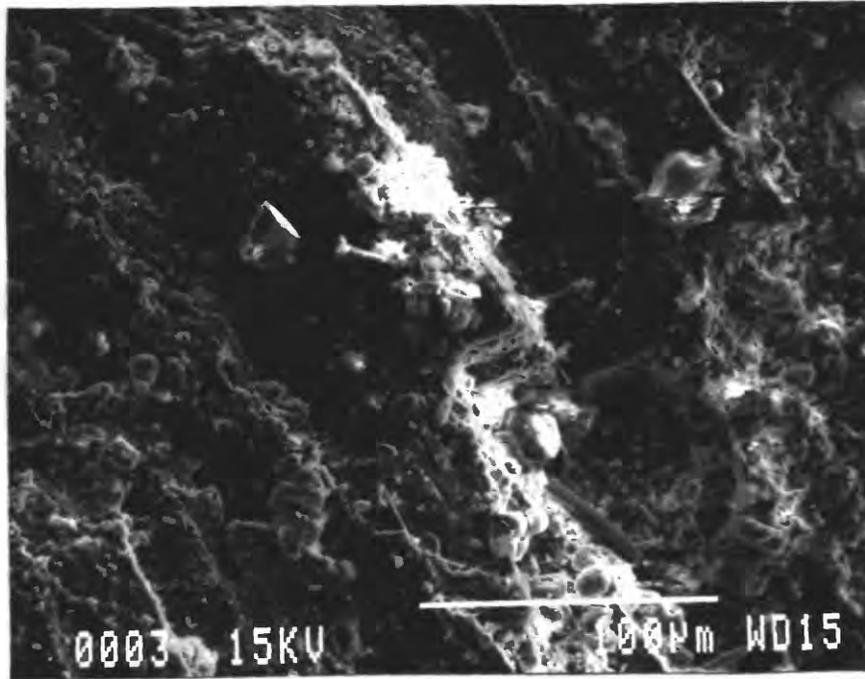
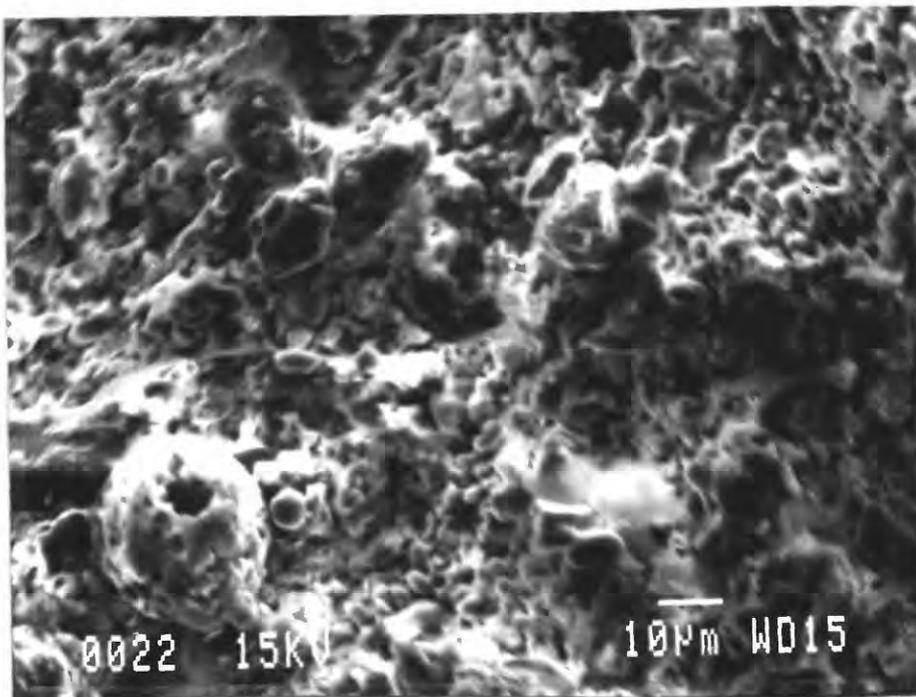
Sample 40A:

0003 - stepped calcite, with minimal surficial dirt accumulated.

0022 - crust and dirt accumulation; calcite surface is hidden.

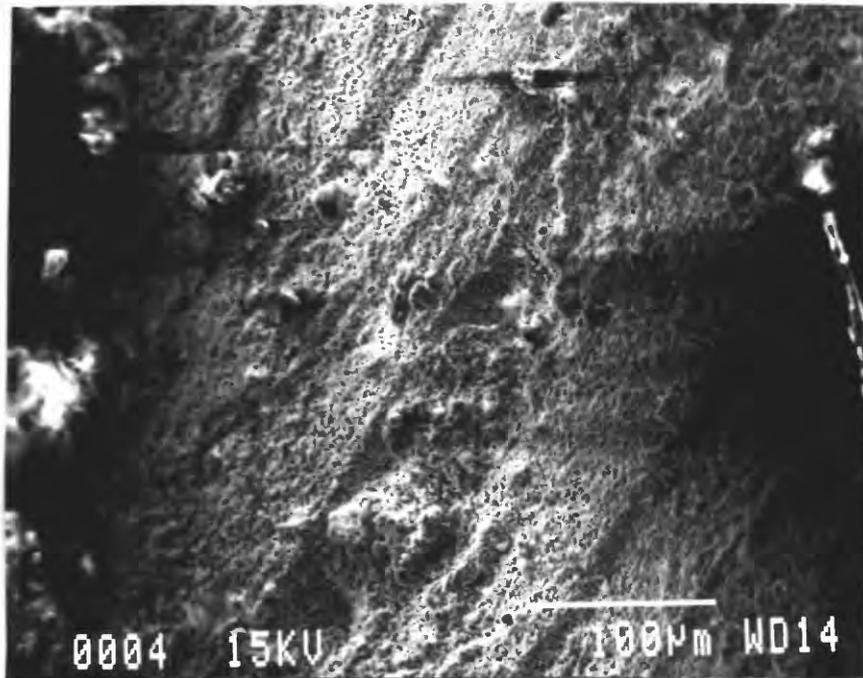
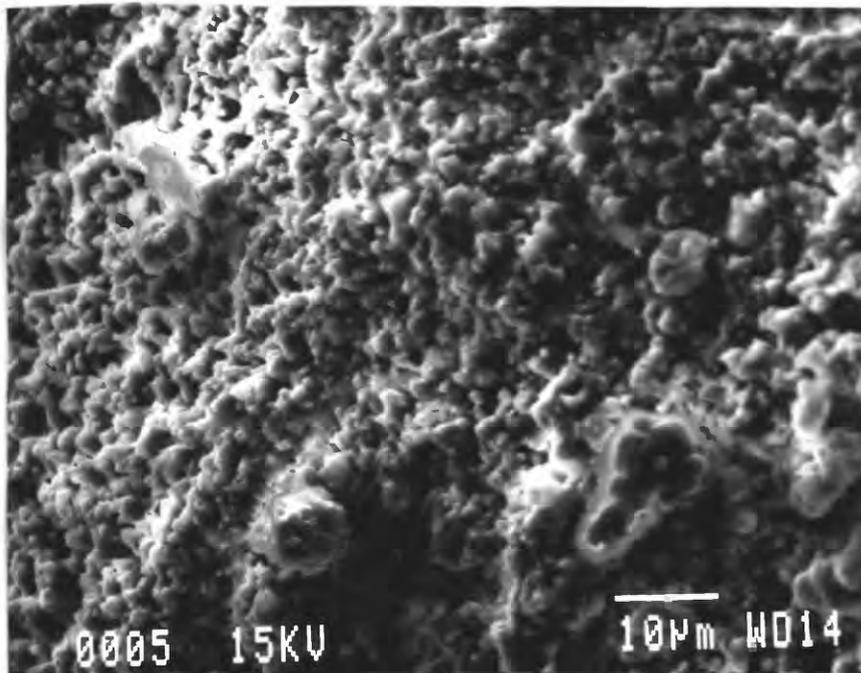
Sample 40A:

0004 - original surface is completely covered but some reflection of underlying calcite steps can be seen (darker "ridges" from lower left to upper right of photo).

0005 - detail of the grains that cover the surface of this sample; possibly adhesive or reprecipitated calcite.

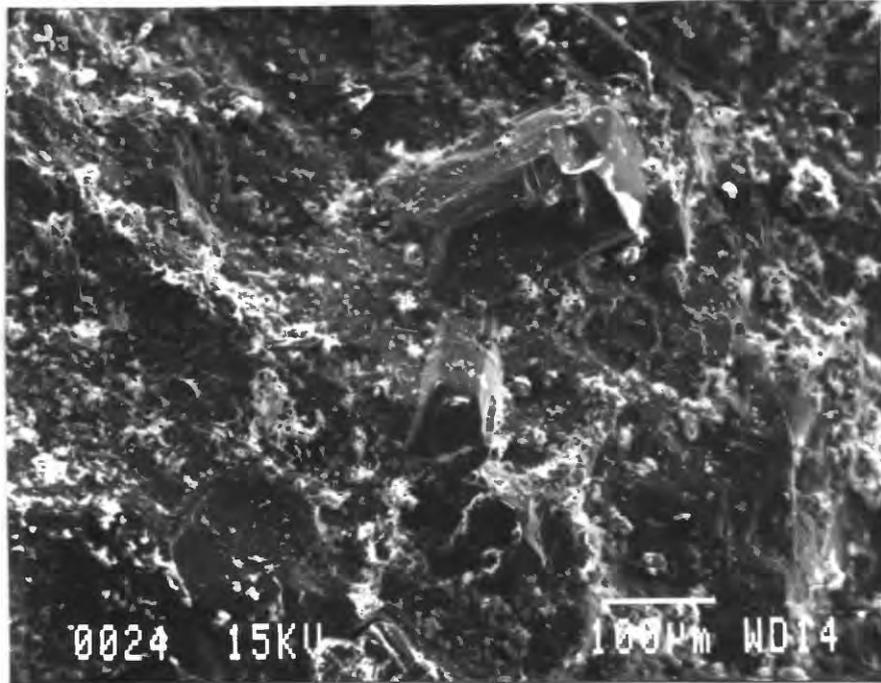
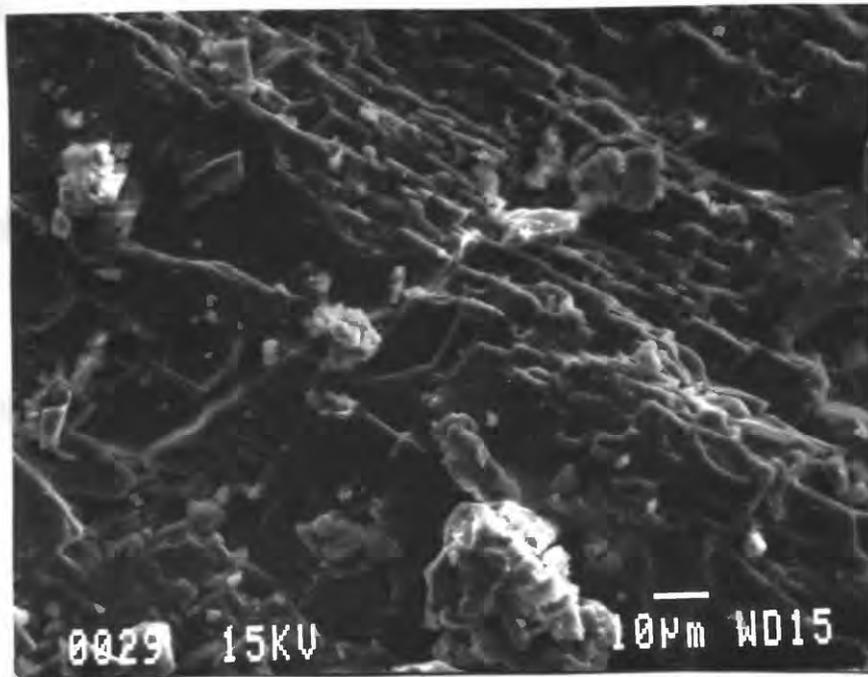
Sample 43B:

0024 - calcite, with surficial dirt; large blocky grain at upper center is a feldspar inclusion.

0029 - stepped calcite with minimal dirt.

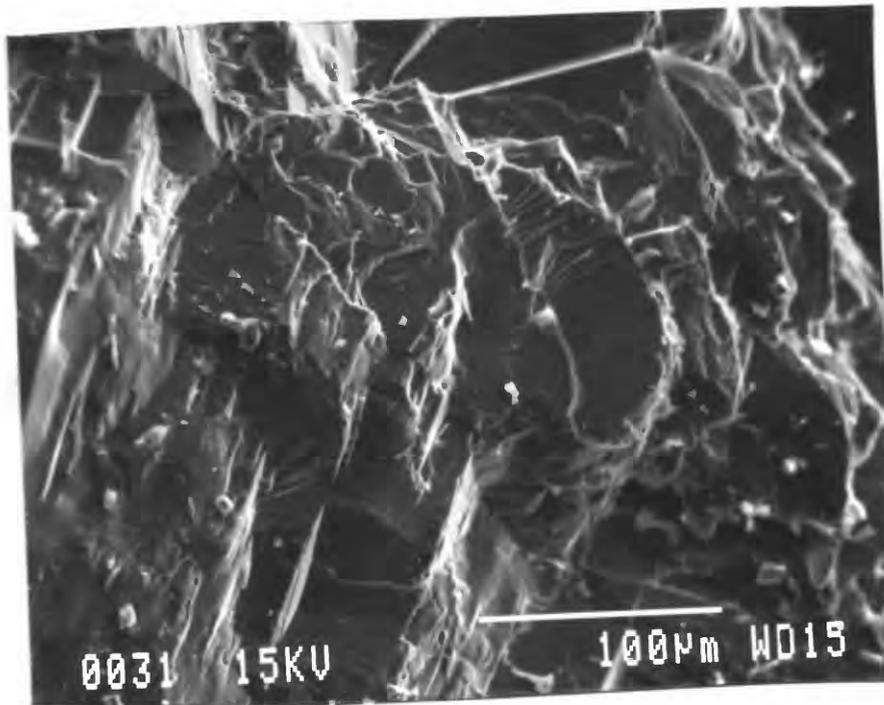
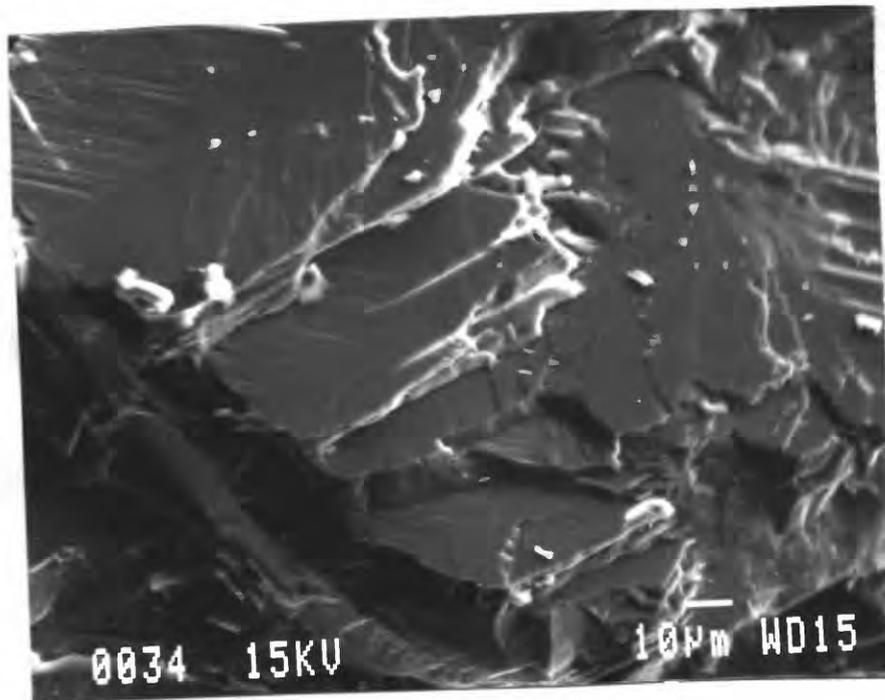
Sample 43B:

0031 - planar calcite and stepped calcite.

0034 - calcite steps persist even at a very small scale.

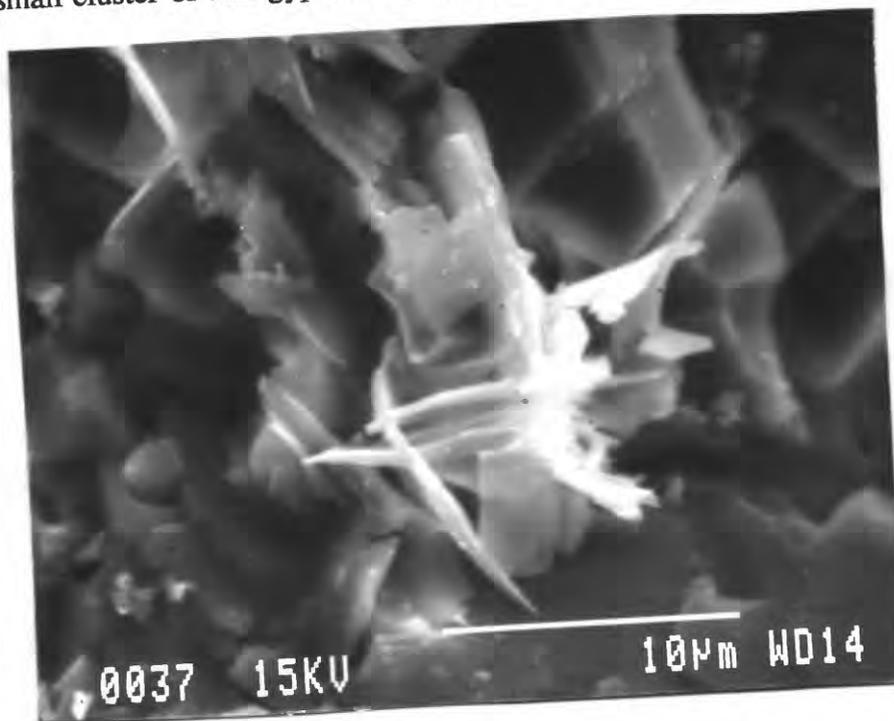
Sample 43B:

0037 - small cluster of thin gypsum crystals (lighter grains at center) on blocky calcite.

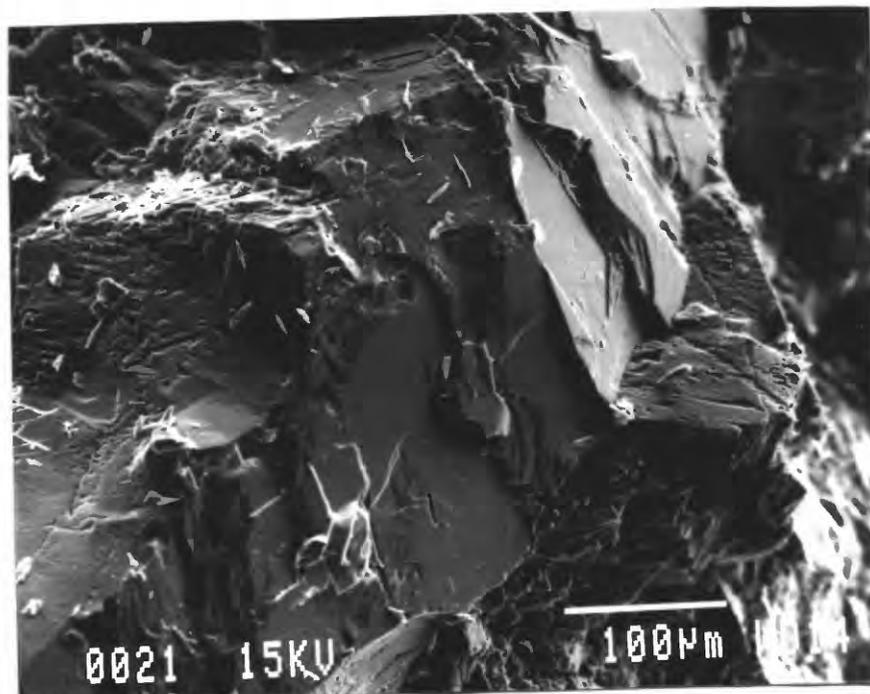
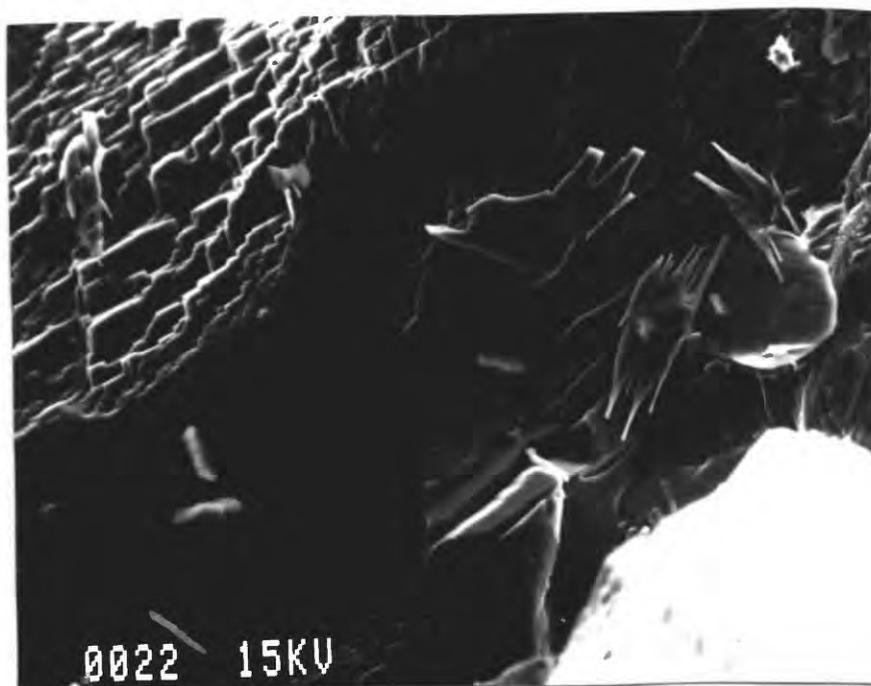
Sample 51D:

0021 - fine needles of gypsum on calcite.

0022 - gypsum crystal "mats" on calcite.

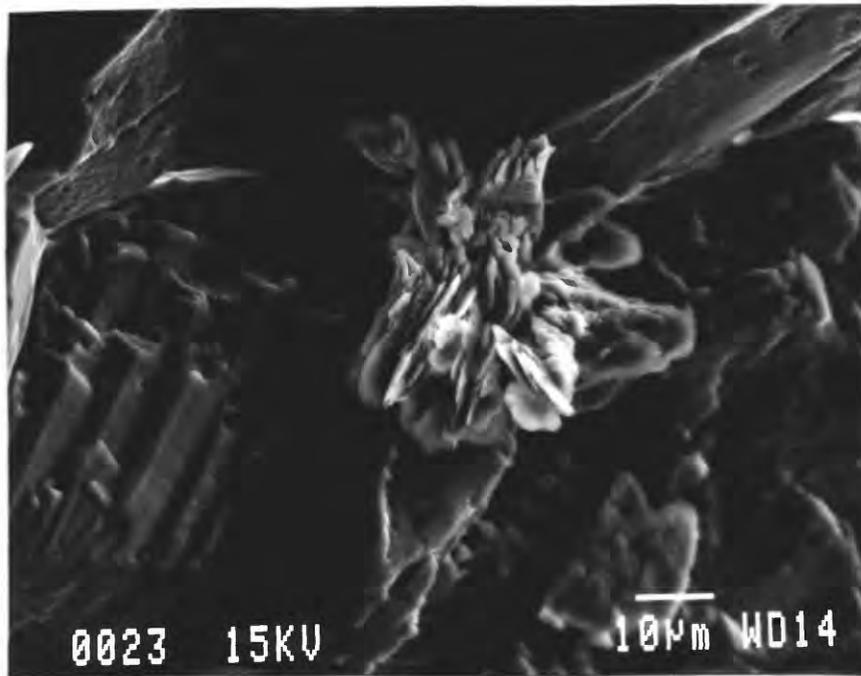
Sample 51D:

0023 - small cluster of gypsum crystals on calcite.
