**Preliminary Evaluation of the Landslide Potential in
Capulin Canyon Following the Dome Fire,
Bandelier National Monument, New Mexico**

By Susan H. Cannon and W.L. Ellis

Open-File Report 97-141

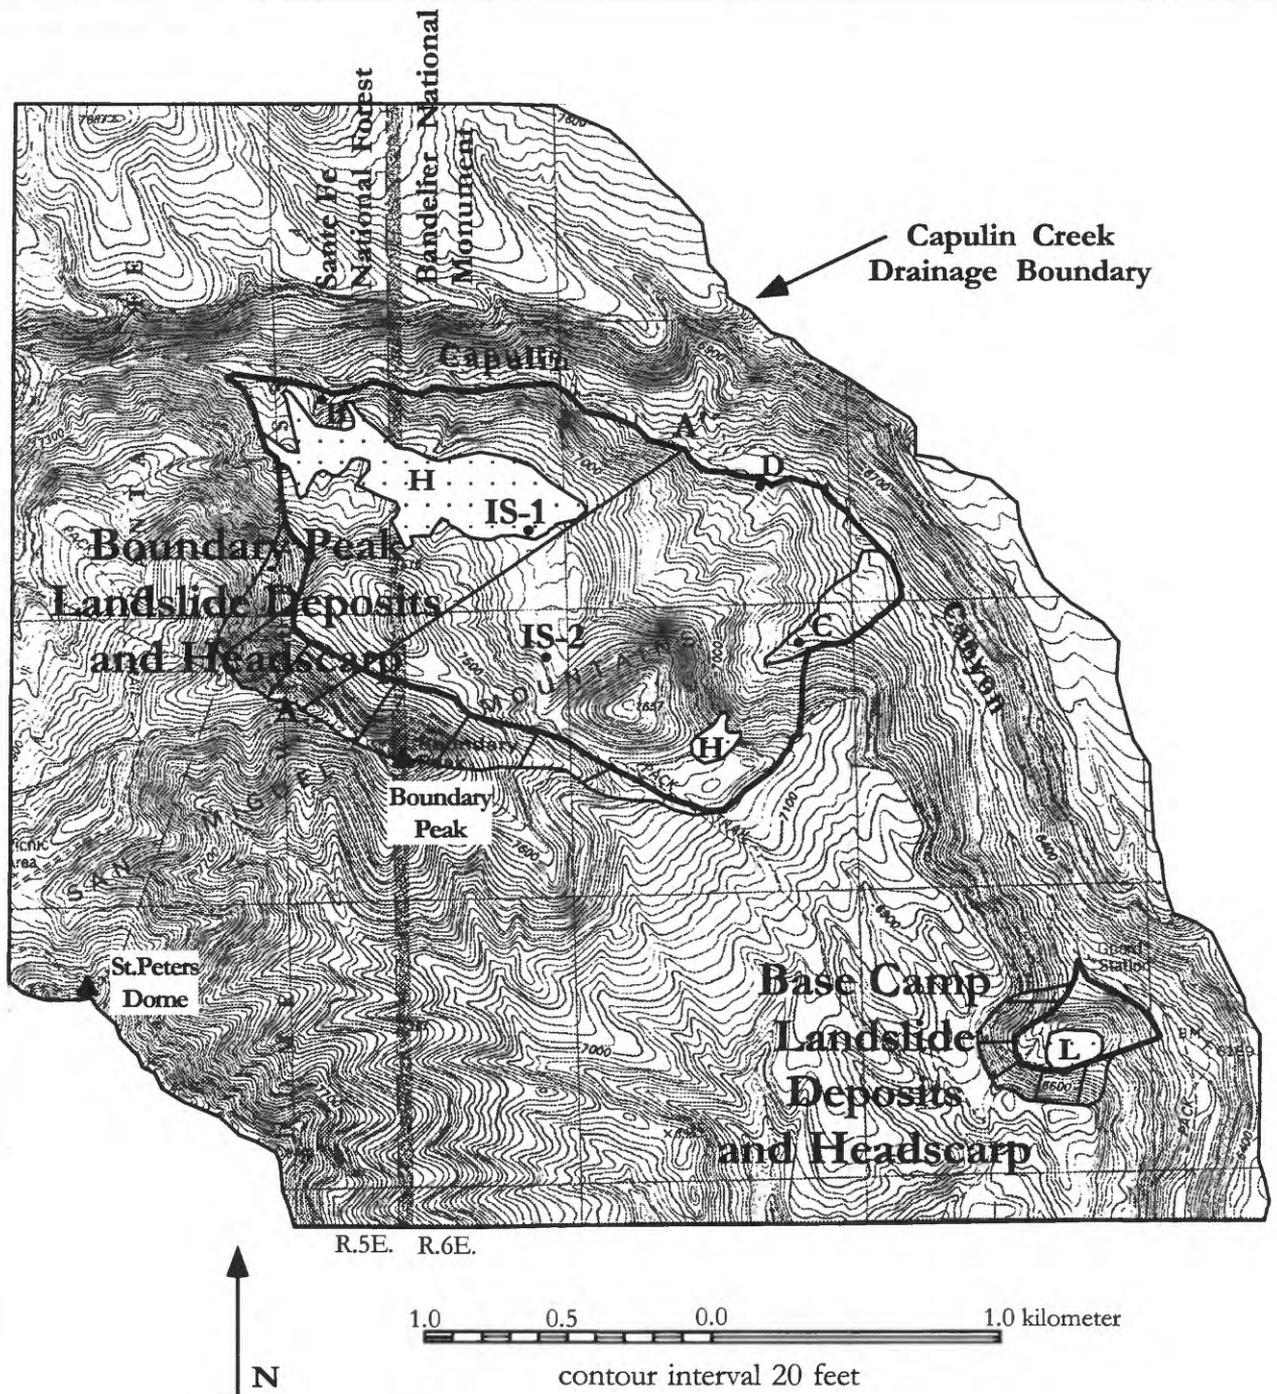
Figure 1. Topographic map of portion of Capulin Canyon in Bandelier National Monument showing locations of Boundary Peak and Base Camp Quaternary landslide deposits and instrumentation sites. Burned site is IS-1, while the unburned site is IS-2. Stippled areas denote areas of high (H) burn intensity on the Boundary Peak landslide deposits, and an area of low (L) burn intensity on the Base Camp landslide deposits. Letter B marks the location of a possible basal slip surface. Letter C denotes the location on the alluvial fan where C-14-dated samples were obtained. Letter D shows the location of surficial raveling of the landslide toe. Base is from U.S. Geological Survey Frijoles, New Mexico, 7.5' quadrangle map.

Deposits from the Boundary Peak landslide, as outlined in figure 1, extend a distance of 1.2 km from the base of the headscarp to Capulin Canyon and are approximately 2.4 km wide in the canyon. Delineation of the landslide deposits was accomplished through examination of the 1:8,000-scale color IR aerial photographs taken on May 5, 1996, and field examination. The western and southwestern boundaries of the deposits were readily delin-

The Base Camp landslide deposits, as outlined on figure 1, extend 0.5 km from the headscarp to the canyon and are 0.4 km wide at their broadest point. The landslide appears to have formed in the Upper Bandelier Tuff. The arcuate headscarp is as steep as 85%, and the toe of the landslide also rests in Capulin Canyon, with a slope of 53%. This landslide also failed as a single rotational unit that left deposits on the hillside and in the canyon. Material did not travel down Capulin Canyon. No sedimentological evidence was observed upstream from the landslide deposit that would indicate that the landslide ever dammed Capulin Creek, suggesting that the rates of movement into Capulin Creek were sufficiently slow to allow the creek to maintain a channel.

One area of low-burn intensity that covers approximately 0.03 km², or one-sixth of the deposits, is shown on the U.S. Forest Service map of fire intensity (fig. 1).

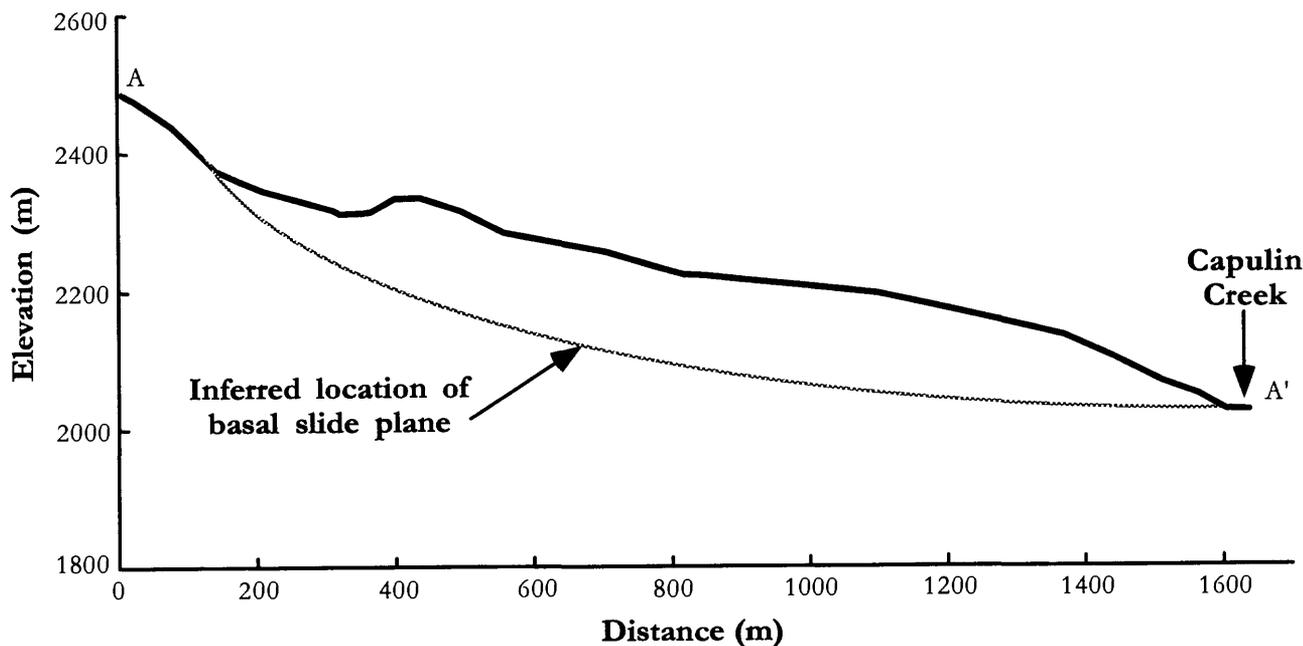
Movement of the Boundary Peak landslide likely occurred along a deep-seated, convex-upward failure surface, which resulted in a rotational transfer of material downslope and out onto the valley floor. Material did not travel down Capulin Canyon for any distance. The topography of the landslide suggests that it moved primarily as one unit, although it appears that the main rotational block broke into a number of smaller, nested blocks at its lateral margins, resulting in a stepped topography on either side of the main block. No sedimentological evi-

Figure 2. Cross section through Boundary Peak landslide deposits. Topography is from U.S. Geological Survey's Frijoles 7.5' quadrangle.

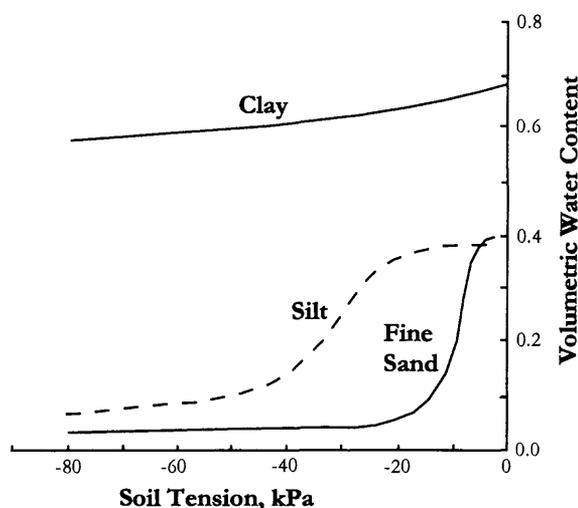
Figure 3. Soil water retention curves for clay, silt, and fine sand.

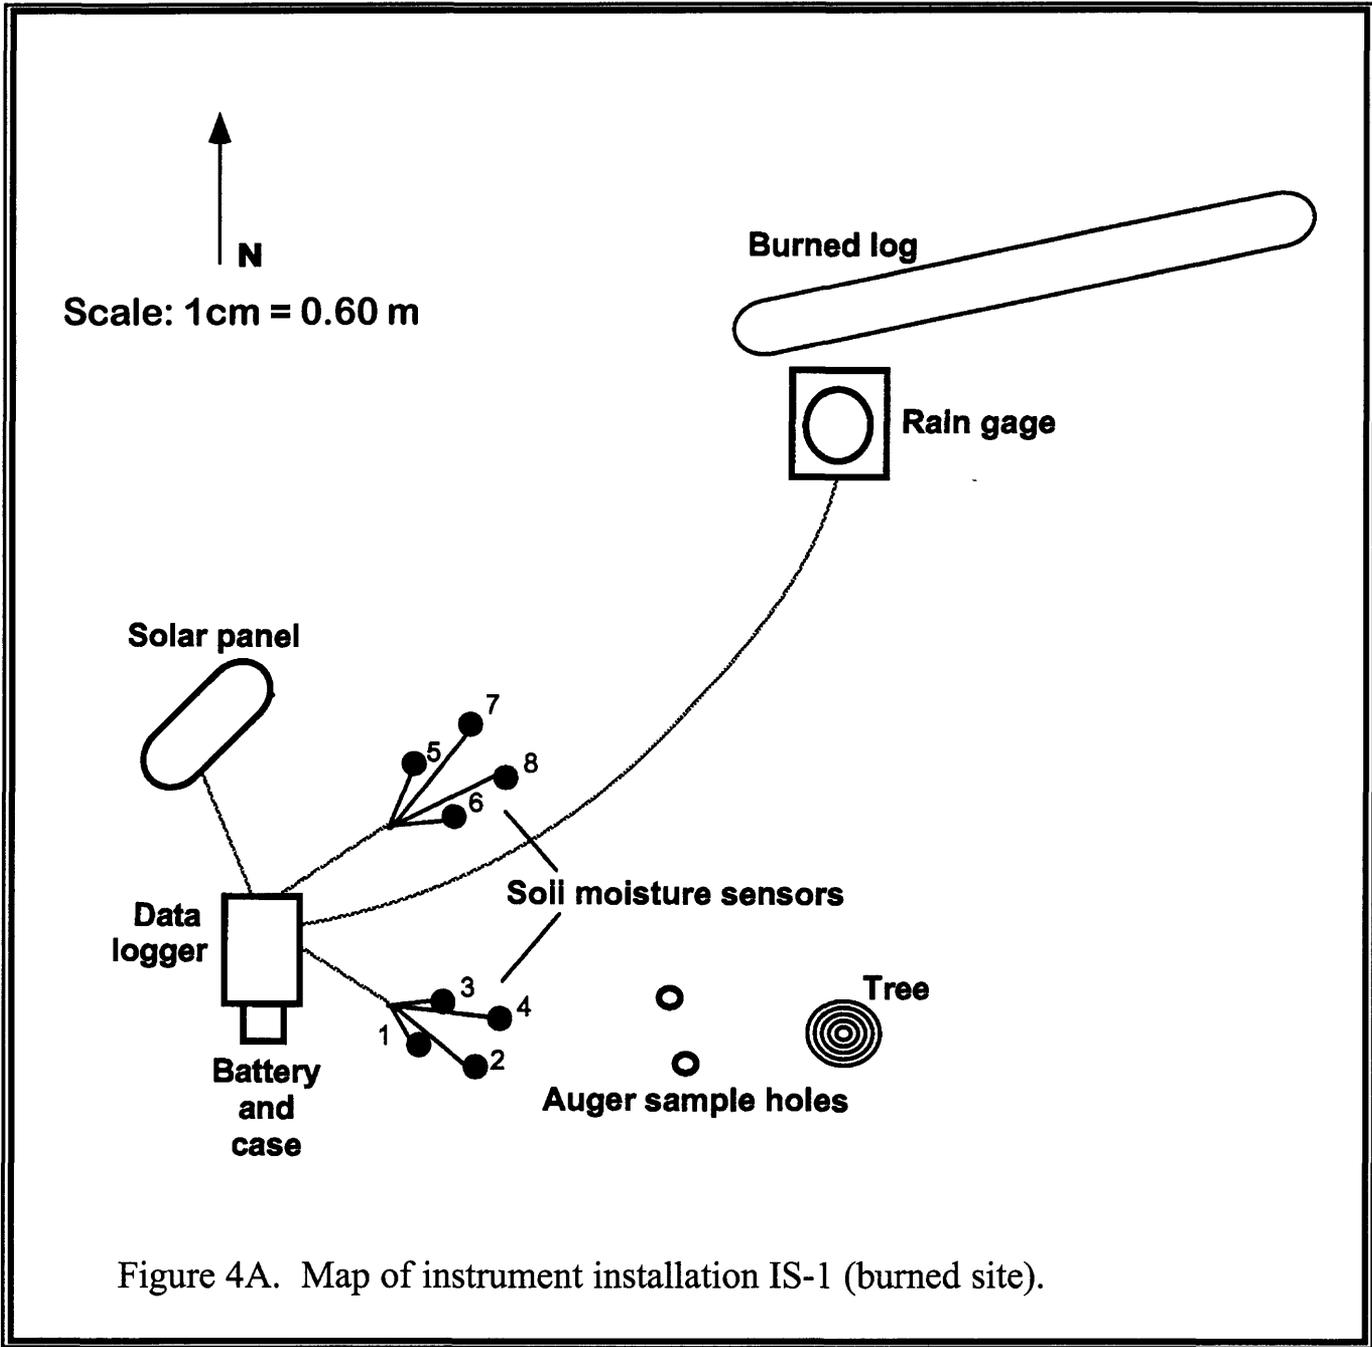
Figure 4A. Map of instrument installation IS-1 (burned site).

Figures 4A and 4B are sketch maps showing the location of the soil-moisture sensor emplacement holes, thermistor emplacement holes, rain gages, dataloggers, and solar panels at each instrumentation site. The depths of installation of the soil-moisture sensors at each site are listed in table 1. The depth to which the deepest sensors were installed was controlled by the presence of unweathered pumice. Note also that sensors 5 through 8 at site IS-2 are not in the same sensor number-depth sequence as the other array due to installation constraints.

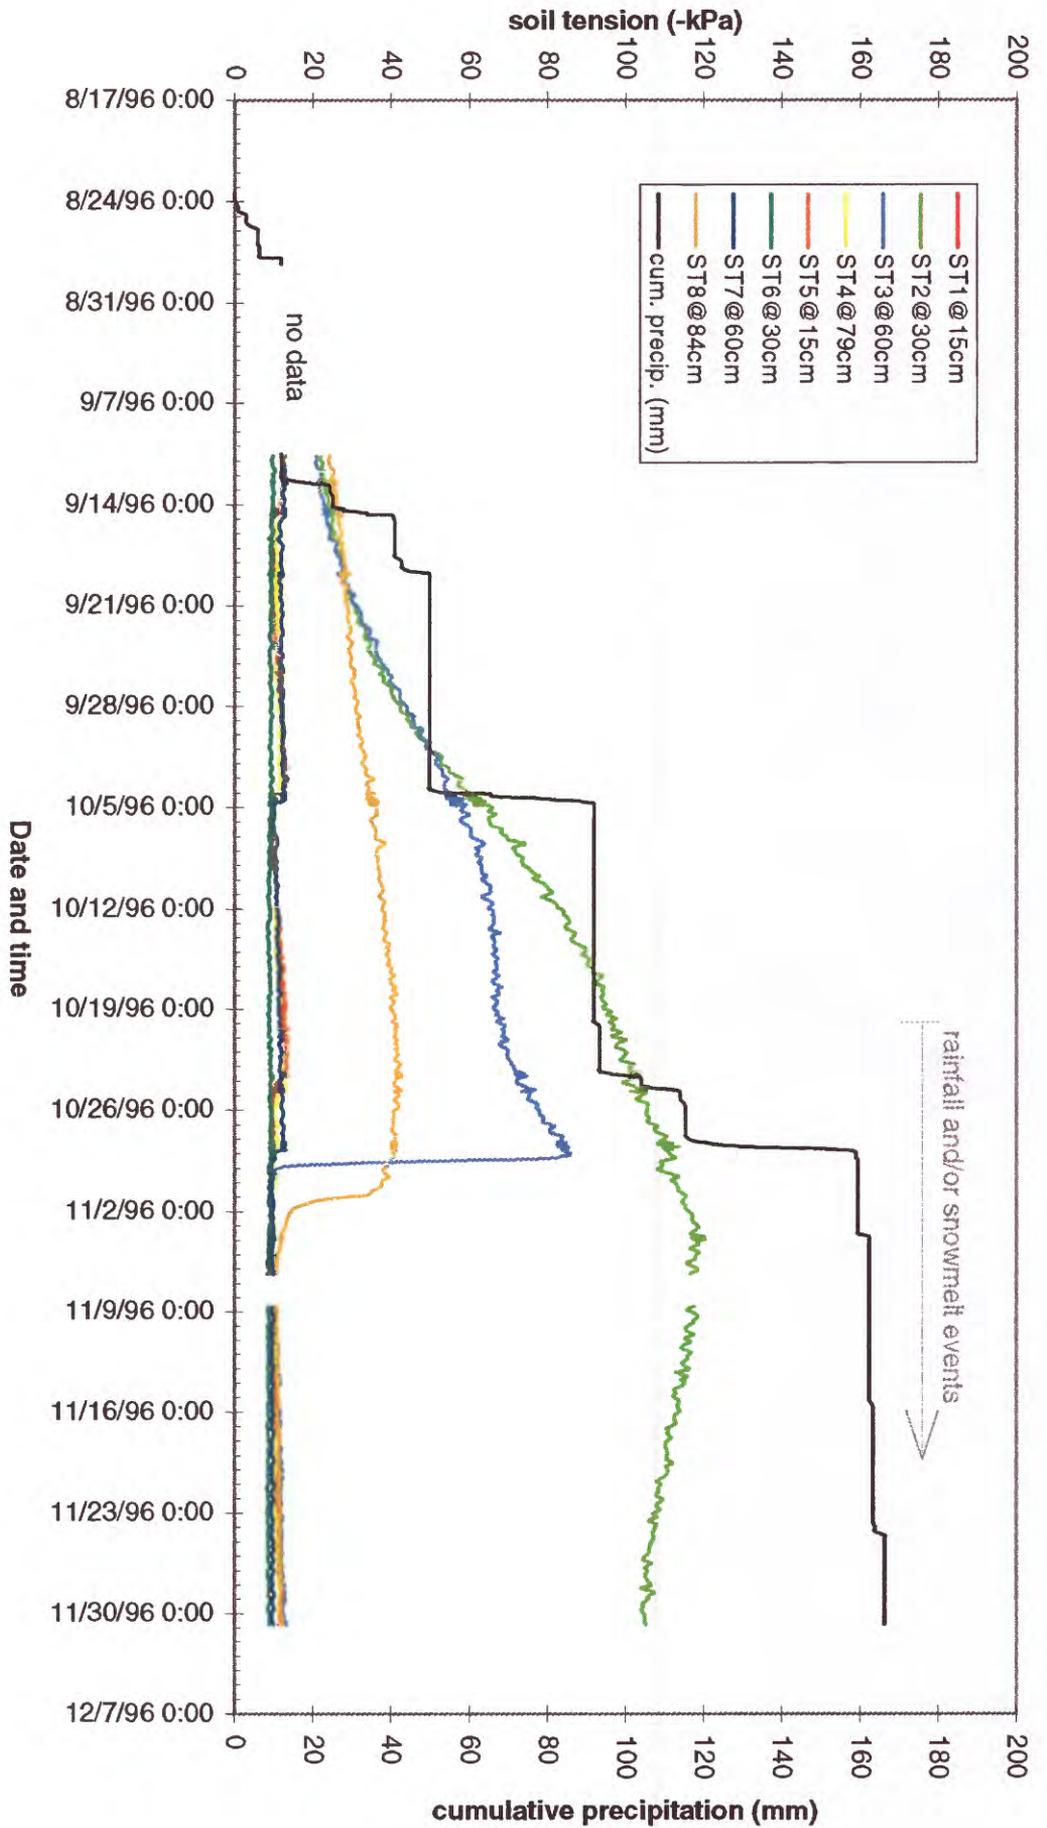
A qualitative comparison of the soil-tension responses of the burned and unburned sites (figs. 5 and 6), recorded from September 10 to November 30, 1996, indicates that rainfall infiltrates more readily, and to greater depths, at the burned site than at the unburned site. With some notable exceptions, most of the burned-site sensors responded immediately to the three moisture events recorded and show a repeated pattern of immediate wetting during a rainfall or snowmelt event, followed by gradual drying between events. In contrast, and also with exceptions, the sensors at the unburned site showed a continued drying trend until the late October event (which was a combined rainfall and snowmelt event spread over a few days), at which time only the four shallowest probes wetted (the 15 cm and 30 cm), and the deeper probes continued drying. Note that this drying trend may also be attributed to the moisture state of the soil and the sensors at the time of installation; the sensors, and presumably the surrounding soil, at the burned site were considerably wetter at installation than those at the unburned site. The permeability of soil is very low at such low moisture contents, and thus any wetting is a difficult proposition.

And finally, some aspects of the data remain to be explained. For example, at the burned site, one of the 30-cm sensors showed neither a wetting or drying response throughout the recorded period, while the other sensor at 30 cm showed only a drying response. In addition, one of sensors at 60 cm and the sensor at 84 cm did not respond to the September or early-October rainfall events, but did wet up dur-

Figure 5. Plot of cumulative precipitation and soil-tension measurements with time for IS-1 (burned site). ST refers to soil-moisture sensors. Cumulative precipitation totals do not include data from rainfall events that occurred between August 29 and September 10, 1996. A total of 13.6 mm of rainfall was recorded at IS-2 between those dates.

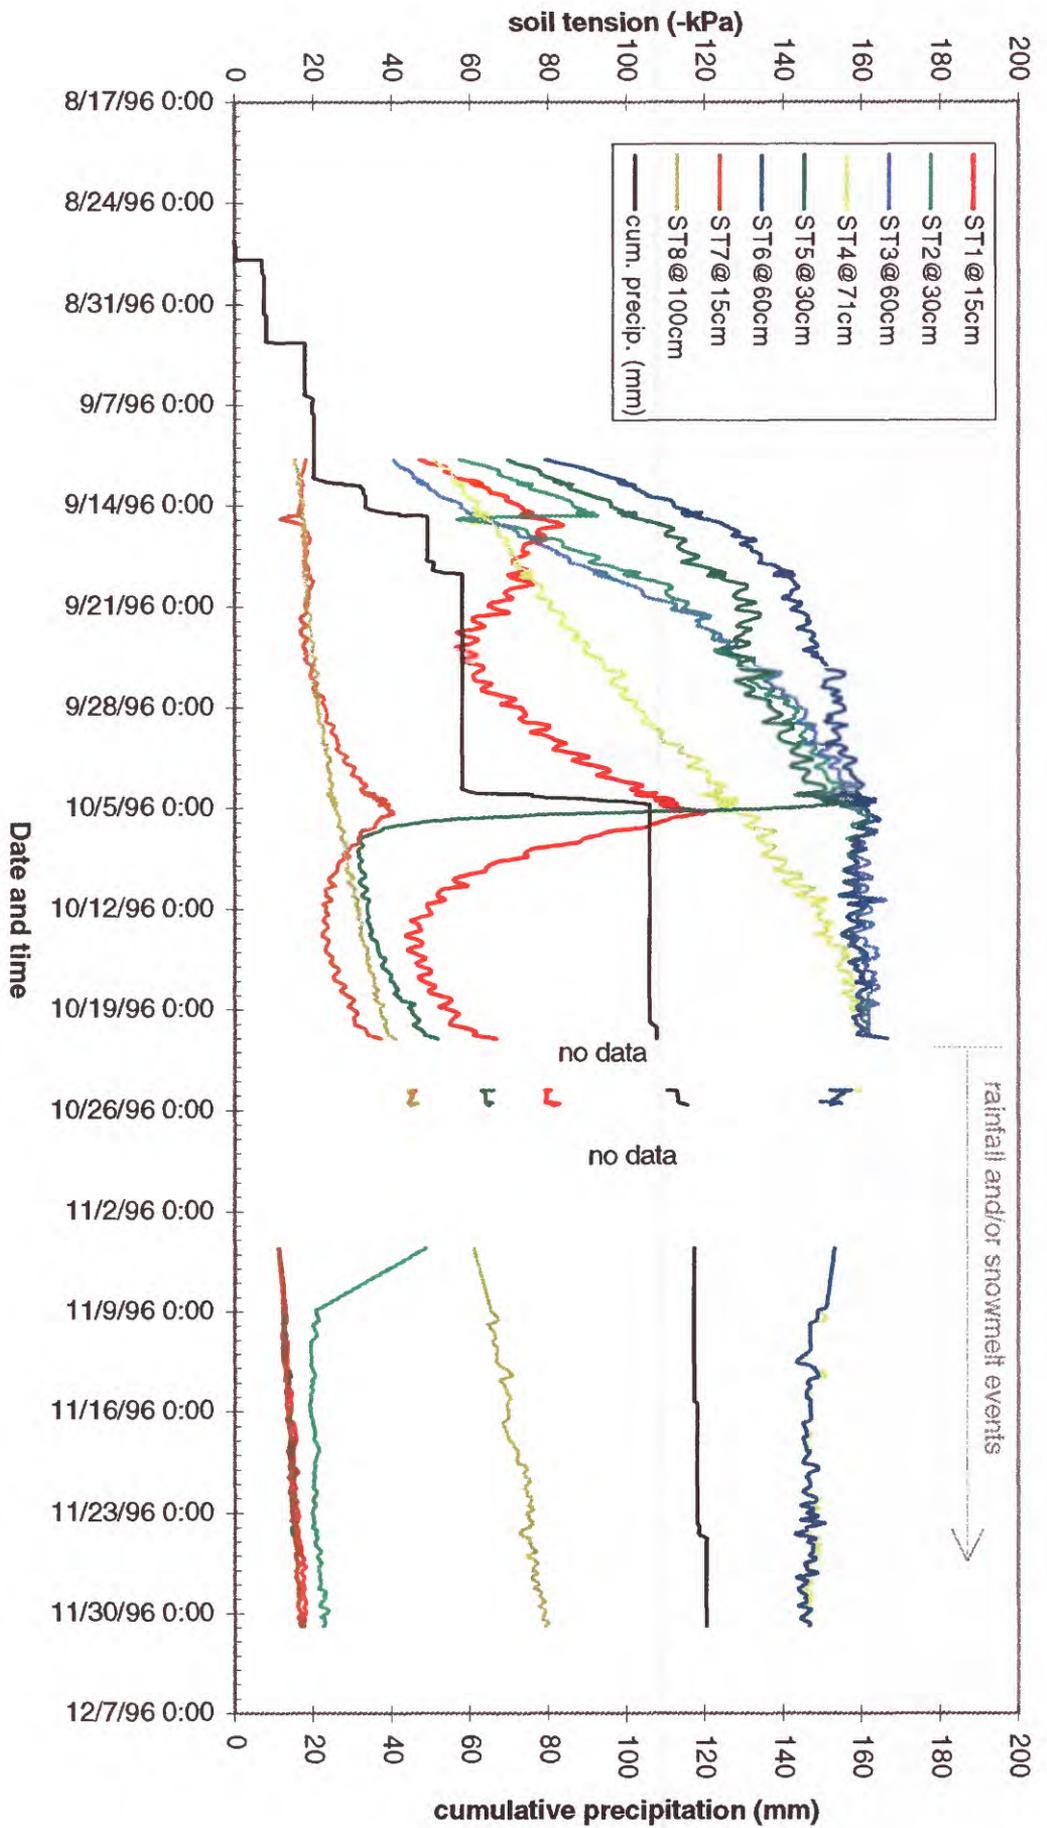
at the burned site is much more rapid than that at the unburned site. For example, at the unburned site one of the sensors at 15 cm showed some wetting over an 8-day period in response to the September rainfall events, and the two probes at 15 cm and one probe at 30 cm also showed very slow wetting in response to the early October rainfall. These responses are in contrast with those at the burned site, which occurred over much shorter time periods and over a considerably smaller data range. This relation may again be due to the moisture state at the time of the rainfall events. Soil permeabilities are very low at the extremely low pore-pressure values recorded at the unburned site.

In addition, the drying responses for some rainfall events might be preliminarily taken to indicate the influence of active transpiration by the vegetation at the unburned site and a lack of transpiration at the burned site. The drying response of the sensors following the rainstorms at the burned site is very gradual and over only a limited range, while the pore pressures determined for the shallow probes at the unburned site dissipate much more rapidly, and to much higher tension values. Also note that the most-negative soil-tension values at the unburned site are considerably greater than those at the burned site. These differences might be due to the removal of soil water by the living vegetation at the unburned site.

Figure 6. Plot of cumulative precipitation and soil-tension measurements with time for IS-2 (unburned site). ST refers to soil-moisture sensors. Records between October 21 and November 8, 1996, are discontinuous due to electrical power problems at the site. Cumulative precipitation totals do not include 56 mm of the 67.5 mm of precipitation from rainfall and snowmelt events recorded at IS-1 between those dates.
