Landslides Triggered by the Winter 1996-97 Storms in the Puget Lowland, Washington

Rex L. Baum¹, Alan F. Chleborad¹, and Robert L. Schuster¹

U.S. Geological Survey Open-File Report 98-239

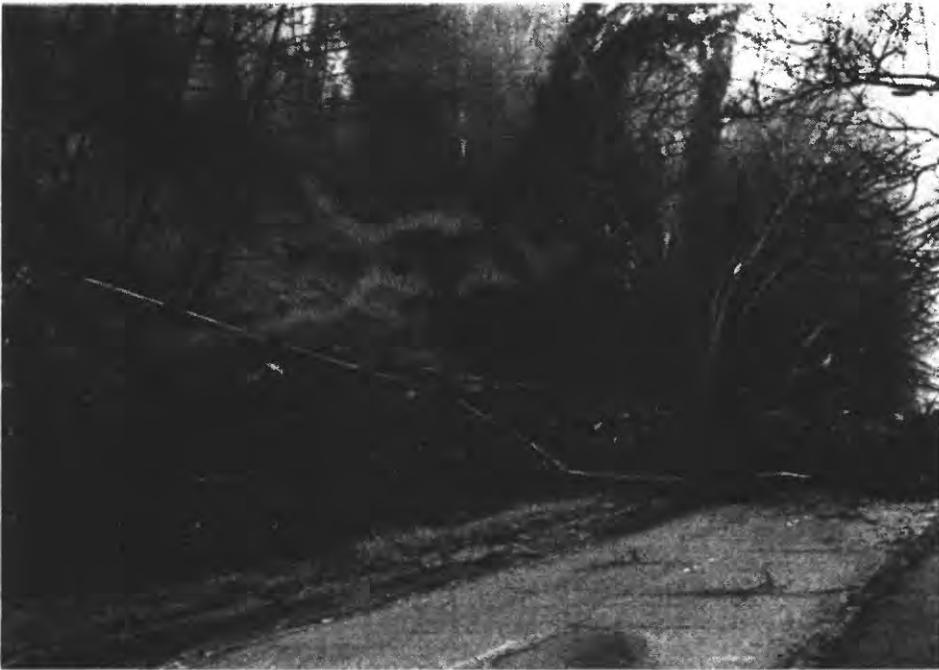
Figure 3. Shallow debris slide blocking California Way SW in West Seattle (#9, pl. 1).

Shallow slides, many of which mobilized into debris flows were by far the most common type in Seattle. A number of debris flows partially blocked roads or impacted structures (#9 and 14, pl. 1; figs. 3 and 4). Structural damage from debris flows ranged from slight to severe. At least two homes in the Magnolia Bluffs area were damaged by debris flows (#15, pl. 1; fig. 5). Debris-flow sites we studied January 8-10 at Magnolia Bluff and near Lake Union (#16, pl. 1) showed no signs of renewed activity when we returned on January 22.

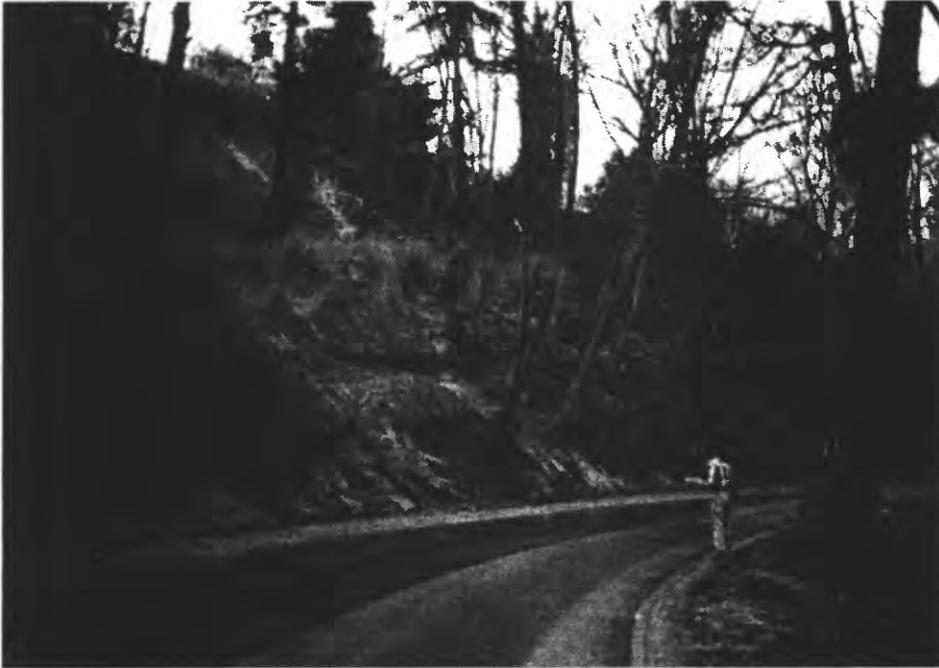
Figure 4. Shallow debris-flow scar about 1 km east of Lake Union, upslope from Interlaken Boulevard (#14, pl. 1). Trees in scar were in danger of falling onto road. Mud line on tree near right edge of photograph indicates approximate depth of flow (1 m).

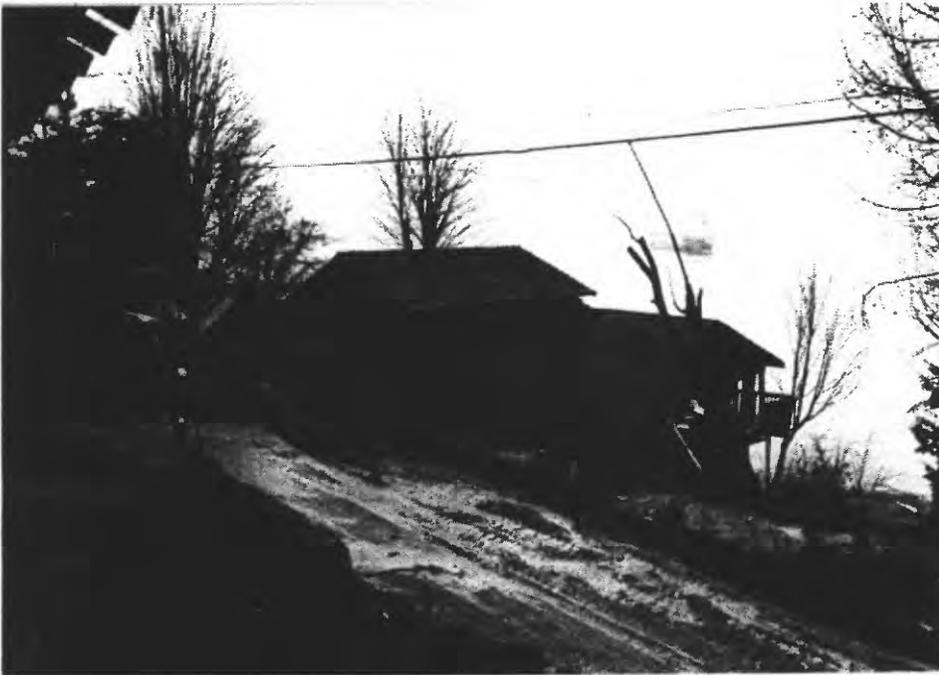
Figure 5. House in the Magnolia Bluffs area overlooking Puget Sound that was struck by a debris flow (#15, pl. 1). The flow deposited material in the garage (upper level) and collapsed the front wall of the living quarters (lower level).

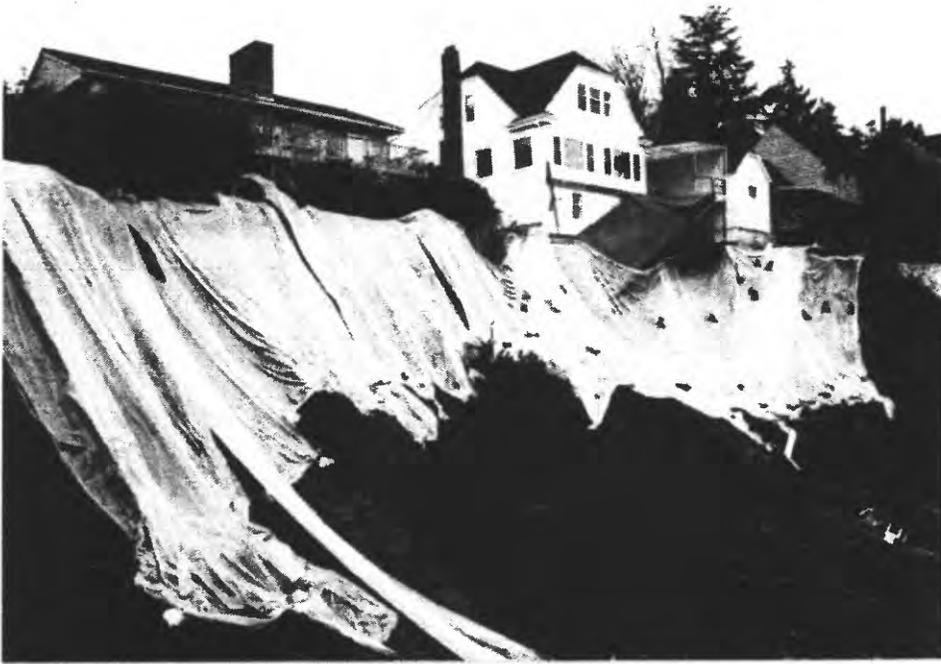
Slumps and deep-seated slides, though less common than debris flows, caused severe damage to land and structures. A deep slide at Magnolia Bluff undermined and destroyed a covered porch at the back of one house and endangered several other houses (#12, pl. 1; fig. 6A and 6B). Part of this slide mobilized

Figure 6. Slide at Magnolia Bridge, Seattle (#12, pl. 1). *A*. Head of slide, porch at back of light-colored house was undermined and collapsed. Head of slide covered with plastic sheets to prevent additional rain water from entering the slide. *B*. Slide deposits on uphill side of bridge.

into debris flows that damaged supports for the Magnolia Bridge. Another deep slide on a bench at Magnolia Bluff destroyed part of a residential street and severely damaged several homes founded on the slide (#13, pl. 1; fig. 7A and 7B). This slide was active previously in March 1996 and renewed or continuing movement between January 8 and January 22, 1997, caused additional damage to the homes. Evidently, the slide remained active throughout 1997 and into 1998, because it had enlarged and still appeared to be active when we observed it again in February 1998. A deep slide in the extreme northwestern part of Seattle seriously damaged several homes early in January 1997 but showed no signs of additional movement between January 9 and 22, 1997 (#24, pl. 1). Debris flows from the front of this slide deposited debris on the railroad tracks downslope from the toe of the slide; the tracks had been cleared by the time of our survey on January 9, 1998. Another deep slide in northwest Seattle undermined the foundations of houses built on its margin (#21, pl. 1; fig. 8).

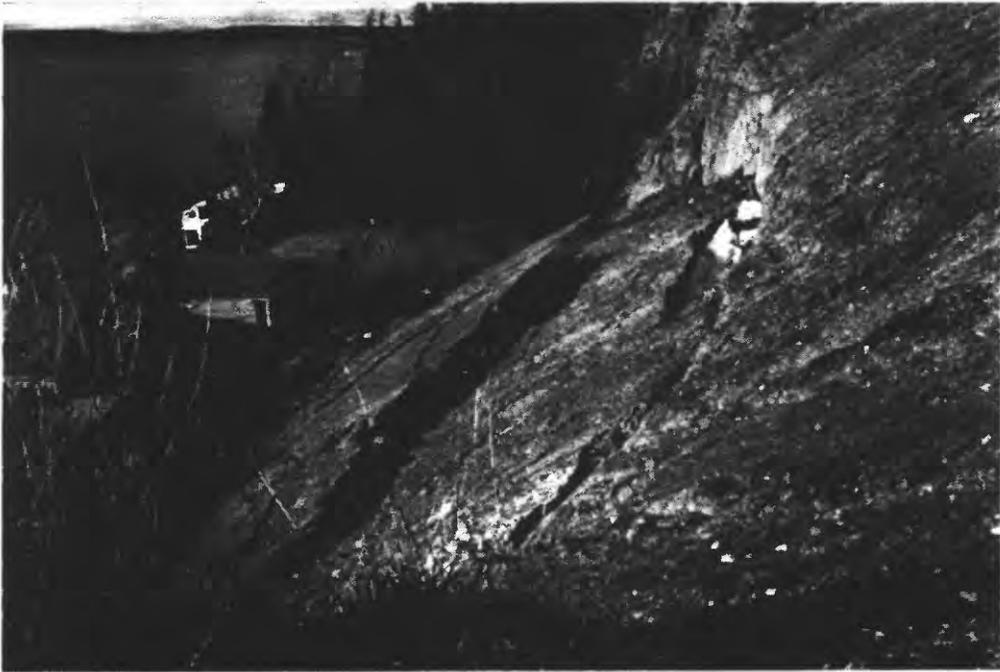
Figure 7. Large, deep-seated slide in Magnolia Bluffs area of Seattle (#13, pl. 1). *A.* Graben at head of slide, looking north. House at left edge of photograph was beginning to tilt downslope by January 22, 1997. The house appeared to be plumb two weeks earlier when we surveyed the same site. *B.* Scarp at right flank of slide is about 1 m high.

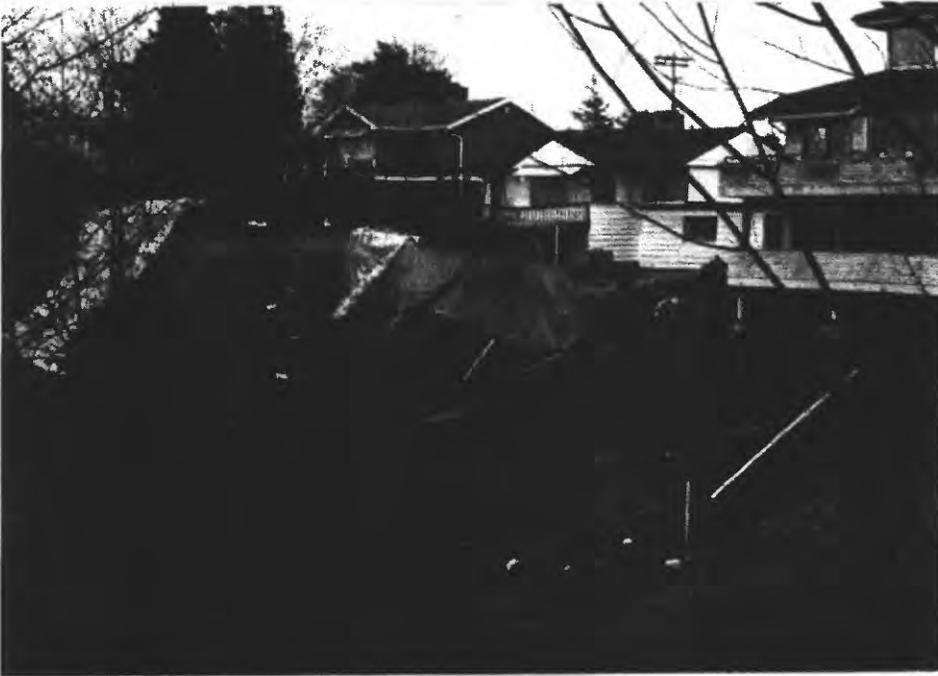
Figure 8. Slide on wall of small drainage in northwest Seattle (#21, pl. 1). Foundation of house on right edge of photograph and decks of neighboring houses had been undermined.

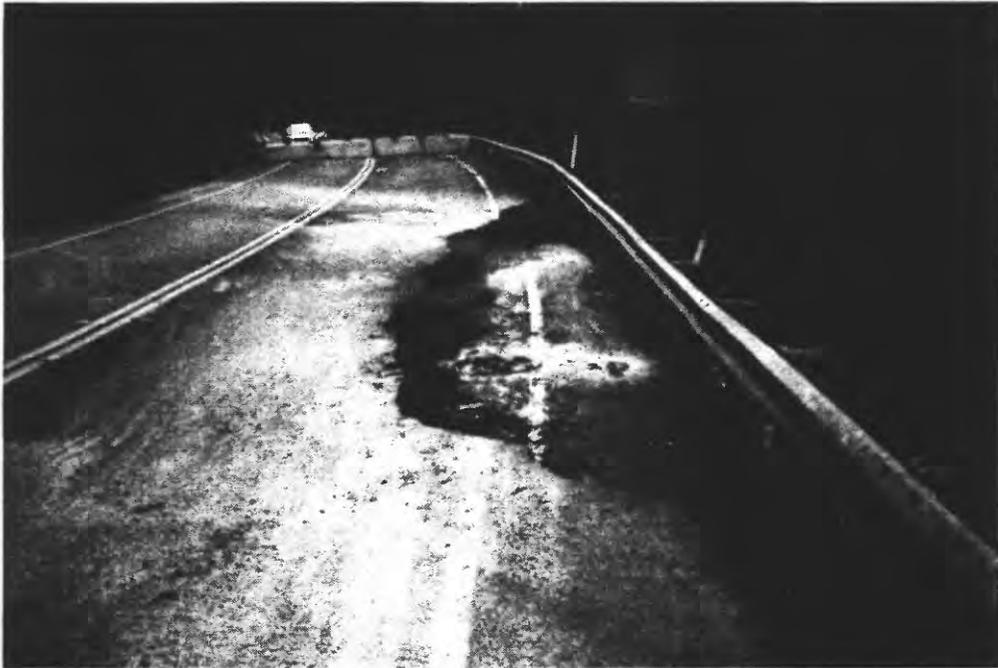
Seattle seemed to be less abundant away from the lake and coastal bluffs. Most of the landslides in these areas affected roadways, were classified as rotational slides, and appeared to have occurred in glacial outwash of gravely sand (#23, pl. 1; fig. 9). One landslide, which had a volume of about 1500 m³, had broken apart and may have turned into a flow or avalanche according to the description given by a county employee we met at the site. Unfortunately, King County road crews had nearly finished repairing the road and landslide scar by the time we were able to study it (#5, pl. 1).

Figure 9. Slump in outwash deposits on bluff east of Lake Washington (#23, pl. 1). On January 25, 1997, water was flowing from seeps on the uphill side of the road (left side of photograph).
