# **Observations and Recommendations Regarding Landslide Hazards Related to the January 13, 2001 M-7.6 El Salvador Earthquake**

*By* Randall W. Jibson and Anthony J. Crone

**Open-File Report 01-141  
Paper Edition**

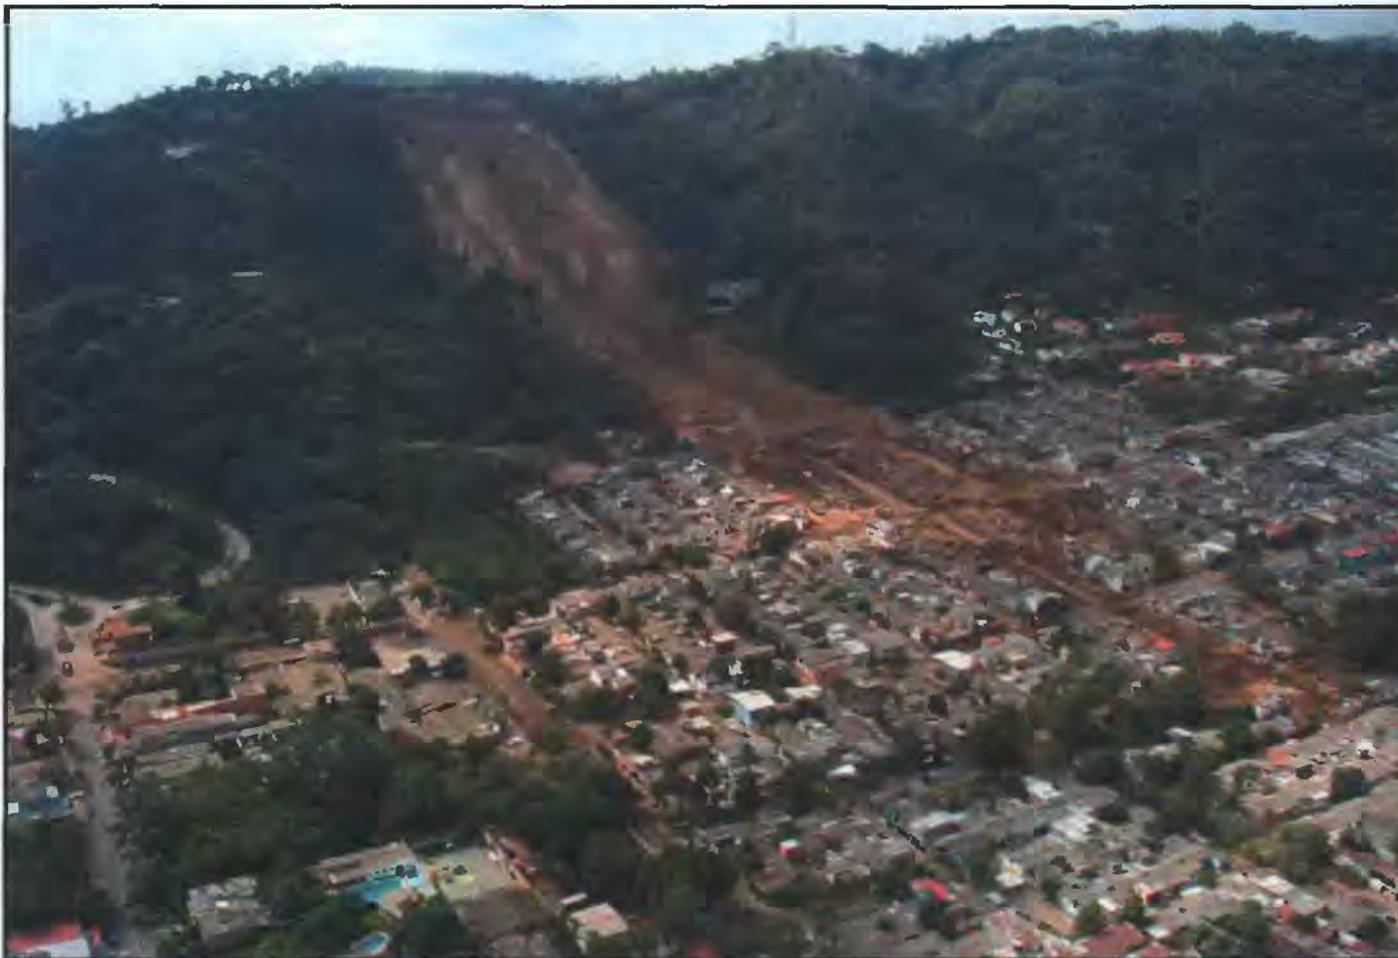
The January 13 earthquake triggered the Las Colinas landslide off the steep northern flank of Balsamo Ridge (fig. 1). The landslide—a rapid

**Figure 1.** Las Colinas landslide. (Photo by E.L. Harp, USGS)

0.7 g, which is a very high level of shaking at this distance from the epicenter (>100 km), but shaking on the ridge top appears to have been greater still. This exceptionally strong shaking, along with the presence of thick, loose to poorly consolidated, young volcanic deposits, the steep topography on the northern flank of Balsamo Ridge, and possibly the presence of a relatively impermeable ancient soil at the top of the Balsamo Formation were contributing factors to the triggering of the Las Colinas landslide.

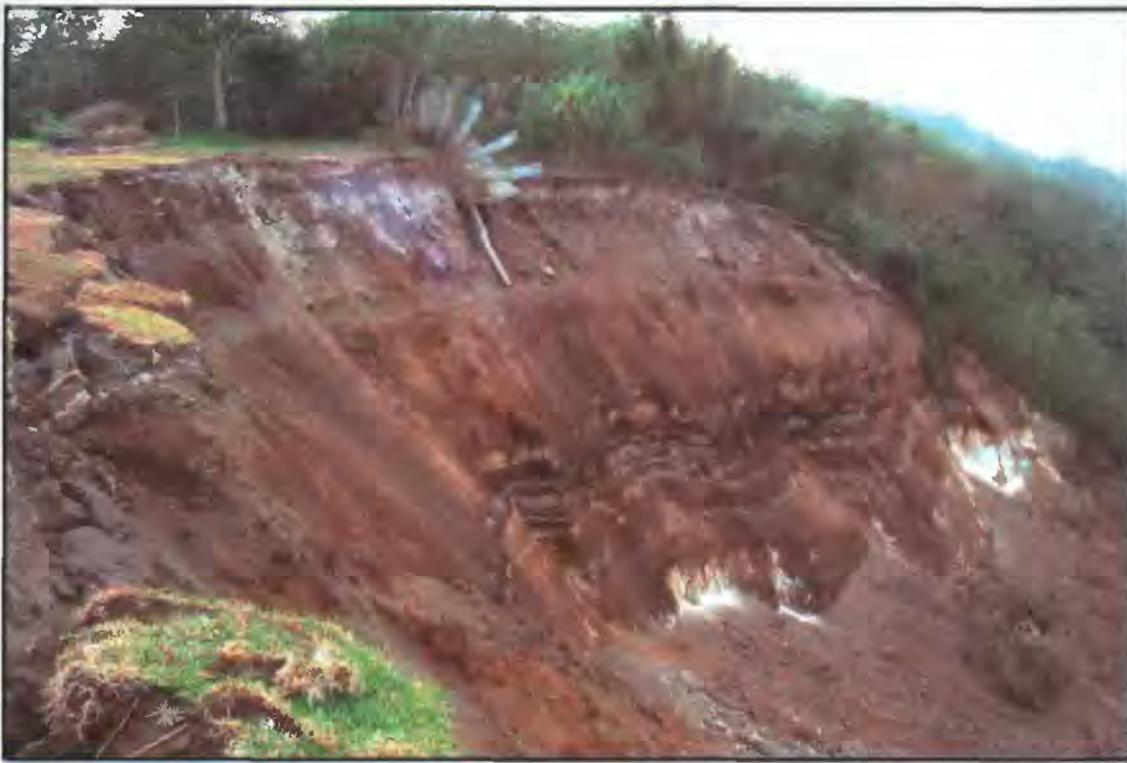
**Figure 2.** Head scarp of Las Colinas landslide (view to southwest). The whitish layer in the lower right part of the photo is the TB4 tephra. (Photo by E.L. Harp, USGS)

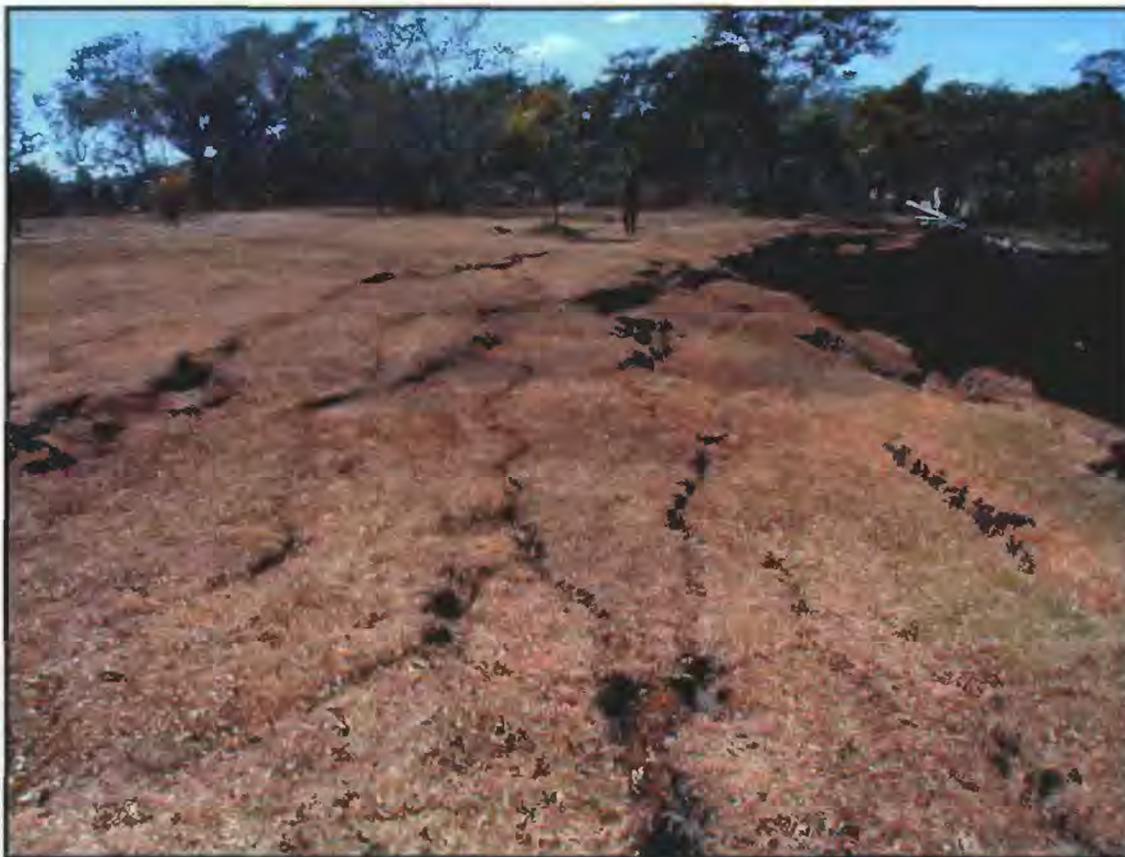
and (2) landslides that could be triggered by future large earthquakes similar to that of January 13. Landslides likely to be triggered by aftershocks or during the rainy season are likely to be much smaller than the Las Colinas slide. Cracks are present all along the crest of Balsamo Ridge, but they bound relatively small masses of earth that, if they fail, may not reach the base of the slope and are unlikely to move far

beyond the base of the slope (fig. 3). Also, loose landslide material still remains in the Las Colinas landslide scar that could move when the rains start, but the volume of this material is small enough that it is unlikely to travel far from the slope base. The potential for large slides in future large earthquakes is more difficult to define and will require detailed study, as outlined below. Listed below is a prioritized list of actions that should be taken to mitigate landslide hazards along the base of Balsamo Ridge:

**Figure 3.** Cracks above head scarp of Las Colinas landslide.

**First Priority: Construct a debris basin below the source of the Las Colinas landslide.** This project should begin immediately and be completed before rainy season.

- More landslide material—both from the top of the slope and from within the landslide scar—will inevitably move downslope at the Las Colinas landslide. There is enough space between the base of the slope and the area formerly occupied by houses to construct a basin large enough to catch additional landslide debris. A qualified engineer or geologist should esti-

mate potential landslide volumes on the slope and design a debris basin with sufficient capacity to impound the material. Part of the landslide and in-place material excavated to create the basin should be used to construct a berm at the downslope end of the basin to further protect developed areas from landslides.

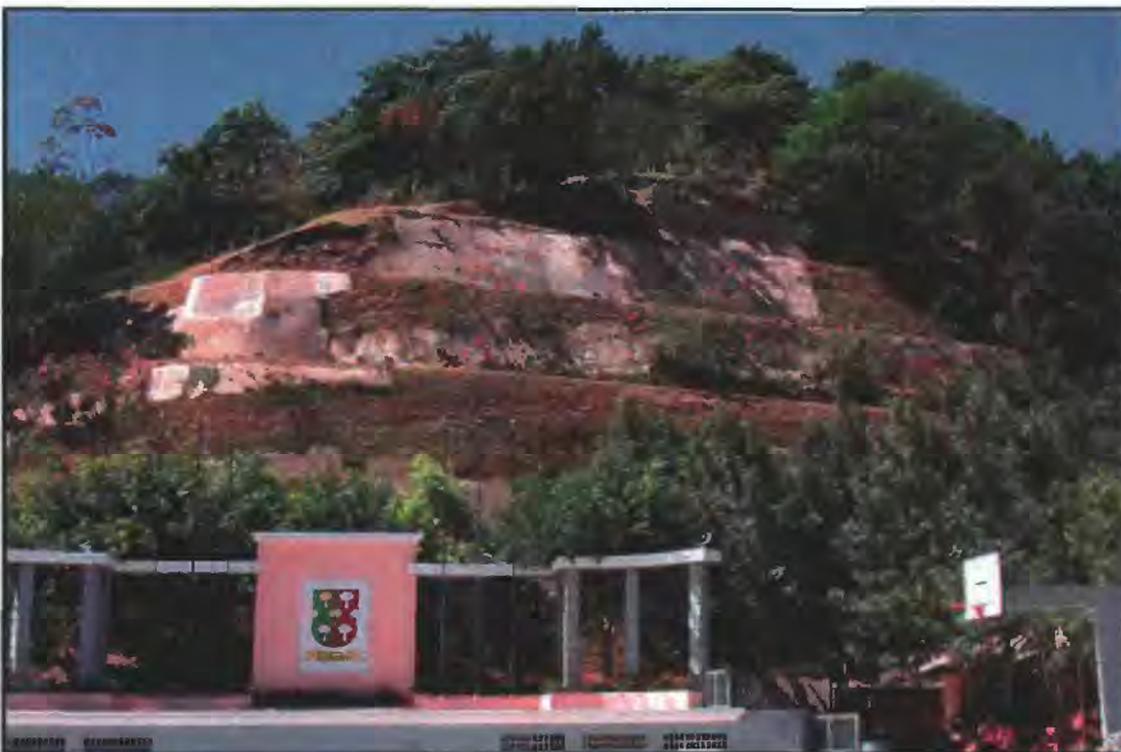
**Figure 6.** Cut slope above La Floresta school for girls. Scar on upper left part of slope is a small landslide triggered by the January 13 earthquake.

either covered by grass, a thin veneer of weak concrete, or a thicker concrete cover over about 1 m of soil mixed with concrete. The rationale for which parts of the slope are covered in concrete and which are not is unclear; apparently identical sections of the cut slope are treated differently in different areas. Both Hurricane Mitch and the earthquake triggered failures of a few hundred cubic meters along the top tier of the cut slope, and deep cracks remain open there. Also, the top of the ridge far above the cut slope (above the coffee plantation) has extensive open fractures that extend for several tens of meters. School officials are concerned about a Las Colinas-style failure of the slope above the cut slope as well as the stability of the cut slope itself.

The cracks on the top of the ridge appear related to localized amplified ground shaking that caused ridge-top spreading. There are small, shallow landslides in the road cut on the back side of the ridge, but there is no evidence that the cracks on top of the ridge are related to landsliding above the school. The slope between the ridge crest and the cut slope is only moderately steep, and this makes a Las Colinas-style failure very unlikely at this site. The more immediate concern should be the stability of the cut slope above the school.

**Recommendations:** The material on the top tier of the cut slope that failed during the earthquake needs to be removed and the cracks sealed before the rainy season begins to prevent mobilization of the failed material, which could move rapidly downs-

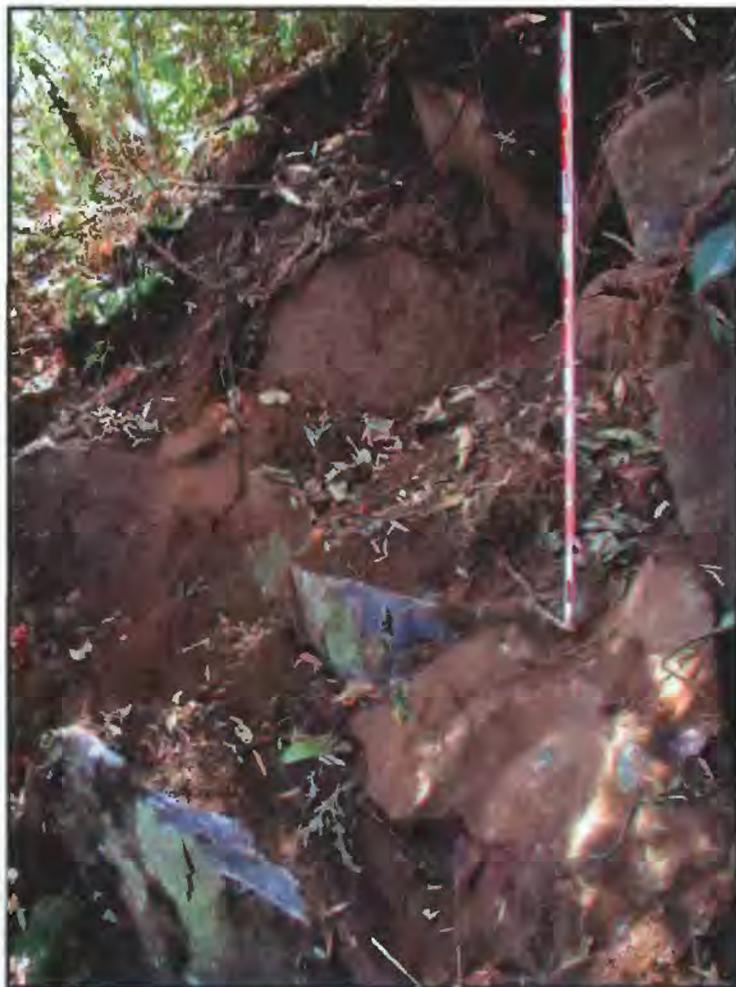
**Situation:** A steep ridge extends along the southwest edge of Santa Elena. Massive, hard lava flows crop out on the upper part of this ridge, and these rock outcrops produced rock falls during the earthquake. Fractures in the rock outcrops create rock blocks 1-20 m<sup>3</sup> in volume (fig. 4) that can be shaken loose by earthquake shaking; the blocks then

cascade down the 30-40° slope at high enough speed to bounce and become airborne. Several such boulders are strewn throughout the forest all the way to the base of the slope, indicating that this process has been occurring for some time. During the recent M-7.6 earthquake, a 5-m<sup>3</sup> boulder released from the outcrop (see fig. 4) and moved downslope rapidly enough to knock down a 0.5-m-diameter tree and stop within 30 m

**Figure 4.** Rock-fall source on ridge above Santa Elena. The boulder shown in Figure 5 came from this source.

**Recommendations:** Several methods exist for mitigating rock-fall hazards. At the rock-fall source, loose boulders can be bolted into

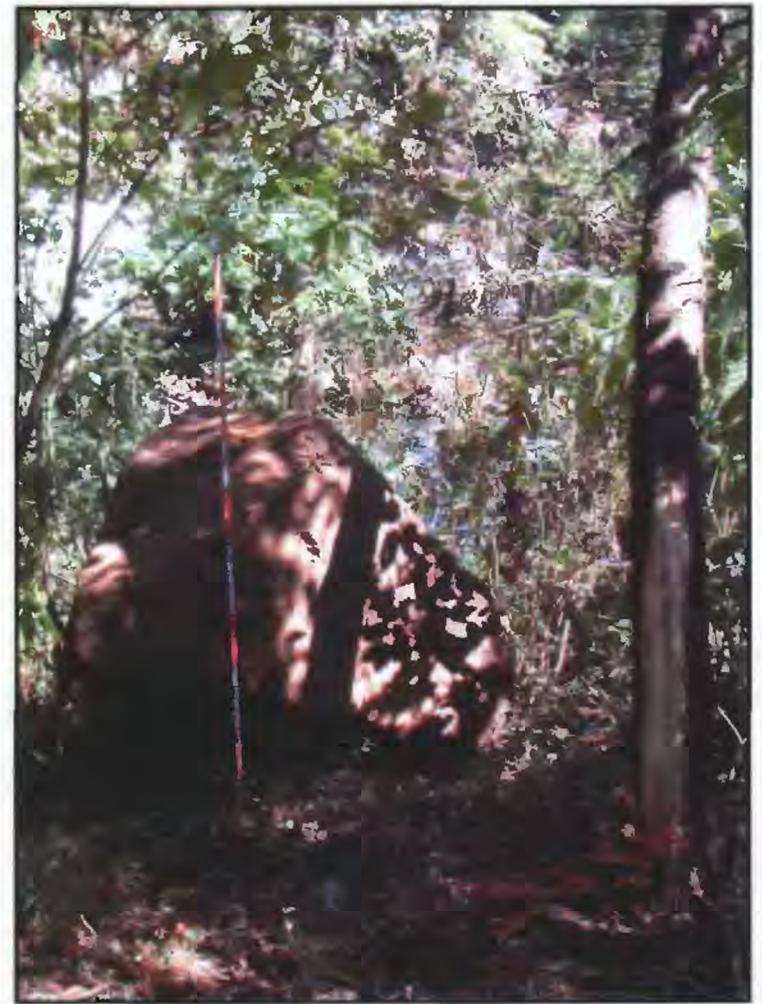
**Figure 5.** Boulder shaken loose by January 17 earthquake that came to rest near houses in Santa Elena. The measuring stick is 2 meters long. Note the scars on the tree at the right where the boulder tore the bark off the trunk.

of houses at the base of the slope (fig. 5). Had this boulder continued downslope, it would have severely damaged any structure it hit. The hazard from rock falls is greatest along the western end of the ridge and lessens somewhat eastward as the rock-fall sources are higher on the slope in that direction (boulders released higher on the slope are more likely to be slowed and stopped by the thick forest covering the slope). Although heavy rainfall could also trigger rock falls in this area, the greatest hazard is probably from rocks shaken loose in future earthquakes. Houses in this area are built at the base of the slope, and houses in the uppermost part of this neighborhood face the greatest risk.

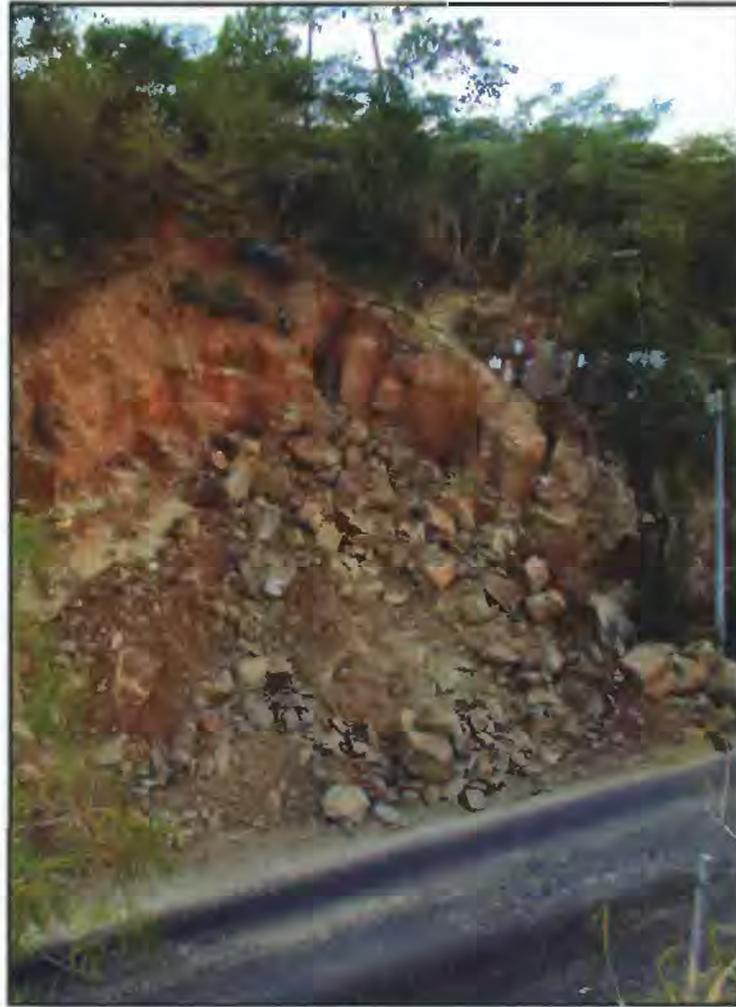
**Situation:** The earthquake triggered a rock fall having a volume of about 2,500 m<sup>3</sup> from the road cut at this location (fig. 7). One house was

**Figure 7.** Rock fall between Zaragoza and El Transito.

destroyed in the initial rock fall. Several additional houses are located along the new rock-fall scarp. The rock mass below these houses is fractured and dilated and is at great risk of failing in aftershocks, heavy rainfall, or future large earthquakes (fig. 8). This poses risks to both the residents of the houses and motorists on the road below.

**Recommendations:** Houses along the fresh scarp should be removed immediately and the residents relocated. Rock-fall material from the earthquake should be removed from the landslide scar, and the rock face should be graded back to a more stable slope angle.

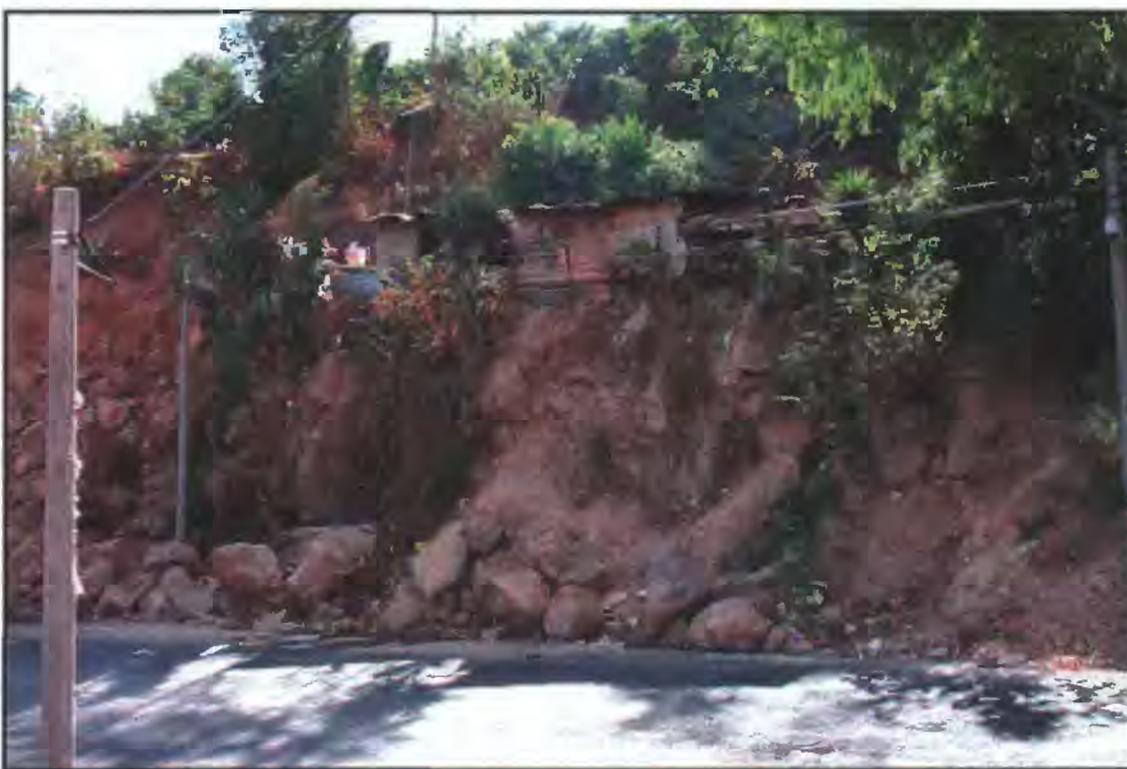
**Figure 8.** Houses along rock-fall scarp between Zaragoza and El Transito.

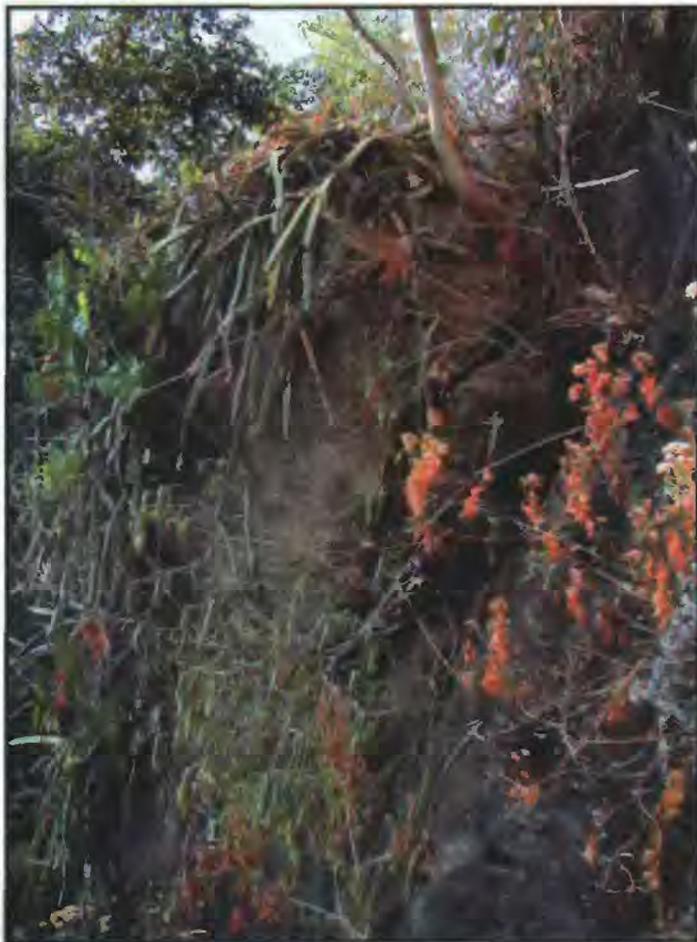
**Situation:** Several houses are located below and near vertical rock faces that produced rock falls during the earthquake. The faces are moderately fractured and could produce future rock falls during earthquakes or intense rainfall. The face on the east end of this area is particularly hazardous and has a large (10 m<sup>3</sup>) boulder that is detached and ready to fall (fig. 9). Several houses are directly in the path of this boulder.

**Figure 9.** Precariously perched boulder above houses in Santa Teresita.

**Recommendations:** Removal of the precariously perched boulder from the eastern rock face would be the most effective course. This will require attaching cables to the rock and either pulling it to the top of the slope with heavy equipment or causing it to fall with restraints so that it will not continue into the houses below. Cable fences to catch boulders could be installed in other

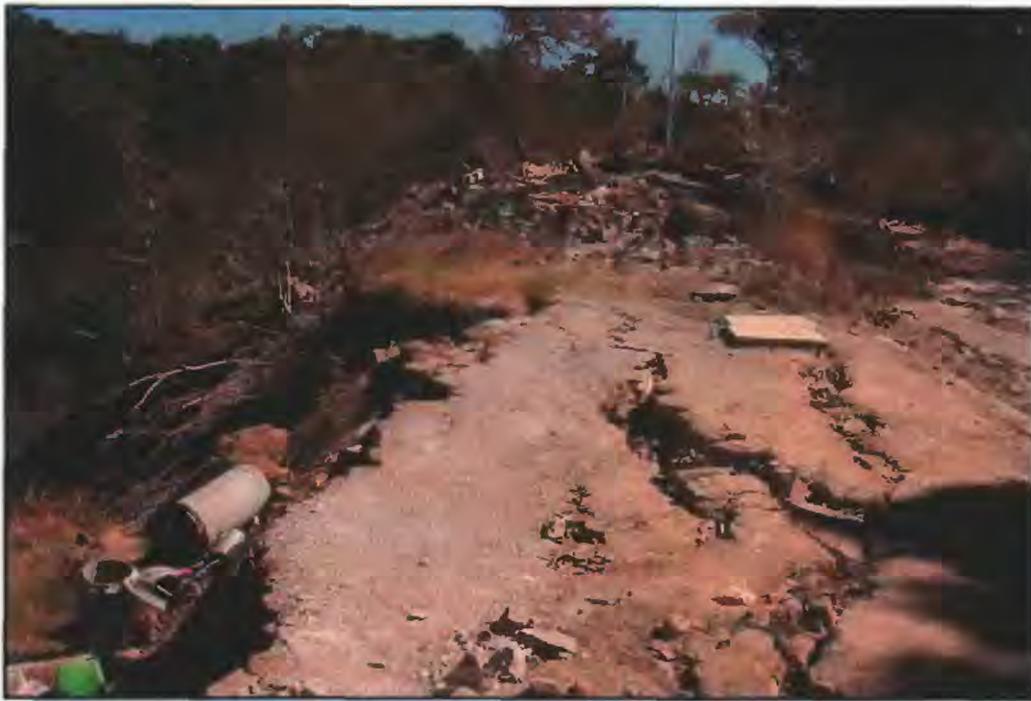
**Situation:** Almost the entire length of the road extends along a narrow, steep-sided ridge. The ridge experienced amplified ground shaking and is thoroughly shattered along most of its length (fig. 10). The ground surface is fissured and shattered, road cuts have failed continuously, and nearly all structures have collapsed. The road is in very poor condition—it is covered by as much as 0.5 m of fine, powdery dust, and the failed road cuts are depositing more material on the road (fig. 11). When this material gets wet in the rainy season, the road is likely to be impassable. On the east end, the road traverses a large, deep debris slide triggered by the earthquake that is similar to the Las Colinas landslide.

**Figure 10.** Shattered ridge near Comasagua.

**Recommendations:** The road cuts should be stabilized by regrading and removing failed material. The road itself needs to be regraded to remove the thick layer of dust; it should then be graded with gravel or other aggregate to provide stability to the road base. This needs to occur before the rainy season if the road is to remain open. Keeping the road open across the large landslide at the east end may be very difficult. It may require building retaining walls above the road to catch additional landslide material that is likely to fall from the scarp area.

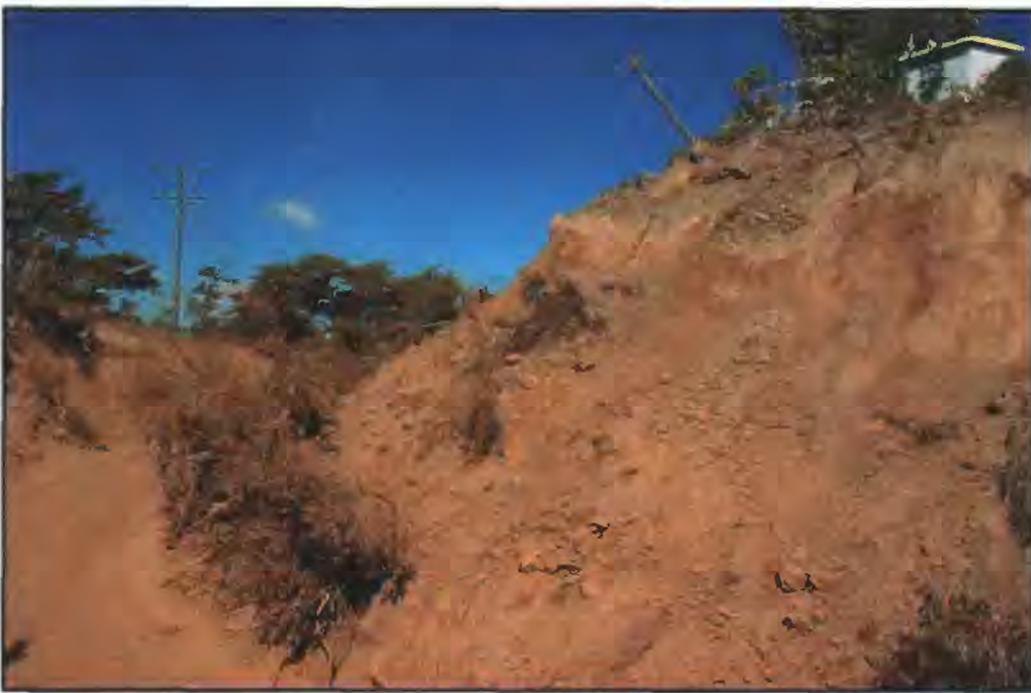
**Figure 11.** Road-cut failures on road from Las Delicias to Comasagua.

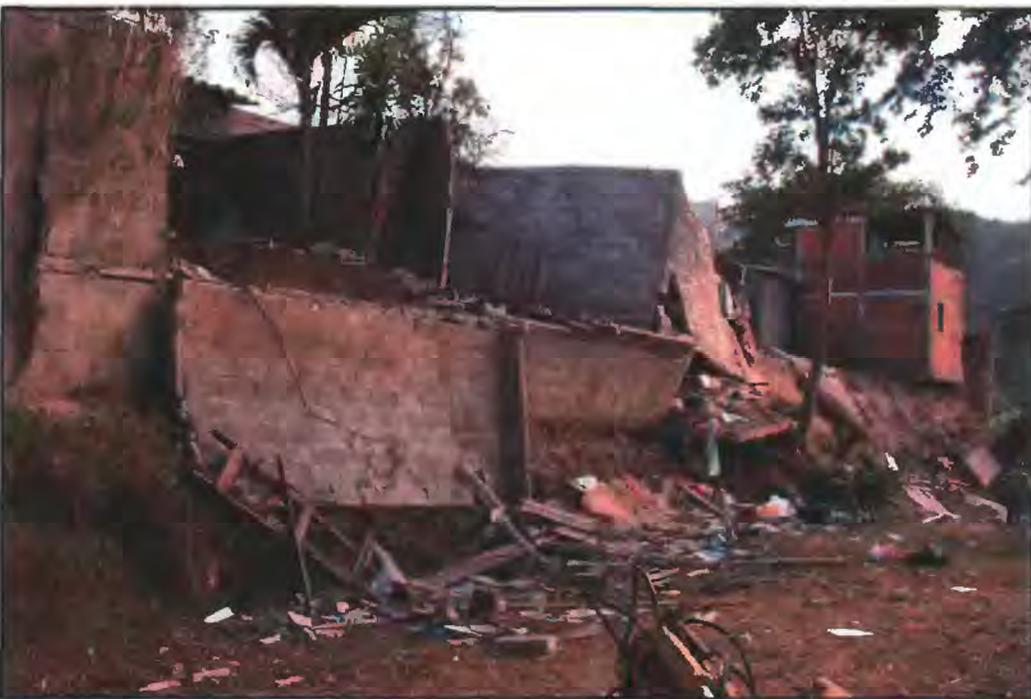
**Figure 12.** Damage from strong shaking and landsliding at Alpes Suizos.

**Situation:** Several houses built on the edge of the slope overlooking the highway were severely damaged during the earthquake by a combination of strong shaking and failure of the slope beneath the houses (fig. 12). The rear half of the houses detached in many cases and moved several centimeters toward the slope. Houses across the street to the east also had serious cracking and damage but not as severe. The area is currently evacuated, and many residents are eager to repair and rebuild their homes.

**Recommendations:** The likelihood of continuing slope movement is high, both in earthquakes and rainfall, and the slope movement will be difficult to stabilize economically and reliably. The cost of slope stabilization will likely be much greater than the value of the affected houses; therefore, the houses on the outer edge of the slope should be condemned and removed rather than repaired. The houses on the east side of the street could be repaired and salvaged if a detailed study indicated that the slope failure will not extend that far behind the edge of the slope.

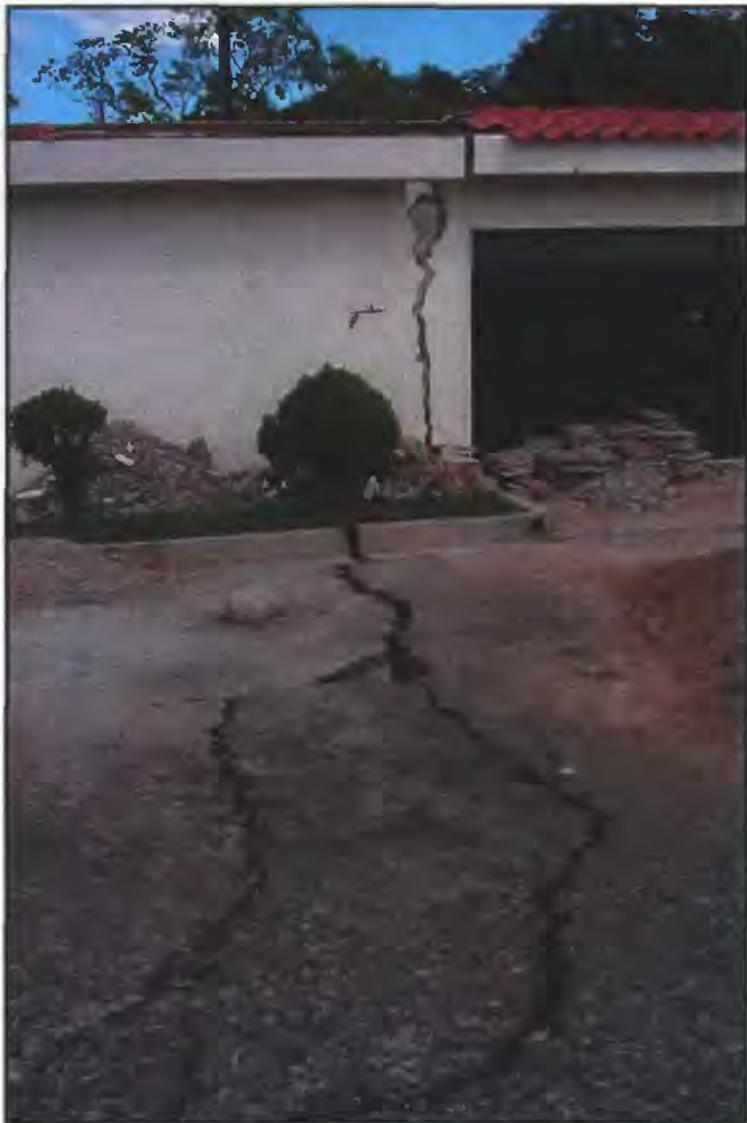
**Situation:** Cracks as wide as 10 cm opened during the earthquake. The cracks separate road pavement and extend through several houses, causing serious damage (fig. 13). The cracks appear to occur near the boundary of the cut slope and the fill slope, a situation that has been observed in earthquakes elsewhere. Renewed cracking in future earthquakes is likely, and failure of the edge of the fill during the rainy season is possible.

**Figure 13.** Cracks along the edge of a fill slope at La Cima 3.

**Recommendations:** Cracks should be carefully filled and sealed before the rains begin. Homeowners should be informed that renewed cracking is likely in future earthquakes and rainy seasons. A detailed geotechnical study should be conducted to determine the stability of the edge of the fill in the rainy season. Homes below

this fill slope may need to be temporarily or permanently evacuated while this study is being conducted.

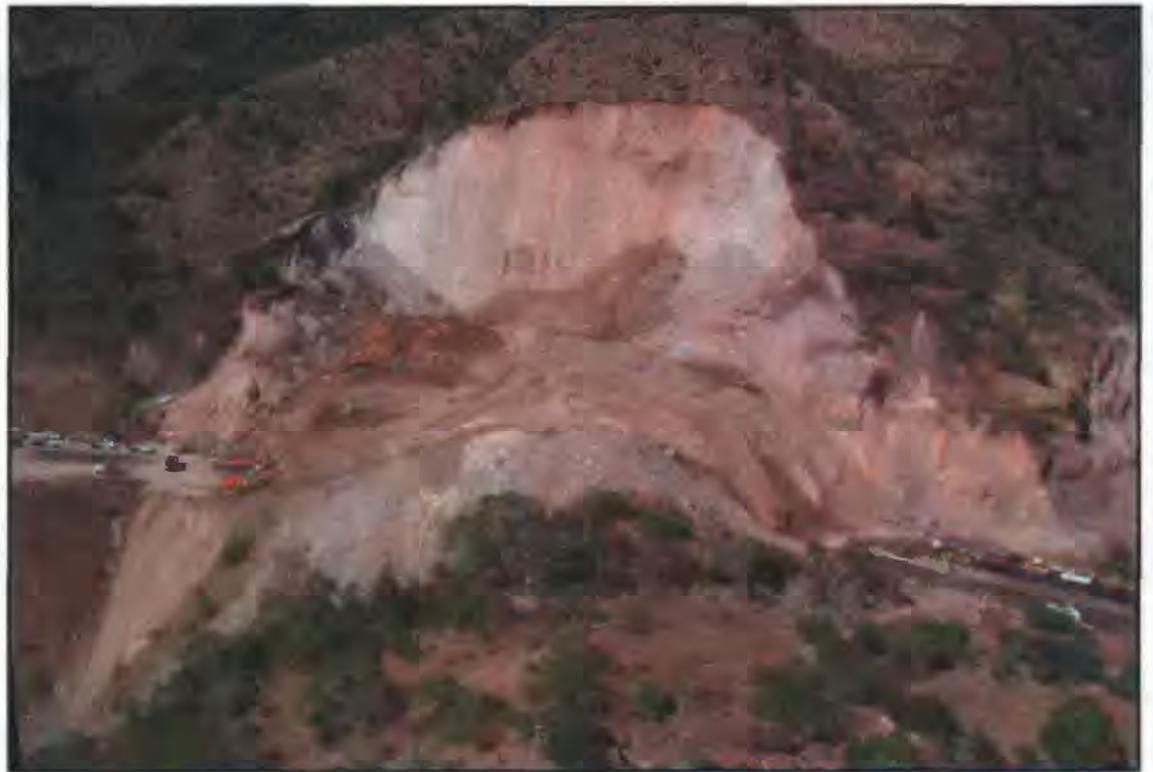
**Situation:** The earthquake triggered a massive debris slide from a road cut on the Pan-American Highway (fig. 14). The slide is approximately 250 m wide at its base, 120 m high, and 25 m thick, which yields an estimated volume of 500,000-700,000 m<sup>3</sup>. The main scarp of the landslide formed along the surface of a south-dipping normal fault, which created a zone of weakened, sheared material

**Figure 14.** Landslide blocking the Pan-American Highway near San Vicente. (Photo by E.L. Harp, USGS)

that facilitated slope failure during the earthquake shaking. Excavation of the landslide deposit from the road was almost complete as of February 7, 2001. Local residents stated that the road cut had been oversteepened by people excavating rocks from the cut to sell as building aggregate. We inspected the slope above the crown of the landslide and saw no open cracks or other indications of impending failure of material above the scarp, but near-vertical scarps in weak material commonly retreat through time, so small landslides from the scarp should be expected; most of these will come to rest on the remaining landslide deposit that is above the road. Landslide material removed from the roadway was dumped over the edge of the slope below the road. This uncompacted fill slope is highly susceptible to failure during rainy periods or future earthquakes, which could endanger homes downslope.

**Recommendations:** Water will tend to collect on top of the remaining landslide deposit, which is above the highway. A drainage system should be installed to keep as much water as possible from the top of the landslide material. The cut slope above the road in the landslide material is rather steep and can be expected to produce small- to moderate-size landslides that could close the road and endanger motorists in rain storms or moderate to large earthquakes; therefore, this cut may need to be laid back to a gentler slope angle. The waste slope below the road will be diffi-

cult to stabilize and will require a detailed geotechnical study to recommend solutions.

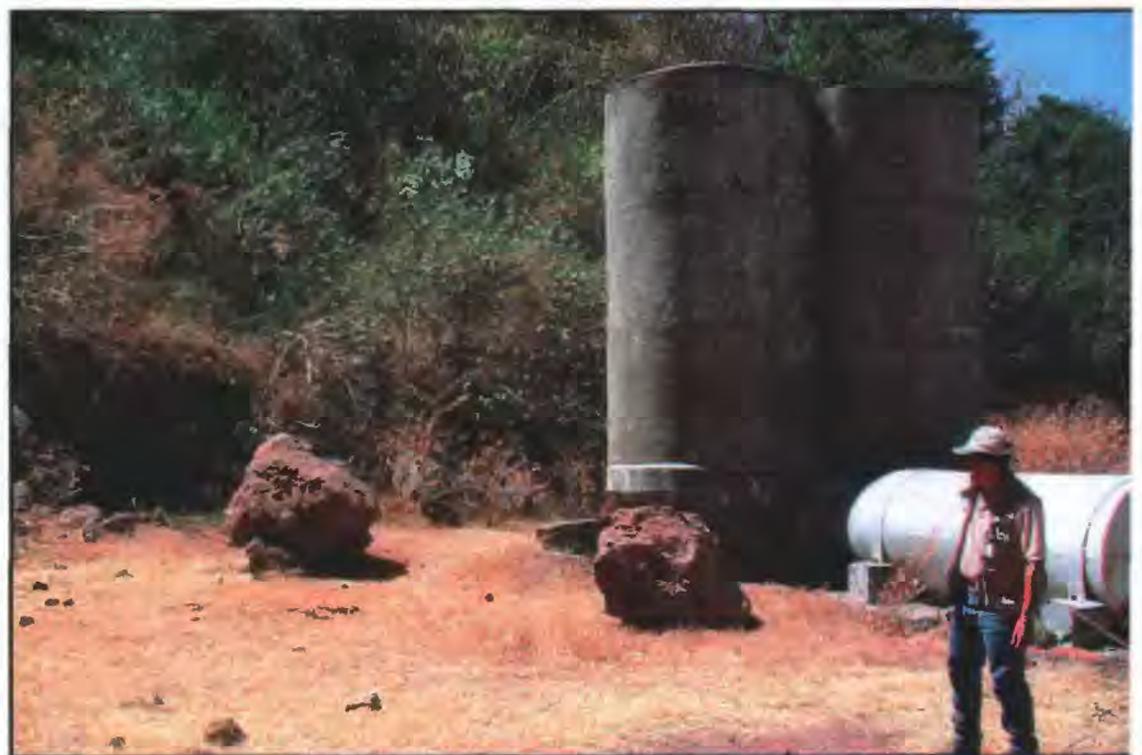
**Situation:** A rock fall of several hundred cubic meters occurred on the steep slope behind the well; the slope is the scarp of an older, larger landslide. Several boulders from the rock fall stopped within a few meters of the well equipment; the biggest single boulder is about 5 m<sup>3</sup> (fig. 15). Another landslide heads just below the road to the well. The road itself has cracks parallel to the edge of the slope.

**Figure 15.** Boulders from rock fall above geothermal well near Berlin.

**Recommendations:** More boulders are likely to come off the slope above the well in future earthquakes and heavy rain storms. The best solution may be to construct a cable fence to catch and stop the boulders at the base of the slope. The fence will need to be designed by a qualified rock engineer and constructed to specifications if it is to perform properly.

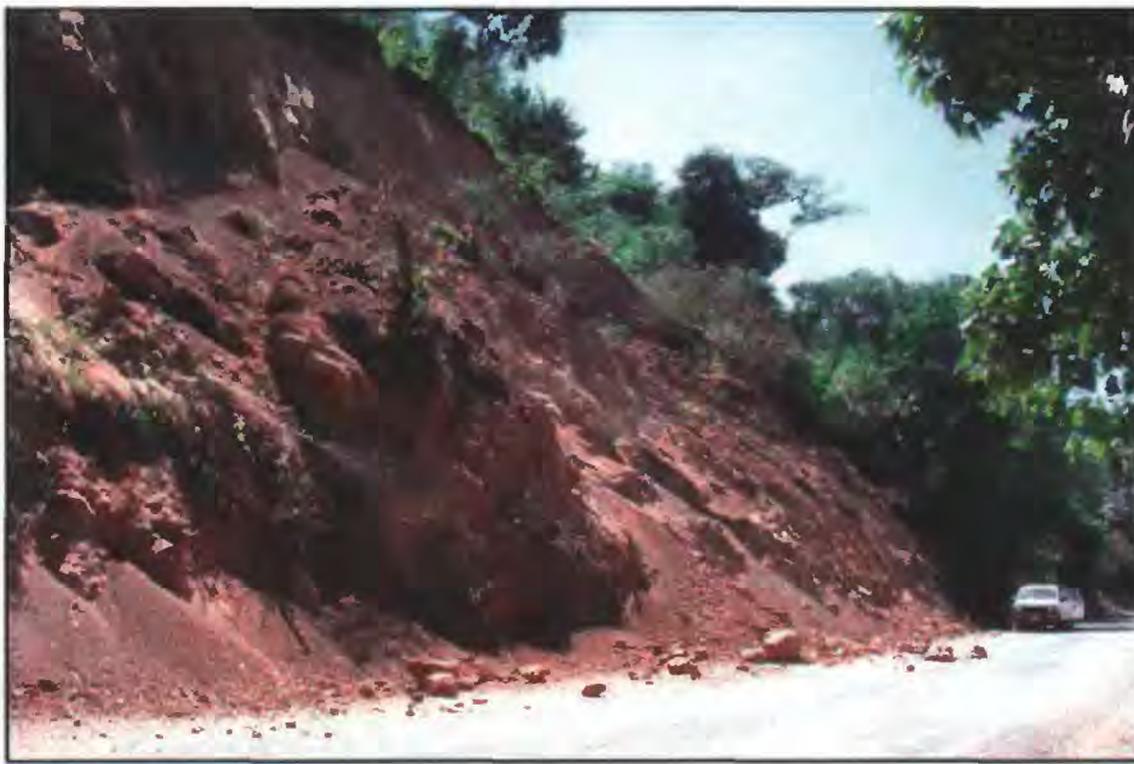
**Situation:** The road from Berlin to Alegria has numerous rock falls from the earthquake (fig. 16). In places, both sides of the road have large, continuous piles of landslide debris that has been removed from the road. Some of the larger rock falls have volumes of several thousand cubic

**Figure 16.** Landslide on road from Berlin to Alegria.

meters. At least one also failed during Hurricane Mitch. Some of the rock-fall scars have open fractures and precariously perched boulders, indicating that more rocks will fall during future earthquakes and storms.

**Recommendations:** Some boulders that are ready to fall can be removed carefully by properly trained construction crews. Local officials should be informed that landslides along the road should be expected in future earthquakes and during the rainy season.

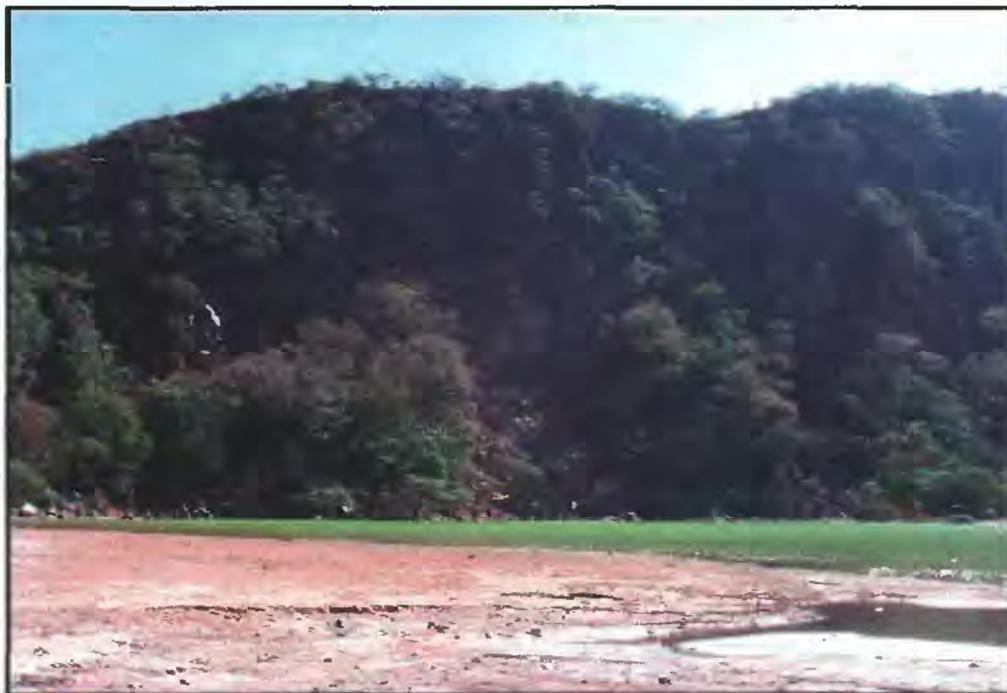
**Figure 17.** Rock falls from slopes surrounding Laguna Alegria.

**Recommendations:** Clear the road of rock-fall debris and be prepared for future rock falls. Post signs warning visitors of the possibility of rock falls.

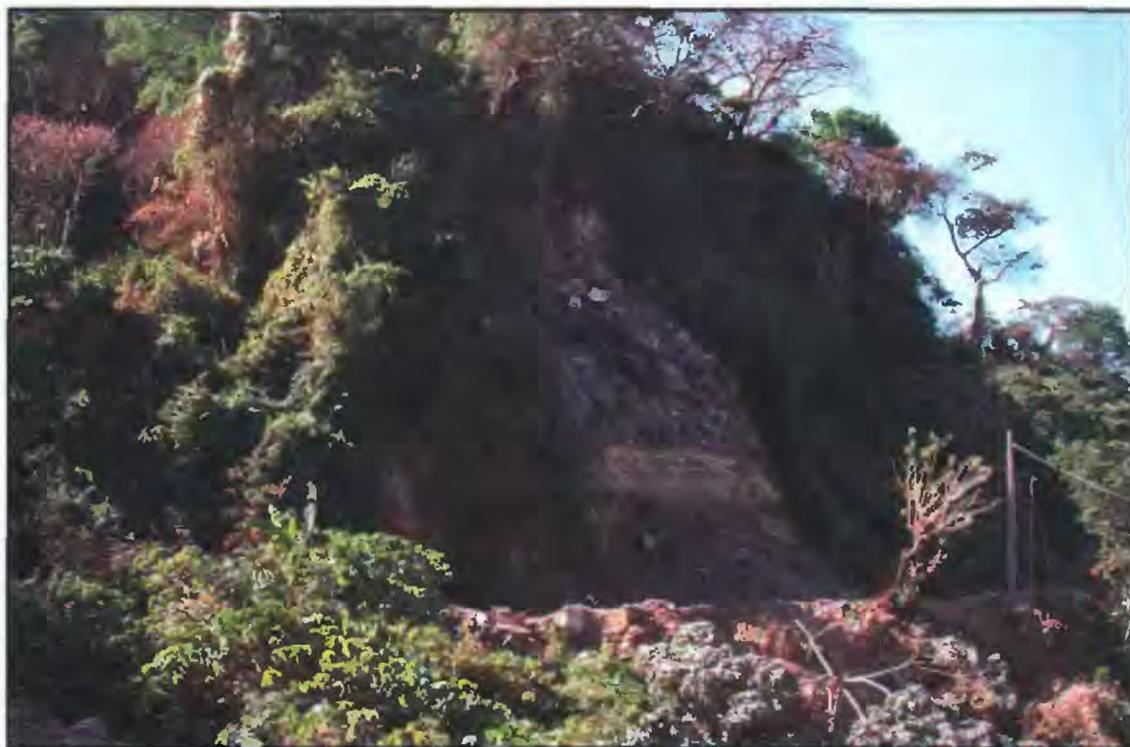
**Situation:** The earthquake triggered many rock falls along the road having volumes as great as to several hundred cubic meters. The largest of these (at the coordinates given above) is particularly hazardous (fig. 18). Many dilated fractures have openings of 10 cm or more. Many boulders are precariously perched and ready to fall. Modest rainfall or earthquake shaking will bring down more material unless immediate remedial work is undertaken

**Figure 18.** Rock fall on road from Alegria to Santiago de María.

**Recommendations:** The road cut needs to be stabilized by removing loose boulders and perhaps using additional rock engineering measures to stabilize the rocks.

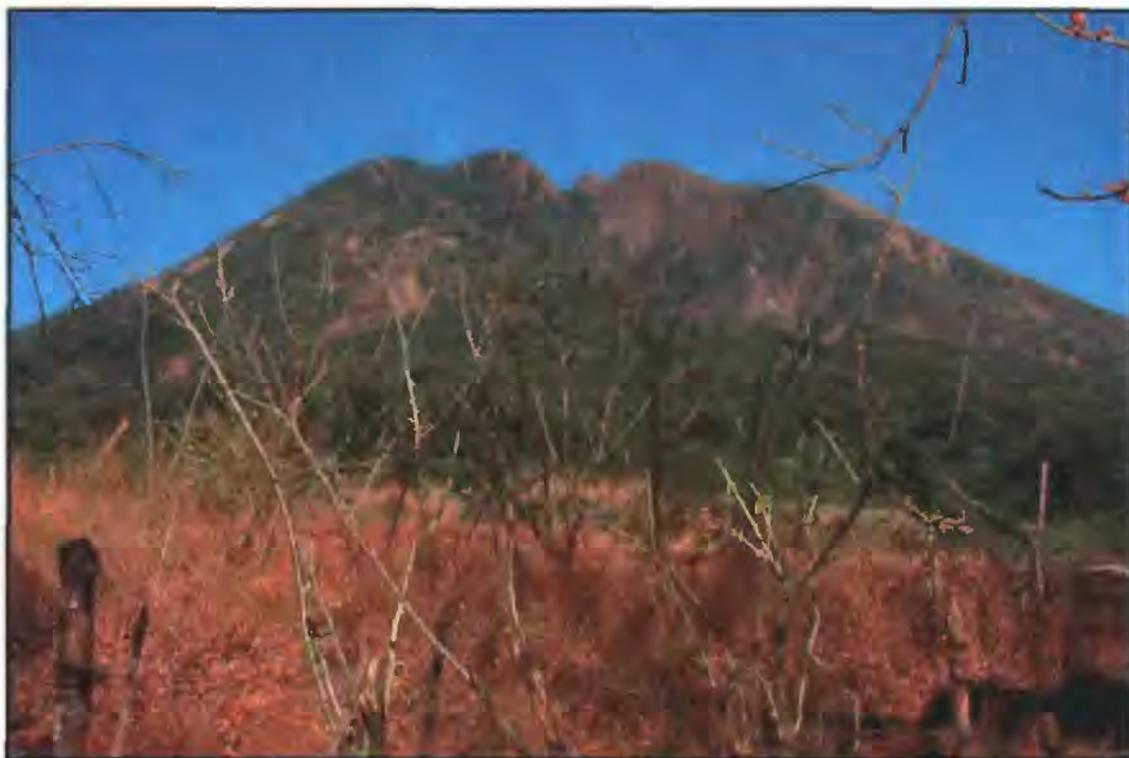
**Situation:** Many large landslides occurred on the flanks of Usulután Volcano (fig. 19). They probably affect only the coffee plantations on the slopes, but sediment from these land-

**Figure 19.** Landslides from the flanks of Usulután volcano.

slide deposits will wash into drainages over time and could cause sedimentation problems downstream.

**Recommendations:** Plantation owners should address landslide problems. Communities downstream from the flanks of the volcano should be warned of possible sedimentation issues in the future.

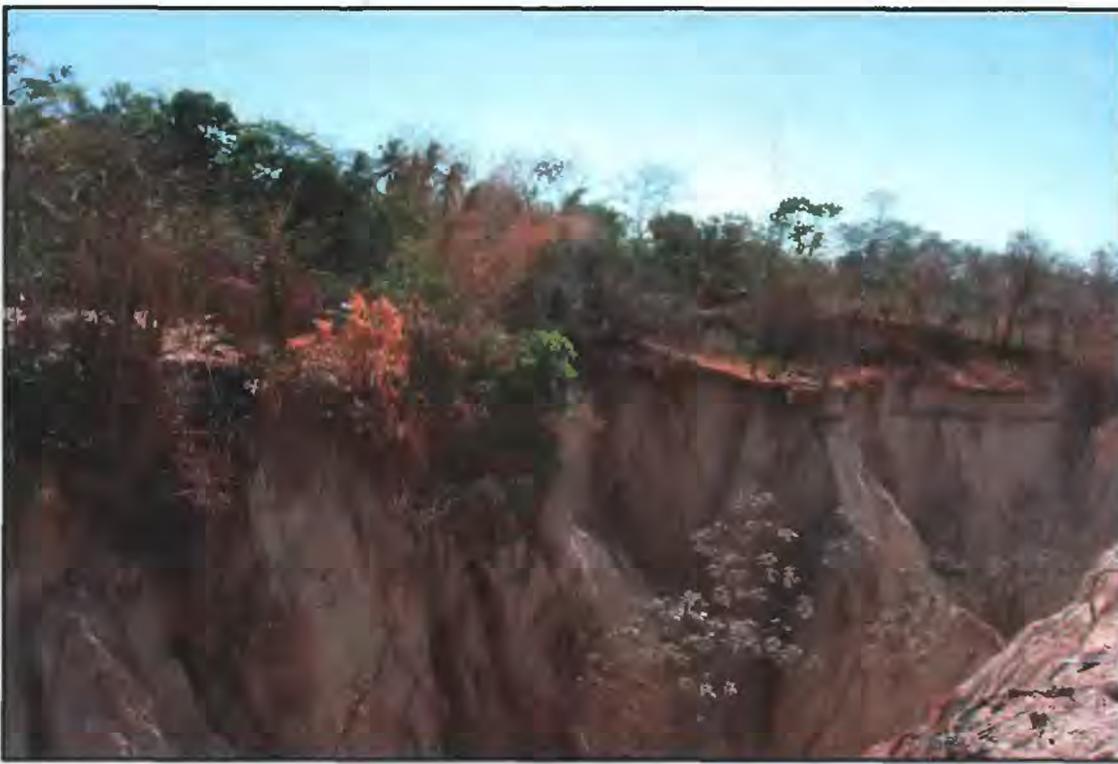
**Situation:** This town is built on a very thick layer of white, powdery volcanic tephra. Deep gorges have been eroded into the ash deposits on the edge of town. These gorges have nearly vertical walls 70-80 m high and are about 50 m or more wide. The earthquake triggered massive failures along the walls of the gorges; blocks and slabs of material hundreds to thousands of cubic meters in volume cascaded to the base of the very steep slopes (fig. 20). Numerous cracks and fissures parallel to the edge of the gorge and as far as 30 m from the edge define additional slabs of material that are likely to fail in the rainy season or in future earthquakes. The head of one gorge is already undermining the edge of a street in the town, and headward erosion will undermine this street until it is

**Figure 20.** Failures of near-vertical slopes in San Pedro Masahuat.

impassible. The soccer field near town is near the edge of a gorge. Cracks extend across the length of the field parallel to the edge of the bluff. The cracks have 1-3 cm of displacement downward and toward the bluff edge. These cracks probably define an incipient landslide triggered by the earthquake. This slide is not likely to move catastrophically in the rainy season, but it may experience some additional movement. Future earthquakes are also likely to renew movement at this site.

**Recommendations:** The ongoing enlargement of the gorges through headward erosion and lateral retreat of the walls is an continuing natural process that cannot be practically or economically controlled. Therefore, residents and local officials need to

accommodate this situation and plan to adapt to the inevitable consequences. The first priority is life safety; therefore, houses very near (within a few meters) the current edge of the gorge need to be removed and the residents relocated. Additionally, houses between large cracks parallel to the edge of the gorge and the edge of the gorge itself may also need to be removed; in such situations, the houses are on a potential landslide block that could fail catastrophically during earthquakes or the rainy season. A thorough investigation of the locations of cracks should be made by carefully inspecting areas along the edge of the bluff and recording houses with nearby cracks. Filling open cracks with dirt or cement will prevent infiltration of water in the rainy season and may delay the failure of new areas outlined by cracks. The second priority is to make a long-term plan to accommodate the retreat of the walls of the gorge. Local officials may want to establish a setback limit from the edge of the gorge. A limit of about 30 m may be reasonable, but the limit should be set based on the observed distance of earthquake-related cracks from the edge of the bluff. Homes within this 30-m setback zone would be scheduled for relocation over the next few years as resources are available. This will allow the natural process of bluff recession to occur within a safe zone where no houses exist. The street at the head of the gorge will become impassible soon, and plans should be made immediately to relocate this street.
