# STABILITY ASSESSMENT OF A HURRICANE MITCH-INDUCED LANDSLIDE DAM ON THE RÍO LA LIMA, SIERRA DE LAS MINAS, EASTERN GUATEMALA

Robert L. Schuster<sup>1</sup>, Robert C. Bucknam<sup>1</sup>, and Manuel Antonio Mota<sup>2</sup>

Open-File Report 01-120 (*English and Spanish*)

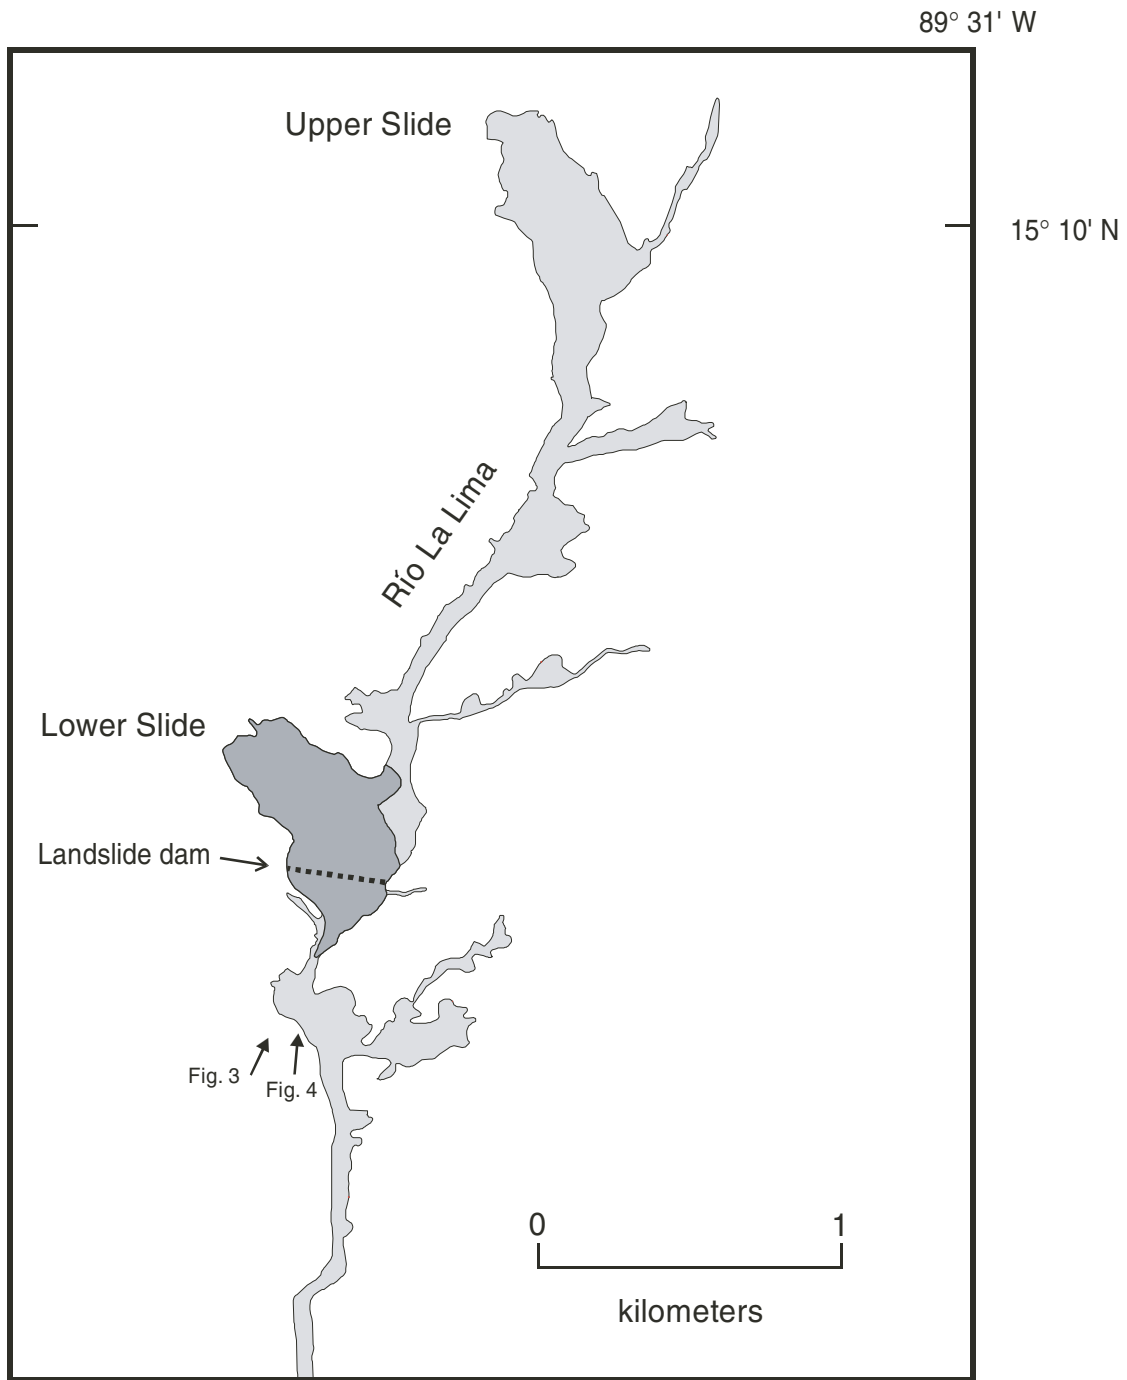
Fig. 2. Map showing areas (shaded) affected by landslides, debris flows, and flooding in the upper Río La Lima drainage. Dark shading shows the landslide complex that produced the landslide dam. Arrows show the approximate photo points and directions of view of Figs. 3 and 4.

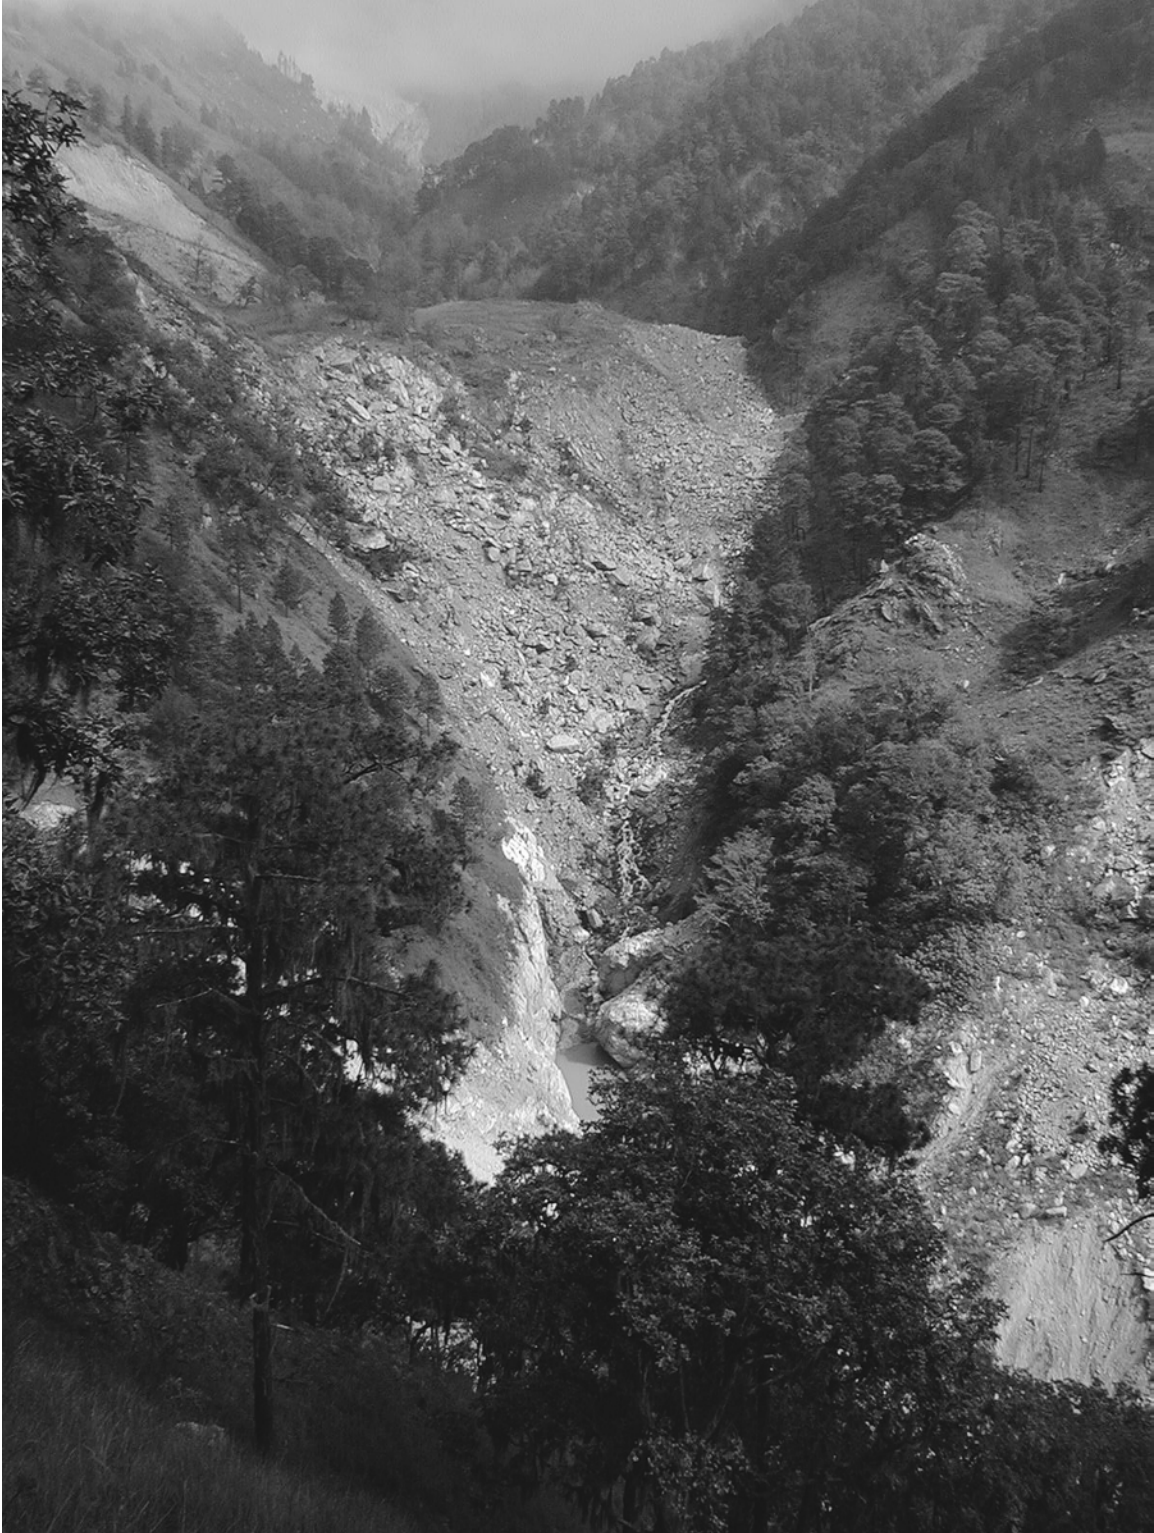
At the time of our visit, there was no flow of water over the crest of the dam. Instead, the Río La Lima flowed through continuous voids in the dam, exiting the dam about half way down its face as a large spring at the contact between the dam and the valley-wall left abutment. Although we were did not reach the point of discharge through the dam, it appeared from a distance that there was no evidence of active internal erosion (i.e., the exiting water appeared to be clear).

**Figure 3.** Landslide dam on the Río La Lima, looking upstream (north) from a point 4 km north of Jones; photograph taken 25 January 2000. The landslide originated on the steep slope in the upper left corner of the photograph (see figure 4). The point of discharge of the river from the debris that forms the dam is at the point where the water is first visible at the middle right part of the photograph.

However, we do recommend that the condition of the dam, its impoundment, and the outlet of the river through the dam be observed on a regular basis. This can be done by means of binoculars from the trail on the west side of the canyon at a location about one kilometer downstream from the dam and at a site where the trail intersects the landslide above the dam. If additional landslides occur in the vicinity of the landslide dam or elsewhere in the Río La Lima drainage above the landslide dam the stability of the dam should be reevaluated.

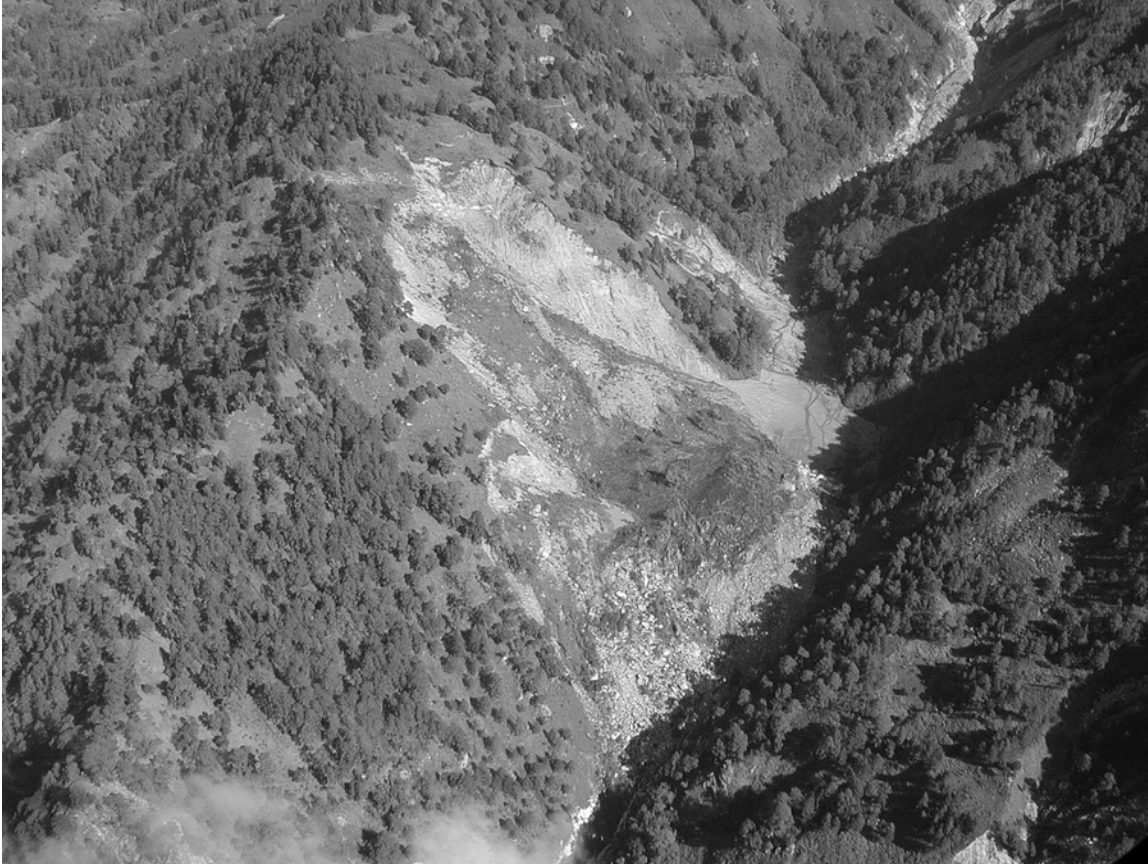
Shortly after the dam formed, the retention basin behind the dam partially filled by sediment eroded from the debris flow deposits that originated from the upstream slide. By the time of our visit, this basin had been almost filled by deposition of sediment from both slides. The only surface indications of impoundment of water by the dam were shallow ponds immediately behind the dam. Thus, the landslide dam functions much like a mine-tailings dam, retaining a mixture of about 200,000 m<sup>3</sup> of water and sediment.

**Figure 4.** Oblique aerial view to north of the landslide that produced the dam on the Río La Lima, photograph by Jeffrey Coe taken 12 January 2001. Smooth even-toned surface crossed by Río La Lima at the toe of the landslide is the sediment fill behind the landslide dam.
