Field Survey and Damage Assessment of the Mineral, Virginia, Earthquake of August 23, 2011

Open-File Report 2012–1198

By Helen R. Thomas and Katharine Turkle

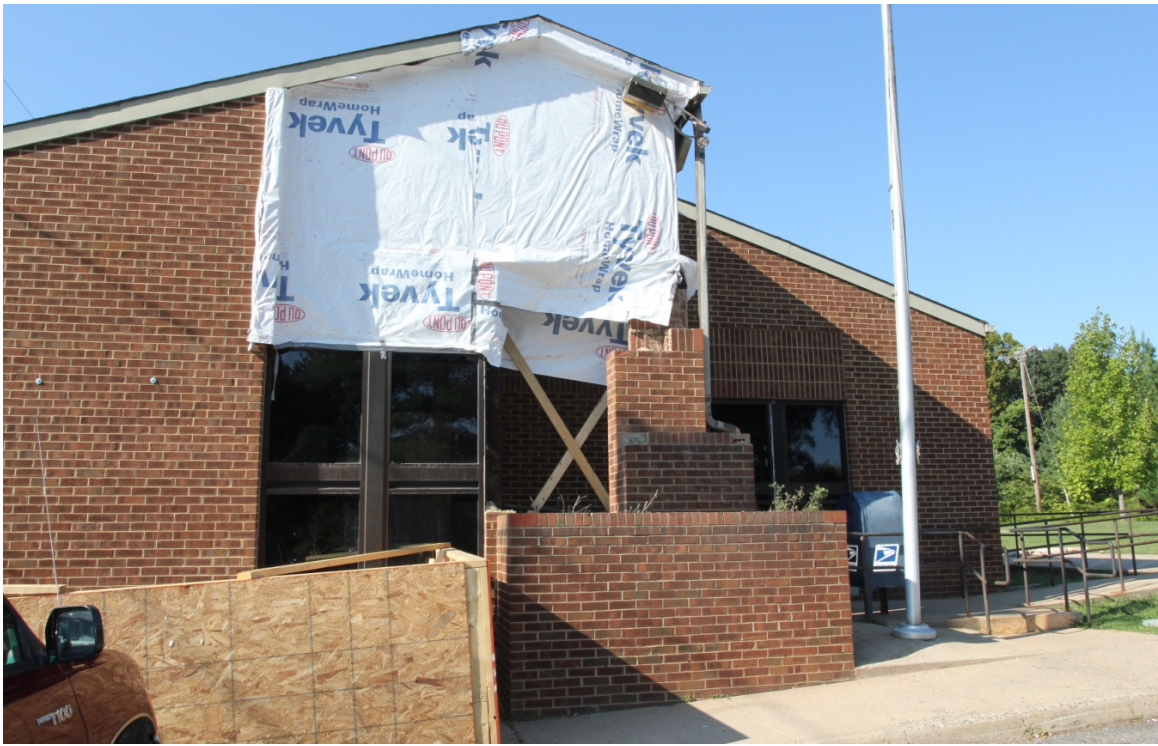
The town of Mineral, Va., sustained the most damage from the earthquake. Approximately 70 percent of the structures in downtown and rural Mineral were damaged (Louisa County Fire Department, oral commun., August 2011), including the local high school, post office, grocery store, and many residences. All the buildings that sustained damage were constructed of either unreinforced masonry or brick with concrete foundations. After the earthquake, the high school was closed for repairs (Mineral High School superintendent, oral commun., August 2011). The post office sustained severe damage, losing one of its brick-and-glass façades (fig. 6). Several ceiling panels in the grocery store fell down, and the floor was cracked along its entire length (figs. 7, 8).

Figure 6. Photograph of the brick façade of the U.S. Post Office in Mineral, Virginia, which collapsed during the August 23, 2011, Mineral, Virginia, earthquake.

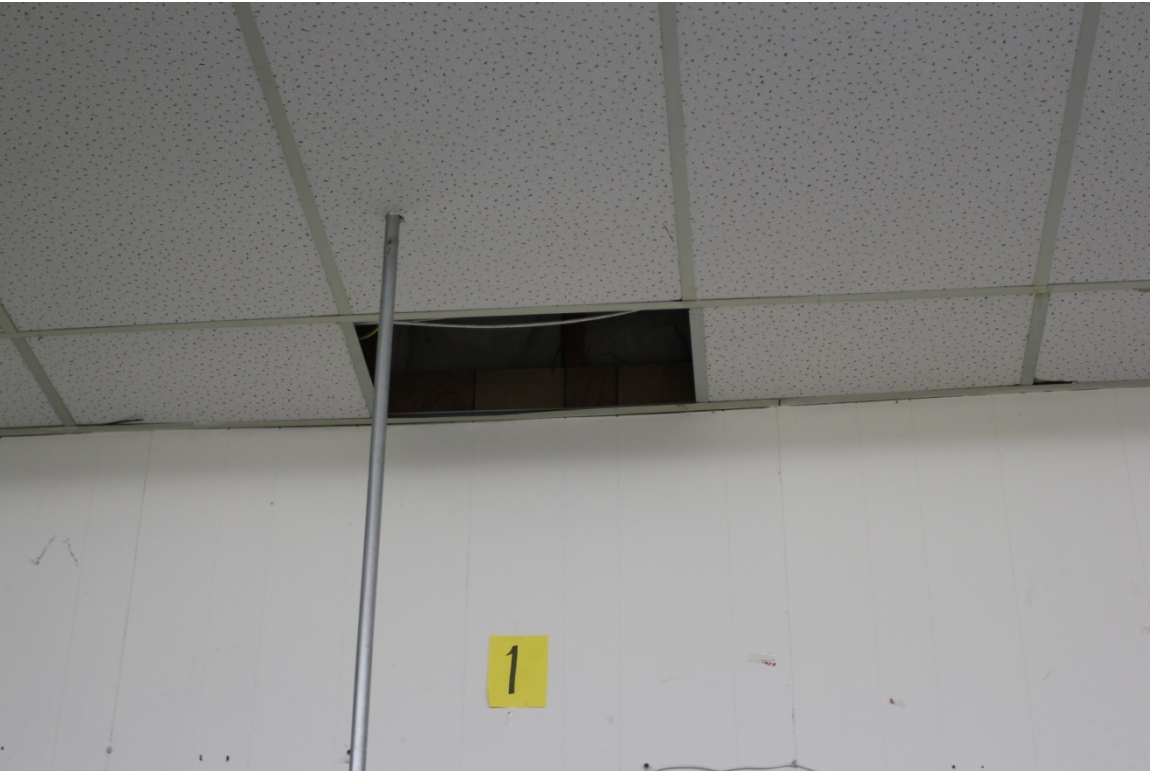
Figure 7. Photograph of a fallen ceiling panel in the local Mineral, Virginia, grocery store after August 23, 2011, Mineral, Virginia, earthquake.

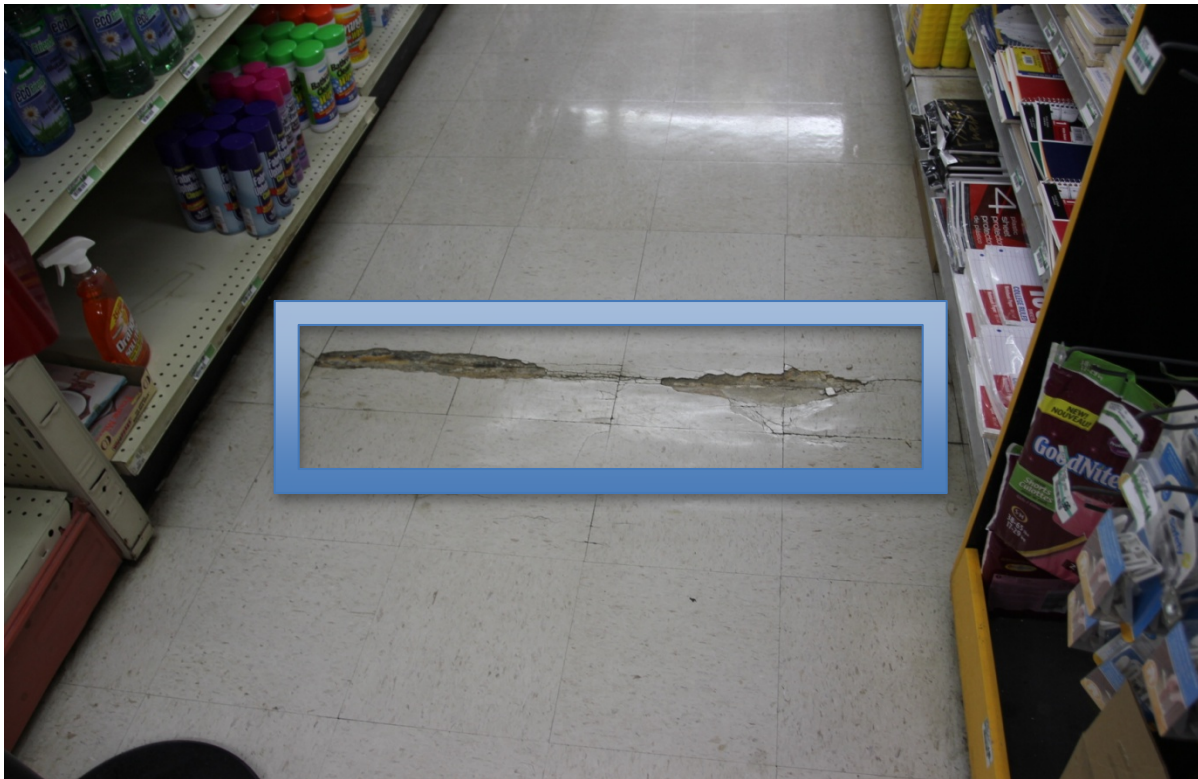
Figure 8. Photograph of one of several large floor cracks (outlined by blue rectangle) in the local Mineral, Virginia, grocery store after August 23, 2011, Mineral, Virginia, earthquake.

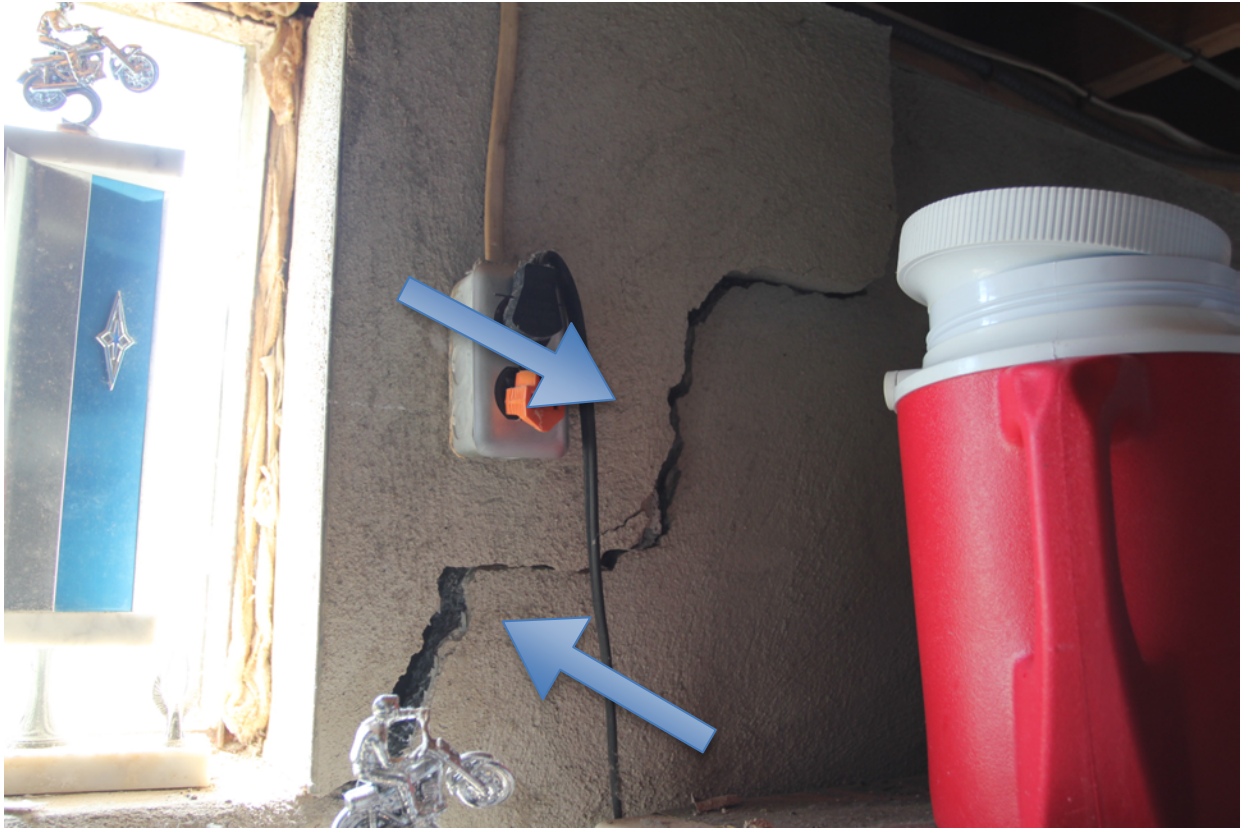
One residence outside of downtown Mineral was significantly damaged: the foundation was cracked, the chimneys were damaged, and the windows and walls were bowed away from their framework (figs. 9–12). Aftershocks continued to exacerbate the damage for as long as 2 weeks after the main shock. We spoke with several residents in the town of Mineral who pointed out fresh cracks on the walls of their houses that began the day before we arrived (8 days after the earthquake) and continued into the next week. Signs and mailboxes were tilted, and stop-sign poles were displaced by several centimeters along Main Street (fig. 13).

Figure 9. Photograph of a crack in the basement of a Mineral, Virginia, residence after the August 23, 2011, Mineral, Virginia, earthquake. Image shows “stair-stepping” (bottom left to upper right) under the electrical outlet, approximately 0.5 meters visible here.

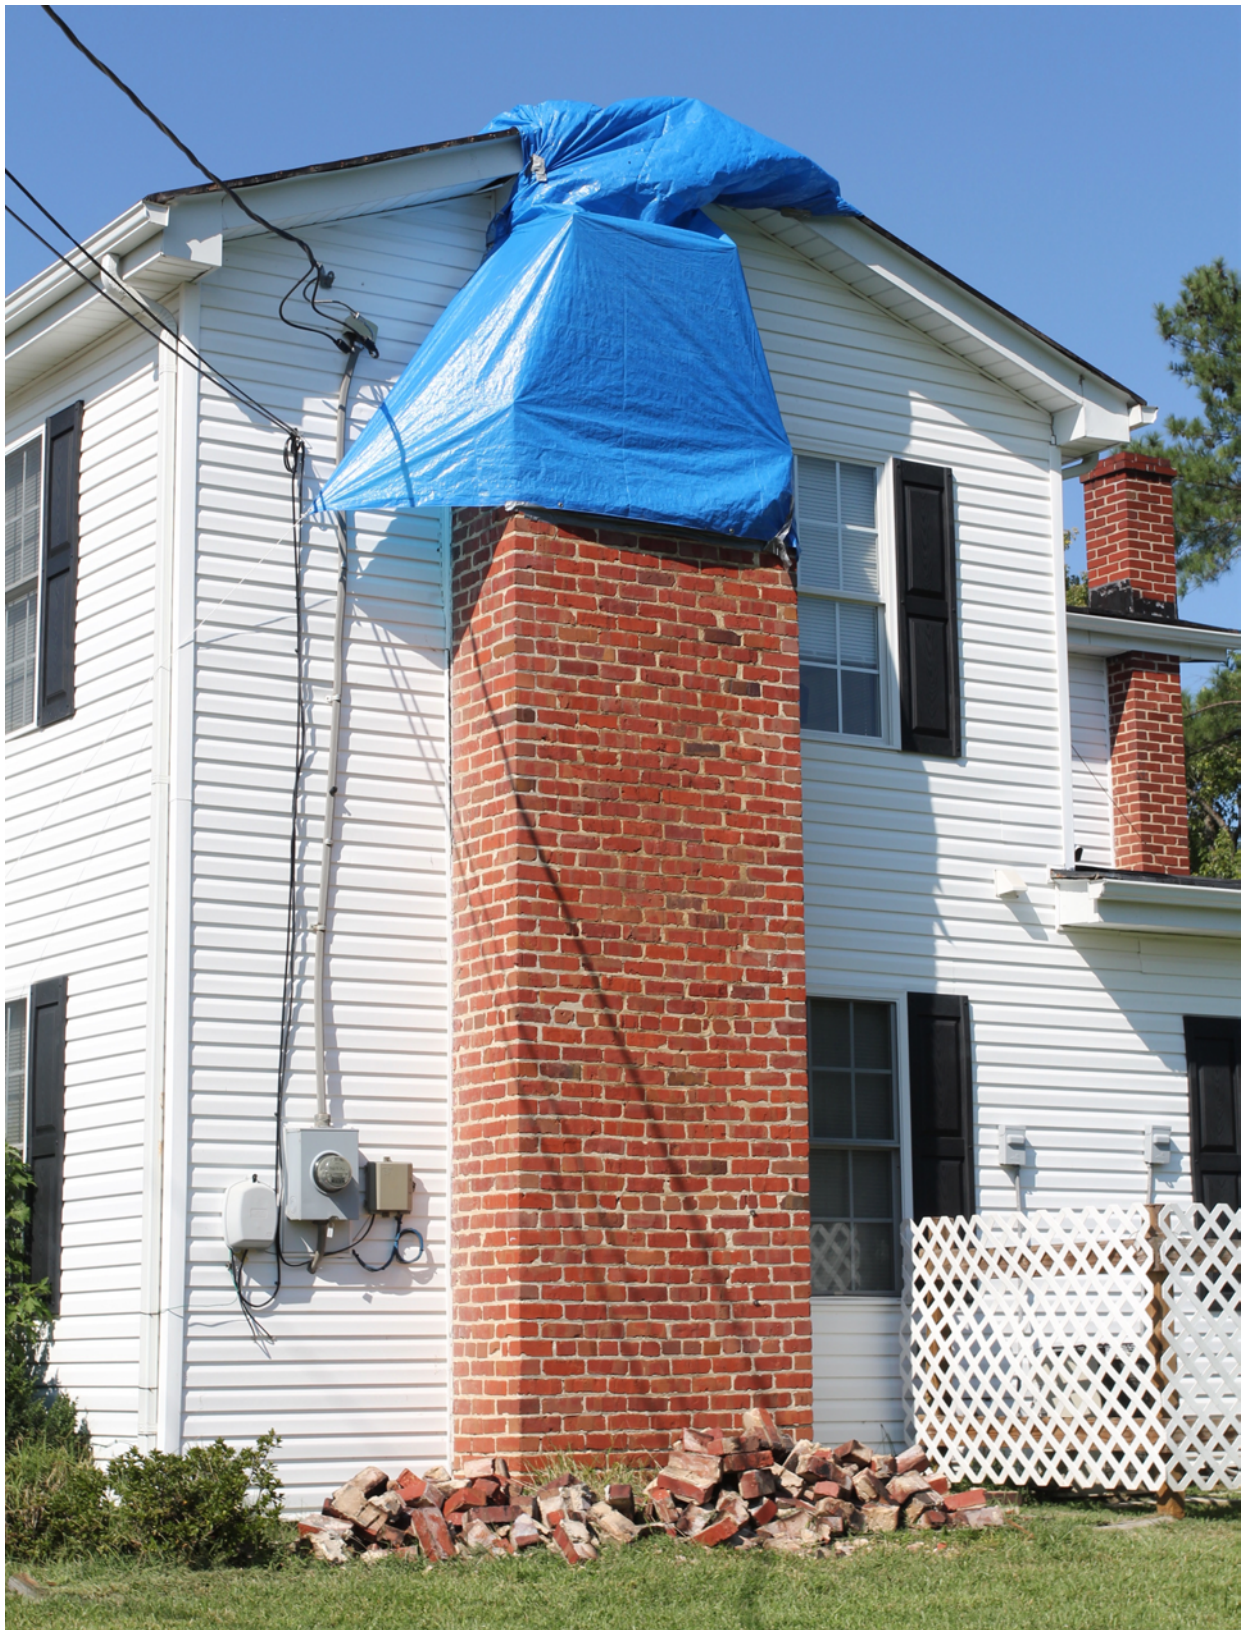
Figure 10. Photograph of broken upper chimney under blue tarp at a Mineral, Virginia, residence after the August 23, 2011, Mineral, Virginia, earthquake. Note the chimney in the right side of the background does not have any visible damage.

The earthquake damage documented by our field work is consistent with MMIs of V though VII. Close to the epicenter, the MMI was VI to VII (strong to very strong): residents reported difficulty in standing, and poorly built structures were destroyed, some chimneys collapsed, and windows and masonry walls were cracked and deformed. The most common types of damage were collapsed chimneys (figs. 10, 11, 14) a classic example of an MMI of VII.

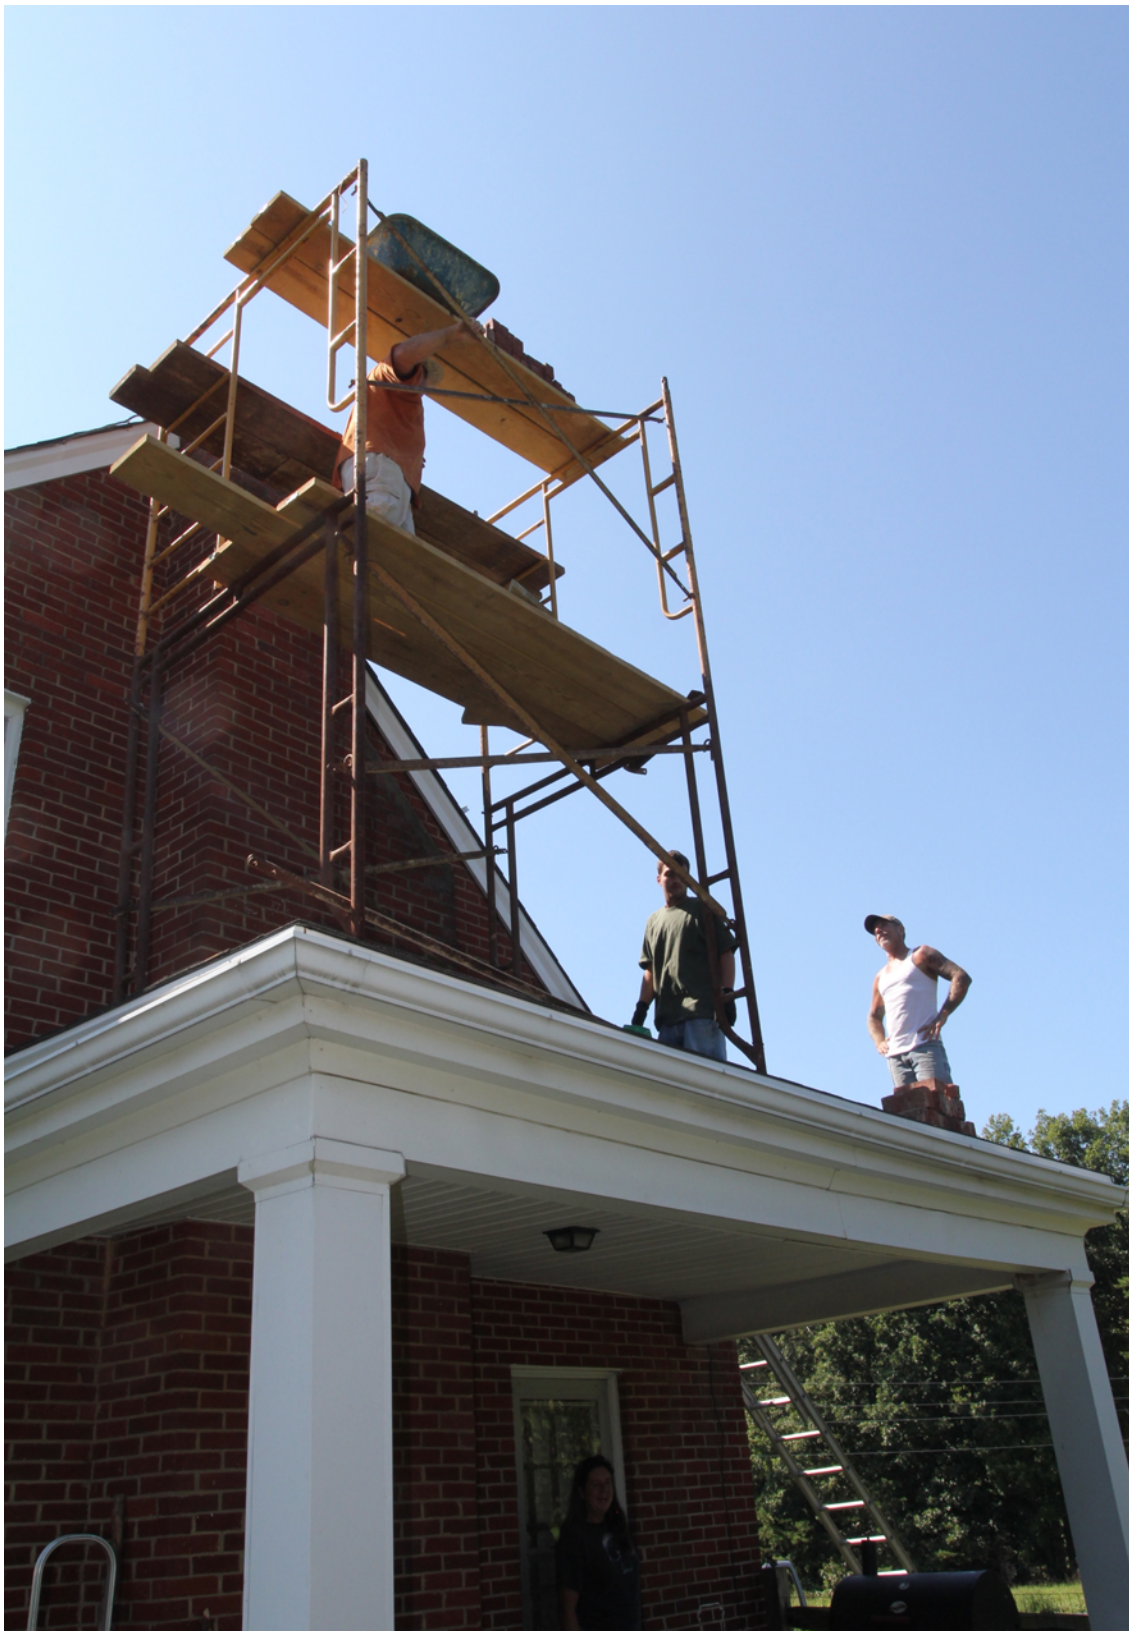
Figure 11. Photograph of chimney repairs beginning on a Mineral, Virginia, residence 7 days after the initial shock of the August 23, 2011, Mineral, Virginia, earthquake.

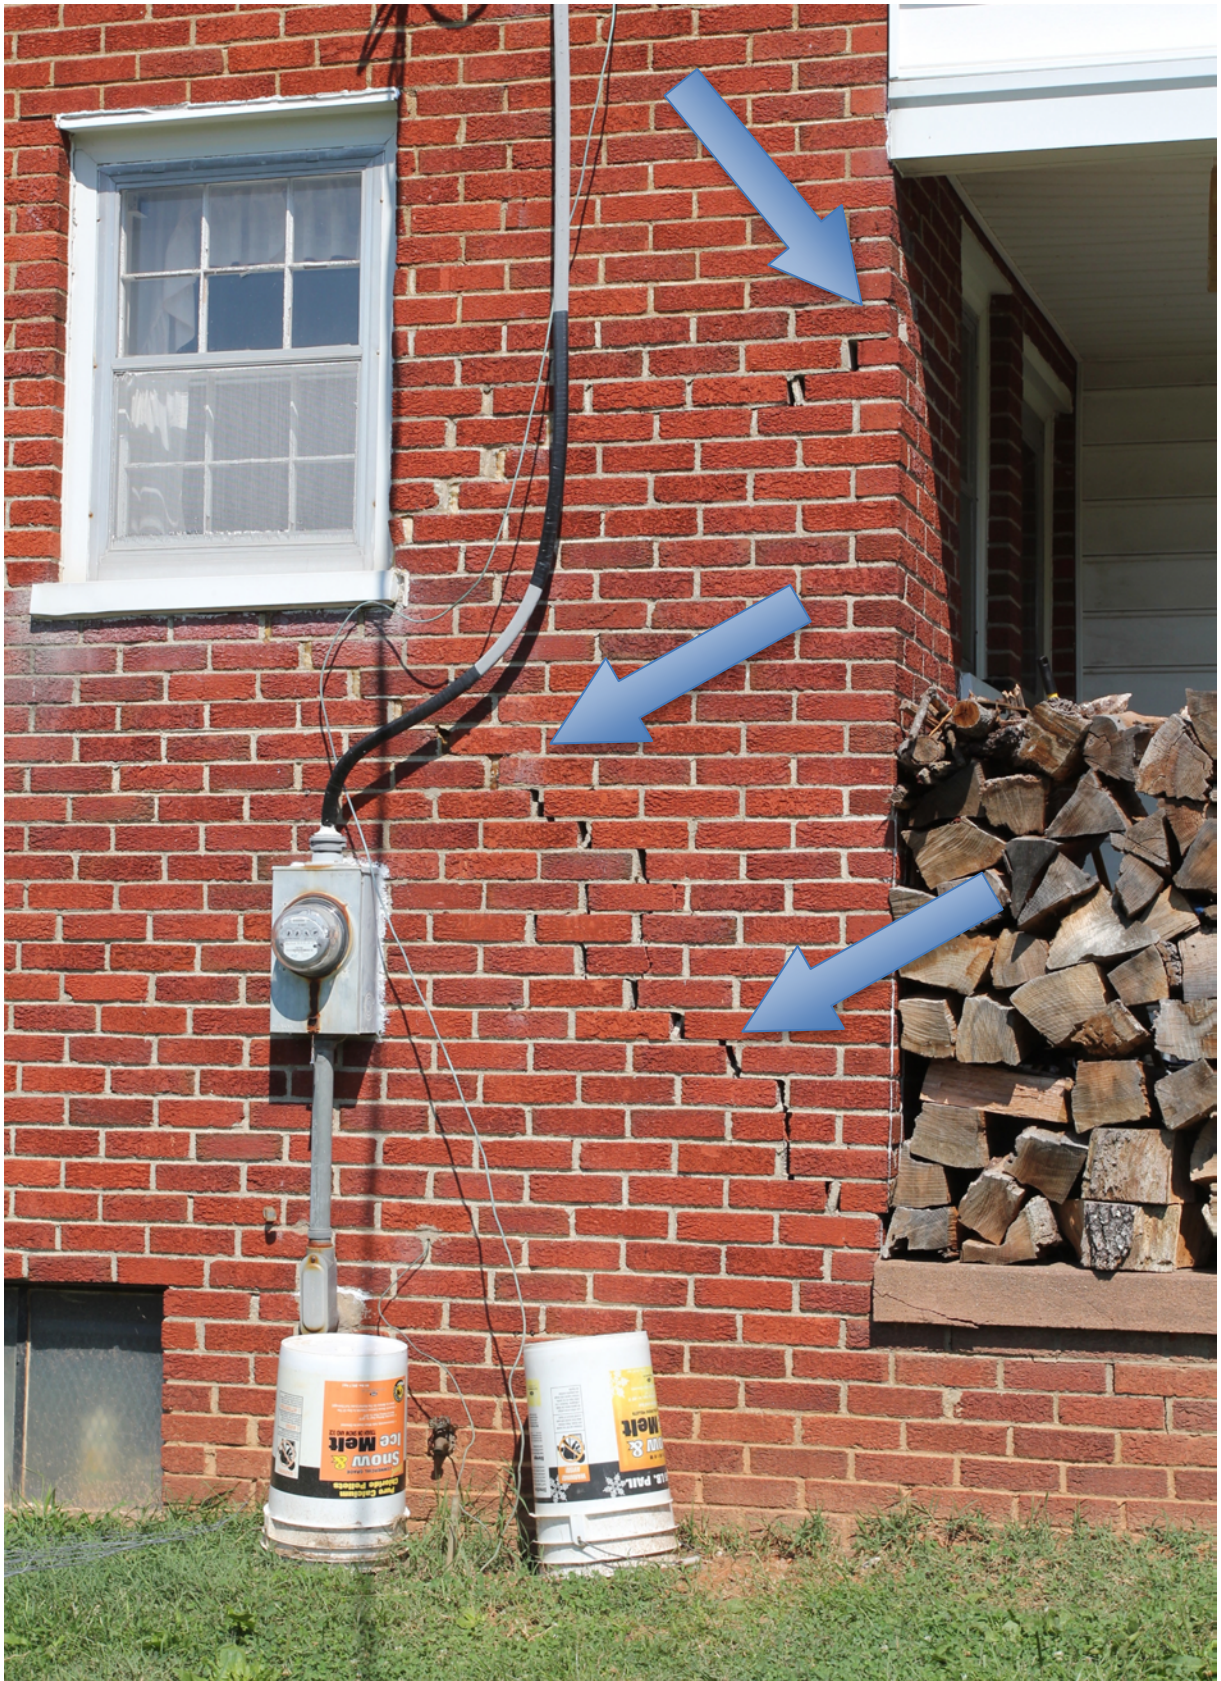
Figure 12. Photograph of a cracked brick wall at a Mineral, Virginia, residence after the August 23, 2011, Mineral, Virginia, earthquake.

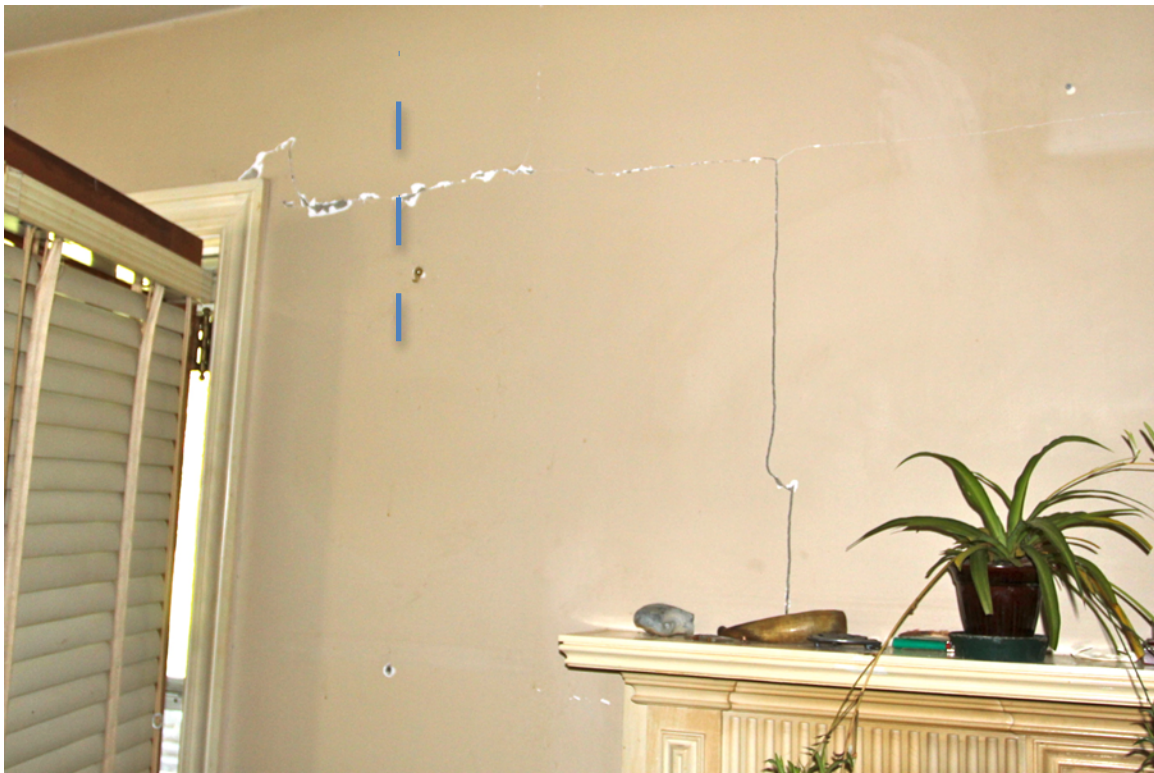
Figure 13. Photograph of cracks in the interior drywall of a Mineral, Virginia, residence after the August 23, 2011, Mineral, Virginia, earthquake. The initial shock caused the crack to extend from the corner of the doorframe to the blue dashed line. All of the cracks emanated to the right and down. Cracks to the right of the blue dashed line occurred during aftershocks. Photograph taken 8 days after initial shock.

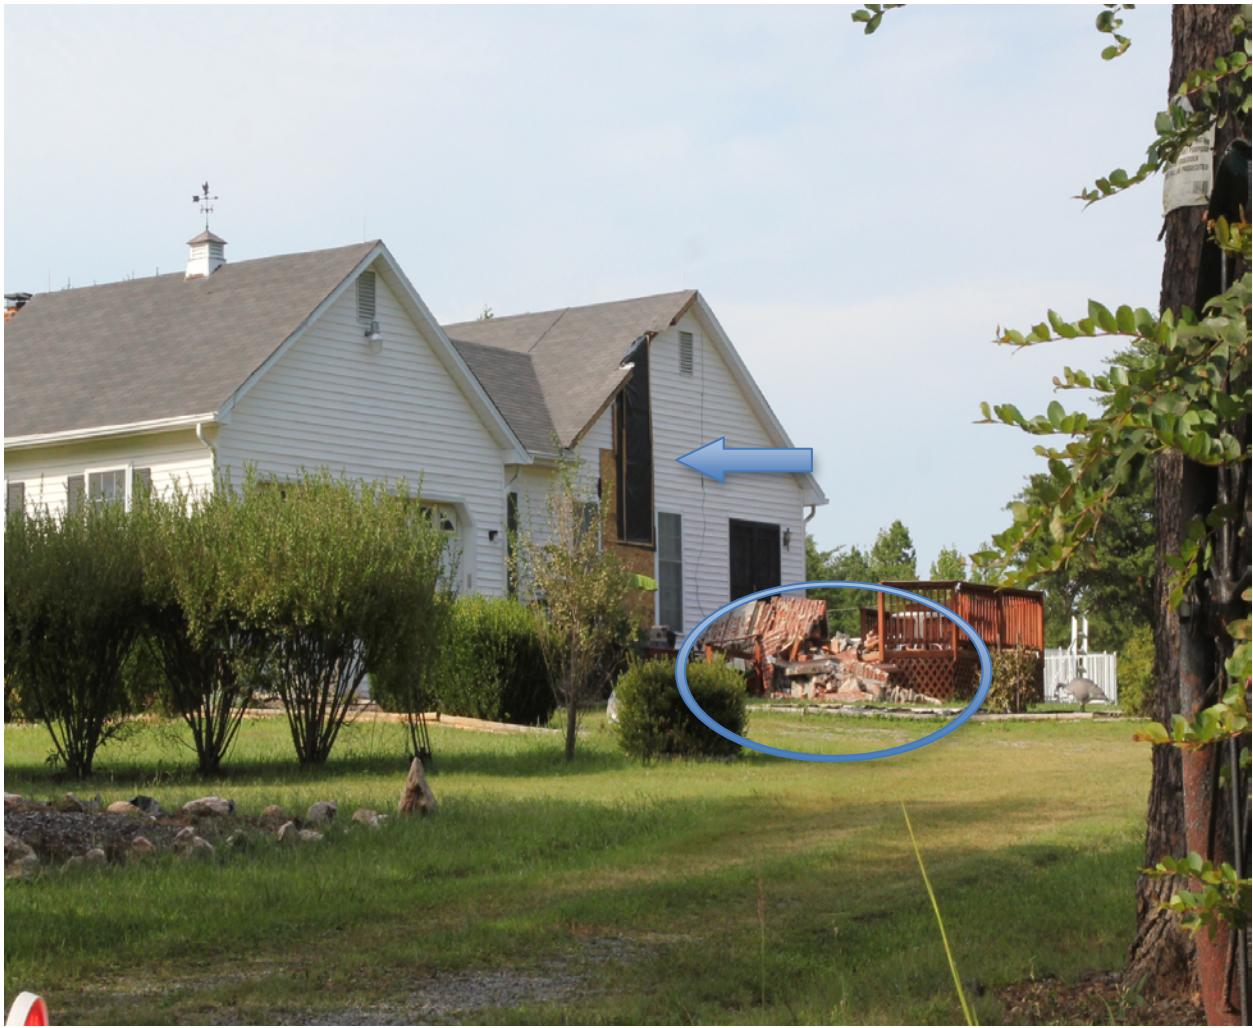
The town of Louisa, Va., also sustained considerable damage from the earthquake. Rural residences sustained most of the damage, including fallen chimneys, cracked foundations, and deformed brick walls (figs. 14-17). Approximately 60 percent of the buildings in Louisa County were significantly damaged (Louisa County Fire Department, oral commun., August 2011). Overall, the county was assigned a MMI of at least VI (strong), as illustrated by several destroyed or partially destroyed brick chimneys. Residents reported glasses, plates, books, and other items falling off shelves and heavy furniture being moved. Cracks formed in the walls of Louisa County High School, and six students sustained minor injuries there (Louisa County High School superintendent, oral commun., August 2011).

Figure 14. Photograph of a Louisa, Virginia, residence with a collapsed chimney after the August 23, 2011, Mineral, Virginia, earthquake. Arrow indicates the exposed black tarpaper on the side of this house where the chimney stood before the earthquake. The oval indicates the pile of rubble left after the chimney fell down.

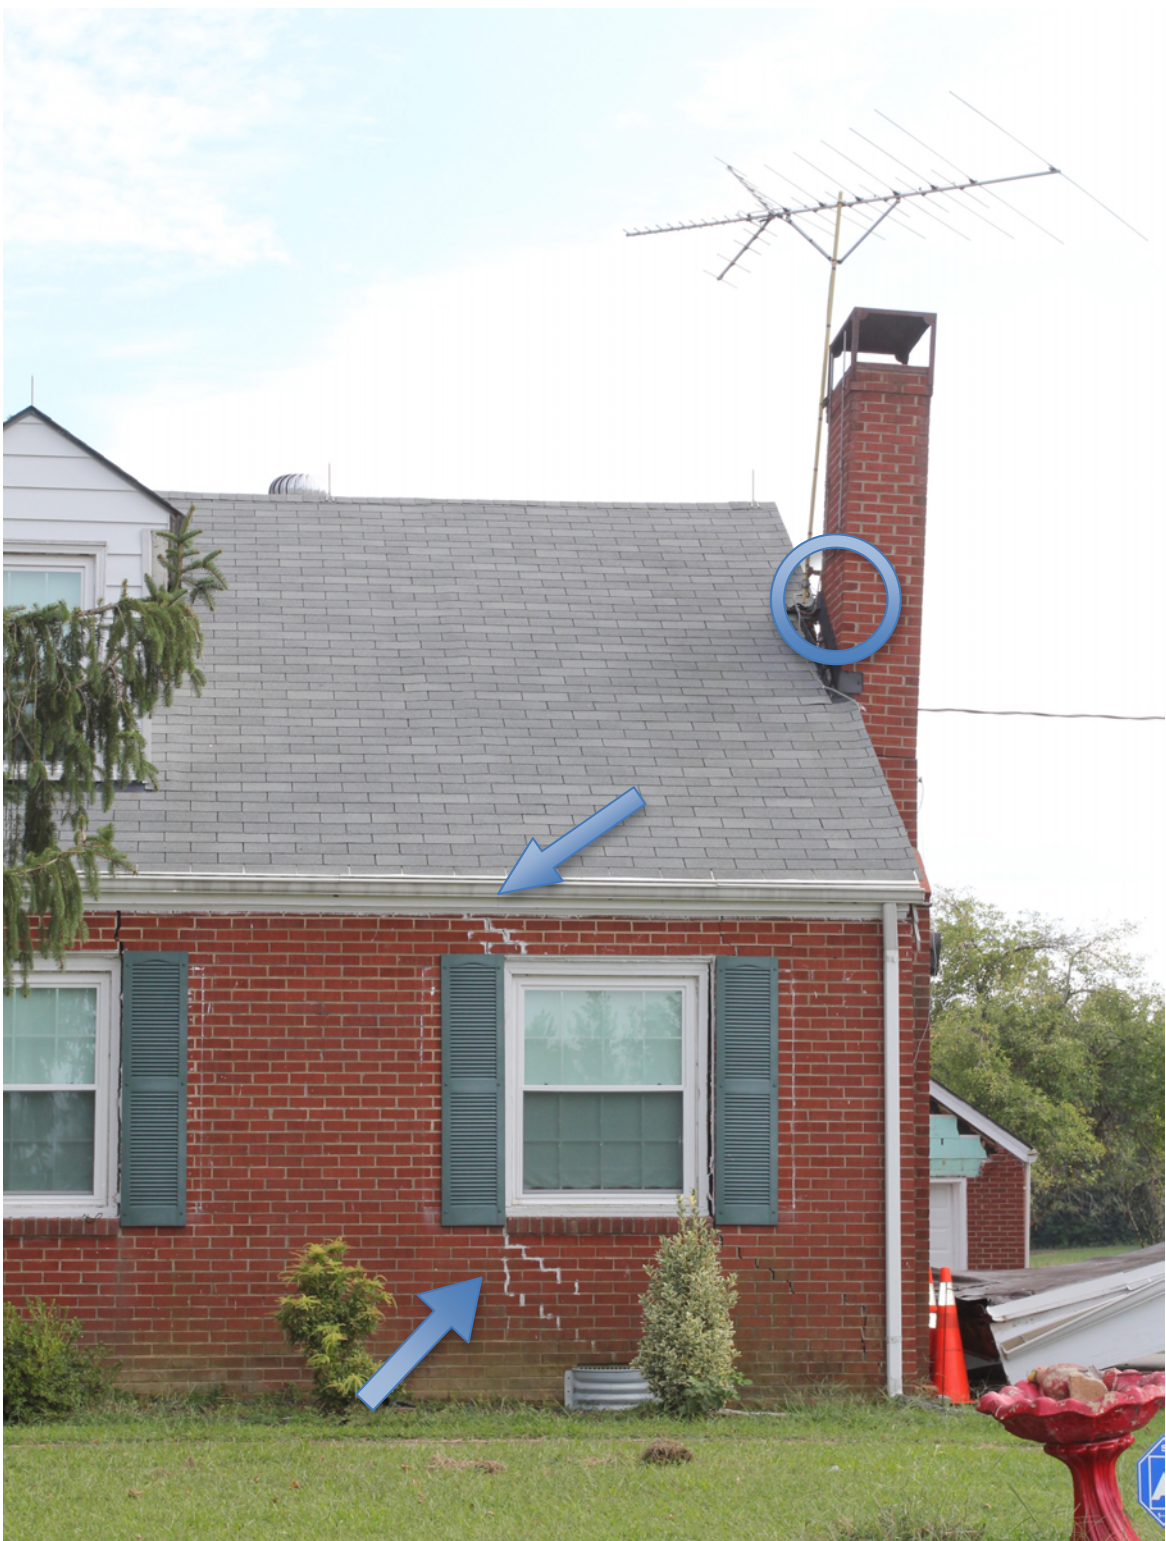
Figure 15. Photograph of a Louisa, Virginia, residence with cracked walls after the August 23, 2011, Mineral, Virginia, earthquake. Blue arrows point at the white cracks stair-stepping along the wall and circle indicates the gap from the leaning chimney; separations from the roof can be seen as the white light between roof and chimney.

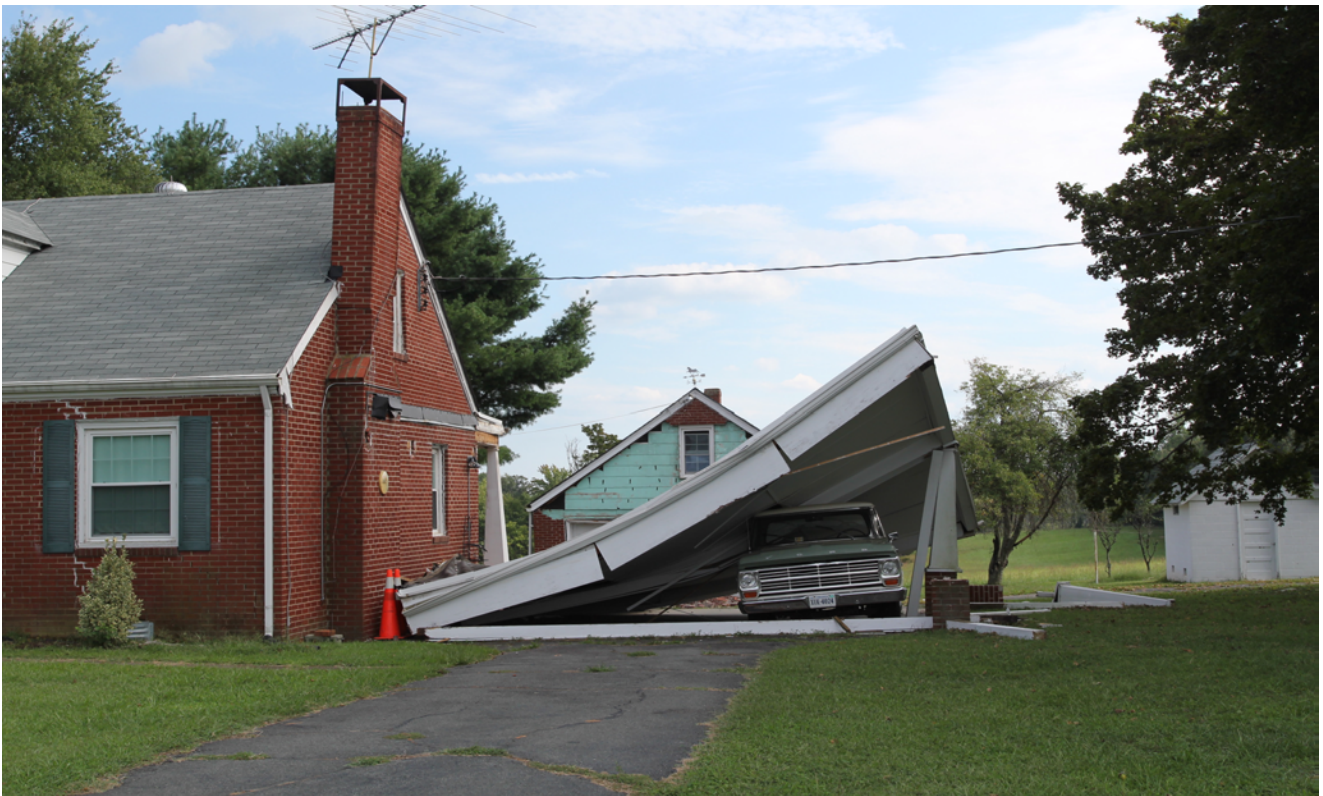
Figure 16. Photograph of the Louisa, Virginia, residence shown in figure 15. The carport shown in the image detached from the house and collapsed as a result of the August 23, 2011, Mineral, Virginia, earthquake, crushing the vehicle underneath it.

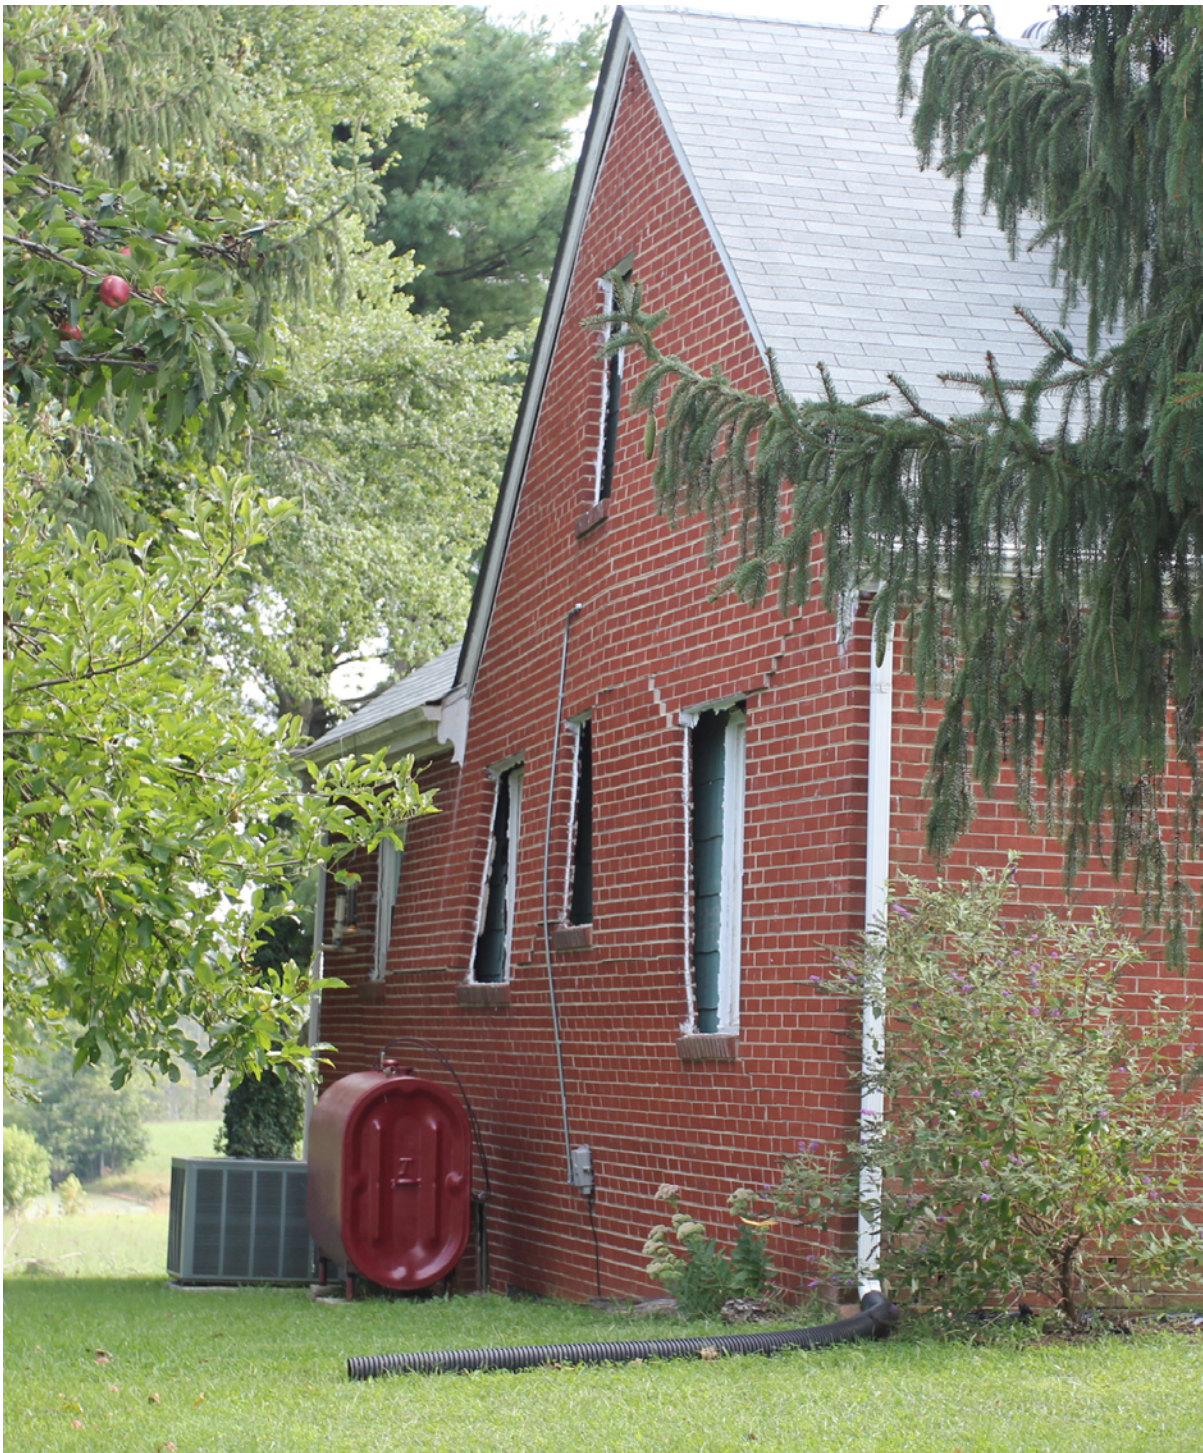
Figure 17. Photograph of a brick wall of a Louisa, Virginia, residence after the August 23, 2011, Mineral, Virginia, earthquake. The wall was damaged in the earthquake and can clearly be seen bowing away from the main structure. The wall collapsed completely a few days after this photo was taken.
