Geomorphology and Groundwater Origin of Amphitheater-Shaped Gullies at Fort Gordon, Georgia, 2010–2012

Open-File Report 2013–1230

By James E. Landmeyer and John B. Wellborn

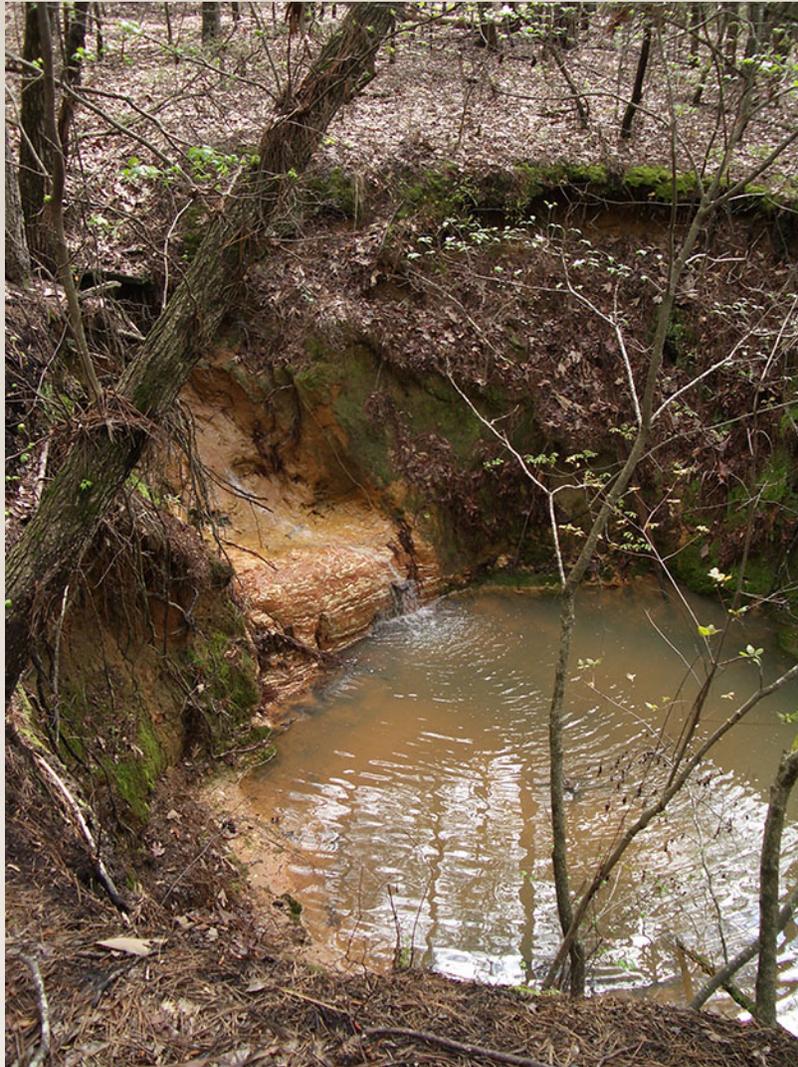
Cover. One of the seven amphitheater-shaped gullies observed at Fort Gordon caused principally by groundwater sapping. To summarize, the sandy surficial sediments and shallow water table were recharged, groundwater flowed laterally along the contact with low permeability marl (yellow-red clay in middle of photograph), and seepage occurred where this geologic contact was exposed at land surface. As seepage continued, either in response to sporadic increases in recharge or continuous, longer-term increases in recharge, sapping moved headward, induced landslides, and resulted in the amphitheater-shaped gully. Photograph by James E. Landmeyer, U.S. Geological Survey.

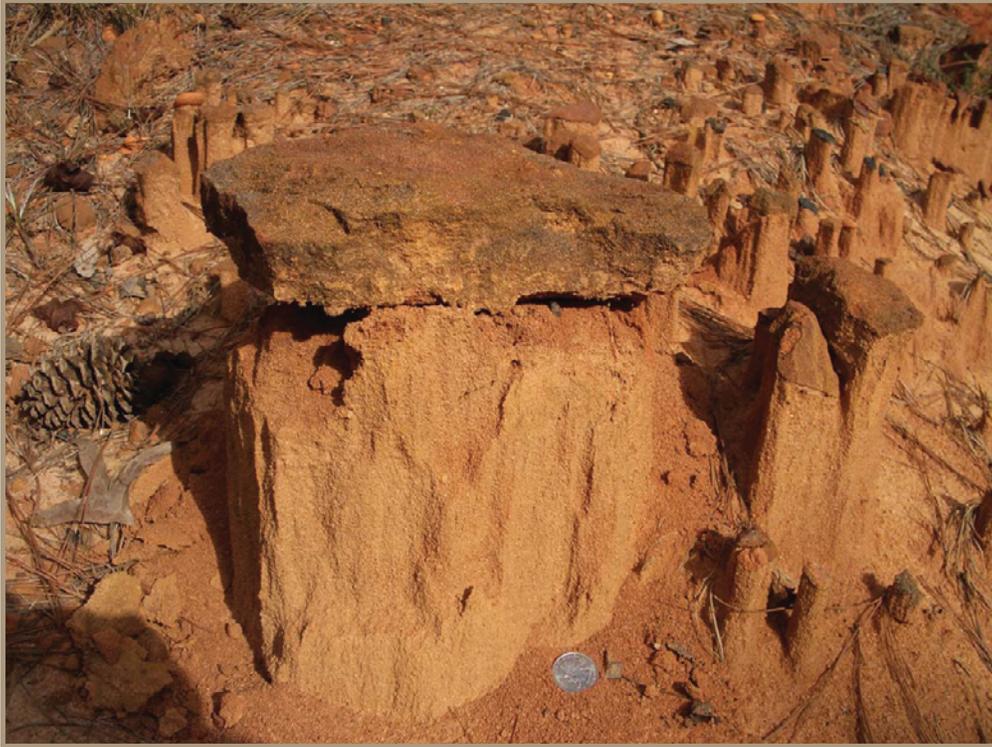
Figure 1. Erosion of surficial soil by rain-drop impact near the cantonment area, Fort Gordon, Georgia, 2012. The hardpan is held together by post-depositional iron cementation (Photograph by J.E. Landmeyer, U.S. Geological Survey, September 13, 2012. U.S. quarter shown for scale).

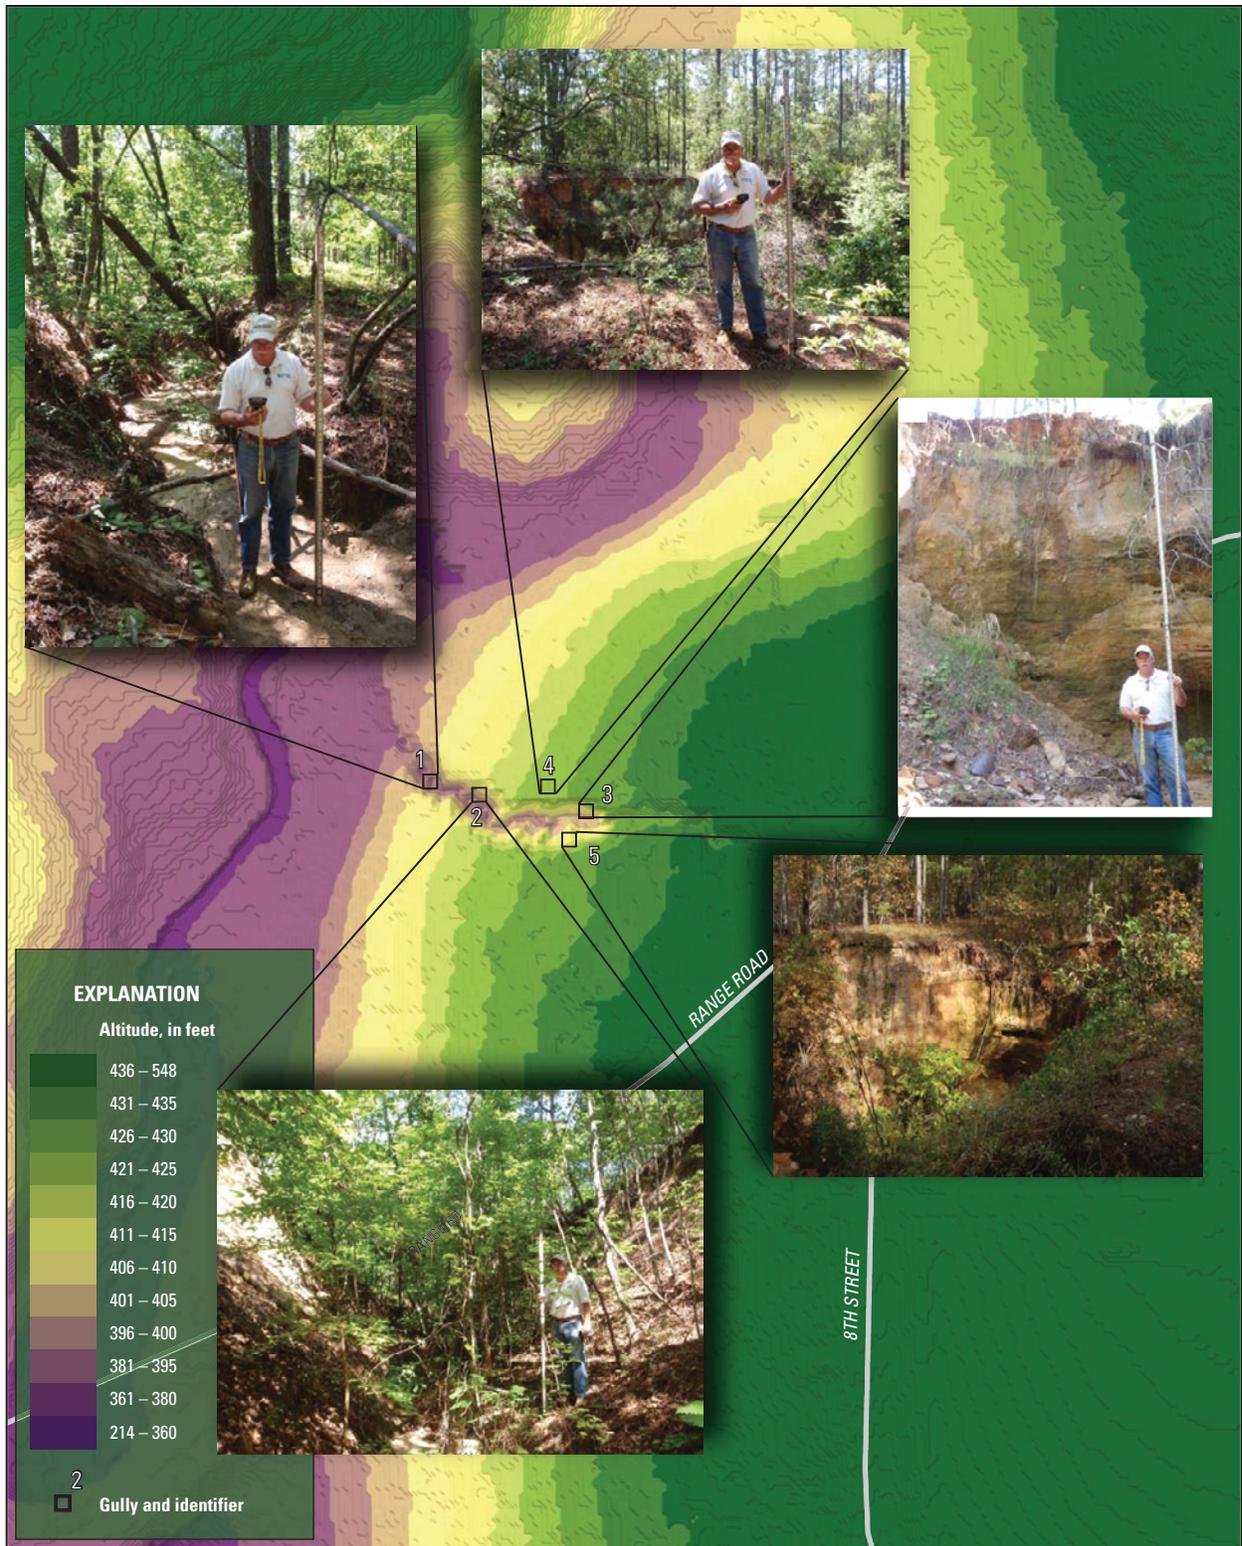
The amphitheater-shaped gully near Range Road and 8th Street (Gully 1) exhibits many of the geomorphologic characteristics that other researchers have related to headward erosion by groundwater seepage. The most prominent characteristic of the erosional feature that relates its formation to headward erosion by groundwater is the large, almost 40-ft wide, amphitheater-shaped headward scarp (fig. 7; inset images for locations 4 and 5). The amphitheater rim of 429 ft in Tobacco Road sand is in direct contrast to the vertical drop of about 26 ft, presumably through sediments of the Dry Branch Formation to the rim base (fig. 7; inset image 3, staff rod is 30 ft; table 1). The combination of the semicircular shape and steep dropoff in an area characterized by flat to gently rolling topography provides a surprise to those who encounter this feature for the first time. The altitude of the toe of Gully 1 (fig. 7; inset image 1) is 395 ft and the length of Gully 1 from rim to toe is about 222 ft (table 1). The total area of eroded material is about 160 ft² (table 1).

floor and side walls contain pine and hardwood trees over 50 years (yrs) old and a thick understory, indicating enough time has elapsed since erosion was last active to permit a mature forest to develop (fig. 7; inset image 2). Multiple slope failures (landslides, slumps) are evident from the scarp rim along the valley in the downgradient direction as the erosional feature narrows into a small square-shaped valley (fig. 7; inset image 1). In addition to the natural vegetation at the sides and base of the scarp, the feature is filled with trash and construction debris, some of which may have been added to prevent slope caving. At the downgradient part of the feature near the toe, the location of the lowest altitude is the current (2013) flood plain of an unnamed tributary to Marcum Branch. No groundwater seepage or surface-water flow was observed at Gully 1 during any time the area was visited between 2008 and 2012.

The outfall of an approximately 2-ft diameter pipe is located about 300 ft upgradient from the rim of Gully 1. The pipe conveys recent stormwater drainage from a nearby paved equipment storage lot. An approximately 10 ft deep channel, apparently dug to convey stormwater to the lowest altitude in the area, namely Gully 1, exists between the pipe outfall and the rim of Gully 1. Aerial photographs from December 1971 indicate that Gully 1 preceded the installation of the stormwater drainage, as Gully 1 is not co-located with the pipe outfall, where most erosion would be expected to occur (fig. 8), and because of the presence of trees greater than 50 yrs old. It is unlikely, therefore, that Gully 1 was caused entirely by recent surface-water flow.

Figure 7. Amphitheater-shaped gully (Gully 1) near Range Road and 8th Street, Fort Gordon, Georgia (Photographs by J.E. Landmeyer, U.S. Geological Survey).

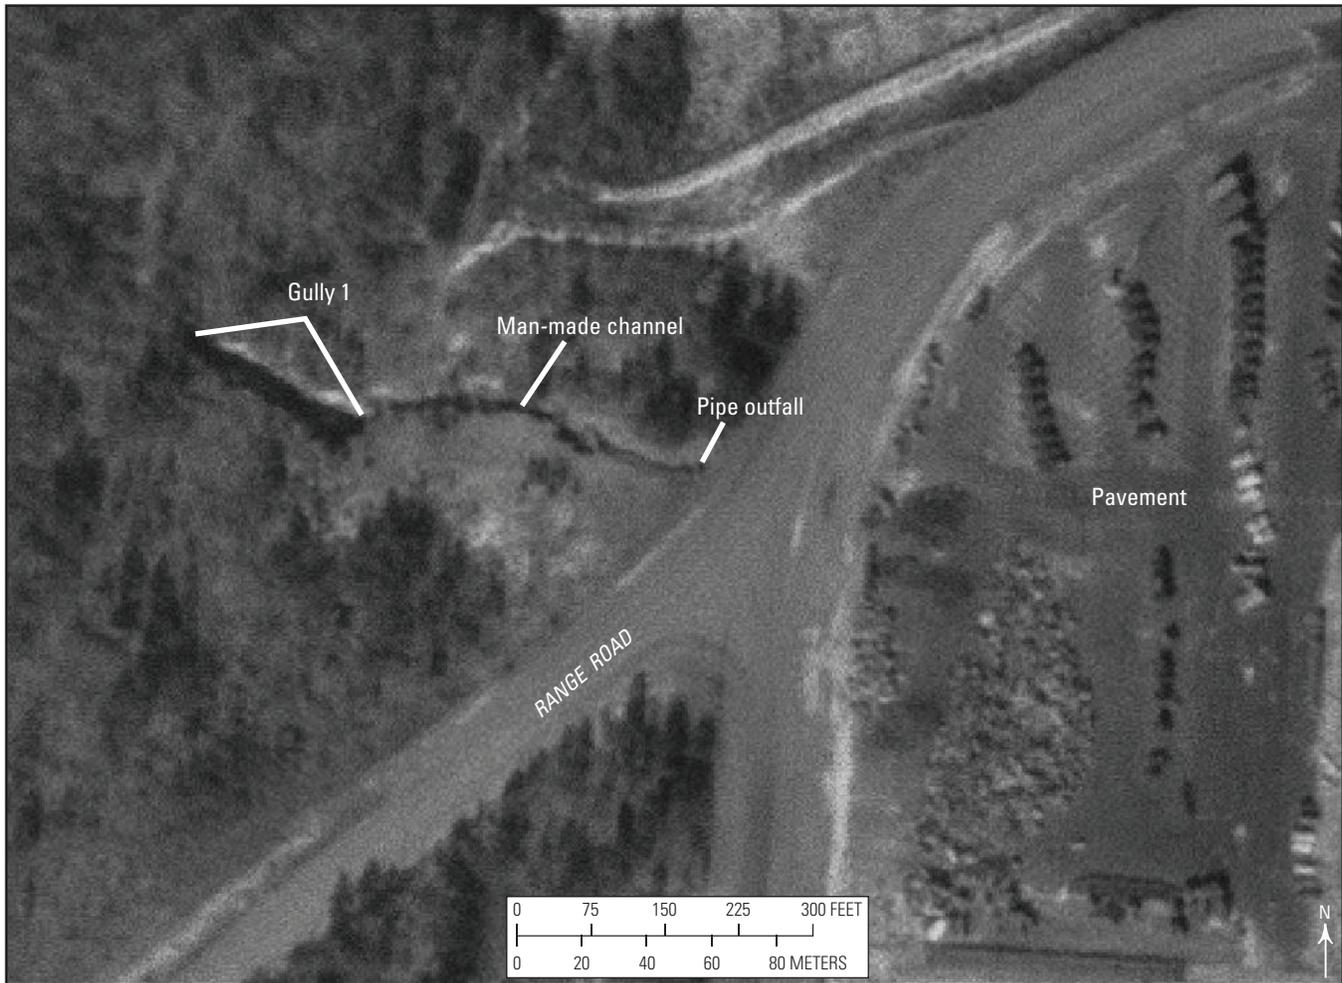
Figure 8. Aerial photograph showing the amphitheater-shaped gully (Gully 1) near Range Road and 8th Street, circa December 1971, Fort Gordon, Georgia (https://lta.cr.usgs.gov/Single_Frame_Records).

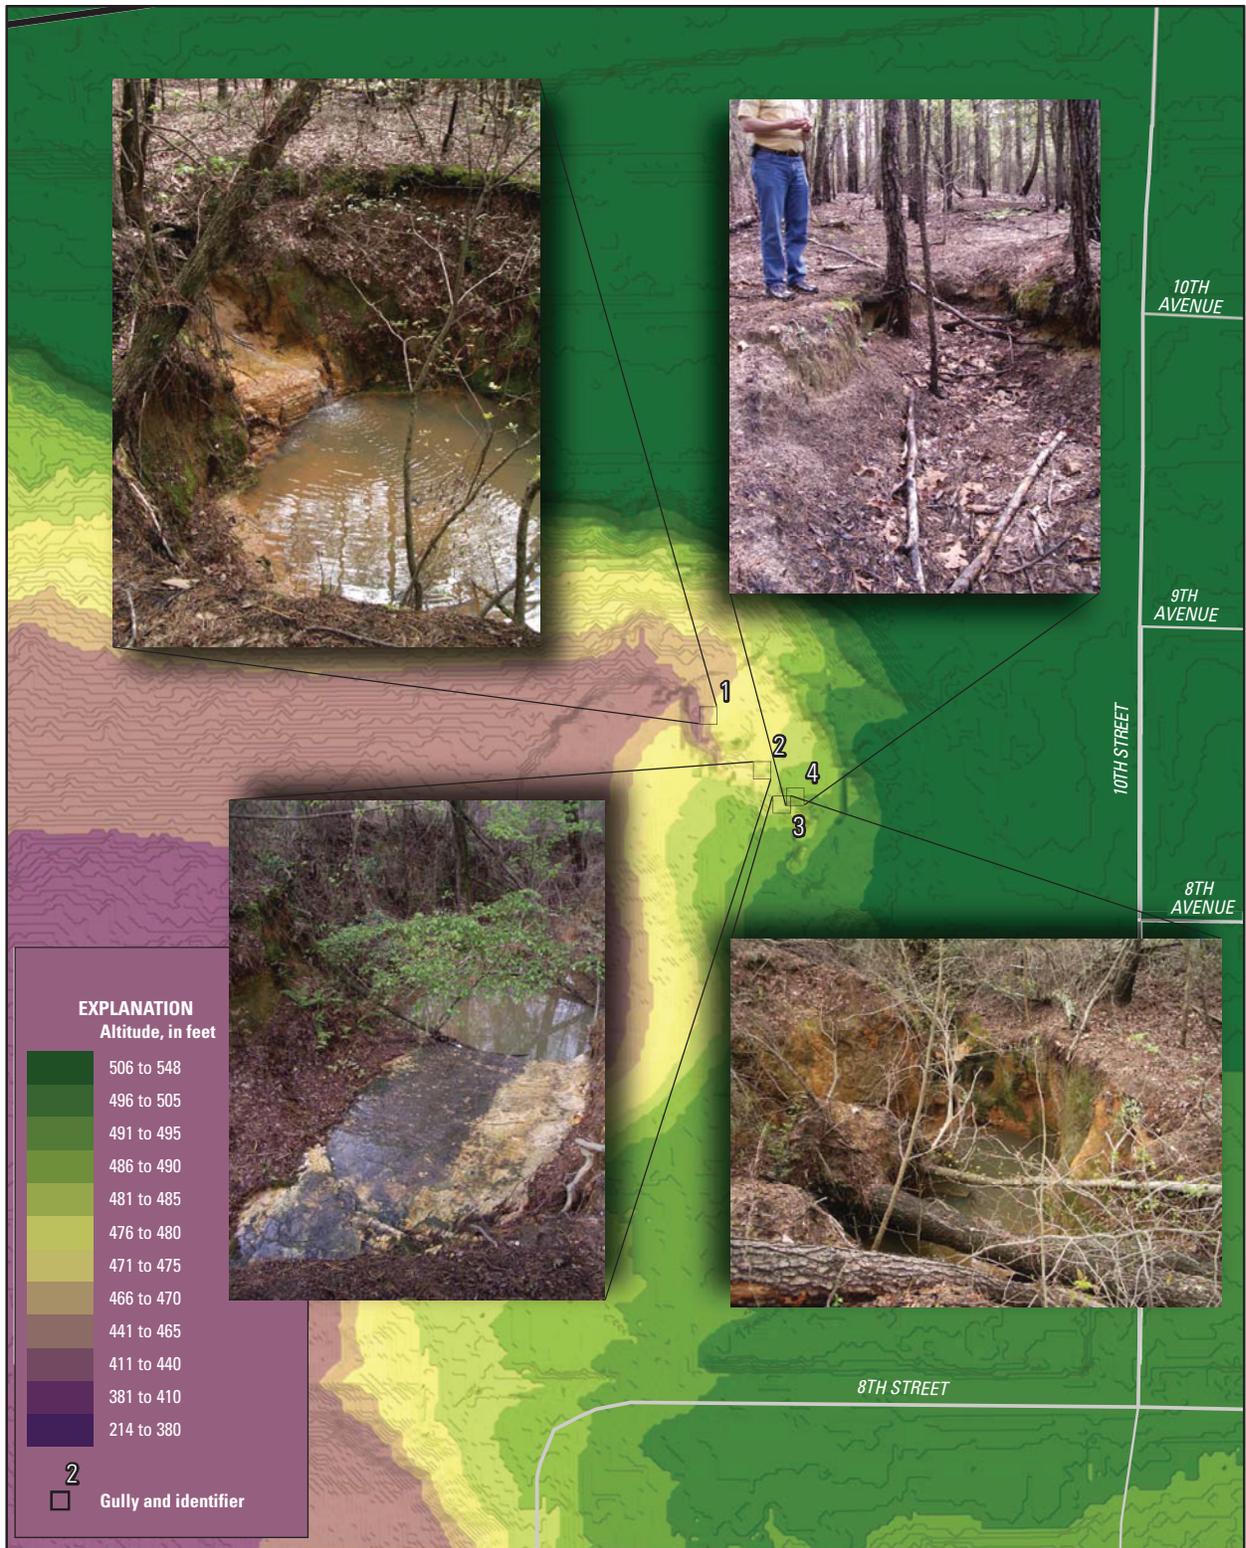
The amphitheater-shaped gullies near 9th Avenue and 10th Street (Gully 2) also exhibit many of the morphological characteristics described for Gully 1. Rather than having one large headward scarp, however, Gully 2 consists of a series of smaller semicircular-shaped scarps, roughly 20 ft wide, and vertical drop-offs of less than 10 ft (fig. 9; inset images 1, 2, and 3). For example, one amphitheater rim has an altitude of 485 ft and a vertical drop of about 10 ft through the Dry Branch Formation to the rim base (fig. 9; inset image 1; table 1). The altitude of the toe of the last amphitheater-shaped gully at Gully 2 (fig. 9; inset image 1) is 456 ft, and the length of Gully 2 from rim to this toe is about 162 ft. The total area of eroded material is about 96 ft² (table 1). Unlike Gully 1, groundwater seepage was observed at Gully 2 at the scarp that had the lowest altitude (fig. 9; inset image 1) even on days when no recent precipitation had occurred. An assessment of the biological diversity of this seep was beyond the scope of this study.

There appears to be another erosional feature at Gully 2 characterized by similar morphology as observed for the other features but smaller than and not as deep as the other features described in this report (fig. 9; inset image 4). Because this erosional feature is located at the highest altitude of all the scarps at Gully 2, the assumption is that it may represent the past location of a relic high water-table altitude for a relatively short period of time, or a past perched water table.

As was the case for Gully 1, this series of erosional features at Gully 2 also has an outfall with a 2-ft-diameter pipe located about 300 ft uphill from the uppermost erosional feature. The pipe is used to convey stormwater drainage from adjacent pavement. Between the pipe outfall and the rim of the erosional feature at the highest altitude, surface-water flow has downcut a V-shaped channel in the upper sediments. Aerial photographs from December 1971 depict the erosional features at Gully 2, although there is no evidence of stormwater drainage as it now exists (fig. 10). It is unlikely, therefore, that the amphitheater-shaped gullies observed at 9th Avenue and 10th Street were caused entirely by recent surface-water flow.

Figure 9. Amphitheater-shaped gullies (Gully 2) near 9th Avenue and 10th Street, Fort Gordon, Georgia (Photographs by J.E. Landmeyer, U.S. Geological Survey).

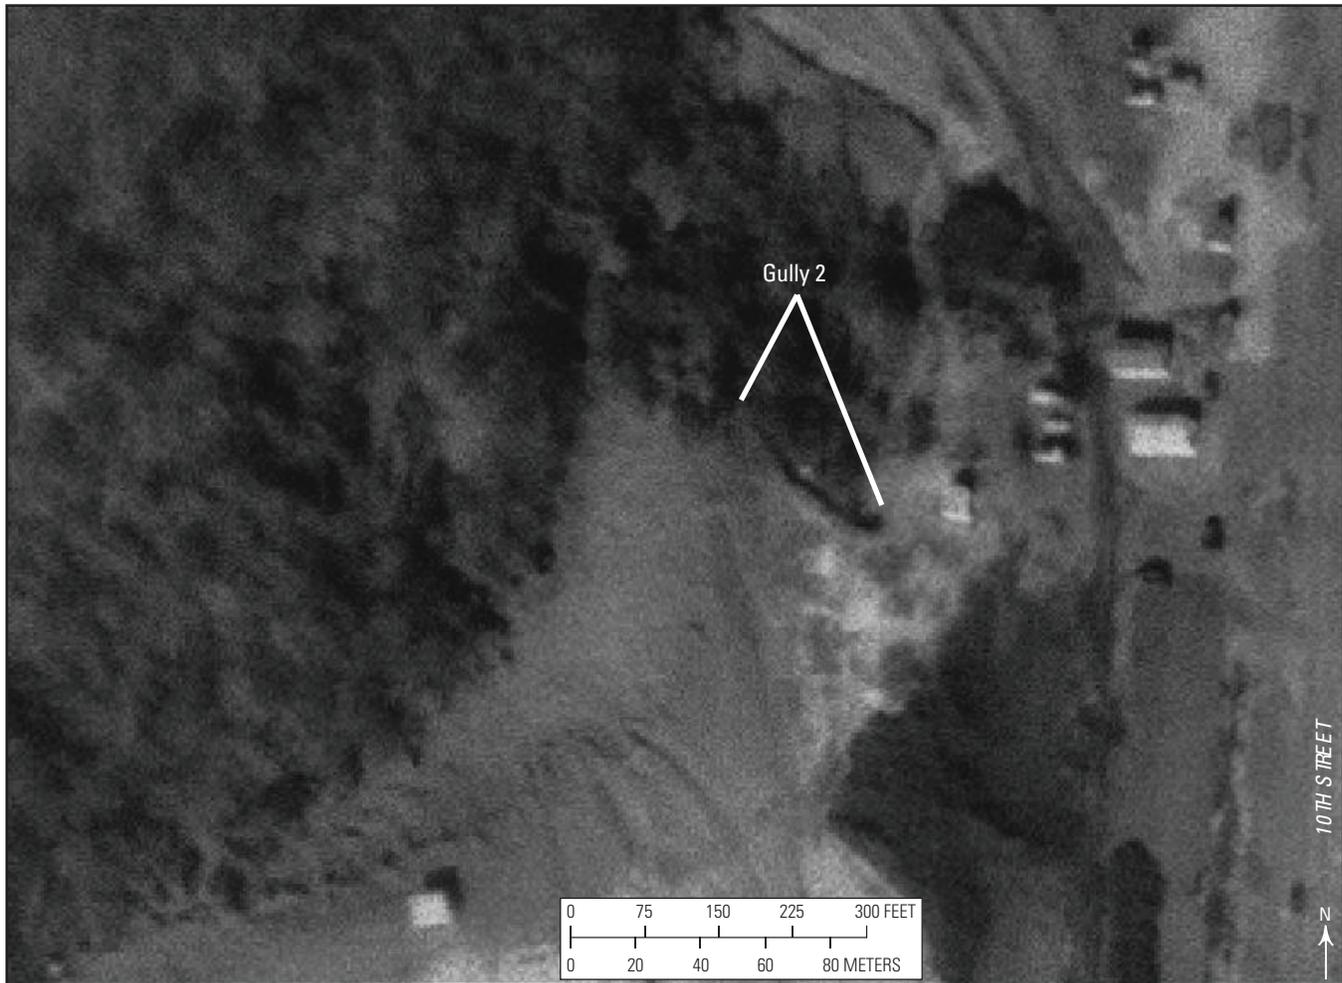
Figure 10. Aerial photograph showing the amphitheater-shaped gullies (Gully 2) near 9th Avenue and 10th Street, circa December 1971, Fort Gordon, Georgia (https://lta.cr.usgs.gov/Single_Frame_Records).

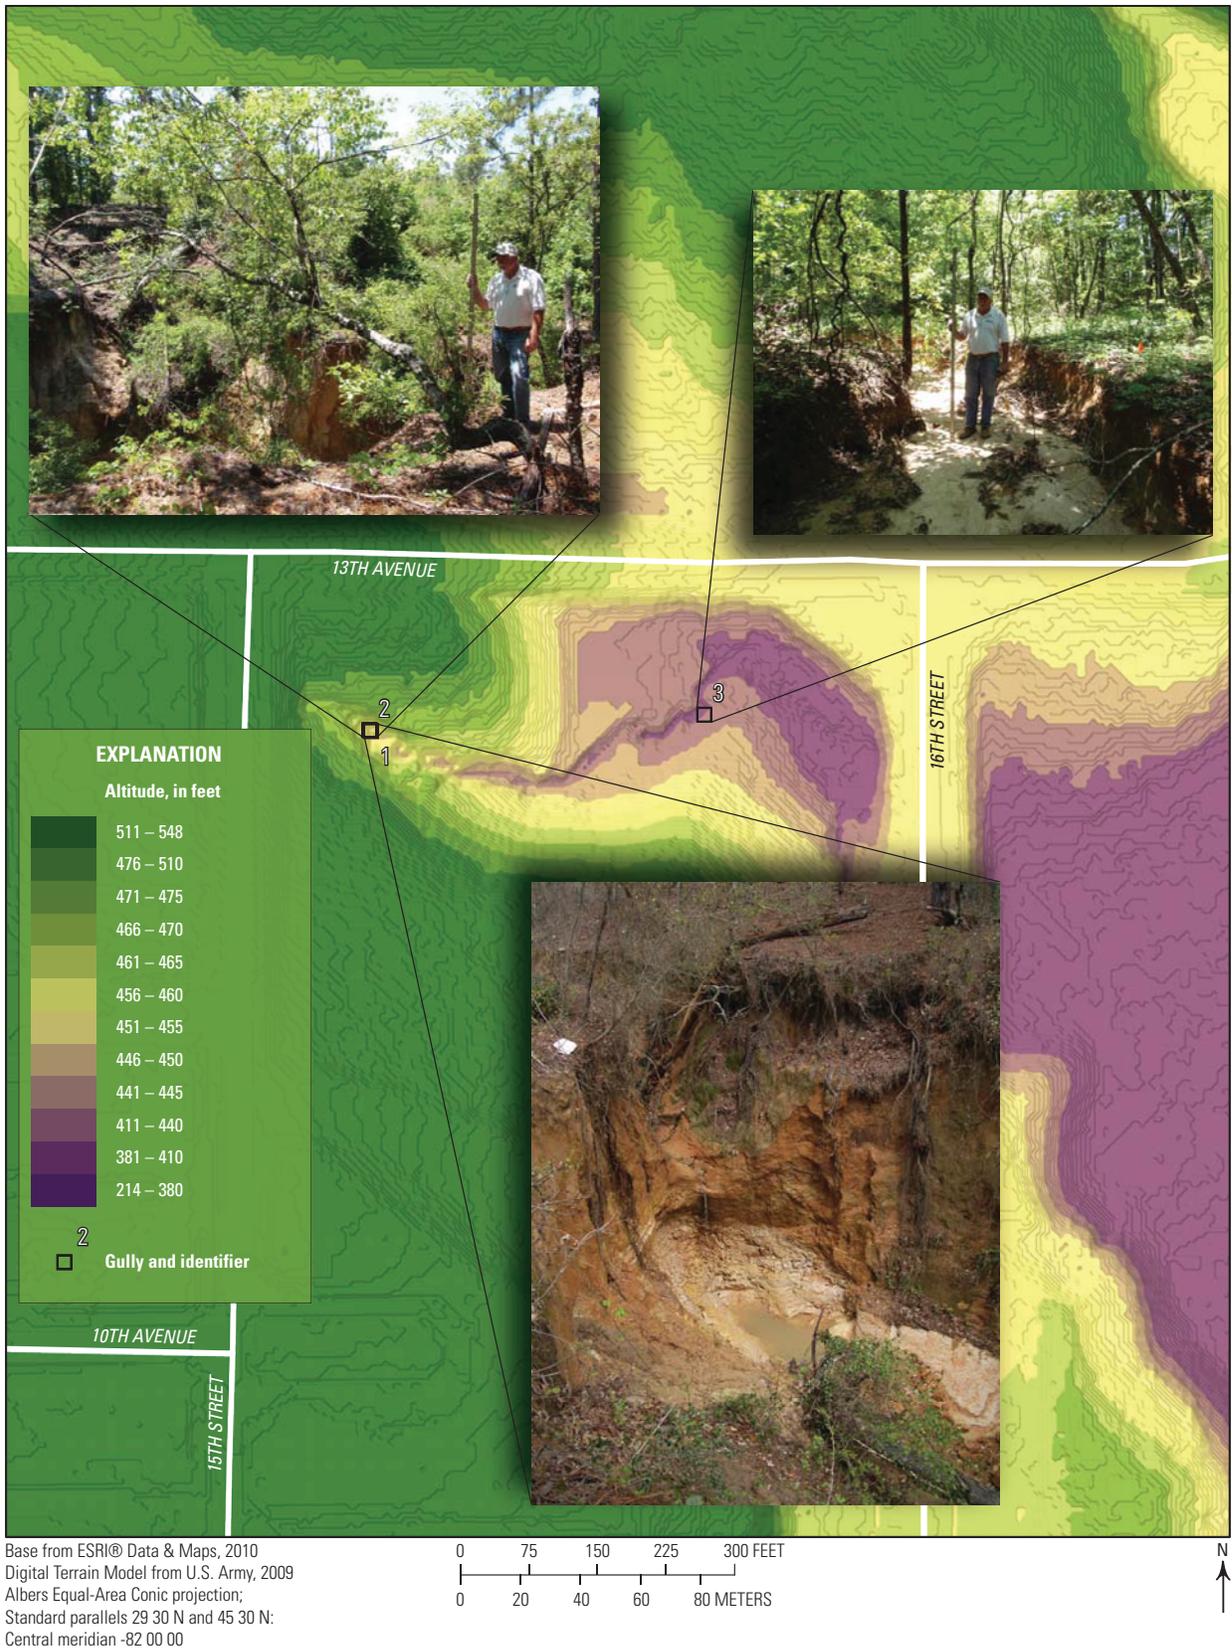
The amphitheater-shaped gully near 13th Avenue and 15th Street (Gully 3) exhibits many of the morphological characteristics already described for Gullies 1 and 2. The most prominent characteristic of the erosional feature that relates its formation to headward erosion by groundwater is the 20-ft-wide, amphitheater-shaped head scarp (fig. 11; inset images 1 and 2). The altitude of the amphitheater rim of 460 ft is in direct contrast to the vertical drop of about 10 ft to the rim base; here, the Dry Branch Formation may be absent with the Tobacco Road unconformably overlying the Upper Cretaceous Galliard Formation (fig. 11; table 1). The altitude of the toe at Gully 3 is 438 ft (fig. 11; inset image 3), and the length of Gully 3 from rim to toe is about 424 ft (table 1). The feature does not terminate at a surface-water body. The total area of eroded material is about 148 ft² (table 1). Groundwater seepage or surface-water flows were not observed at Gully 3 any time between 2008 and 2012. No evidence of a past stormwater drainage system was detected at this location (fig. 12).

Figure 11. Amphitheater-shaped gully (Gully 3) near 13th Avenue and 15th Street, Fort Gordon, Georgia (Photographs by J.E. Landmeyer, U.S. Geological Survey).

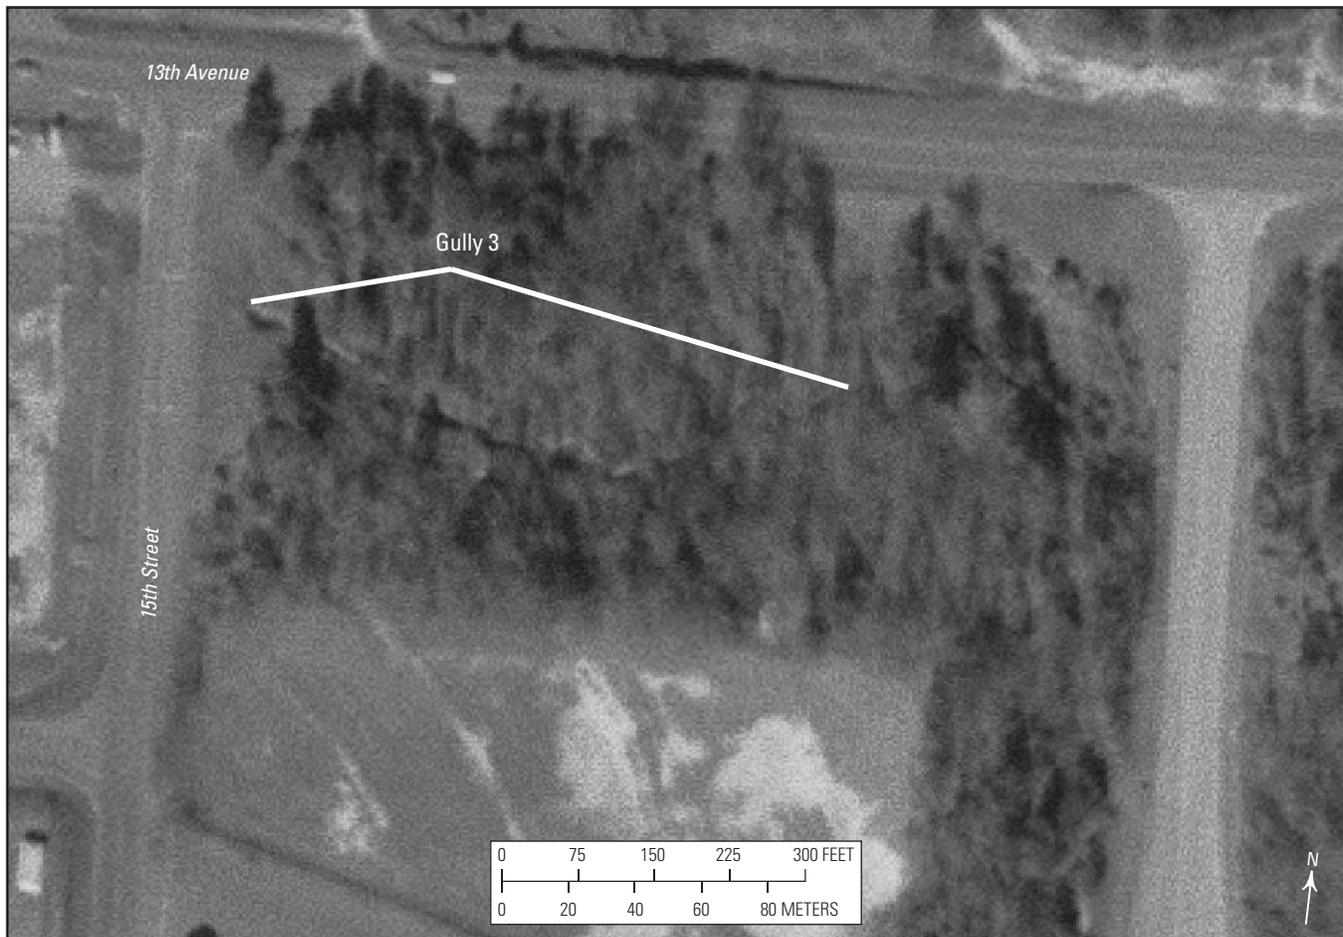
Figure 12. Aerial photograph showing the amphitheater-shaped gully (Gully 3) near 13th Avenue and 15th Street, circa December 1971, Fort Gordon, Georgia (https://lta.cr.usgs.gov/Single_Frame_Records).

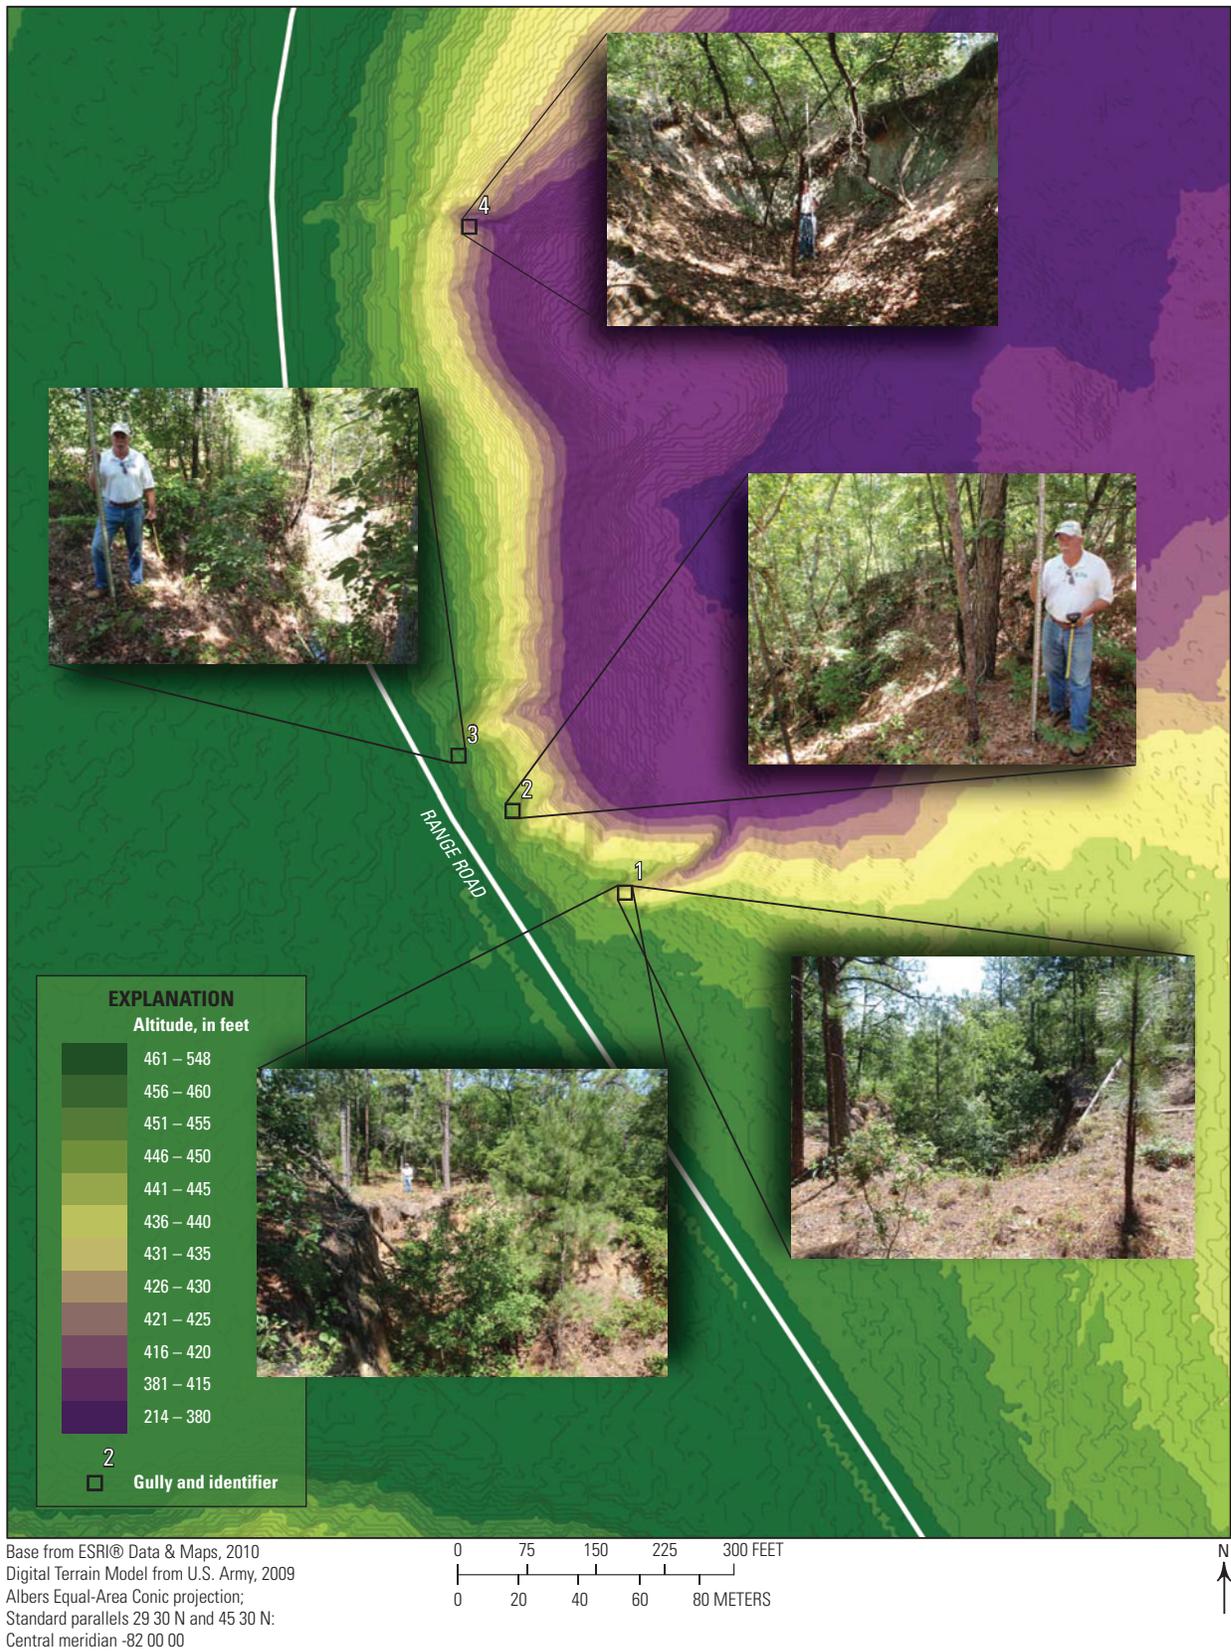
The amphitheater-shaped gullies near Range Road and North Range Road include at least four gullies (Gullies 4–7). The most prominent characteristic of each of the four erosional features that relates its formation to headward erosion by groundwater is a large, about 40-ft-wide, amphitheater-shaped head scarp (fig. 13; inset images 1, 2, 3, and 4). The altitude of each amphitheater rim of 454, 453, 461, and 437 ft, is in direct contrast to the vertical drop of about 24, 18, 26, and 34 ft, respectively, through the Tobacco Road Formation, to each rim base (fig. 13; table 1). The altitude of the toe of Gullies 4, 5, 6, and 7 is 402, 394, 399, and 388 ft, respectively, and the length of each feature from rim to toe is about 222, 207, 148, and 190 ft, respectively. The total area of eroded material at Gullies 4, 5, 6, and 7 is about 249, 191, 263, and 272 ft², respectively (table 1). Groundwater seepage or surface-water flows were not observed at any of these erosional features any time between 2008 and 2012. Unlike Gullies 1 and 2, stormwater pipes were not located at any of these features (fig. 14).

Figure 13. Amphitheater-shaped gullies (Gullies 4–7) near Range Road and North Range Road, Fort Gordon, Georgia (Photographs by J.E. Landmeyer, U.S. Geological Survey).

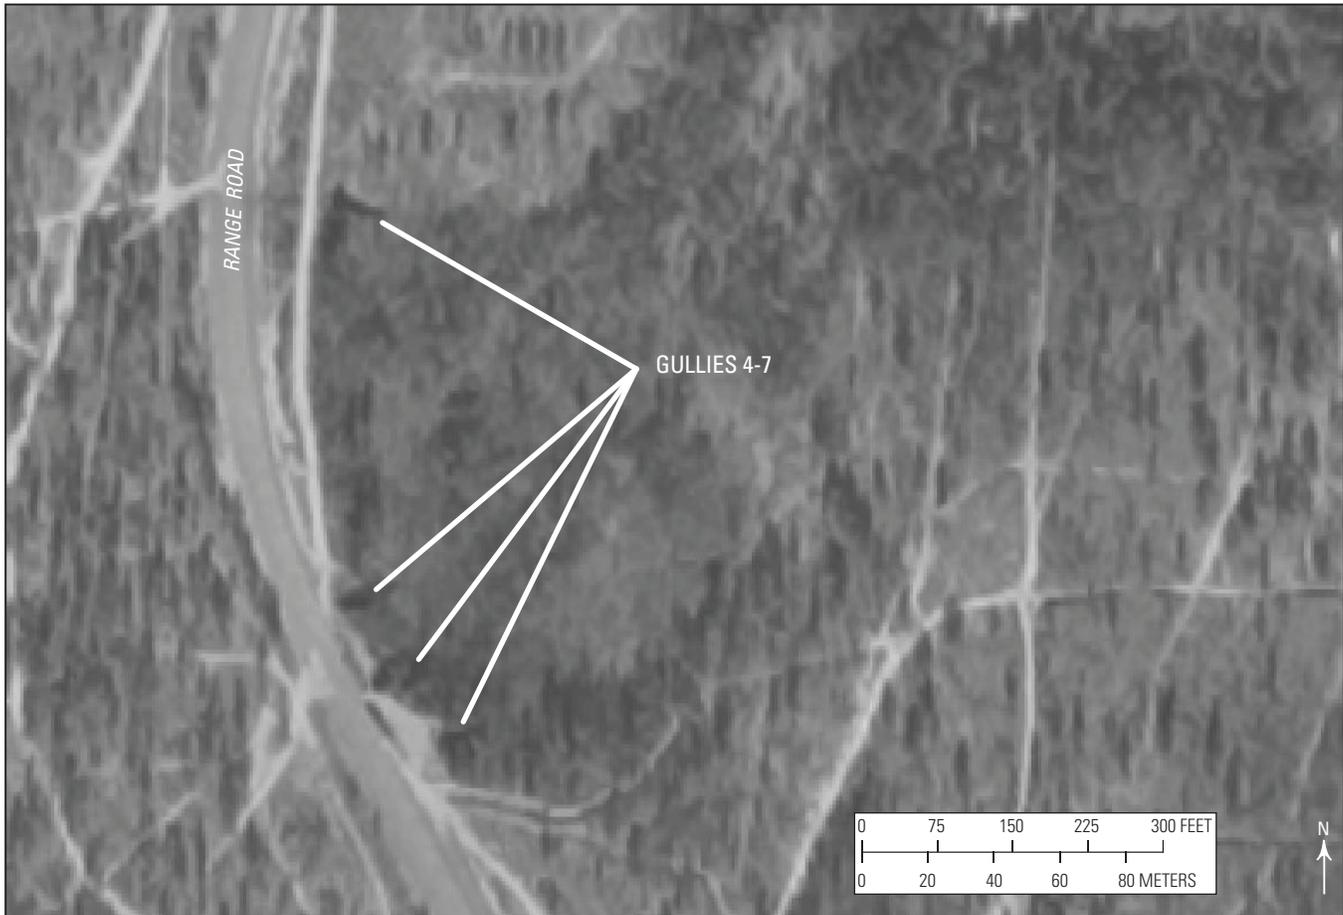
Figure 14. Aerial photograph showing the amphitheater-shaped gullies (Gullies 4–7) near Range Road and North Range Road, circa December 1971, Fort Gordon, Georgia (https://lta.cr.usgs.gov/Single_Frame_Records).
