The Alaska Earthquake

Effects of the Earthquake
Of March 27, 1964
On the Communities of
Kodiak and Nearby Islands

By REUBEN KACHADOORIAN and GEORGE PLAFKER

GEOLOGICAL SURVEY PROFESSIONAL PAPER 542-F

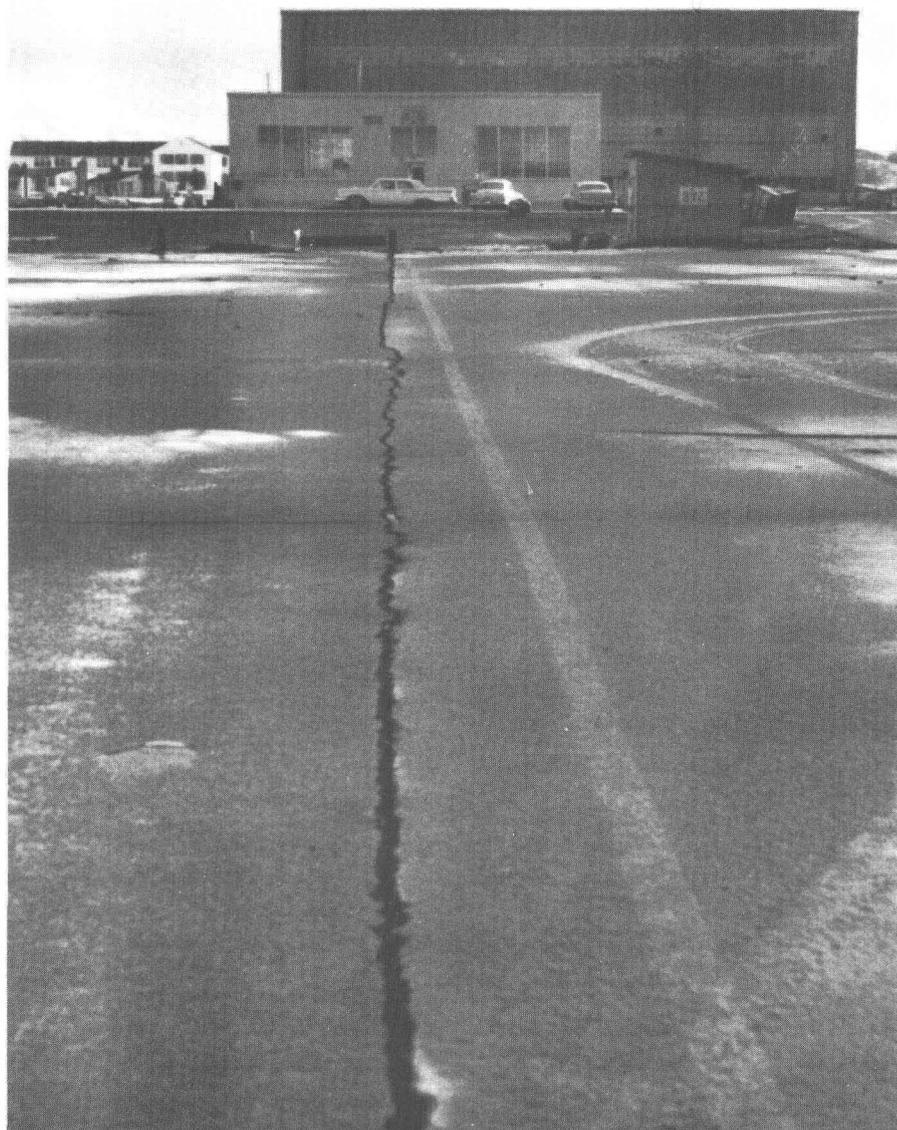
3.—East-west-trending fissure in aircraft parking ramp at Kodiak Naval Station. View is west. Photograph by U.S. Navy, March 29, 1964.

One of the effects of the earthquake was the development of fissures in the low-lying areas underlain by unconsolidated sediments and artificial fill. Fissuring occurred in the asphalt of the aircraft parking ramps at the head of Womens Bay (fig. 3) and along the highways throughout the station. Figure 3 shows a long east-west-trending fissure. The surface ex-

pression of the fissure may in part be controlled by the type of construction that was employed when the asphalt was placed and may actually represent a construction joint. The fissures developed only in areas where more than 5 feet of unconsolidated deposits or fill overlay the bedrock. In at least one locality, at the aircraft parking ramps, fissures developed primarily as a result of seismic shaking that caused some lateral extension or displacement of the unconsolidated deposits and artificial fill toward a free face. The sediments underlying the parking

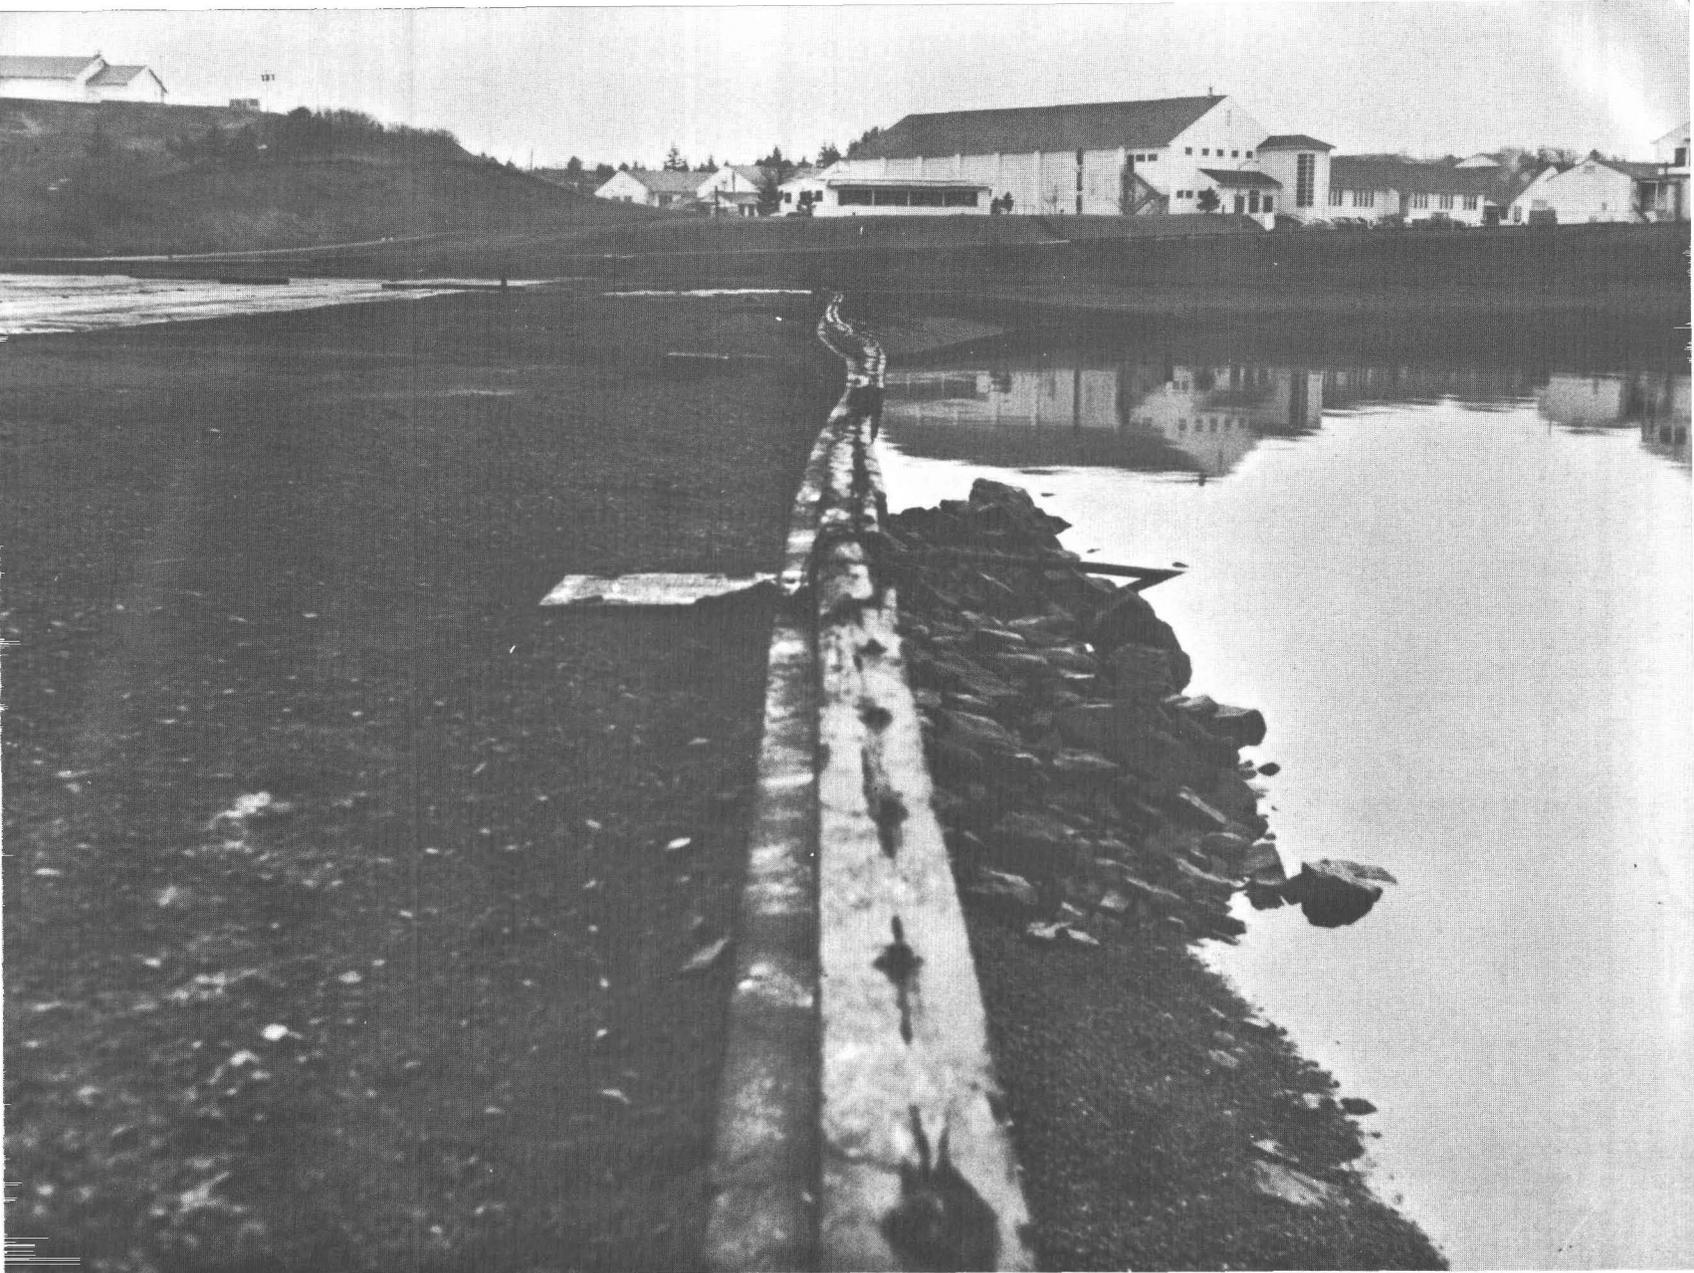
4.—Displacement of seawall toward Womens Bay, Kodiak Naval Station. View is east. Photograph by U.S. Navy, April 1, 1964.

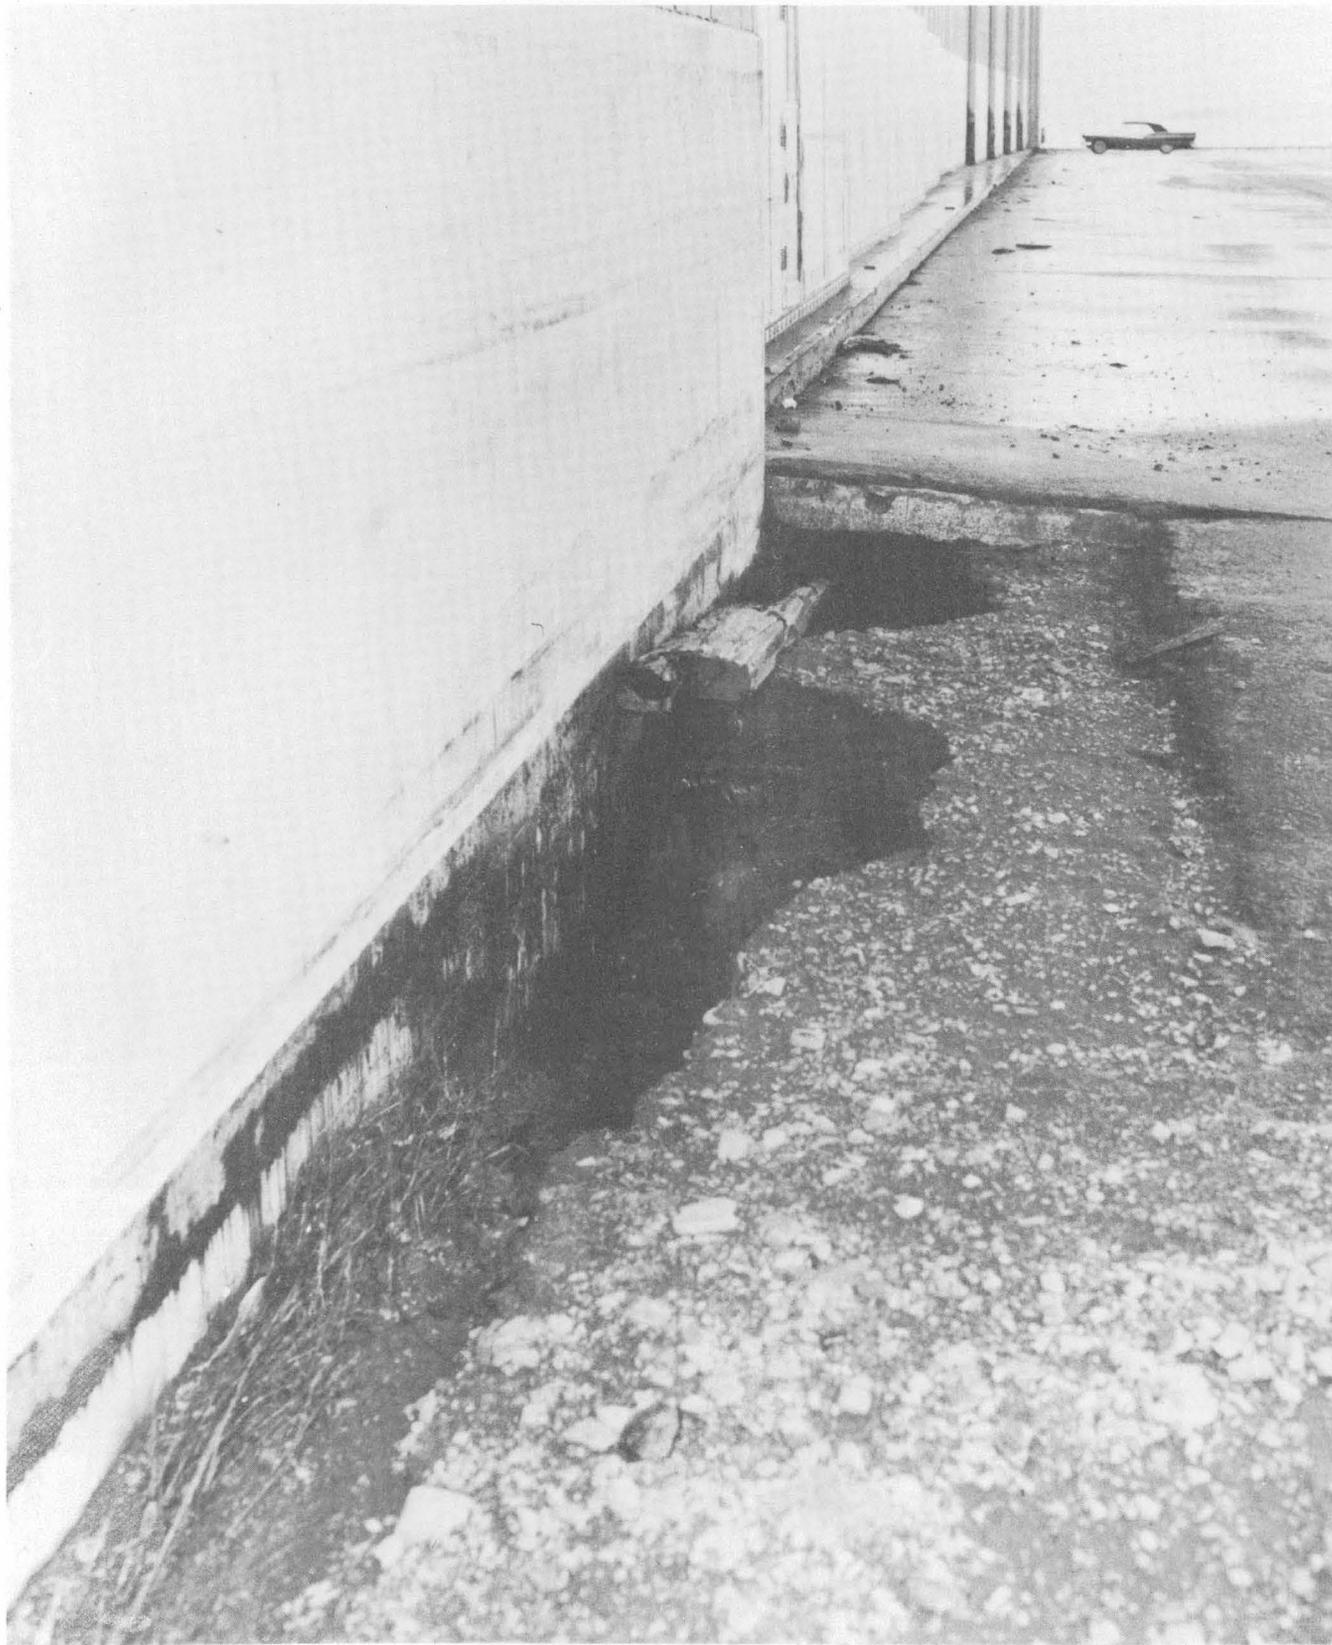
Differential settlement, or compaction, took place in the unconsolidated sediments underlying some of the structures at the Kodiak Naval Station. The compaction was due to seismic action and amounted to as much as 1 foot beneath hanger 1. Compaction of fill also occurred under the asphalt aircraft ramp outside a hangar (fig. 5, next page). The compac-

5.—Result of compaction of fill debris underlying asphalt aircraft ramp outside hangar at Kodiak Naval Station. Note the settlement of back-fill material adjacent to foundation of structure in the foreground. Photograph by U.S. Navy, March 29, 1964.

tion here was so great that a step several inches high developed between the footing of the hangar and the ramp. The hangar footing itself had some slight differential settling. Locally, the backfill material against the foundation of the hangar has compacted substantially. One might expect that scouring would have occurred during the retreat of the inundating seismic sea waves, but if it had occurred, it would have been widespread throughout the naval station, and none was observed. Furthermore, we noted the same

phenomenon of differential compaction at the Eklutna Hydroelectric Project near Anchorage, Alaska, where seismic sea waves had not inundated the area. The hangars were constructed on 15–20 feet of engineered fill consisting of glacial debris (Tudor, 1964). The columns of the hangars rested on piles, whereas the deck of the hangars rested on fill. There apparently was not settlement of the columns of the hangars, but differential settlement of the fill beneath the hangar footings caused slight deformation of the bracing

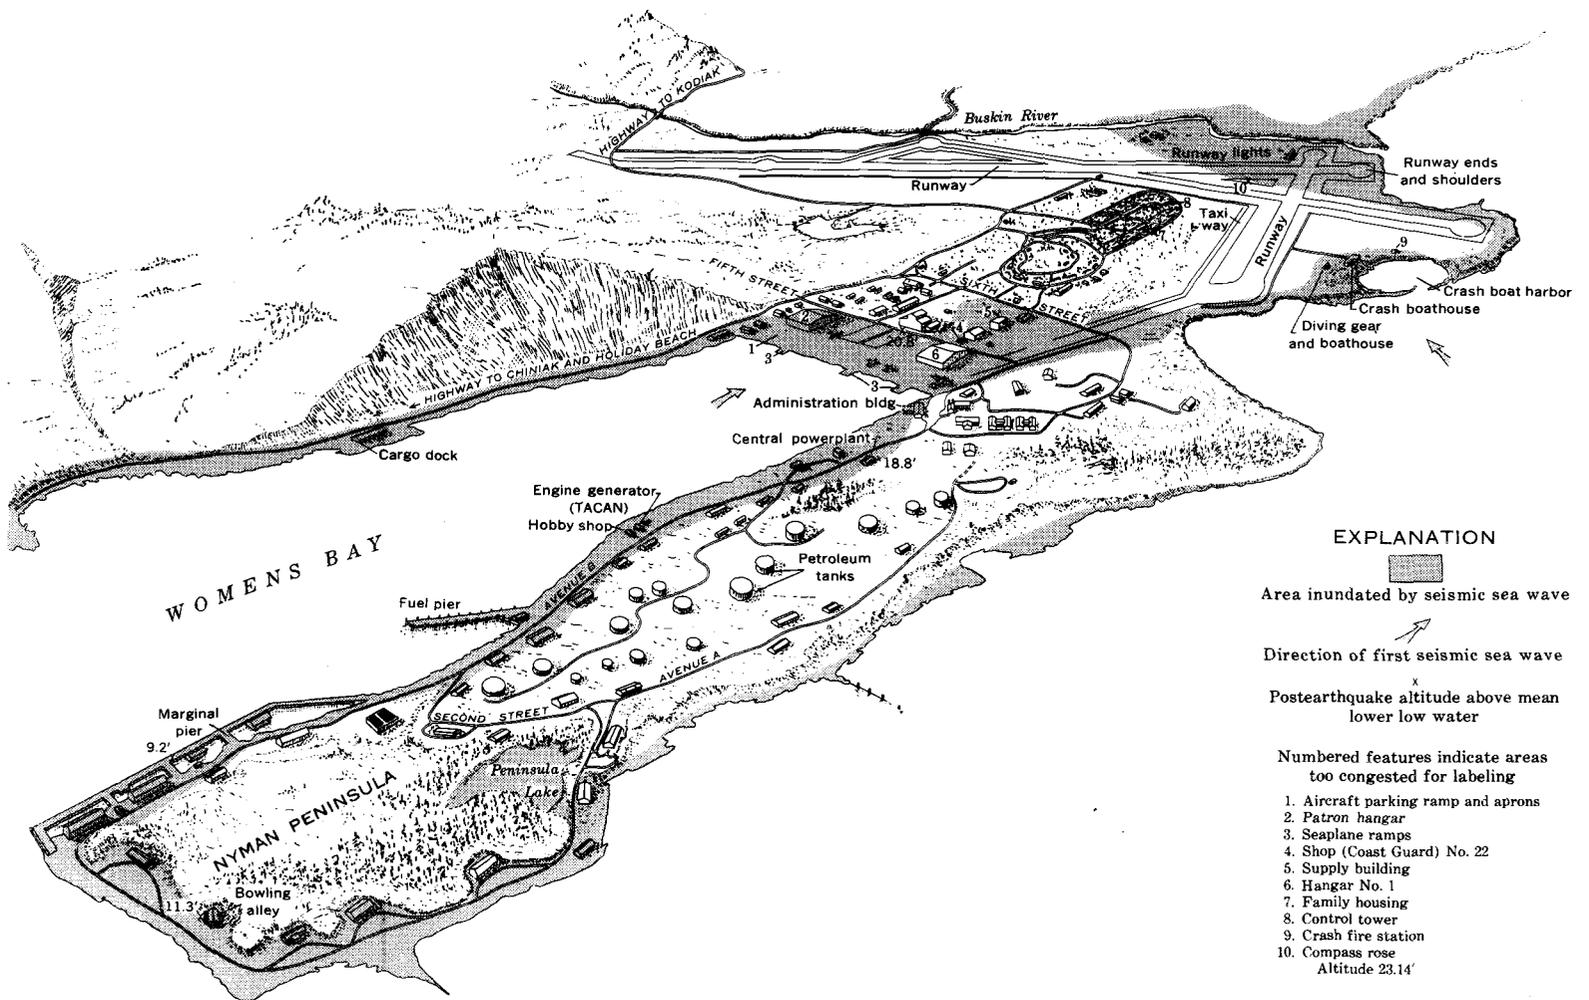
6.—Area of maximum inundation by seismic sea waves and structures damaged at Kodiak Naval Station.

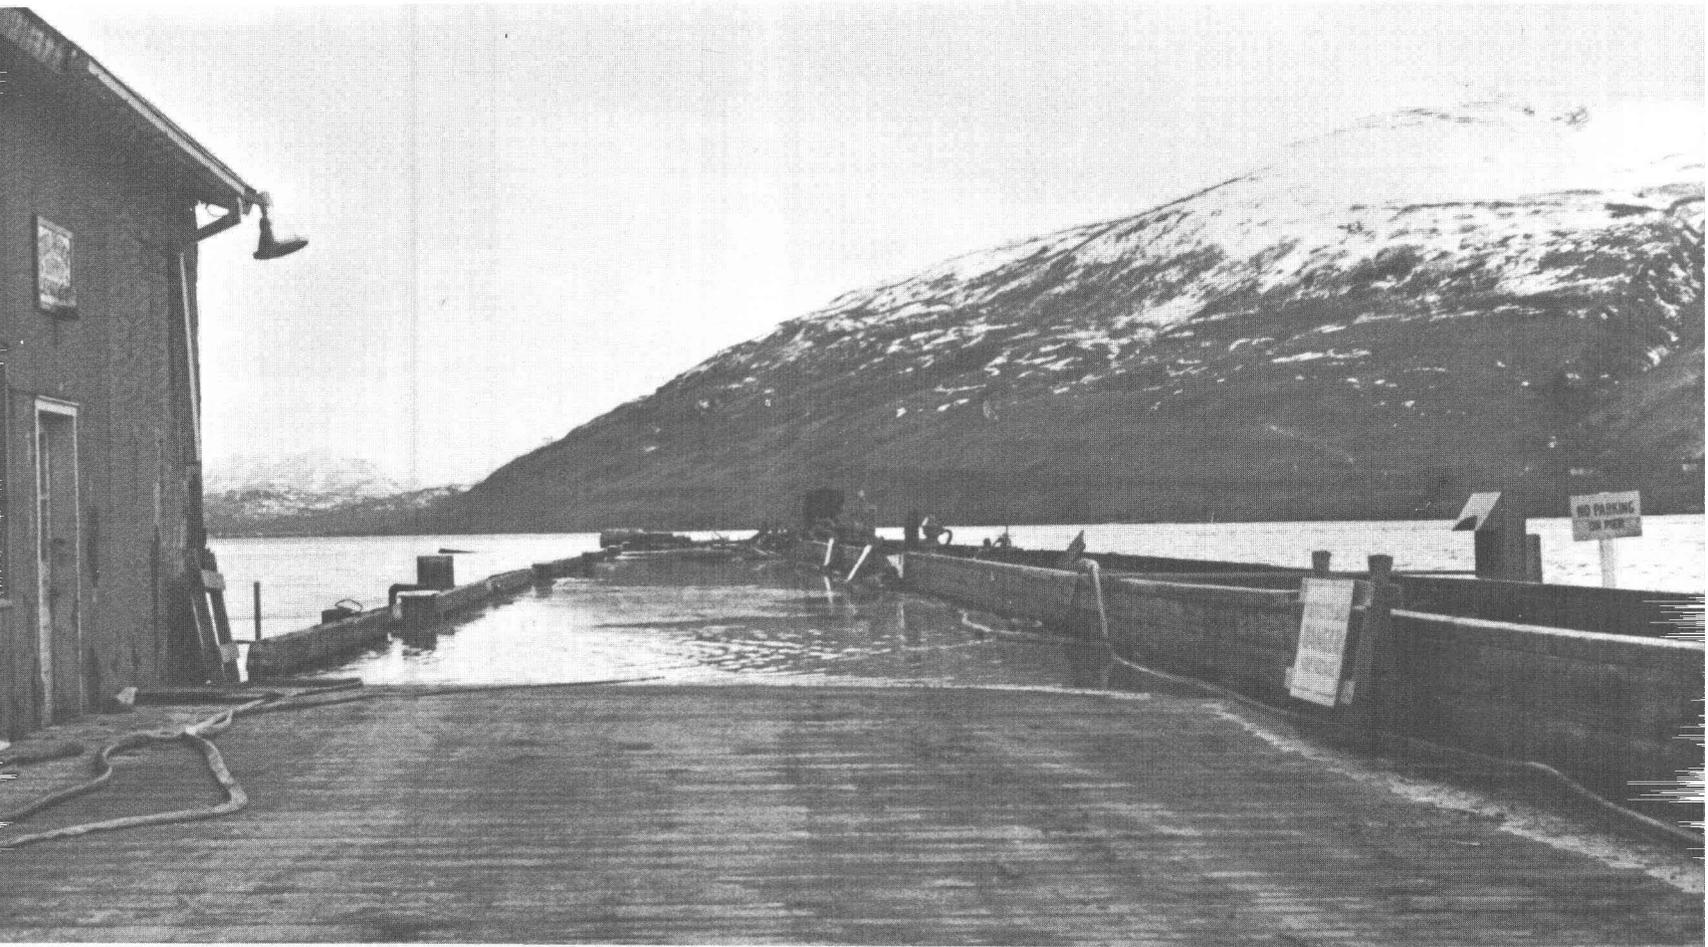
7.—Inundation of fuel pier during high tide at Kodiak Naval Station. Photograph by U.S. Navy, 12:59 p.m., April 12, 1964.

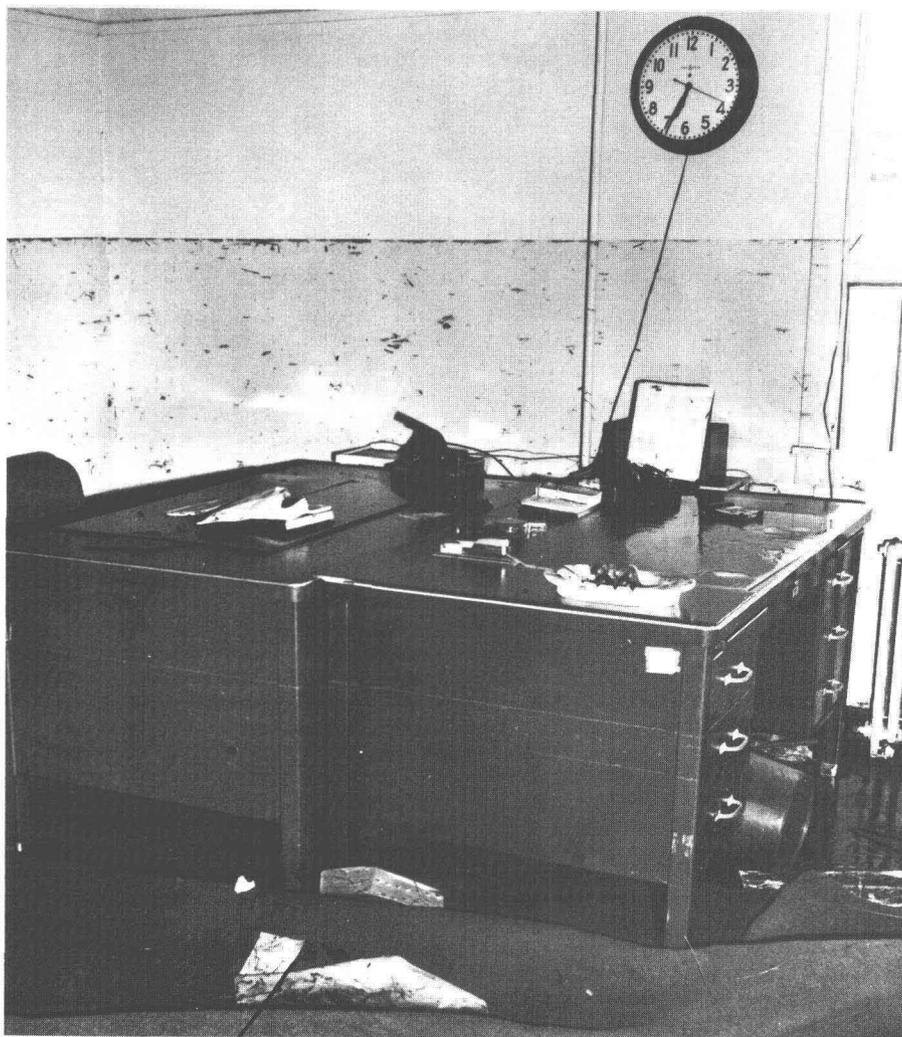
9.—Clock in the intelligence office, Kodiak Naval Station, showing time power failed at the station. Black watermark on the wall indicates maximum height of inundation. Photograph by U.S. Navy, March 29, 1964.

station buildings and living quarters were lost. The same wave broke water mains and disrupted water service to the structures. Figure 9, a photograph of the naval station intelligence office, indicates that power was cut off at about 6:39 p.m. Figure 10 shows the first seismic sea wave striking the hangar area at the northeast head of Womens Bay. The two PV2 Neptune aircraft of Patrol

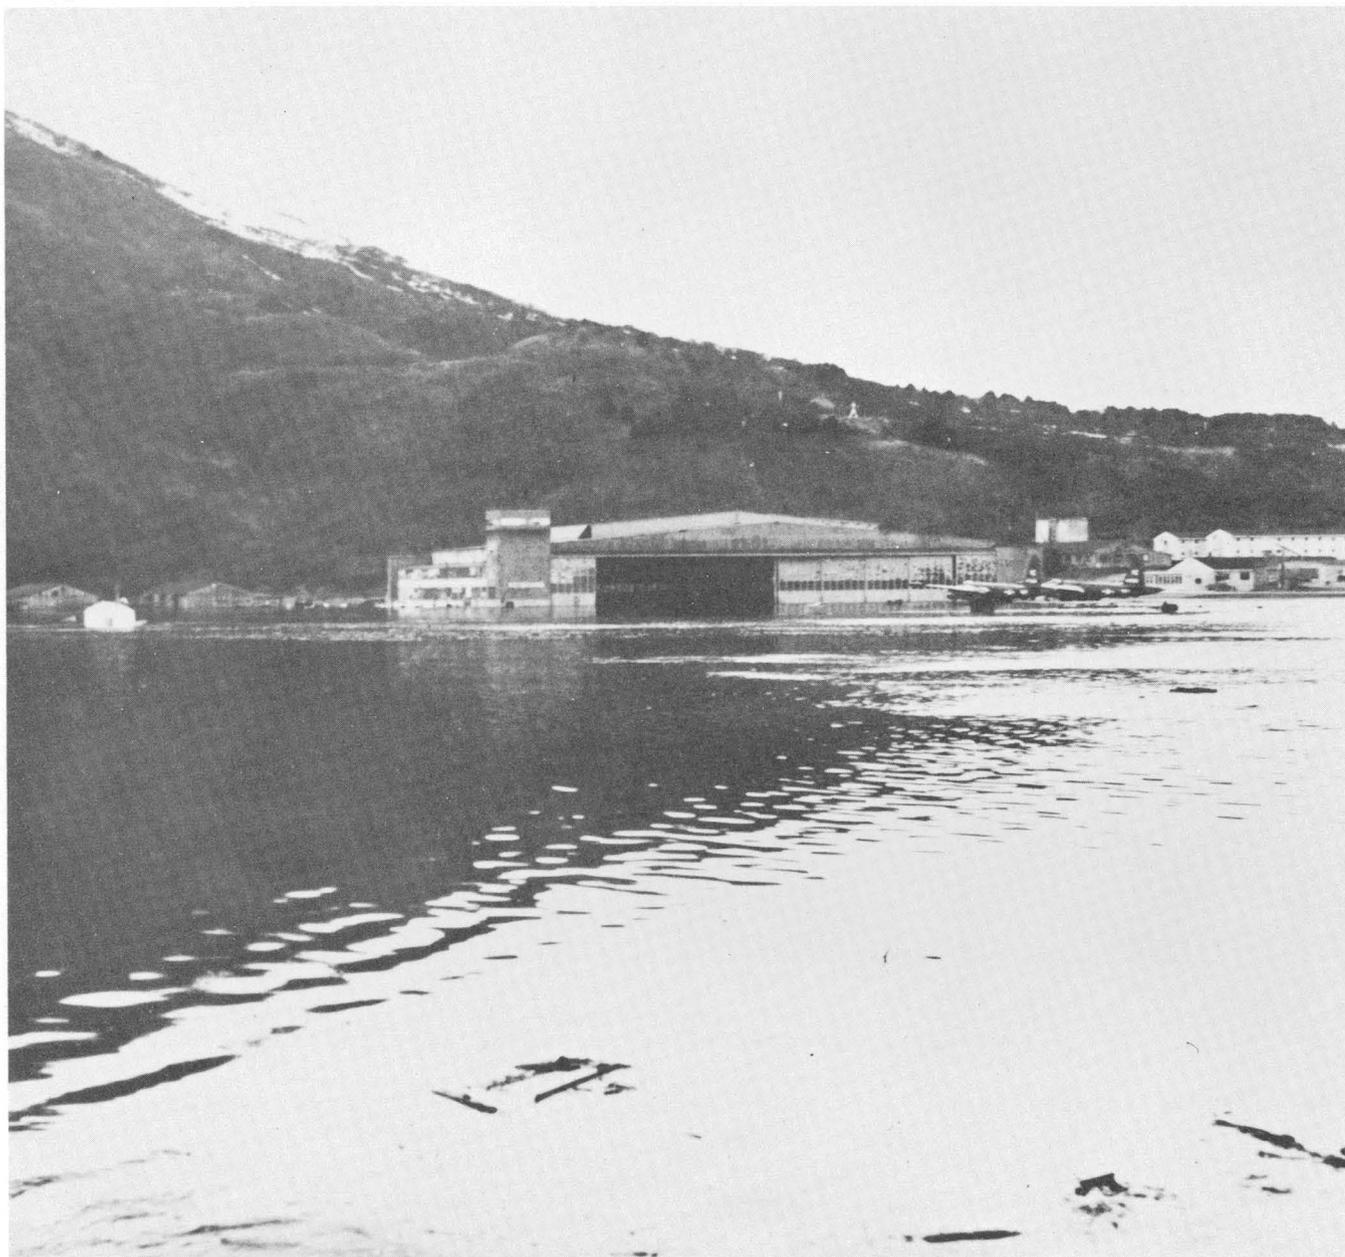
10.—First seismic sea wave flooding parts of the Kodiak Naval Station. View is west. Photograph by U.S. Navy, March 27, 1964.

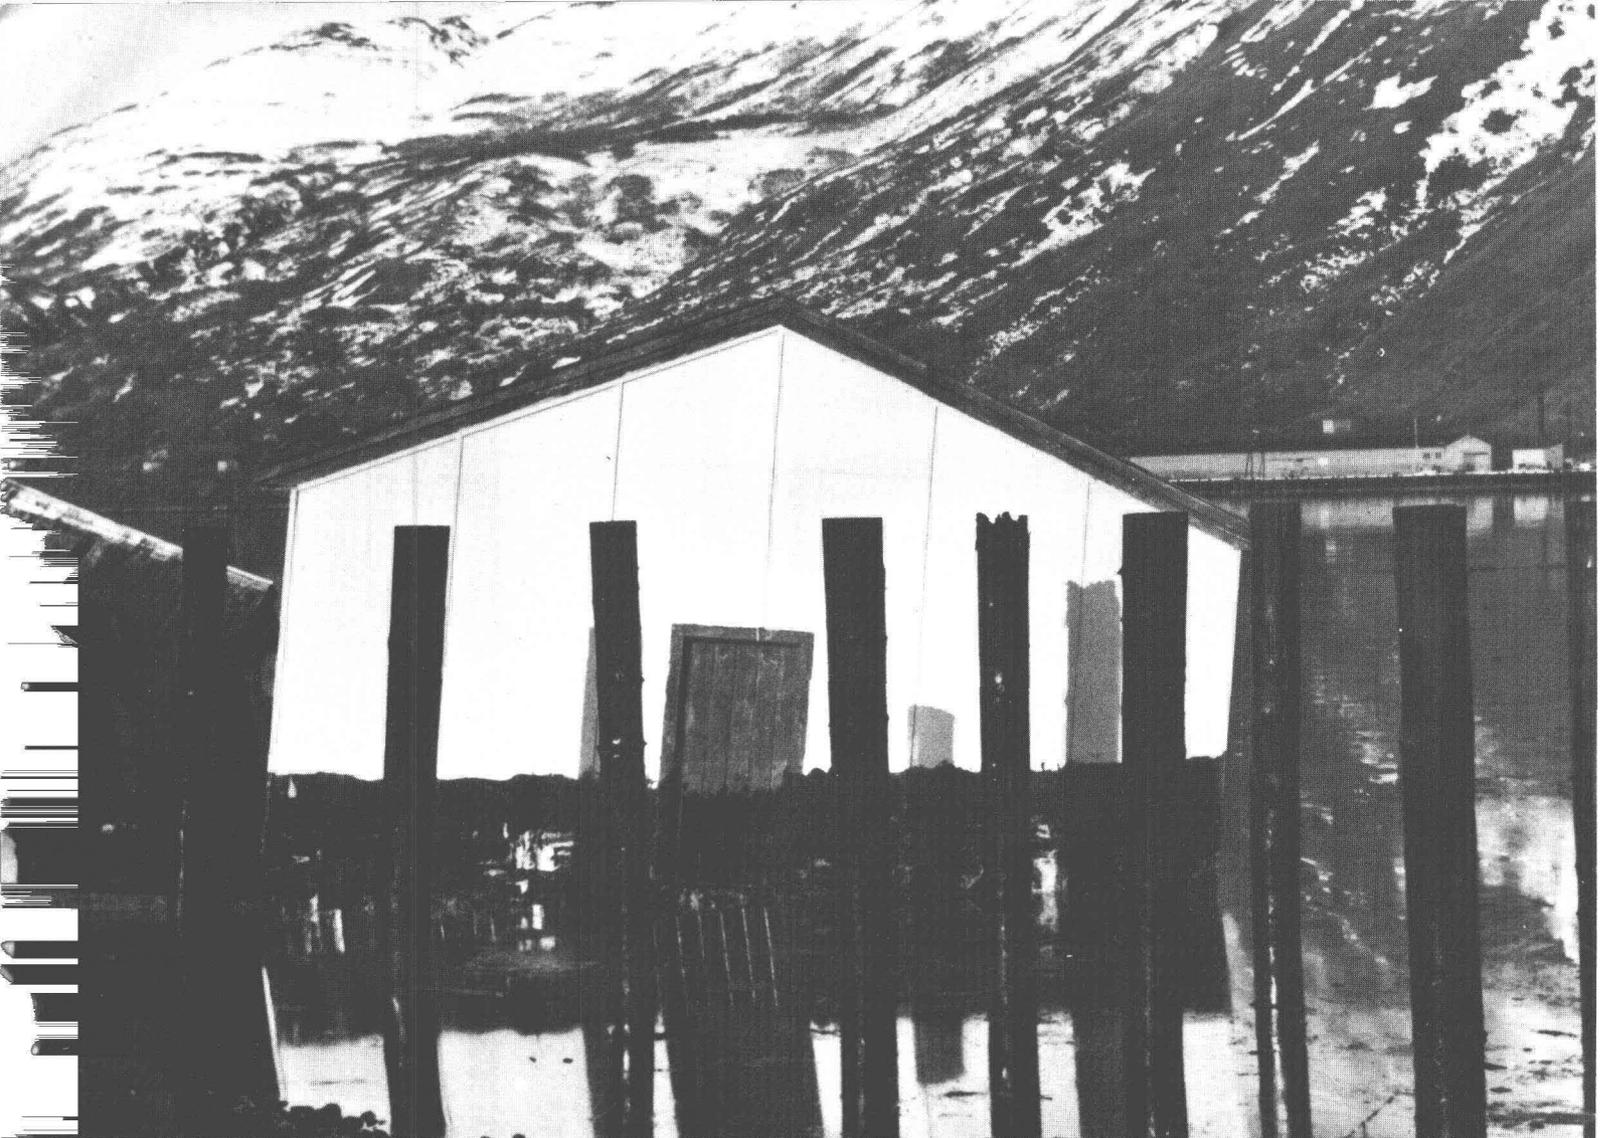
11.—Hobby shop swept off its piling foundation by seismic sea waves, Kodiak Naval Station. Black poles are piles upon which structure rested prior to the earthquake. Photograph by U.S. Navy, March 28, 1964.

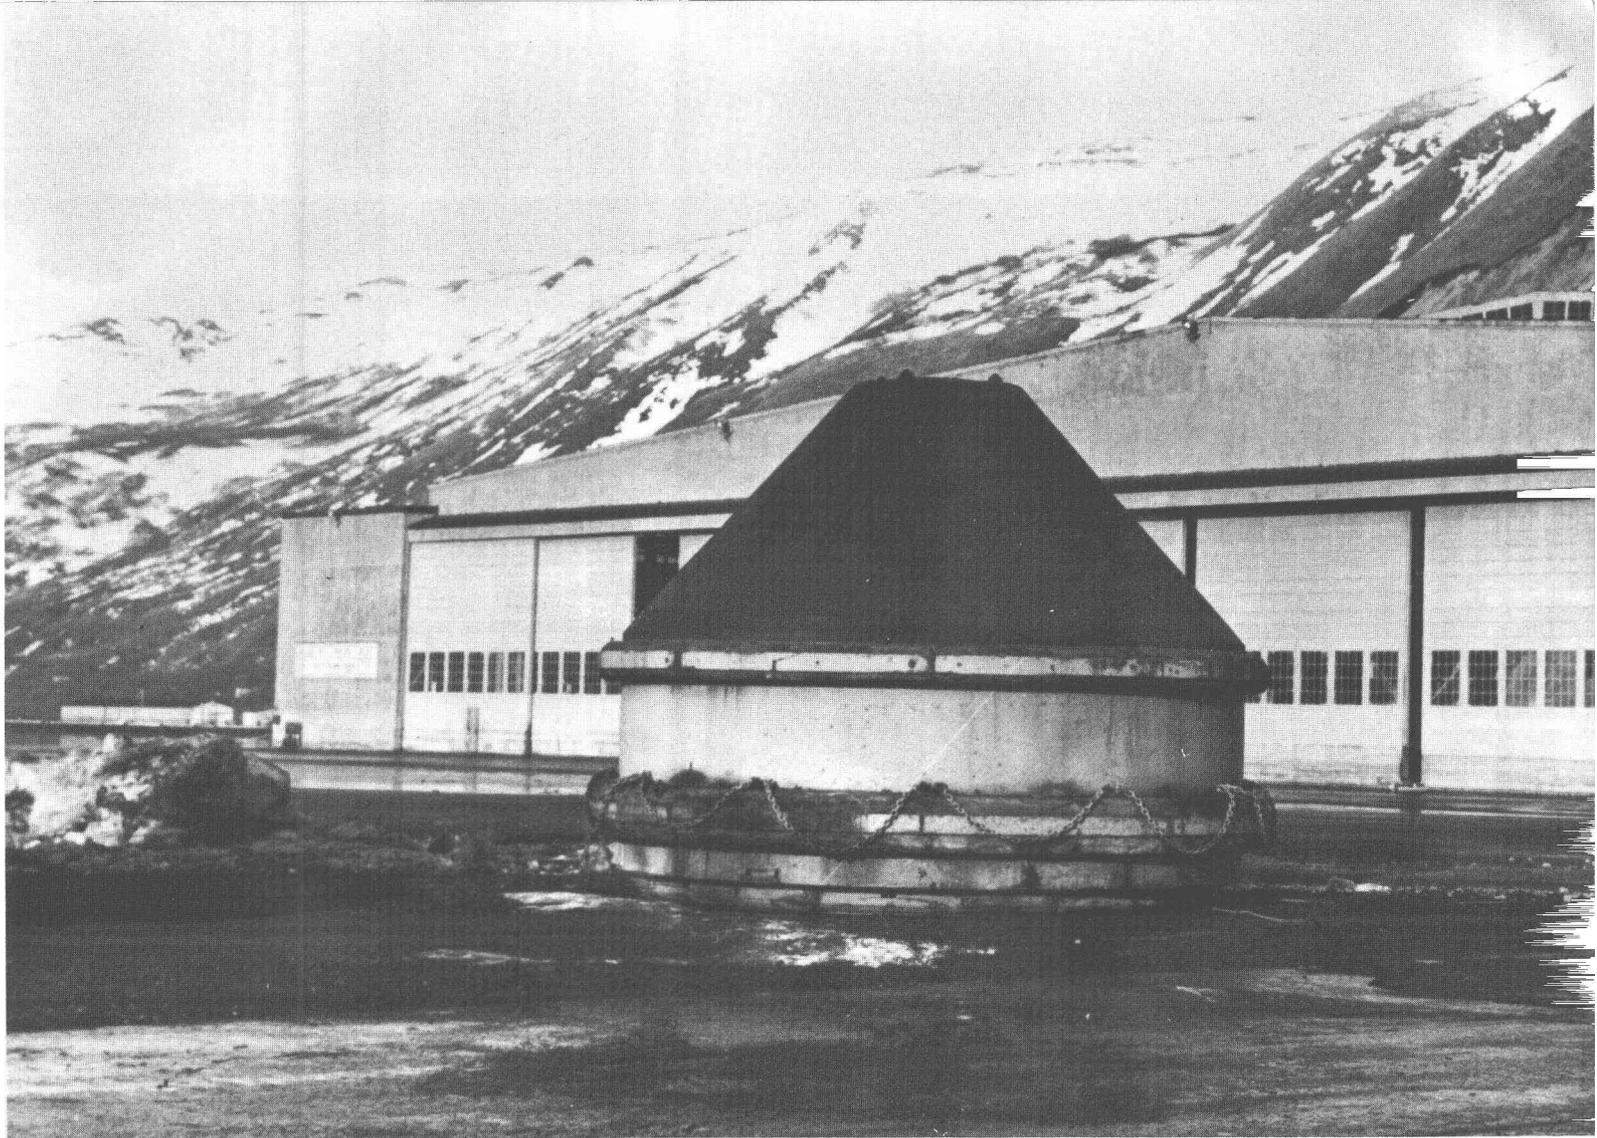
12.—Mooring buoy washed ashore by seismic sea waves, Kodiak Naval Station. Photograph by U.S. Navy, March 28, 1964.

The water also tore loose a 10-ton mooring buoy from its anchorage and deposited it on the taxiway near the supply building (fig. 12). The buoy was carried about a quarter of a mile inland by the water and came to rest at a post-earthquake altitude of about 16 feet. It was carried to this position by the fifth seismic sea wave, which crested, between 11:16 and 11:34 p.m. on March 27, 18.8 feet above postearthquake MLLW.

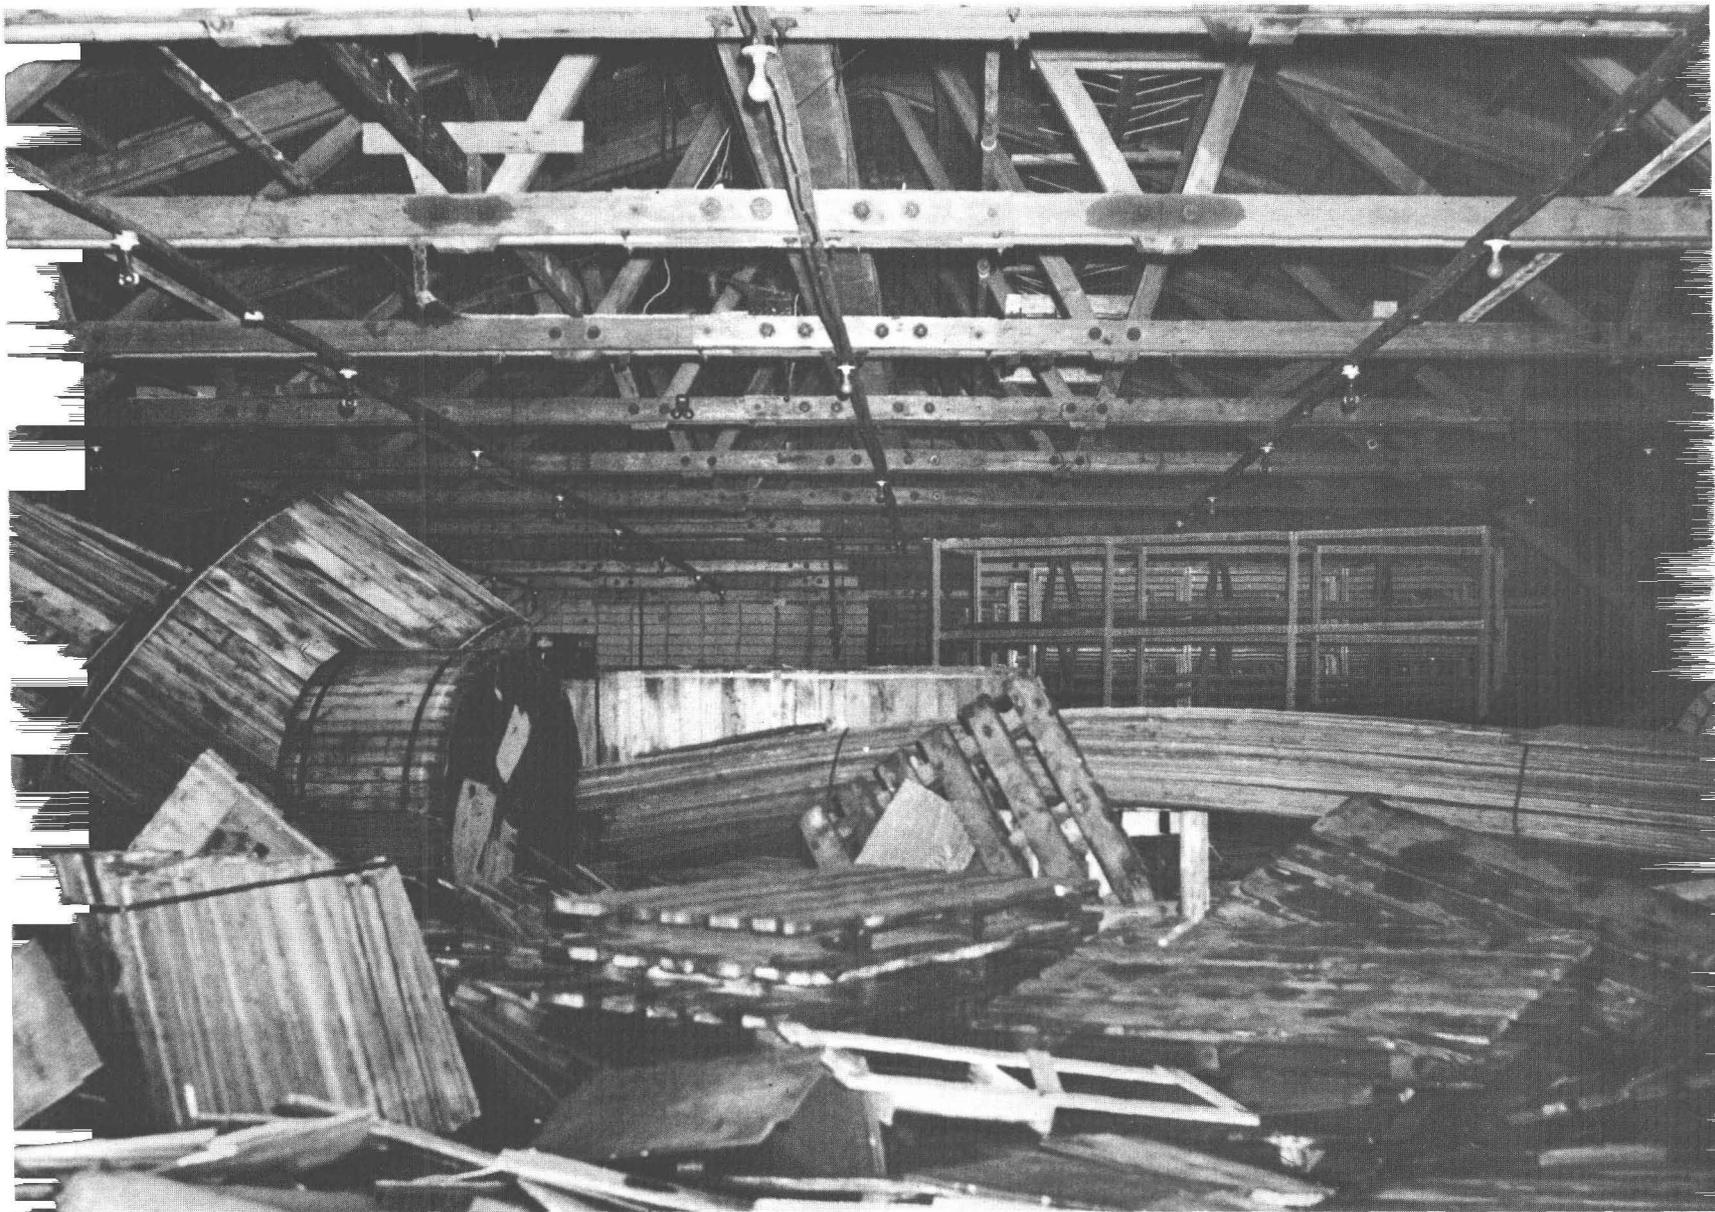
13.—Photograph of interior of supply building, Kodiak Naval Station, showing condition of supplies stored in building after the retreat of the seismic sea waves. Photograph by U.S. Navy, March 29, 1964.

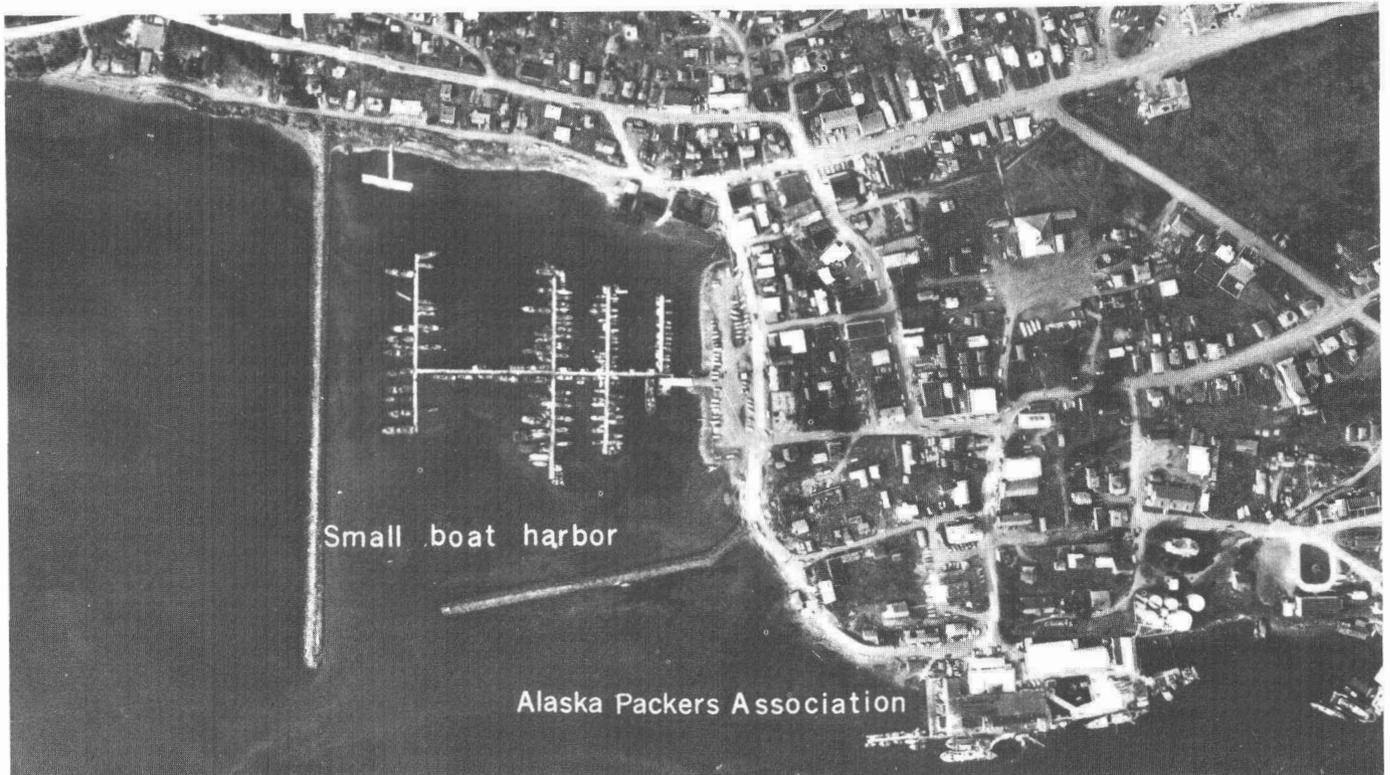
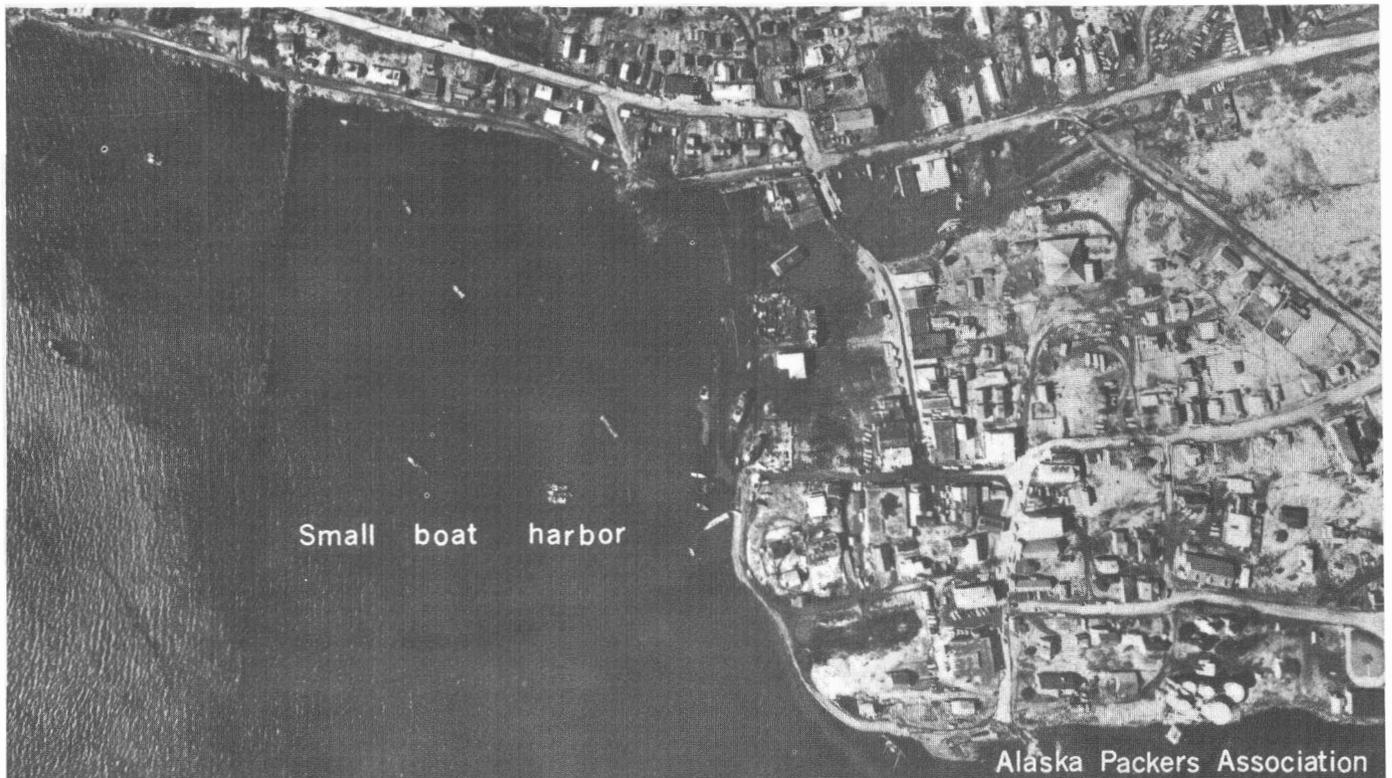
The destructive force of the seismic sea waves in the Kodiak area is shown by figures 15 and 16, on following pages.

15.—Vertical aerial views of downtown Kodiak, scale 1:6,000. Top, preearthquake photograph by Bureau of Land Management, September 10, 1962. Bottom, postearthquake photograph by Air Photo Tech, Anchorage, April 14, 1964.

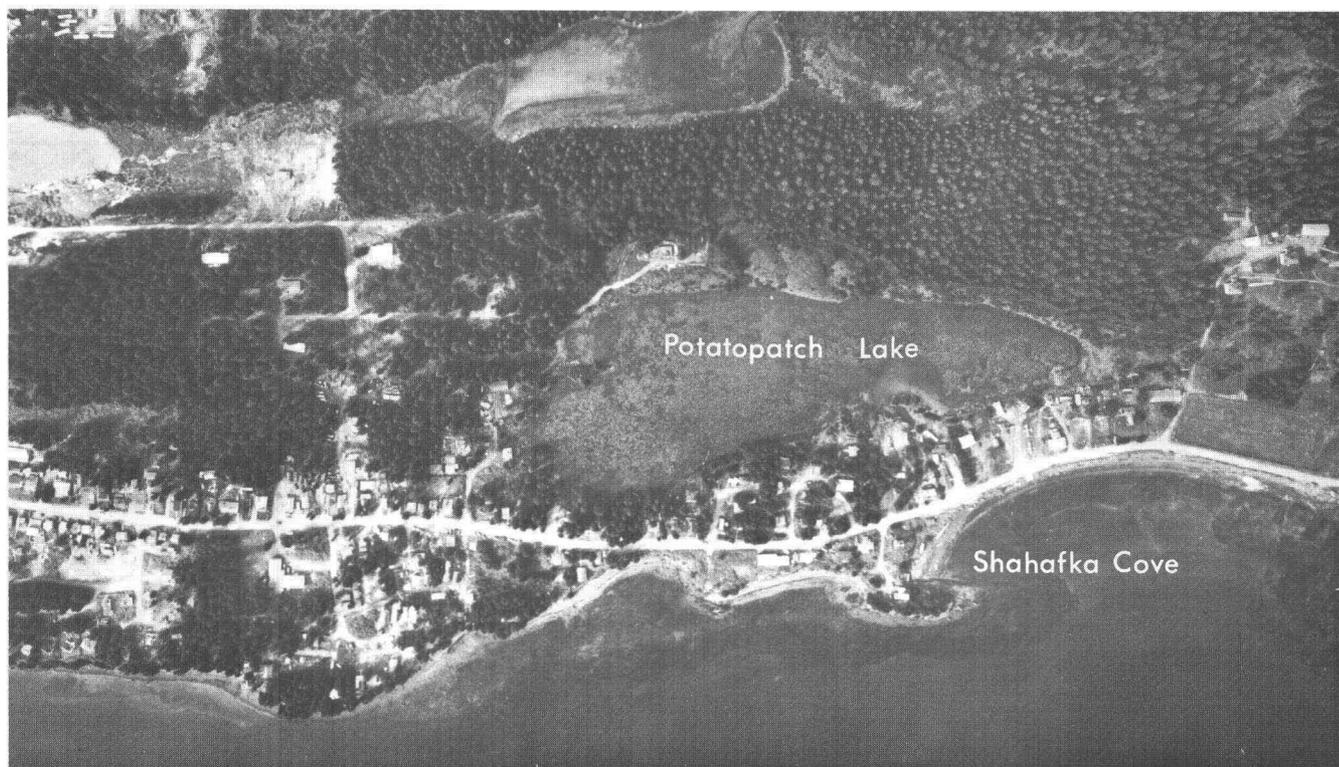
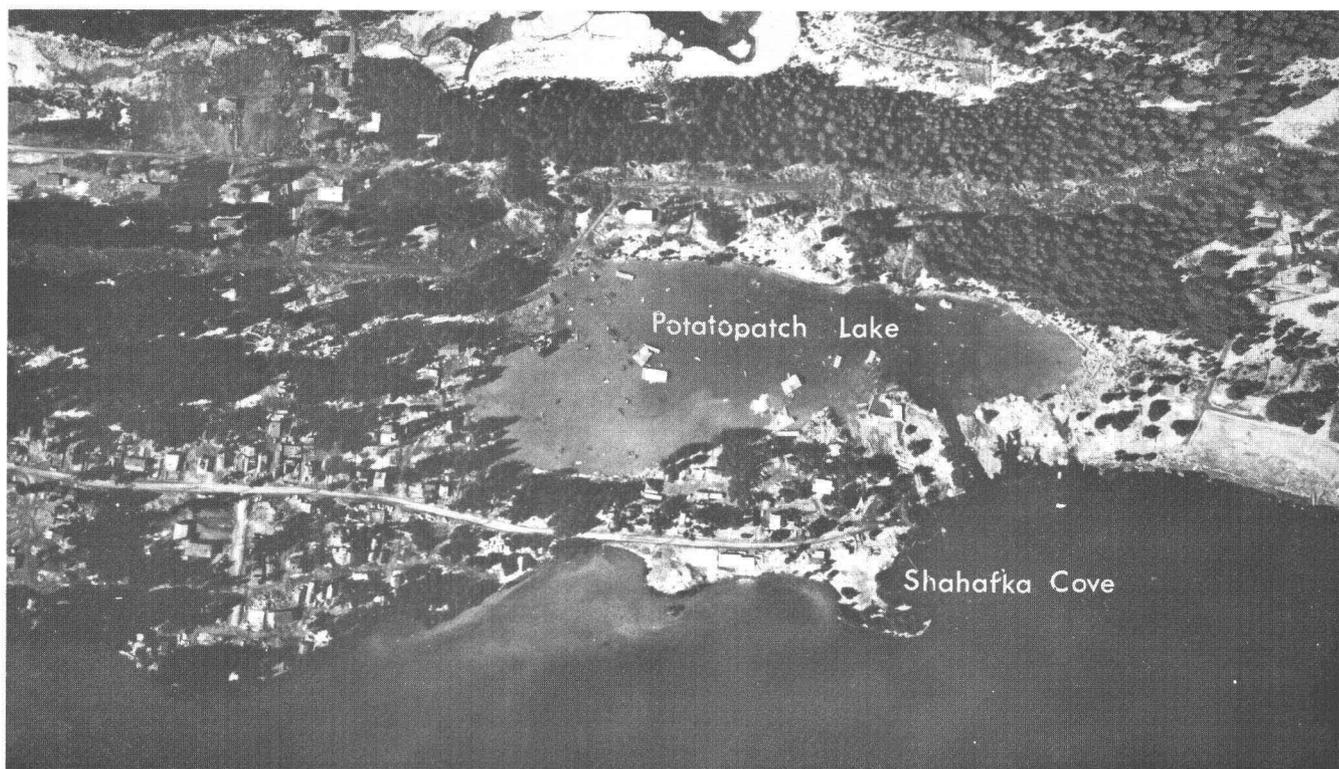
16.—Vertical aerial views of Potatopatch Lake area, northeast of downtown Kodiak, scale 1:6,000. Top, preearthquake photograph by Bureau of Land Management, September 10, 1962. Bottom, postearthquake photograph by Air Photo Tech, Anchorage, April 14, 1964.
