The Alaska Earthquake

Effects of the Earthquake
Of March 27, 1964
On the Communities of
Kodiak and Nearby Islands

By REUBEN KACHADOORIAN and GEORGE PLAFKER

GEOLOGICAL SURVEY PROFESSIONAL PAPER 542-F

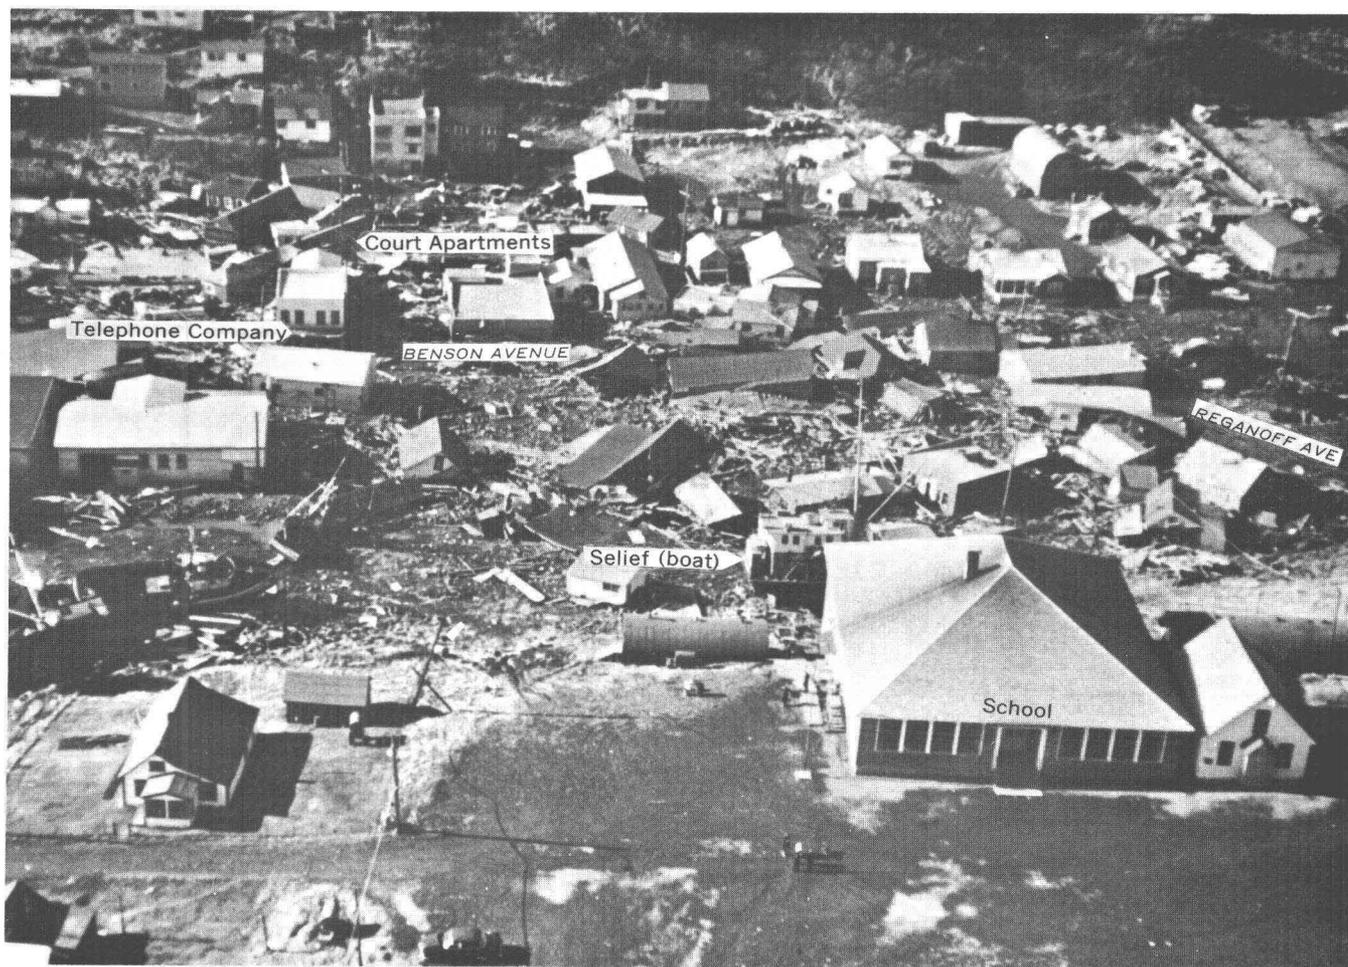
17.—Structures displaced by seismic sea waves, downtown Kodiak. View is west toward intersection of Benson and Reganoff Avenues. Photograph by Mr. Alf Madsen, Kodiak, March 1964.

Many of the displaced structures were moved by the seismic sea waves to the low-lying area on Benson Street; figure 17 shows some of these structures. Along Alaska Way in downtown Kodiak, only structures in the low-lying area east of Benson Street were totally destroyed. Many structures along Marine Way also were

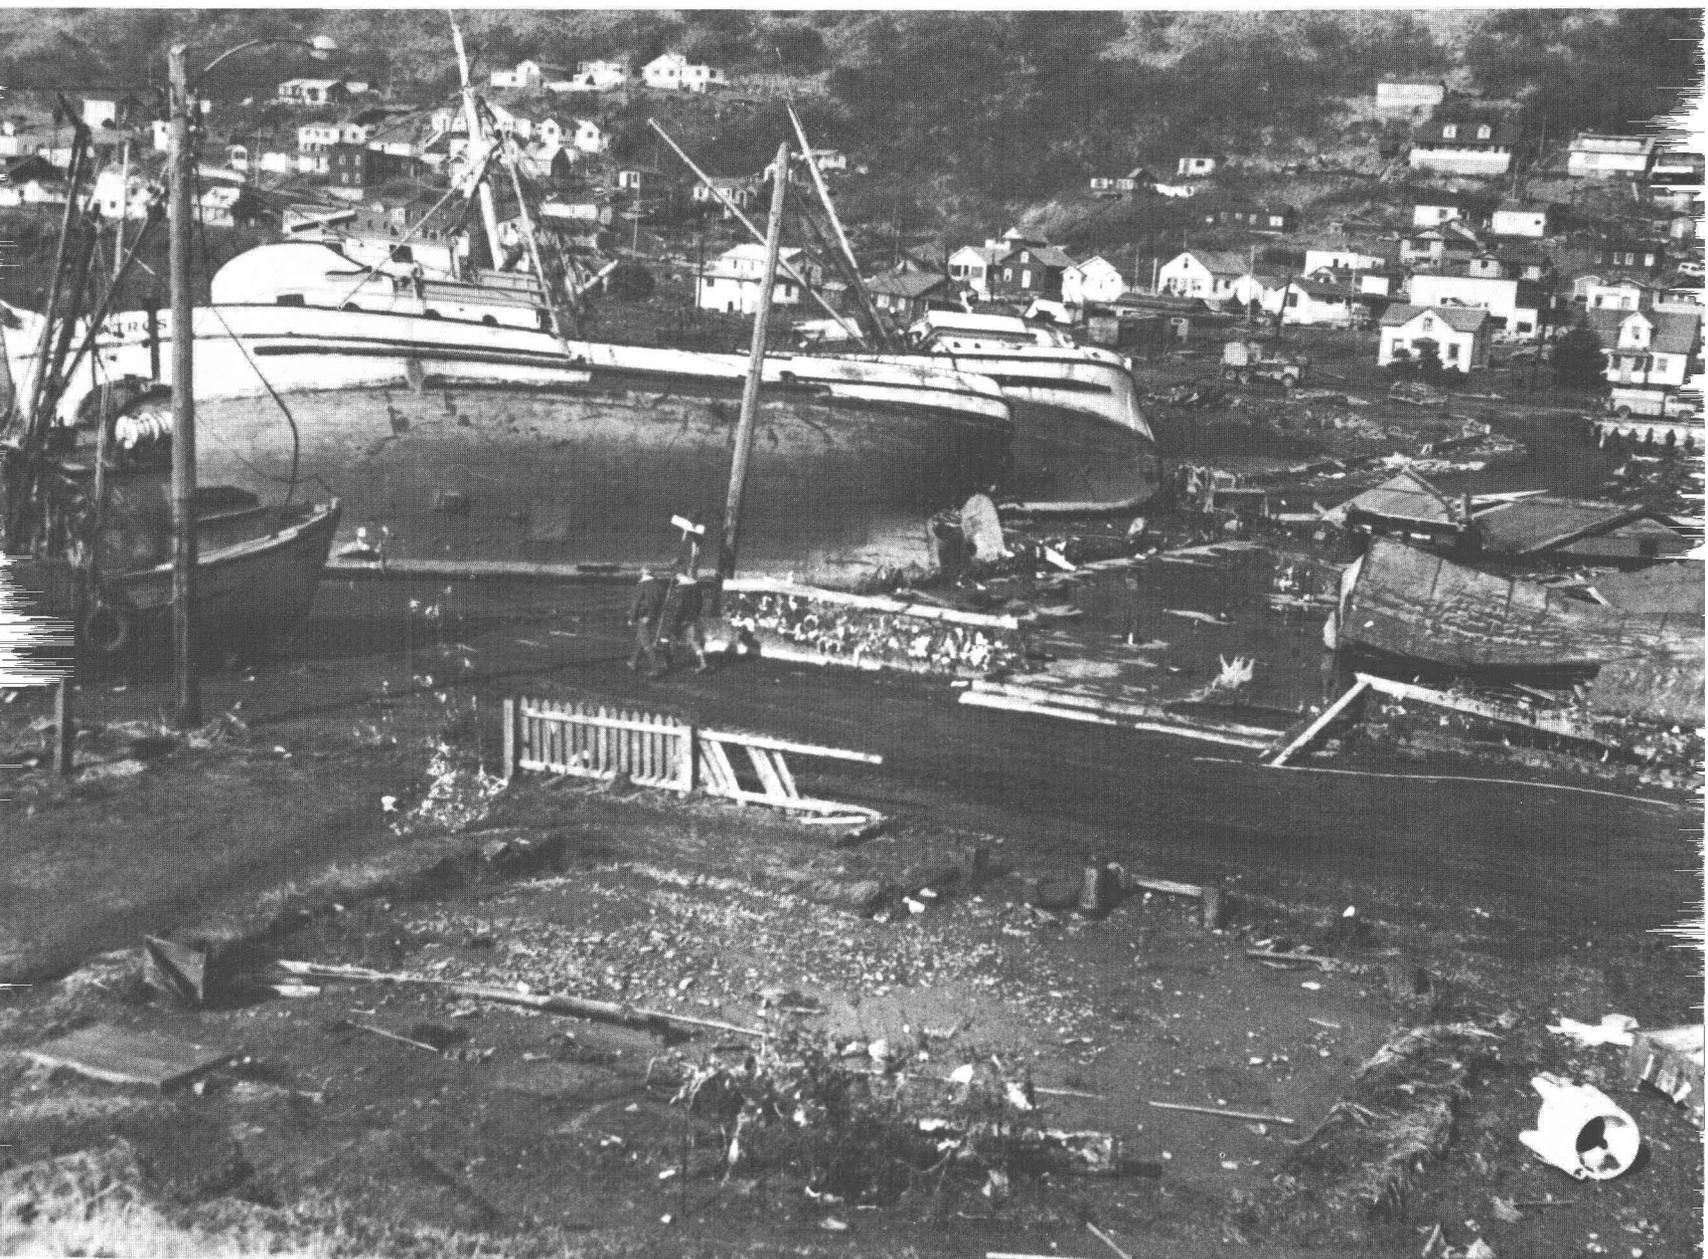
18.—Foundations of structures swept away by seismic sea waves, downtown Kodiak. View is west from intersection of Marine Way and Mill Bay Road. Foundation across Mill Bay Road was the Elks Bowling Alley; the boats are the *Cindy*, *Albatross*, and *Hekla*. Photograph by U.S. Navy, March 28, 1964.

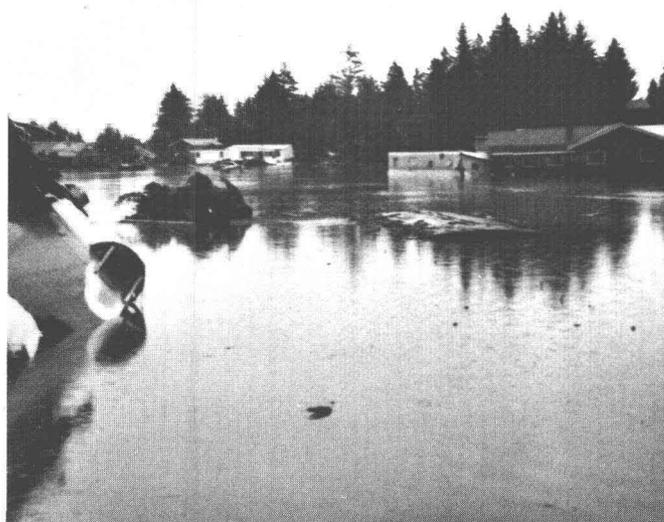
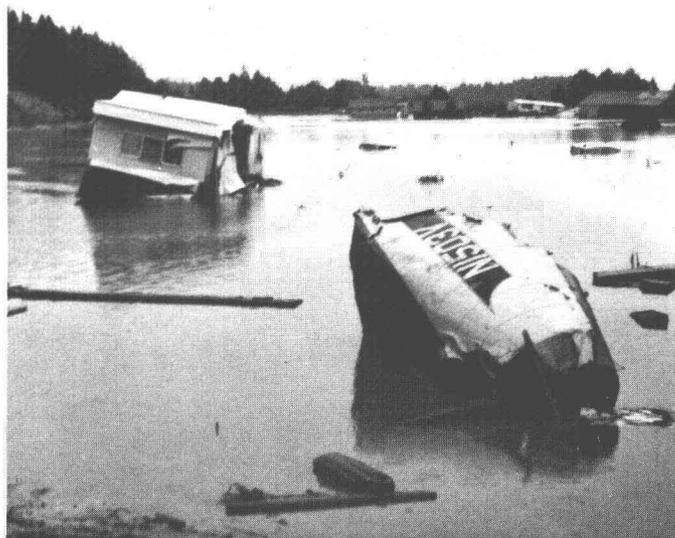
19.—Debris and houses washed into Potatopatch Lake by seismic sea waves. Photographs by Alaska Department of Highway, Kodiak.

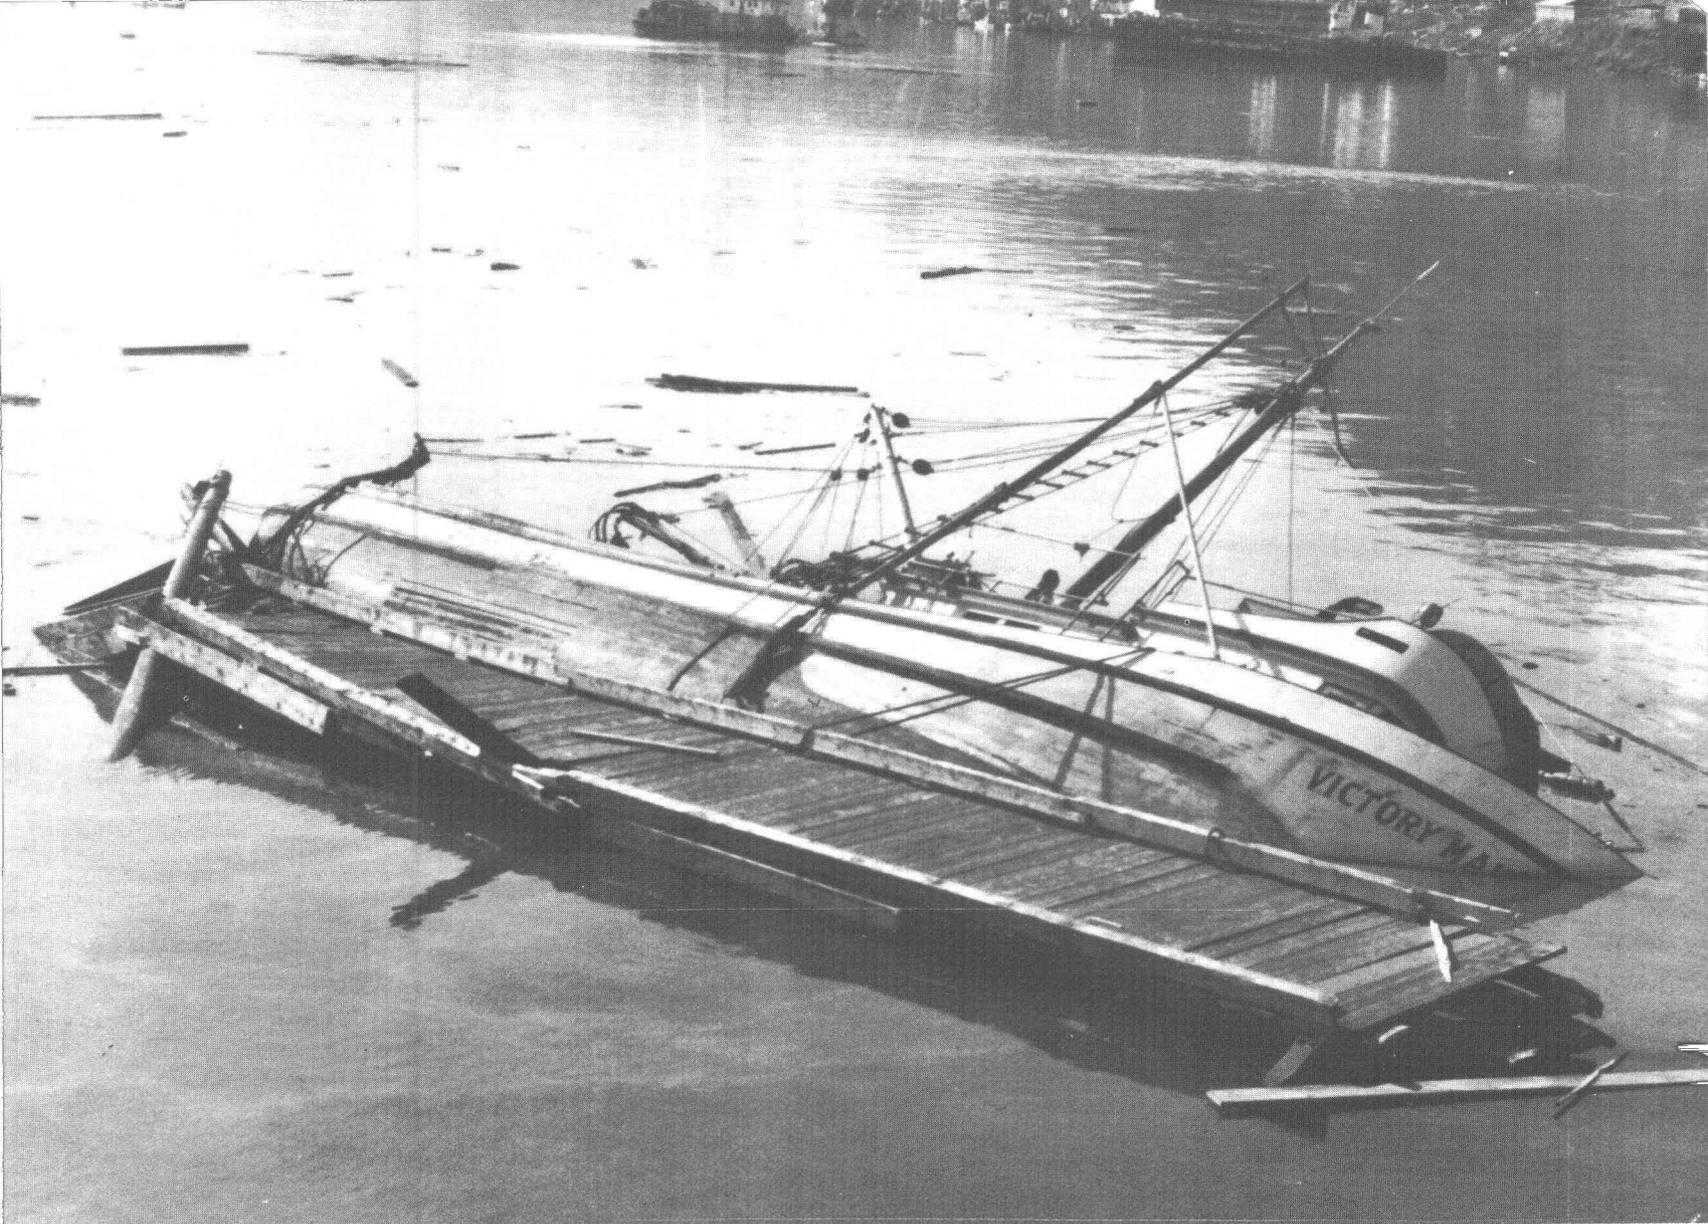
20.—The *Victory Maid* still tied to its dock but aground in Inner Anchorage. City dock is background. Photograph by U.S. Navy, March 28, 1964.

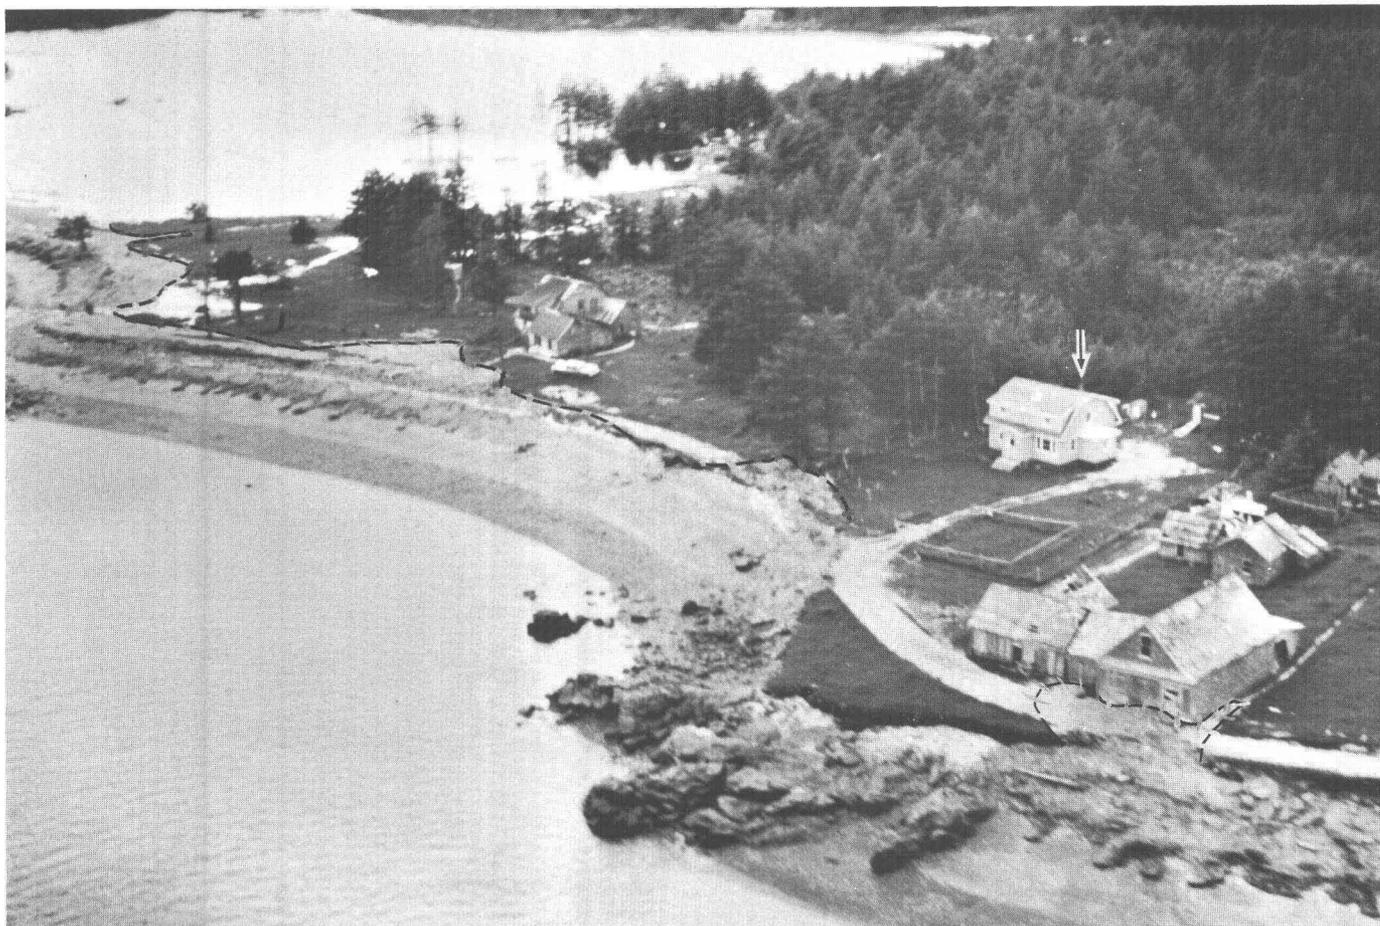
22.—Part of Afognak; note eroded road along coast, new beach berms (outlined by dashed line), and part of large lagoon ponded behind beach berm. The arrow points to undamaged brick chimney. Location of this view is shown on figure 21.

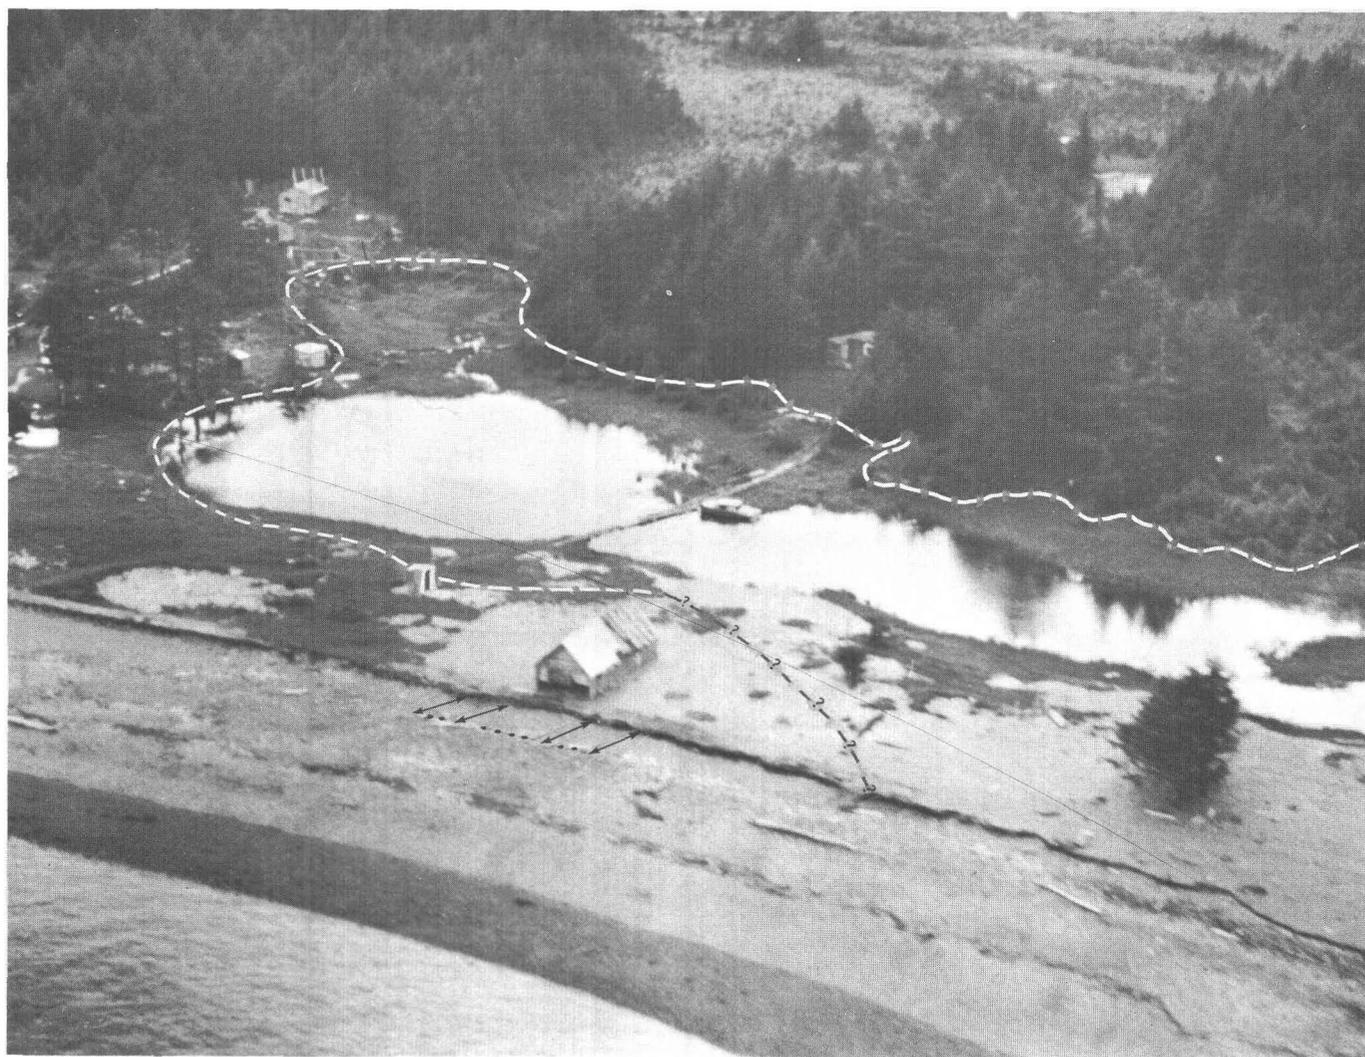
23.—Part of coast at Afognak. Arrows show approximate amount of landward retreat; newly formed beach berm is gray, and approximate extent of seismic sea wave inundation is indicated by dotted line. Note partly submerged automobile in pond.

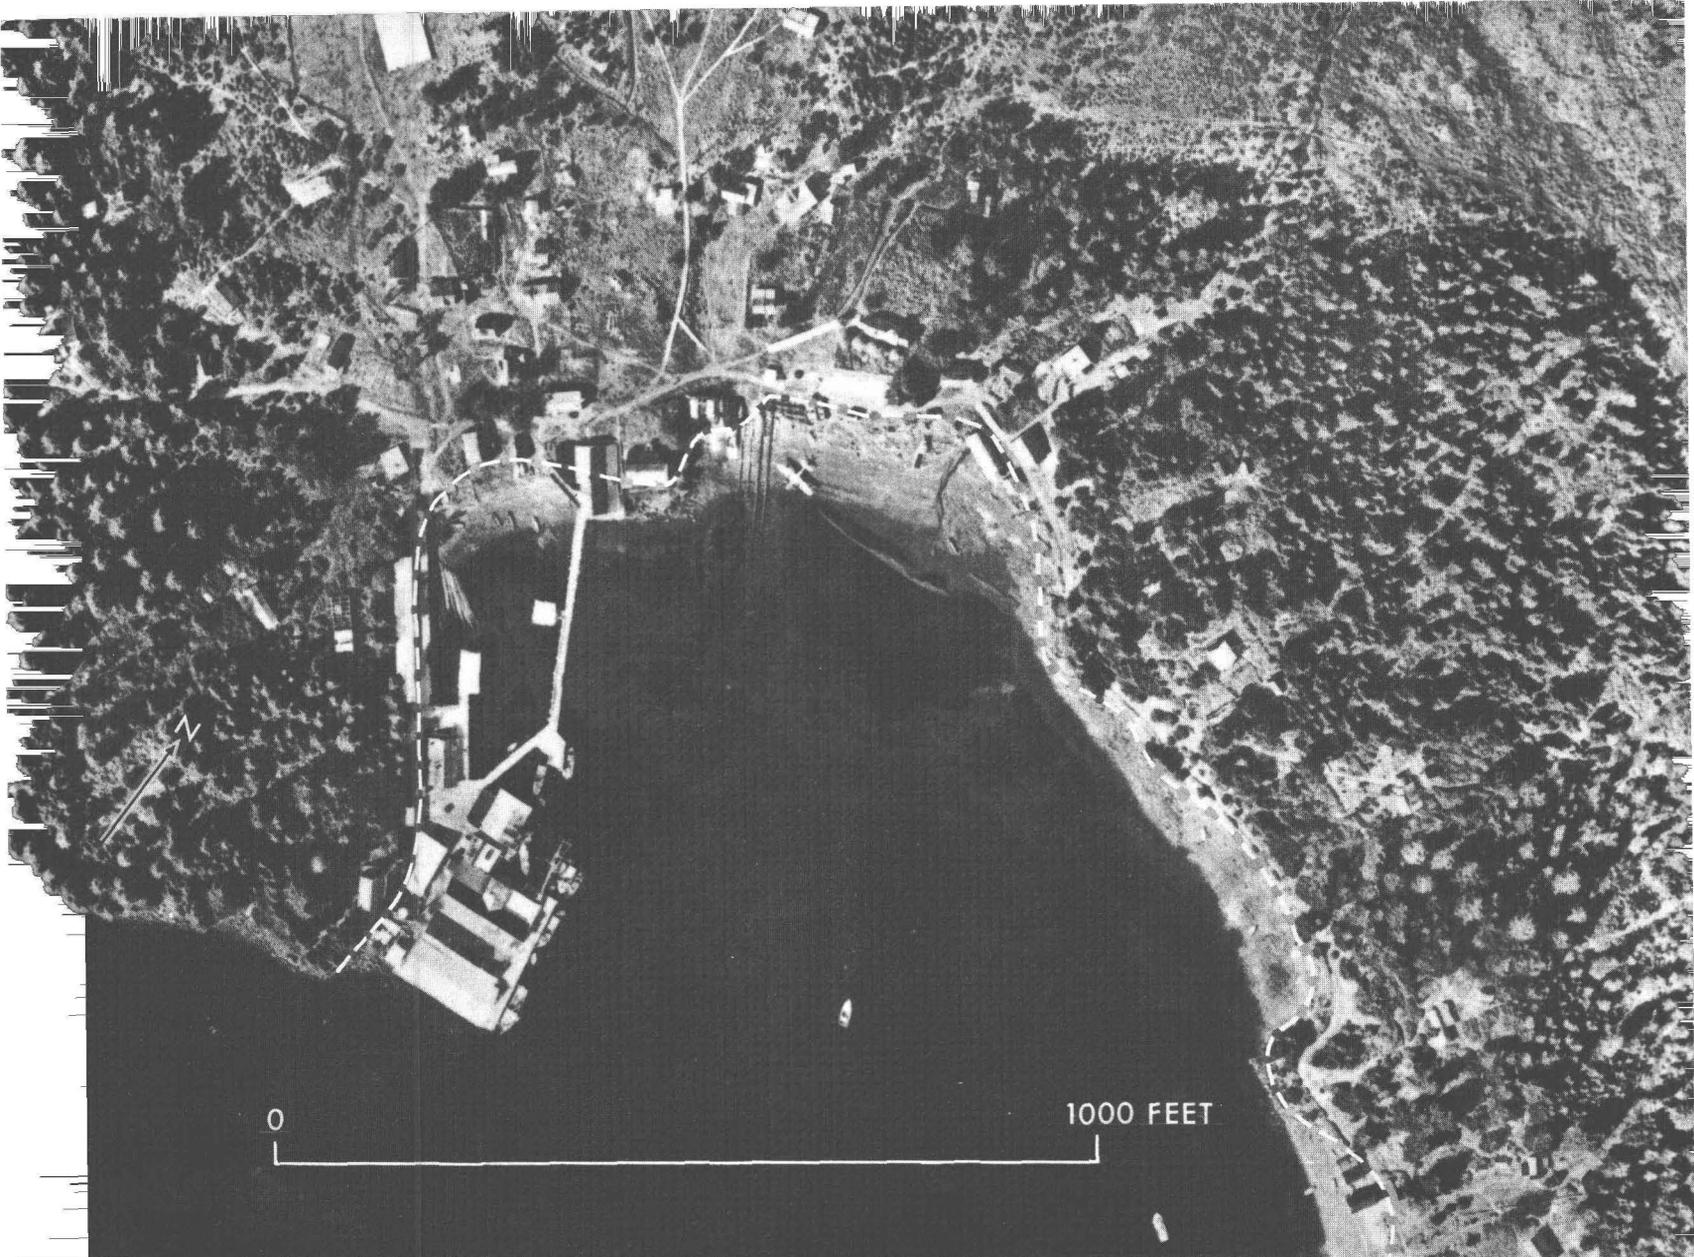
24.—Aerial mosaic of Uzinki in 1962 showing large cannery complex along the waterfront belonging to the Ouzinkie Packing Co. and approximate inland limit of seismic sea wave inundation (dashed line).

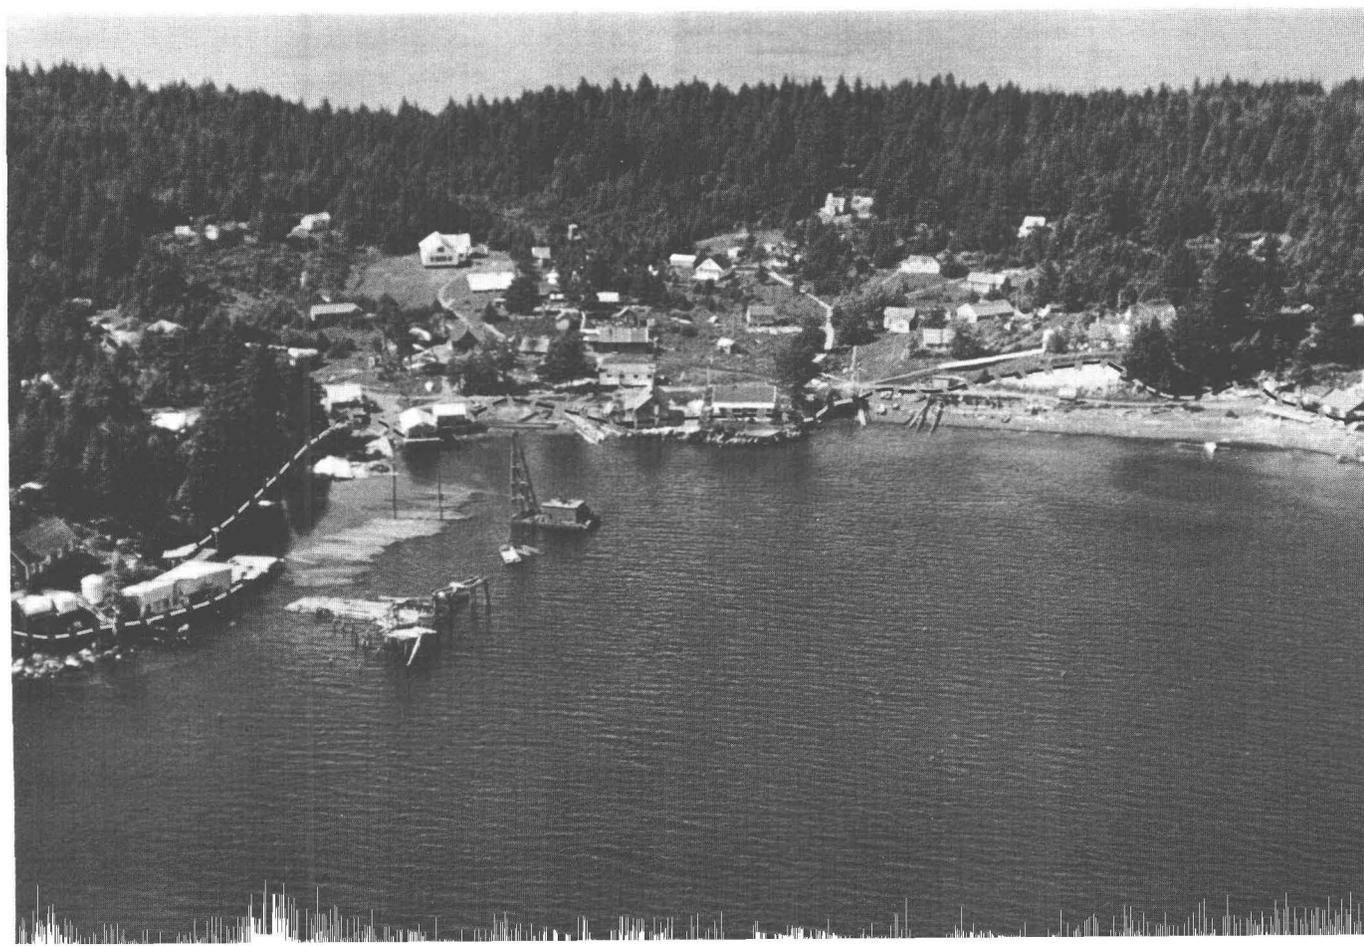
25.—Oblique aerial view of Uzinki in July 1965 showing approximate inland limit of seismic sea wave inundation (dashed line) and remains of the Ouzinkie Packing Co.'s salmon cannery (left center).

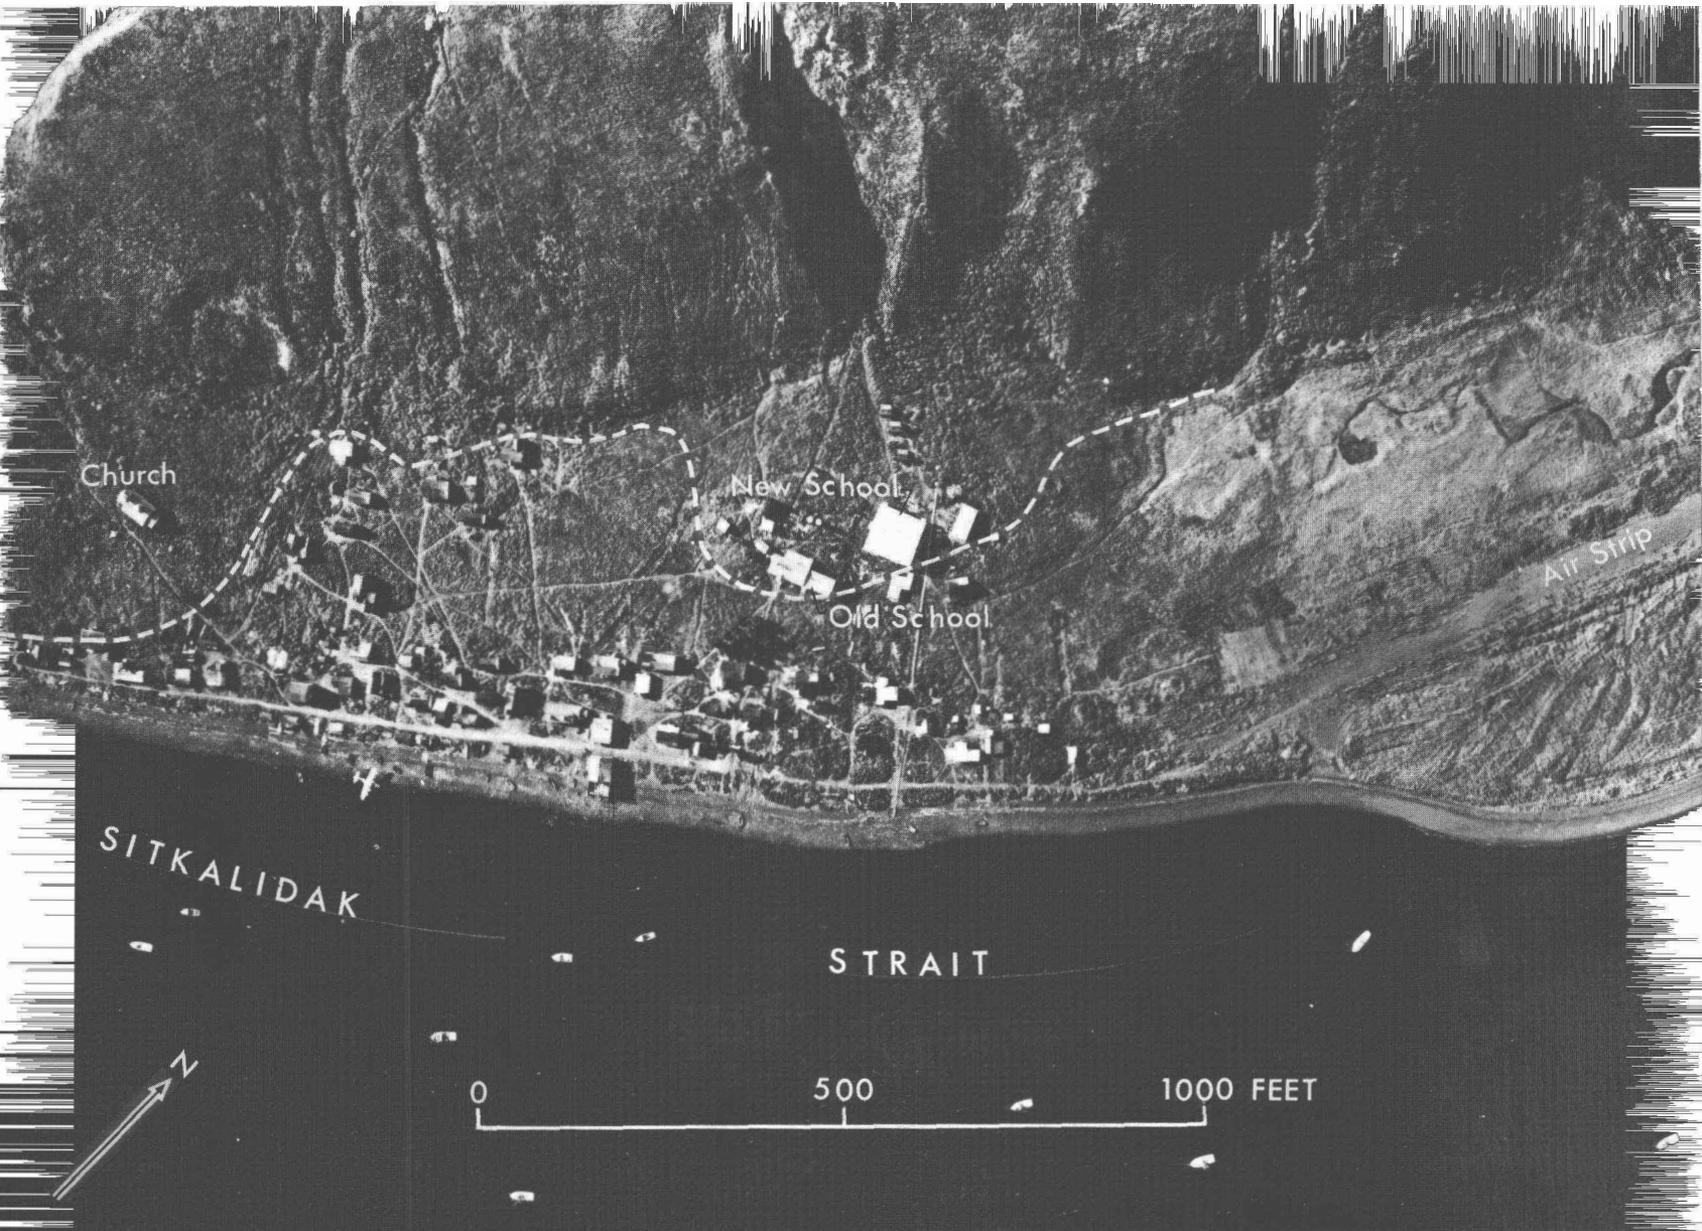
26.—Aerial mosaic of Old Harbor showing approximate inland limit of inundation by seismic sea waves (dashed line). Mosaic by U.S. Bureau of Land Management, 1962.

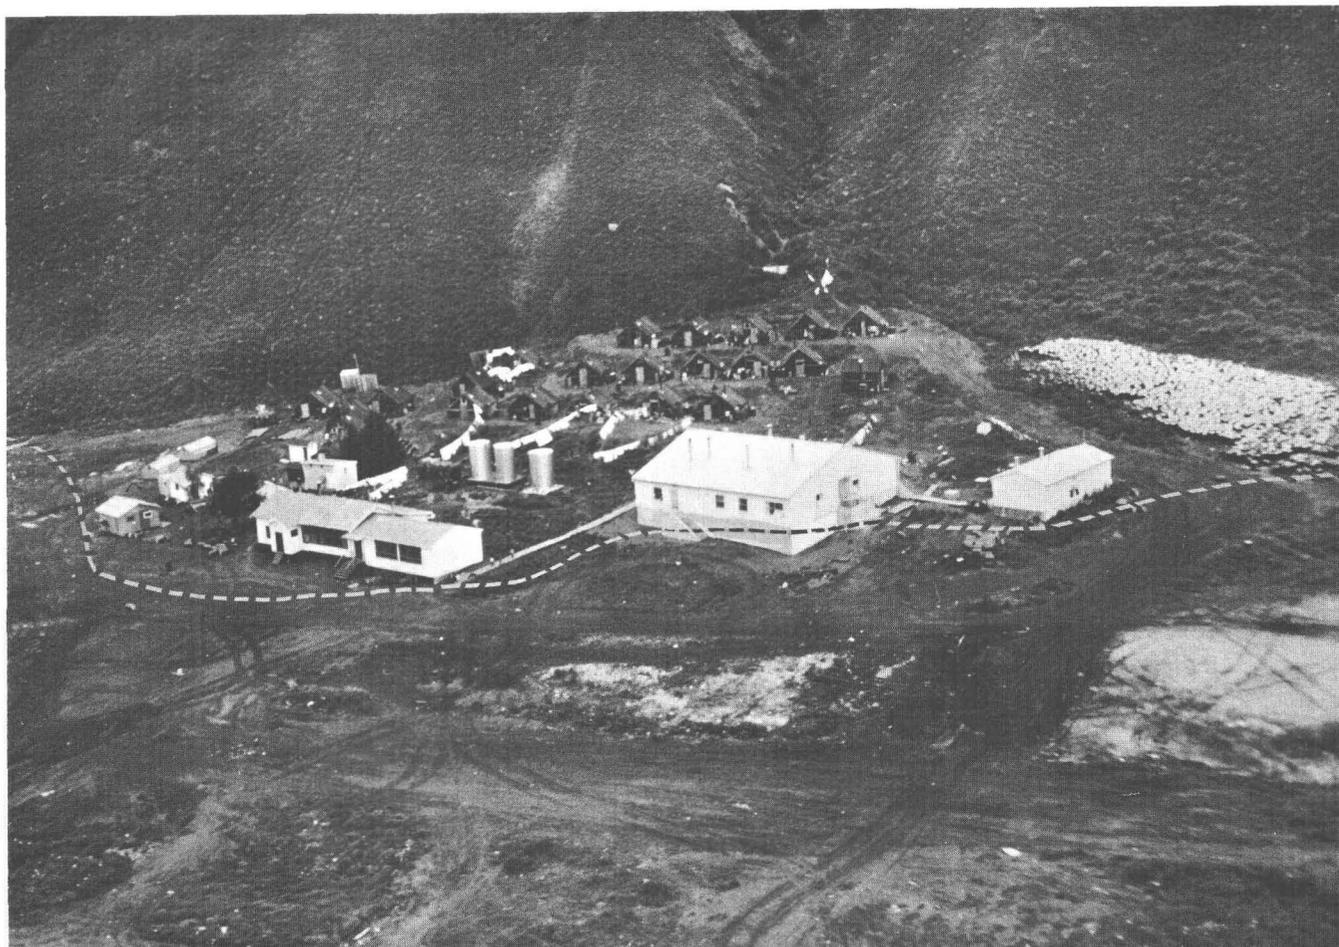
27.—Oblique aerial view of school area, Old Harbor, showing approximate inland limit of seismic sea wave inundation (dashed line). The area below the high-water line had been cleared of debris by the time this photo was taken (July 15, 1964). The structures near the apex of the alluvial fan are temporary shelters.

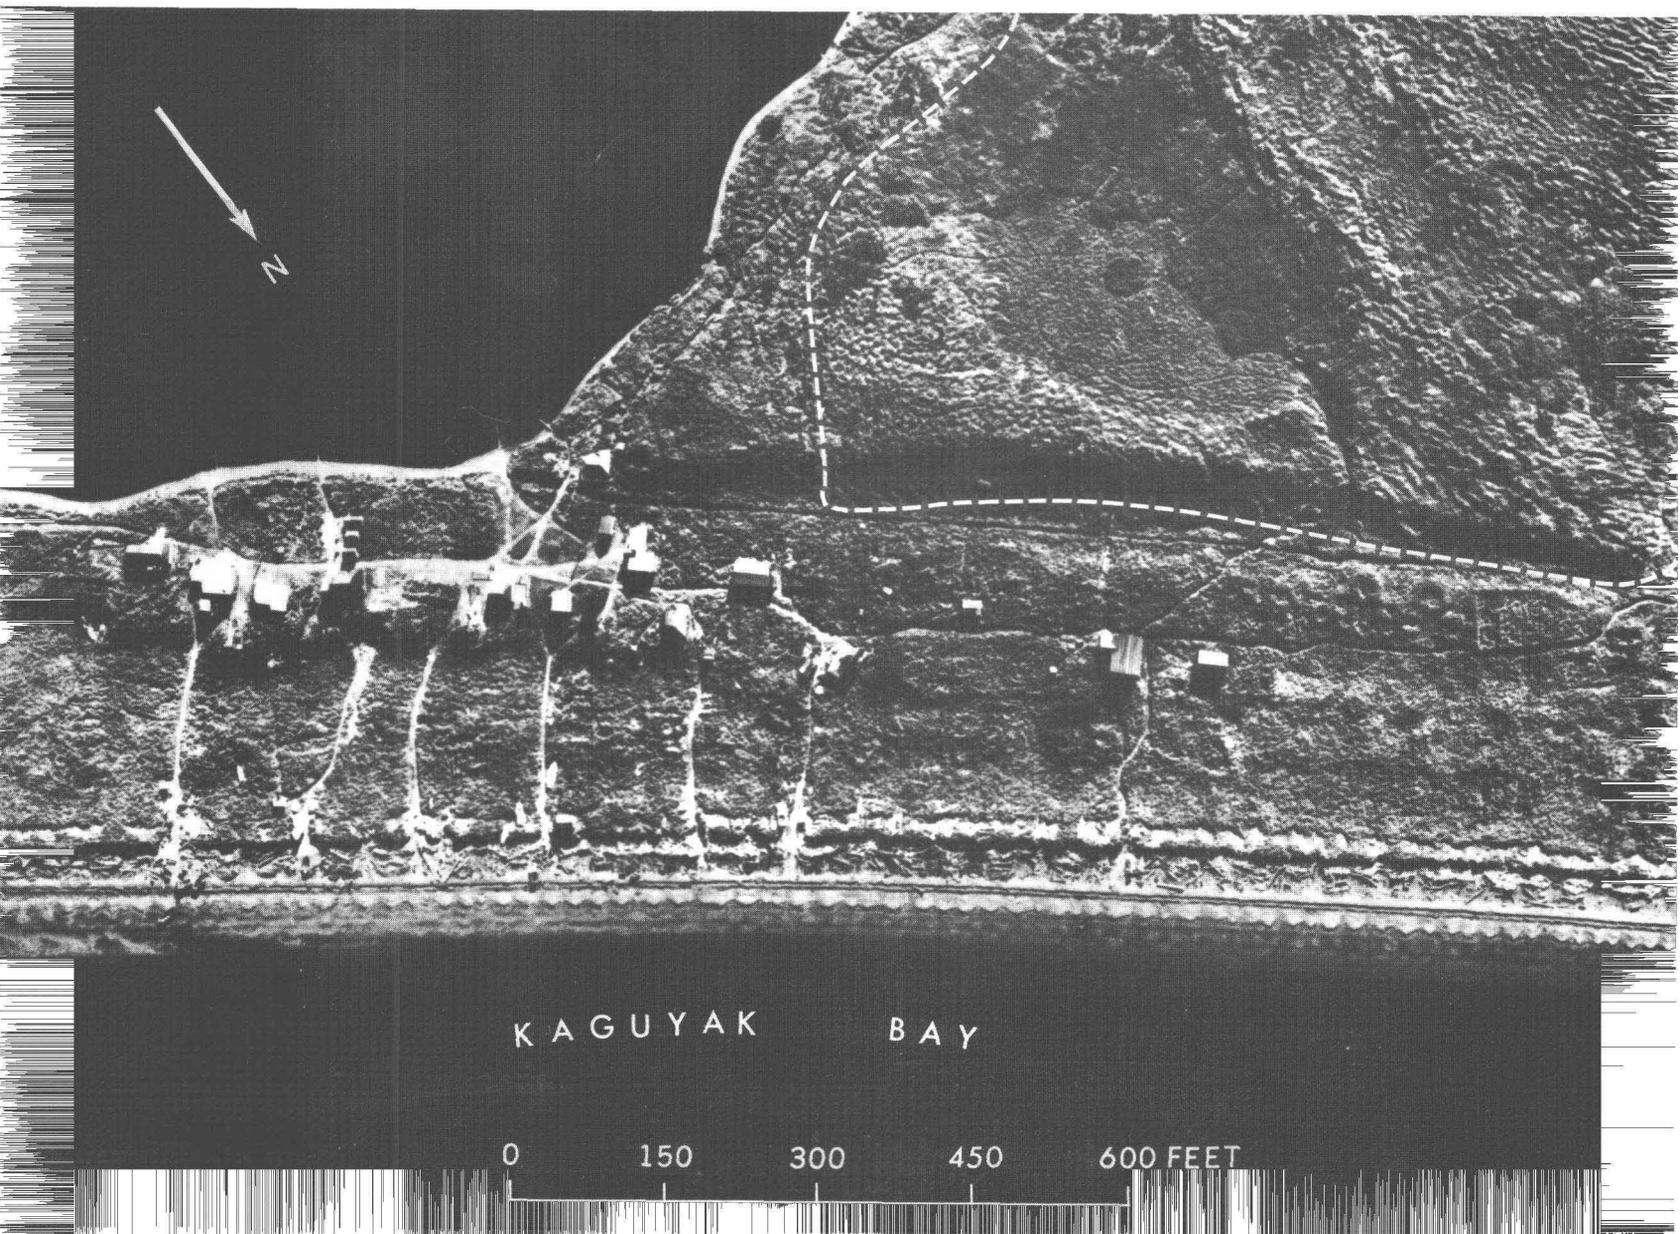
28.—Aerial mosaic of Kaguyak in 1962. Dashed line shows approximate inland limit of seismic sea wave inundation. Mosaic by U.S. Bureau of Land Management.

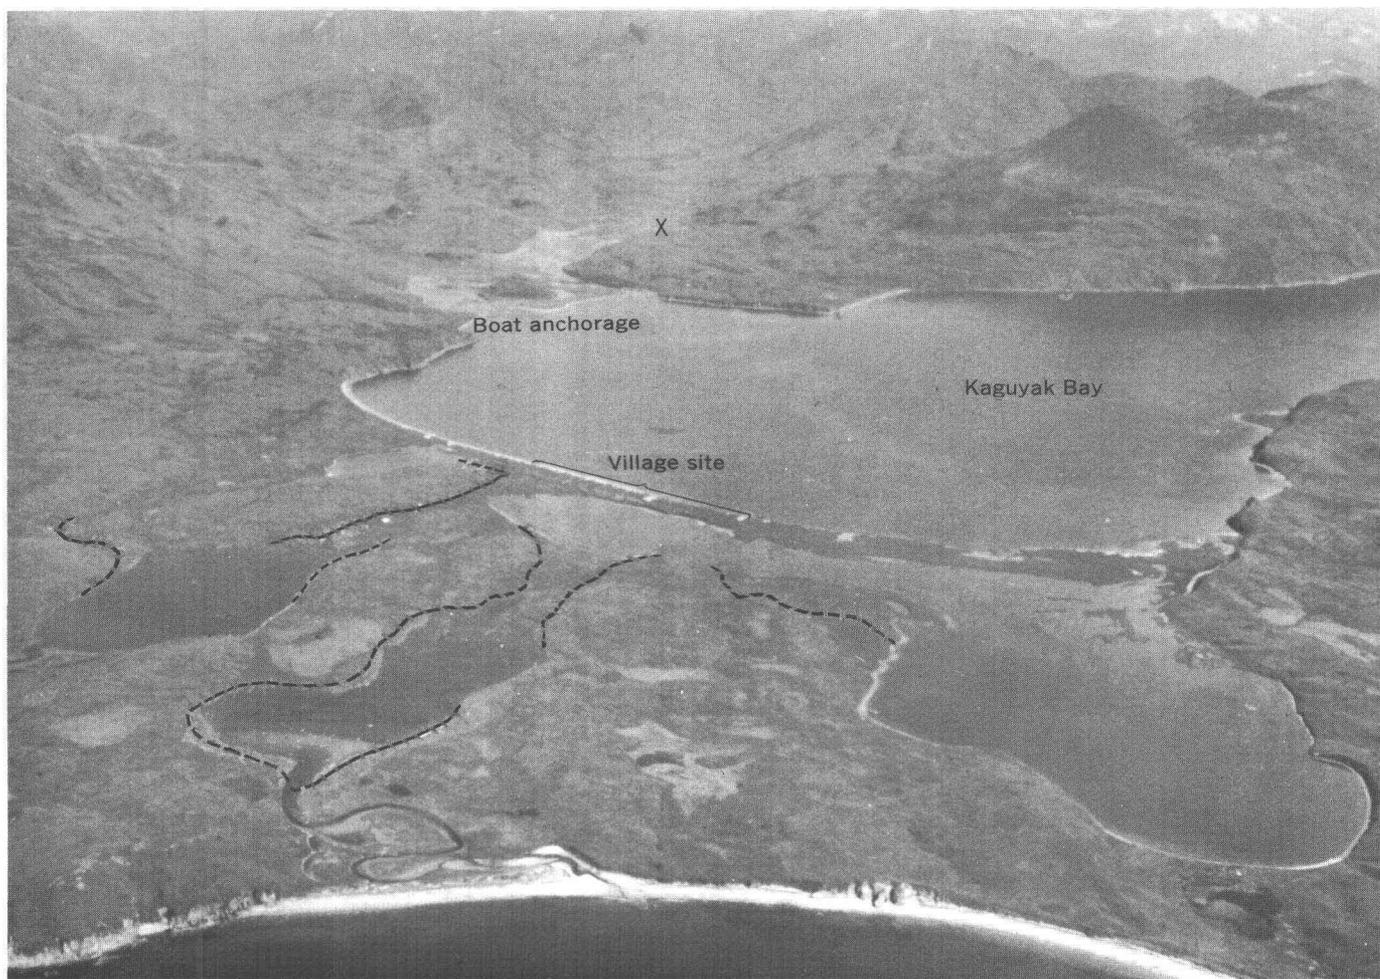
29.—Oblique aerial view of the head of Kaguyak Bay showing site of Kaguyak (fig. 28), approximate inland limits of debris deposited by seismic sea waves (dashed line), and location of small-boat anchorage. X marks position at which one 30-foot salmon trawler was stranded by the waves.

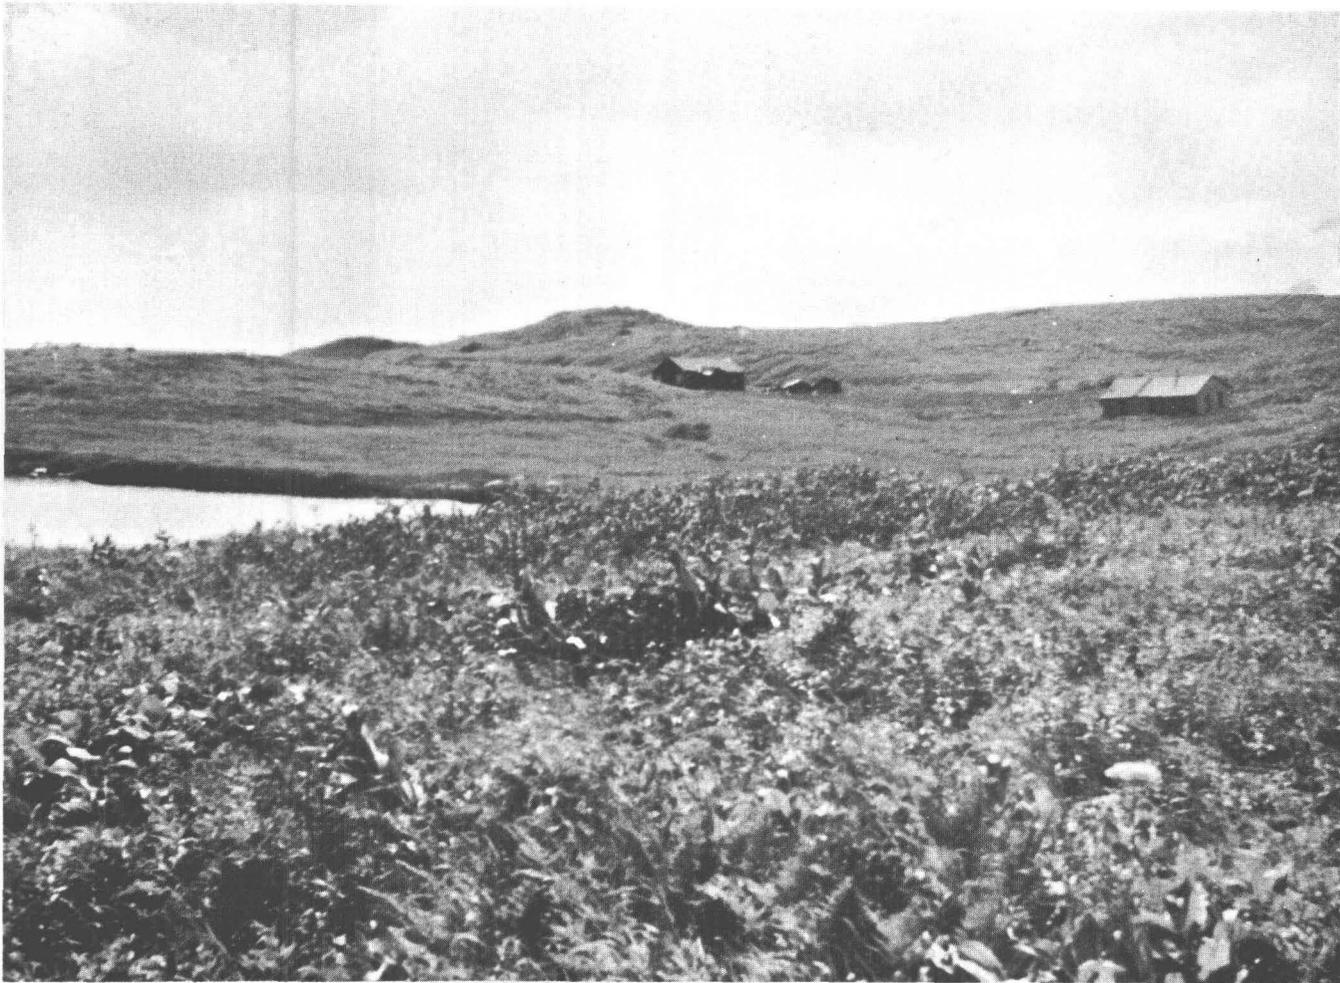
30.—Wood-frame houses that were floated inland from Kaguyak by seismic sea waves and deposited almost undamaged.
