# The Alaska Earthquake

March 27, 1964

Ground Breakage and  
Associated Effects in the  
Cook Inlet Area, Alaska,  
Resulting from the  
March 27, 1964, Earthquake

GEOLOGICAL SURVEY PROFESSIONAL PAPER 543-F

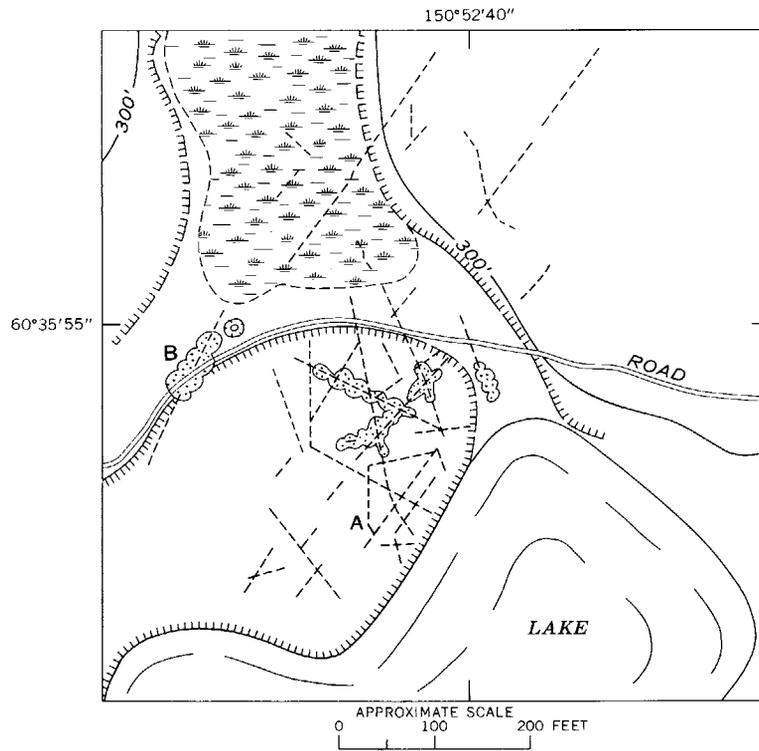
3.—Ground cracks (loc. 1, pl. 1), Kenai Lowland.

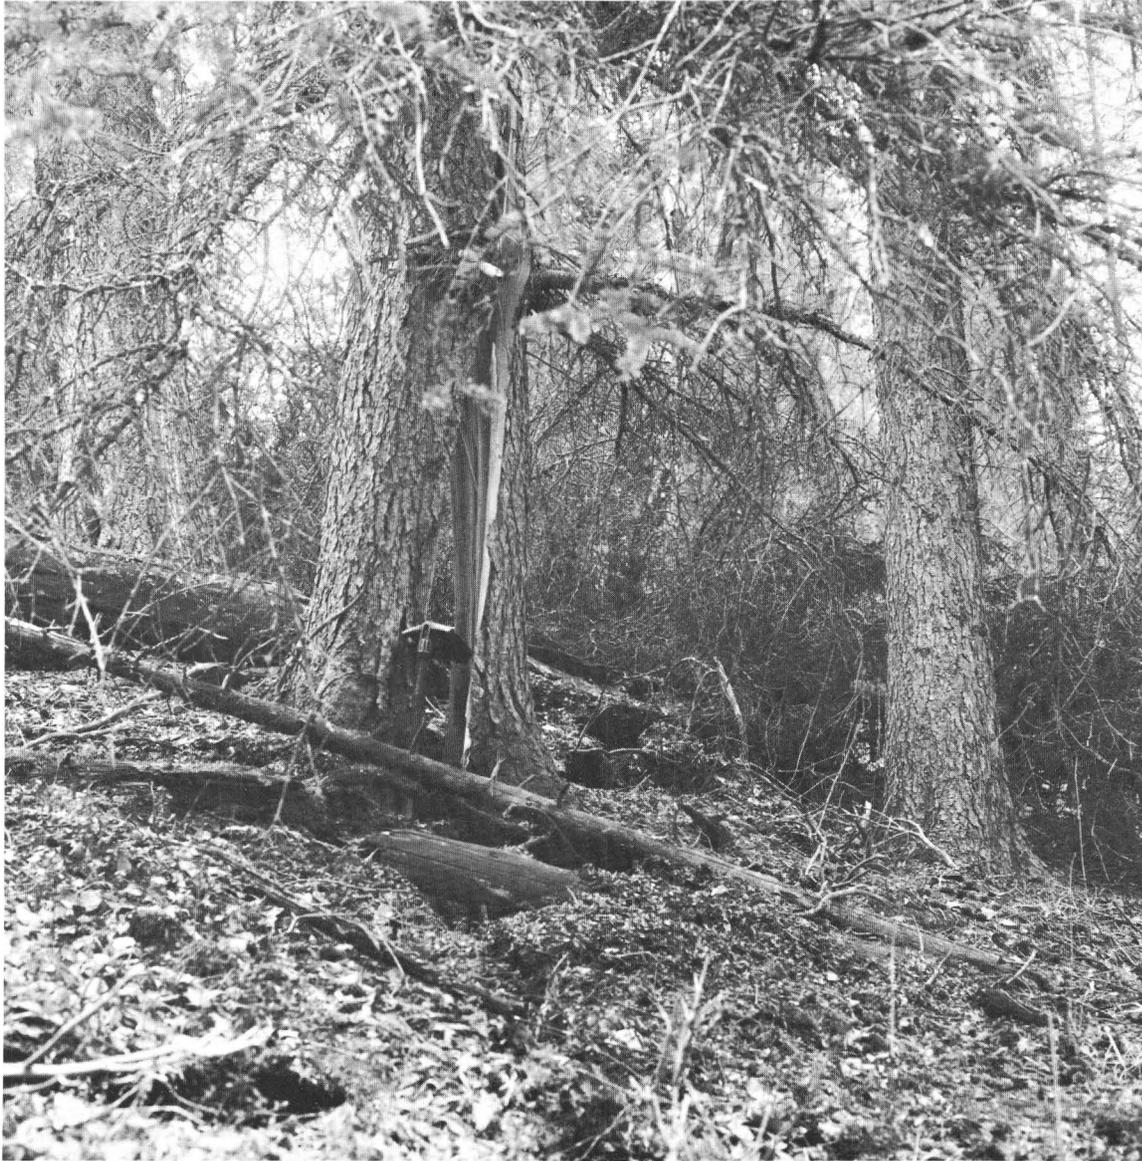
5.—Tree split by ground cracking (loc. 2, pl. 1), Kenai Lowland. The ground crack which trends into the split in the tree (loc. A, fig. 4) cuts across the top of a small knoll in moraine.

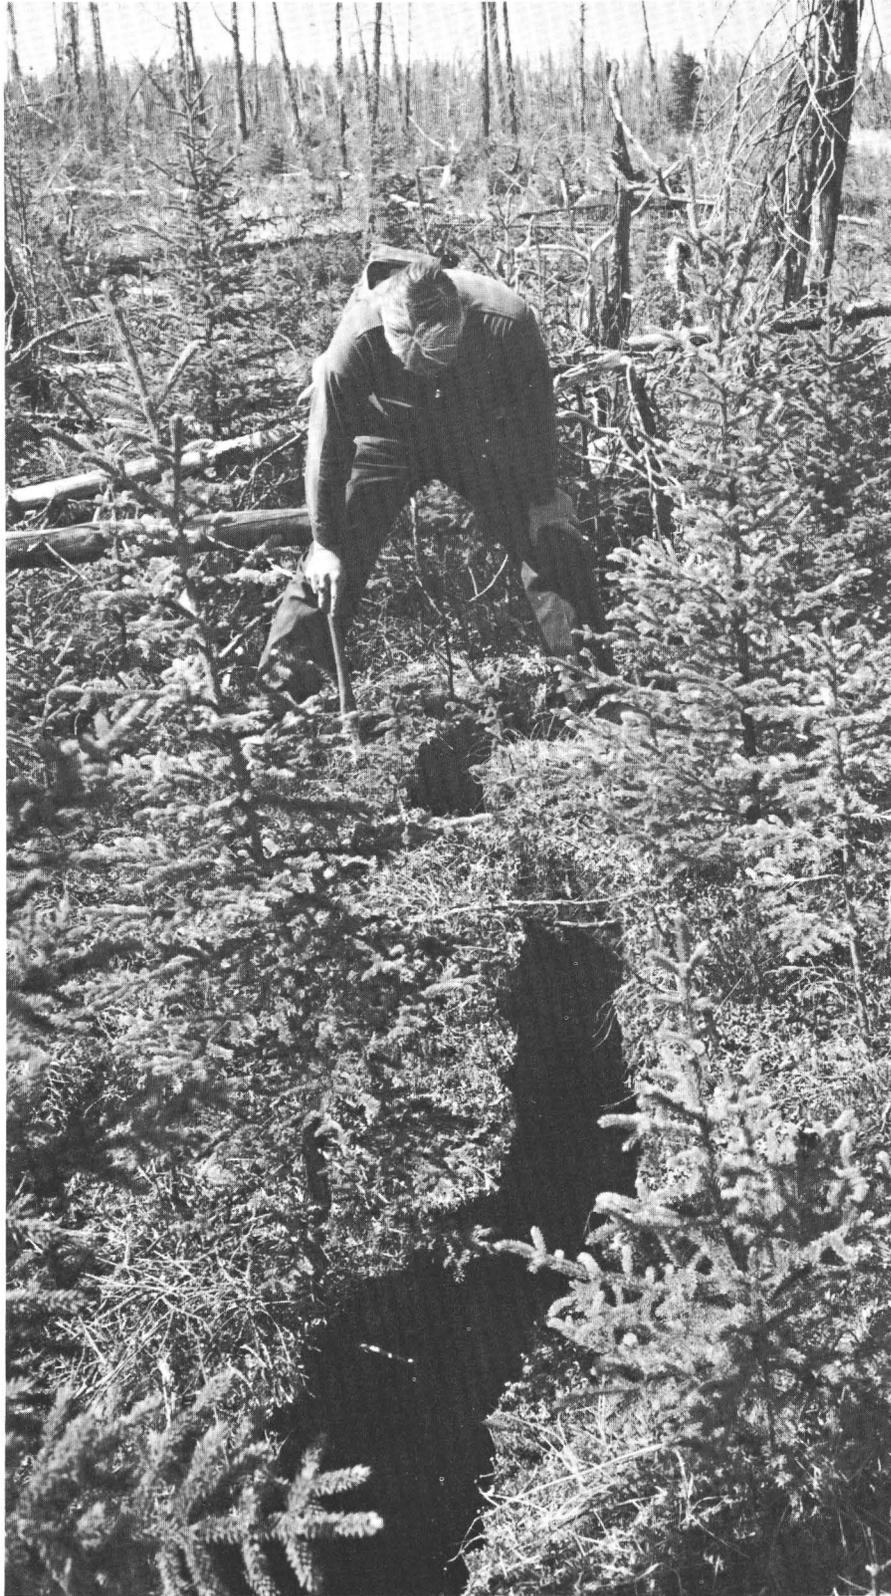
6.—Typical large ground crack (loc. 1, pl. 1), Kenai Lowland. Crack was 4 inches to 1½ feet wide; it cut a sand plain. Sand was not extruded along this crack (loc. A, fig. 3).

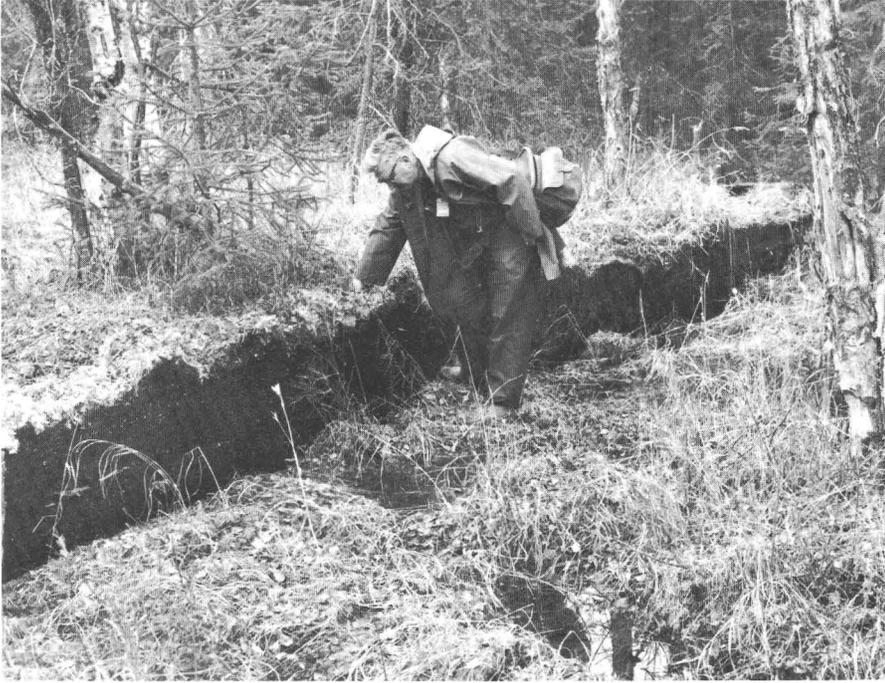
7.—Vertical displacement (loc. 2, pl. 1). A scarp more than 200 feet long and 2 to 3 feet high was produced in a thick section of frozen peat and organic silt (loc. B, fig. 4). Crack at the base of the scarp was 6 inches to 1 foot wide. Another crack intersects scarp at right angles; this displacement probably resulted from differential compaction and downslope extension of silty deposits in a muskeg bordering a small lake.

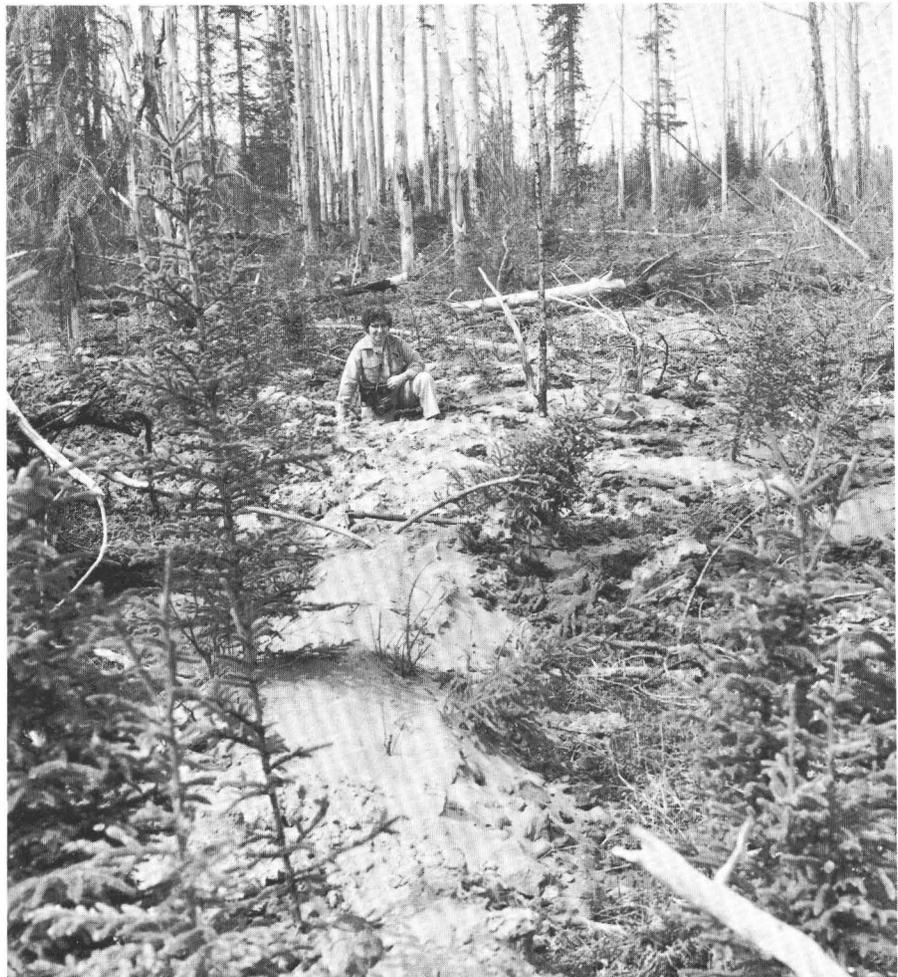
8.—Sand ridges deposited along a ground crack (loc. 2, pl. 1) by eruption of ground water during the earthquake. A sand ridge on the right side of the picture intersects the main ridge at nearly right angles. Person has right leg in deep crack (loc. C, fig. 4).

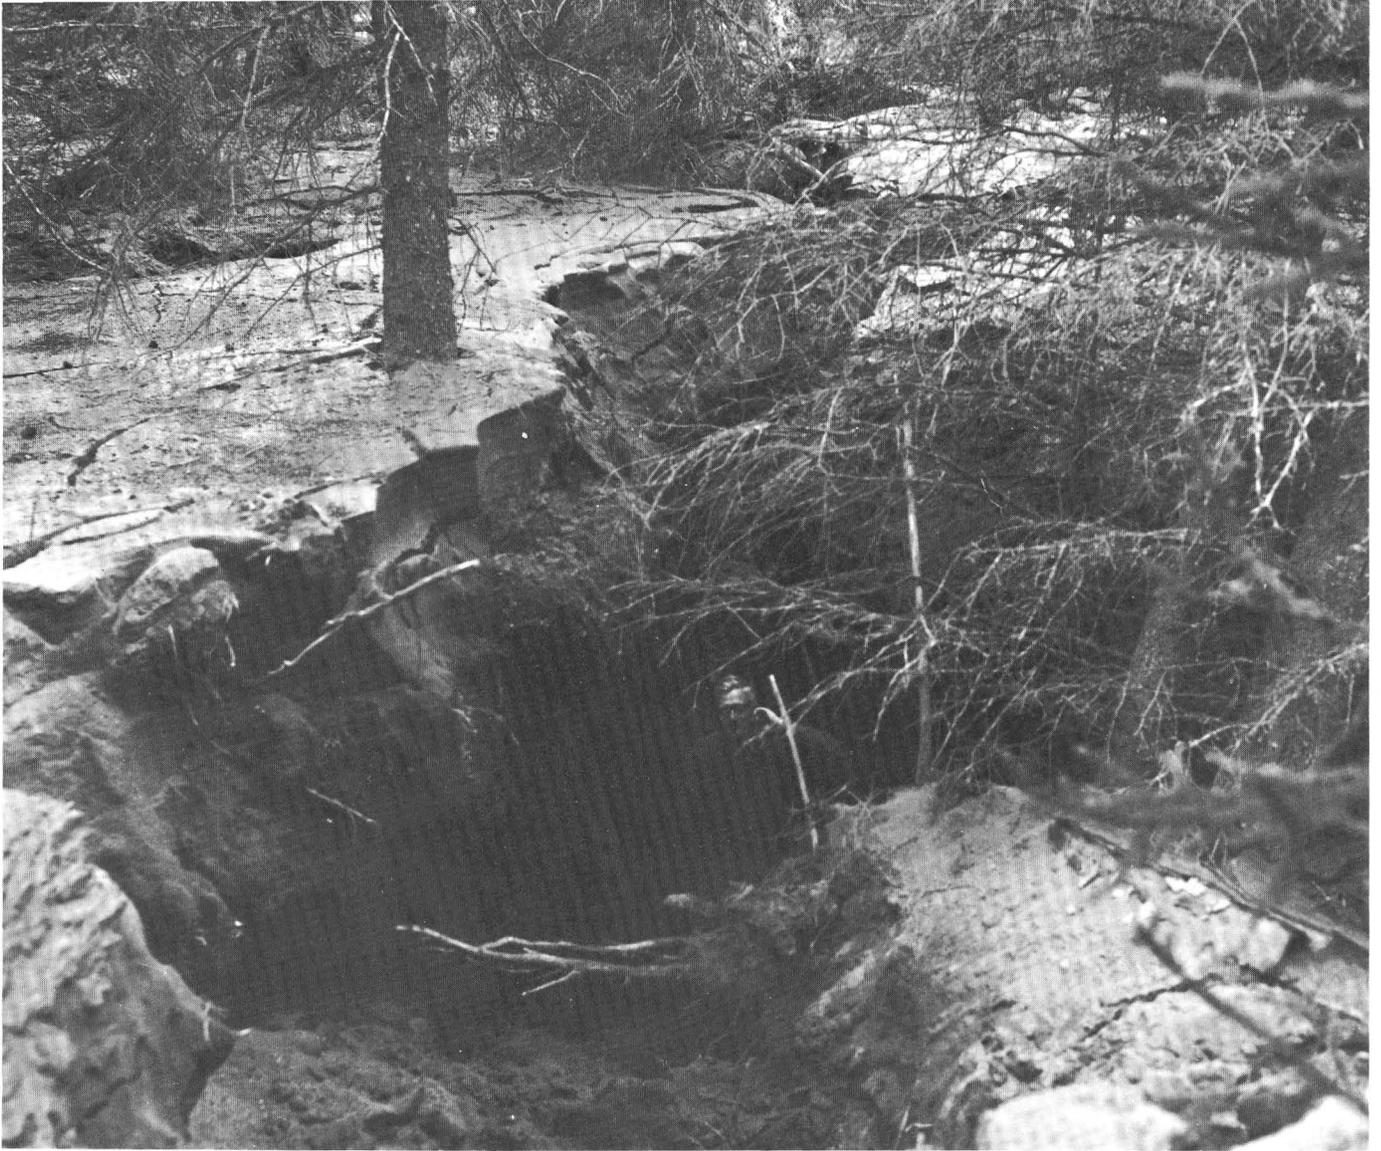
9.—Large fissure at locality 2 (pl. 1). This fissure was 25 or more feet deep and as wide as 20 feet in places. A thickness of 2 or more feet of sand which was extruded from the fissure can be seen around the tree. Photograph was taken at locality D (fig. 4).

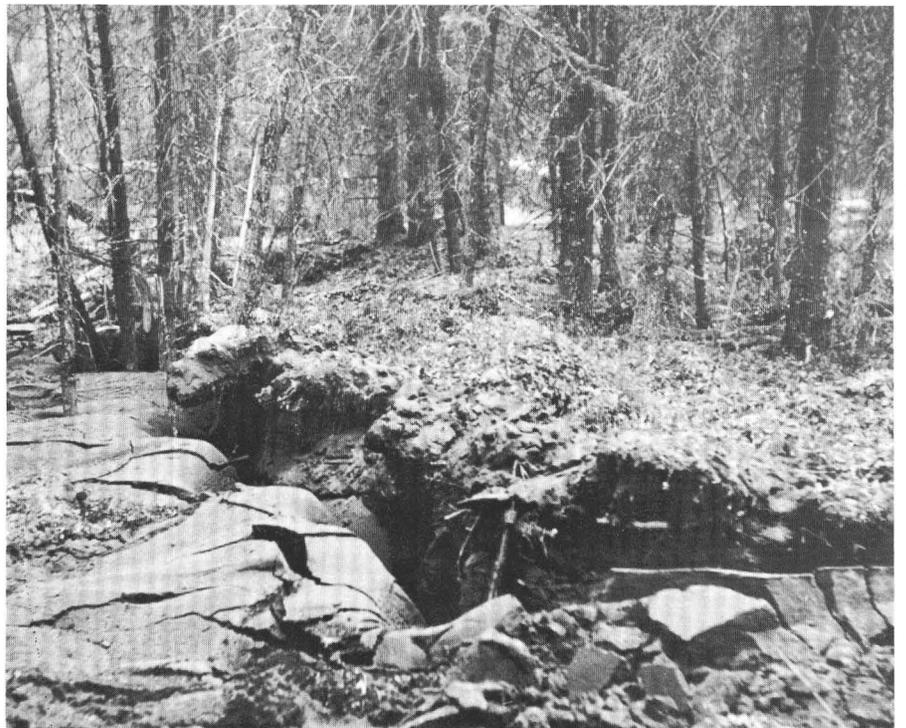
10.—Large ground crack with vertical displacement (loc. 2, pl. 1). Thick deposits of sand border the left side of the crack. Photograph was taken near E (fig. 4).

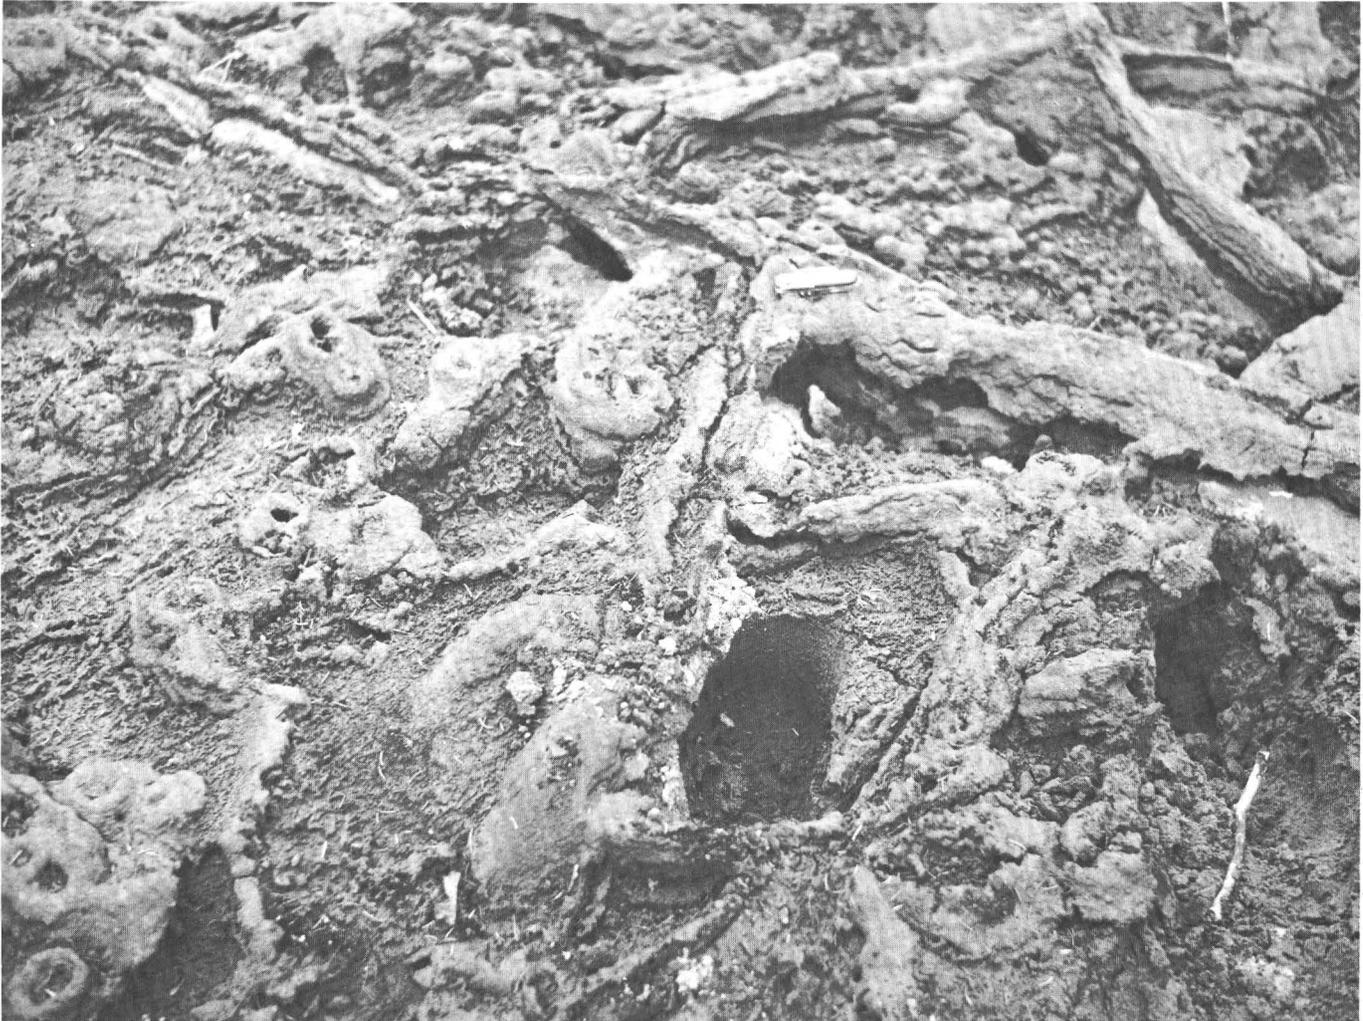
11.—Microrelief features formed in extruded silt (loc. 2, pl. 1). Area pictured is about 48 inches wide) 3-inch-long jackknife is slightly above center of picture). The delicate silt mounds and ridges were formed in the last stages of ground-water eruption on the surface of previous sand extrusions.

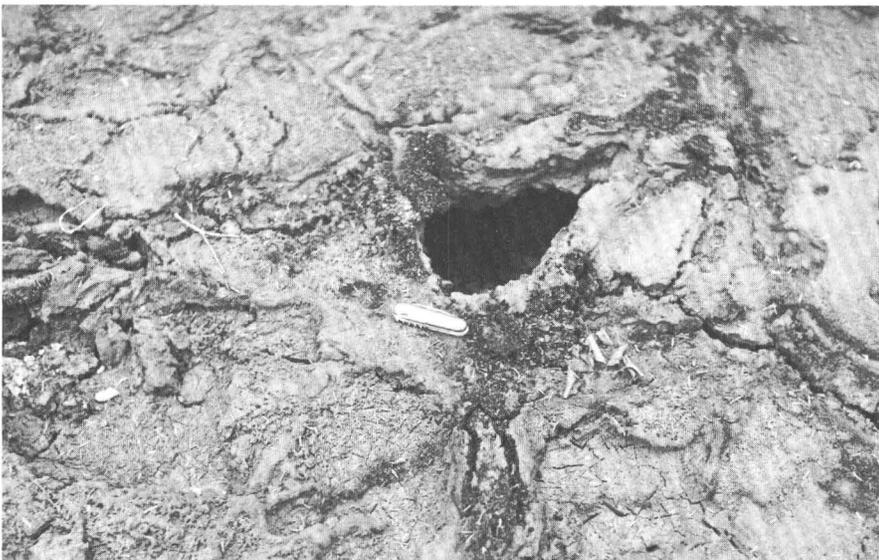
12.—Small vent which extruded watery silt (loc. 2, pl. 1). Jackknife is 3 inches long. Near locality D (fig. 4), watery silt from small vents such as this was extruded in the last stages of eruption and spread out over the top of previously erupted sand.

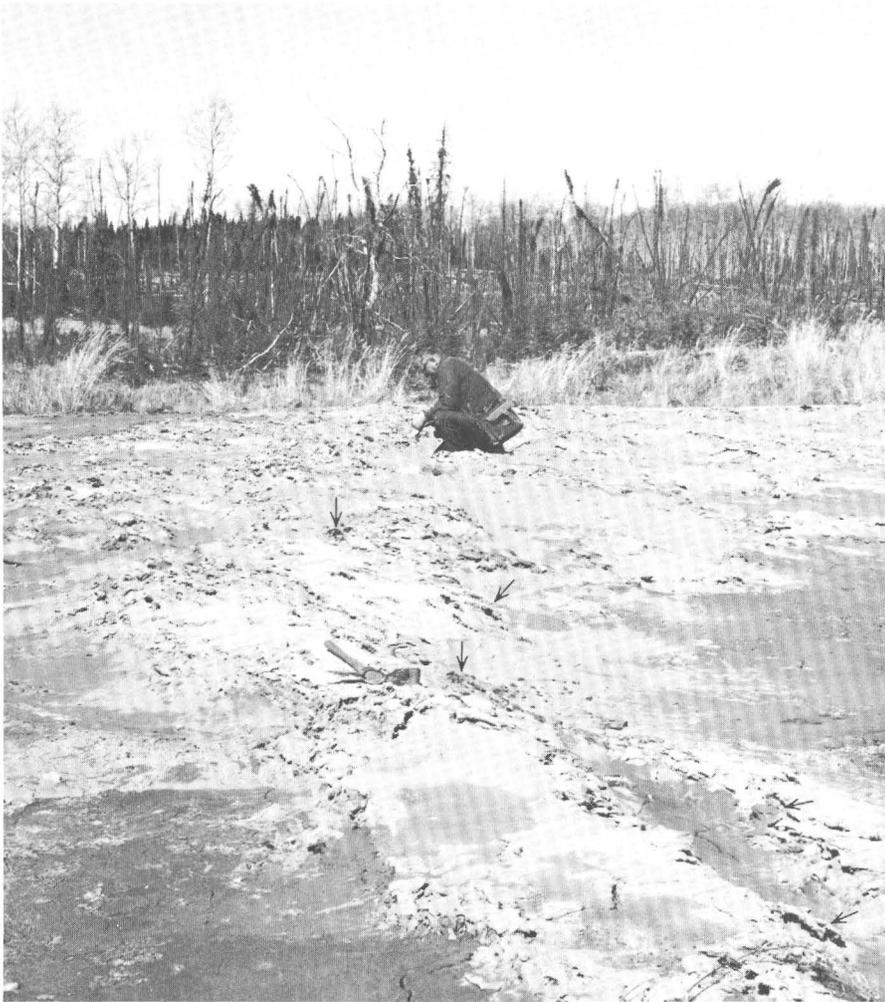
13.—Detrital coal extruded with sand (loc. 1, pl. 1). Copious amounts of sand were extruded from a fissure cutting a gravel road (loc. B. fig. 3). Pieces of coal and lignite as long as 6 inches (some indicated by arrows) were extruded with the sand.

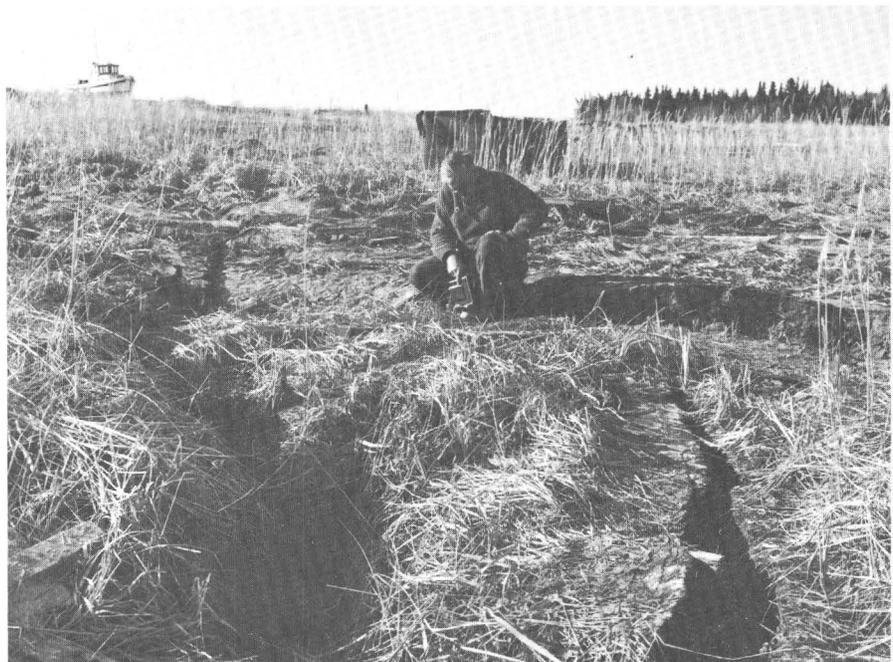
At Kasilof, which is approximately in line with the northeast-trending zone of ground breakage previously described (p. F3), cracks as much as 1 foot wide were formed. The cracks were traceable for several hundred feet and cut sand dunes and beach deposits at the coast (fig. 14). Crack walls were generally sharp—in fact, exceptionally sharp for occurrence in loose sand. Some had small vertical displacements as much as 10 inches high. They had the usual pattern of many branches and cracks intersecting from several directions. Collapse occurred along some cracks where large amounts of sand had been extruded (fig. 15). Pressure ridges a few inches high and 2 to 3 inches across were noted in silt on tidal flats; some radiated from a central point in several directions for distances of 25 feet or more.

14.—Ground cracks at Kasilof in elevated beach deposits. Cracks were as much as 1 foot wide. Vertical displacement is evident along crack near man. Considerable clastic coal was brought up from beneath the surface and deposited with the sand.

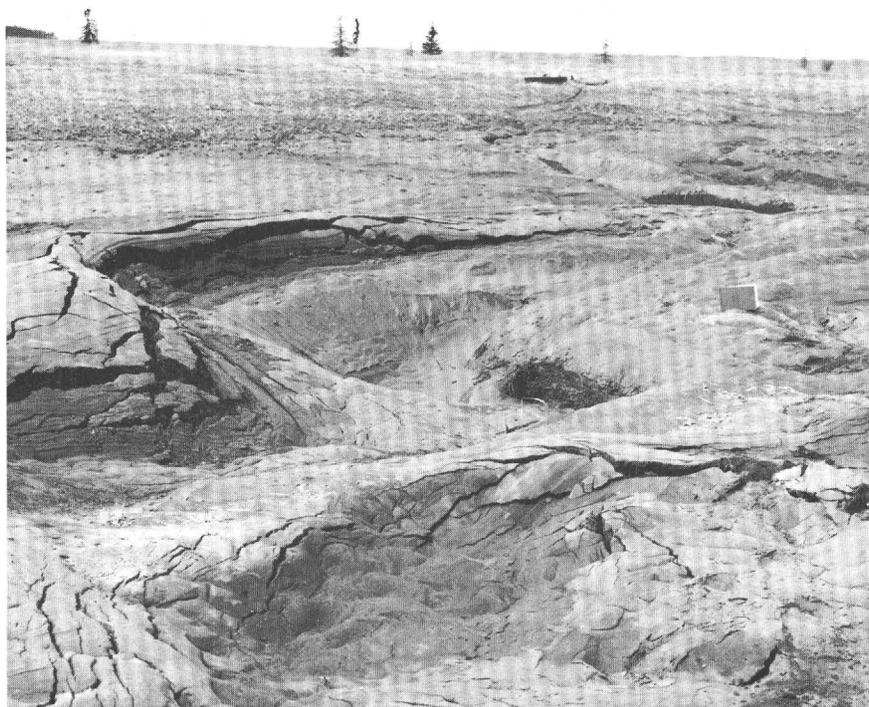
15.—Collapse pits at Kasilof formed after eruptions of ground water and sand. Pit in foreground is about 3 feet in diameter. Erupted sand covers the ground. A large crack extends from the pits in the middle background.

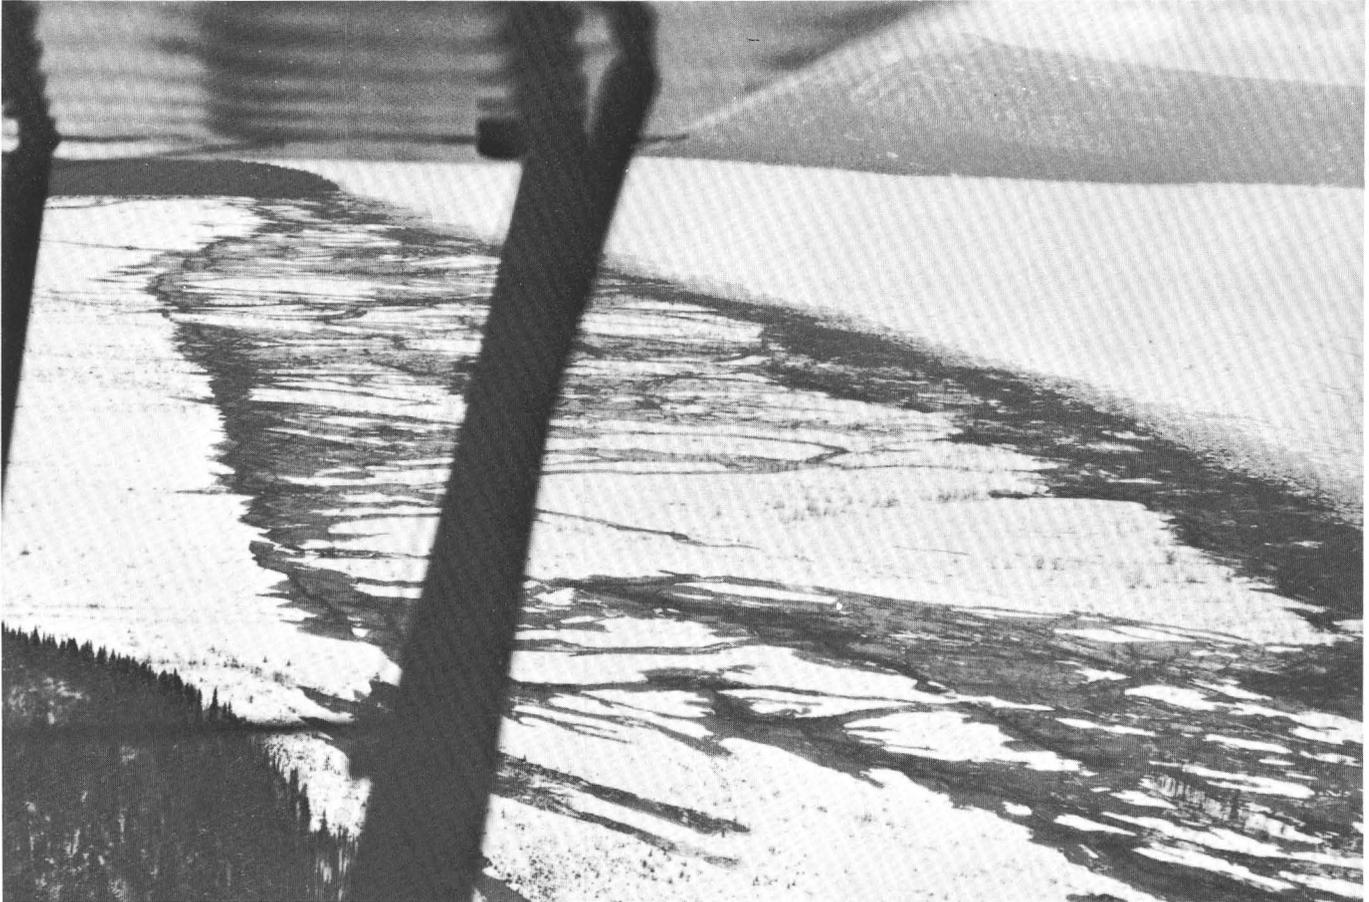
Photographs obtained after the earthquake (fig. 16) indicate that a major zone of fissures oriented N.  $5^{\circ}$ – $10^{\circ}$  W. formed subparallel to the southern delta front about half a mile from the lake shore. This break defined the inland margin of the part of the delta most disrupted by the earthquake. Much sand was extruded along this fracture zone and flowed out upon the snow-covered surface (fig. 16).

16.—Outwash delta at head of Tustumena Lake a few days after the earthquake. View is south (pl. 3). The ground was snow covered, and water and sand erupted along major cracks (dark-gray areas) partly removing the snow and covering the ground surface with sand. The cracked ice-covered lake surface is to the right. A major fissure system paralleling the delta front is seen to the left of center. Photograph by Avery Thayer, Fish and Wildlife Service, Kenai, Alaska.

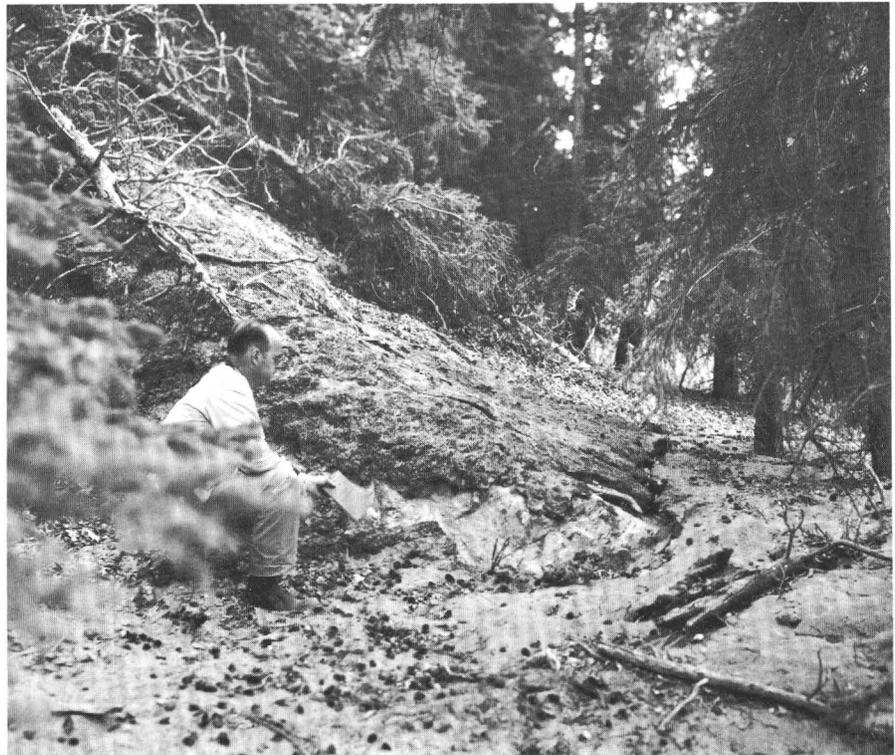
The ground cracks in the outwash delta ranged in width from a fraction of an inch to 4 feet (fig. 17). Most cracks showed no vertical displacement, but a few indicated subsidence of several inches to  $1\frac{1}{2}$  feet on the lake side. Little overall evidence of subsidence of the delta front was observed, and it is estimated to have been less than 10 feet.

17.—Crack between delta front and bedrock at Tustumena Lake (loc. A. pl. 3). A wedge of outwash deposits pulled away from the stable bedrock face during the earthquake shaking.

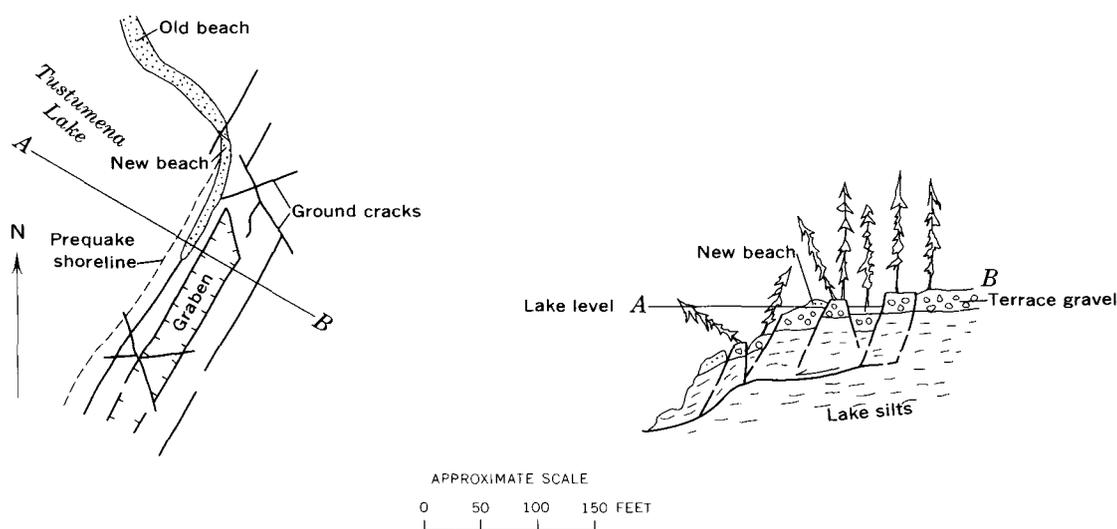
18.—Diagram showing type of ground disruption on the north shore of Tustumena Lake (loc. 3, pl. 1).

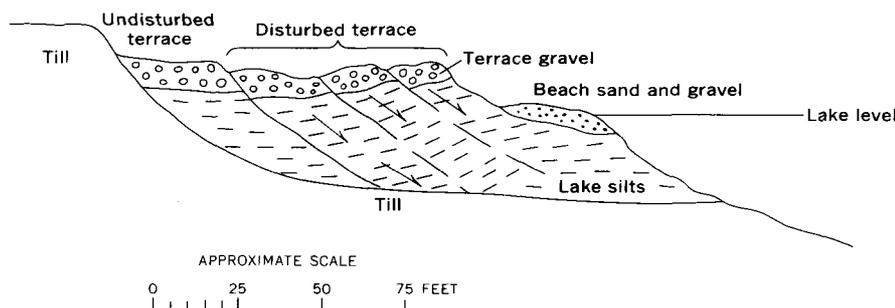
19.—Diagram showing a type of slumping on the south shore of Tustumena Lake (loc. 4, pl. 1).

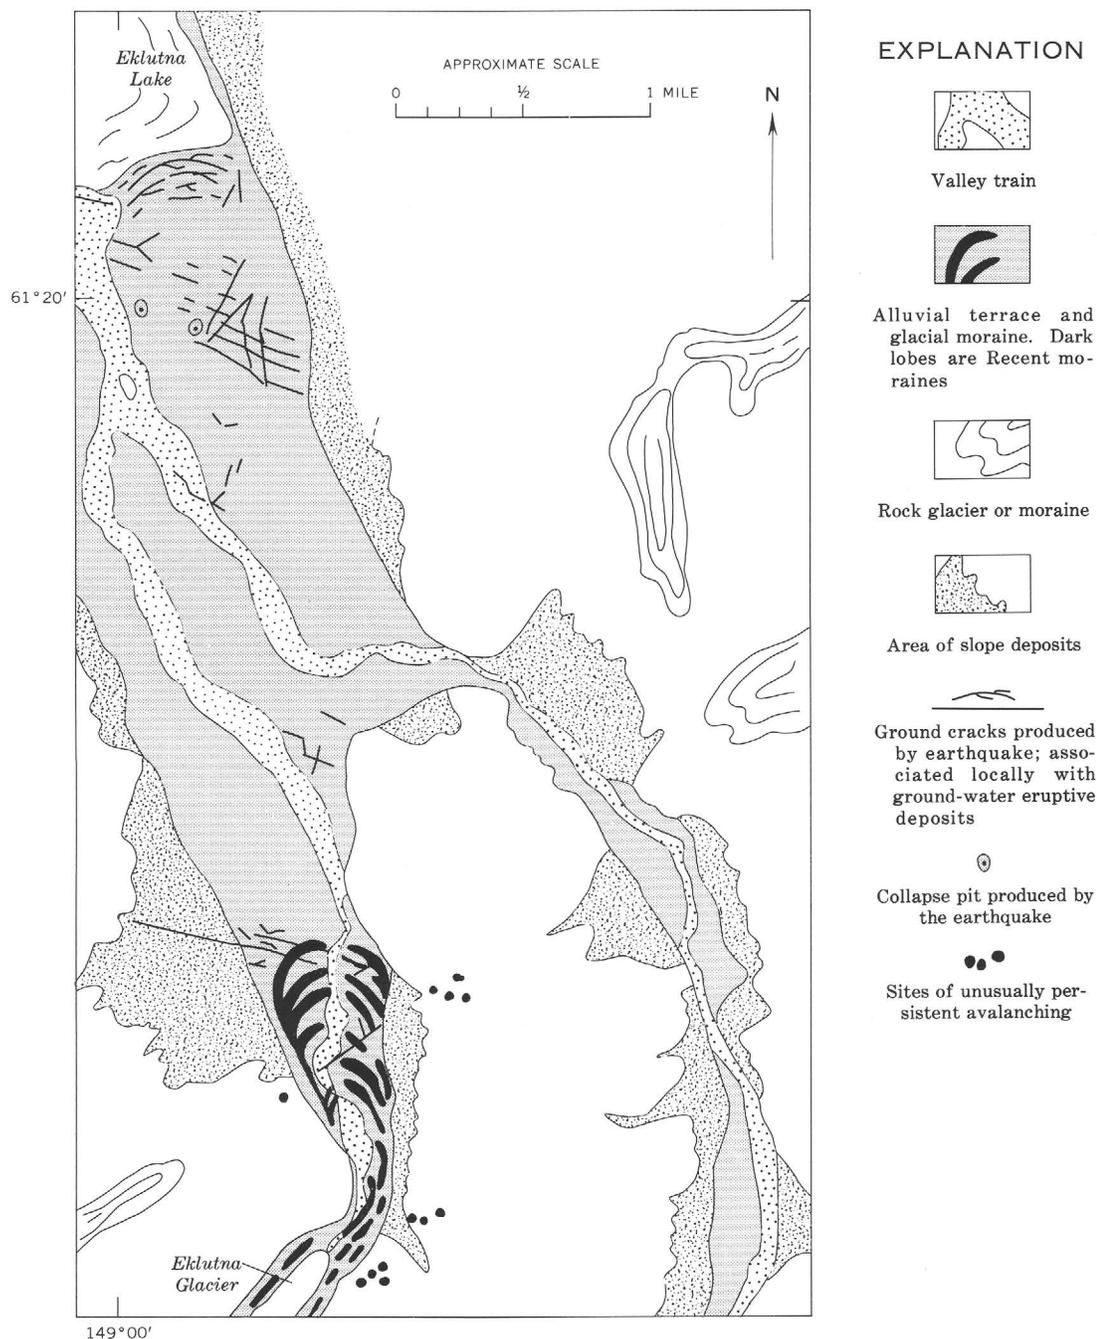
20.—Sketch map of Eklutna valley showing sites of persistent avalanching and location of ground breakage.

In the early part of the summer of 1964, rock debris cascaded nearly continually from three principal places on the steep high cliffs above Eklutna valley (fig. 20). Talus cones at the base of the cliffs were much enlarged (fig. 21). Dense dust clouds emanated from the avalanches and resulted in erroneous reports of volcanic eruptions when spotted by airplane pilots (figs. 21, 22). Later in the summer, several of the avalanches became inactive, and by August 1965 activity was largely

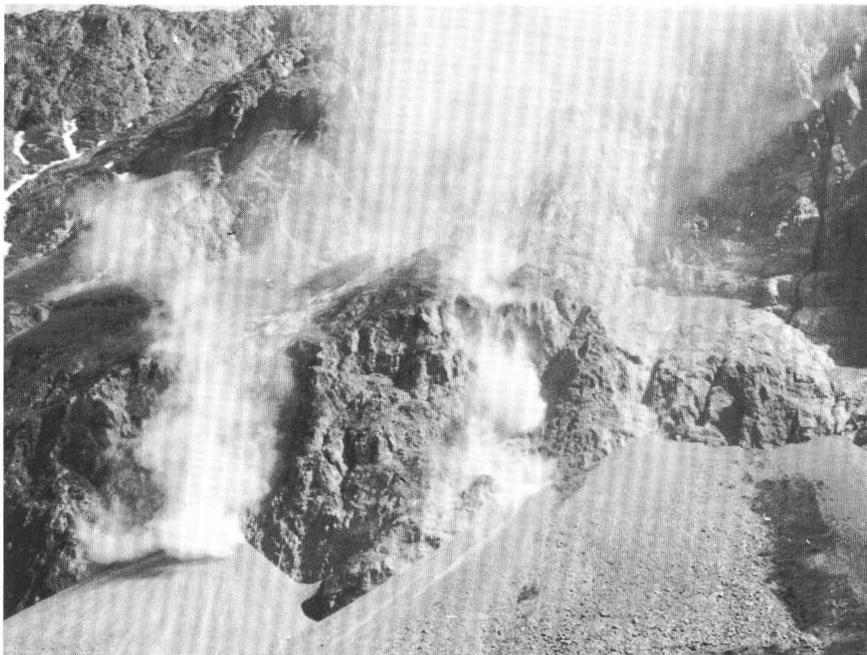
21.—Sites of avalanche activity in Eklutna valley. These talus cones were present before the earthquake but have been enlarged by avalanche activity since the earthquake. The dust clouds are created by the avalanching.

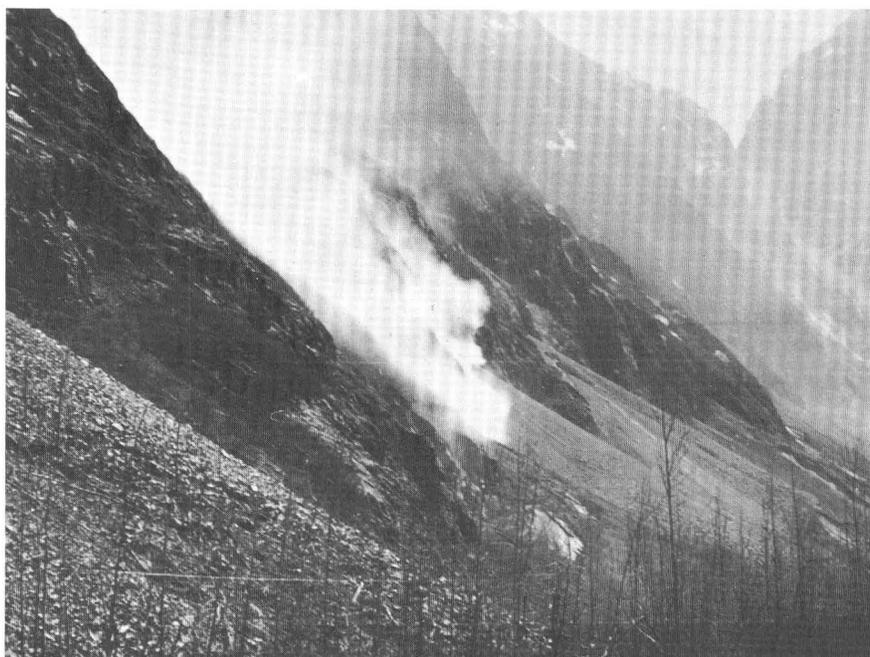
22.—Dust cloud in Eklutna valley caused by avalanche activity. The avalanching has been persistent during the summers since the earthquake.

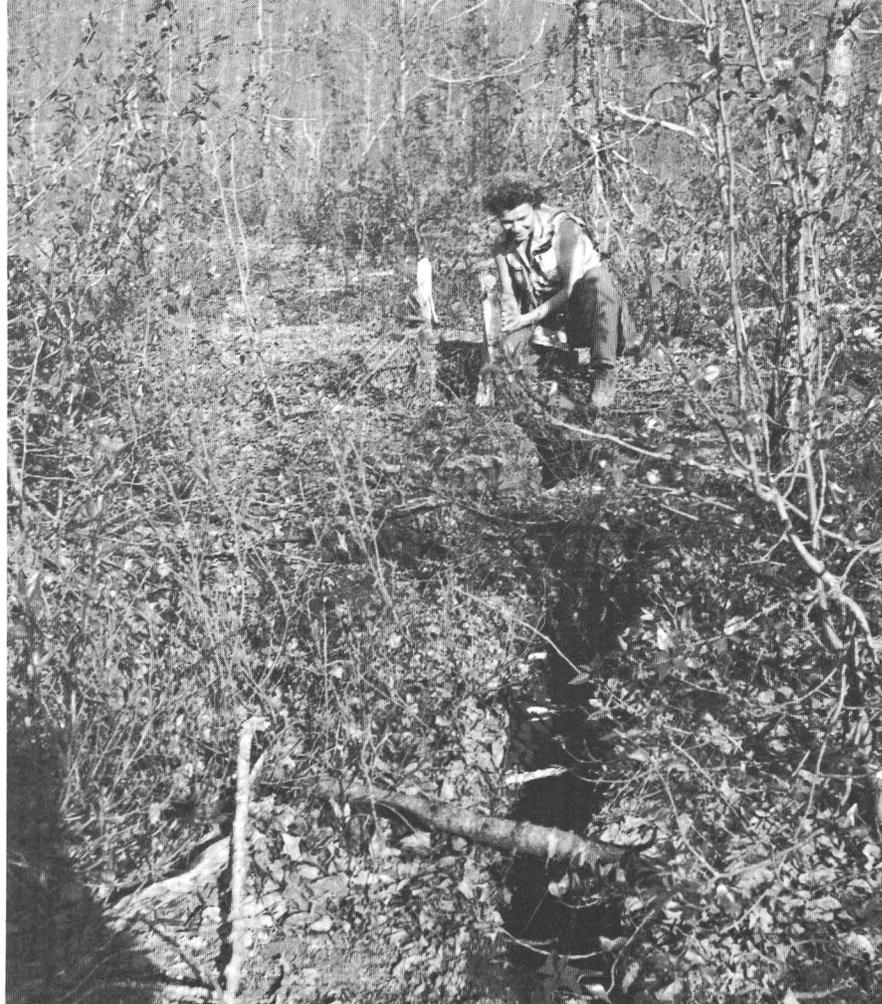
23.—Crack in gravel outwash in Eklutna valley. Crack was about 10 inches wide and split a tree stump. The two halves of the stump were offset about 14 inches.

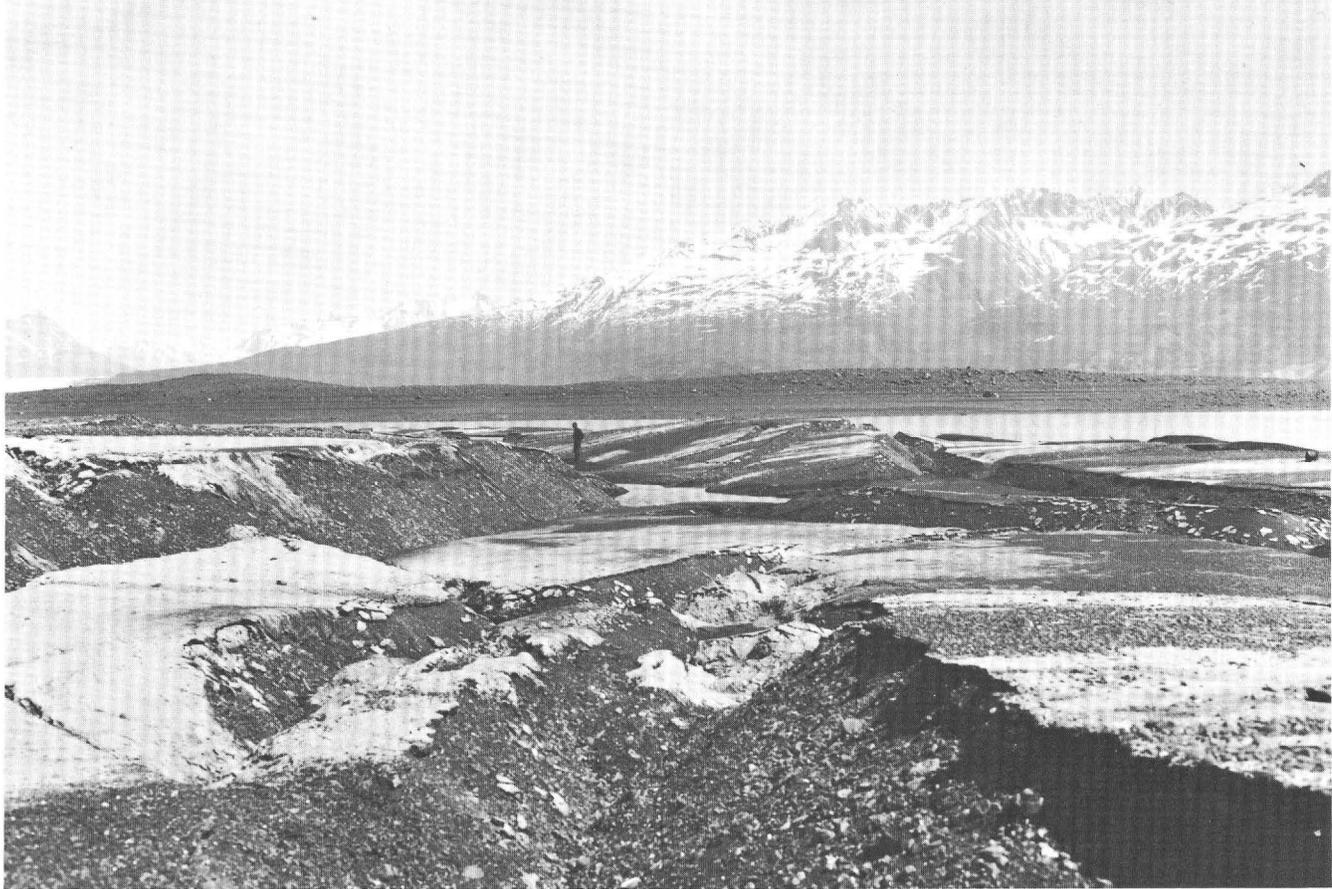
cracking associated with eruptive deposits of emerged bottom sediments at the head of the lake. The most extensive disruption occurred along the front of the Troublesome Creek delta where slumping caused lakeward rotational displacements of frozen gravel blocks as much as 20 feet wide and 100 feet long. Chaotic topography resulted (figs. 24, 25). The delta at the mouth of a creek entering the south end of upper Lake George failed by cracking along the margin of the delta front. Lateral extension, however, was slight, minor vertical or lateral displacements being evident along the cracks.

24.—Failure of the delta front at Troublesome Creek, Lake George (loc. C, fig. 25). Man is standing on a large slumped and rotated block that is bounded front and back by large fissures.

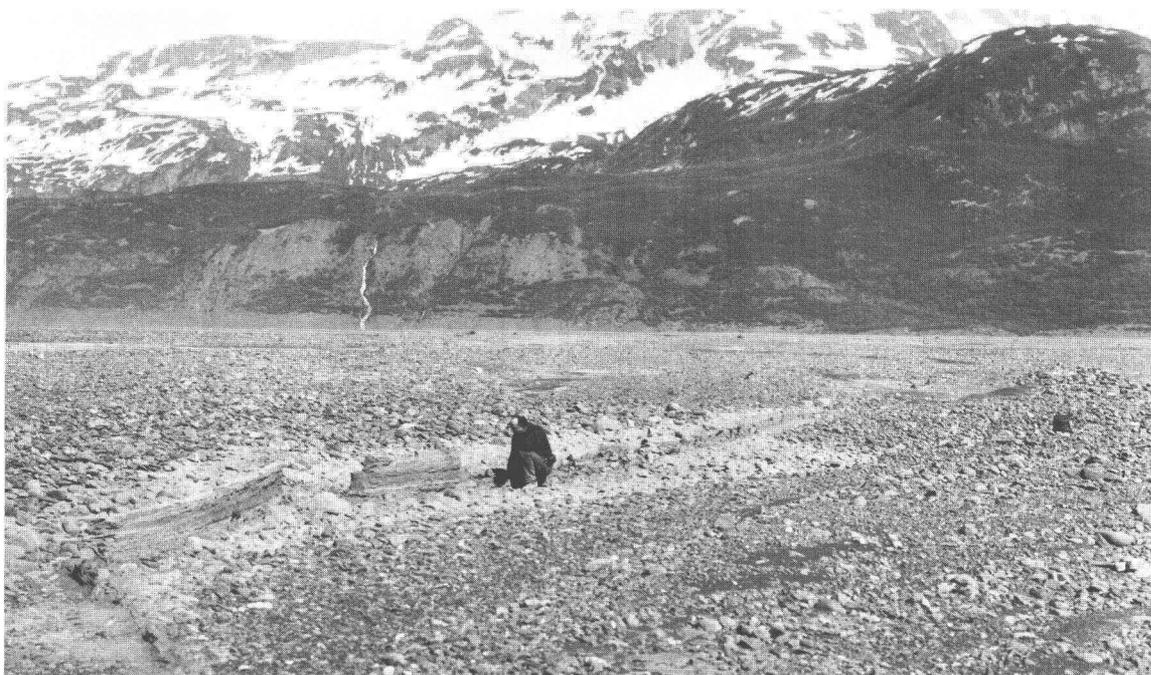
26.—Wall of silt punched up on the emerged bottom of Lake George. The wall was 8 to 24 inches high, 30 feet long, and 6 inches wide (loc. B, fig. 25).

Lake silt was squeezed out of the underlying water-saturated sediments and erupted through cracks in the seasonally frozen surface layer. At one locality a wall of frozen silt, 6 inches wide and about 30 feet long, was punched up 8 to 24 inches by pressures in the underlying unfrozen materials during the earthquake (fig. 26). The undisturbed structure of the fine laminated silts exposed in the wall indicated that the silt must have been rigid and frozen at the time of displacement. Disruption and minor dislocation of the wall along northeast-trending cracks indicate subsequent development of and minor displacements along cracks that cut transversely the northwest set of parallel fractures that defined the wall structure itself. At several locations, mounds of silt 1 to 2 feet high and 2 to 3 feet in diameter and showing internal flow structure formed at the intersection of the cracks. Unfrozen silt was squeezed up as ridges along some of the cracks (fig. 27). On the north side of the moraine along the south side of lower Lake George, some sand eruption occurred at the contact of the moraine with the lake sediments through cracks transecting the moraine.

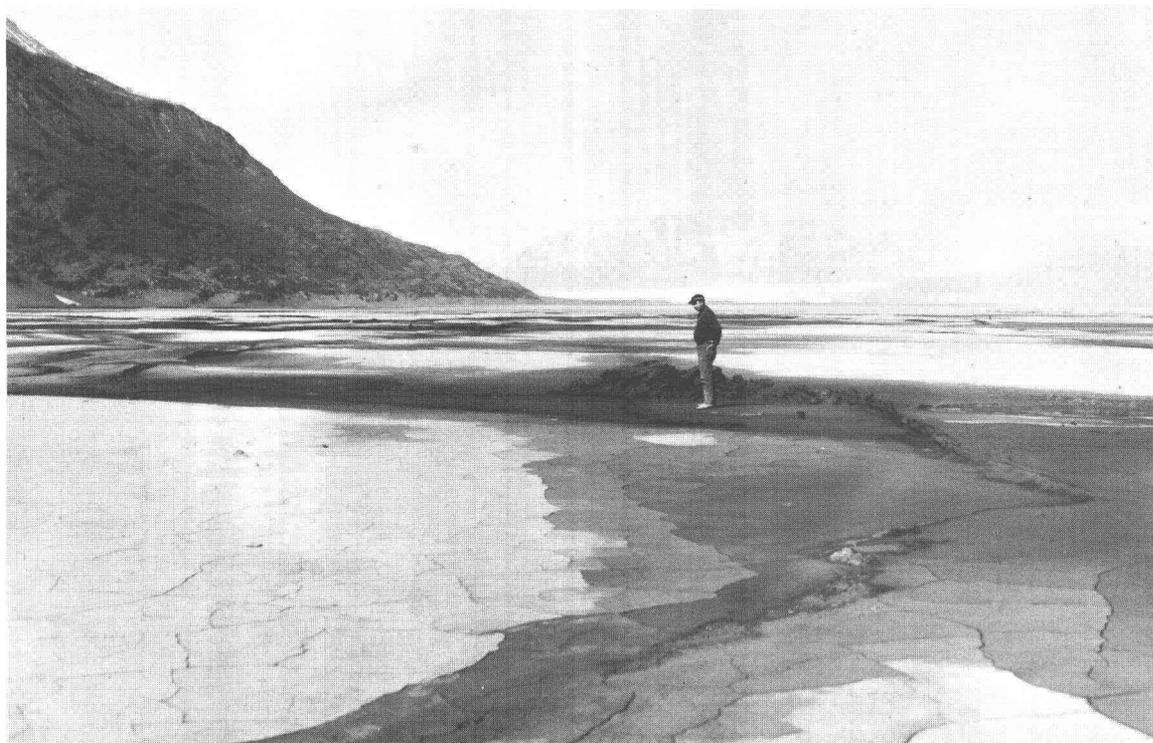
27.—Ridges of silt squeezed up along cracks in the emerged bottom sediments of Lake George (loc. A, fig. 25).

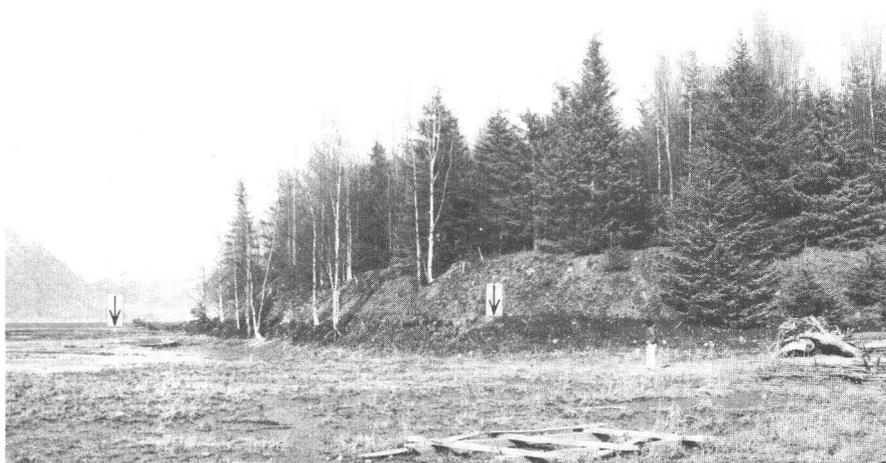
28.—Postearthquake high-tide mark along Turnagain Arm sea bluffs near Hope. Arrows indicate the pre- and postearthquake high-tide positions. The vertical distance of about 5 feet between these two positions approximates the amount of crustal subsidence that accompanied the 1964 earthquake.
