A Hydrologic Assessment of the September 14, 1974, Flood in Eldorado Canyon, Nevada

GEOLOGICAL SURVEY PROFESSIONAL PAPER 930

By PATRICK A. GLANCY *and* LYNN HARMSSEN

*A presentation of hydrologic data and interpretations,
eyewitness accounts of destruction,
and documentation of flooding*

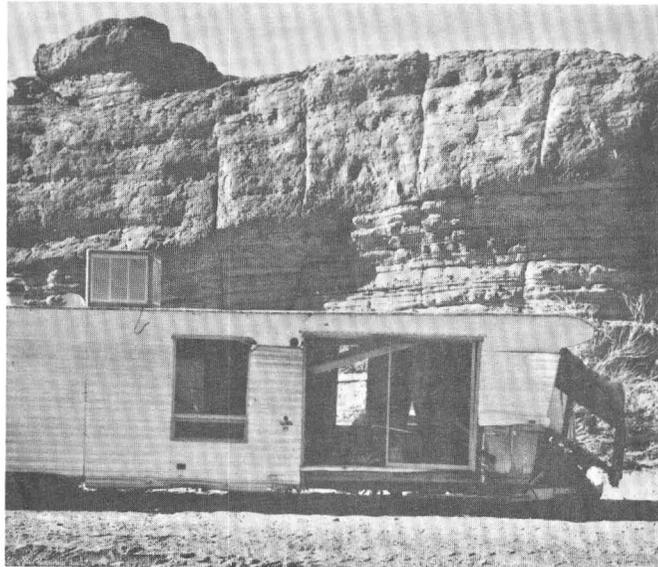
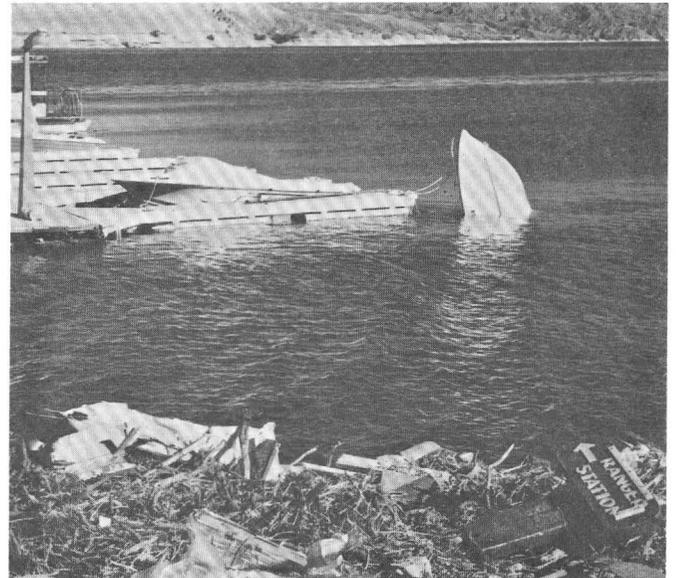
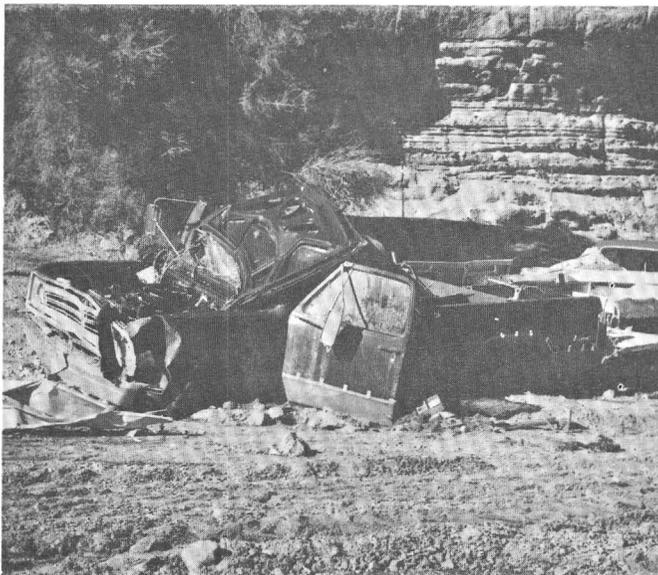
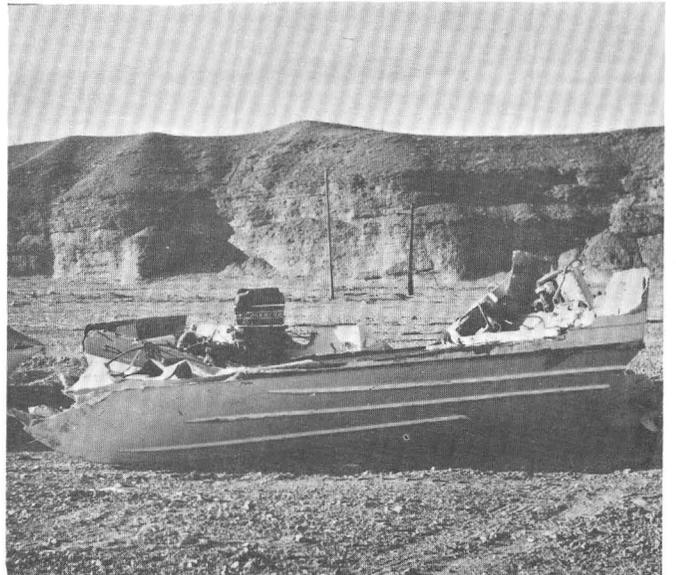
The restaurant was totally destroyed. Five trailer houses were totally destroyed, some have not been found, and a number of others were seriously damaged. Nine cabins near the base of the north canyon wall were destroyed, and 38 vehicles and 19 boat trailers were lost. Twenty-four boat-docking slips were obliterated and 23 boats were lost. Figure 12 shows changes to the boat

FIGURE 1.—Flood-damaged trailer, truck, and boats.

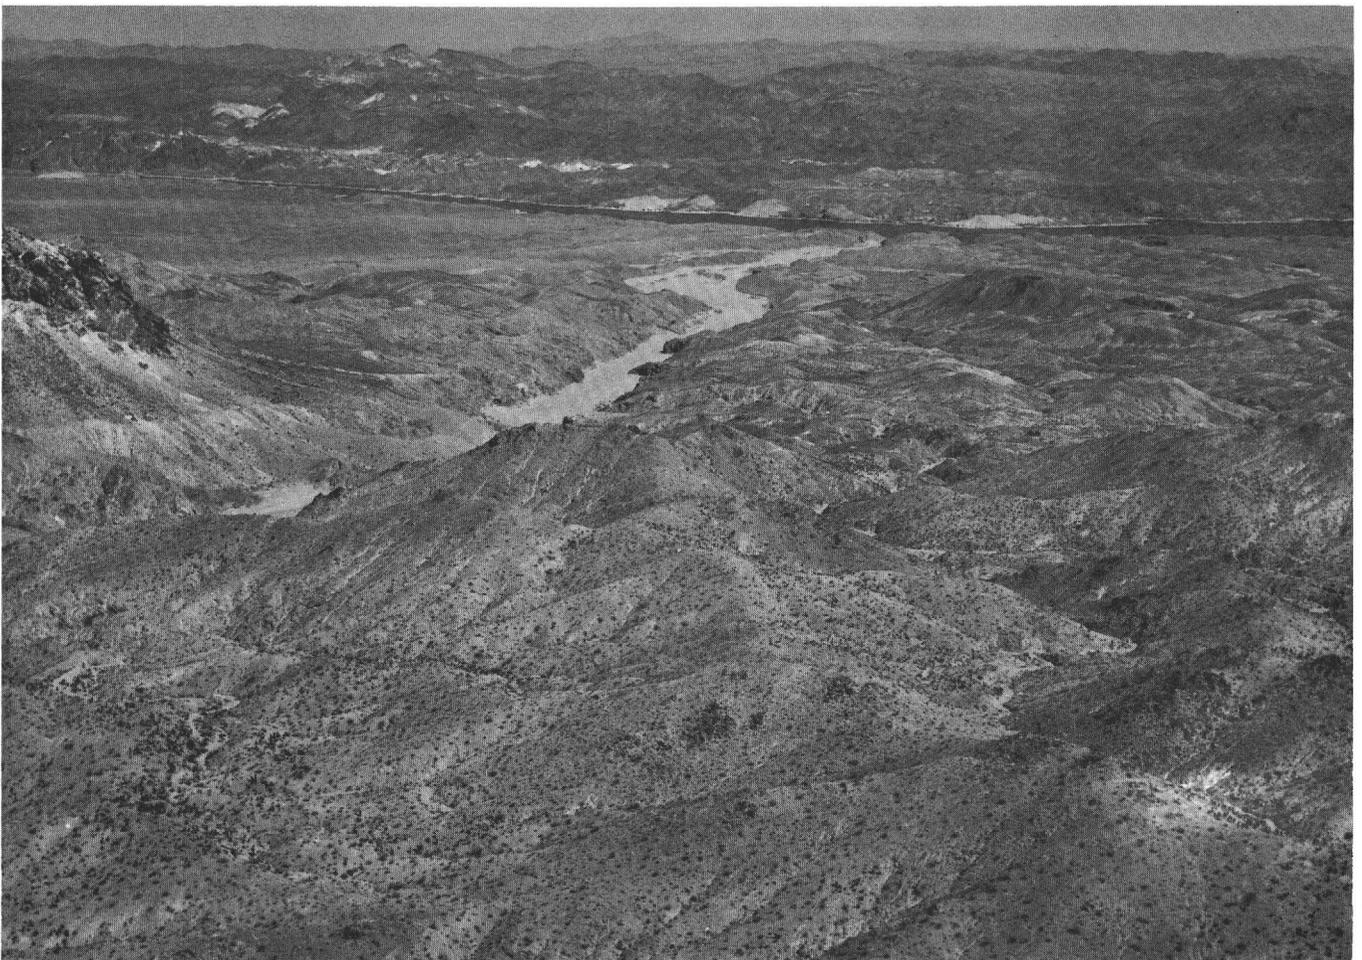
FIGURE 5.—Eastward aerial view of lower Eldorado Canyon. Lake Mohave in background.

the adjacent hill. Figure 5, an aerial view of lower basin terrain, shows distinctive rill-erosion scars. Intensive rill erosion is also clearly visible in figure 24, a photograph taken in NE $\frac{1}{4}$ sec. 9, T. 26 S., R. 65 E., lower Eagle Wash. Large amounts of sediment derived by rill erosion were delivered to main channels and transported further.

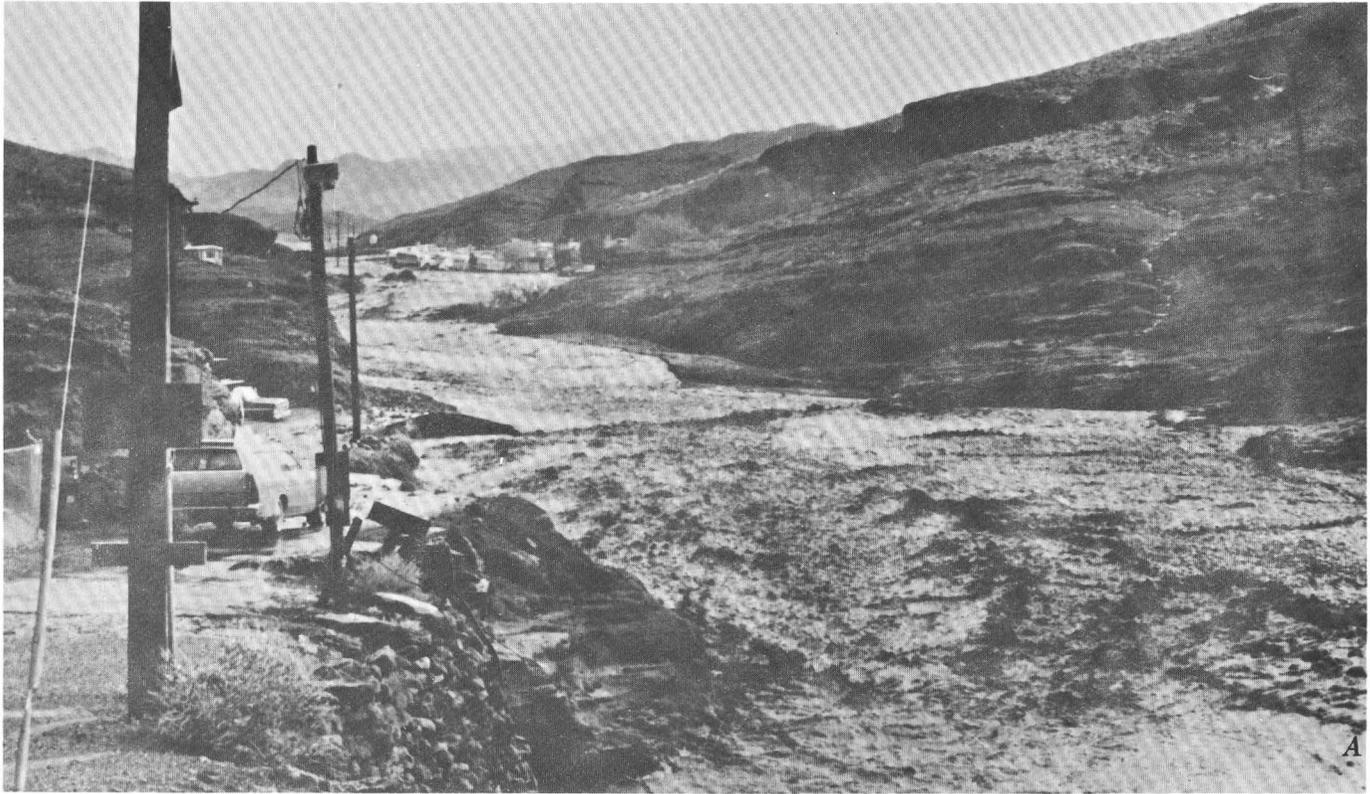
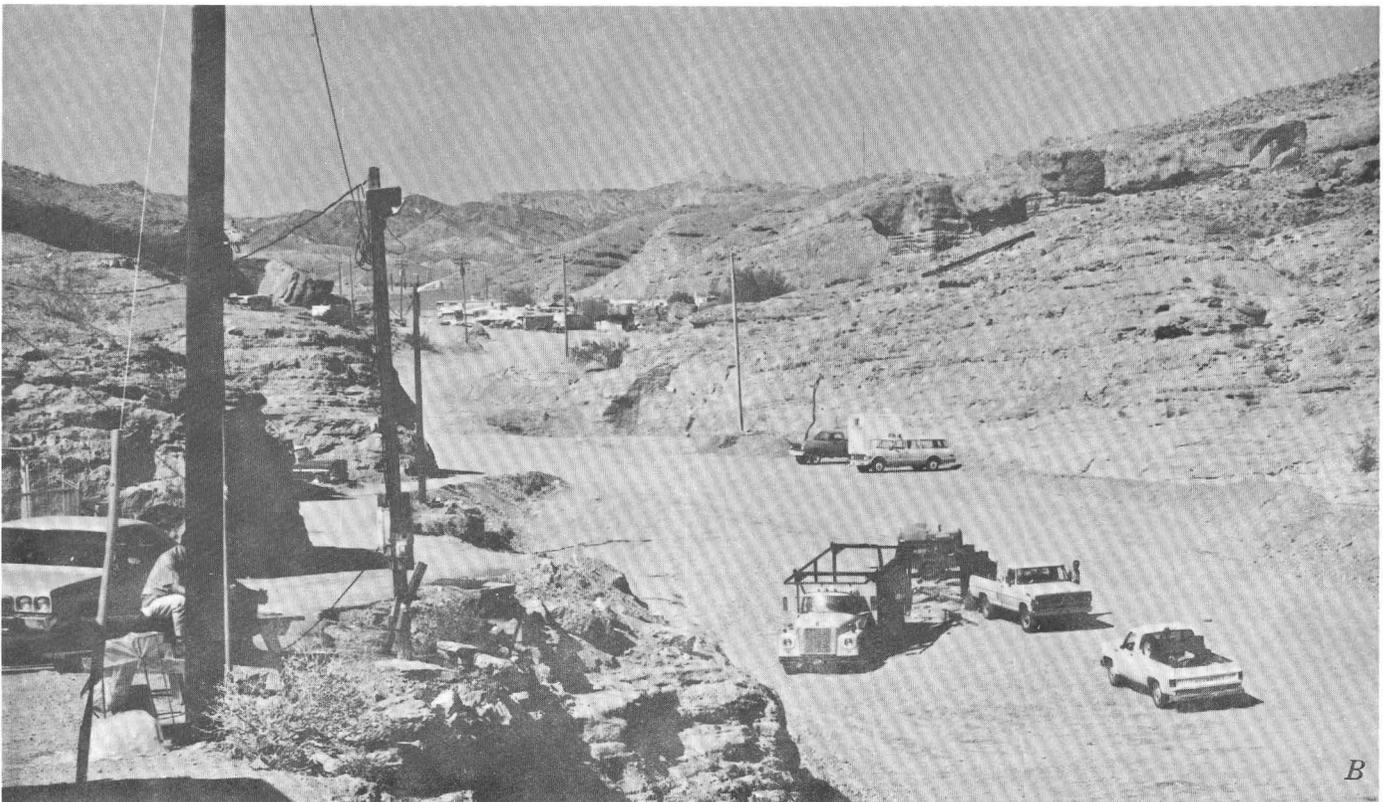
FIGURE 7.—Mouth of Eldorado Canyon. *A*, On September 14, 1974, probably during the late recession of flooding (photograph by Kenneth E. Beales, Las Vegas, Nevada). *B*, On October 1 during excavation of flood sediment deposits.

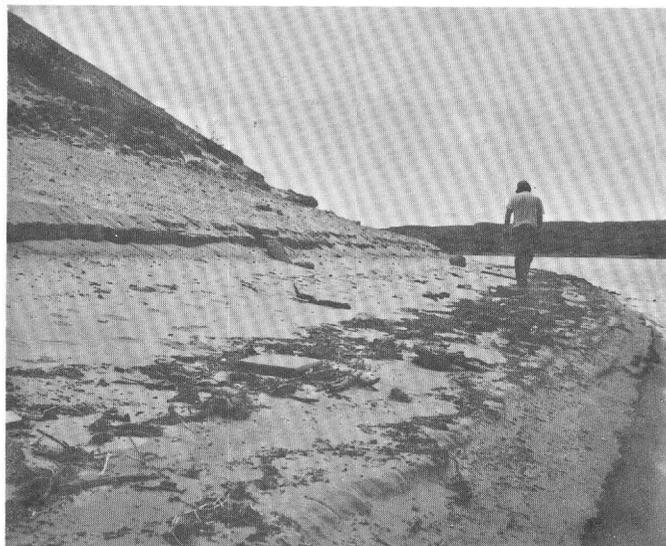
J. P. Monis and P. A. Glancy, U.S. Geological Survey, reconnoitered the east shore of Lake Mohave on September 19, 1974, for evidence of wave action caused by the flood surges entering the lake. Figure 8 shows the best noted evidence of possible flood wave action, at the base of a large sand dune across Lake Mohave about half a mile east and slightly south of the Eldorado Canyon mouth. The dune and its location relative to Eldorado Canyon are shown in the upper right part of figure 15. The horizontal cut in the sand above the flood debris (fig. 8), that was deposited before the lake was purposely drawn down to aid search-and-rescue operations, suggests a maximum wave height of about 1¼ ft. However, the horizontal cut may have originated from a higher pre-flood lake stand. In any event, no known evidence was observed of flood wave action greater than about 1¼ ft.

FIGURE 8.—Wave-cut bench (above debris line) along east shore of Lake Mohave, possibly caused by flood surges entering the lake.

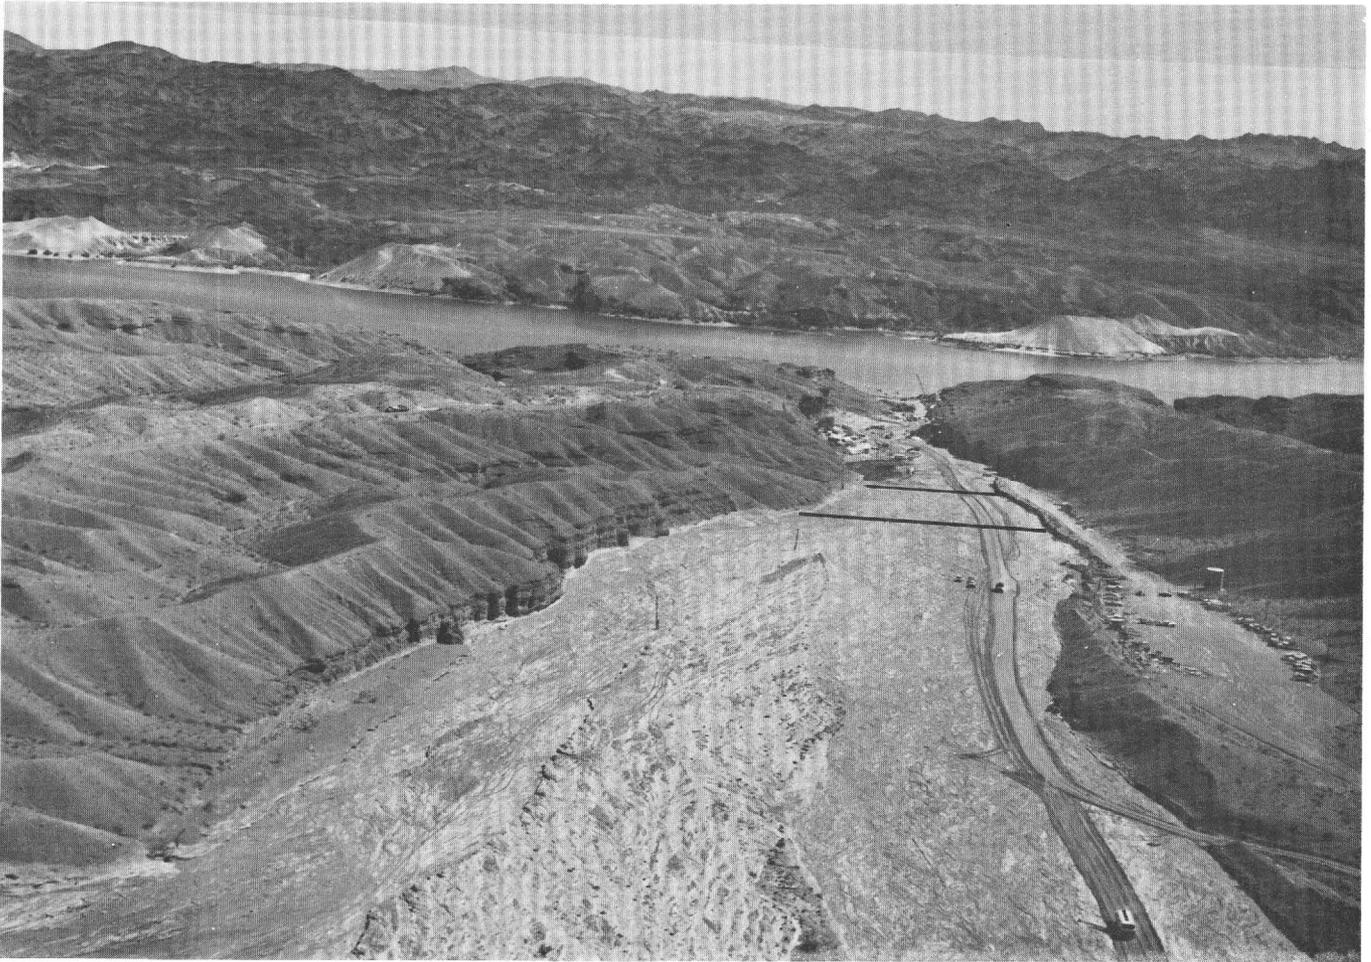
nel just above the trailer parking area (fig. 15 and table 2), using the standard U.S. Geological Survey indirect slope-area method (Dalrymple and Benson, 1967). This technique generally gives reasonable results when prevailing flow conditions are within the limitations for which the technique applies. Flow conditions in Eldorado Canyon may not have been ideal for proper application of the slope-area method; therefore, the peak flow computed may be considerably in error. Some factors that may have caused serious errors in the measurement include: (1) unsteady flow, (2) abnormally high sediment concentrations, causing high fluid viscosity, and (3) a cross-sectional flow area, at the time high-water lines were deposited, that differed from the area determined later at the time of the indirect measurement. These factors are generally influential to varying degrees in peak-flow measurements of most, or all, flash floods in the desert southwest. Nonetheless, the slope-area method is the best available technique.

FIGURE 15.—Downstream (eastward) aerial photograph of Eldorado Canyon terminus taken September 17, 1974. Boat storage area to right. Horizontal lines show approximate slope-area site.

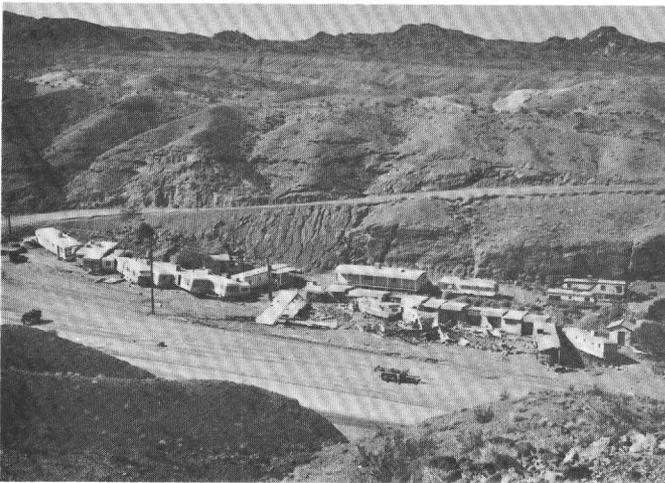
FIGURE 16.—Heavily damaged trailer park at Eldorado Canyon Resort. Afternoon, September 19, 1974.

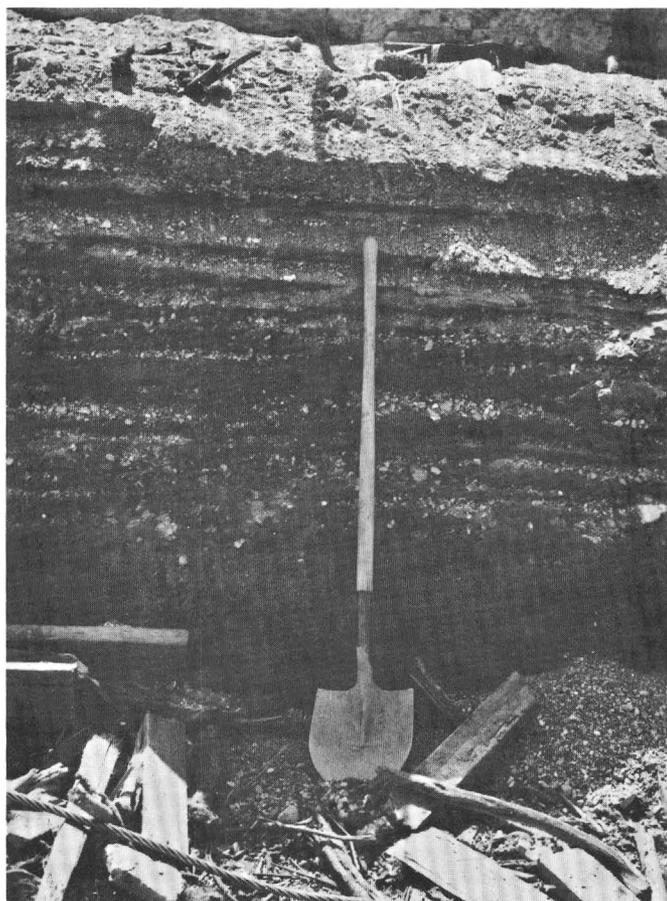
FIGURE 19.—Stratified sediment deposited at the mouth of Eldorado Canyon. Note alternating layers of mixed particle sizes with only a general impression of coarsest sediment in lowest strata.

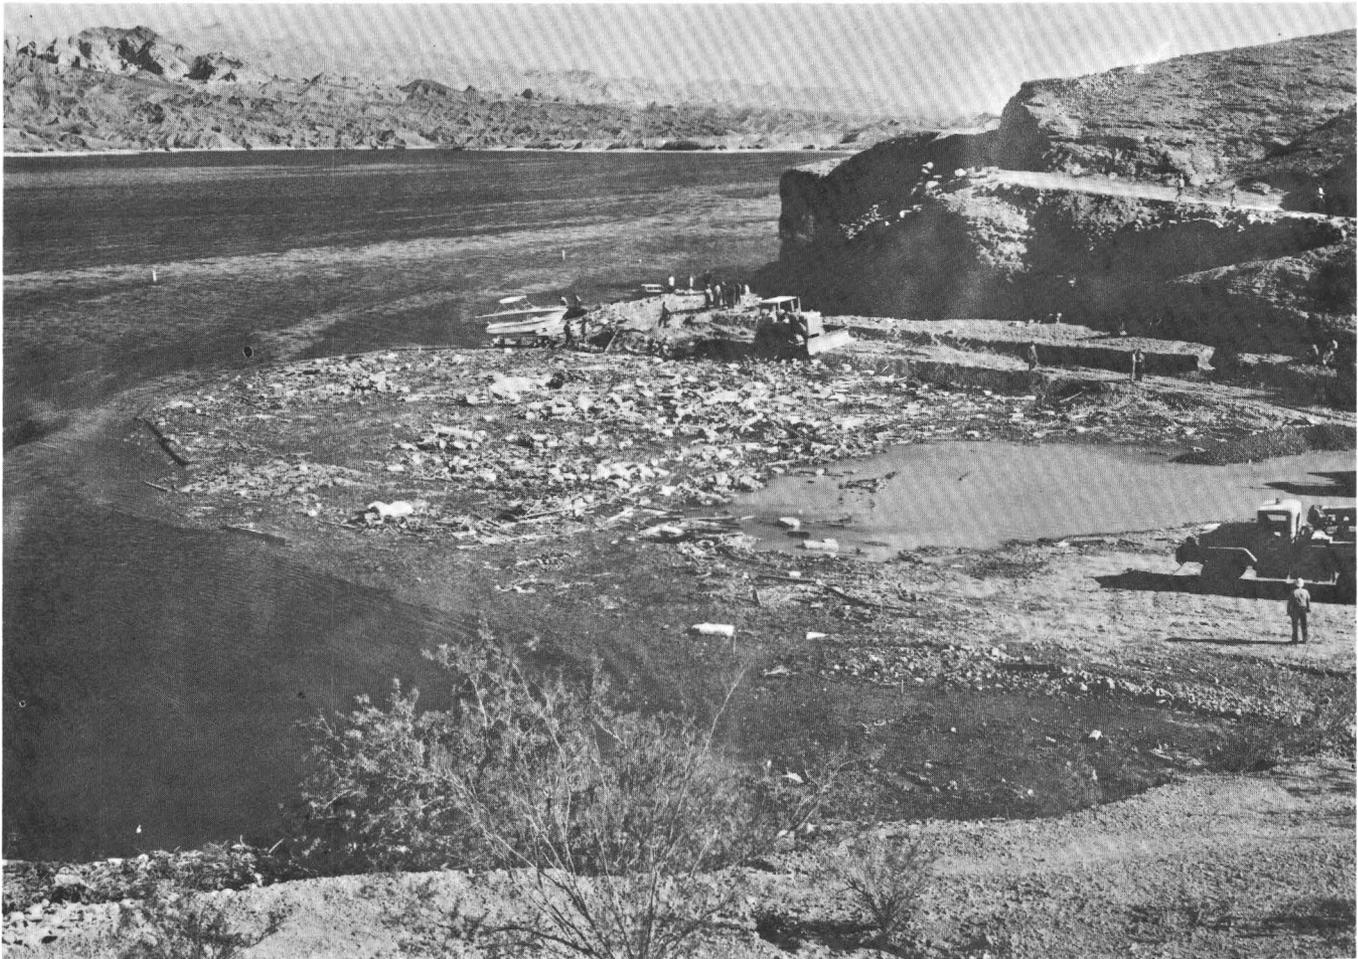
FIGURE 20.—Floating debris at the mouth of Eldorado Canyon. Photograph on afternoon of September 15, about 24 hours after flood and before any significant cleanup of debris.

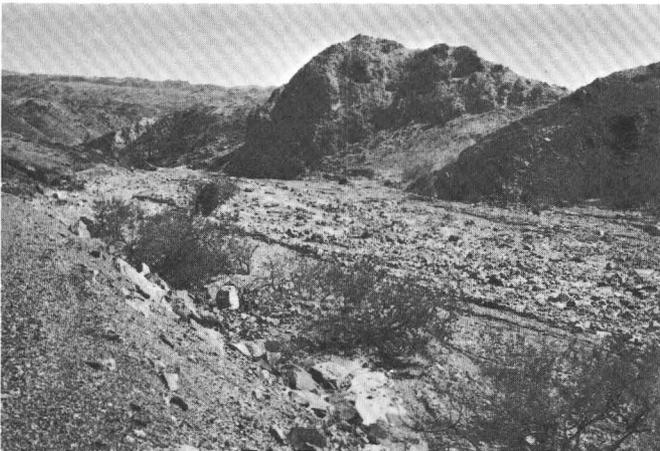
FIGURE 21.—Downstream view of boulder deposits that probably moved on September 14 in Techatticup Wash.

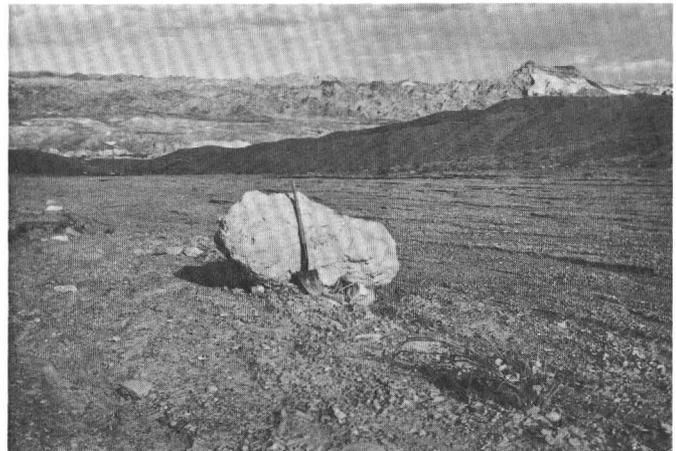
An exceptionally large boulder that may well have moved some distance during the flood is shown in figure 22; its dimensions are 6×4×2.5 ft. Figure 24 shows a boulder lodged under the front bumper of a car abandoned during the flood in the lower reaches of Eagle Wash. The boulder (dimensions 2×1.5×1 ft), overlying a live bush, obviously moved during the flood.

FIGURE 22.—Large boulder that probably moved during flood in lower reaches of Eldorado Canyon.

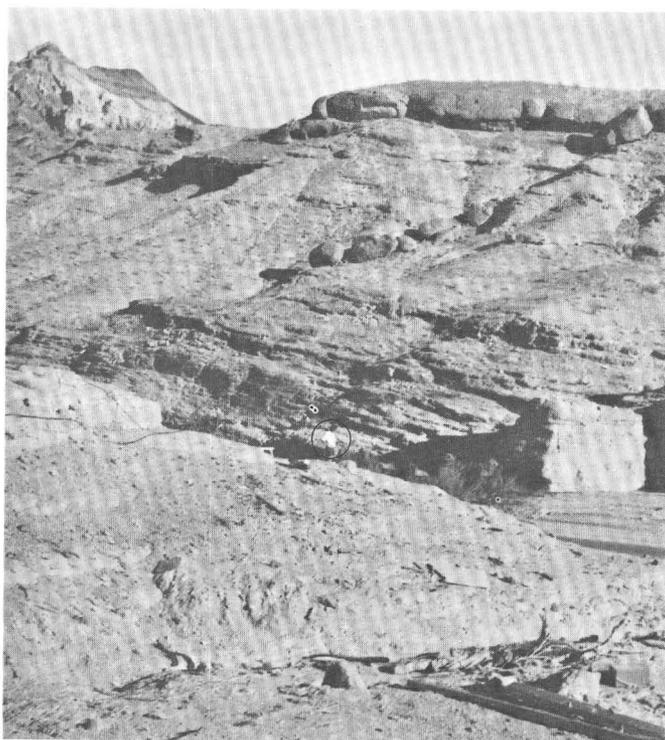
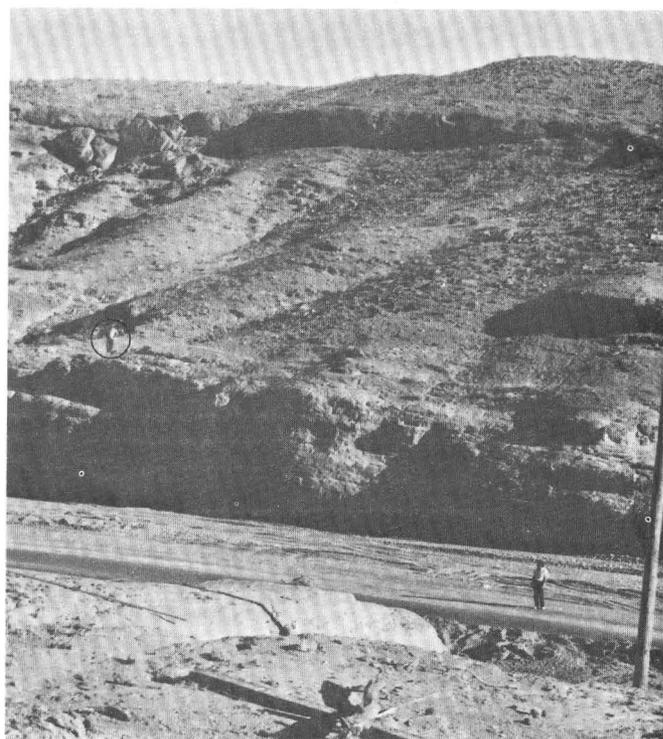
Figure 23 shows the location of high water lines just upstream from the coffee shop site, where the canyon narrows abruptly. Flow depths at this point, approximately where the oncoming surge of water was observed

FIGURE 23.—Position of high water line at canyon narrows just upstream from former restaurant. Note people standing on high water line for scale.

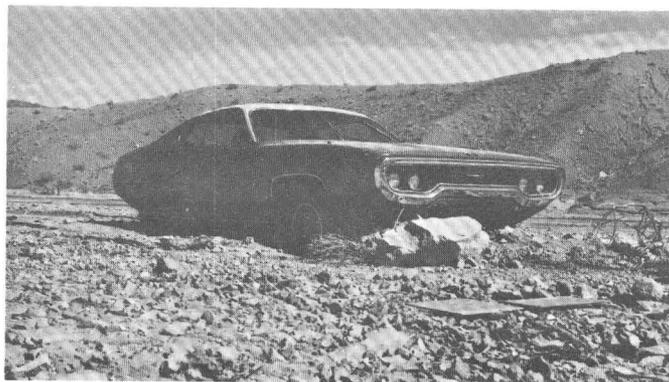
Flow surges continued and added to the stream stage until Sessums' car was swept downstream about a mile. It was subsequently deposited on the floor of the wash by the receding streamflow. Figure 24 pictures Sessums' car on the afternoon of September 20 at its final resting place. The boulder deposited in front of the car was discussed earlier (p. 16). The car paint was unscratched in spite of the fact the car was partly inundated by rapidly flowing turbulent water for a substantial period of time. The flow apparently did not abrade or damage the paint surface, nor were there any visible signs of damage by large moving rocks. This evidence suggests that sediment transport in Eagle Wash apparently was dominated by gravel-size bedload that passed beneath the painted surface of the auto. The apparent dominance of gravel-size sediment agrees with the particle-

FIGURE 24.—An automobile at rest in lower Eagle Wash after about a 1-mile transit in flood.

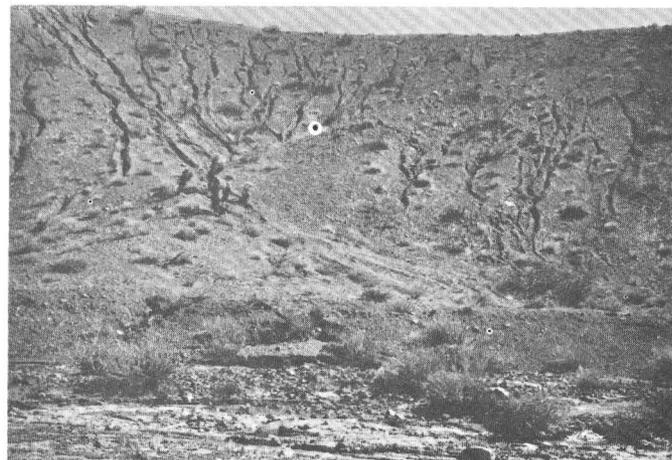
The most intense observed rill erosion was in a lower basin area (SE $\frac{1}{4}$ NW $\frac{1}{4}$ sec. 8, T. 26 S., R. 65 E.) shown in figure 25. In contrast, rill erosion is virtually absent in many parts of upstream areas such as that shown in figure 26, photographed approximately in the N $\frac{1}{2}$ secs. 8 or 9, T. 26 S., R. 64 E. Figure 26 shows that a minor amount of main-channel streamflow and erosion did occur at the site, in spite of the lack of flow evidence on

FIGURE 25.—Evidence of intense rill erosion in unnamed tributary to lower Eldorado Canyon.

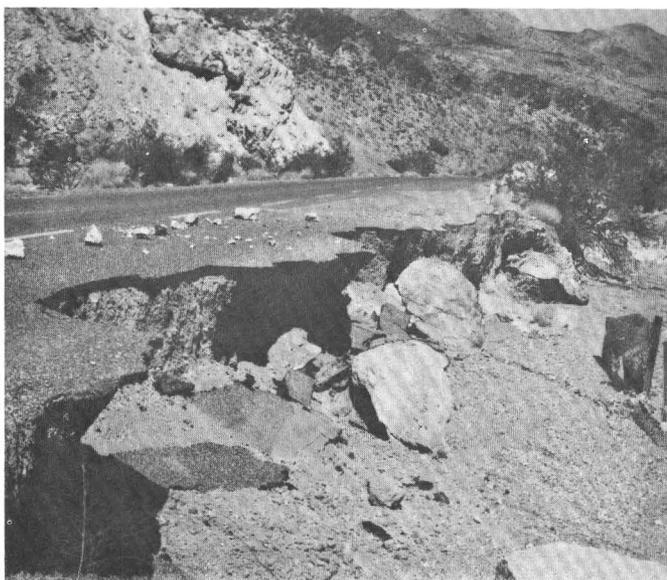
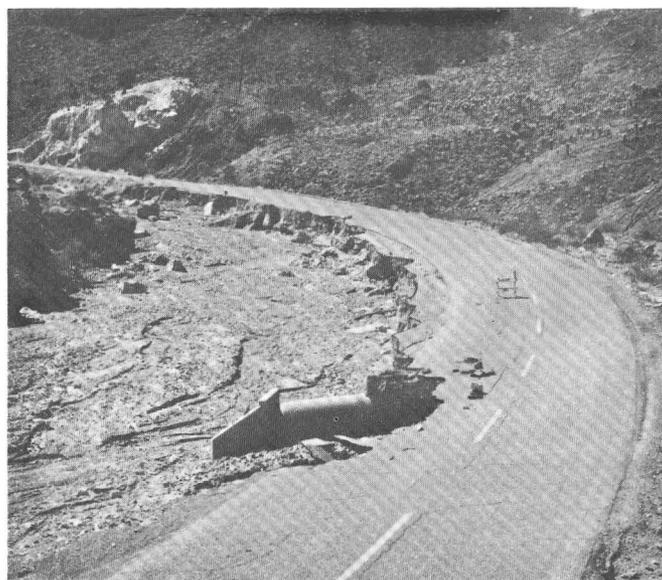
Severe lateral scour did occur in some places along major channels. Figure 27 shows examples of highway damage caused by this type of erosion.

FIGURE 27.—Highway damage in Techatticup Wash caused mainly by lateral channel scour.

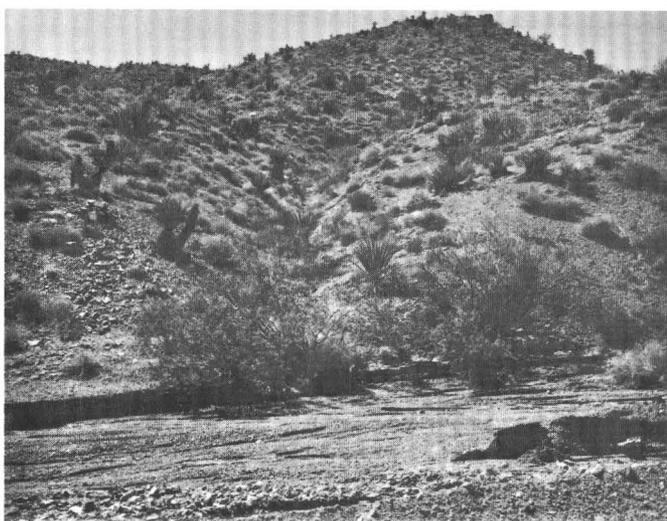
FIGURE 26.—Evidence of minor channel flow and only minimal rill erosion in Copper Canyon.

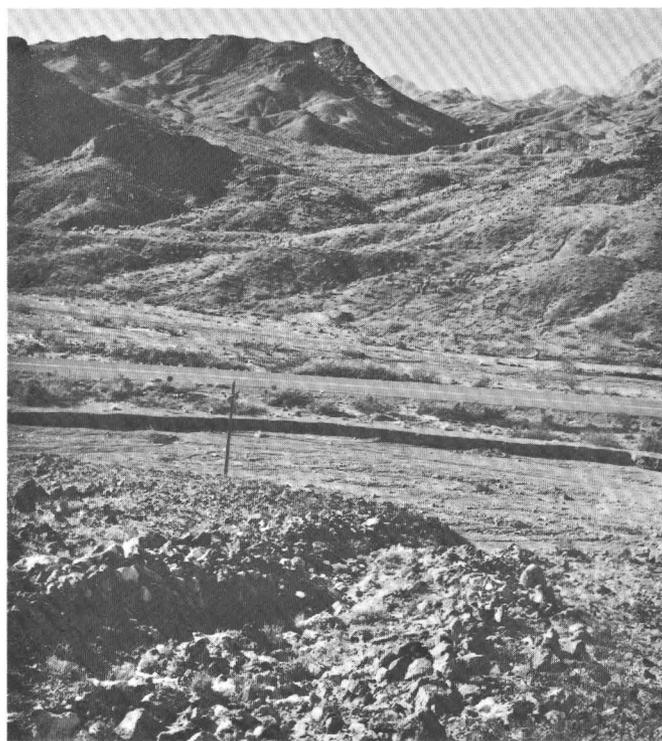
FIGURE 28.—Windrows of boulders bordering a pre-September 14, 1974 erosion scar.
