# Hydrology, Geomorphology, and Dam-Break Modeling of the July 15, 1982 Lawn Lake Dam and Cascade Lake Dam Failures, Larimer County, Colorado

U.S. GEOLOGICAL SURVEY PROFESSIONAL PAPER 1369

By ROBERT D. JARRETT *and* JOHN E. COSTA

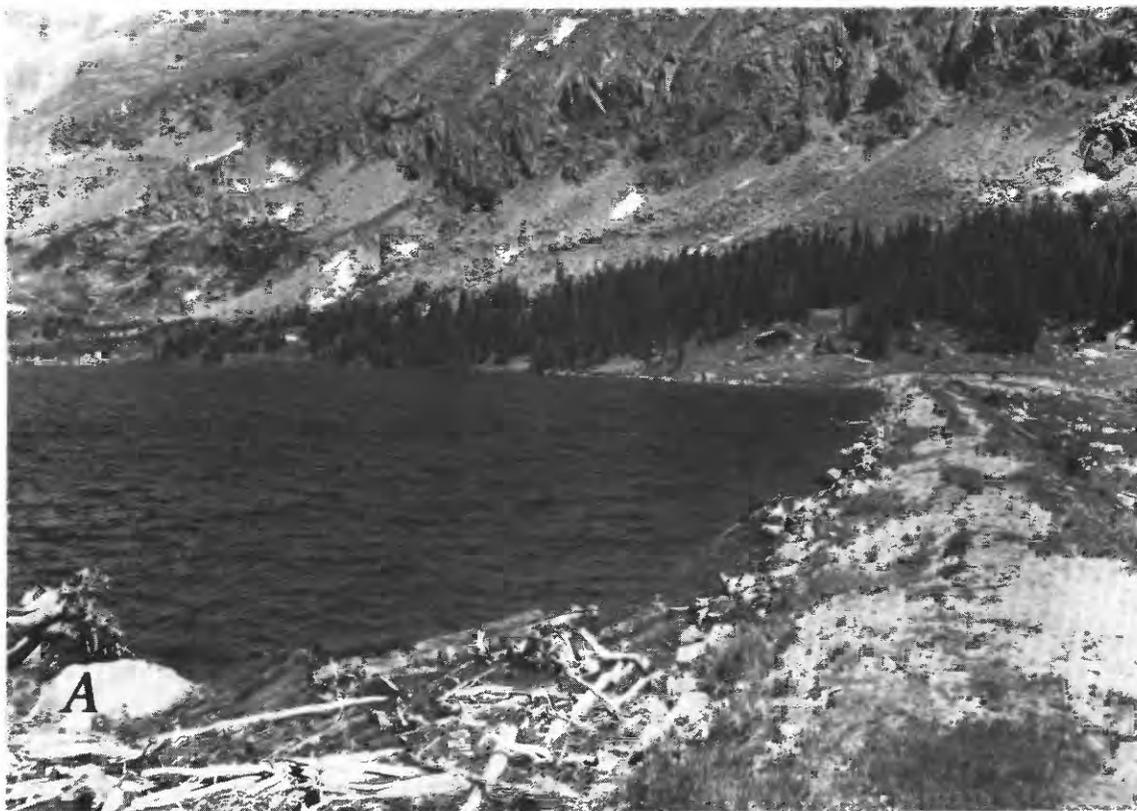
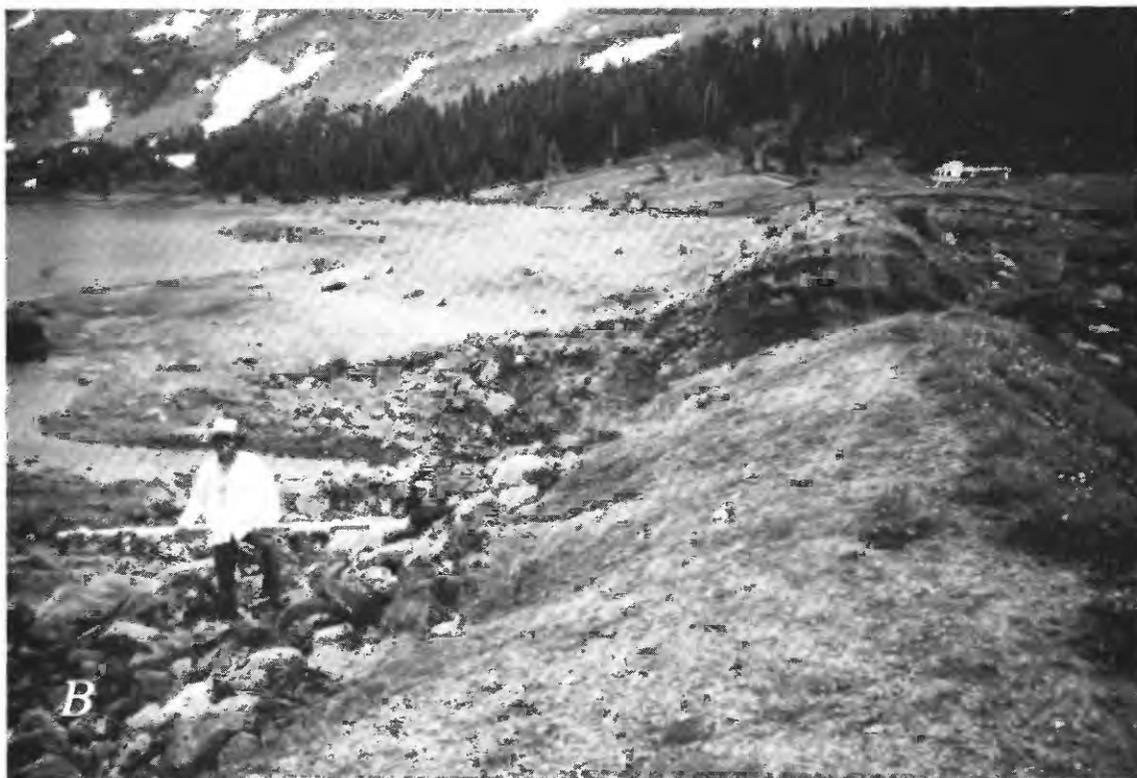
FIGURE 4.—*A*, The top of Lawn Lake Dam, prior to failure, looking north (July 11, 1958). Photo courtesy of the National Park Service. *B*, The top of Lawn Lake Dam, after failure (July 1982). Man is holding rod at elevation of water at time of failure.

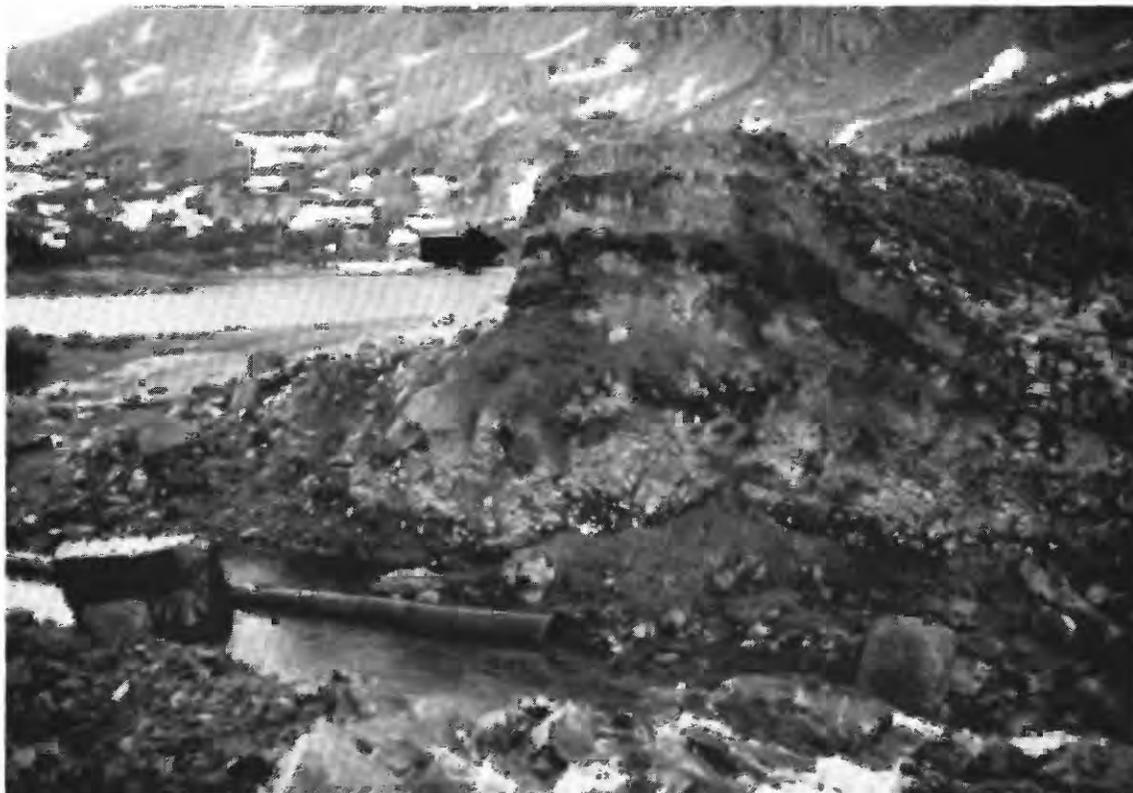
about 25 ft in the immediate vicinity of the dam. The underlying Precambrian igneous and metamorphic bedrock is highly fractured and jointed, but fresh. About 4 to 5 ft below the crest of the dam, a 12-in. layer of dark, organic material appeared to cover the entire dam (fig. 5). The origin of this organic horizon is uncertain, but it probably represents a top layer of humus on the 1903 embankment prior to the height enlargement of 4 to 5 ft in 1931.

FIGURE 5.—The cross section of Lawn Lake dam following failure. Arrow indicates dark organic layer 4 to 5 ft below top of dam.

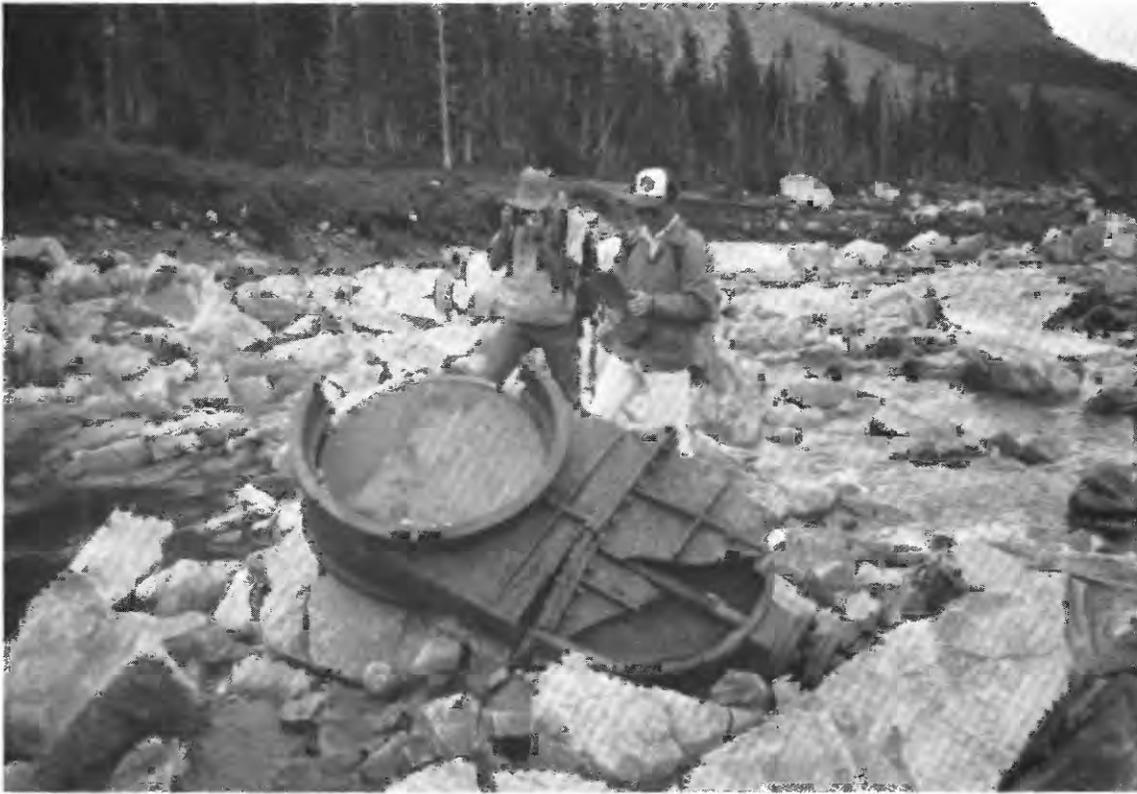
Data gathered by the Office of the State Engineer (1983) indicated that the most likely cause of the Lawn Lake dam failure was deterioration of the lead caulking used for the connection between the outlet pipe and the gate valve. The resulting leak eroded a pipe-shaped cavity in the earthfill (called piping), creating a void along the outlet pipe. The leak continued to remove easily eroded earthfill and may have reduced the strength and stability of the dam embankment. Such a scenario of leakage, piping, and resulting embankment failure

FIGURE 6.—The remains of the outlet valve from Lawn Lake dam. Investigations of this valve led to the conclusion that lead caulking had severely deteriorated.

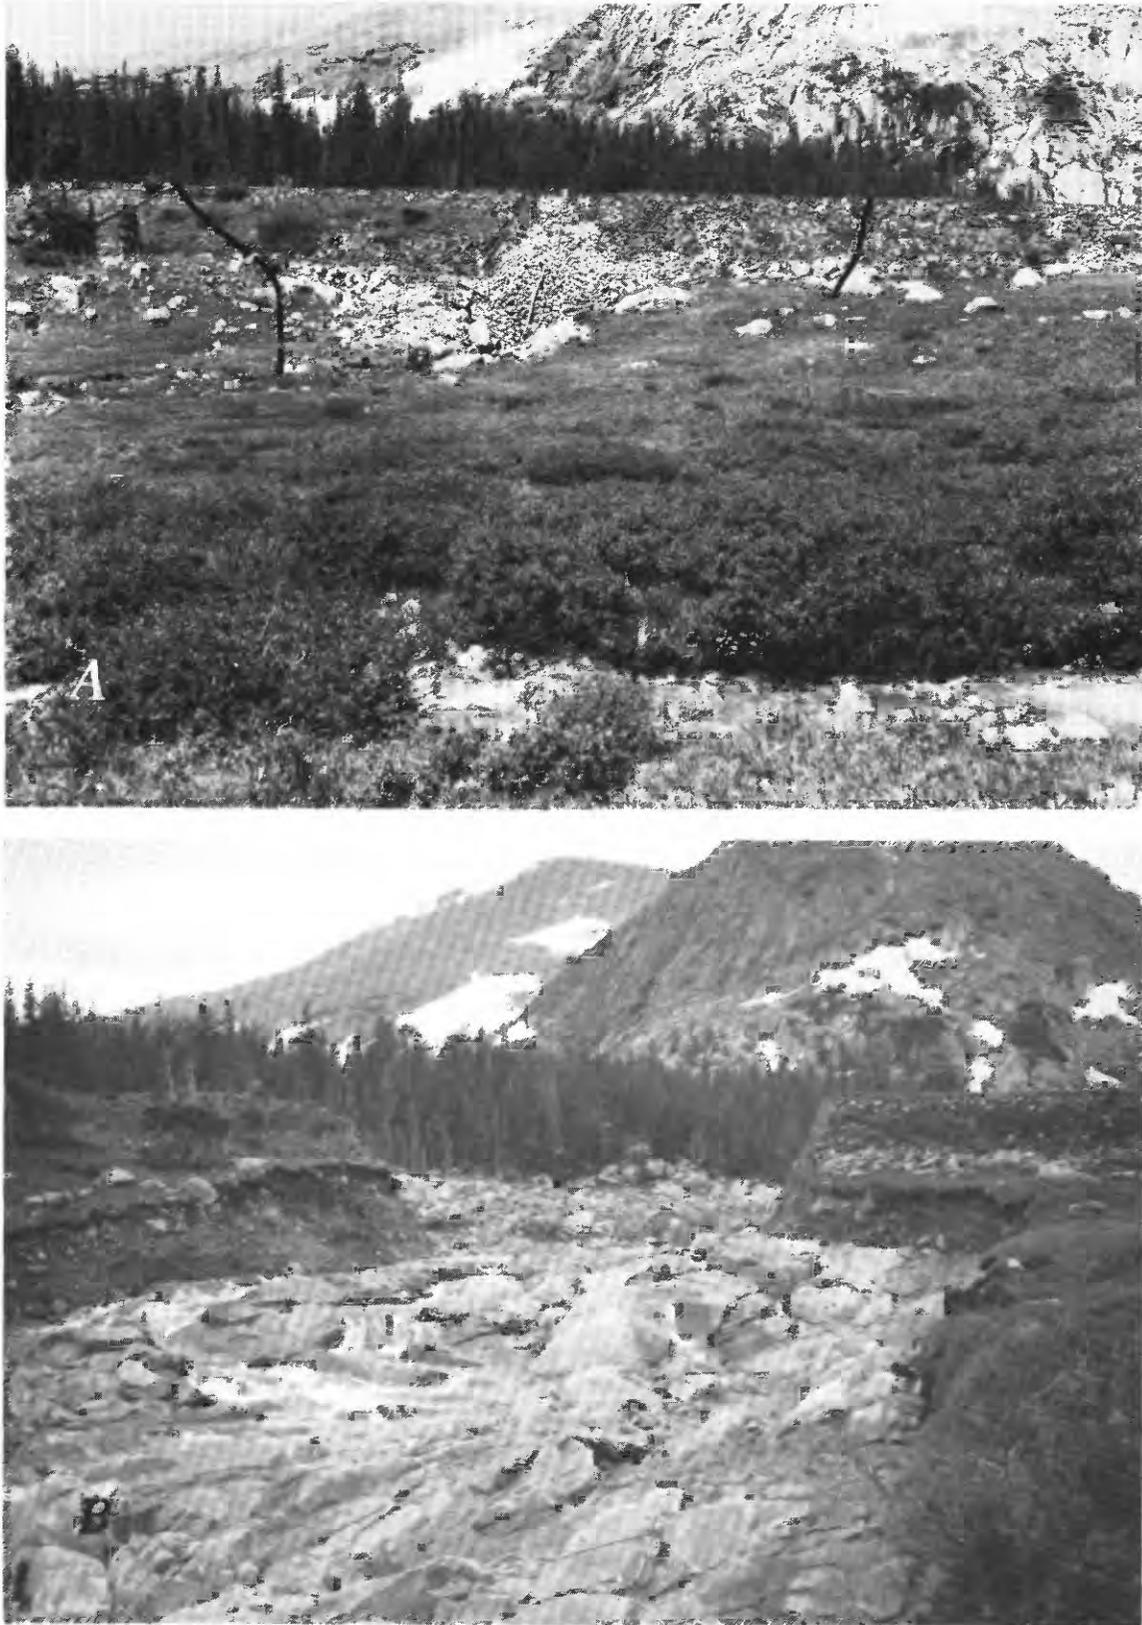
FIGURE 7.—*A*, The downstream face of Lawn Lake Dam prior to failure, showing the location of the outlet well and pipe (July 11, 1958). Dashed lines on dam face show location of eroded breach. Photo courtesy of the National Park Service. *B*, The front of Lawn Lake Dam following failure, showing the breach width.

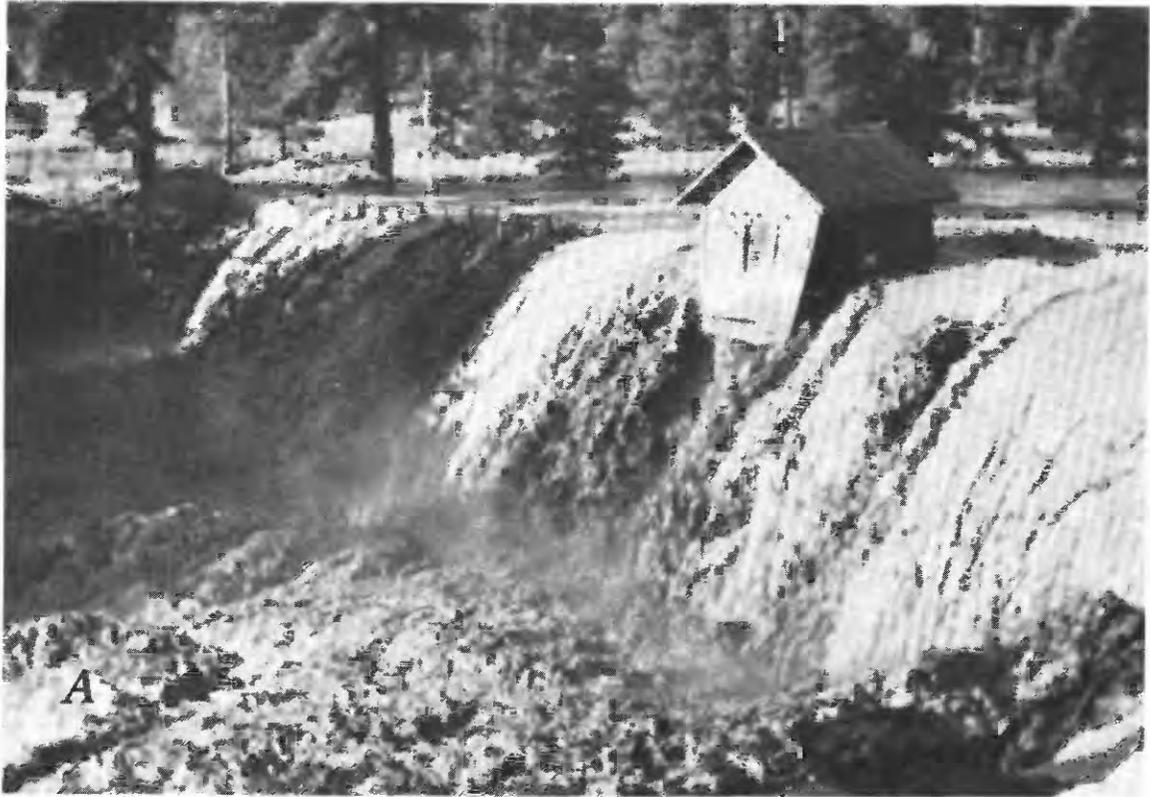
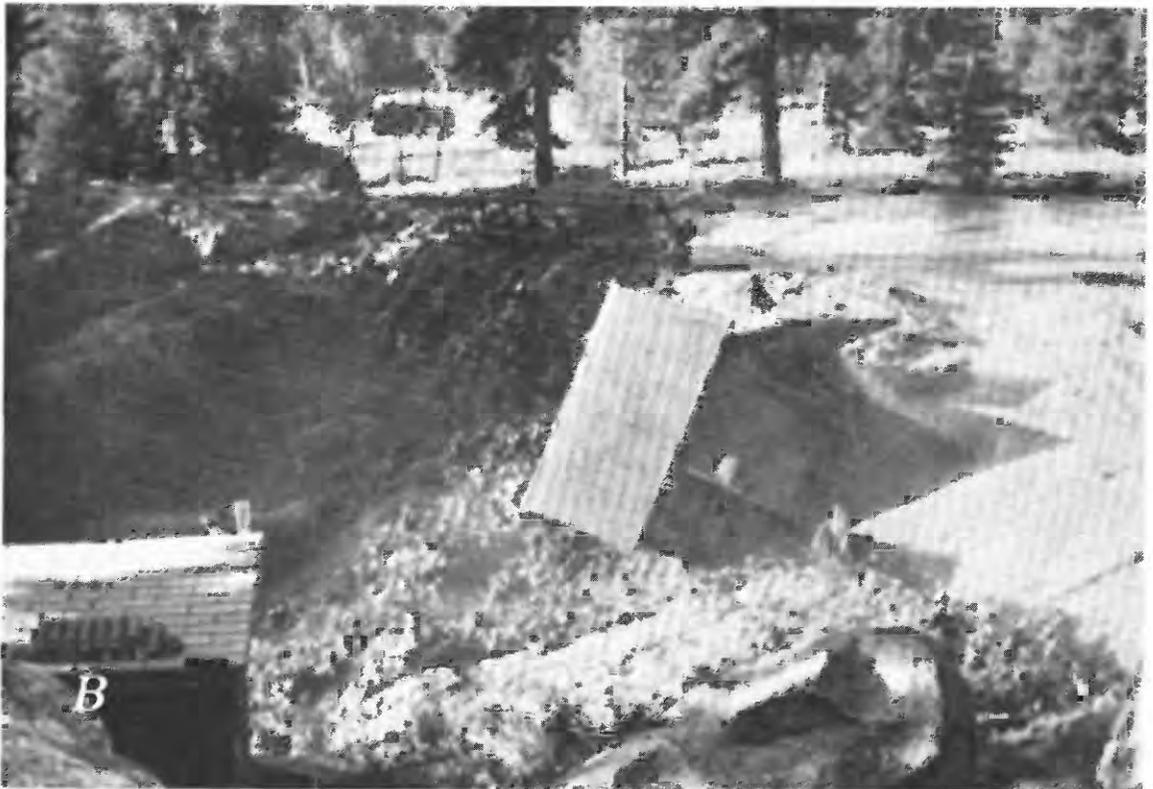
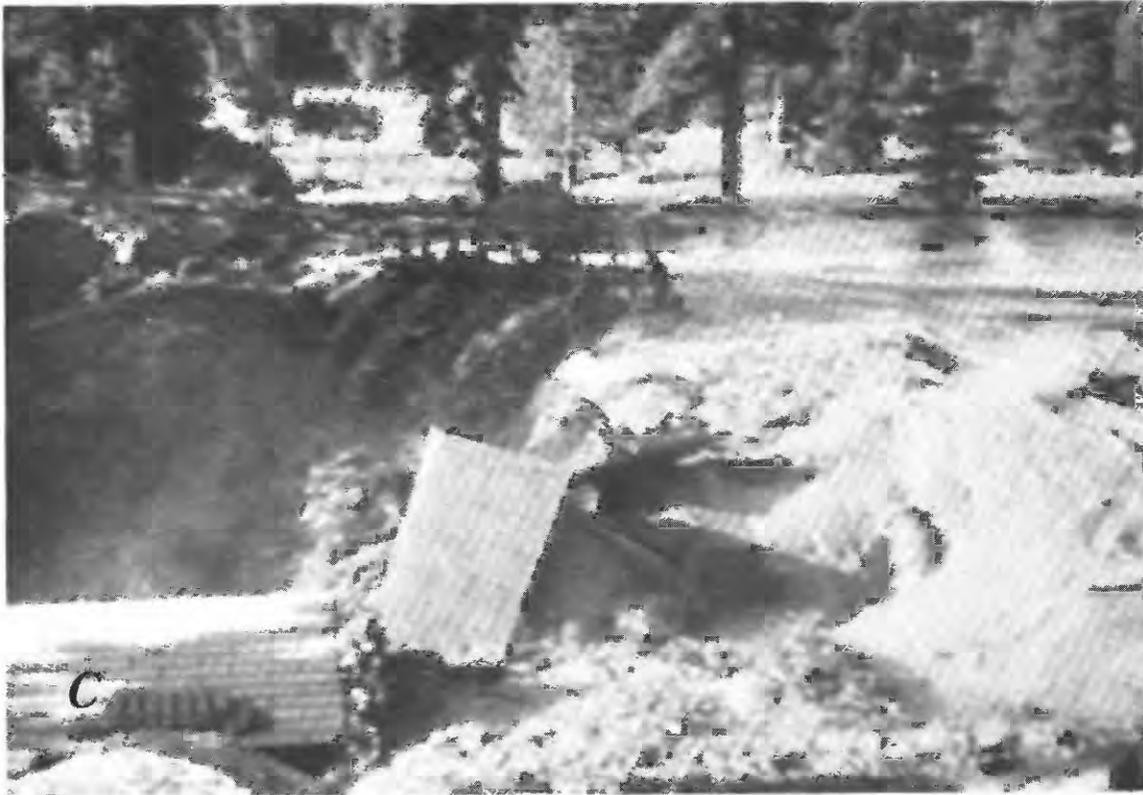
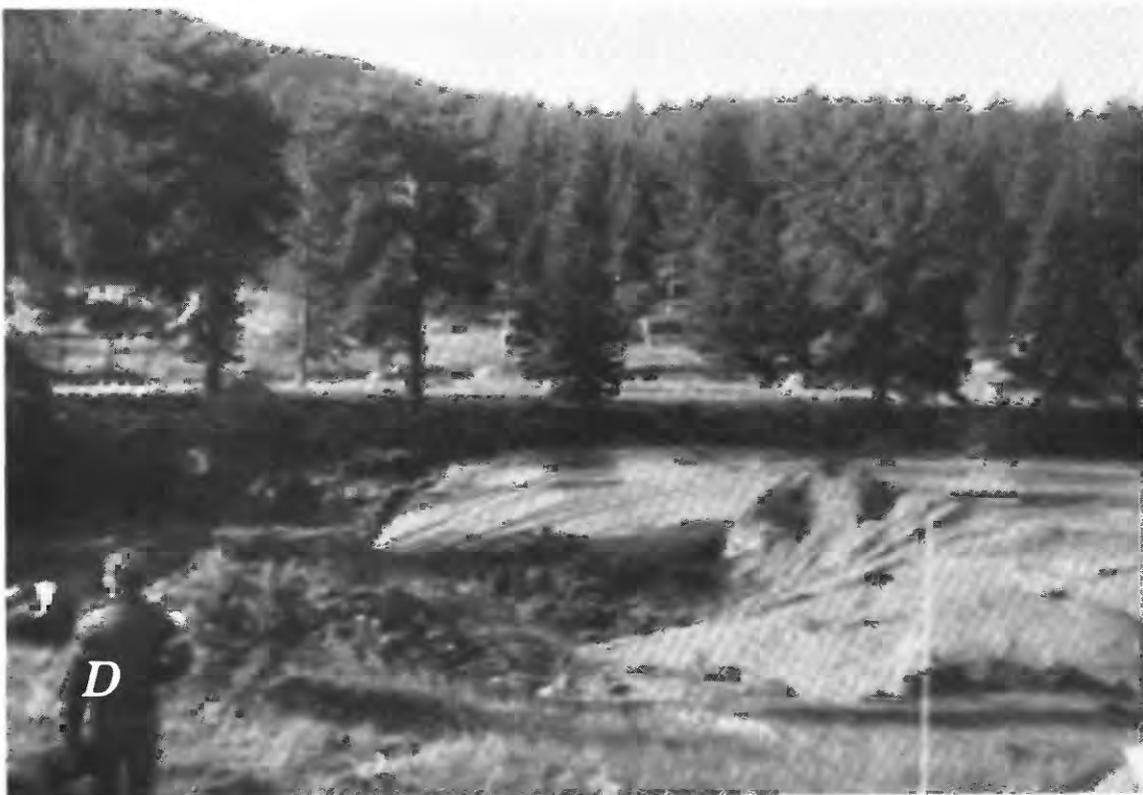
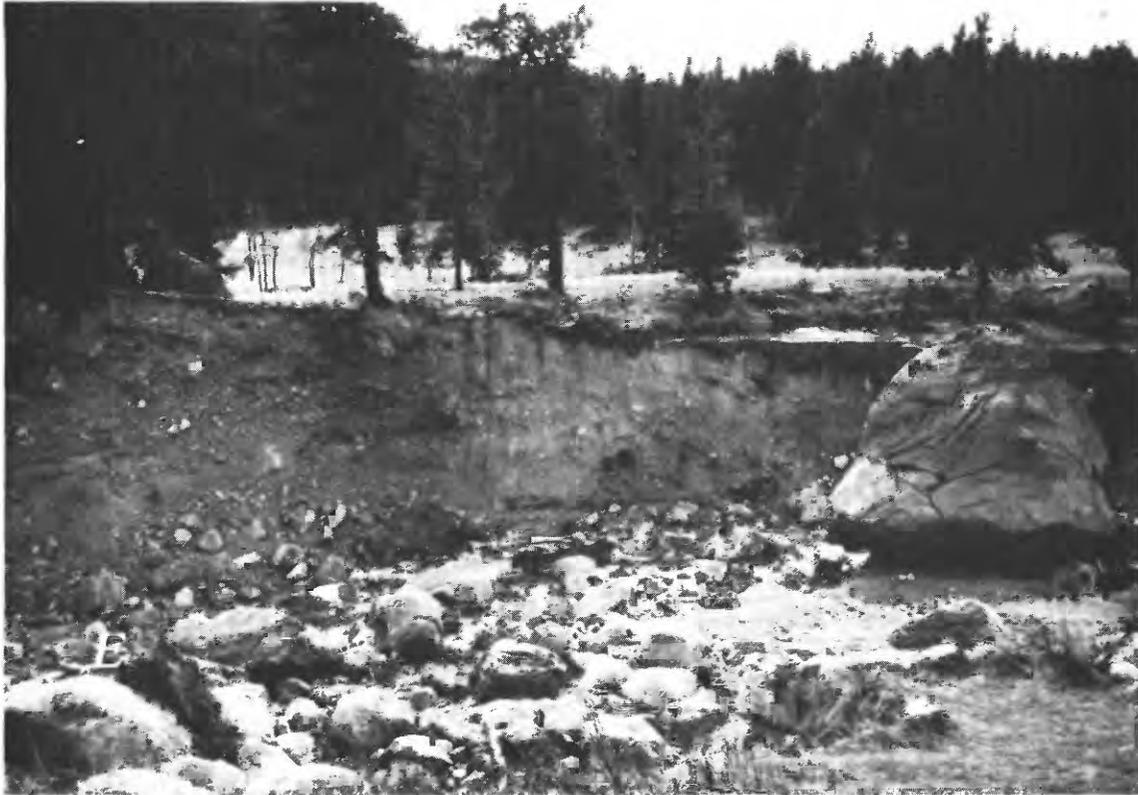
The flood, attenuated by the relatively flat Horseshoe Park (an old glacial lakebed), continued along the Fall River, where it caused Cascade Lake dam (an approximately 17-ft-high, 12-acre-ft capacity concrete gravity dam) to fail because of tipping over from overtopping. Peak discharge upstream from Cascade Lake dam was 7,210 ft<sup>3</sup>/s; however, discharge increased to 16,100 ft<sup>3</sup>/s or more as a result of the Cascade Lake dam failure. The flood continued to attenuate in its passage down the Fall River and through the town of Estes Park.

FIGURE 9.—*A*, Water overtopping Cascade Lake dam. *B*, Cascade Lake Dam in the initial stages of failure. *C*, Cascade Lake Dam taken a few seconds after photograph *B*. *D*, The location of Cascade Lake Dam immediately after total failure. Photos *A-D* courtesy of Grace Davis George and Jennifer D. George. *E*, The location of Cascade Lake Dam following the failure and draining of Cascade Lake. Top of the large boulder on the reservoir floor is shown in *D* and in figure 8.

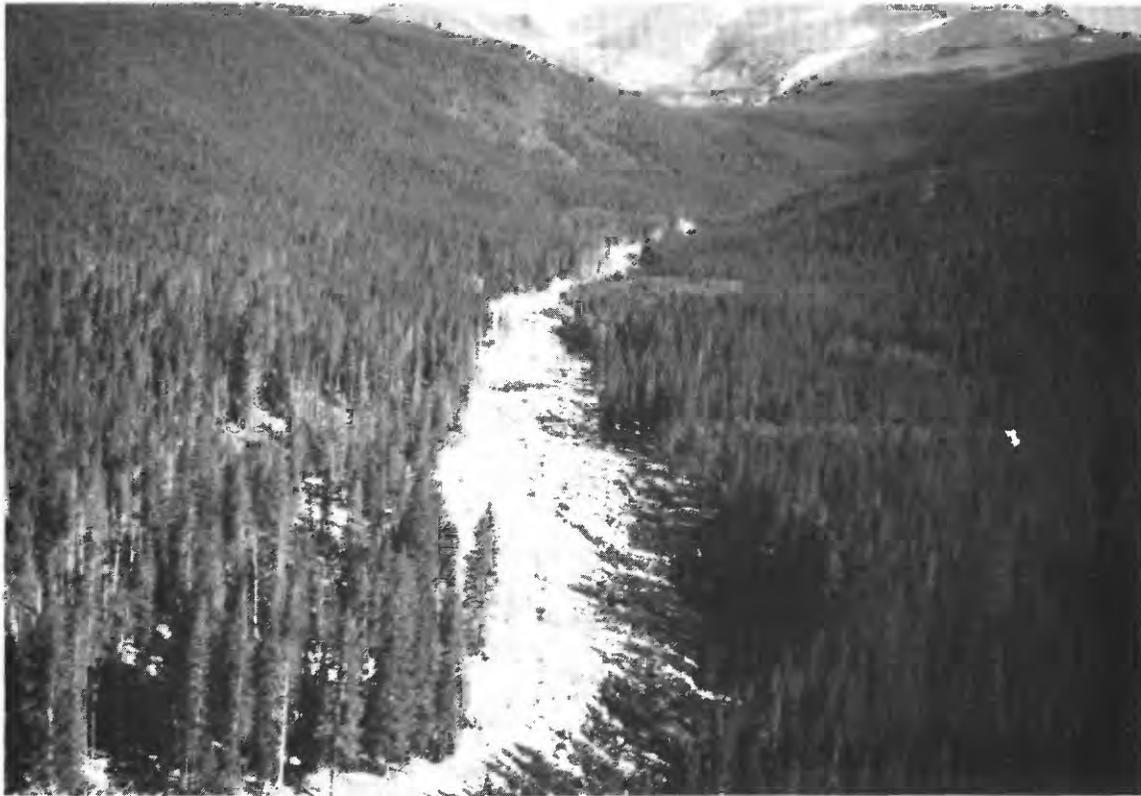
FIGURE 10.—The middle reach (river mile 2.1) of the Roaring River showing the extensive areas of scour and fill along the channel.

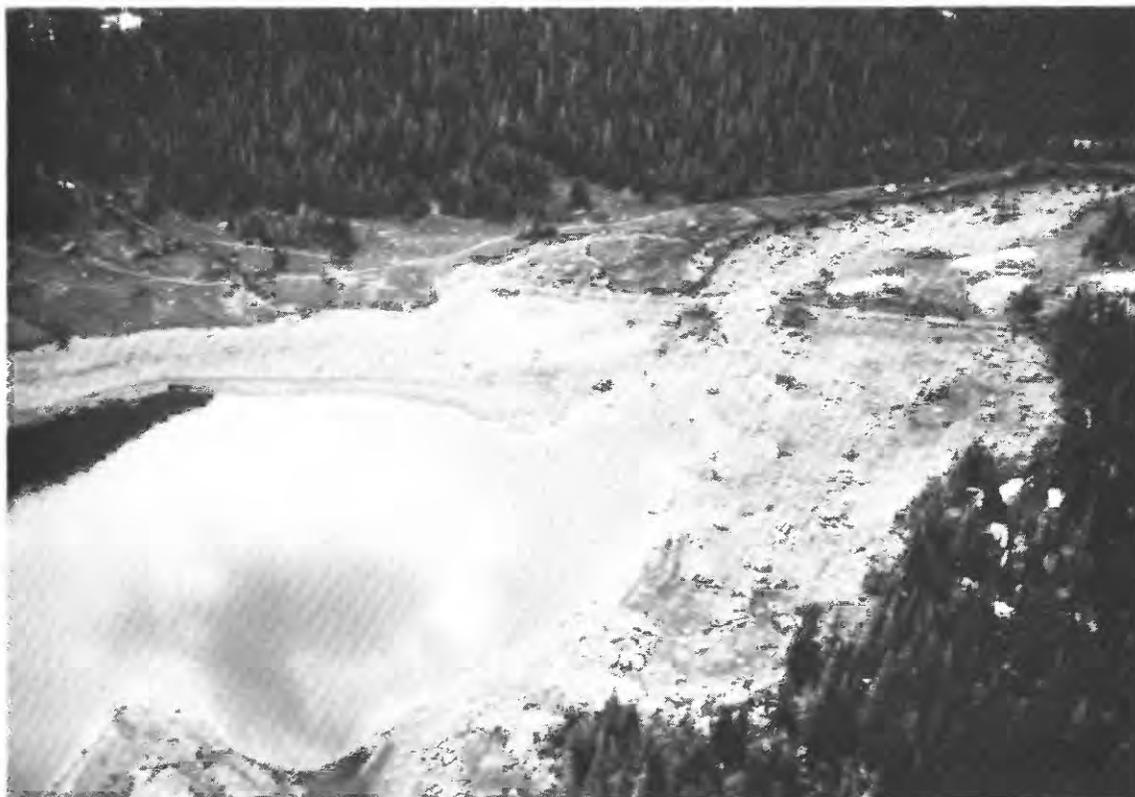
FIGURE 12.—Lawn Lake about 1 week after the dam failure, showing the amount of water still remaining in the natural depression forming the original lake (aerial).

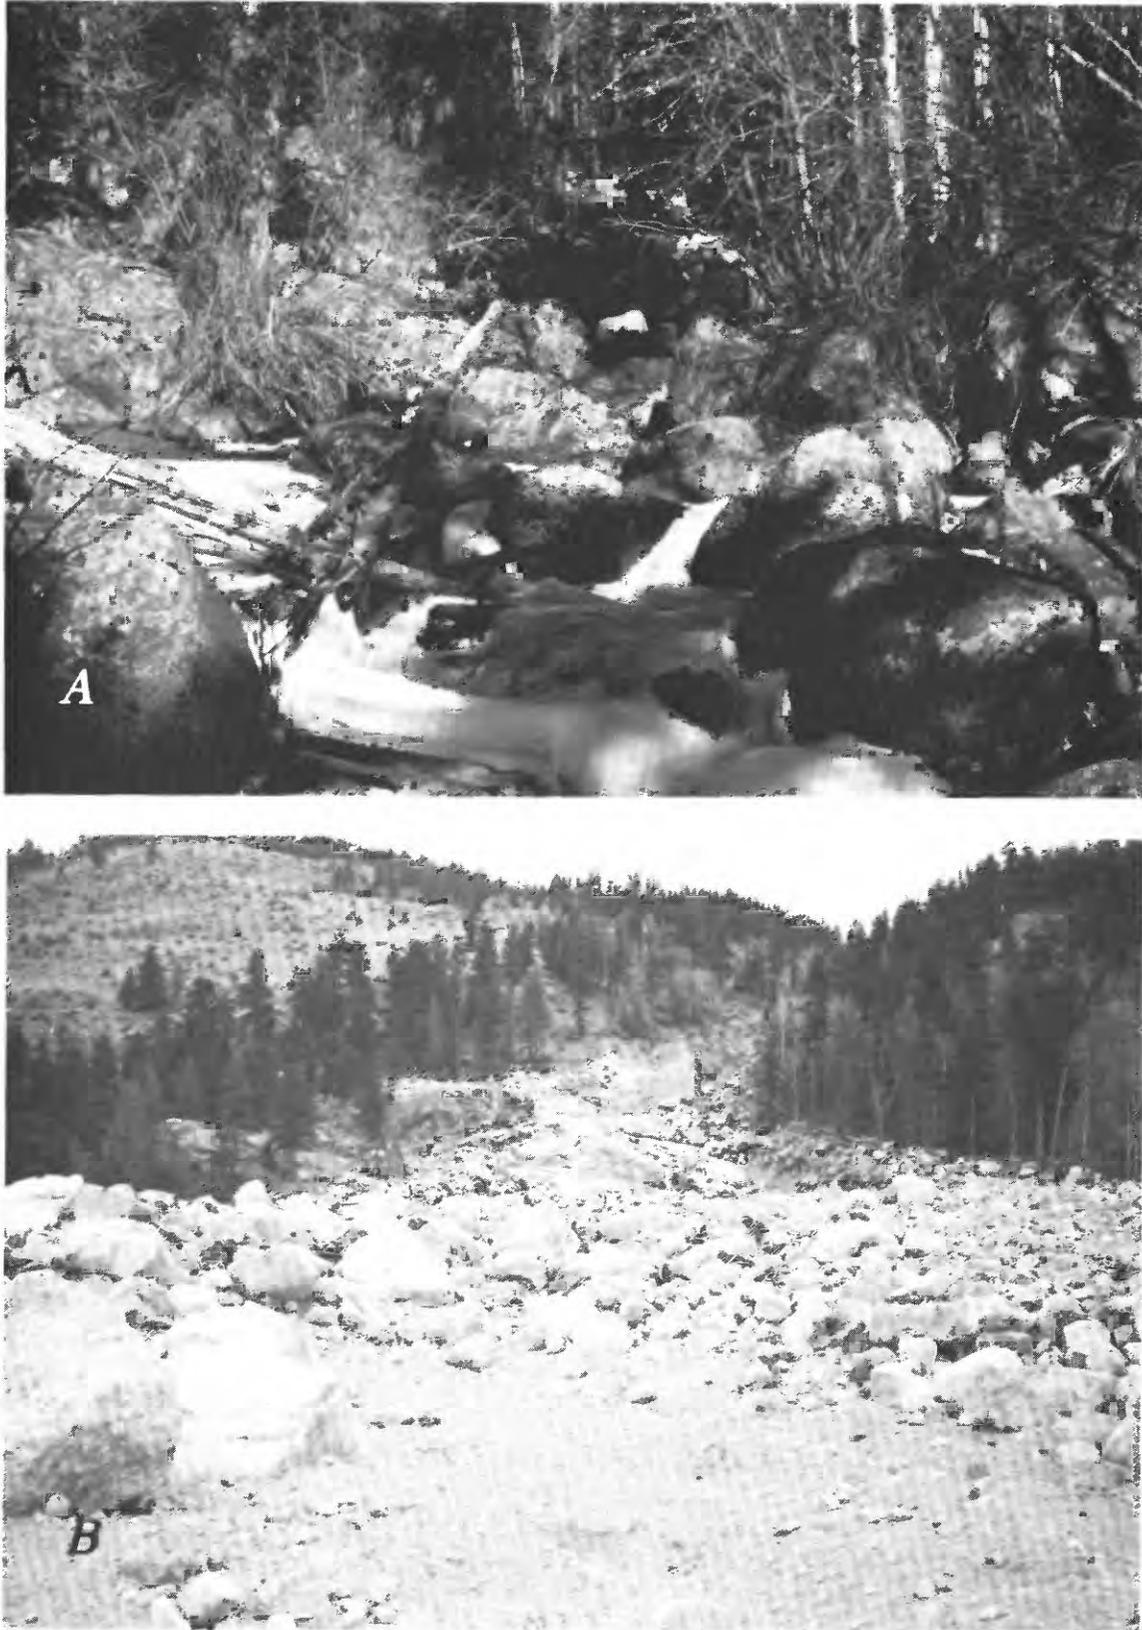
FIGURE 16.—*A*, The Roaring River, looking upstream from the Endovalley Road in 1978. *B*, The Roaring River in 1982, after the flood, from approximately the same location as *A*.

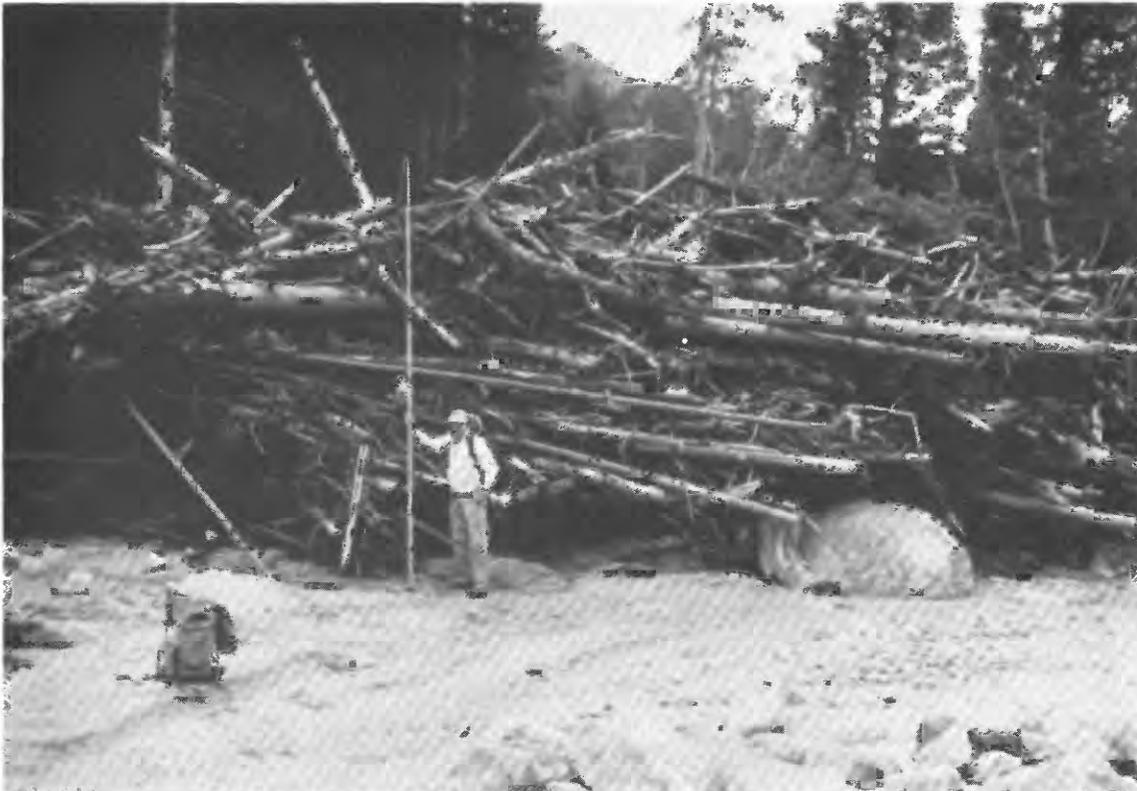
FIGURE 17.—The remains of a large debris dam in the Roaring River valley near river mile 3.21.

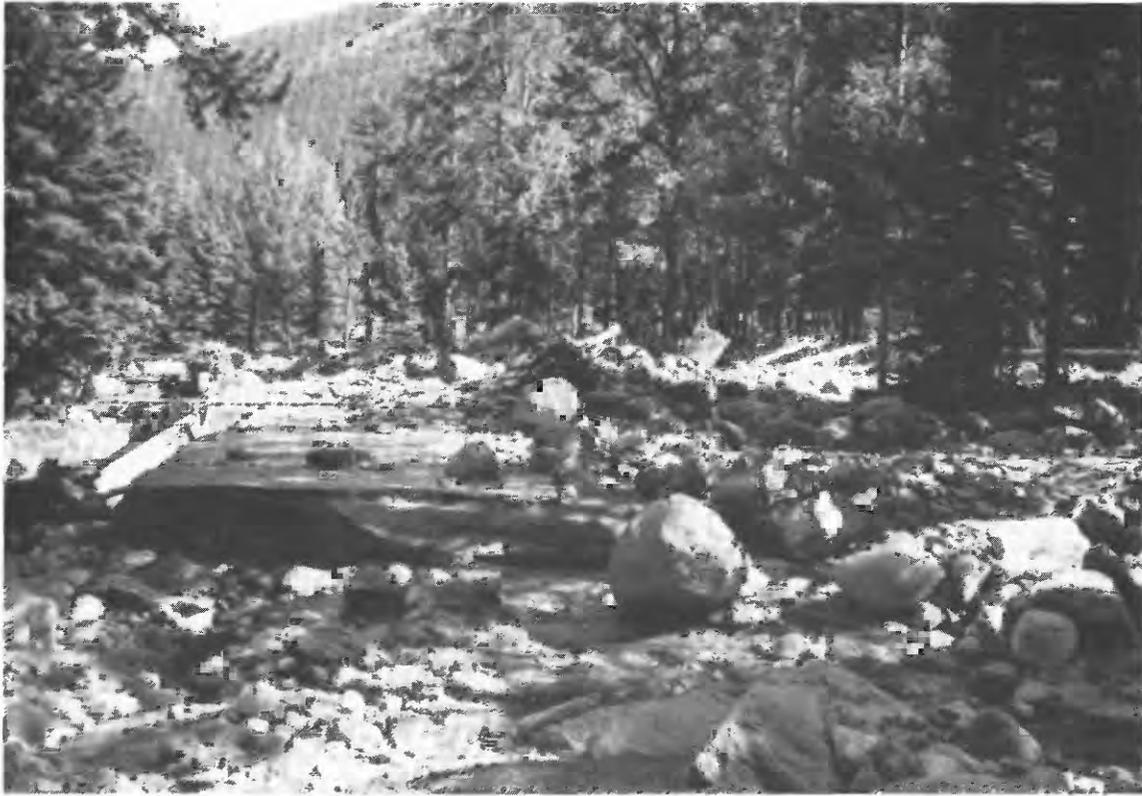
FIGURE 20.—The entrance to Aspenglen Campground downstream from Cascade Lake dam through the campground area at river mile 7.01. Boulders moved by the relatively wide, shallow flow of water (resembling overland flow).

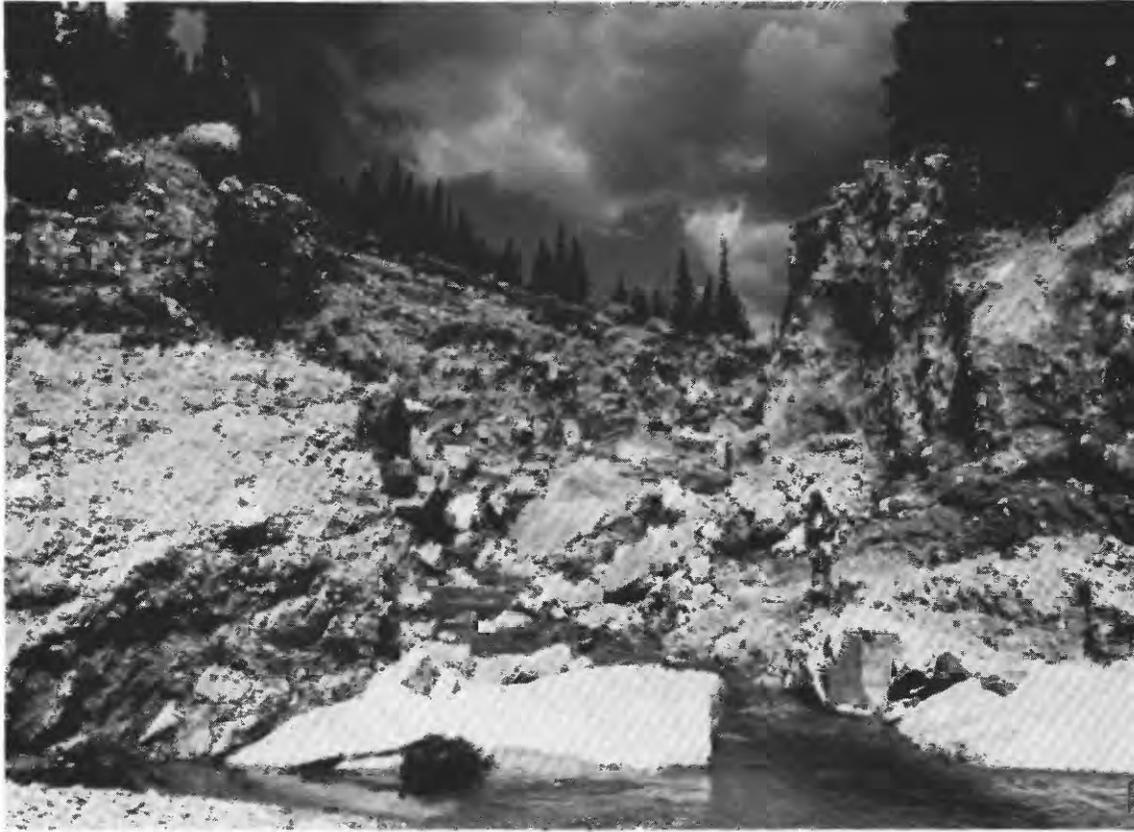
FIGURE 26.—Deeply scoured reach in the Roaring River valley below Lawn Lake dam at river mile 0.28. Ground moraine was scoured 35 feet to bedrock. Man (for scale) in right center of photo.

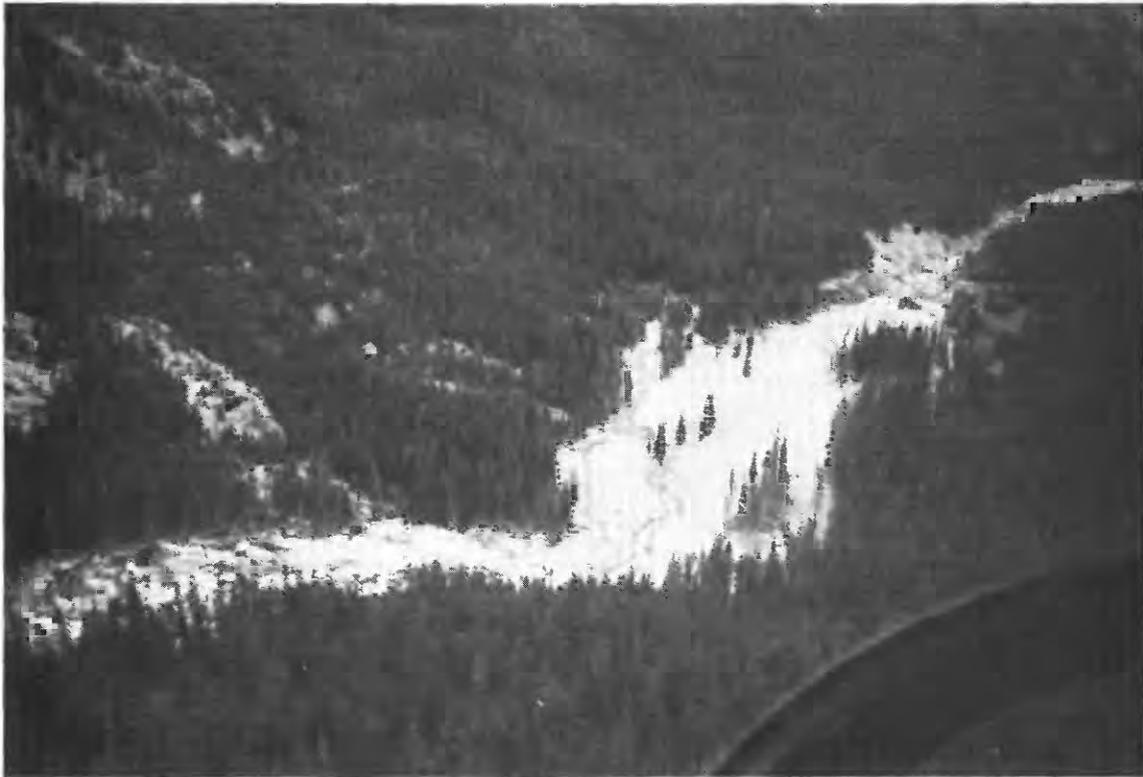
FIGURE 27.—The Roaring River valley at river mile 1.14 (aerial); down-valley is to the right. From the left edge of the photo, the channel is scoured to bedrock and very steep; a wide depositional reach is at a mountain meadow; a short, steep-scoured reach is defined by the slope failures on the left bank; and, finally, a flatter depositional reach extends off the right edge of photo.

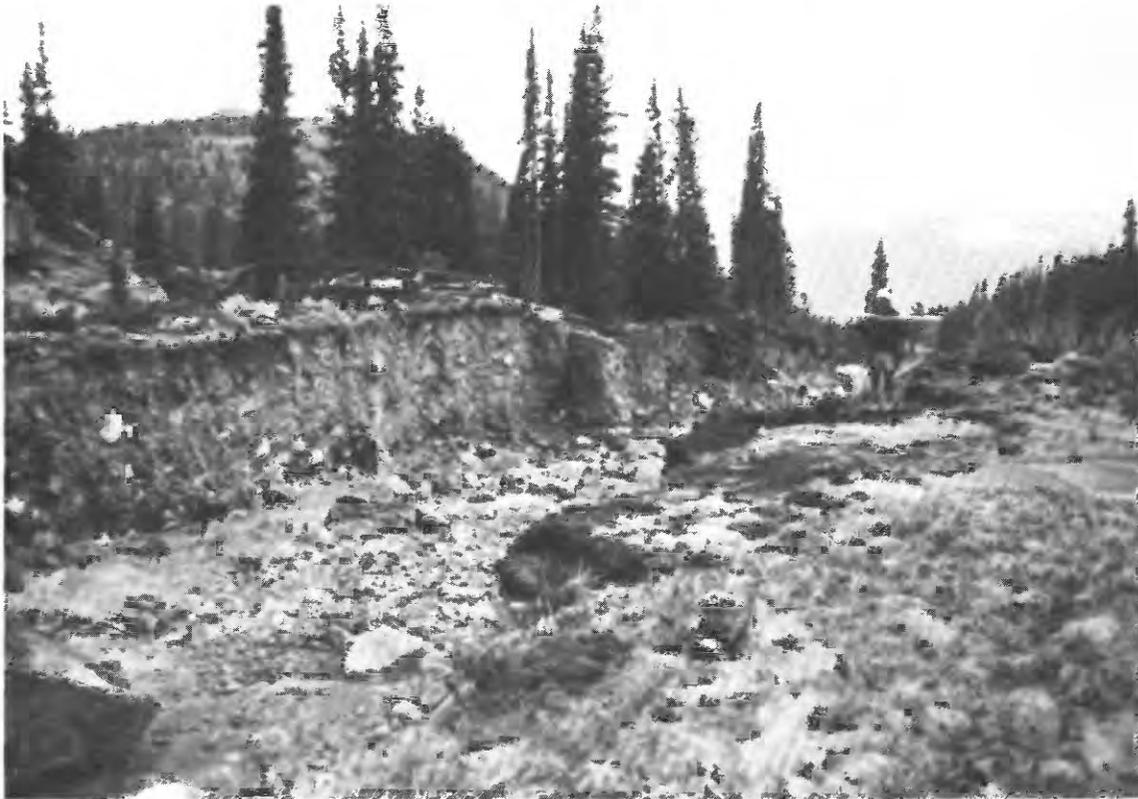
FIGURE 28.—View downstream at river mile 0.55 on the Roaring River valley in a scoured reach. Depth of scour is 25 feet; man is holding rod at the level of high-water marks.

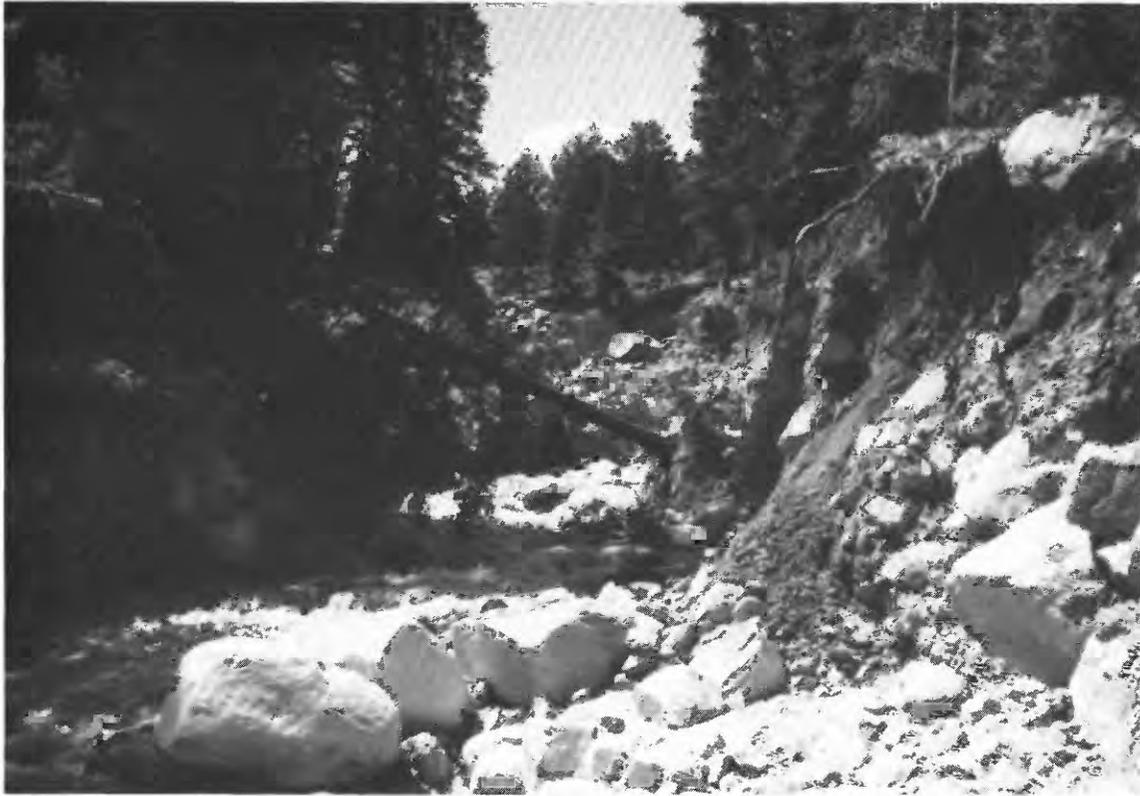
FIGURE 42.—The Fall River channel about 0.3 mile below Cascade Lake dam, showing extensive channel scour. View is upstream.

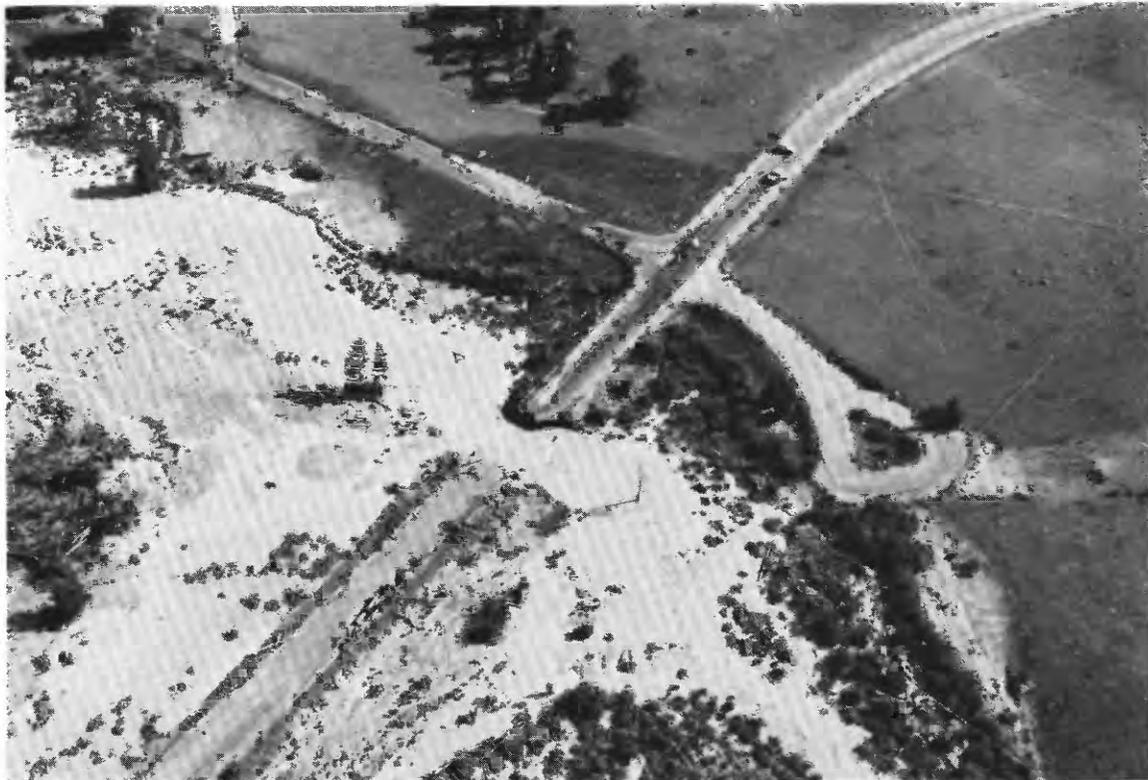
FIGURE 50.—About 0900 MDT on July 15, 1982, looking upstream at washed-out U.S. Highway 34 bridge in Rocky Mountain National Park at river mile 5.3. Photo courtesy of Zenas Blevins, U.S. Bureau of Reclamation.
