# Hydrology, Geomorphology, and Dam-Break Modeling of the July 15, 1982 Lawn Lake Dam and Cascade Lake Dam Failures, Larimer County, Colorado

U.S. GEOLOGICAL SURVEY PROFESSIONAL PAPER 1369

By ROBERT D. JARRETT *and* JOHN E. COSTA

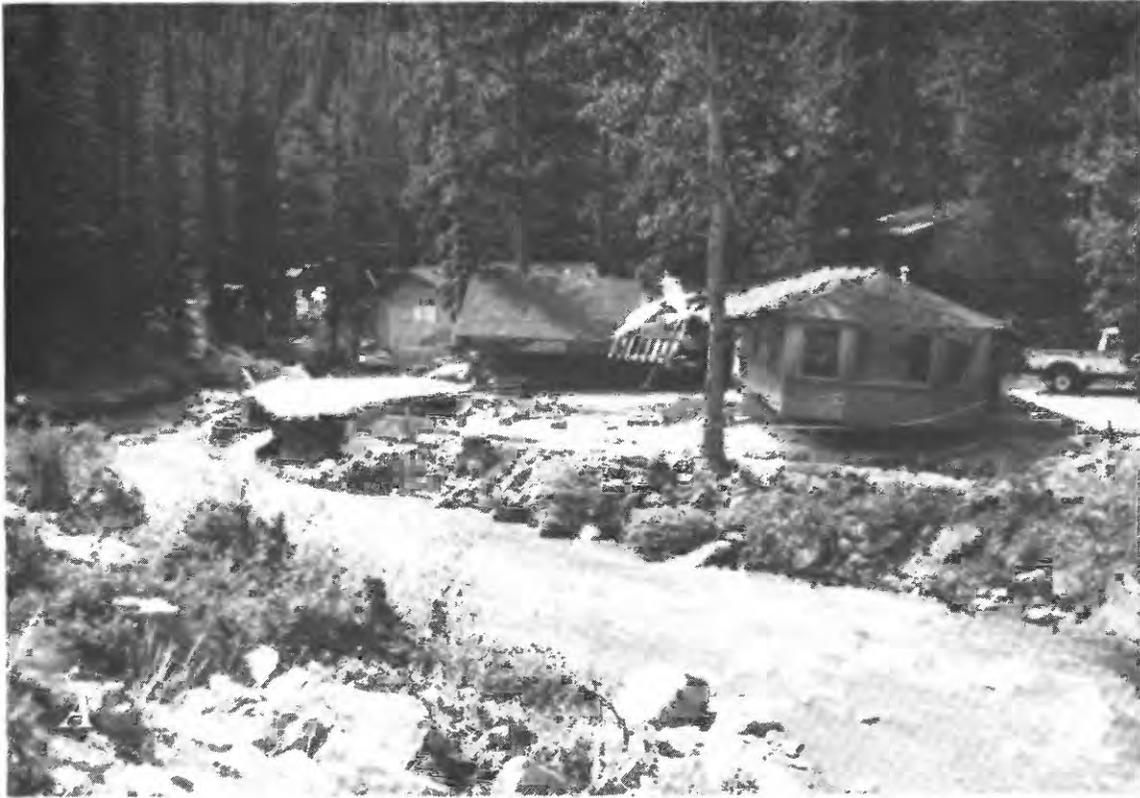
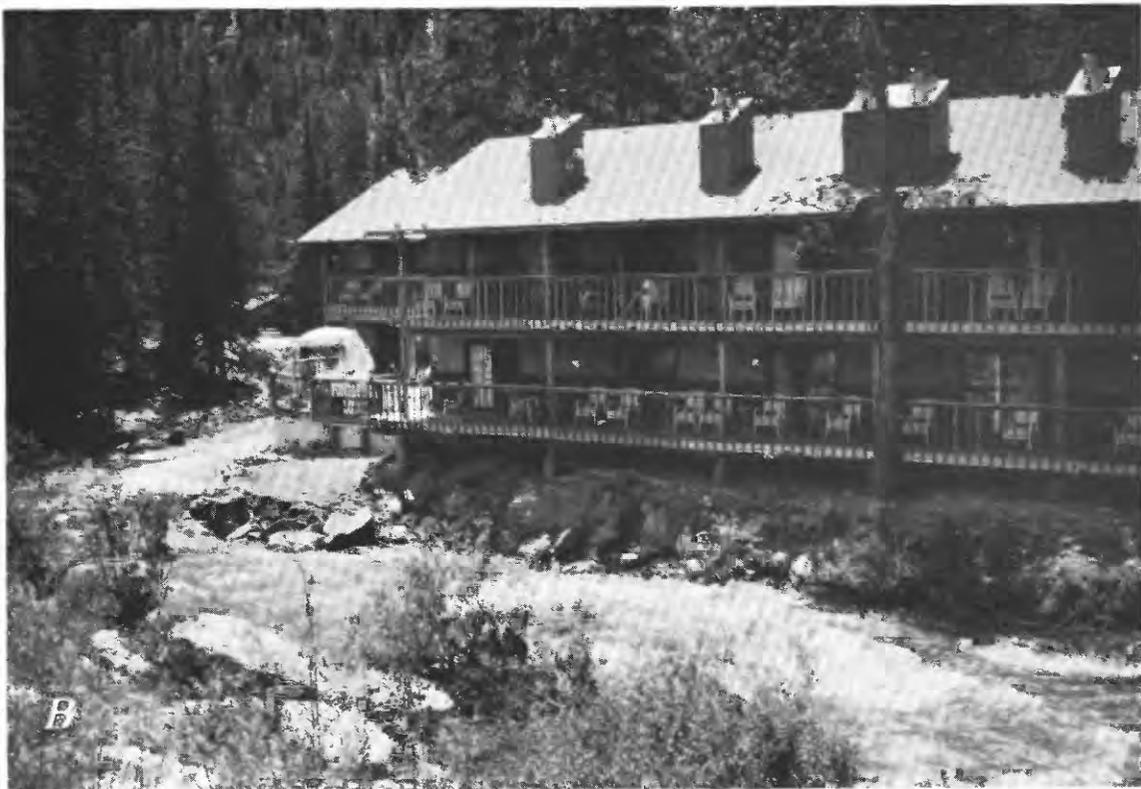
FIGURE 51.—*A*, The Ponderosa Lodge, which was destroyed by the flood, at river mile 9.9 on the Fall River. Note the structure was rotated almost 90° off its foundation. *B*, The Ponderosa Lodge, as rebuilt after the flood, from the same perspective as *A*. The structure is above the 100-year flood elevation.

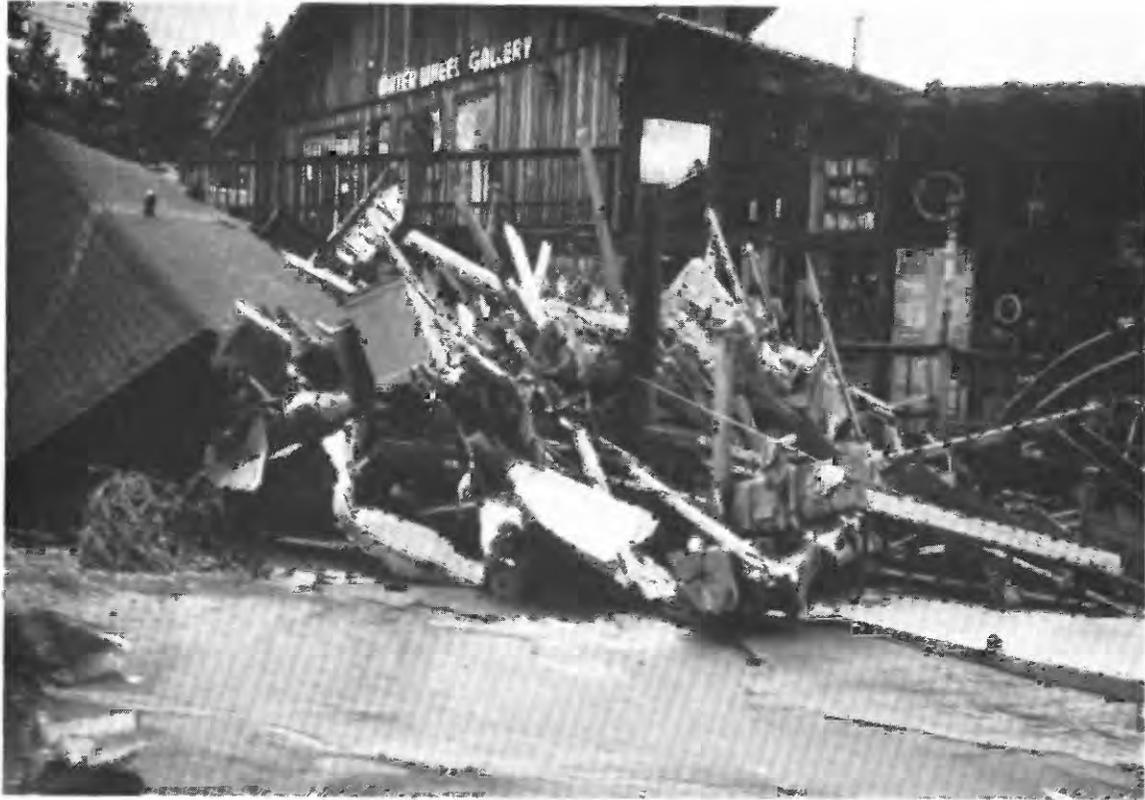
FIGURE 52.—Debris jam on the upstream side of Elkhorn Avenue at river mile 11.8 along the Fall River in Estes Park.

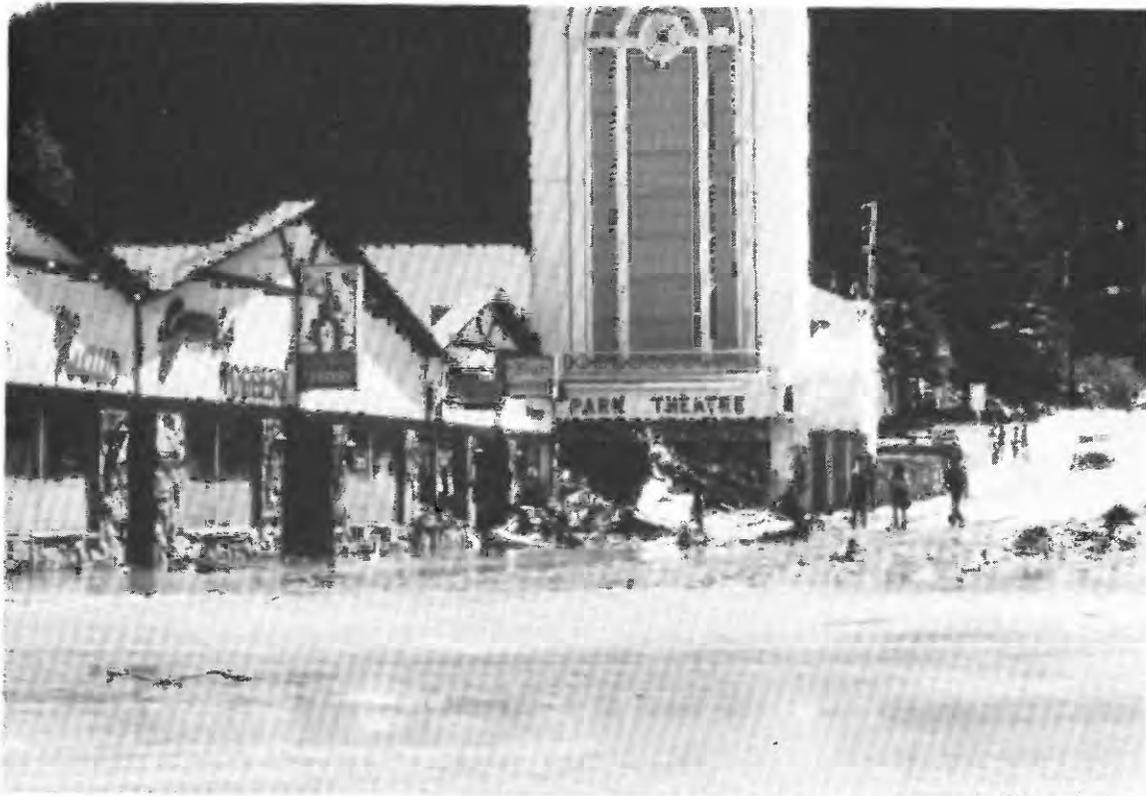
FIGURE 53.—High-water lines on buildings along the Fall River at Estes Park.
