# The Loma Prieta, California, Earthquake of October 17, 1989— Liquefaction

THOMAS L. HOLZER, *Editor*

STRONG GROUND MOTION AND GROUND FAILURE

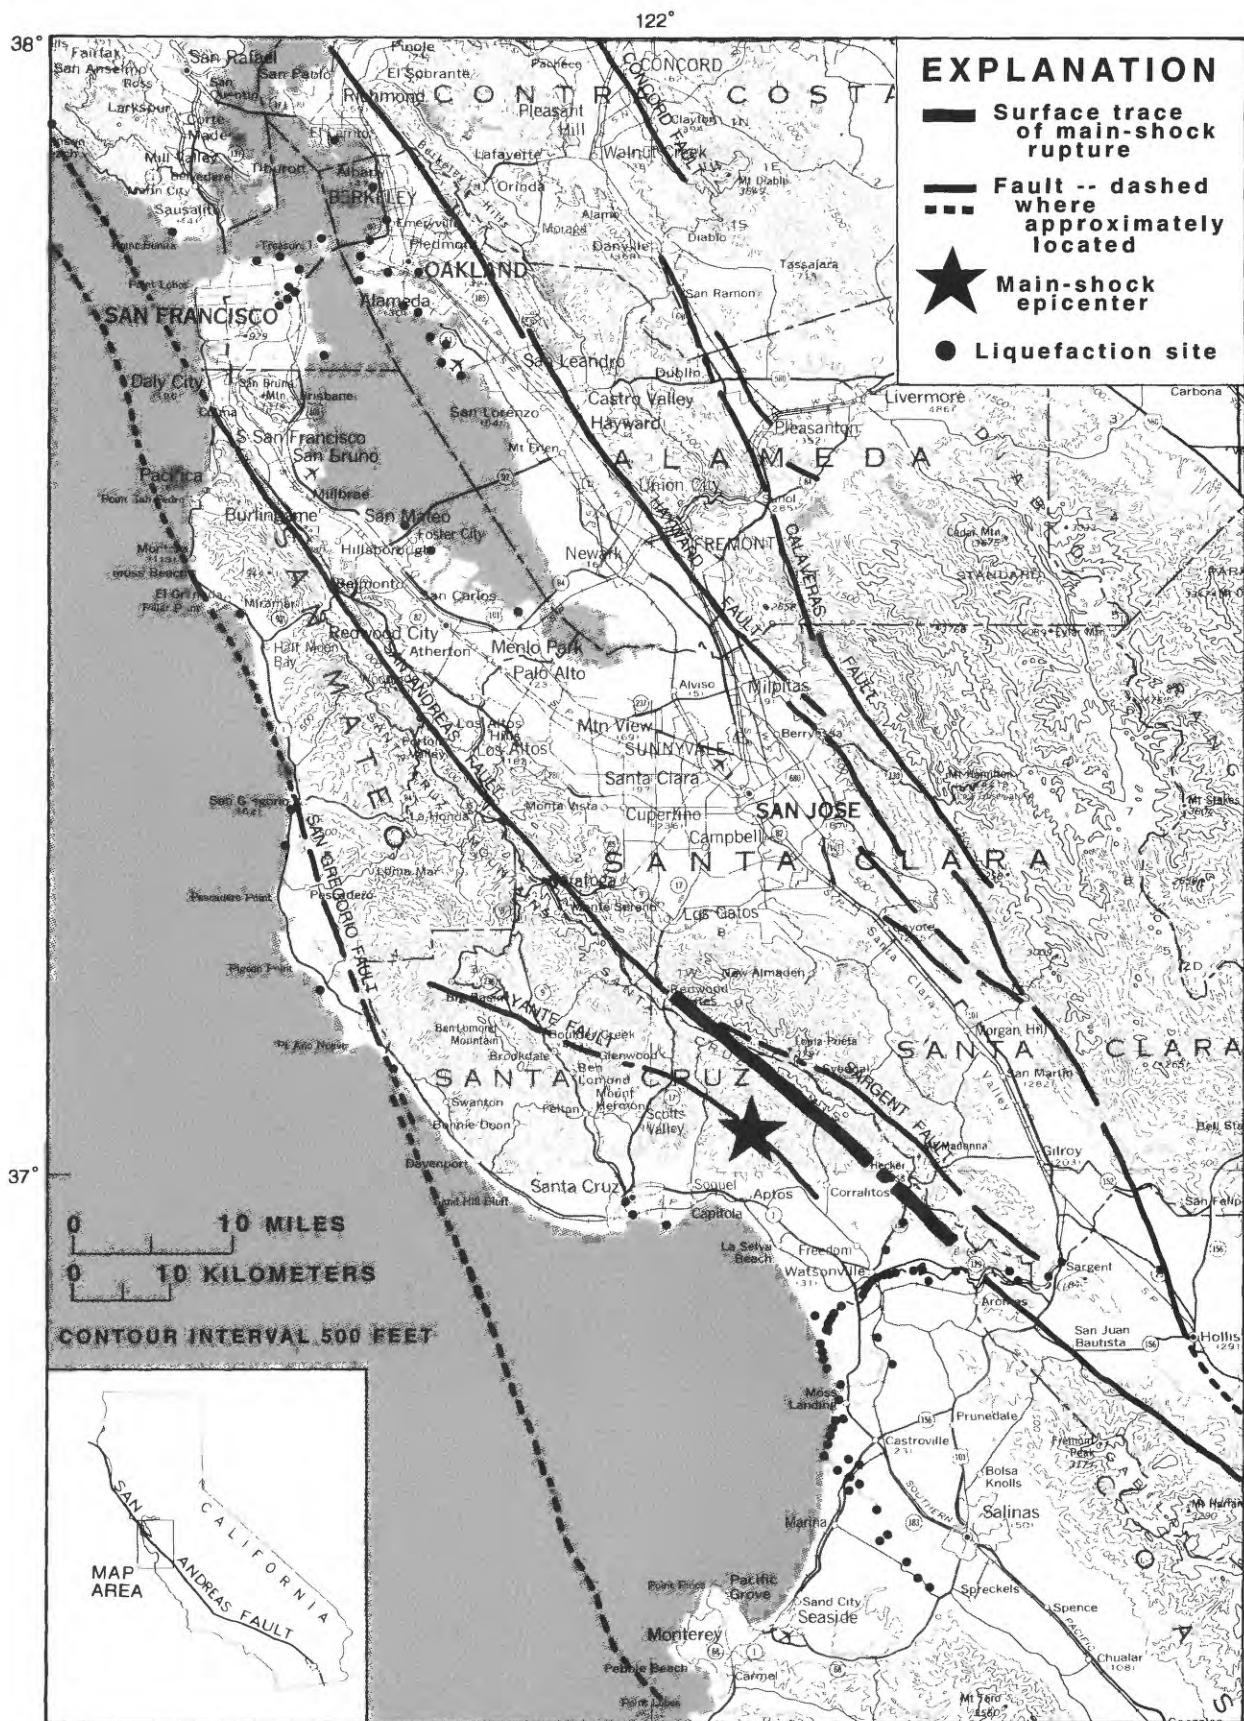
Figure 1.—San Francisco-Monterey Bay region, showing locations of sand boils, lateral spreads, and significant ground settlements associated with liquefaction caused by 1989 Loma Prieta earthquake (adapted from pls. 2 and 3).

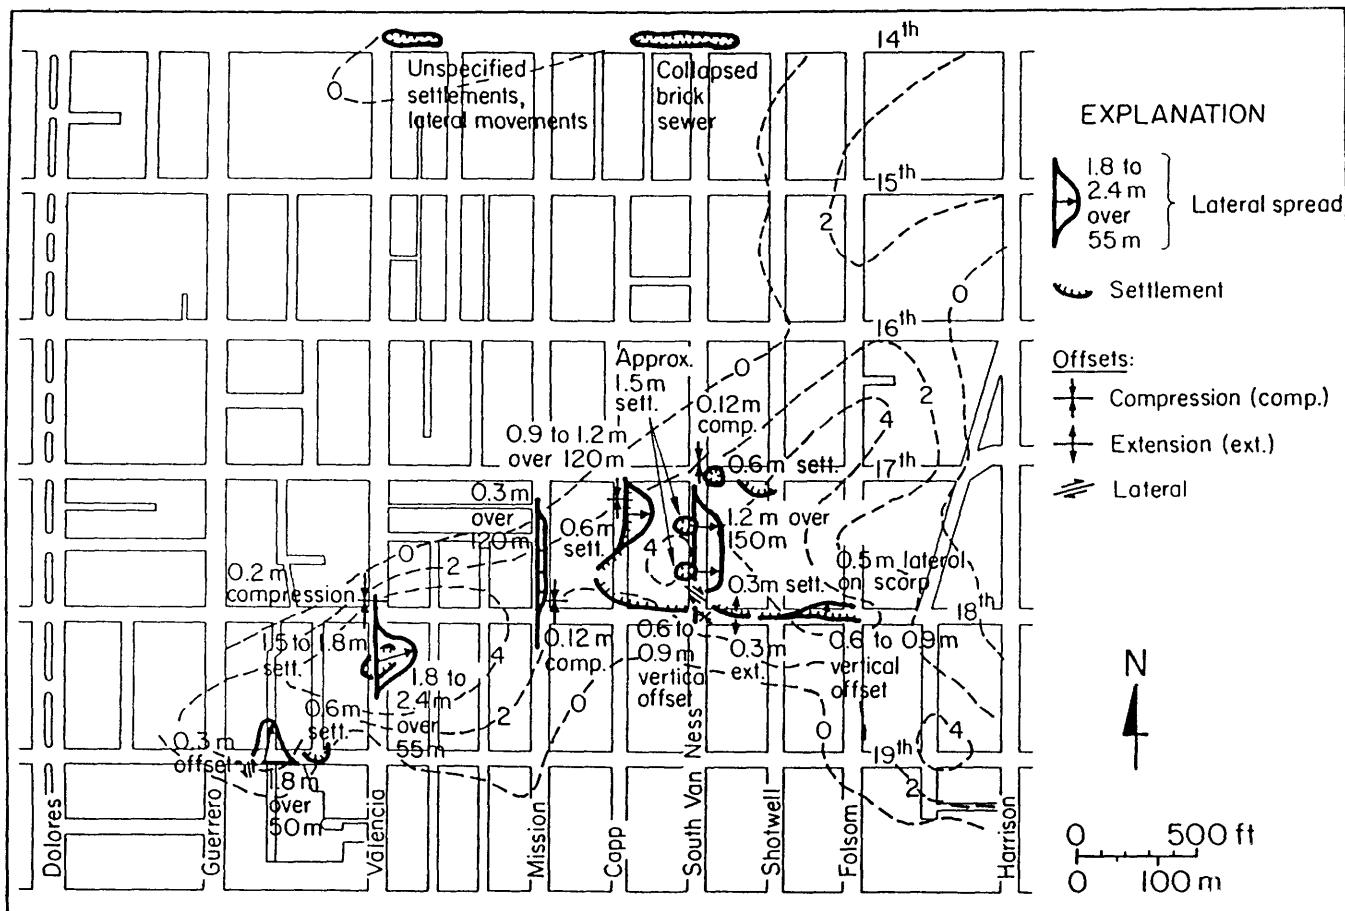
Figure 11.—Mission District study area, showing thickness of submerged fill (dashed contours; interval, 2 m) and locations of lateral spreading, differential settlement, and offsets in 1906 San Francisco earthquake. Hachures, which point toward area of settlement, may indicate either

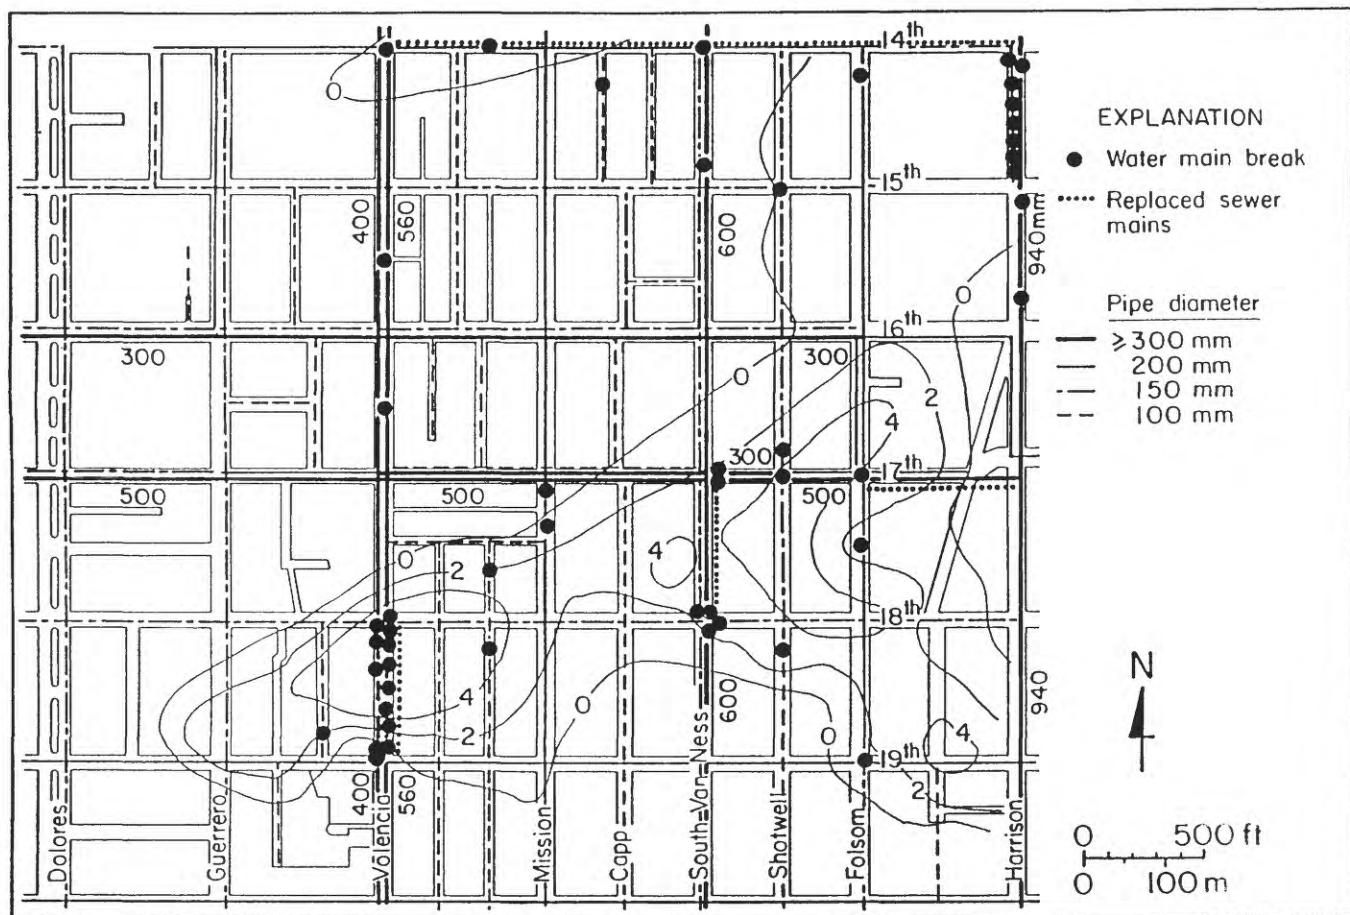
Figure 12.—Mission District, showing thickness of submerged fill (contour interval, 2 m), diameters of pipes, locations of water-supply pipelines, and locations of broken water mains and replaced sewer mains from 1906 San Francisco earthquake reported as of July 1906. Broken water mains were reported by the Spring Valley Water Co. (Schussler, 1906; Manson, 1908). In some places where pipelines cross or run parallel, it is

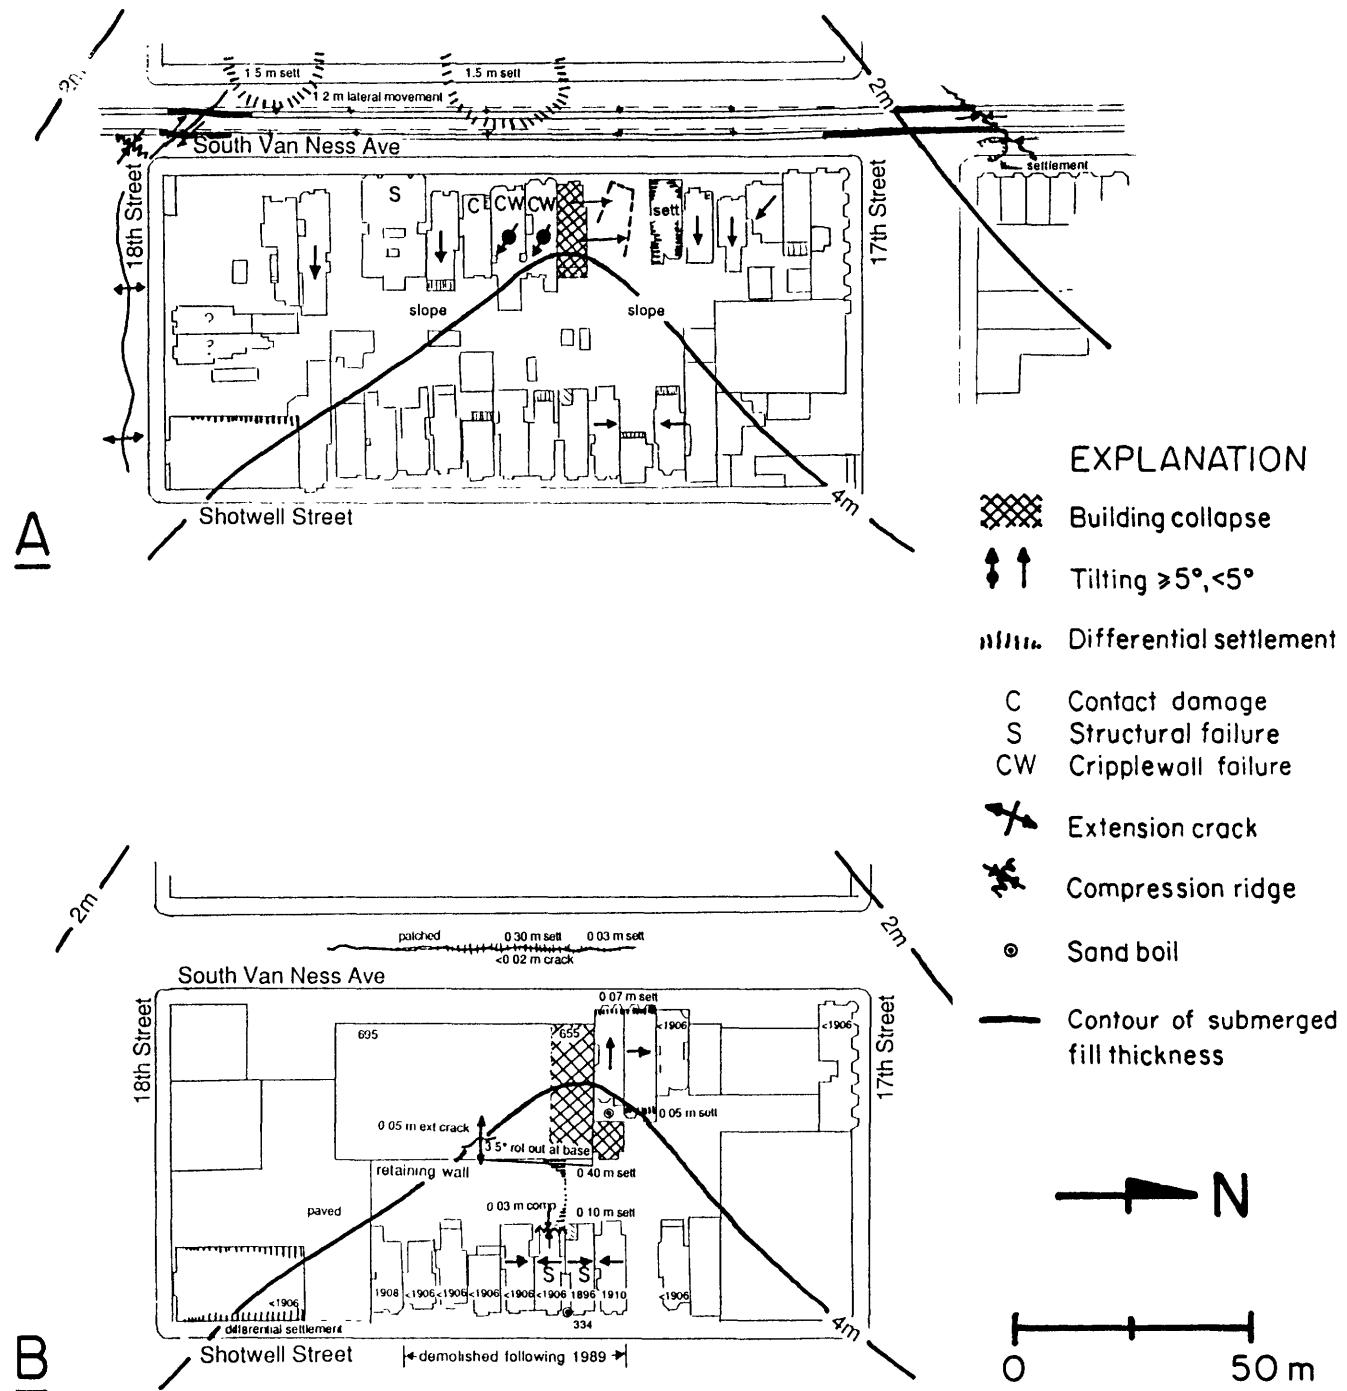
Figure 14.—Ground deformation and building damage from liquefaction in 1906 San Francisco (A) and 1989 Loma Prieta (B) earthquakes in block bounded by South Van Ness Avenue and Shotwell, 17th, and 18th Streets. Outlines of buildings not visible in photographs are queried or omitted for clarity. Where no symbol appears, damage cannot be inferred from photographs, but building should not be interpreted as undamaged. Length of lines indicates severity of differential settlement. Contact

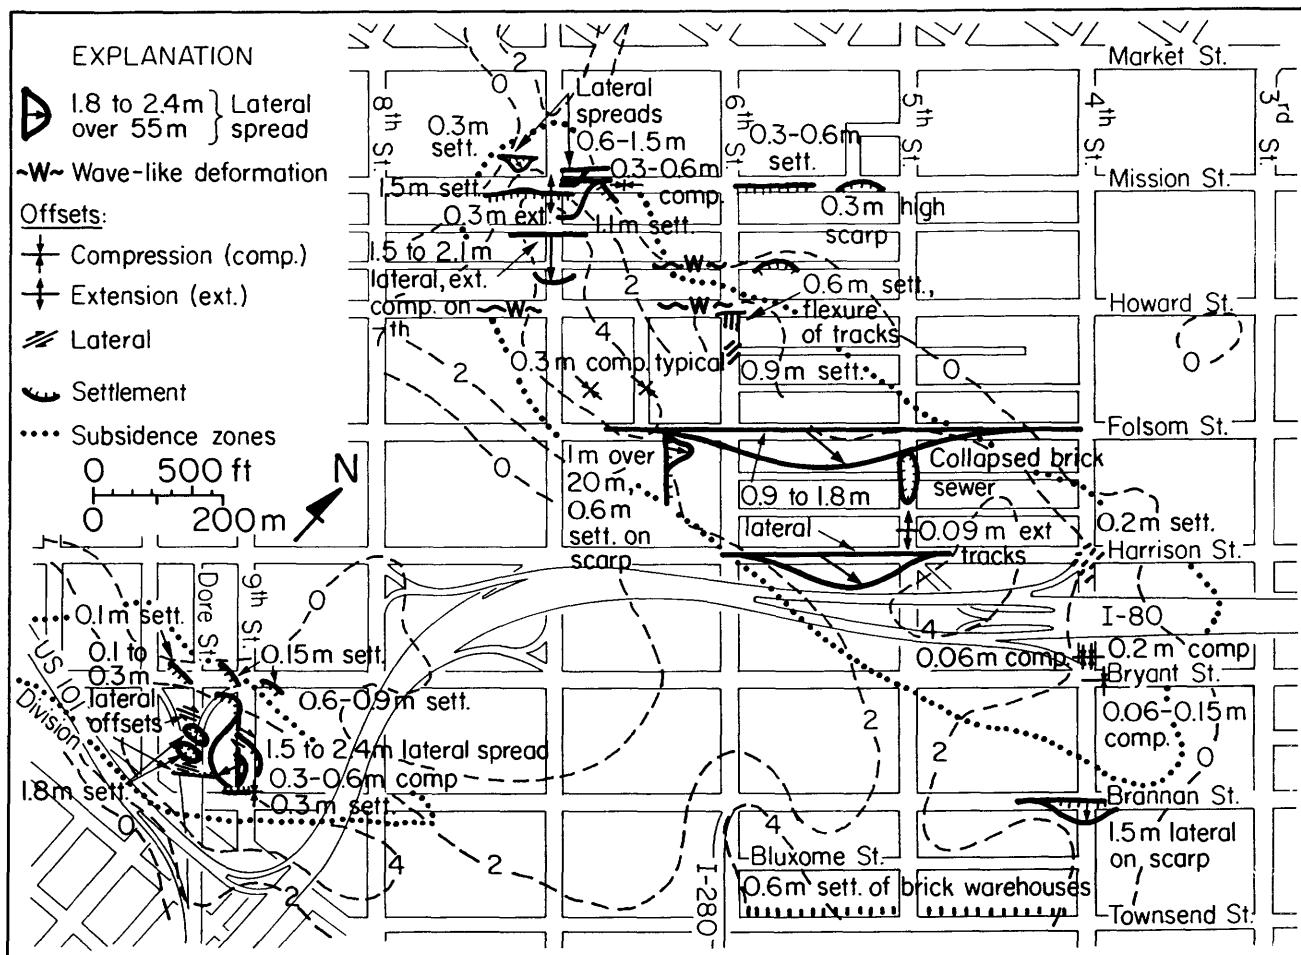
Figure 20.—South of Market study area, showing thickness of submerged fill (dashed contours; interval, 2 m) and locations of lateral spreading, differential settlement, and offsets in 1906 San Francisco earthquake. Hachures, which point toward area of settlement, may indicate either gradual subsidence or an abrupt scarp. Dotted outline denotes major subsidence zones reported by Schüssler (1906). From O'Rourke and others (1992a).

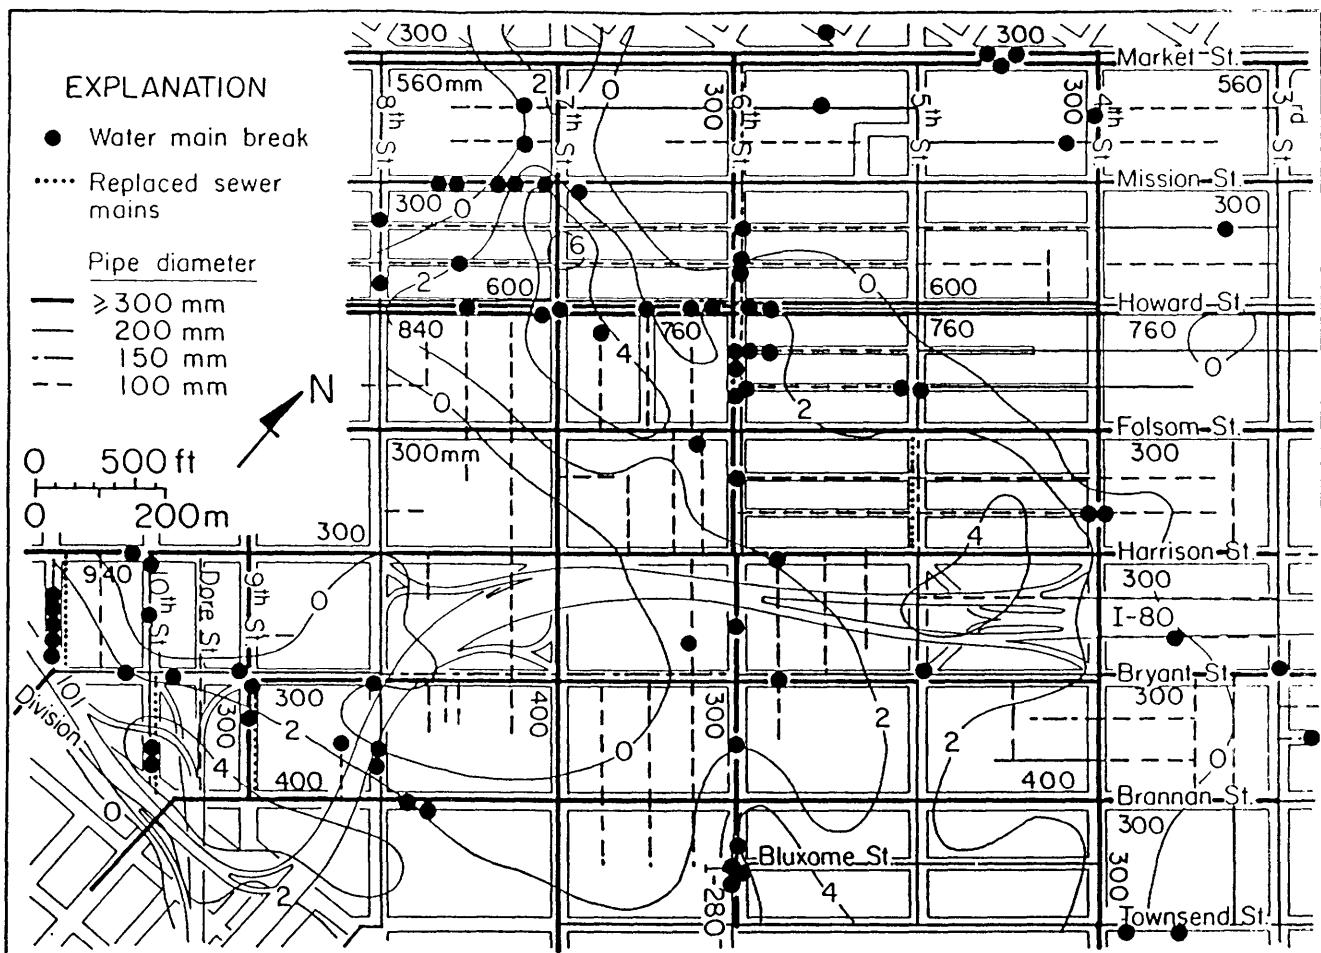
Figure 21.—South of Market area, showing thickness of submerged fill (contour interval, 2 m), diameters of pipes, locations of water-supply pipelines, and broken water mains and replaced sewer mains from 1906 San Francisco earthquake reported as of July 1906. Broken water mains were

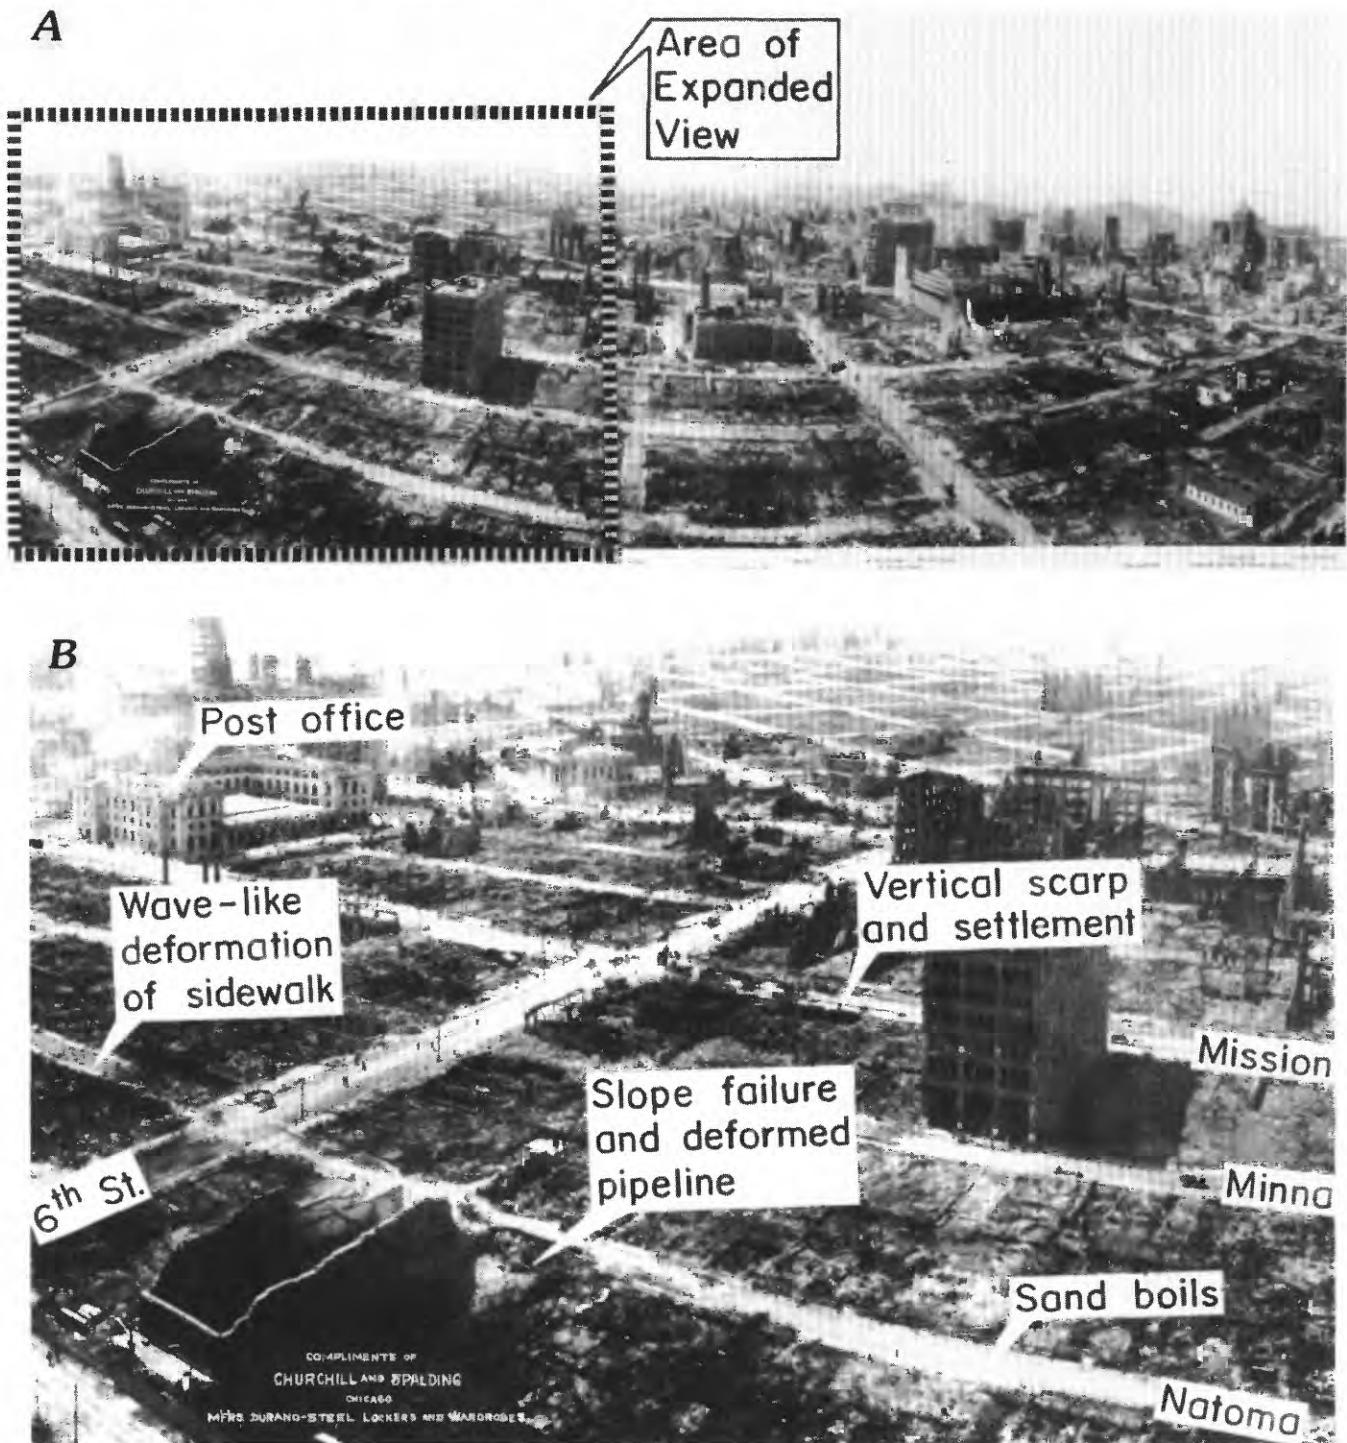
Figure 22.—Part of panorama of San Francisco after 1906 earthquake and fire (A), showing liquefaction-induced ground deformations in devastated area bounded approximately by Mission, Fifth, Seventh, and Natoma Streets (B). Between Sixth and Seventh Streets, ground deformation falls within zone of submerged fill overlying former marsh. Extension cracks, vertical scarps, and settlement monoclines were photographed on Mission Street. At south corner of Post Office, which was built on isolated grillage footings as deep as 6 m below surface,

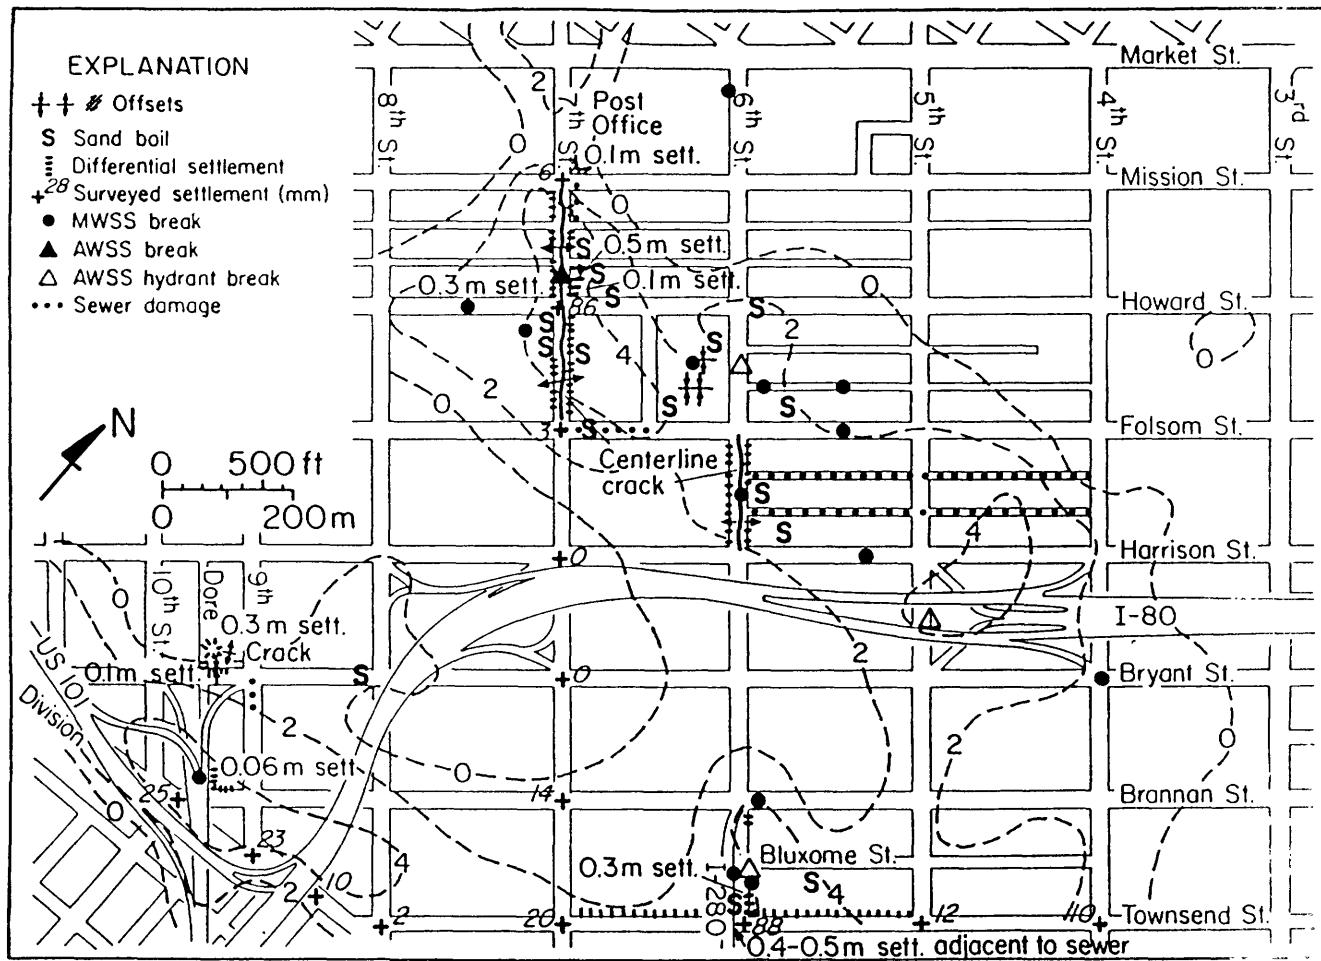
Figure 24.—South of Market area, showing thickness of submerged fill (dashed contours; interval, 2 m) and locations of lateral spreading, differential settlement, offsets, and broken water main (dots) in 1989 Loma Prieta earthquake. Surveyed settlements are differential settlements mea-

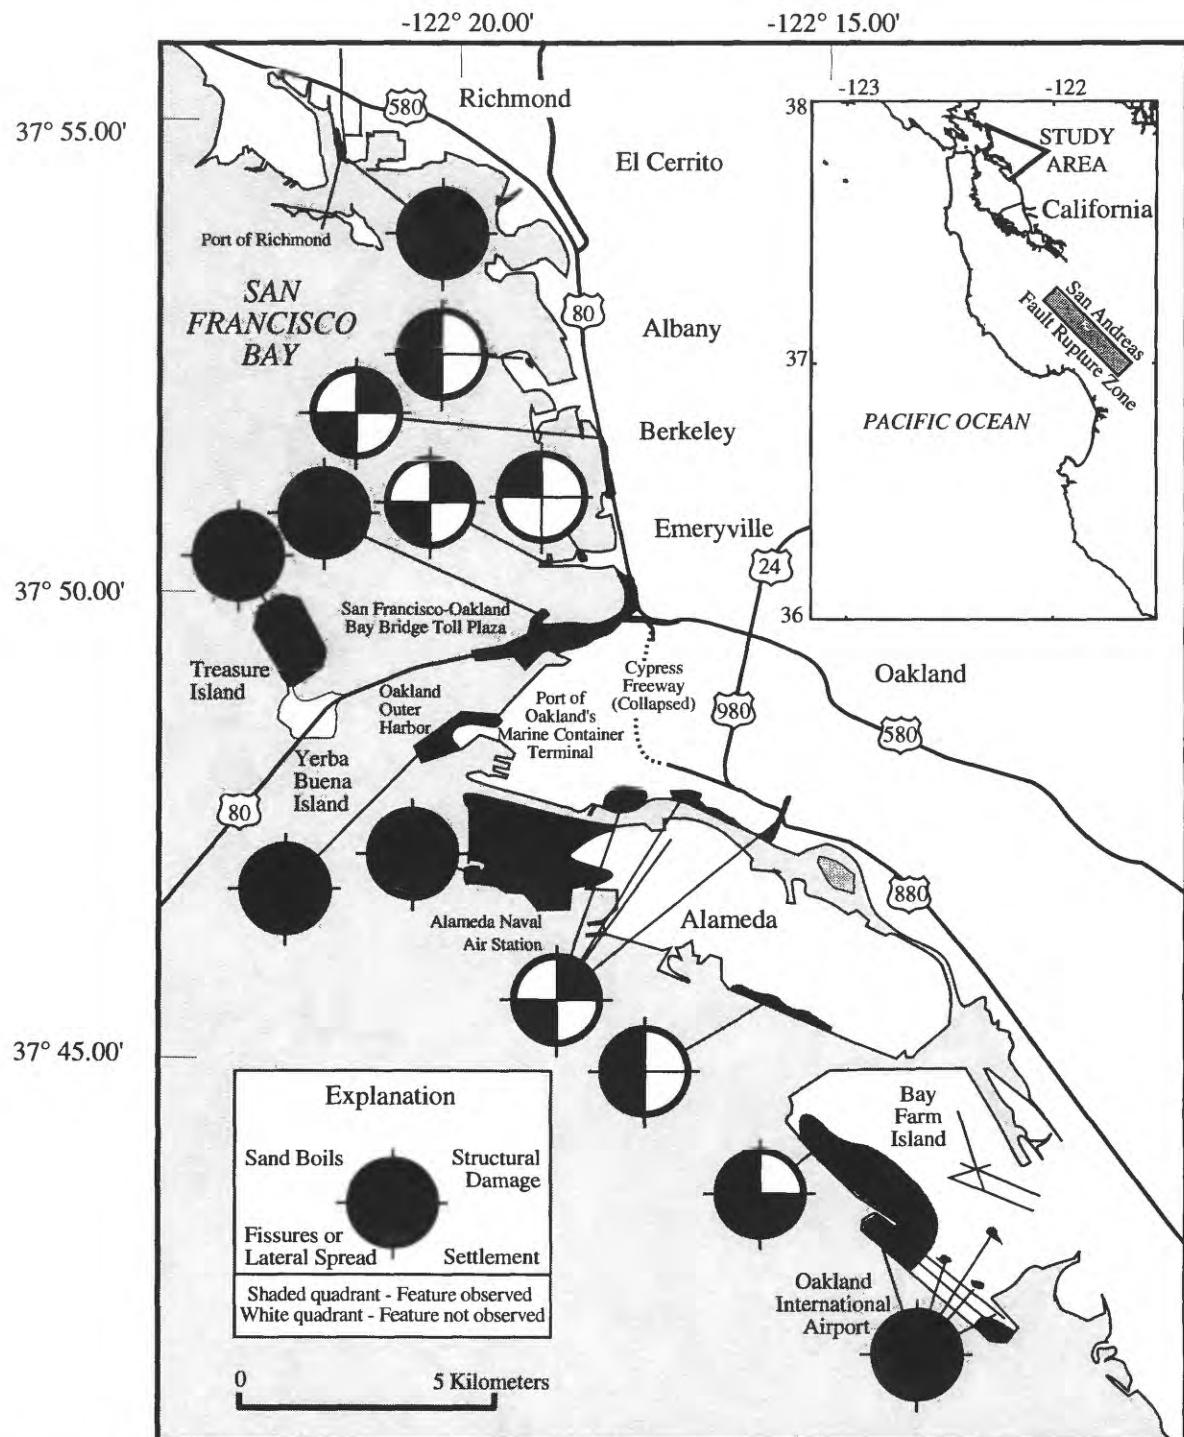
Figure 1.—San Francisco east-bay shoreline, showing locations of sites where liquefaction-induced damage occurred from 1989 Loma Prieta earthquake and of study sites where soil investigations were performed.

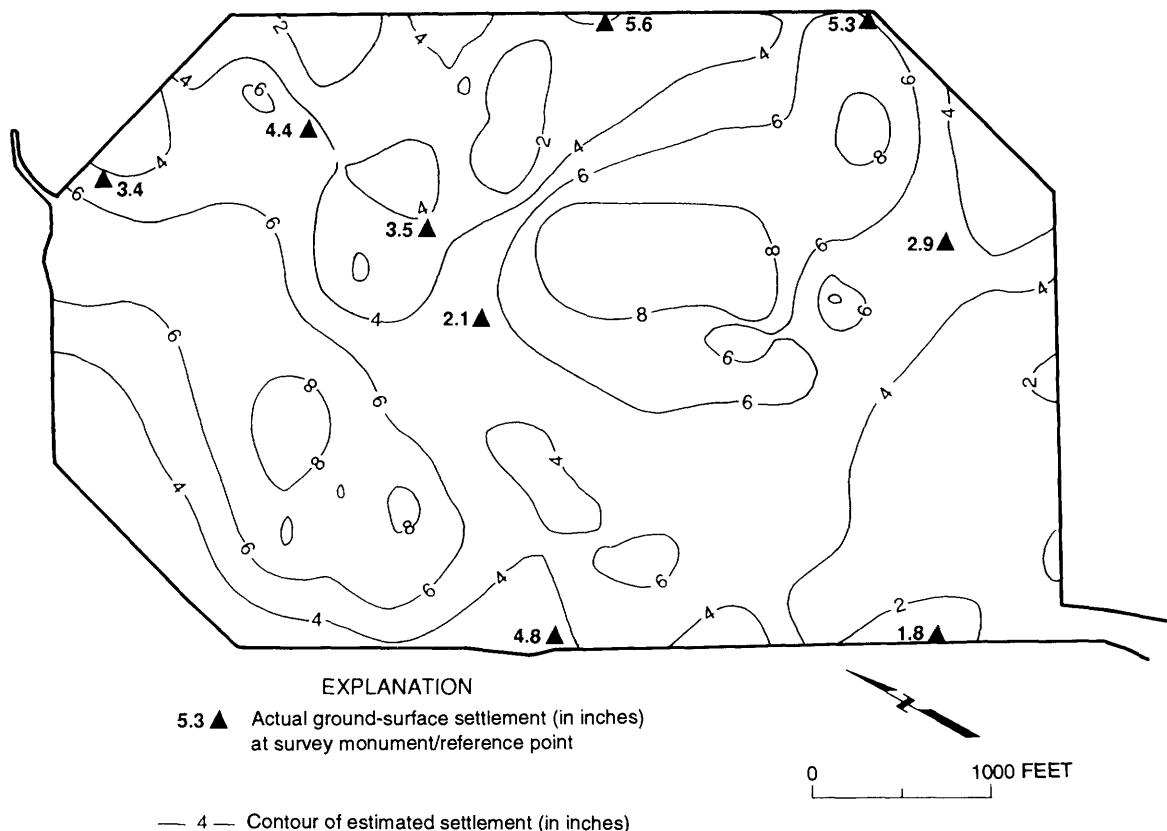
Figure 13.—Sketch map of Treasure Island, showing actual ground-surface settlements and contours of estimated settlement caused by compaction (see text for discussion).

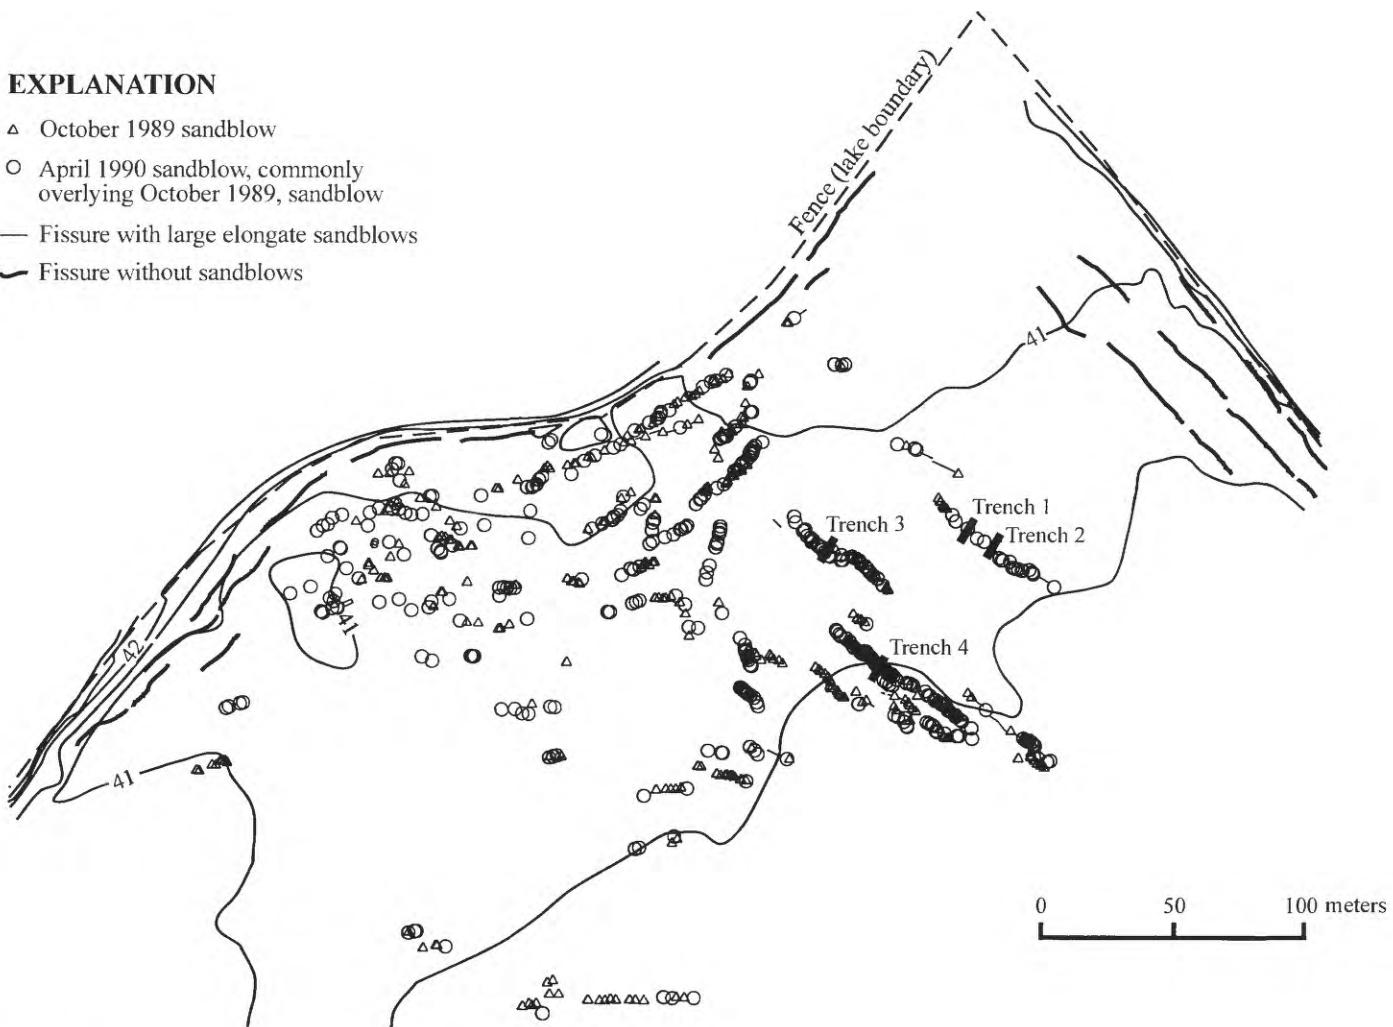
Figure 3.—Topographic map of Soda Lake, Calif., showing distribution of fissures and sandblows formed in October 17, 1989, Loma Prieta earthquake and April 18, 1990, aftershock, and locations of four trenches. Contour interval, 0.5 m.

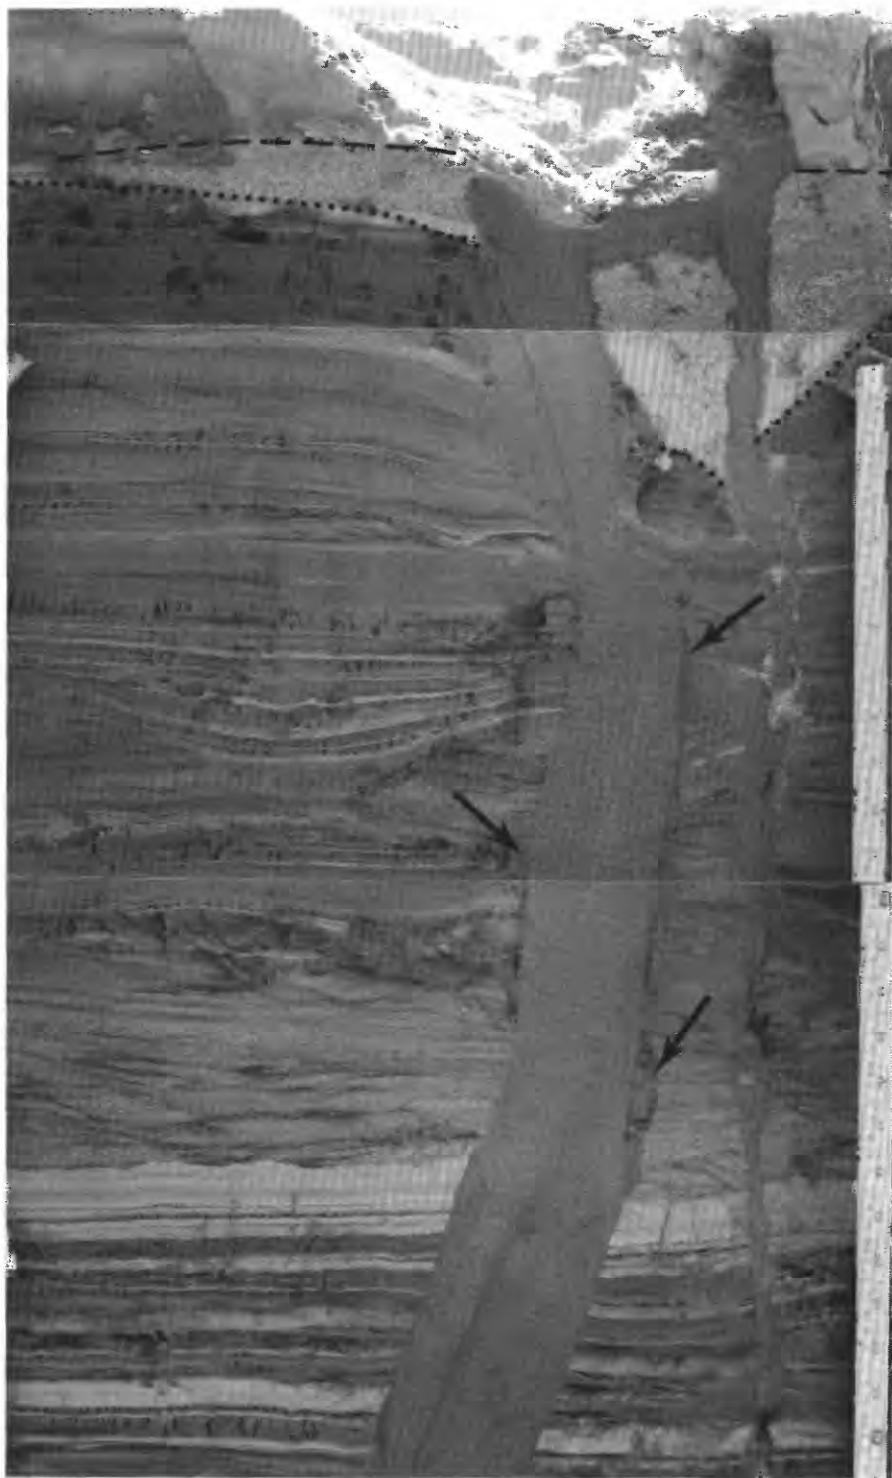
Figure 11.—Vertical section through sand dike and sandblow, showing internal lamination subparallel to dike walls in sand dike. Dike walls are undulatory, and most concave sections are filled with lenses of darker silt- and clay-rich sediment (arrows). Note details of stratigraphy of host sediment. Dotted line, contact between finely laminated host sediment and erupted sand of sandblow surface shield; dashed line, upper contact of basal subunit of coarse sand that was first material erupted from fissure.

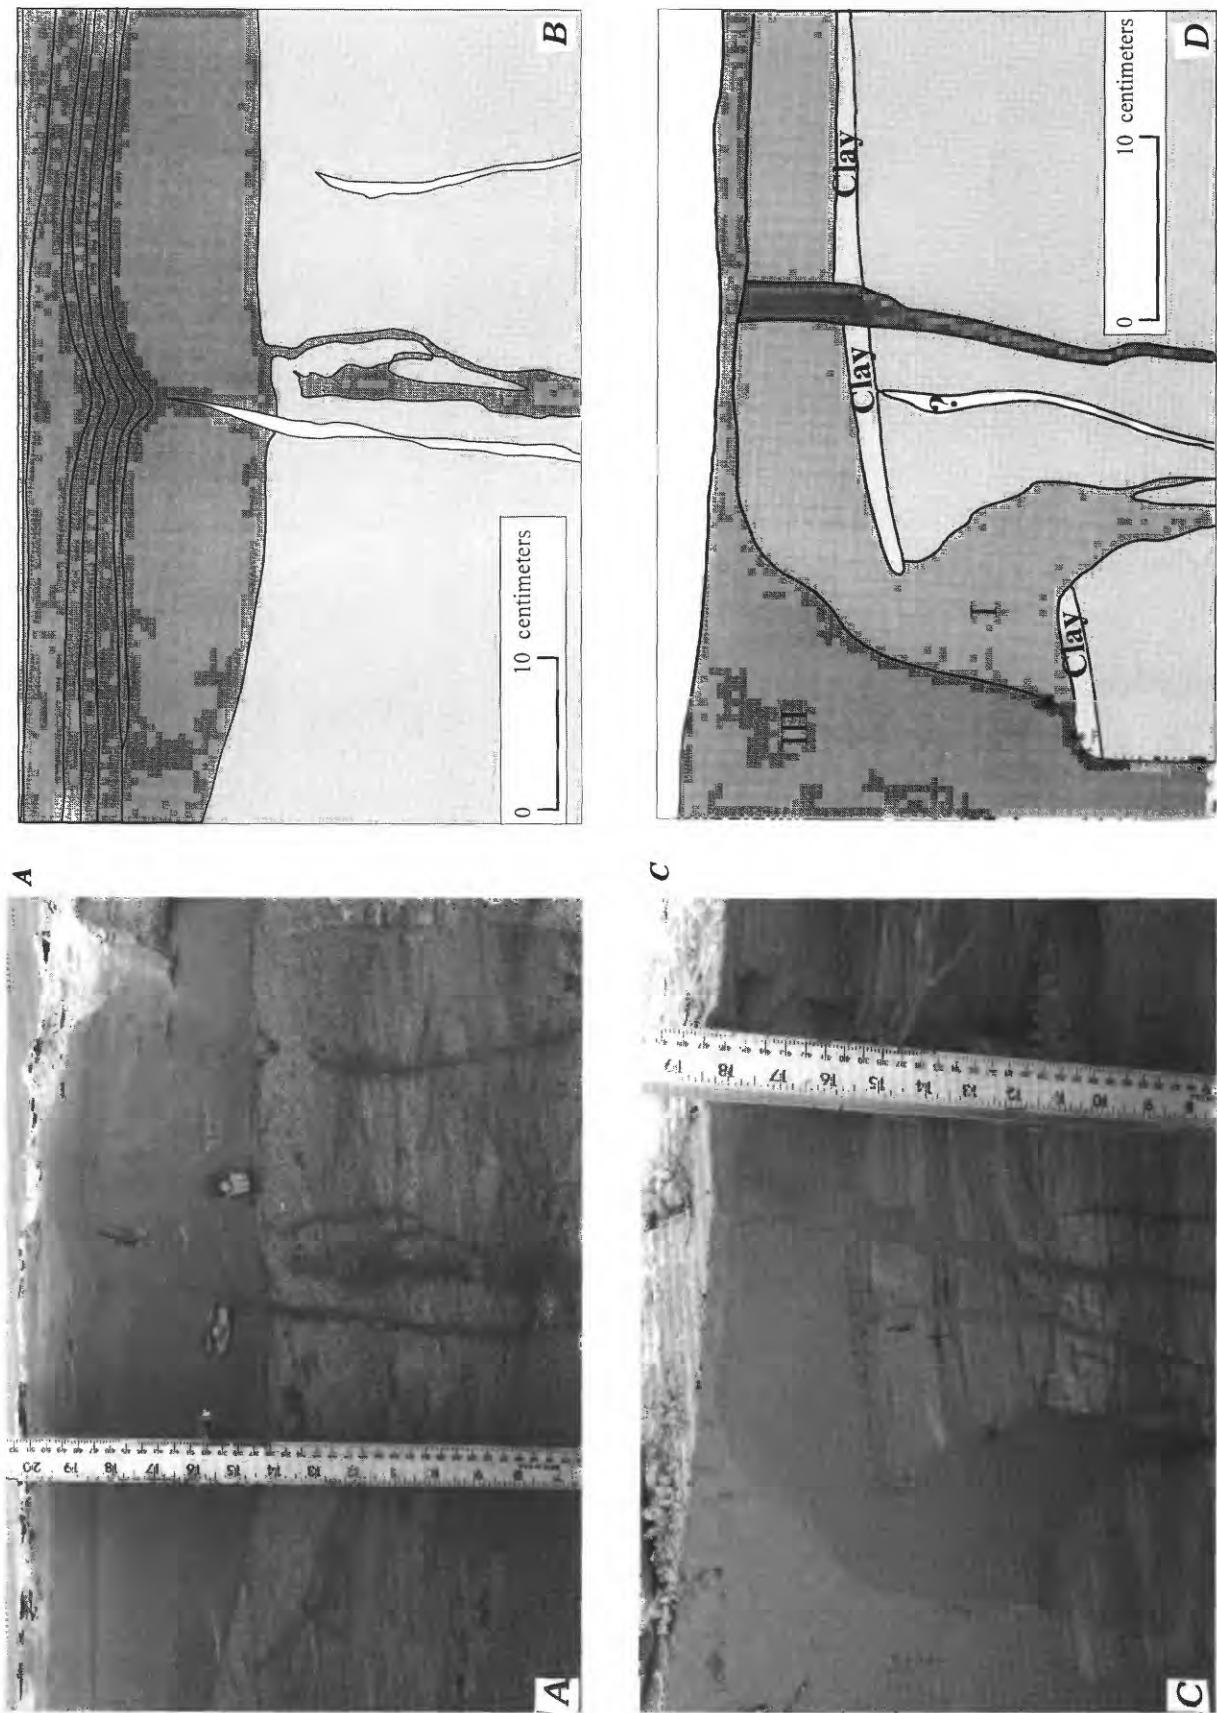
Figure 12.—Sediment exposed in trenches 3 (A) and 4 (C) (see fig. 3 for locations), with sketches illustrating stratigraphic relations (B and D, respectively). Photograph in figure 12A shows small sand dikes, terminating at different stratigraphic levels, that formed on either October 17, 1989, or April 18, 1990. Photograph in figure 12C shows three crosscutting liquefaction structures, I through III, and a small sand dike that terminates at a clay layer.

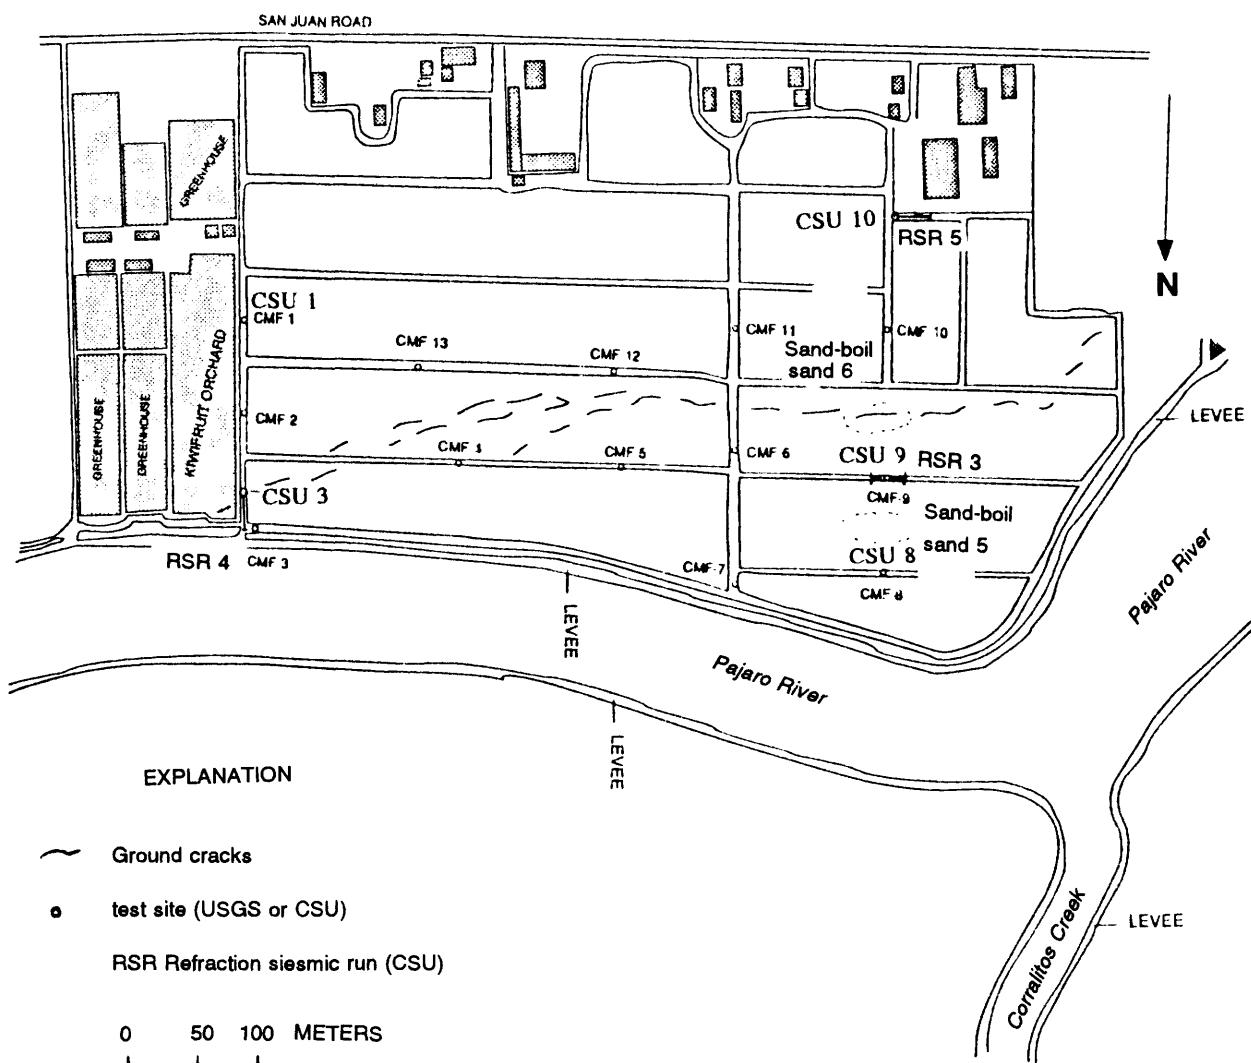
Figure 14.—Miller Farm study site (fig. 7), showing locations of liquefaction features and tests by Colorado State University (CSU) and U.S. Geological Survey (USGS).
