The Loma Prieta, California, Earthquake of October 17, 1989—Lifelines

PERFORMANCE OF THE BUILT ENVIRONMENT
Thomas L. Holzer, *Coordinator*

U.S. GEOLOGICAL SURVEY PROFESSIONAL PAPER 1552-A

LIFELINES

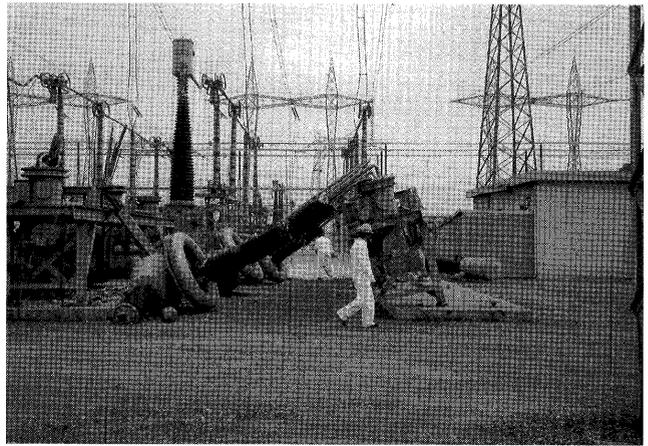
Figure 6.—Overturned 500-kV circuit breaker at the Moss Landing Substation (fig. 1).

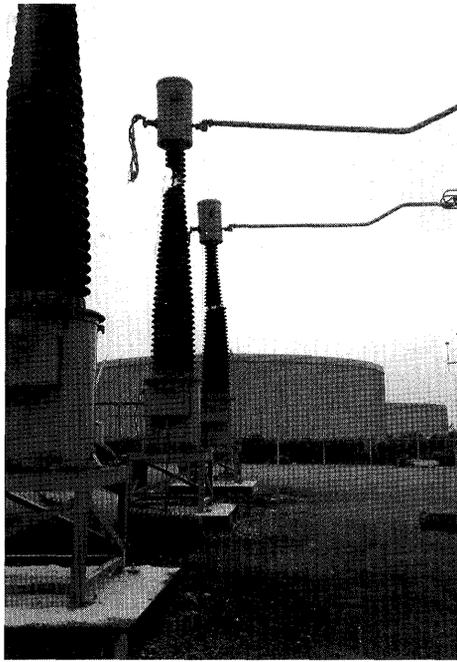
undamaged. Most current-transformer failures were caused by cracking of the porcelain member in its upper half, as shown in figure 9. Several current transformers folded over at the porcelain break, located at about the three-fourths level. The two current transformers that did not fail had flexible connections to the circuit breakers. In most of the circuit breakers that fell over, the connection between the circuit breaker and the current transformer failed after the current transformer had been severely damaged. A simple analysis of similar current transformers and support structures that was performed after the 1984 Morgan Hill, Calif., earthquake (Schiff, 1985) indicated that the support structure was relatively flexible and that the current transformer had a natural frequency of about 2 Hz.

Figure 9.—Damaged 500-kV current transformer at the Moss Landing Substation (fig. 1).

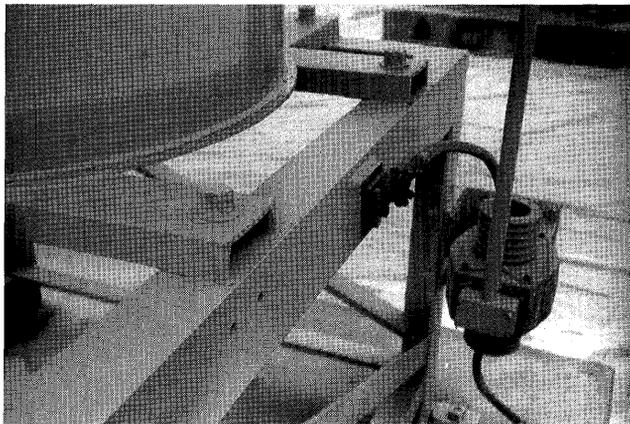
Figure 10.—Detail of damaged 500-kV current transformer (fig. 9) at the Moss Landing Substation (fig. 1).

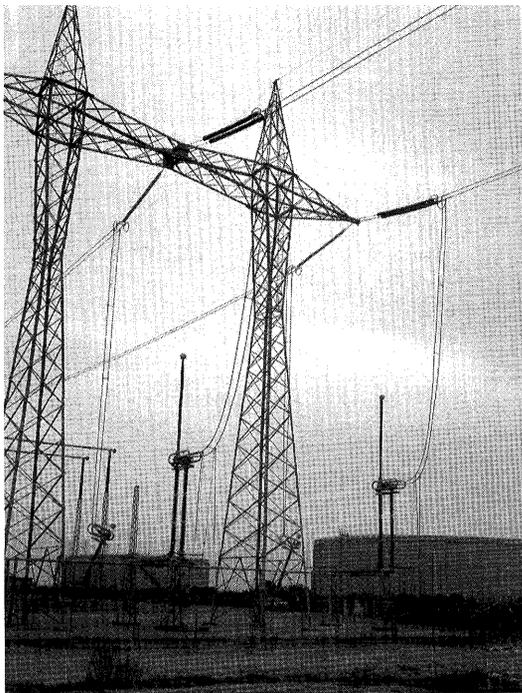
Figure 12.—Disconnect switch with flexible bus at the Moss Landing Substation (fig. 1).

Two of the three phases of bus 1 are shown in figure 12. The support column without the post insulator is associated with the failed bus phase. Failure of a single bus support on bus 2 allowed the bus to sag, but the bus remained operational.

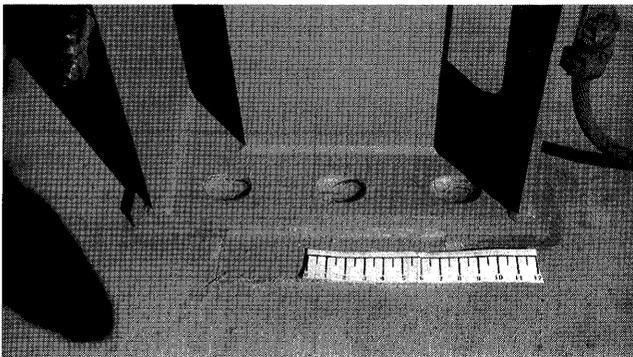
Figure 15.—Detail of welded anchorage on 500-kV dead-tank circuit breaker at the Moss Landing Substation (fig. 1).

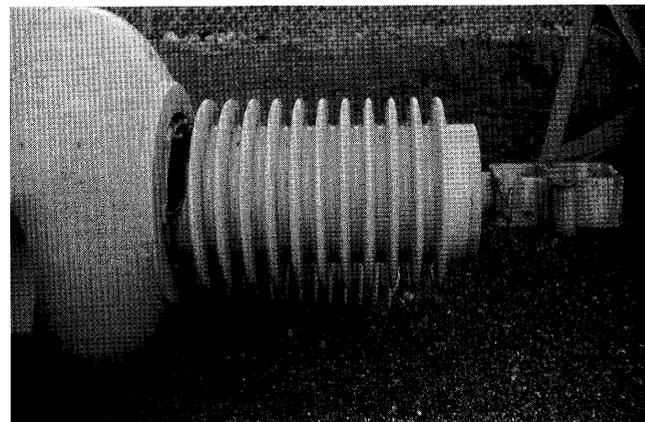
Figure 23.—Blown interrupter-head gasket on 230-kV circuit breaker at the San Mateo Substation (fig. 1).

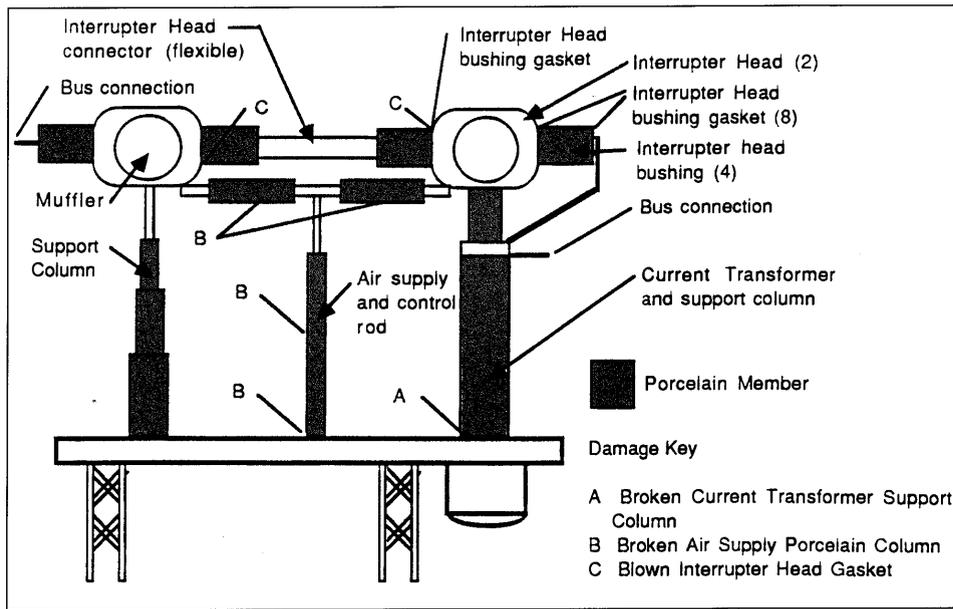
Figure 24.—Schematic diagram of General Electric model ATB7 circuit-breaker failures at the San Mateo Substation (fig. 1).

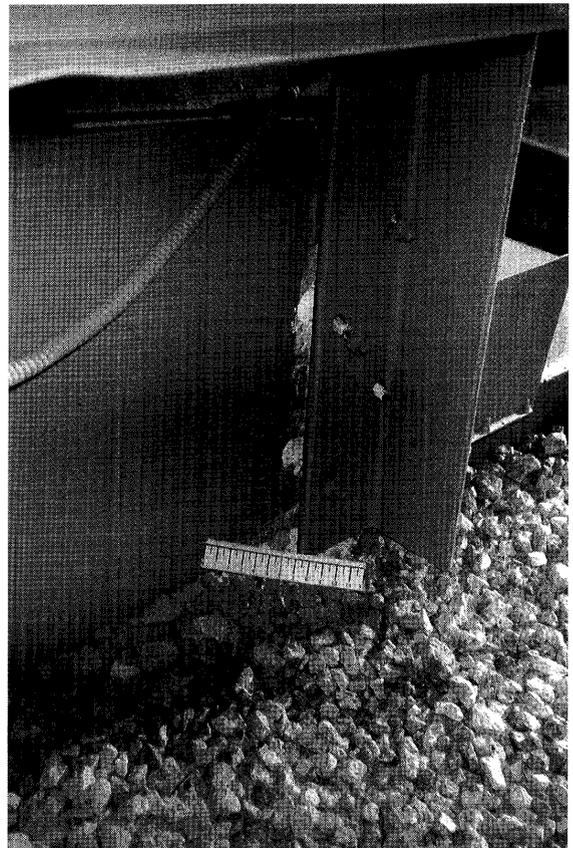
Figure 26.—Anchorage failure on 115/60-kV transformer at the San Mateo Substation (fig. 1).

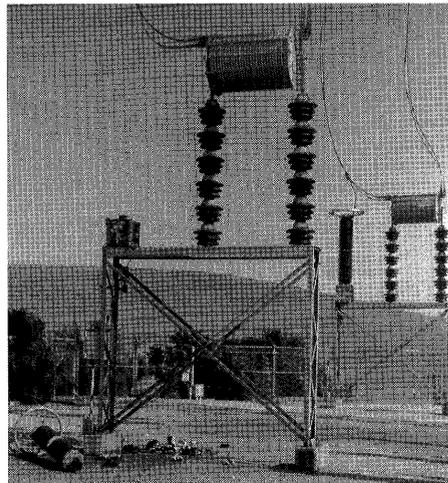
Figure 27.—Damaged capacitatively coupled voltage transformer at the Monte Vista Substation (fig. 1).

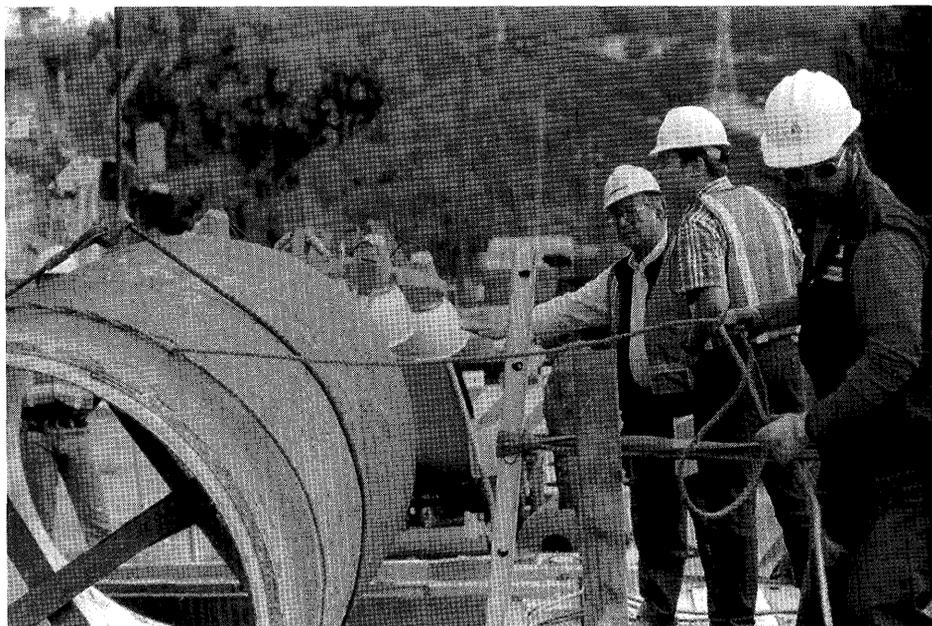
Figure 4.—Damaged 60-in.-diameter raw-water line to the Sobrante Water Filtration Plant.

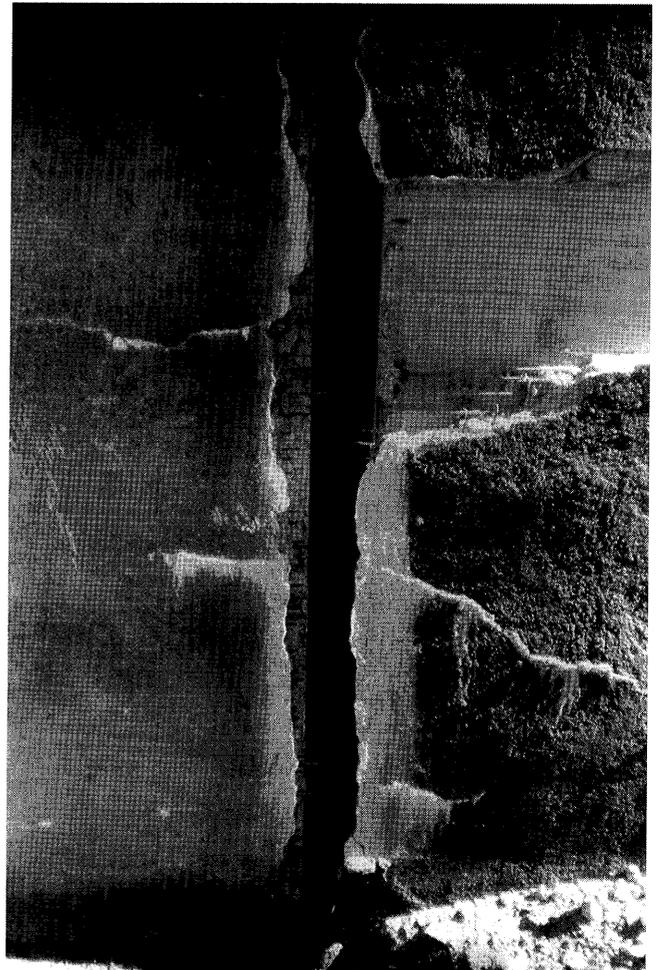
Figure 5.—Failure in 1.1-million-gal posttensioned-precast-concrete water tank in Los Altos Hills.

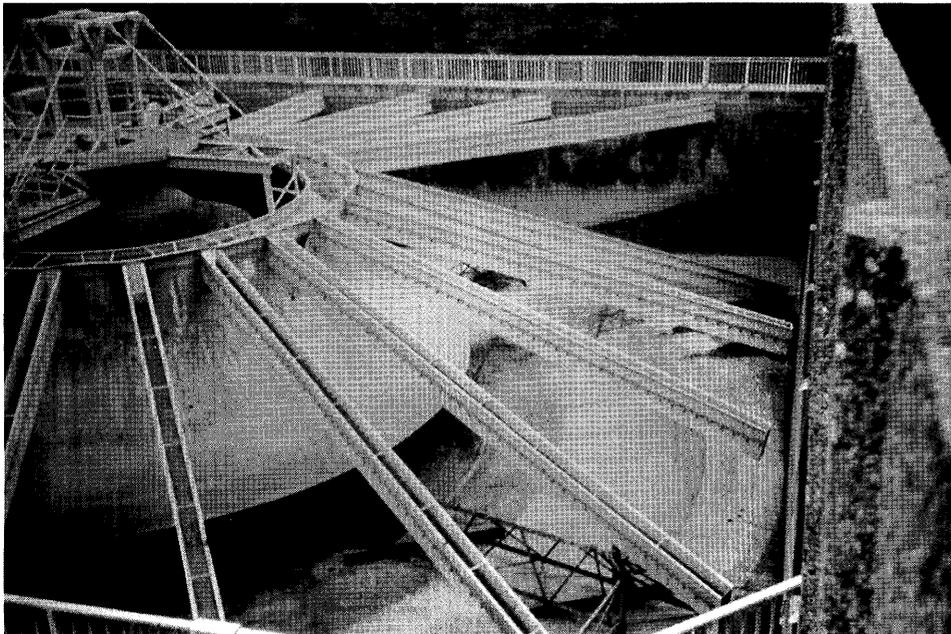
Figure 6.—Damaged water purifier at the Rinconada Water Treatment Plant.

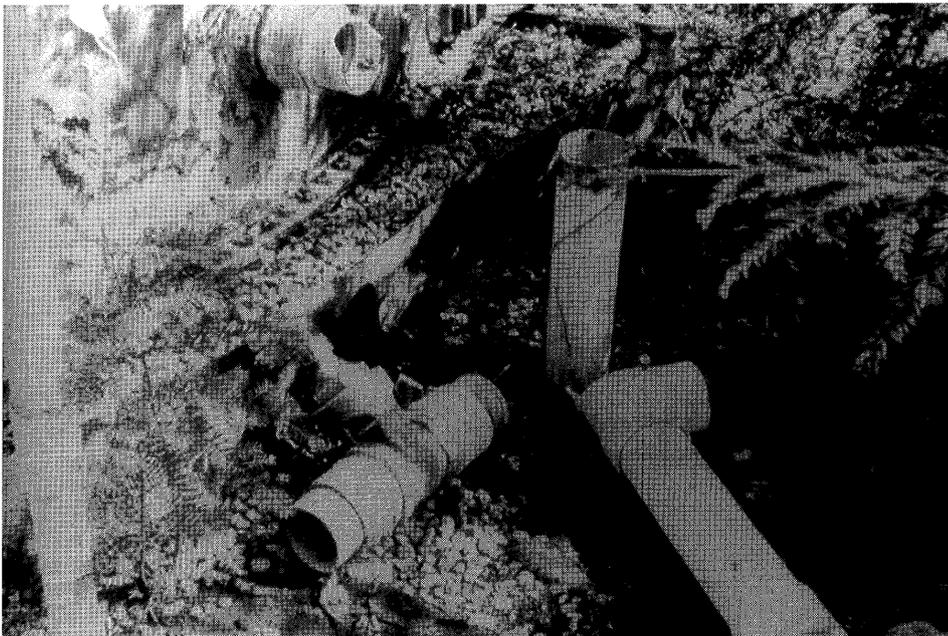
Figure 8.—Tank inlet-outlet piping in the Santa Cruz Mountains damaged because of inadequate flexibility.

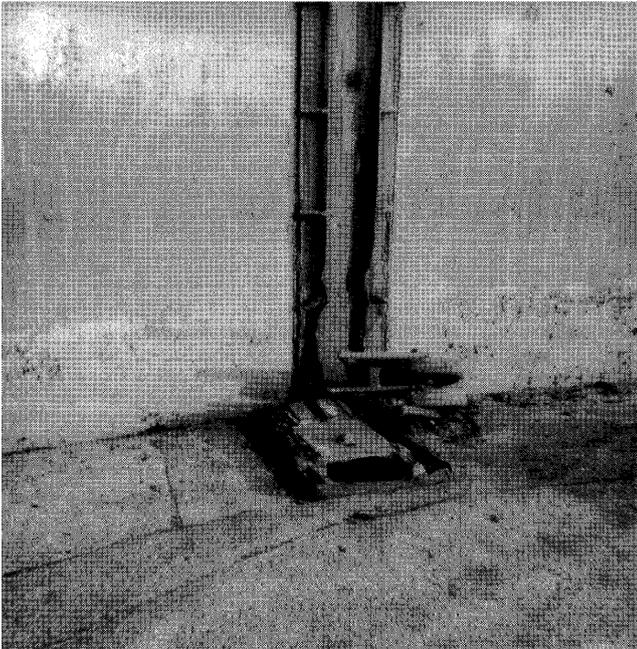
Figure 9.—Failed roller-guide assembly on digester cover at regional wastewater-treatment plant in Oakland (fig. 1).

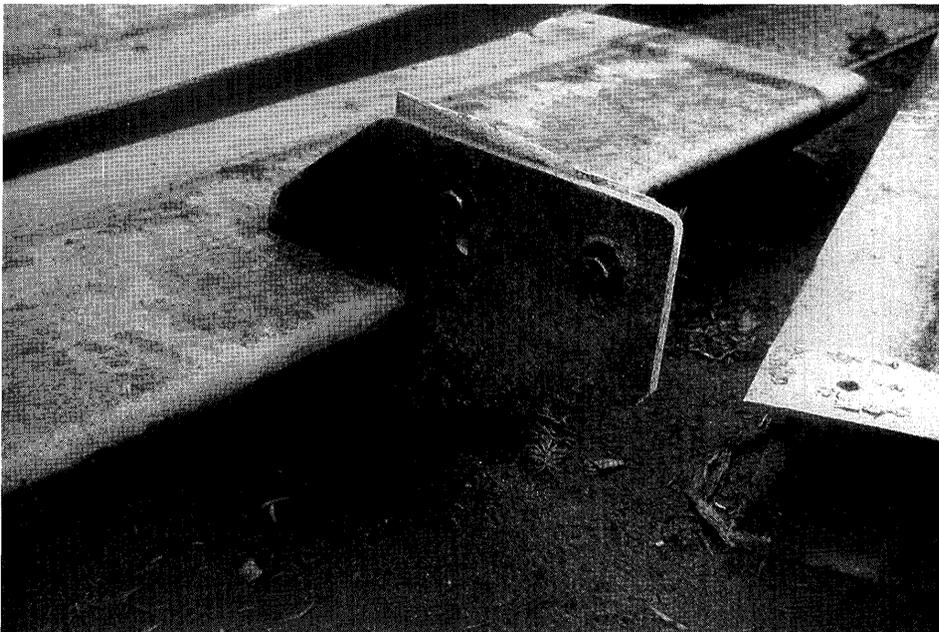
Figure 10.—Damaged bracket on scum trough of clarifier at the Palo Alto Wastewater Treatment Plant (fig. 1).

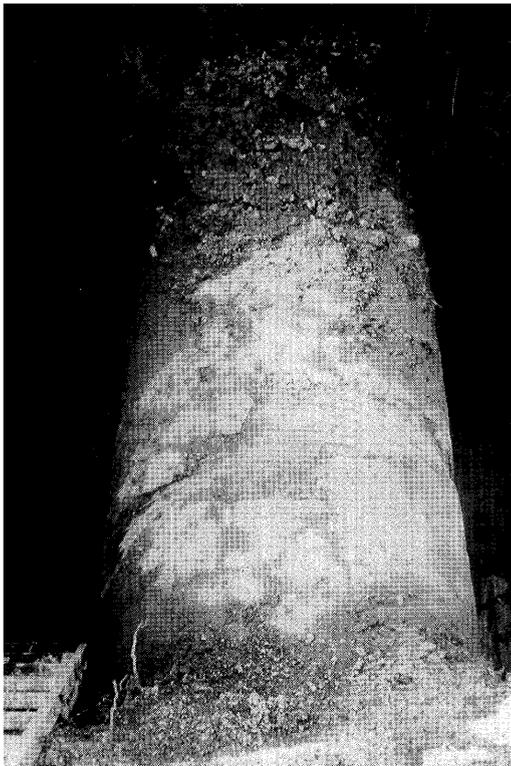
Figure 1.—Split on 14-gage-steel spiral-welded water barrier in 60-in.-diameter raw-water line.

Figure 2.—Repair crew replacing section of split 60-in.-diameter raw-water line shown in figure 1.

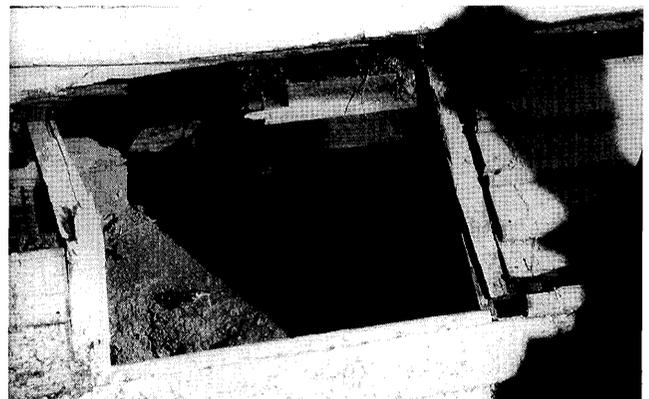
Figure 5.—Typical shear failure of cripple wall in a house in Hollister due to lateral ground motion and insufficient shear connectors.

Figure 6.—Repair of cripplewall in a private residence in Hollister.

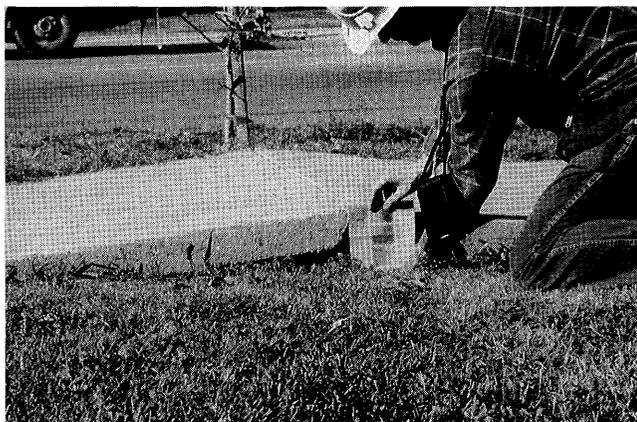
Figure 7.—Buckling of sidewalk in Hollister due to ground settlement.

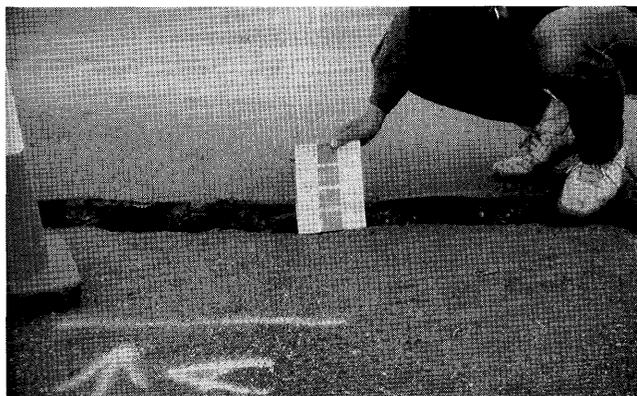
Figure 8.—Cracking of pavement in Hollister due to differential ground settlement.

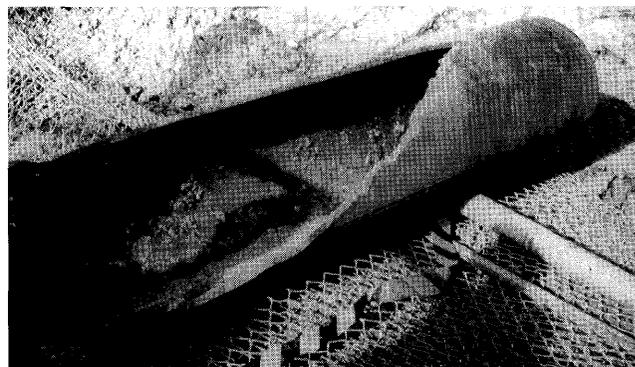
Figure 9.—Failure at bell-and-spigot connection of 20-in.-diameter cast-iron pipe in Oakland due to axial thrust in waterline.

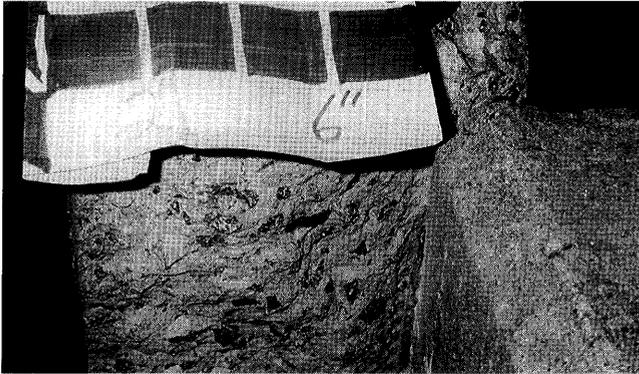
Figure 10.—Differential lateral motion between curb on a pile-supported bridge and the curb on approach road would break any waterlines conveyed by this bridge in Santa Cruz.

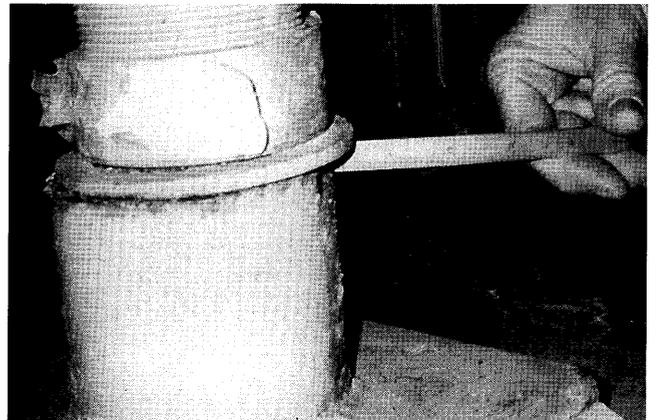
Figure 13.—Detail of gradual lateral displacement of pipe support shown in figure 12, due to ground creep in area of the Hayward fault.

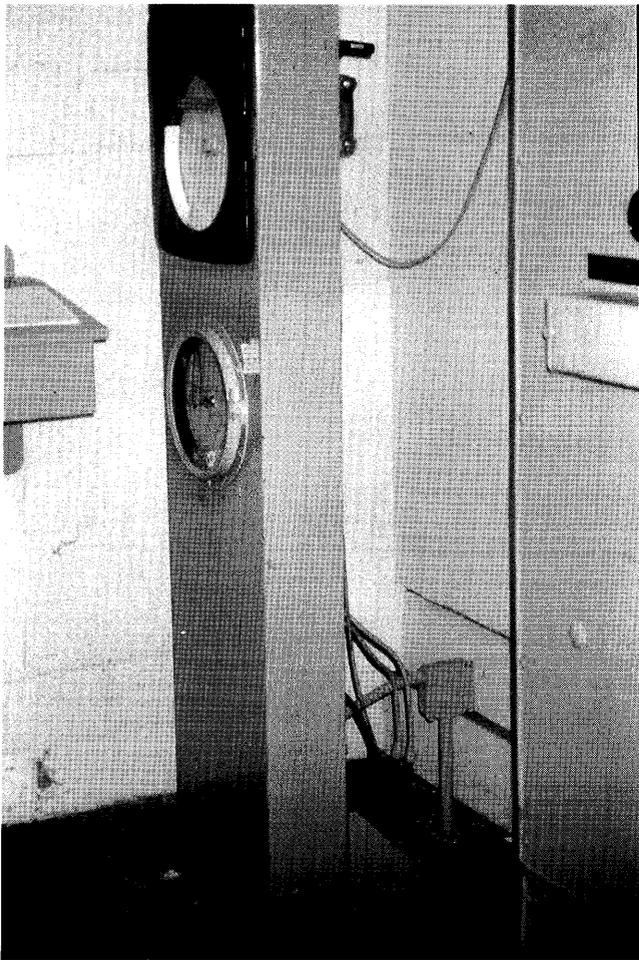
Figure 16.—Typical monitoring panel with no lateral restraint at top.

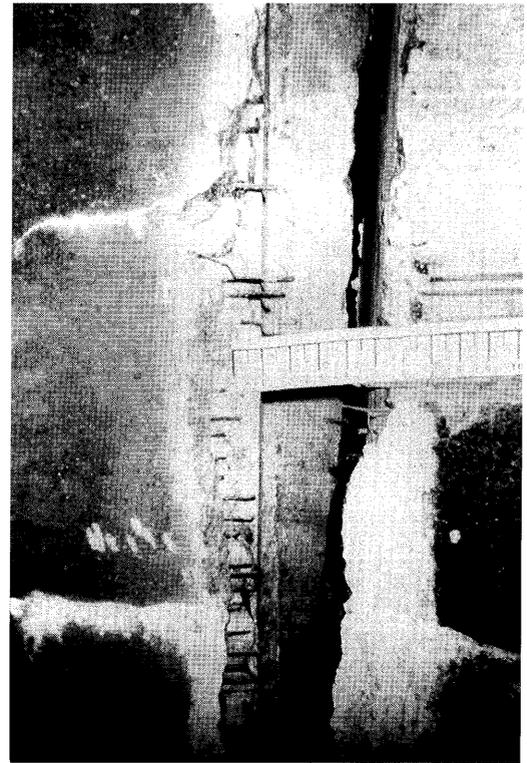
Figure 18.—Water tank shown in figure 17 completely lost its contents because of collapse of the column-supported roofslab and opening of vertical panel join.

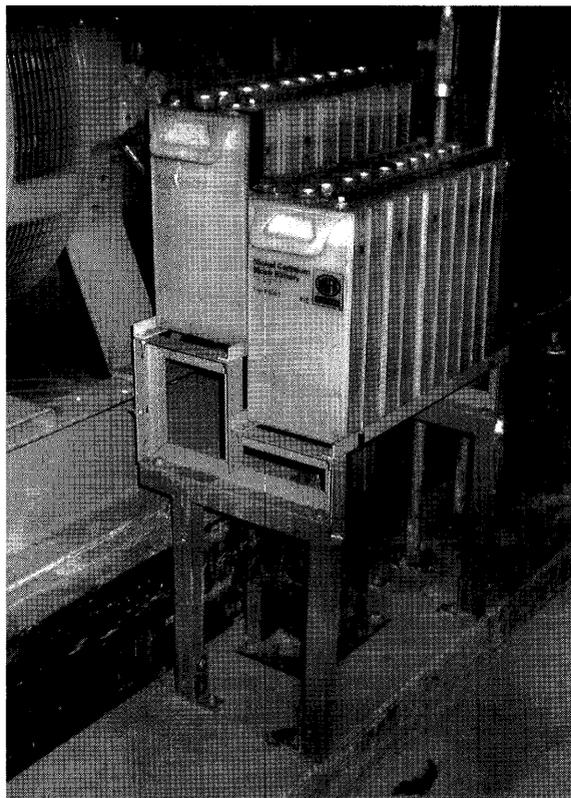
Figure 1.—Emergency-power generator with unsecured batteries.
