Boney Branch at Rock Port, Missouri

(Miscellaneous ungaged site in the Boney Branch basin,
USGS Missouri Water Science Center)

Review of peak discharge for the flood of July 18, 1965

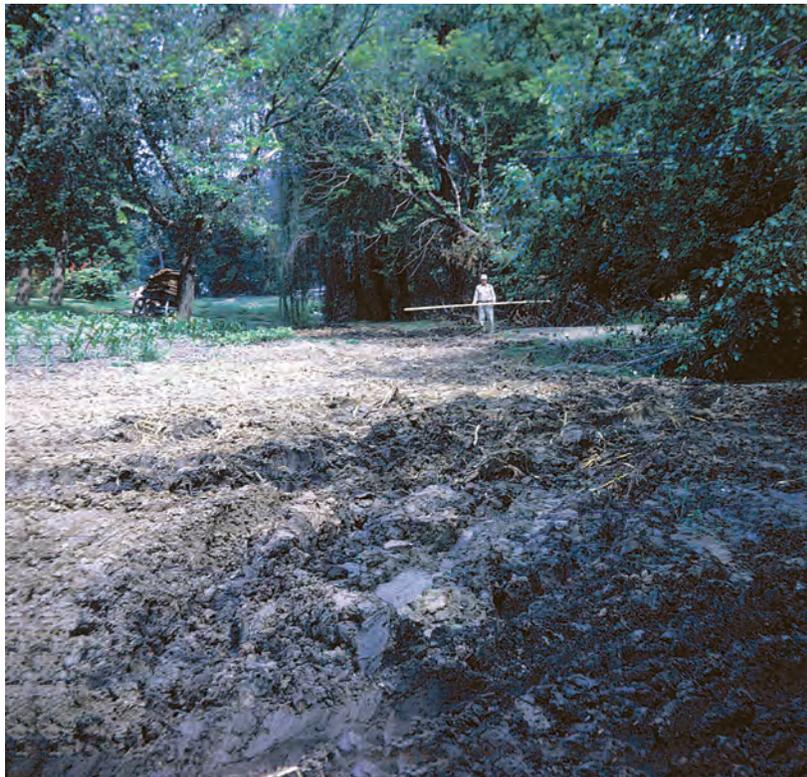
Figure 198. View looking downstream of left bank of cross section 3, Boney Branch at Rockport, Missouri, August 1965.

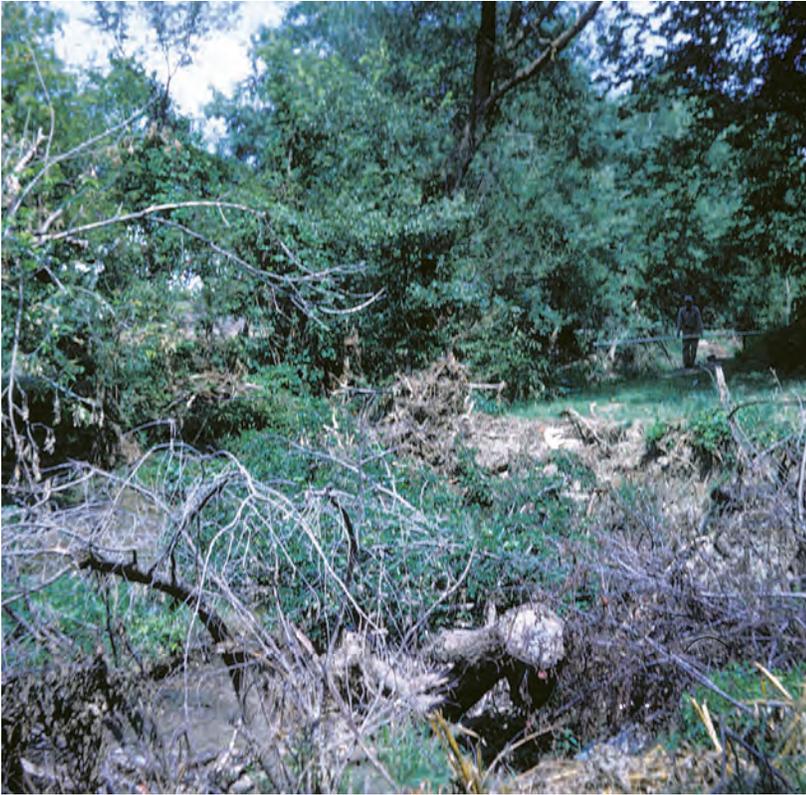
Figure A199. View looking downstream of right endpoint of cross section 2, Boney Branch at Rockport, Missouri, August 1965.

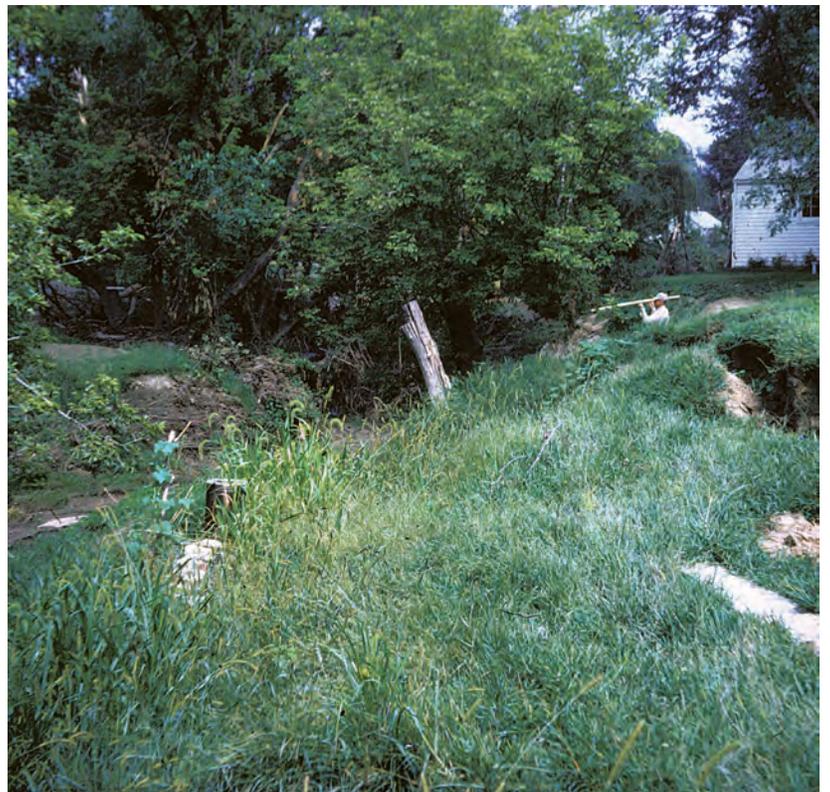
Figure A200. View looking downstream of right endpoint of cross section 3, Boney Branch at Rockport, Missouri, August 1965.

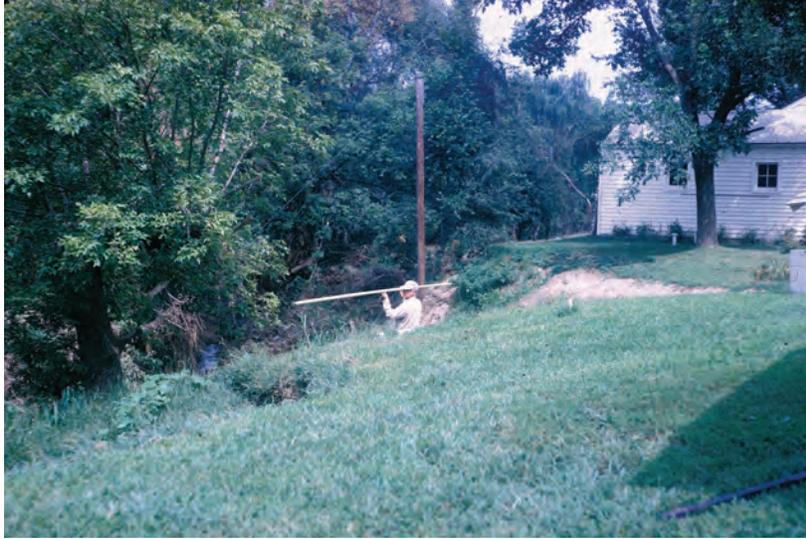
Figure A201. View looking downstream of right endpoint of cross section 1, Boney Branch at Rockport, Missouri, August 1965.

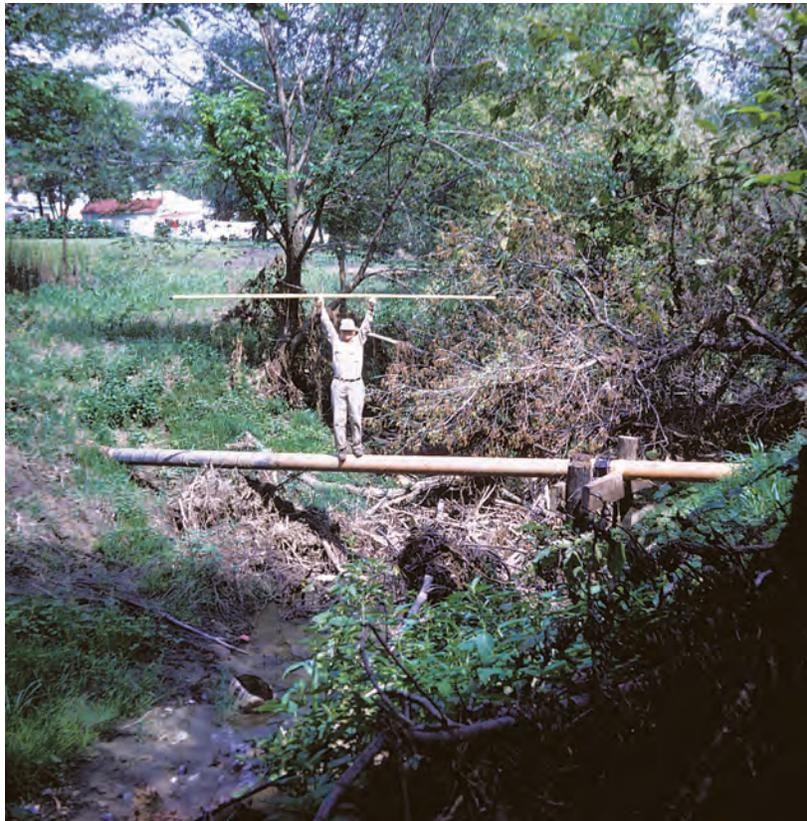
Figure A202. View looking downstream at cross section 1, Boney Branch at Rockport, Missouri, August 1965.

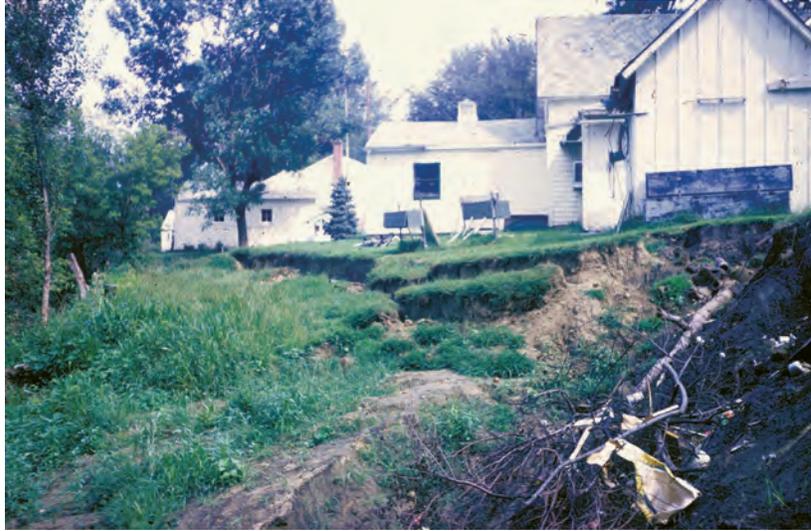
Figure A203. View looking downstream of right bank between sections 2 and 1, Boney Branch at Rockport, Missouri, August 1965.

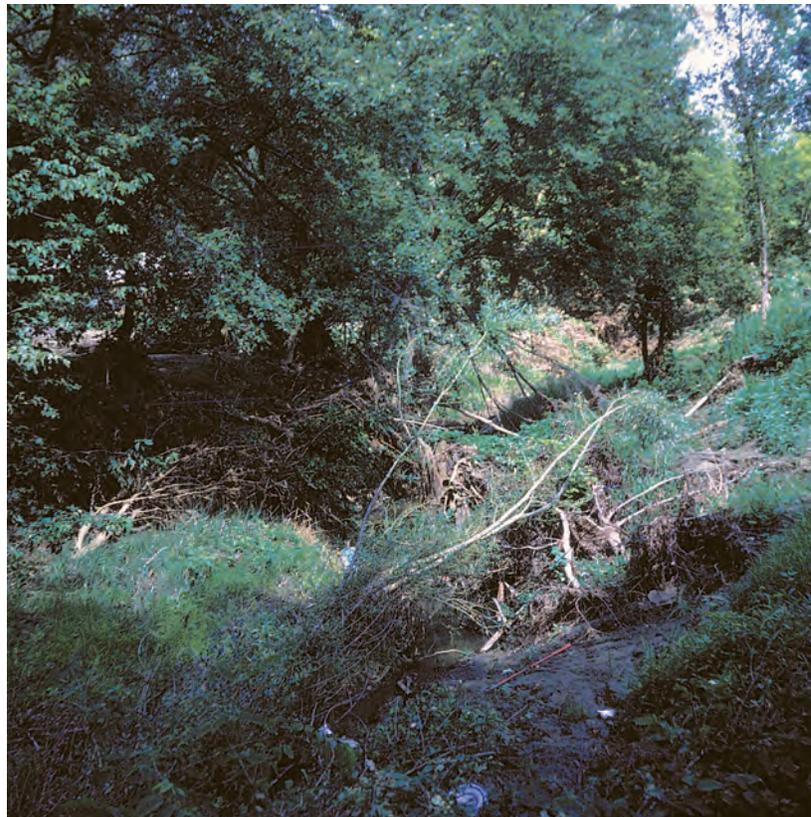
Figure A204. View looking downstream of cross section 2, Boney Branch at Rockport, Missouri, August 1965.

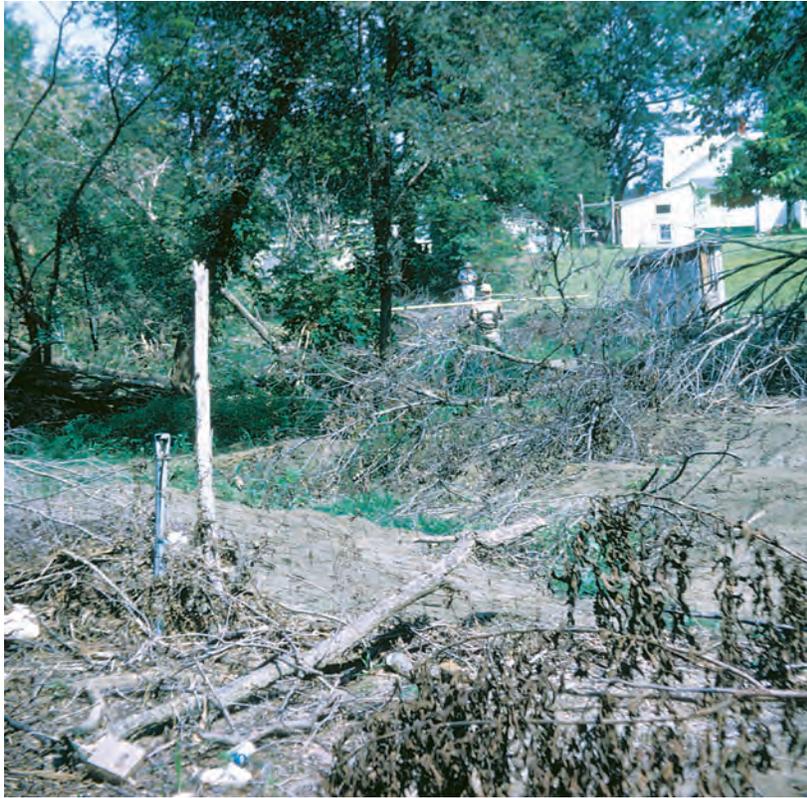
Figure A205. View looking downstream of cross section 1, Boney Branch at Rockport, Missouri, August 1965. Rod between sections 1 and 2.

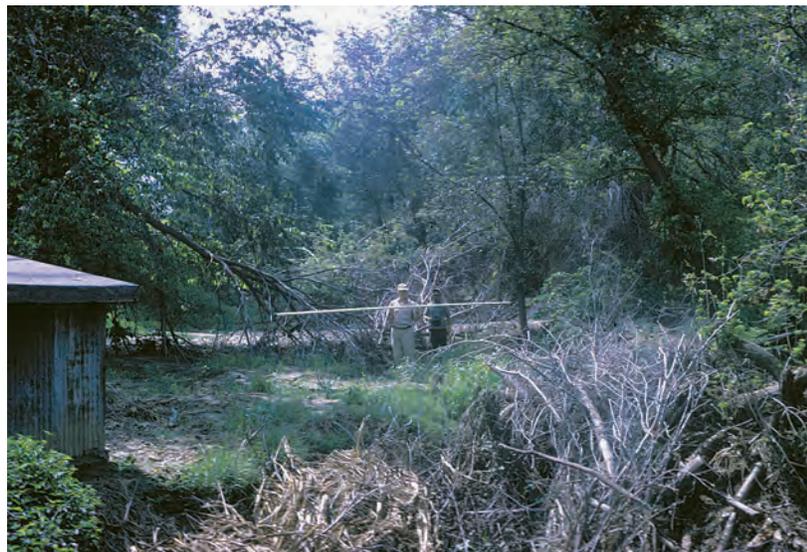
Figure A206. View looking upstream of right bank between cross sections 2 and 3, Boney Branch at Rockport, Missouri, August 1965.

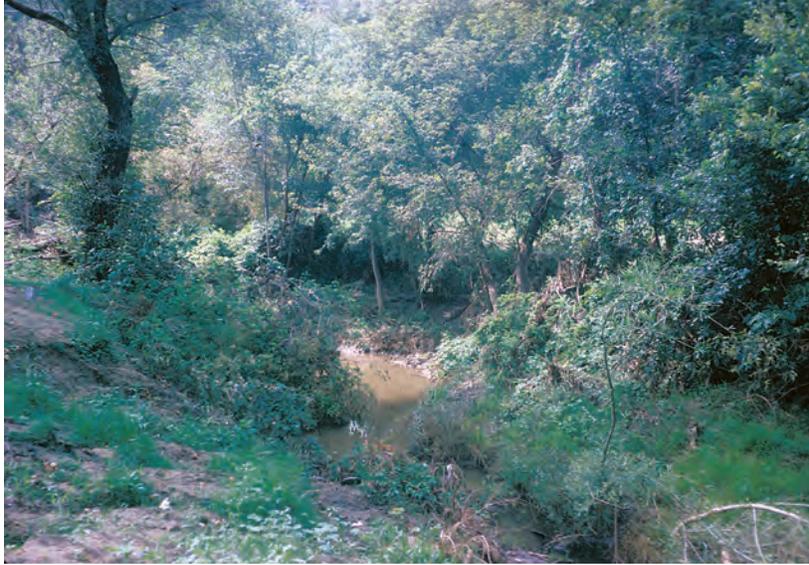
Figure A207. View looking upstream of cross section 1 to section 2, Boney Branch at Rockport, Missouri, August 1965.

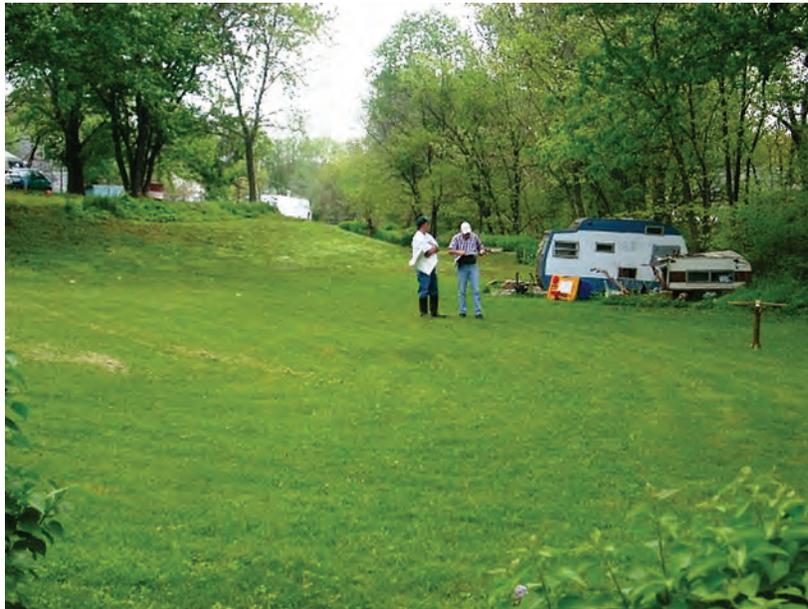
Figure A208. View looking downstream between cross sections 2 and 3, Boney Branch at Rockport, Missouri, May 6, 2003.

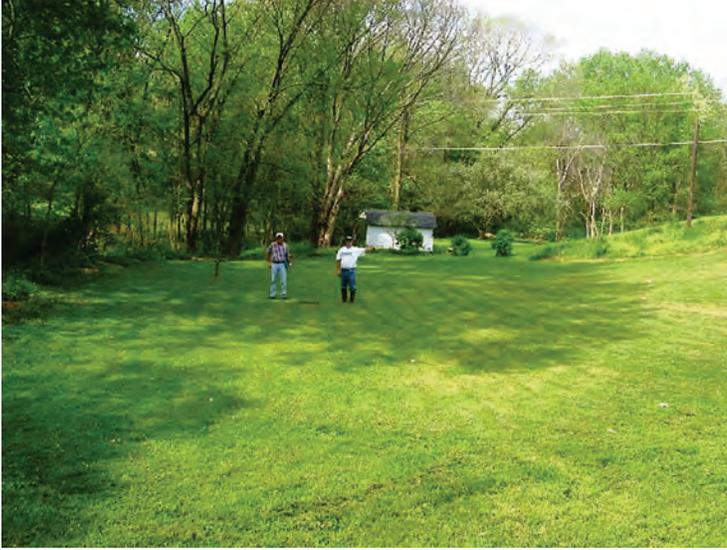
Figure A209. View looking upstream at cross section 2, Boney Branch at Rockport, Missouri, May 6, 2003.

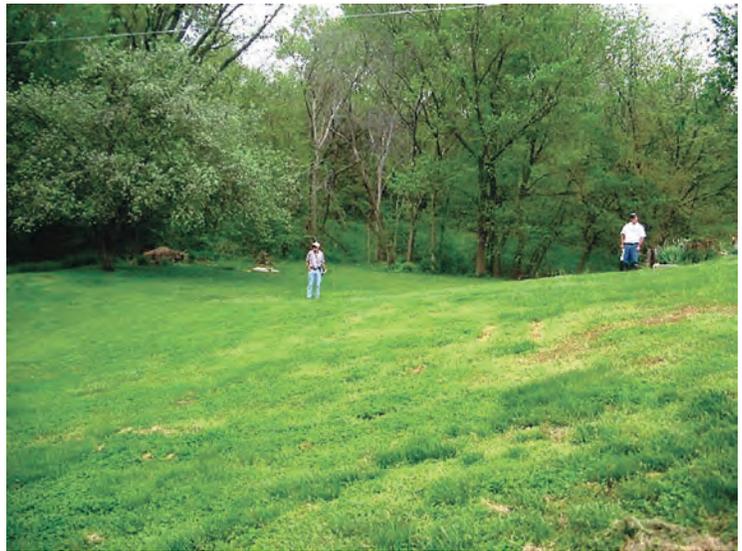
Figure A210. View looking upstream to cross section 2, Boney Branch at Rockport, Missouri, May 6, 2003.

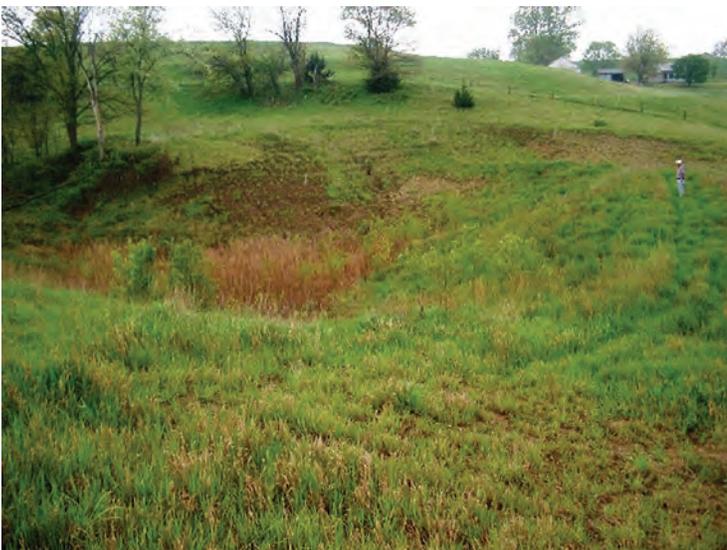
It is not known how much rain fell in the upstream part of the basin during the storm. There is no evidence that anyone investigated the possibility of failed storage ponds or ponding upstream of the road embankment.

Figure A211. Small agricultural dams in loess headwaters of Boney Branch at Rockport, Missouri May 6, 2003.
