Jimmy Camp Creek at Fountain, Colorado

(Miscellaneous ungaged site, Arkansas River basin, USGS Colorado Water Science Center)
(1976–present, streamflow-gaging station number 07105900)

Review of peak discharge for the flood of June 17, 1965

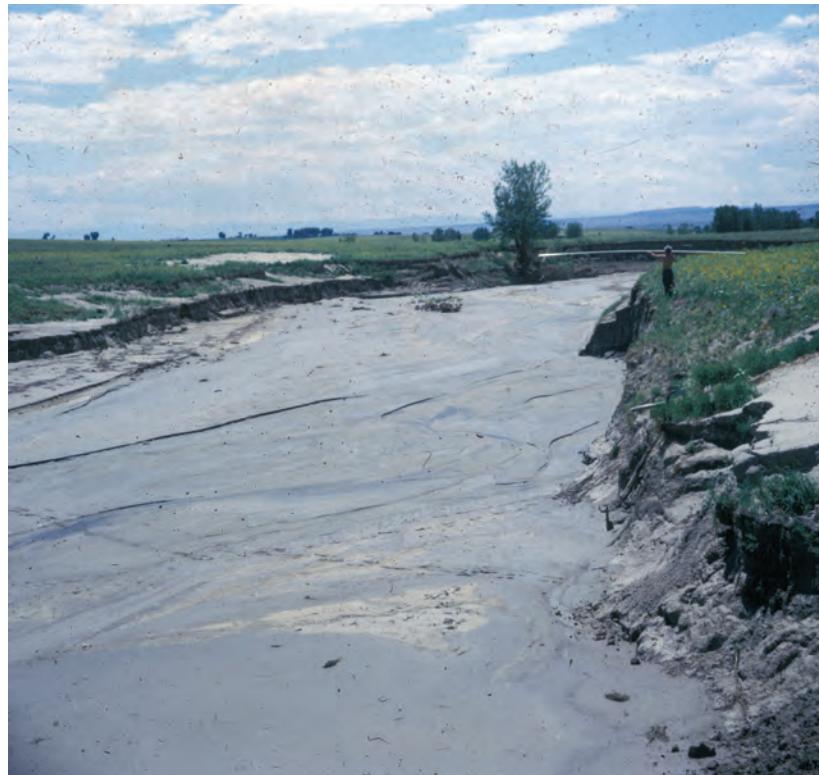
Figure A76. View looking downstream from about 200 feet above cross section 2, Jimmy Camp Creek at Fountain, Colorado, July 17, 1965. (Man is holding rod at high-water mark at cross section 2.)

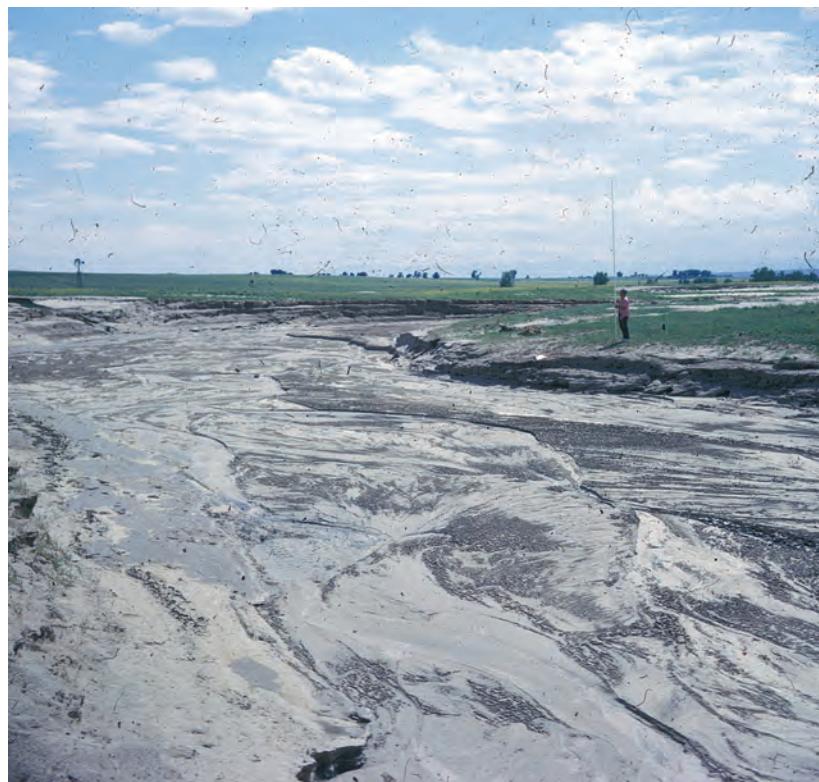
Figure A77. View looking downstream from about 200 feet above cross section 1, Jimmy Camp Creek at Fountain, Colorado, July 17, 1965. (Man is holding rod at cross section 1.)

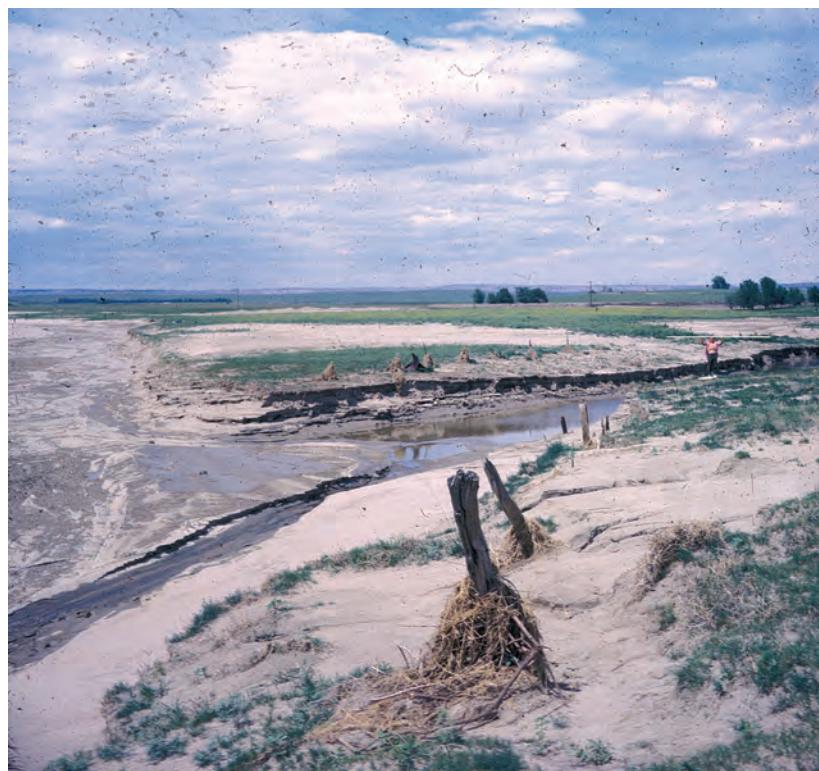
Figure A78. View looking upstream, Jimmy Camp Creek at Fountain, Colorado, July 17, 1965. (Man is holding rod at high-water mark at cross section 1, 250 feet right of left end of cross section.)

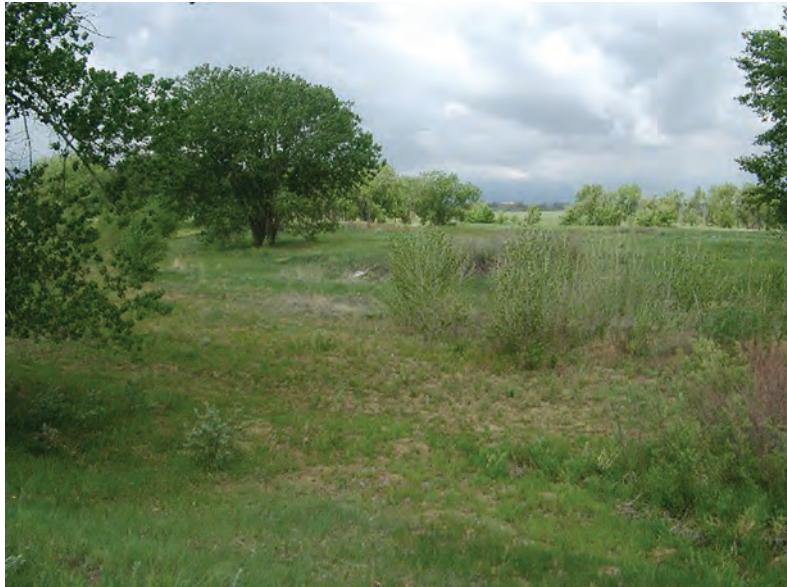
The site and many reaches of Jimmy Camp Creek have changed a great deal since the 1965 flood. The 1965 photographs show a wide main channel with raw, eroded banks; top width was almost 300 ft at section 1 and more than 100 ft at section 2. Field data from 1965 show that the main channel is relatively straight through the reach, staying near the left side of the valley, and the flood plain is nearly devoid of trees and brush. In 2003, the main channel width averaged perhaps 40 ft, and the main channel meandered over perhaps a 1,000 ft of width as it passed through the reach. In addition, there were a considerable number of what appeared to be mature cottonwood trees along the channel and in the flood plain.

Figure A79. View looking downstream near cross section 2, Jimmy Camp Creek at Fountain, Colorado, June 4, 2003.

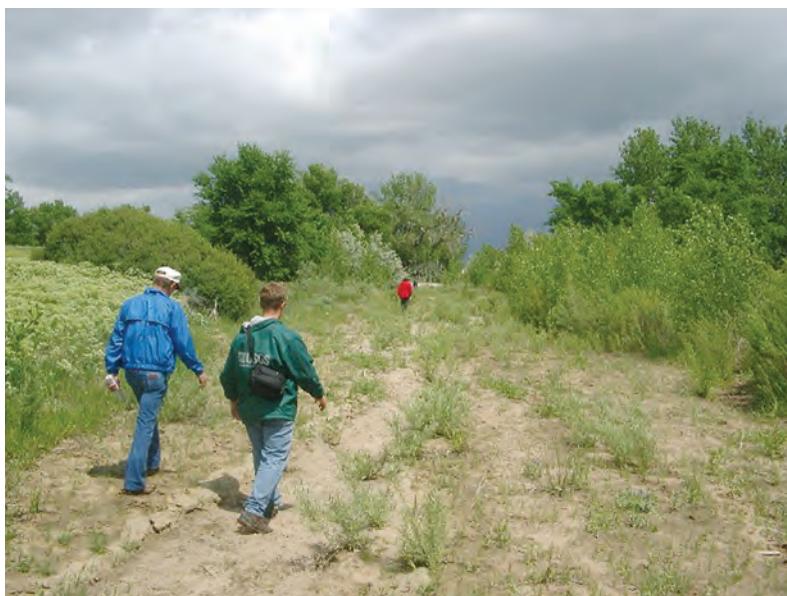
Figure A80. View looking upstream of main channel flood plain, Jimmy Camp Creek at Fountain, Colorado, June 4, 2003.

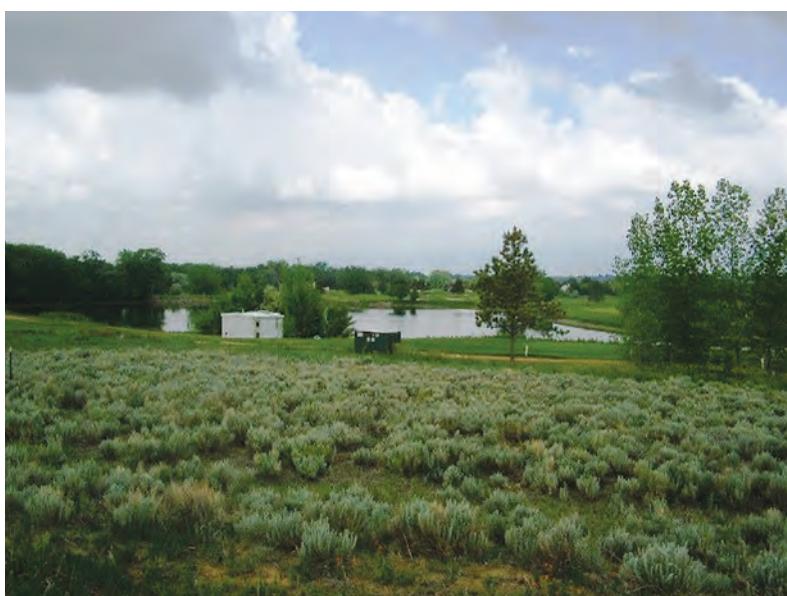
Figure A81. View looking downstream toward flood plain upstream of slope-area reach, Jimmy Camp Creek at Fountain, Colorado, June 4, 2003.
