UNITED STATES GEOLOGICAL SURVEY

No. 40

THE AUSTIN DAM.—TAYLOR

WASHINGTON
GOVERNMENT PRINTING OFFICE
1900

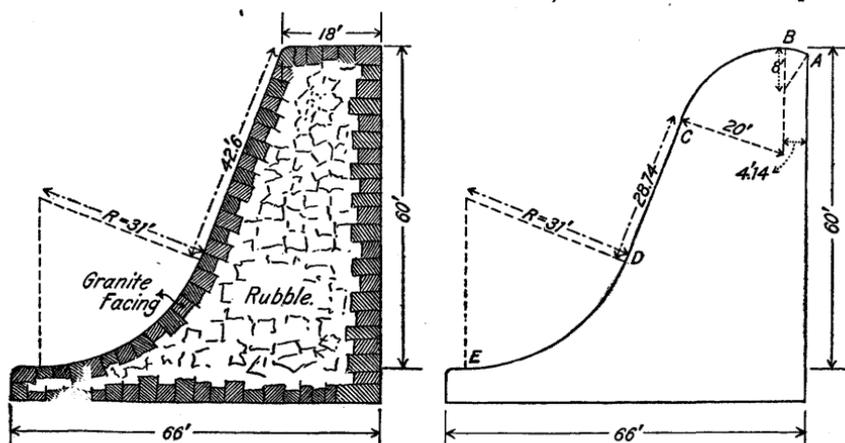
The profile [fig. 3, left half] as shown to me seems not to fulfill the required conditions for passing the floods, because of the slightly rounded or nearly angular form at the front of its crest. Another diagram [fig. 3, right half] presented shows an advised modification of the profile of the upper part of the dam, which is better adapted to pass the flood in a gliding sheet down the face of the dam and to deliver it to the lower level without a direct blow, and so that its velocity will

FIG. 3.—Cross sections of dam: Left side as proposed by Frizell; right side as constructed by Fanning.

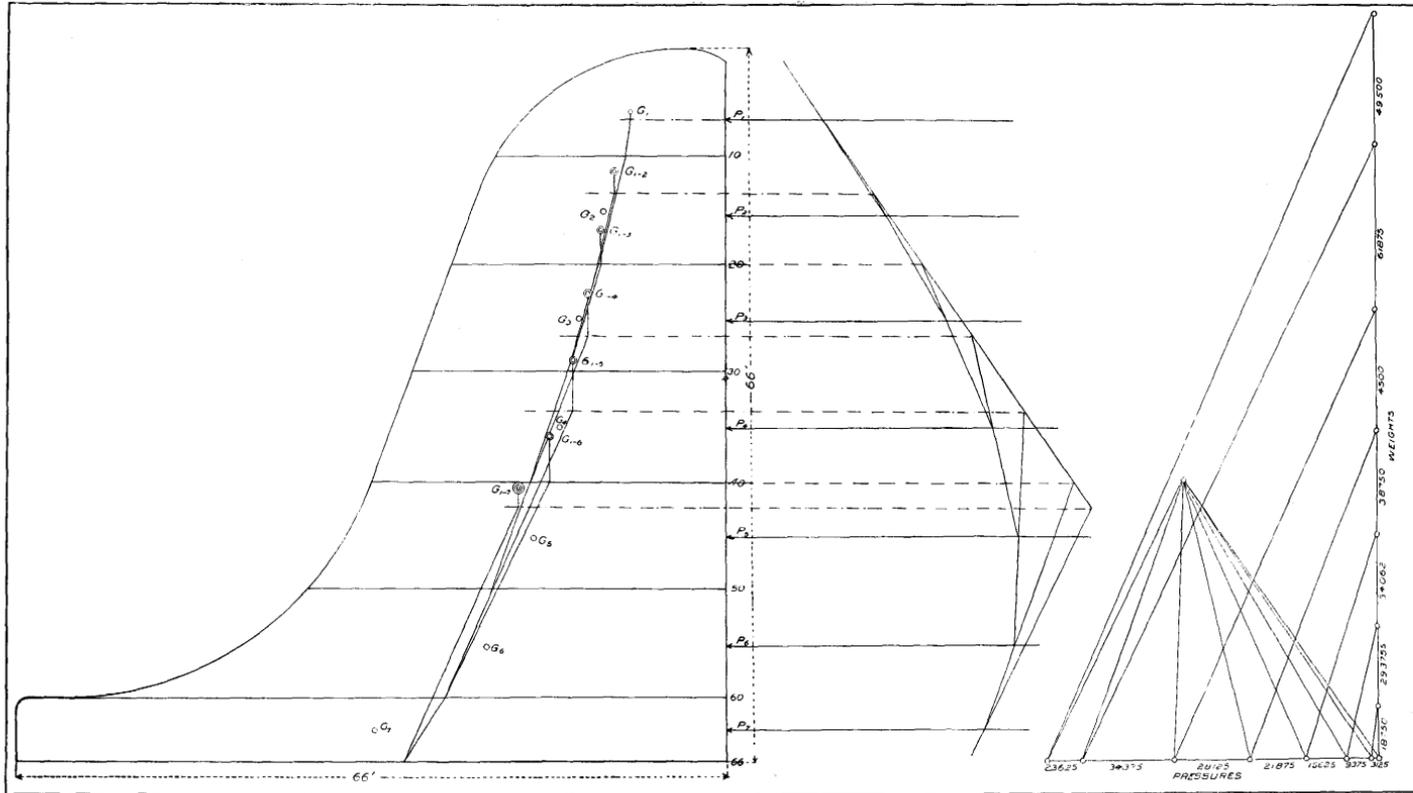
RESISTANCE LINE OF DAM.

In the case of the Austin dam the line of resistance fell within the middle third of the bed joints, and there was therefore no tension on any bed joint.

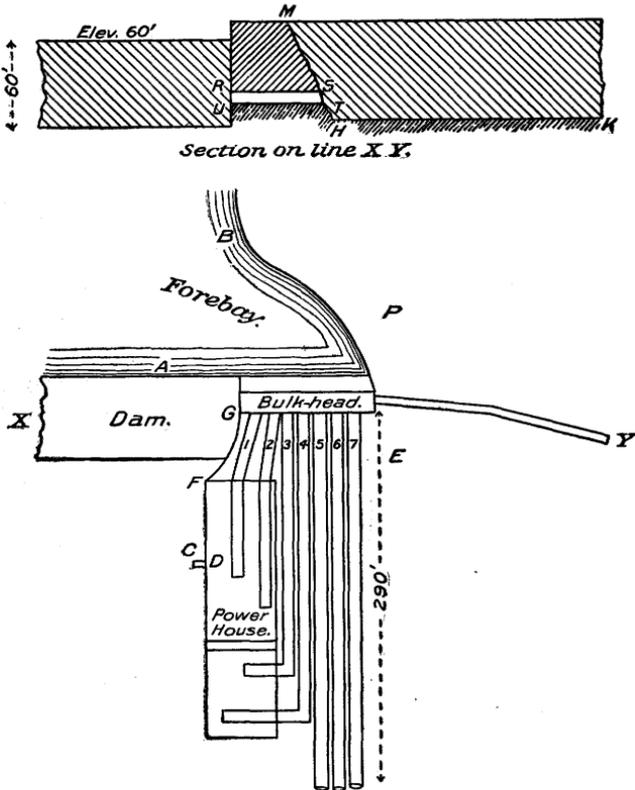
On May 30, 1893, the water from the lake cut under the east bulk-head and undermined the proposed foundation of the power house. It entered a seam in the limestone slightly above the point indicated at B in fig. 5, about 90 feet from the dam. From this point the course of the water was at an angle of about 30 degrees to the axis of the river to the left, and it also took a downward course and passed about 25 feet under the foundation of the head-gate masonry. A view of the power-house foundation a few days before the break is given in Pl. VI, *A*. The water issued from the west wall of the proposed power-house foundation and soon wrecked it. The general course of the water was from a point near the east end of the head-gate masonry diagonally across the foundation to the point of exit.

The head-gate masonry cracked about 40 feet from the end of the

dam, along the line HM in fig. 5, and settled. The earth east of the east end of the head gate settled for a distance of 25 feet. Plans were immediately adopted for raising and strengthening the cofferdam so as to provide against floods, for rebuilding the head gate, and for the construction of a power-house foundation. The broken part of the head-gate masonry was removed (leaving only that over penstocks 1

FIG. 5.—Section and sketch plan of bulkhead, showing location of power house and penstocks. HK is bottom layer of concrete filling resting on hard limestone strata; HM is line of crack; RS is the original level of bulkhead masonry; RSTU is tunnel (6 feet by 6 feet by 60 feet long) filled with concrete; A is point where drift indicated leak in the spring of 1899; B is location of leak discovered in the fall of 1899; P is point from which view shown in Pl. VII, B, was taken; FG is wing wall; C is 10-inch horizontal pipe projecting from wall of power house, known as "the spring;" D is cement chamber for controlling water and directing it through C; 1 to 7 are penstocks; E is the point at which the leak in penstock was found in February, 1900.

and 2), and an excavation nearly 200 feet long and 70 feet deep, with an average width of 7 feet, was made. This trench reached to a level of 57 feet below the crest of the dam, or within 3 feet of the level of the toe. The head-gate masonry was rebuilt, provision being made for only seven 9-foot penstocks, the rest of the excavation being filled by a concrete wall 112 feet long, which was 8 feet thick for the 90

feet next to the head gate and only 5 feet thick for the rest of the distance. In excavating for this extension wall, alternate layers of hard and soft limestone were encountered, as shown in Pl. VI, *B*. The bottom layer of the concrete filling (HK, fig. 5) was laid on one of these hard strata, but it was fully demonstrated that a current of water was running underneath. Several holes were drilled, through which the water welled up in jets several inches high. However, it was thought safe to plug these holes and to ignore the stream below. The bulkhead masonry originally extended to the level RS, fig. 5, 36 feet below the top of the dam; but as an extra precaution a tunnel (RSTU) 6 feet by 6 feet square and 60 feet long was cut under the bulkhead masonry back to the end of the dam proper, and the space was filled with concrete. The space below the 42-foot level under the tunnel was not disturbed.

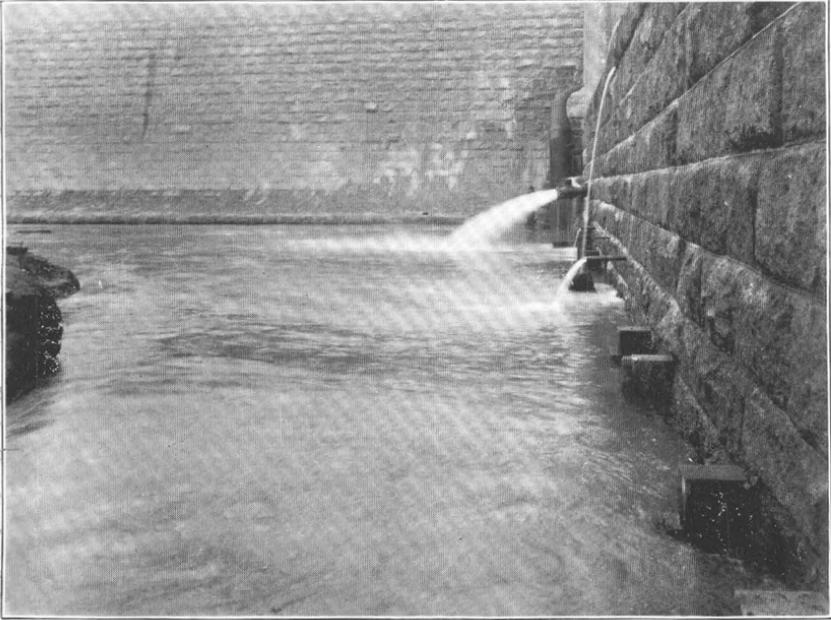
A. DISCHARGE OF LAKE THROUGH DAM, OR THE SO-CALLED "SPRING."

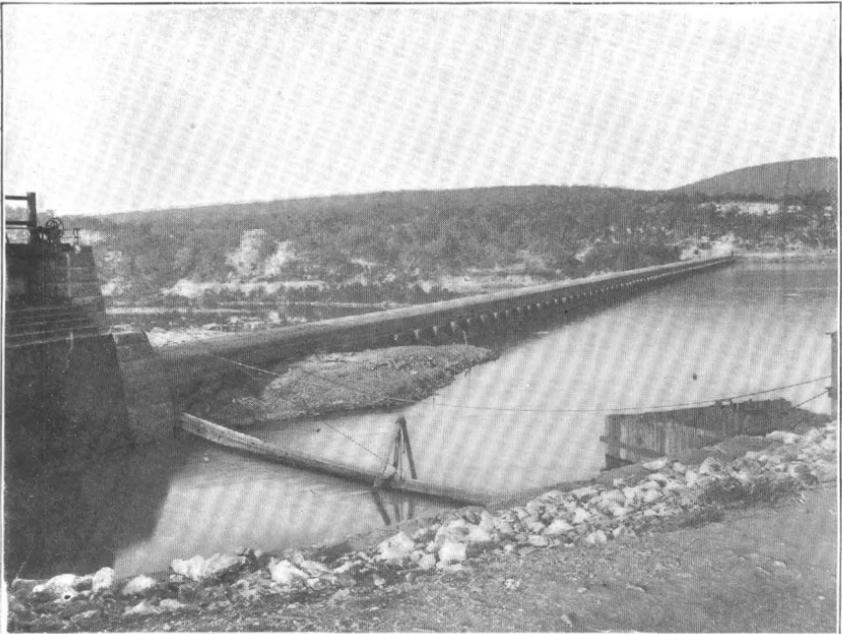
B. VIEW SHOWING TWO METHODS EMPLOYED TO STOP LEAK THROUGH DAM.

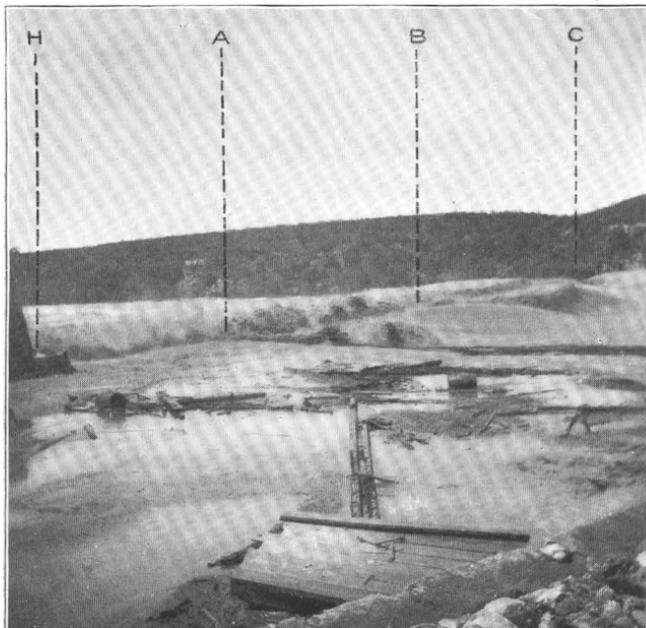
A. VIEW THREE MINUTES AFTER FAILURE OF DAM.

A—B and B—C are portions of dam first broken; H—A is eastern part of dam (83 feet long on crest) left standing.

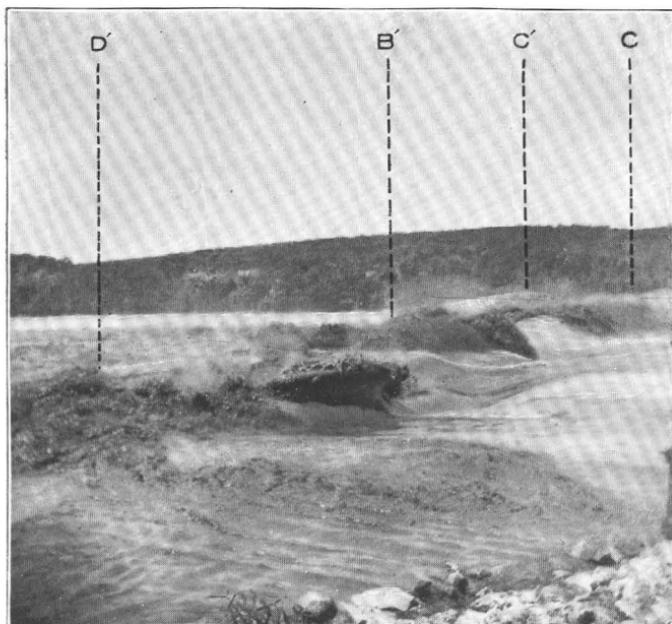
B. VIEW TEN MINUTES AFTER FAILURE OF DAM.

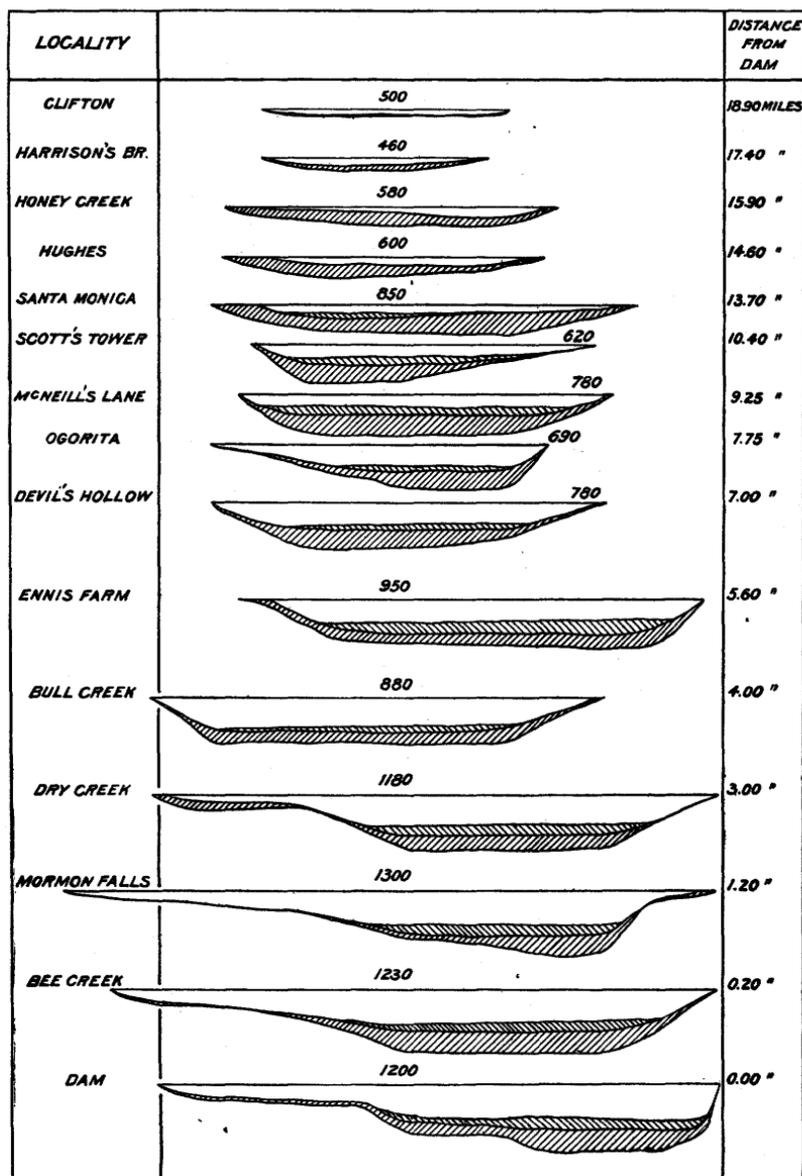
FIG. 6.—Cross sections of Lake McDonald, illustrating accumulation of sediment between 1893 and 1897 (illustrated by the lower shaded area) and between 1897 and 1900 (illustrated by the upper shaded area). The number above each section indicates its length, in feet.

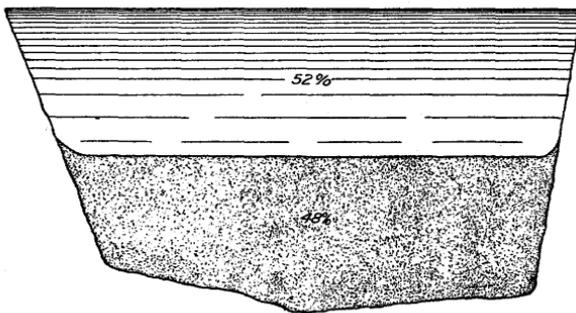
FIG. 7.—Generalized cross section of Lake McDonald, showing accumulation of sediment.

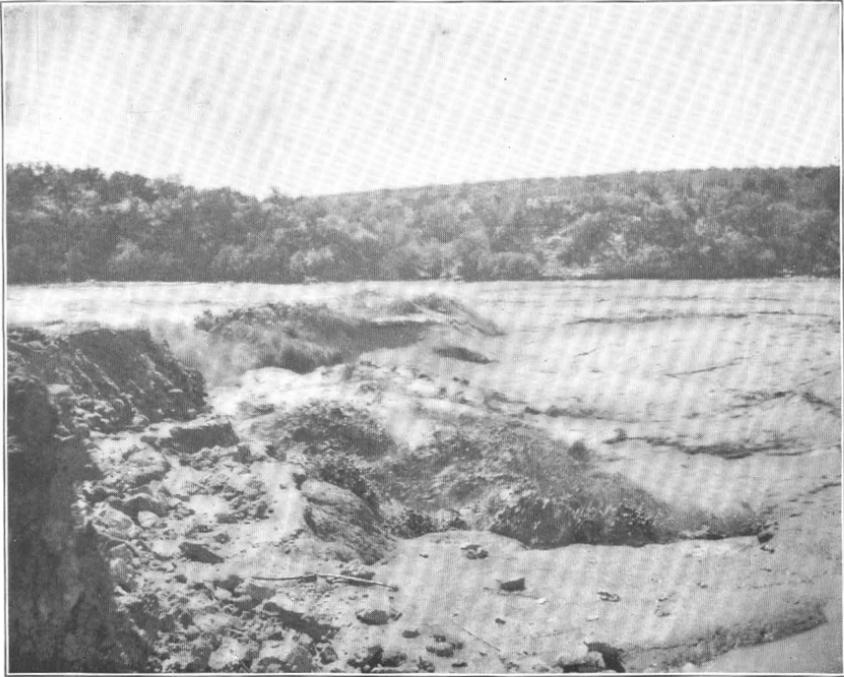
A. VIEW ABOUT 350 FEET BELOW DAM, SHOWING WAVES THOUGHT TO BE DUE TO SECONDARY DAM FORMED BY DÉBRIS FROM WRECK.

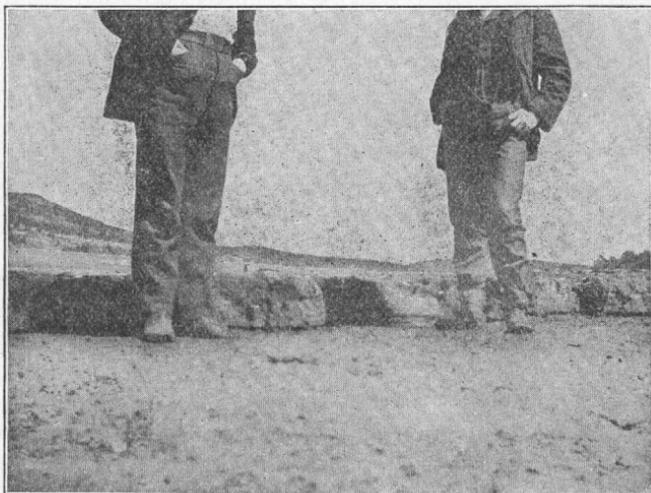
FIG. 8.—Layer of silt remaining on plateau after destruction of dam.

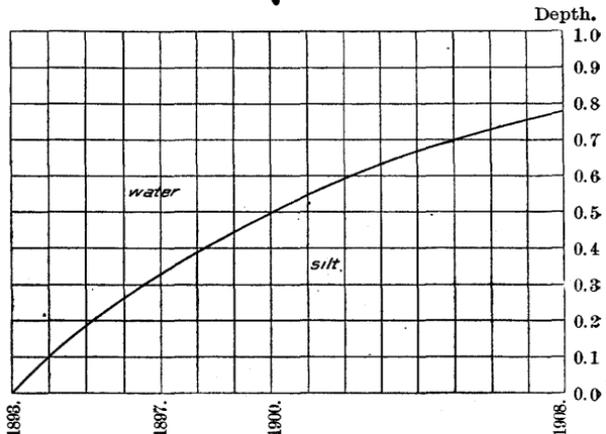
FIG. 9.—Curve illustrating progress of silting in Lake McDonald.

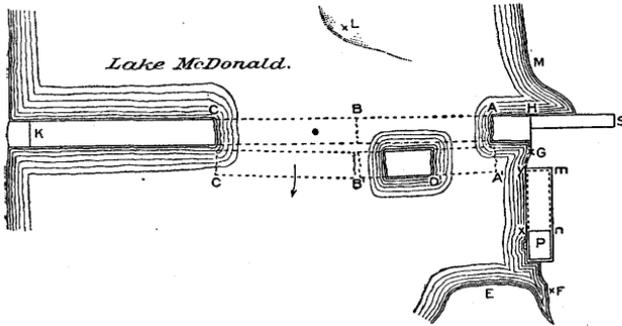
FIG. 10.—Plan showing break in dam April 7, 1900. KC is western part of dam (456 feet long on crest) left standing; HA is eastern part (83 feet long on crest) left standing; AB and BC are portions of dam first broken; xymn is dynamo room at power house; P is pump room; L is point from which view shown in Pl. XV, A, was taken; F is point from which view shown in Pl. XIII, A, was taken; G is point from which view shown in Pl. XIII, B, was taken; M is point from which view shown in Pl. XI, A, was taken; E is point from which view shown in Pl. IX, A, was taken; HS is bulkhead; B'C' and D'A' are portions of dam that broke and disappeared 45 minutes after break; B'D' is the broken portion of dam still standing; S is point from which view shown in Pl. XI, B, was taken.

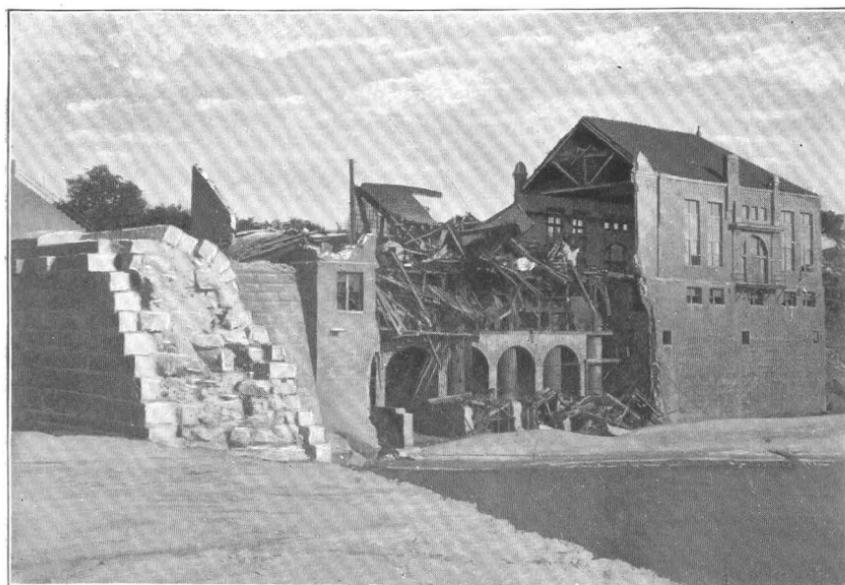
B. WRECK OF POWER HOUSE.

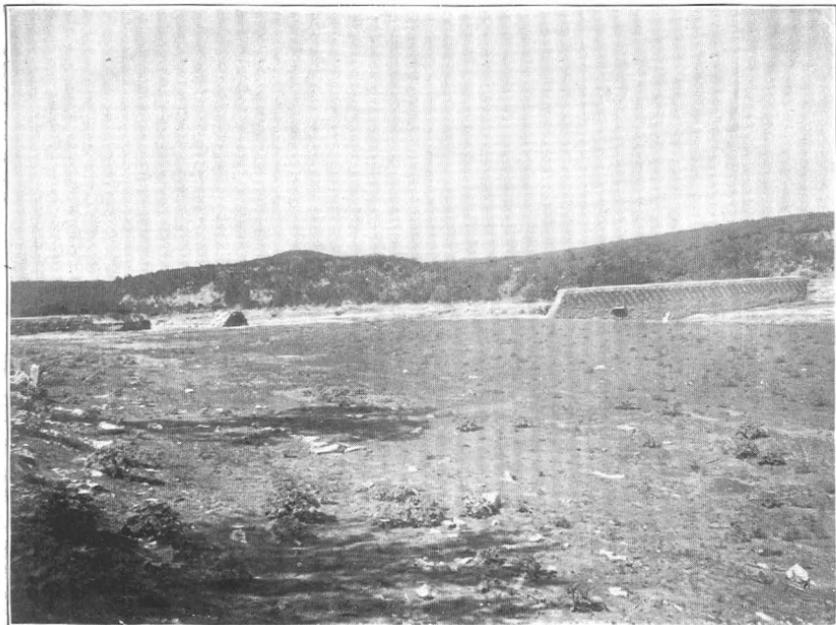
A. WESTERN PORTION OF DAM REMAINING AFTER BREAK.

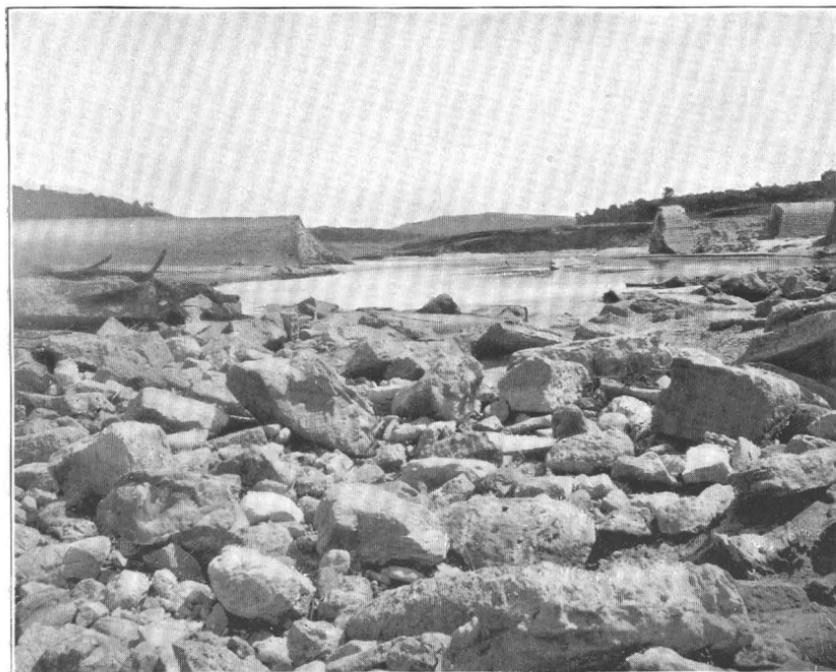
B. PORTIONS OF BROKEN DAM BROUGHT DOWN BY FLOOD.

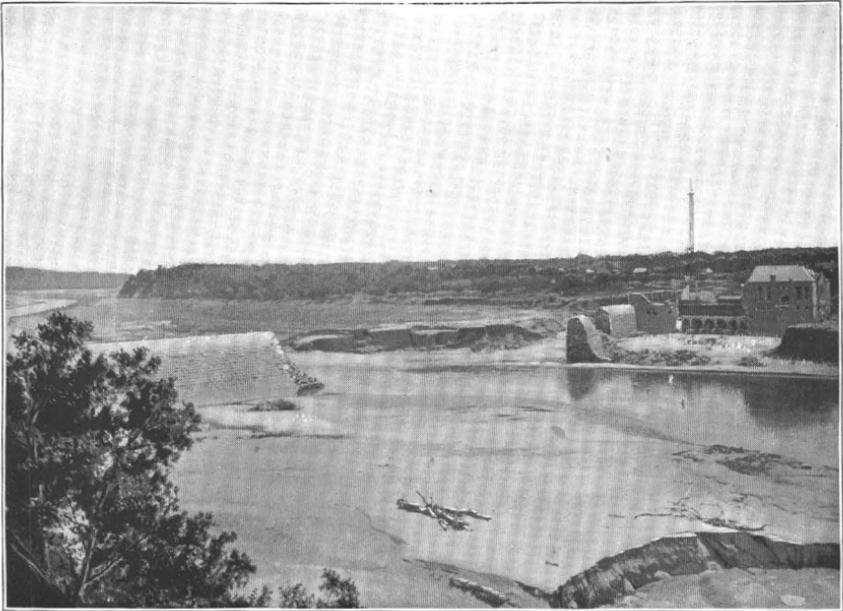
A. BROKEN DAM, SHOWING IN FOREGROUND SAND BAR LEFT IN MAIN CHANNEL.

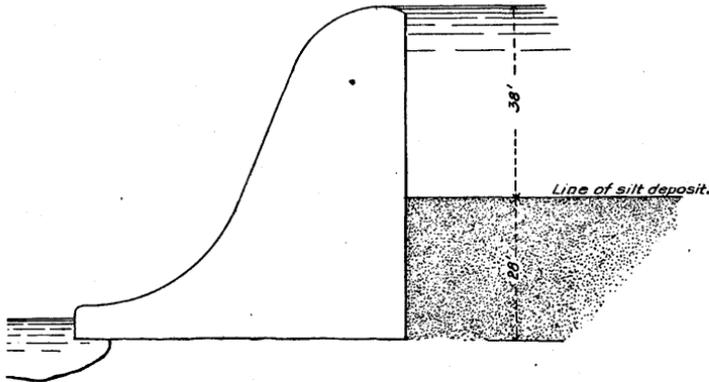
On April 8, 1896 (four years before the dam failed), in a letter to the mayor, Mr. Frizell called attention to the fact that dangerous abrasion might occur near the point mentioned, i. e., 300 to 400 feet from the east end. The waters of the tailrace followed the toe of the dam fully 600 feet and were discharged through a narrow neck 45 feet wide, at an average depth of 2.8 feet during the day and about 3 feet at night when the full power was on. In March, 1899, the writer, with Mr. H. K. Seltzer, made soundings along the toe of the dam between this narrow neck and the power house. At or near the point where the break occurred the bottom was not reached with a rod 5.3 feet long, even when the hand holding it was thrust at least 2 feet below the surface. The water surface of the tailrace was then 2.5 feet below the toe of the dam. This makes the bottom of the tailrace more than 9.5 feet below the top of the toe of dam. The tailrace near the dam passed over a shoal-like formation and entered the tailrace pond about 50 feet from the east end of the dam. Between this point and the narrow neck alluded to the tailrace was bounded by the toe of the dam and an elliptical shore line. Its maximum width was 125 feet, its narrowest width (at the neck) 45 feet. It was at this neck that many measurements of flow were made during 1888 and 1889 for the United States Geological Survey. In March, 1899, simultaneous measurements were made of the tailrace at this neck and of the forebay; and while the flow through the tailrace exceeded that in the forebay, the difference was not greater than could be accounted for by the fluctuations of flow caused by increased demands on the street-car service. Early in 1899, when the lake level was 10 feet below the crest of the dam, the writer urged some of the authorities to shut off all power some night at 12 o'clock, and after the tailrace water had run off to have the flow measured in order to ascertain the leakage, if any; but there were difficulties which prevented the stopping of the works. It is probable that there was no leak under the dam from the lake. Water from the lake going under the dam would have been under a head of 66 feet, and would have emerged with a velocity of

FIG. 11.—Cross section showing undermining of toe of dam.
