DEPARTMENT OF THE INTERIOR  
UNITED STATES GEOLOGICAL SURVEY  
GEORGE OTIS SMITH, DIRECTOR

THE  
SAN FRANCISCO EARTHQUAKE AND FIRE  
OF  
APRIL 18, 1906  
AND THEIR EFFECTS ON STRUCTURES AND  
STRUCTURAL MATERIALS

REPORTS BY  
GROVE KARL GILBERT, RICHARD LEWIS HUMPHREY,  
JOHN STEPHEN SEWELL, AND FRANK SOULÉ

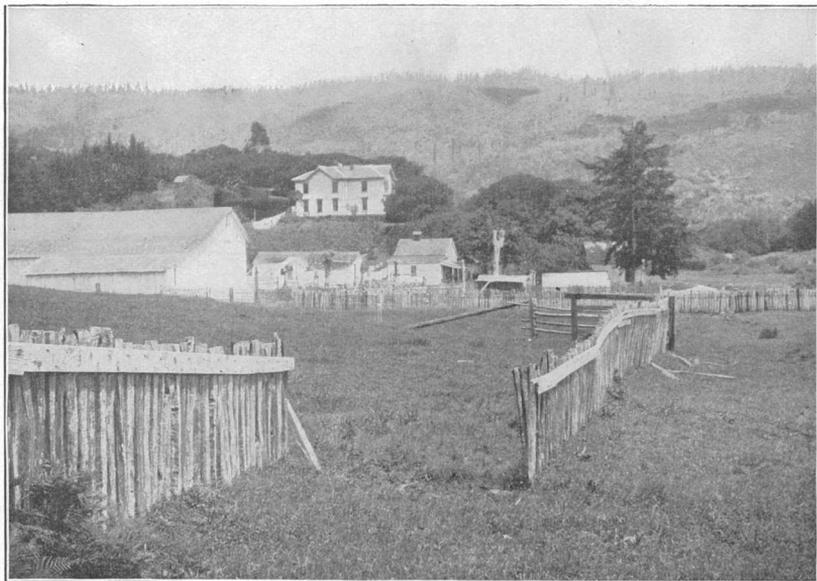
B. FENCE PARTED BY EARTHQUAKE FAULT.

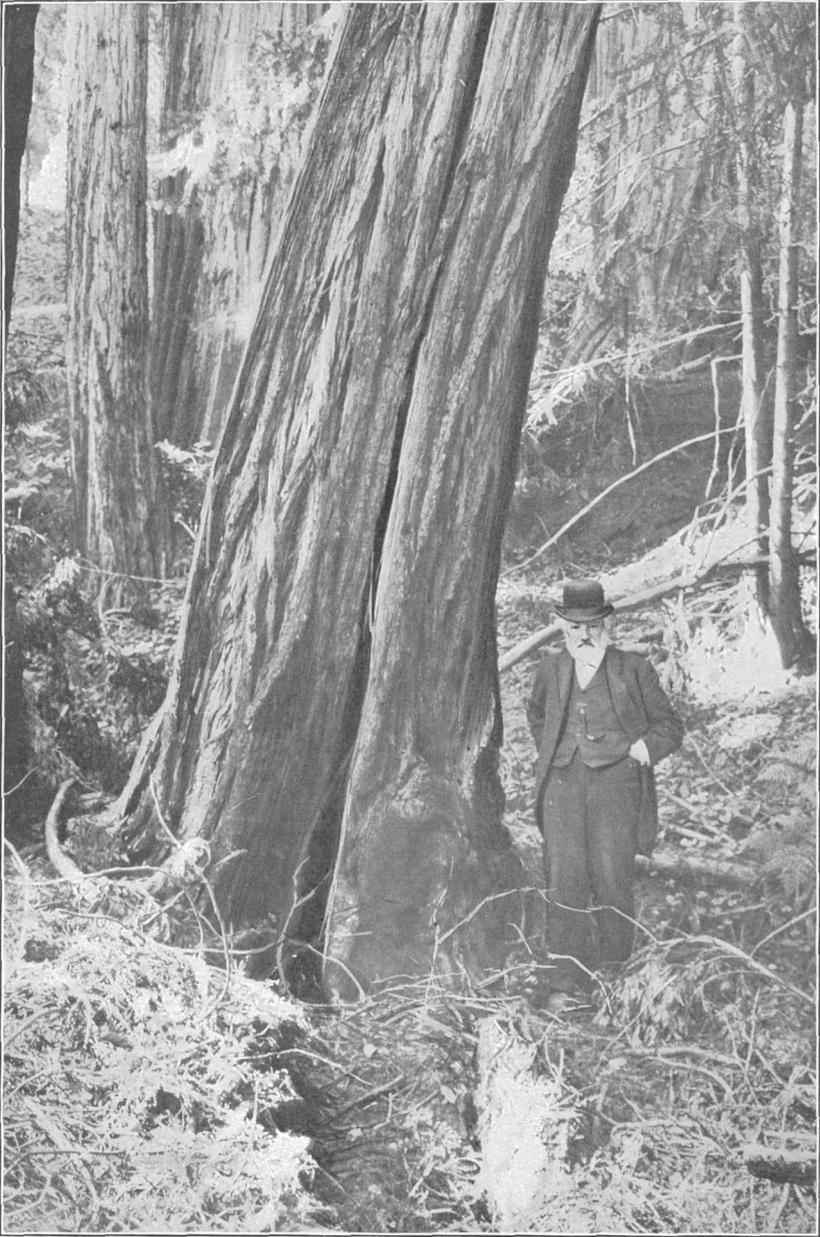
REDWOOD TREE 6 FEET IN DIAMETER ON LINE OF FAULT SOUTH OF FORT ROSS.

The tree was split to a height of 35 feet, although the horizontal displacement was slight. The opening is wedge-shaped at the base, running from a width of 8 inches on the side shown to a fine crack on the farther side. Photograph by Richard L. Humphrey.

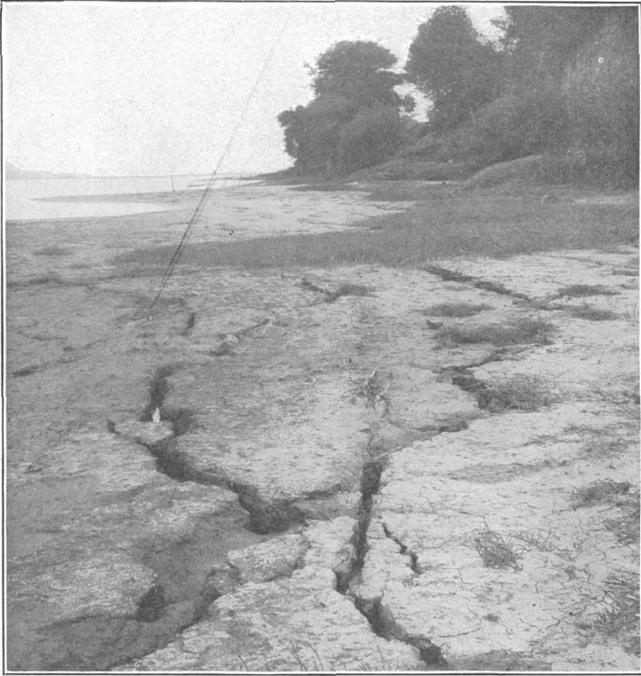
A. SECONDARY CRACKS, SHORE OF BOLINAS LAGOON.

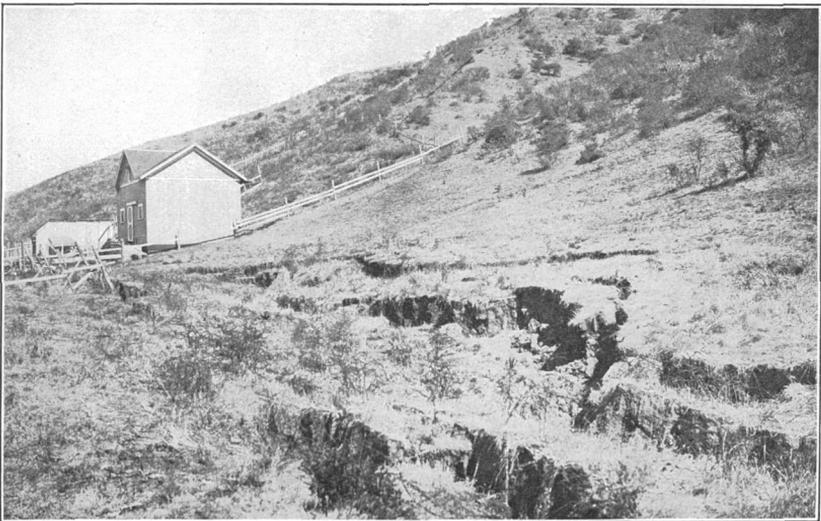
B. SECONDARY CRACKS, WITH SETTLING, BOLINAS.

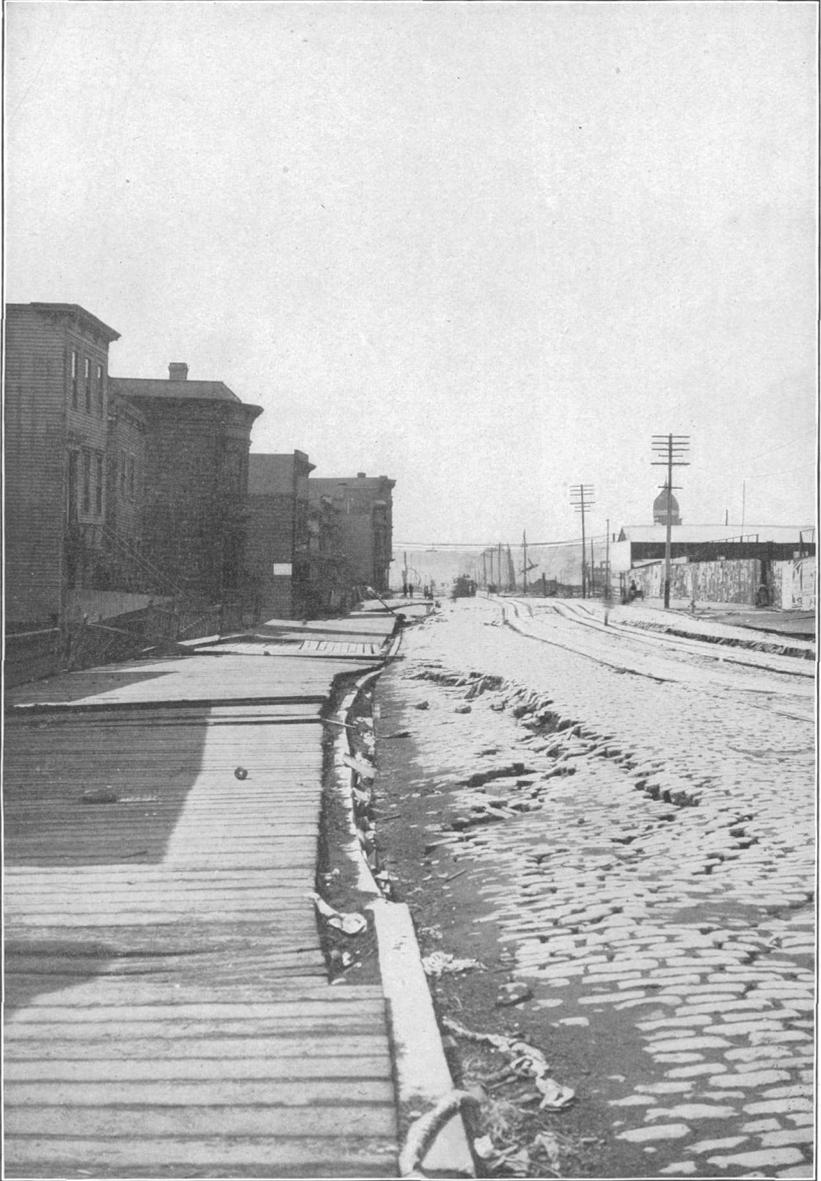
RESULTS OF EARTH FLOW, NINTH STREET, SAN FRANCISCO.

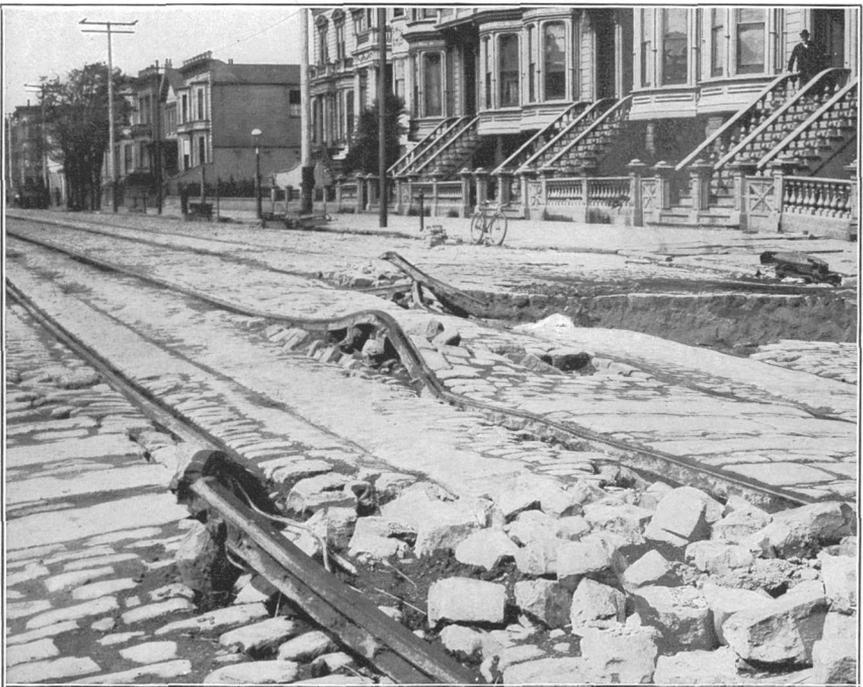
B. BUCKLING CAUSED BY EARTH FLOW, HOWARD STREET, SAN FRANCISCO.

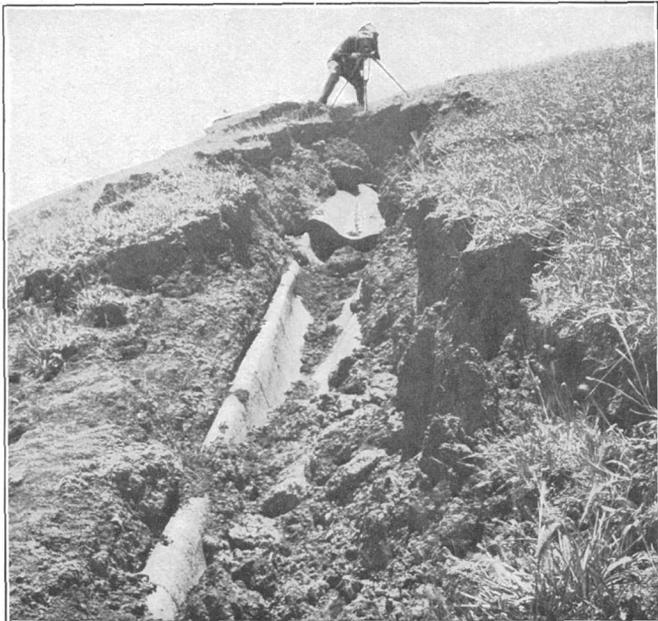
A. COLLAPSED PILARCITOS 30-INCH WROUGHT-IRON PIPE LINE, NEAR TRESTLE CROSSING THE FAULT.

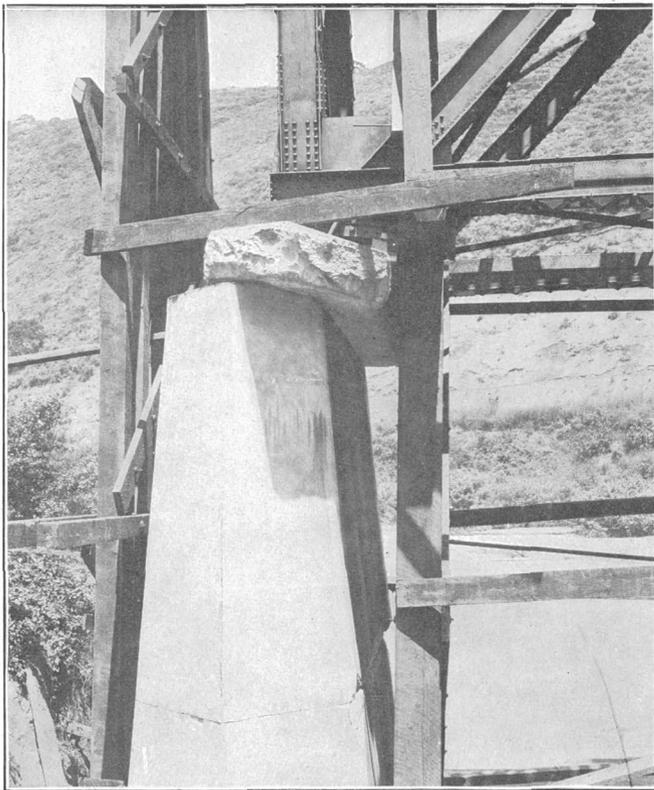
A. RACKING AND SPALLING OF CONCRETE PIER DUE TO EARTHQUAKE.

Near south abutment of Southern Pacific Railroad bridge over Pajaro River. Photograph by Richard L. Humphrey.

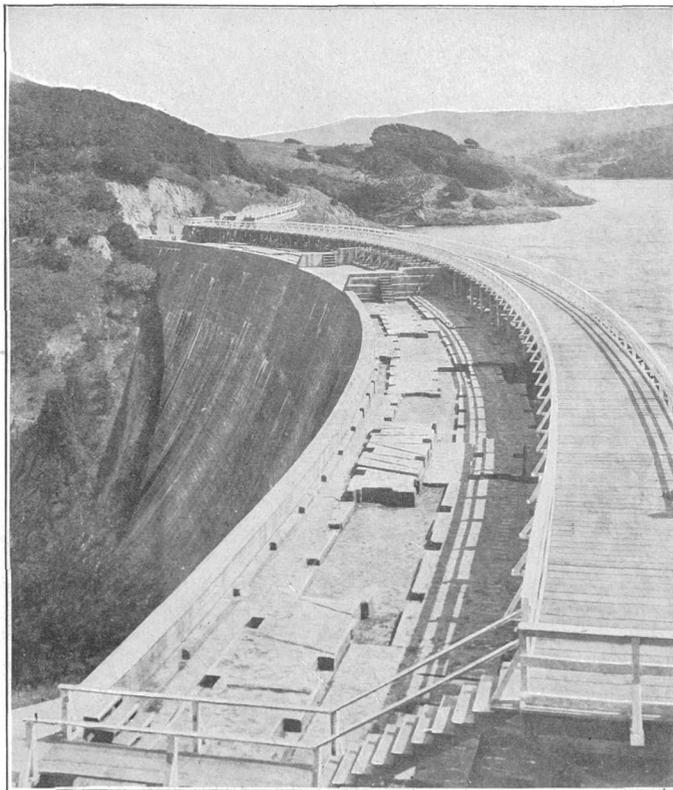
B. ENDURANCE OF CONCRETE DAM NEAR FAULT TRACE, AT CRYSTAL SPRINGS LAKE, SAN MATEO:

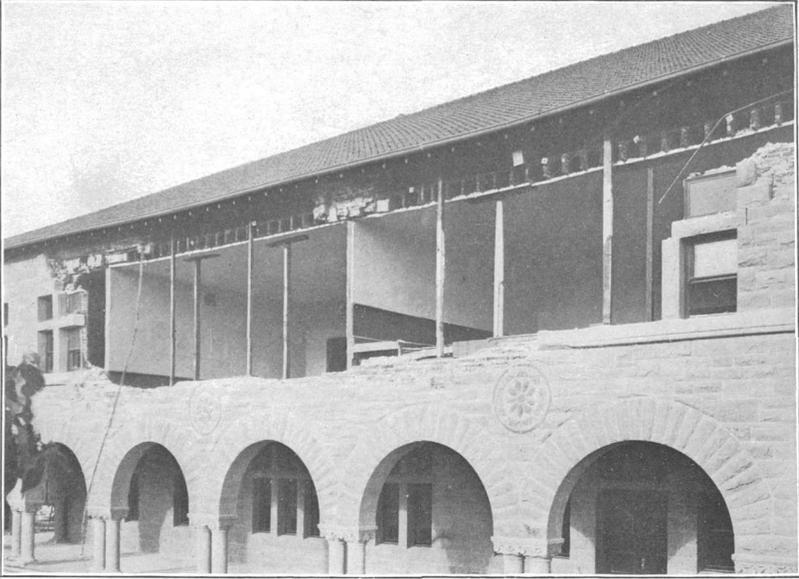
A. EARTHQUAKE DAMAGE DUE TO LACK OF TIE AND BRACING, GEOLOGICAL DEPARTMENT, LELAND STANFORD JUNIOR UNIVERSITY.

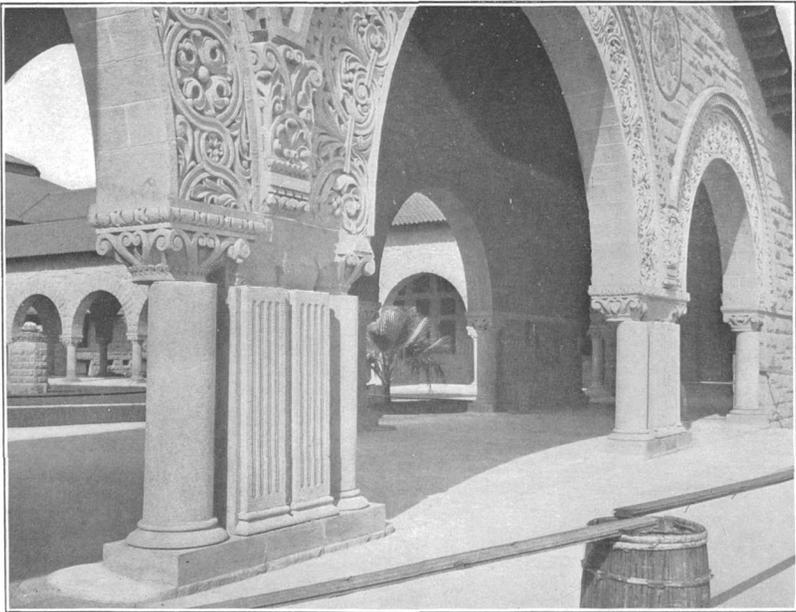
B. EARTHQUAKE EFFECT ON ARCHES, LELAND STANFORD JUNIOR UNIVERSITY.

Spalling of caps and movement of upper part of columns. Photograph by Richard L. Humphrey.

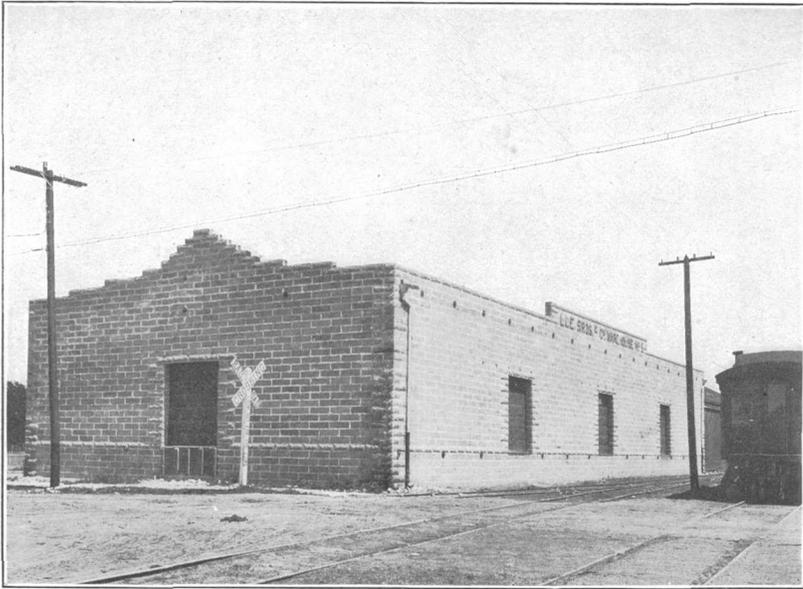
A. ENDURANCE OF WALLS TIED TOGETHER WITH STEEL RODS, LEE BROTHERS' WAREHOUSE, SANTA ROSA.

Slightly damaged at cornice. The few blocks which were thrown down by the earthquake were replaced previous to the taking of the photograph.

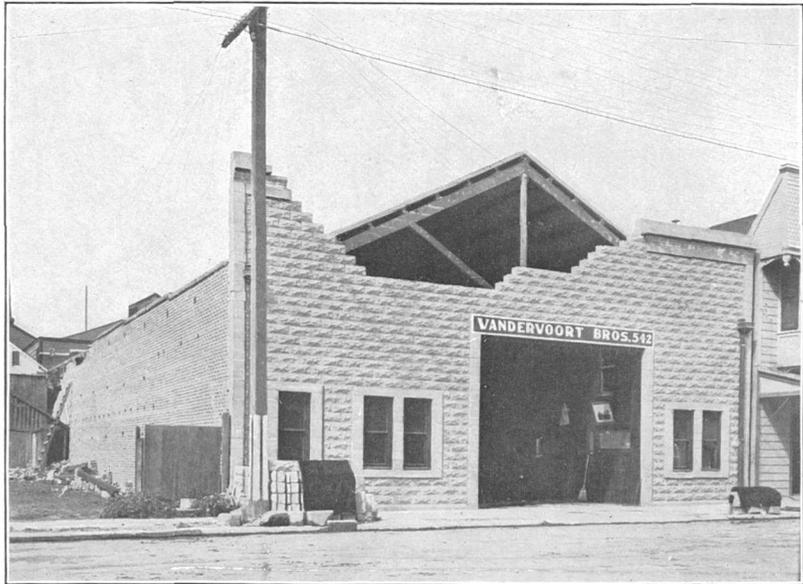
B. WALL THROWN DOWN BY EARTHQUAKE VIBRATIONS OF ROOF TRUSSES WHICH WERE NOT TIED TO WALL, VANDERVOORT BROTHERS' LIVERY, PALO ALTO.

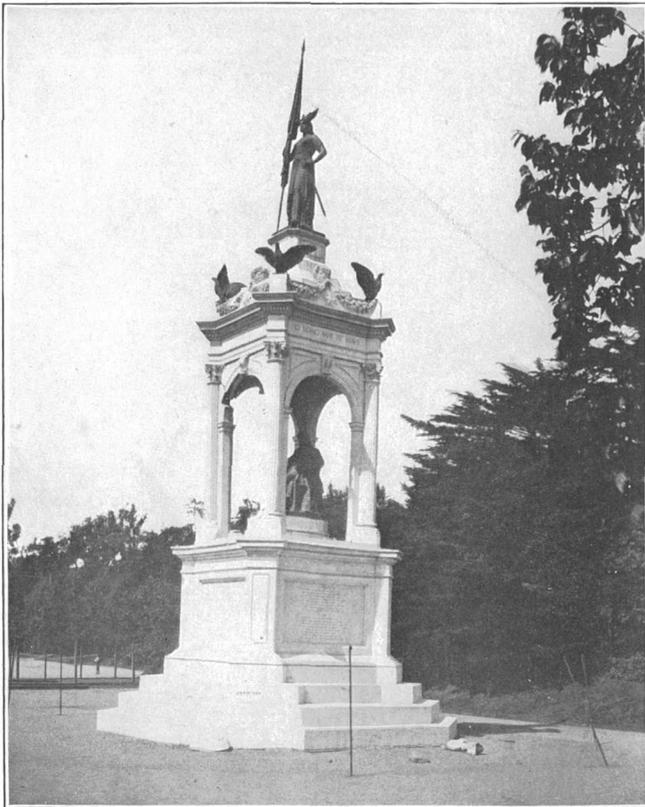
A. LOOSENING OF ARCH STONES AND SPALLING OF COLUMNS BY EARTHQUAKE, FRANCIS SCOTT KEY MONUMENT, GOLDEN GATE PARK, SAN FRANCISCO.

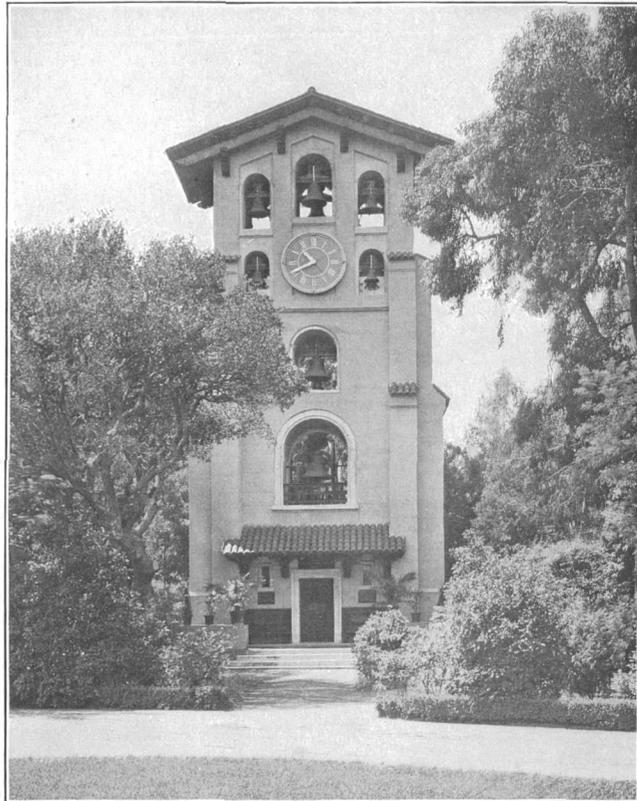
B. UNDAMAGED REINFORCED-CONCRETE STRUCTURE AT MILLS COLLEGE, NEAR OAKLAND.

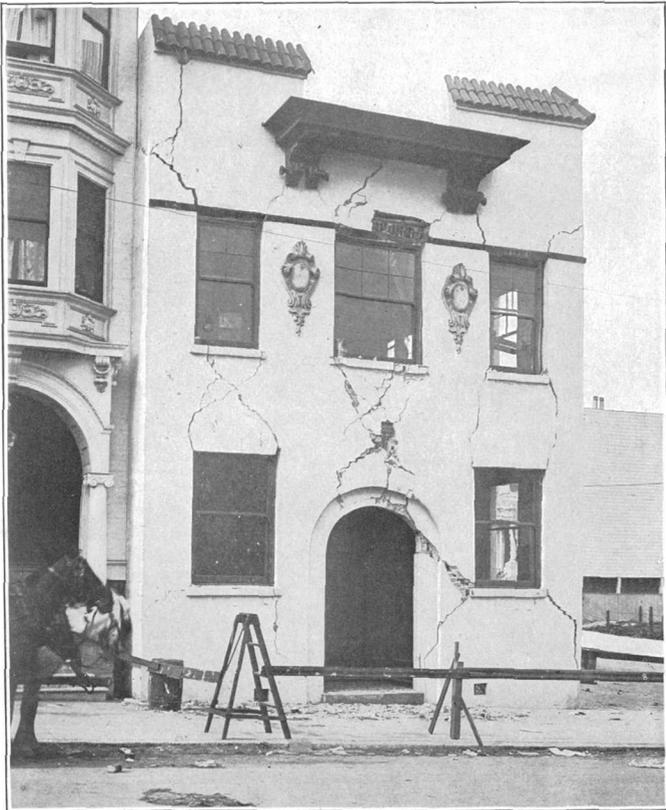
A. X CRACKS IN BRICKWORK, CAUSED BY ROCKING, HOUSE IN SAN FRANCISCO.

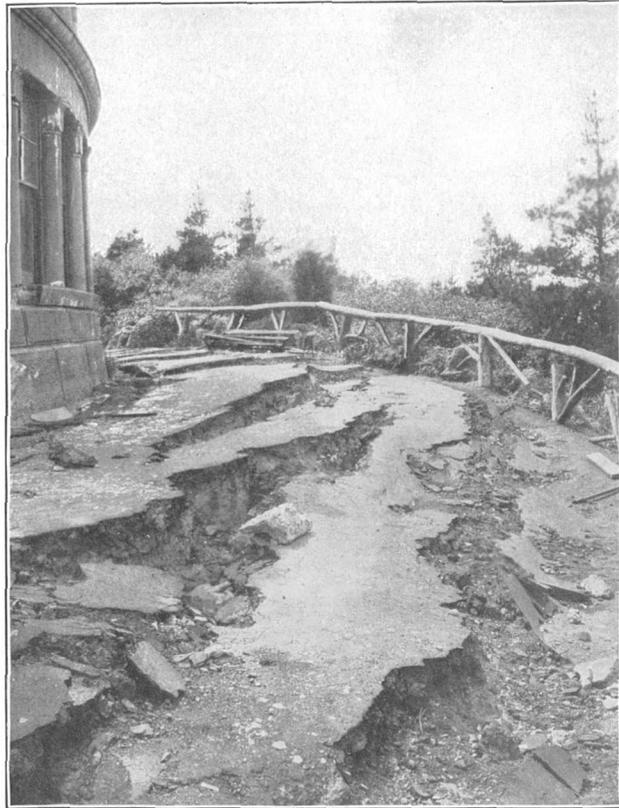
B. SLIP OF FOUNDATION OF CYCLORAMA, STRAWBERRY HILL, GOLDEN GATE PARK, SAN FRANCISCO, CAUSING COLLAPSE OF THE STRUCTURE.

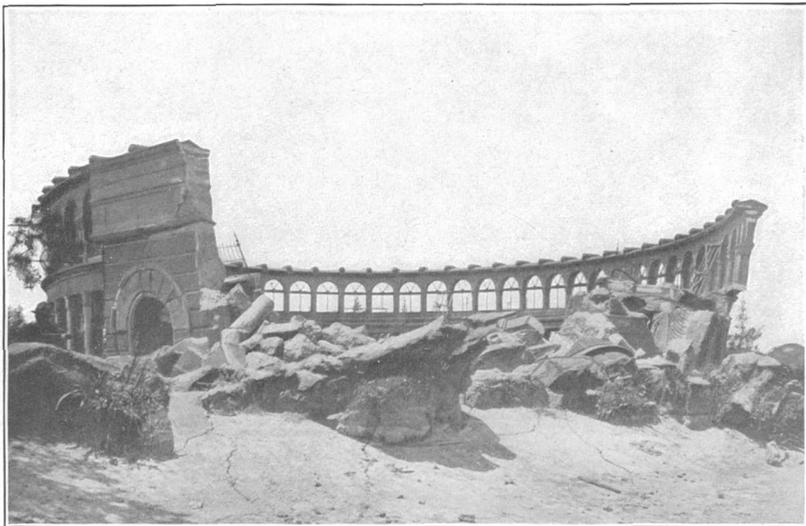
A. EARTHQUAKE EFFECT ON STRUCTURE OF REINFORCED CONCRETE OF POOR QUALITY.  
Cyclorama, Strawberry Hill, Golden Gate Park, San Francisco. Photograph by Richard L. Humphrey.

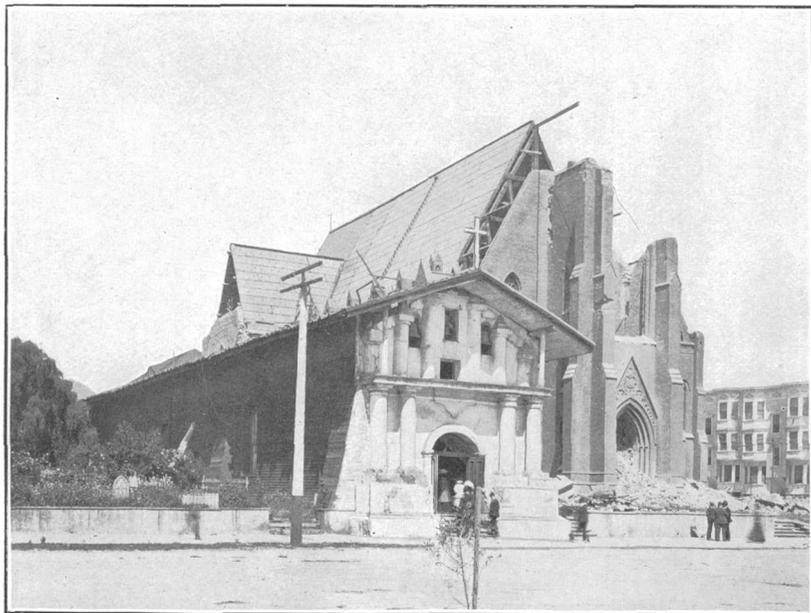
B. EFFECT OF EARTHQUAKE ON ADJACENT BUILDINGS OF DISSIMILAR TYPE AND CONSTRUCTION.

Old Mission Dolores, San Francisco, undamaged. Tower of new church adjoining was so badly damaged that it had to be taken down. Photograph by Richard L. Humphrey.

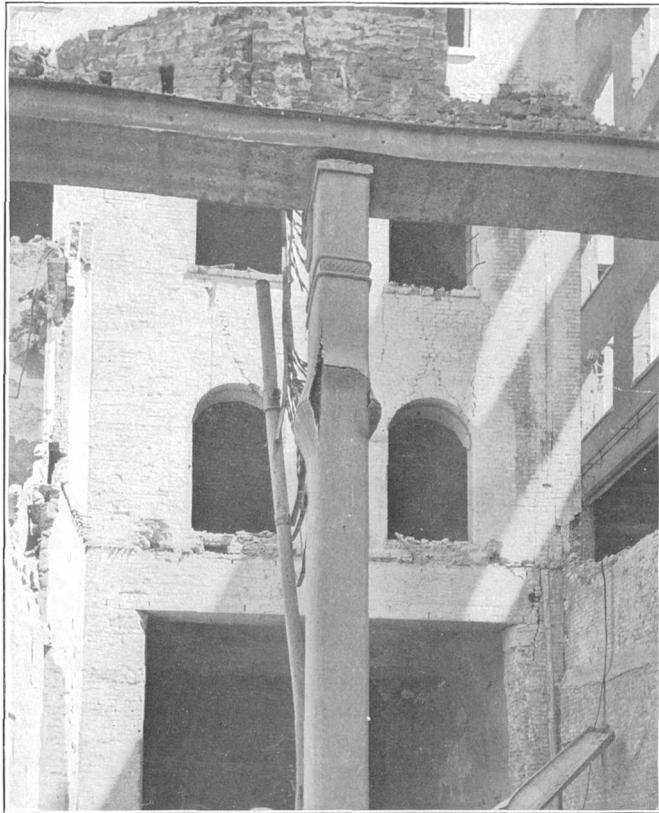
A. FAILURE OF CAST-IRON SHELL OF CONCRETE-FILLED CAST-IRON COLUMN BY FIRE, ACADEMY OF SCIENCES BUILDING, SAN FRANCISCO.

The concrete core supports the load. Note also the effect of the earthquake on the brick wall in the rear. Photograph by Richard L. Humphrey.

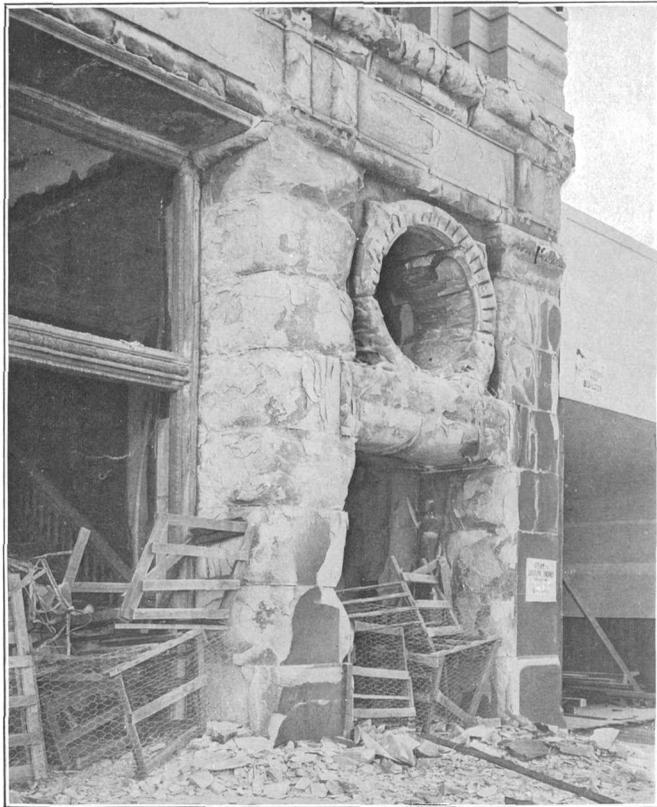
B. SPALLED GRANITE, MARKET STREET ENTRANCE OF AETNA BUILDING, SAN FRANCISCO.

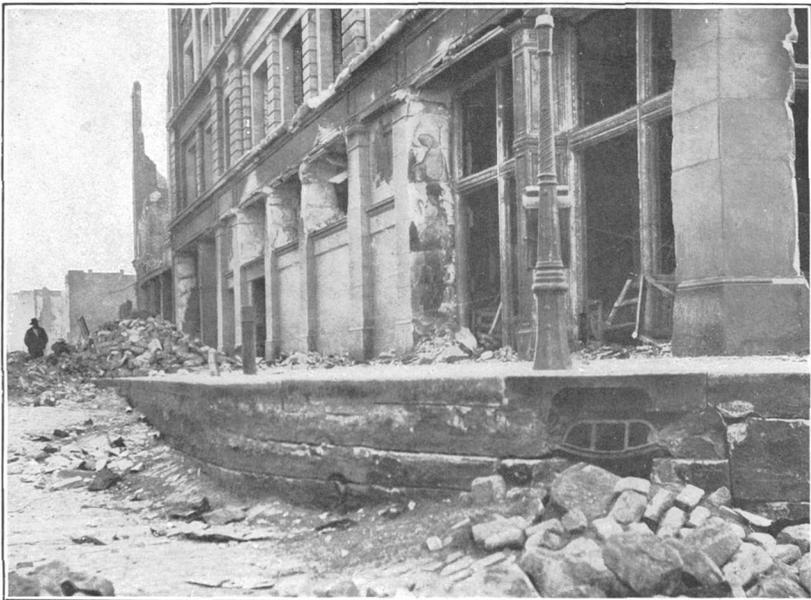
.1. SUBSIDENCE OF STREET IN FRONT OF ÆTNA BUILDING, SAN FRANCISCO.

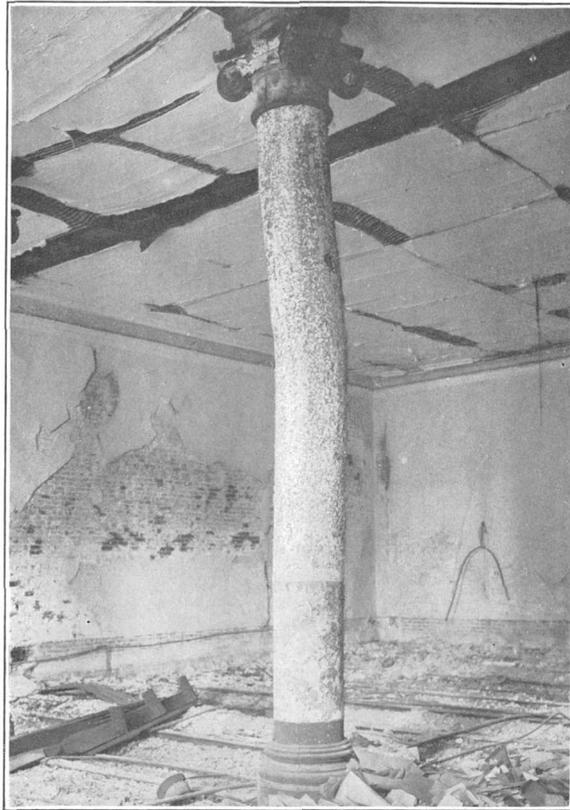
B. INCIPIENT FAILURE OF NAKED CAST-IRON COLUMN IN CITY  
HALL, SAN FRANCISCO.

Ceiling on the point of falling. Photograph by John Stephen Sewell.

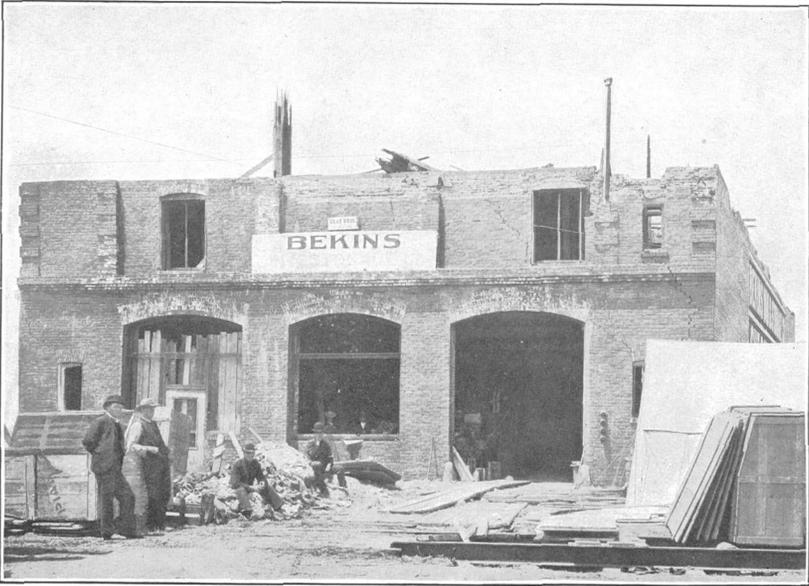
A. EARTHQUAKE ENDURANCE OF REENFORCED-CONCRETE BUILDING, BEKINS VAN AND STORAGE COMPANY'S WAREHOUSE, SAN FRANCISCO, UNDER CONSTRUCTION.

The only building of pure reinforced-concrete type in the city. The brick walls composing the shell of the building were cracked, but the reinforced-concrete floors and columns were uninjured. Photograph by Richard L. Humphrey.

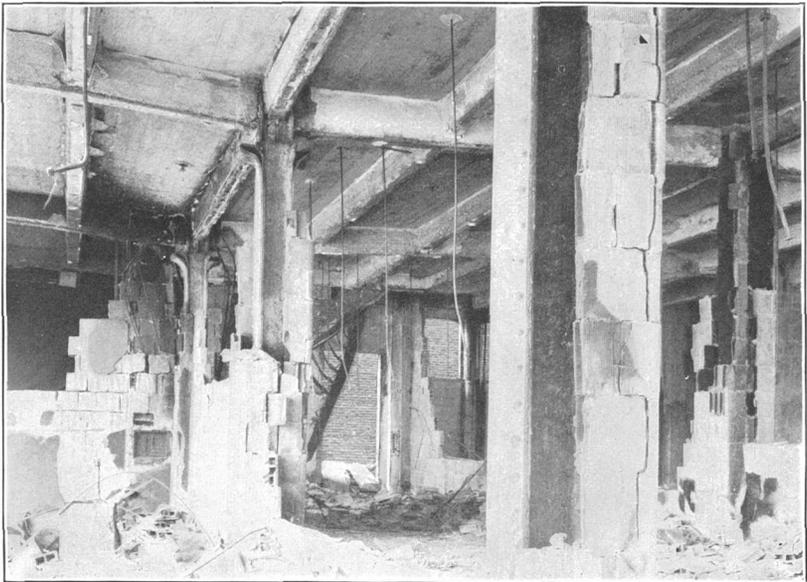
B. FAILURE OF TERRA-COTTA COLUMN COVERINGS, RESULTING IN BUCKLED COLUMNS; ENDURANCE OF CINDER-CONCRETE FLOORS; CENTER OF GROUND FLOOR, ARONSON BUILDING, SAN FRANCISCO.

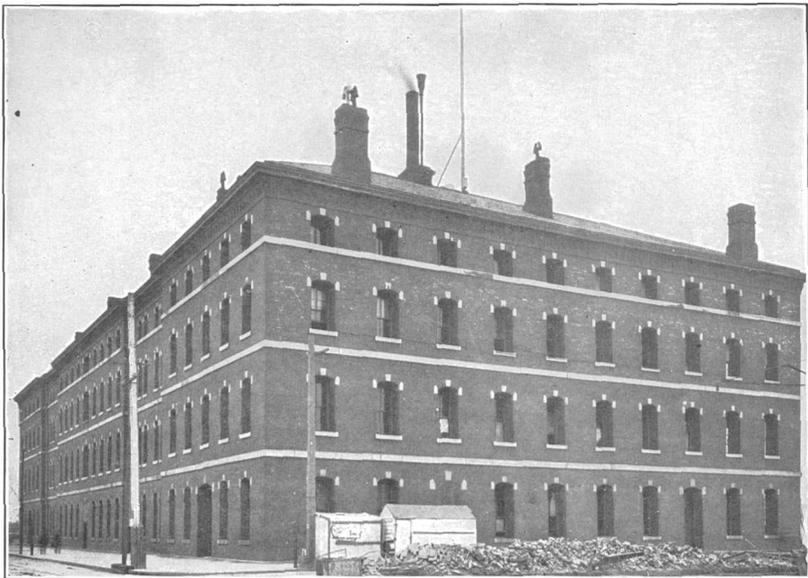
**A. EARTHQUAKE ENDURANCE OF A WELL-CONSTRUCTED BRICK BUILDING: APPRAISERS' WAREHOUSE, SAN FRANCISCO.**

The walls were built with full-header courses and show only a few slight cracks, although the building was located on alluvial soil. Photograph by Richard L. Humphrey.

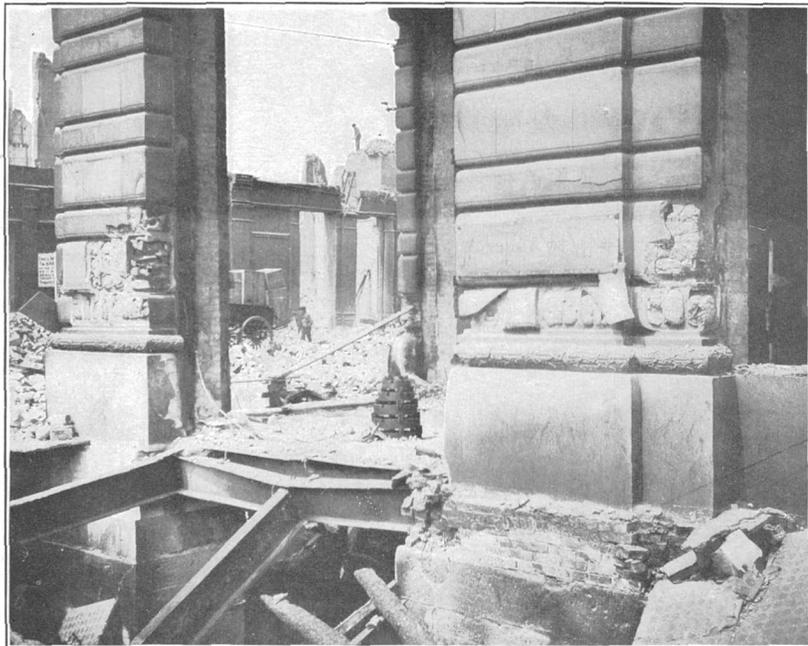
**B. FAILURE OF ORNAMENTAL TERRA COTTA, CROCKER ESTATE BUILDING, SAN FRANCISCO.**

This terra cotta failed, though solidly filled with brick mortar. The damage shown was probably due to fire, although damage of this kind was caused by both earthquake and fire. Photograph by John Stephen Sewell.

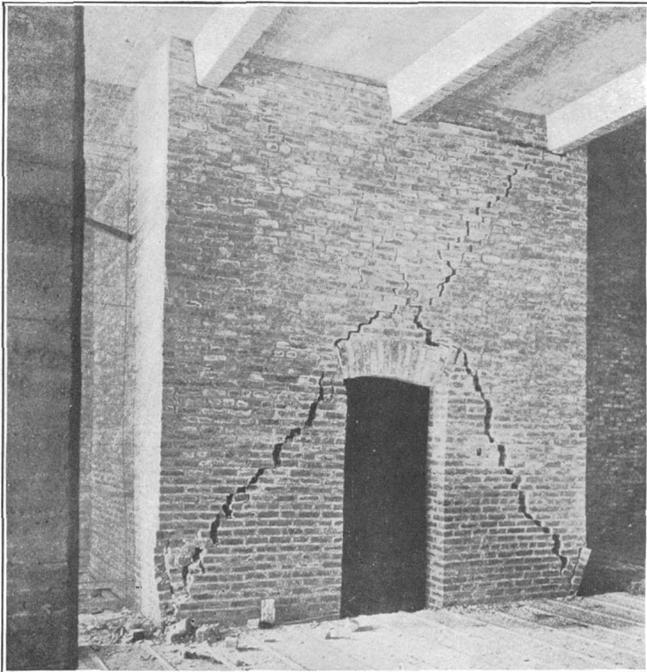
A. EARTHQUAKE CRACKS IN WALL OF VAULT, CALIFORNIA CASKET COMPANY'S BUILDING, SAN FRANCISCO.

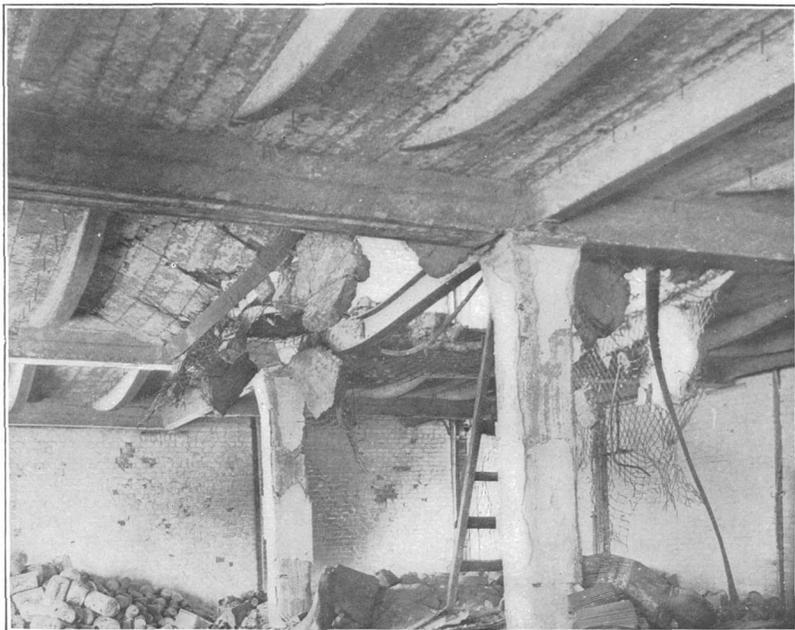
B. COLLAPSE OF FLOOR PANEL, CAUSED BY LOAD FALLING FROM A FLOOR ABOVE, THIRD FLOOR OF ÆTNA BUILDING, SAN FRANCISCO.

The failure of the upper floor was due to the softening by heat of reinforcing steel bands. Photographs by Richard L. Humphrey.

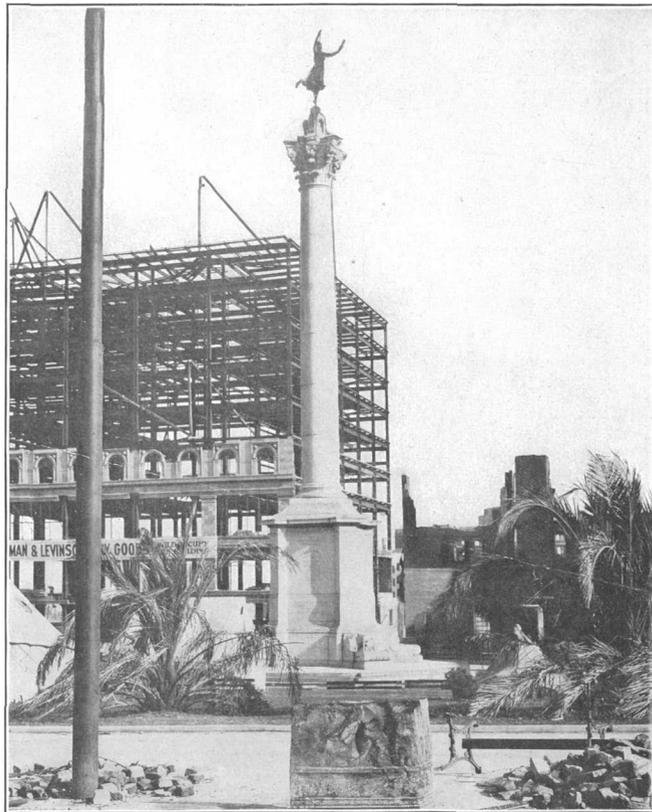
A. EARTHQUAKE DAMAGE MINIMIZED BY SPECIAL CONSTRUCTION, DEWEY MONUMENT, SAN FRANCISCO.

The drums on the shaft were displaced slightly, but were kept from falling by a steel core. Photograph by John Stephen Sewell.

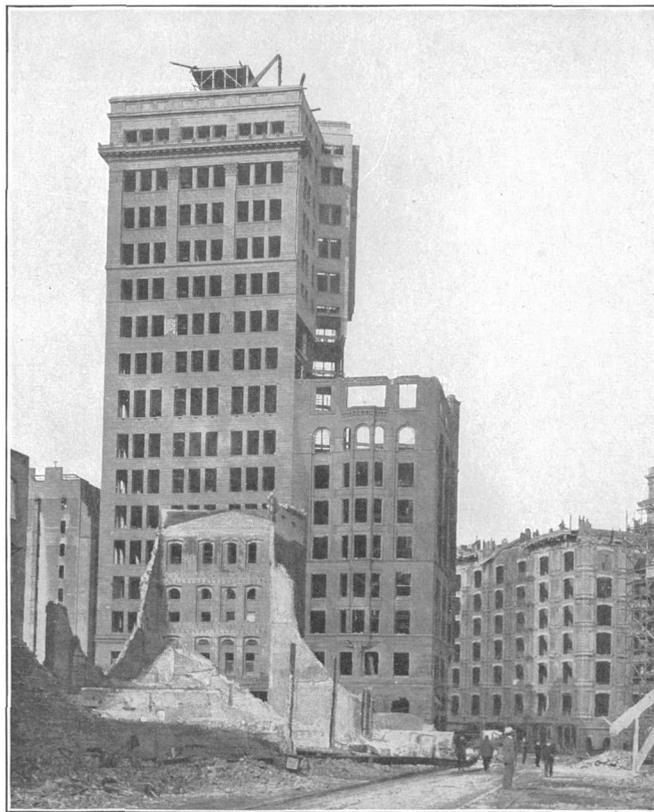
B. X CRACKS IN WALLS, DUE TO ROCKING OF BUILDING BY EARTHQUAKE, CHRONICLE BUILDING AND ANNEX, SAN FRANCISCO, LOOKING EAST.

The Palace Hotel (at the right) was completely gutted by fire, but the walls remained in good condition. Photograph by Richard L. Humphrey.

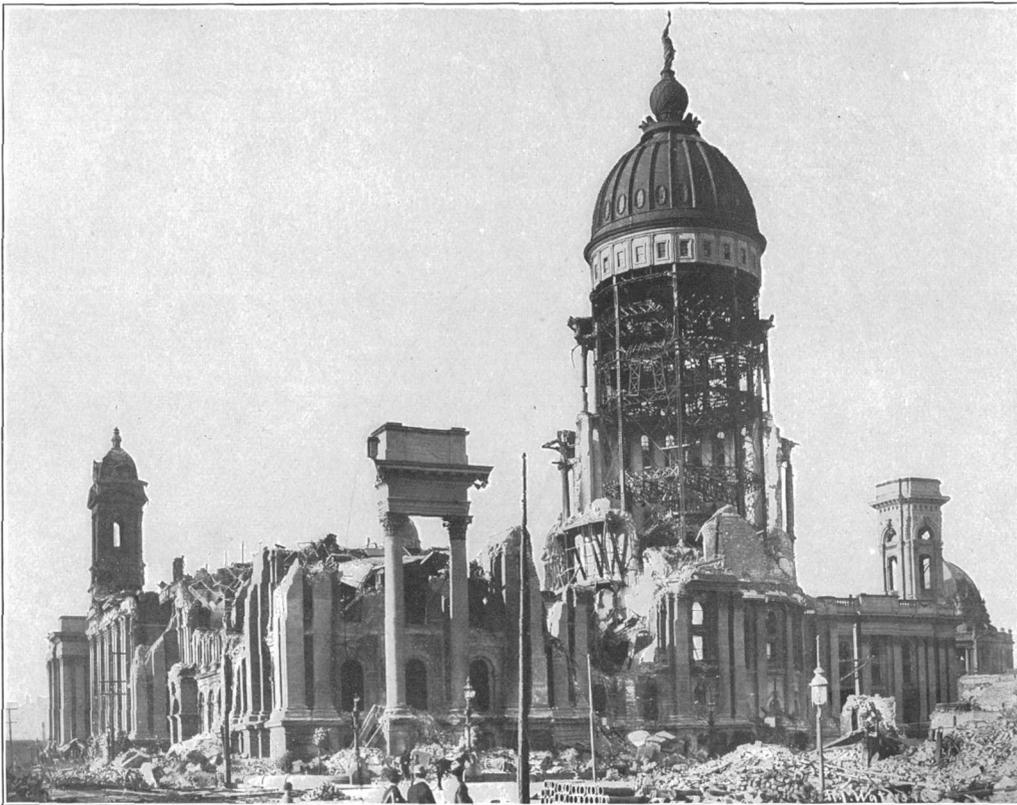
RUIN OF THE \$7,000,000 CITY HALL, SAN FRANCISCO, BY EARTHQUAKE AND FIRE.

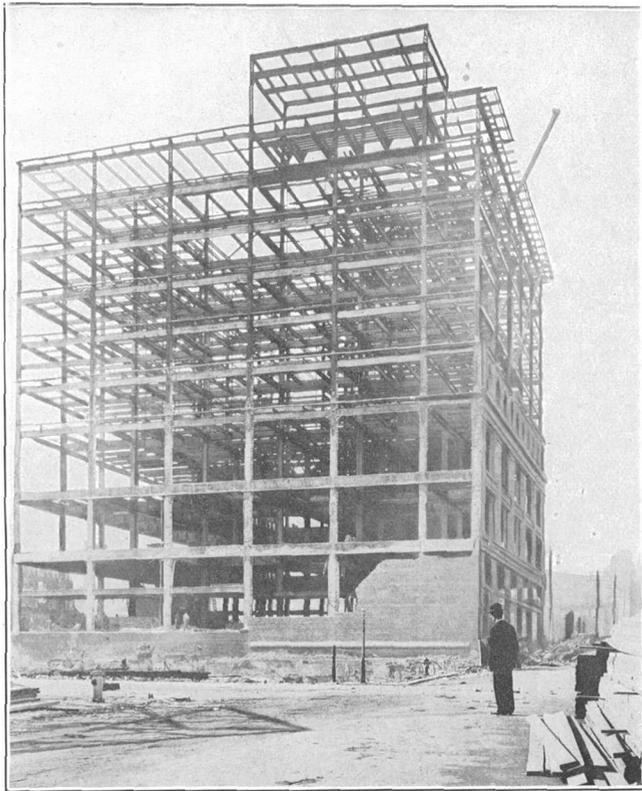
A. BEHAVIOR OF STEEL FRAME, BUTLER BUILDING (INCOMPLETE), AT THE SOUTHWEST CORNER OF GEARY AND STOCKTON STREETS, SAN FRANCISCO.

Walls taken down in places because of earthquake damage, although damage to steel by earthquake and fire was nominal. Photograph by John Stephen Sewell.

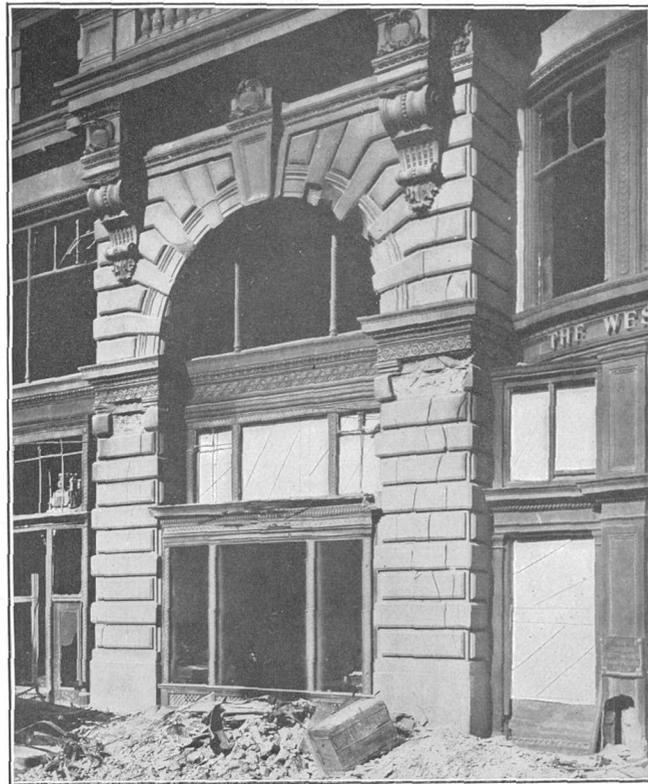
B. EARTHQUAKE DAMAGE TO STONE PIERS, JAMES FLOOD BUILDING, SAN FRANCISCO.

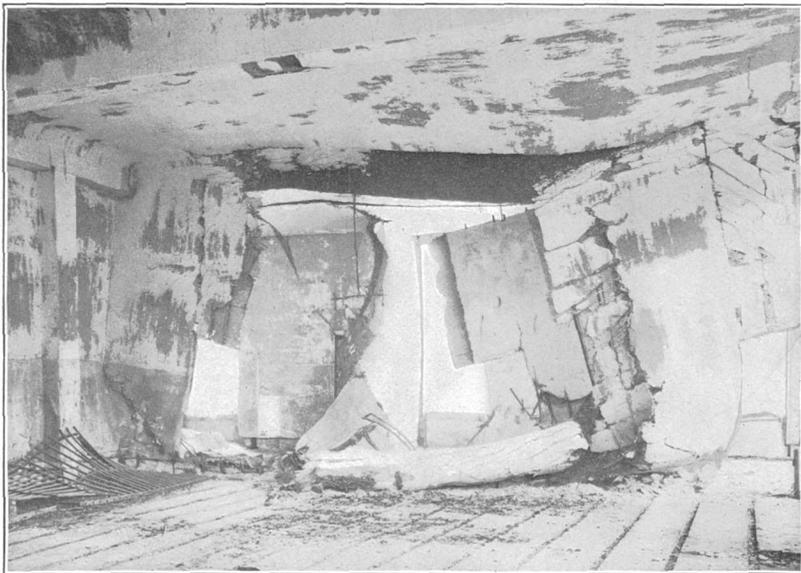
B. FAILURE OF SUSPENDED CEILING, HALL OF JUSTICE, SAN FRANCISCO.

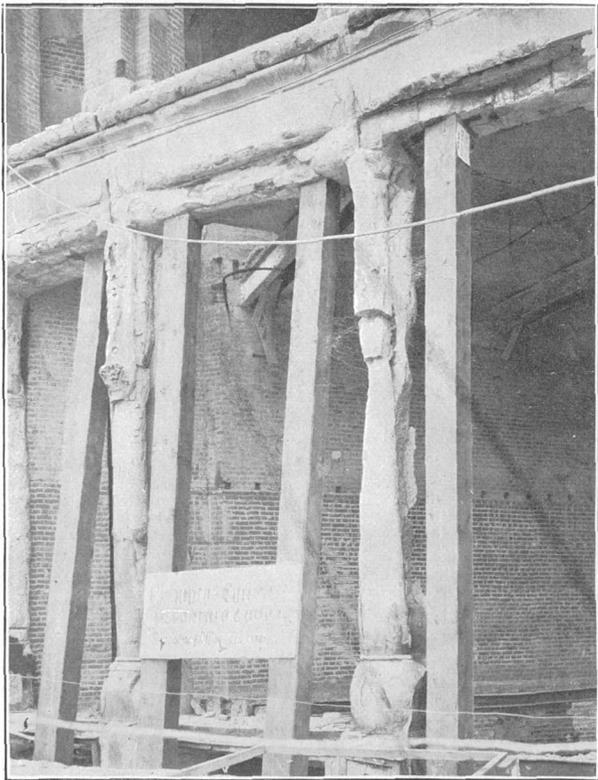
A. GRANITE COLUMNS SPALLED BY FIRE, HOBART BUILDING, SAN FRANCISCO.

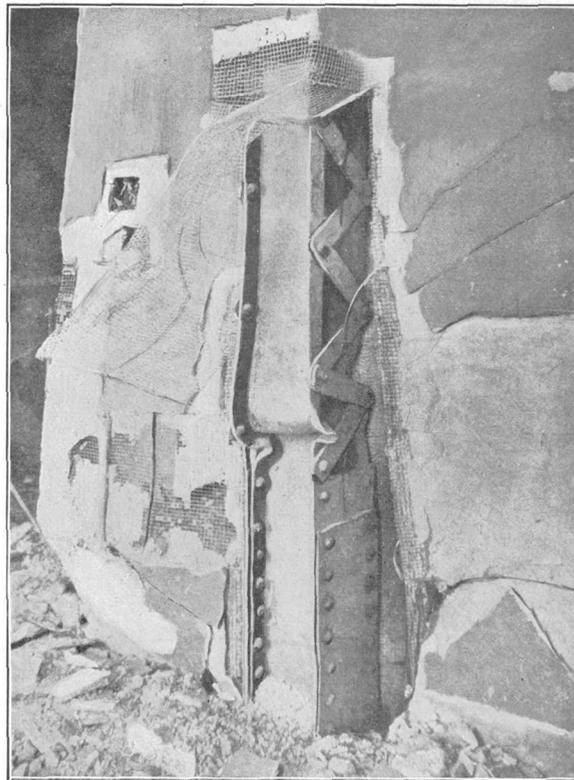
B. BUCKLING OF COLUMNS DUE TO FAILURE OF WIRE-MESH-AND-PLASTER FIREPROOFING, HOTEL HAMILTON, SAN FRANCISCO.

The fireproofing on either side shows the general condition in which it was left by the fire. It was stripped away from the column just before the photograph was taken in order to show the buckling. Photograph by A. L. A. Himmelwright.

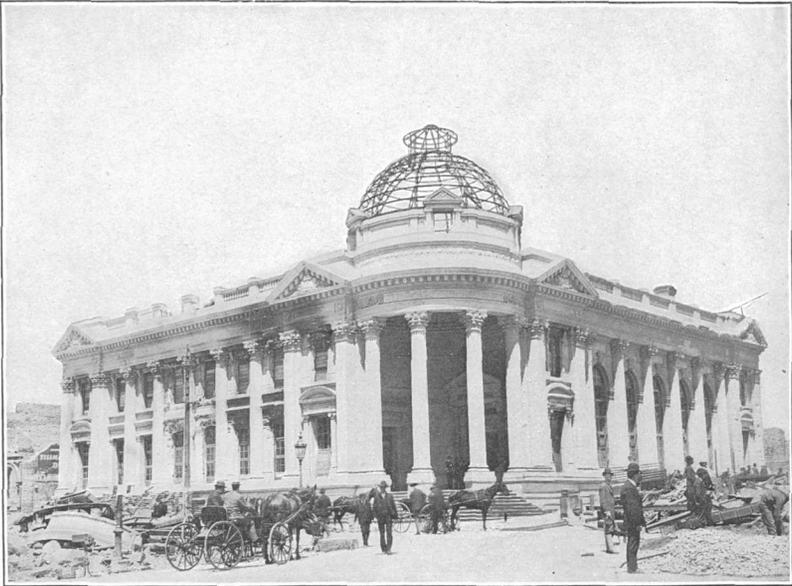
A. STONEMWORK SPALLED BY FIRE, HIBERNIA SAVINGS AND LOAN SOCIETY'S BUILDING, SAN FRANCISCO.

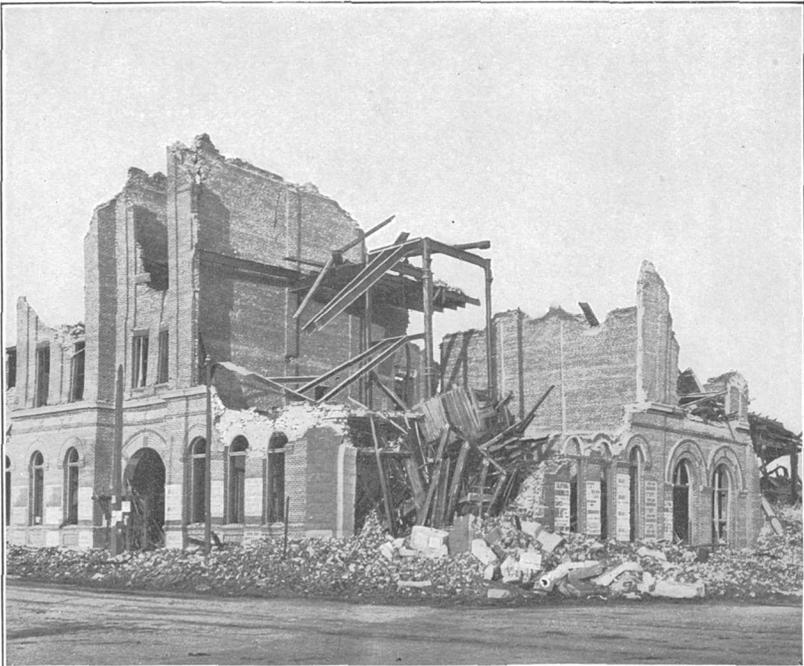
B. EARTHQUAKE DAMAGE, JACKSON BREWING COMPANY'S BUILDING, SAN FRANCISCO.

Light walls, badly bonded and laid up with poor lime mortar, and flimsily constructed steel work. Photograph by Richard L. Humphrey.

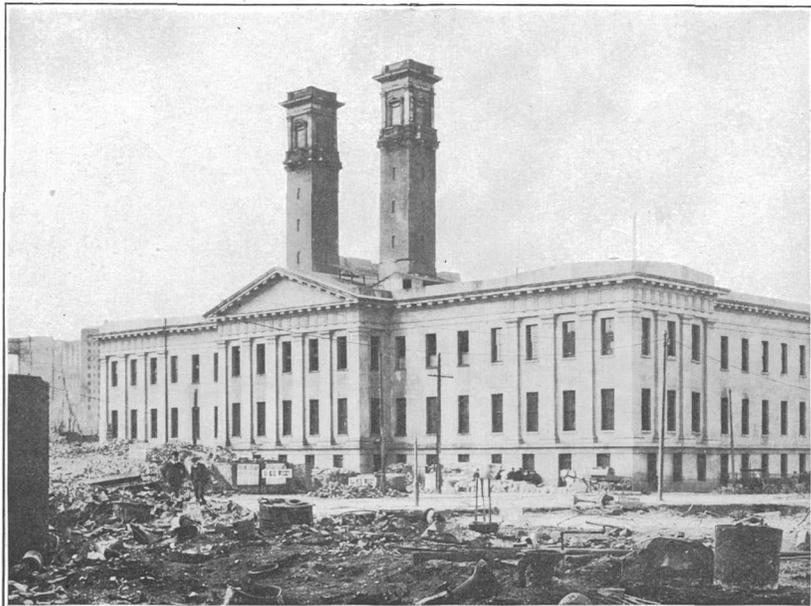
A. GOOD EARTHQUAKE ENDURANCE OF A BUILDING OF THE MONUMENTAL TYPE: UNITED STATES MINT, SAN FRANCISCO.

Showing only slight damage to brick stack, probably due to earthquake. Photograph by John Stephen Sewell.

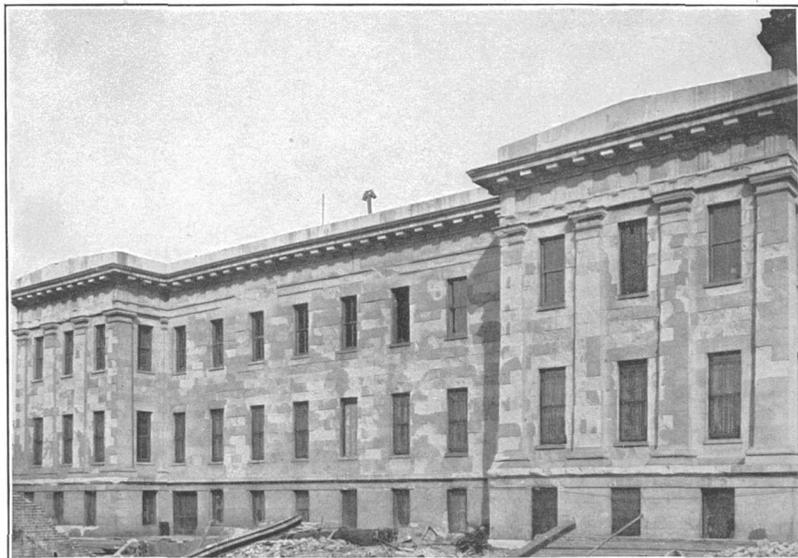
B. SPALLING OF STONWORK BY FIRE, NORTHWEST FRONT OF UNITED STATES MINT.
