DEPARTMENT OF THE INTERIOR  
UNITED STATES GEOLOGICAL SURVEY  
GEORGE OTIS SMITH, DIRECTOR

THE  
SAN FRANCISCO EARTHQUAKE AND FIRE  
OF  
APRIL 18, 1906  
AND THEIR EFFECTS ON STRUCTURES AND  
STRUCTURAL MATERIALS

REPORTS BY  
GROVE KARL GILBERT, RICHARD LEWIS HUMPHREY,  
JOHN STEPHEN SEWELL, AND FRANK SOULÉ

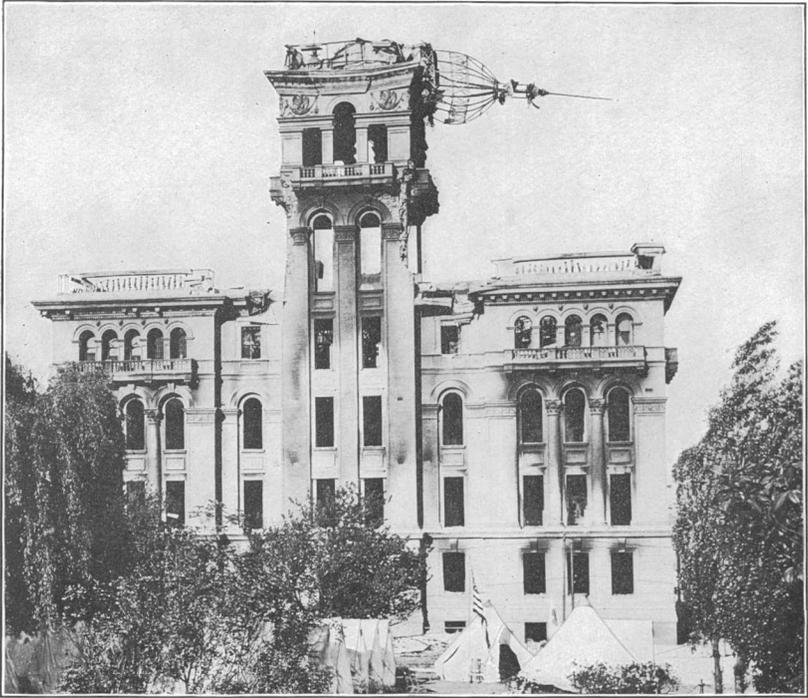
A. WRECKED TOWER AND SPALLED STONEWORK, HALL OF JUSTICE, SAN FRANCISCO.  
Photograph by John Stephen Sewell.

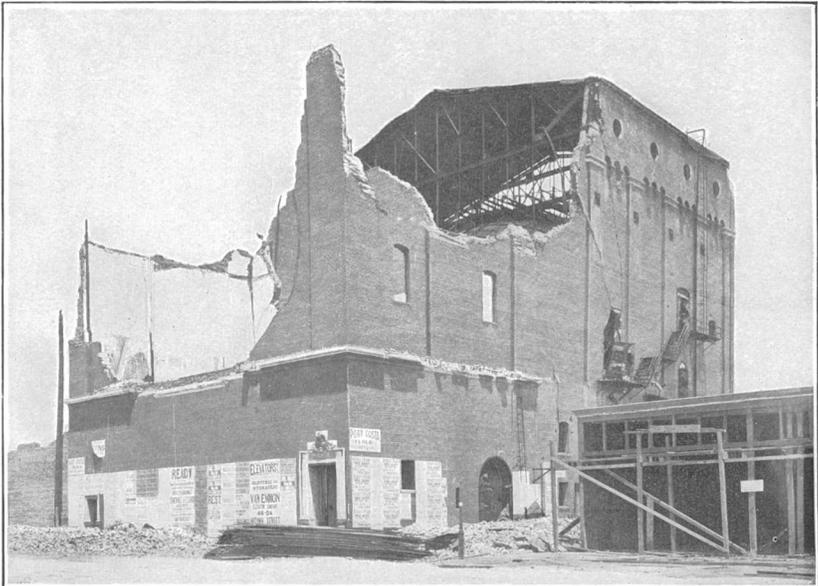
B. COMPLETE WRECK BY EARTHQUAKE, DUE TO POOR DESIGN, MAJESTIC THEATER,  
SAN FRANCISCO.  
Photograph by Richard L. Humphrey.

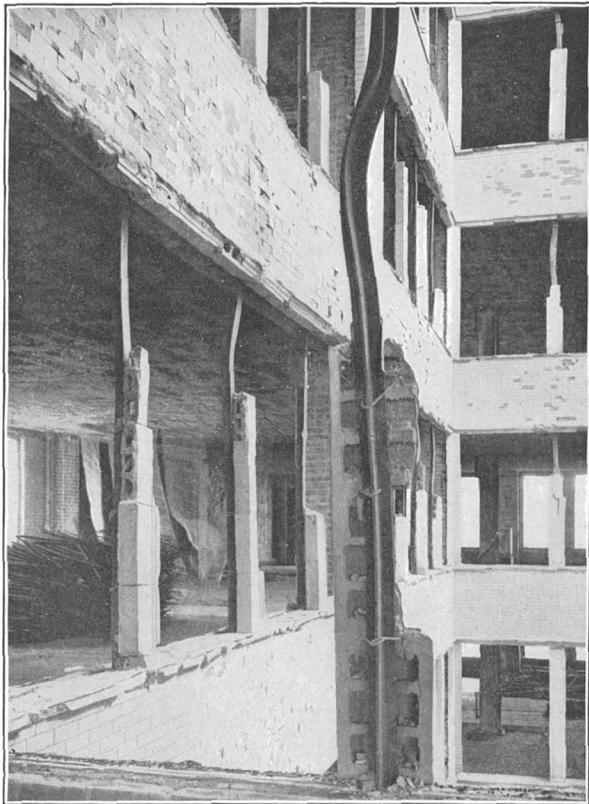
A. SPALLING OF ENAMELED BRICK IN LIGHT WELL, AND FAILURE OF FIREPROOFING OF WINDOW-FRAME SEPARATORS, MERCHANTS' EXCHANGE BUILDING, SAN FRANCISCO.

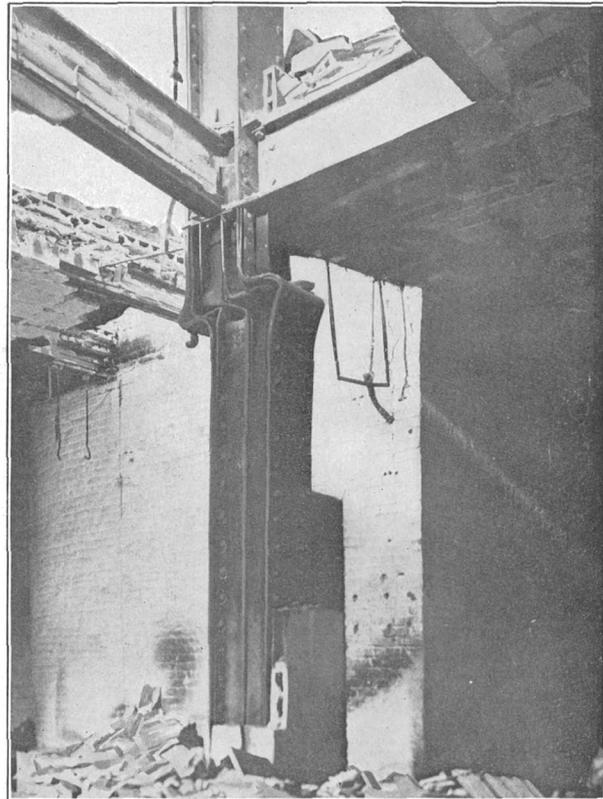
B. BUCKLING OF BASEMENT COLUMN DUE TO FAILURE OF TERRA-COTTA COVERING IN FIRE, MILLS BUILDING, SAN FRANCISCO.

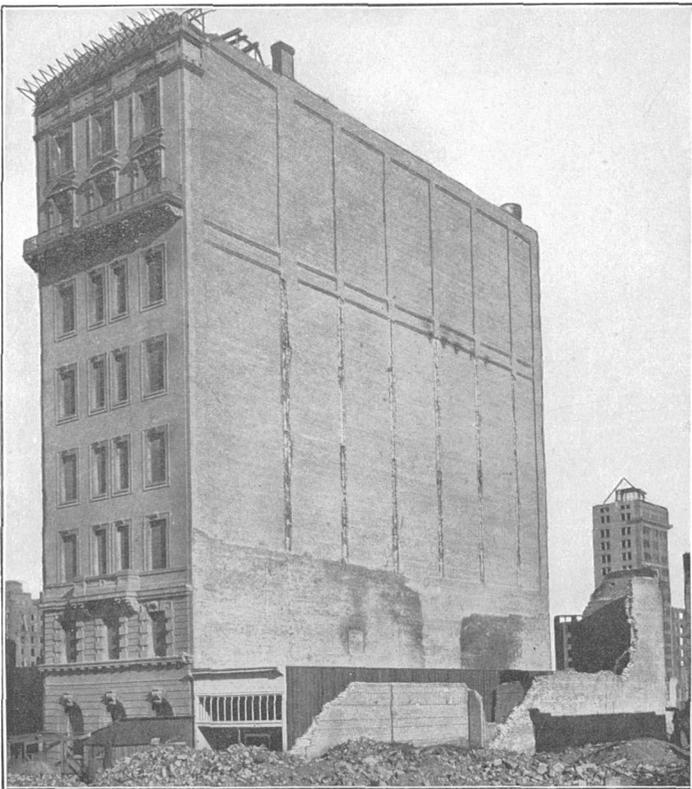
A. ENDURANCE OF A WELL-PROTECTED BUILDING SUBJECTED TO SEVERE HEAT, MAIN EXCHANGE OF PACIFIC STATES TELEPHONE AND TELEGRAPH COMPANY, SAN FRANCISCO.

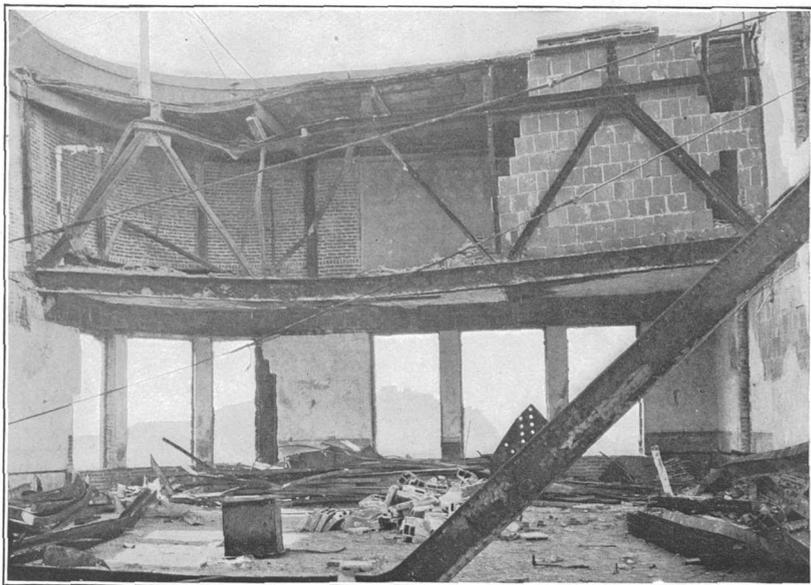
A. ROOF TRUSSES DAMAGED BY HEAT, THROUGH FAILURE OF TERRA-COTTA COVERING, MUTUAL LIFE BUILDING, SAN FRANCISCO.

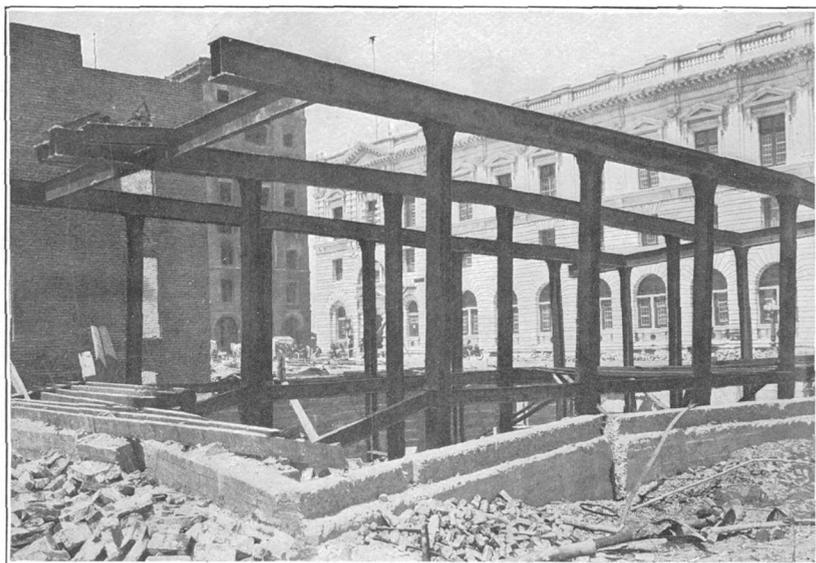
B. EFFECT OF SETTLING OF GROUND SUBJECTED TO EARTHQUAKE VIBRATIONS, STEEL-FRAME BUILDING UNDER CONSTRUCTION.

The concrete basement walls were not reinforced. Post-office in the background. Photograph by Richard L. Humphrey.

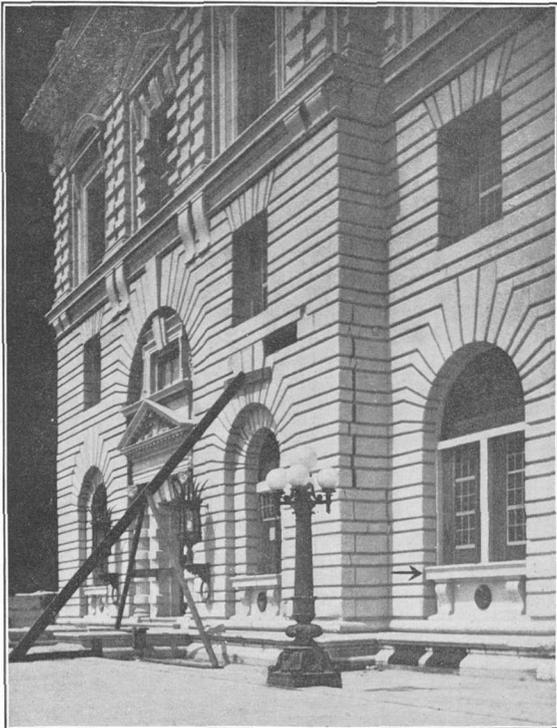
A. CRACKS IN MASONRY, PAVILION OF POST-OFFICE, SAN FRANCISCO.

The window reveal and sill were jostled together by the earthquake at the point indicated by the arrow. Photograph by John Stephen Sewell.

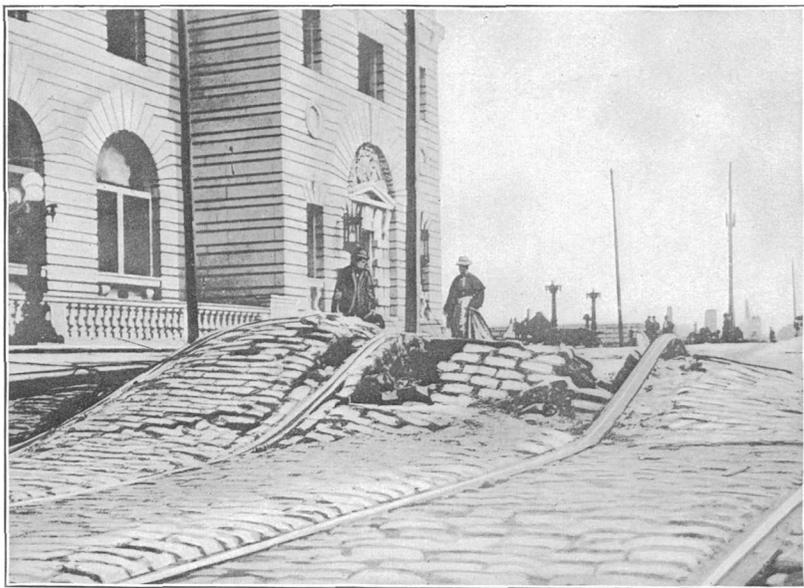
B. EFFECT OF SLIP, MISSION STREET, SAN FRANCISCO.

Corner of post-office building at the left. Photograph submitted by Richard L. Humphrey.

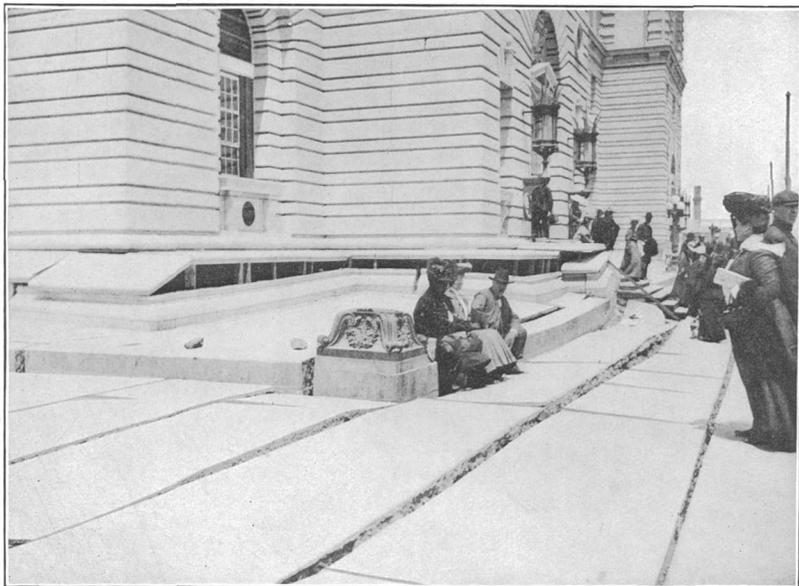
A. CRACKS IN MASONRY AND SETTLING OF OUTER TERRACE, POST-OFFICE BUILDING, SAN FRANCISCO.

The surface of the street went down at this point at least 4 feet. Photograph by John Stephen Sewell.

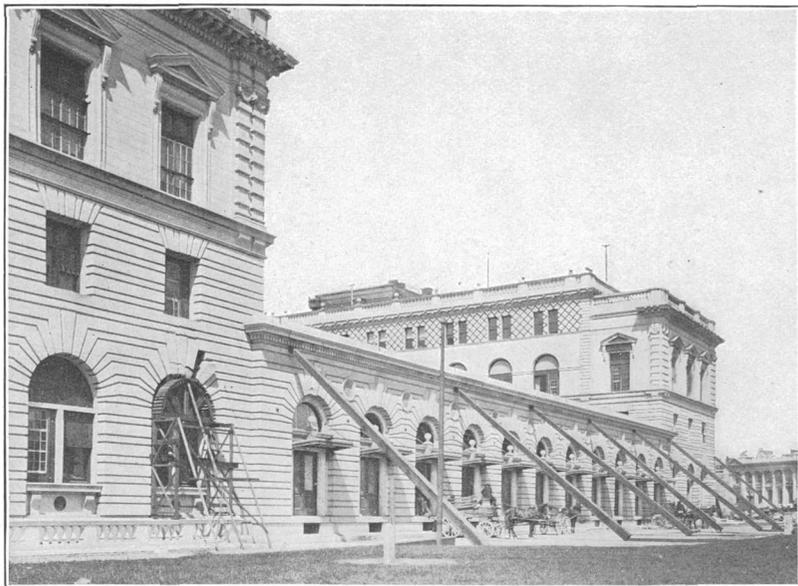
B. EFFECT OF EARTHQUAKE IN LOOSENING STONWORK, NORTHEAST FACE OF POST-OFFICE BUILDING.

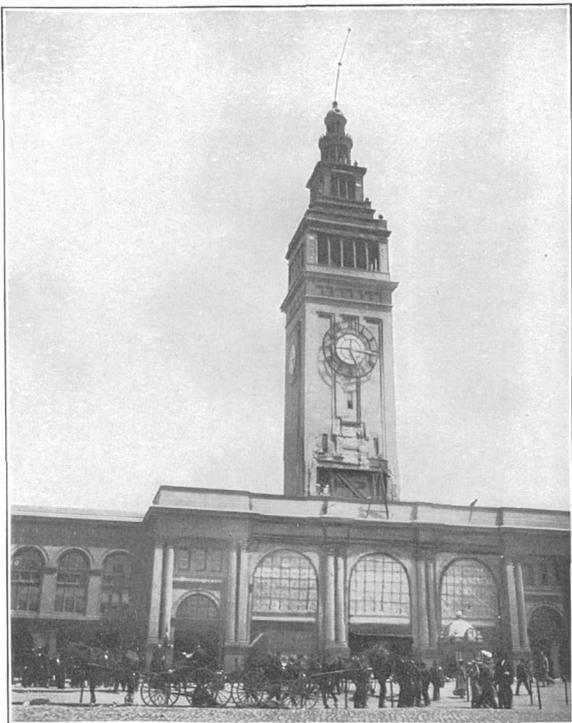
*A.* BRICKWORK THROWN DOWN BY EARTHQUAKE VIBRATION,  
TOWER OF UNION FERRY BUILDING, SAN FRANCISCO.

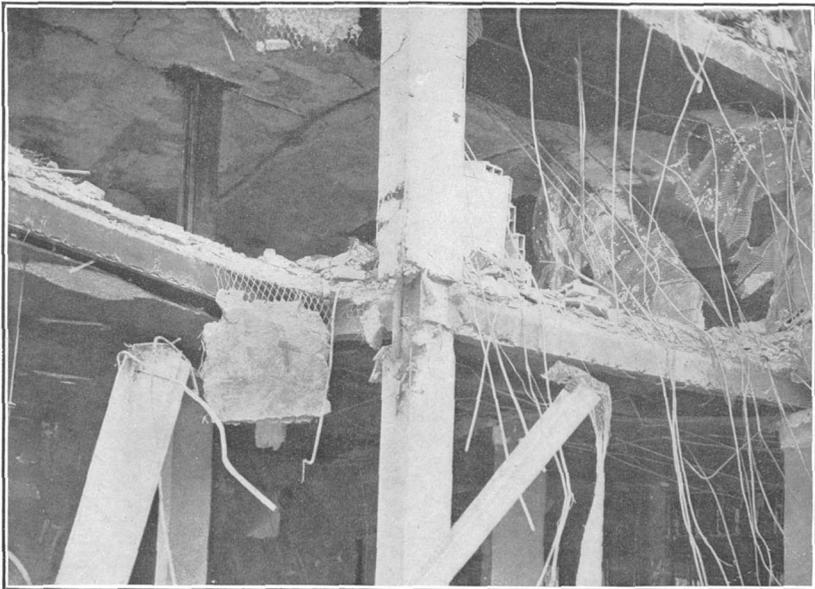
B. DAMAGE SAID TO HAVE BEEN CAUSED BY DYNAMITE, RIALTO BUILDING.

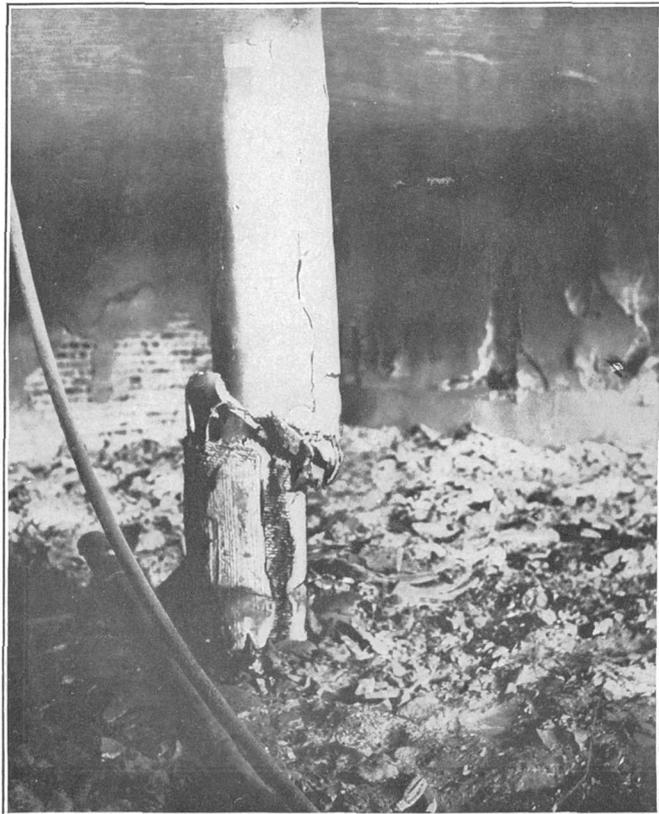
A. FAILURE OF BASEMENT COLUMN DUE TO FIRE, SLOANE BUILDING, SAN FRANCISCO.

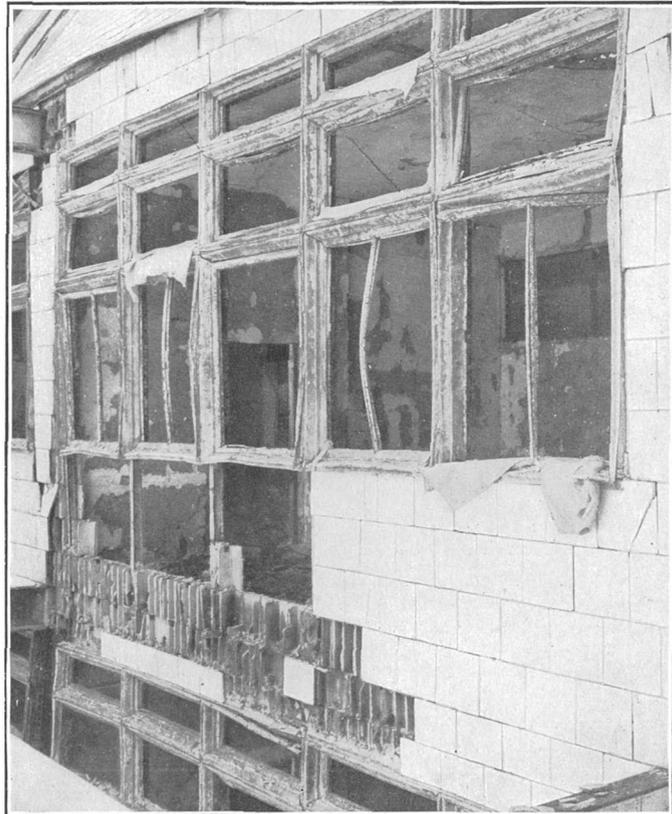
B. FAILURE OF TERRA-COTTA TILING AND METAL-FRAME WIRE-GLASS WINDOWS BY FIRE, LIGHT-WELL COLUMN, WELLS-FARGO BUILDING, SAN FRANCISCO.

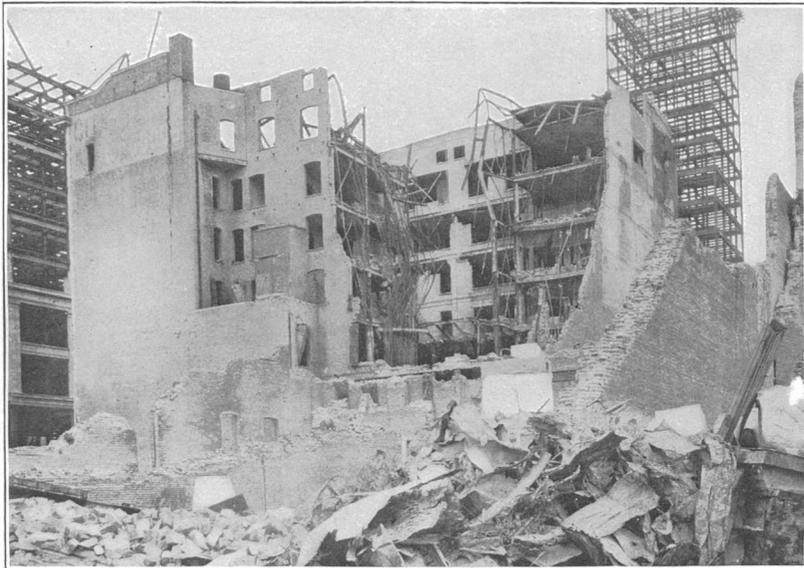
A. COLLAPSE OF BUILDING DUE TO BUCKLING OF COLUMNS, SPRING VALLEY WATER COMPANY'S BUILDING, SAN FRANCISCO.

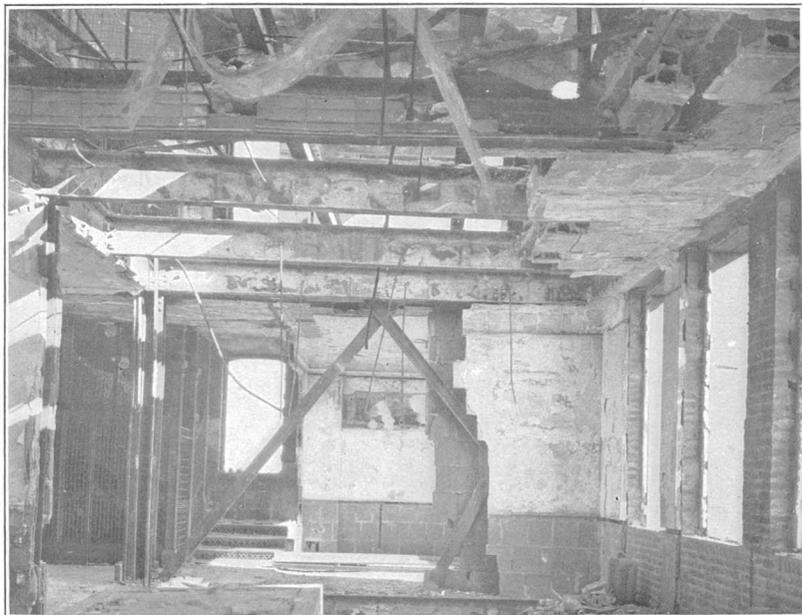
B. FAILURE OF TERRA-COTTA TILE COVERING IN FIRE, UNION TRUST COMPANY'S BUILDING, SAN FRANCISCO.

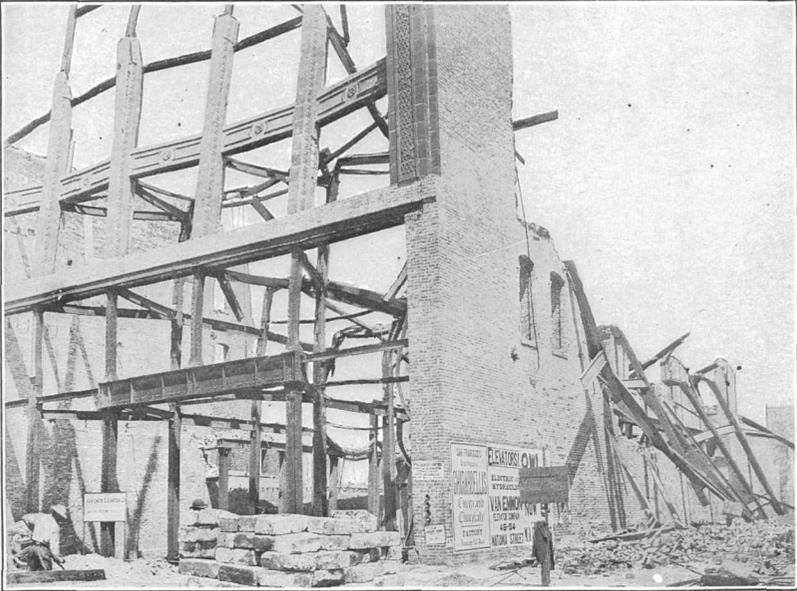
.A. AN UNFINISHED STEEL SKELETON, WITH NONFIREPROOFED STEEL WORK.

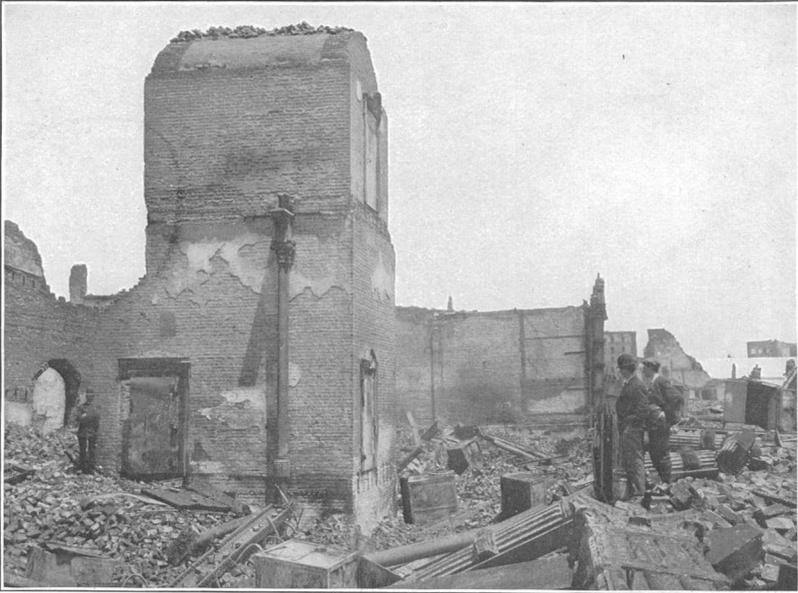
A. ENDURANCE OF BRICK VAULT.

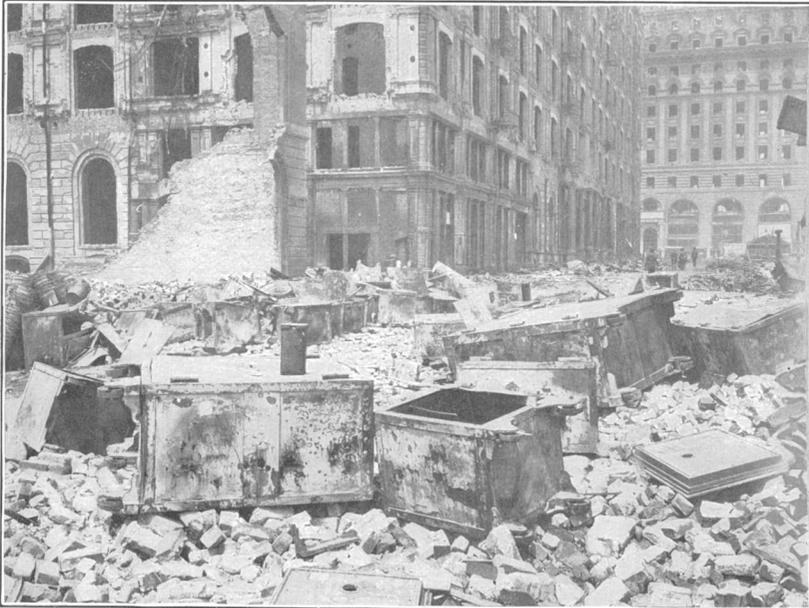
B. ABSOLUTE FAILURE OF SO-CALLED "FIREPROOF" SAFES.

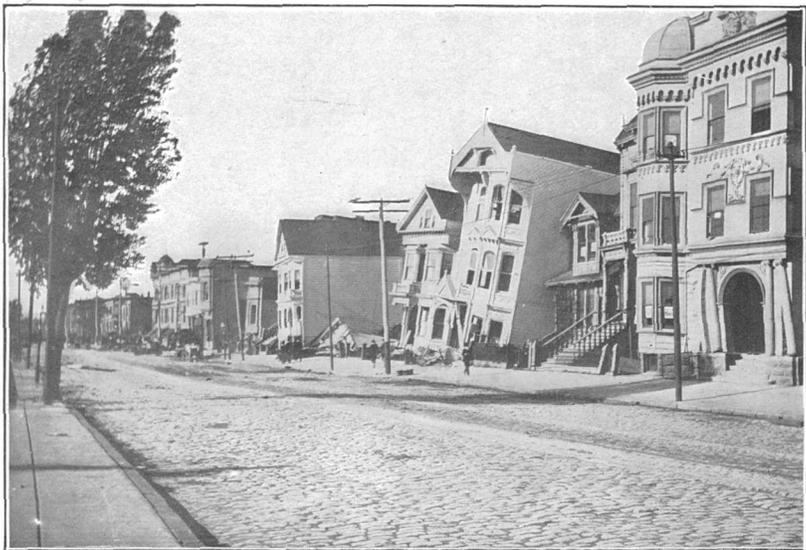
B. GENERAL EARTHQUAKE EFFECT ON FRAME BUILDINGS SITUATED ON ALLUVIAL SOIL, HOWARD STREET, SAN FRANCISCO.
