Stability of the
West Slope of Government Hill
Port Area of Anchorage,
Alaska

GEOLOGICAL SURVEY BULLETIN 1258-D

By DAVID J. VARNES

*An evaluation of the stability of
gravel-capped bluffs of Bootlegger
Cove Clay under static and
seismic conditions*

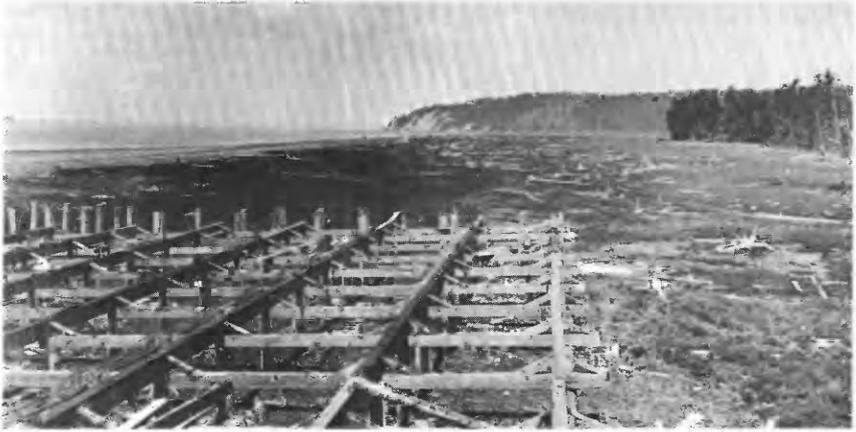
FIGURE 4.—Coal-bunker site as seen from marine ways, Anchorage, Alaska, July 1, 1917. Toe of flow slide is in the woods (on the right). Photograph by Alaskan Engineering Commission.

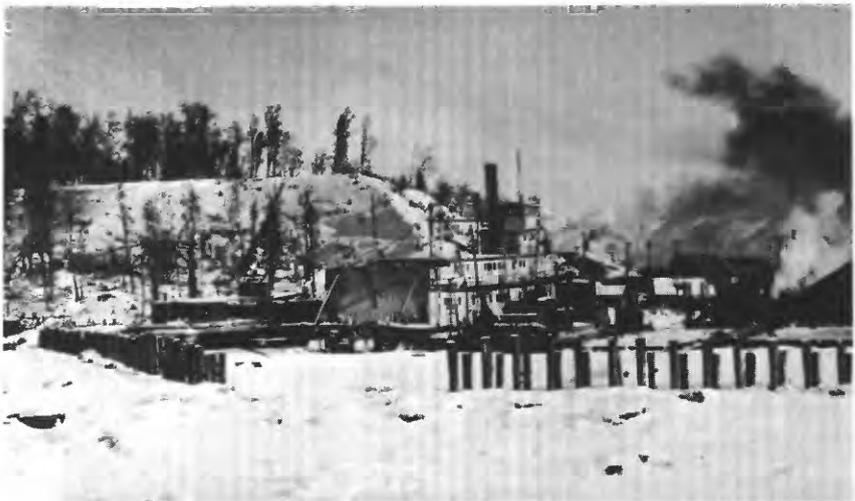
FIGURE 5.—Ships ways, Anchorage, Alaska. Nose at southwest end of Government Hill is visible (on the left) with landslide deposits at the toe of the slope. Photograph by Alaskan Engineering Commission, March 1, 1917.

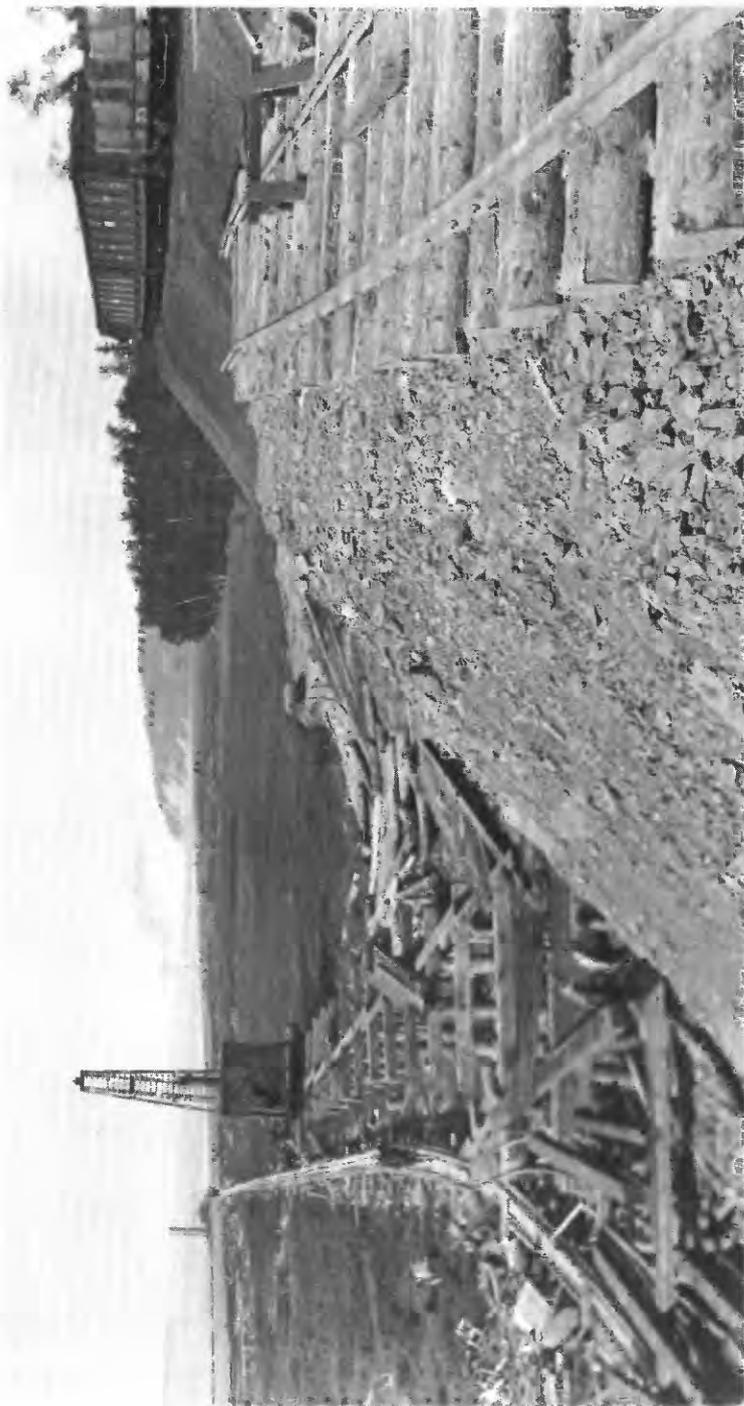
FIGURE 7.—Coal-dock site, Anchorage, Alaska, June 27, 1918. Note fallen trees at toe of flow slide in the middle distance at right. Railway cars are on the coal-storage bunker. Photograph by Alaskan Engineering Commission.

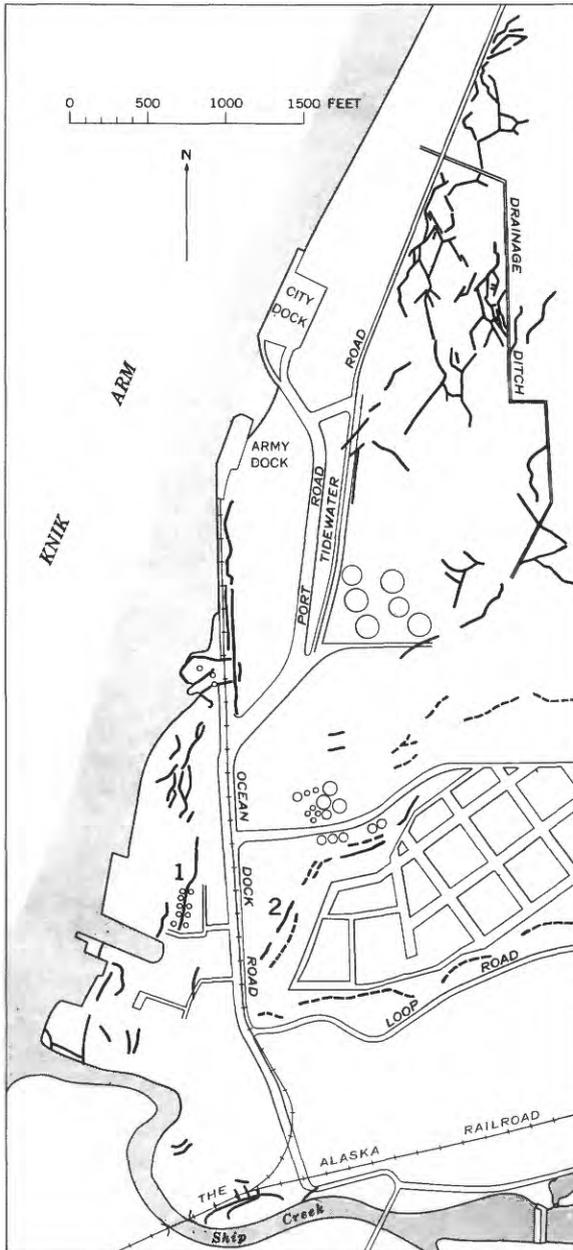
A crack in the fill in the area of the Union Oil Co. asphalt tanks is designated as No. 1 in figure 15. Plate 1 shows a line of hachures that passes under these same tanks. This line, transferred from the 1914 topographic map, indicates the break in slope between grass-covered marsh, to landward, and the bare inclined slippery clay surface, to seaward, that extends to the surface of the water. This boundary is shown (left-center) in figures 4 and 8. The underlying shore topography seems likely to have influenced cracking in the fill during the 1964 earthquake, for most of the cracks west of Ocean Dock Road (fig. 15) are at or below the break in slope of the old shore.

A crack east of the Independent Lumber Co. warehouse at the base of the slope (fig. 15, No. 2; fig. 16, upper right) crossed boring line 1. The crack provided some direct evidence for the potential instability under seismic shaking that is inferred in the analyses to follow. Regrading since the earthquake has obscured the crack.

FIGURE 15.—Ground cracks caused by the March 27, 1964, earthquake (solid lines) and scarps of old landslides (dashed lines), port of Anchorage and vicinity. From Hansen (1965, fig. 14), with additions. Numbered cracks are discussed in text.

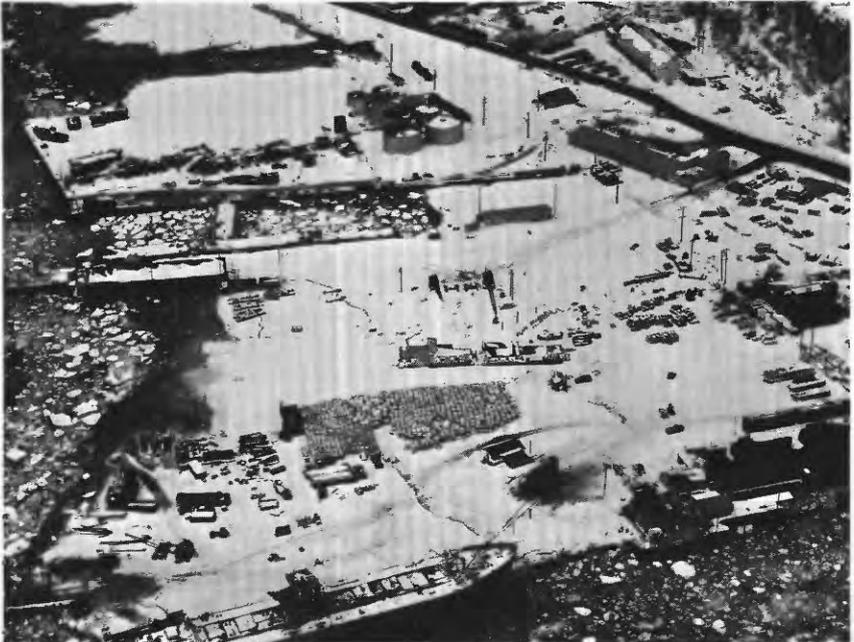
FIGURE 16.—View northeastward over the south end of the port area as seen from above Ship Creek after the earthquake of March 27, 1964. Cracks in the filled areas are mostly parallel with the shoreline as it was before filling. Note cracks at the base of slope, to right side of power poles near warehouse (upper right corner). Boring line 1 passes down the slope and about midway through the warehouse. U.S. Army photograph.

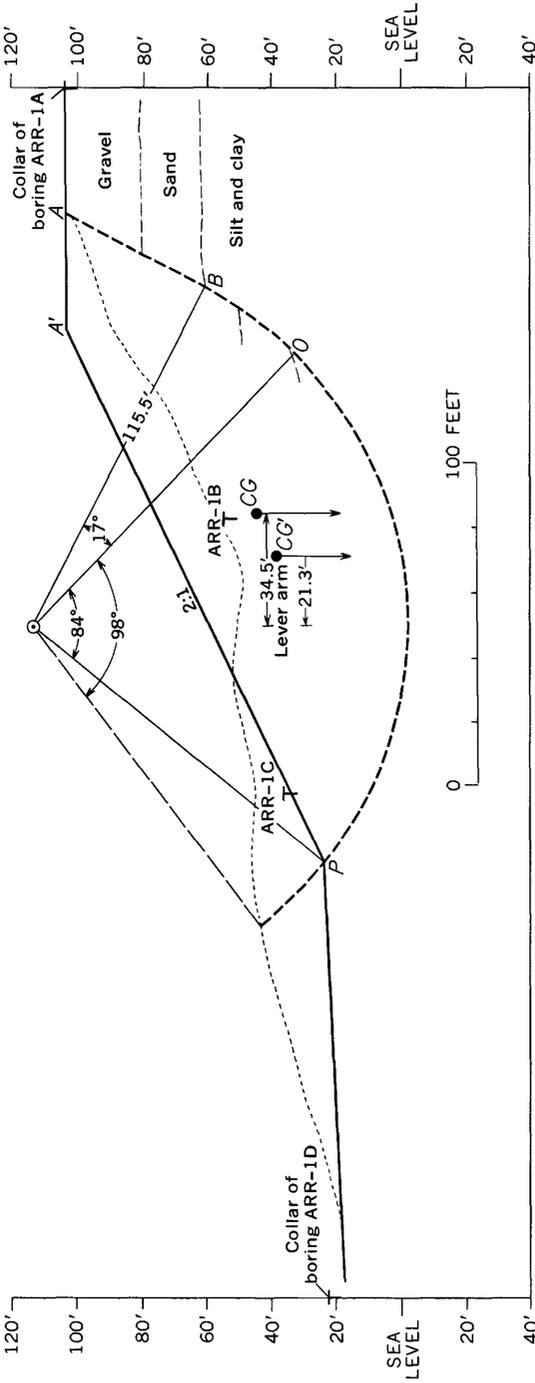
In figure 21 the probable configuration of the pre-1916 slide is shown with an assumed circular arc failure in the Bootlegger Cove Clay. A stability analysis was made to estimate cohesion of the clay, independent of laboratory test results. Also, if it is assumed that the ground surface defined by the 1916(?) contours, and shown by the dotted line, represents the general shape of the slide at cessation of movement ($S.F.=1$), then a measure of the loss of cohesion upon sliding may be estimated, assuming that the angle of internal shearing resistance, ϕ , remains equal to zero. The original face of the bluff is shown as extending from point A' , whose position is determined by the balancing procedure outlined in figure 22, downward to P at a

FIGURE 21.—Probable configuration of pre-1916 slide in section along boring line 1. Stability analysis was made to estimate the original cohesion and the amount that cohesive strength decreases upon sliding. Point *A'*, the crest of the slope prior to sliding, was determined by the balancing procedure sketched in figure 22. The assumed original slope is shown by the solid line, and the ground surface after sliding by the dotted line, which is constructed from contours on the Alaskan Engineering Commission's unpublished 1916(?) map.

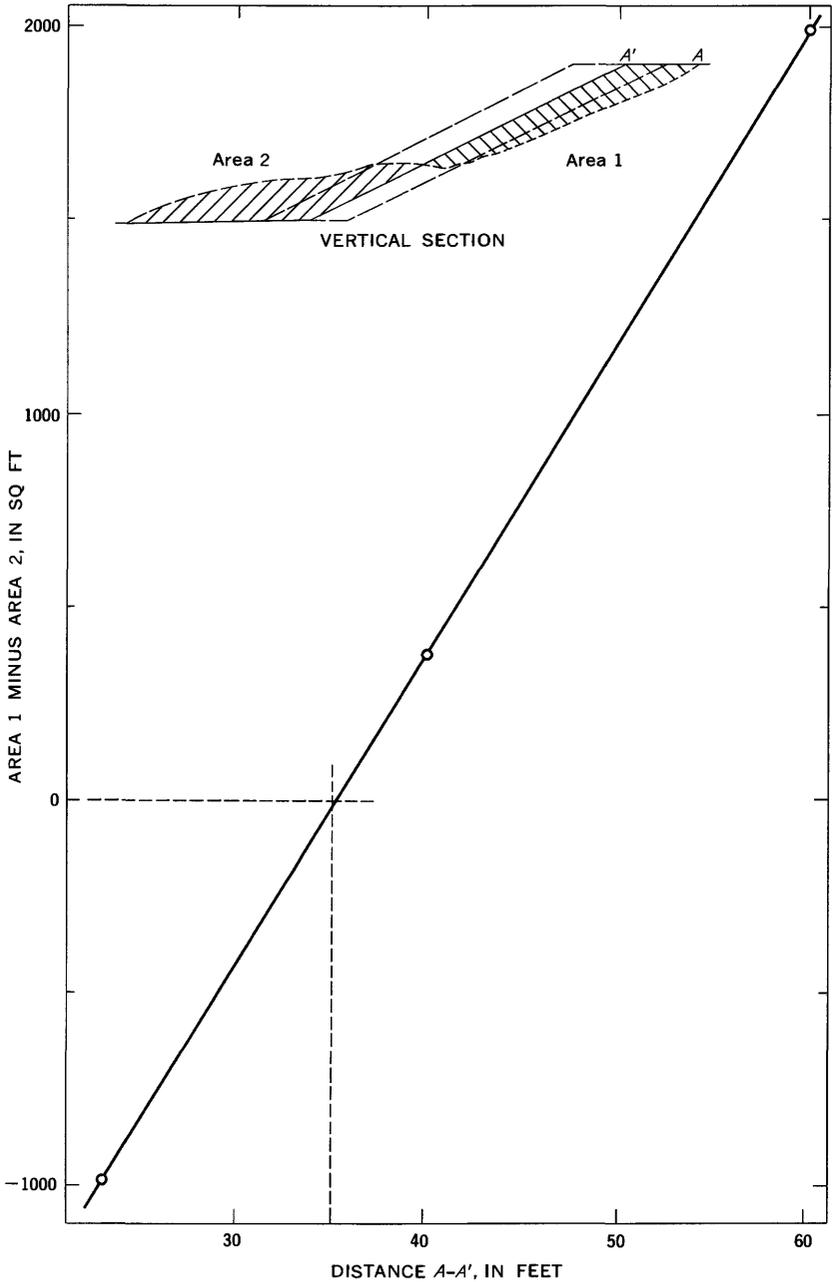
FIGURE 22.—Determination of position of former crest of slope, A' , boring line 1. Various initial positions of the slope are sketched. The one chosen achieves a balance of cross-sectional area between (1) the material that was removed from beneath the original ground surface, at the head of the slide, and (2) the material that came to rest above the original ground surface, in the lower part of the slide. Balance is obtained at 35 feet of retreat of crest.

slope of 2:1. A 2:1 slope is somewhat gentler than the adjacent undisturbed slope to the north and steeper than the slopes on the nose of Government Hill to the south. Unit weight of all materials was assumed to be 125 pounds per cubic foot. Frictional force acting along AB in sand and gravel was estimated at 38.4 kips (kilo-pounds). The unit cohesion along arc BO was assumed to be 1.5 times that of the clay lower in the section along arc OP . Analysis was by static equilibrium of moments, using the center of gravity before and after sliding, as determined by suspending templates of the slide mass, and using before and after weights of 1,251 and 1,107 kips. The position of the sliding surface was estimated. Under the conditions shown and prior to sliding, cohesion of 1,520 psf (pounds per square foot) would have been necessary to maintain a safety factor of 1.0; after sliding, cohesion of 720 psf would suffice to maintain a safety factor of 1.0. This suggests that cohesive shear strength may be decreased by sliding to approximately one-half its original value.

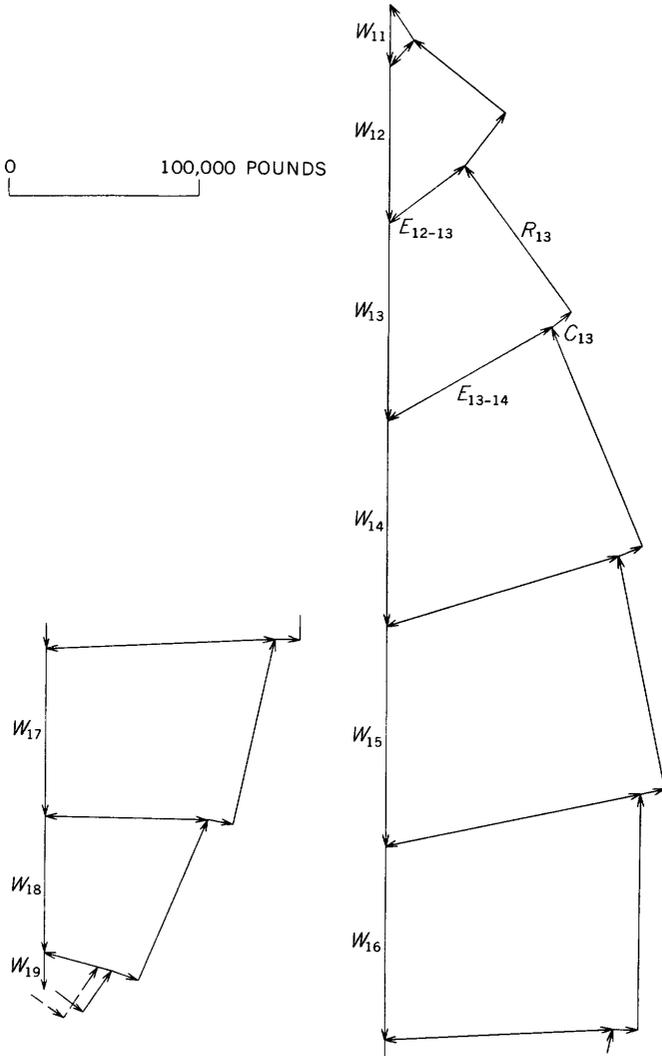
The two methods agree in indicating that failure along arc $ABCJ$ under static conditions is unlikely unless the toe of the slope is removed. If the ground was removed to the level of GH (base of warehouse), the stability along arc $ABCJ$ (through the removal of wedge $JNHI$) would be reduced markedly.

FIGURE 23.—Force-polygon stability analysis of potential failure along circular arc $ABCJ$, line 1, under static conditions, wedge $JNHI$ in place. (See pl. 3.) Assumption that safety factor equals 1.4 (dashed lines, last polygon) leads to excess resistance; assumption that safety factor equals 1.5 (solid lines) leads to deficiency. True safety factor is about 1.44.

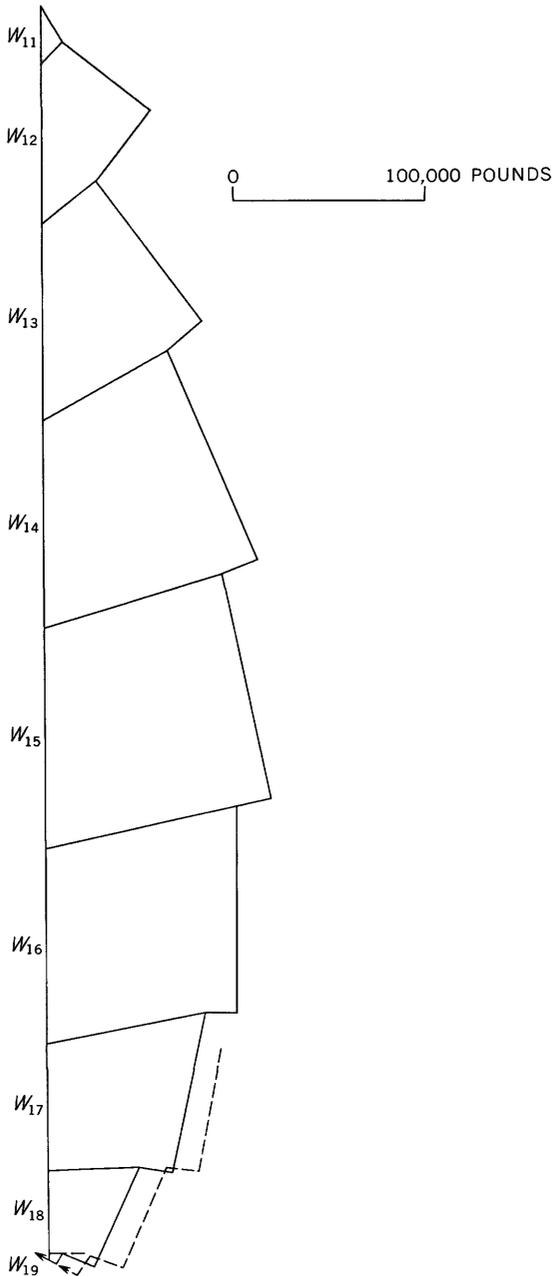
FIGURE 24.—Force-polygon stability analysis of potential failure along circular arc $ABCN$, line 1, under static conditions, wedge $JNHI$ removed. (See pl. 3.) Assumption that safety factor equals 1.1 (solid lines) leads to excess resistance of 5,600 pounds; assumption that safety factor equals 1.2 (dashed lines in last polygons) leads to deficiency of 6,000 pounds. True safety factor is about 1.15.

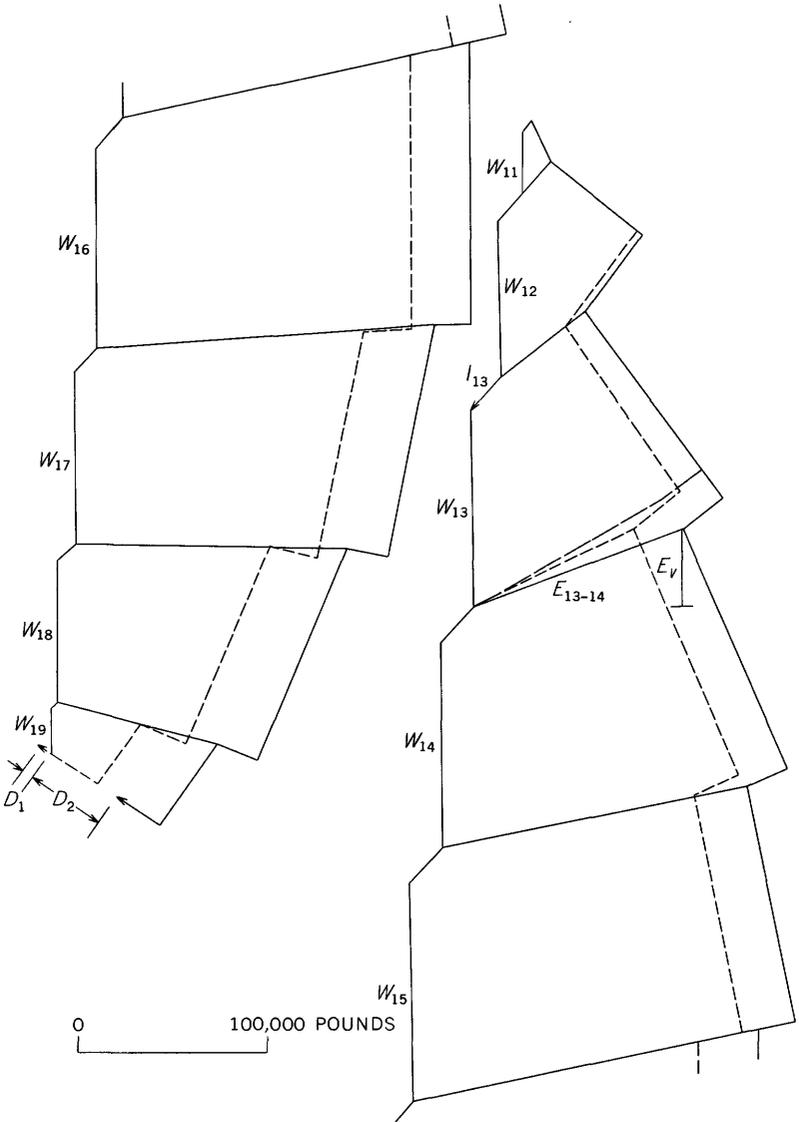
According to the stability computations that follow, failure along circular arc $ABCJ$ under seismic conditions seems to be less probable than failure along an almost horizontal surface. Nevertheless, figure 25 shows that the mass above circular arc $ABCJ$ has a safety factor of only 0.83 with respect to available cohesion, if combined seismic coefficients of 0.15 horizontal and 0.15 vertical are used in stability computations. If the available cohesion were completely used, an estimated seismic coefficient on the order of 0.06–0.065 would reduce the safety factor to a seismic value of 1.0 from its static value of 1.44.

FIGURE 25.—Force-polygon stability analysis of potential failure along circular arc $ABCJ$, line 1, under seismic coefficients of 0.15 horizontal and 0.15 vertical. Inertial forces are shown by force vectors, such as I_{13} . Assumption that safety factor equals 0.8 (short dashes) leads to excess resistance, D_1 , of 7,000 pounds. Assumption that safety factor equals 1.0 (solid lines) leads to deficiency, D_2 , of 41,000 pounds. True safety factor is about 0.83 with respect to available cohesion. Direction of action of E_{13-14} is lowered from long dashed line so that vertical force component, E_v , on face 13-14, does not exceed available cohesion.

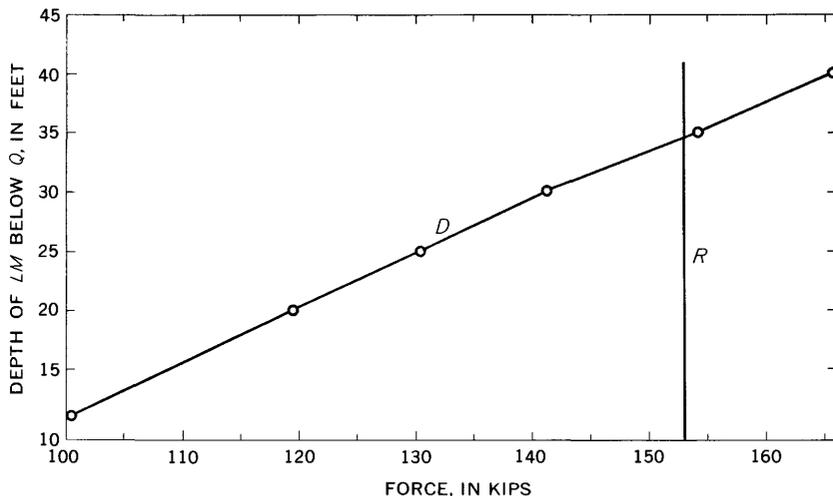
1. Surface of potential failure will be taken to be at the shallowest location of LM at which active pressure on MA (E_a), requiring mobilization of block $MSRA$, exceeds passive resistance on LQ (E_p) plus cohesion on LM . (See fig. 26; app. A.)
2. Driving component of weight due to seaward dip of bedding of about 1° is neglected.

FIGURE 26.—Determination of depth of potential failure surface LM , boring line 1, for static conditions. Depth must be such that driving force ($E_a - E_p$) shown by D line exceeds resistance offered by cohesion along LM shown by R line.

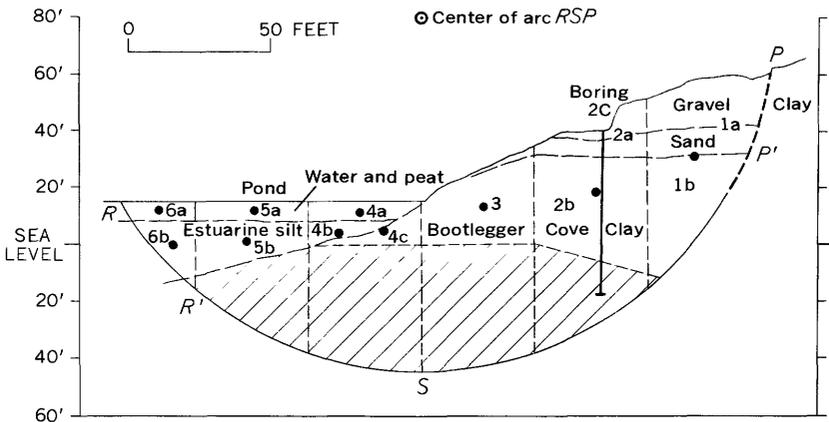
FIGURE 27.—Stability analysis by moments about center of arc RSP , boring line 2, static conditions; cross section of slide. The angle of shearing resistance, ϕ , is assumed to equal zero; centers of gravity of segments (solid dots) are estimated visually, and the moments of ruled area are equal and are neglected.
