Slope Movements in the Warren-Allegheny Reservoir Area, Northwestern Pennsylvania

U.S. GEOLOGICAL SURVEY BULLETIN 1650

By JOHN S. POMEROY

Discussion of slope movements along the Allegheny River valley from the area southwest of Warren to the Allegheny Reservoir at the New York State line

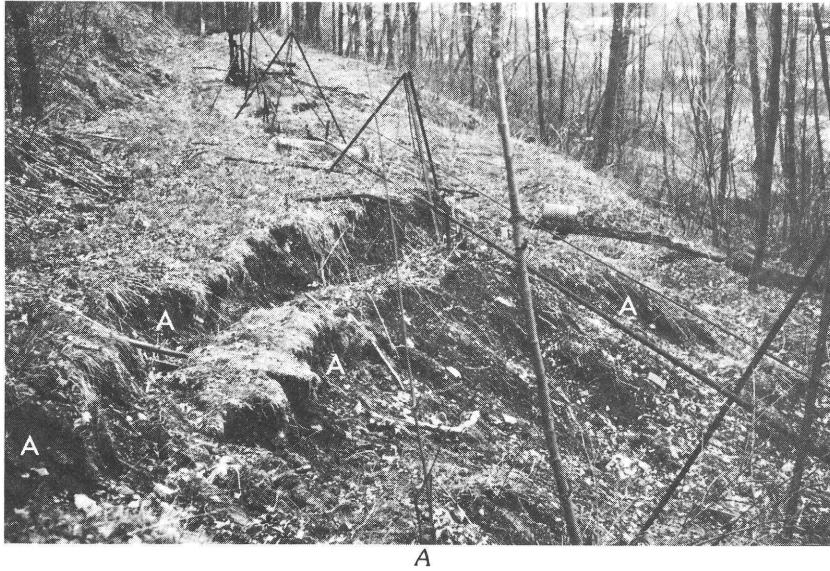
Locality G. (pl. 1)—Many slope movements occur both above and below the road opposite Warren along the south side of the Allegheny River. An extensive 200-m-wide regraded area between the road and the railroad tracks next to the river showed renewed slumping in addition to surface cracks along the road surface. Shallow slumping, where an oil pump is located on the main scarp 20 to 25 m above the road, resulted in the bowing of horizontal pipes installed on the surface across the slope (fig. 4A). Crown cracks and smaller discontinuous scarps occur above the main scarp. Bluish-gray clay, which serves as the sliding plane, forms an impermeable surface in the head area where seeps are common. At least 12 m of clayey silt and silty clay containing rock fragments (colluvium) underlie the land surface (Pennsylvania Department of Transportation, unpub. data), and there is no indication of bedrock.

◀ **Figure 4.** Slope movements in the Warren area. A, Slope opposite Warren along south side of Allegheny River. Scarps (A) and movement in head area have affected oil pipeline installation (locality G, pl. 1). B, Recently renovated road with renewed displacement at A and cracks in the foreground along north side of Allegheny River east of Warren (locality H₁, pl. 1). Reconstructed slope is below road. Accelerated creep occurs above road, indicated by leaning trees. C, Slump, predominantly with head scarp (A) above cut bench 2.5 km east of Warren (locality H₂, pl. 1). D, Slow slope movement has necessitated costly road reconstruction on Pennsylvania Rte. 59 east of Warren (locality I, pl. 1).

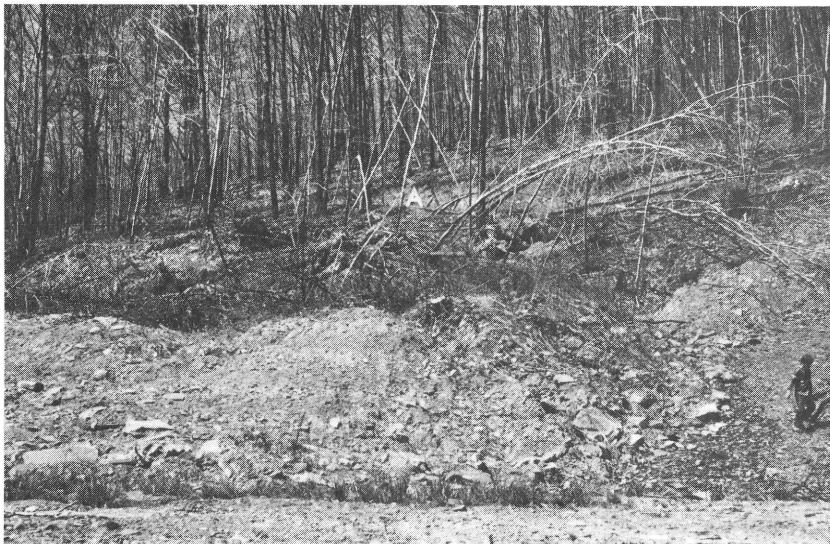
C

A 30-m-wide zone of recent shallow rotational and translational (planar) movement (H_2) (fig. 4C) along a 22° (44 percent) slope was noted in 1978 above a man-made bench about 1.5 km east of locality H_1 . Blue-gray clay, less than 1 m below the surface in front of the main scarp, probably served as the shear plane. Excavating for house sites along the lower part of the slope triggered the slope movement. In 1981, retrogressive movement

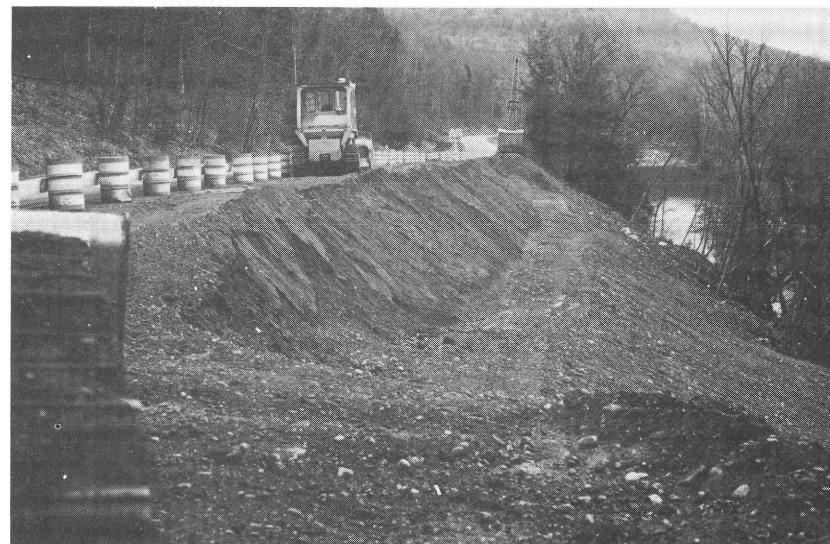
D

Locality I. (pl. 1)—Pennsylvania Rte. 59 has been subject to accelerated creep and sliding in recent years. Movement has been particularly obvious along a 1-km-long section of the road where it has resulted in riverside cottages being destroyed. The larger of the two major problem areas is 60 m wide (fig. 4D). A naturally caused debris avalanche above the road shows evidence of flowage but does not extend to the highway. About 11 m of brown to gray silty clay containing rock fragments overlies gray siltstone bedrock at this westernmost location. Nearly 14 m of colluvium overlies a 1.5-m-thick gray claystone at the larger slope movement to the east (Pennsylvania Department Of Transportation, unpub. data). The slippage surface was within the colluvium (R.T. Fox, oral commun., 1982). The extremely hummocky terrain above the road eastward to Kinzua Dam attests to the instability of the colluvium.

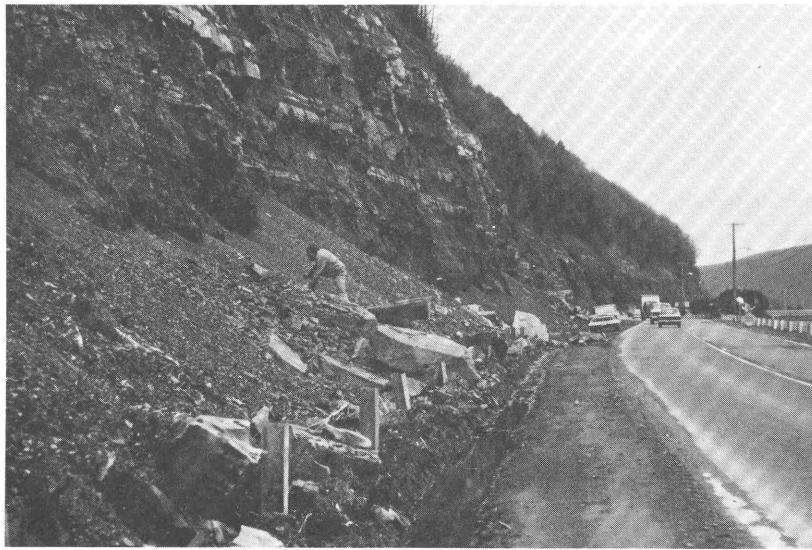
Locality R. (pl. 1)—Nowhere in the study area does a greater rockfall hazard exist than along Pennsylvania Rte. 59 in the Kinzua Dam area. The most dangerous rockfall zone is behind Kinzua Dam (fig. 5A), but a nearly continuous 5-km-long hazardous zone lies to the northeast. During the reservoir construction, Pennsylvania Rte. 59 had to be raised because of the pool elevation, and new highway cuts were made. Weathering and erosion in a sequence of closely spaced open joints in competent sandstones and siltstones and incompetent shales have produced a serious problem along the steep rock cut. Blocks of rock, weakened by undercutting of the softer lithologies and by joint widening, have fallen onto the road. Because of its northeast to northwest orientation, the cut retains moisture for long periods.

Figure 5. Slope movements in the Allegheny Reservoir area. A, Rockfall area above Pennsylvania Rte. 59 at Kinzua Dam (locality R, pl. 1). Note alternation of competent and incompetent lithologies and influence of jointing. B, Small planar (less than 0.3-m-thick) earthflow with head scarp (A) and toe (B) at locality S₁, plate 1. Pool elevation (Allegheny Reservoir) at time of investigation was 2 m below normal pool elevation. C, Hummocky terrain along concave slope (locality S₂, pl. 1) above reservoir. Ground cracking and scarps are numerous. D, Toe of recent slide in reservoir (locality T, pl. 1). Reservoir level was slightly more than 1 m above normal pool elevation. A is part of head scarp. E, Recent planar (translational) movement near Tracy Run (locality V, pl. 1). A is head scarp. Allegheny Reservoir in background. Blue-gray clay in head area.

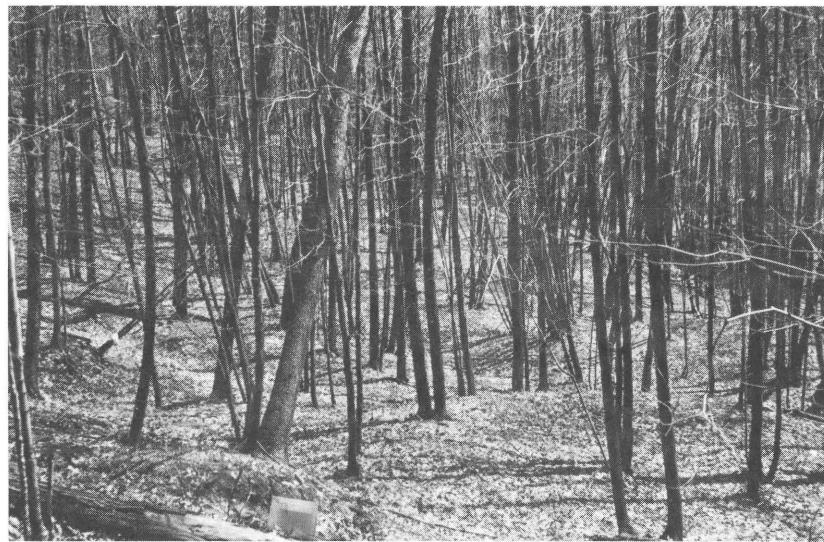
C

Locality S₂. (pl. 1)—A 450-m-wide laterally concave slope to the south, which appears to be an old slope-movement site, contains many recent planar slides and very shallow seated earth slumps (fig. 5C). A thin clay horizon was found within 0.5 m of the surface in the head area of one slope movement. Some main scarps are 60 m wide and as much as 1 m high. The slope surface is extremely hummocky and averages 20° (36 percent) (fig. 5C). The highest recent head scarp is at 1,470 feet altitude or about 43 m above the pool elevation. The bench surface in front of the highest scarp shows a 4° reverse dip, which implies rotational slippage.

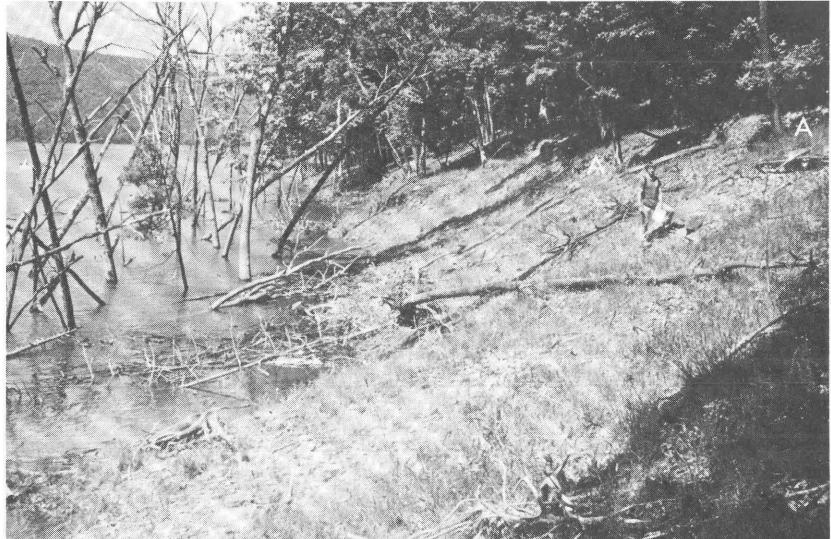
D

Locality T. (pl. 1)—Dead trees on hummocky ground immersed in the reservoir indicate slope movement (fig. 5D) along the north side of Sugar Bay. The main scarp is 4.5 to 6.0 m above the water, and the width of the movement is 134 m along a 21° (39 percent) slope. The fact that hummocky terrain is evident as high as 42 m

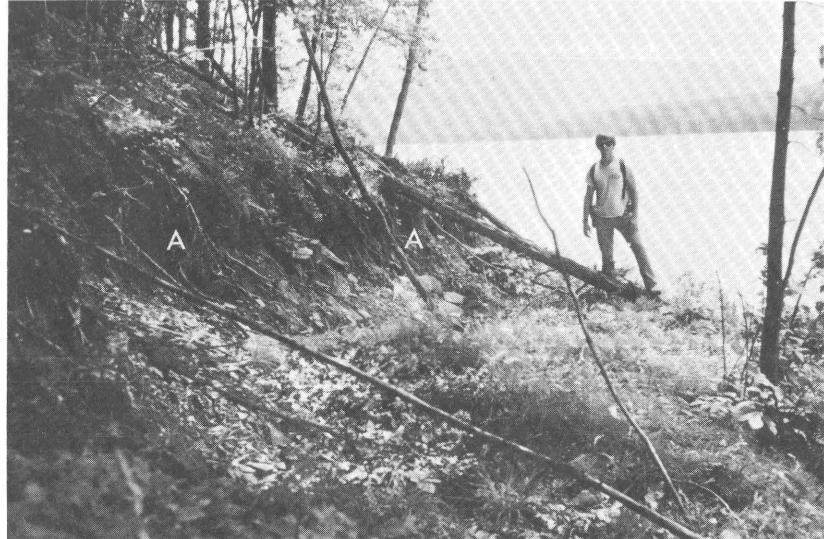
E

Locality V. (pl. 1)—Slope movements include an 18-m-wide planar (translational) movement that shows a 1.5-m-high main scarp 2.5 m above the reservoir (fig. 5E), an estimated 120-m-wide slump-earthflow 4.5 m above the shoreline, and a very fresh bell- (or pear-) shaped translational or planar movement that measures 18 m across its midsection. A light bluish-gray clay slippage plane occurs 0.3–0.6 m below the surface in the head area of the planar movement. Ponding in the head area, which is 7.0 m above the reservoir, is caused by the impermeable clay barrier. The slope steepens significantly at about 12 m above the head of the movement.

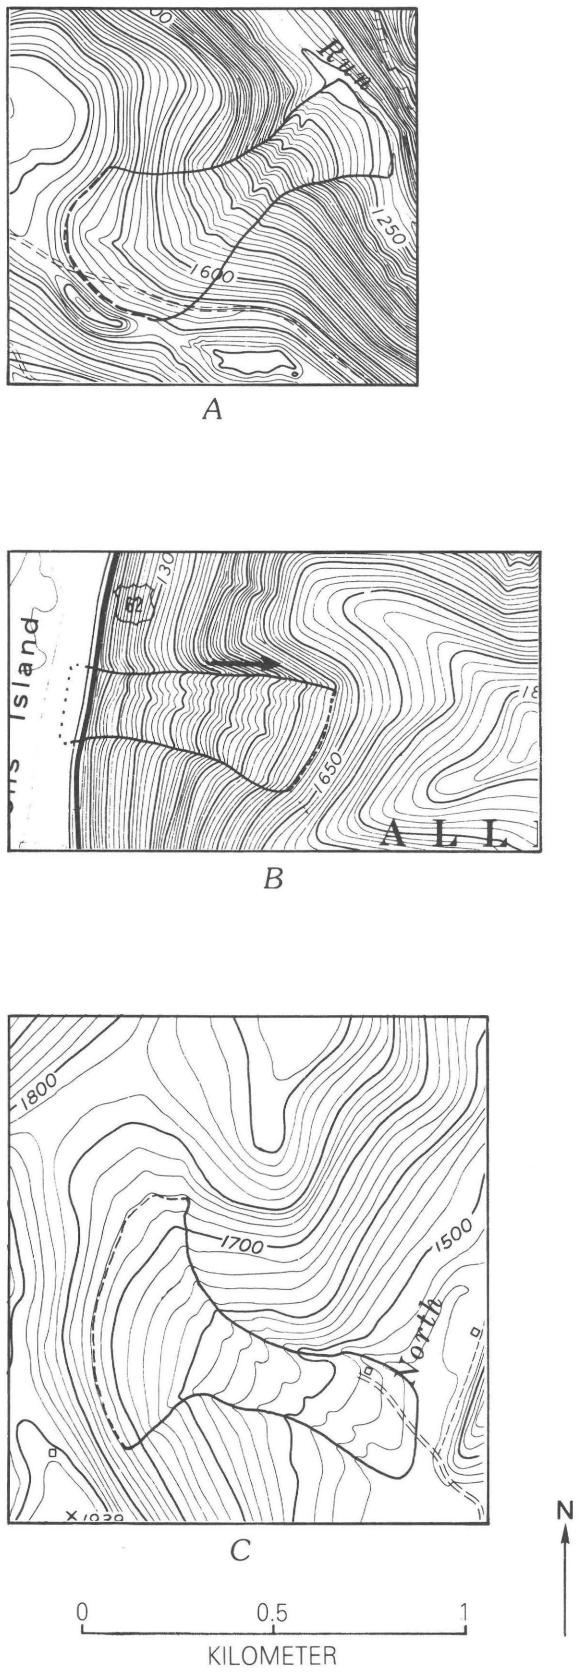
► **Figure 6.** Selected prehistoric slope movements (includes head area and deposit. Localities are shown in plate 1). Note concavity in upper part, convexity (protuberance) in lower part, and a more moderate slope in contrast to adjacent areas. *A*, Slope above Thompson Run, 10 km south of Youngsville. *B*, Slope above Allegheny River 7 km southeast of Youngsville. Arrow indicates location of figure 7*A*. *C*, Slope above North Fork, Sixmile Run, 8 km southeast of Warren.

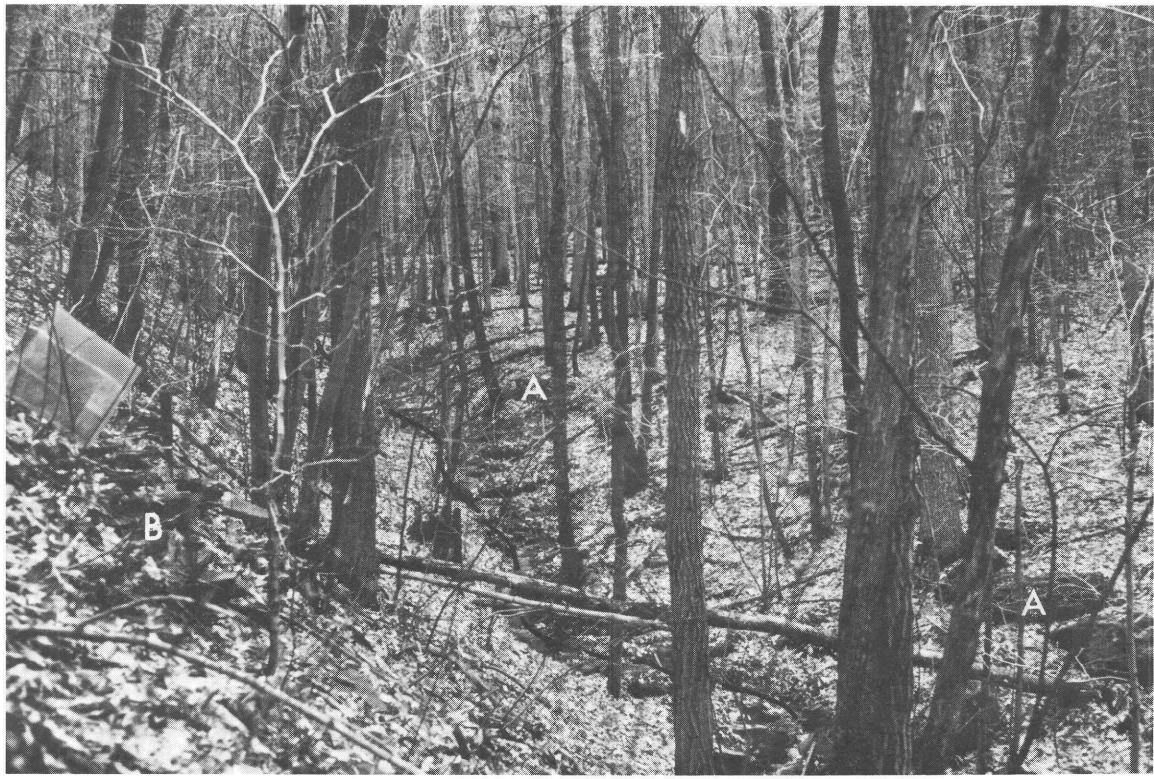
► **Figure 7.** Lateral margins of relict debris flows. *A*, Lateral margin of ancient debris flow 8 km southeast of Youngsville (fig. 1). Bouldery flow of Pottsville Group conglomerate (A) separated by drainage from siltstone outcrop (Devonian) at B. See figure 6*B*. *B*, Lateral margin of debris flow 10 km southeast of Youngsville (fig. 1). Hammer at A for scale. Note conglomeratic sandstone boulders (B) on flow surface and adjacent boulder-free slope on left (C). Dashed line is approximate boundary of flow.
