Slope Stability in the Marietta Area,
Washington County,
Southeastern Ohio

U.S. GEOLOGICAL SURVEY BULLETIN 1695

By JOHN S. POMEROY

An investigation of the distribution of slope movements
in a part of southeastern Ohio—a discussion of
geologic and other factors involved in their genesis

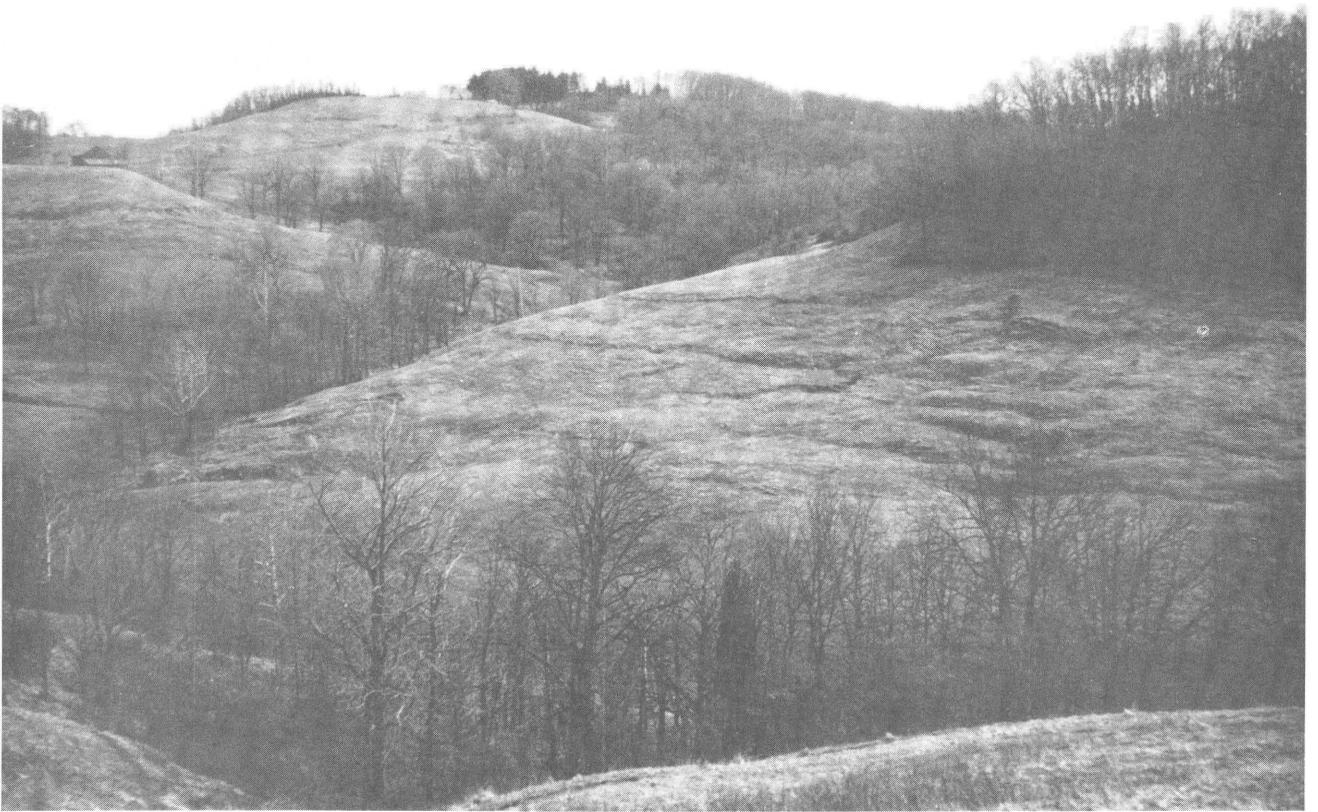
Frontispiece: Earth flows and creep along the northeast-facing slope 2 kilometers northwest of Stanleyville.

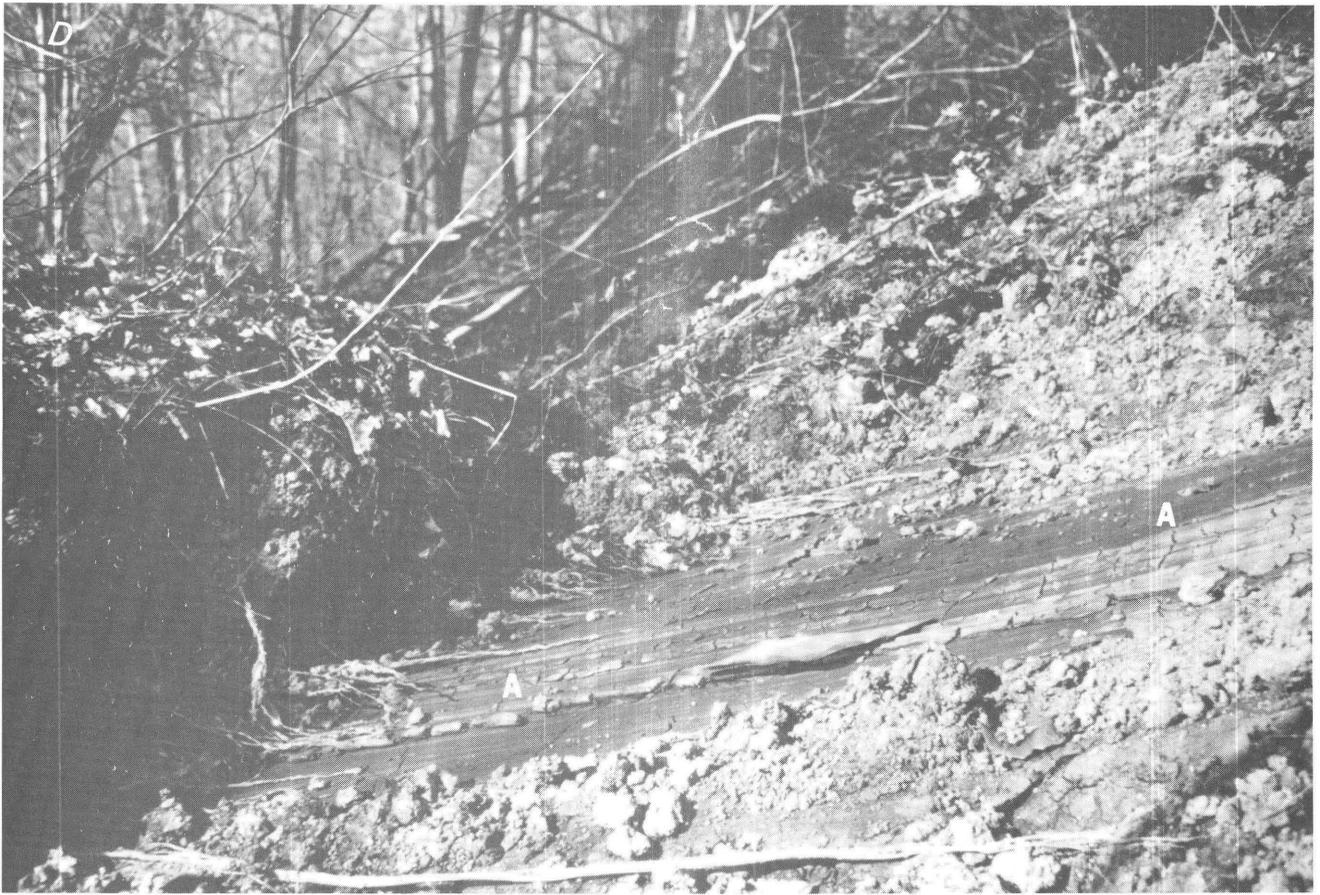
Figure 2D. Slickensided basal shear surface (A) of a fresh earth flow.

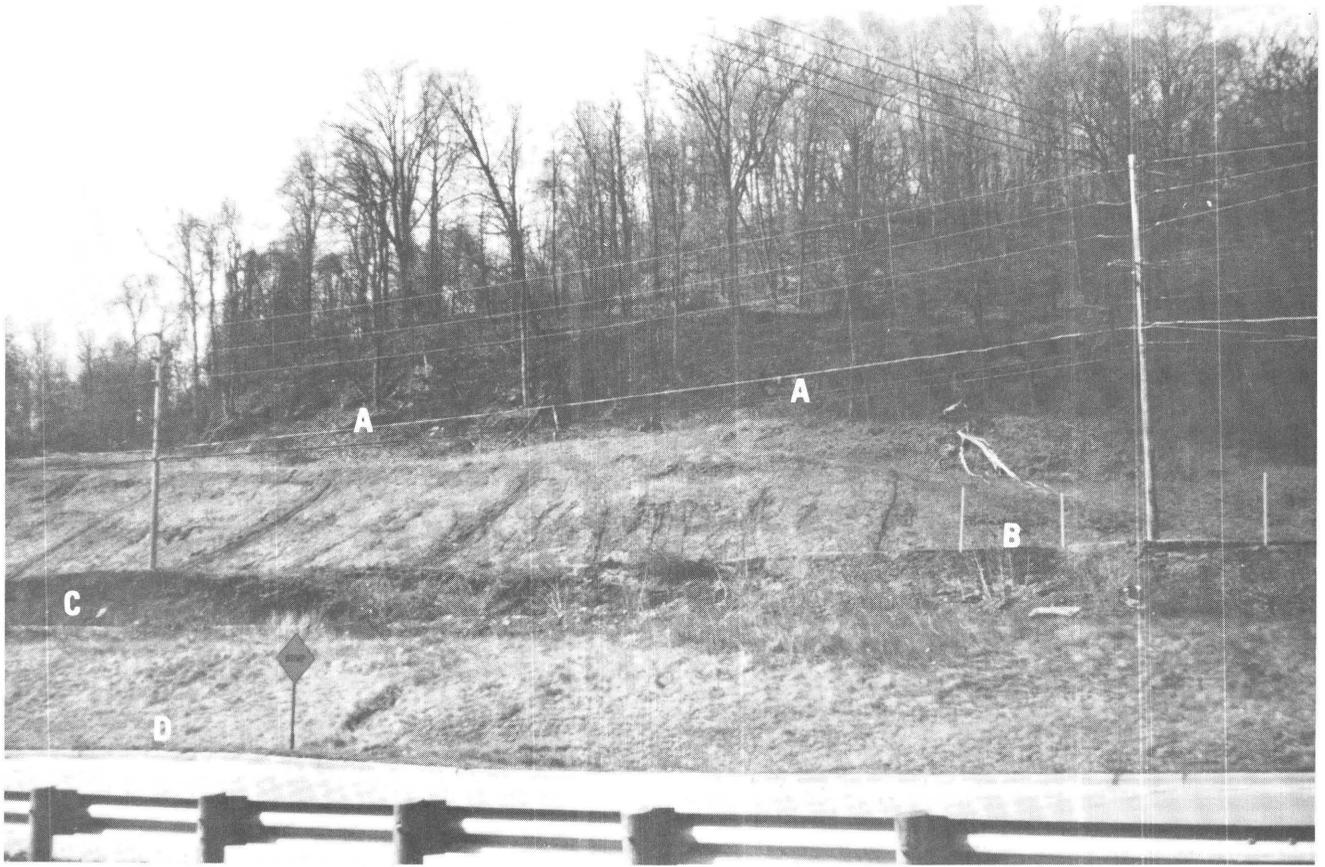
A major failure above Leland and Gilman Streets (locality J; fig. 5) damaged three houses, which were later razed. Most of the colluvial material has been removed from an area where movement had accelerated in March 1976. Costs arising from repurchase of the condemned properties and remedial work exceeded \$350,000. The movement apparently developed after Gilman Street was widened (fig. 5). Slow movement (mostly creep) is continuing in the lower part of the area and still is affecting sections of Leland and Gilman Streets, as well as the railroad track ballast. The lower slope has a subtle hummocky surface of low relief. The problem is compounded by a movement of water-saturated fill from under the road into the Muskingham River, resulting in some subsidence of Gilman Street (Robert Badger, *Marietta Times*, September 20, 1980). Efforts to intercept the drainage continued in 1984.

Figure 5. Site of the slope failure above Gilman Street (fig. 4, locality J). Shown are the base of the sandstone ledge (A), Leland Street (B), the railroad track (C), and Gilman Street (note "Bump" sign) (D).

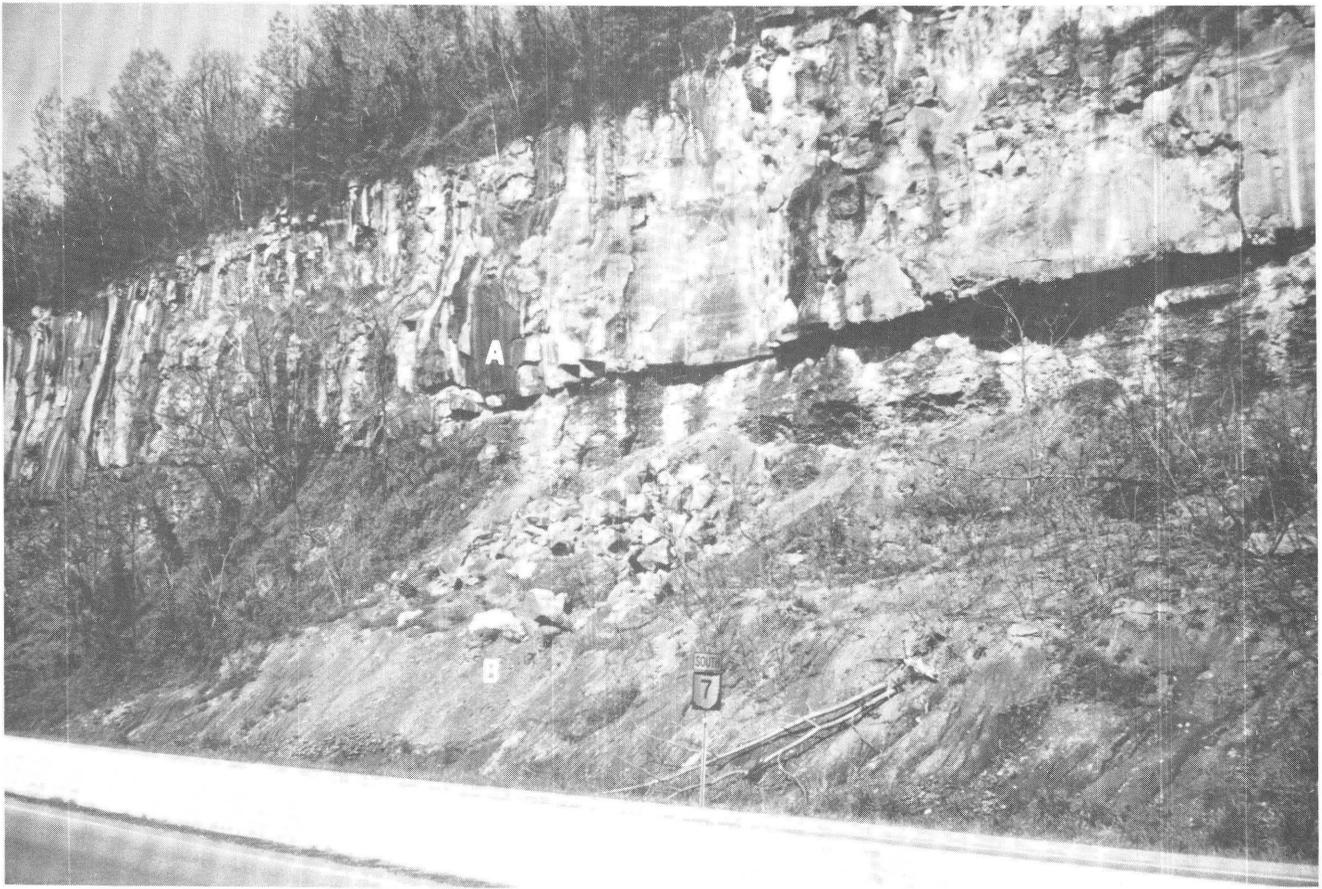
A rockfall hazard lies above Ohio 7 to the southwest (locality C). When the highway was constructed in 1940, considerable excavation was necessary to provide adequate width for increased traffic. Two large rockfalls occurred in the 1940's, and another, on January 31, 1950. The latter rockfall is pictured in the Ohio State University Engineering Experiment Station News (Ohio State University, 1950) along a 3.0- to 4.5-m-thick mudstone and minor shale slope overlain by 9.0 to 11.0 m of thick-bedded sandstone (fig. 7). Separation along nearly vertical joints in the sandstone and rapid weathering of the underlying mudstone continues to cause additional rockfalls.

Figure 7. Rockfall area along Ohio 7 (fig. 6, locality C) to the southwest of Marietta. Shown are the lower part of a major sandstone bed (A) and mudstone with some shale (B).

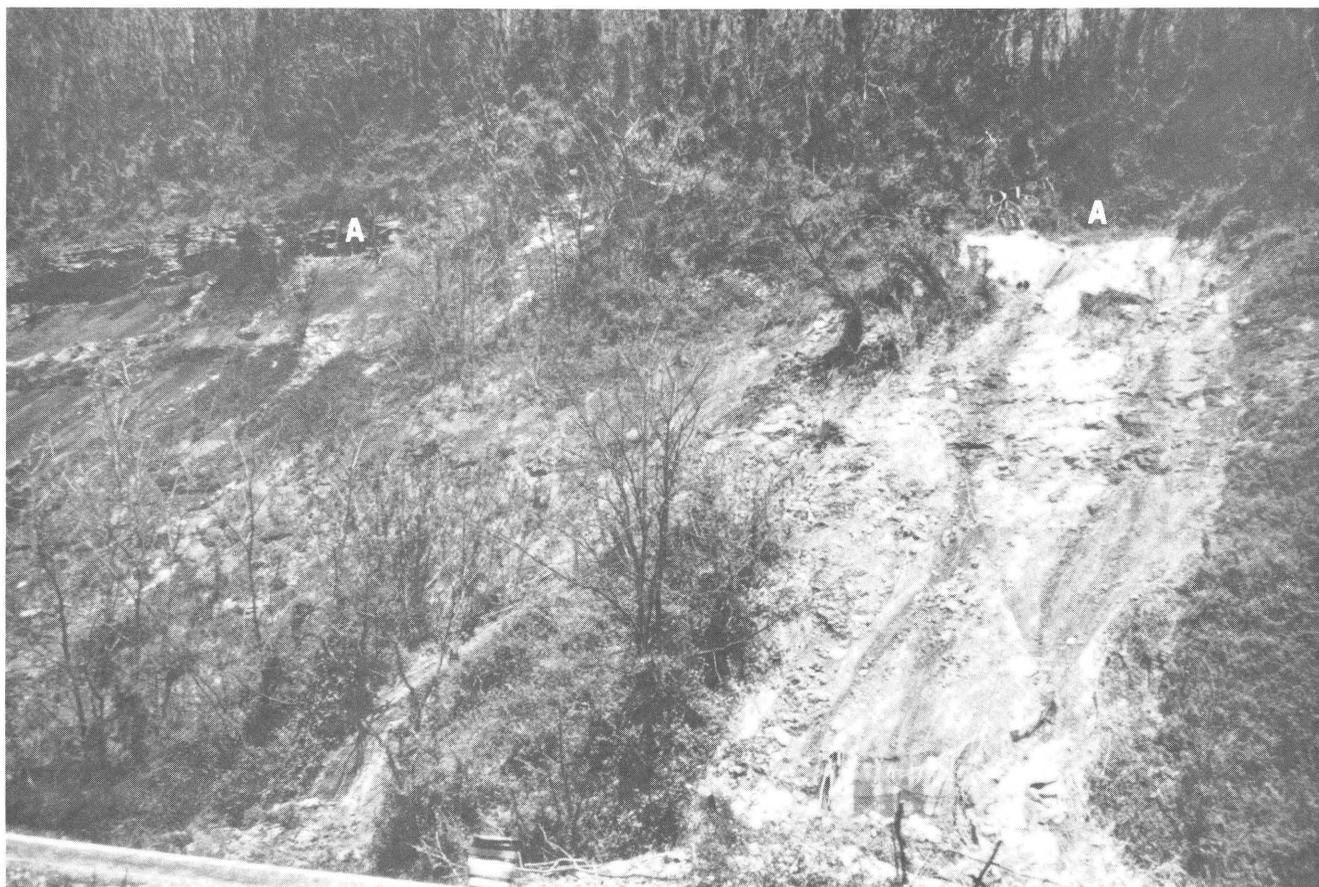
Figure 8. Debris slide along Ohio 550 (fig. 6, locality G) during the early May 1983 wet period. Shown is the seep at the base of the sandstone (A).

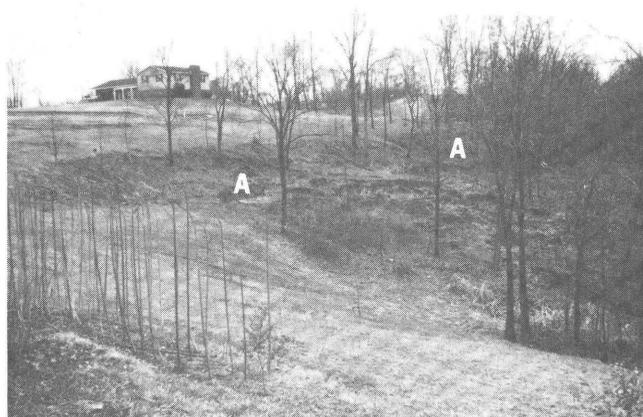
Figure 9. Earth flow 2 km northwest of Moore Junction. Shown are the base of the sandstone ledge (A), seepages common at contact with impermeable mudstone-shale, and an earth flow immediately below contact.

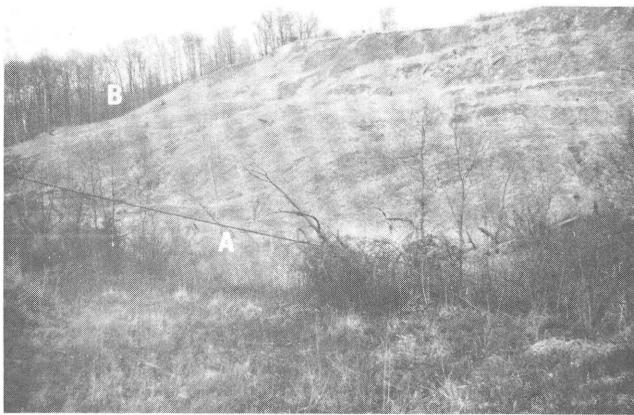
Figure 11. Fill and subjacent slope failure along the western side of Interstate 77 (fig. 10, locality A). Shown are the toe of the 350-m-wide movement (A) and the edge of Interstate 77 (B).

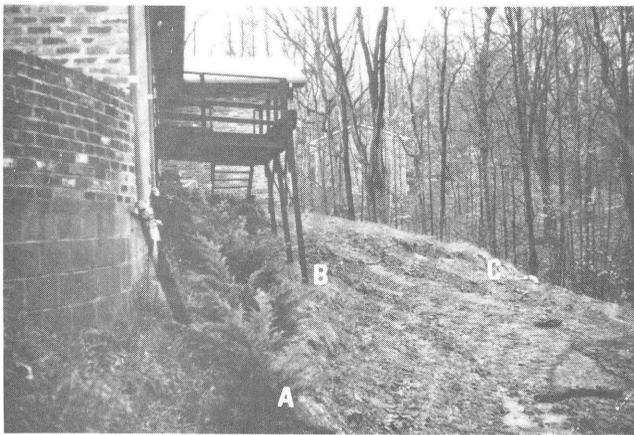
Houses have been built along a natural slope to the east of locality E on the eastern side of Sylvan Way (locality F). The use of fill has been minimal in backyard areas in contrast to the Strecker Lane locality. The head scarp of one earth flow is only 1 m from the foundation of one house. The rear porch sloped downhill in April 1983 (fig. 12). Other earth flows in the immediate vicinity include a 24-m-wide hollowed-out slope with one large beech tree near the base of the movement, a smaller earth flow below the backyard of the house adjacent to that shown in figure 12, and a

Figure 12. Backyard failure in Devola (fig. 10, locality F). Shown are the head scarp (A), the out-of-plumb porch column (B), and the lateral margin of the earth flow (C).

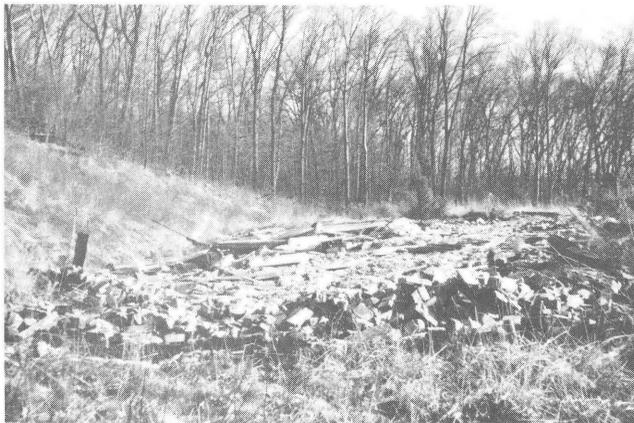
The western side of the forested highland to the east of Ohio 60 shows many slope movements. A 340-m-wide failure (locality G) extending in elevation from as high as 850 ft to as low as 620 ft lies mainly to the south of the ruins

According to information given Marilyn Ortt (Marietta botanist, written commun., 1984), the house was built in 1968. Slippage first occurred during spring 1975. The contractor did extensive renovation, including reinforcement of the rear concrete block wall, in December 1975. Trees and soil were removed from behind the house after recommendations by "authorities." A local real estate salesman took a 1-yr option to buy and moved in at the beginning of 1979 or 1980. No apparent movement had occurred during the interval that had elapsed since the "repair work." During an especially wet spring in 1979 or 1980, the occupant noticed that a drainpipe parallel to the basement wall jutted into a room within the period of 1 d. The house was abandoned after the occupant confirmed his

Figure 13. Ruins of a large house at the northern end of a 340-m-wide slope failure (fig. 10, locality G) to the east of Devola.

suspicious that the house was shifting by checking the floor with a level. The house was dismantled in either 1981 or 1982 after continued movements precluded habitation.

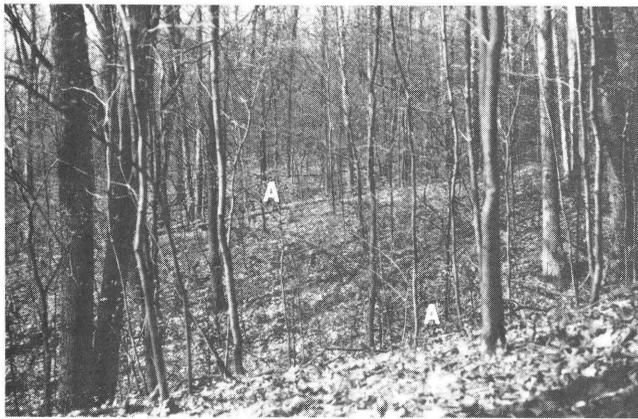
Figure 15. Slope drainage channels prevalent along the southwest-facing slopes. Shown are the drainages (A) along the slope lacking in recent failures.

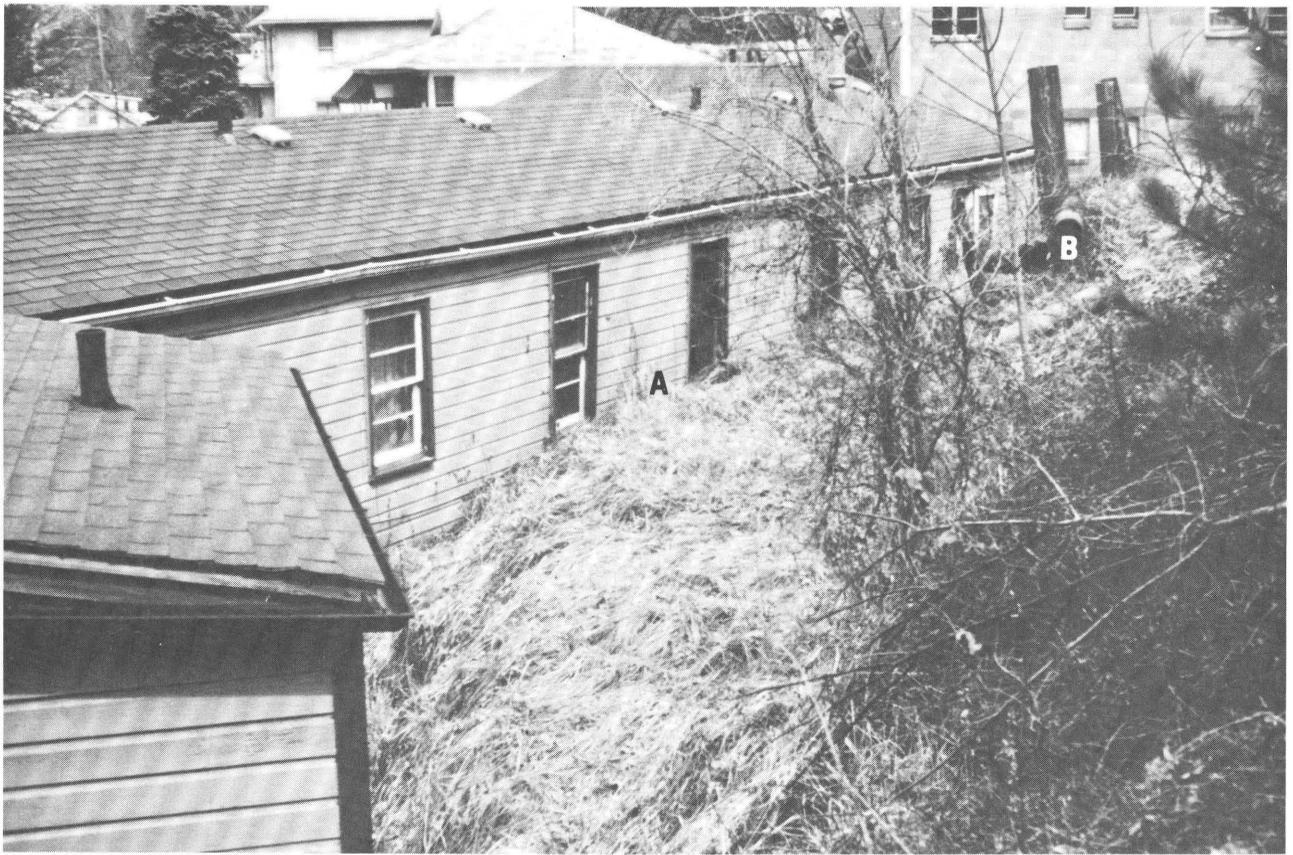
has caused extensive property damage despite remedial measures (fig. 17).

Figure 17. Crib failure behind the motel to the east of Ohio 60 (fig. 16, locality B). Shown is the toe of the earth flow that pushed in an exterior wall (A) and the cribbing that moved downslope and almost touched the structure (B).

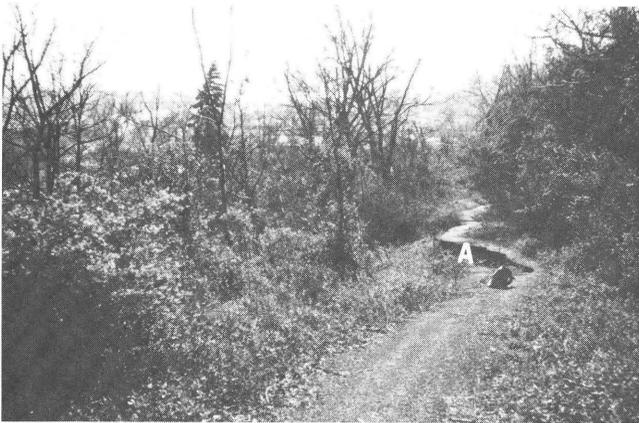
The Walnut Hills Drive slope failure (locality F), probably the best-known slope movement in Marietta, lies below Grandview Avenue and is part of a prehistoric(?) failure that extends to the railroad tracks below Greene Street. The hummocky head area is downslope from a thick-bedded sandstone that underlies Grandview Avenue. Springs at the base of the sandstone contribute to a wet slope. The 350-m-wide, very slow movement has sealed off Walnut Hills Drive, which cuts diagonally across the affected slope. The city officially closed Walnut Hills Drive on August 29, 1972, because of the slow continual damaging earth flow accompanied by some slumping in the head area. The macadam surface of the closed Walnut Hills Drive has been overgrown by vegetation and is cracked locally (fig. 18). The few houses along the Drive, as well as a larger number along the northern side of Greene Street, have been removed. A total of approximately 18 houses has been razed within this large earth flow [approximately 54,000 square meters (m^2)].

Figure 18. Walnut Hills Drive slope movement (fig. 16, locality F). Shown is one of the many scarps in the upper areas of the 350-m-wide movement (A). Macadam surface is a vestige of Walnut Hills Drive.

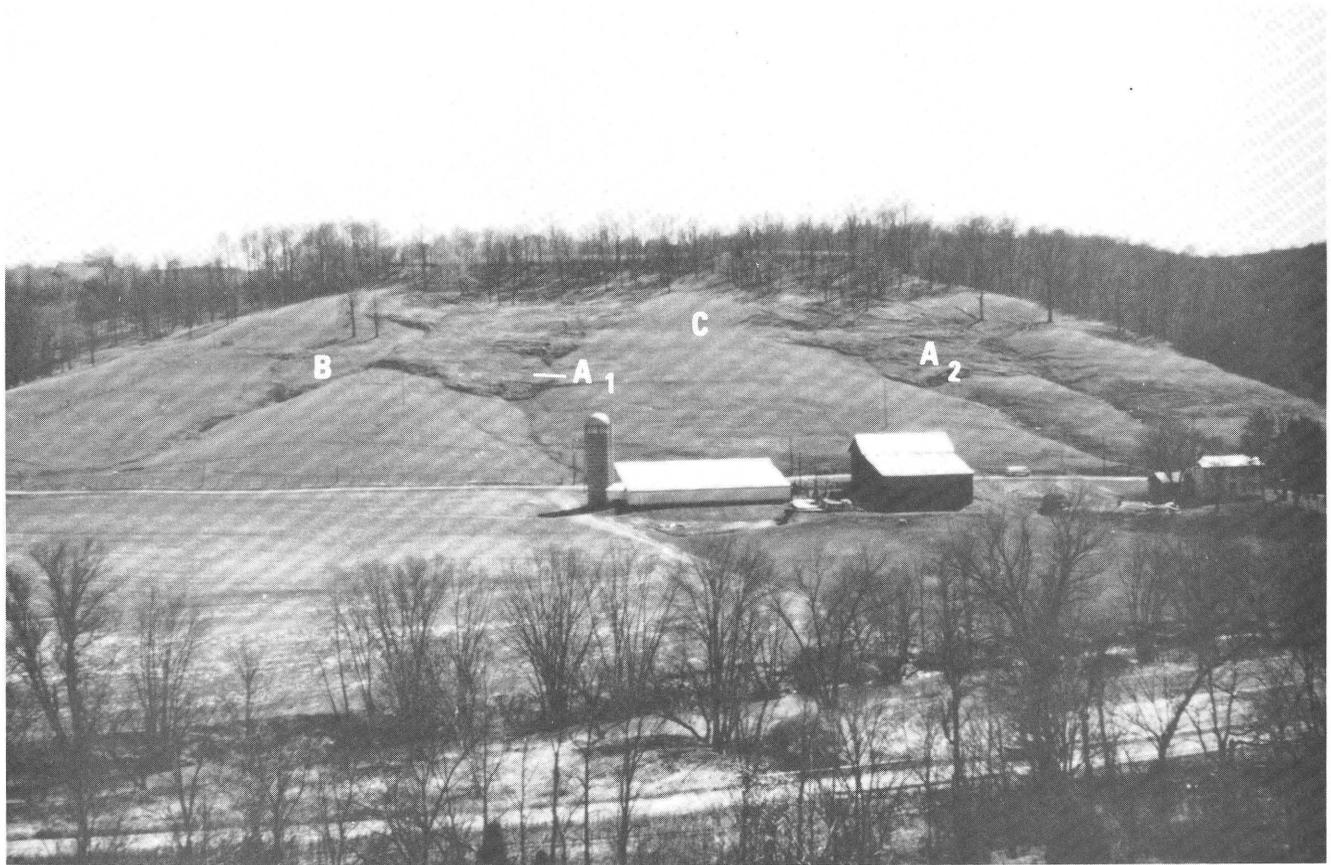
Figure 20. Earth flows opposite of Stanleyville (fig. 19, locality A). Shown are recently active earth flows (A_1 and A_2), the toe of an old earth flow (B), and the natural bench below the currently active part of earth flow A_1 (C).

and 800-ft contours. Most of the larger sized movements postdate the 1968 aerial photographs. The largest failure, an earth flow-slump (locality A), is a nearly 100-m-wide, relatively thin planar movement. A nearly 1.0-km-long segment of Duck Creek was rerouted sometime before 1956 to its present alignment along a more direct route against the slope. During high water, the lower slope probably is subject to increased pore-water pressure and resultant reduction in shear strength. Also, increased lateral erosion by Duck Creek probably has reduced the stability of the lowermost slopes by unloading support from the toe slope.

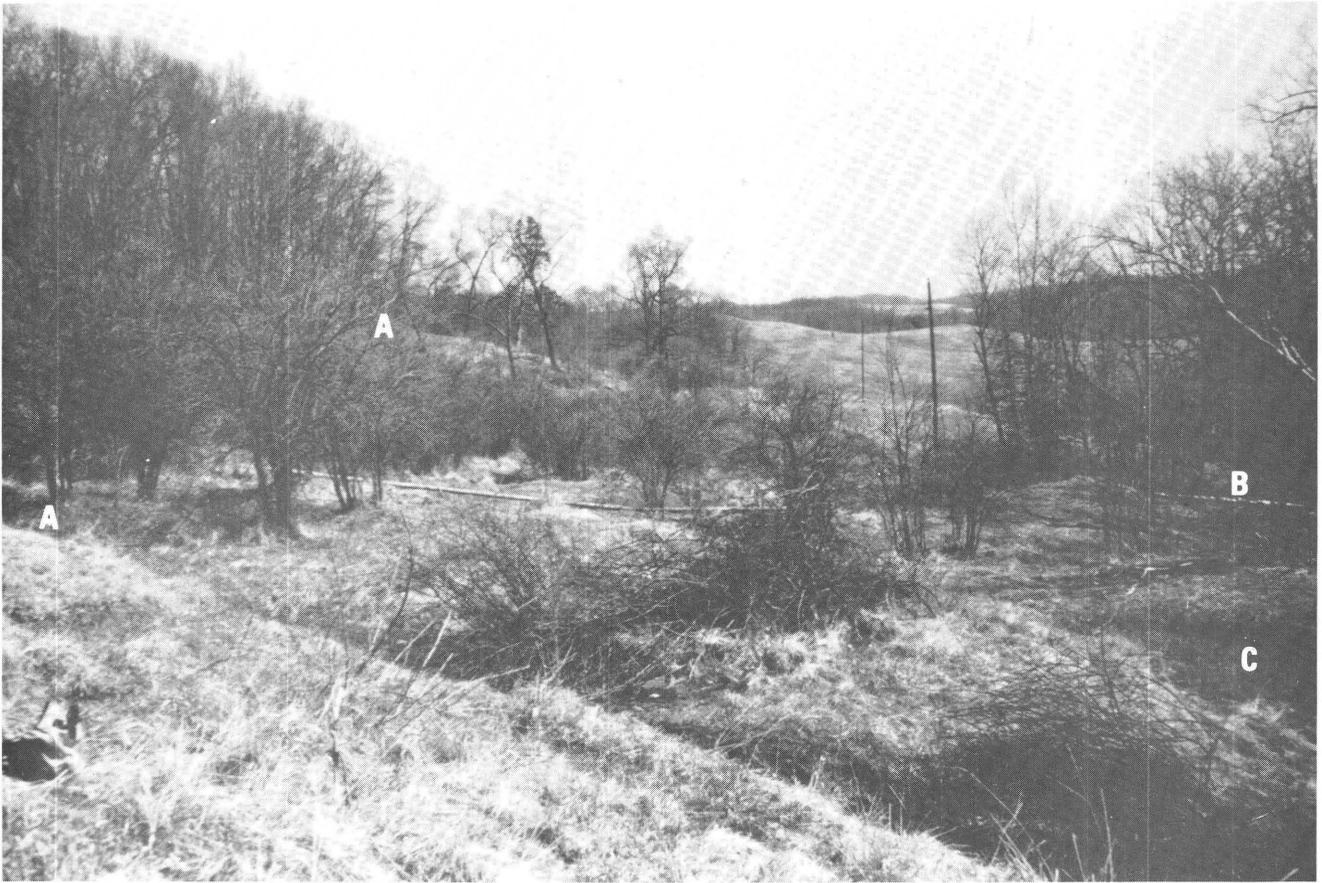
Figure 21. Looking across the less than 100-m-wide earth flow (fig. 19, locality B). Shown are the lateral margins (A), the repaired pipeline aligned parallel to the direction of movement (B), and the ponded area (C).

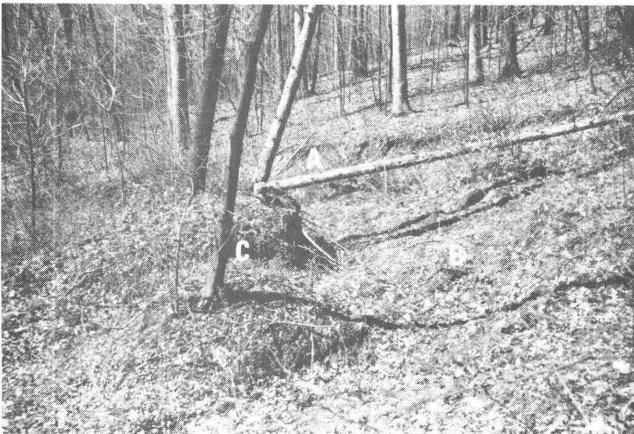
Figure 22. Head area of earth flow to the east of Ohio 821 (fig. 19, locality C). Shown are part of the north lateral margin (A), the basal shear surface (B), and the clump of a displaced regolith (C).

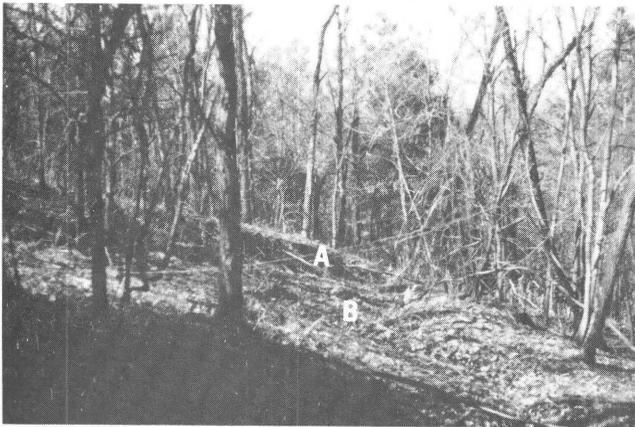
Figure 24. Head of the earth flow (fig. 19, locality A). Shown are the upper left margin of the scarp (A) and the basal shear surface (B).

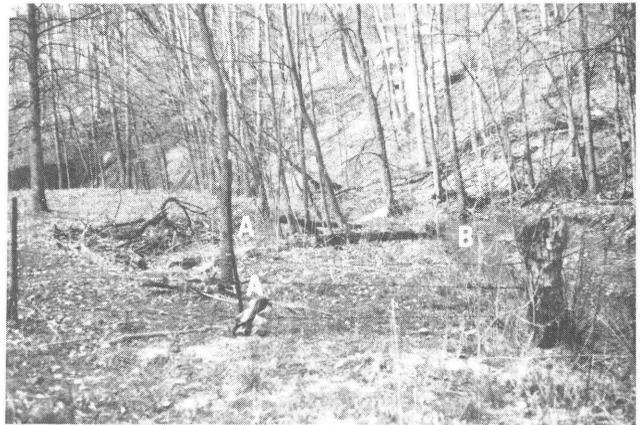
Figure 26. Earth slump along Brush Run (fig. 23, locality C). Shown are the lateral margins (A) and the creek (B). Note the group of rotated trees between A and B.

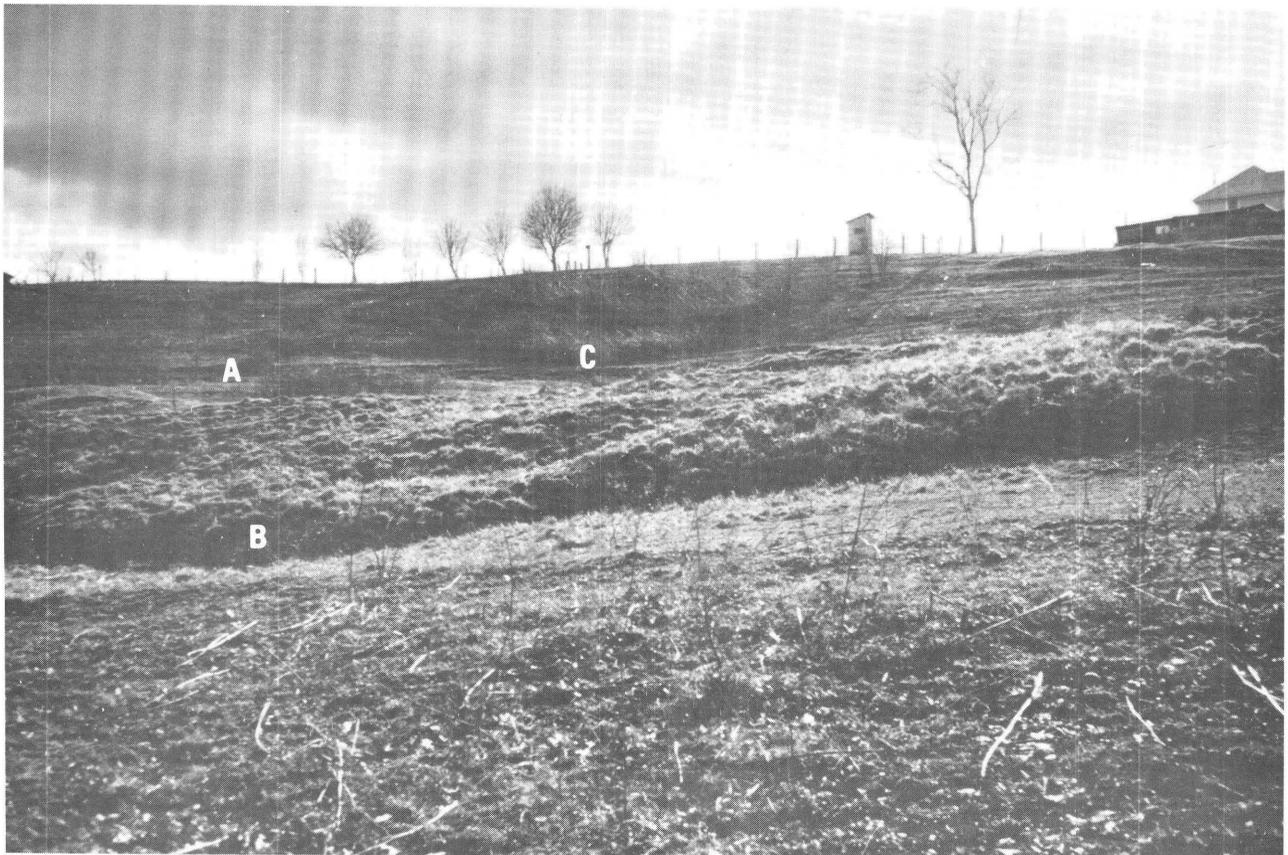
Figure 25. Earth flow within the concave slope (contour cavity) (fig. 23, locality A). Shown are the less than 1-m-high head scarp (A), the toe (B), and the dense, brushy area that conceals the seep (C).
