Some Slope-Movement Problems in Windsor County, Vermont, 1984

U.S. GEOLOGICAL SURVEY BULLETIN 1828

Prepared in cooperation with the
Vermont Geological Survey

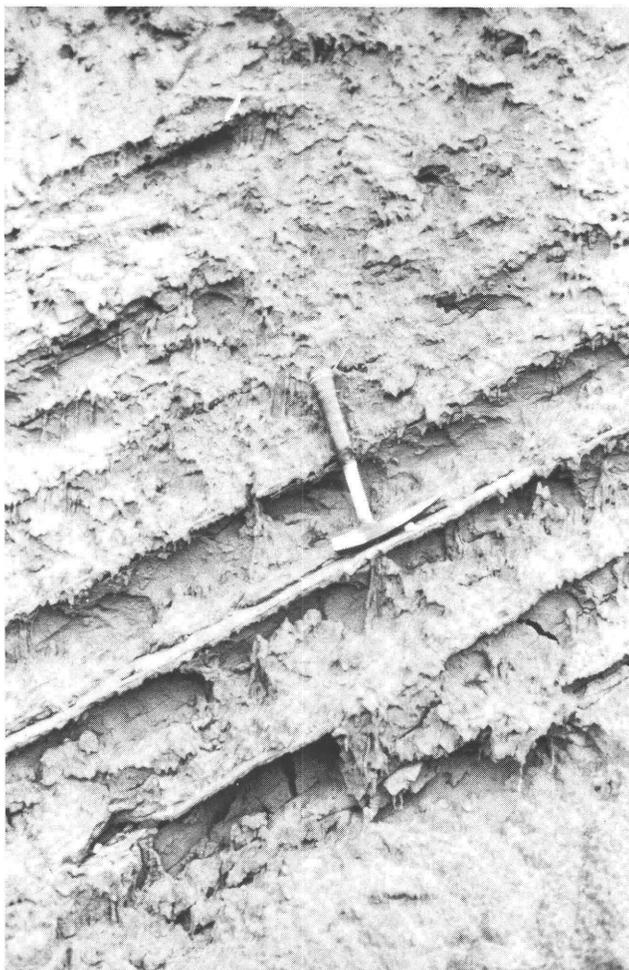
Some of the rhythmite deposits no longer show their original horizontal bedding (fig. 4). These materials were deposited on or around stagnant ice blocks. As the ice melted, the depositional units collapsed; an example occurs at the North Springfield Reservoir. Most of these rhythmites dip toward the failure face.

Figure 4. The Glacial Lake Hitchcock rhythmite deposit at the North Springfield Flood-Control Reservoir. The deposit is dipping to the west (left side of photograph) and has several calcite-cemented sand layers (hammer rests on one of these).

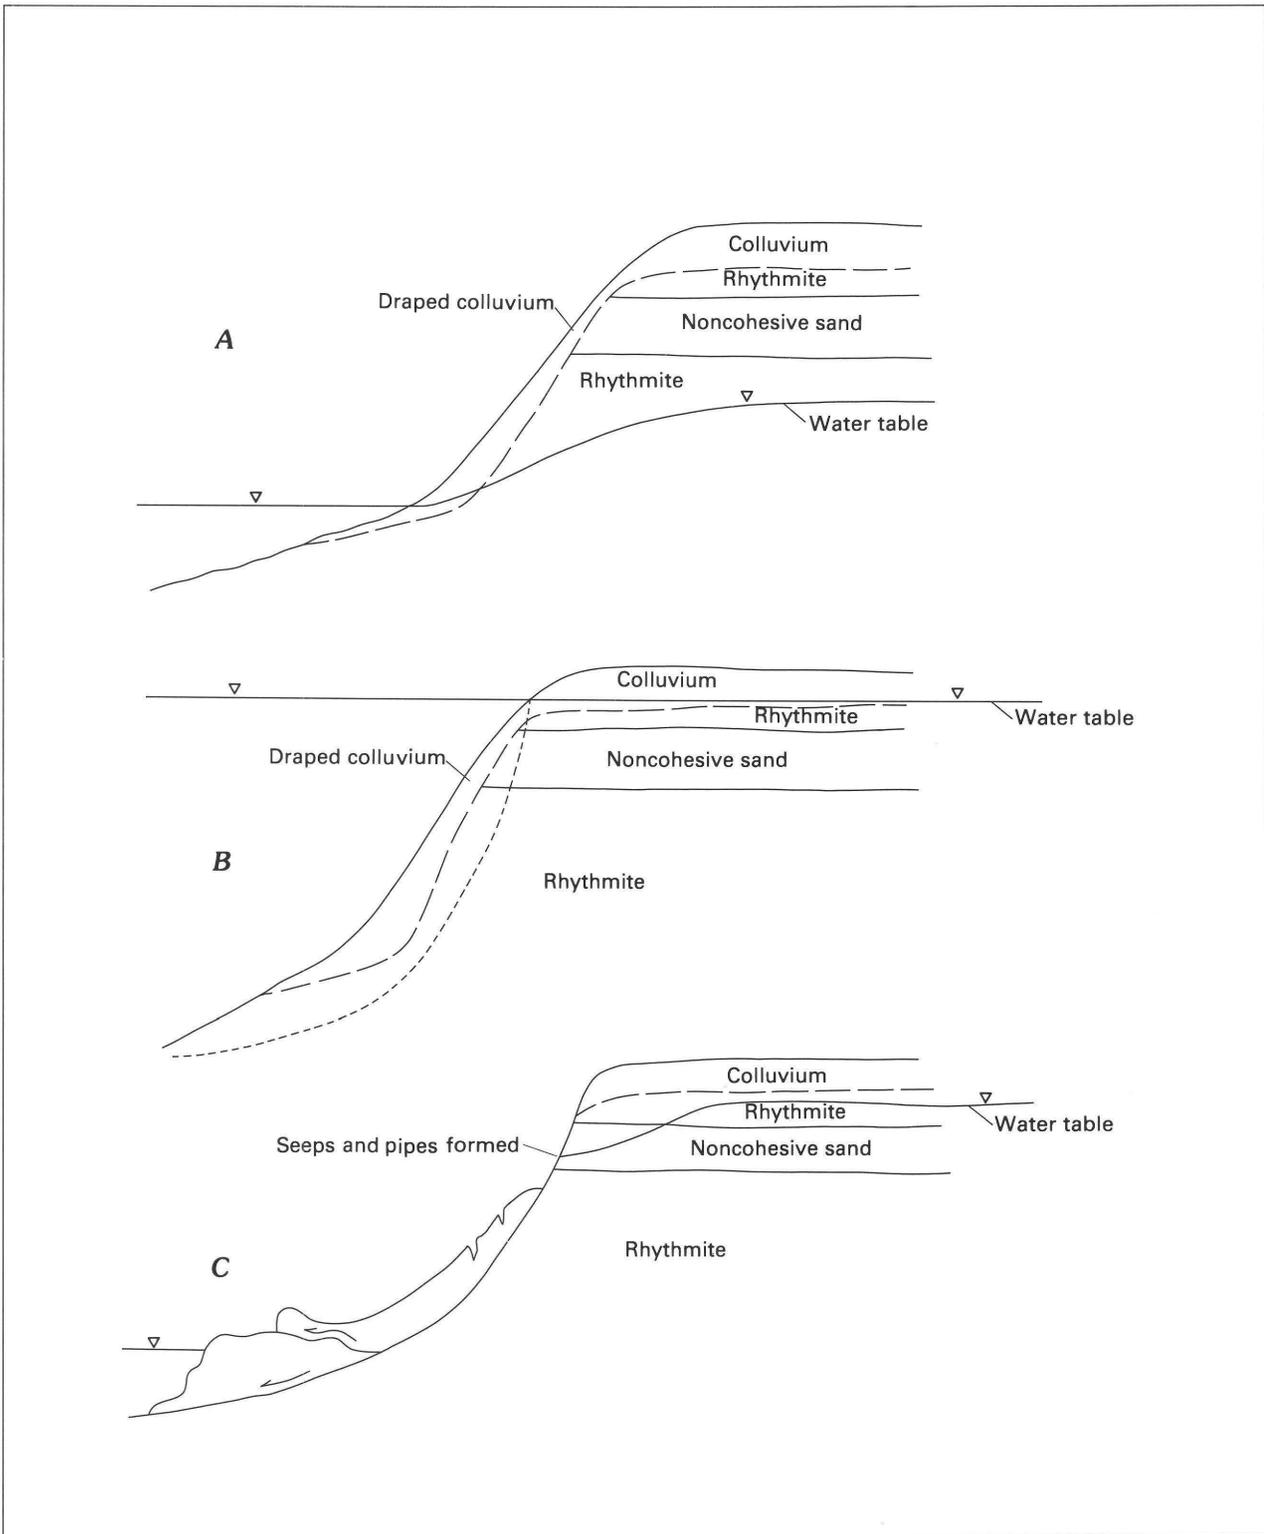
little clay, which gave the layer a very low cohesion. After the earth flow occurred, this unit was piped extensively by ground water escaping from the scarp along the length of

the layer (fig. 5). The high water conductivity through these sandier layers and parallel to the surfaces of the clay layers helped add water to the ultimate failure surface.

Figure 5. A typical flood-reservoir slope configuration in which earth-flow and piping failures have developed. *A*, Preflooding configuration. *B*, Flood stage. *C*, Postslide and piping configuration. The inverted delta symbol indicates the water surface. The sketches are not drawn to scale.

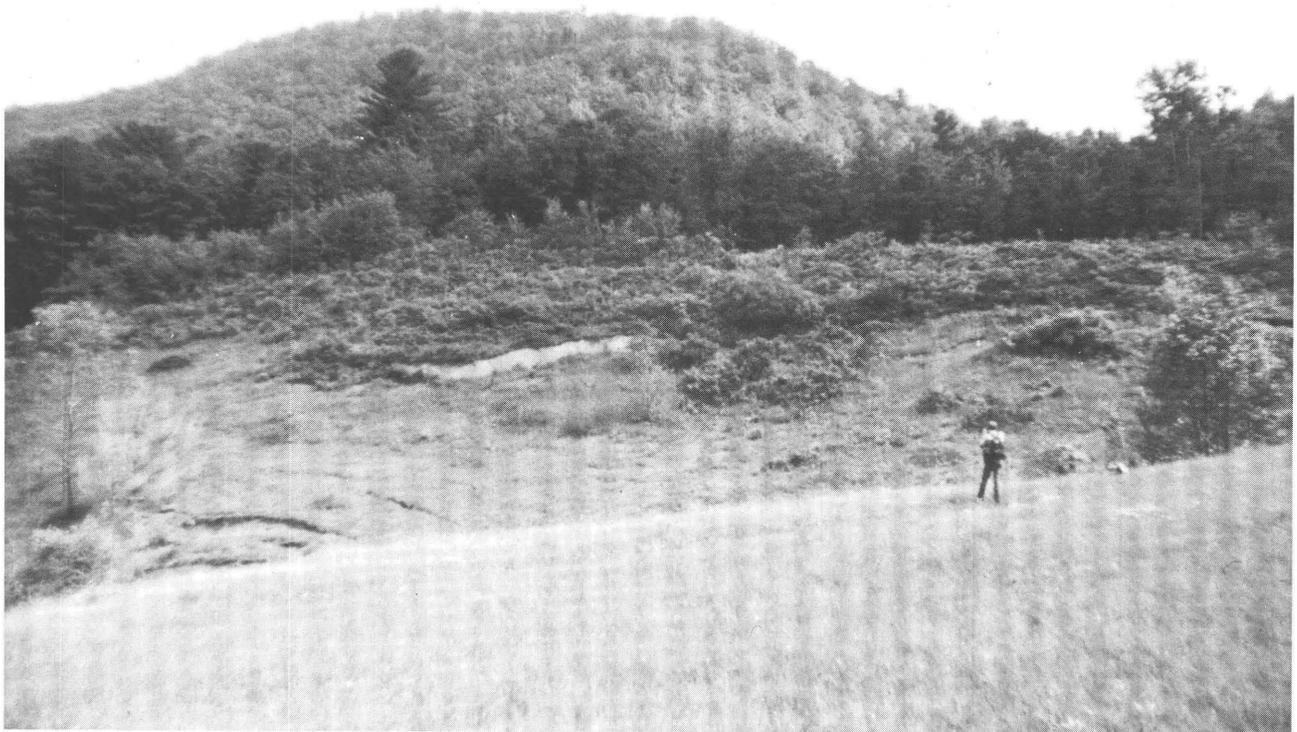
A slide located on the northeastern valley wall of the reservoir (fig. 7) near the North Hartland Dam emergency spillway was an example of the slump-earth flows encountered. This slope movement occurred in spring 1984 along the face of a terrace that formed the northeastern valley wall. An unnamed stream flows southwestward into the reservoir from the west flank of Miller Hill (fig. 1, locality 11; A in fig. 6) along the base of the terrace. The toe of the failure temporarily blocked the stream, but, by eroding the toe, the stream has reoccupied its original channel.

The eastern side of the failure mass (just out of view on the right side of fig. 7) had numerous en echelon transverse tension gashes and small vertical displacements. The western side of the mass was bounded by an irregular, curving scarp and one or more lateral shear planes. Except for some tension cracks, the central portion of the slope movement had a relatively smooth upper surface.

The lateral tension cracks seen in the left foreground of figure 7 resulted from an increase in friction on the basal shear surface of the failure as the fluidized substrate pinched out, placing the basal shear surface in direct contact with the sole of the slide mass. This caused drag on the sole of the slide mass pulling it apart (extension) as shown in figure 9. Drag on the basal shear surface in the head scarp area generated tension crack openings (tensile

Figure 7. Slope movement on the northeastern wall of the North Hartland Flood-Control Reservoir west of the spillway. The head scarp is in the center. Tension cracks on the midsection of the flow can be seen on the lower left. The shrubs on the lower left were mud coated due to the high water during reservoir flooding. The smooth area in the foreground is the edge of a grass-covered hill on the southeastern side of the unnamed stream valley from which the photograph was taken.

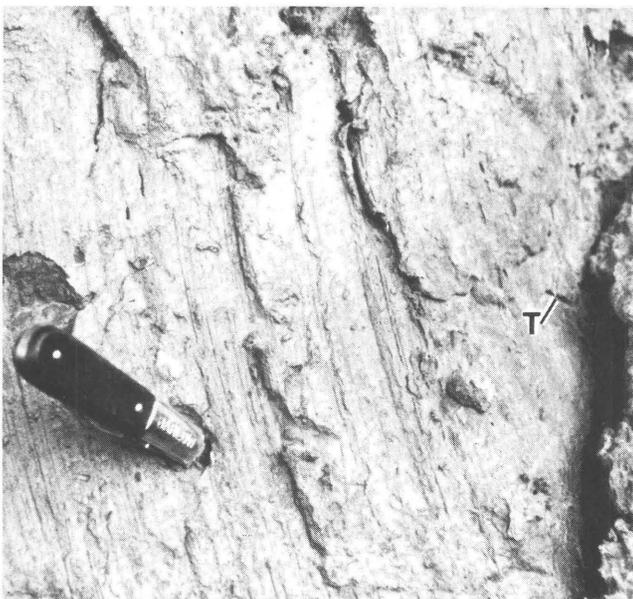
Figure 8. Slickensides on a clay-smear head-scarp surface of the slump-earth flow on the northeastern valley wall of the North Hartland Flood-Control Reservoir. T is the location of a horizontal tension crack.

stress) normal to the direction of movement during sliding as shown at T in figure 8. The entire upper surface of the slide mass has undergone some extension in the direction of movement. Hummocks and lobes of slide material formed the distal part of the toe of this earth flow. Tension cracks also were found throughout the toe area.

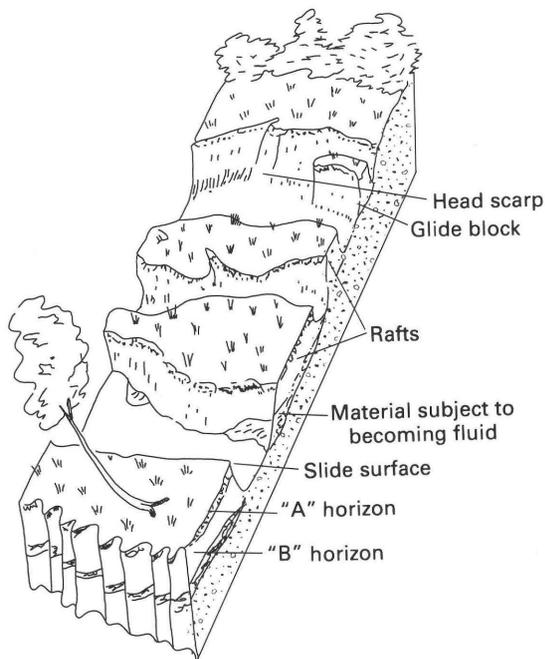
In the upper part of the slide mass near the head scarp, the basal zone of liquified material pinched out and was replaced by a planar failure surface (fig. 9). In the head scarp area of these earth flows, some small minor rotational slumps that were separate from the main failure mass were seen.

Figure 9. Rafts of intact material sliding on a fluidized substrate that pinches out headward. The failure surface above the pinchout point becomes a planar frictional surface. This friction creates a pulling apart of the slide material on tension cracks; as a result, some separated glide blocks developed. This sketch is not drawn to scale.

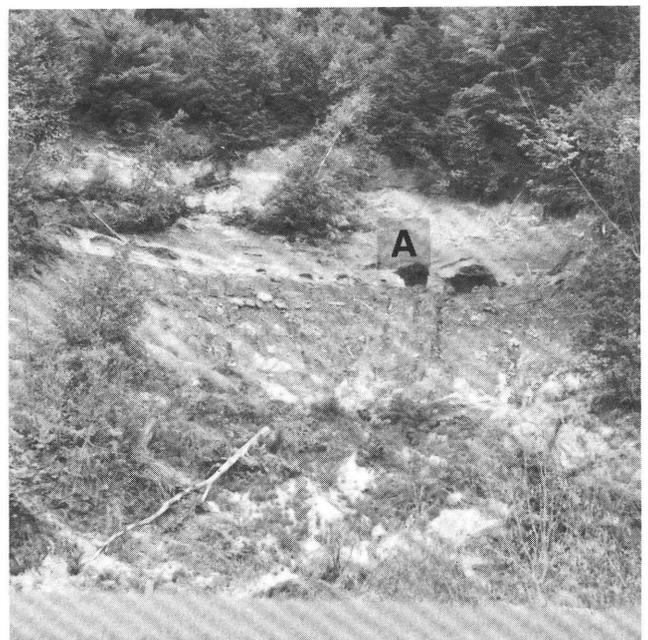
Of the many landslides that occurred on the southwestern valley wall of the North Hartland Reservoir, one in particular, just west of the boat ramp parking lot, had piping associated with the failure (fig. 10). The site, a terrace, consisted of a rhythmite sequence covered by a layer of colluvium. Near the top of the terrace, the rhythmite sequence was interrupted by a 4-ft (1.2-m)-thick medium sand layer. The noncohesive sand layer, which had a higher hydraulic conductivity than the surrounding rhythmites, acted as a confined aquifer as shown in figure 5.

Figure 10. Part of the southwestern valley wall of the North Hartland Flood-Control Reservoir showing piping cavities (A) in a sand layer confined between two rhythmite sequences. These cavities are up to 3.9 ft (1.2 m) in diameter.

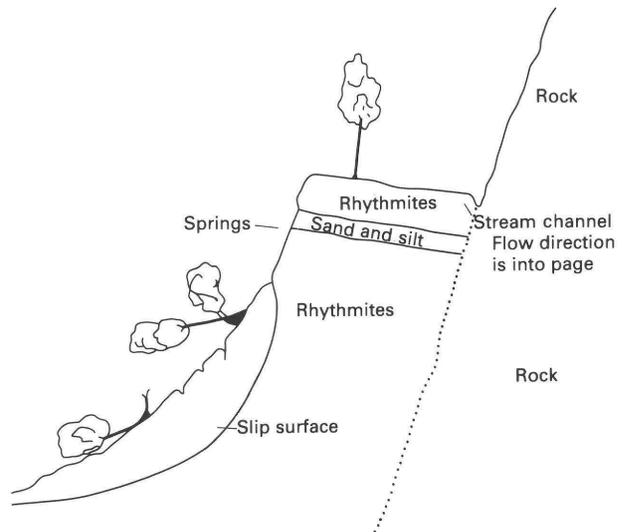
Numerous springs issue from the bedrock hill above the terrace. The terrace surface has a slight slope back toward the bedrock-defended hill. A small stream drains the swamp area along the proximal side of the terrace surface and runs in an easterly direction parallel to the bedrock hill. Water from these springs also soaks into the terrace sediments and reemerges as springs on the terrace front (fig. 12). In a trench excavated in the scarp face to

Figure 12. The terrace configuration at the Vermont Route 11 landslide site near Springfield showing strata and water-flow direction. This sketch is not drawn to scale.

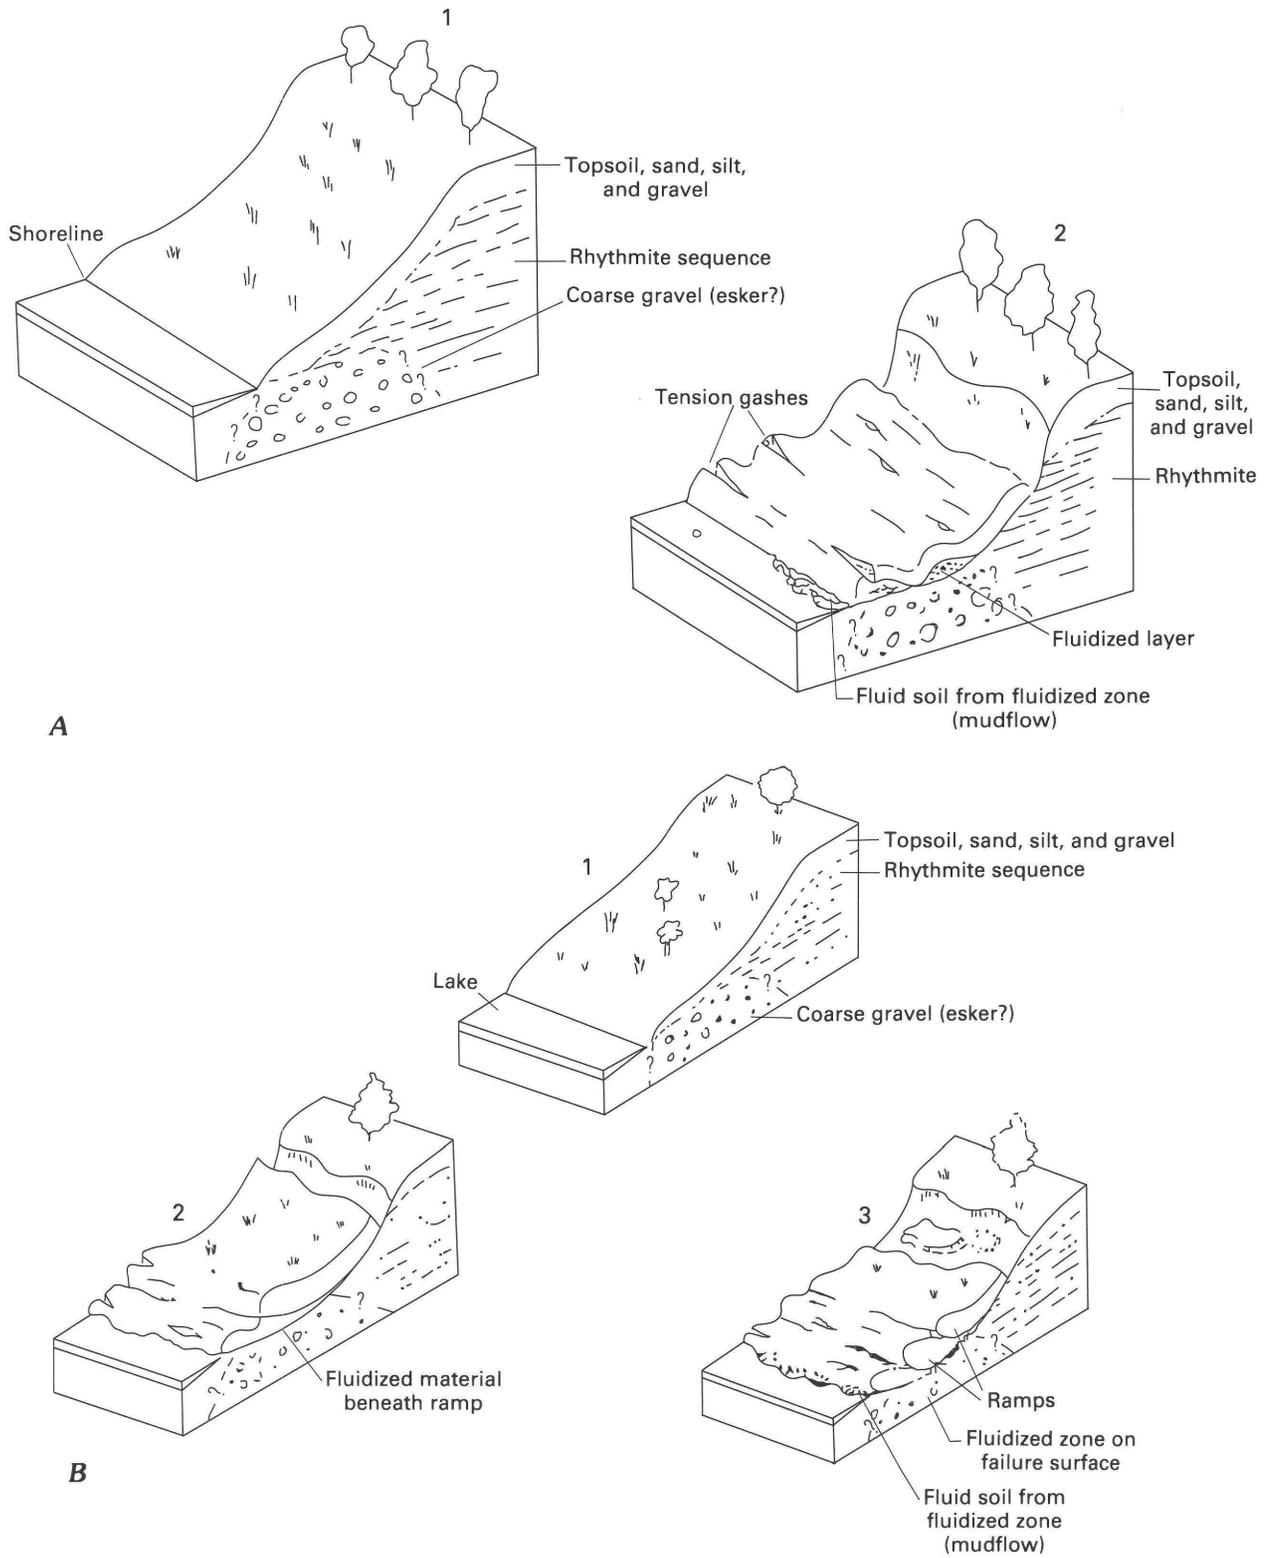
Figure 15. The processes for the formation of multiple ridges or hummocks at the eastern abutment of the North Springfield Dam. A, The hummocks developed in the intact layer are shown with the fine-grained fluidized material from beneath penetrating the cracks in the upper layer. B, Mode of overthrusting and ramping in the toe area of slope movements is shown. The numbers represent the order of the development of the failures. These sketches are not drawn to scale.

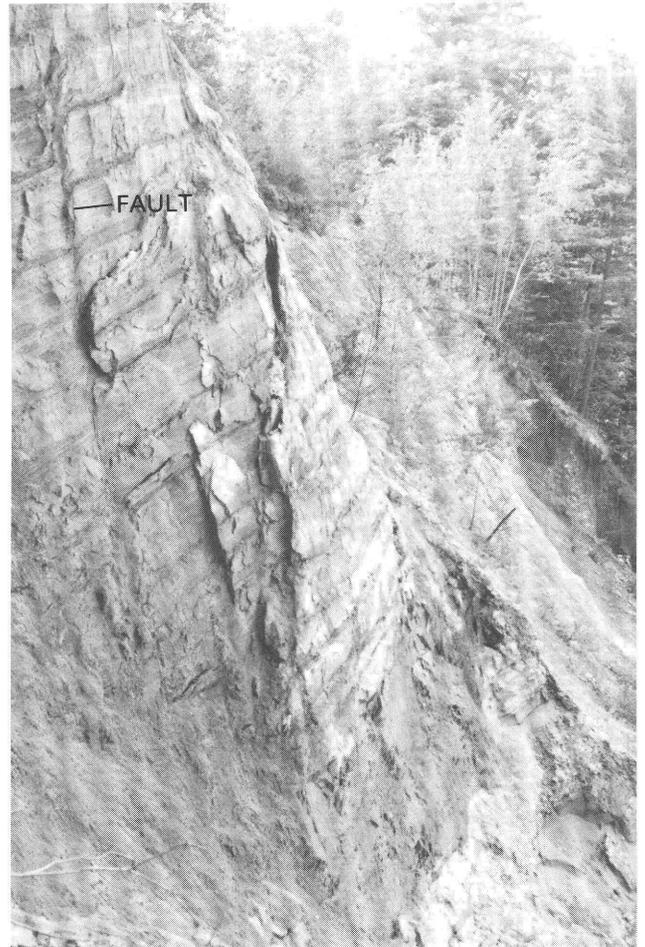
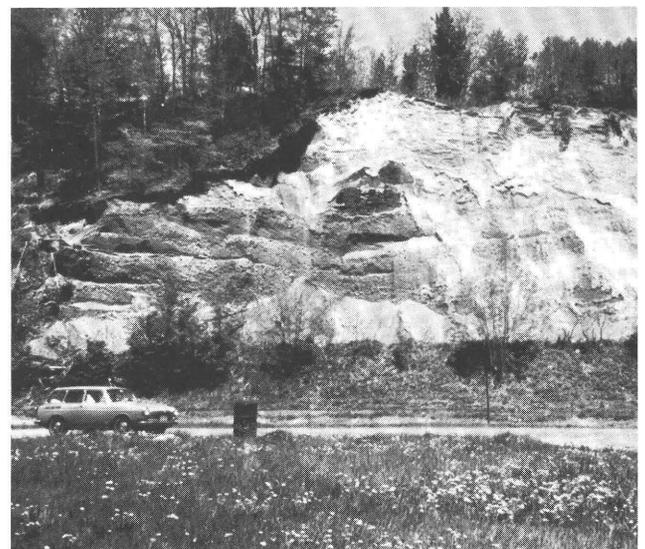
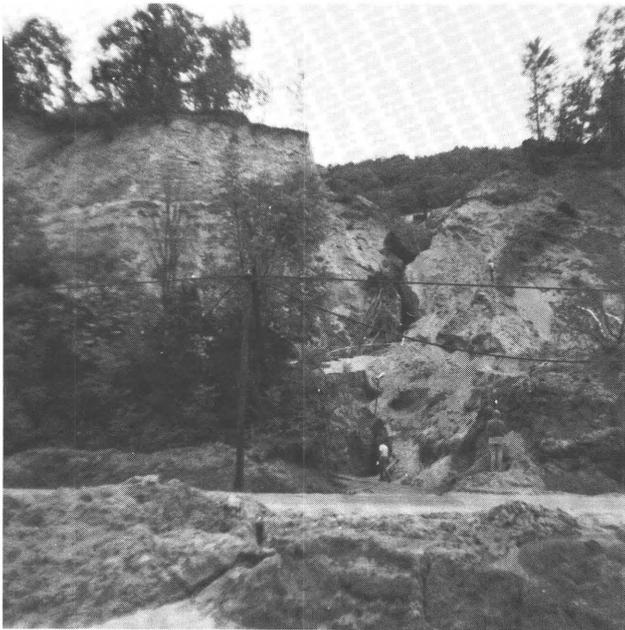
Figure 17. The landslide site north of Sharon on Vermont Route 14. *A*, This fault is one of several reverse faults exposed at this site. *B*, How the site looked as a borrow pit facing Route 14 before the failure. *C*, The breach channel that developed during the failure is seen to the left of center. (Photograph *B* courtesy of Charles A. Ratté.)

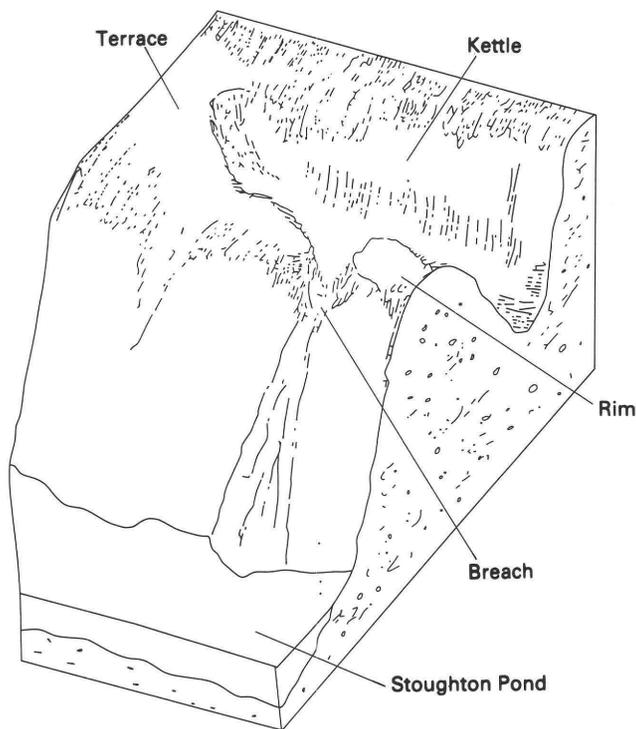
Figure 19. A portion of the eastern shore of Stoughton Pond that shows the reservoir-terrace kettle-rim relation. This sketch is not drawn to scale.

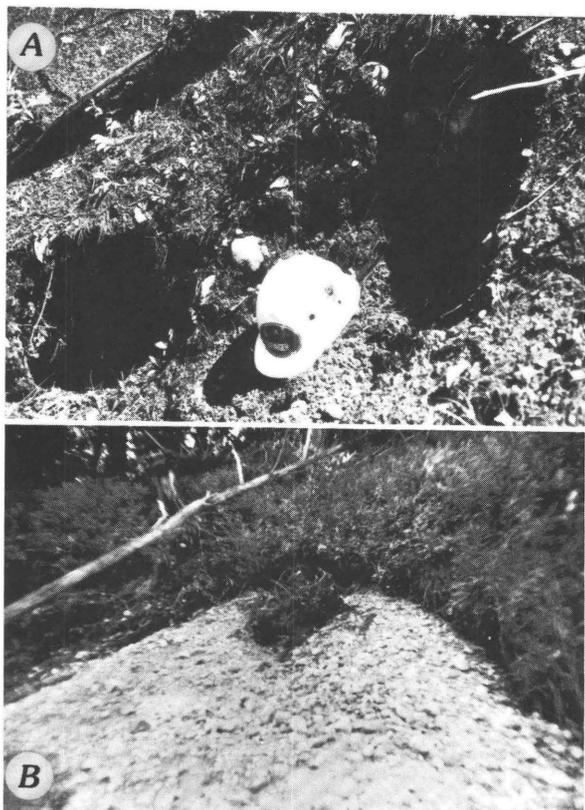
A piping of the glacial deposits also was observed just south of the kettle slides (fig. 20). The pipes varied from a little over 1 to over 3 ft (0.3-over 1 m) in diameter. In some of the incipient slide areas, evidence of high-velocity underground flow was seen. Several piping failures beneath the slope surface were evidenced by collapse and (or) sagging of the ground surface over some of these pipes. The soil cover over piping tubes was composed of mats of topsoil and vegetation, underlain by a layer of loam, all of which was held together by a network of plant root systems. Beneath these sagging mats were large cavities (fig. 20A). Sand and gravel on the cavity floors had a flow-produced appearance similar to that seen on some large open slope movements.

Figure 20. Piping failures in the eastern slope of Stoughton Pond; an impoundment. *A*, Collapse pits over pipes. *B*, Outflow delta deposits from mouth of pipe at pond level.
