LANDSLIDES OF THE CINCINNATI, OHIO, AREA

U.S. GEOLOGICAL SURVEY BULLETIN 2059-B

# Landslides in Colluvium

*The behavior of colluvial  
landslides is strongly affected  
by differences in thickness*

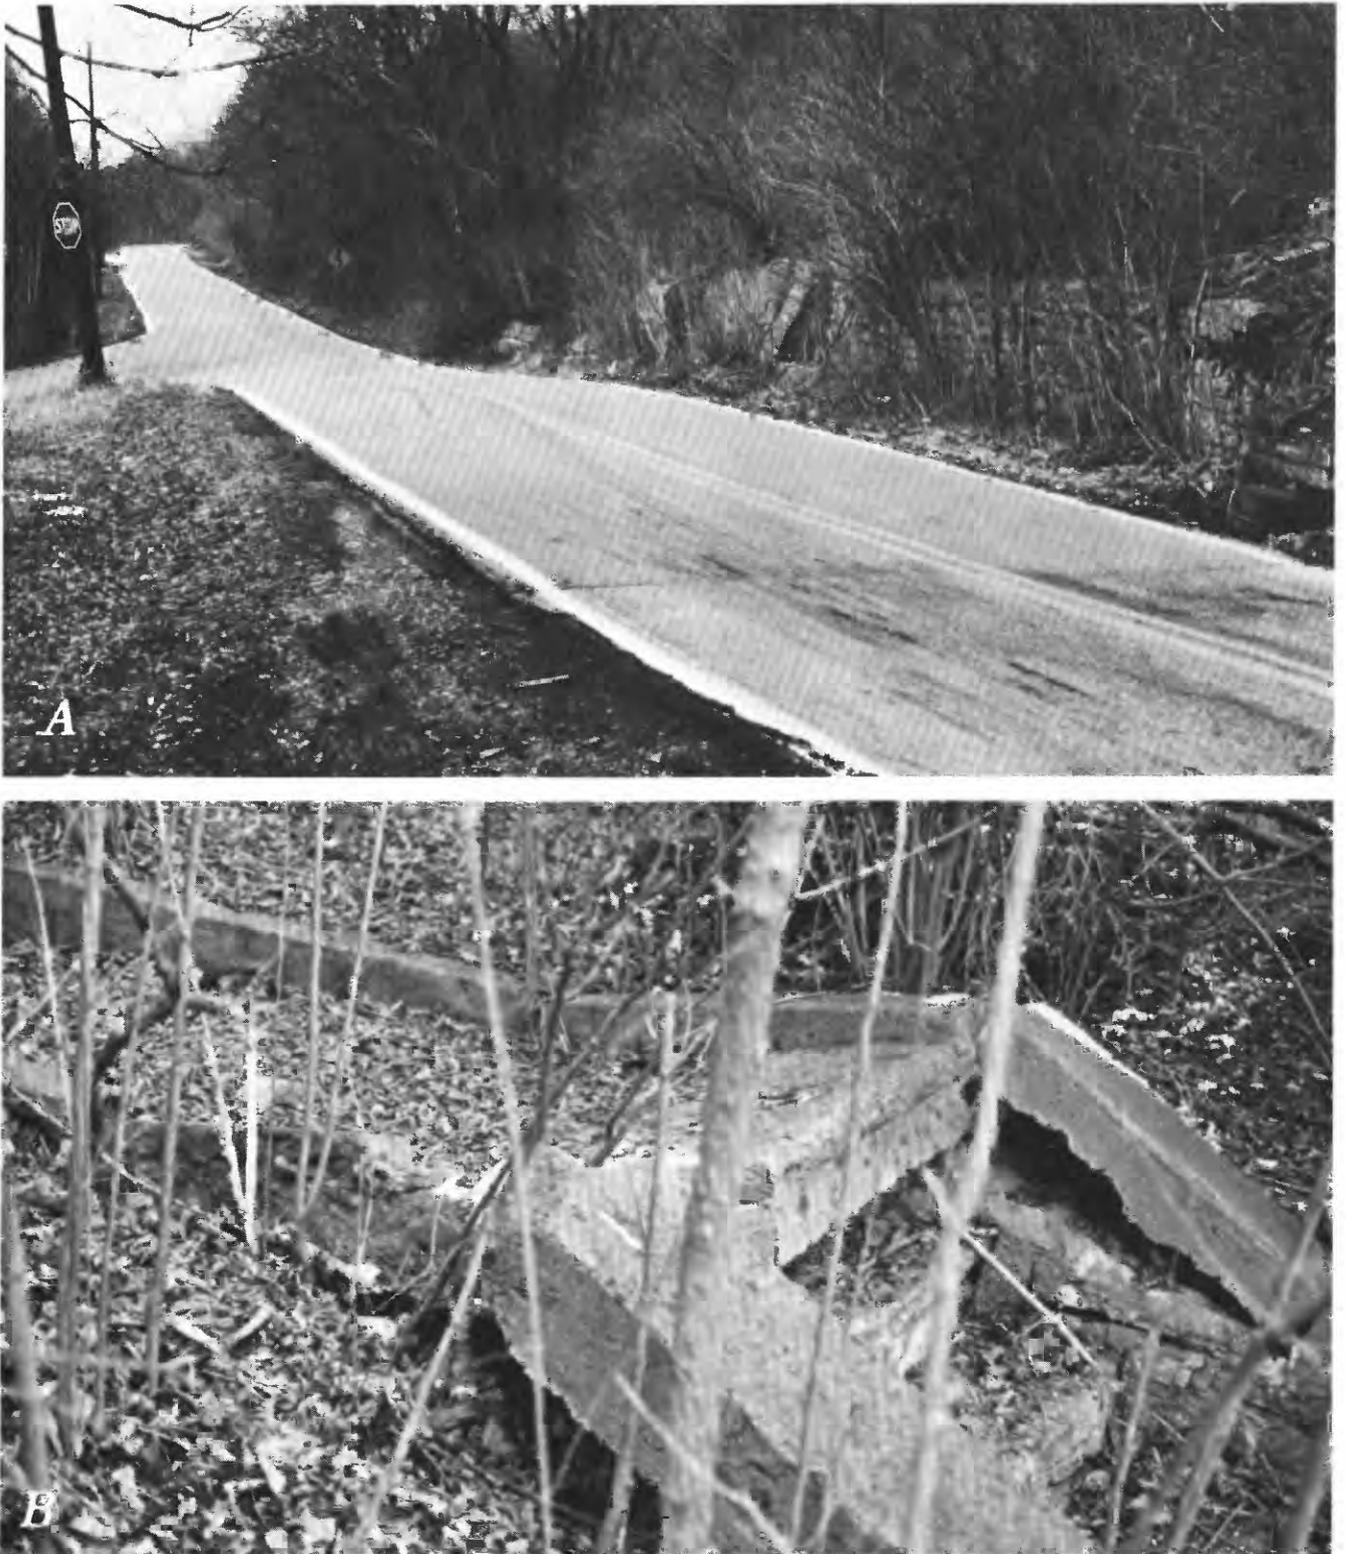
**Figure 3.** Emergent toes of deep-seated landslides near intersection of Hillside Avenue and Darby Road. See map on plate 1 for locations. *A*, View west toward the intersection. The broad bump in the middle of view is a toe for a thick landslide that extends 60 m upslope. Note the tilted utility pole at the left of the view and damage to the stone wall on the right. The asphalt paving over the bump has recently been replaced. The dark-colored marks in the eastbound (oncoming) lane are produced by vehicles scraping on the road surface after bouncing over the bump. The road has not been significantly displaced laterally; the principal movement direction is vertical. *B*, Stairway, about 18 m farther upslope, displaced a few centimeters to the right (south). Principal movement direction is horizontal.

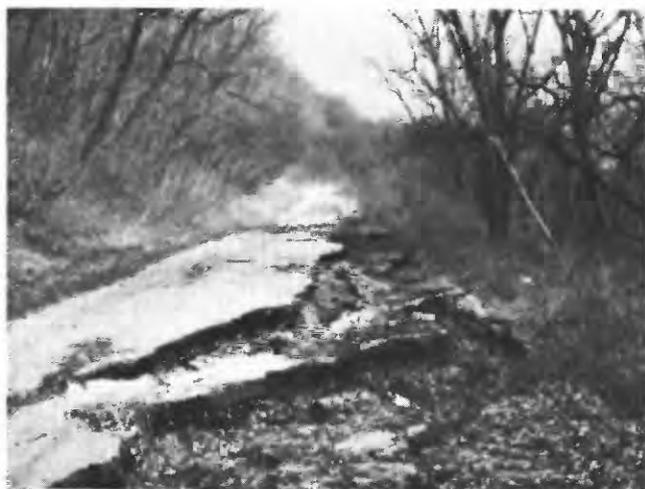
**Figure 4.** View to northeast of landslide scarp for thick slide that heads on Delhi Pike.

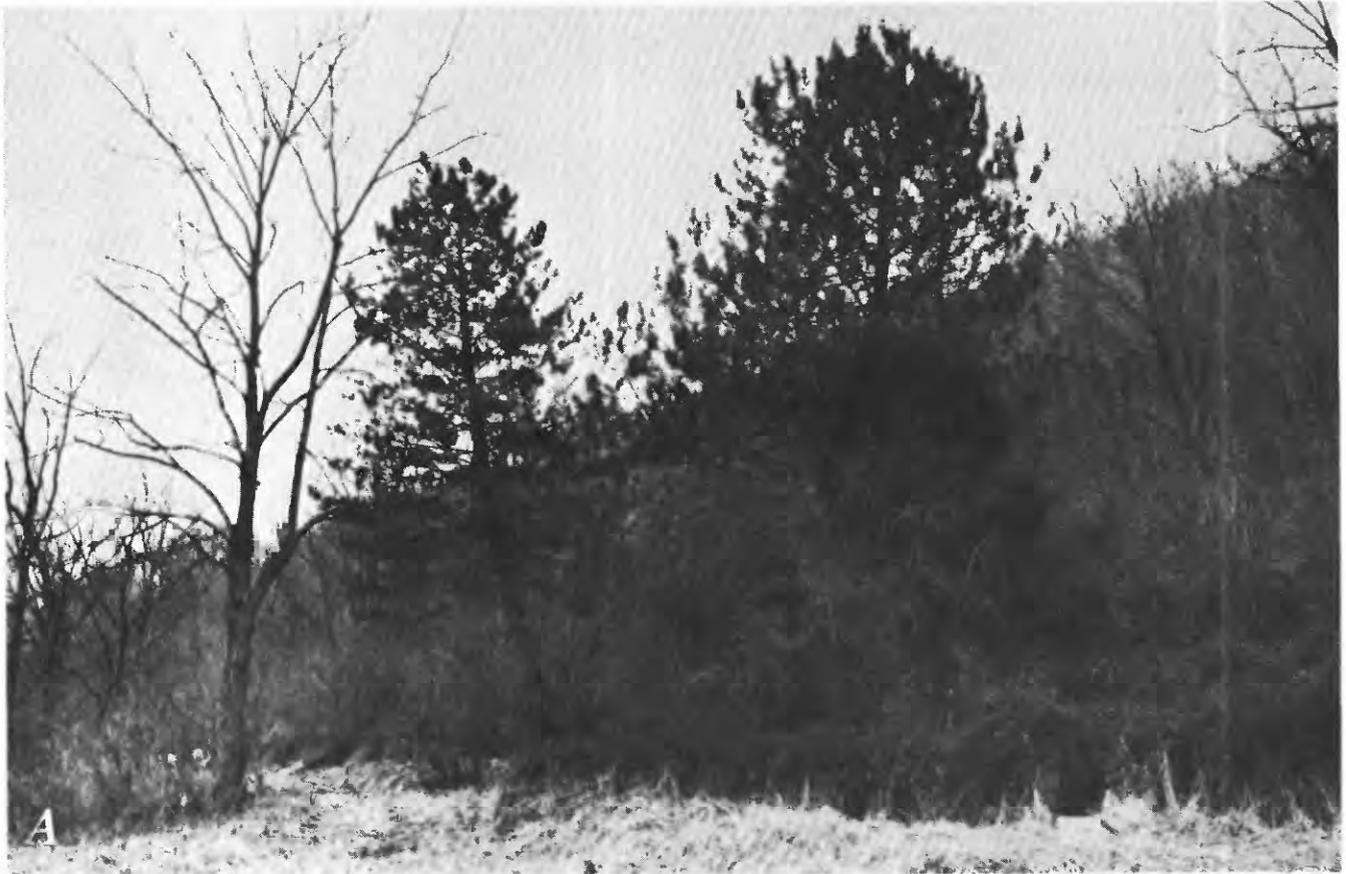
Figure 6A is a photograph of the two pine trees viewed northwest from near the site of the house at 5434 Hillside Avenue. The tree on the left is termed the "west tree" and the tree on the right the "east tree." The bulge in the foreground is a toe bulge that, from right to left, trends through dry grass and crosses the ivy-covered stone wall about in line with the west tree. The bulge passes just to the right of the

west tree, and landslide movement has pushed the tree toward the left or downslope. In response, the tree has grown straight for about 5 m and then is continuously curved except for one small, more abrupt bend about halfway to the top. The continuously curved portion of the tree appears to be a response to small annual increments of landslide movement, and the single, abrupt bend could be a response to one event of more than normal movement of the landslide.

**Figure 6.** Two pine trees tilted by landslide movement at 5434 Hillside Avenue. *A*, Both trees as seen from the southeast. “West tree” is on left and “east tree” is on right. *B*, “East tree” as seen from the northwest.

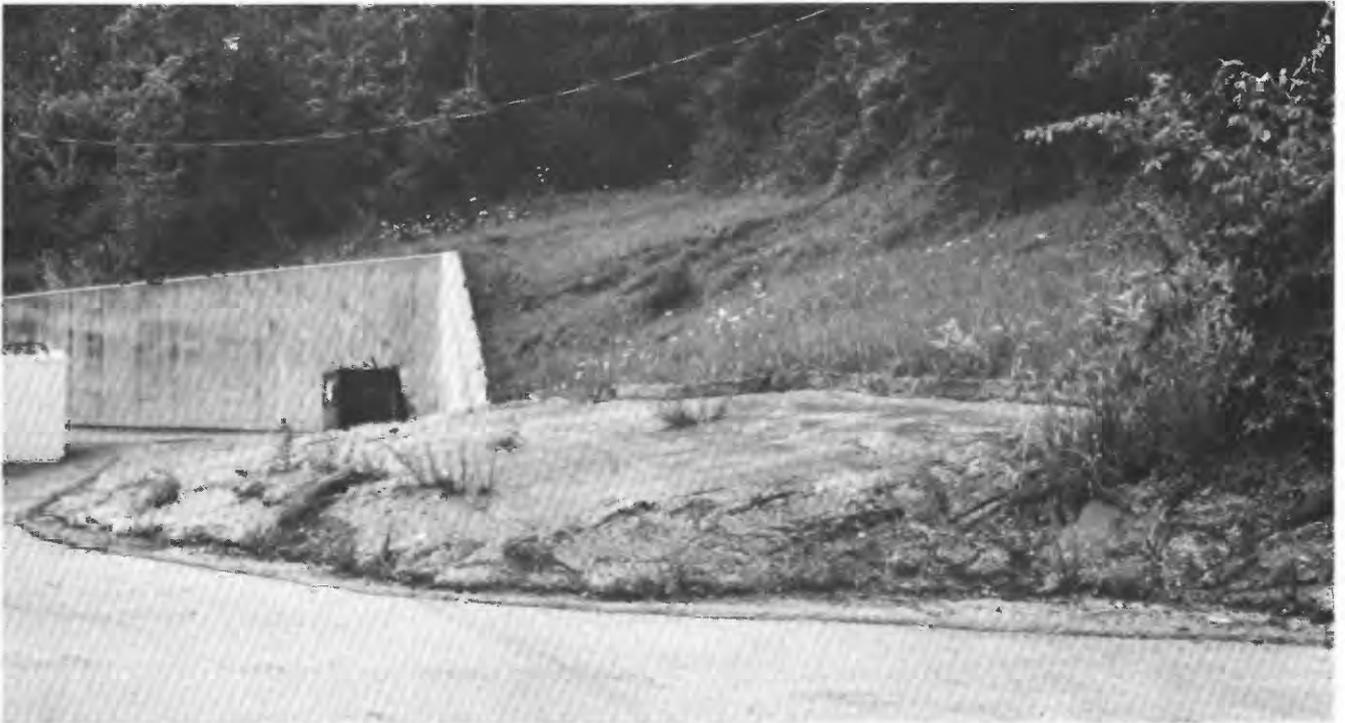
**Figure 9.** Bulge produced by landslide toe in asphalt parking area at Anderson Ferry Road and River Road. Vertical displacement in the toe greatly exceeds horizontal displacement.

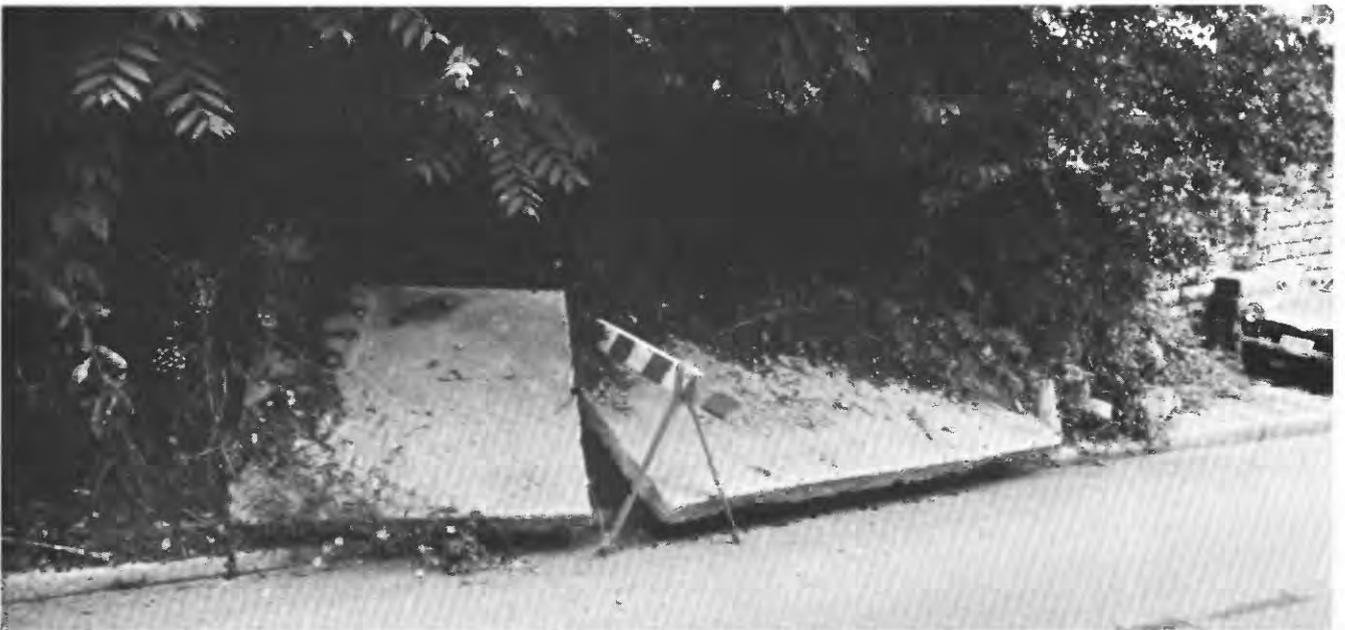
Figure 10 shows another example of deformation produced by movement of a landslide toe. In this case, at a landslide in the Mt. Adams area of Cincinnati, the curb of the street has not been displaced, but two slabs of concrete sidewalk have been lifted and displaced over the curb. For the larger slab on the right, horizontal displacement is 0.60 m, and the uphill edge of the slab is elevated 0.82 m.

**Figure 10.** Landslide toe formed in Mount Adams section of Cincinnati. Ratio of vertical to horizontal displacement is 1.4:1.

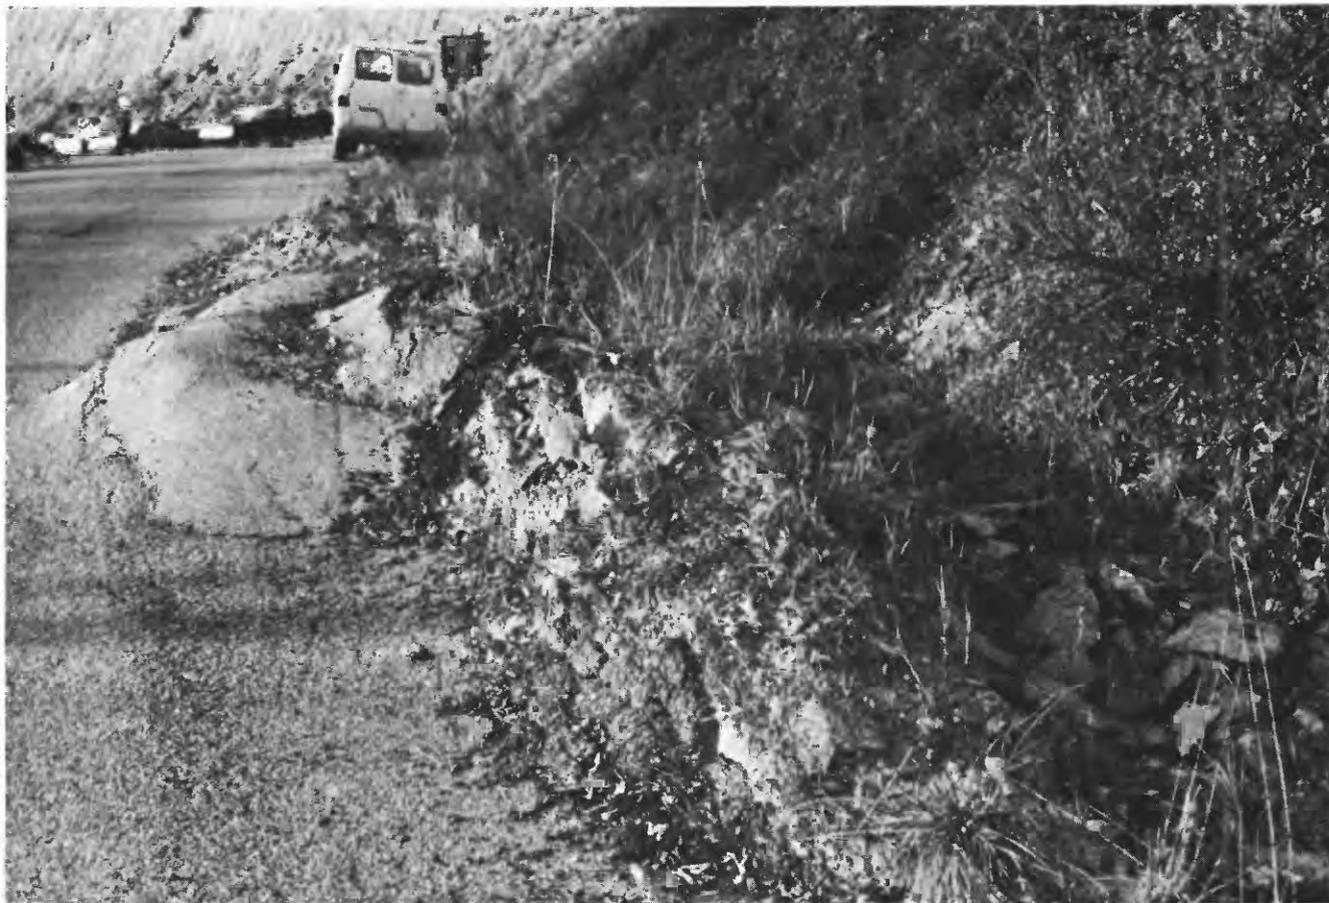
**Figure 11.** Near-vertical bump formed in landslide toe. Limestone clasts have been preferentially oriented with their minimum dimension at right angles to the direction of pervasive shearing. The bump has formed without appreciable horizontal offset.

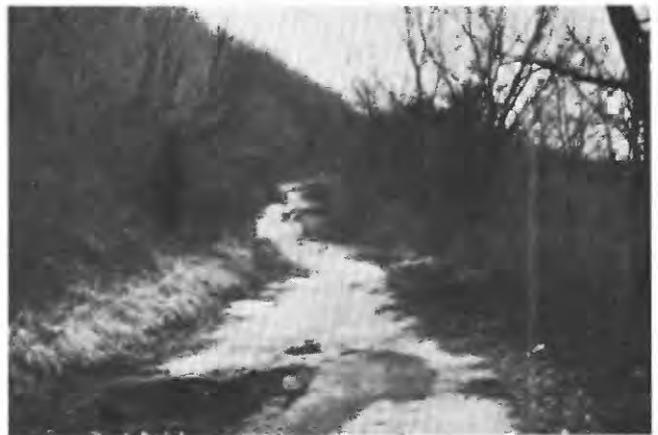
The toe of thin-landslide movement (fig. 2) is at Delhi Pike where colluvium has spilled onto the uphill side of the road. Figure 13, a photograph of Delhi Pike from about the location of trench 2 (for location, see pl. 1), gives the impression that the road is very crooked. The road, however, contains only a gentle curve toward the left in the middle of the view and a curve to the right in the distance; otherwise it is straight. The uphill side of the road is covered in varying amounts by lobes of thin slide debris that have accumulated since the road was closed in 1973. The downhill edge of the road has been displaced by scarps of the thick landslides, but the uphill side of Delhi Pike has not moved.

**Figure 13.** View uphill along Delhi Pike from the location of trench 2. Landslides affect both sides of road. Despite appearances, the road is not crooked; thin landslides from upslope have spilled onto the left side and scarps of thick landslides have broken the right side of the road.

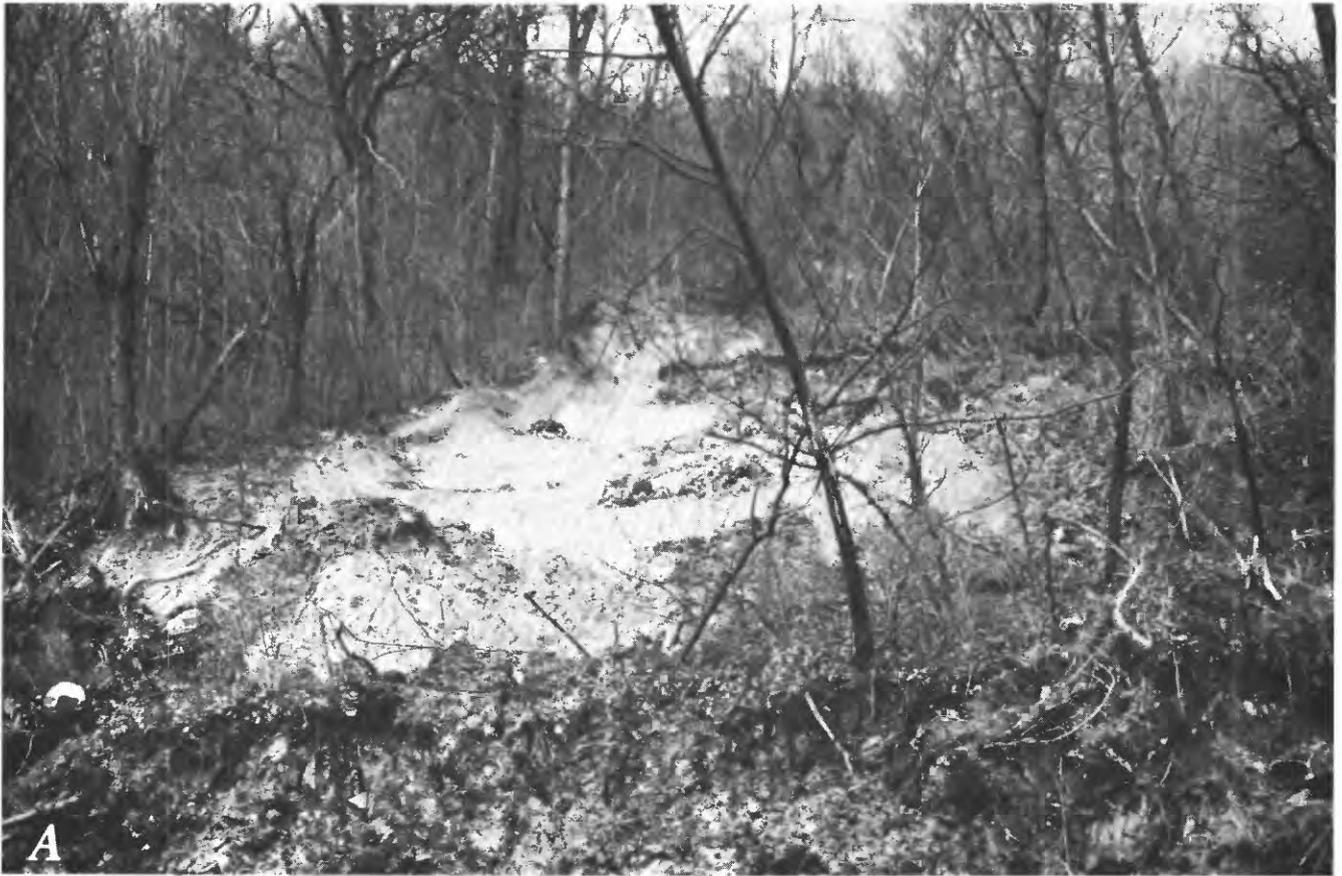
*A*

Another example of extreme extension of thin landslides is shown in figure 14. This landslide, which occurred in 1973 a few kilometers east of downtown Cincinnati along Columbia Parkway, is typical of many thin landslides. The landslide slid completely out of its site of failure, moved about 20 m over the ground surface, and spilled over a retaining wall onto Columbia Parkway. In figure 14A, part of the landslide path is indicated by the light-colored material in the middle of the view. The initial failure occurred at the uphill end of the light-colored area. Individual landslide blocks that have separated during movement but remain on the slope are on the right side of the light-colored area. Unfailed material is on the left. At the extreme upper end of the scar, bedrock was exposed (not visible in the photograph) at the sole of the landslide. The lower part of the landslide scar contains four discontinuous benches or undulations. At least two of these benches continue to the left into the unfailed colluvium and are probably expressions of buried limestone layers in the bedrock underlying the colluvium.

The benches that are visible in the light-colored area in figure 14A are formed within the colluvium. Here, the colluvium has not failed to the level of the bedrock as part of the initial landslide but, rather, has been overridden by landslide debris from the deeper scar upslope. The landslide apparently pushed away a layer of the upper part of the slope including the vegetation, the pedologic A horizon, and underlying colluvium to a depth that contained most of the

**Figure 14 (on facing page).** Thin landslide along Columbia Parkway, east of downtown Cincinnati. *A*, Slide path was created when landslide from upslope slid completely out of its original position and pushed the colluvium and vegetation, including roots, off the remainder of the underlying colluvium. Undulations in the light-colored colluvium in the path of movement are benches reflecting limestone layers in underlying bedrock. *B*, Landslide debris has spilled over retaining wall onto Columbia Parkway.

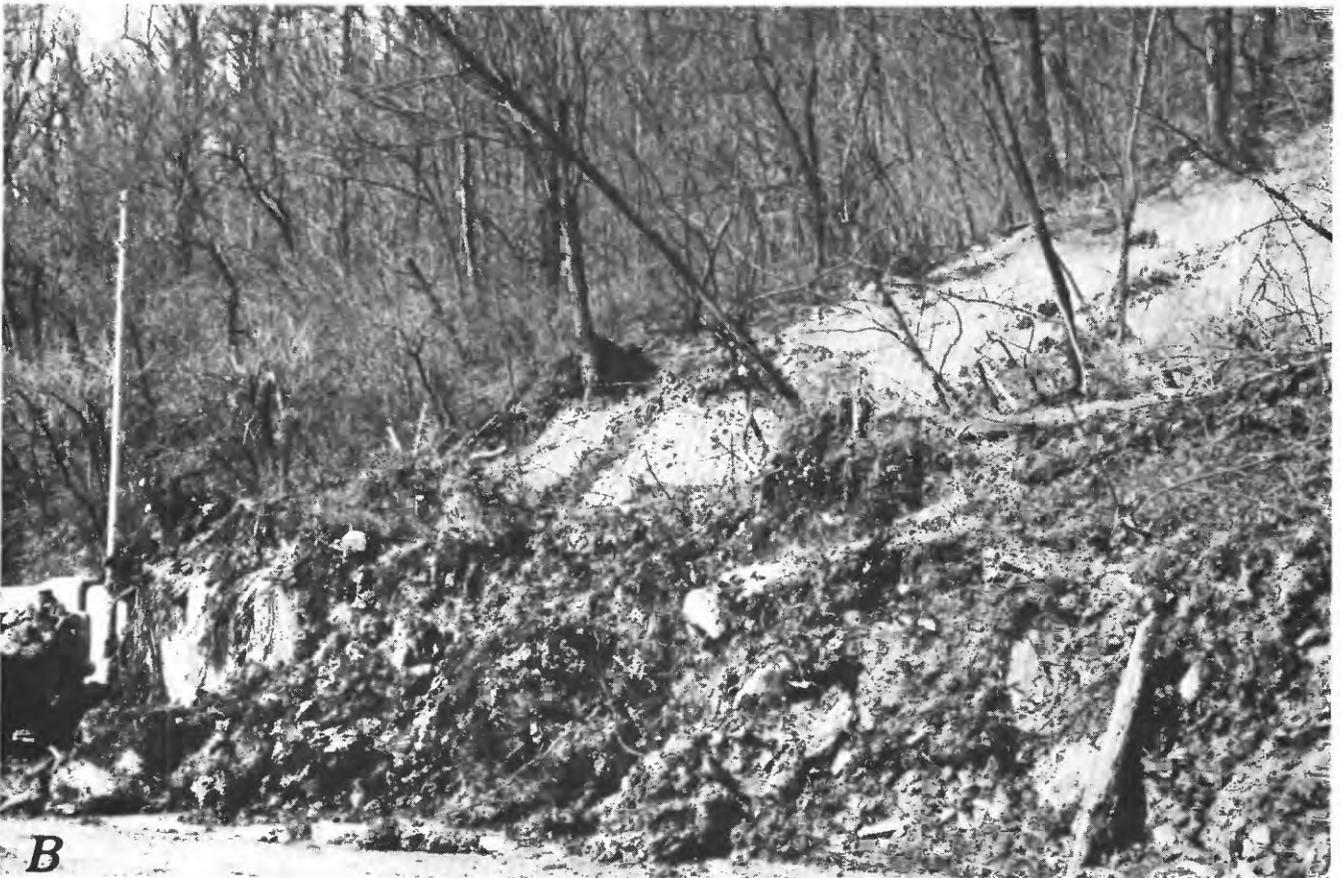
*B*

tree roots. Figure 14B shows a portion of the landslide debris that has spilled over the retaining wall onto Columbia Parkway. The retaining wall was not damaged by the shallow landslide, which, by the time it reached the wall, was moving over unfailed colluvium. Note the colluvium piled against the uphill side of the tree on the far left side of figures 14A and B. This movement history also is suggestive of a large drop in strength following initial failure of the landslide.

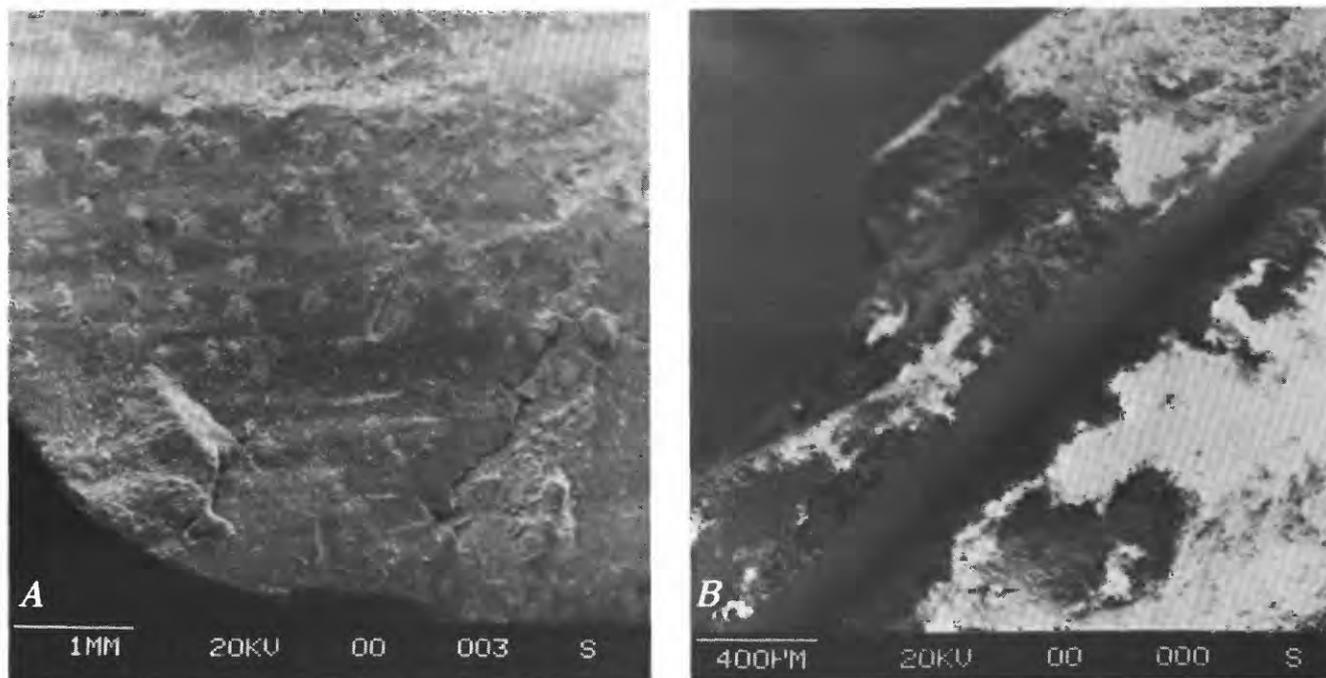
**Figure 16.** Scanning-electron micrographs of portions of the failure surface. *A*, View normal to a slickensided surface. *B*, View oblique to several subparallel slickensided surfaces.

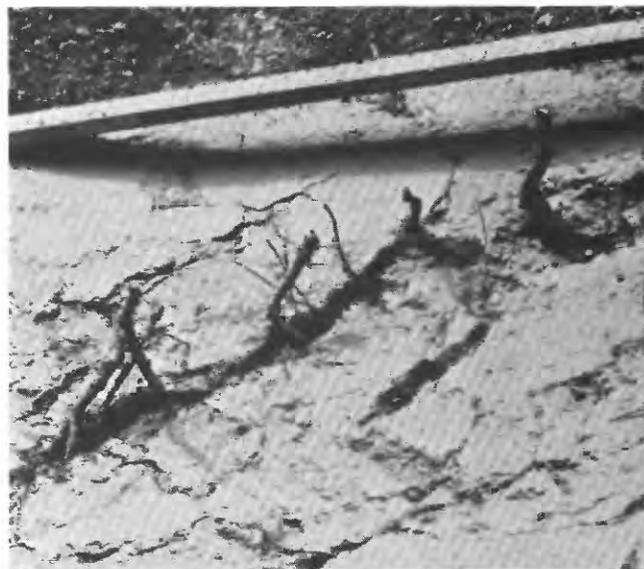
**Figure 17.** Kinked roots on an exposed failure surface. The abrupt kinks in the roots formed at the position of the failure surface. There were at least two failure surfaces at this position near the toe of the landslide, but the roots were deformed only along the surface exposed in the photographs. (Photograph by Mary Riestenberg, College of Mount St. Joseph.)
