GEOLOGICAL SURVEY CIRCULAR 31

LANDSLIDE PROBLEMS OF SOUTHWESTERN
COLORADO

By
Helen D. Varnes

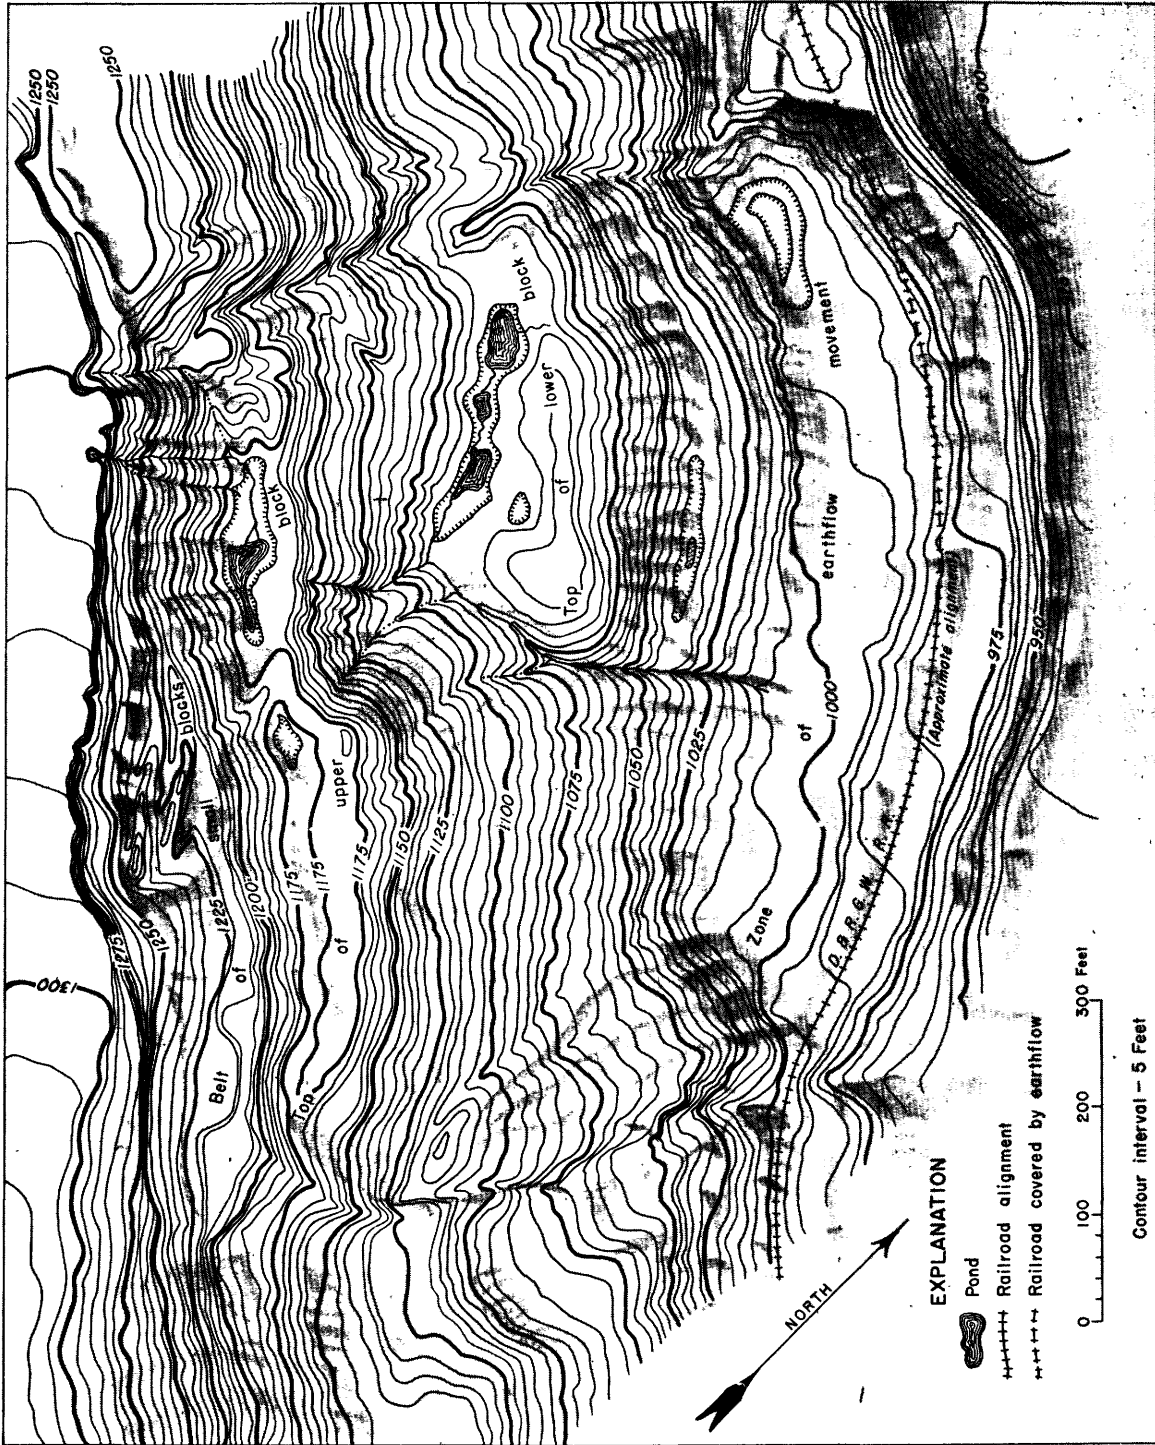
**FIGURE 3 — CEDAR CREEK LANDSLIDE
 NEAR MONTROSE, COLORADO**

The Cedar Creek landslide (fig. 3) was formed primarily by the breaking off and downward movement of large masses of Mancos shale along the north end of a mesa. The part of the slide above the 1040-foot contour (fig. 3) is composed largely of steeply like blocks of shale, which broke off and moved

types, large tilted blocks of shale and gravel in the upper part and ridged and rolling slopes of loose soil, clay and shale in the lower part. The scale and contour interval of figure 3 unfortunately do not permit adequate representation of several small but significant features, such as the small blocks at the head of the slide area, or the ridge and trough structure that characterizes the lower part.

The part of the slide above 1,040 feet is composed almost entirely of large blocks, the width of which increases progressively downward from the top of the slide. Just below the cliff that rises from the head of the landslide is a belt of small blocks. Some of these were recently separated from the mesa and still retain intact the complete gravel capping and cover of sage and other low brush. On the older blocks, repeated movements have shattered the gravel cap so that only a few elongated pinnacles of weakly cemented gravel remain. Rotation of these small blocks toward the slide plane is generally greater than 10°; one has a slope of as much as 25°.

From the base of the large blocks (1,040 foot-contour on fig. 3) down to the line of the railroad, the slide is composed of rolling slopes and ridged benches. These show the general characteristics of earthflow masses, although the portion immediately above the roadbed has been somewhat altered by roadbed relocations. The outstanding feature of this lower section is the development of pressure ridges and troughs, which closely parallel the toes of the slide blocks above them. As this mass of largely unconsolidated material moved down in front of the slide blocks, it piled up, ridged, and broke because its internal friction was greater than that of the better lubricated clays along the slip surface. The ridges are traversed by two sets of deep cracks. One longitudinal set of tension cracks follows the crests of the ridges; a second set of cracks is almost at right angles to the pressure ridges and forms a radial pattern from the toe behind them. This lower part of the slide is bounded on both sides by the prominent raised rims of shale and clay characteristic of earthflow masses.

Activating or initiating causes.—Actual movement in the Cedar Creek landslide can be attributed almost entirely to the relatively large amount of water supplied to that area. About 300 acre-feet of water is used each season in a 12-acre area immediately south of the active landslide. The porous boulder gravels take up all water not held by the top soil and transmit it along the gravel-shale contact. For a long period some of that surplus water contributed towards the establishment of the slip plane by working into the hairline joints characteristic of the more massive phases of the Mancos. The initial quantity able to penetrate such joints below the gravel-shale contact would have been almost negligible. Over a sufficient period of time, however, continued action of the

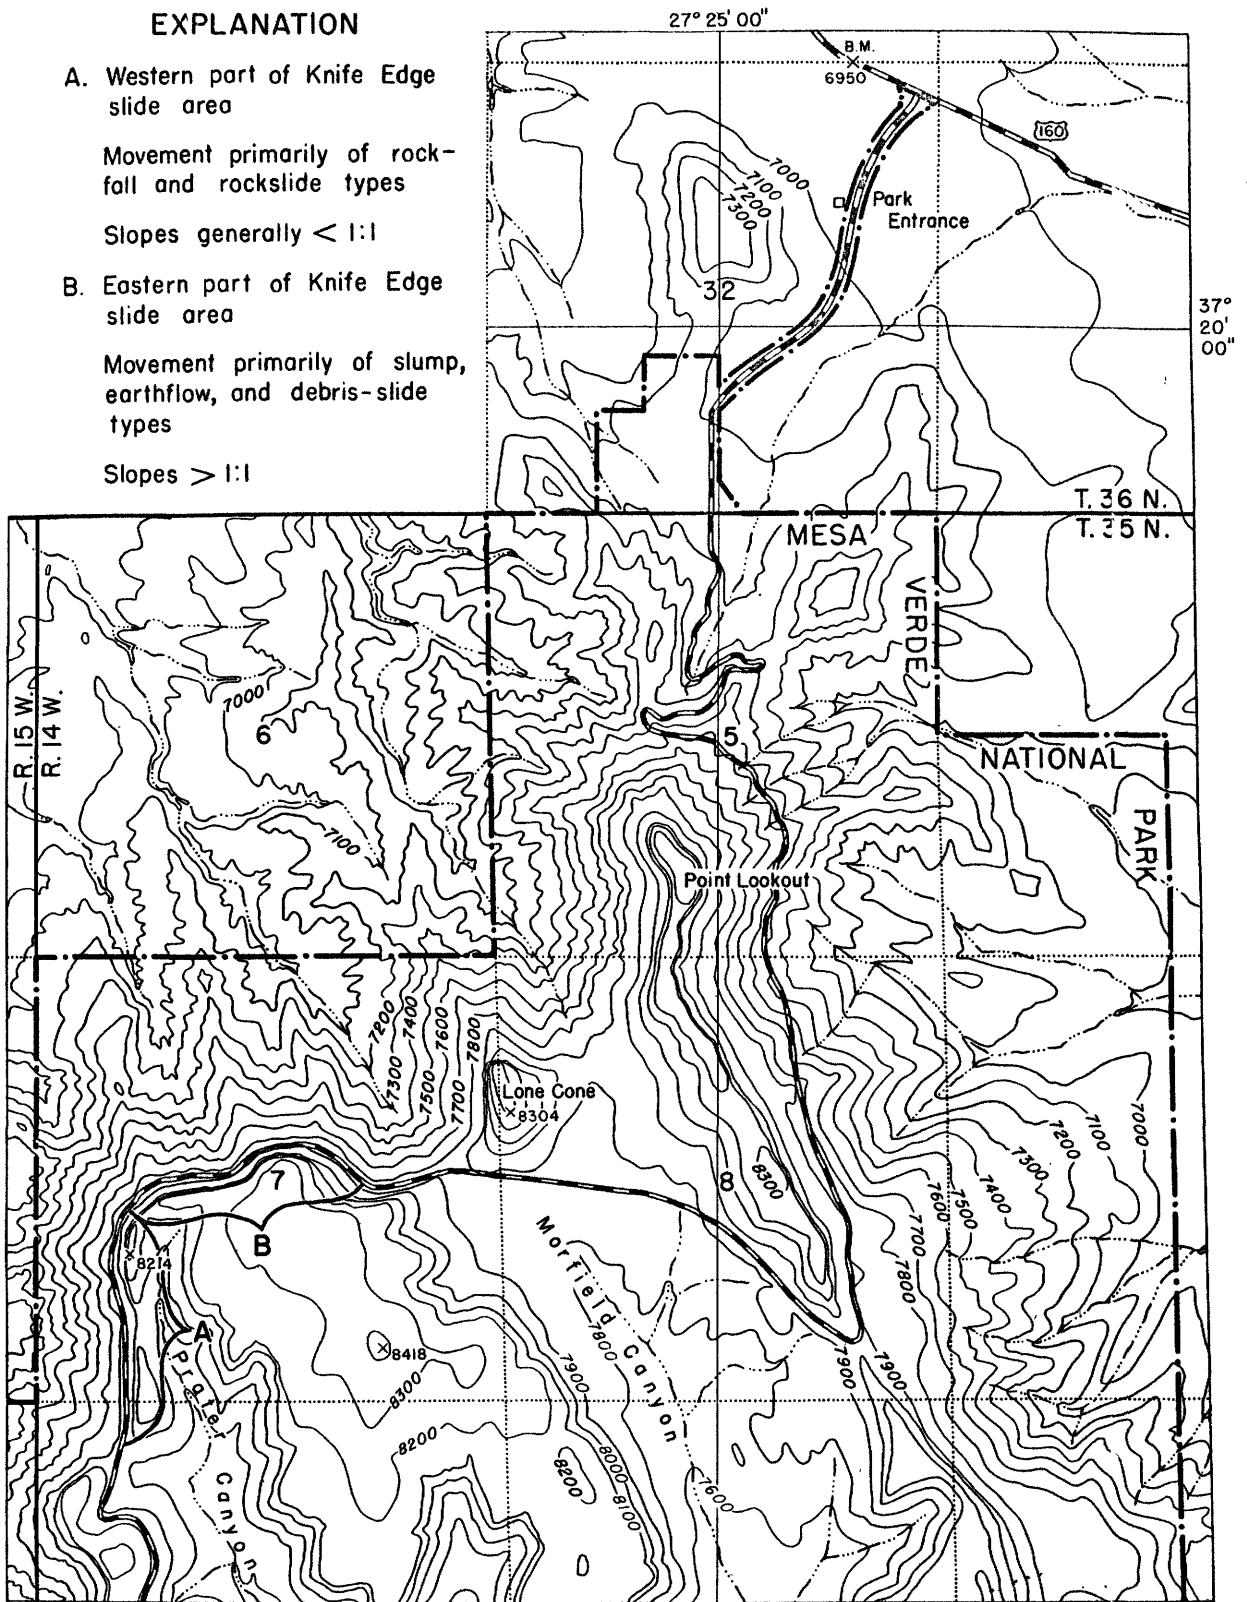
FIGURE 4 — KNIFE EDGE LANDSLIDE AREA AT NORTH END OF MESA VERDE NATIONAL PARK

Edge." (See fig. 4.) This area was the focal point of reconnaissance studies in Mesa Verde National Park during the 1946 field season, because it represents a kind of slope failure that is common to the Mancos formation of the southwestern Colorado plateaus but is different in several respects from the Cedar Creek landslide.

Activating causes.—Removal of support through natural and artificial means is the outstanding activating cause of movement along the Knife Edge. Rapid weathering of the soft shales has continually undermined the resistant sandstone caprock, so that the escarpments are always retreating by means of rockfalls and slides. Construction of the road has considerably accelerated removal of the shale through weathering and washing as well as sliding.

Knife Edge landslide area.—No satisfactory solution has yet been found for this landslide area. Although the drainage area supplying water to the slide faces is very limited, the extreme oversteepening in the weak shale gives the small quantity of water a maximum effectiveness. One section of the oversteepened shale face was coated with gunite in an attempt to reduce weathering and disintegration of the shale. Water working down from the capping sandstone and along joint and bedding planes and sandy lenses in the shale has caused most of the gunite to push away from the face and to spall off. Steel cribbing was installed along one stretch to hold the fill in place and to stop subsidence and sliding of the road. In general, this has proved successful, although some displacement of the cribbing has occurred.
