# Notes on Earth Fissures in Southern Arizona

GEOLOGICAL SURVEY  
CIRCULAR 466

**By G. M. Robinson and D. E. Peterson**

**Washington 1962**

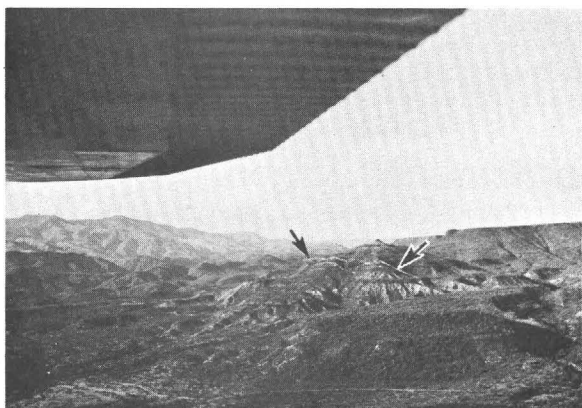
Figure 1.—Aerial views looking north at fissures near Black Canyon; A, distant view; B, closer view. Light-colored areas indicate the recent exposures. Photographed on February 1, 1962, by H. T. Chapman and A. E. Robinson.

The sequence, in time, of the fissure development is not known. Aerial photographs of the general area, taken from an altitude of about 11,000 feet in 1936, clearly show the east-west traces of earlier fissures developed in conjunction with faulting. On February 1, 1962, however, Phoenix newspapers reported the discovery by local residents of new earth movement in the fissure area. The exact time of occurrence seems to have gone unnoticed but air and ground inspection confirmed that the movement was indeed new and that it had been substantial. A photograph (fig. 1A) taken on February 1, 1962, from a

low-flying light plane, shows (white trace between arrows) freshly exposed areas on the face of the uppermost fissure or fault in relation to the local relief. The vertical interval from the valley floor (approximate elevation 2,100 feet, mean sea level) to the small cone-shaped hill that rises to the distant skyline (right of center) is between 600 and 700 feet. A similar photograph (fig. 1B) on the same date gives a closer aerial view of this and adjoining major fissures. The cone-shaped hill is again a convenient reference marker. A vertical aerial photograph (fig. 2) taken from an altitude of about 4,000 feet (mean sea level) identifies the major fissure pattern. The fresher and lighter appearing areas, along the northernmost fissure in the photograph, identify the new exposures associated with the most recent earth movement. The duller and darker areas denote exposures dating back to earlier movements. These details, as well as the vertical movement (about 10 to 15 feet) at this particular fissure, show to advantage in figure 3A, as photographed on February 3, 1962. The black band (fig. 2) along the lower or southernmost principal fissure is the shadow that the sharply defined southern rim casts into the opening. The opening size can be judged from figure 3B, photographed on February 3, 1962, from a ground vantage point on the fissure rim at about the western quarter point with respect to its length as indicated in figure 2.

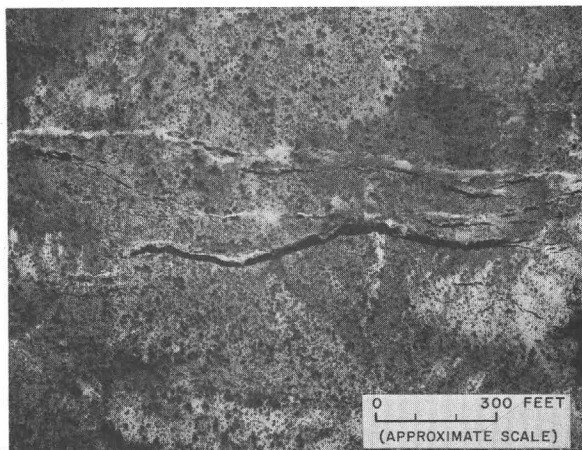
Figure 2.—Aerial photograph from altitude of 4,000 feet showing principal fissures near Black Canyon. Photographed on March 26, 1962, by H. T. Chapman.

Figure 2 is one of a series of six overlapping aerial photographs which when viewed stereoscopically give dramatic evidence of the substantial earth movement. At each opening the earth or rock material appears to have failed in tension or to have been literally pulled apart. The photographs show no significant differential horizontal movement along the fissures. Elongate islands or blocks of material, created when fissures intersected one another, in some instances settled or slumped as grabens. Examples are found by carefully studying stereoscopically various pairs of fissures.

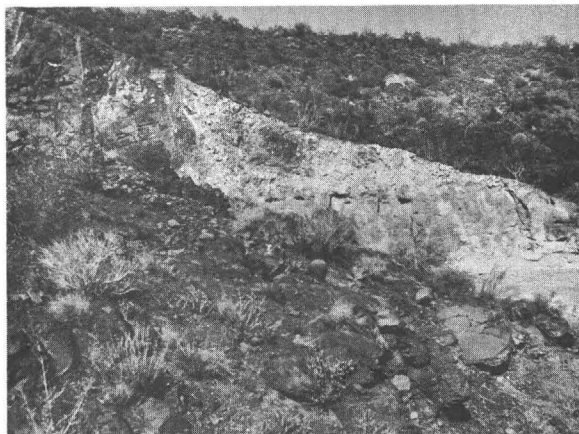
A

Figure 3.—Ground views of uppermost and lowermost principal fissures near Black Canyon. A, View looking north at vertical displacement near east end of slippage fault produced by upper fissure. B, View looking west at size of opening near western end of lower fissure. Photographs taken on February 3, 1962, by H. T. Chapman.

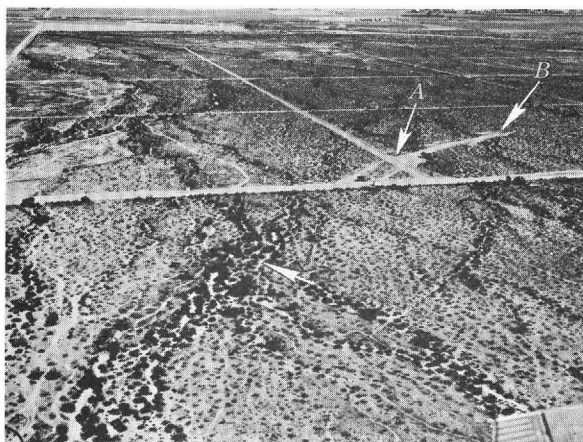
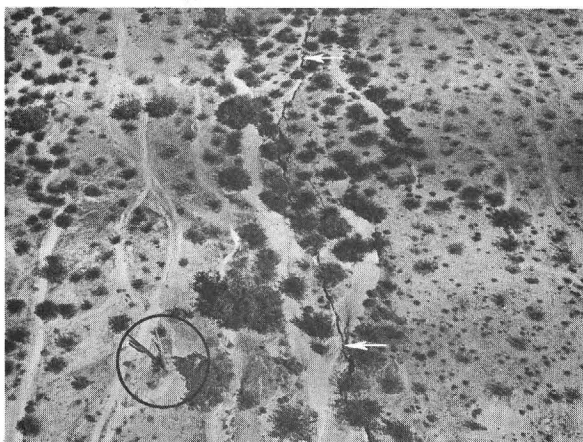
Close to the northernmost flank of Santan Mountain, approximately 30 miles southeast of Phoenix and 12 miles southeast of Chandler, local residents report that earth fissures have occurred on several occasions. The fissures are oriented roughly parallel to the nearest exposed segment of the mountain mass (pl. 1). The trace of a spectacular opening that formed in 1961 is marked on photographs (figs. 4A and B), which were taken from the air on February 10, 1962, to show the fissure site and part of the surrounding area. The lower left part of figure 4A is viewed closer up in figure 4B to show more clearly some details of the fissure trace. The circled saguaro cactus, about 30 feet tall, is also partly circled in the lower left corner of figure 4A. Irrigated land is visible to the north (fig. 4A) of the fissure site but the principal irrigated acreage and area of ground-water withdrawal lies to the northwest. The white scar bracketed by arrows A and B marks the interval in which the fissure terminated. The area was reworked by earth-moving equipment to fill the fissure. The magnitude of the fissure opening is graphically revealed in figure 5, as photographed on September 16, 1961, from a ground site near arrow A (fig. 4A). These photographs suggest that again the earth material has simply pulled apart. No differential horizontal movement can be seen along the fissure and no differential vertical movement is apparent. Where islands or blocks of material have been left standing in the larger openings some crumbling and slumping have occurred.

Figure 4.—Aerial views looking north at fissure near Chandler Heights. A, General view of the area with arrows denoting fissure trace. B, Closer view of fissure trace with same saguaro cactus circled. Photographs taken on February 10, 1962, by H. T. Chapman and A. E. Robinson.

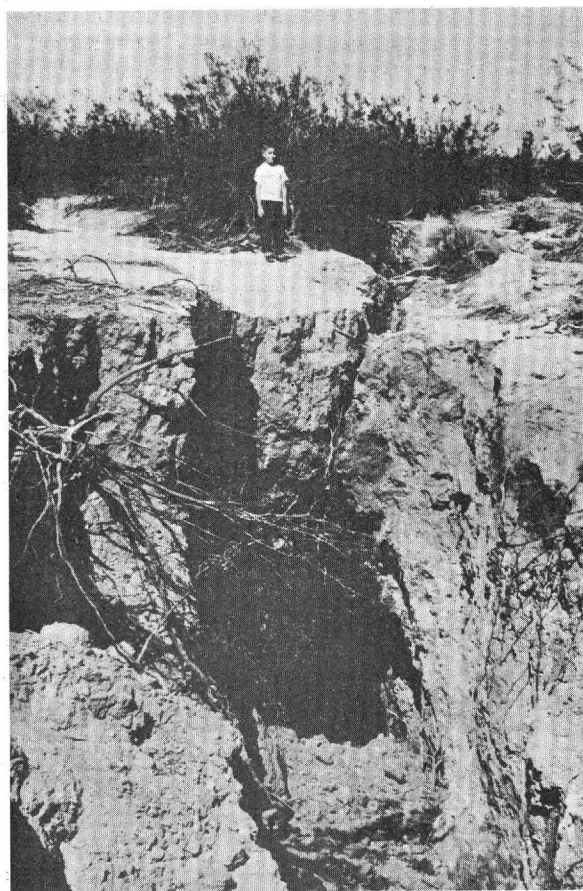
Figure 5.—Magnitude of fissure opening near Chandler Heights, viewed from site marked by arrow A in figure 4A. Photographed on September 16, 1961, by D. E. Peterson.

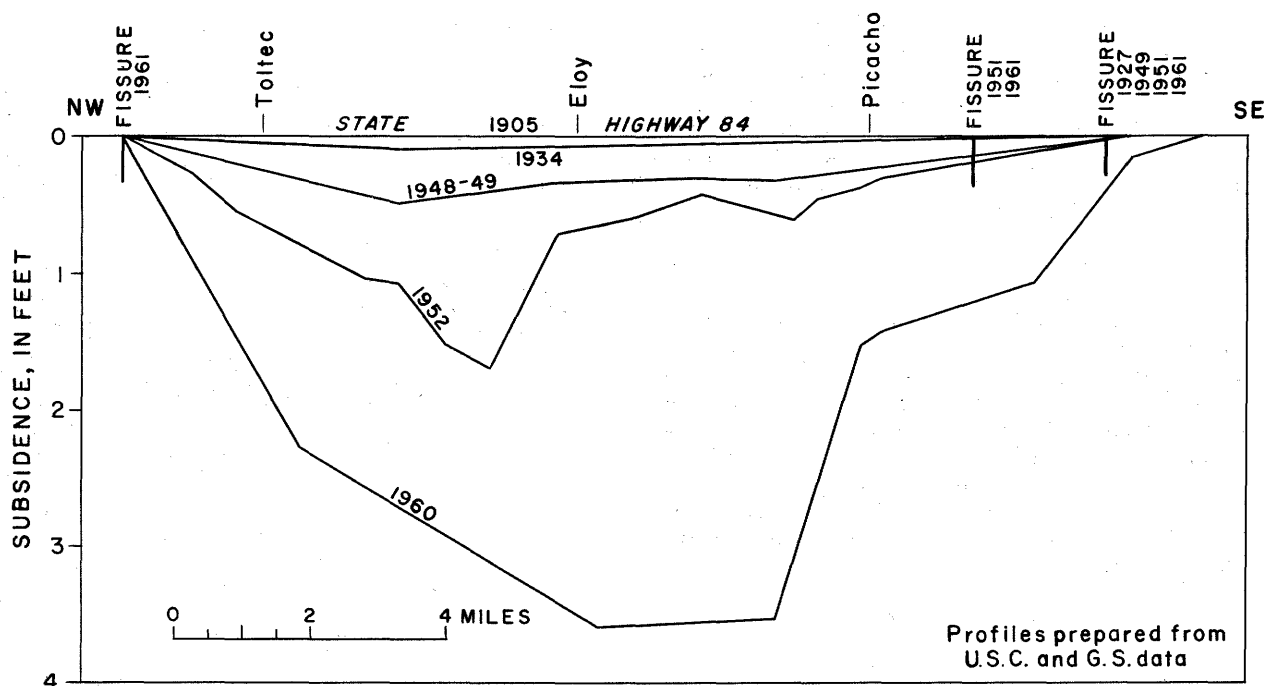
First-order leveling and subsequent checks, by the U.S. Coast and Geodetic Survey, of bench marks along Arizona Highway 84 yield extremely valuable subsidence data. The surveys span the 55-year period from 1905 to 1960 and show (fig. 6) how markedly subsidence rates have increased in the valley alluvium, especially in the Eloy-Picacho region. Of particular interest is the fact that the data show some land-surface subsidence

centered around Eloy over the period from 1905 to 1934, before extensive ground-water development. However, the process seems to have been greatly accelerated, probably beginning in 1936, by the effects of persistently increasing ground-water pumpage and application of the water to the steadily increased acreage placed under cultivation. The correlation between subsidence rate and ground-water development is strengthened by noting (fig. 6) how the point of maximum subsidence migrated southeastward with time. This roughly correlates with the similar shift in the deepest part of the cone of depression in the water table. Maximum subsidence along the profile is now approaching 4 feet.

Also shown in figure 6 are the points at which several observed earth fissures intersect the profile along Arizona Highway 84. As might be expected, the fissures are near the outer limits of the subsidence profiles where the earth material could have been subjected to tensile stresses.

The fissure shown at the extreme right in figure 6, at a point on Highway 84 about 3 miles southeast of Picacho, is the one described by Leonard (1929) as having first opened in September 1927. Subsequent filling and reopening of this and other fissures in the general area are described by Heindl and Feth (1955). Leonard's description mentions the fissure length as one-fourth mile; it is now at least 8 miles long. Part of the fissure appears in a photograph (fig. 7A) taken on August 6, 1961, looking northeast across

Figure 6.—Changes in land-surface elevation in the Eloy-Picacho area, Pinal County, Arizona.

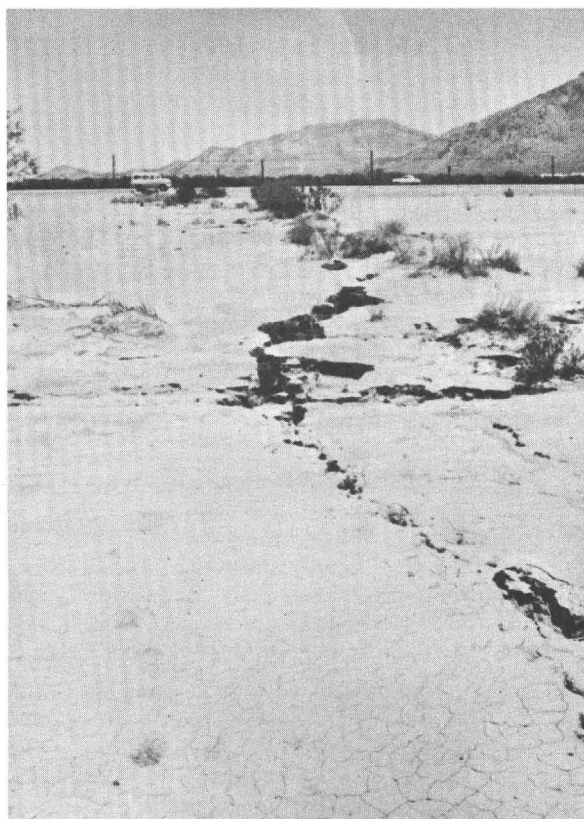
Figure 7.—Views looking northeast at fissures crossing Arizona Highway 84 near Picacho Mountains. A, Fissure 3 miles southeast of town of Picacho; 2 days previous width appeared less than half an inch; torrential rain on previous day revealed this opening; note vegetal growth along fissure. B, Fissure 1 mile southeast of Picacho. Photographs taken on August 6, 1961, by D.E. Peterson.

Arizona Highway 84 at the distant Picacho Mountains. A second photograph (fig. 7B) shows a similar fissure about 1 mile southeast of Picacho. Again the view is northeastward across Highway 84 with the Picacho Mountains in the distance. Note the absence (figs. 7A and B) of differential vertical or horizontal movement along the two fissures. The openings are characterized by clean breaks and near-vertical walls.

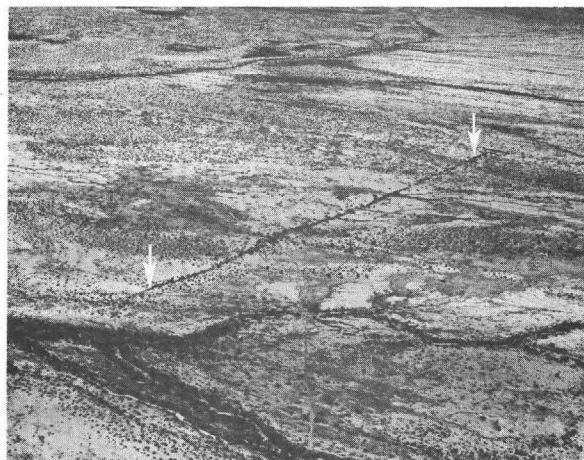
Figure 8.—Aerial view looking northeast at east-west trending fissure near Sells. Fissure intersects, nearly at right angles, a wash that is tributary to Chukut'Kuk Wash. Photographed on February 8, 1962, by H. T. Chapman and A. E. Robinson.

An earth fissure 1/2 to 3/4 mile long was first observed in the early 1950's by personnel of the Bureau of Indian Affairs. The fissure is about 12 miles southwest of Sells near (east of) the Indian settlement of Chukut Kuk (pl. 1), in an area where irrigation farming, using ground water, has not been extensively practiced. A photograph (fig. 8) taken on February 8, 1962, from a low-flying light plane shows the straight east-west fissure trace intersecting at right angles with a wash tributary to Chukut Kuk Wash.
