Effects of the Truckee California, Earthquake of September 12, 1966

By Reuben Kachadoorian, R. F. Yerkes, and A. O. Waananen

GEOLOGICAL SURVEY CIRCULAR 537

A contribution to west-coast earthquake investigations

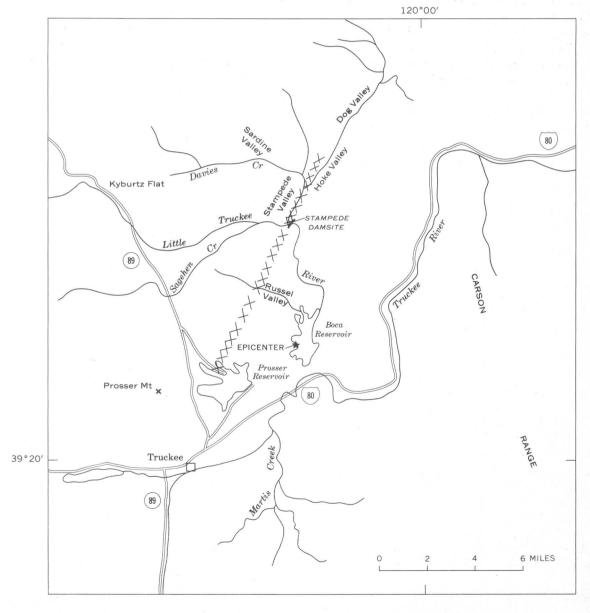
FIGURE 2.—Location of zone of ground breakage.

Minor but extensive ground breakage occurred in a zone about 10 miles long that trends about N. 30° E.; the zone ranges in width from about 75 ft near Prosser Reservoir and Hoke Valley to about 1 mile in Russel Valley. Ground breakage was confined to low elongated areas of unconsolidated natural fill, commonly subparallel to the zone. The breakage is expressed locally as cracks, slightly sinuous small ridges, wedges, and mounds of freshly disturbed soil and turf; the linear features are commonly oriented subparallel to the zone and are as much as 20 ft long. Pebbles were locally overturned. All these effects are attributed entirely to shaking but are in no case associated with lateral spreading of the ground toward an unconfined face. They may be, however, associated with the effects of topography on the passage of gravitational waves. (See Coulter and Migliaccio, 1966, p. 20.)

Alinement of the zone of ground breakage with the trend of a fault exposed at the Stampede damsite (fig. 2) suggests an association with the fault; however, a thin veneer of undisturbed soil overlying the fault trace indicates that movement did not occur here during the earthquake.

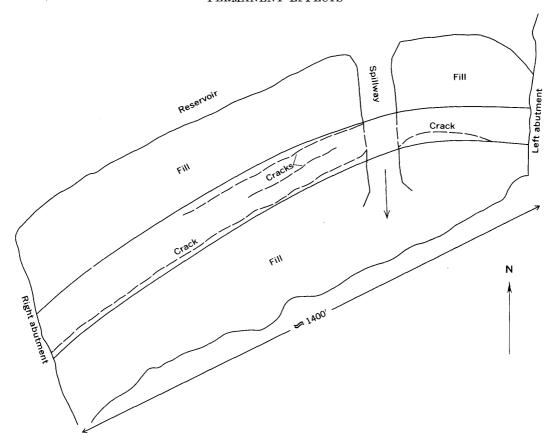
Prosser Dam is located about 3 miles southeast of Russel Valley and within a mile of the zone of ground breakage (fig. 2). The dam rests upon lake sediments and apparently received severe seismic shaking. Two axial cracks, one on the downstream side and one on the upstream side of the dam, developed along the northeastward-trending crest and extended over most of its length (figs. 4 and 5). A third less conspicuous crack was confined to the center of the crest. Drill holes by the Bureau of Reclamation indicate that the cracks do not extend into the impervious core of the dam (Brent Crater, oral commun., 1966). Maximum downslope displacement of the well-graded selected compacted fill of 2 in. vertically and 3 in. horizontally occurred in the vicinity of the spillway (fig. 6).

FIGURE 4.—Plan-view of Prosser Dam showing extent and relative locations of cracks in crest of dam.

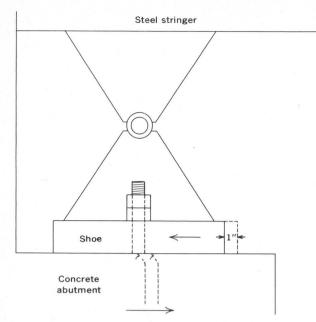
Damage to the westbound lane bridge at Union Mills was less severe than that to the eastbound lane bridge. The concrete pedestals of the westbound lane bridge were displaced as much as 11/8 in. relative to the shoe plate by which the stringers

are attached to the pedestal, and some lateral displacement downslope of the abutments and pedestals of both approaches occurred (fig. 9).

FIGURE 9.—West abutment of westbound lane bridge, Interstate
Highway 80 at Union Mills; arrows indicate displacement of
pedestal relative to span.

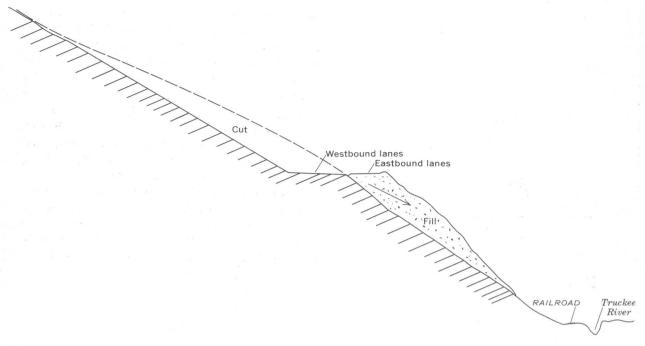
Artificial fill along a 3-mile section of Interstate Highway 80 southeast of Boca Reservoir locally slumped during the earthquake. The longest of these slumps was a 1,100-ft section near Hinton that failed along the cut-fill contact and resulted in displacements of as much as 6 in. horizontally and 10 in. vertically (figs. 10 and 11). The several smaller failures along the 3-mile section southeast of Boca Reservoir were chiefly in the eastbound or outer lanes or in filled sections of the highway. The failures occurred at the cut-fill contact.

FIGURE 11.—Schematic section of Interstate Highway 80 near Hinton showing location of break at cut-fill contact.
