Preliminary Report on the
Geologic Events Associated
With the May 31, 1970,
Peru Earthquake

By George E. Ericksen and George Plafker,
U.S. Geological Survey, and
Jaime Fernández Concha, Lima, Perú

GEOLOGICAL SURVEY CIRCULAR 639

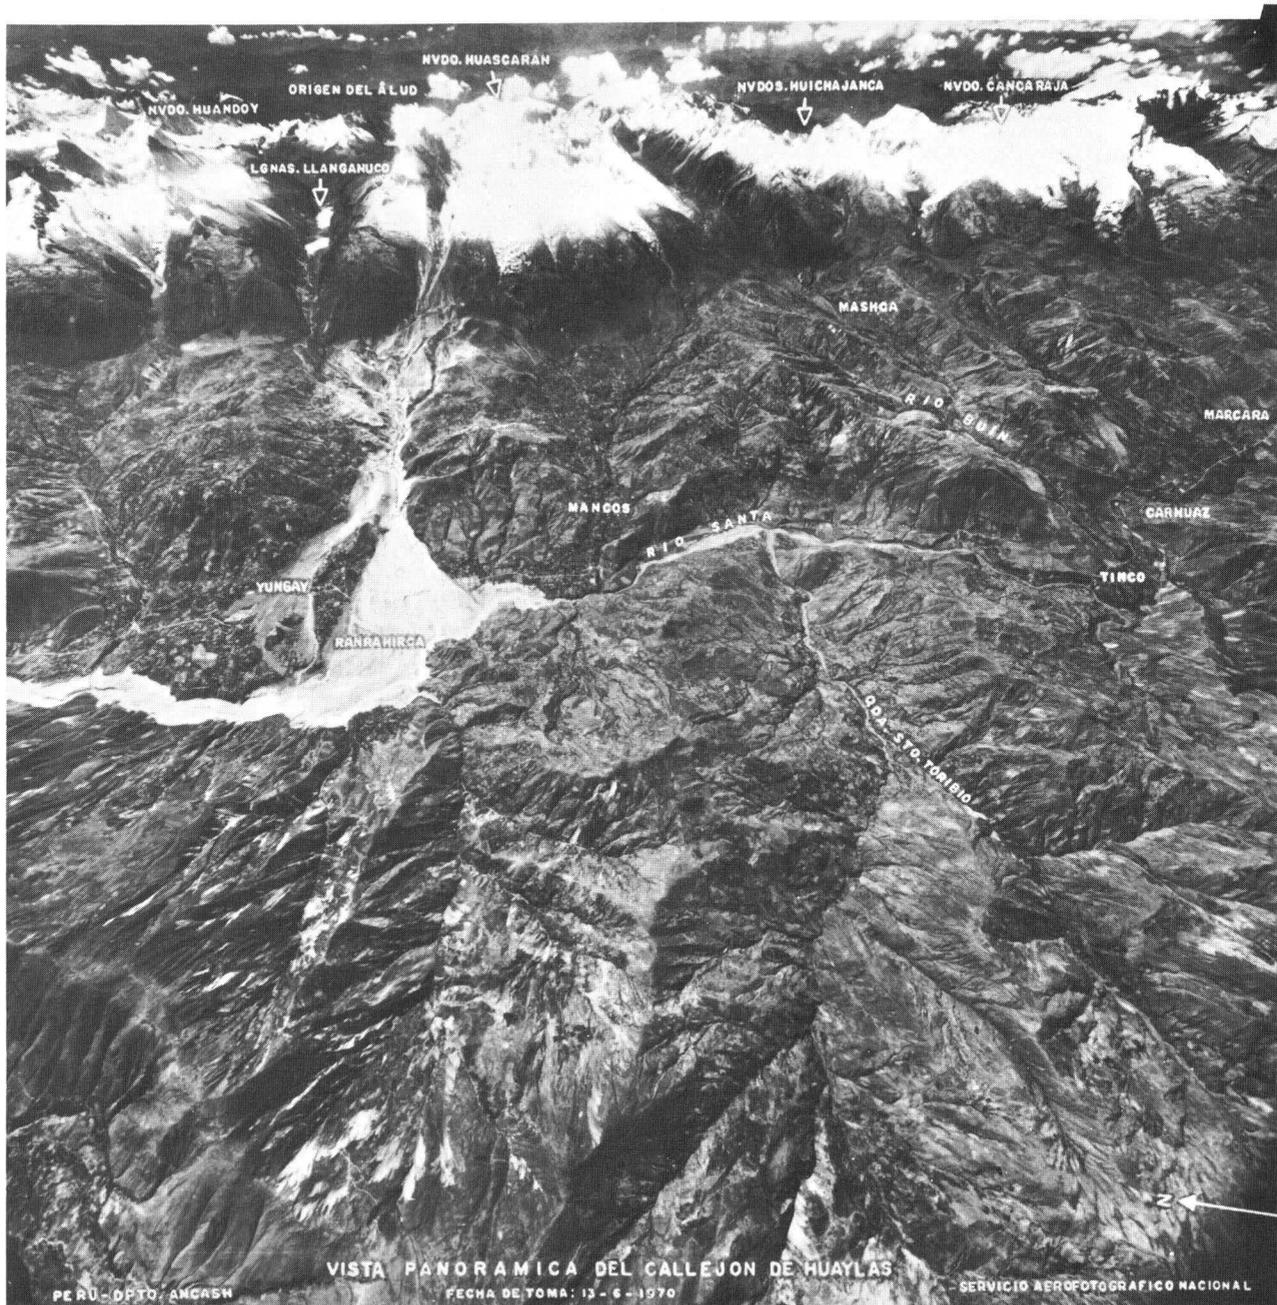
Figure 2.—Oblique aerial view of Nevados Huascarán and the Huascarán debris avalanche that destroyed Yungay and Ranrahirca.

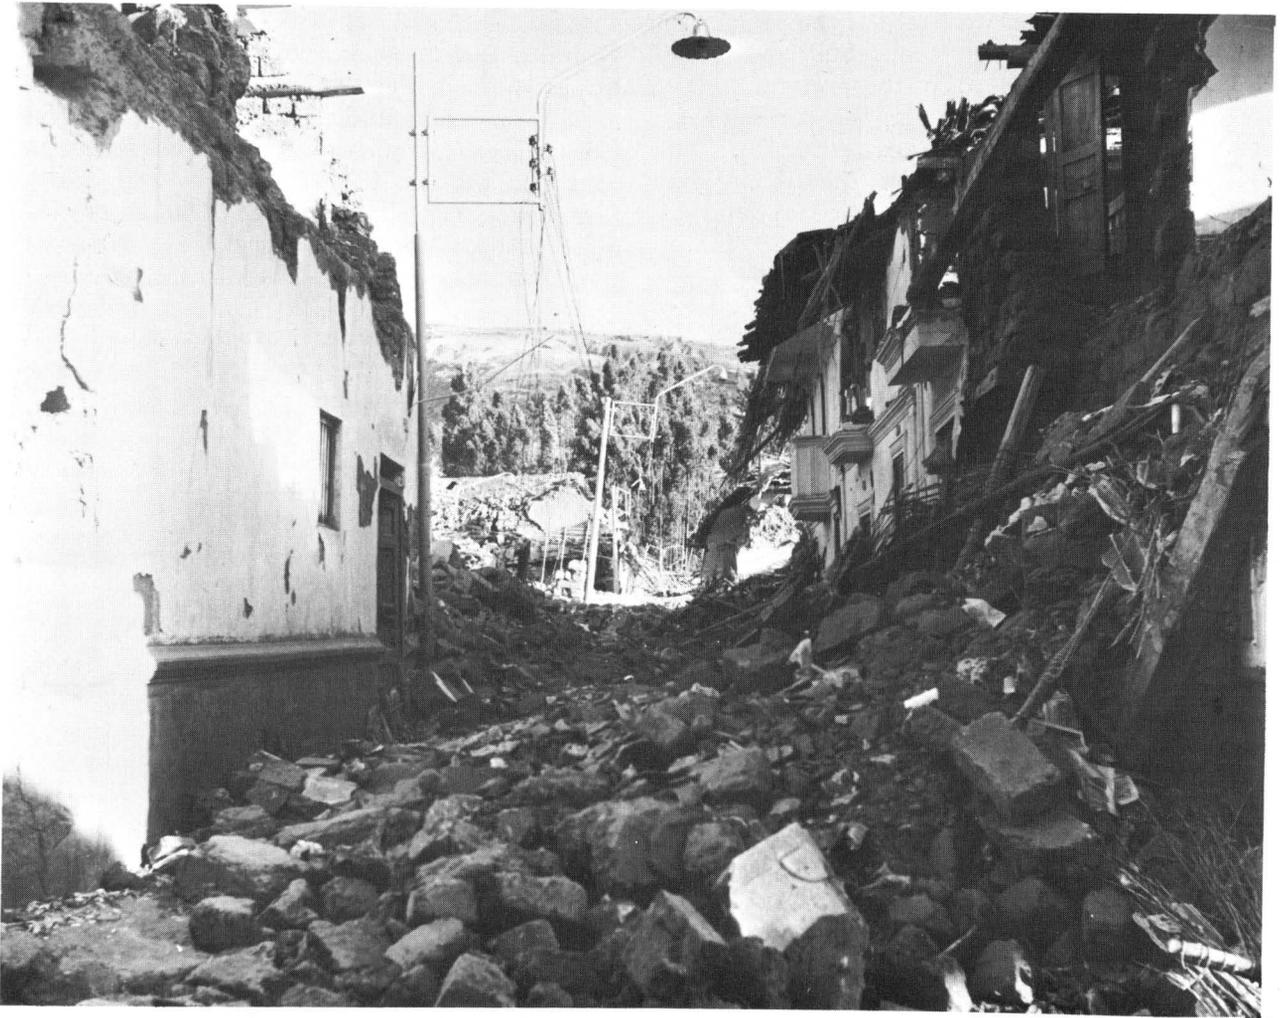
Figure 3.—Destruction of adobe buildings in Huaraz as a result of the May 31, 1970, earthquake.

100 square blocks now is a mass of rubble and broken adobe walls where streets are filled with rubble to depths of as much as 10 feet. Figure 3 is a typical street scene in this area of Huaraz. At the time of our visit (end of June 1970), local authorities estimated that several thousand people were still buried beneath the rubble of collapsed buildings. In striking contrast to this adobe disaster, most of the few buildings in Huaraz that were built of brick with reinforced concrete frames, including one of four stories and one of five stories, were only slightly to moderately damaged. On the other hand, a four-story school building of reinforced concrete and brick with inadequate shear walls did collapse.

In summary, there are no geologic conditions precluding reconstruction of Huaraz at its present site. The main preoccupations in reconstruction should be the widening of streets and limiting of height of unreinforced adobe buildings to one story.

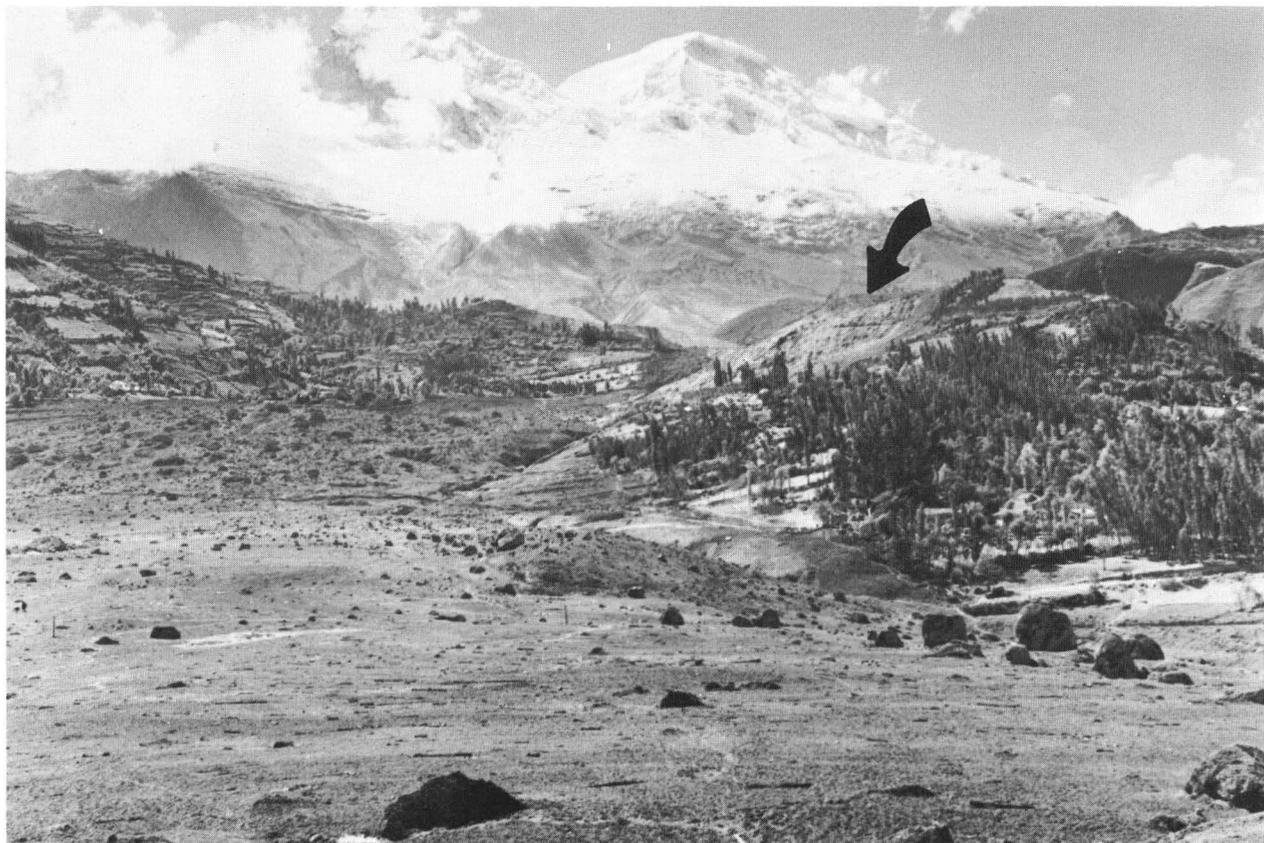
An area of more than 15 sq km was devastated. Yungay was obliterated by a relatively small tongue of mud and rock several meters thick that swept over a ridge 100–200 meters high that stood between Yungay and the main stream of the avalanche, which followed the Rio Llanganuco Valley to the south (fig. 4). Only the tops of a few palm trees in the central plaza and part of the main cathedral now protrude above the mud, and mark the site of this formerly prosperous and picturesque city.

Figure 4.—A lobe of the Huascarán debris avalanche that now covers the former city of Yungay; the avalanche flowed over a 100- to 200-meter-high ridge (arrow) between Yungay and Llanganuco Valley.

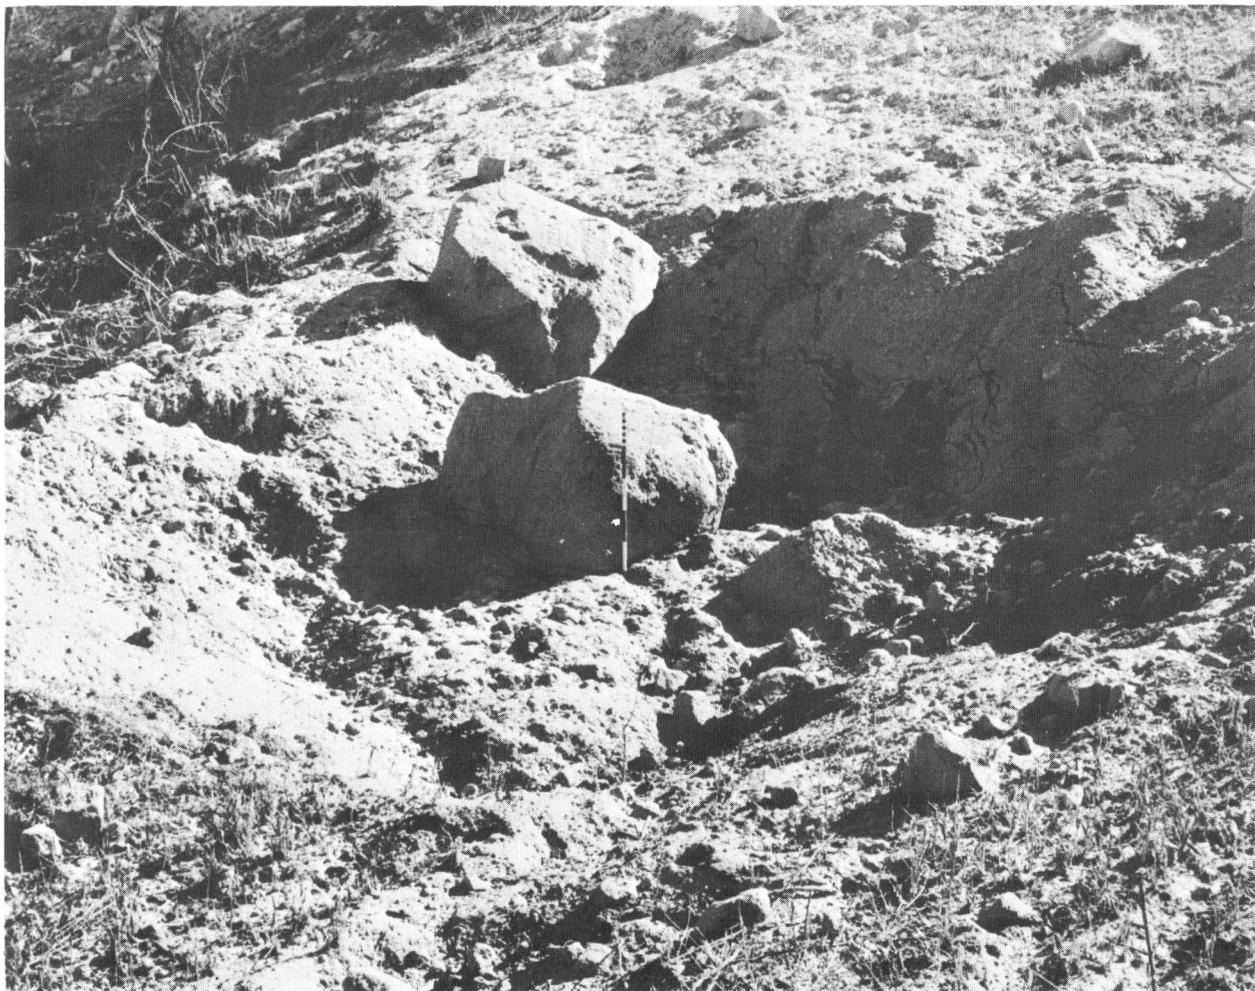
Figure 5.—Large impact crater (2.5 meters deep, 7 meters wide, and 11 meters long) in field at the south side of Quebrada Llanganuco, which was made by a huge block of rock or cluster of rocks hurled several hundred meters by the Huarascán debris avalanche. All rocks in or near crater are projectiles or fragments of projectiles from the avalanche. The two large rocks in the crater are about 2½ meters in longest dimension.

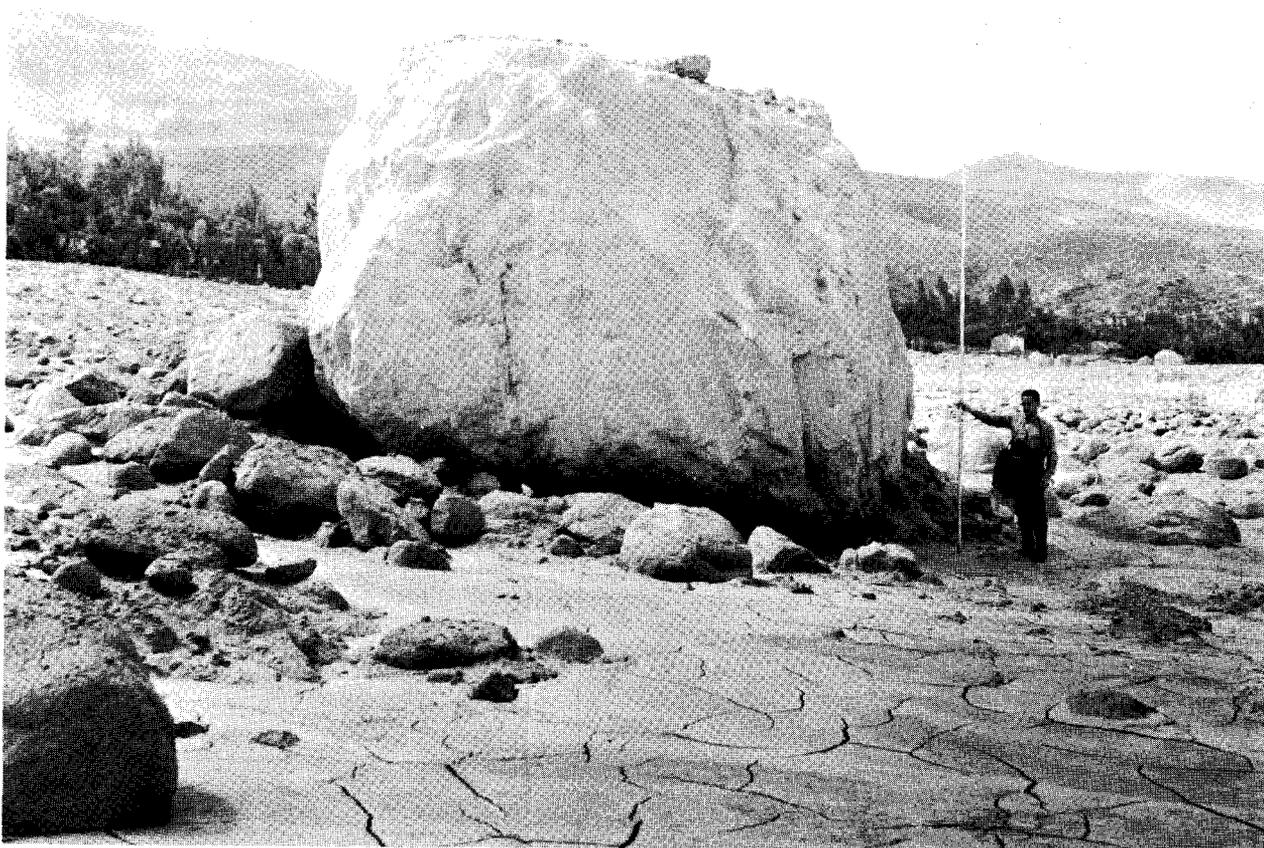
Figure 6.—Block of granodiorite (estimated to weigh 700 tons) that was transported by the May 31, 1970, Huascarán debris avalanche, located near the site of the former town of Ranrahirca. Layer of mud showing polygonal cracks resulted from seepage from the avalanche after it had come to rest. Top of block is covered with mud and rock fragments deposited by the avalanche after the block had come to rest.

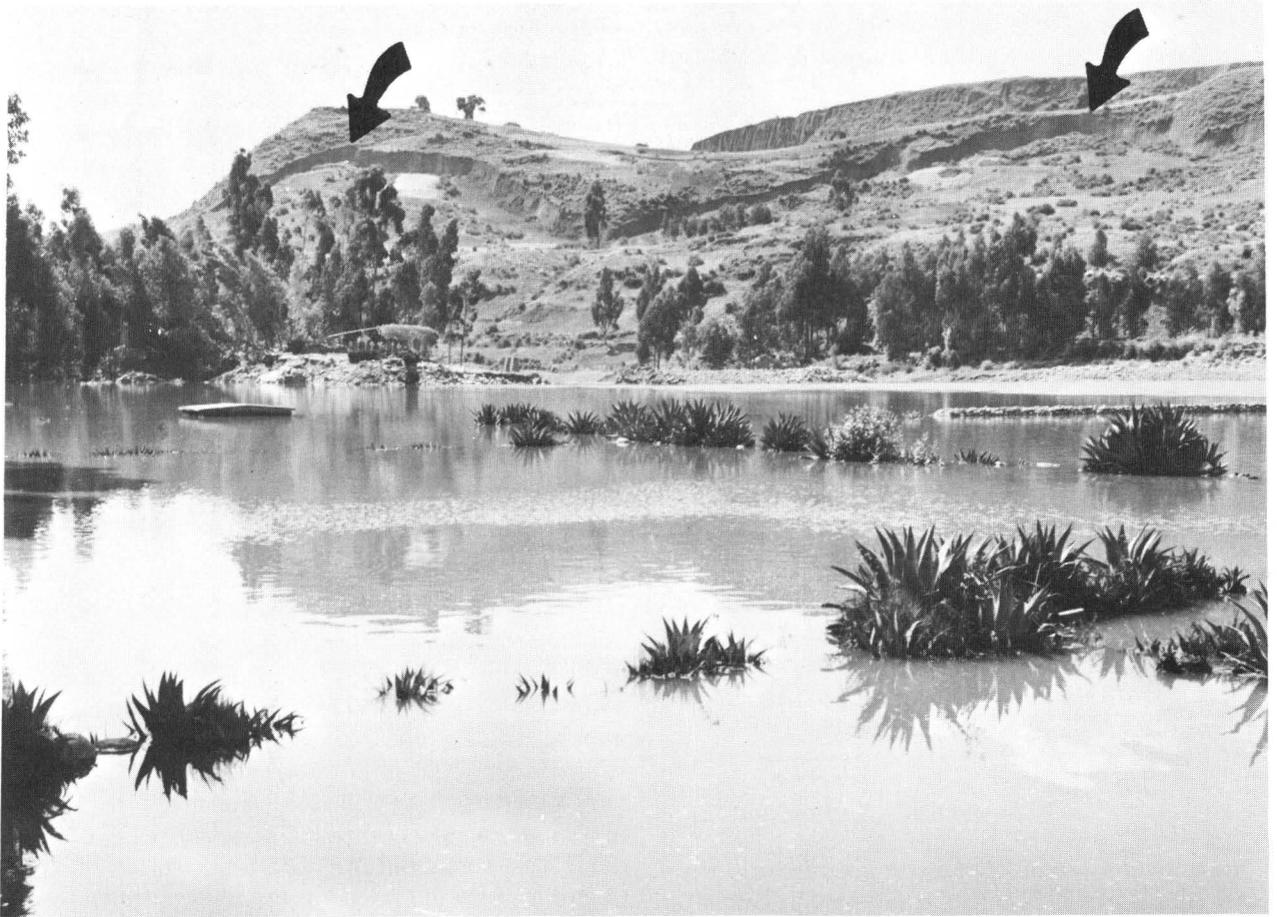
A large rotational slide was observed along the east bank of the Río Santa at Recuay (fig. 7). This slide involves a block of fluvio-glacial sediments about 1 km long and 100–200 meters high above river level, and has a headwall scarp estimated to be as much as 15 meters high. At its northern end, the toe of the slide extends across the Río Santa, which is about 50 meters wide at this point. The rotational movement thrust the river bottom upward about 5 meters, thereby blocking flow of the Río Santa. This landslide-dammed lake is described below.

Figure 7.—Rotational slide in unconsolidated fluvio-glacial sediments, east side of Rio Santa at Recuay; a small lake formed behind toe of slide. Headwall of slide (arrows) is as much as 10–15 meters high.

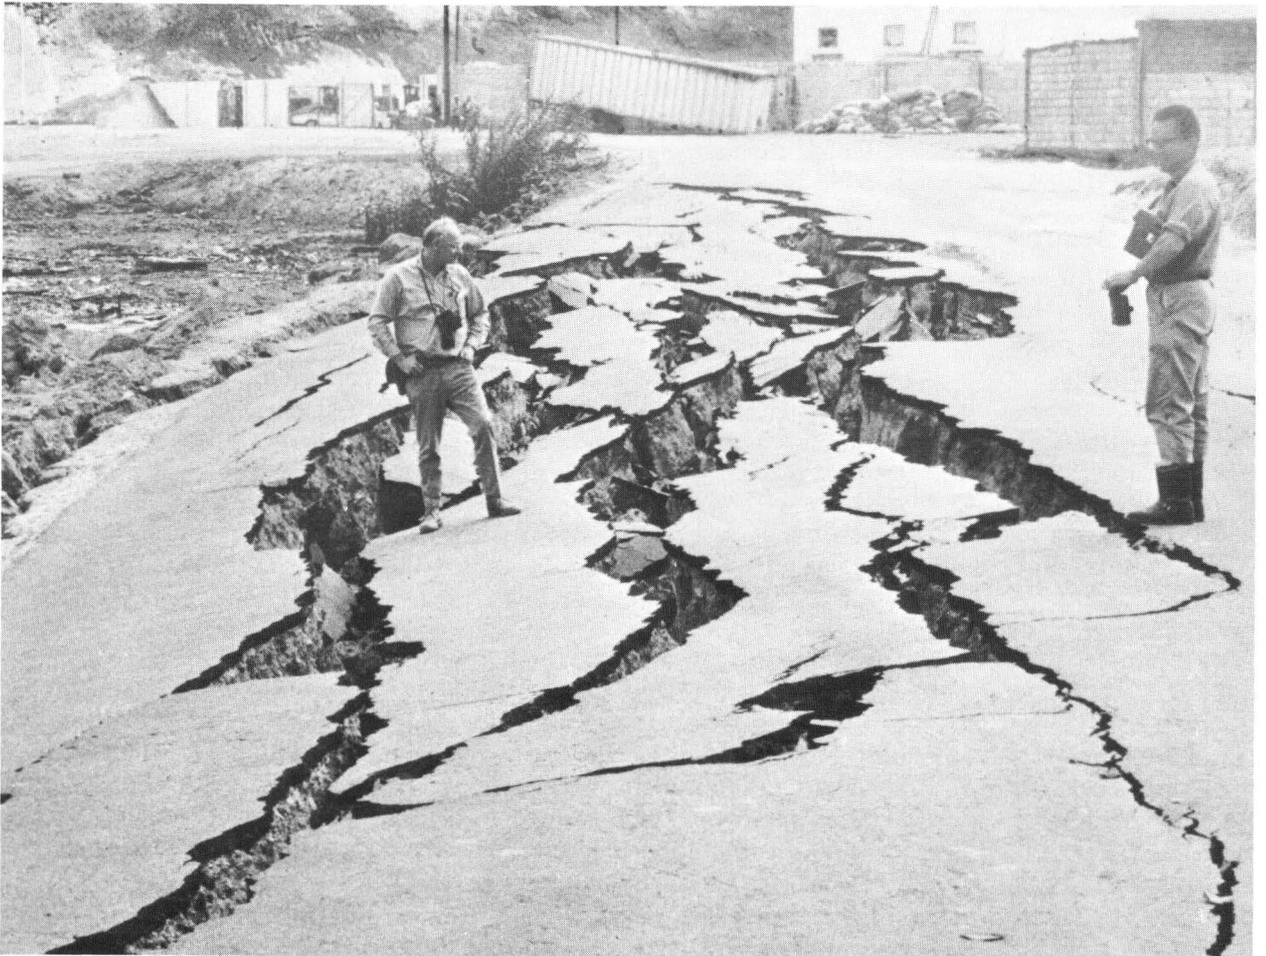
Figure 8.—Slumping and fissuring of paved road near the bay shore in western Chimbote due to liquefaction and lateral spreading of water-saturated beach sediments.

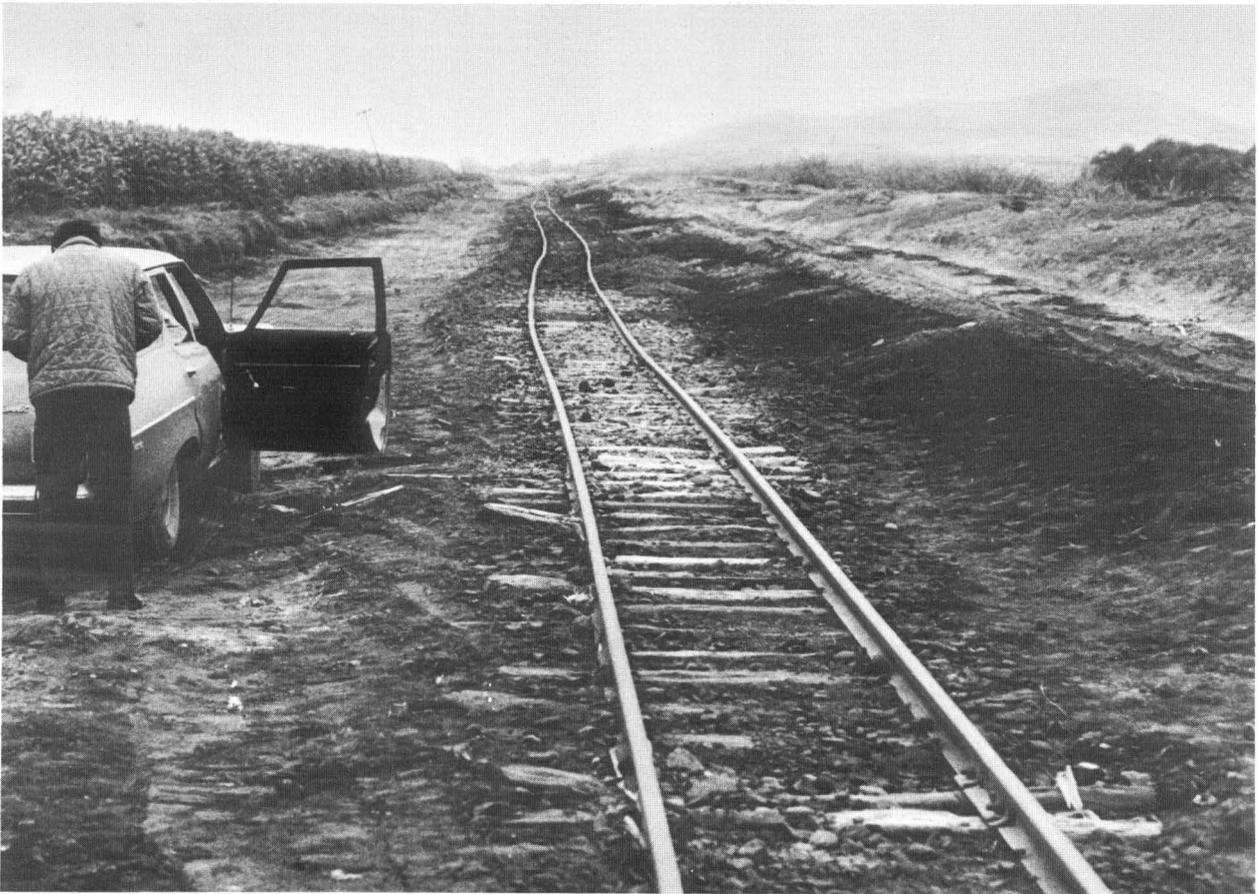
Figure 9.—Chimbote-Huallanca railroad damaged as the result of differential compaction and lateral spreading of water-saturated unconsolidated sediments.

6. A few kilometers northeast of Chimbote, the narrow-gage Chimbote-Huallanca railroad passes through farmland in which the ground-water table is near the surface. Differential compaction during the earthquake caused irregular settling of the railroad bed in such a manner that the once straight rails are now undulating; highs and lows show differences in elevation of as much as 1–2 feet in distances of 100 feet (fig. 9). Furthermore, slumping and lateral spreading of water-saturated ground resulted in several feet of horizontal displacement of the rails in some areas.

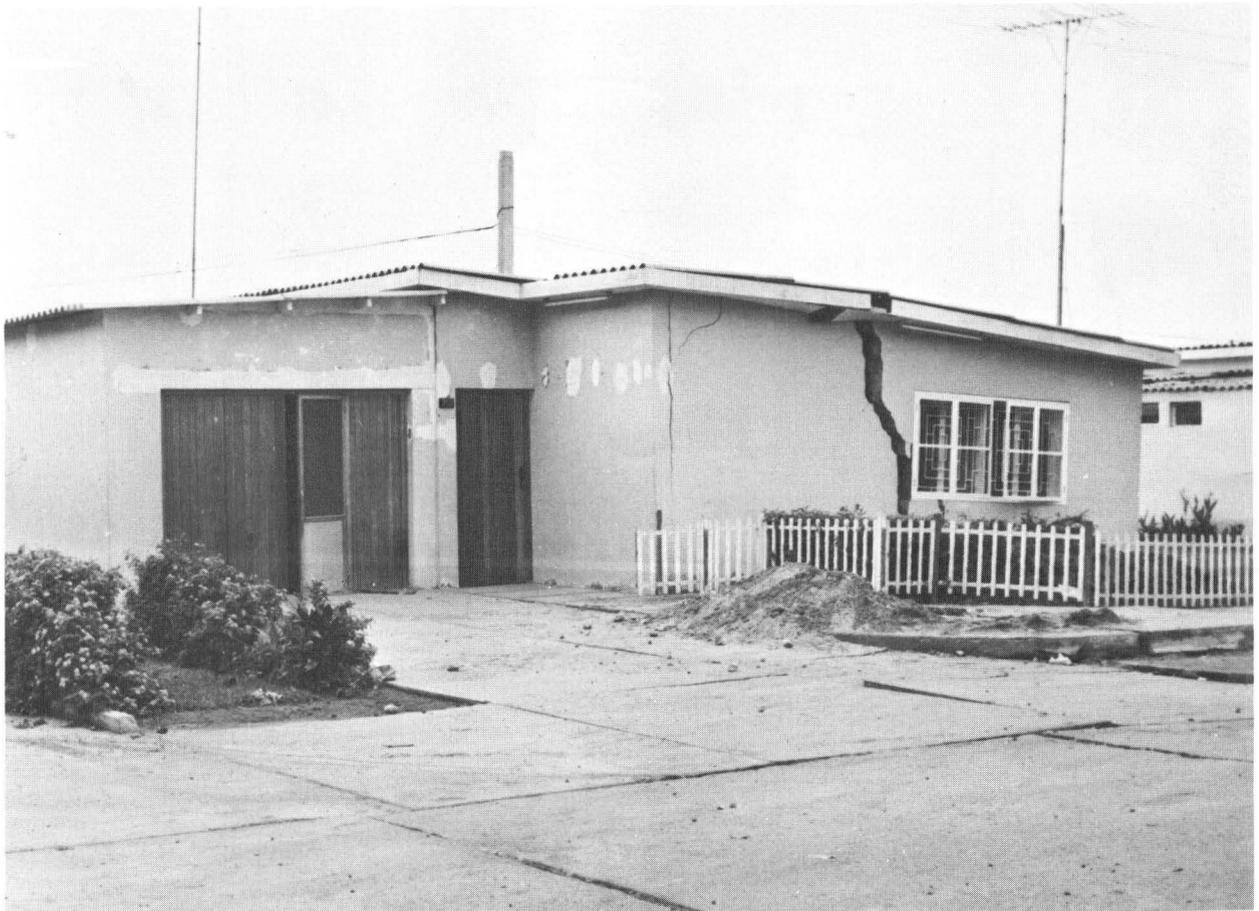
Figure 10.—Concrete-block house, Corporación Peruana del Santa housing development, Chimbote, which was torn apart by liquefaction and lateral flow of beach sediments that constitute the foundation material.

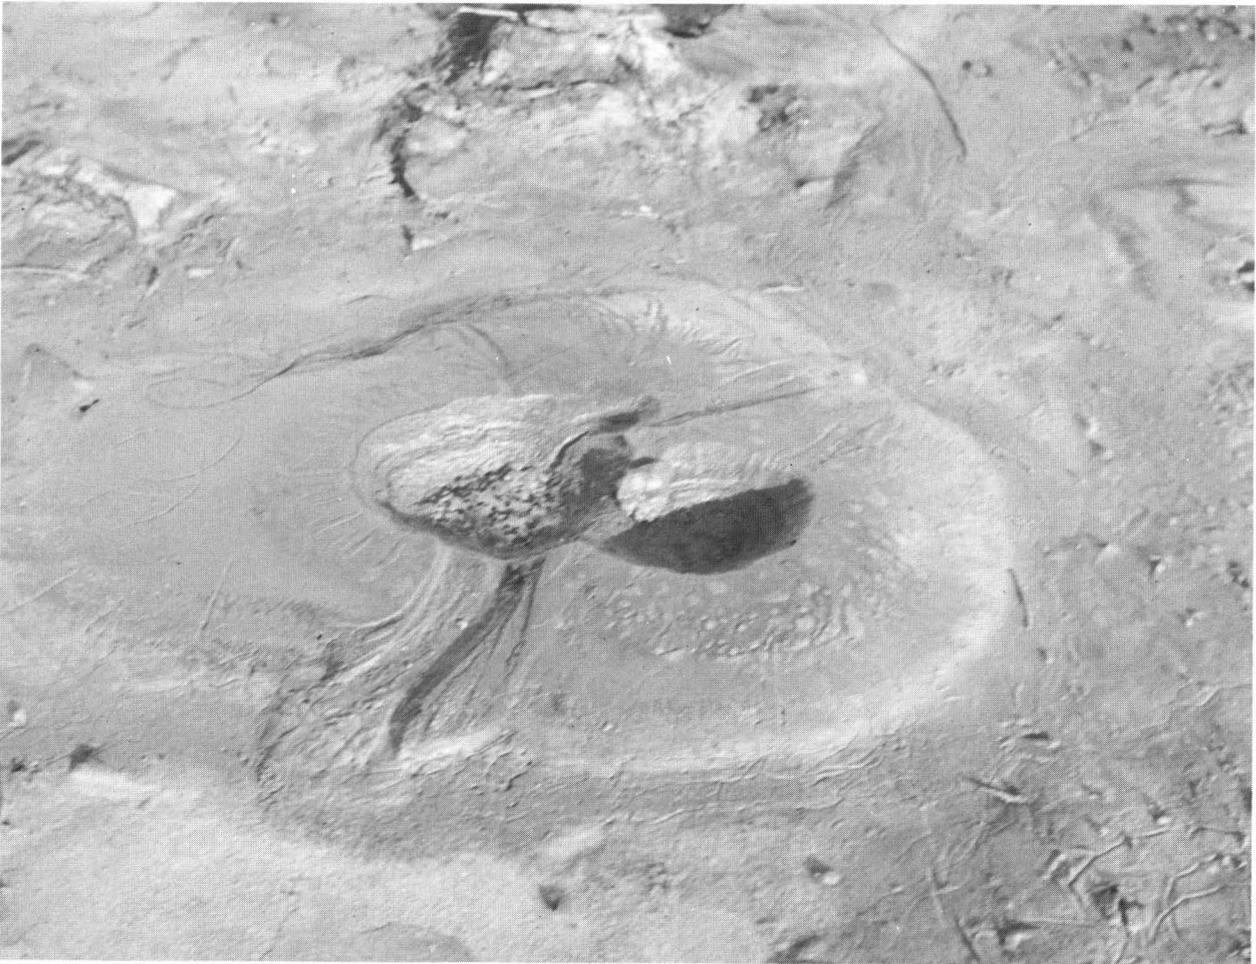
In a few areas of near-surface ground-water table, sand boils are numerous and large. These resulted from squirting of muddy and sandy water from fissures that opened during earthquake shaking in response to compaction and cracking of the saturated surficial deposits. At some places, eyewitnesses report that water was ejected to heights about a meter above the ground surface. The sand boils are commonly marked by a central hole a few centimeters to a meter in diameter, surrounded by a mound of ejected sand and silt as much as 15 meters in diameter (fig. 11).

Figure 11.—Sand boil in water-saturated unconsolidated sediments of the Casma Valley; during earthquake jets of muddy and sandy water squirted from the two pits. The mound of ejected sand is more than 1 meter in diameter.

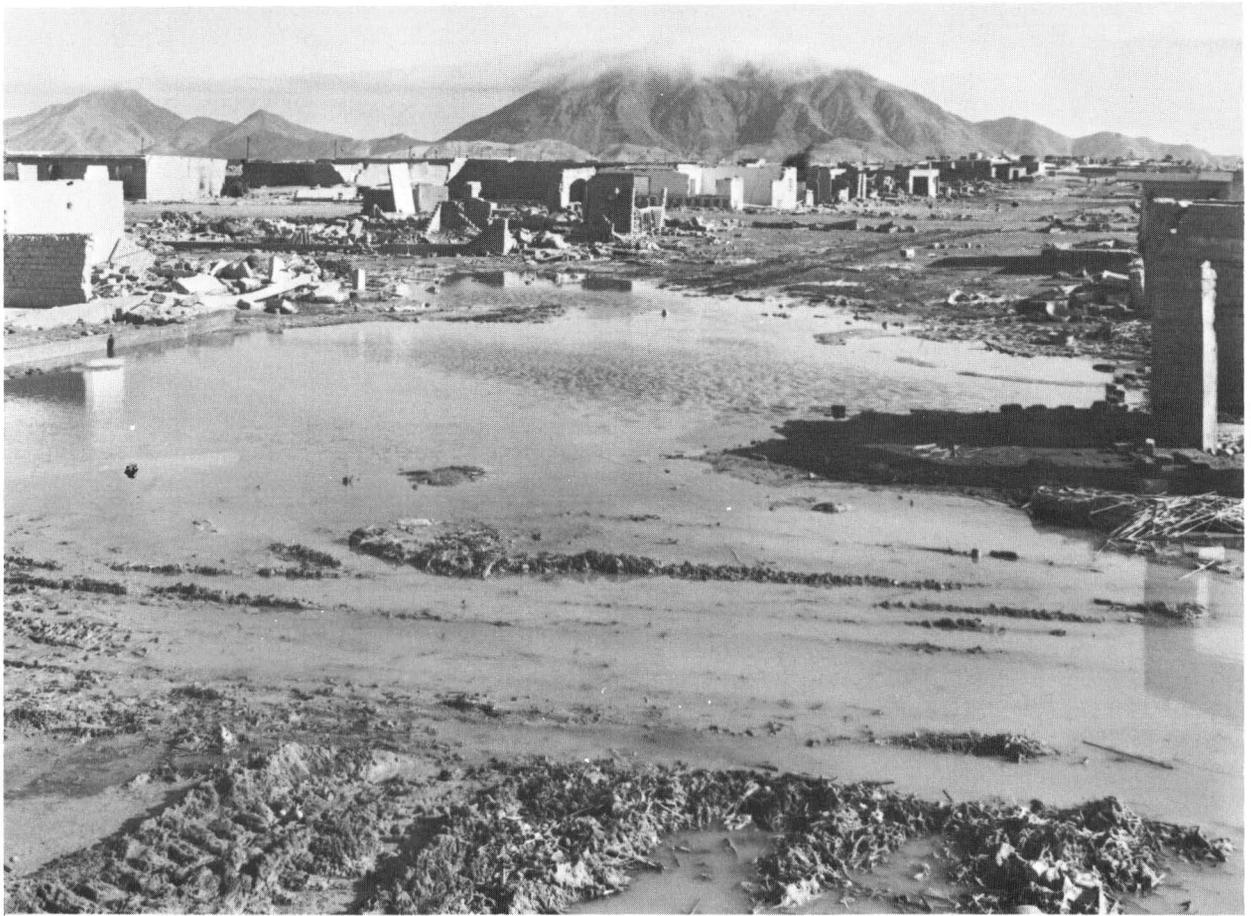
Figure 12.—Destruction of houses in a residential area of southeastern Chimbote where the ground settled due to compaction of water-saturated sediments; flooded area was dry before the earthquake.

abandoned. One of these areas is that in the eastern part of the city, now flooded because of soil compaction during the earthquake. This area would be subject to additional compaction and flooding during future earthquakes. Inasmuch as the central part of Chimbote is virtually at sea level, the city is in potential danger of destruction by tsunamis originating at almost any place in the Pacific region. Although it would be unreasonable to consider relocation of the city because of this danger (Callao is in an equally or even more dangerous position for tsunami destruction), it is not unreasonable to consider reconstructing the destroyed part of the city on higher ground.
