LANDSLIDING IN ALLEGHENY COUNTY, PENNSYLVANIA

Landsliding in Allegheny County, Pennsylvania

By Reginald P. Briggs, John S. Pomeroy
and William E. Davies

GEOLOGICAL SURVEY CIRCULAR 728

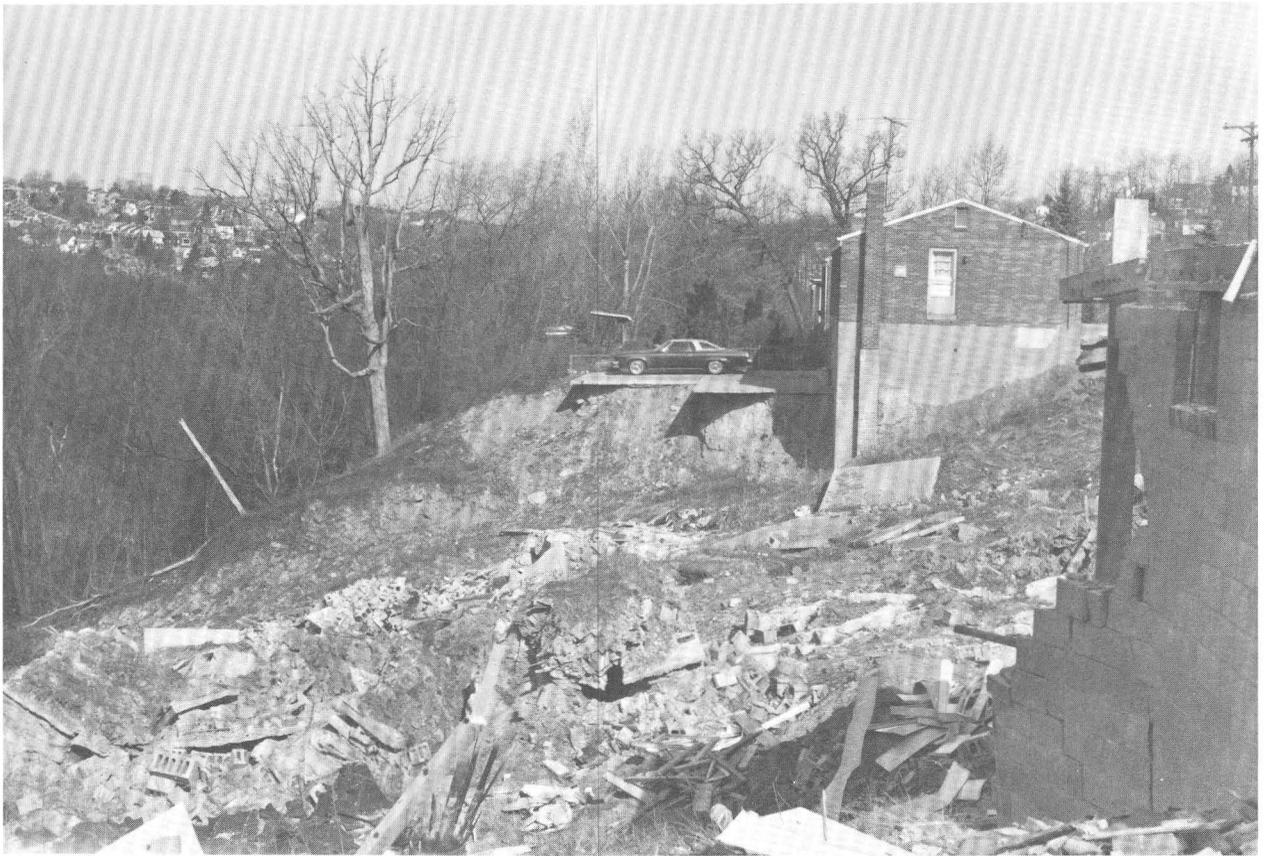
resulting in failure. Structures also are loading factors. In most places they are set on bedrock, but when they are not, destruction may result—as occurred on Lawnwood Avenue (fig. 8; selected landslide locality 8).

FIGURE 8.—Landslide largely in fill, Lawnwood Avenue, Brentwood and Baldwin Boroughs. Warped wall of partially dismantled house in right foreground results from movement of footings that were not set in bedrock. House in right background is set on bedrock and apparently is not distressed structurally even though side and backyards have slipped away. Note large trees inclined strongly downslope behind car and house, evidence of a history of movement in the area. Photographed in April 1975.

ever, the side yard and part of the backyard had slumped away, exposing part of the foundation (fig. 8). Downslope movement in this area is not all recent, as is well indicated by large trees leaning strongly downhill a short distance to the west (fig. 8). The Pittsburgh coal bed has been mined out beneath this area, and mine drainage is evident at the foot of the slide. Lubrication and increased buoyancy from mine waters may be factors in the Lawnwood Avenue landslide (Craft, 1974).

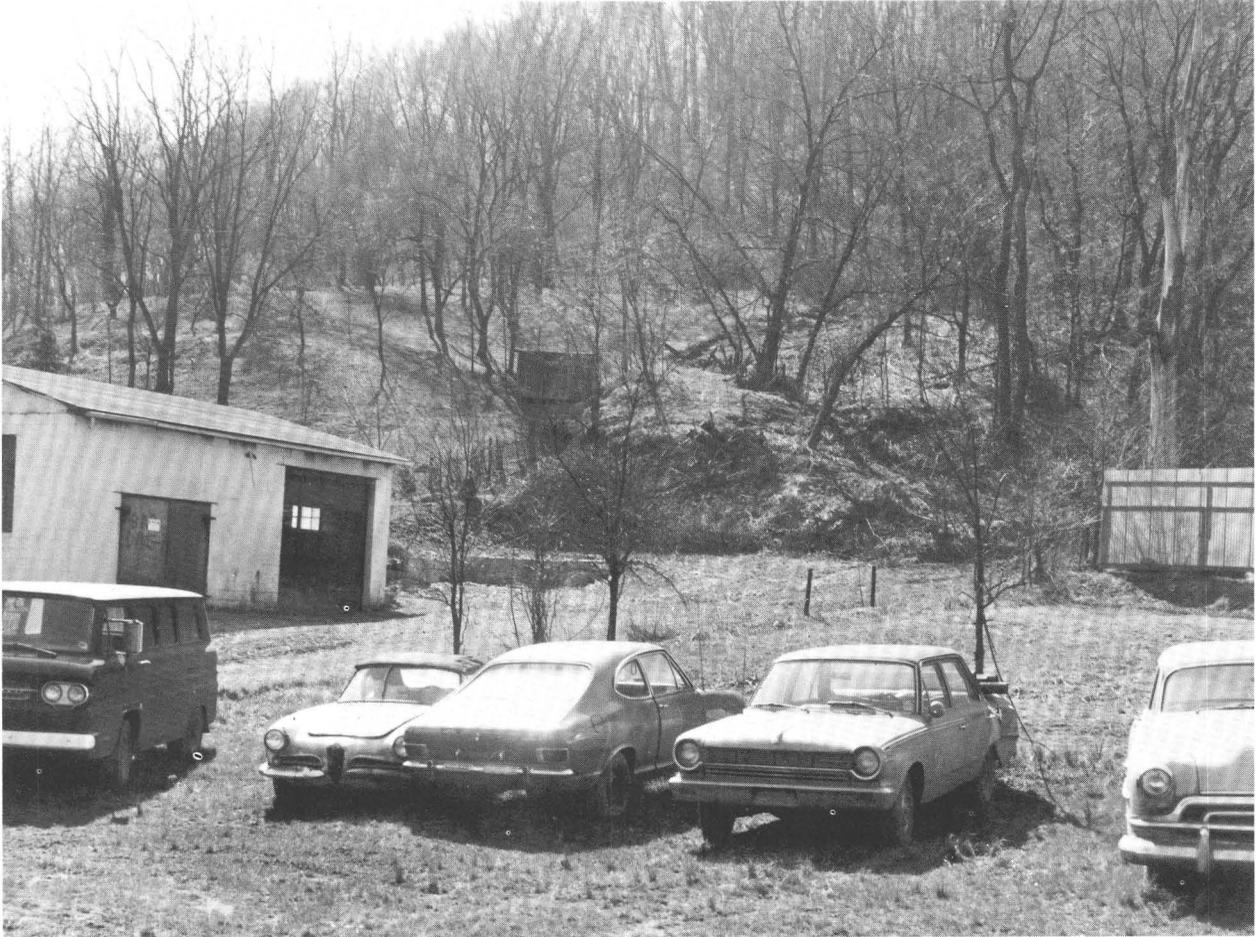
FIGURE 9.—Active earthflow on south side of West Smithfield Road, between locality 11 and Boston. Toe is visible at base of slope from just above second car from right to just above the small car. Head is more than 100 feet upslope. Excavation that triggered earthflow was to valley-floor level as far back as small shed on slope. Left limit of earthflow is just to the right of shed, which itself has not moved appreciably. Note tilted trees on earthflow surface, and hummocky ground typical of surfaces of prehistoric landslides on slope to left of shed. Photographed in April 1975.

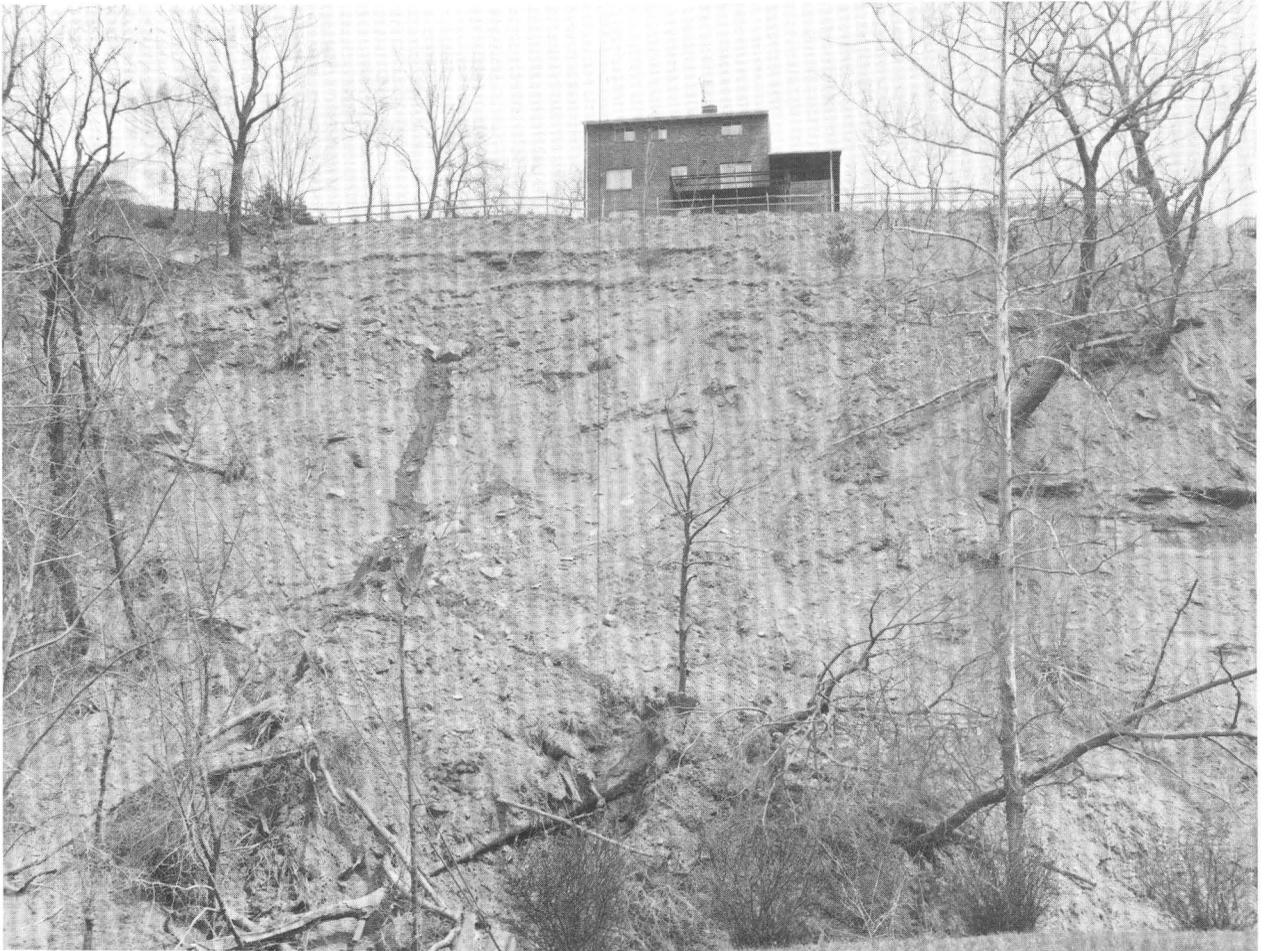
FIGURE 10.—Landslide on Painters Run, Upper St. Clair Township. Debris at foot of slope partially blocks the creek, which is between camera station and slope. Note seepage from slope in left center; nearly horizontal bedrock exposed at right. House is set on bedrock and apparently is not threatened structurally. Photographed in April 1975.

(5) *Painters Run Road, Upper St. Clair Township, about 1/4 mile east of Bower Hill Road.*—The landslide on the northeast side of the creek (fig. 10) formed in 1971 after a fill was placed to extend the backyard of the house at the top of the bluff. The fill failed shortly afterwards, and additional fill was placed. During tropical storm Agnes in 1972, the landslide mass moved down to the creek, leaving a bedrock face exposed. Since then, the fill on the flat above has slumped, forcing a change in the alignment of a fence. The rocks on which the slide formed are in the middle part of the Monongahela Group, about 100 feet above the Pittsburgh coal bed, which is exposed at road level on the south side of the road.

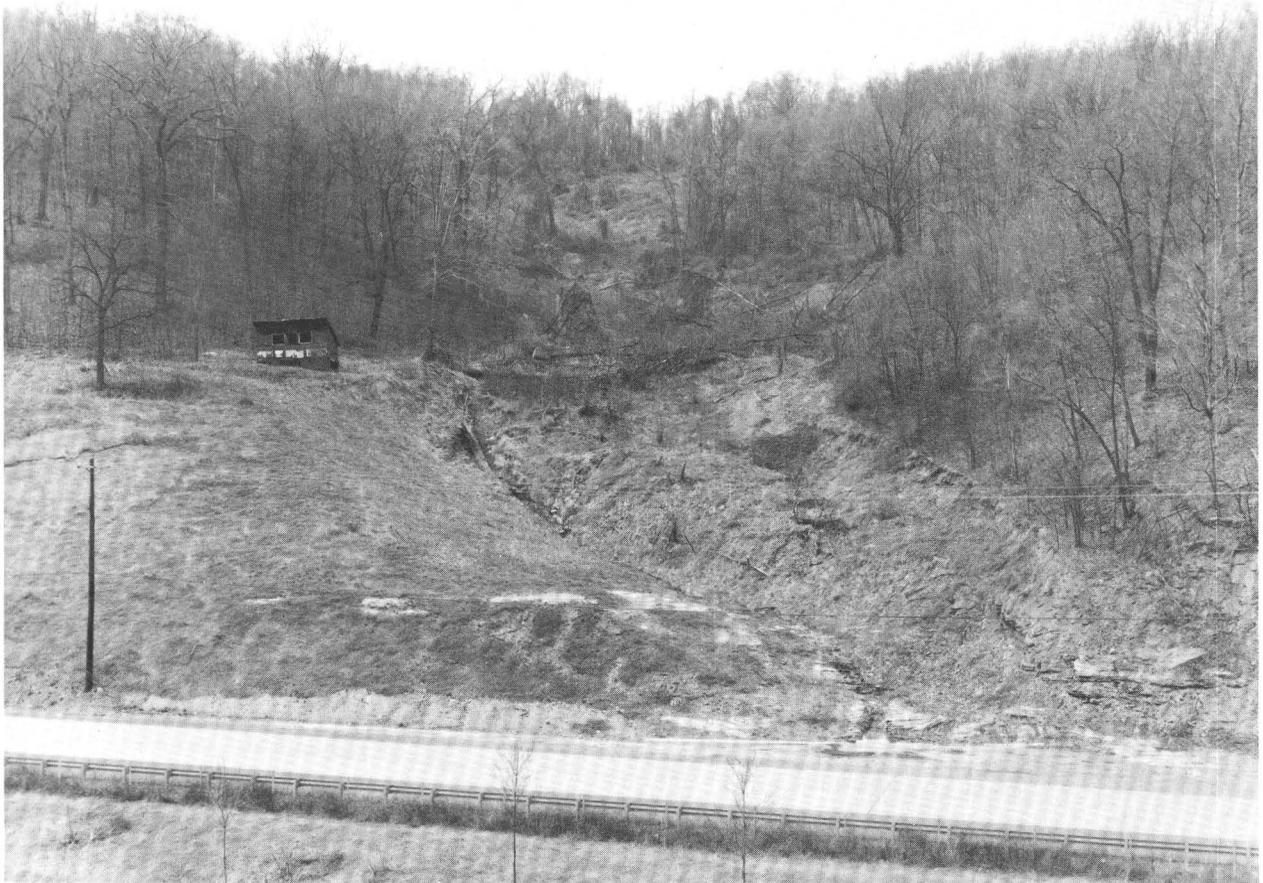
FIGURE 11.—Landslide on southeast-facing slope in Glenfield area extends almost from ridgetop to road. Note tilted and fallen trees on the landslide and grapevines on and adjacent to the landslide. Shed on left is on hummocky ground typical of surfaces of prehistoric landslide deposits. Relocation of the road in the foreground may have triggered the earthflow. Photographed from Interstate 79 in April 1975.

tive materials resulted in serious and recurring landslide problems (fig. 11; fig. 13; Hamel and Flint, 1969).

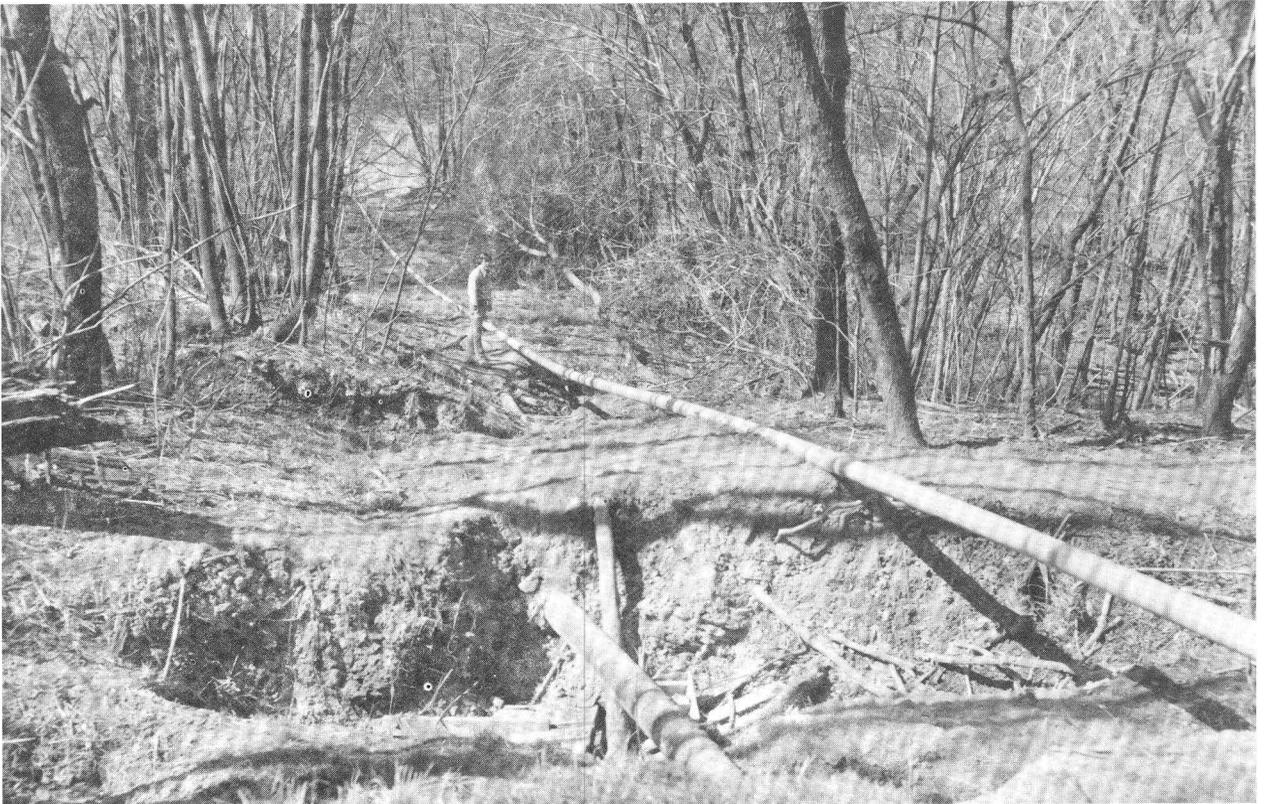
(9) *Cracks in the ground.*—Cracks more or less parallel (across) to a slope usually are indications that the slope is moving. Unusually wide cracks are shown in figure 12.

FIGURE 12.—View southwestward down cleared pipeline path toward Fallen Timber Run and Pennsylvania Highway 51, visible through trees. Ground cracks as much as 10 feet wide parallel across slope. Note segments of broken and abandoned pipe in foreground crack and in background crack near foot of man. Replacement pipe laid on surface. Photographed in April 1975.

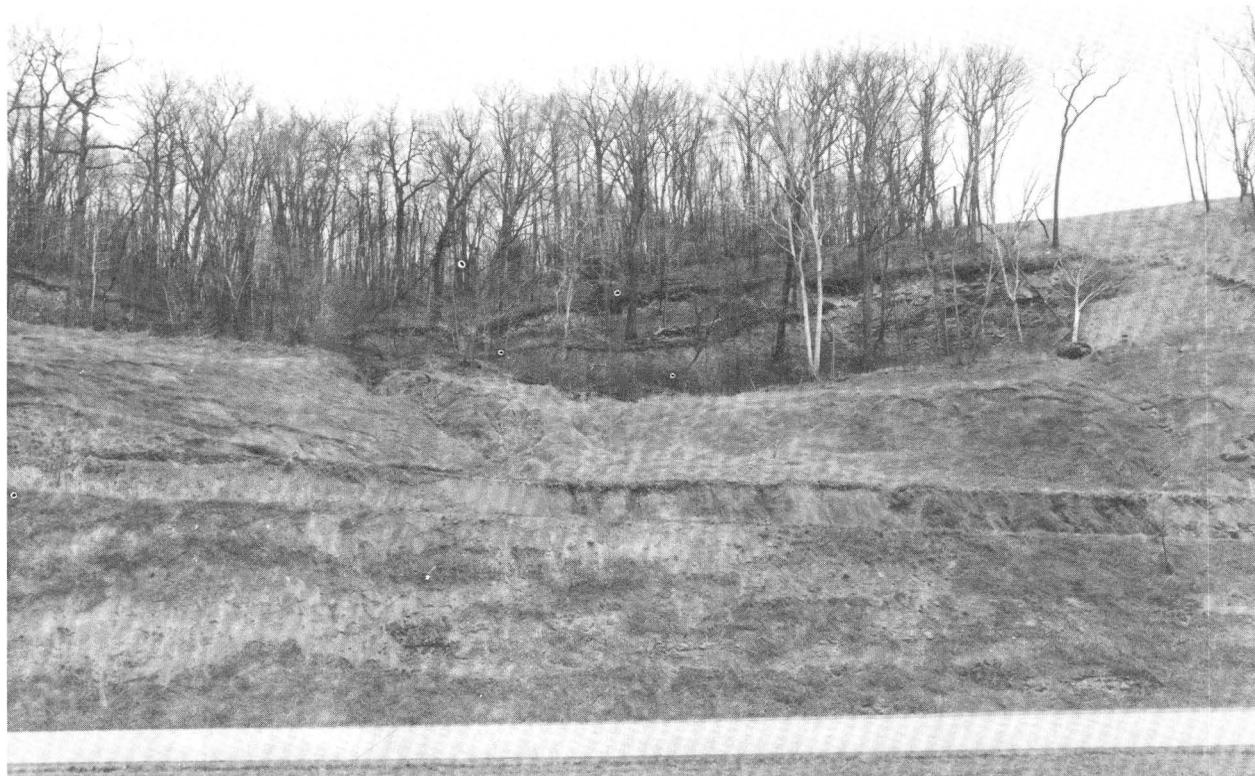
(10) *Steplike ground features.*—Slumping of ground usually results in steplike scarps (fig. 2) that may range from very low to many feet high. When relatively new, the “risers” of the scarps usually expose fresh earth (fig. 13). Older scarps may have subdued angles because of erosion and may be vegetated, making them more difficult to identify. Whether old or new, these features are evidence of unstable conditions.

FIGURE 13.—Slumped area above northwest-facing roadcut for northbound lane of Interstate 79, Glenfield area. Scarps define slump blocks on which tilted trees are in contrast to upright trees on undisturbed slopes above. Note small scarps and hummocky ground below trees and above bench. Photographed in April 1975.

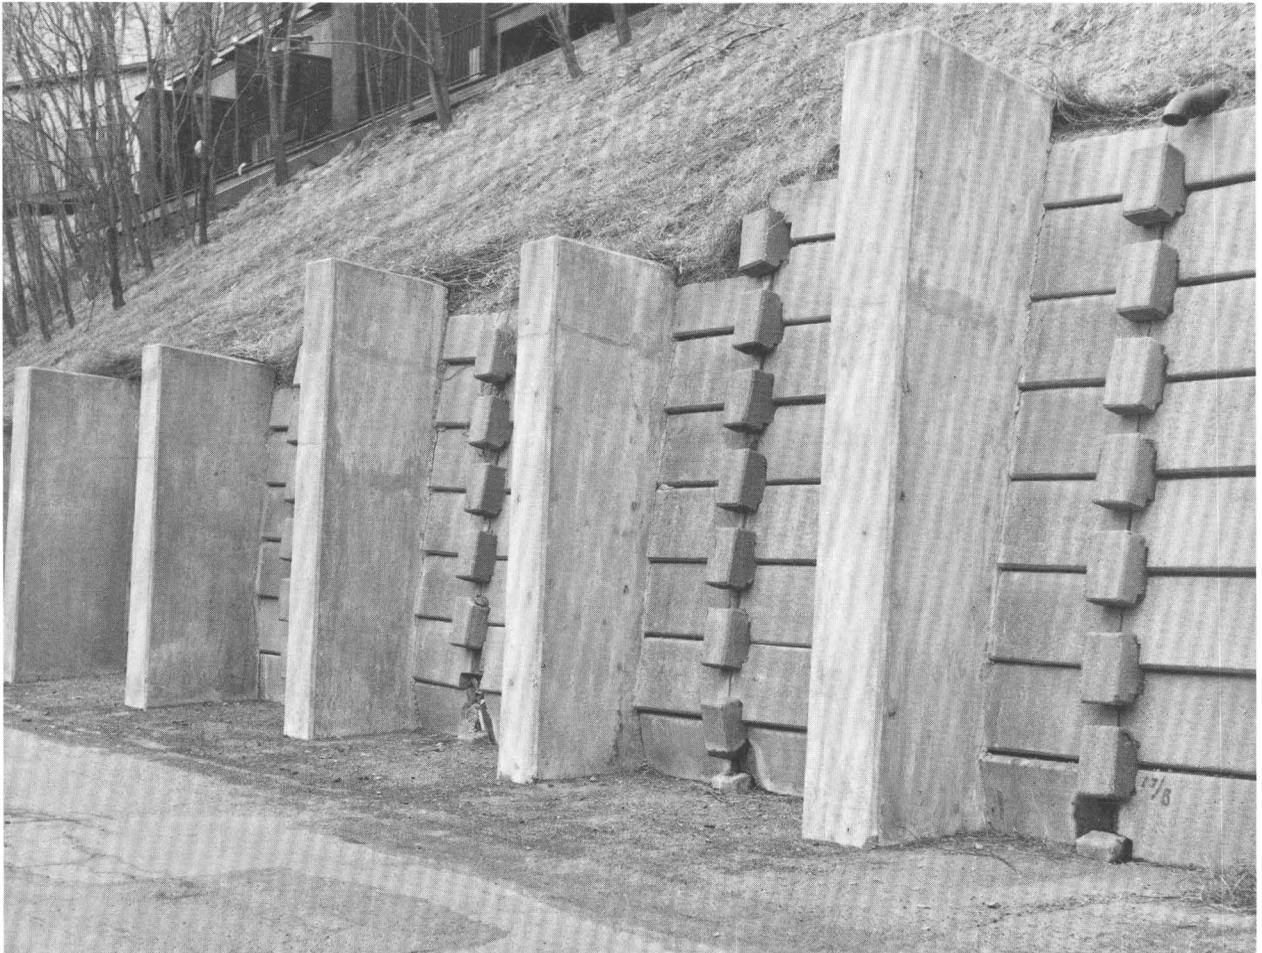
(3) *Baldwin Road, Robinson Township, about 1/4 mile north of Penn-Lincoln Parkway, "Parkway West."*—Along the southeast side of the apartment complex on the northwest side of Baldwin Road is a steep fill slope in which some slumping occurred. Brick walls of some units of the complex cracked, and slumping forced removal of back porches of several units. Additions to downspouts were made to direct water, a possible causative factor in the slumping, away from foundations. A concrete retaining wall between the lowest developed level and the second level was distressed (fig. 15). The Pittsburgh coal bed here is at or slightly below the

level of the lowest buildings of the complex, and the coal has been mined out, according to information from the Pennsylvania Division of Mine Subsidence Regulation. Possible mine subsidence, soil creep, and landsliding, and the potential for lateral spreading under footings may have combined to make assurance of structural integrity more difficult here than elsewhere.

FIGURE 15.—Distressed concrete retaining wall near Baldwin Road, Robinson Township, which has missing key block at bottom of third segment from right. Vertical buttresses aid in repair effort. Note saplings leaning strongly downhill at left. Photographed in April 1975.

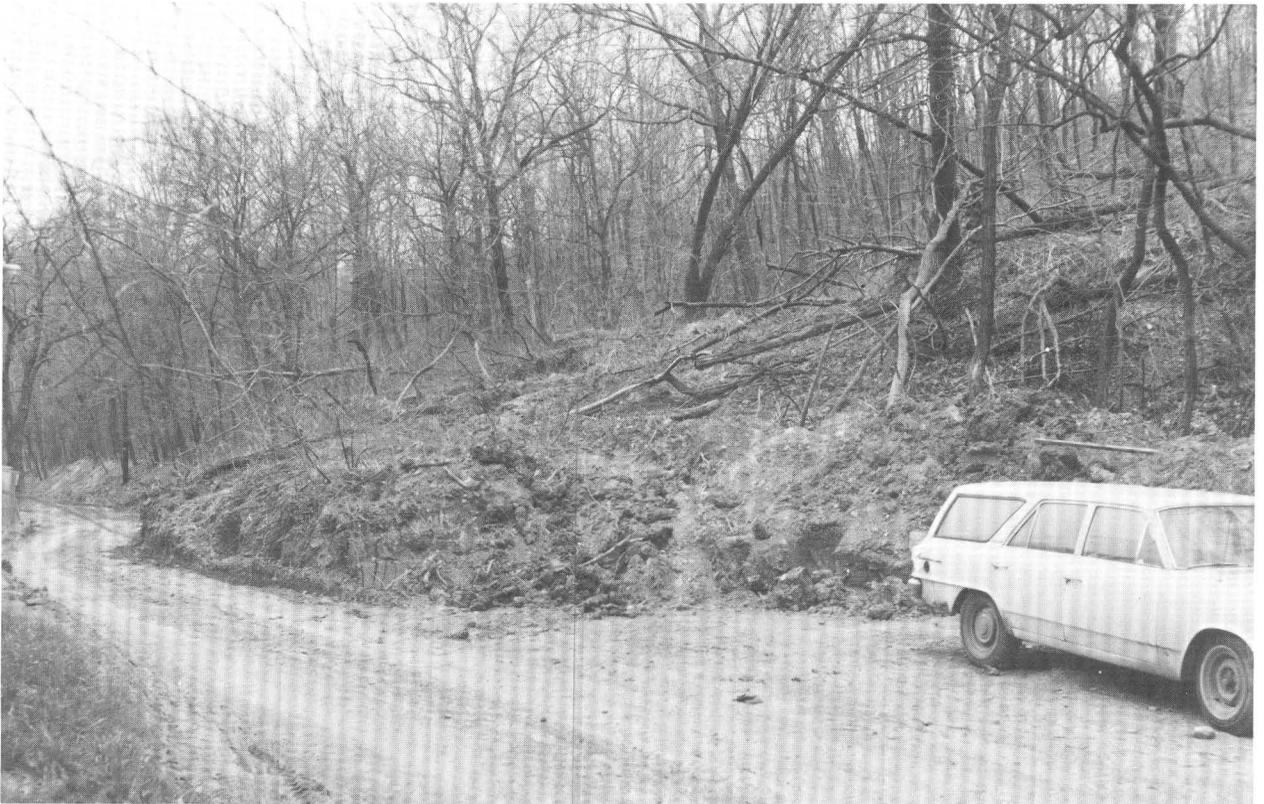
FIGURE 16.—Toe of landslide encroaches on Kilbuck Drive opposite park maintenance office adjacent to fence at left edge of picture. Car on right is parked at right edge of road, which was two lanes wide and straight before landsliding. Continuous excavation is required to keep road open. Photographed in April 1975.

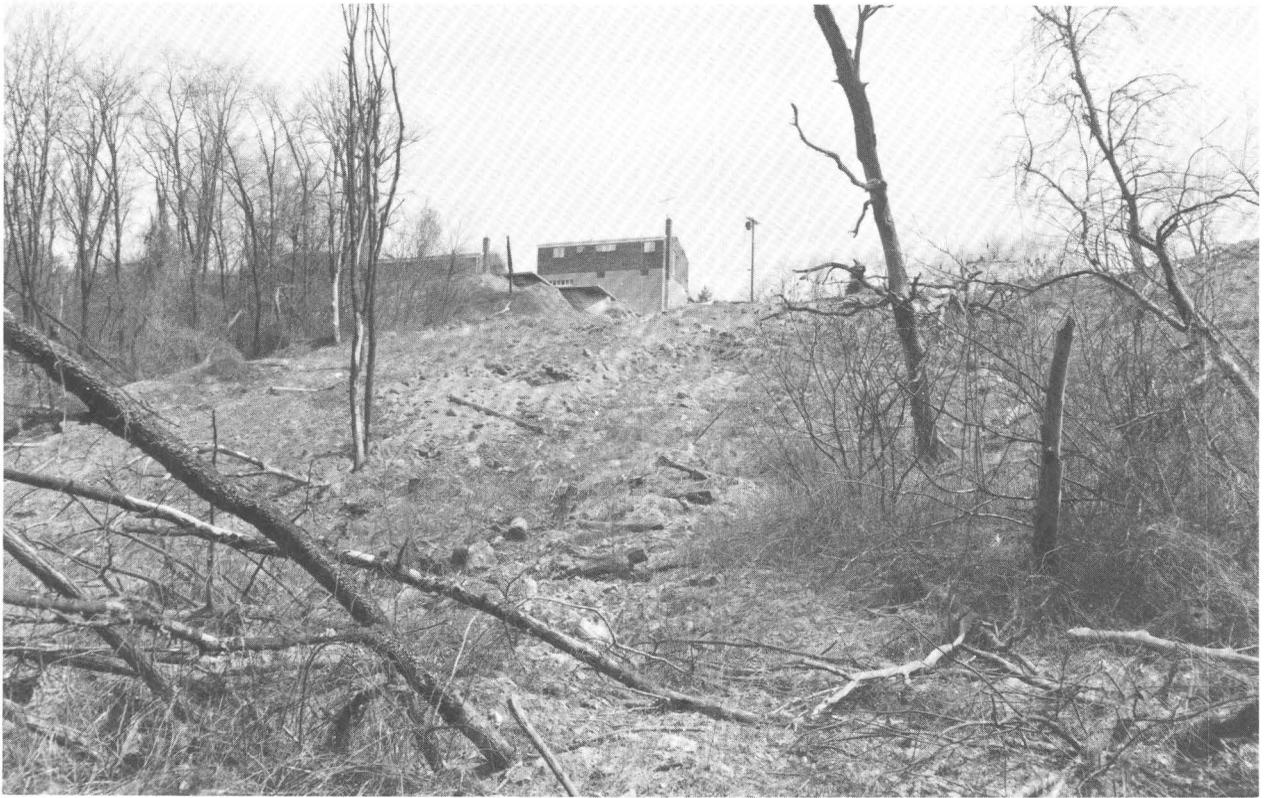
(8) *Lawnwood Avenue, Boroughs of Brentwood and Baldwin.*—Failure after placing foundation footings on fill is well illustrated here where three houses have been destroyed and a fourth appears to be in danger (fig. 17). The first fill was placed across a narrow valley on the slope. The houses were built in the 1960's; footings were placed in the old fill, and backyards were built up by emplacement of additional fill. Movement began shortly after the houses were completed, when the backyards slumped. The backyards were built up again, but further movement occurred, and by June 1972, two houses were so damaged that they were abandoned. The third house, on the east, was evacuated in February 1974, when the back wall began to collapse (fig. 8). The fourth house, on the west, had suffered no apparent structural damage and was still occupied in late 1974. How-

FIGURE 17.—Landslide on Lawnwood Avenue, Brentwood and Baldwin Boroughs, from base of slope. Fallen trees in foreground are in toe of landslide. House in center is in right background of figure 8. Clearly shown is undercutting of slabs in backyard of this house. Area to right of house was occupied by three houses destroyed by landslide. Photographed in April 1975.
