# **EARTHQUAKES AND RELATED CATASTROPHIC EVENTS, ISLAND OF HAWAII, NOVEMBER 29, 1975**

**A Preliminary Report**

**GEOLOGICAL SURVEY CIRCULAR 740**

By Robert I. Tilling, Robert Y. Koyanagi,  
Peter W. Lipman, John P. Lockwood, James G.  
Moore, and Donald A. Swanson

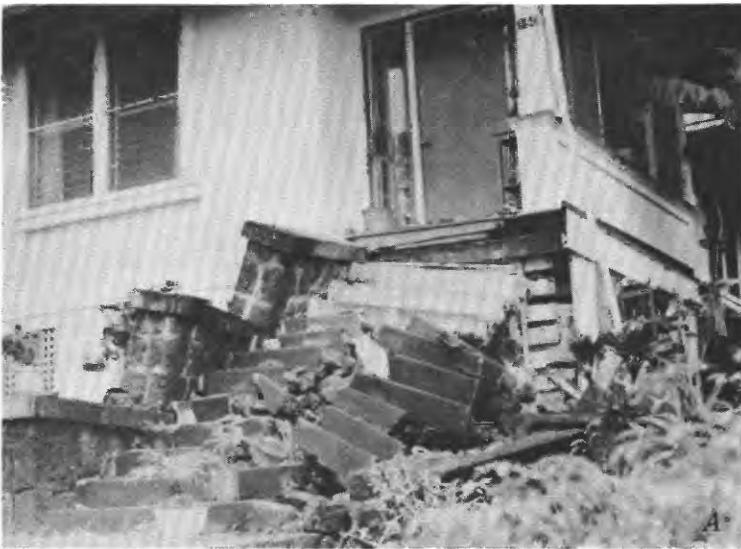
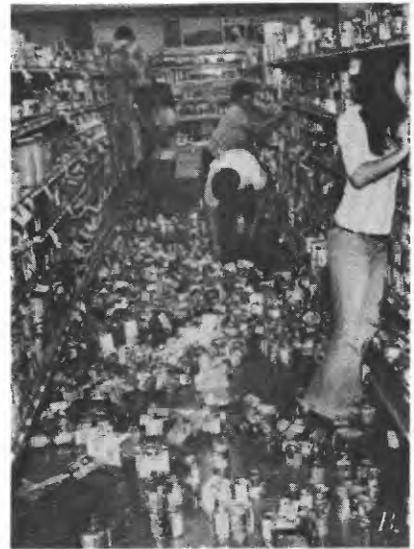
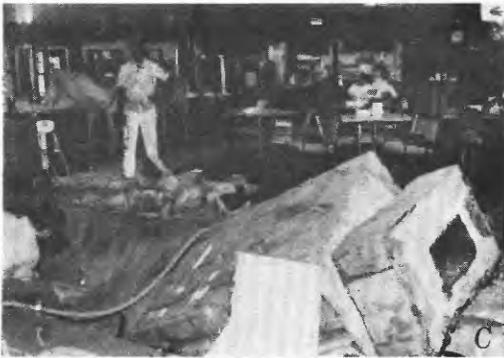
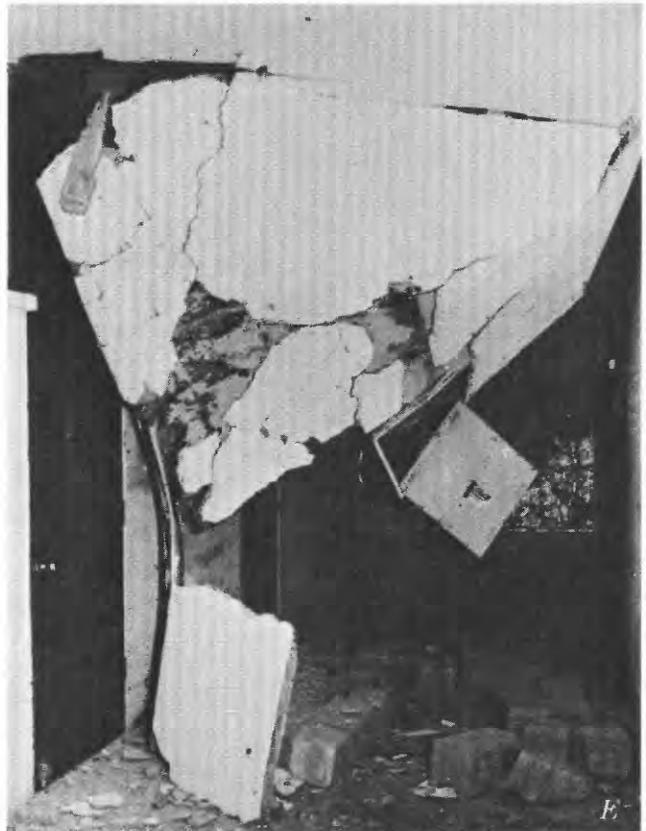
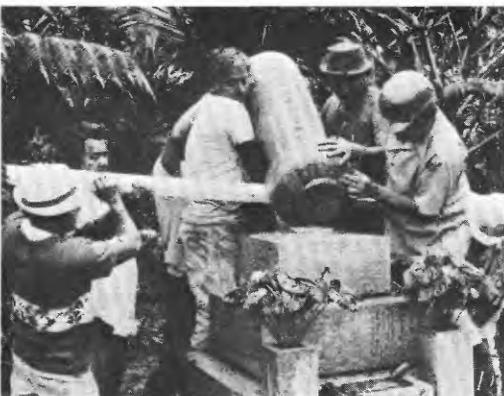
The main earthquake caused structural damage estimated at about \$2.7 million. A preliminary survey conducted by various governmental agencies showed minor to moderate damage to 5 churches (4 in Hilo, 1 in Opihikao), 11 commercial buildings (10 in Hilo, 1 in Mountain View), and 80 homes (51 in Hilo, 23 in Puna, 2 in Hamakua, 3 in Ka'u, and 1 in Kona). Five poorly constructed or old houses were reported completely demolished (4 in Hilo, 1 in Ka'u) (fig. 3).

FIGURE 3.—Damage caused by November 29, 1975, earthquake. *A*, Two children were trapped in this damaged home about 7 km north of Hilo. *B*, Spilled merchandise in Hilo supermarket. *C*, Collapsed chimney that fell through roof, dining room, Kilauea Military Camp, Hawaii Volcanoes National Park. *D*, Volunteers replace 300-lb granite headstone toppled by earthquake at churchyard, Kurtistown, 14 km south of Hilo. *E*, Fallen ceiling plaster and cinder blocks, Hilo High School. (Photographs: *A*, UPI; *B*, *C*, *E*, Larry Kadooka, *Hawaii Tribune-Herald*; *D*, George Abe, Hawaii Island Chamber of Commerce.)

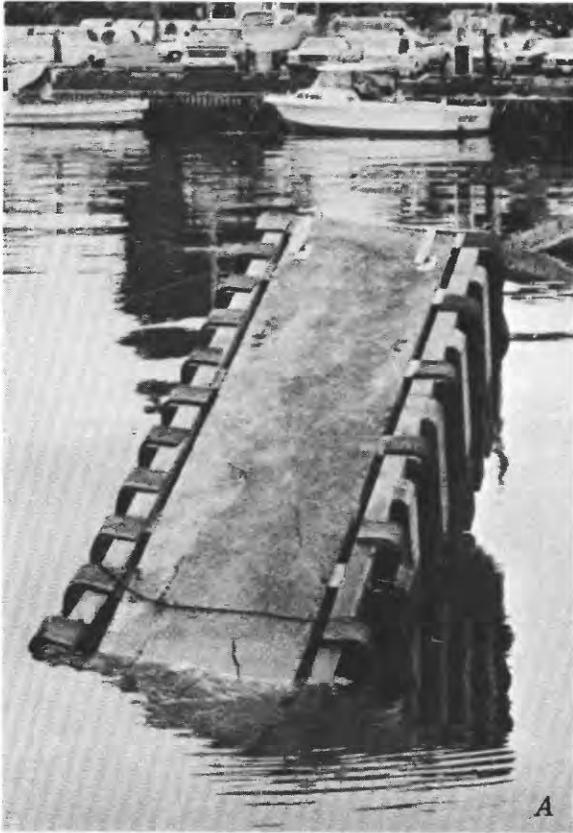
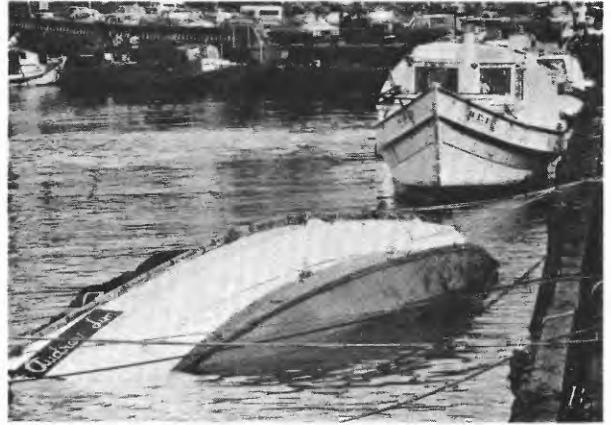
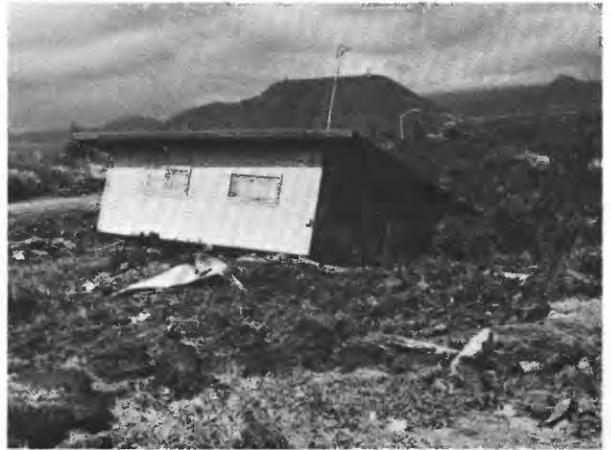
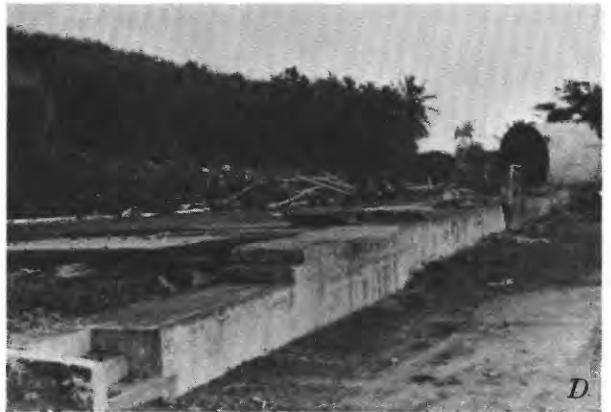
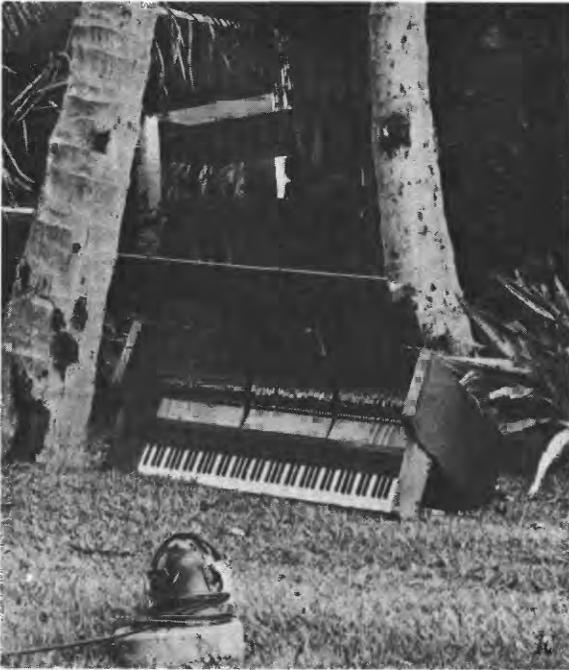
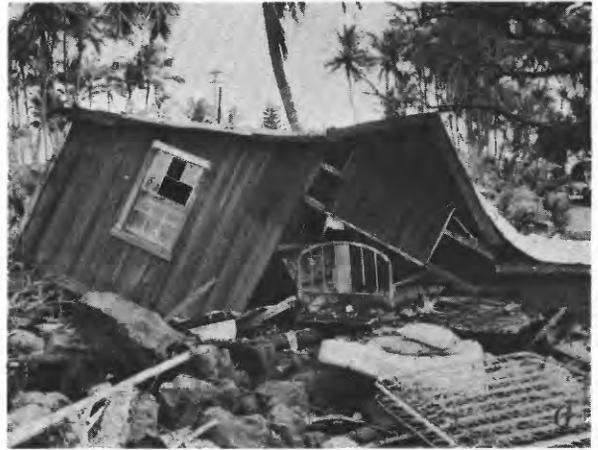
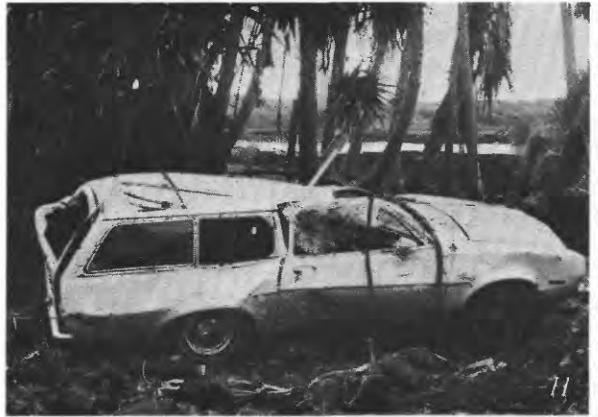
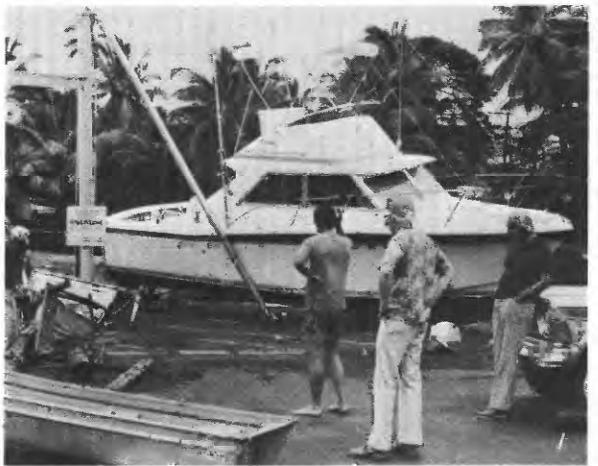
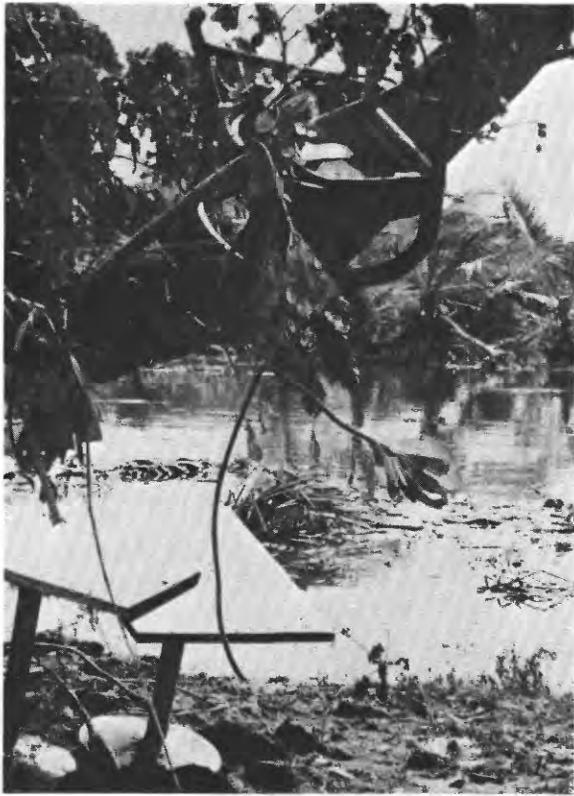
struck the highly developed west (Kona) coast of Hawaii at about 0515. At Keauhou Bay, some fishing boats were sunk and others damaged by a 2.5-m wave that crested over the pier, crashed through a house, and left one fishing boat stranded on the dock. At Kailua-Kona, the wave crested at 2.1 m, piled debris against a newly completed hotel, sank one boat, and damaged three others (fig. 8).

FIGURE 8.—Damage caused by earthquake-related tsunami, November 29, 1975. *A*, Collapsed concrete finger pier, Wailoa River estuary, Hilo. *B*, Overturned boat, Wailoa River small-boat harbor. *C*, House shoved 25 m inland off its foundation, Punaluu. *D*, Foundation remains of a warehouse destroyed at Honuapo. *E*, Piano washed out of restaurant, Punaluu. *F*, Tables and chair (on branch) from restaurant deposited near pond, Punaluu. *G*, Demolished home, Punaluu. *H*, Car com-

pletely turned around and smashed, Punaluu. I, Powerboat washed onto dock, Keauhou Bay, Kona. (Photographs: A, B, Hugh Clark, *Honolulu Advertiser*; C, Paul Miyasaki, *Hawaii Tribune-Herald*; D, H, Andy Badig, *Ka'u News*; E, F, George Garcia, Kilauea Military Camp; G, David Shapiro, *Star-Bulletin*; I, Leigh Critchlow, *Hawaii Tribune-Herald*.)

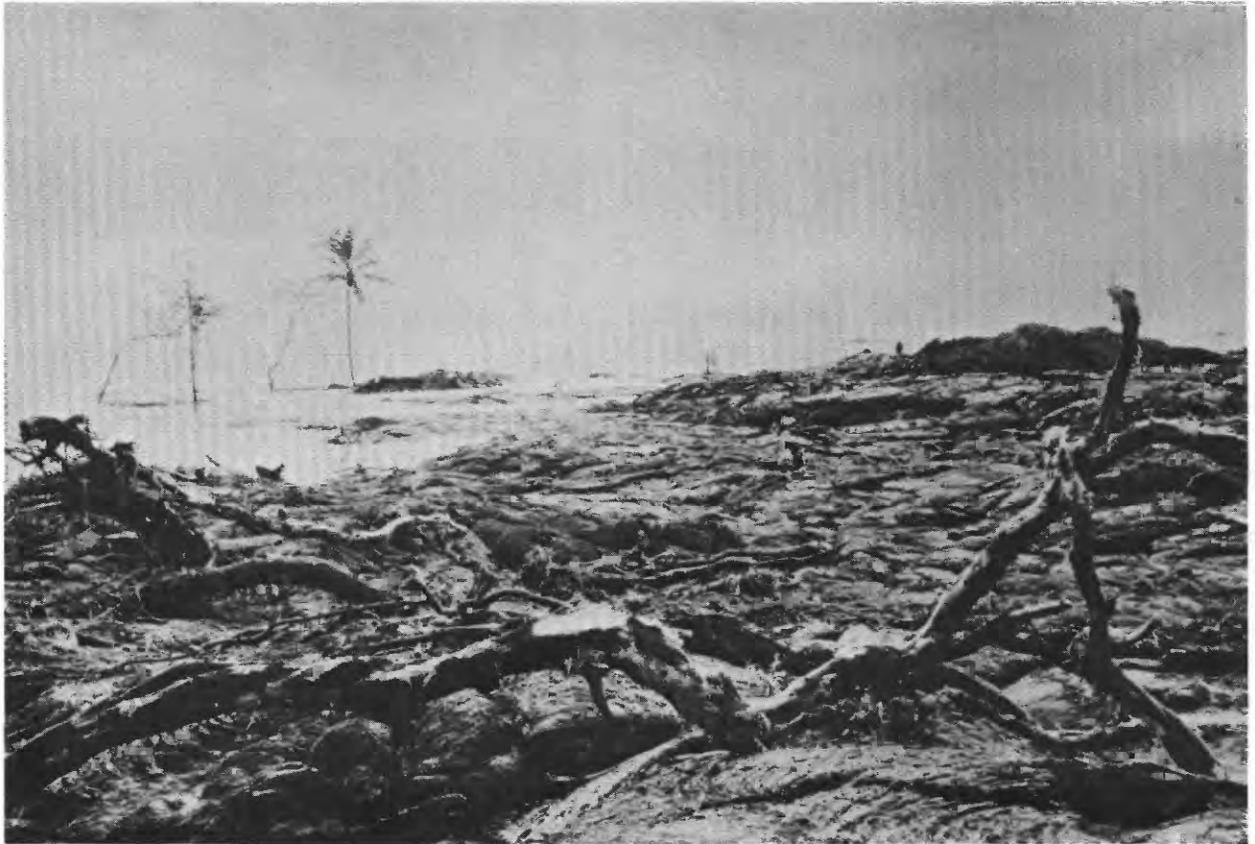
FIGURE 9.—Part of a keawe tree toppled and scarred by wave action at Keauhou Landing. Note coconut palms standing in the sea.

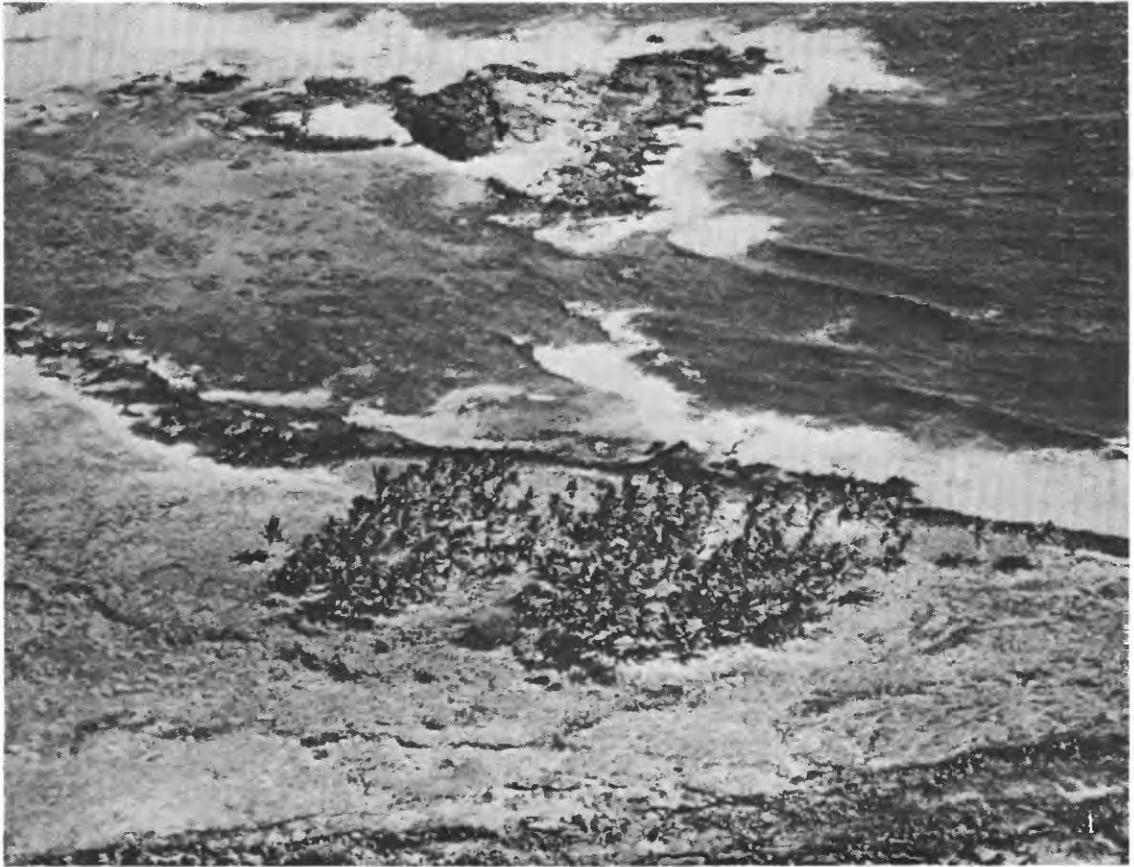
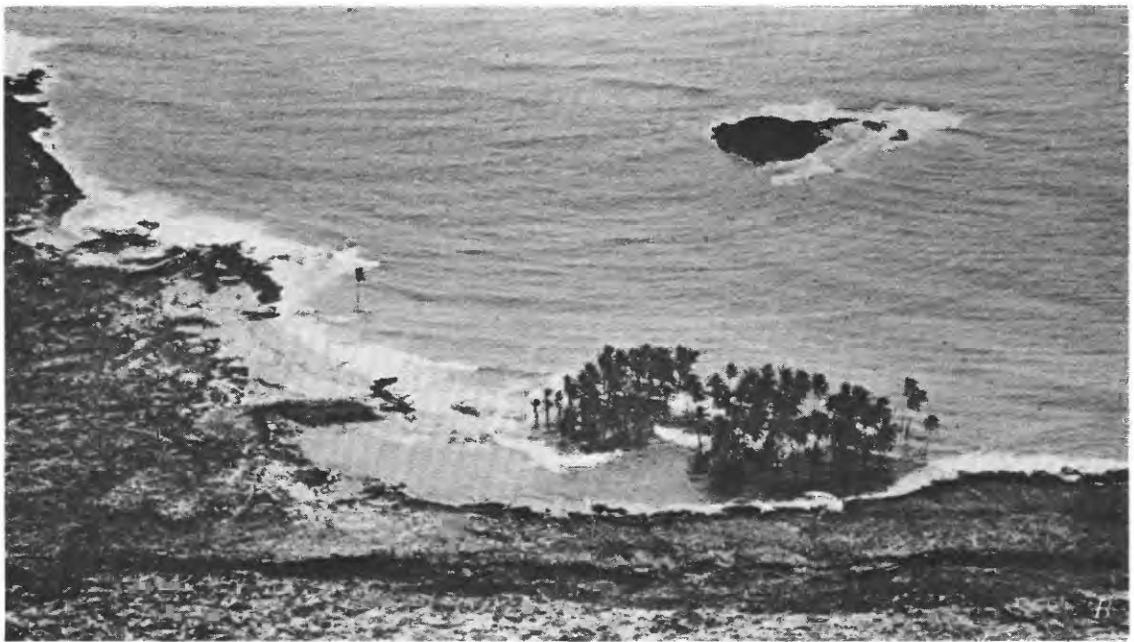
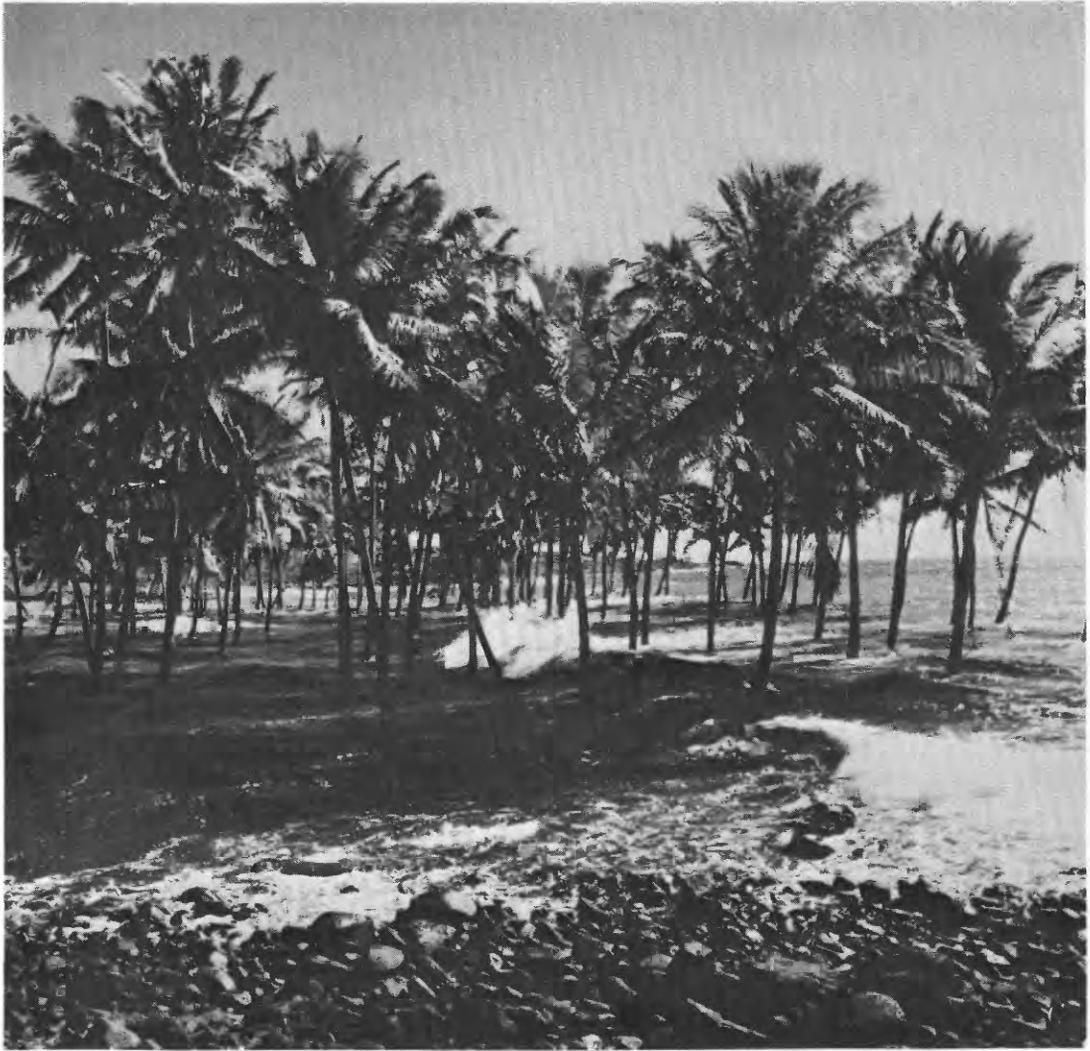
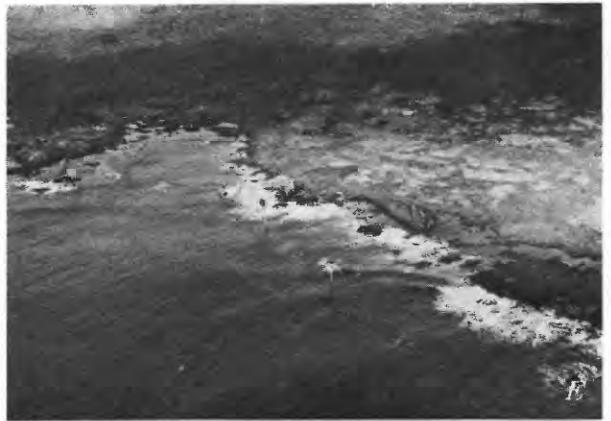
At Halape, the subsidence left a grove of coconut palms standing in water averaging 1.2 m deep and 100–150 m landward of the presubsidence shoreline (fig. 15). Halape's old rocky beach is submerged, but a larger, sandy beach had formed by mid-December 1975. Broad areas of the peninsulas at Kakiwai and Kalue, 2 and 3 km respectively west of Halape, are now submerged beneath crashing surf. A shallow, tranquil lagoon covers 2.2 hectares (1 hectare=2.47 acres) of what formerly was a sand-covered flat above a low sea cliff at Kaaha, 1.5 km west of Kalue. At Keauhou Landing, 2.3 km east of Halape, a brackish Hawaiian water well is submerged, the narrow beach destroyed, and its fringing thicket of keawe trees swept away.

FIGURE 15.—Preearthquake and postearthquake views of coast illustrating subsidence. *A*, Preearthquake view of Halape area from Puu Kapukapu. *B*, Postearthquake view of Halape from Puu Kapukapu showing the palm grove standing in the sea and the offshore island nearly submerged as a result of 3.5 m subsidence; on November 29, 1975, campers were swept by the tsunami into the crack behind the palm grove. *C*, After subsidence, surf surges through the palm grove at

Halape. *D*, Preearthquake aerial view of Keauhou Landing; note shelter and trees. *E*, Postearthquake aerial view of Keauhou Landing; the shelter and nearly all of the keawe trees have been washed away by the tsunami; palm trees now stand in the sea. (Photographs: *A*, Don Reeser, National Park Service; *C*, *E*, Boone Morrison; *D*, Robin Holcomb, U.S. Geological Survey.)

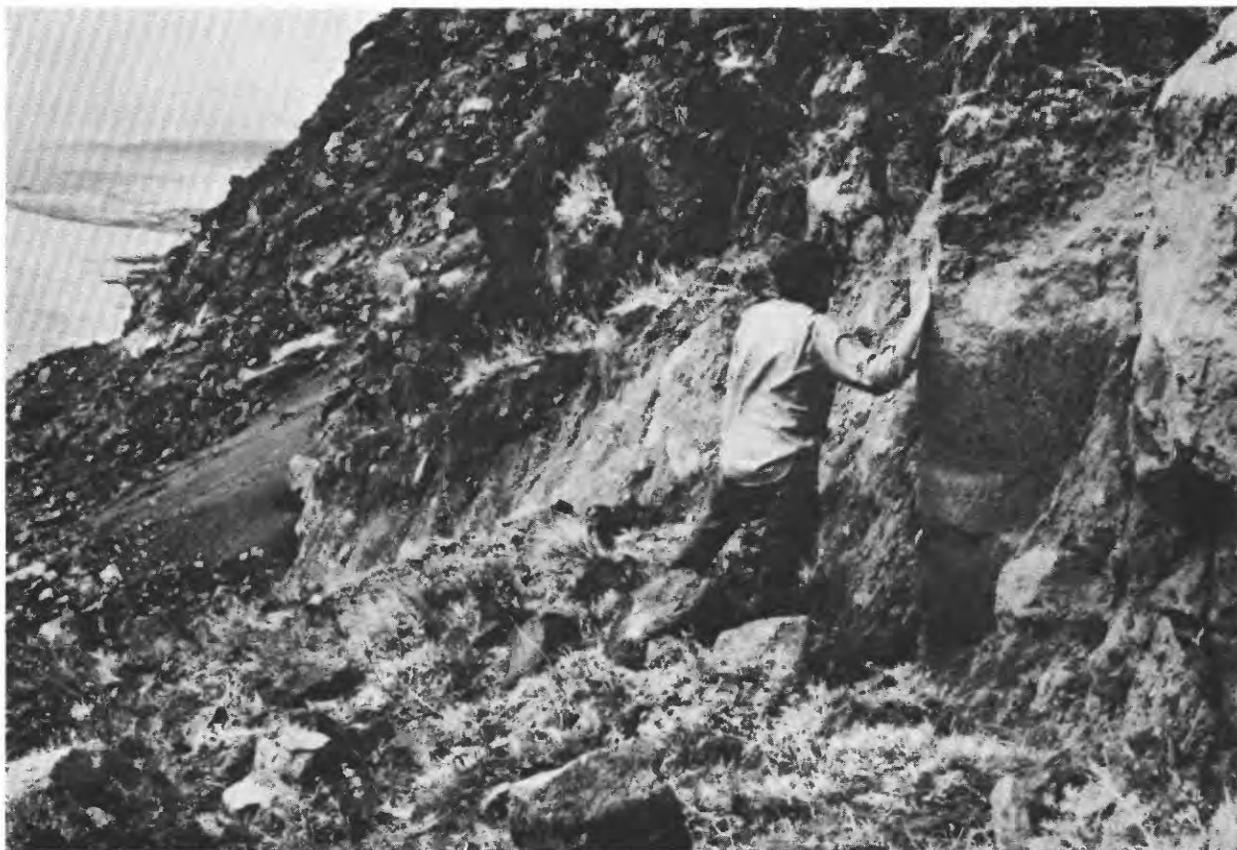
FIGURE 19.—Vertical offset of about 1.5 m along new fault, south face of Puu Kaone (see fig. 18B).

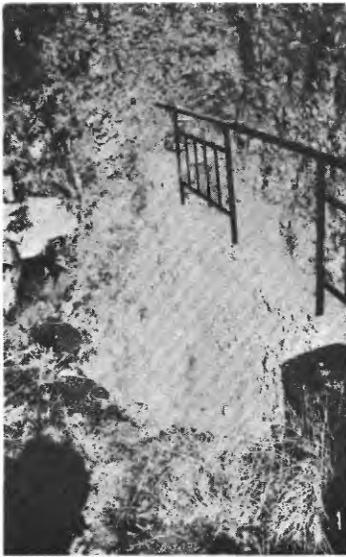
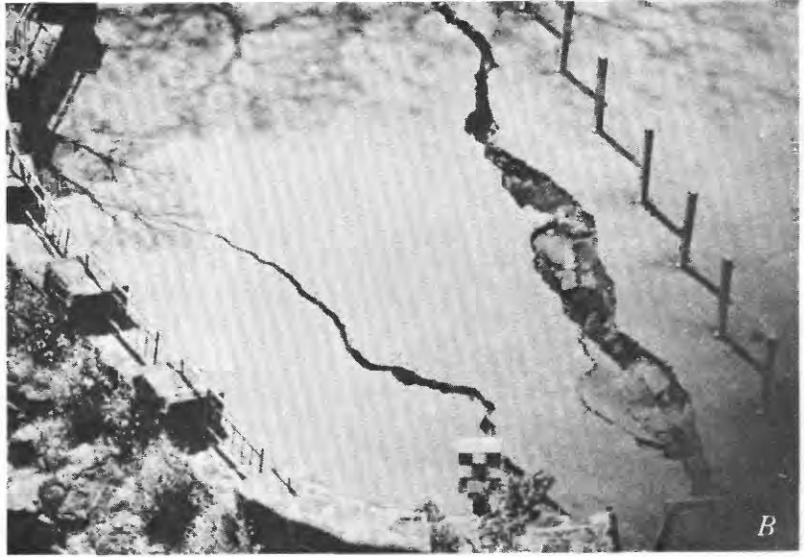
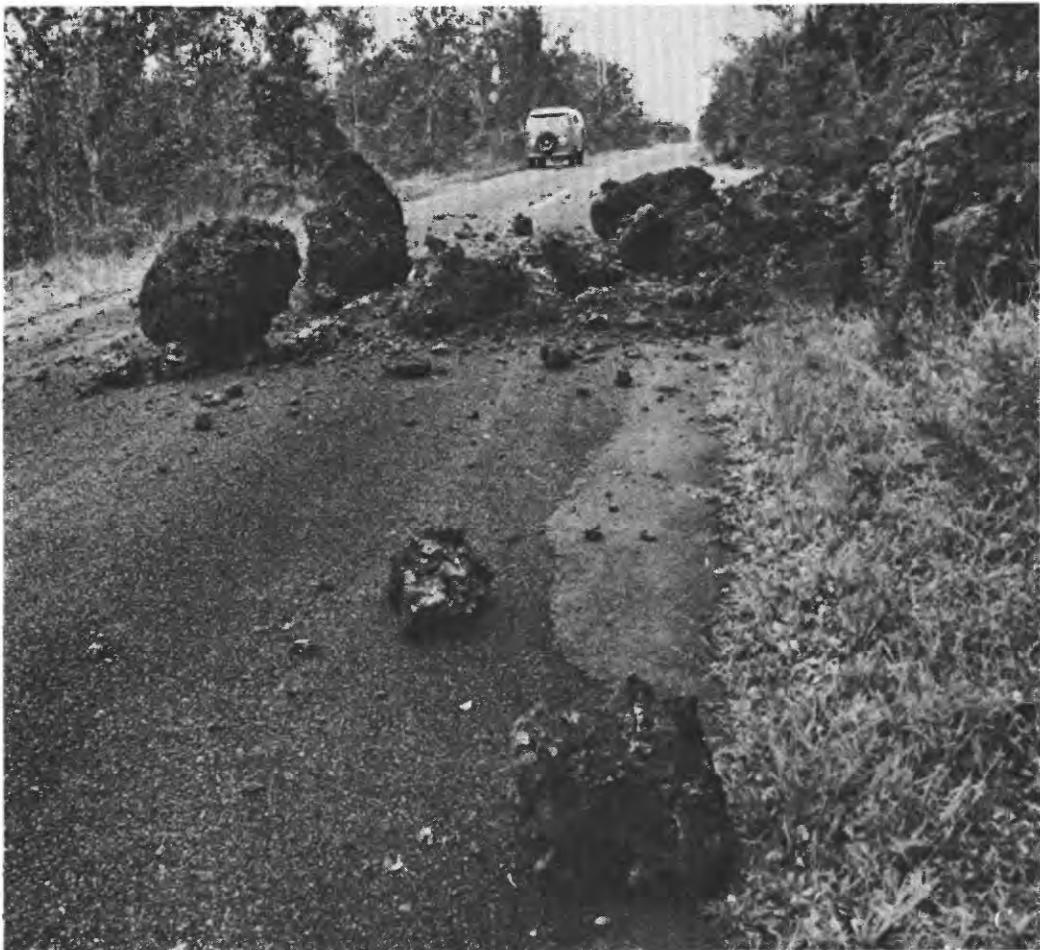
FIGURE 20.—Ground cracking and landslides in Hawaii Volcanoes National Park. *A*, Back part of viewing overlook area at Puhimau Crater slumped completely into the crater, leaving guardrail projecting into space. *B*, Aerial view of large cracks in viewing overlook area of Pauahi Crater. *C*, Small landslide from spatter and cinder cone partially blocking Chain of Craters Road (Photographs: *B*, Hugh Clark, *Honolulu Advertiser*; *C*, Boone Morrison.)

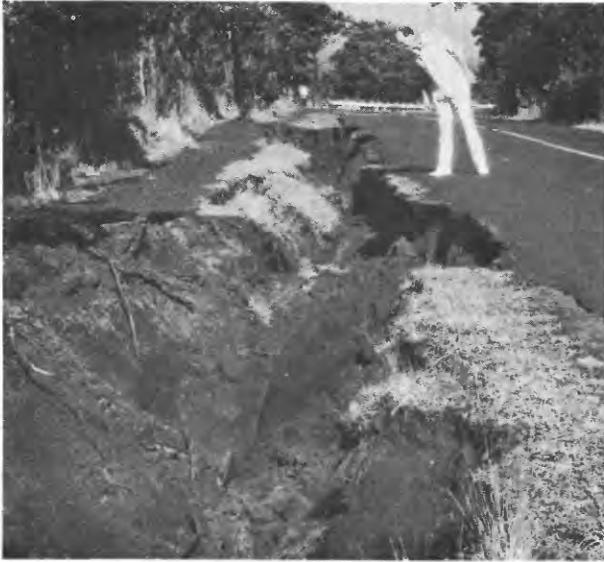
FIGURE 21.—Large crack in Crater Rim Road, Hawaii Volcanoes National Park. Cracking resulted from slumping of rim block toward caldera, the edge of which is a few meters to right of road.

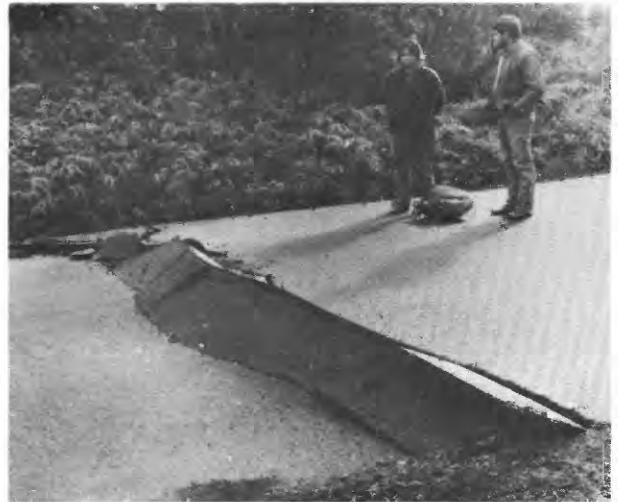
FIGURE 22.—Small compressional chevron fold across road on southeast side of Kilauea Military Camp, Hawaii Volcanoes National Park.

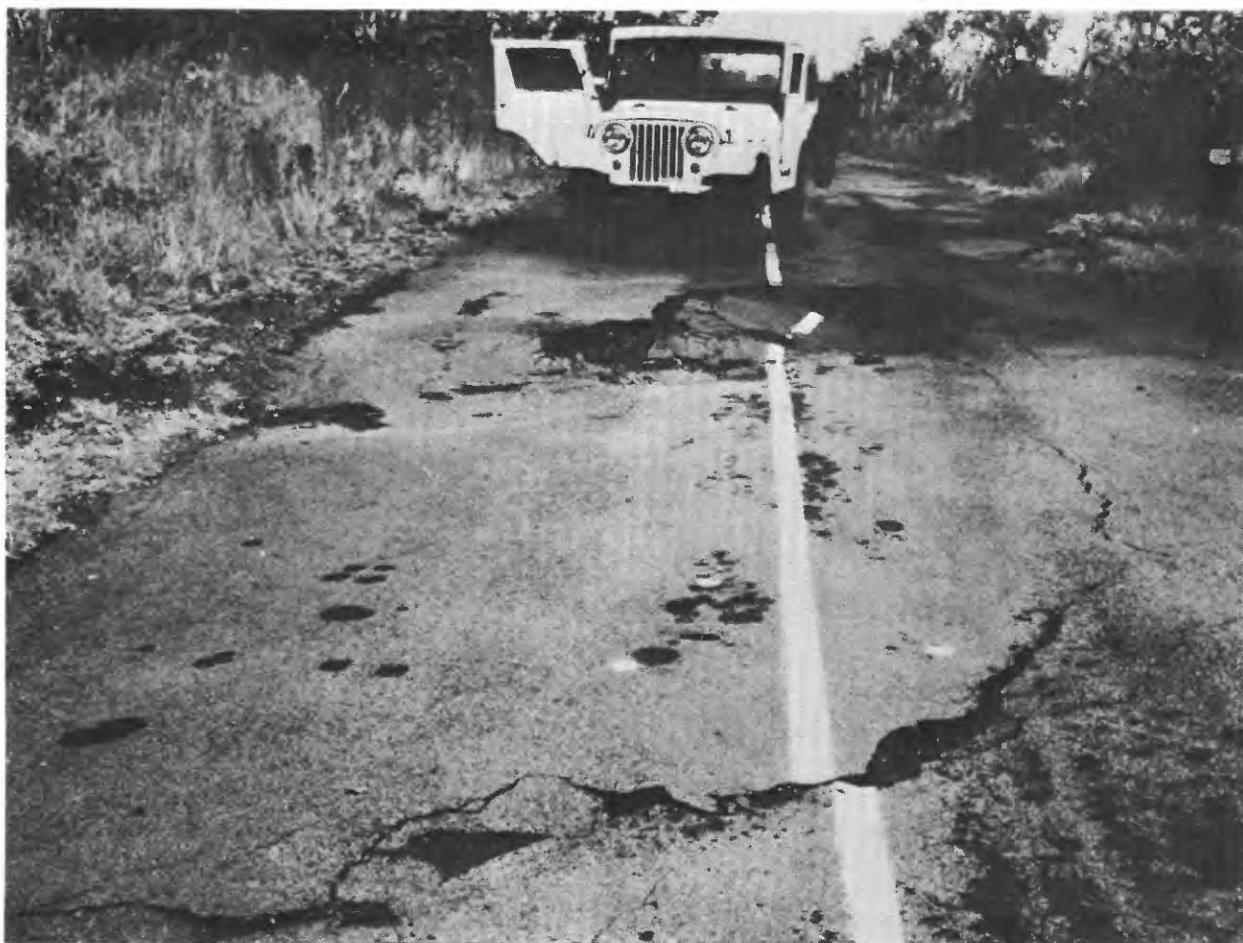
Hilina Pali Roads (fig. 12). While most of the ground breakage was extensional, producing new or widened cracks, local compressional features formed where slices of ground swayed between bounding open fractures and ended on one side or the other. A 5-cm partial closing of one crack in this manner produced a striking chevron fold across a road on the southeast side of Kilauea Military Camp (fig. 22). In a few places, movements along cracks produced apparent lateral offsets of as much as 10 cm (fig. 23).

FIGURE 23.—Collapse offsetting center line of Chain of Craters Road, just south of Pauahi Crater, Hawaii Volcanoes National Park.
