# Implications for Earthquake Risk Reduction in the United States from the Kocaeli, Turkey, Earthquake of August 17, 1999

U.S. Geological Survey Circular 1193

Field investigations were coordinated with the U.S. Army Corps of Engineers and National Institute of Standards and Technology

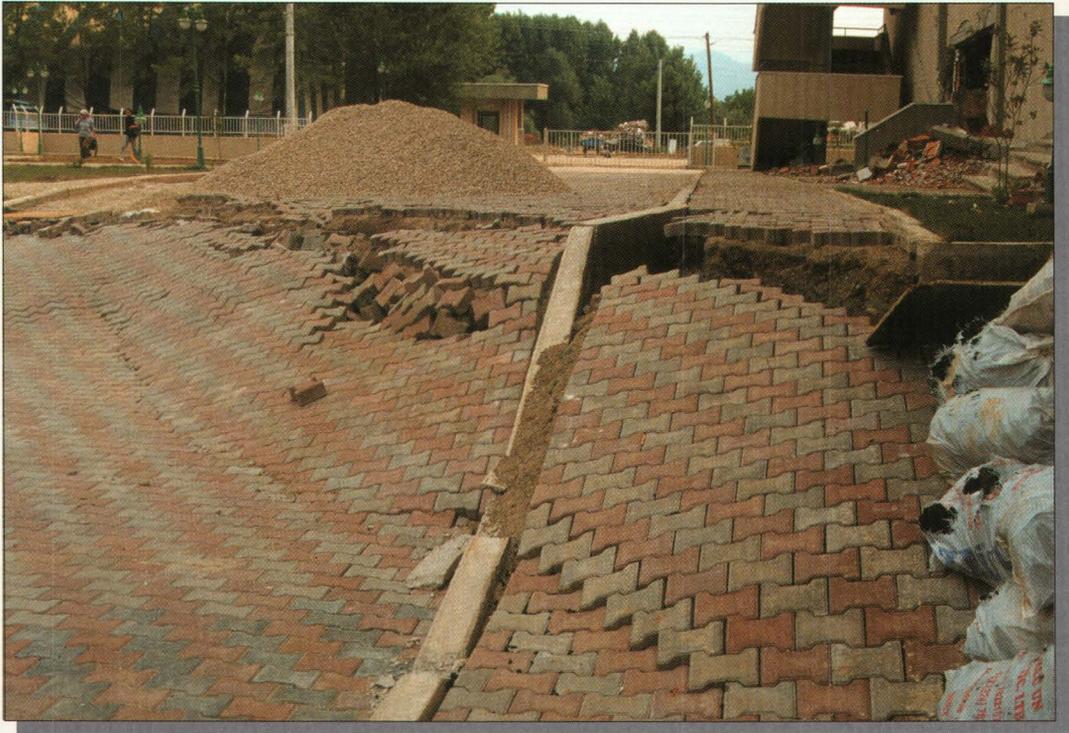
**Figure 10.** Tectonic scarp along the normal fault in Gölcük in a cobblestone pavement with both vertical (~1 m) and horizontal (~0.3 m) components of offset. *Photograph by Robert Langridge.*

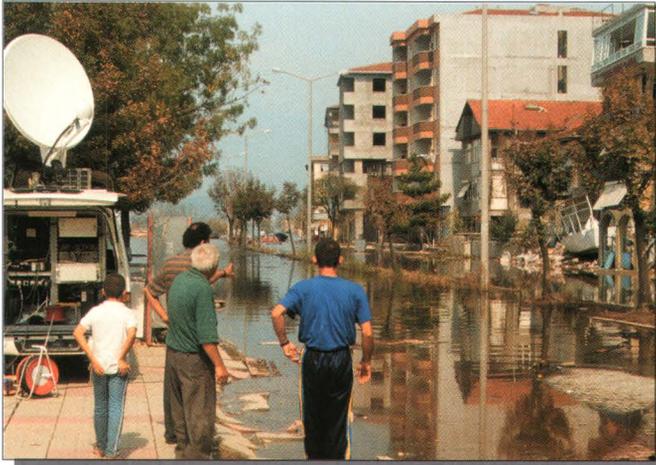
**Figure 12.** Submergence of shoreline in Gölcük caused by tectonic subsidence associated with normal faulting. *Upper photograph by Robert Langridge; lower photograph by Thomas L. Holzer.*

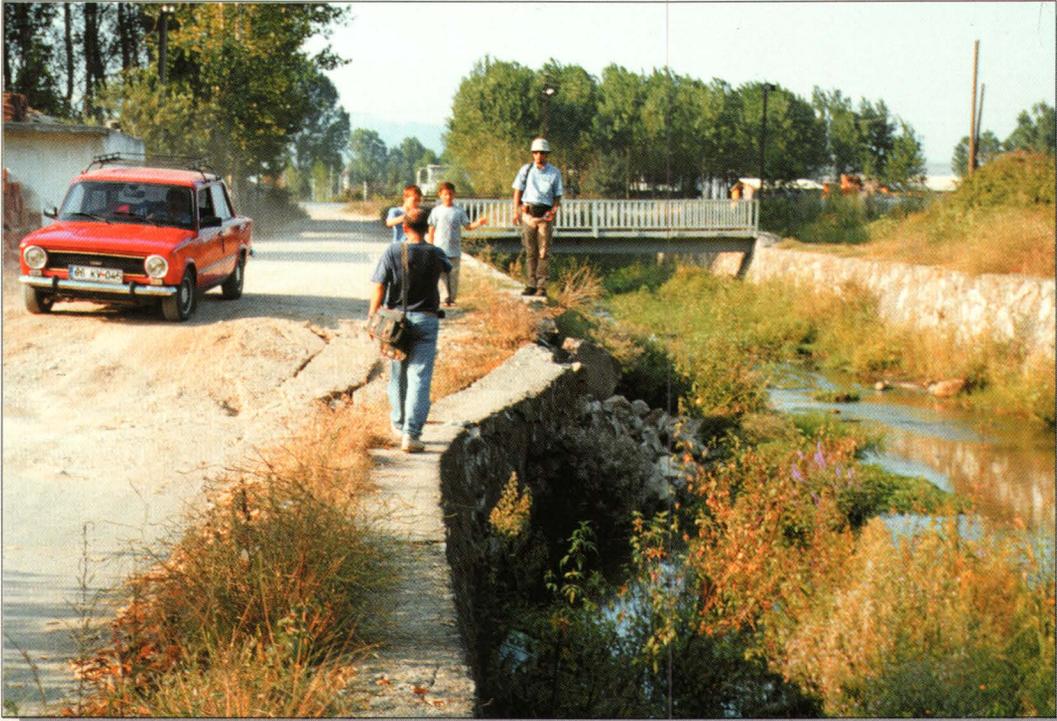
**Figure 14.** Offset canal near Izmit. Strike-slip displacement across the whole zone here was more than 2.5 m and included a vertical component (middle left). *Photograph by Heidi Stenner.*

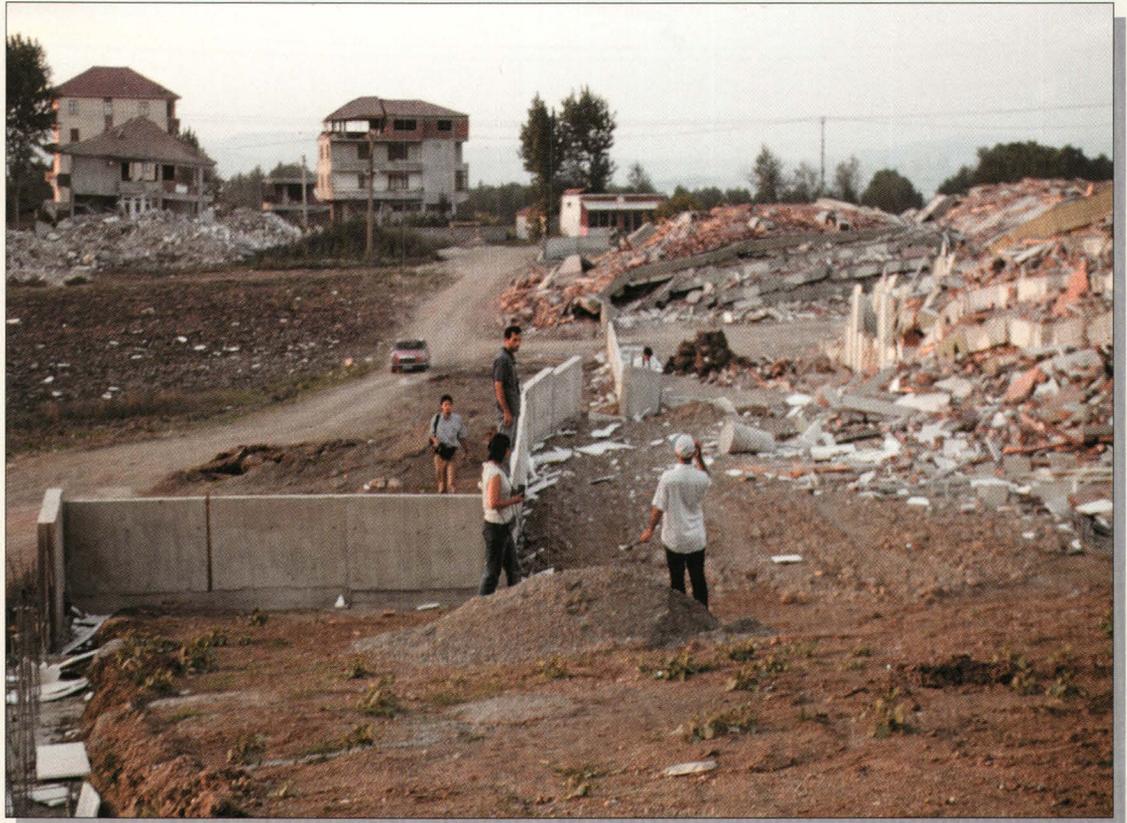
**Figure 15.** Surface rupture extending through boundary wall and collapsed apartments, to the east of Izmit. Strike-slip displacement here was about 3 m. *Photograph by Heidi Stenner.*

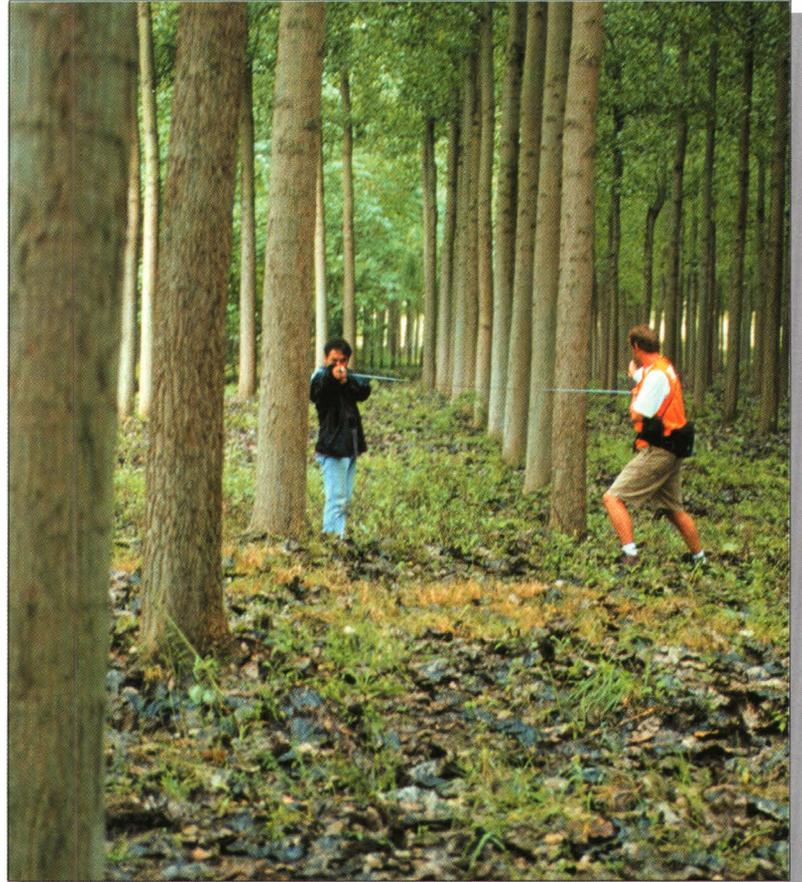
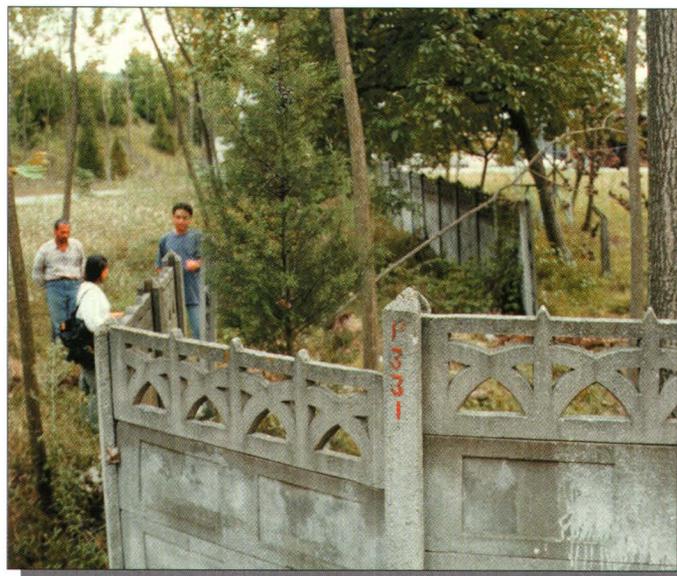
**Figure 18.** Offset wall near Arifiye. The right-lateral displacement is 4.58 m. *Photograph by Heidi Stenner.*

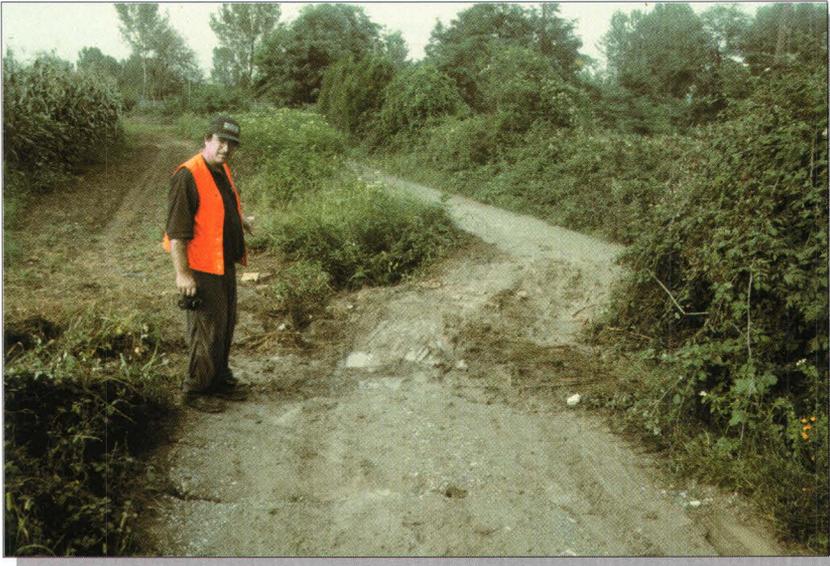
**Figure 19.** Road offset right laterally 4.66 m near Arifiye. *Photograph by Robert Langridge.*

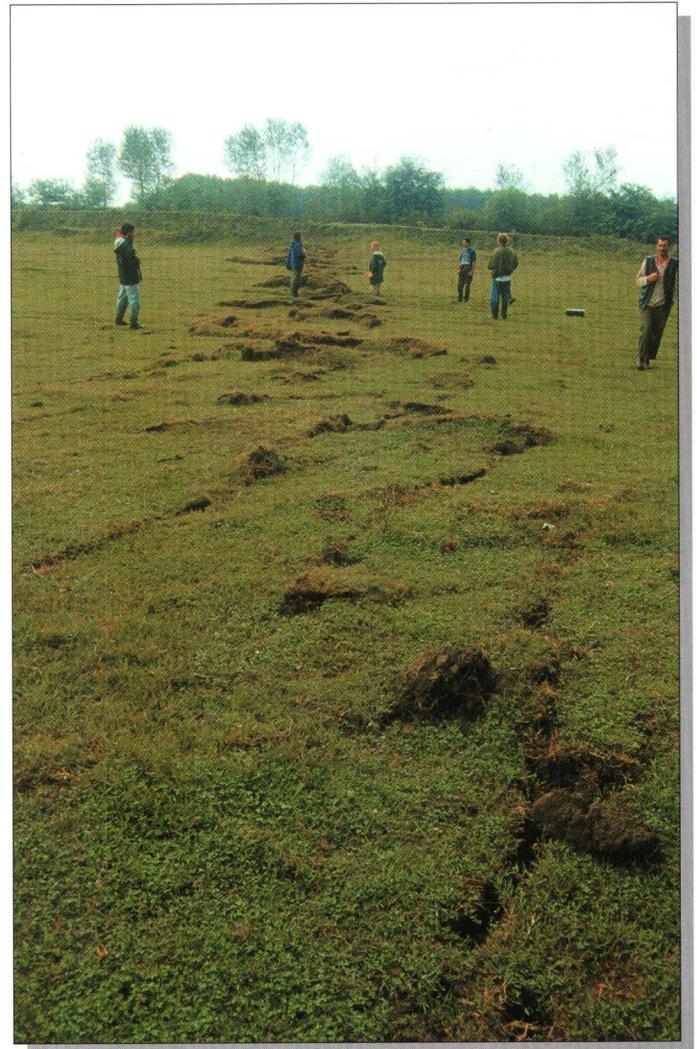
**Figure 20.** Complex surface rupture pattern with linking en echelon cracks seen near the Açmalık canal site. Right-lateral strike-slip displacement here amounted to 2.26 m and was 2.40 m in the dike of the canal, seen in the distance. *Photograph by Robert Langridge.*

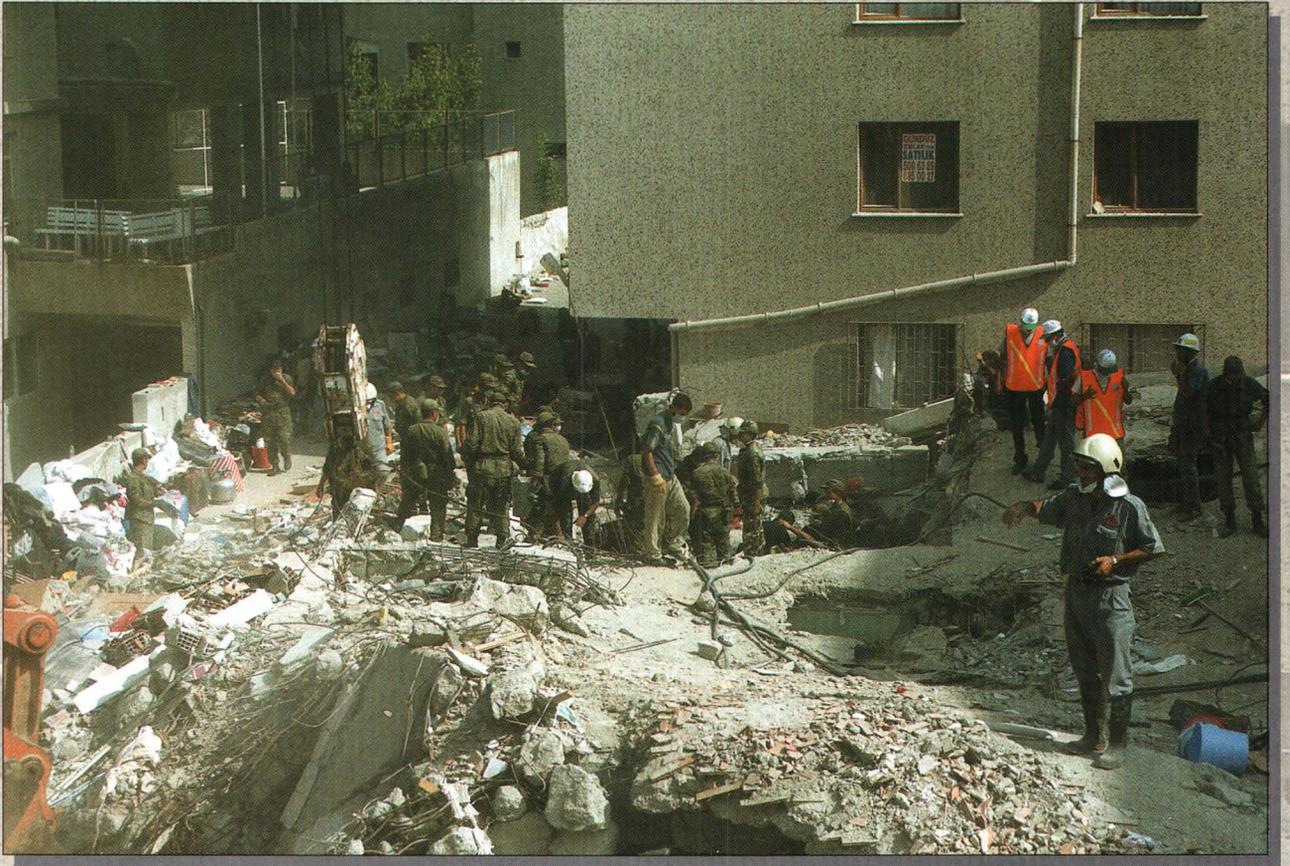
**Figure 31.** Rescue effort 4 days after the main shock at a collapsed building in area of concentrated damage in Avcilar. *Photograph by Thomas L. Holzer.*

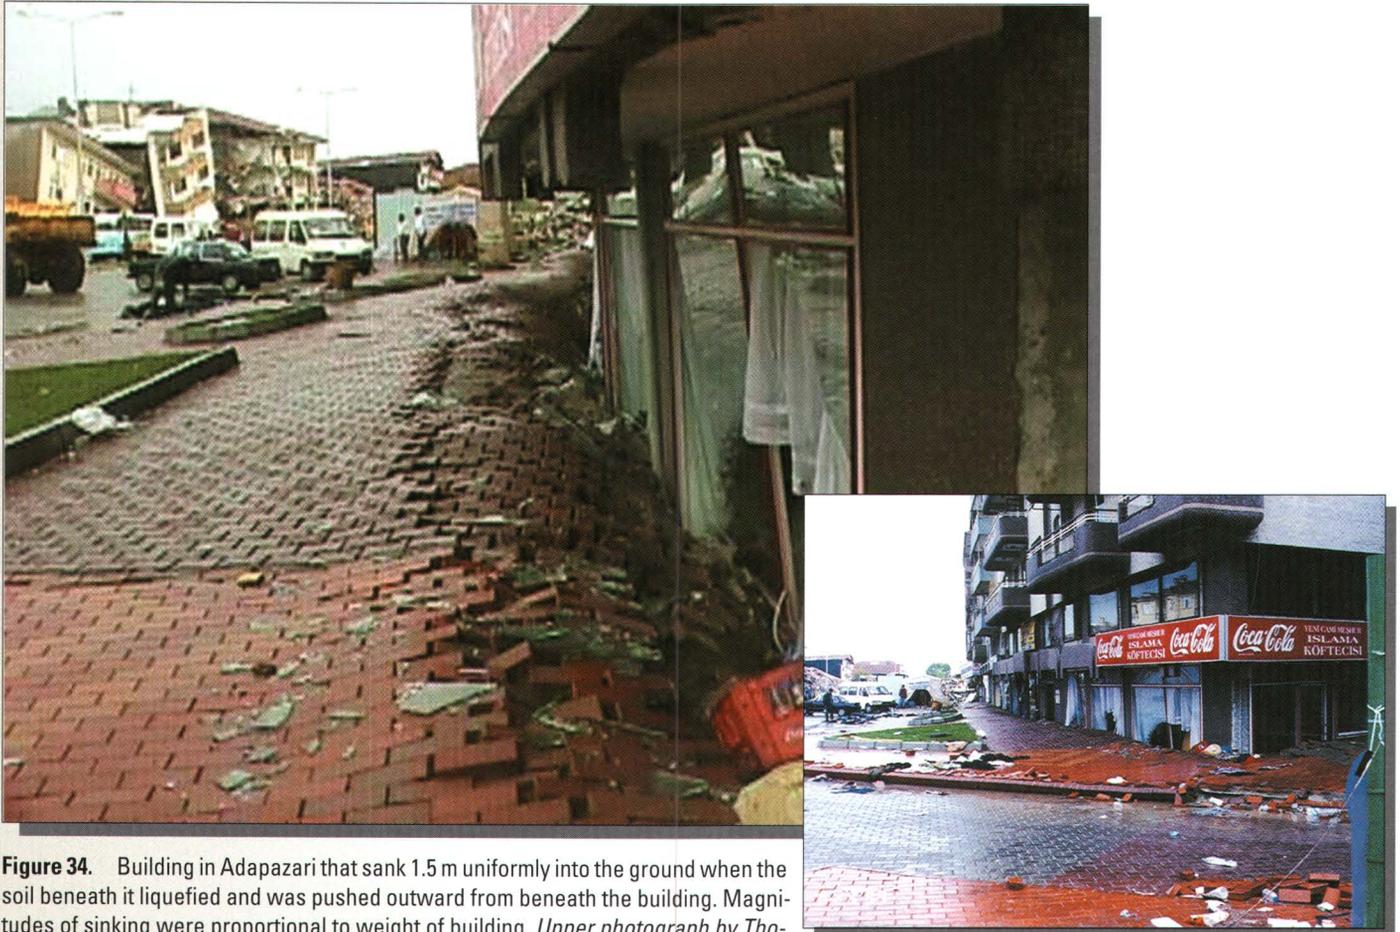
**Figure 34.** Building in Adapazari that sank 1.5 m uniformly into the ground when the soil beneath it liquefied and was pushed outward from beneath the building. Magnitudes of sinking were proportional to weight of building. *Upper photograph by Thomas L. Holzer; lower photograph by National Institute of Standards and Technology.*

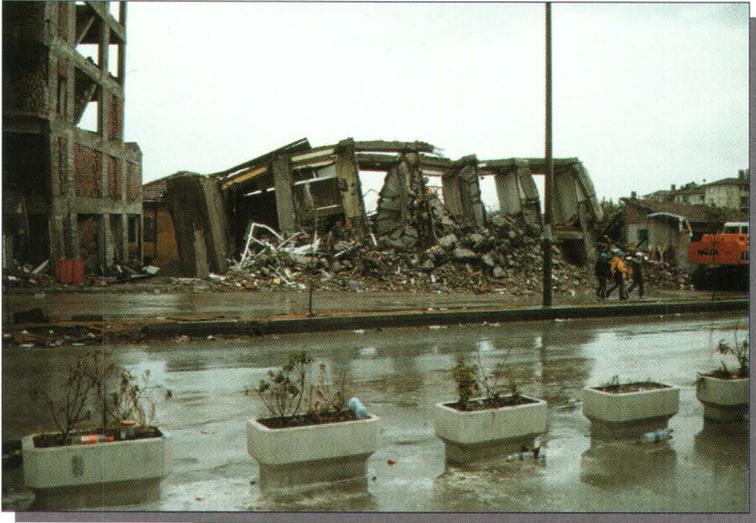
**Figure 35.** Buildings in Adapazari that either toppled or partially overturned because soil beneath them liquefied and weakened the foundation. *Upper photograph by Thomas L. Holzer; lower photograph by Richard S. Olsen.*

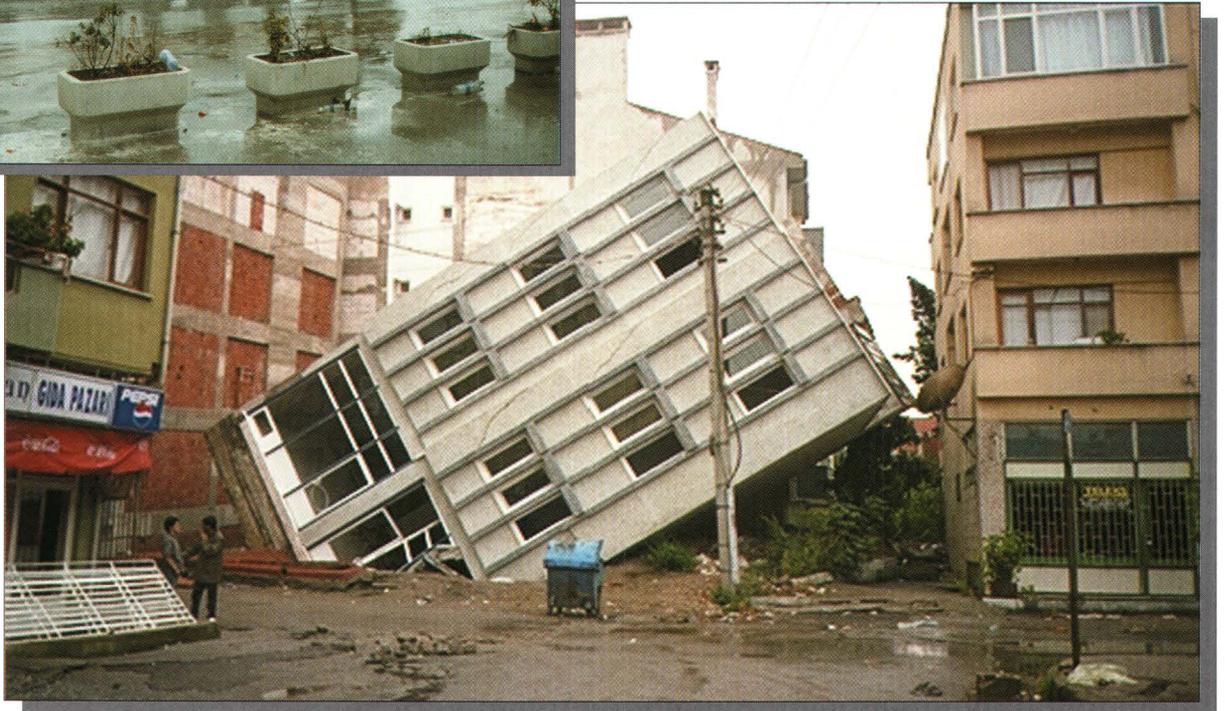
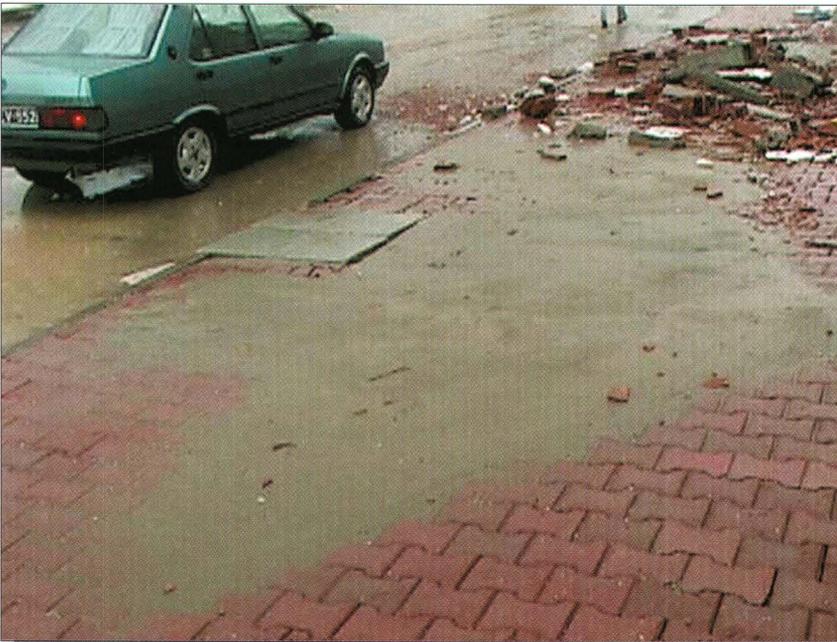
**Figure 36.** Sand boil on sidewalk in Adapazari. Sand ejected from underground when sandy soils beneath the ground-water table liquefied during the earthquake. *Photograph by Mehmet Çelebi.*

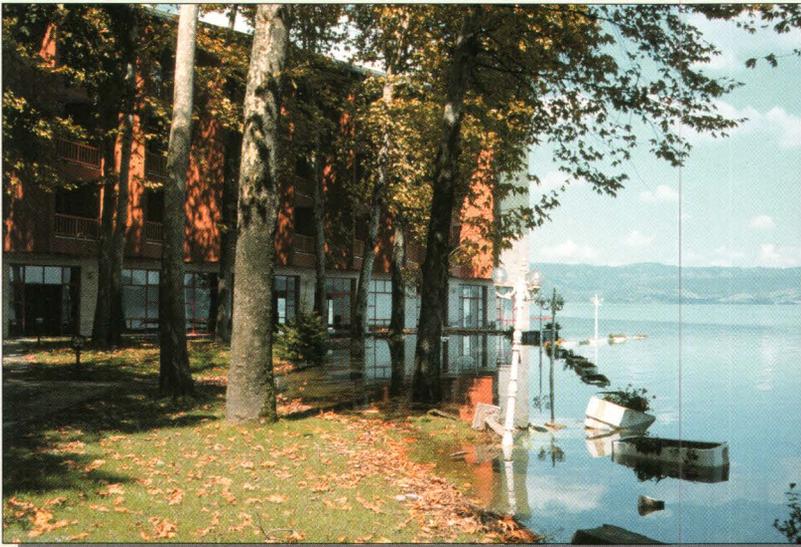
**Figure 37.** Submergence of shoreline at Lake Sapanca and settlement of Sapanca Hotel. "Moat" adjacent to wall indicates the hotel has sunk into the ground because of liquefaction of underlying sandy soil. *Photographs by Thomas L. Holzer.*

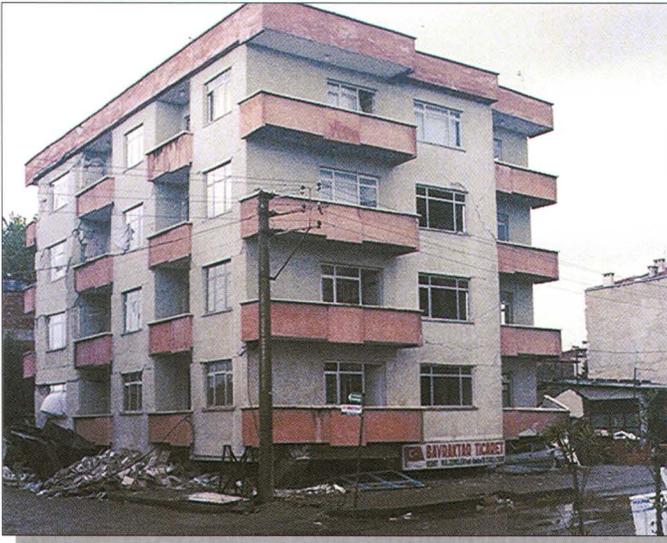
**Figure 41.** Partial building collapse in Yalova as the result of shear failure of first story columns. *Photograph by National Institute of Standards and Technology.*

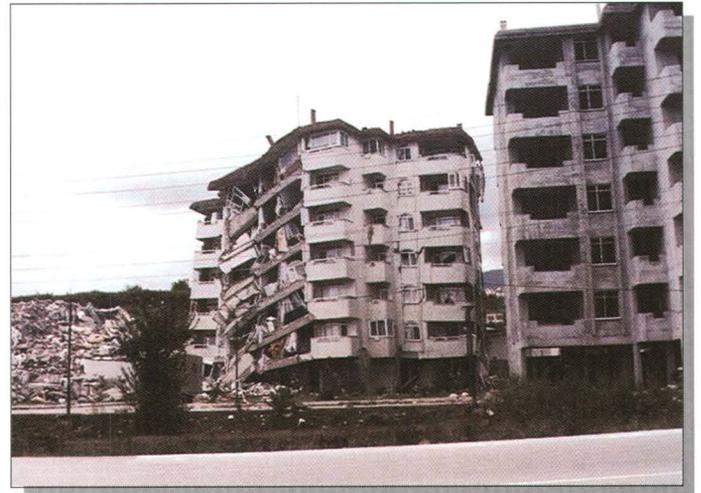
**Figure 42.** Partial collapse of building near Izmit as the result of shear failure of intermediate columns. Note various stages of damage despite apparently similar construction. *Photograph by National Institute of Standards and Technology.*

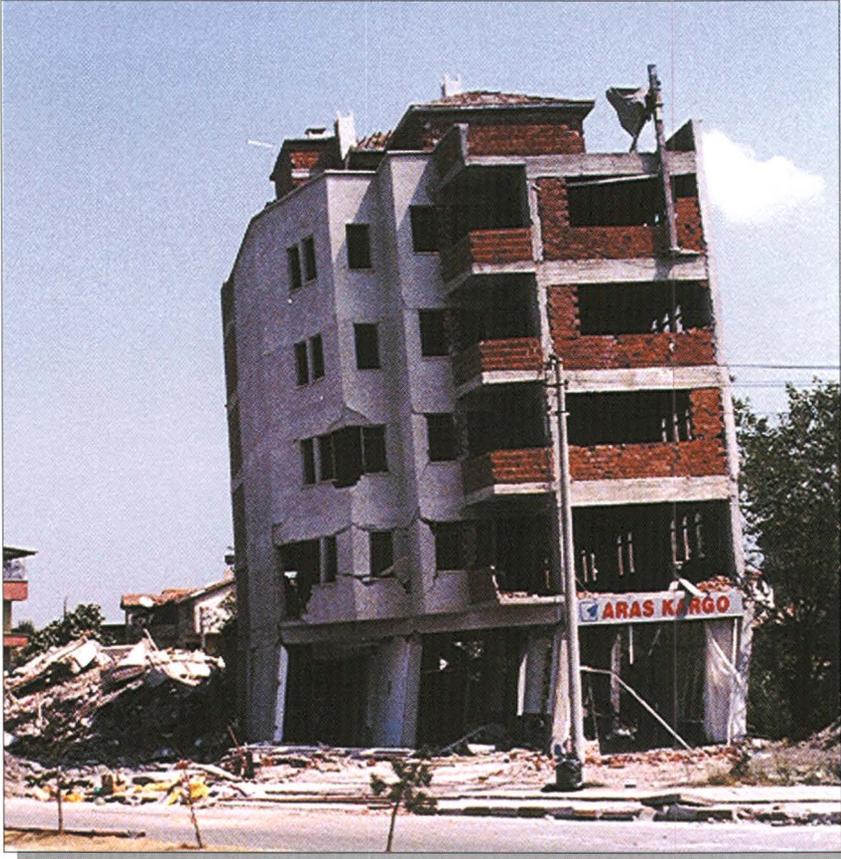
**Figure 43.** Near collapse of building in Adapazari as the result of formation of column hinges in the first story. *Photograph by National Institute of Standards and Technology.*

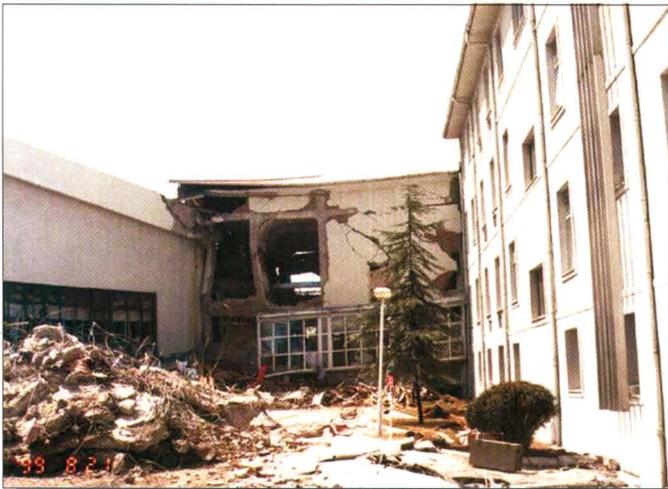
**Figure 44.** Damage to Officer's Club on Turkish Naval Base, Gölcük, which was located directly on the surface fault rupture. *Photograph by National Institute of Standards and Technology.*

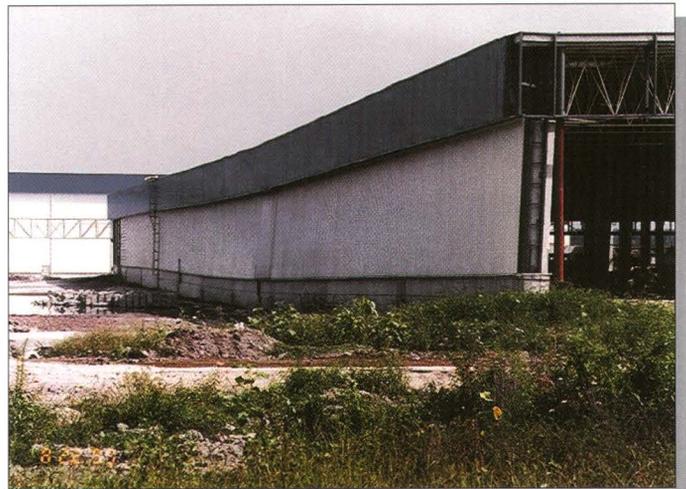
**Figure 45.** Industrial building damaged by near-fault ground movements east of Gölcük. Building is on downthrown block of normal fault and near a major change of strike in the surface fault scarp. *Photograph by National Institute of Standards and Technology.*

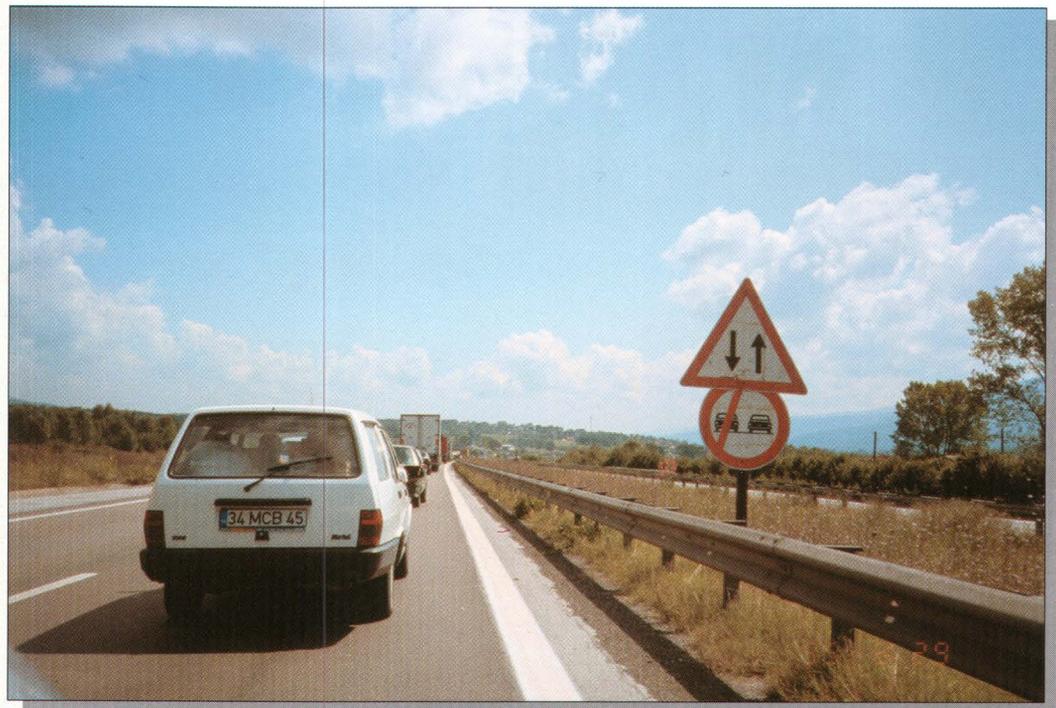
**Figure 48.** Following the earthquake, road surface repairs forced alternative use of the eastbound and westbound lanes of the Trans European Motorway as a two-way highway with greatly reduced speeds from Izmit to about 50 km east of Izmit. *Photograph by Thomas L. Holzer.*

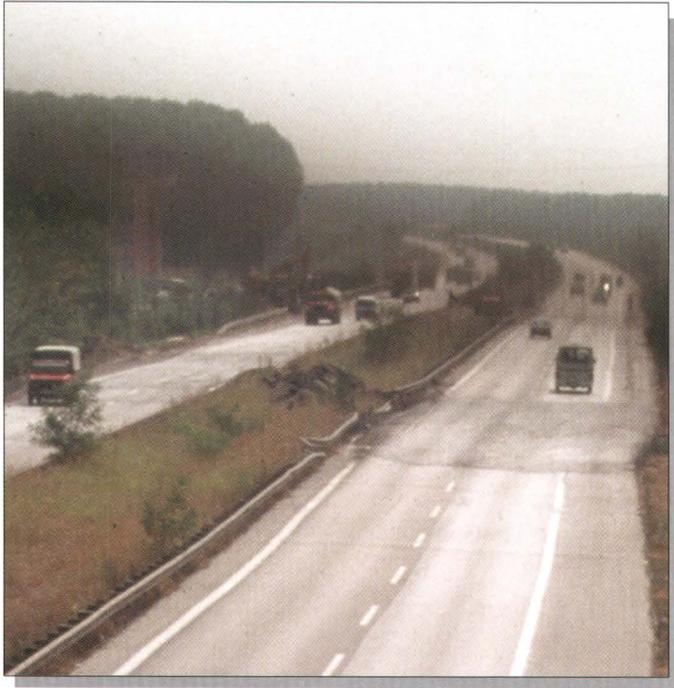
**Figure 49.** The North Anatolian fault, which crossed the Trans European Motorway at several locations in Turkey, caused major disruptions to the roadway surface. *Photograph by Robert K. Langridge.*

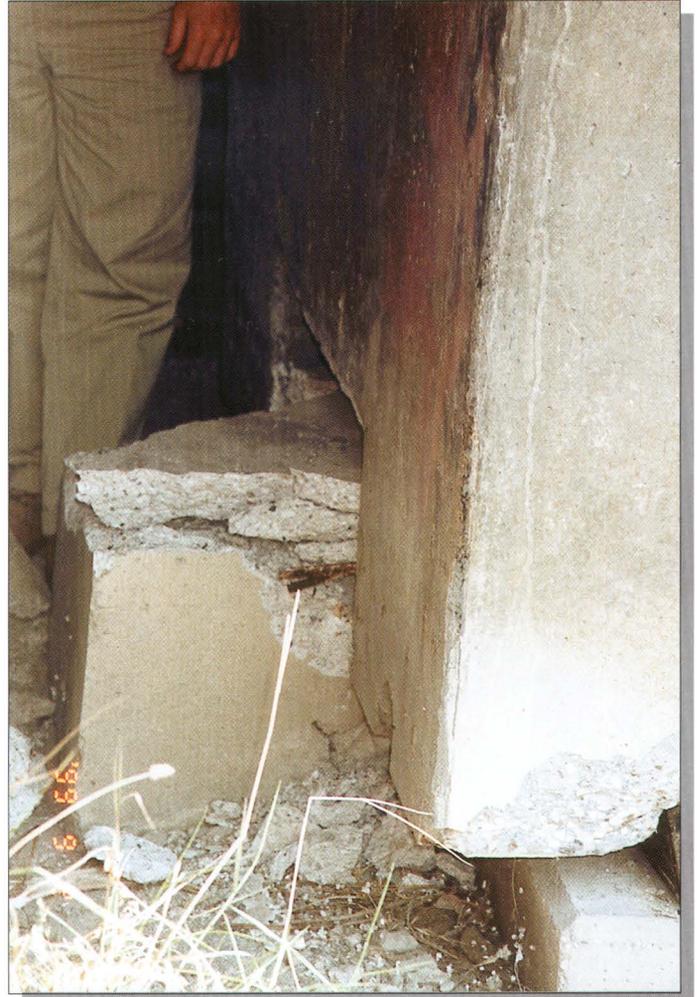
**Figure 50.** Failure of shear keys was common at bridges of the Trans European Motorway. Shear keys at the end of girders prevent transverse and longitudinal seismic movements. *Photograph by Selcuk Toprak.*

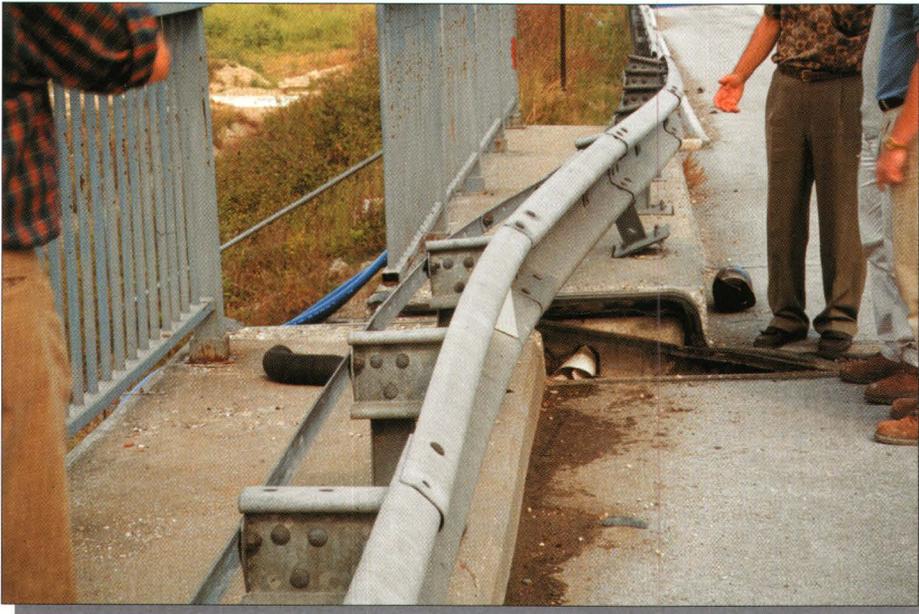
**Figure 51.** Ground shaking caused the westbound span of the Sakarya River bridge to displace 50 cm relative to the east abutment. This was the largest permanent displacement caused by shaking at any bridge. *Photograph by Selcuk Toprak.*

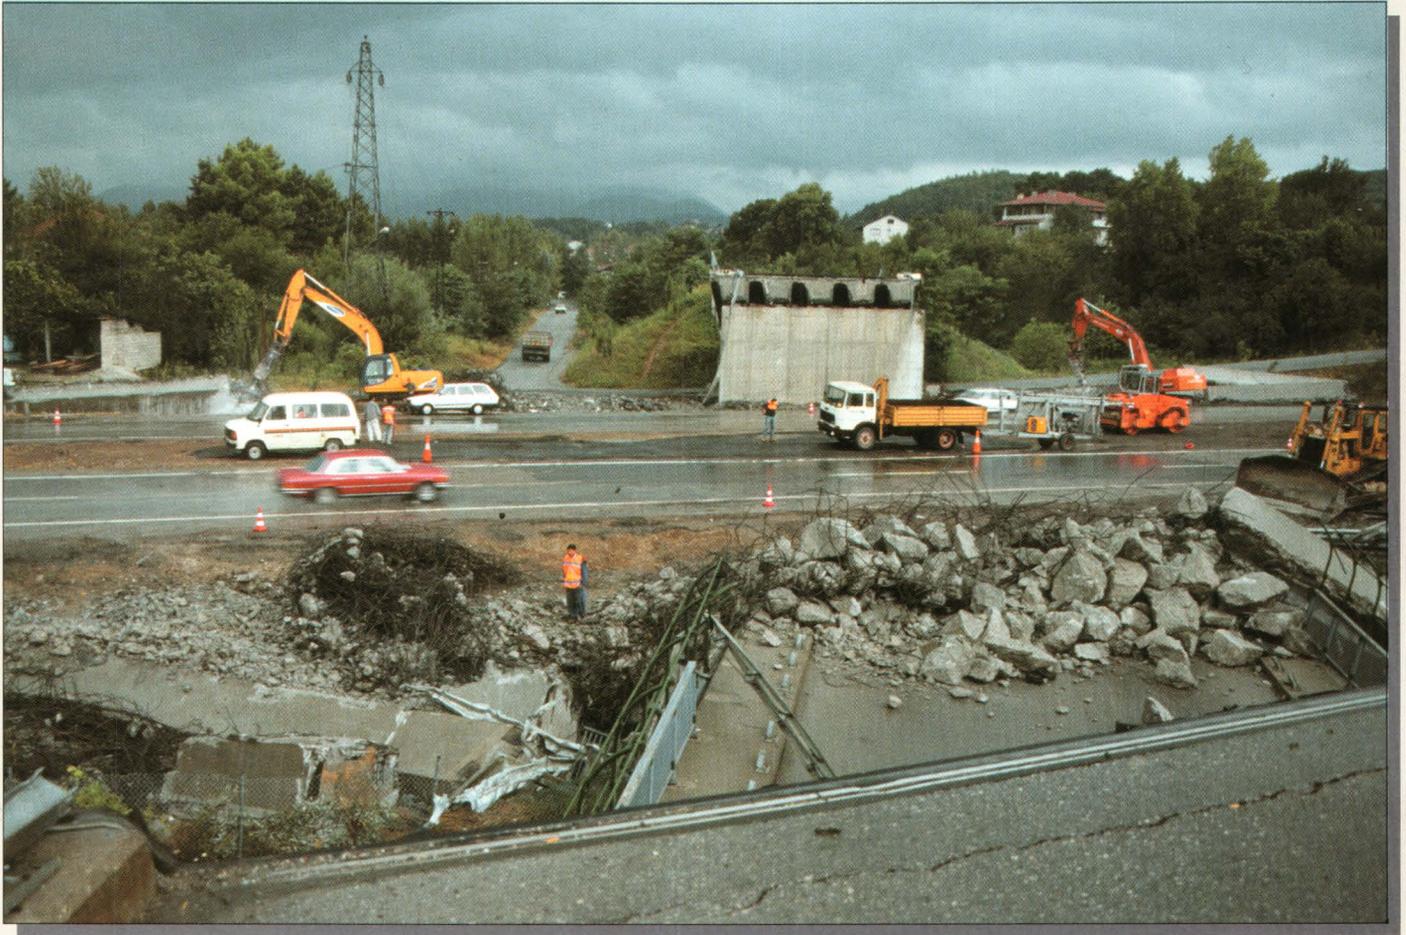
**Figure 53.** The Arifiye overpass collapsed because the surface fault rupture passed directly through its north abutment (foreground). Ten riders of a bus were killed when the bus collided with the collapsed overpass. *Photograph by Thomas L. Holzer.*
