Implications for Earthquake Risk Reduction in the United States from the Kocaeli, Turkey, Earthquake of August 17, 1999

U.S. Geological Survey Circular 1193

U.S. Department of the Interior
U.S. Geological Survey

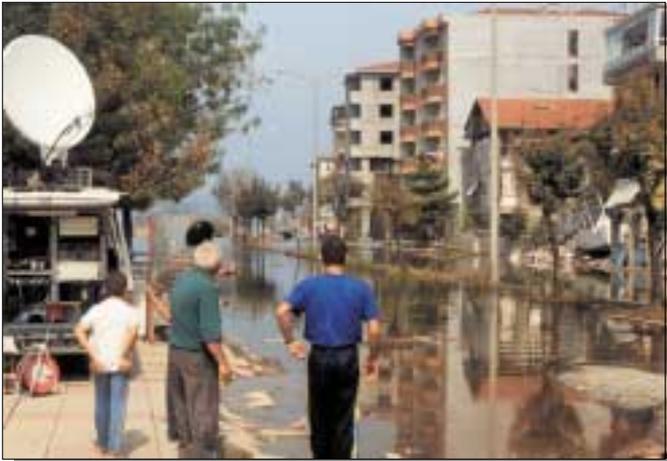
Figure 12. Submergence of shoreline in Gölçük caused by tectonic subsidence associated with normal faulting. *Upper photograph by Robert Langridge; lower photograph by Thomas L. Holzer.*

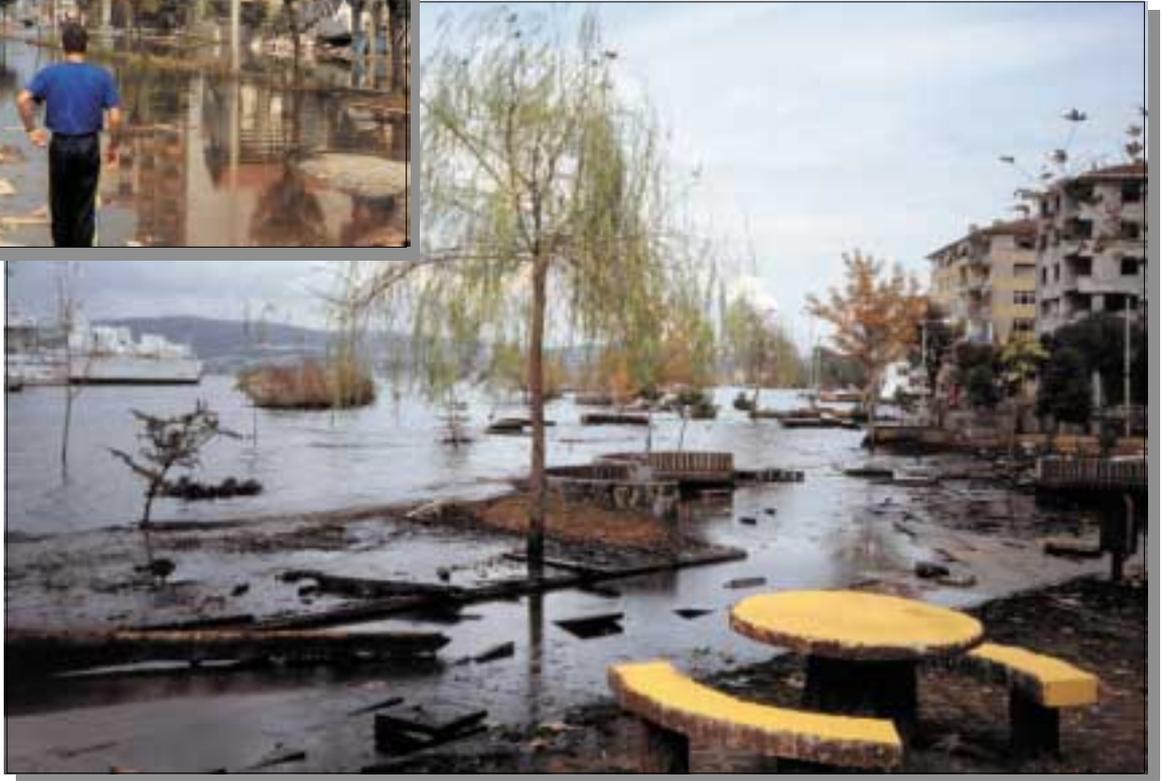
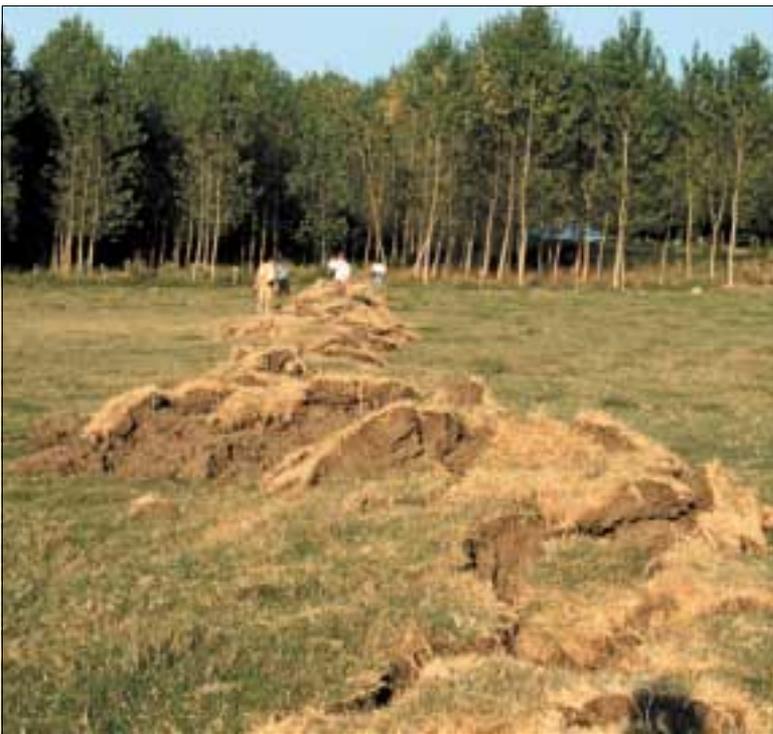
Figure 13. Mole track along ground rupture near Izmit. Right-lateral strike-slip displacement was about 3 m. Positive topographic relief of the mole track was localized and did not represent a component of the motion. *Photograph by Heidi Stenner.*

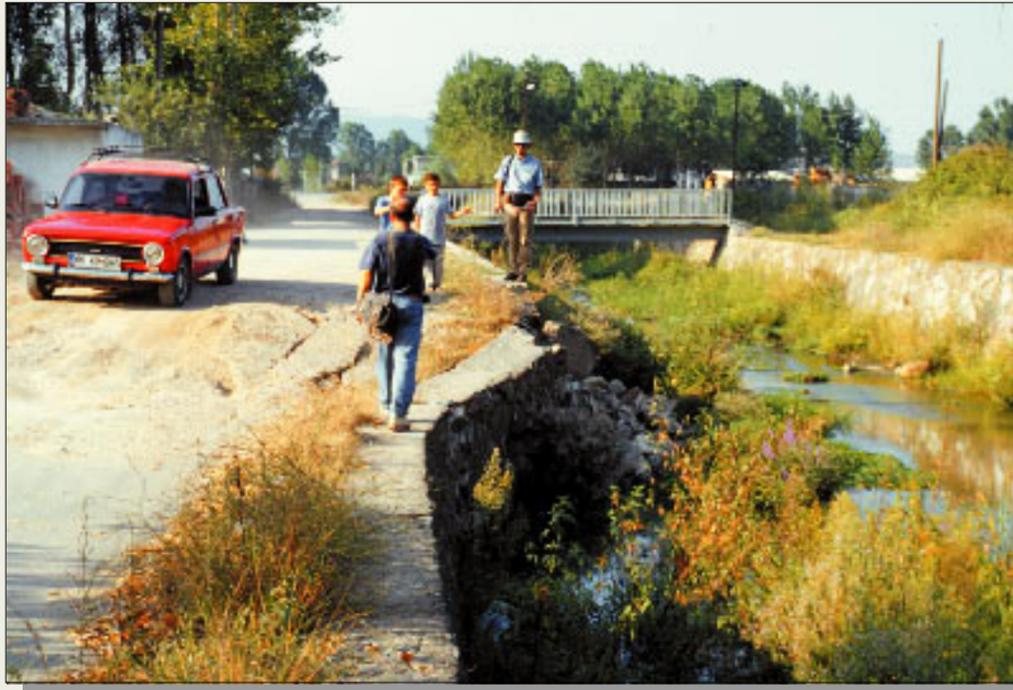
Figure 14. Offset canal near Izmit. Strike-slip displacement across the whole zone here was more than 2.5 m and included a vertical component (middle left). Photograph by Heidi Stenner.

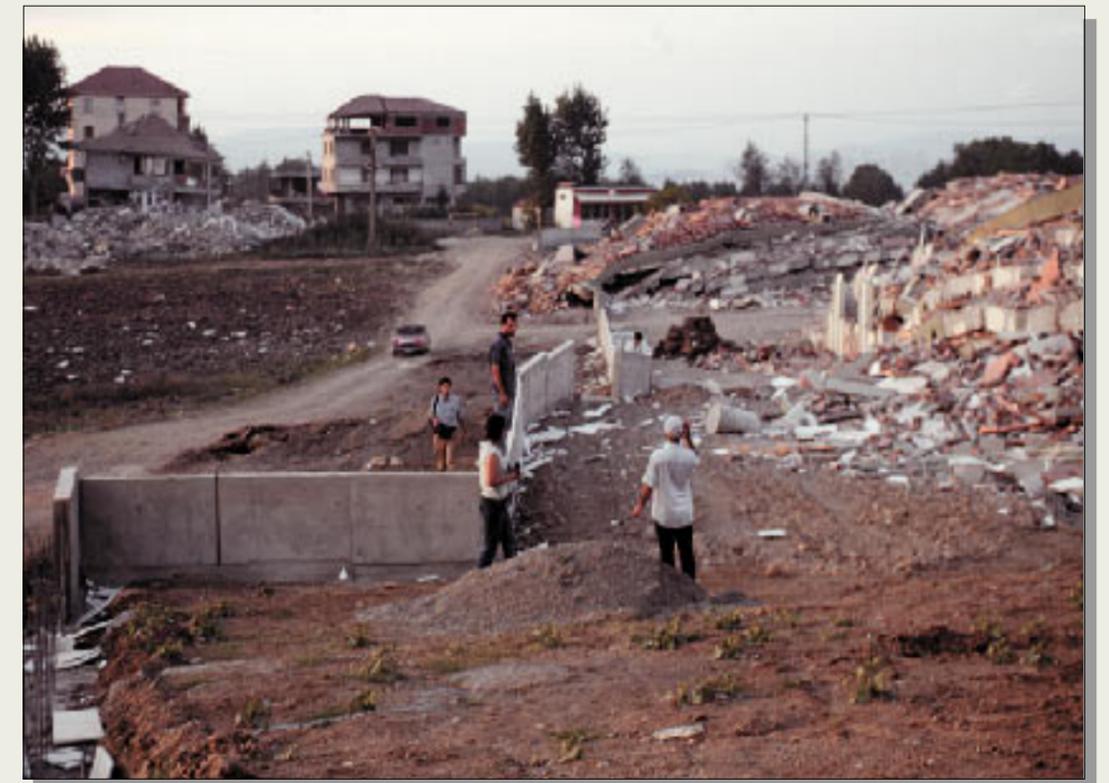
Figure 15. Surface rupture extending through boundary wall and collapsed apartments, to the east of Izmit. Strike-slip displacement here was about 3 m. Photograph by Heidi Stenner.

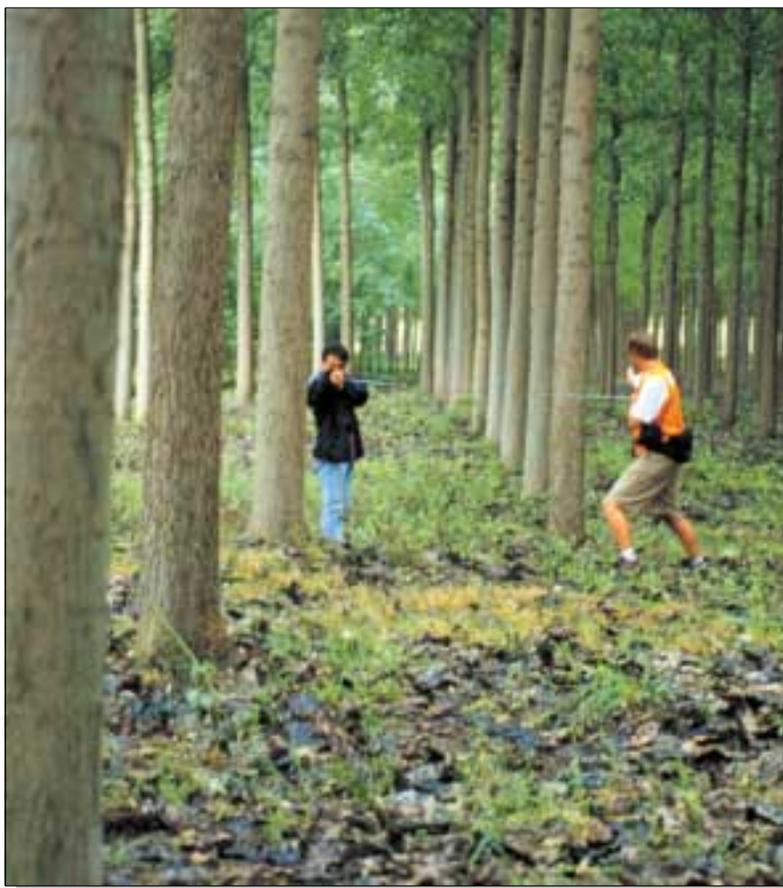
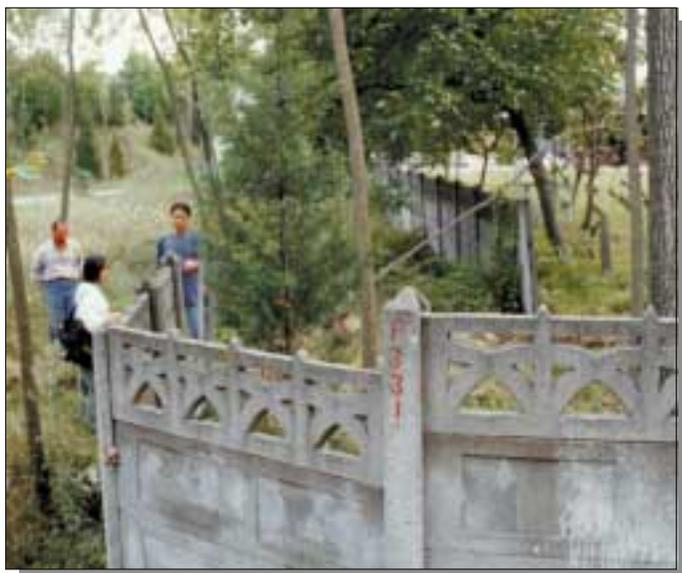
Figure 18. Offset wall near Arifiye. The right-lateral displacement is 4.58 m. *Photograph by Heidi Stenner.*

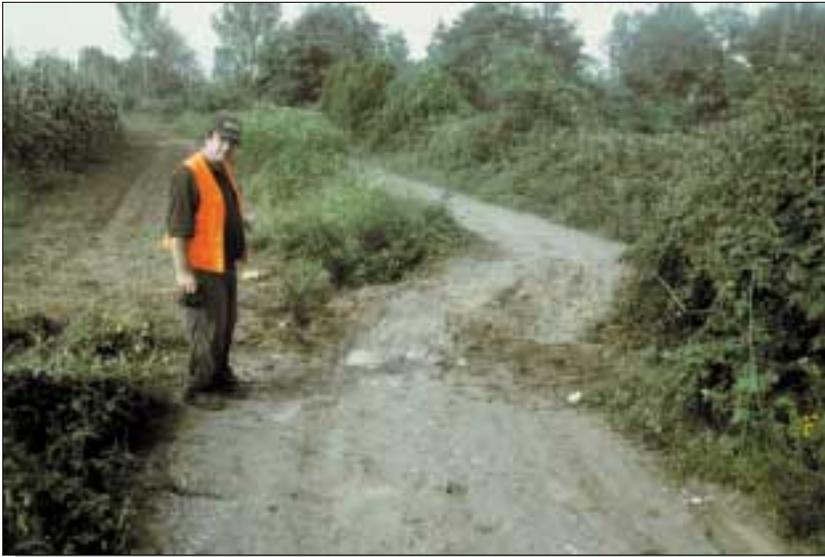
Figure 19. Road offset right laterally 4.66 m near Arifiye. *Photograph by Robert Langridge.*

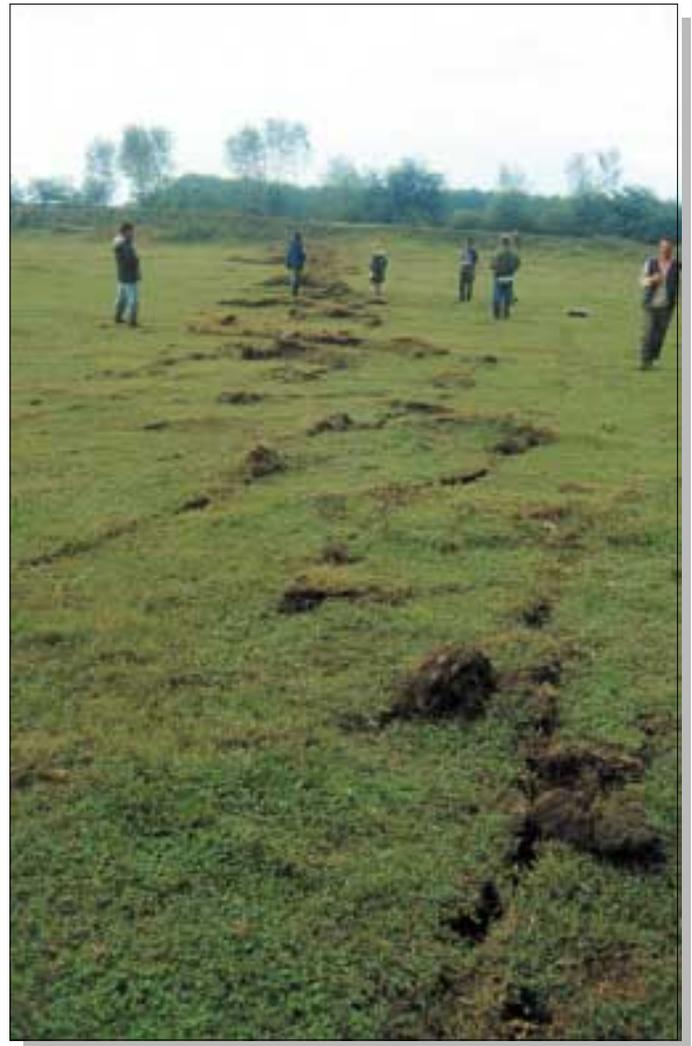
Figure 20. Complex surface rupture pattern with linking en echelon cracks seen near the Açalık canal site. Right-lateral strike-slip displacement here amounted to 2.26 m and was 2.40 m in the dike of the canal, seen in the distance. *Photograph by Robert Langridge.*

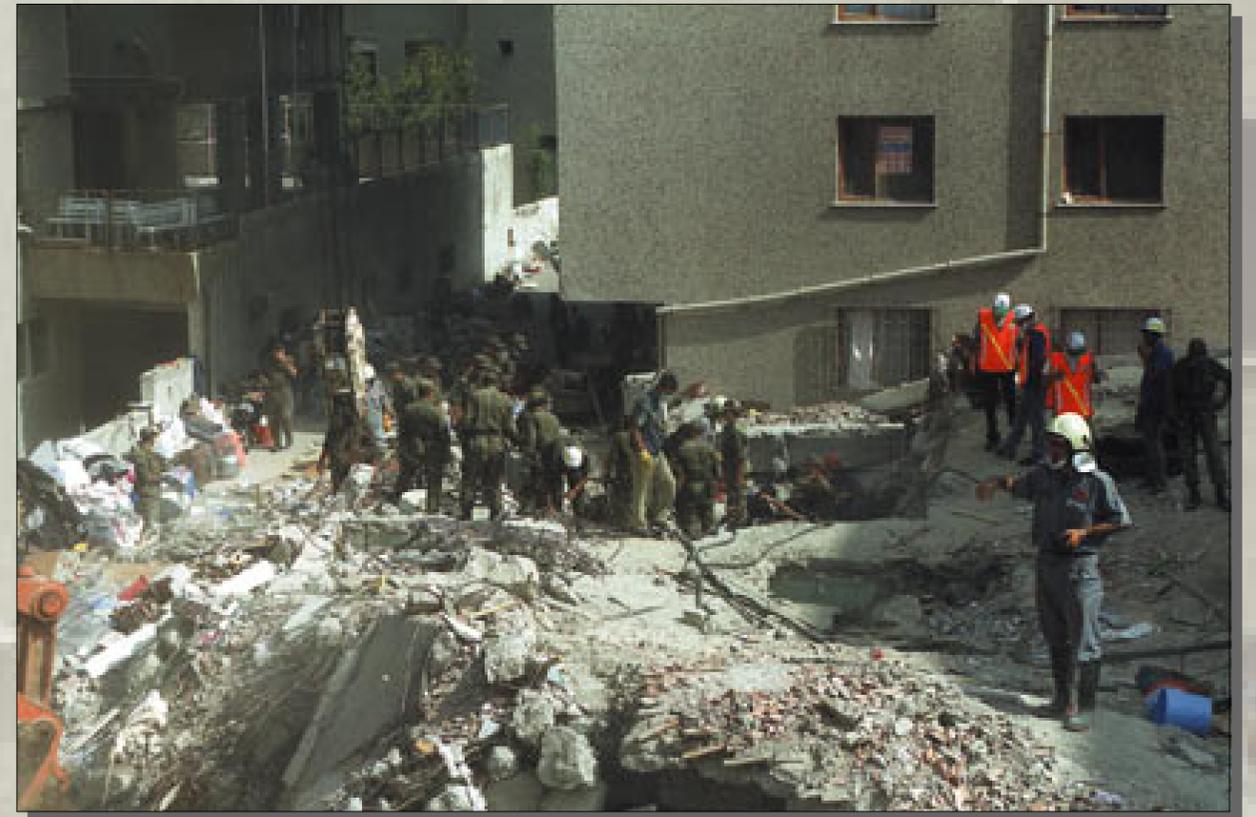
Figure 31. Rescue effort 4 days after the main shock at a collapsed building in area of concentrated damage in Avcilar. *Photograph by Thomas L. Holzer.*

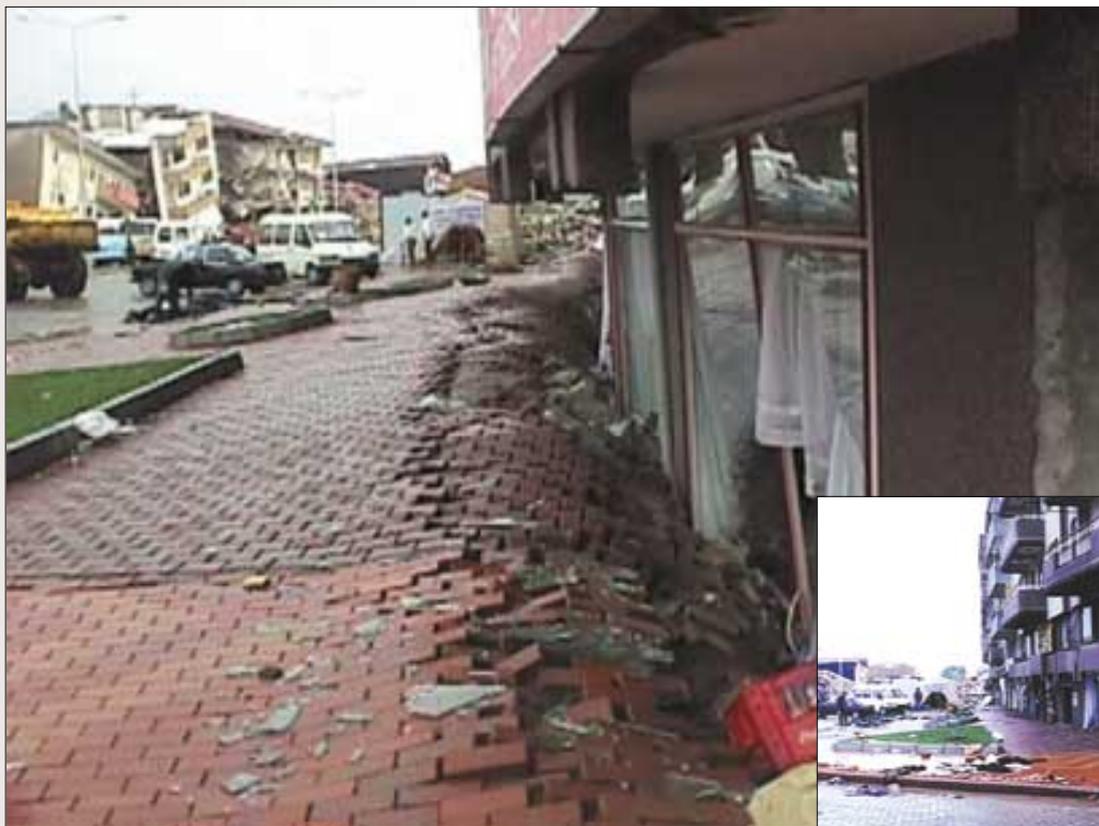
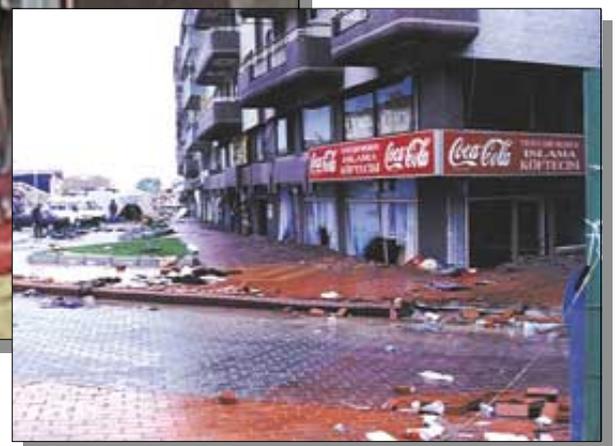
Figure 34. Building in Adapazari that sank 1.5 m uniformly into the ground when the soil beneath it liquefied and was pushed outward from beneath the building. Magnitudes of sinking were proportional to weight of building. *Upper photograph by Thomas L. Holzer; lower photograph by National Institute of Standards and Technology.*

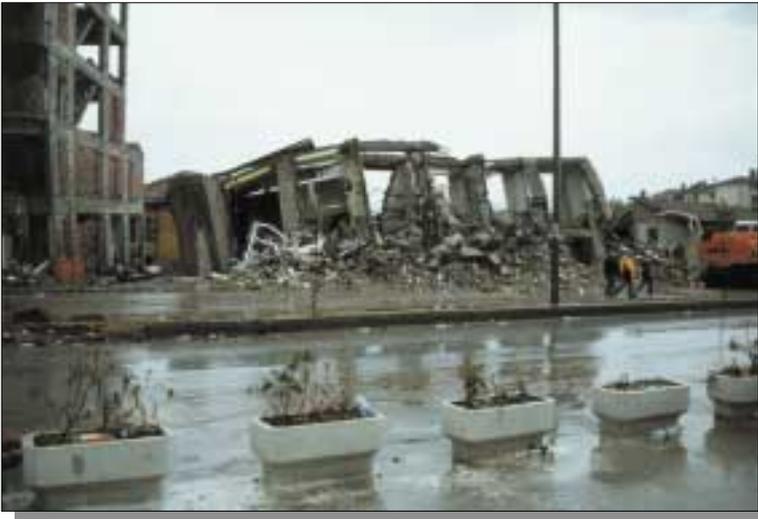
Figure 35. Buildings in Adapazari that either toppled or partially overturned because soil beneath them liquefied and weakened the foundation. *Upper photograph by Thomas L. Holzer; lower photograph by Richard S. Olsen.*

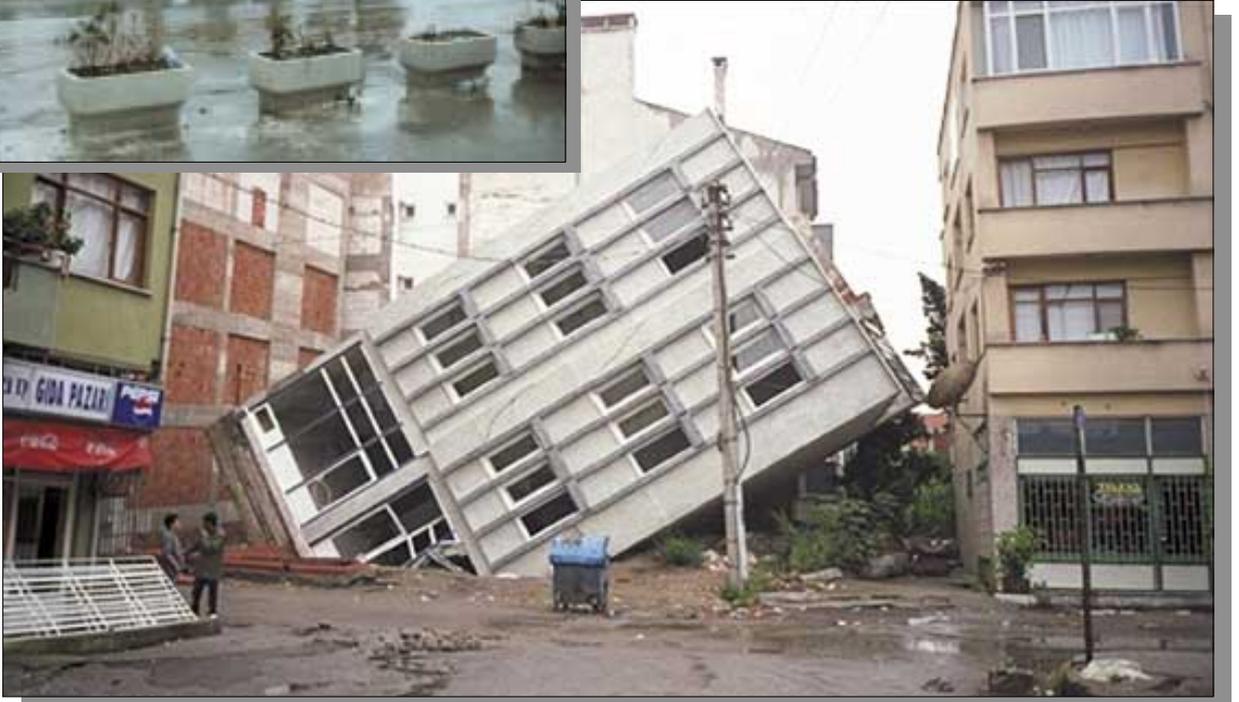
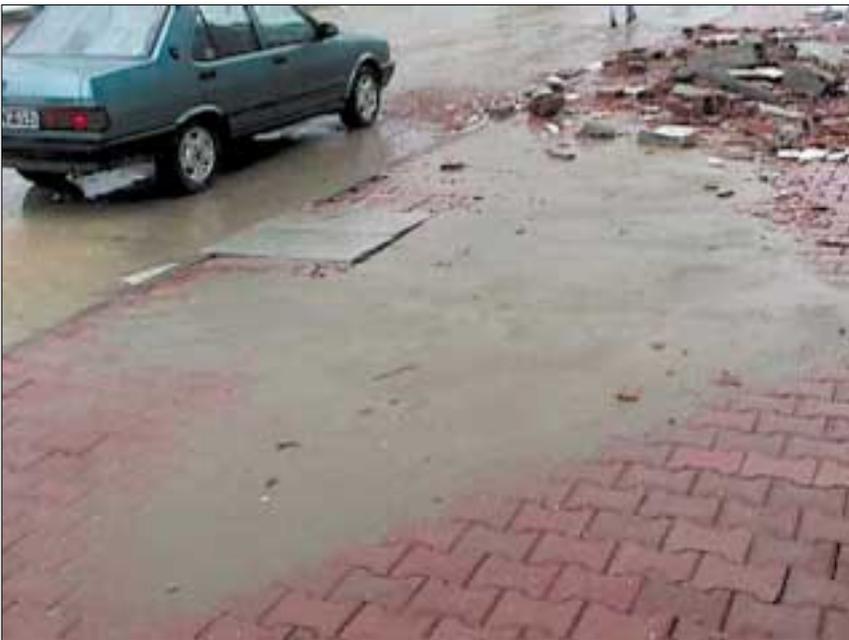
Figure 36. Sand boil on sidewalk in Adapazari. Sand ejected from underground when sandy soils beneath the ground-water table liquefied during the earthquake. *Photograph by Mehmet Çelebi.*

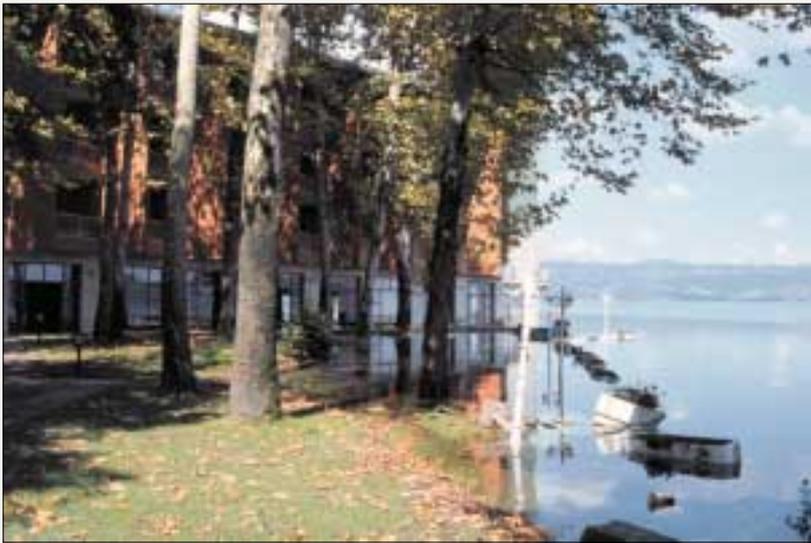
Figure 37. Submergence of shoreline at Lake Sapanca and settlement of Sapanca Hotel. "Moat" adjacent to wall indicates the hotel has sunk into the ground because of liquefaction of underlying sandy soil. *Photographs by Thomas L. Holzer.*

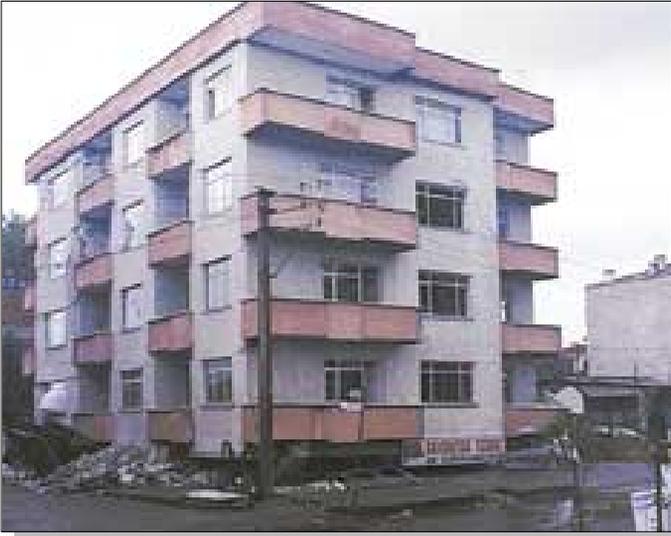
Figure 41. Partial building collapse in Yalova as the result of shear failure of first story columns. *Photograph by National Institute of Standards and Technology.*

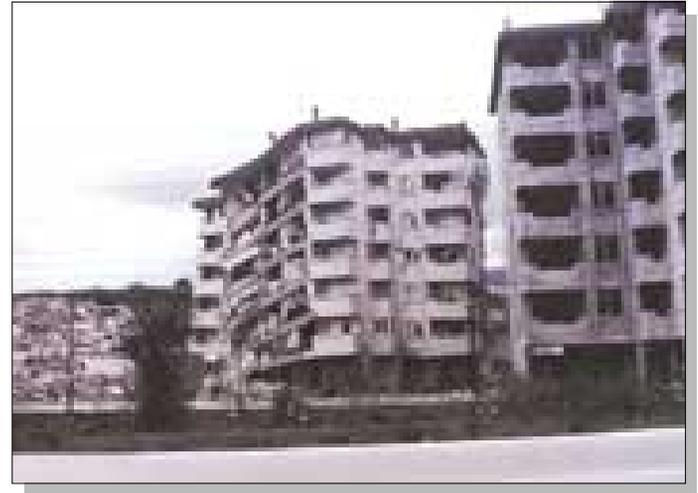
Figure 42. Partial collapse of building near Izmit as the result of shear failure of intermediate columns. Note various stages of damage despite apparently similar construction. *Photograph by National Institute of Standards and Technology.*

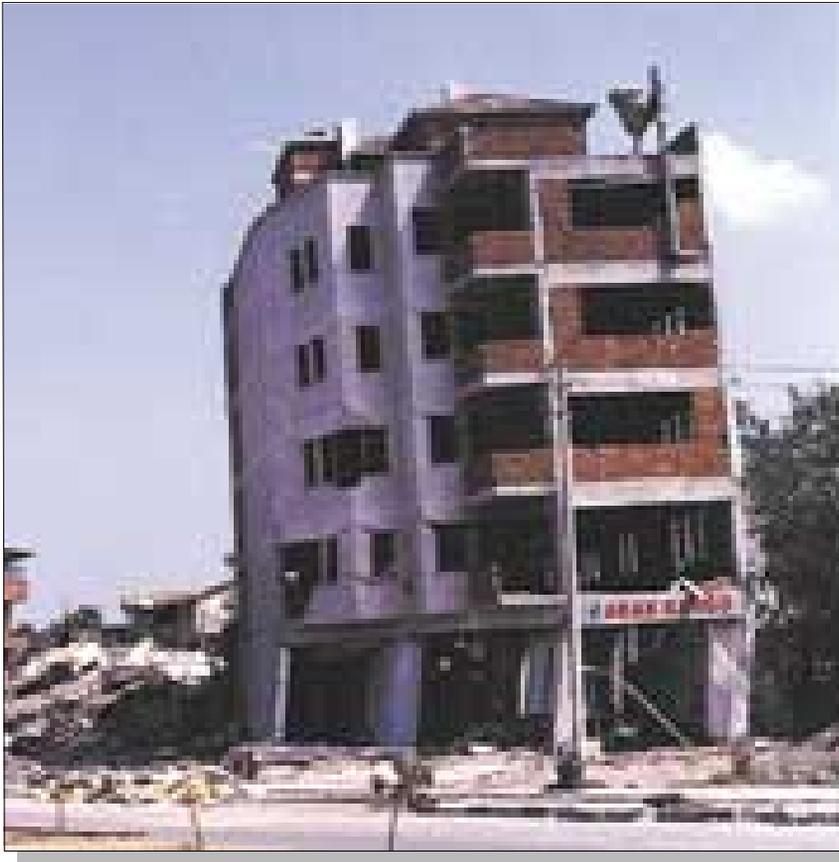
Figure 43. Near collapse of building in Adapazari as the result of formation of column hinges in the first story. *Photograph by National Institute of Standards and Technology.*

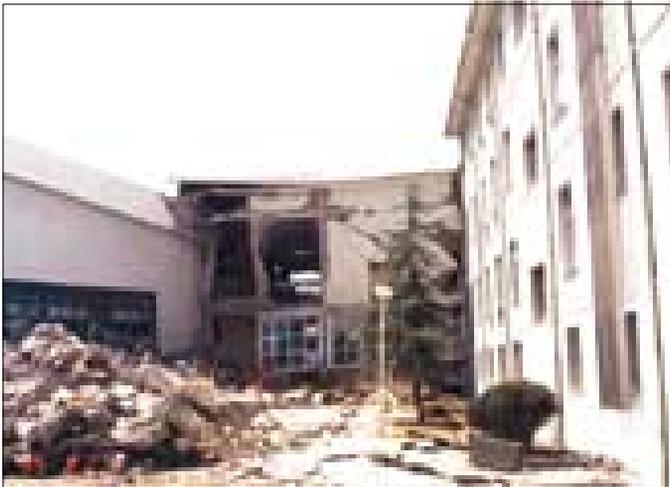
Figure 44. Damage to Officer's Club on Turkish Naval Base, Gölcük, which was located directly on the surface fault rupture. *Photograph by National Institute of Standards and Technology.*

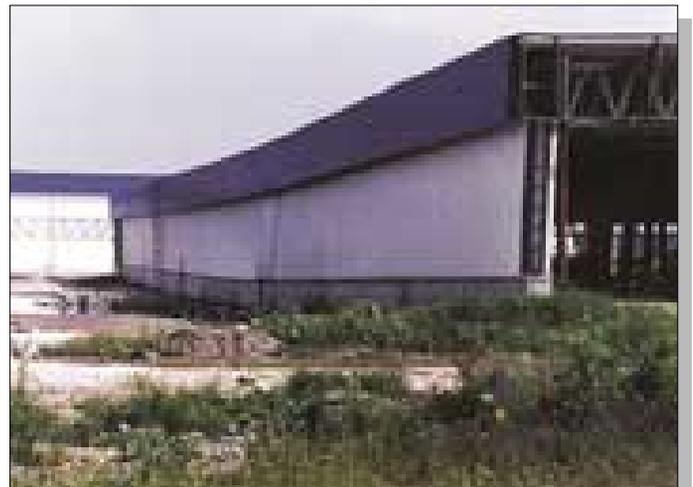
Figure 45. Industrial building damaged by near-fault ground movements east of Gölcük. Building is on downthrown block of normal fault and near a major change of strike in the surface fault scarp. *Photograph by National Institute of Standards and Technology.*

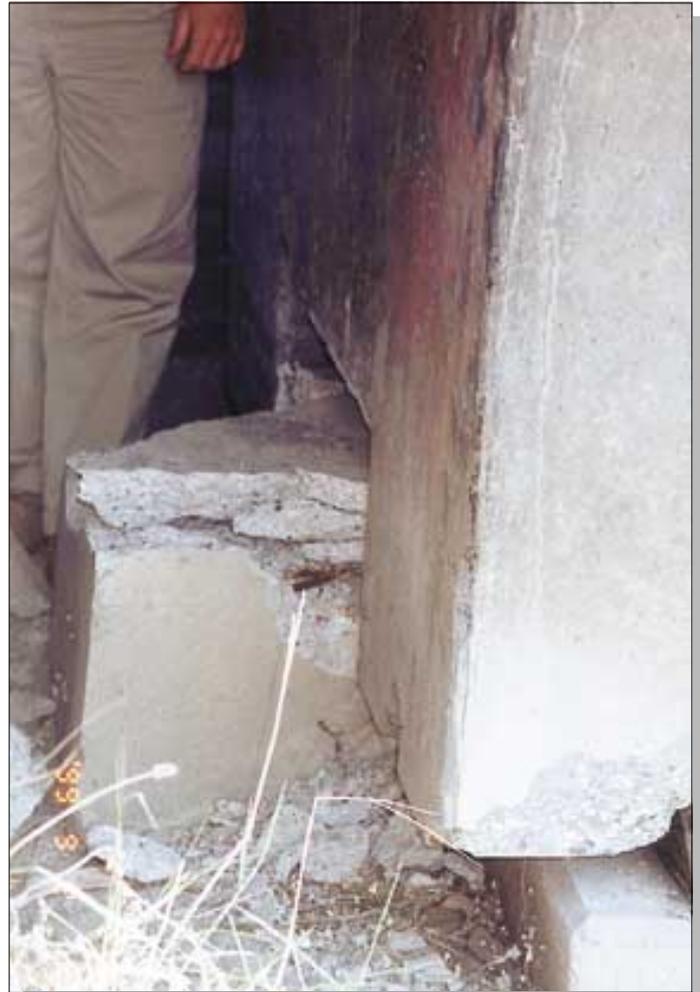
Figure 50. Failure of shear keys was common at bridges of the Trans European Motorway. Shear keys at the end of girders prevent transverse and longitudinal seismic movements. *Photograph by Selcuk Toprak.*

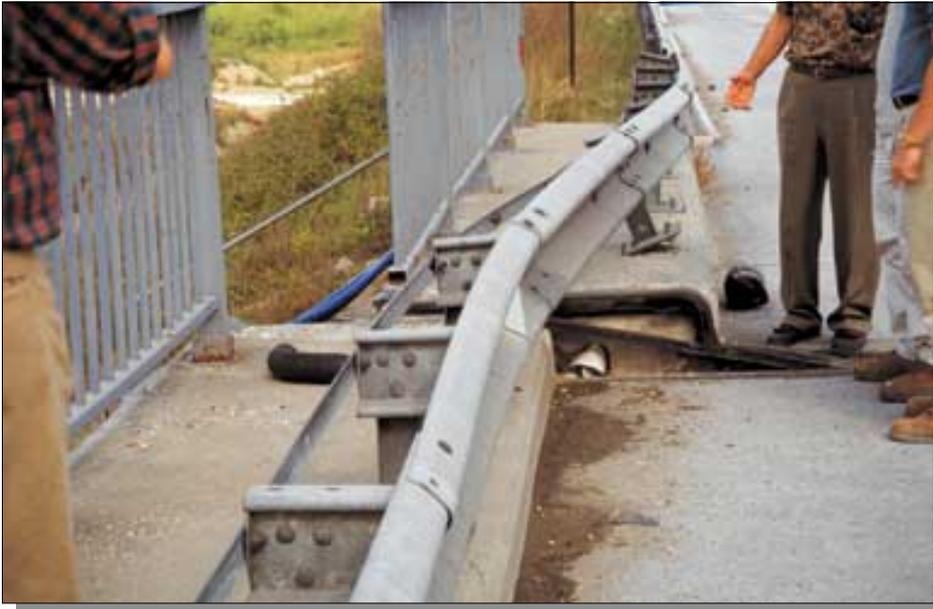
Figure 51. Ground shaking caused the westbound span of the Sakarya River bridge to displace 50 cm relative to the east abutment. This was the largest permanent displacement caused by shaking at any bridge. *Photograph by Selcuk Toprak.*

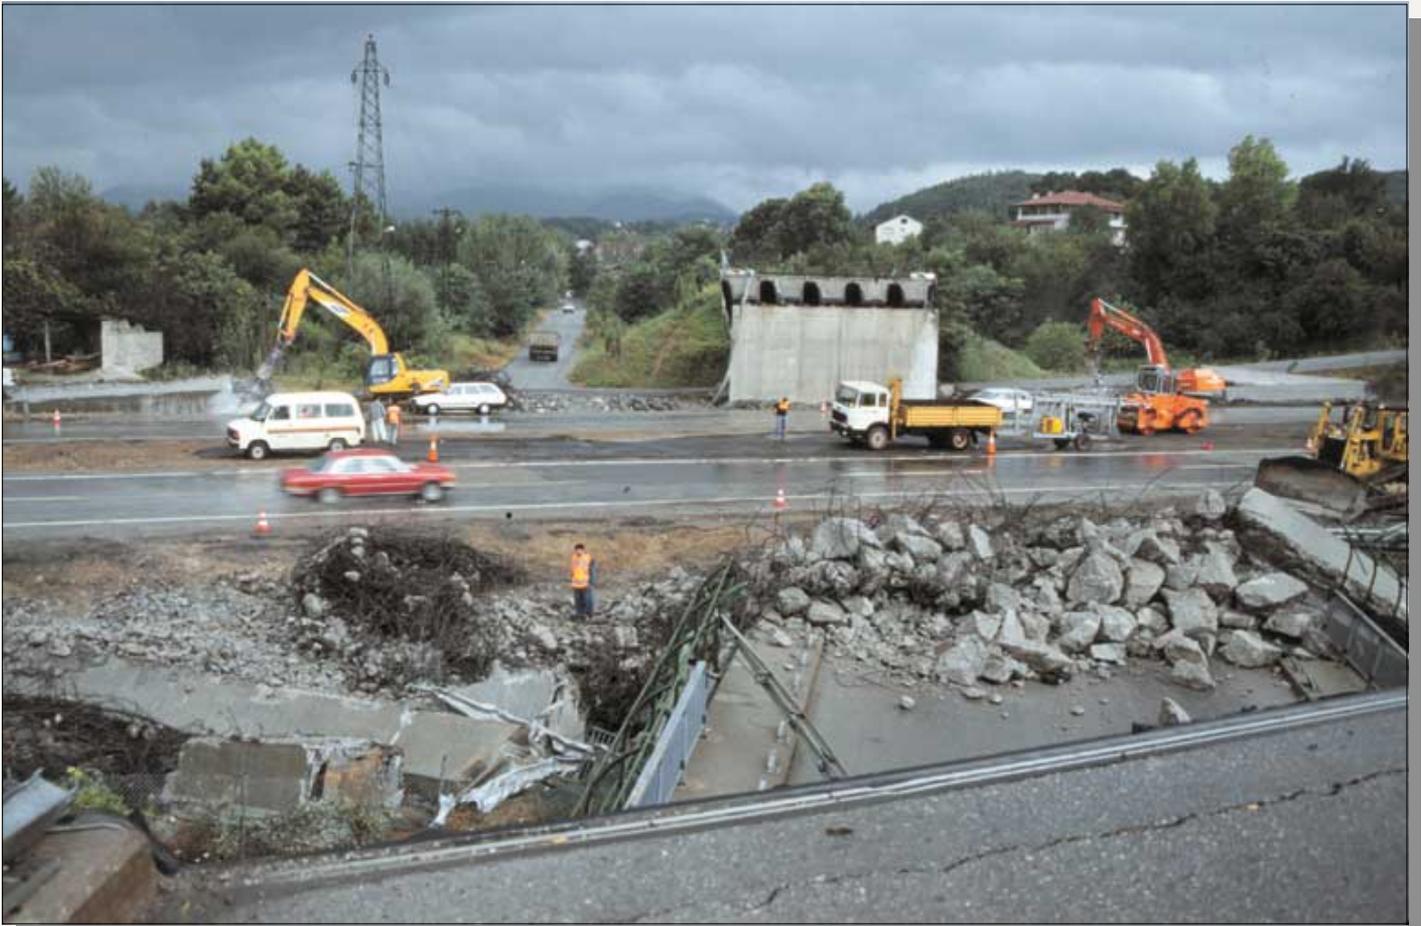
Figure 53. The Arifiye overpass collapsed because the surface fault rupture passed directly through its north abutment (foreground). Ten riders of a bus were killed when the bus collided with the collapsed overpass. *Photograph by Thomas L. Holzer.*

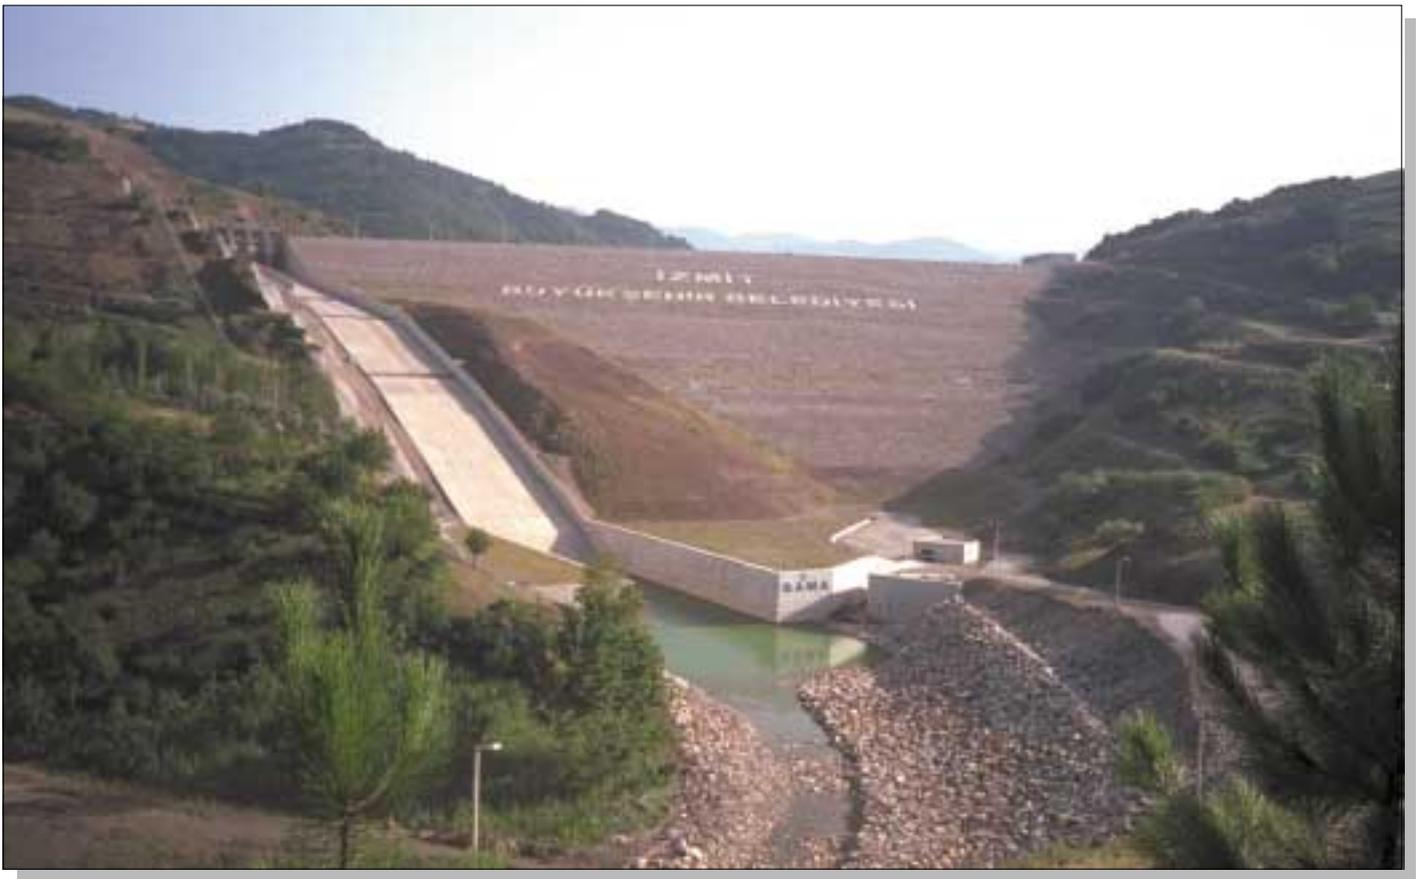
Figure 55. View of Kirazdere (Yuvacik) Dam after the Kocaeli earthquake. The dam was only about 4 km from the surface rupture and did not suffer damage. *Photograph by Richard S. Olsen.*

Kirazdere Dam, also known as Yuvacik Dam, is an earth-fill dam with a clay core, sand and gravel filters, and a rock shell (fig. 55). Kirazdere Dam is of particular interest because it is only 4 km from the surface rupture associated with the Kocaeli earthquake. The dam is inferred to have experienced 0.3 to 0.4 g of peak horizontal acceleration, a shaking duration of 30 s with accelerations greater than 0.05 g, and a spectral range of excitations from 0.2 to 6.0 Hz. However, the dam appears to have suffered no damage from the earthquake. The dam manager stated that a few short 2-mm-wide cracks resulted from the earthquake on the gravel road along the crest near the left abutment looking upstream, parallel to the axis of the dam. The lengths of these cracks were not measured. The road on the crest is heavily used and the cracks quickly disappeared. A few hairline cracks were seen in a one-story concrete structure at the dam. No cracks were seen in the concrete of the spillway.
