## Coastal Change During Hurricane Isabel 2003

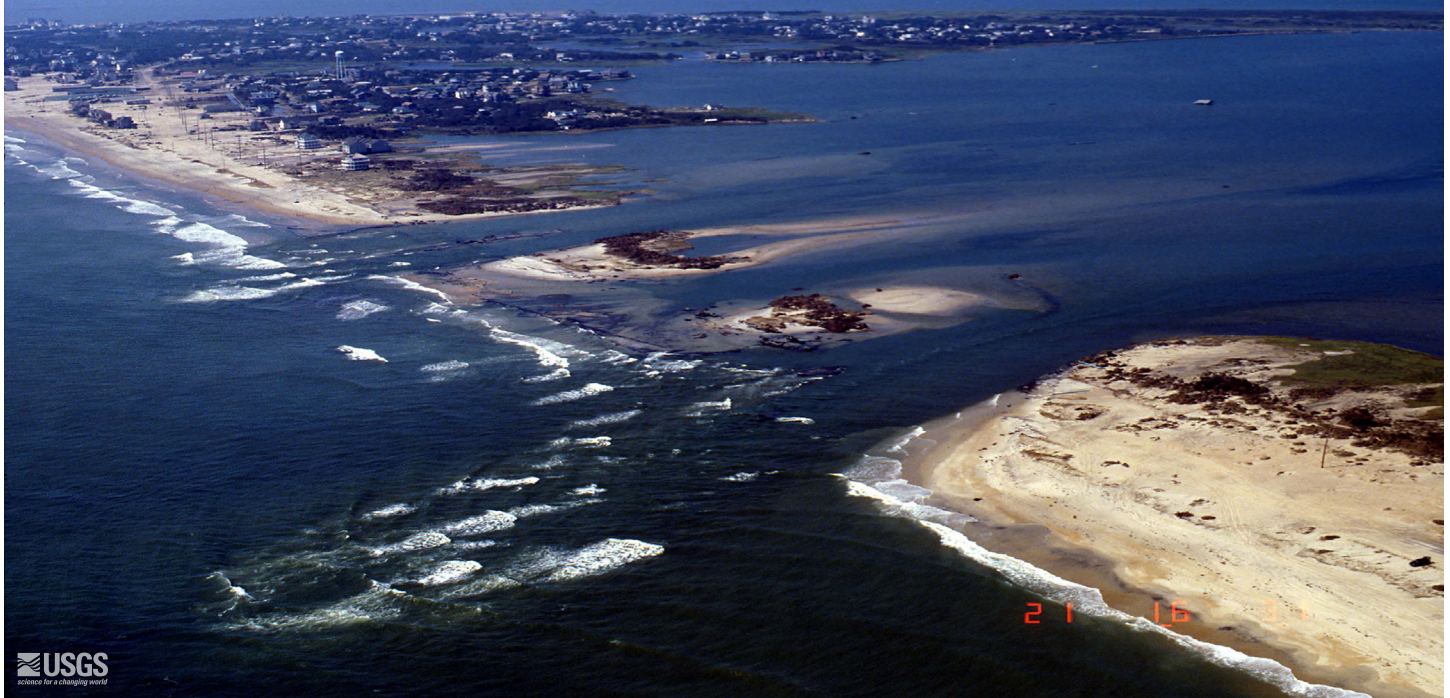
September 21, 2003 - Post-Isabel

associated with the opening of a new breach about 500 m wide that divided into three separate channels that completely severed the island southwest of Cape Hatteras. The main breach, and a smaller one several kilometers to the south (not shown), occurred at minima in both island elevation and island width.

**Figure 2.** Hurricane Isabel opened a breach in the island southwest of Cape Hatteras. Combined waves and storm surge attacked the island where the dunes were lowest and the island was narrowest.

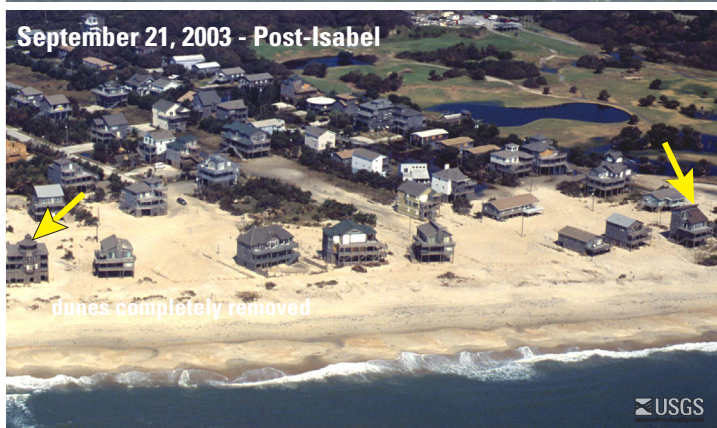
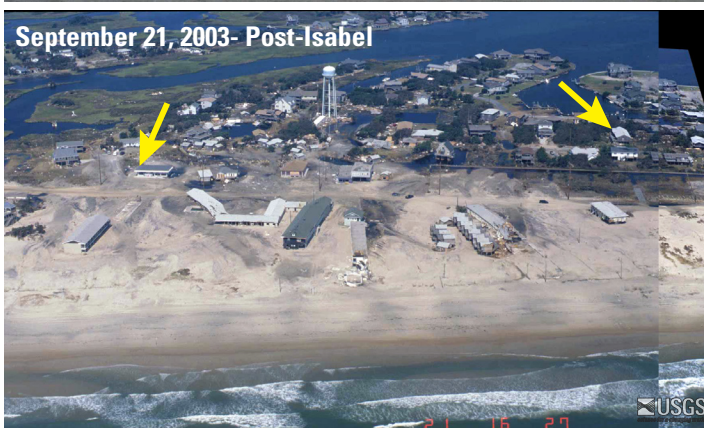
**Figure 4.** Hatteras Village, North Carolina. USGS aerial photography taken before and after the landfall of Hurricane Isabel. Storm surge and waves destroyed and inundated the dunes protecting the hotels. The water washed the buildings from their foundations and covered roads with sand. (Arrows in all images point to the same features.)

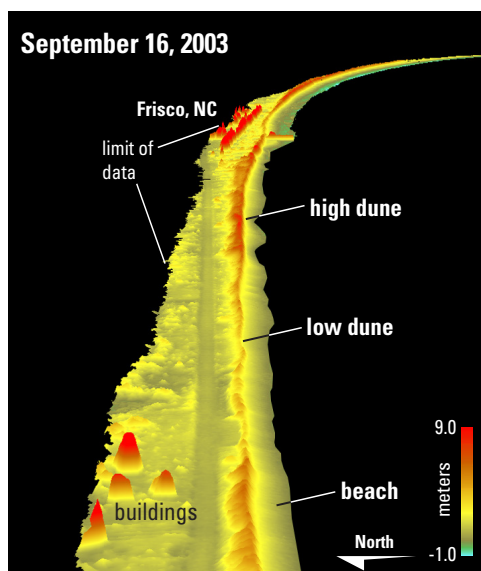
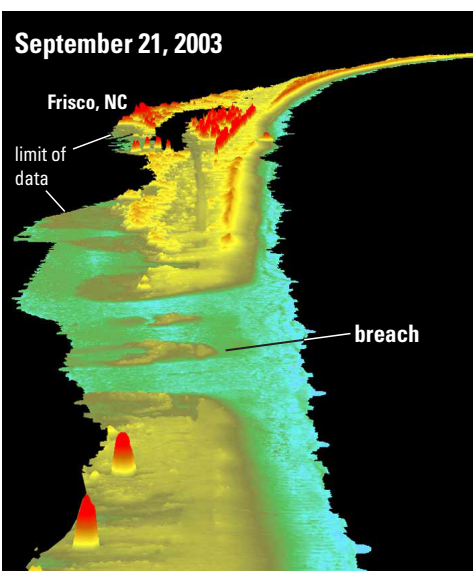
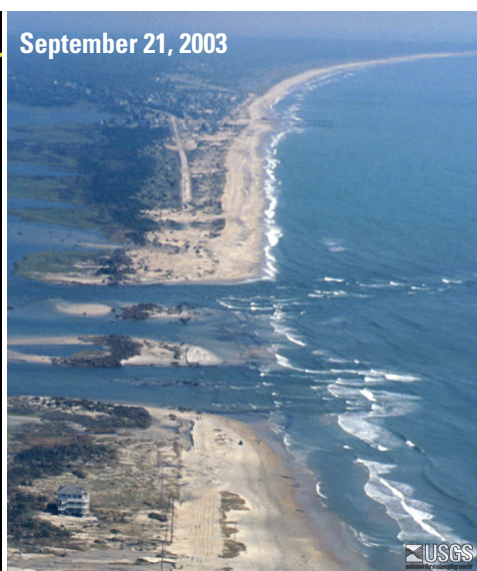
**Figure 5.** Hatteras Island, North Carolina. Analyses of NASA Experimental Advanced Airborne Research Lidar (EAARL) data from the island show extensive beach changes and dune erosion, as well as the destruction of infrastructure and buildings. Upper right and center: Lidar images show high-resolution topography of a portion of the coast measured with NASA's EAARL before and after Hurricane Isabel. The different colors indicate different elevations, where in the warmer colors represent higher elevations (see scale). Right: An oblique photograph taken by USGS on the same day as the post-storm lidar survey.
