## Coastal Change During Hurricane Ivan 2004

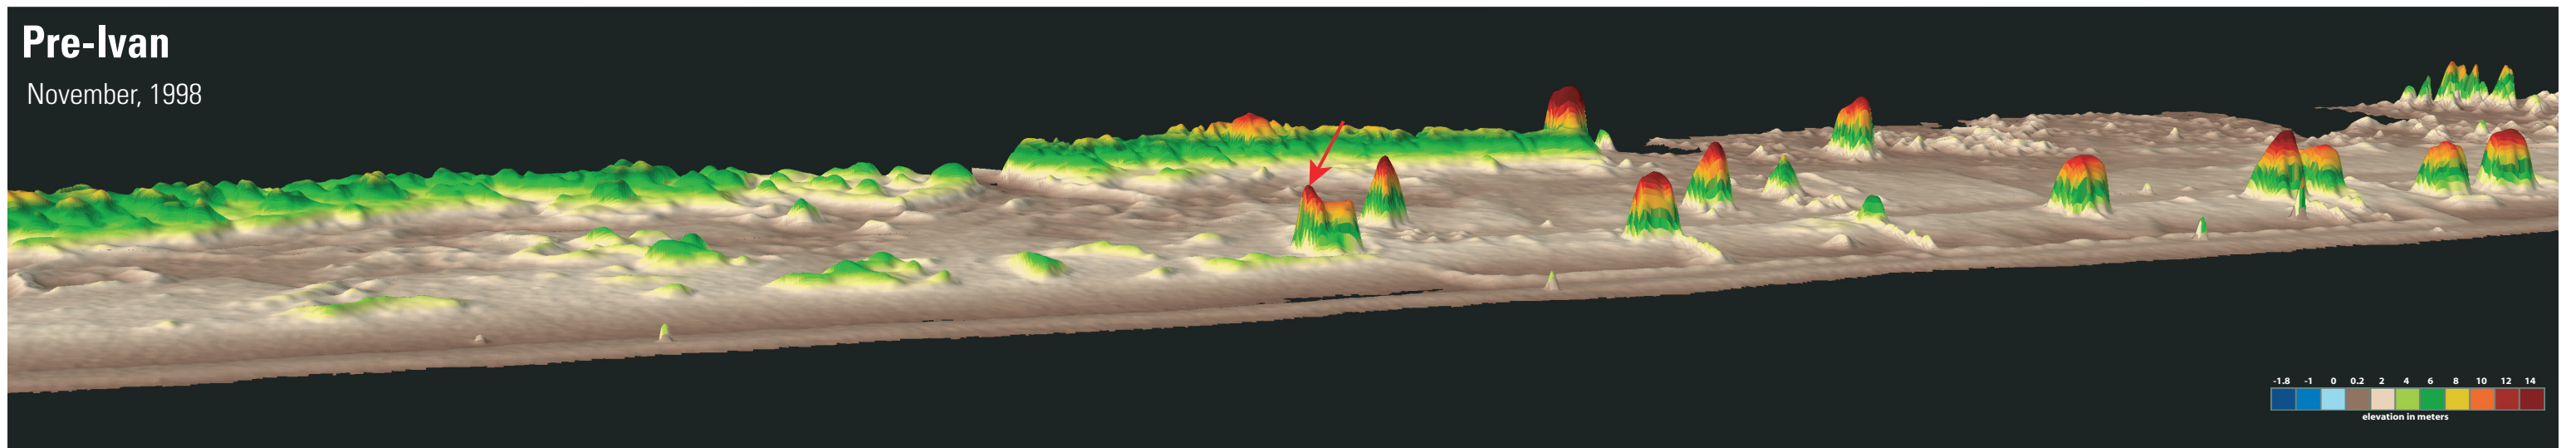
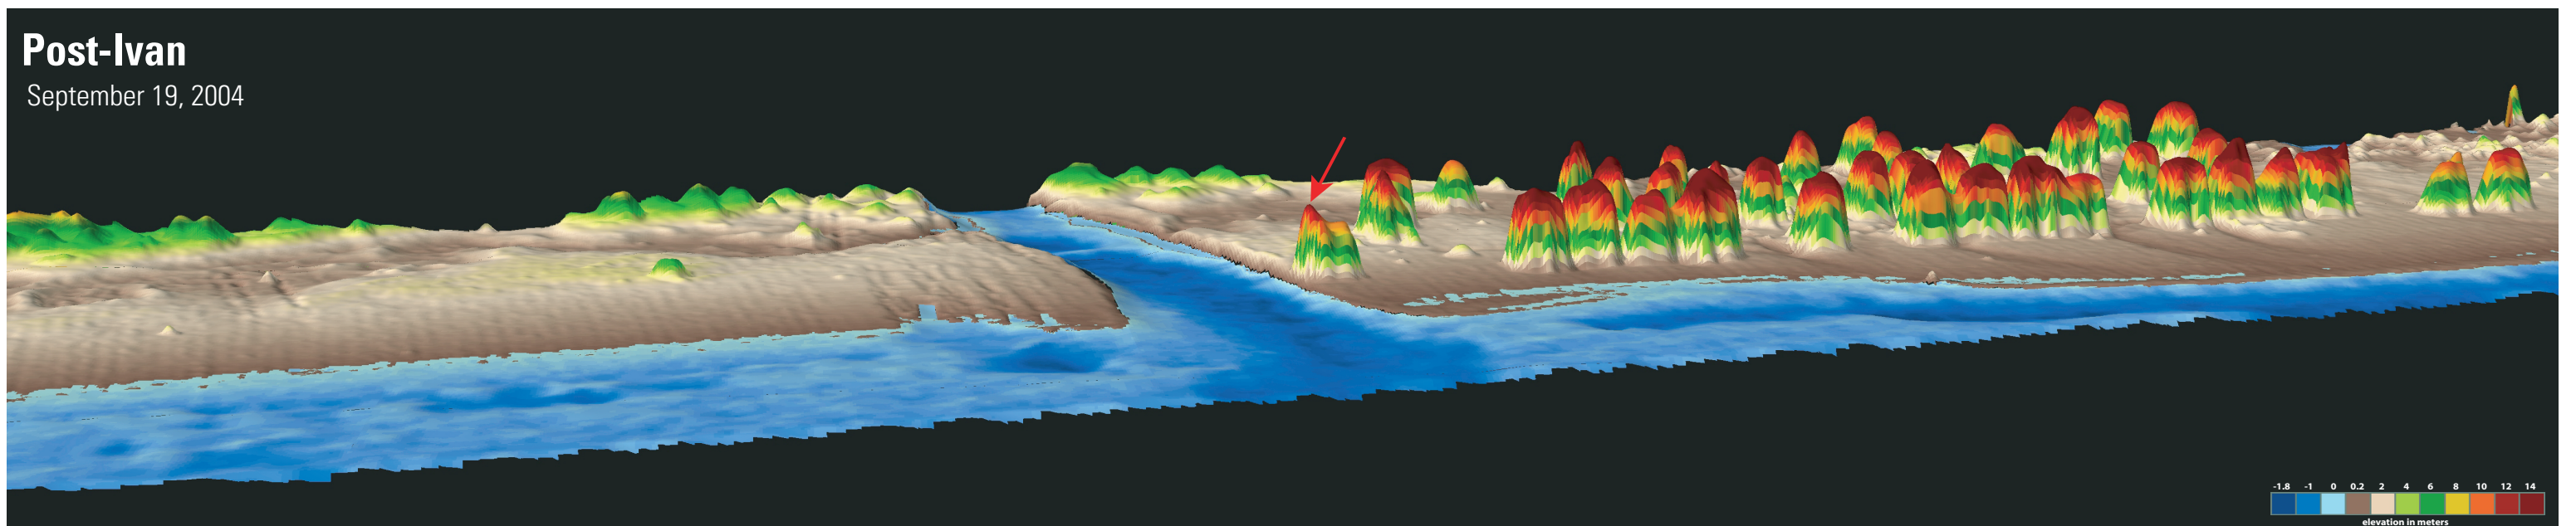
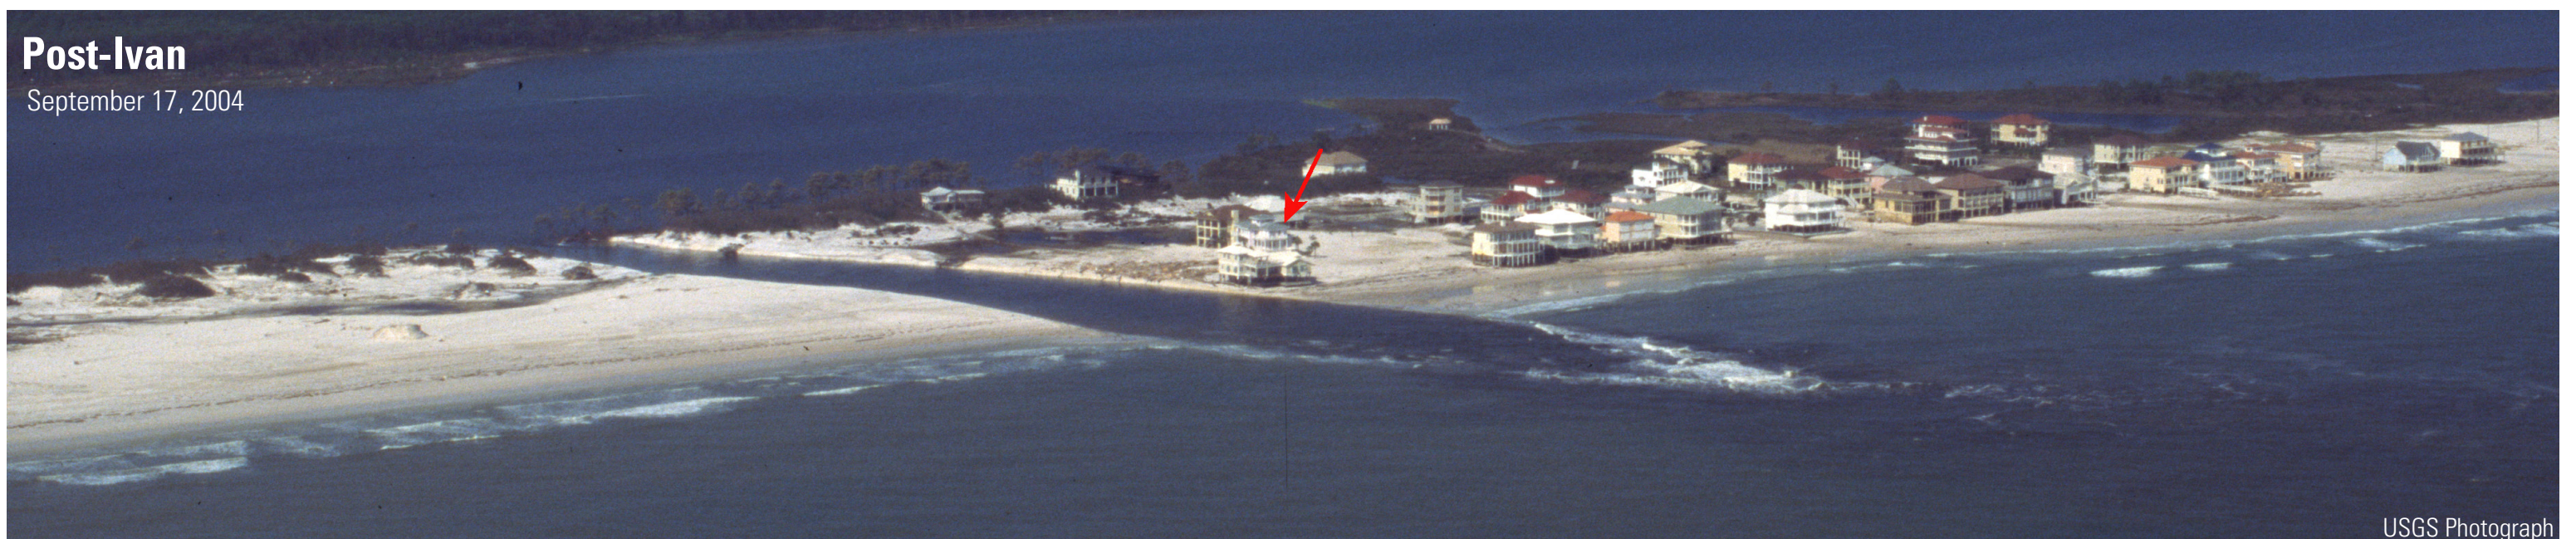
**Figure 3.** Pine Beach, Alabama. Top and Center: Topography/bathymetry measured with lidar before and after the impact of Hurricane Ivan showing a new breach that severed the island. (Note the new houses that were built between the surveys. Houses appear in the topography as rectangular mounds. Their warmer colors indicate higher elevations.) Bottom image: A USGS aerial photograph shows the new breach following landfall. (Arrows in all images point to the same features.)

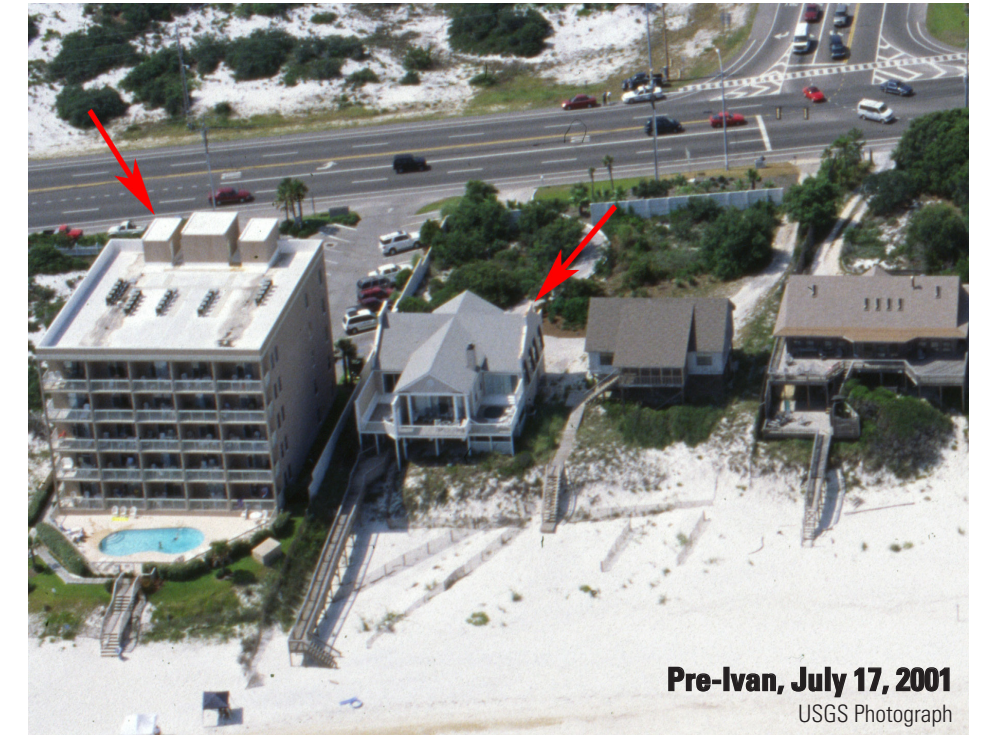
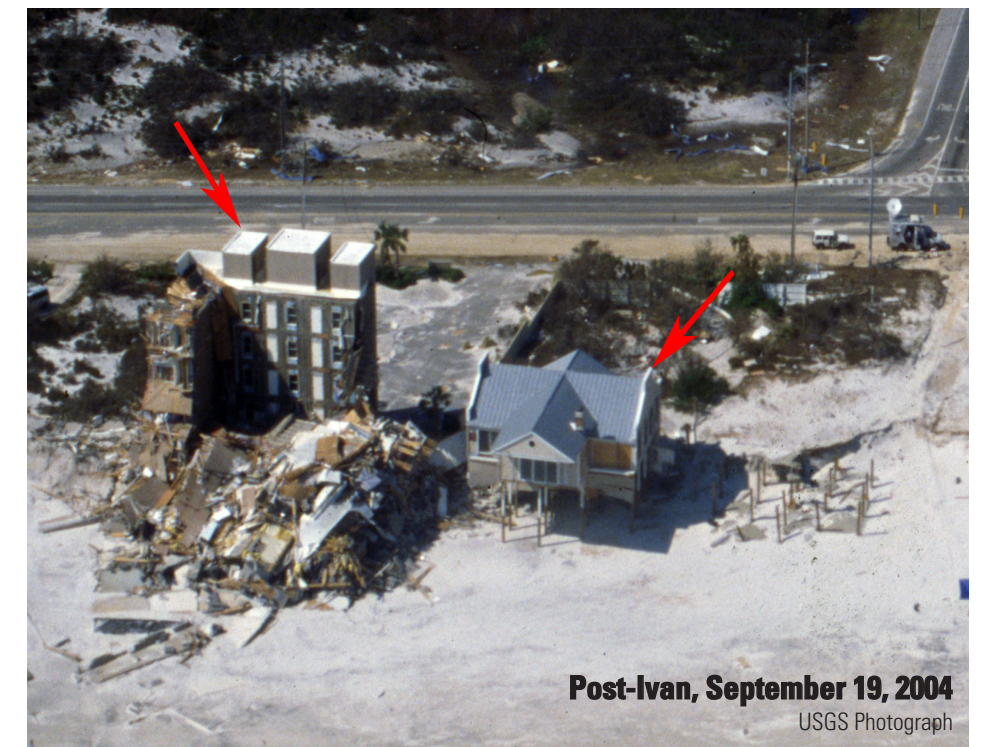
**Figure 2.** Orange Beach, Alabama. USGS aerial photographs taken before and after the landfall of Hurricane Ivan show the failure of a five-story condominium tower. The only parts of the structure that remain standing after Hurricane Ivan are the elevator and stairwell shafts. Airborne laser mapping data showed that the sand dune on which this building was constructed was subjected to about 3 m of vertical erosion during the storm. (Arrows in all images point to the same feature.)

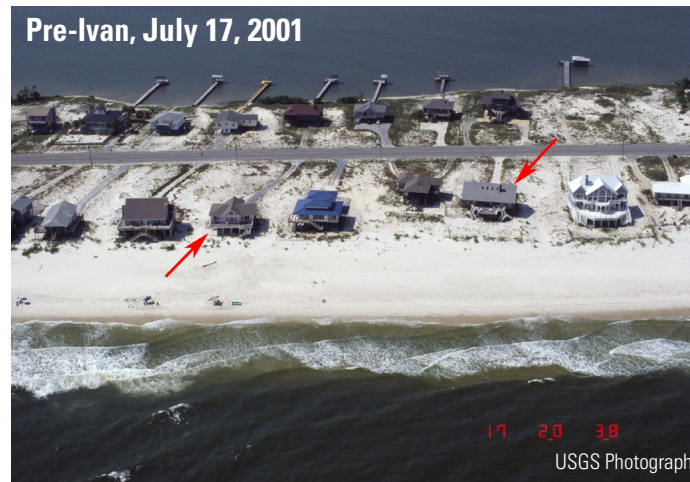
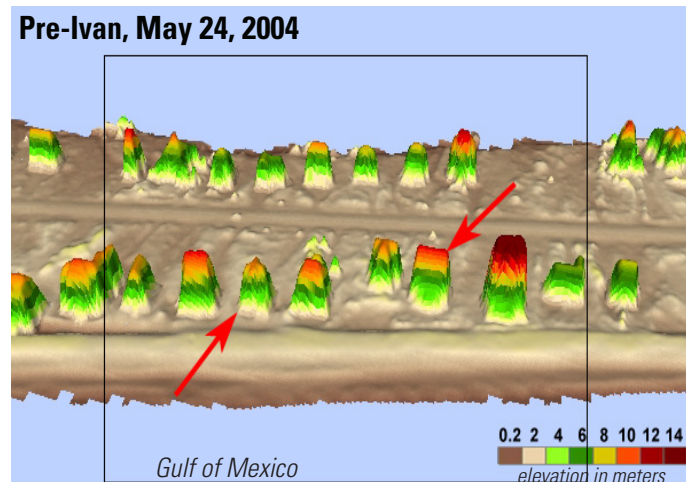
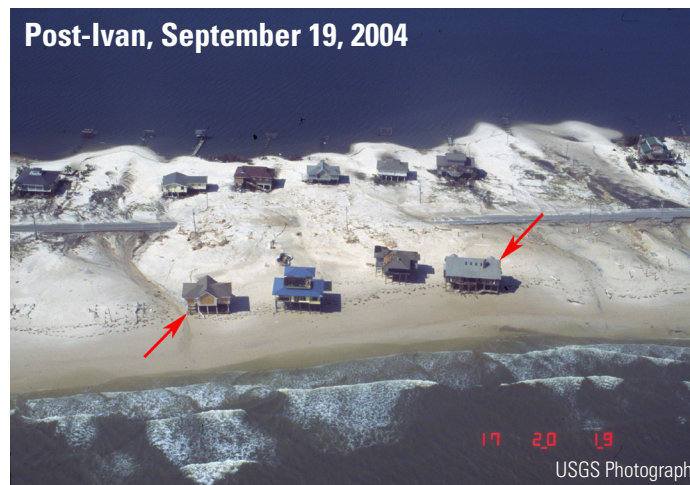
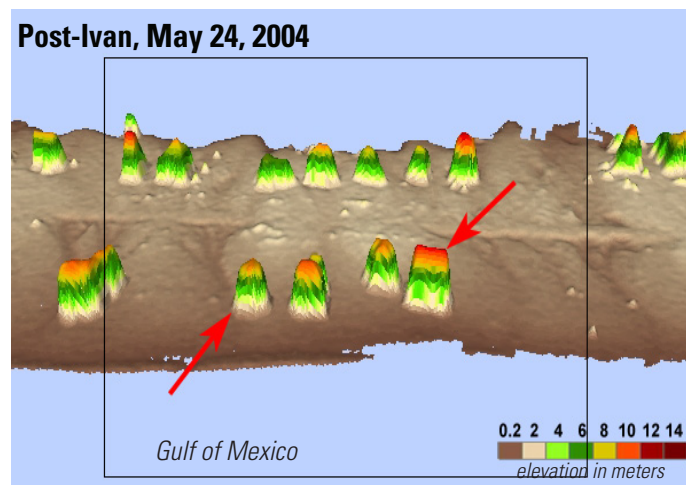
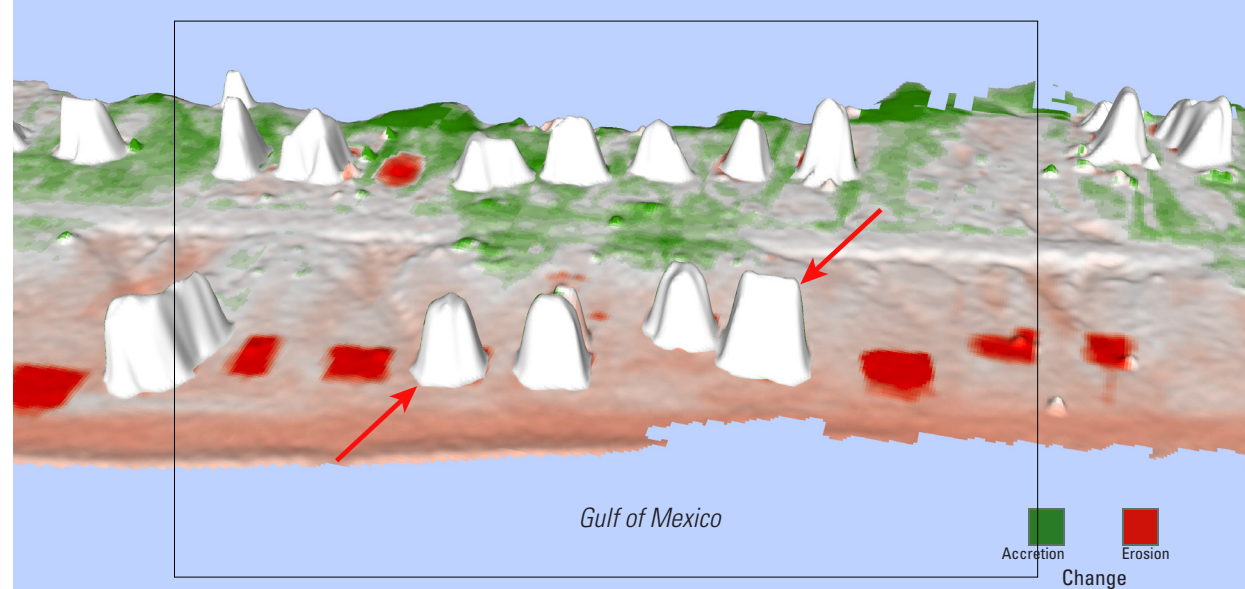
**Figure 4.** Gulf Shores, Alabama. Upper left: USGS before and after aerial photographs showing the loss of houses during Ivan. Upper right: Before and after laser mapping (lidar) topography of the same area shown in the photos (warmer colors represent higher elevations, for example, houses). Bottom center: Vertical elevation change (erosion and accretion) that occurred as a result of the storm. The red rectangles indicate houses that were completely destroyed and swept from the island into the back bay. (Arrows in all images point to the same features. Black lines in lidar images indicate limits of photos. )
