National Cooperative Geologic Mapping Program, in collaboration with the National Park Service

Assessing Geohazards to the Denali National Park Road with Geologic Mapping

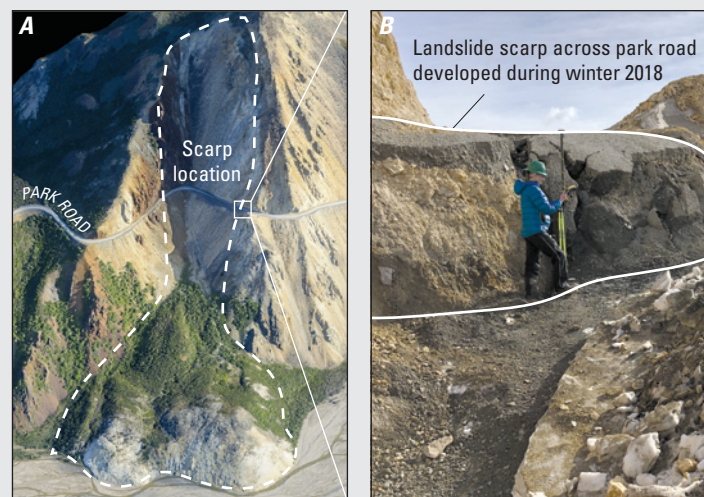
Figure 2. A, Pretty Rocks landslide (dashed outline) and location of scarp photograph. B, 2-meter landslide scarp (outlined in white) in Park Road caused by slump at the head of Pretty Rocks landslide (Photographs from Denny Capps, National Park Service).

The Park Road crosses a steep, constantly changing landscape, shaped by the rapid uplift of the Earth's crust along the central part of the Alaska Range, by glacier and meltwater erosion, and by permafrost heaving. Geologic hazards (geohazards) such as rockfall, flooding, and landsliding (fig. 2) cause significant damage to the Park Road every year, requiring periodic closure, and costing millions of dollars in repair and maintenance. In addition, DENA is situated along a major fault system and experiences numerous earthquakes every year. Most are too weak to be felt, but a 7.9 magnitude earthquake shook the region in 2002, and at least one major landslide, which formed Bergh Lake along the Park Road corridor, was caused by seismic shaking in 1953 (Capps and others, 2017).

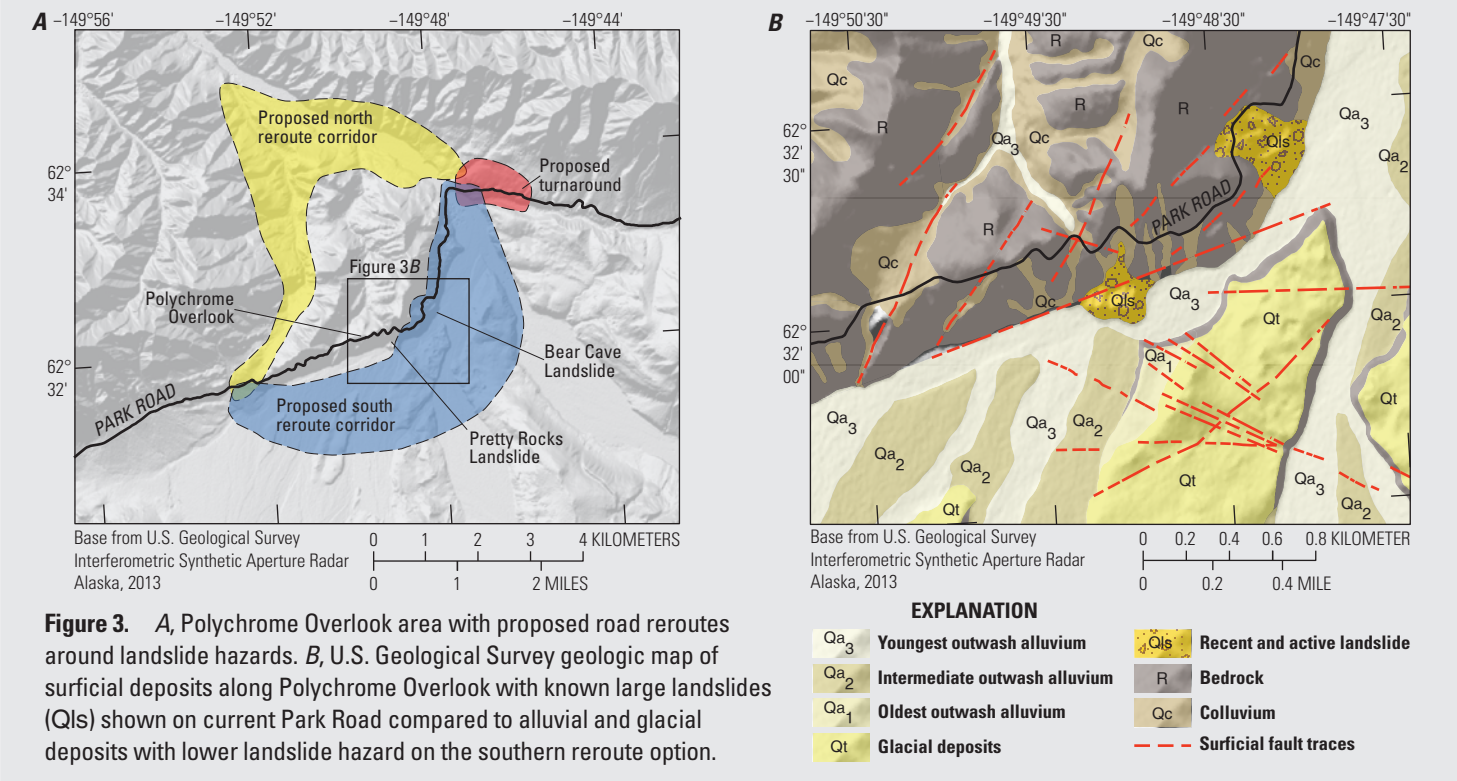
The Park Road crosses steep topography in the area surrounding the Polychrome Overlook. This section is the most immediate infrastructure concern because it crosses several active landslides (figs. 2 and 3). Maintaining the current (2020) road course is costly and poses a high risk to DENA staff and visitors. However, closing the road to vehicle traffic would greatly restrict visitor access and negatively affect tour businesses operating within the park.

Figure 3. A, Polychrome Overlook area with proposed road reroutes around landslide hazards. B, U.S. Geological Survey geologic map of surficial deposits along Polychrome Overlook with known large landslides (QLs) shown on current Park Road compared to alluvial and glacial deposits with lower landslide hazard on the southern reroute option.

Thus, NPS is considering options for rerouting the road, either to the north or southeast of its current path (fig. 3A). New surficial geologic mapping in this region will help identify potential geohazards and define geologic substrates in the areas of rerouting (fig. 3B). This will help road engineers ensure safe, cost-efficient, and resilient road infrastructure can be built and maintained for the long term.

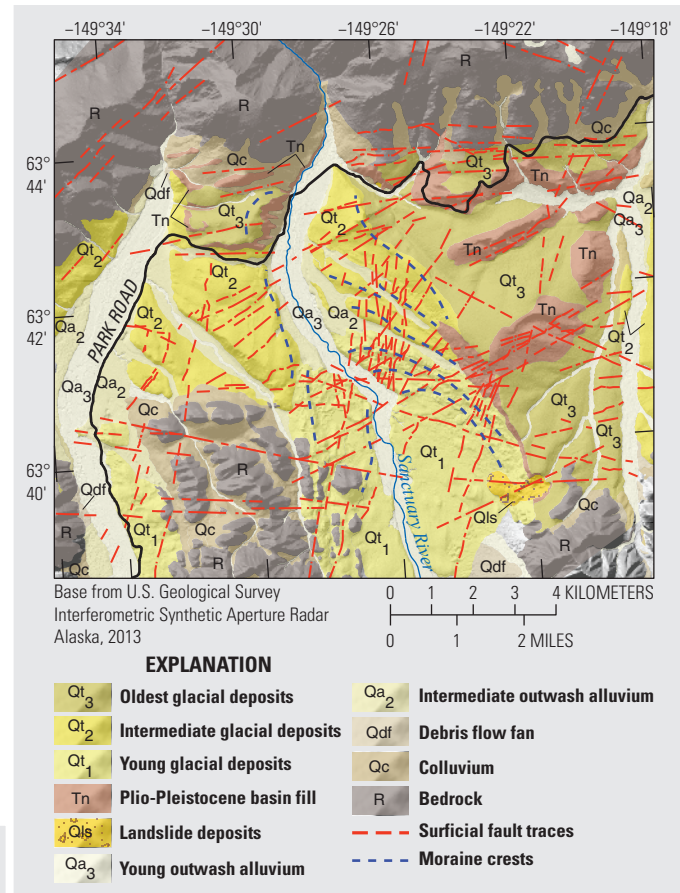
The USGS and the NPS are collaborating with colleagues at Purdue University to date glacial sediments using cosmogenic nuclide exposure methods. Multiple generations of Pleistocene glaciers have crossed the Sanctuary River valley south of the Park Road. The glacial sediments left behind are all crosscut by active faults (fig. 4). In general, the oldest sediments show the most surface offset along faults, whereas modern streams show the least. Dating of the glacial deposits, therefore, constrains (1) the history of glaciation in the central Alaska Range and (2) rates of fault slip posing earthquake hazards to NPS infrastructure. This scientific research contributes to both geohazard assessment and furthering understanding of the geologic history of Denali National Park.

Figure 4. Pleistocene glacial deposits, Neogene sediments, and surficial fault traces near Sanctuary River, Park Road corridor.
