Acid Rain and Our Nation's Capital

A Guide to Effects on Buildings and Monuments

by Elaine McGee

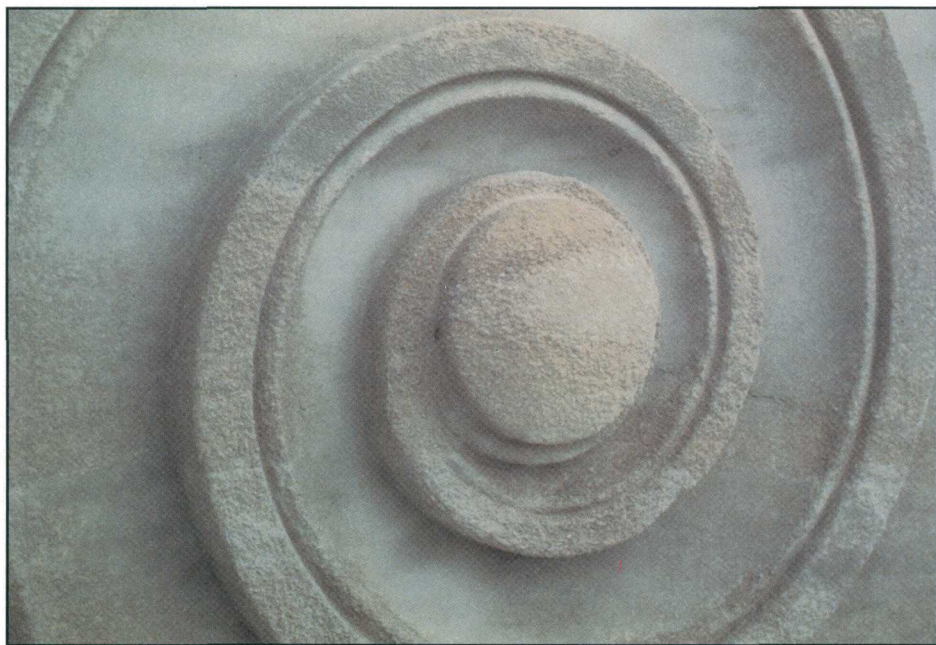
Marble surfaces exposed to rain develop a rough "sugary" texture because the calcite grains are loosened as the edges dissolve in the rain water. Column capital volute, Jefferson Memorial, Washington, D.C.

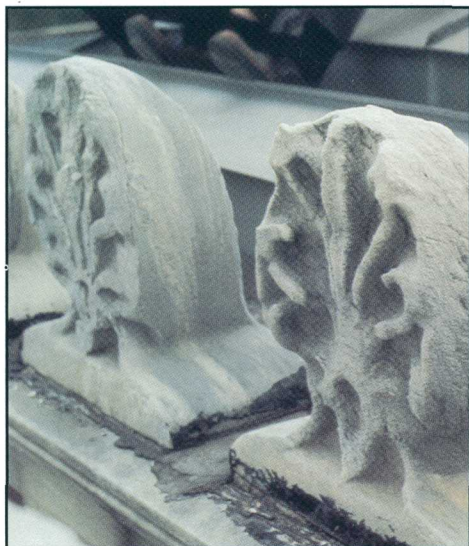
When marble is exposed to acidic rain, sharp edges and carving details gradually become rounded. Antefixes, roof of the Philadelphia Merchants' Exchange (built in 1832).

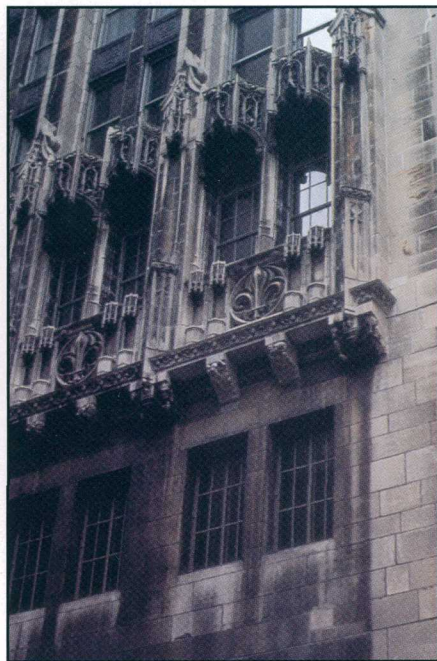
Blackened crusts on sheltered portions of the limestone Chicago Tribune Building, Chicago, Illinois.

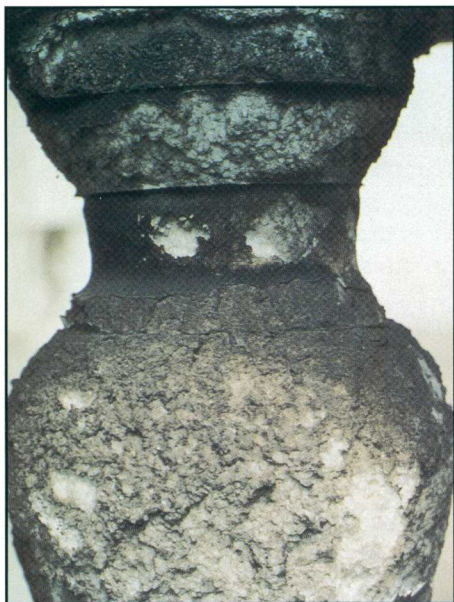
Formed as a result of air pollution, gypsum alteration crusts have blackened, blistered, and spalled from a marble baluster at the Organization of American States building, Washington, D.C.

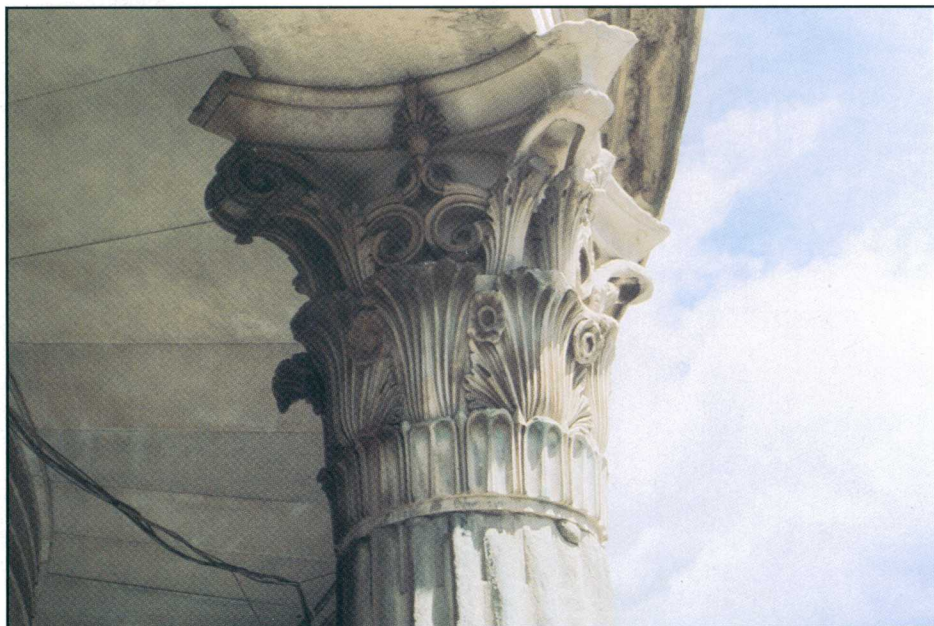
A marble column at the Merchants' Exchange in Philadelphia shows loss of material where the stone is exposed to rain and blackening of the stone surface where the stone is sheltered from rain.

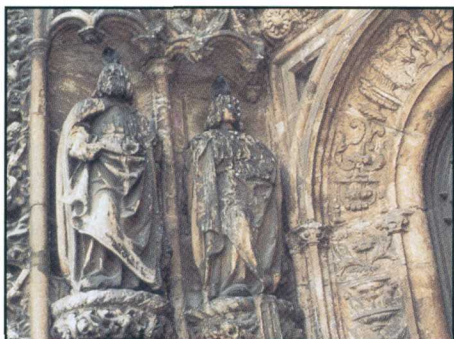
Pigeons sitting on the statue heads have created distinctive deterioration on this building.

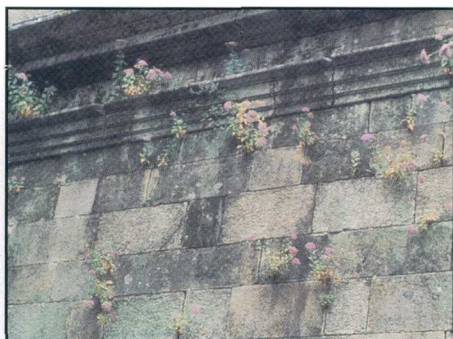
Flowers and grasses have grown in the cracks between stones on this church.

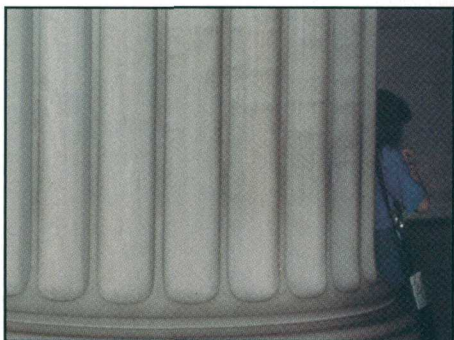
This limestone column in the Lincoln Memorial is darkened and dirty from people's hands touching the stone.

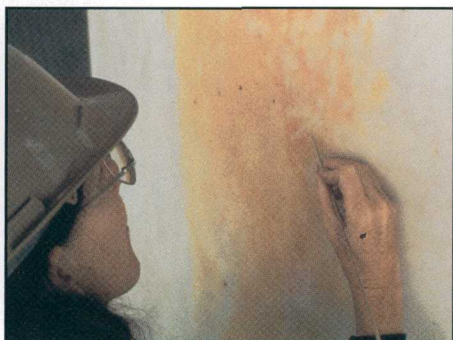
Microorganisms have caused this stain to appear on a marble column at the Jefferson Memorial.

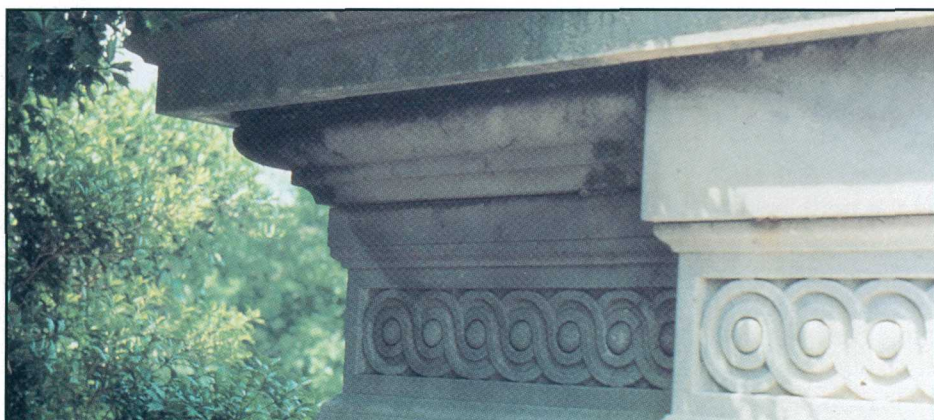
balustrade at the southeast corner of the building. The black crust is made of gypsum plus dirt that accumulates in sheltered areas. No black crust is present along the cracks between the stones; rain water probably flows in these areas, dissolving the gypsum and preventing accumulation of a crust. Not all black areas on this

Blackened alteration has accumulated under the overhanging edge of this marble balustrade corner. Southeast corner, U.S. Capitol Building.

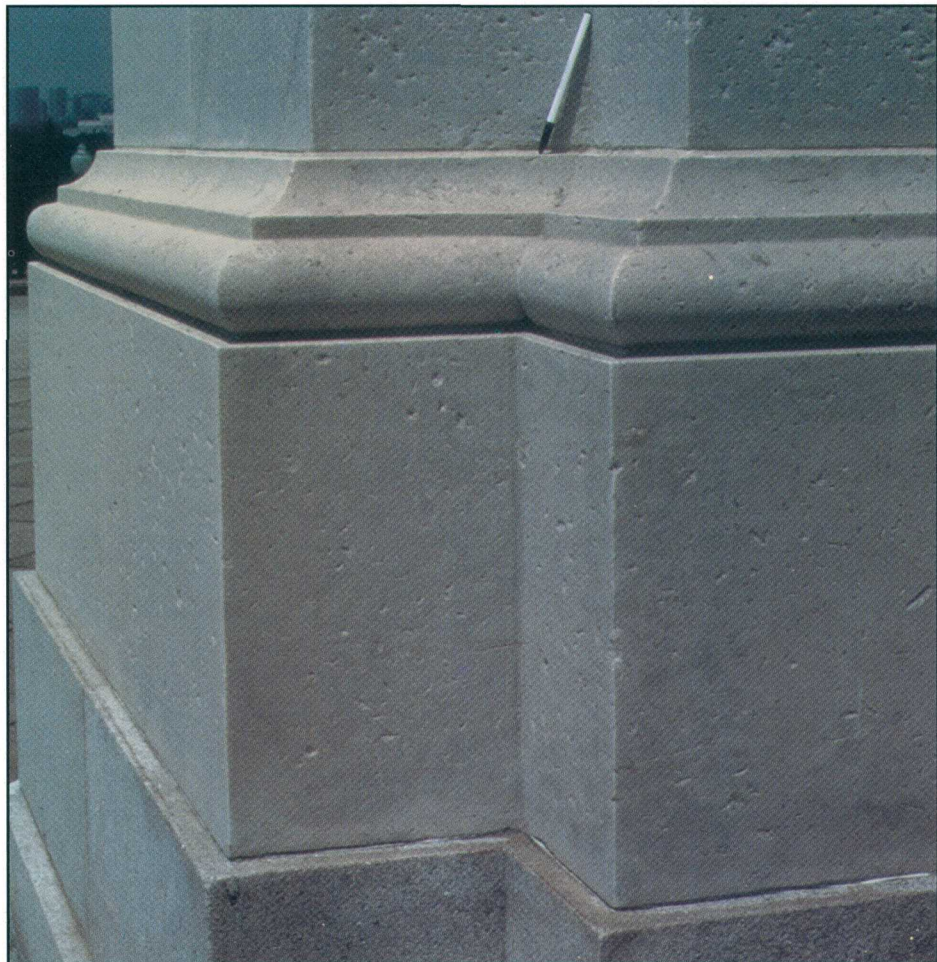
Pock marks in marble columns, south side of U.S. Capitol building. Silicate mineral inclusions in the marble loosen and fall out when the calcite around them is dissolved by acid rain.

Another dissolution feature of marble is the pock-mark effect on the square bases of the building columns. Silicate mineral inclusions in the marble were loosened by the dissolution of the surrounding calcite, causing the inclusions to fall out of the stone. A particularly good example of this is found on the fourth column west from the southeast corner of the Capitol building. The pock-mark dissolution is also found at several other places on the building.

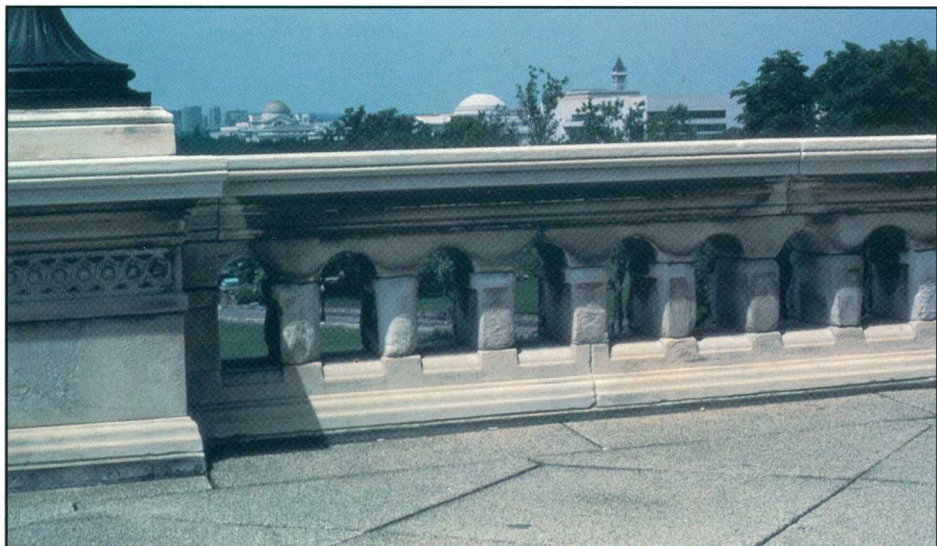
The marble balustrade on the west side of the Capitol building shows both dissolution and alteration.

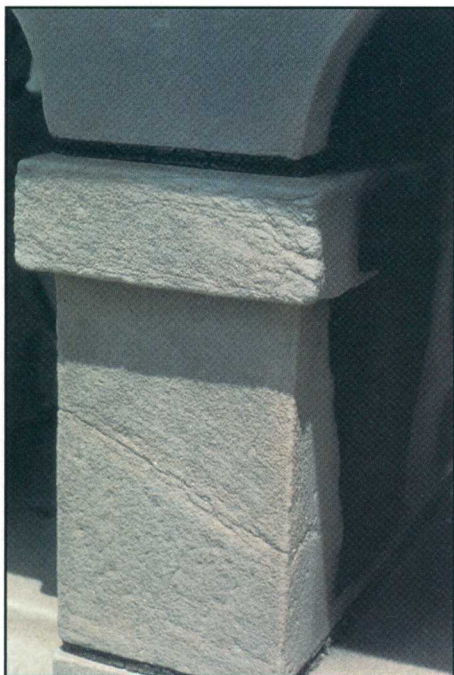
A recently replaced marble baluster at the Capitol has edges that are only beginning to round.

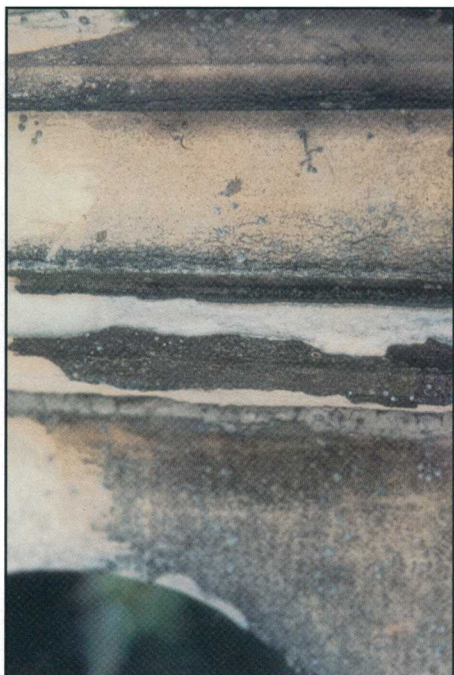
Black alteration crusts under the west balustrade of the Capitol have begun to spall (peel) off, revealing crumbling white marble underneath.

some spots under the rail the blackened crust has spalled off, exposing fresh surfaces and more vulnerable stone. Some carvings on the balustrade corners are worn, whereas others have blackened alteration; this difference in weathering may be due to local effects of wind and rain. Along the steps leading to the terrace on the west side of the Capitol, gypsum has accumulated on large areas of the wall. Gypsum can accumulate on any surface that is not washed by water.

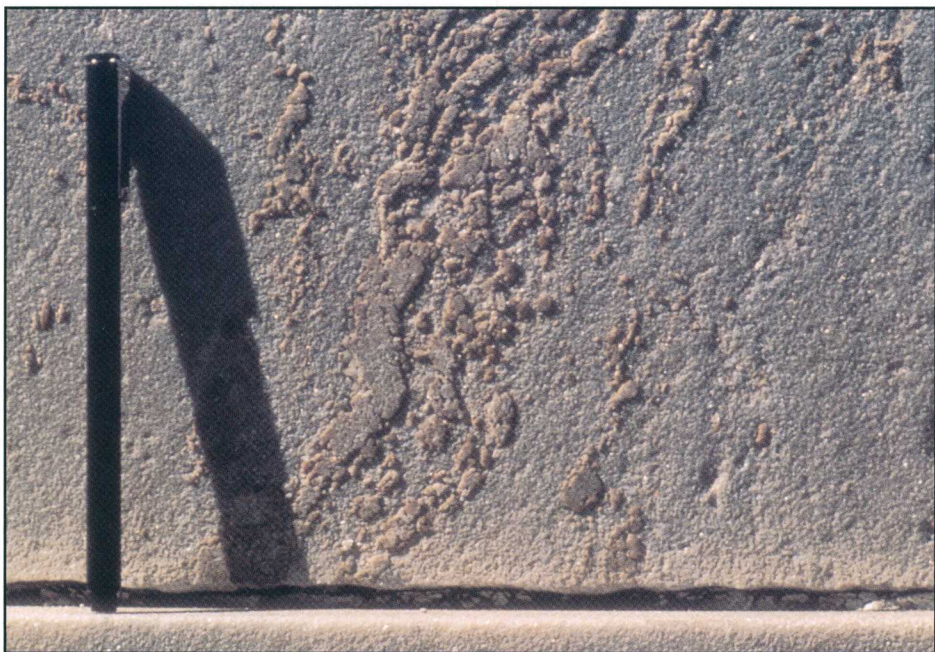
At the northeast corner of the Capitol building, the marble balustrade ends in square blocks like the ones we first examined. Here you can see an example of preferential dissolution where the silicate mineral inclusions remain and the calcite around them has been dissolved away. Also, on the north side of this block, examine the blackened grains on the top surface with a hand lens. Not all of the black material you see on stone is gypsum; some is of biological origin, probably algae or a fungus.

A marble block that forms the northeast corner of the Capitol balustrade shows preferential erosion of the calcite around a silicate mineral inclusion.

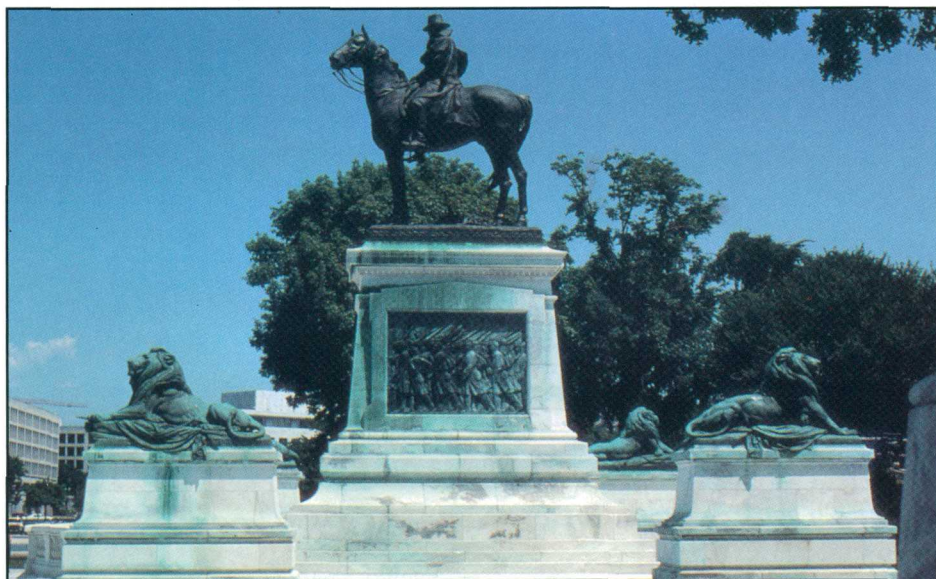
The Grant Memorial consists of bronze statues on marble bases; although the statues were cleaned, the staining on the marble remains.

This memorial, dedicated in 1922, consists of a group of bronze sculptures mounted on marble bases. Bronze weathers outdoors if it is not cleaned and waxed regularly. Like stone, bronze dissolves where it is exposed to rainfall, developing a green color and a pitted surface, and it also alters in sheltered areas, with accumulation of a blackened layer. The most notable stone deterioration visible here is the green stain on the marble bases, caused by runoff from the weathered bronze. The green stain does not damage the marble, but it is unattractive, and there are no methods currently available to remove the stain without damaging the marble.

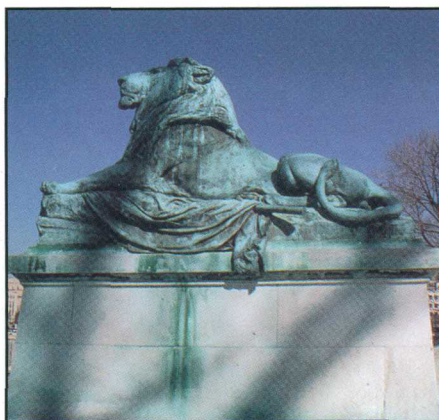
The light-green color on the bronze statues at the Grant Memorial is typical of the way bronze weathers when it is exposed to acidic rain; the rain dissolves some of the metal and causes staining of the white marble bases.

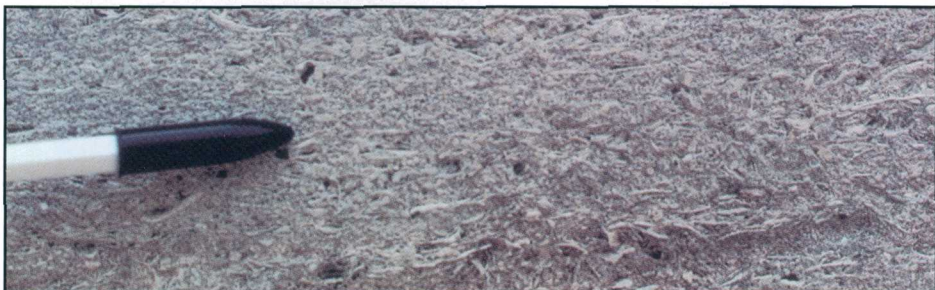
Fossil details stand out on the limestone at the Botanic Gardens building; the fossils are more resistant to dissolution than the calcite matrix that holds the fragments together.

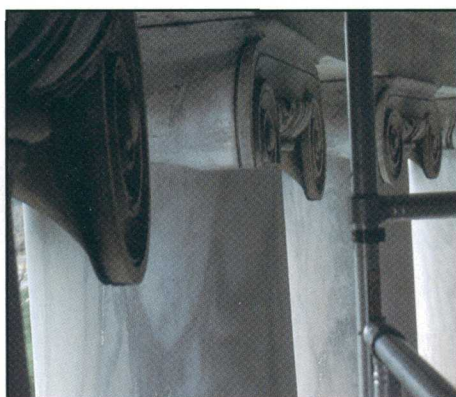
The Jefferson Memorial is a marble building, dedicated in 1943. One of the most striking deterioration features to observe here is the loss of silicate mineral inclusions in the marble columns because of dissolution of the calcite matrix. Close examination of the grooves shows flakes of mica and sometimes grains of pyrite. Blackened crusts are visible on the column capitals that are sheltered from rain and from regular washing of the monument.

Several of the column shafts at the Jefferson Memorial have grooves that follow the inclusion traces in the marble, where the mineral inclusions have weathered out and been lost.

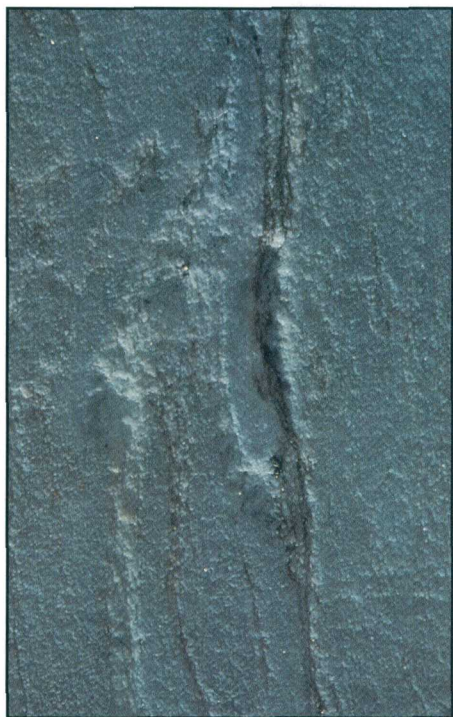
A close look at some of the weathered grooves in the columns shows that small bits of mica and pyrite remain.

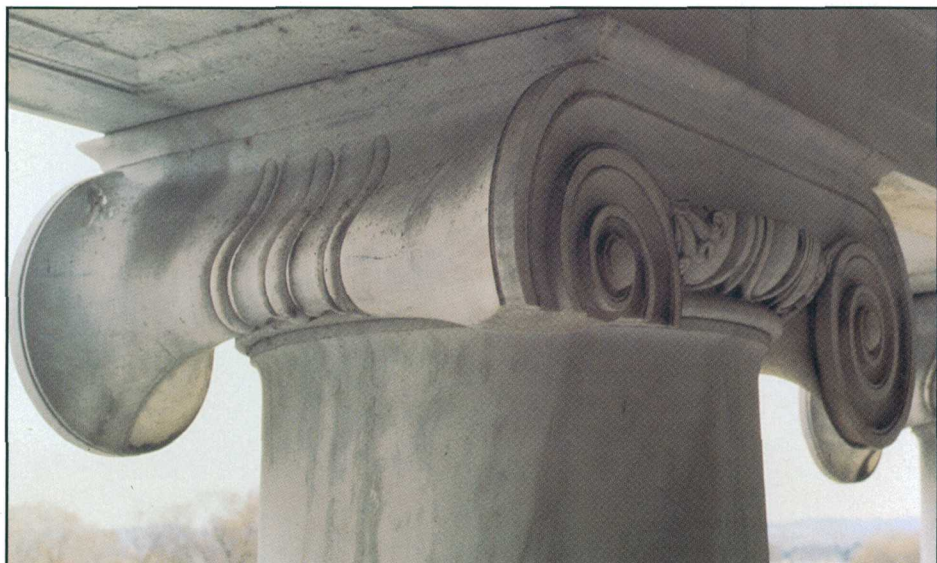
Part of one of the column capitals at the Jefferson Memorial broke off and fell onto the portico in 1990.

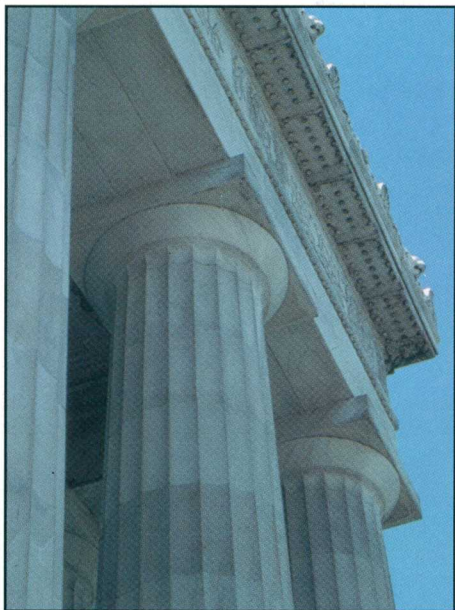
Under the roof overhang is one of the few places at the Lincoln Memorial where alteration crusts have developed on the marble.

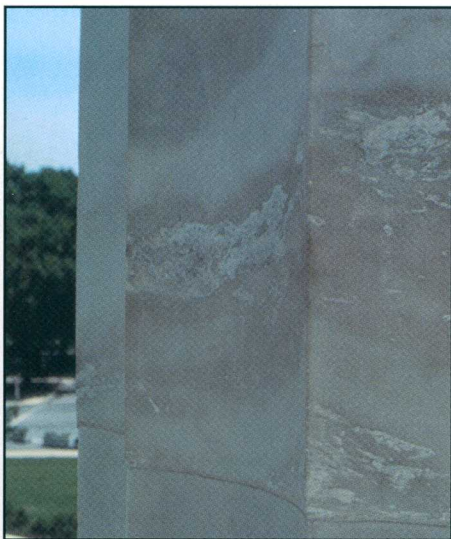
Some columns at the Lincoln Memorial have flattened chalky areas where inclusions have weathered differently from the surrounding calcite.

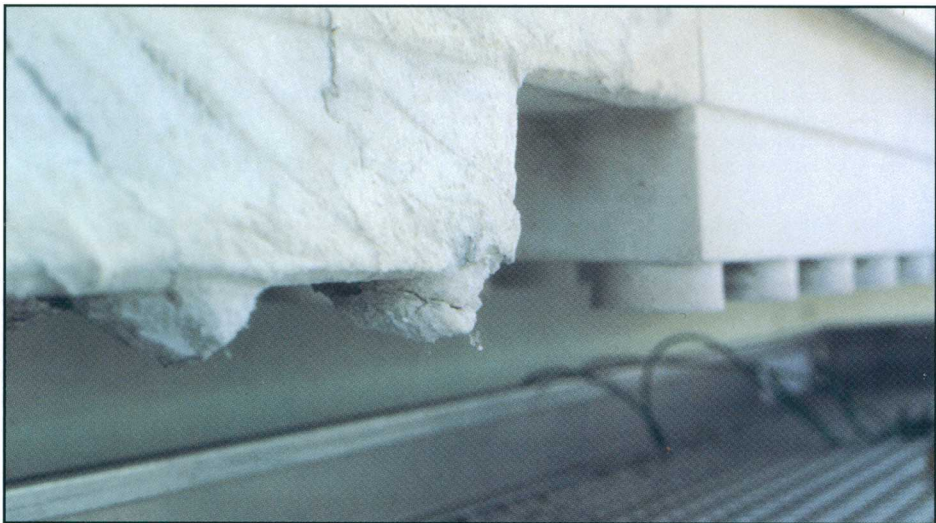
The marble guttae on the roof overhang are crumbling and falling apart underneath blackened alteration crusts.

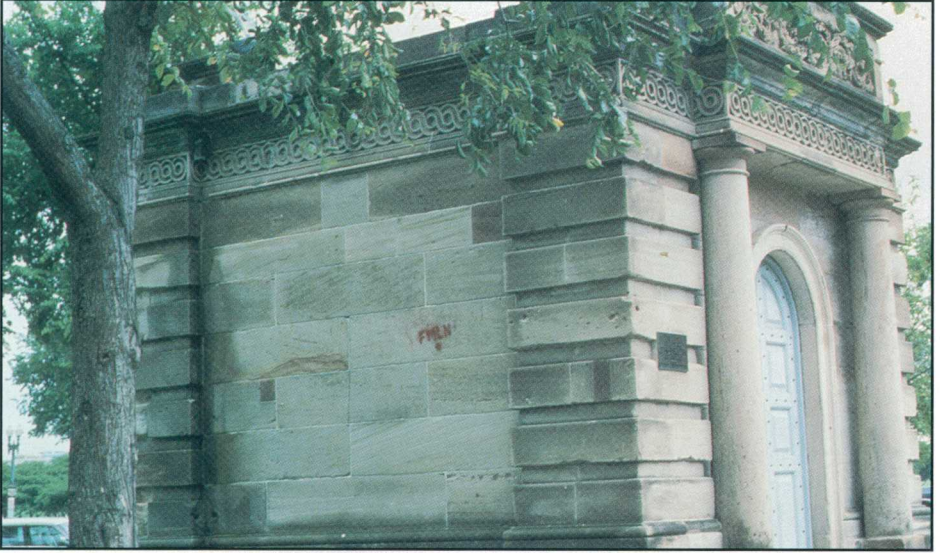
The Capitol Gatehouse, now located at 17th Street and Constitution Avenue, is made of the same sandstone used in the White House and the center part of the Capitol, but it was left unpainted. Deterioration of this stone is due to the clay it contains, not to the effects of acid rain.

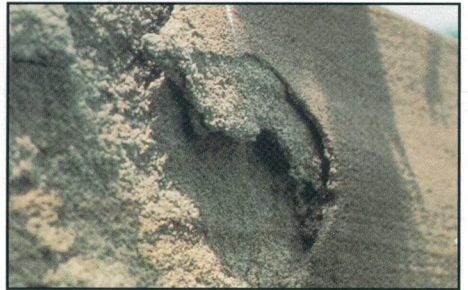
This kind of sandstone was soon found to be a poor building stone because of its tendency to spall. (detail on Capitol Gatehouse)

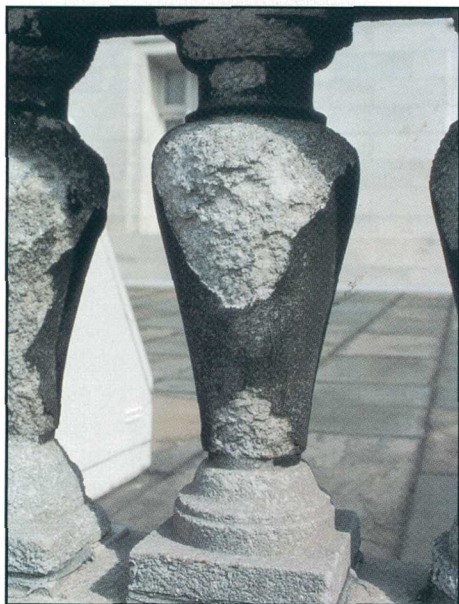
Blackened gypsum crusts may blister and spall off, exposing a crumbling stone surface to further pollution.

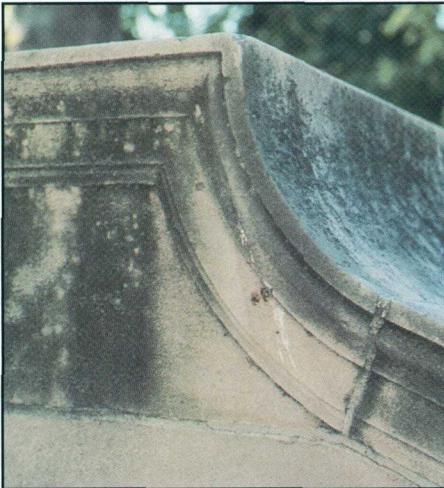
The main damage on this limestone building, built in the 1930's, is the blackening of the side balustrade from algae or fungi. The stone is porous and therefore retains moisture, thus encouraging growth of organisms. The limestone in this building is quite uniform and shows little preferential dissolution, except in a few places. On the top of the balustrade along C Street, for example, some of the calcite matrix has dissolved from around the fossil fragments, and some holes are filled with calcite crystals.

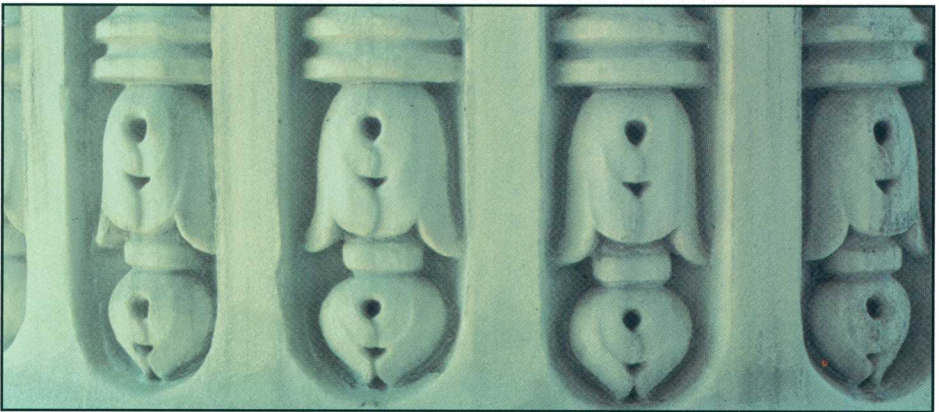
Carvings at the base of the columns on the south side of Memorial Continental Hall show that carved details and sharp edges remain on sheltered areas.

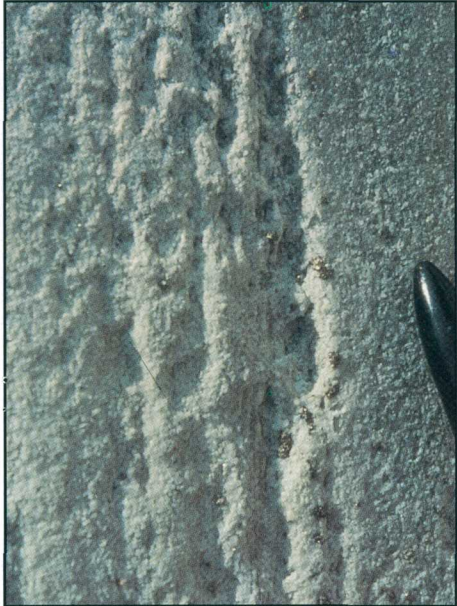
Pyrite grains stand in relief where calcite and micas have weathered out of the marble at Memorial Continental Hall.

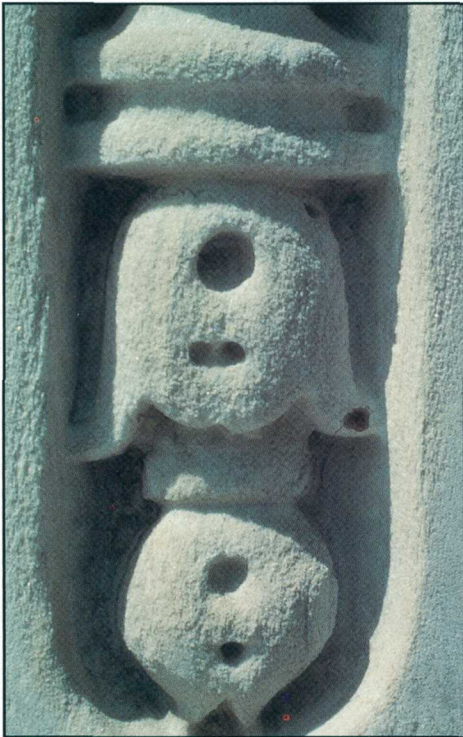
On an exposed portion of the carving on the columns at Memorial Continental Hall, the edges of the marble have rounded and the surface has roughened.

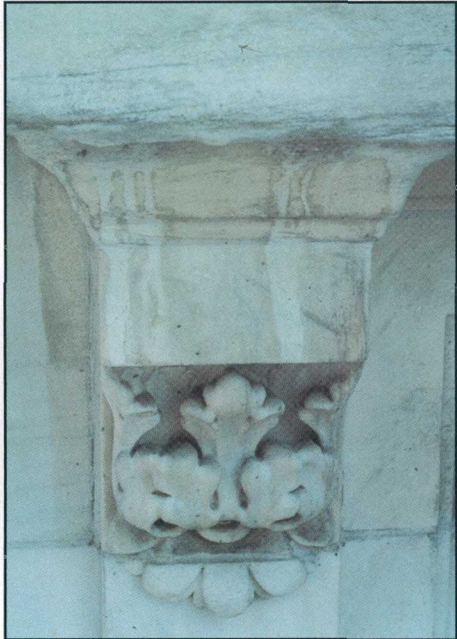
A dull gray surface on the marble on the window sill support shows where an alteration crust is just beginning to develop.

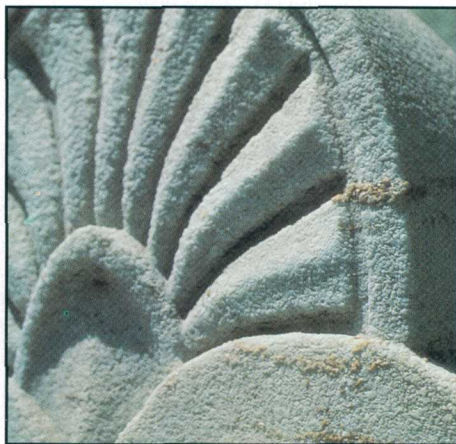
Marble bases for bronze lions outside the entrance to the Corcoran Gallery have feldspar inclusions that stand in relief compared to the roughened surrounding calcite.

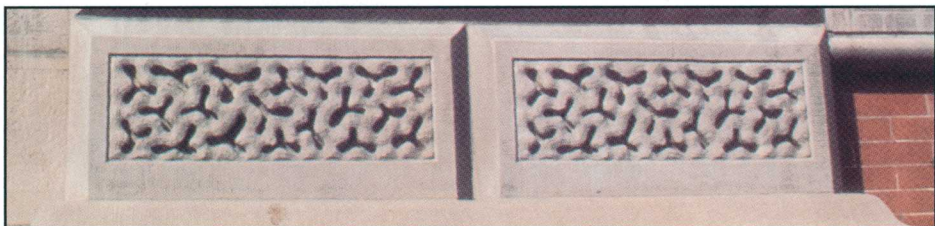
This building of brick and sandstone, completed in 1859, is interesting from a stone preservation point of view. The decorative sandstone panels were badly deteriorated, so in 1968 the panels were saturated with epoxy to strengthen them. This treatment actually accelerated the deterioration because

when water penetrated behind the epoxy-filled area, large portions of the treated panels spalled off. A second renovation attempt was therefore necessary two years after the first, and the present panels are cast sandstone. A post of the original sandstone stands at the southeast corner of the building.

Casts of ground sandstone and epoxy replaced the original carved sandstone decorative trim at the Renwick Gallery when a first attempt to preserve the carved stone failed.
